**CULLATON LAKE GOLD MINES LTD.
WATER LICENCE 1BR-CUL1828**

ANNUAL WATER LICENCE REPORT 2023

BARRICK GOLD INC.

March 2024

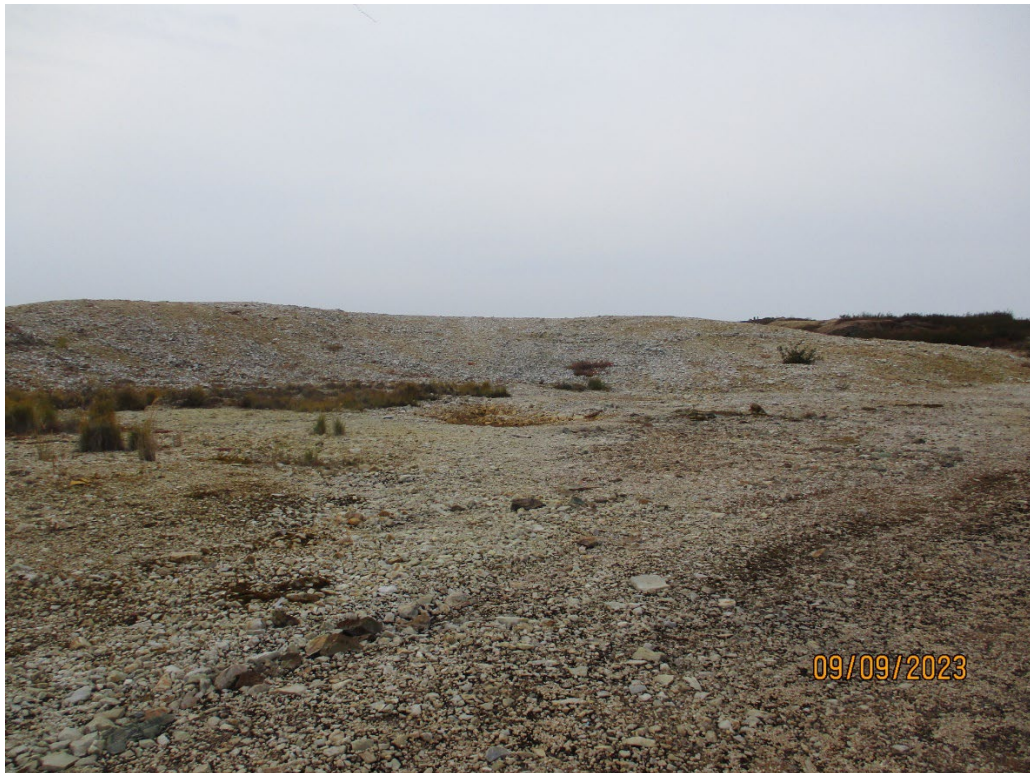
Photo 6: Shear Lake low pH pool area dry.

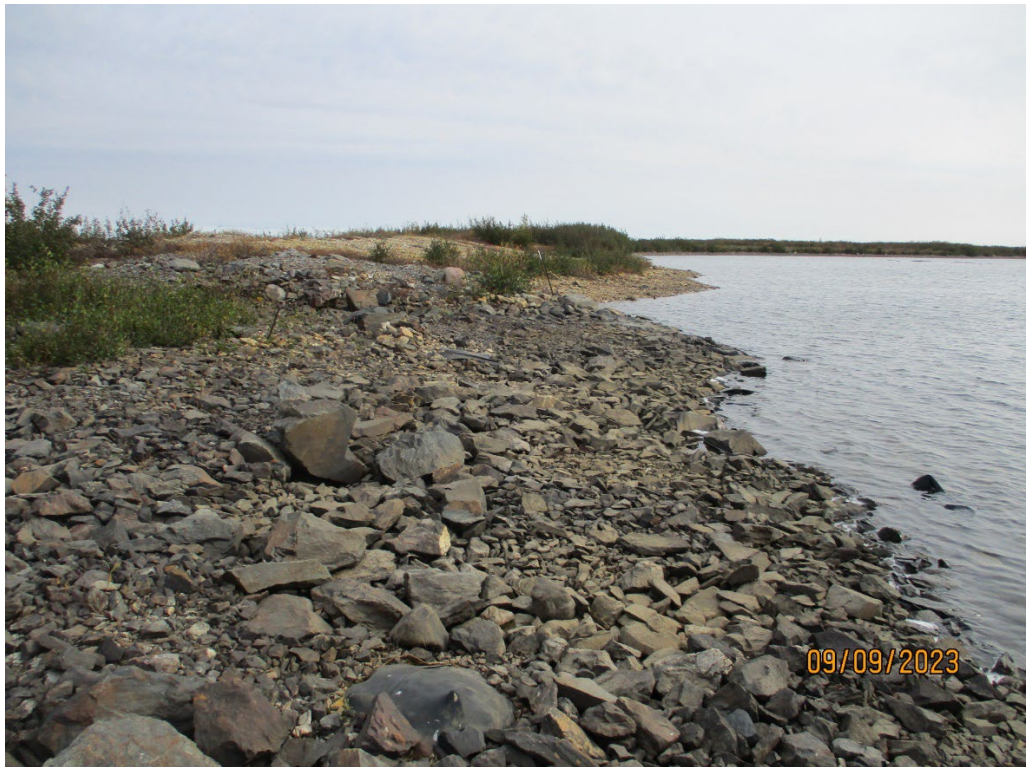
Photo 11: Tailings Pond No. 1 spillway (dry) looking south.

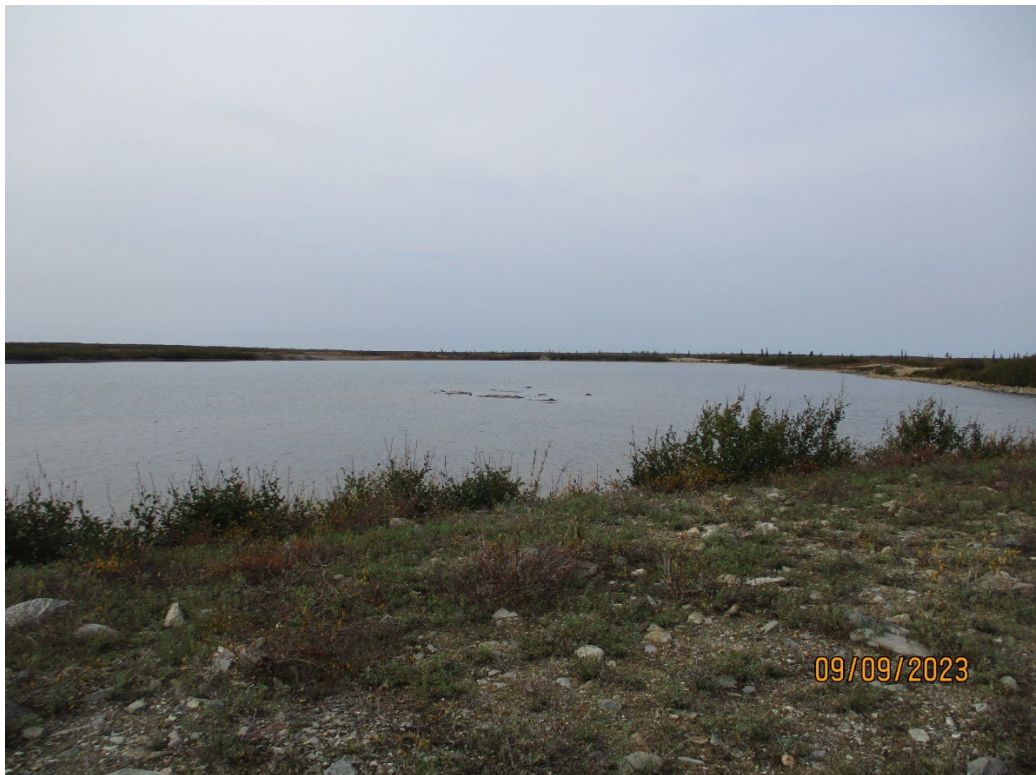
Due to the previous summer's extended drought the Tailings Pond No. 1 water level dropped to the historic low most recently observed in 2018 (See Photo 12 in Appendix 1).

Photo 12: Tailings Pond No .1 waste rock island due to low water level.

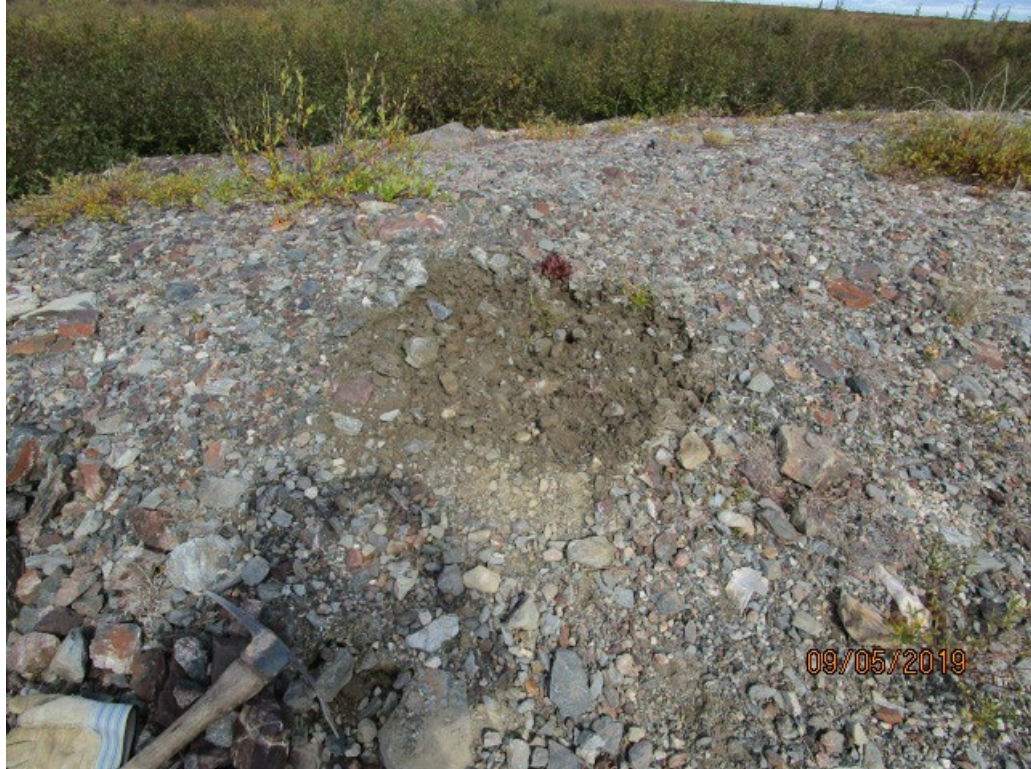
The minor subsidence found on the B-Zone fresh air raise in 2018 and subsequently filled in 2019 remains unchanged. (See Photos 13 and 14 in Appendix 1). The affected area will continue to be monitored during future inspections until stability is confirmed.

Photo 13: Small area of subsidence at B-zone Vent Raise in 2019 after filling.

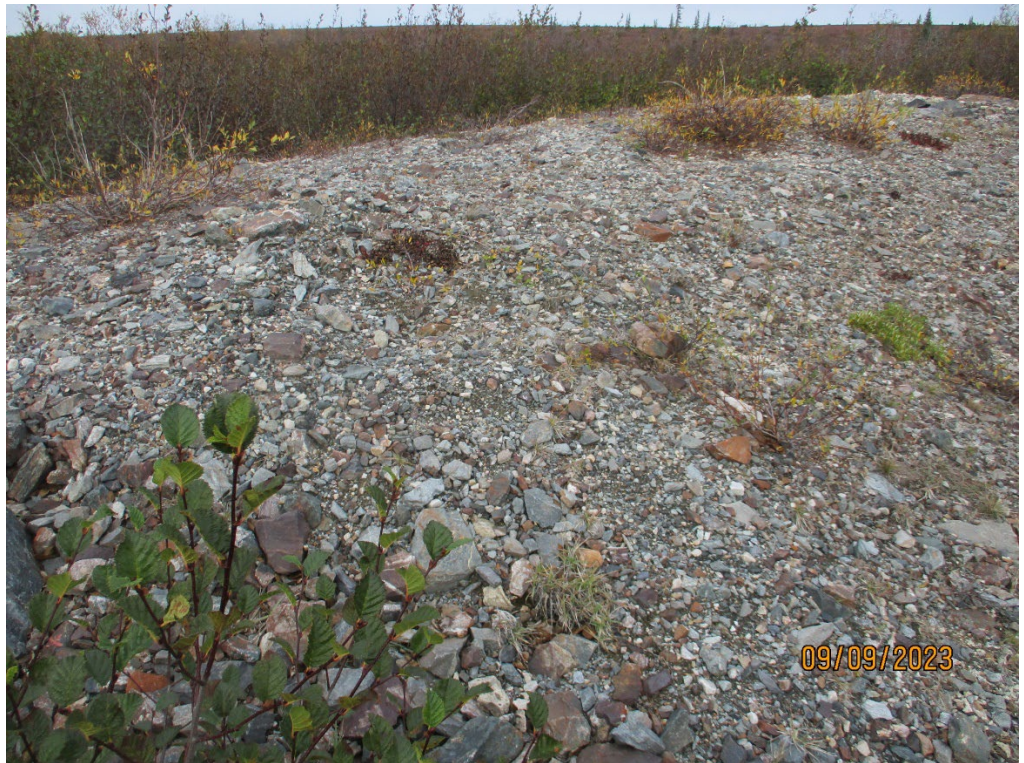
Photo 14: Filled area in 2023.

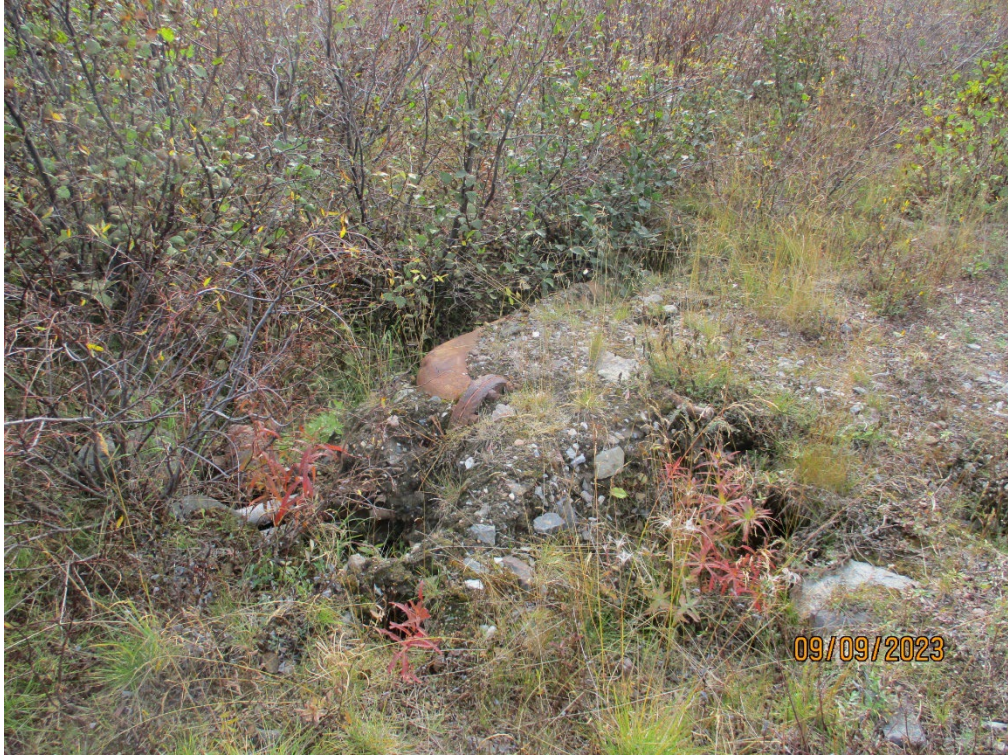
The minor subsidence areas on the quarry pit landfill remain largely unchanged. Most of the affected areas are occupied by arctic ground squirrels (See Photo 17 in Appendix 1).

Photo 17: Quarry Pit main subsidence area – no change from previous years.

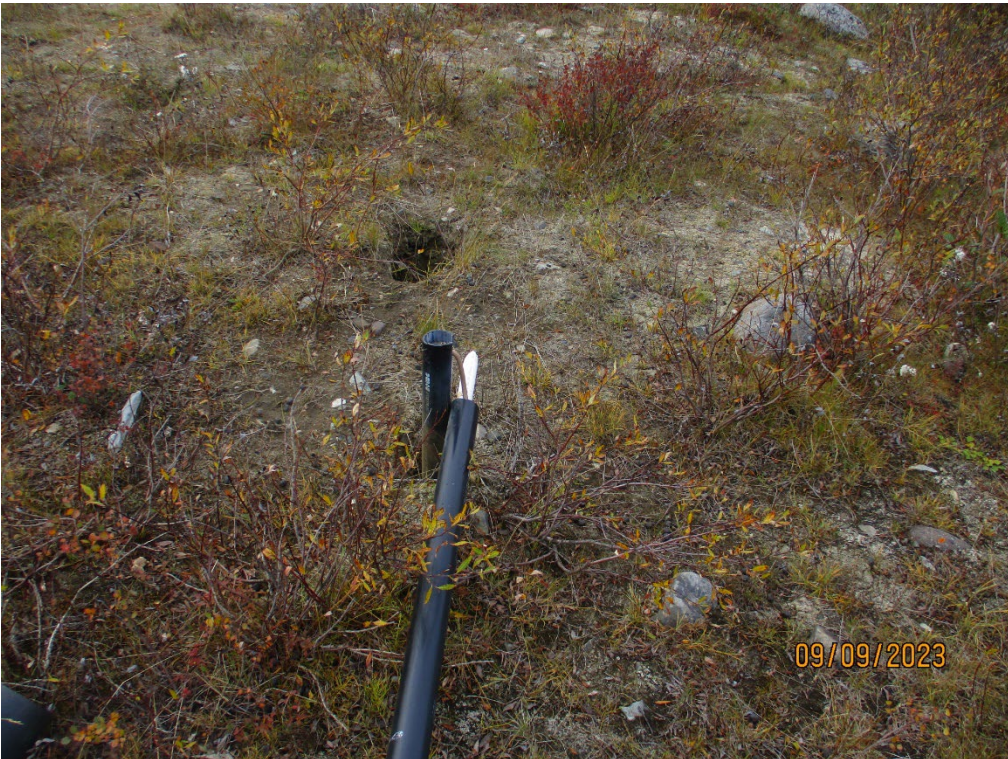
The 2018 installed thermistors that were subsequently damaged by wildlife, repaired and then damaged again were found undisturbed compared to their 2022 positions (See Photos 18 to 21 in Appendix 1). Based on this observation, the intent is to leave them lying on the ground to prevent further damage.

Photo 18: Thermistor T-2 casing damage unchanged from last year.

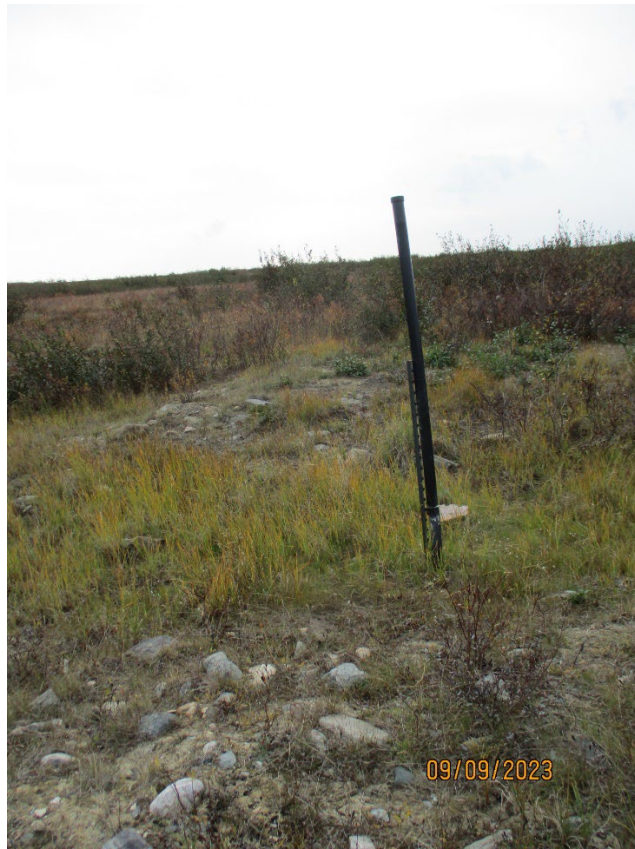
Photo 19: T3 thermistor casing intact.

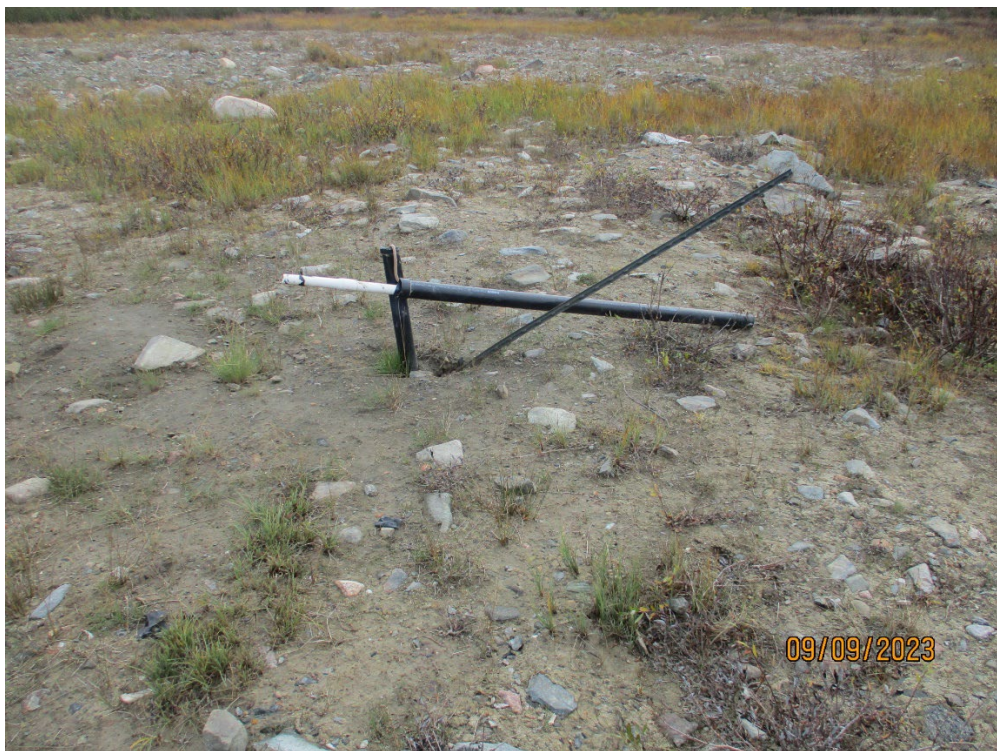
Photo 20: T4 thermistor unchanged from last year.

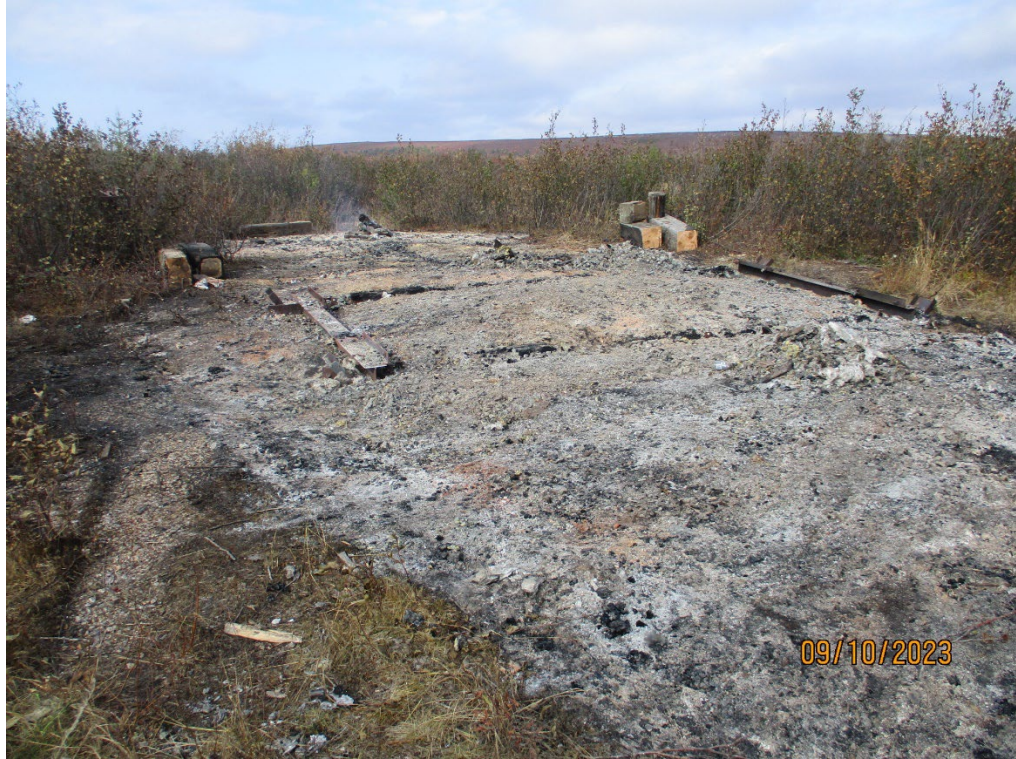
The original survival shelter once again suffered considerable bear damage. During this trip useable fixtures and furniture were transferred to the new shelter and the original shelter was burned. Scrap metal and non combustibles have been consolidated and stored at the airstrip for future removal (see Photo 22 in Appendix 1).

Photo 21: Original shelter area after burn and clean-up.

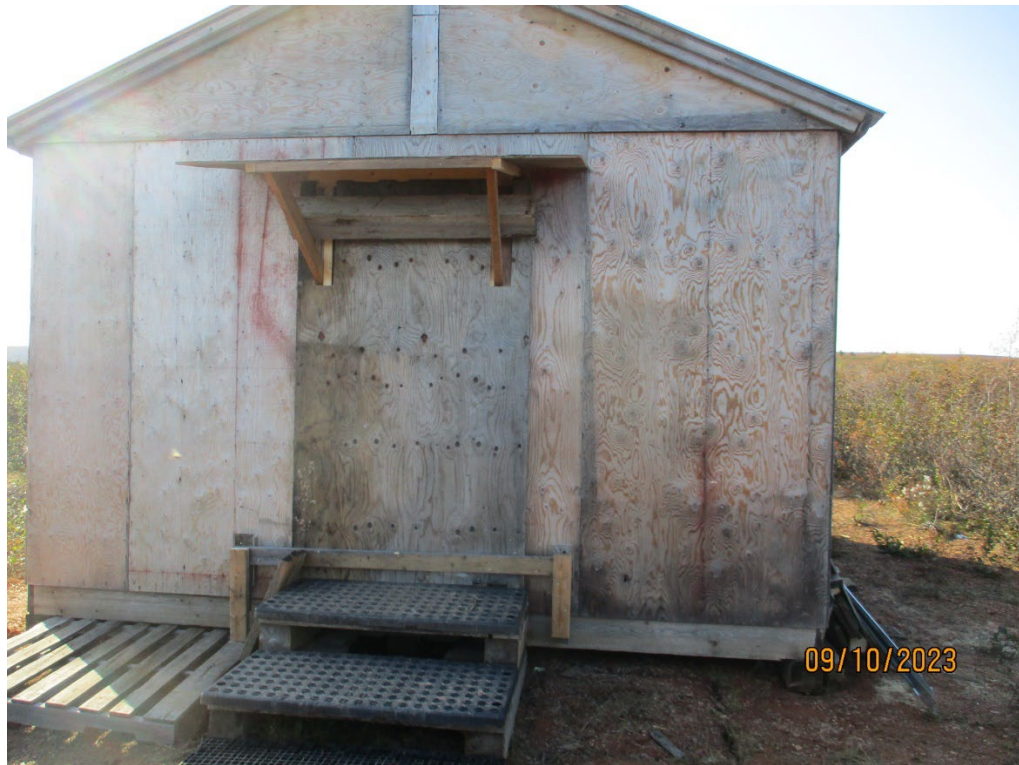
Photo 22: New survival shelter condition on leaving the site.
