**CULLATON LAKE GOLD MINES LTD.
WATER LICENCE 1BR-CUL1828**

ANNUAL WATER LICENCE REPORT 2025

BARRICK GOLD INC.

**By P.J. Brugger and Associates
1084 County Rd 8
Campbellford, ON
K0L 1L0**

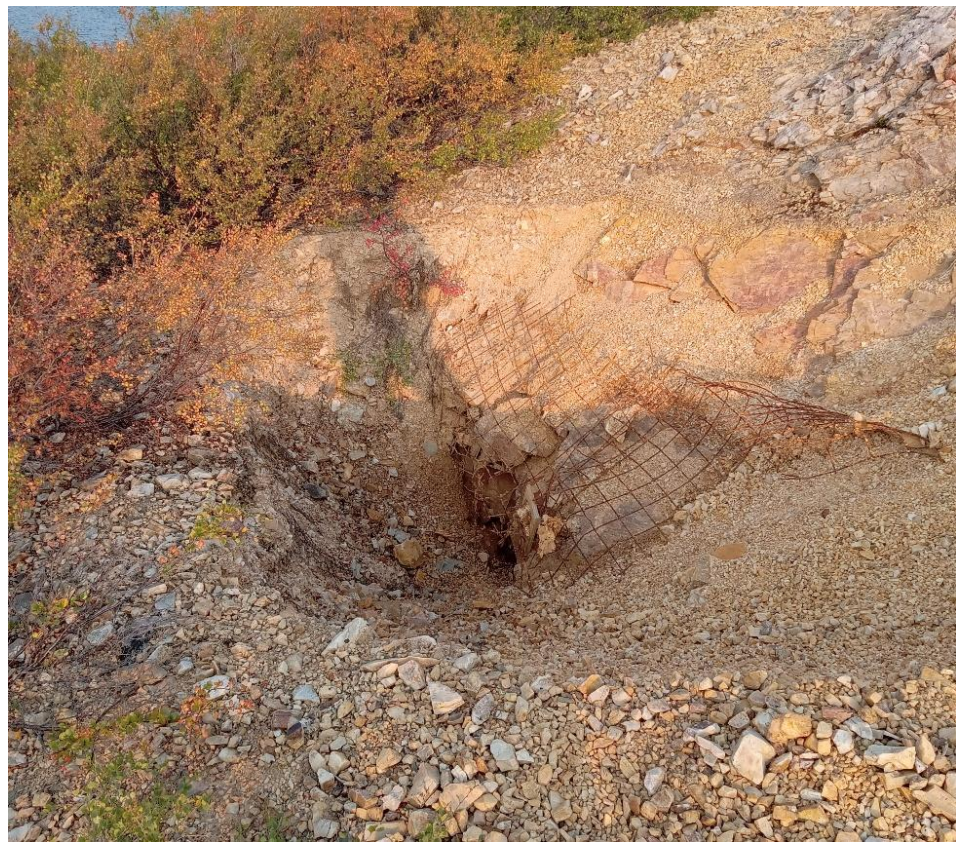
A minor area of subsidence has re-appeared at the Shear Lake portal brow, at the same location as previously observed and repaired in 2007 (see Photo 2 in Appendix 1).

Photo 2: Shear Lake Portal subsidence at brow.

Airstrip shrub maintenance will continue along with minor regrading at the Shear Lake Portal to correct fill settlement.

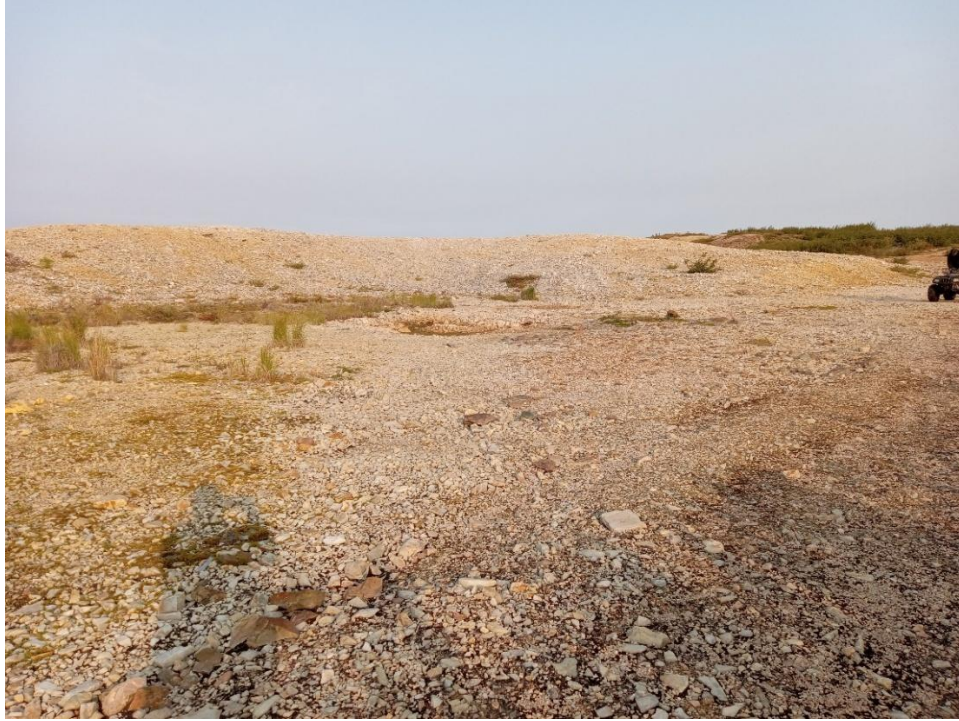
Photo 3: Shear Lake low pH pool area dry.

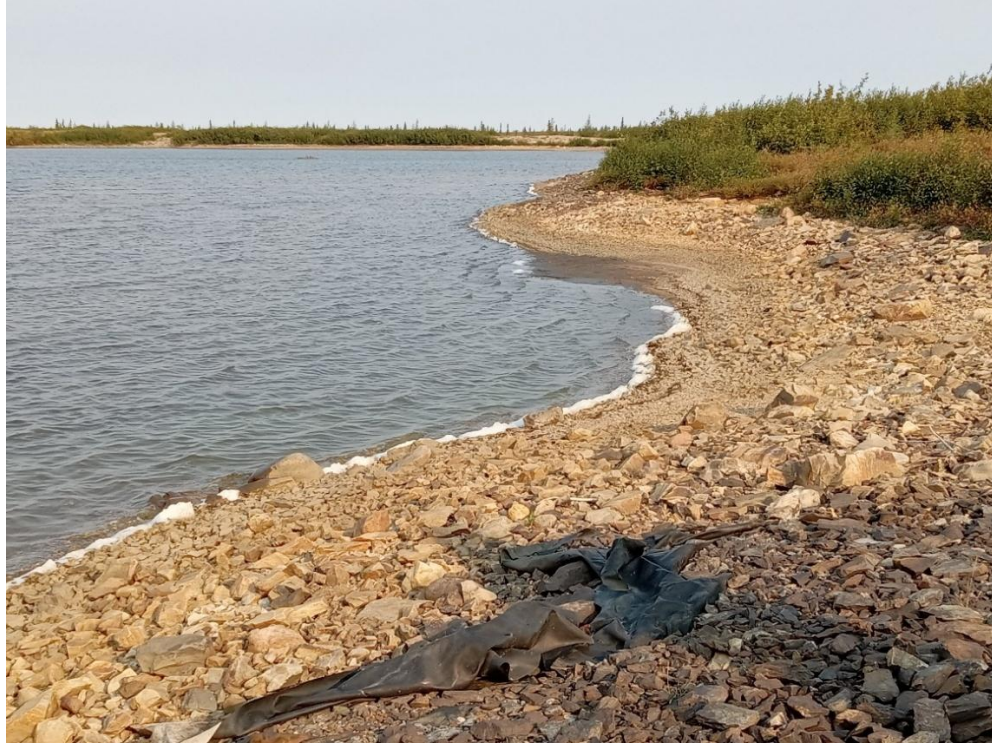
The regional drought continued in 2025 resulting in the Tailings Pond No. 1 water level remaining at the level observed in 2024 (See Photos 7 and 8 in Appendix 1).

Photo 7: Tailings Pond No 1 water cover east shore looking north.

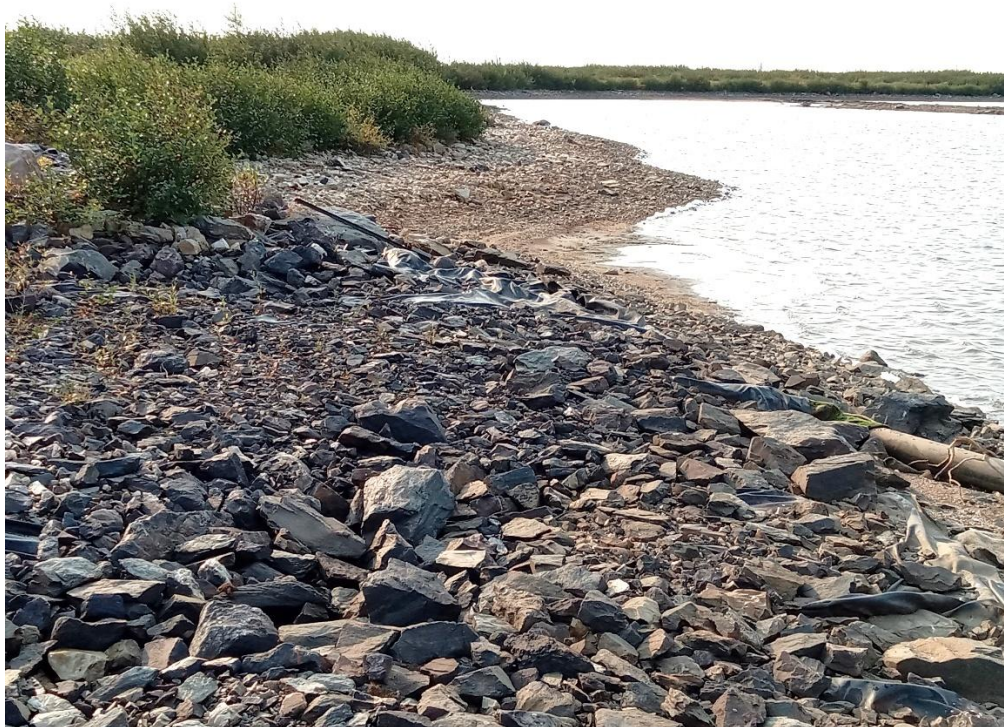
Photo 8: Tailings Pond No. 1 Spillway (dry) looking south along east shore.

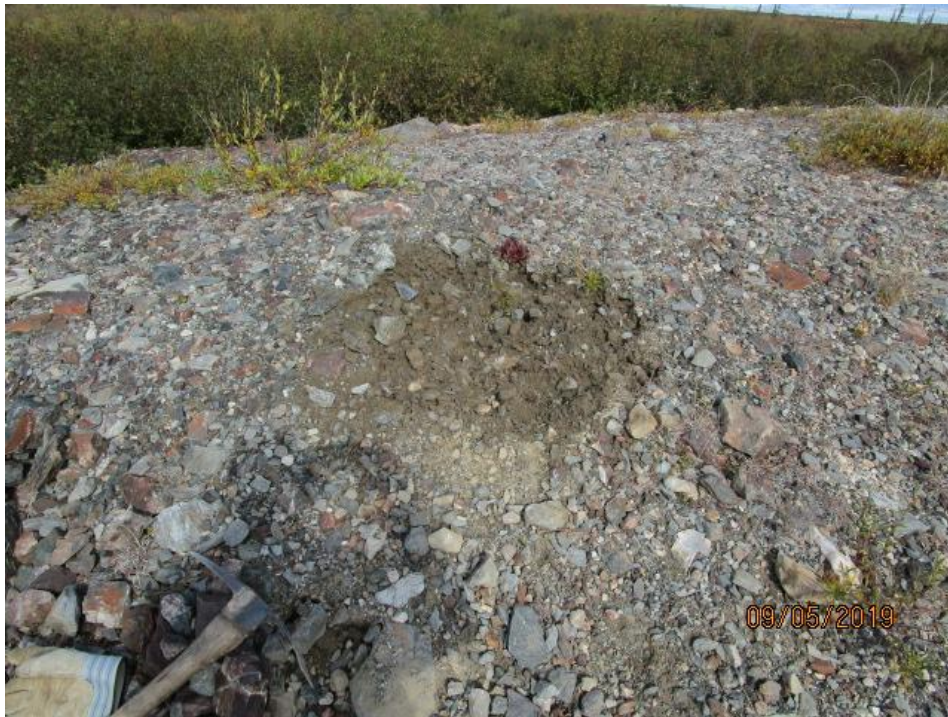
The minor subsidence found on the B-Zone fresh air raise in 2018 and subsequently filled in 2019 remains unchanged. (See Photos 10 and 11 in Appendix 1). The affected area will continue to be monitored during future inspections until stability is confirmed.

Photo 10: Small area of subsidence at B-zone Vent Raise in 2019 after filling.

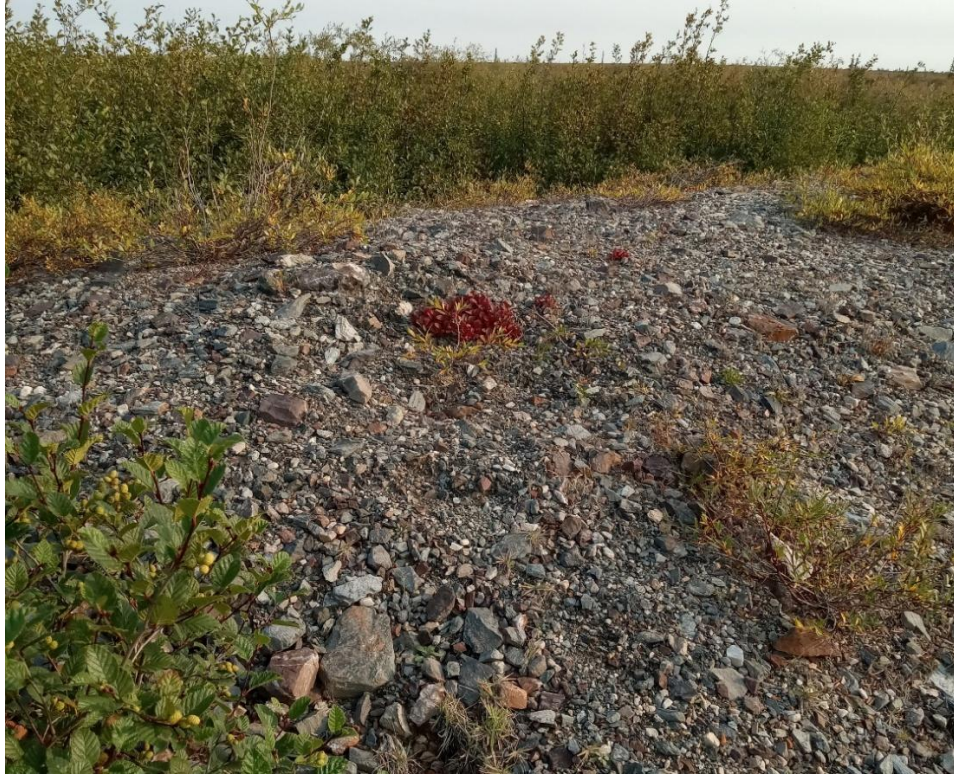
Photo 11: Filled area in 2025.

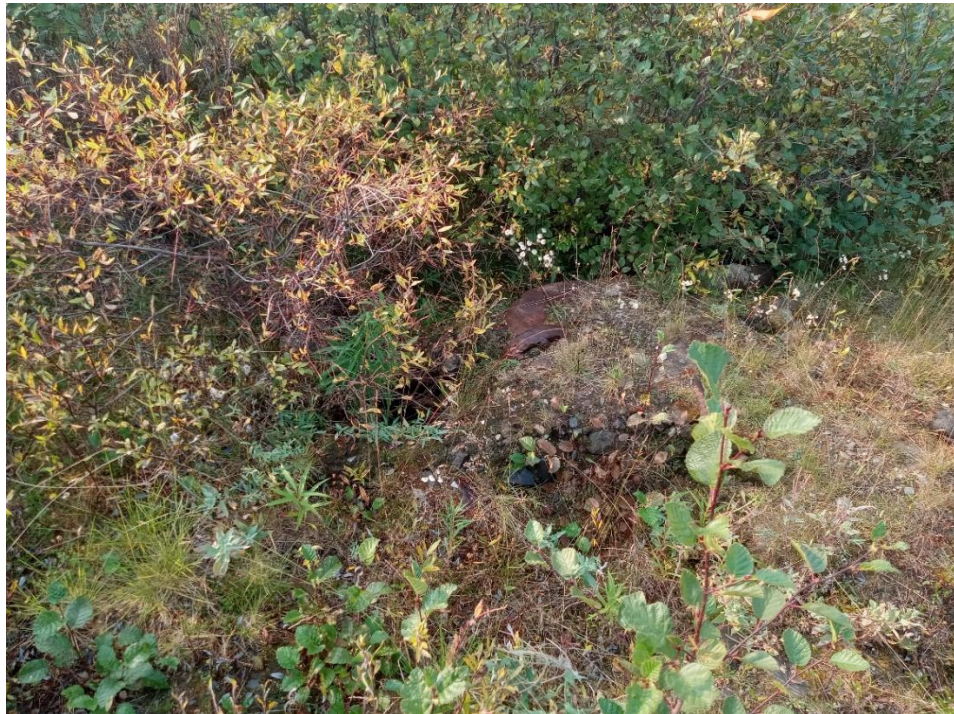
The minor subsidence areas on the quarry pit landfill remain largely unchanged. Most of the affected areas are occupied by arctic ground squirrels (See Photo 14 in Appendix 1).

Photo 14: Quarry Pit main subsidence area – no change from previous years.

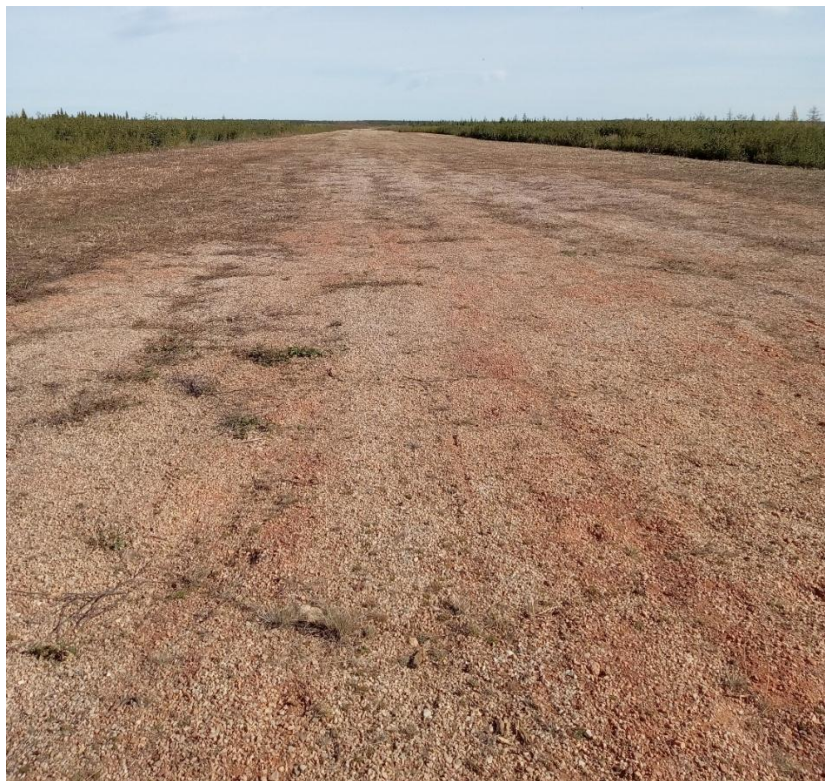
Photo 18: Airstrip condition, looking east from apron after cleaning.

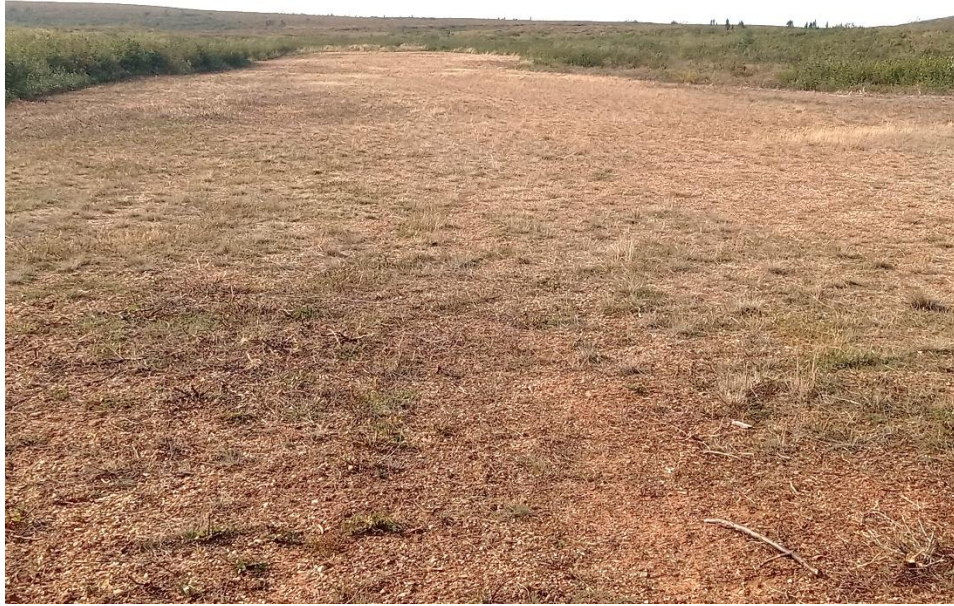
Photo 19: Airstrip looking west from apron after cleaning.

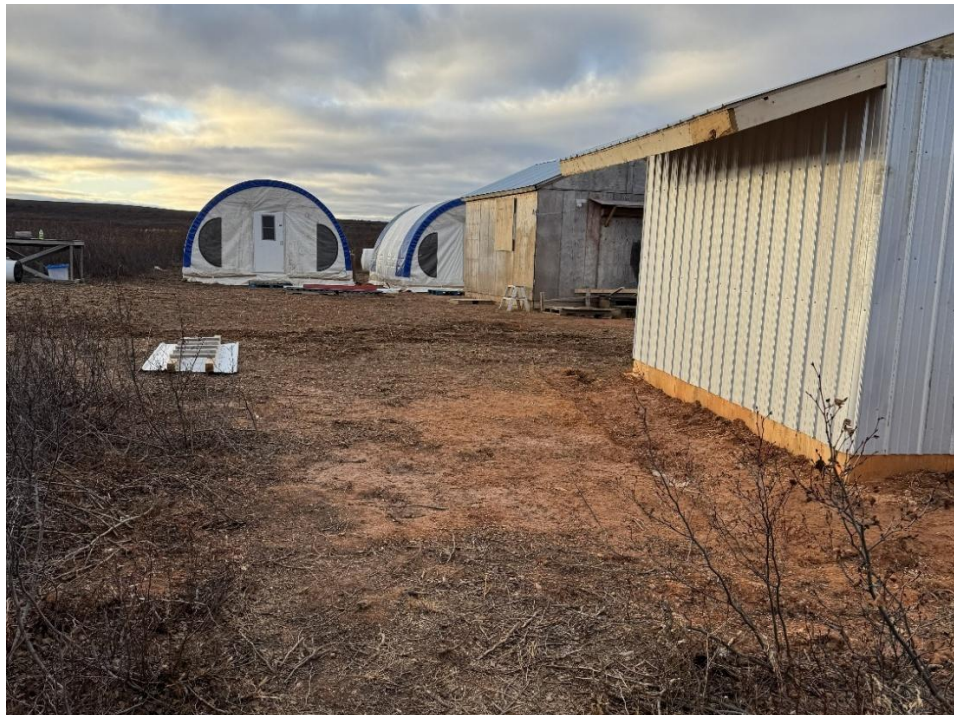
Guardian subsequently advised they have stored some equipment at the strip for the winter, including a mini excavator, 2 Weather Haven tents, a small wood wash shed and miscellaneous hand tools (see Photo 19 in Appendix 1). Guardian has since been advised that this equipment must be removed in the spring.

Photo 20: Tents and equipment stored at airstrip by Guardian Exploration.
