**CULLATON LAKE GOLD MINES LTD.**  
**WATER LICENCE 1BR-CUL1828**

**ANNUAL WATER LICENCE REPORT 2021**

**BARRICK GOLD INC.**

**By P.J. Brugger and Associates**  
**1084 County Rd 8**  
**Campbellford, ON**  
**K0L 1L0**

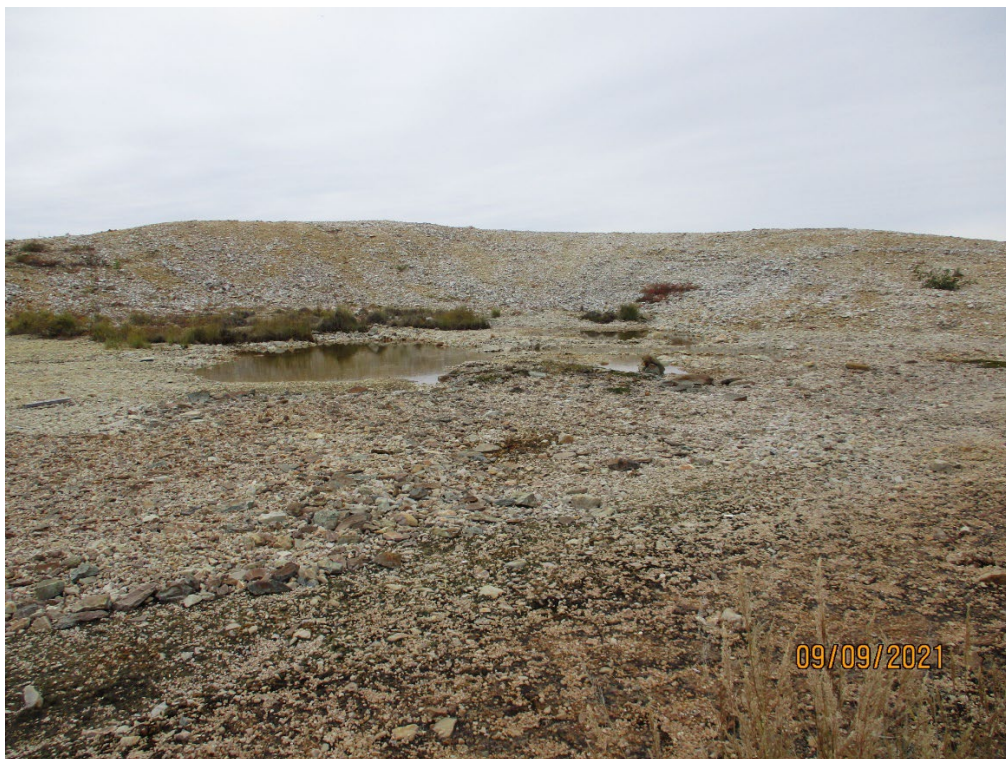
Photo 6: Shear Lake low pH pool area.

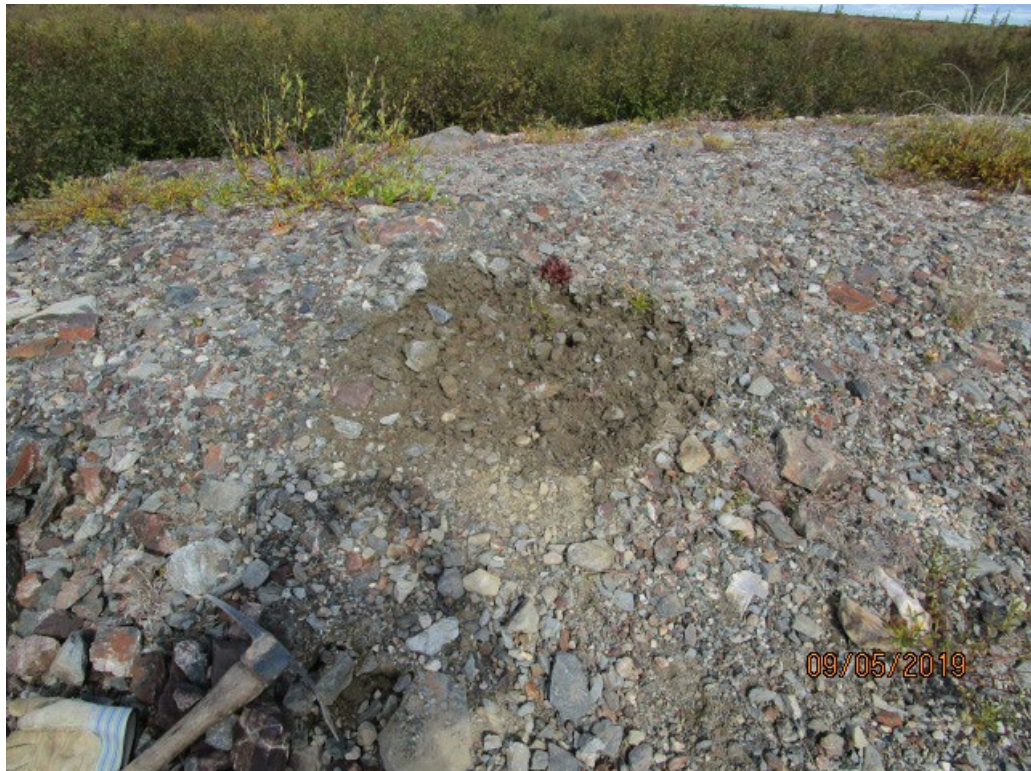
The minor subsidence found on the B-Zone fresh air raise in 2018 and subsequently filled in 2019 remains unchanged. (See Photos 13 and 14 in Appendix 1). The affected area will continue to be monitored during future inspections until stability is confirmed.

Photo 13: Small area of subsidence at B-zone Vent Raise in 2019 after filling.

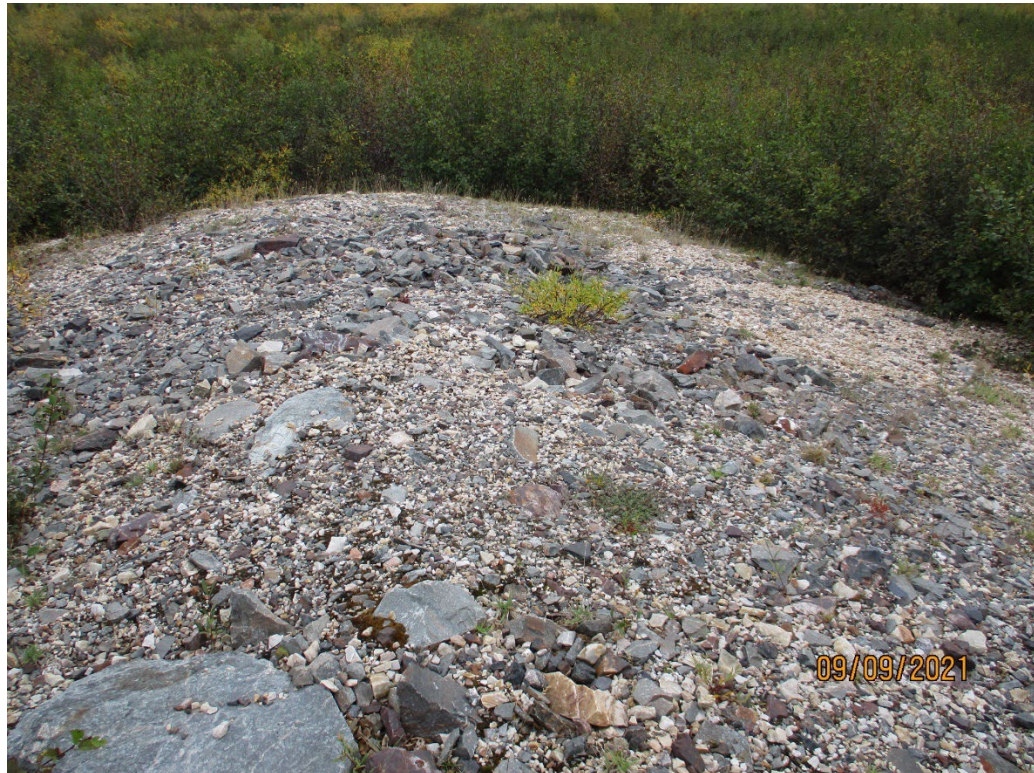
Photo 14: Filled area in 2021.

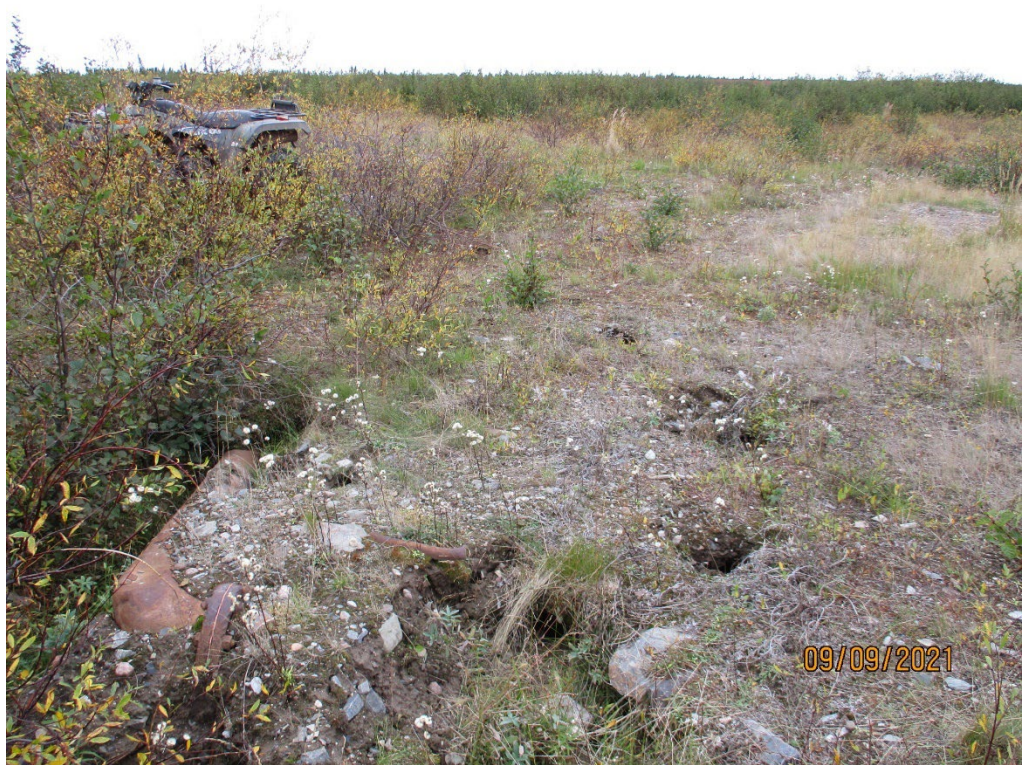
The minor subsidence areas on the quarry pit landfill remain largely unchanged. Most of the affected areas are occupied by arctic ground squirrels (See Photo 17 in Appendix 1).

Photo 17: Quarry Pit main subsidence area – no change from previous years.

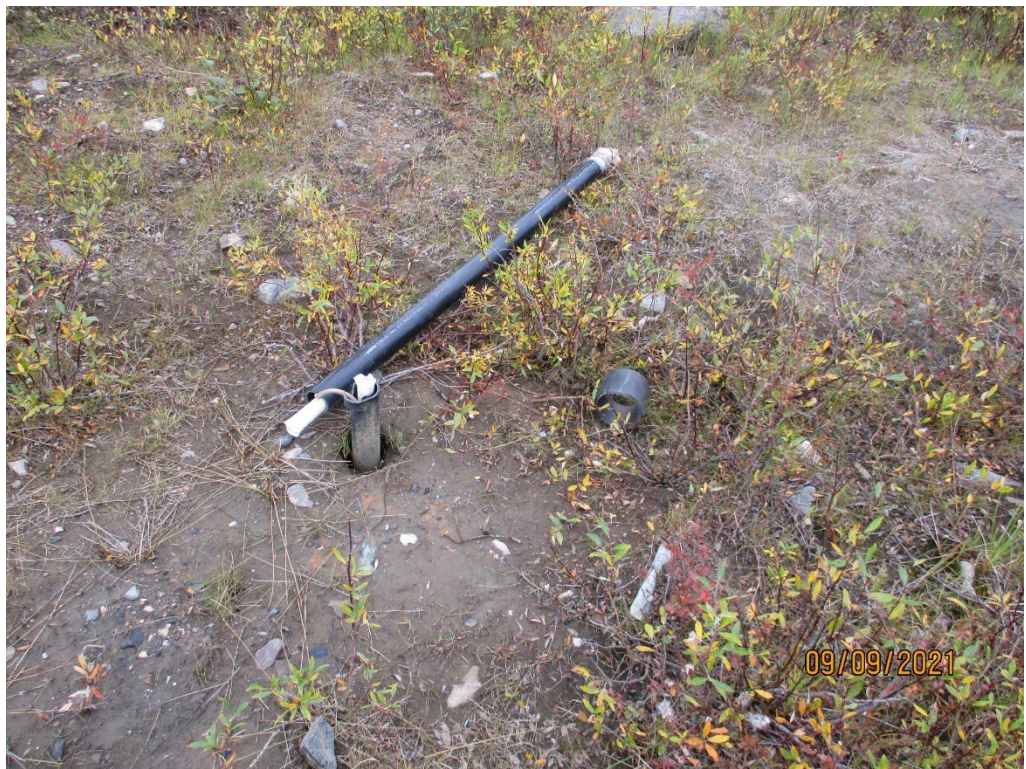
Two of the 2018 installed thermistors were found once again with casings snapped off at ground level. Evidence of muskox or caribou rubbing against the tubes was found on an older thermistor casing (See Photos 18 to 21 in Appendix 1).

Photo 18: Thermistor T-2 casing damage.

- The site remains in good condition.
- The tailings storage facility continues to remain stable. The water level in the pond remains low but has risen approximately 5cm above the last measurement in September 2020.
- Thermistor casings T2 and T4 were found damaged due to animal activity. Repairs will be made in 2022.

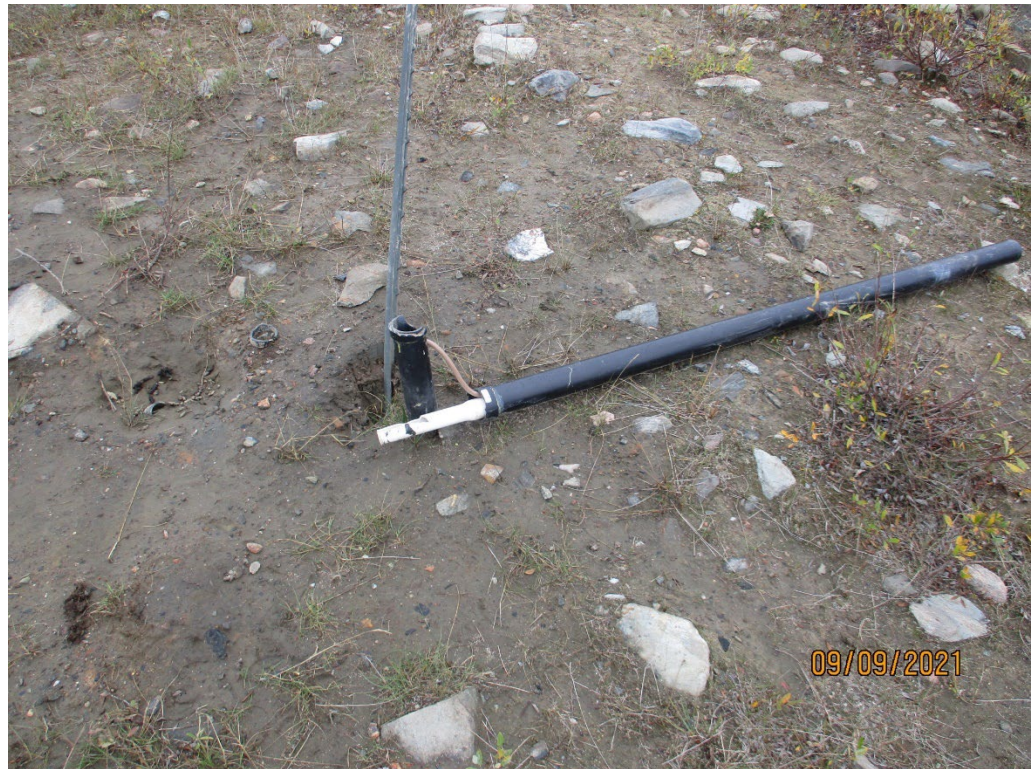
Photo 19: T3 thermistor casing damage.

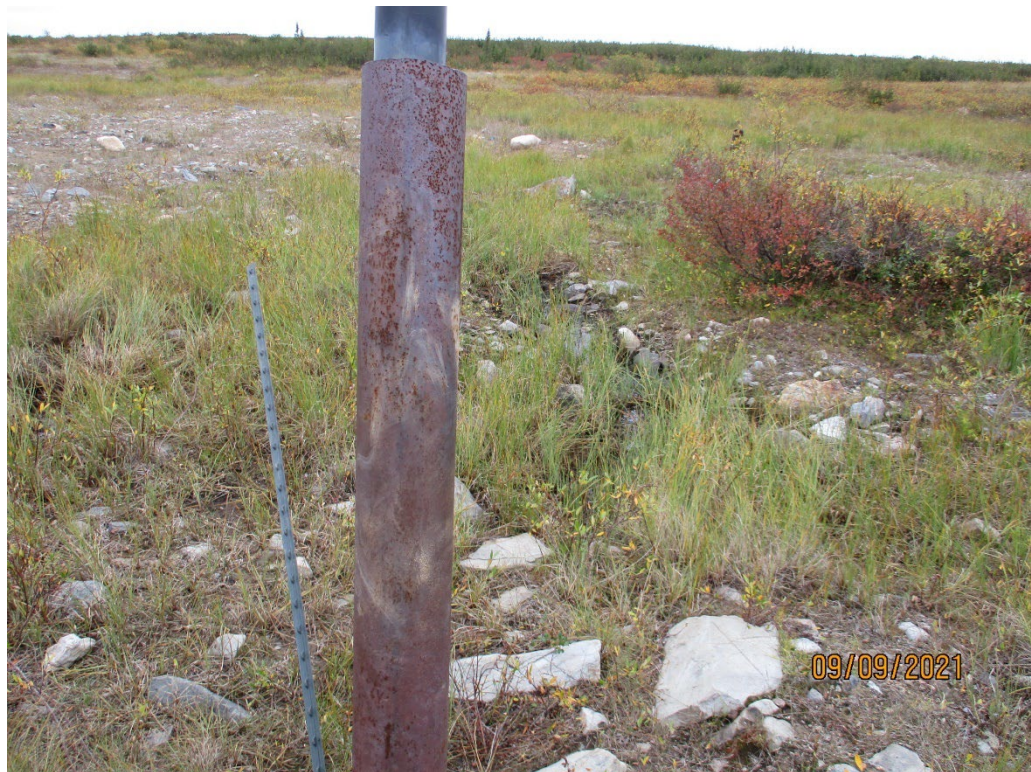
Photo 20: Evidence of animal rubbing on old thermistor pipe.

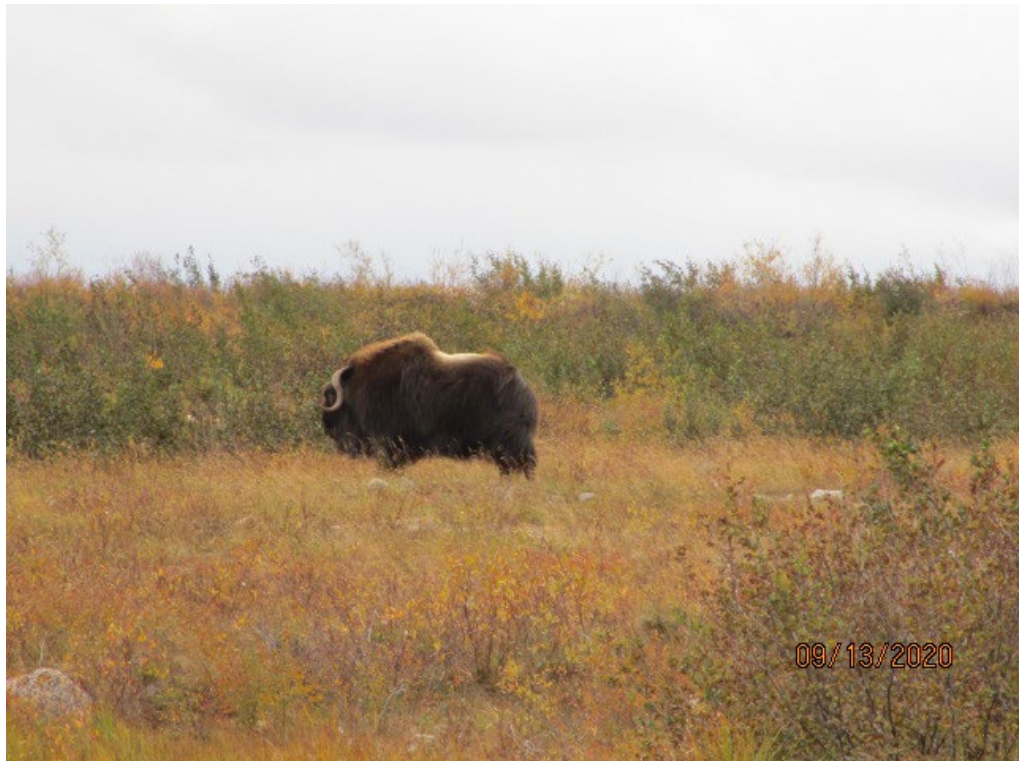
Photo 21: Muskox on tailings cover south of T4 (September 2020 photo).

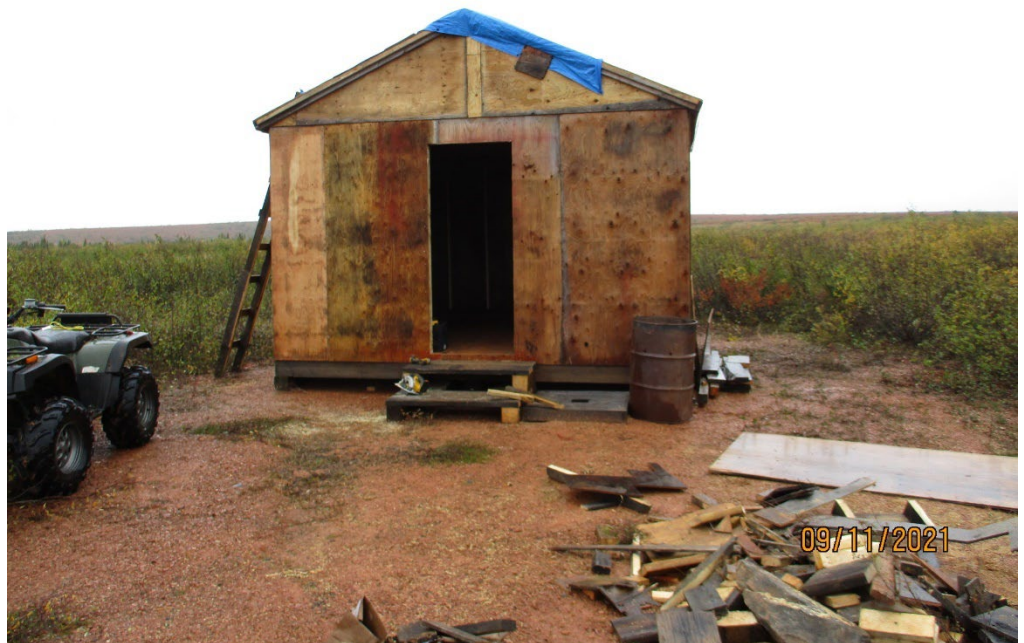
The survival shed once again suffered considerable bear damage and was patched for current use while a replacement shelter is being constructed on the north side of the airstrip (see Photo 22 in Appendix 1).

Photo 22: New survival shelter shell completed.
