Thunder Bay Branch

February 1, 1995

RE: Cullaton Lake Gold Mine
Our Reference No. F-90132-B/E

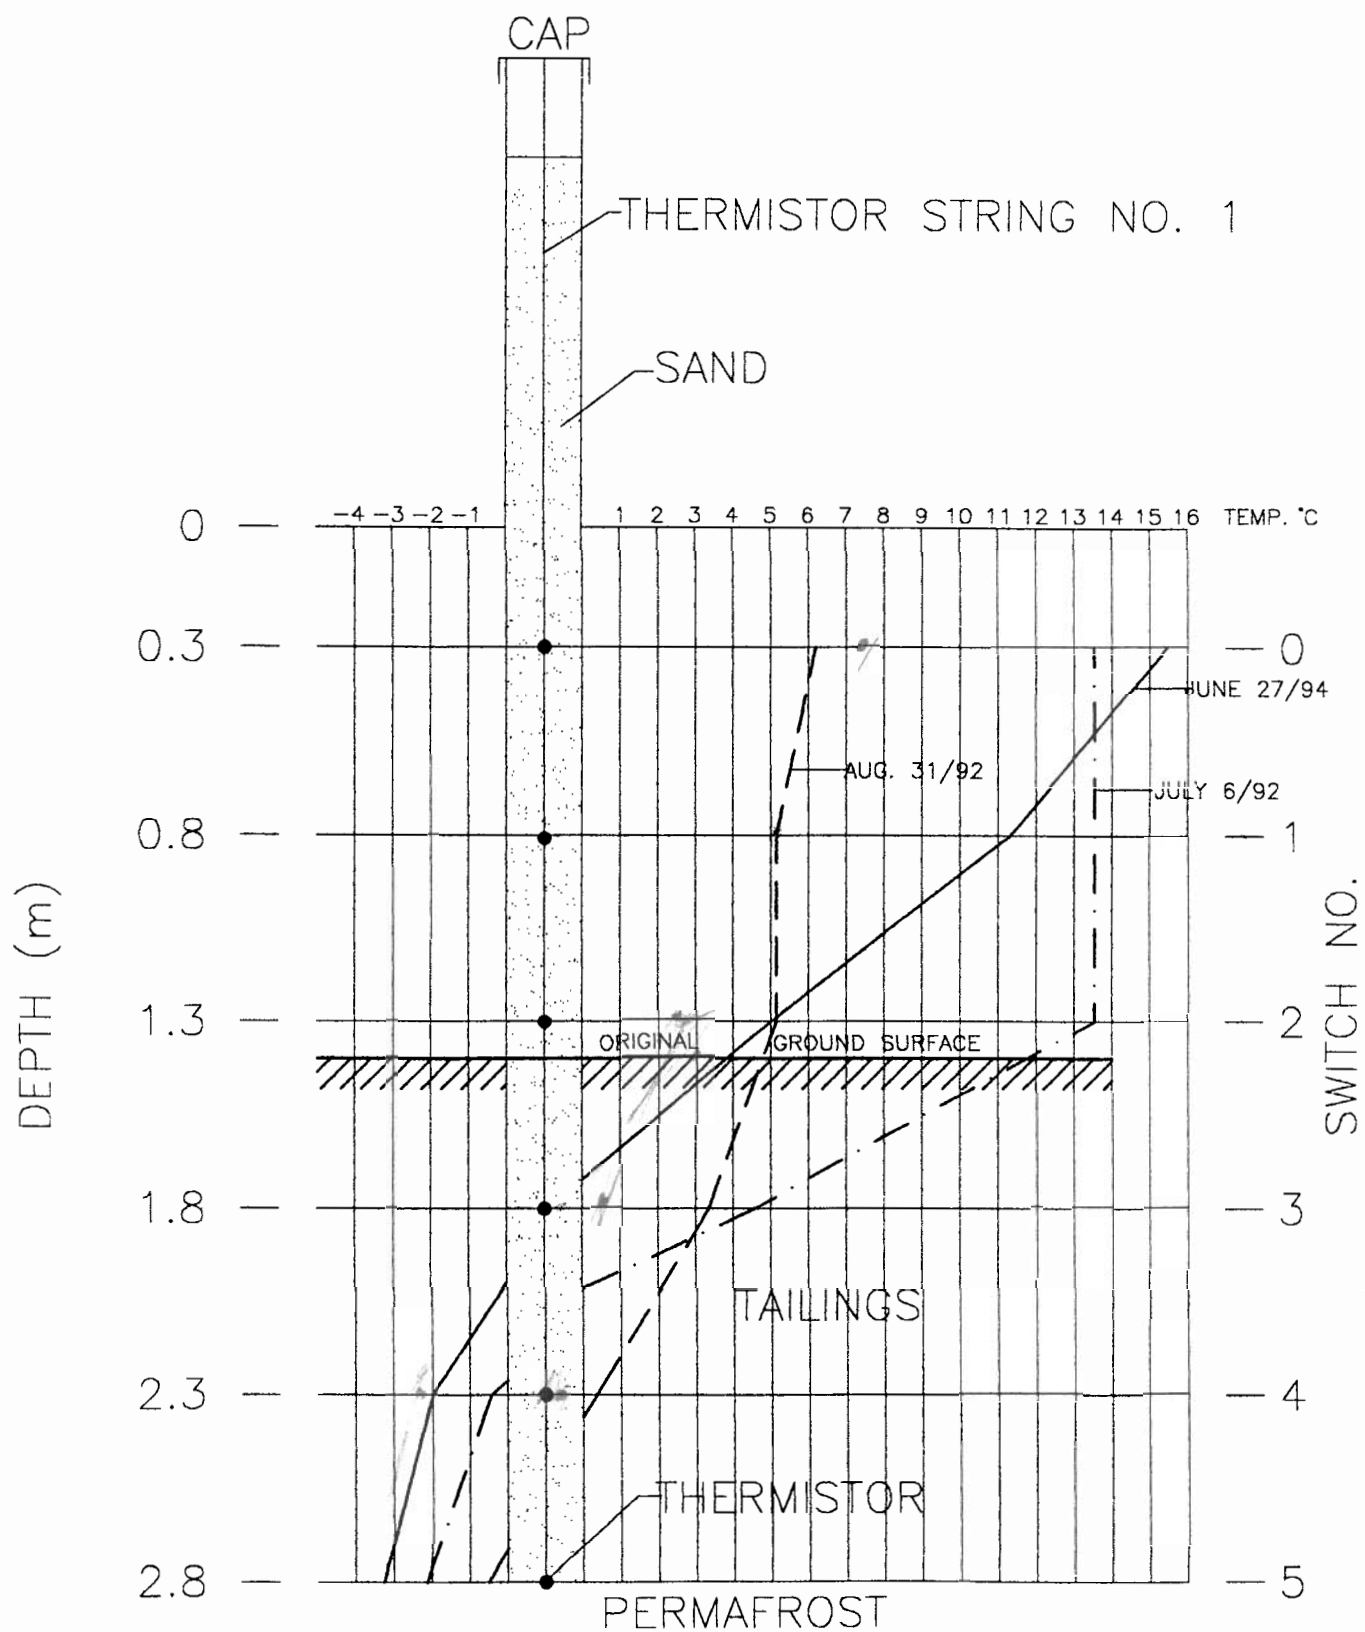
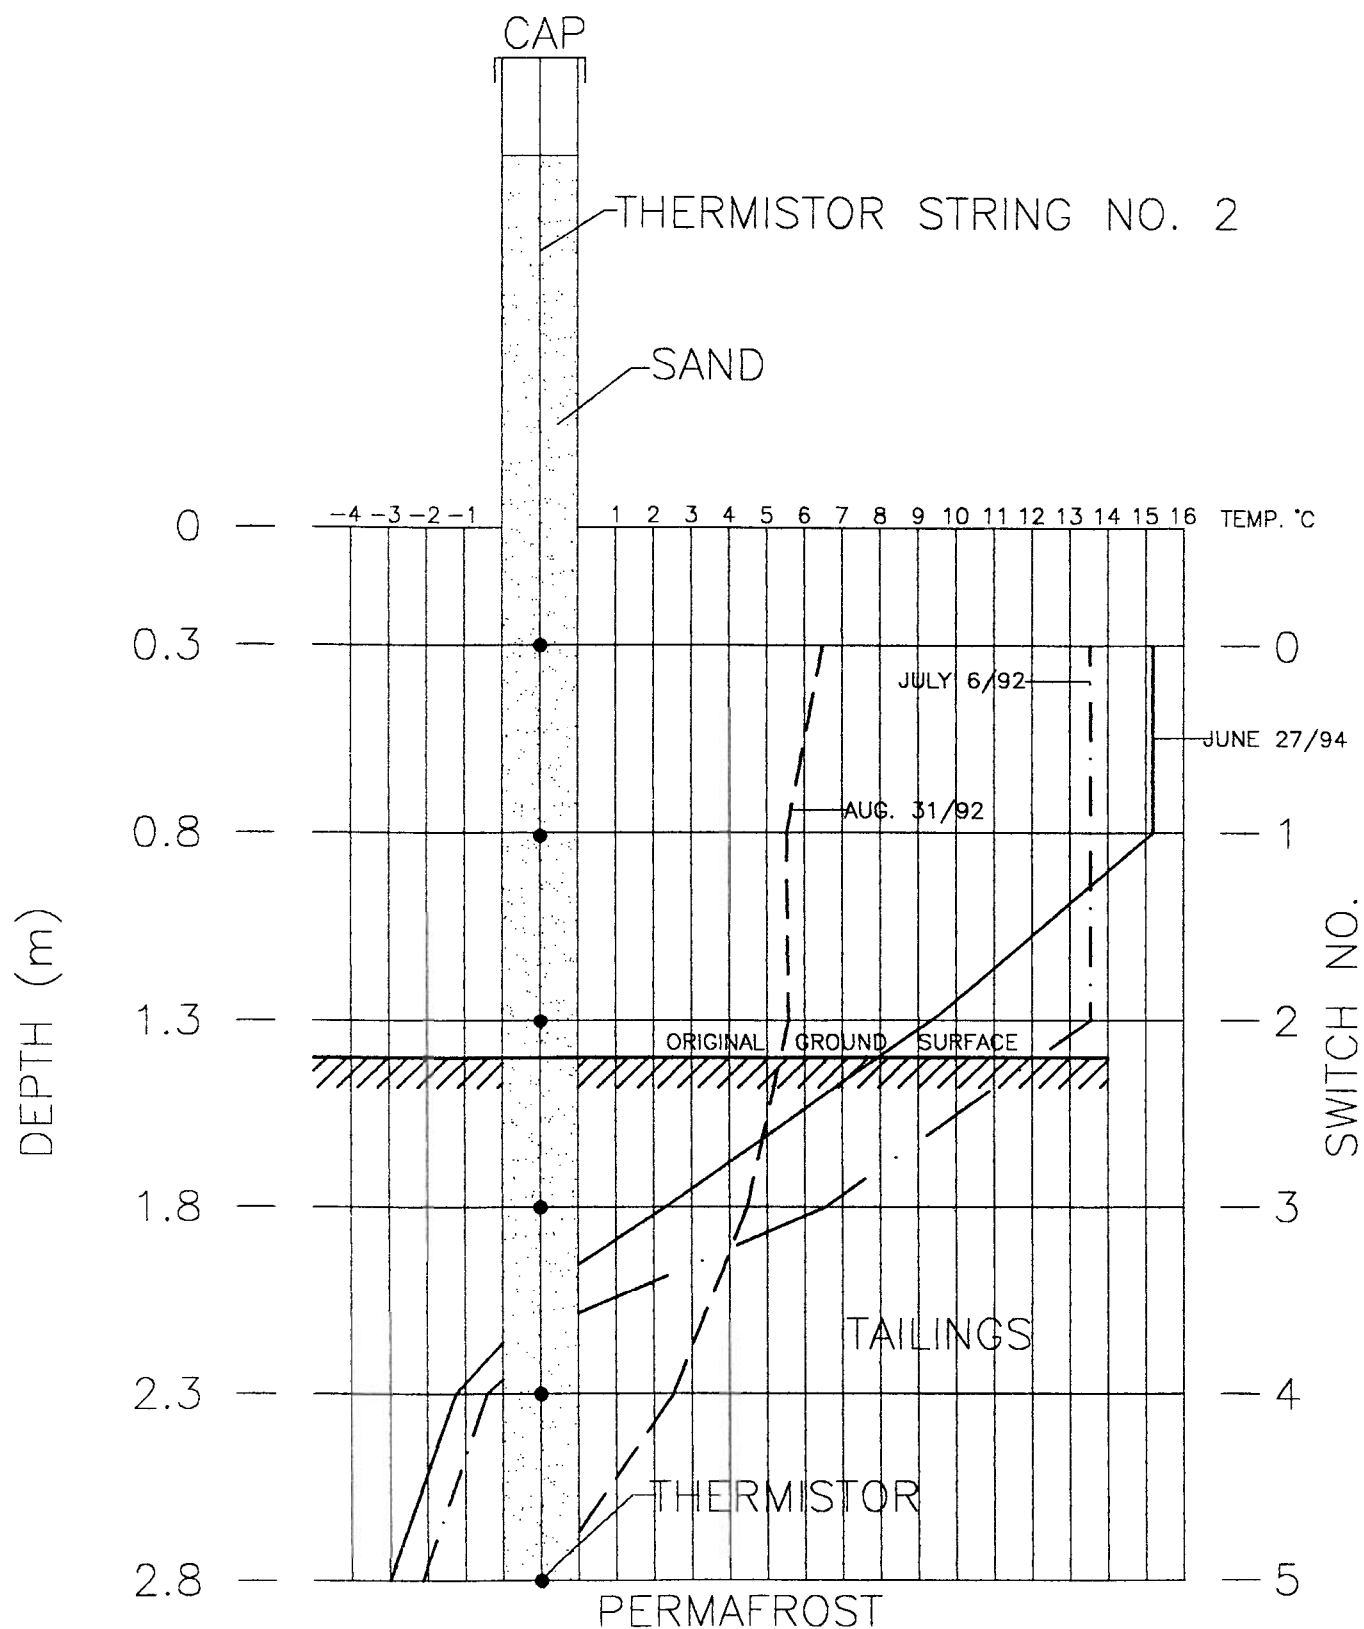
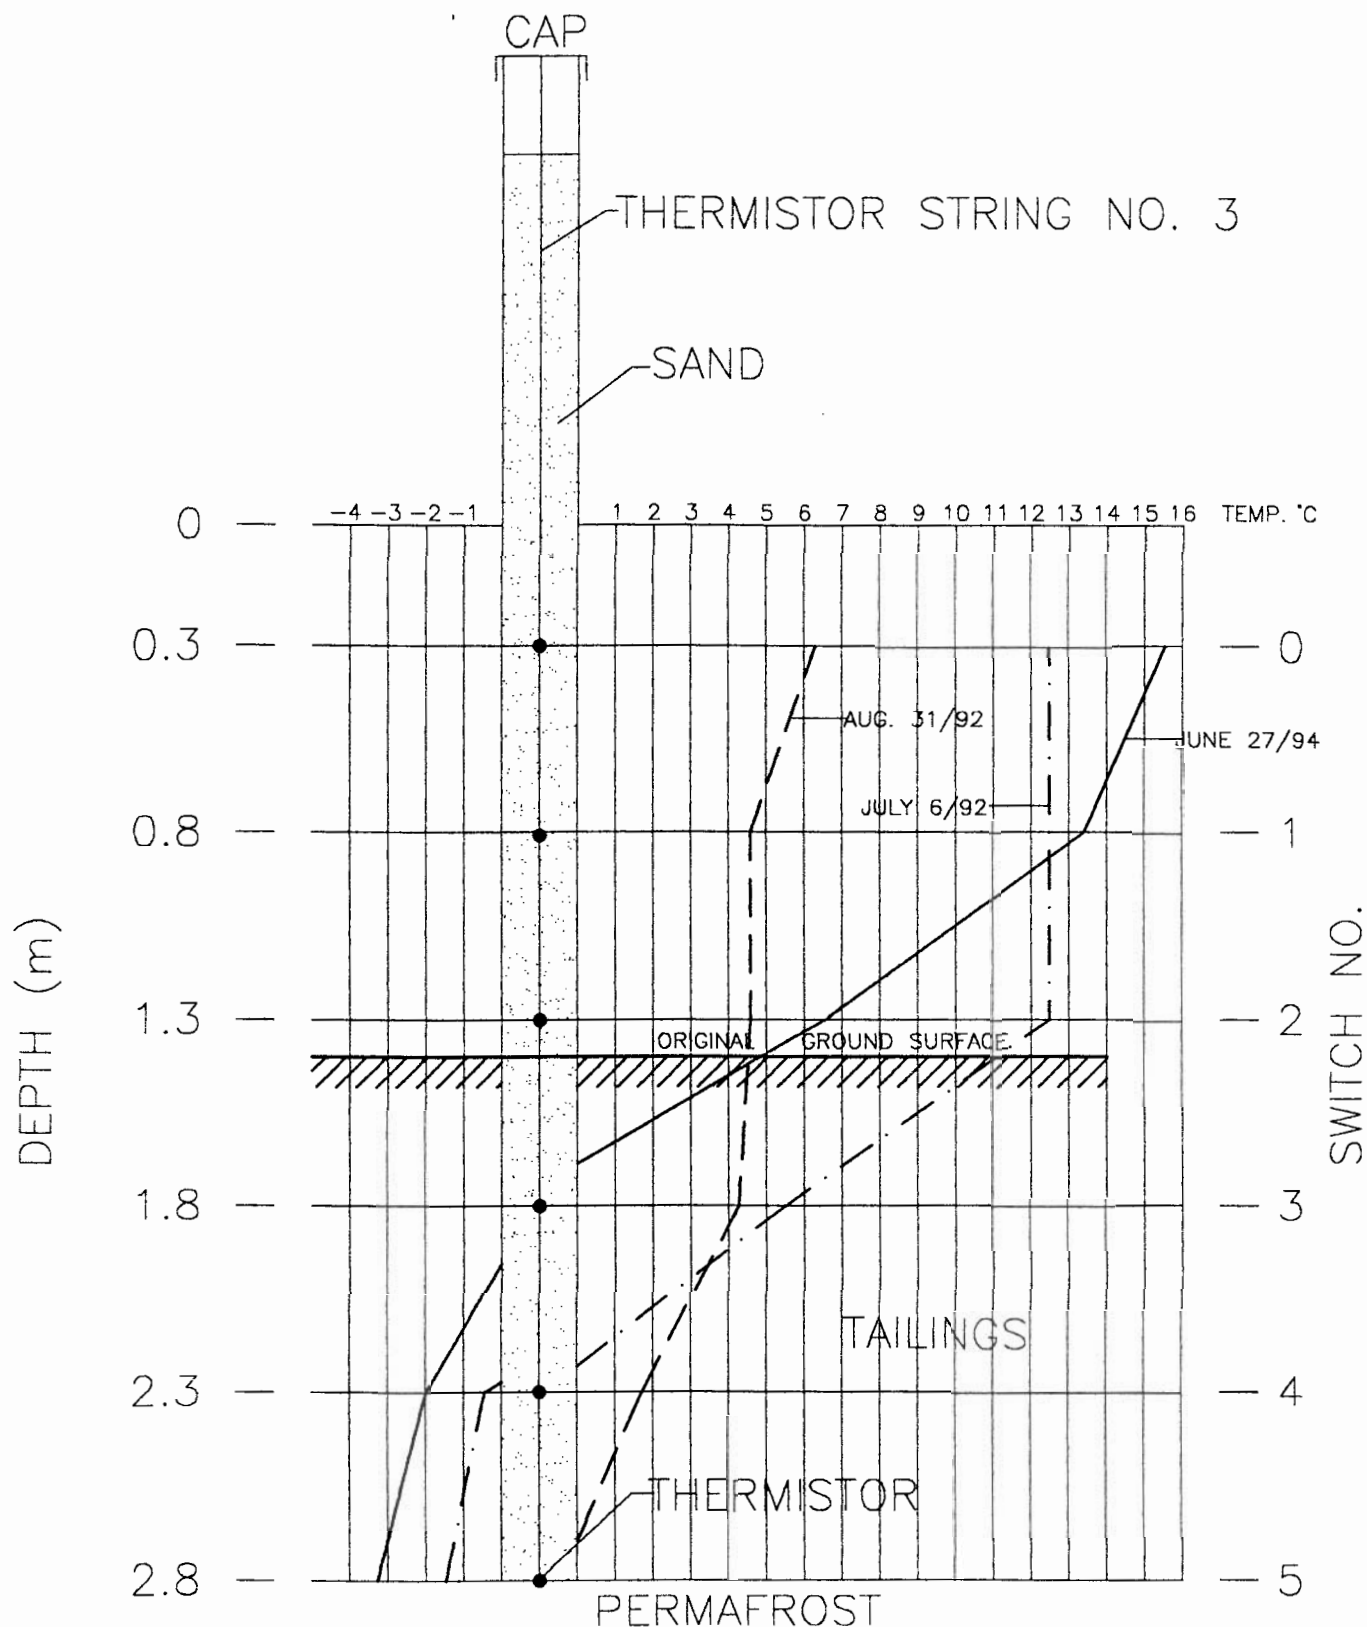
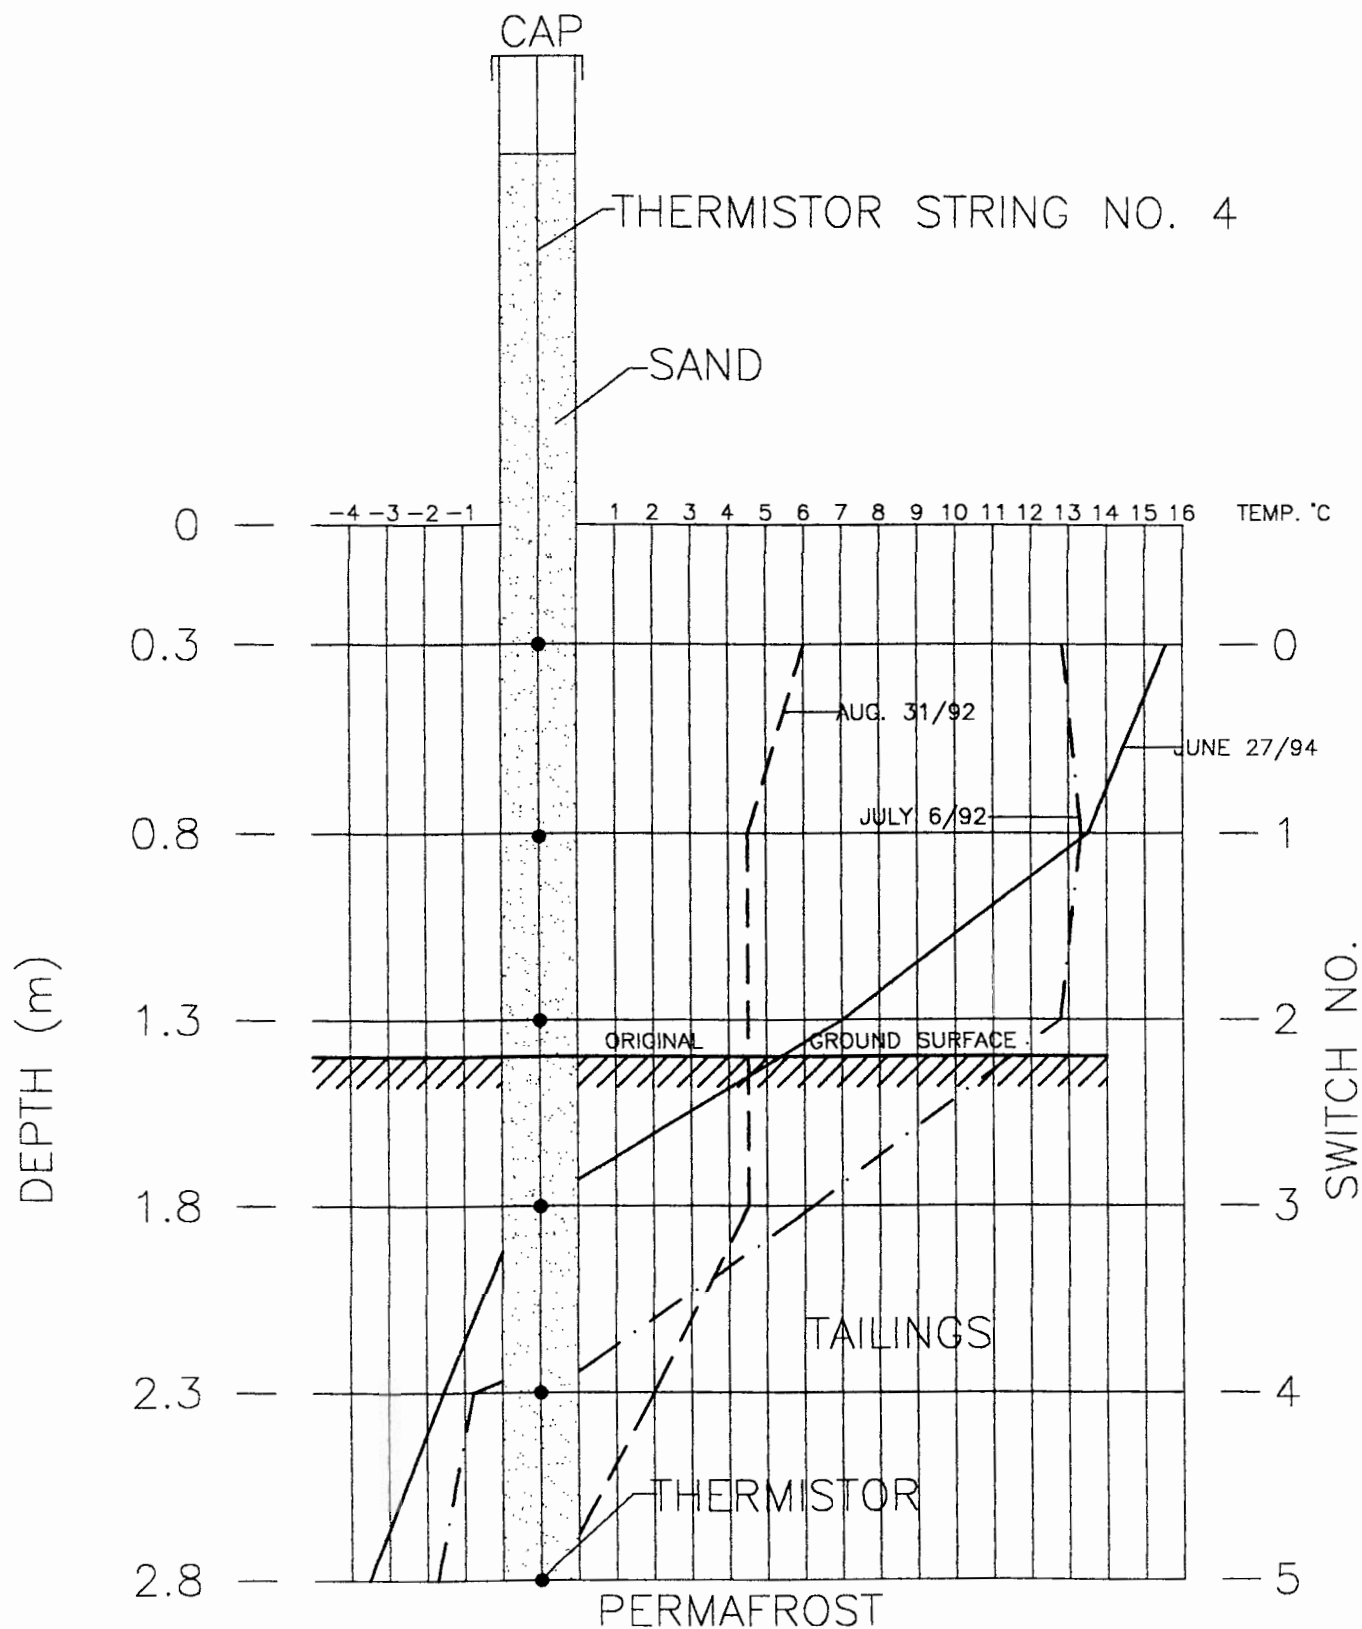
The comparative results from the four thermistor installations indicate that there is an upward trend in the level of permafrost. The average depth of frost was approximately 400 mm below the tailings ground surface during the time of this study. This compares to a frost level of a 800 mm below the ground surface during a similar time period in 1992 (July 6, 1992). It should be noted, however, that the greatest depth of thaw occurs at the end of the summer season which will lower the level of frost to the greatest seasonal depth. To obtain the level of maximum thaw, thermistor readings should be taken sometime in the month of September. A more accurate level of permafrost can then be recorded. At the current rate of

rise in frost levels, it is expected that the covered tailings area will be in a permanently frozen state (permafrost) in 2 to 3 more years.

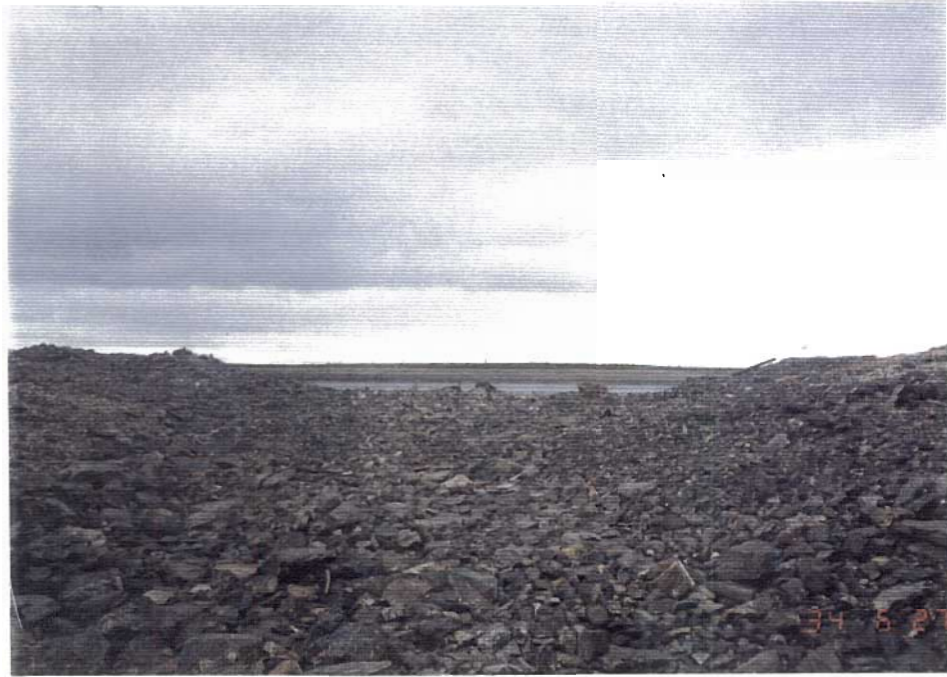
The spillways at each of the two dams appear to be in good condition. However, some levelling of some small rock piles immediately adjacent to the spillway in Dam No. 2 would provide a better appearance and provide better control of surface runoff. A slight trickle of water was noted through the rock fill in the spillway on Dam No. 1. Photographs, No.s 1 and 2 show the conditions of the two spillways.

Photograph No. 1
Spillway at Tailings Dam No. 1

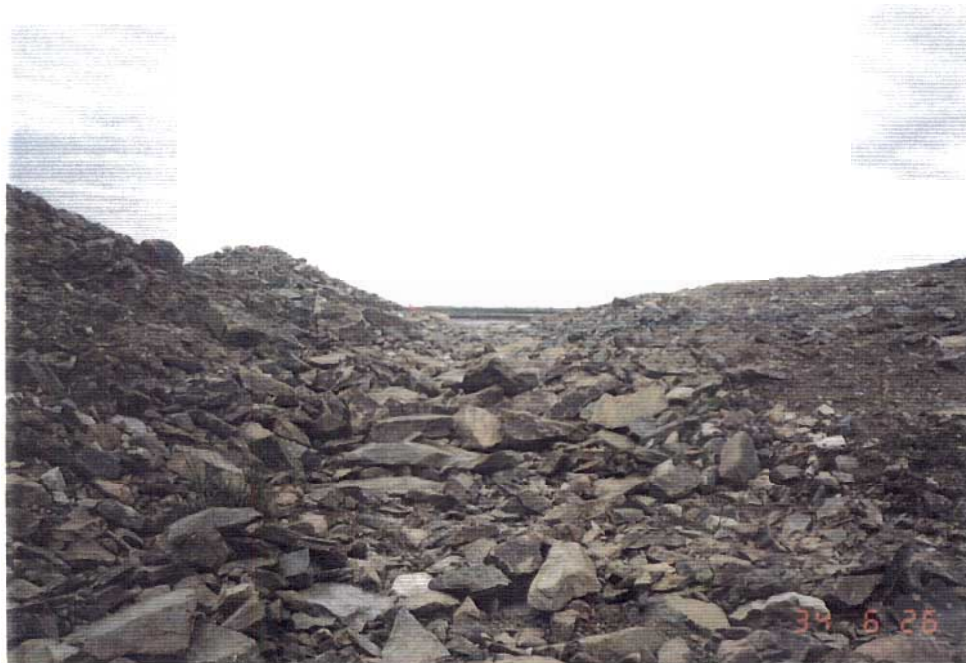
Photograph No. 2
Spillway at Tailings Dam No. 2

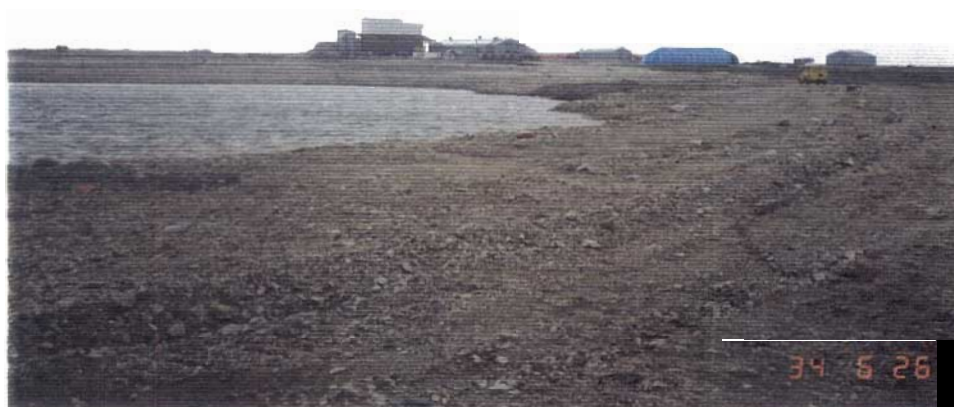
There was no evidence of any exposed tailings in Tailings Area No. 1. Field measurements from a September 1990 site visit indicate that the maximum depth of seasonal thawing (active zone) is estimated to be 1.4 m. Measurements from a subsequent field visit of August 11, 1992 show that the cover material over the tailings is approximately 1.2 m thick. Photographs, No.s 3 and 4 show the covered tailings area.

Photograph No. 3
Covered Tailings at Tailings Pond No. 1
View Looking South

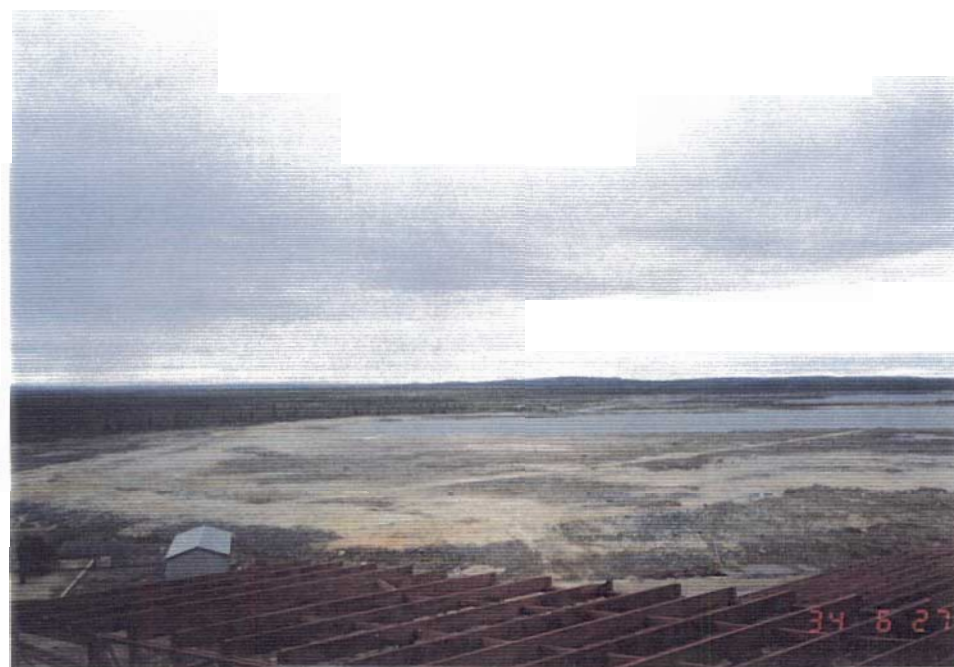
Photograph No. 4
Covered Tailings at Tailings Pond No. 1
View Looking North
