**Reference F90132**

**1999 Tailings Dam Examination**  
**Cullaton Lake Gold Mine, Nunavut**

RE: Cullaton Lake Gold Mine  
Our Reference No. F-90132-B/E

REVISIONS		
No:	Date:	Revision
Client: HOMESTAKE CANADA		
Project: CULLATON LAKE MINE CLOSURE		
Title: TAILINGS POND SURVEY CULLATON LAKE, N.W.T.		
Project No. F-90132-A/G		Dwg. No.: 1
Drawn By: PW/DT		Reviewed By: DK
Date: JANUARY 30, 1995		
Scale: 1 : 2500

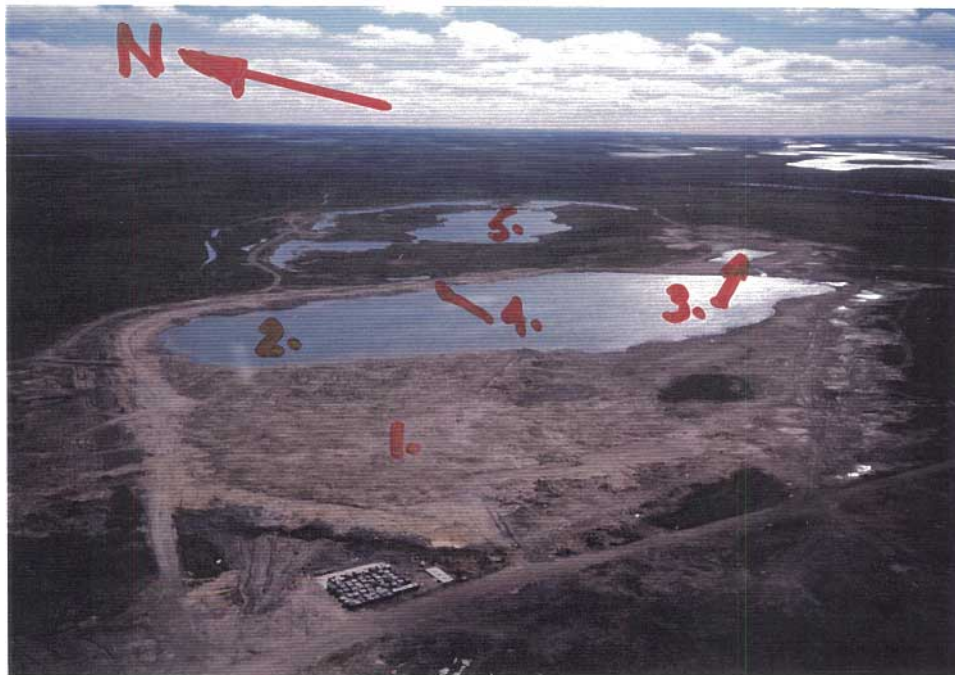
The field examination was carried out by Mr. Demetri Georgiou, P.Eng. on July 24, 1999. Photos 1 and 2, attached, show oblique views of the site taken from the air on the date of the site examination, July 24, 1999. The tailings area, marked 1. in the foreground of Photo 1, has been covered with local till as reported in Trow's previous inspection reports. Vegetation on the tailings is small and sparse.

Photo 1. Oblique view of tailings impoundment looking east.  
1. Covered Tailings, 2. Pond, 3. Quarry, 4. Dam 1 and Spillway 1, 5. Pond 2

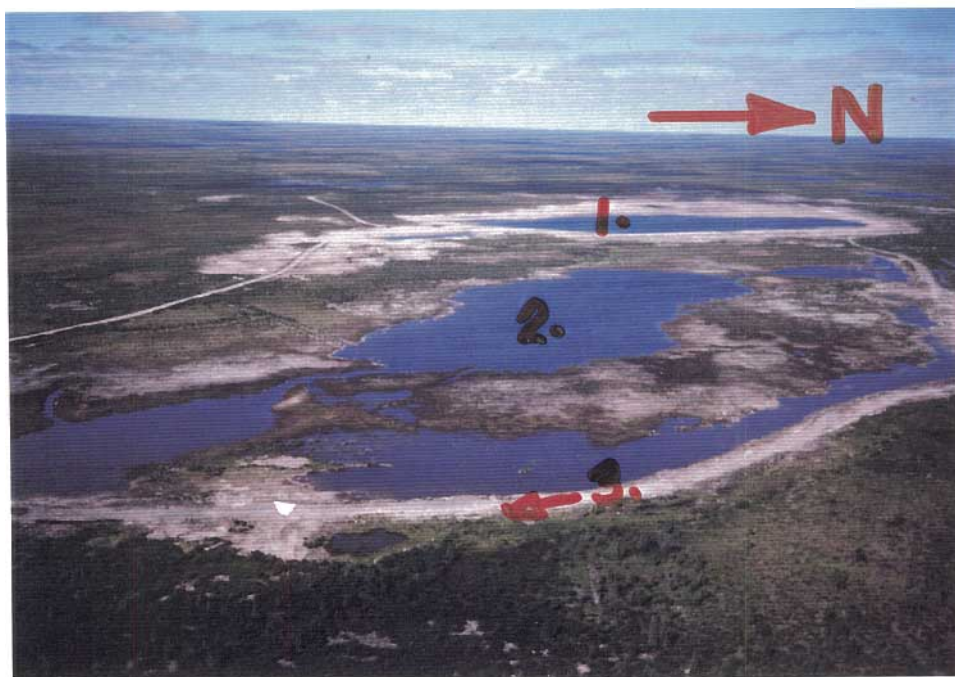
Photo 2. Oblique view of tailings impoundment looking west.  
1. Pond 1, 2. Pond 2, 3. Dam 2 & Spillway 2

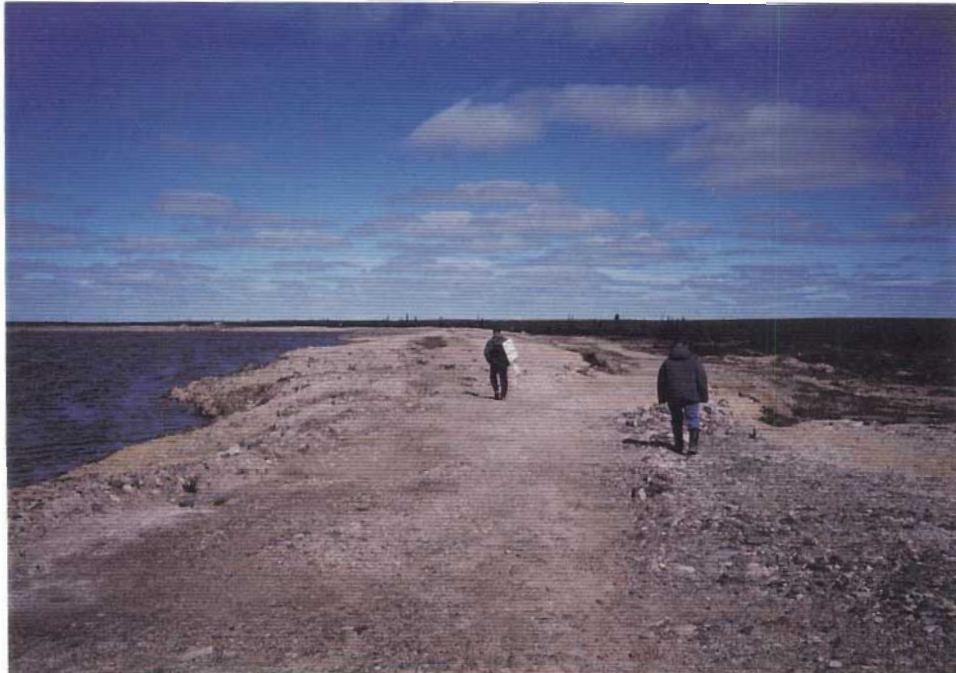
Photos 3 and 4 show views of the dam and spillway, respectively. Typically, the embankment which is constructed principally with local cohesionless till, is irregular in section and surface grade. Average side slopes of the upstream and downstream sides were typically about 3H:1V and 6H:1V, respectively. Some small erosion scars were observed on both the upstream and downstream sides. This is likely due to adjustment of the fill that was placed several years ago during the flattening of the side slopes. The crest width varies but is in the order of 15 m. No seepages were observed on the day of inspection. Based on our 1999 examination and our previous involvement with the project, the dam is considered to be stable.

Photo 3. Tailings Dam No. 1 looking north.

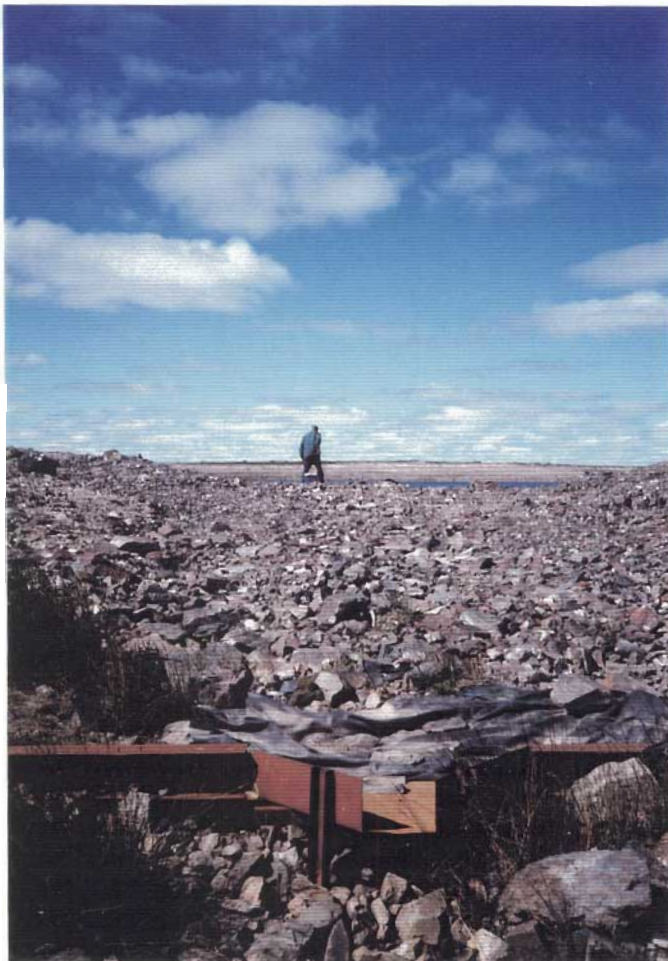
The pond level was estimated to be at an elevation of about 93.7 m, approximately 0.3 m below the spillway crest level and no spillway flow was occurring. This is slightly lower than that observed in the 1994 and 1996 examinations when the levels were at about 94.0 m. The slight drop in water level, compared to what was observed previously is likely due to natural seasonal hydrologic variations, including precipitation, infiltration, runoff and evaporation. Within the tailings pond itself, no unsubmerged tailings were observed.

Photo 4. Spillway No. 1 looking upstream (west). Note flow measurement weir.

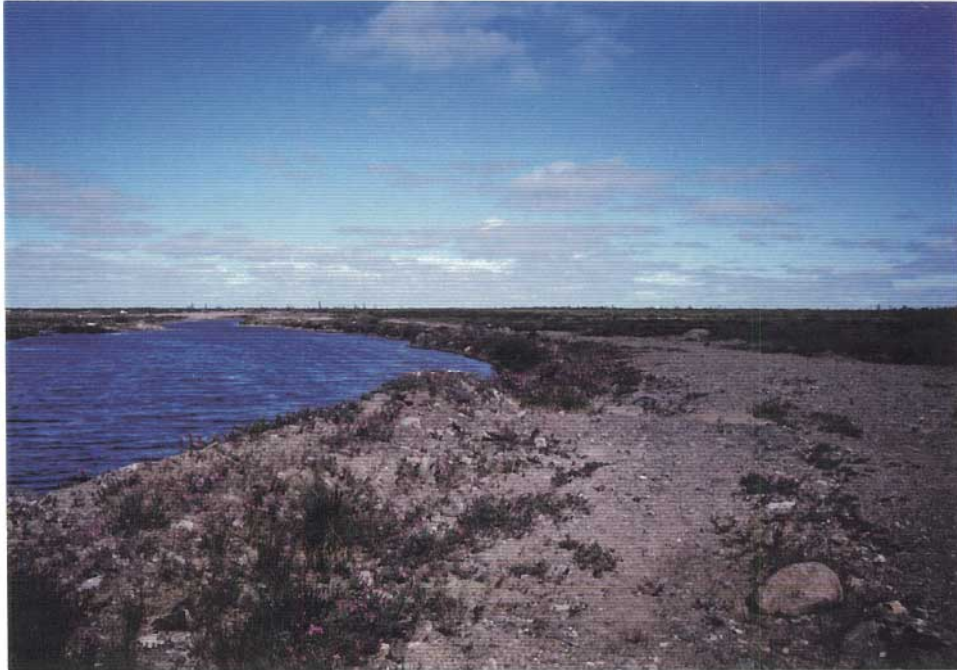
Photos 5 and 6 show views of the dam and spillway, respectively. As with the No. 1 dam, the principal construction material is local cohesionless till. The dam section and surface grade is irregular, although less so than the No. 1 dam. The crest width varies but is in the order of 15 m. No seepages were observed on the day of examination. Based on our 1999 examination and our previous involvement with the project, the dam is considered to be stable.

Photo 5. Tailings Dam No. 2 looking north, north of Spillway.

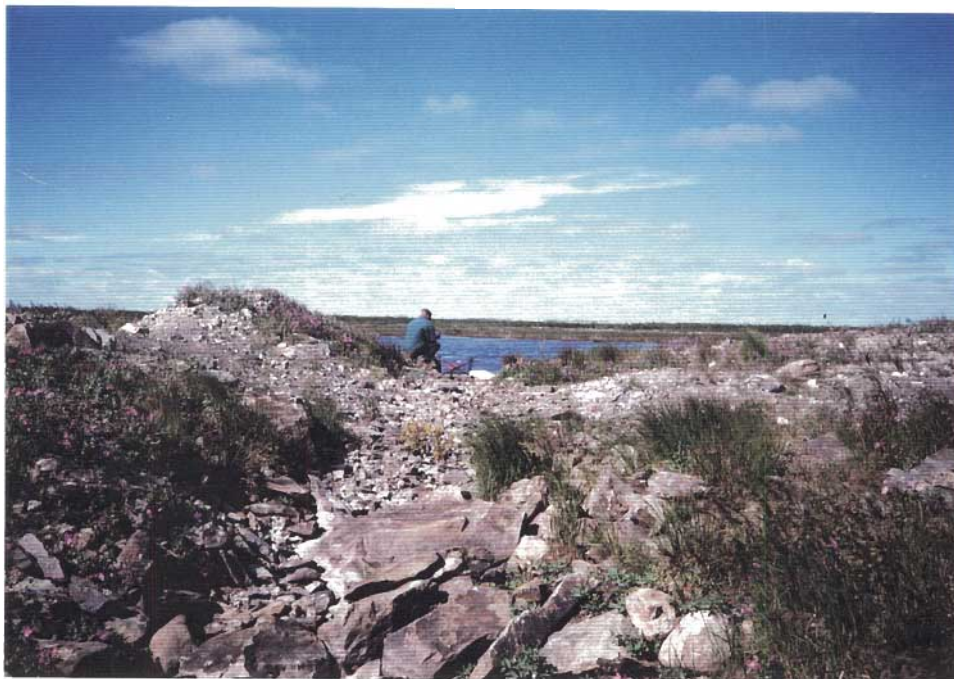
Photo 6. Spillway No. 2 looking upstream (west).

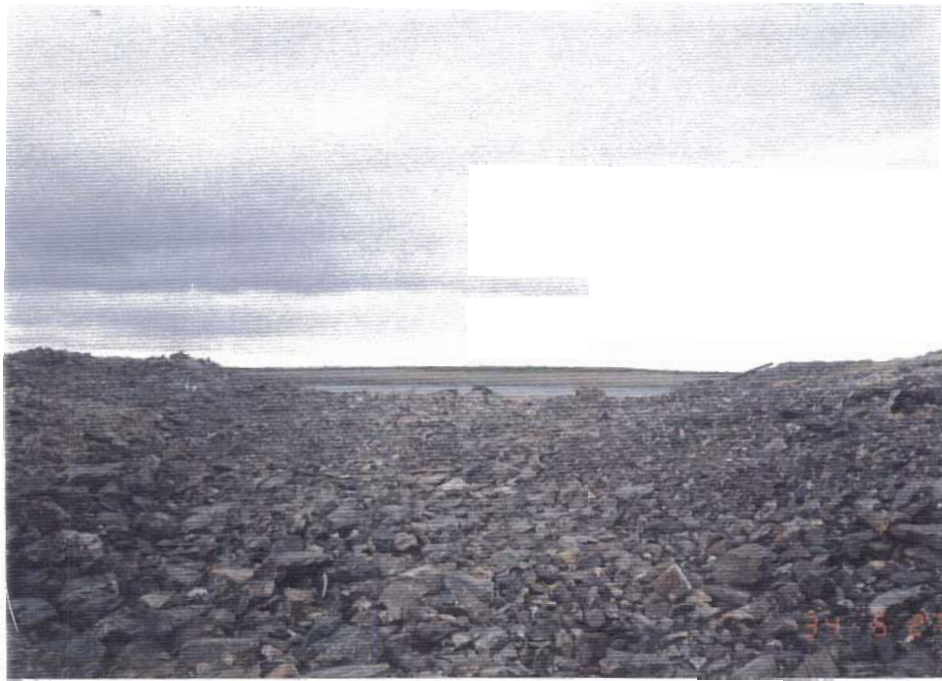
The spillways at each of the two dams appear to be in good condition. However, some levelling of some small rock piles immediately adjacent to the spillway in Dam No. 2 would provide a better appearance and provide better control of surface runoff. A slight trickle of water was noted through the rock fill in the spillway on Dam No. 1. Photographs, No.s 1 and 2 show the conditions of the two spillways.

**Photograph No. 1**  
**Spillway at Tailings Dam No. 1**

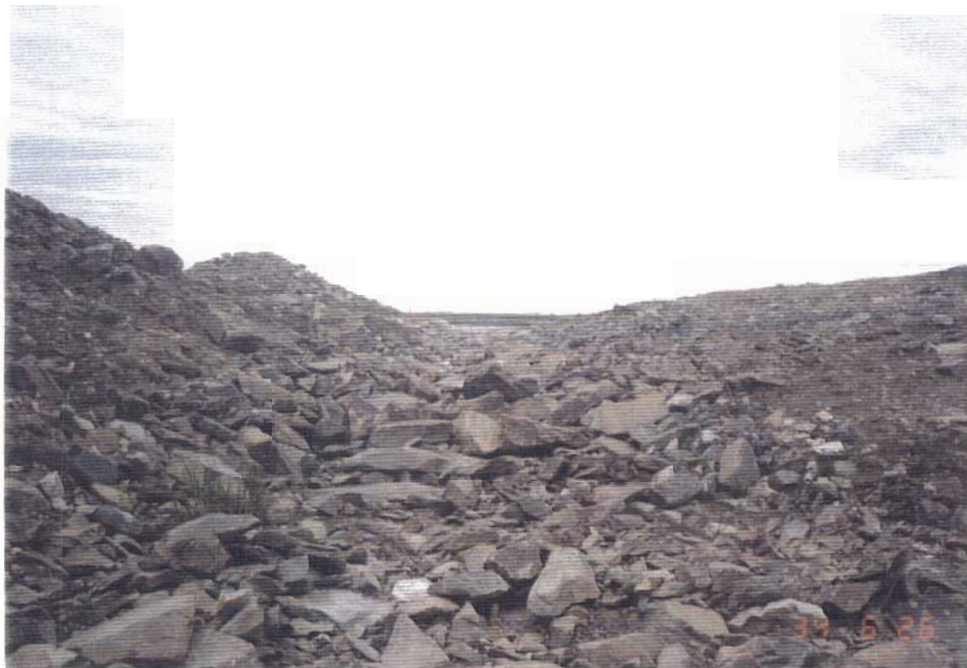
**Photograph No. 2**  
**Spillway at Tailings Dam No. 2**

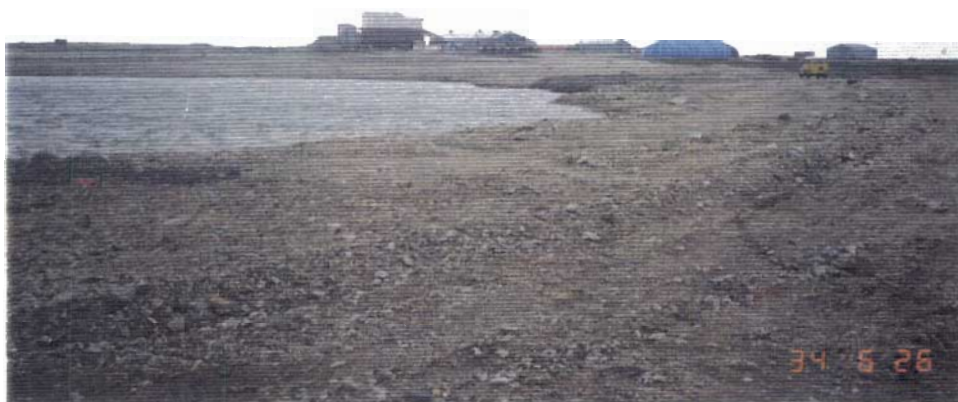
There was no evidence of any exposed tailings in Tailings Area No. 1. Field measurements from a September 1990 site visit indicate that the maximum depth of seasonal thawing (active zone) is estimated to be 1.4 m. Measurements from a subsequent field visit of August 11, 1992 show that the cover material over the tailings is approximately 1.2 m thick. Photographs, No.s 3 and 4 show the covered tailings area.

**Photograph No. 3**  
**Covered Tailings at Tailings Pond No. 1**  
**View Looking South**

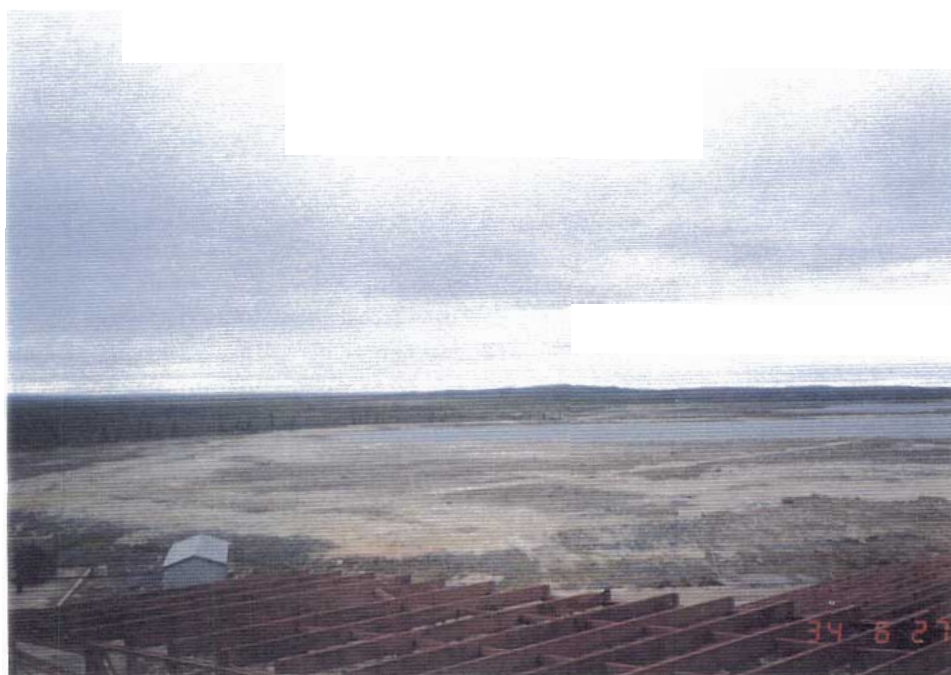
**Photograph No. 4**  
**Covered Tailings at Tailings Pond No. 1**  
**View Looking North**

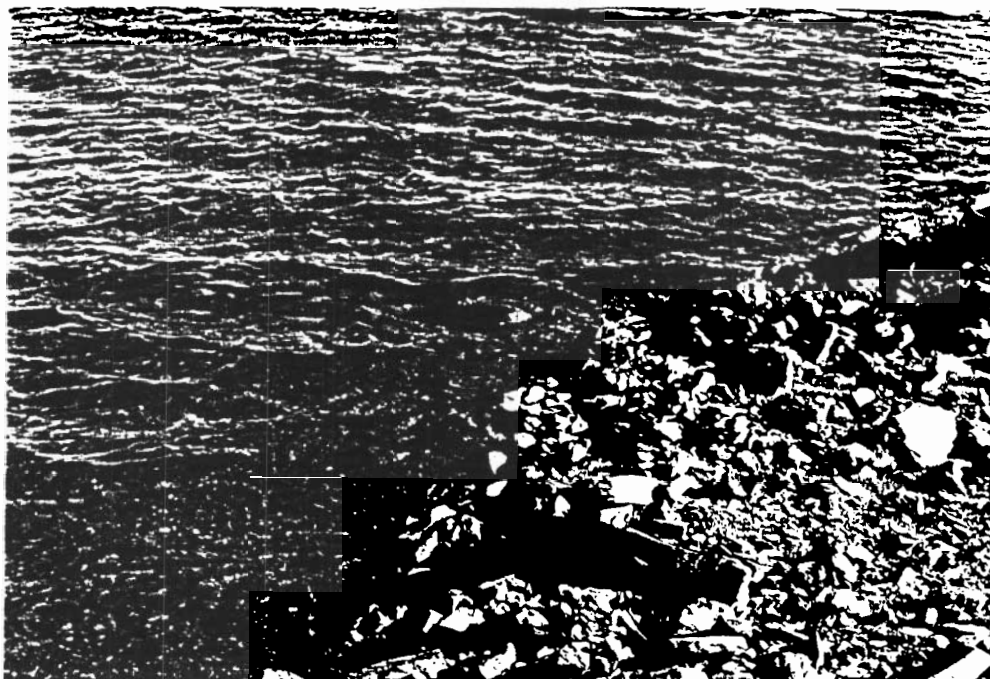
There were no exposed tailings in the pond, shoreline, or covered areas. However, the tailings were within approximately 150 mm of the water surface on the western shoreline, adjacent to the covered tailings area near the interface between the B-zone and Shear zone tailings. There appear to be some pockets of tailings which may be near the surface of the water in centre of the pond. Unfortunately, a boat was not available to measure the water depth. It is understood that an attempt will be made to measure the water depth when the pond is ice covered. Photographs 1 and 2 show evidence of the tailings being close to the surface of the water.

Figure 1: Tailings near surface at west shoreline.

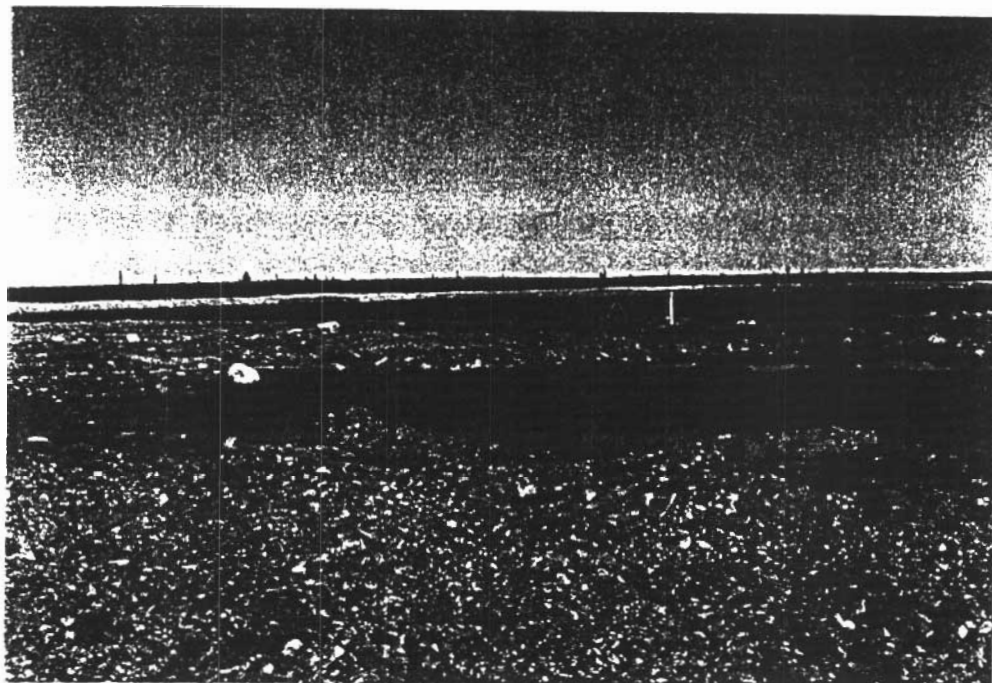
It appears that some thaw settlement may have occurred in the B-zone covered tailings area. The area was ponded with water and stained reddish brown during this site visit. The settled area is shown on Photographs 3 and 4.

Figure 3: Surface depression in B-zone covered tailings area.

Due to the limited amount of available material, placing an additional 2.0 m of cover material may not be achievable. However, placing an additional 0.6 m of cover material and 0.1 m of natural surface material with existing vegetative matter will reduce the duration of the thaw in the underlying tailings considerably. Promotion of vegetation on the surface will help shield the permafrost from
