October 27, 2020

Re: **Project No. THB-00090132-IG**  
**2020 Tailings Facility Examination**  
**Cullaton Lake Gold Mine, Nunavut**  
**Licence No. 1BR-CUL1828**

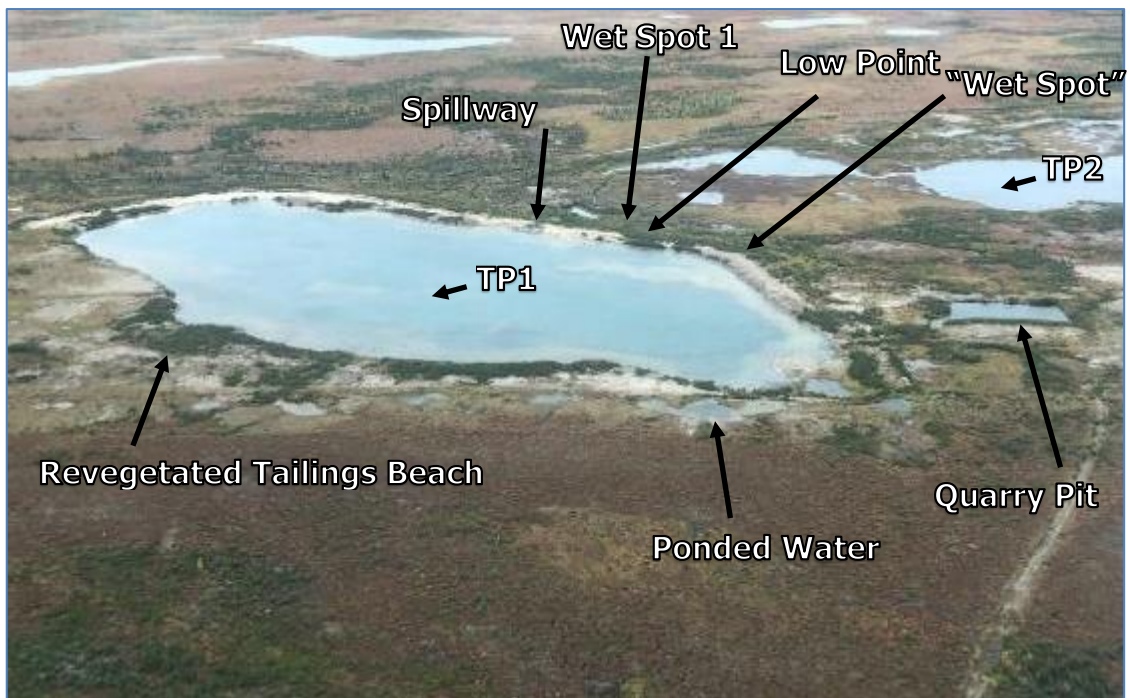
Minor ponding west of the TP1 pond shown in Photo 2 was observed consistent with observations from previous years.

Wet Spot 1 first identified in 2018 was observed in 2020. Wet Spot 1 is in the area of the low point, about 20 m north of the low point and 15 m downstream of the dam toe, as shown in Photo 2. Wet Spot 1 exhibited slightly more wetness than in 2018, as shown in Photo 7. Taking a few steps through the bush up-elevation from Wet Spot 1 towards the pond revealed a small area of ponding located tight against the access road embankment. The access road adjoins the crest south of TP1 spillway. While no water flow was observed, the small area of ponding appeared to be draining to Wet Spot 1. The elevation of Wet Spot 1 and the small area of ponding appeared to be below the water level of the pond. The area of Wet Spot 1 is marked with pink flagging. This area should be monitored during future inspections.

The spot first identified as wet in 2010 and called the “wet spot” was observed in 2020. The “wet spot” exhibited no wetness in 2020. The spot is located south of the spillway halfway down the downstream face of Dam 1, as shown on Photo 2 and the survey plan in Appendix A. The “wet spot” is visible from the dam crest and is currently marked with a piece of rebar and red flagging.

Photo 2: Aerial view of TP1 (looking northeast).

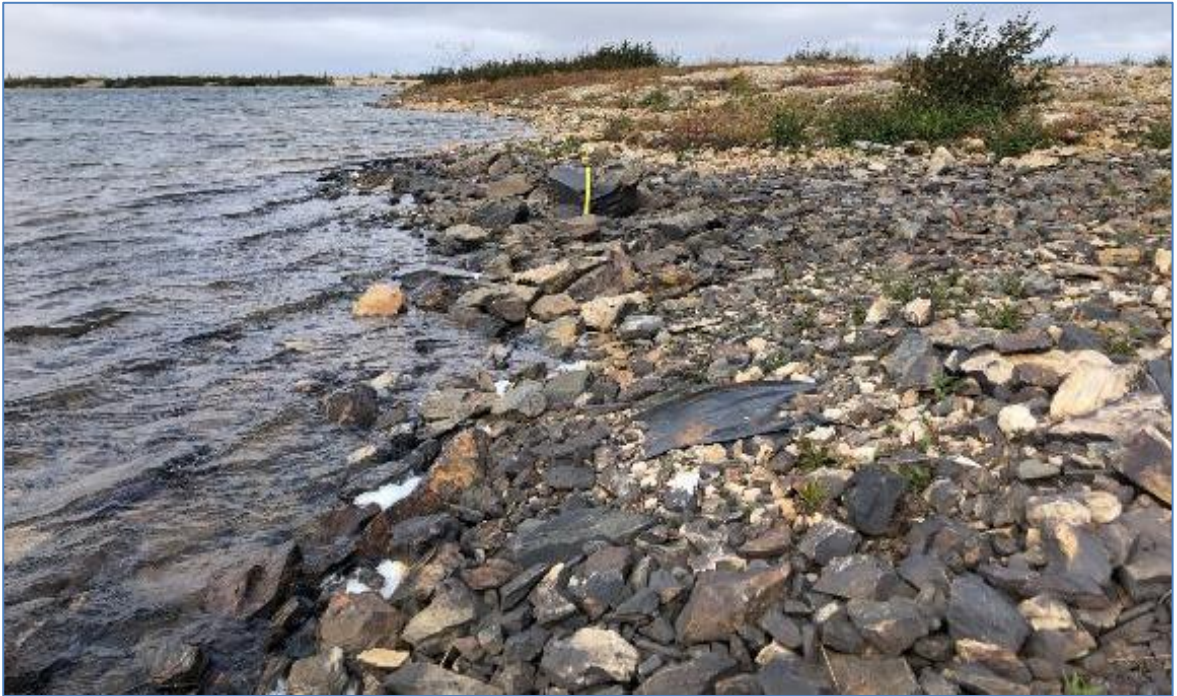
**Photo 3: No water visible in TP1 spillway (looking north across the spillway).**

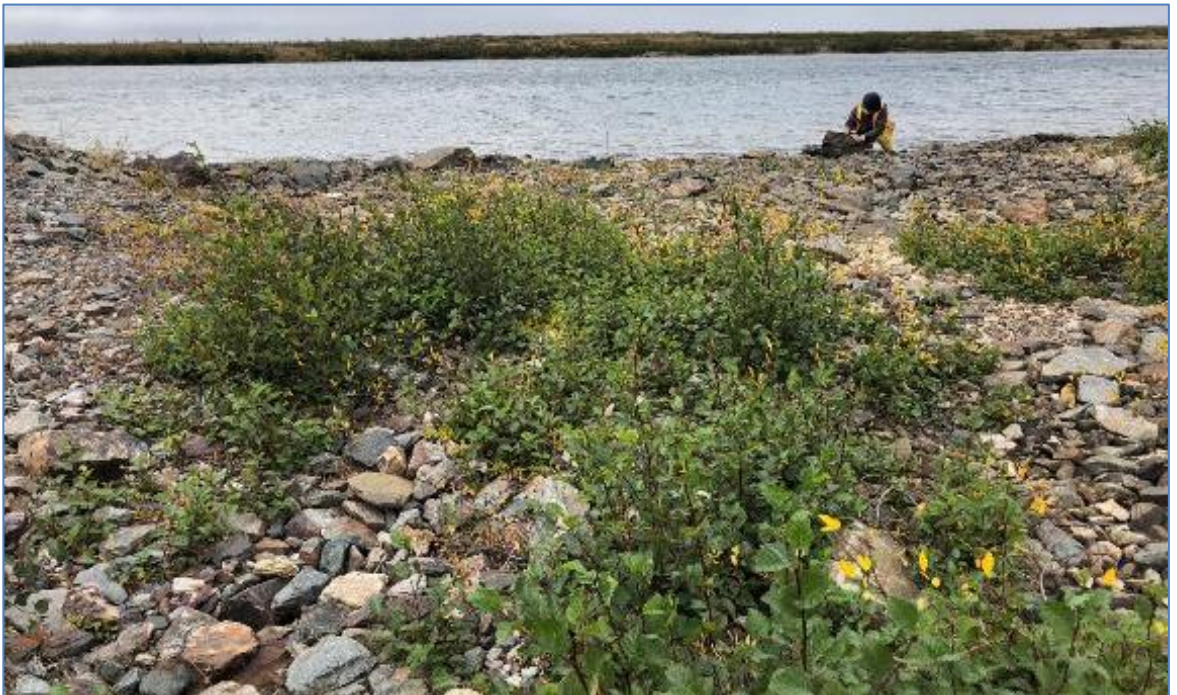
The TP1 spillway was visually inspected. The spillway appeared to have more vegetation growth compared to 2018, as shown in Photo 4. The inspection revealed that the rockfill covering the liner in the spillway works as intended thus confirming that addition of fine rockfill in 2005 was an enough treatment. The small erosion of the rockfill on the south bank of the spillway was noted to be in a

similar condition as in 2018. Small areas of the liner became exposed in this area most likely due to a steeper grade. Minor liner was found exposed near the water's edge similar to 2017. The rockfill in the spillway should be monitored for erosion and rockfill replaced if the exposed areas become larger.

**Photo 4: No water visible in TP1 spillway (looking up-spillway towards the pond).**

- the condition of the TP1 spillway continues to be monitored for erosion and if any is apparent, remedial measures, such as the addition of additional rockfill, be implemented;
- the water levels are monitored for how they serve as cover for the tailings;
- Wet Spot 1 and the “wet spot” exhibiting no water in 2020 are monitored during each subsequent visit;
- the cracking first identified in 2017 is monitored during each subsequent visit; and
- the frequency of the formal geotechnical inspections be reduced to once every three years. While the inspections have been largely qualitative, there has been no visible evidence of deterioration of the dam or spillway structures over the last several years.

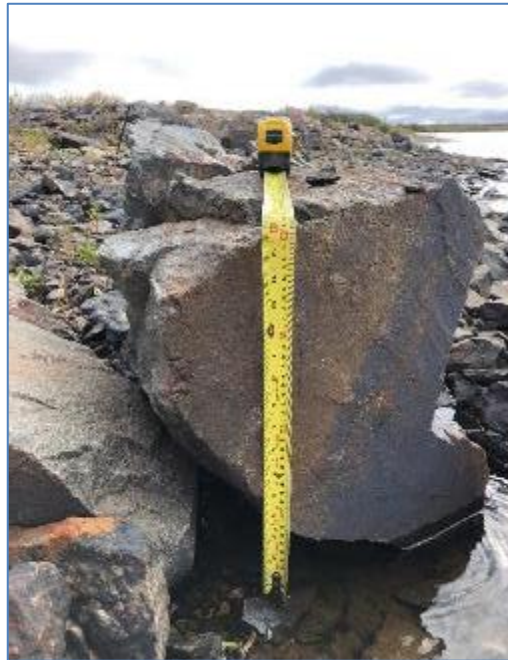
The water level in TP1 was slightly higher than in 2018 but slightly lower than in 2017. Comparison of photographs from present and past inspections suggests that the water level this year was about 0.1 m lower than in 2017 at a similar time. The spillway appeared dry. No water was observed in the rockfill comprising the spillway channel bottom, as shown in Photos 3 and 4. A piece of rock marked with a measuring tape observed from the south as shown in Photo 4 appears somewhat away from the water's edge in 2020. Photo 5 shows the measuring tape on the rock observed from the north.

**Photo 5: 0.4 m between the water surface and top of rock is marked with a measuring tape.**

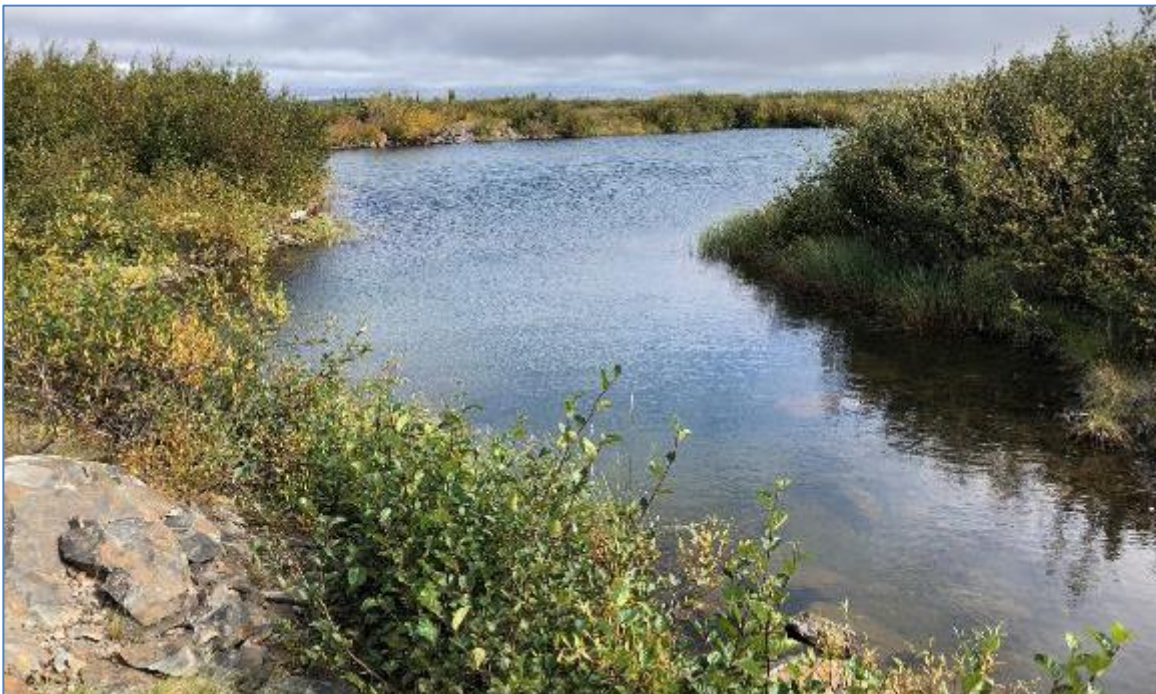
**Photo 6: Water level in the quarry (looking southeast).**

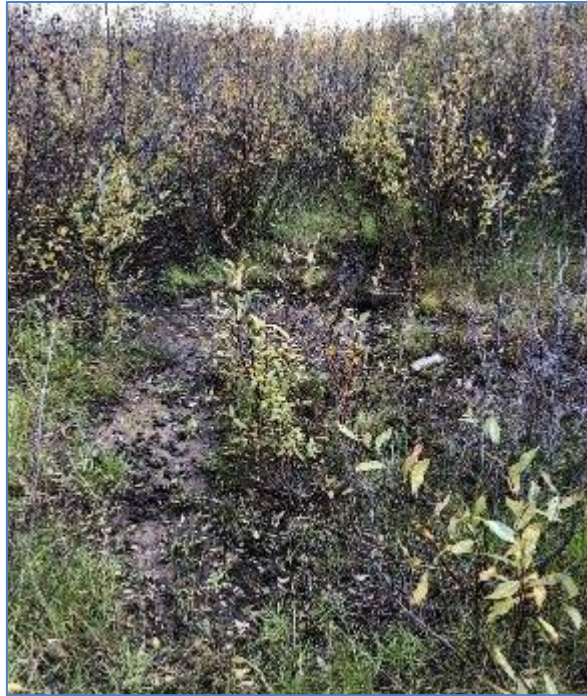
**Photo 7: Wet Spot 1 exhibiting wetness.**

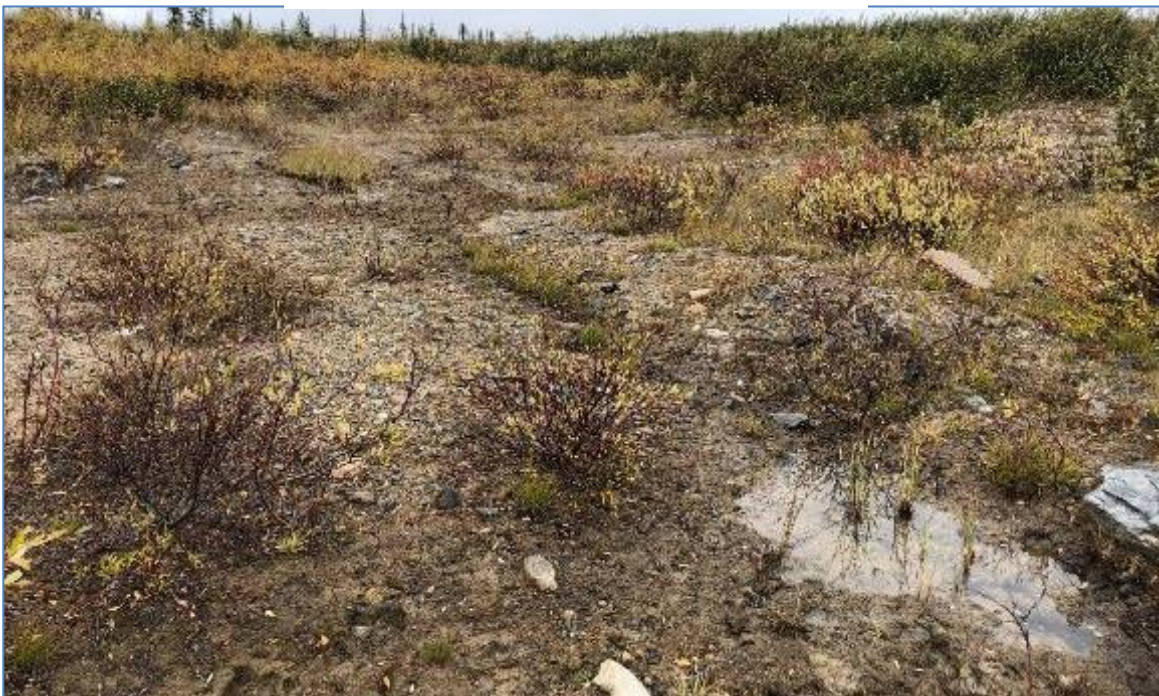
Wet Spot 2 first identified in 2018 was observed in 2020. Wet Spot 2 is on the north side of the dam near the water sampling point 940-22, about 15 m downstream of the dam toe. Wet Spot 2 had a trace of standing water by a cluster of boulders like in 2018, as shown in Photo 8. Closer observation of the

**Photo 8: Wet Spot 2 likely related to drainage from surrounding area.**

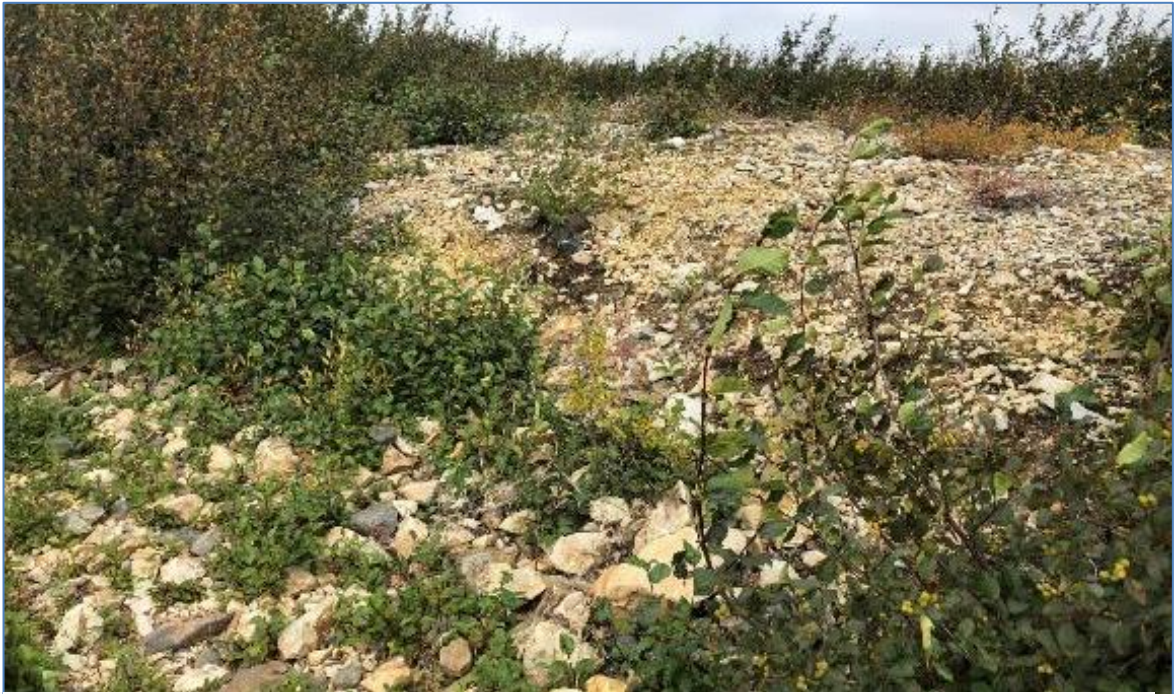
Some small erosion scars were observed on both the upstream and downstream sides; however, as described below, they appear to continue to stabilize with vegetation and self-armouring with larger rock particles from the till and previously placed mine waste rock. These scars do not appear to be increasing in size, based on visual comparisons of previous years. Minor sloughing on the upstream slope south of the low point was observed similar as in 2018, as shown in Photo 11 and on the survey plan in Appendix A.

**Photo 11: Minor sloughing on the upstream slope south of the low point.**

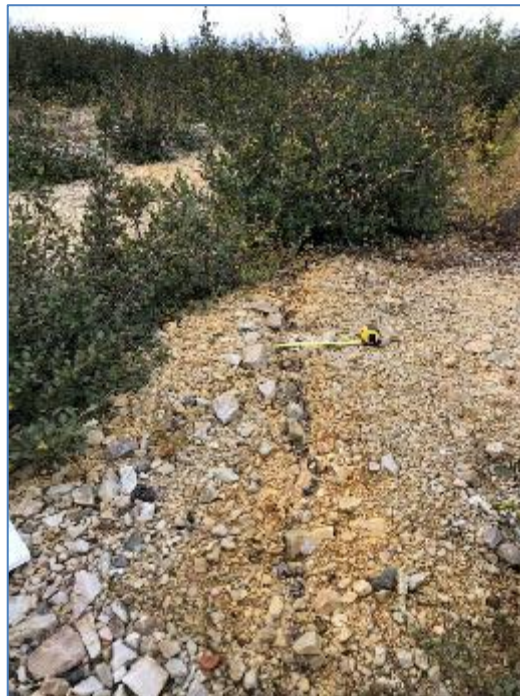
Localized longitudinal cracking first identified in 2017 was observed in 2018, as shown in Photo 12. The cracking was located where the access road adjoins the crest south of the spillway, as shown on the survey plan in Appendix A. The cracking appeared to be self-armouring with rock and vegetation. The localized surface cracking first identified in 2017 on the crest north of the spillway was observed filled with smaller size granular material. These cracks do not have an impact on Dam 1 performance. The cracking should be monitored during subsequent inspections.

**Photo 12: Longitudinal cracking self-armouring with rock and vegetation.**

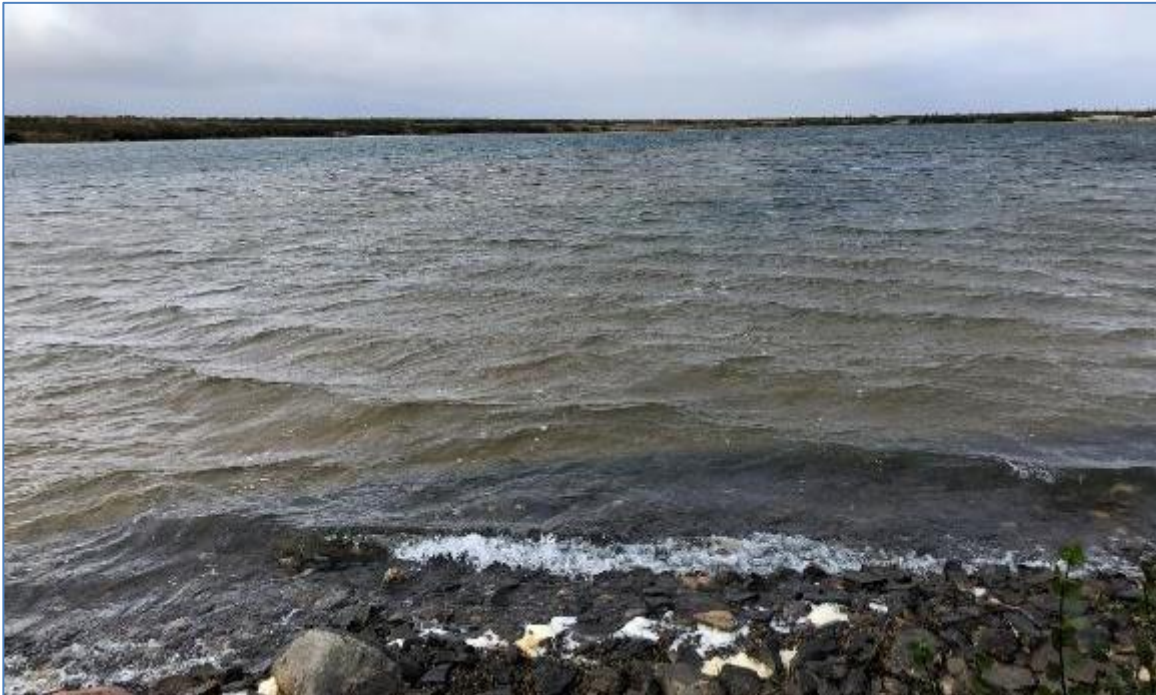
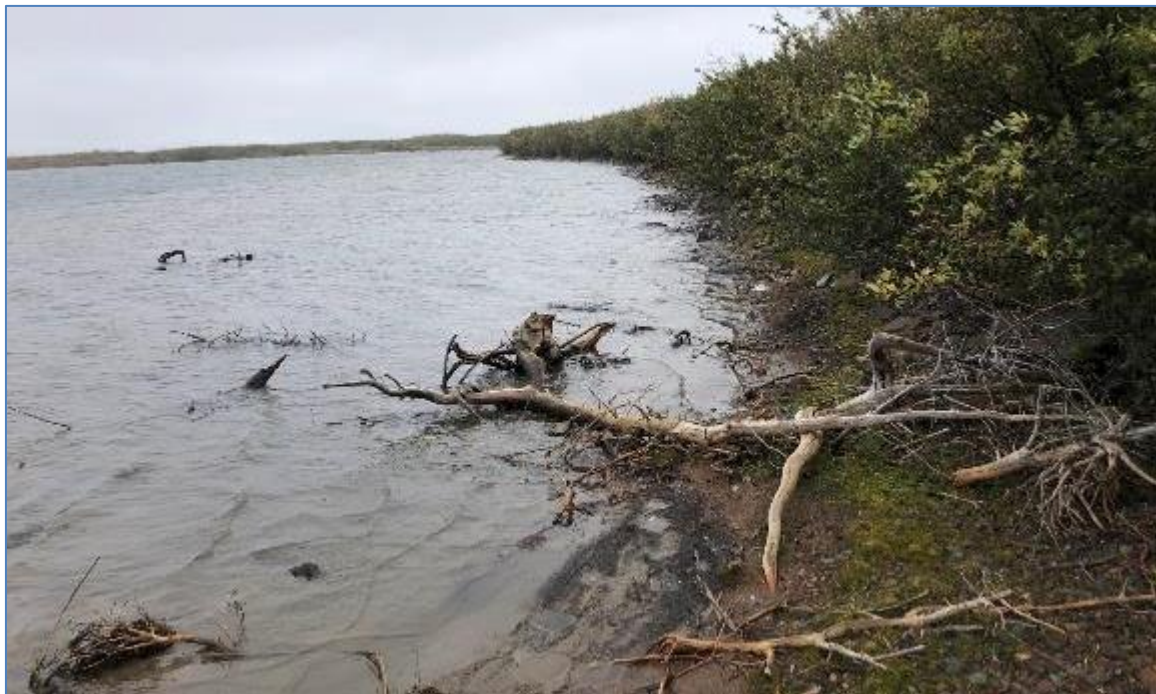
No unsubmerged or exposed tailings were observed within the pond. Photos 13 and 14 show the overall view of the pond and the west side of the pond.

**Photo 13: TP1 (looking north).**

**Photo 14: West side of the TP1 pond with the water level near the vegetation line (looking south).**

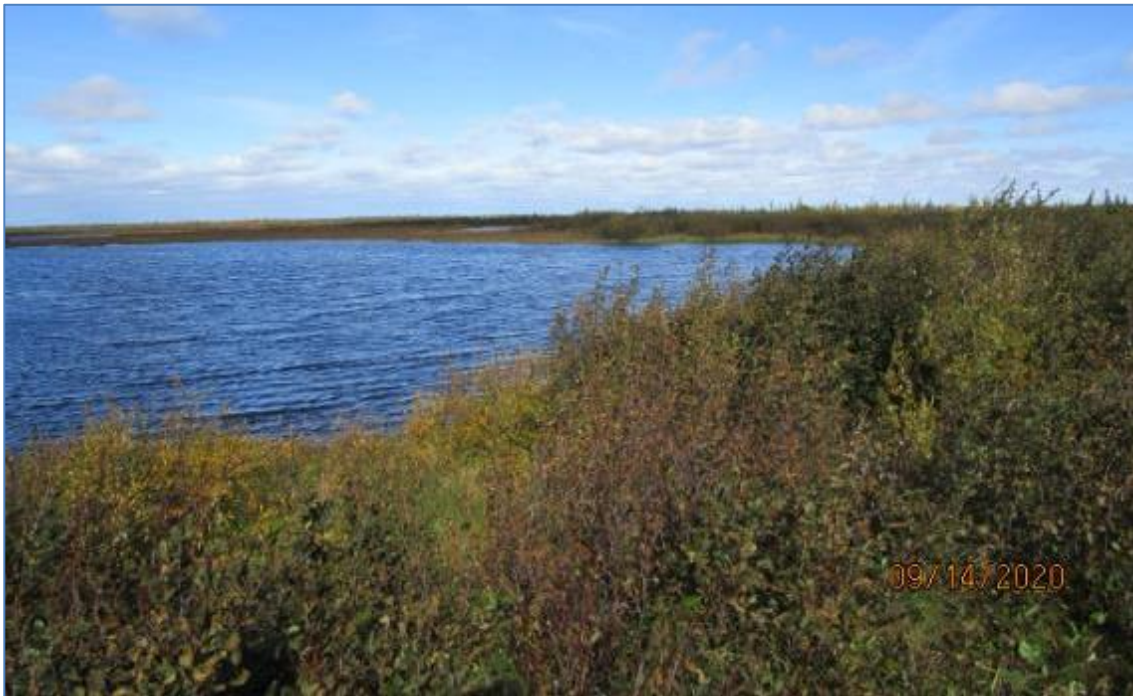
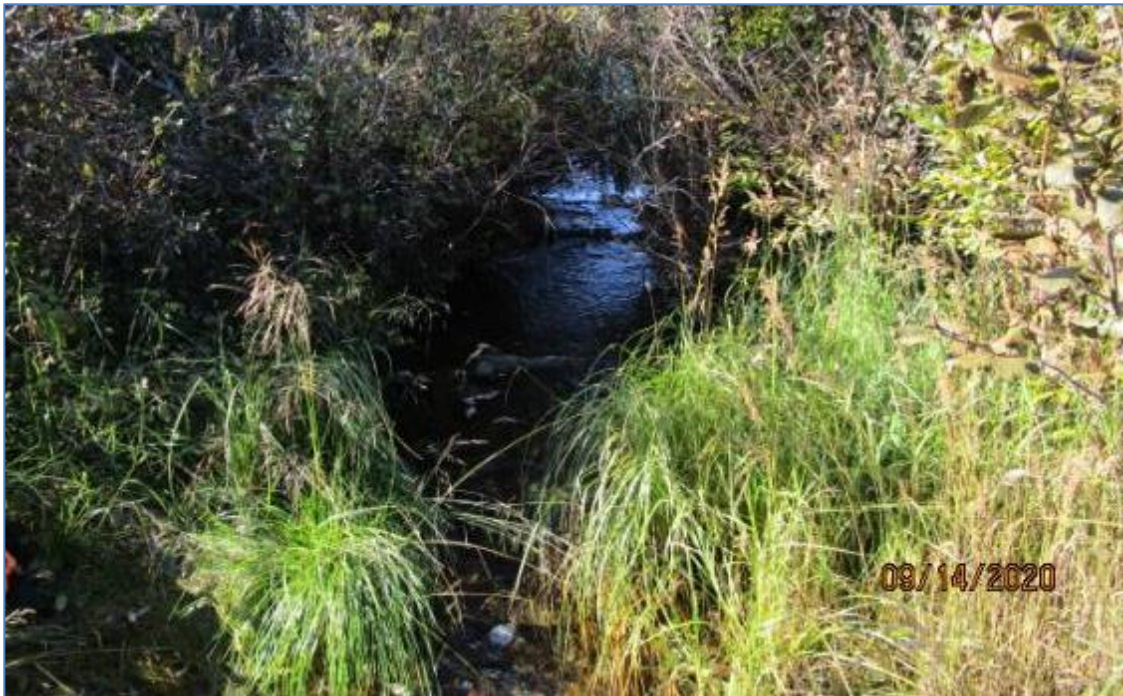
Tailings pond TP2 and Dam 2 were not visited by EXP in 2020 due to limited time on site. Our review is only based on photographic comparison between ones provided by Barrick taken on September 14, 2020 (Photos 15 and 16) and EXP photos taken in the past years. Photo 15 shows Dam 2 observed from the TP2 spillway location. As with Dam 1, the principal construction material was local cohesionless till. Dam 2 section and surface grade is irregular, although less so than Dam 1. The crest width varies but is in the order of 15 m.

**Photo 15: Dam 2 (on the right) seen from TP2 spillway (looking northwest). Photo provided by Barrick.**

**Photo 16: TP2 spillway with flow looking upstream to TP2 pond. Photo provided by Barrick.**

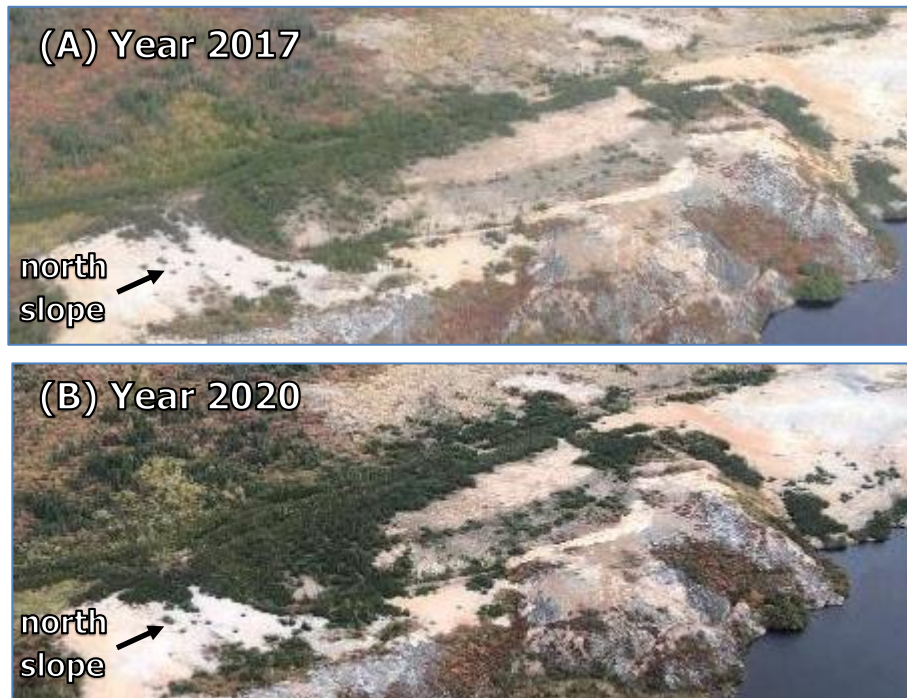
The Shear Lake waste rock cap was inspected this year. The Shear Lake waste rock pile, located on the east side of Shear Lake, some 4.5 km north of the former mill site (at the TP1), was reportedly capped with local, compacted glacial till to promote runoff and reduce infiltration. Some erosion control on the till cap was performed in 2005. A berm approximately 0.5 m high is surrounding the pile near the bottom reaching to the pile top on the south and west sides. Photo 17 (B) shows a 2020 aerial view of the Shear Lake waste rock pile.

**Photo 17: Comparison between aerial views from 2020 and 2017 of Shear Lake Waste Rock Pile**

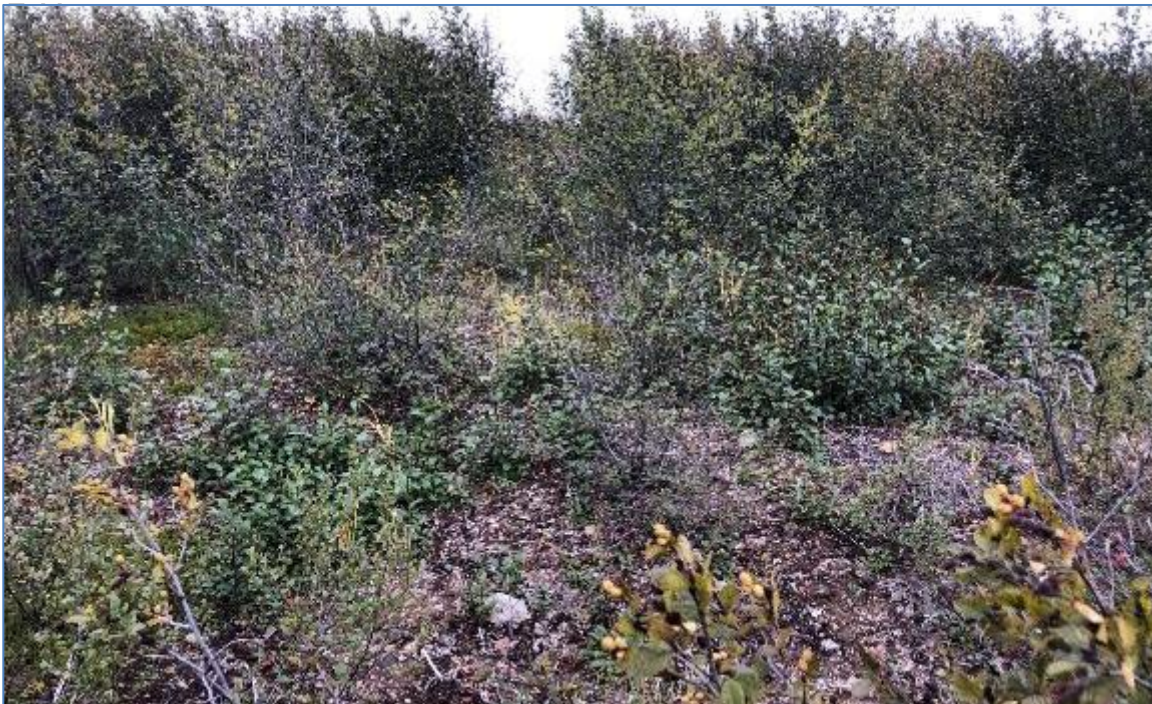
**Photo 18: Stable gravel/till covered east slope of Shear Lake Waste Rock Pile (looking west)**

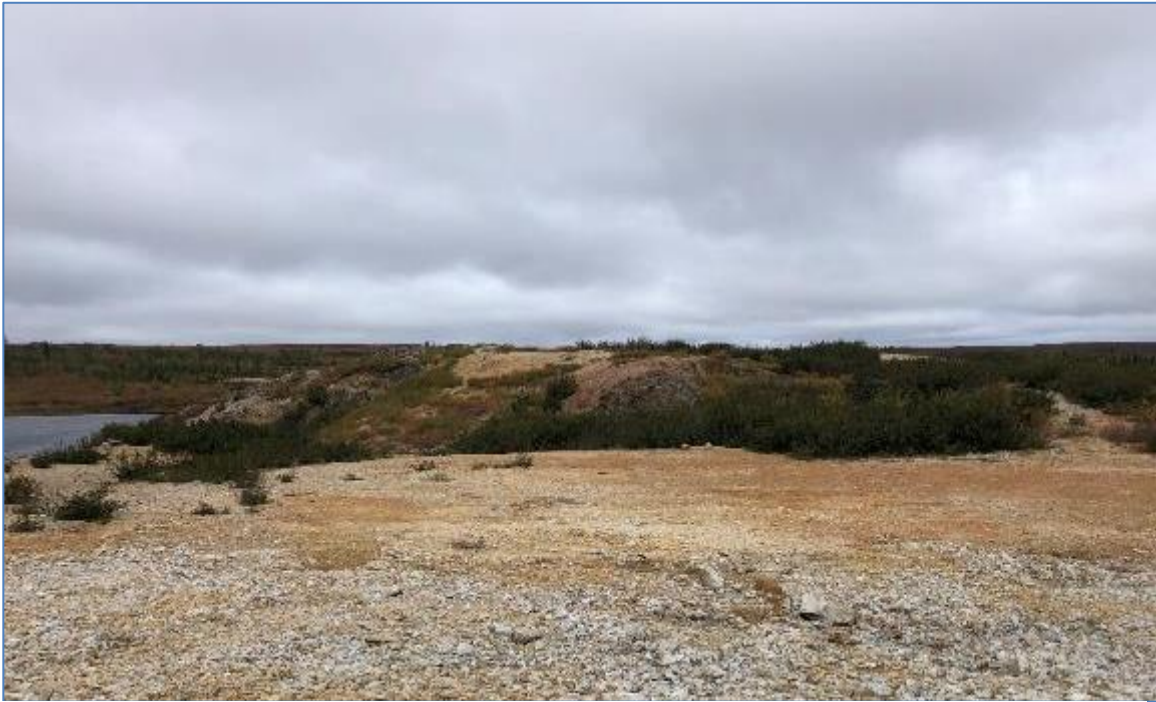
**Photo 19: South slope of Shear Waste Rock Pile showing grasses (looking north).**
