Re: **Project No. THB-00090132-JG**
2022 Tailings Facility Examination
Cullaton Lake Gold Mine, Nunavut
Licence No. 1BR-CUL1828

Further to your authorization, EXP Services Inc. (EXP) has performed a visual geotechnical examination of the tailings impoundment facility at the former Cullaton Lake Gold Mine (the Site) in Nunavut. The Site is owned by Barrick Gold Corporation (Barrick). The facility includes Tailings Ponds 1 and 2 (TP1 and TP2) and associated dams. The field examination was performed between August 31, 2022 and September 1, 2022 by the undersigned, Ms. Renata Klassen, P.Eng. The attached survey plan in Appendix A (January 30, 1995) illustrates the general layout of the facility.

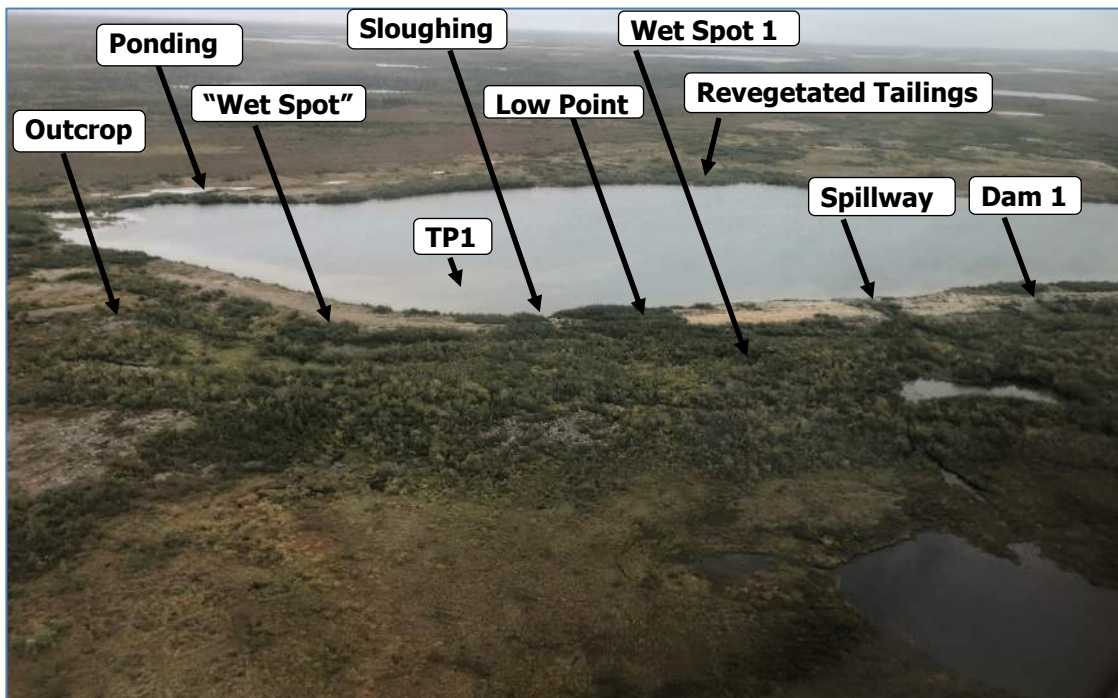
Ponding west of the TP1 pond shown in Photo 2 was observed consistent with observations from previous years.

Wet Spot 1 first identified in 2018 was observed in 2022. Wet Spot 1 is south of the spillway about 20 m north of the low point and 15 m downstream of the dam toe, as shown in Photo 2. The area of Wet Spot 1 was evidently wetter in 2022 compared to 2020 and 2018, as shown in Photo 7. Ponding up to about 0.05 m deep was observed throughout the area of Wet Spot 1. Probing of the water surface with a piece of metal rod suggested a hard surface beneath the water such as glacial till, rock fill or bedrock. Despite the area being surrounded by thick bushes, it was attempted to estimate the elevation of Wet Spot 1 with respect to the water level in TP1. Wet Spot 1 was estimated to be about 1.8 m below the water level in TP1. Several pieces of flagging were affixed to mark the area. This area should be monitored during future inspections.

Photo 2: Aerial view of TP1 (looking west).

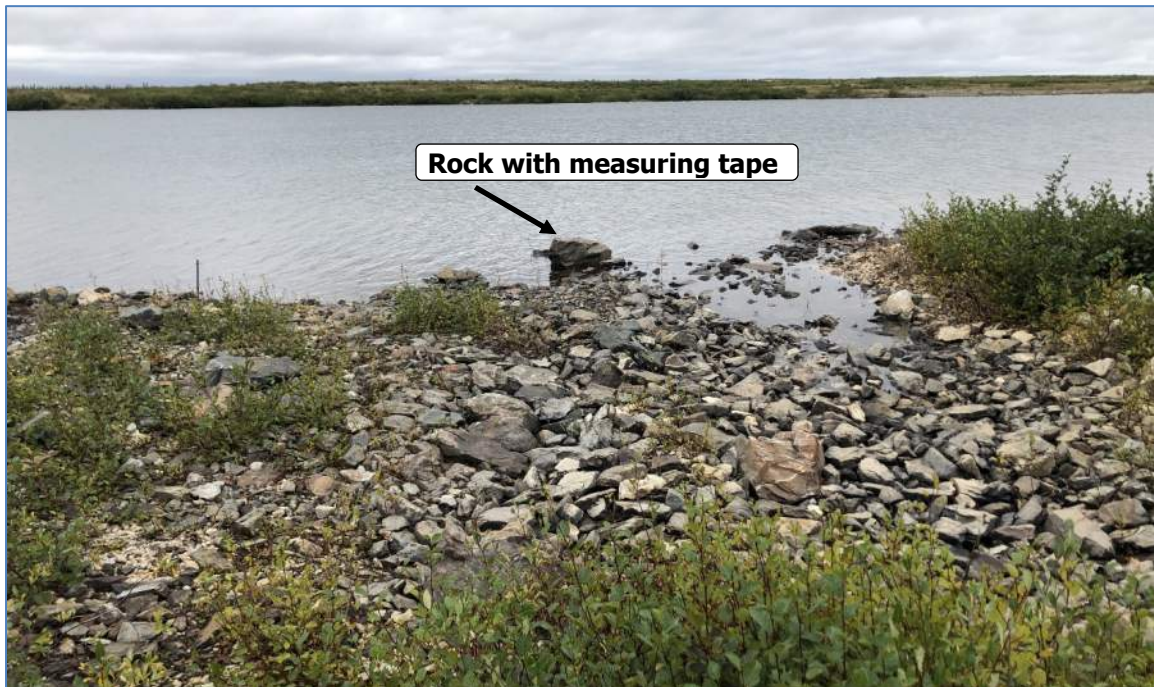
The water was observed slightly reaching into the spillway at the upstream side as shown in Photo 3. The rockfill comprising the spillway channel bottom appeared dry except for one small spot on the downstream side that was damp as shown in Photo 4. This spot was estimated to be lower than the water in TP1 by about 0.3 m.

Photo 3: Water at TP1 spillway (looking up spillway) and rock with measuring tape.

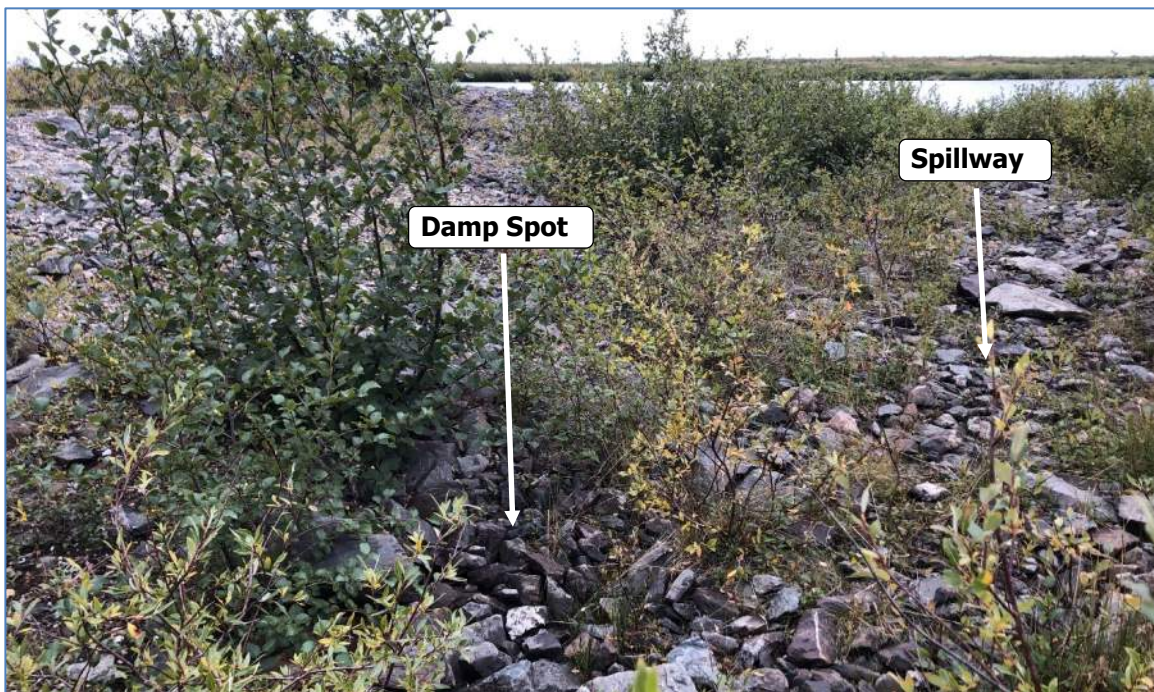
The TP1 spillway was visually inspected. The spillway appeared to have more vegetation growth compared to 2020, as shown in Photo 4. The inspection revealed that the rockfill covering the liner in the spillway works as intended thus confirming that addition of fine rockfill in 2005 sufficiently addressed the issue. The small erosion of the rockfill on the south bank of the spillway was noted to be in a similar condition as in 2020. Small areas of the liner became exposed in this area most likely due to a steeper grade. The rockfill in the spillway should be monitored for erosion and rockfill replaced if the exposed areas become larger.

Photo 4: No water visible in TP1 spillway (looking up-spillway towards the pond).

- the condition of the TP1 spillway continues to be monitored for erosion and if any is apparent, remedial measures, such as the addition of additional rockfill, be implemented;
- the water levels are monitored for how they serve as cover for the tailings;
- Wet Spot 1 and the “wet spot” are monitored during each subsequent visit;
- the cracking first identified in 2017 is monitored during each subsequent visit;
- routine inspections should be provided by Barrick personnel during their site visits to collect water samples, and

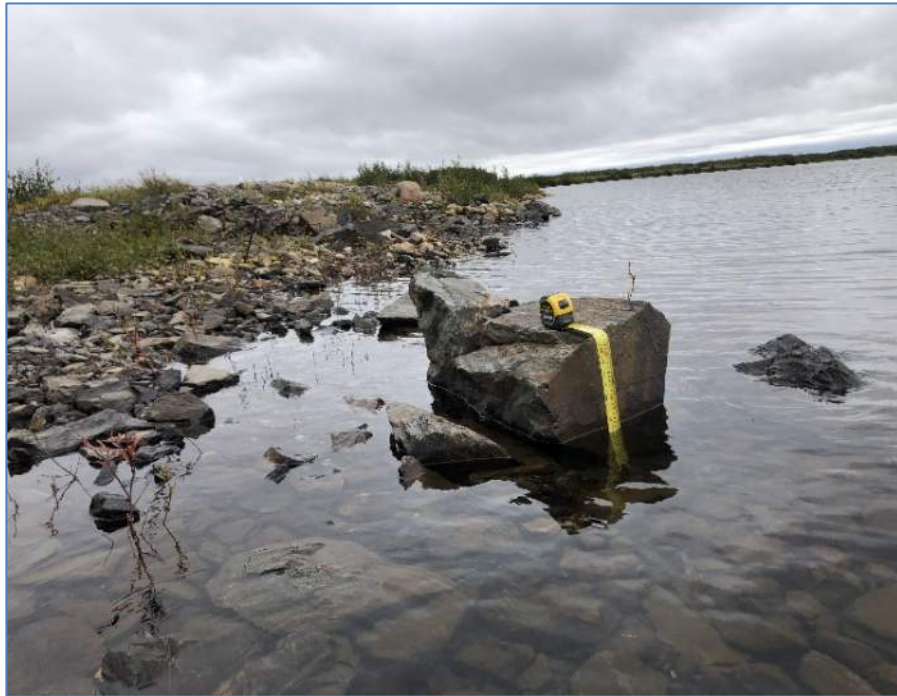
Photo 5: Measuring tape fixed on rock - water level is at 0.23 m and top of rock at 0.43 m.

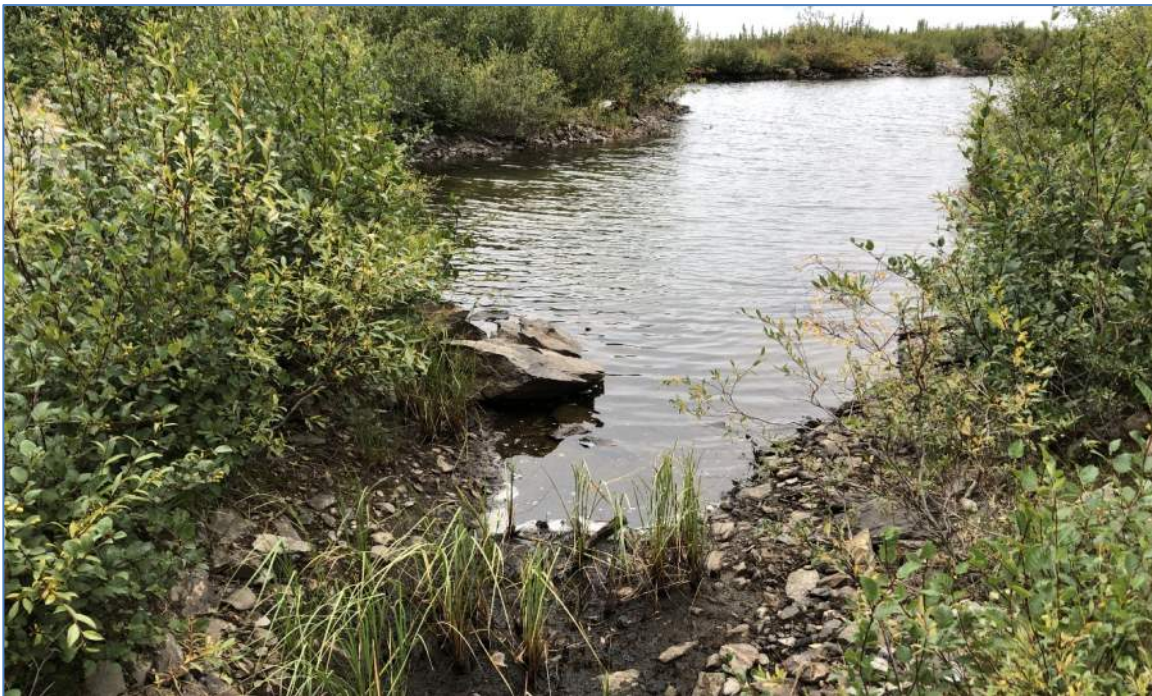
Photographs of the quarry and the low area downstream of the TP1 spillway were taken and compared to the photographs taken in previous years. The comparison indicated that the water level in the quarry was lower in 2022 than in 2020 but higher than in both 2018 and 2017 as shown in Photo 6. The water level in the low area downstream of the TP1 spillway appeared to be slightly higher this year compared to 2020 and higher than observed in 2018 and 2017.

Photo 6: Water level in the quarry (looking southeast).

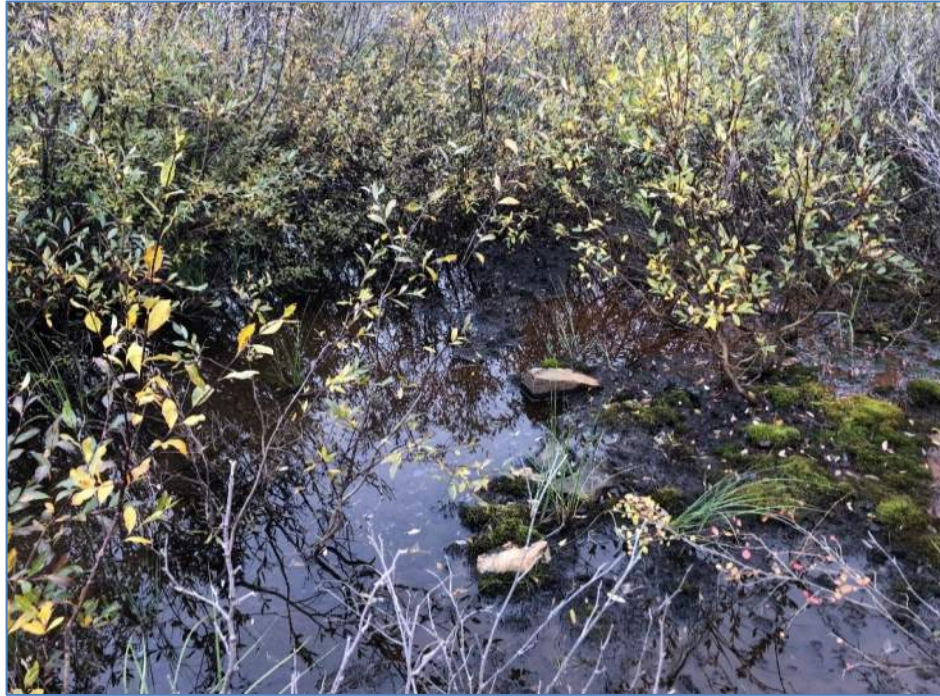
Photo 7: Wet Spot 1.

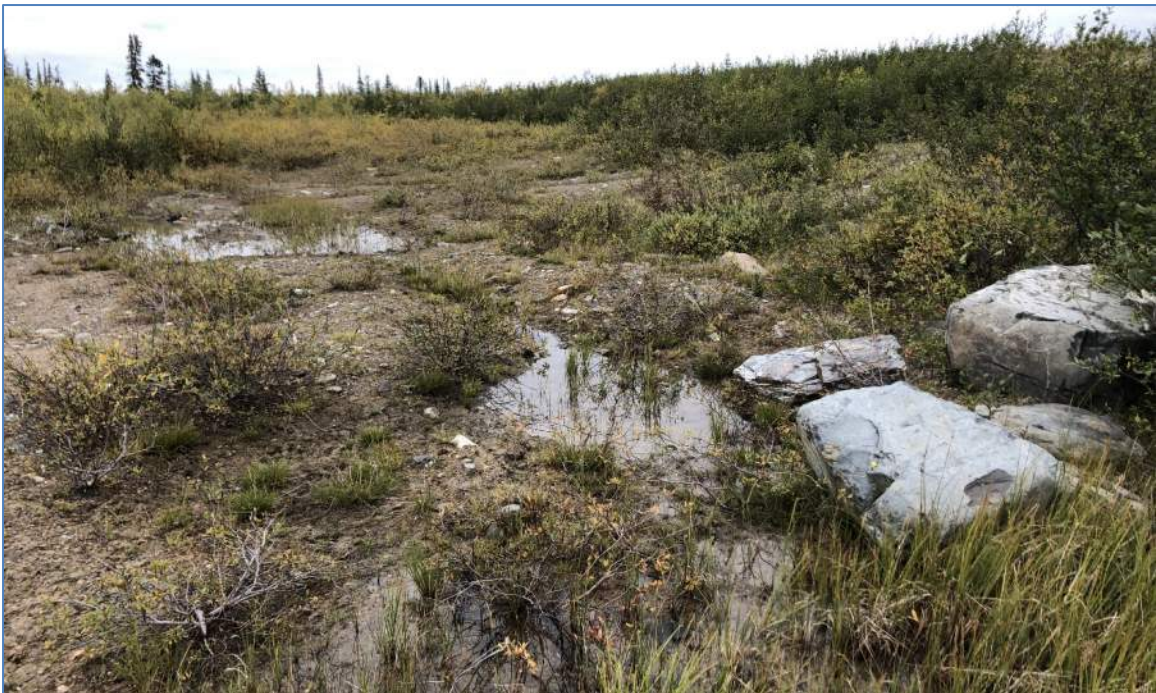
Wet Spot 2 first identified in 2018 was observed in 2022. Wet Spot 2 is on the north side of the dam near the water sampling point 940-22, about 15 m downstream of the dam toe. Wet Spot 2 had some standing water by the cluster of boulders like in 2020 with the addition of some ponding further to the east, as shown in Photo 8. Wet Spot 2 was estimated to be about 1.2 m below the water level in TP1. The area might be affected by the drainage from the surrounding area.

Photo 8: Wet Spot 2.

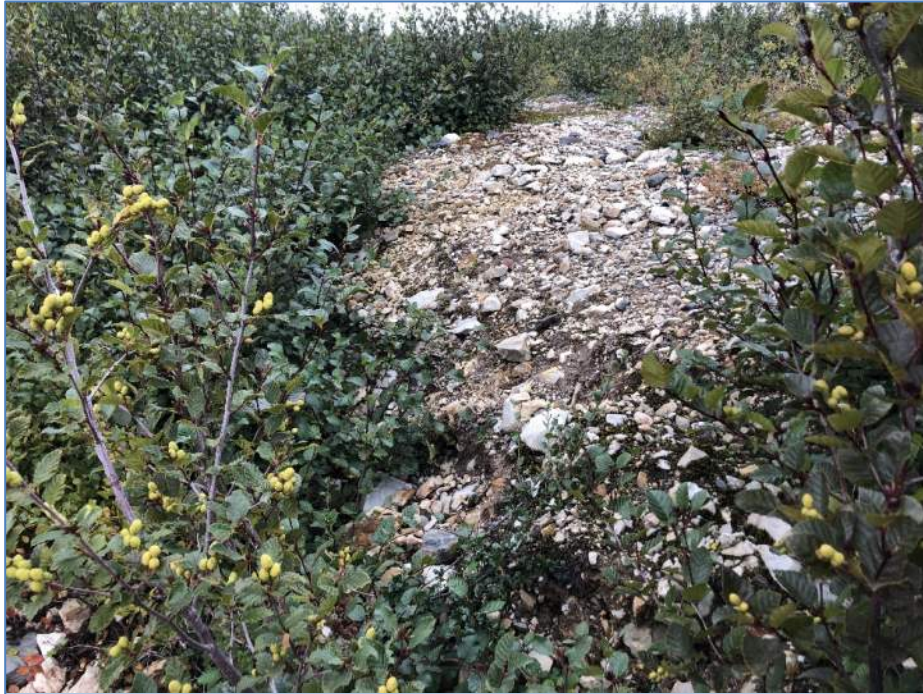
Minor sloughing observed in 2020 on the upstream slope south of the low point was observed in 2022, as shown in Photo 11. Minor sloughing was also observed on the north side of the dam on the upstream slope, as shown in Appendix A.

Photo 11: Minor sloughing on the upstream slope south of the low point.

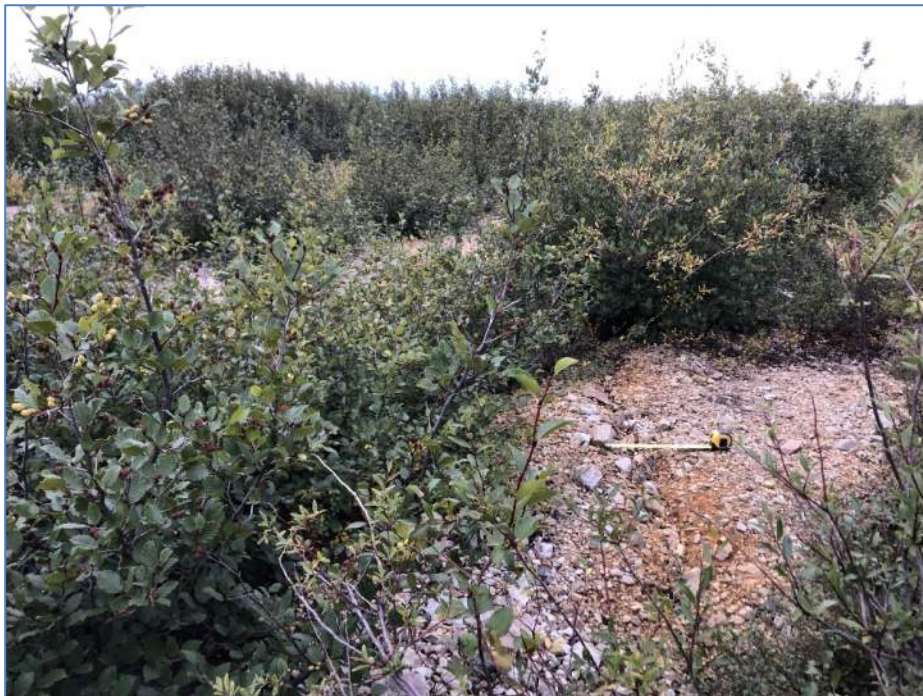
Localized longitudinal cracking first identified in 2017 was observed in 2022, as shown in Photo 12. The cracking was located where the access road adjoins the crest south of the spillway, as shown in Appendix A. The cracking appeared to be self-armouring with rock and vegetation. The localized surface cracking first identified in 2017 on the crest north of the spillway was not seen in 2022. These cracks do

not have an impact on Dam 1 performance. The cracking should be monitored during subsequent inspections.

Photo 12: Longitudinal cracking self-armouring with rock and vegetation.

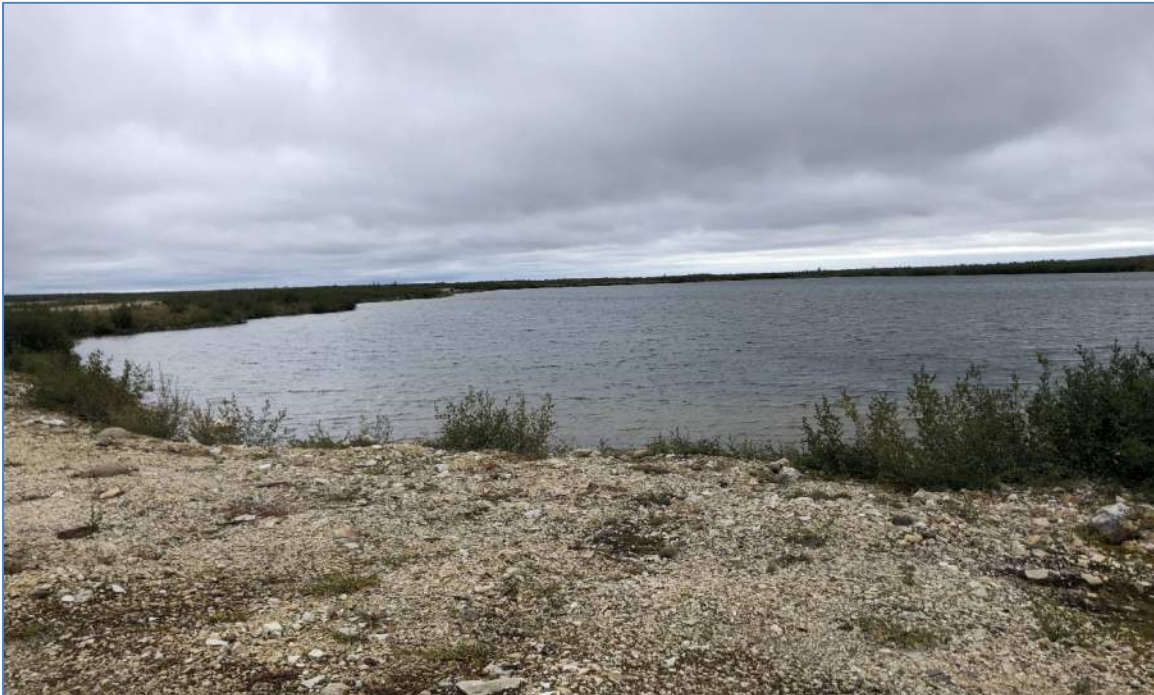
No unsubmerged or exposed tailings were observed within the pond. Photos 13 and 14 show the overall view of the pond and the west side of the pond.

Photo 13: TP1 (looking south).

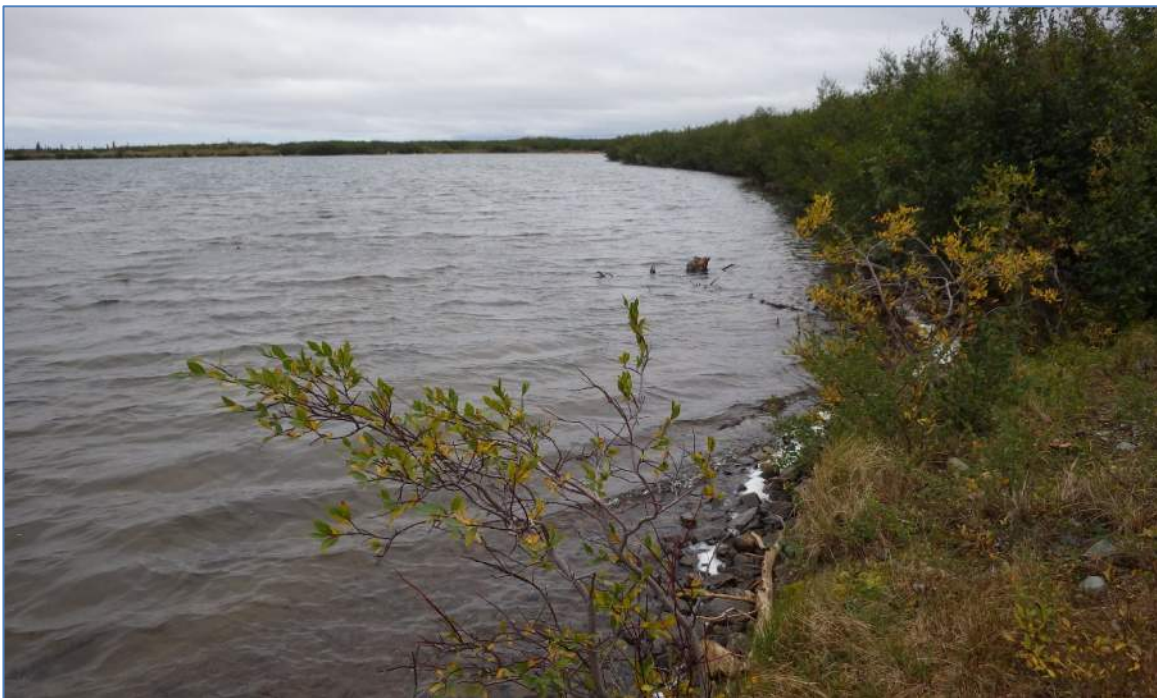
Photo 14: West side of TP1 pond with water level near vegetation line (looking south).

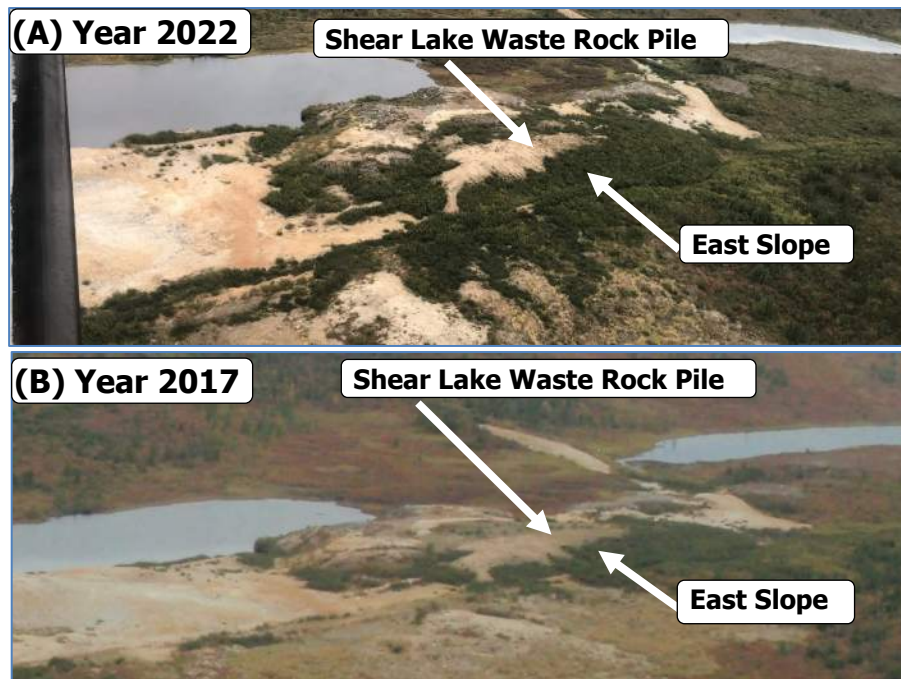
Photos 18, 19 and 20 compare vegetation growth on the Shear Lake waste rock pile between 2022 and 2017. The comparison indicates that the vegetation has improved since 2017, especially on the side slopes. Photos 18 and 19 show improved vegetation on the east slope. Photo 19 features a white rock observed on the east slope in 2022 and 2017. The rock is exposed in 2017 and hardly visible in 2022 due to vegetation growth. Photo 20 shows vegetation growth improvement on the south slope. The vegetation growth is still sparse on the top of the pile, as shown in Photo 21.

Photo 18: East slope – aerial view comparison 2022 vs. 2017 (looking northwest).

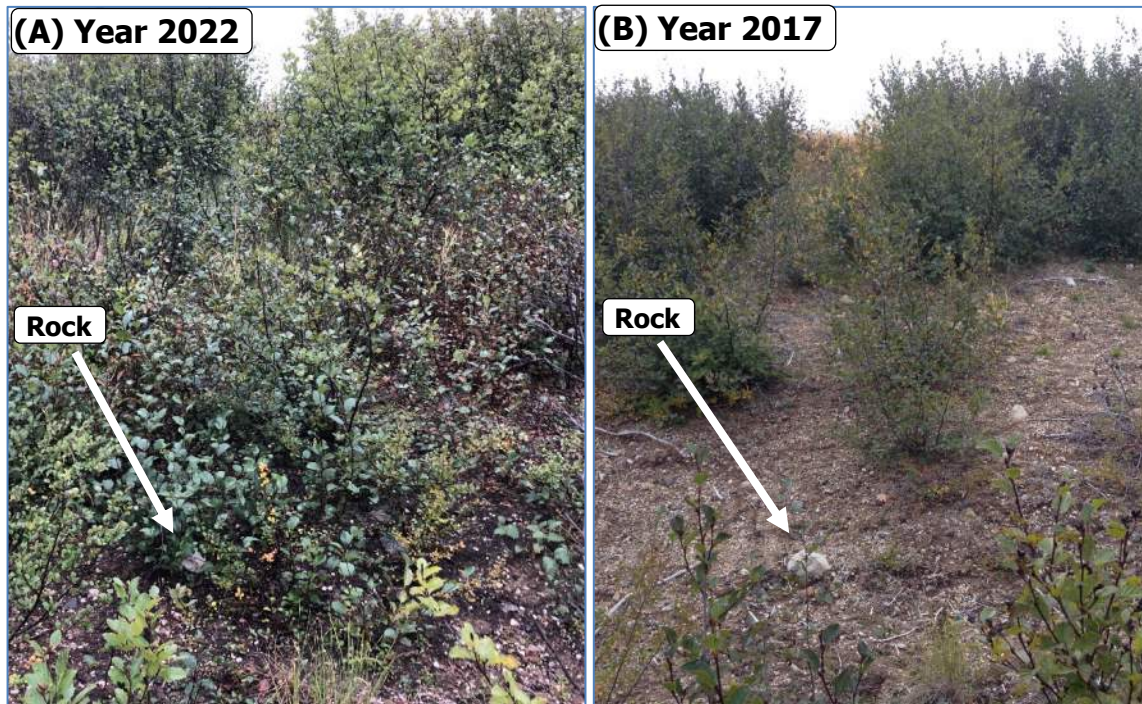
Photo 19: Stable gravel/till covered east slope (looking west) – 2022 vs. 2017 comparison.

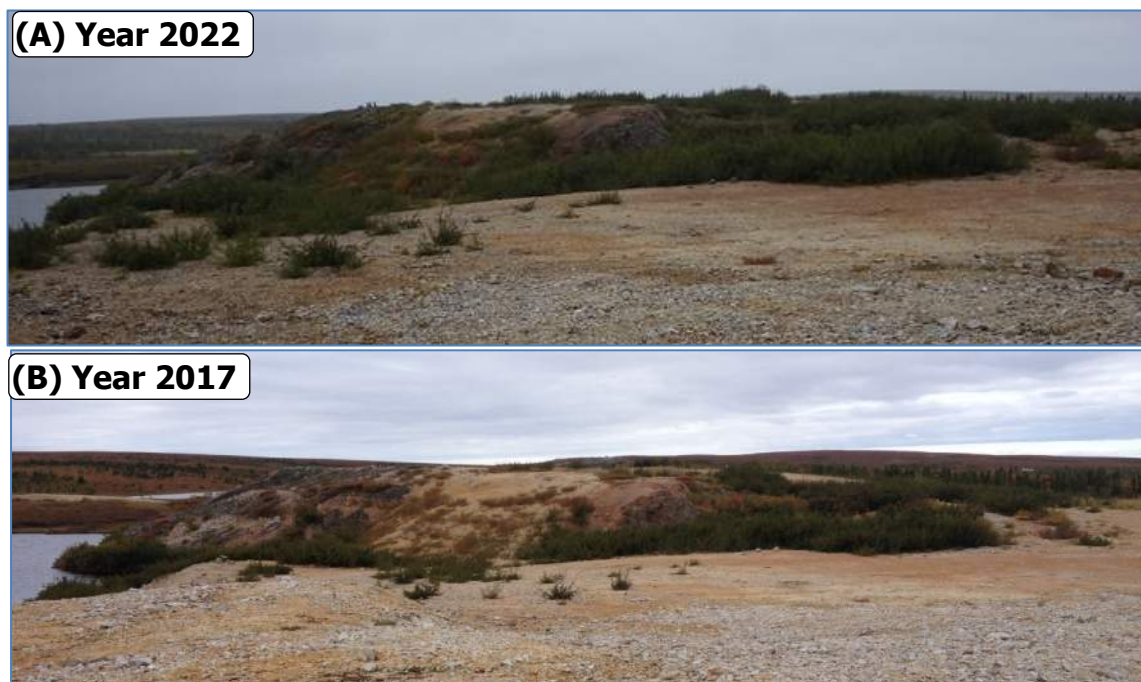
Photo 20: South slope (looking north) – 2022 vs. 2017 comparison.

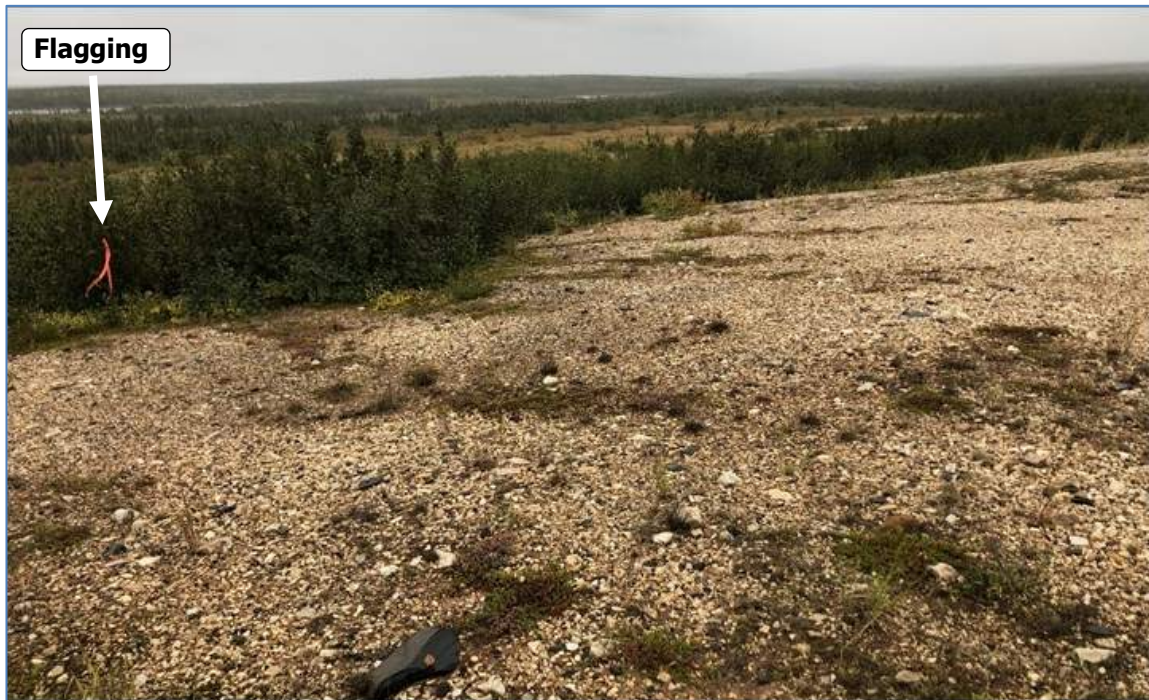
Photo 21: Top of Shear Lake waste rock pile (looking southeast).

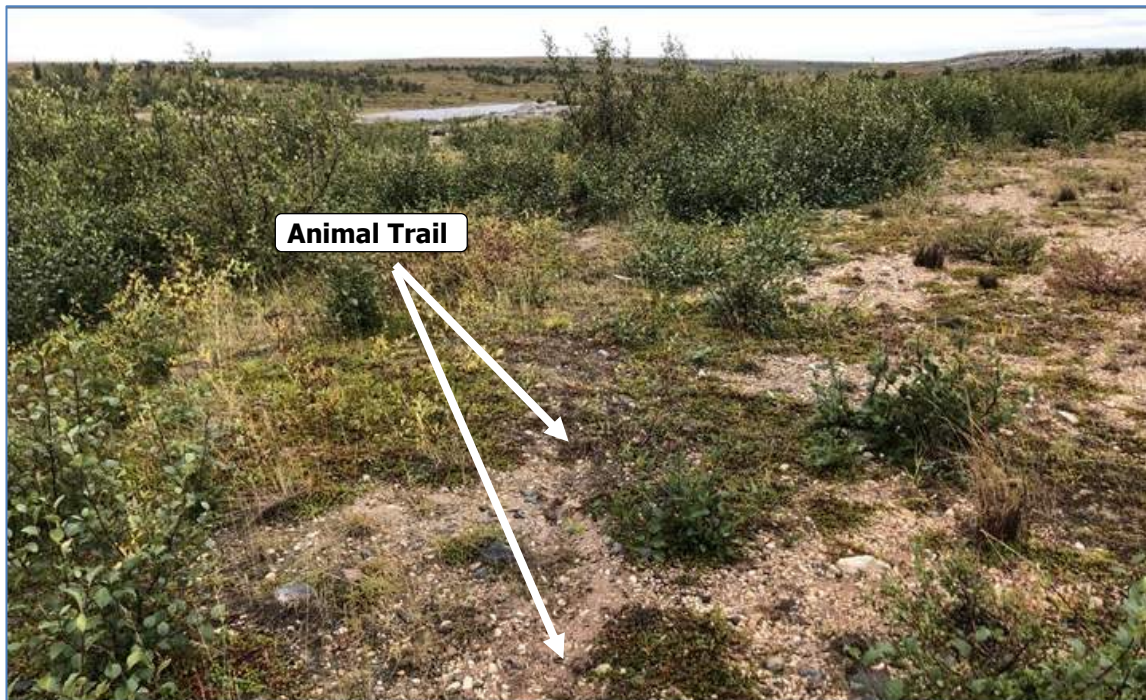
A shallow channel with numerous animal tracks was observed crossing the top of the pile, as shown in Photo 22. The narrow shape of the channel and the presence of animal tracks strongly suggest that the feature was caused by animals.

Photo 22: Animal trail on top of Share Lake waste rock pile (looking northwest).

The vegetation/till cover system has been proving to be increasingly effective over the last five years. Subsequent inspections should be made to monitor the efficacy of the vegetation/till cover system and the time when the vegetation establishes itself fully. It might take several more years for the vegetation to establish itself fully. Any erosion gullies that form should be repaired with fine rock/gravel.
