**Re: Water License NWB1CUL0207 – Part C, 1d – Annual Geotechnical Report**

**Reference No. F-90132**

### **2003 Tailings Dam Examination Cullaton Lake Gold Mine, Nunavut**

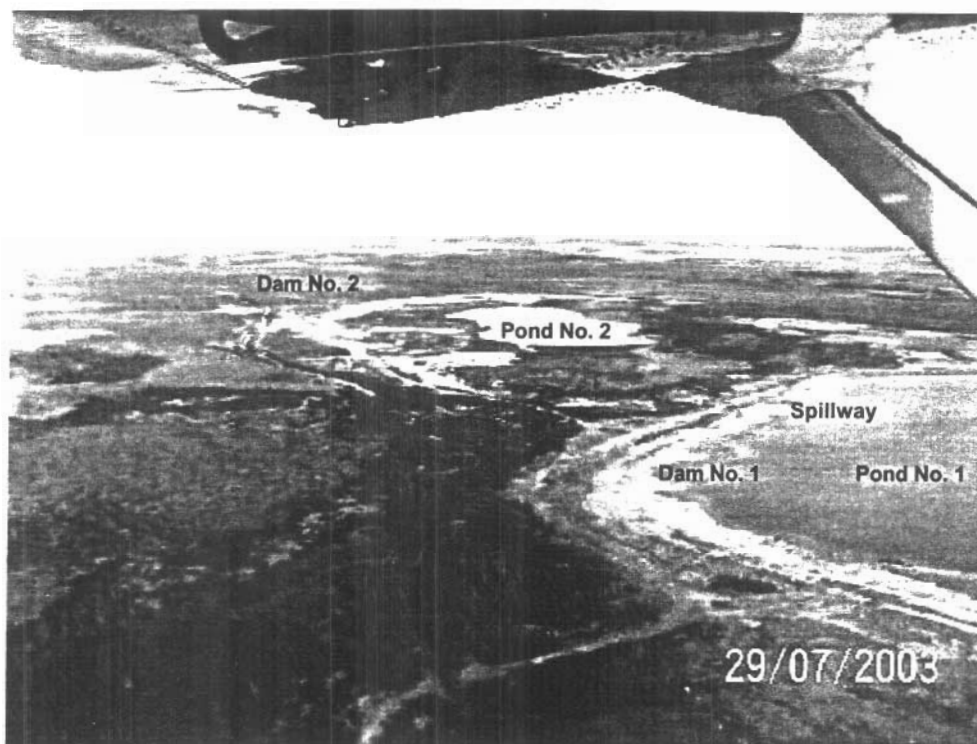
Photo 1: Tailings facility - looking east

The field examination was carried out by Mr. Demetri Georgiou, P.Eng. on July 29, 2003. Photos 1 and 2, attached, show oblique views of the site taken from the air on the date of the site examination, July 29, 2003. The tailings area had been previously covered with local till as reported in Trow's previous inspection reports. Vegetation on the till covered tailings is small and sparse. However, it is noted that the density of the vegetation is increasing, based on the comparative visual observations of previous years.

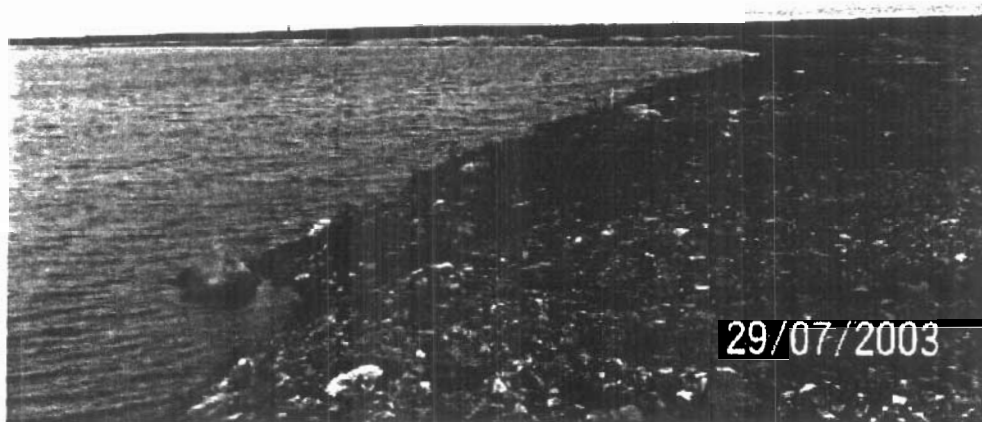
Photo 3: Dam No. 1 - looking along crest

Photos 3 and 4 show views of Dam No. 1. Typically, the embankment, which is constructed principally with local cohesionless till, is irregular in section and surface grade. Average side slopes of the upstream and downstream sides were typically about 3H:1V and 6H:1V, respectively. The downstream side was estimated to be as steep as about 3H:1V in a few areas. The dam height ranges up to about 4 m. Some small erosion scars were observed on both the upstream and downstream sides, however, as described below, they appear to be stabilizing with vegetation and self-armouring with larger rock particles from the till and previously placed mine waste rock. The crest width varies but is in the order of 15 m. No seepages were observed on the day of inspection.

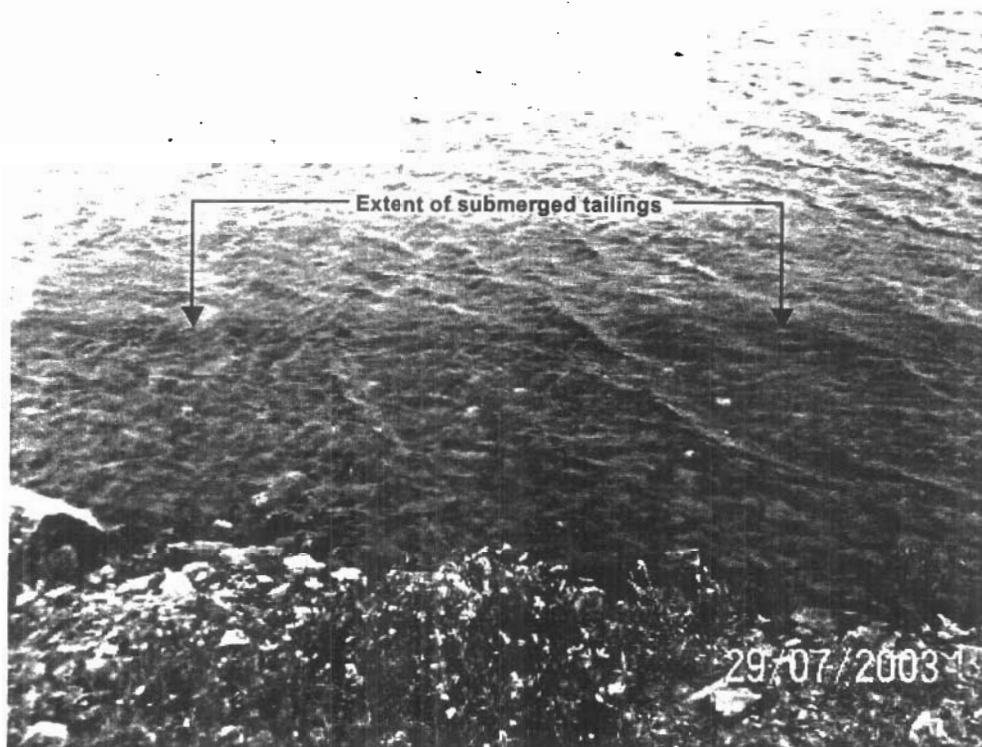
Photo 5: Upstream toe of Dam No. 1

Within the tailings pond itself, no unsubmerged tailings were observed. Photo 5 shows submerged tailings in the pond. Photo 6 shows that vegetation has taken hold on the dam slopes.

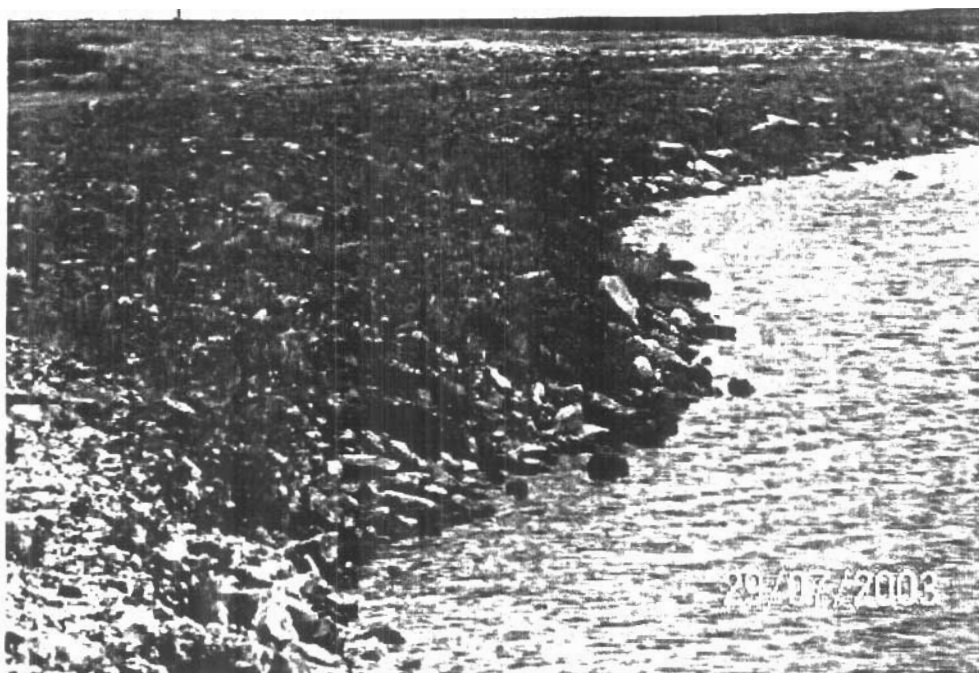
Photo 6: Upstream section of Dam No. 1 showing vegetation and self-armouring of the toe.

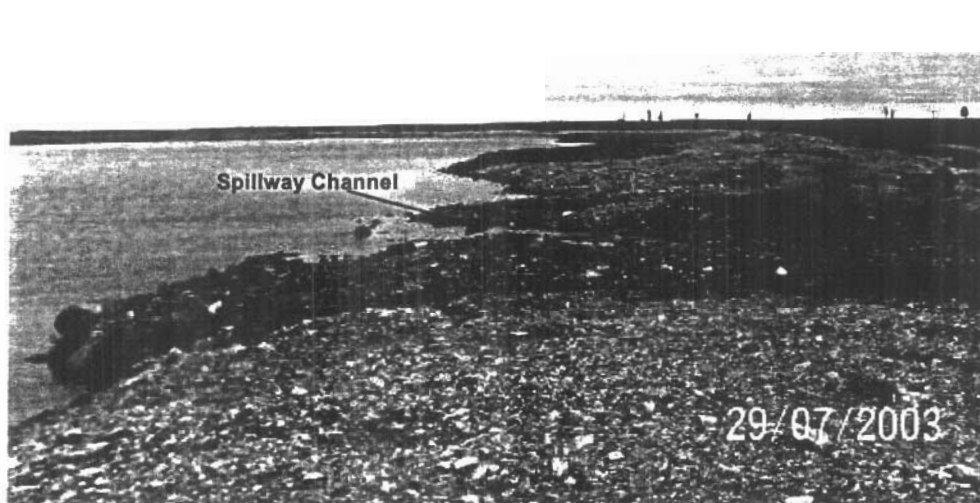
Photo 7: View of Dam No. 1 and spillway channel inlet

Photos 7 and 8 show views of the spillway channel. We note that the weir has been removed since our 2001 inspection. The Pond No. 1 level was estimated to be at an elevation of about 94.0 m, approximately at the spillway crest level and minor flow was occurring over the spillway, as can be seen in Photo 8. This is approximately the same water level that was observed in the 1994, 1996 and 2001 examinations when the levels were at about 94.0 m, and slightly higher than the 93.7 m estimated in 1999. The difference in water levels is likely due to natural seasonal hydrologic variations, including precipitation, infiltration, runoff and evaporation.

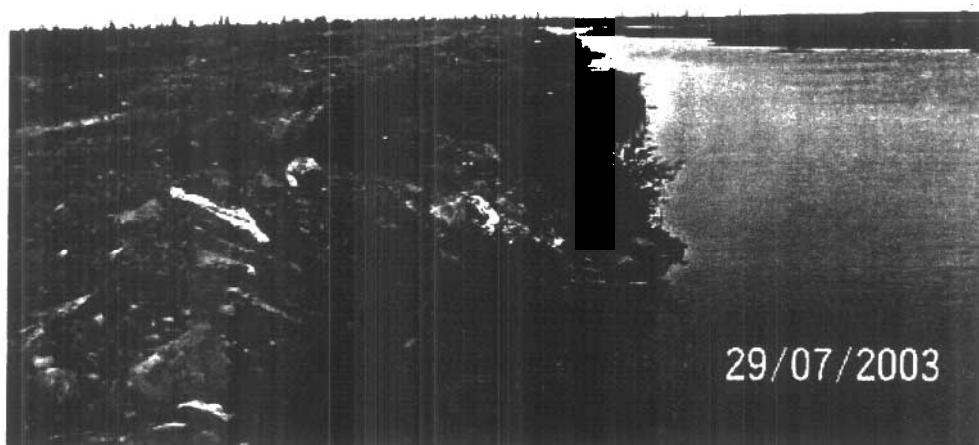
Photo 9: View of Dam No. 2 crest and pond

Photos 9 and 10 show views of Dam No. 2. As with the No. 1 dam, the principal construction material is local cohesionless till. The dam section and surface grade is irregular, although less so than the No. 1 dam. The crest width varies but is in the order of 15 m. No seepages were observed on the day of examination. Based on our 2003 as well as previous inspections and involvement with the project, the dam is not in any distress and is considered to be stable.
