February 9, 2005

Reference: F-90132

***2004 Tailings Dam Examination
Cullaton Lake Gold Mine, Nunavut
Licence NWB1CUL020***

Current Inspection - July 2004

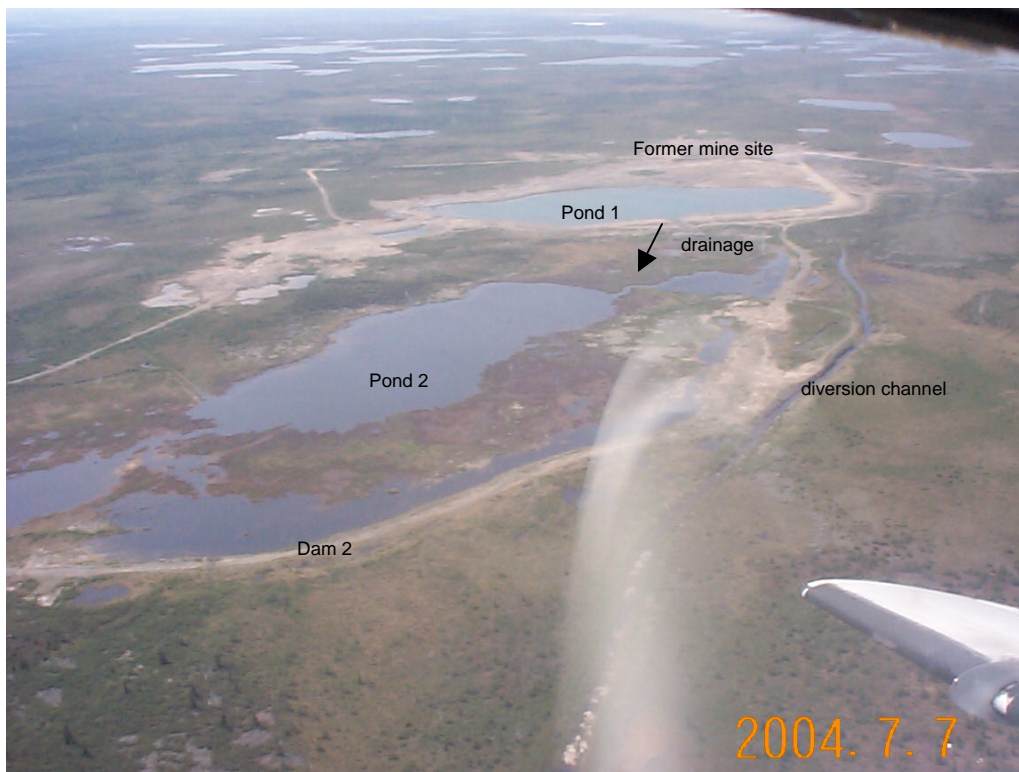
The field examination was carried out by Mr. Demetri Georgiou, P.Eng. on July 7, 2004. Photos 1 and 2, attached, show oblique views of the site taken from the air on the date of the site examination, July 7, 2004. The tailings area had been previously covered with local till as reported in Trow's previous inspection reports. Vegetation on the till covered tailings is small and sparse. However, it is noted that the density of the vegetation is increasing, based on the comparative visual observations of previous years.

Photo 1: Tailings facility – looking west

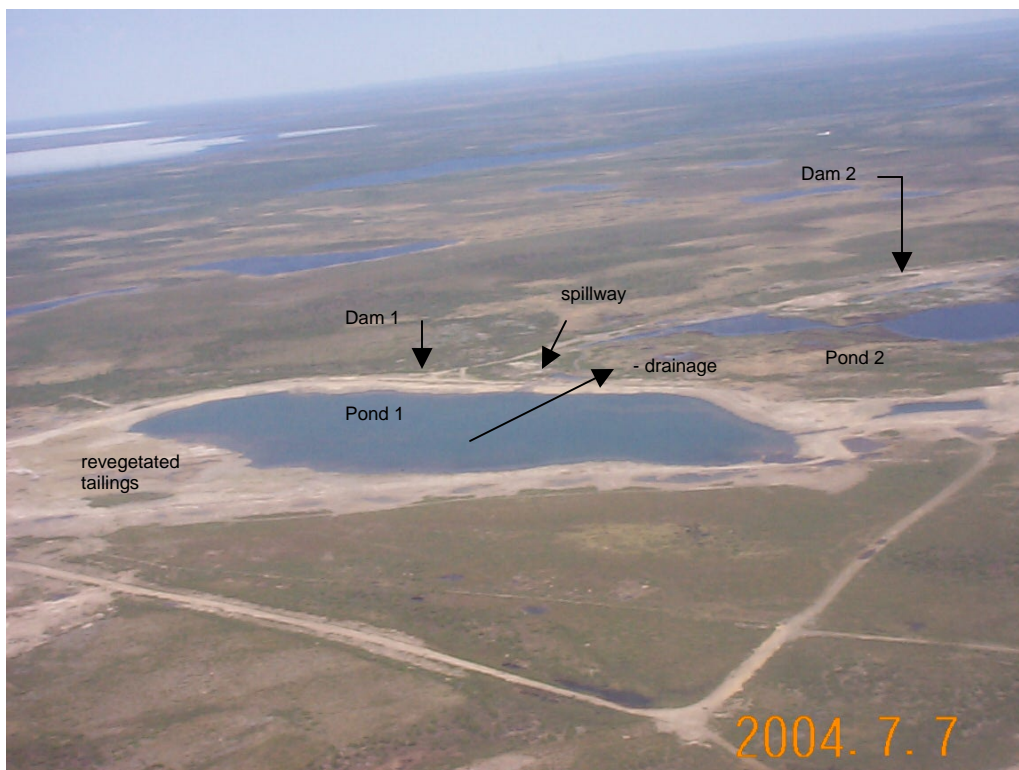
Photo 2: Tailings facility looking east

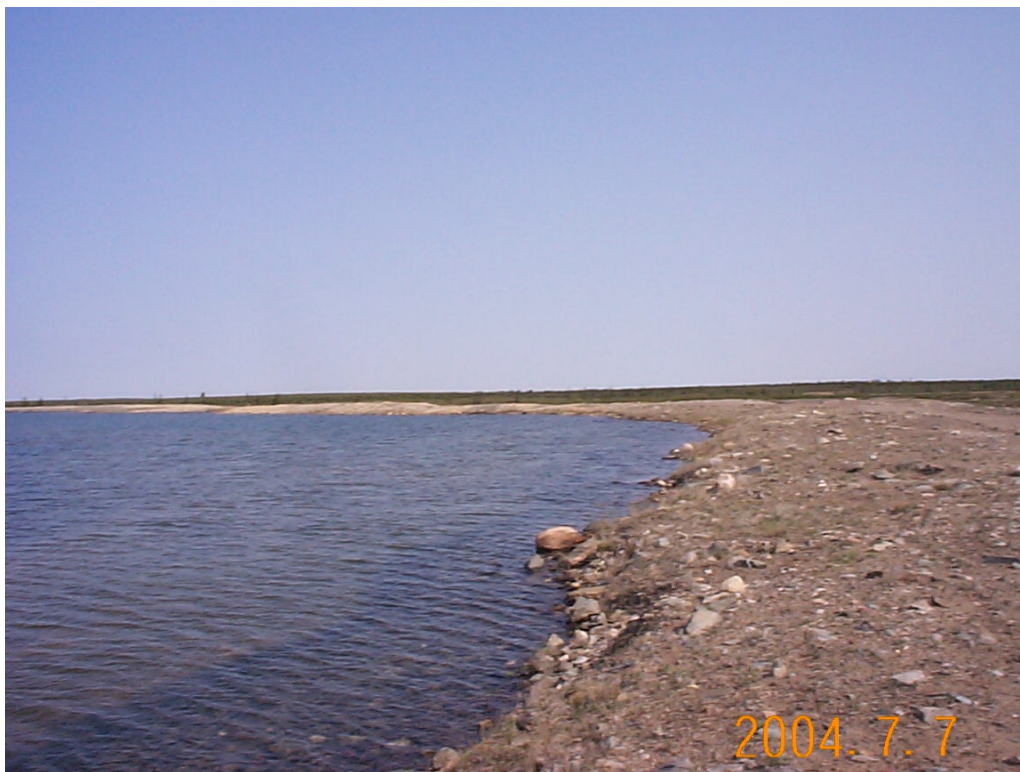
Photos 3 and 4 show views of Dam No. 1. Typically, the embankment, which is constructed principally with local cohesionless till, is irregular in section and surface grade. Average side slopes of the upstream and downstream sides were typically about 3H:1V and 6H:1V, respectively. The downstream side was estimated to be as steep as about 3H:1V in a few areas. The dam height ranges up to about 4 m. Some small erosion scars were observed on both the upstream and downstream sides; however, as described below, they appear to be stabilizing with vegetation and self-armouring with larger rock particles from the till and previously placed mine waste rock. The crest width varies but is in the order of 15 m. No seepages were observed on the day of inspection.

Based on the current as well as previous inspections and involvement with the project, the dam is not in any distress and is considered to be stable.

Photo 3: Dam No. 1 - looking northeast

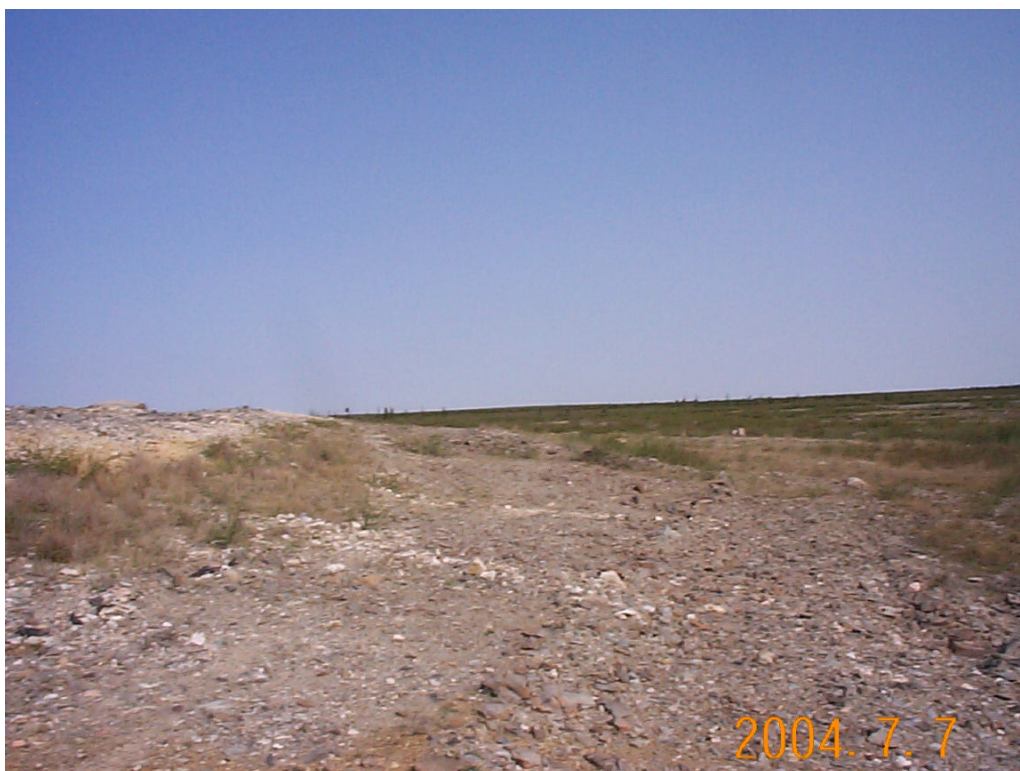
Photo 4: Downstream section of Dam No. 1

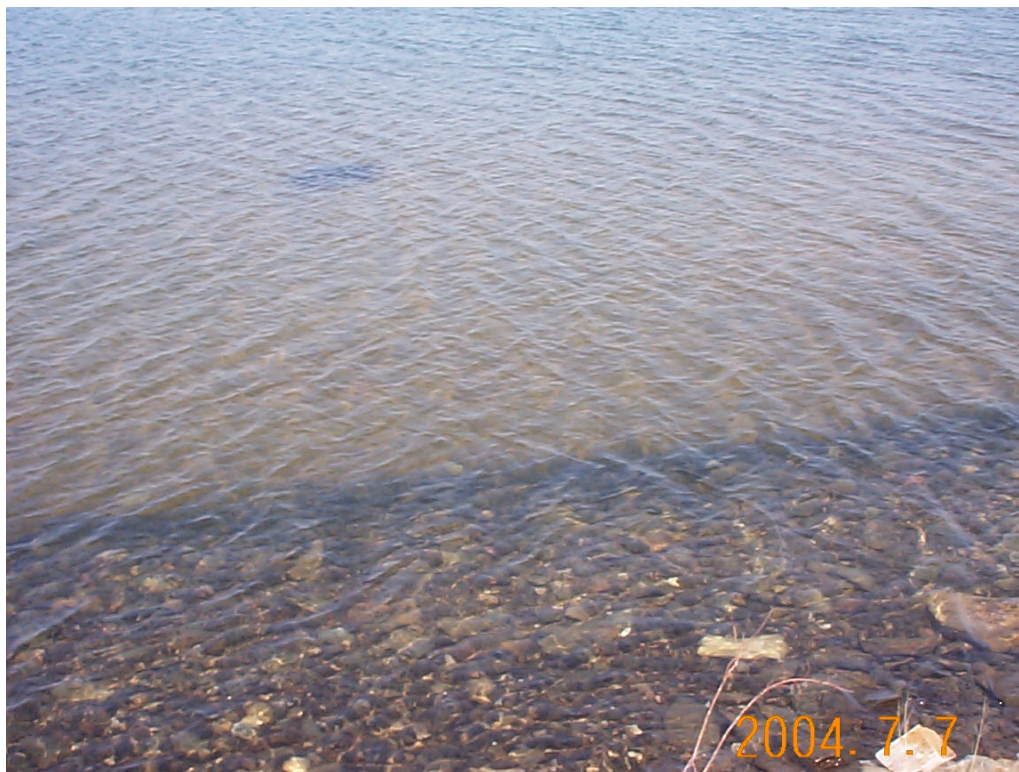
Within the tailings pond itself, no unsubmerged or exposed tailings were observed. Photo 5 shows submerged tailings in the pond.

Photo 5: Edge of submerged tailing in Pond 1

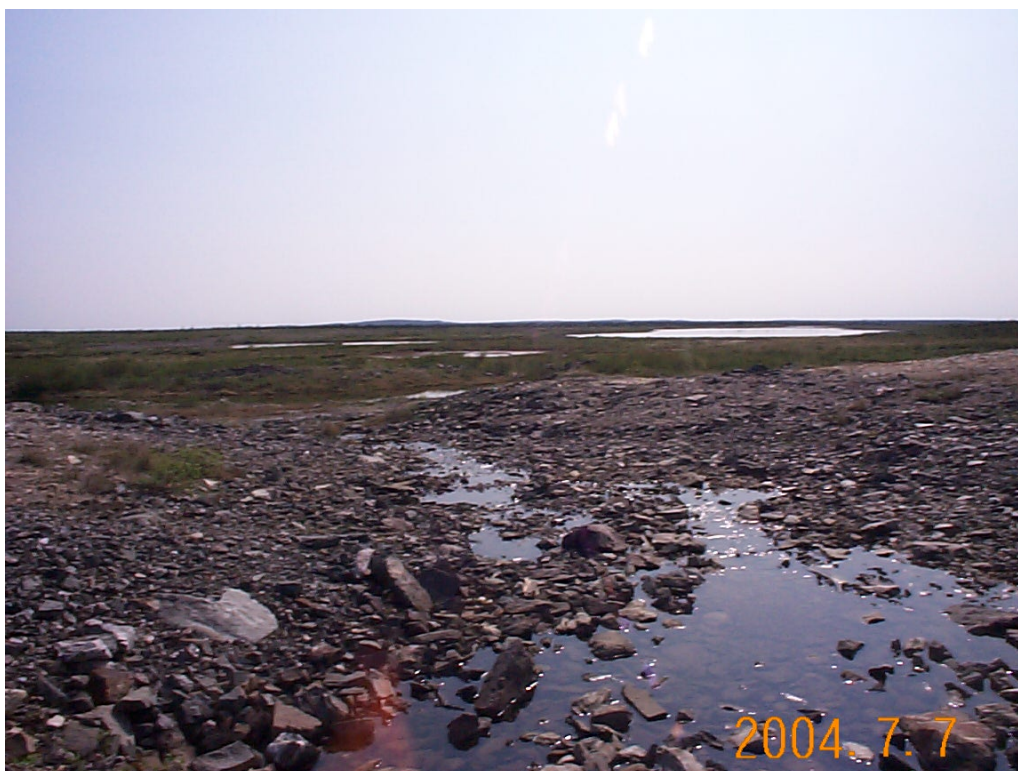
Photo 6 shows a view of the spillway channel. The Pond No. 1 level was estimated to be at an elevation of about 94.0 m, approximately at the spillway crest level and minor flow was occurring over the spillway, as can be seen in Photo 6. This is approximately the same water level that was observed in the 1994, 1996 and 2001 examinations when the levels were at about 94.0 m, and slightly higher than the 93.7 m estimated in 1999. The difference in water levels is likely due to natural seasonal hydrologic variations, including precipitation, infiltration, runoff and evaporation.

Portions of the rubber liner in the spillway channel were exposed, as they were in 1996. No repairs were made subsequent to the recommendation of 1996. We have not observed any change in the configuration since this was identified. However, at issue is the potential for the liner to degrade and expose the underlying cohesionless subsoil. This could conceivably subject the channel base to erosion during periods of high runoff, ultimately creating an erosion channel which would lower the nominal pond level, thereby exposing the tailings. At worst, an erosion breach could occur, resulting in the loss of tailings into Pond 2. Accordingly, it is considered prudent to restore the design configuration of the spillway channel.

Photo 6: Dam No. 1 Spillway Channel looking downstream to Pond 2

It is recommended that the rubber liner in the Dam 1 spillway be repaired and restored to its original design configuration, to ensure that it is recovered with the appropriate rip-rap, such that erosion of the subbase does not occur.

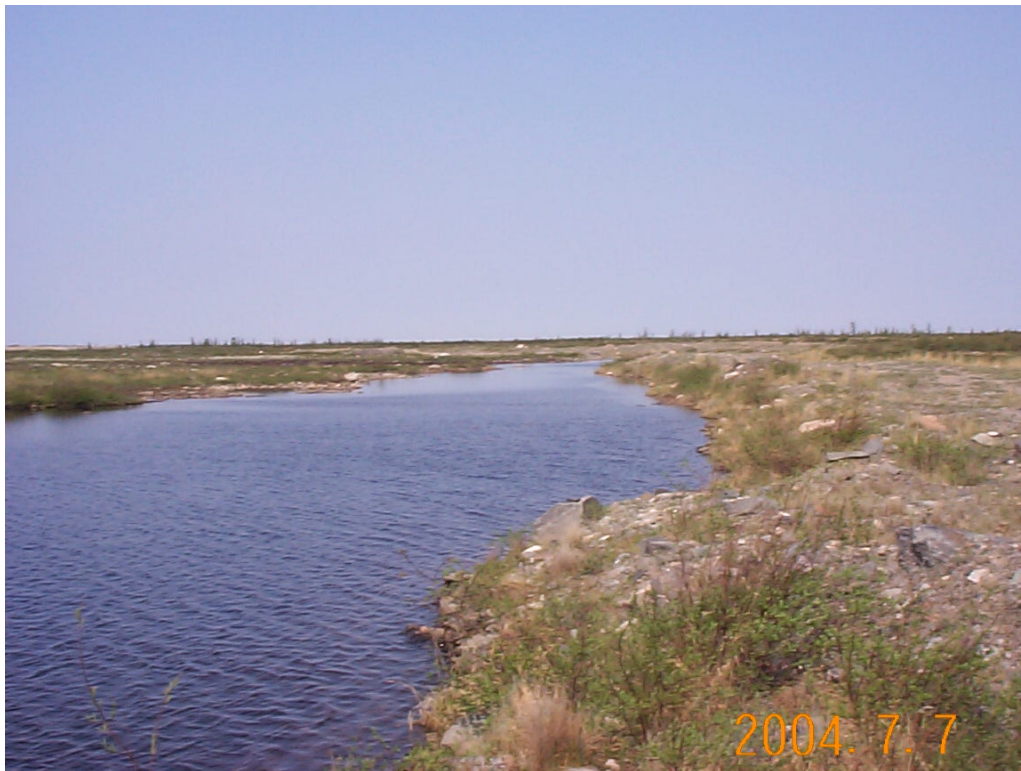
Photo 7 shows a view of Dam No. 2. As with the No. 1 dam, the principal construction material is local cohesionless till. The dam section and surface grade is irregular, although less so than the No. 1 dam. The crest width varies but is in the order of 15 m. No seepages were observed on the day of examination. Photo 8 shows a view of the Dam 2 spillway channel. Based on our 2003 as well as previous inspections and involvement with the project, the dam is not in any distress and is considered to be stable.

Photo 7: View of Dam 2 and pond

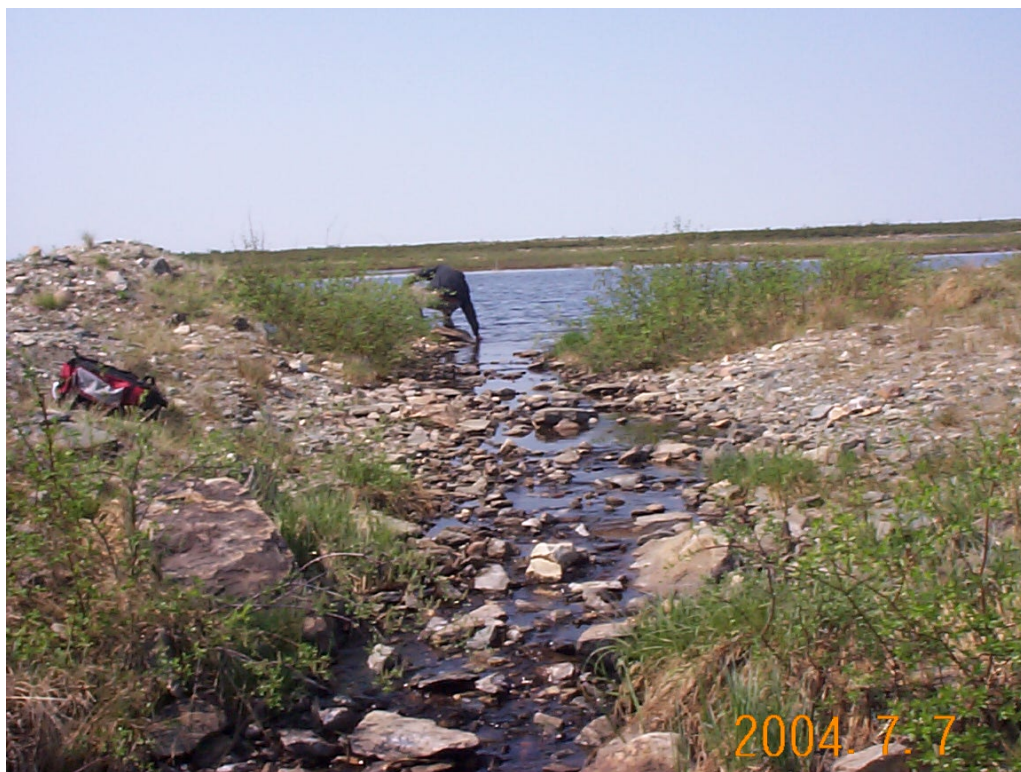
Photo 8: View of Dam 2 Spillway looking upstream
