October 3, 2005

Reference: F-90132

***2005 Tailings Dam Examination  
Cullaton Lake Gold Mine, Nunavut  
Licence NWB1CUL020***

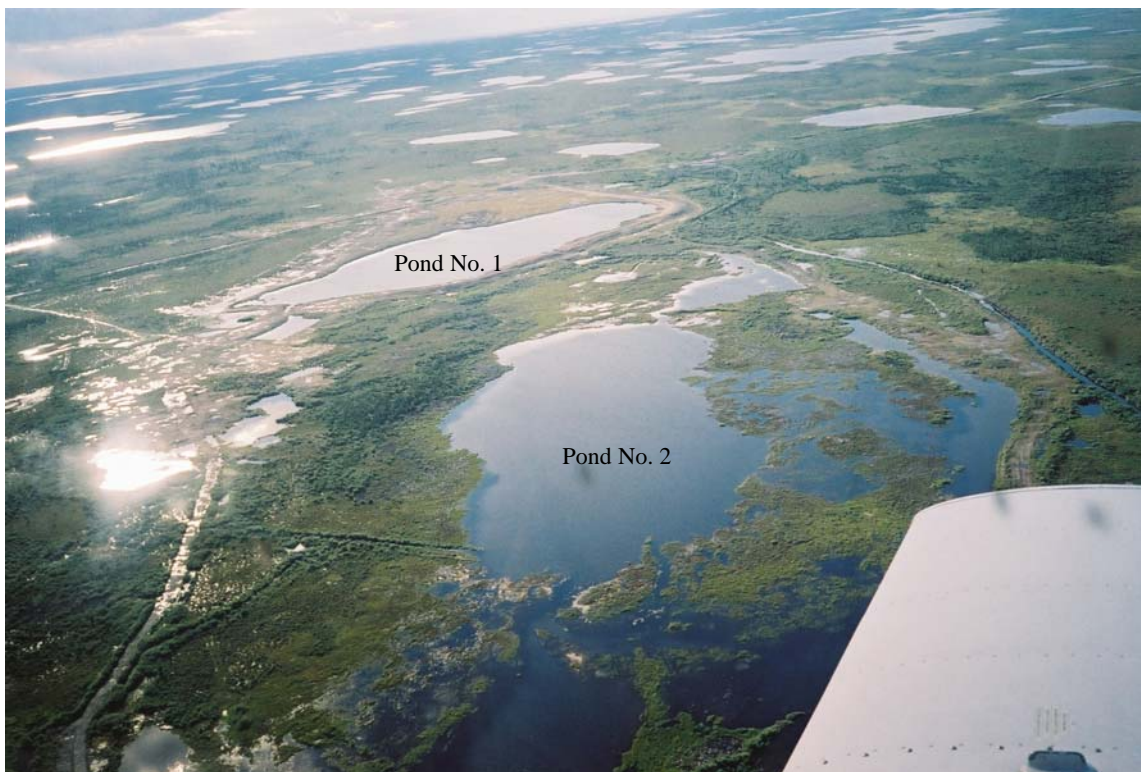
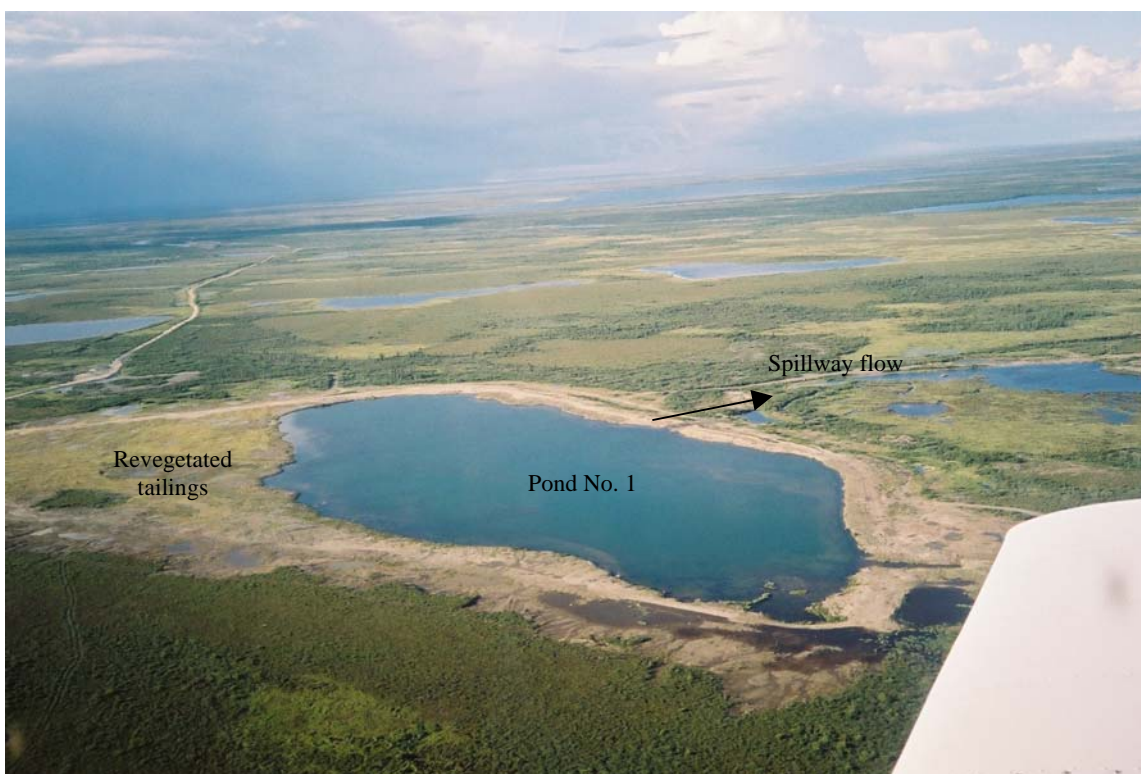
Photos 1 and 2, attached, show oblique views of the site taken from the air on the second day of the site examination, August 3, 2005. The tailings area had been previously covered with local till as reported in Trow's previous inspection reports. Vegetation on the till covered tailings is small and sparse. However, it is noted that the density of the vegetation is increasing gradually, based on the comparative visual observations of previous years.

*Photo 1: Tailings facility – looking northwest*

*Photo 2: Tailings facility looking southwest*

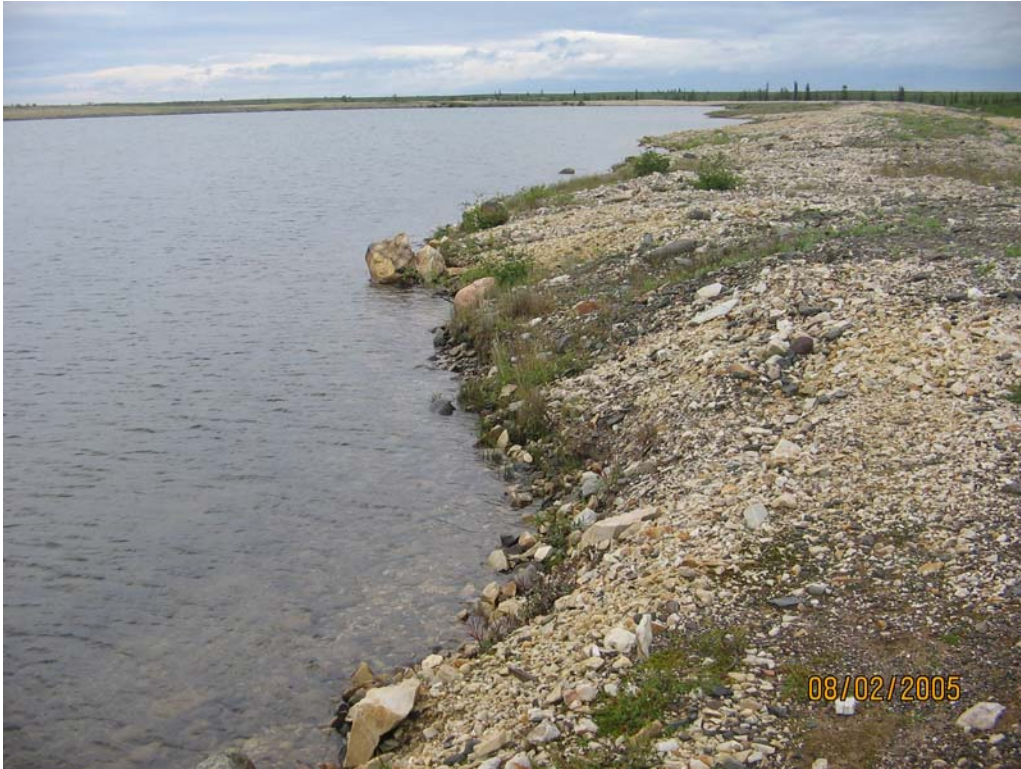
Photos 3 and 4 show views of Dam No. 1. Typically, the embankment, which is constructed principally with local cohesionless till, is irregular in section and surface grade. Average side slopes of the upstream and downstream sides were typically about 3H:1V and 6H:1V, respectively. The downstream side was estimated to be as steep as about 3H:1V in a few areas. The dam height ranges up to about 4 m. Some small erosion scars were observed on both the upstream and downstream sides; however, as described below, they appear to be stabilizing with vegetation and self-armouring with larger rock particles from the till and previously placed mine waste rock. These scars do not appear to be increasing in size, based on visual comparisons of previous years. The crest width varies but is in the order of 15 m. No seepages were observed on the day of inspection; however, this could not be confirmed since it had been raining quite heavily on the inspection dates and considerable water was ponded in localized depressions at the downstream toe of the dam.

*Photo 3: Dam No. 1 - looking northeast*

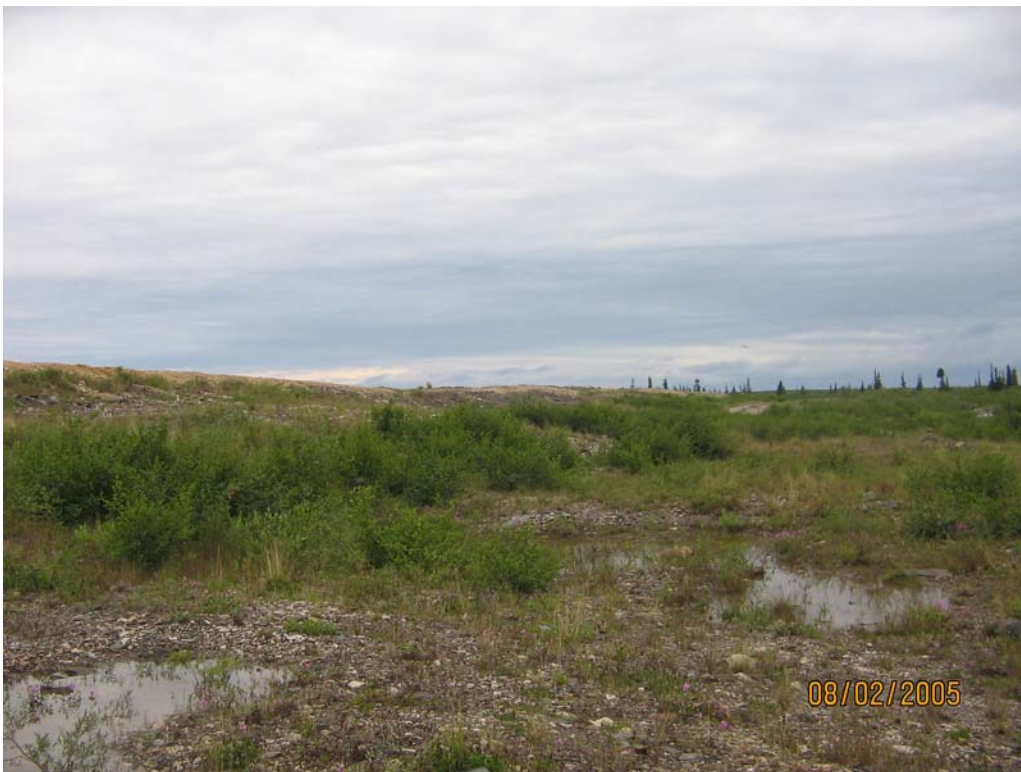
*Photo 4: Downstream section of Dam No. 1*

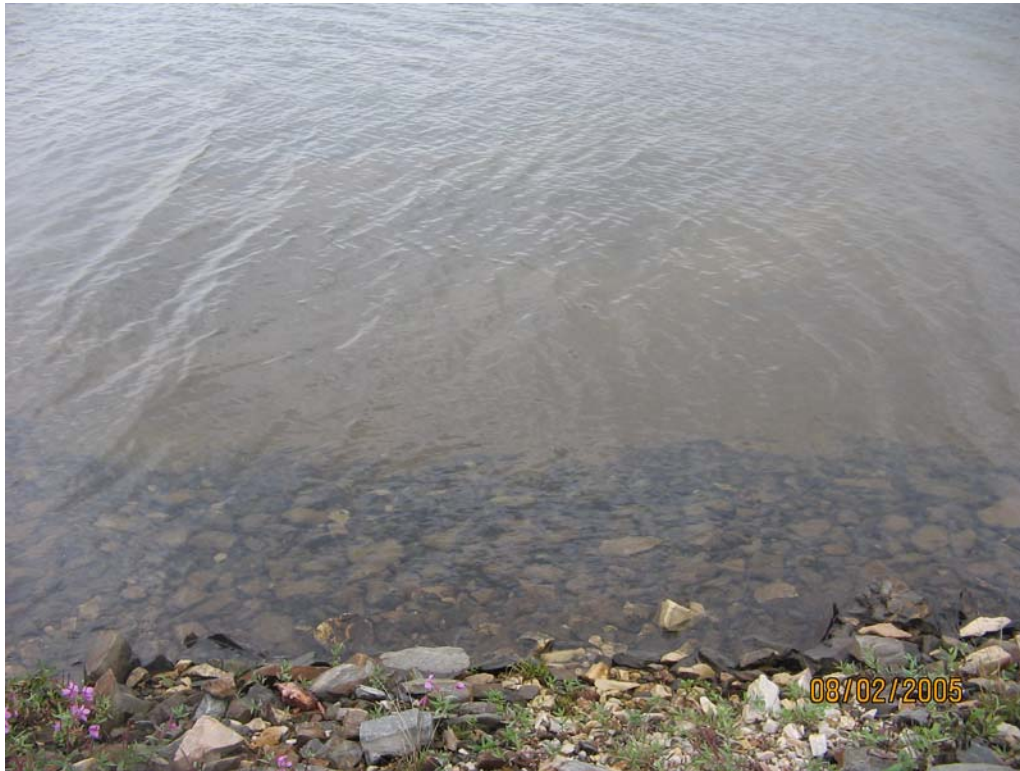
Within the tailings pond itself, no unsubmerged or exposed tailings were observed. Photo 5 shows submerged tailings in the pond.

*Photo 5: Edge of submerged tailings in Pond 1*

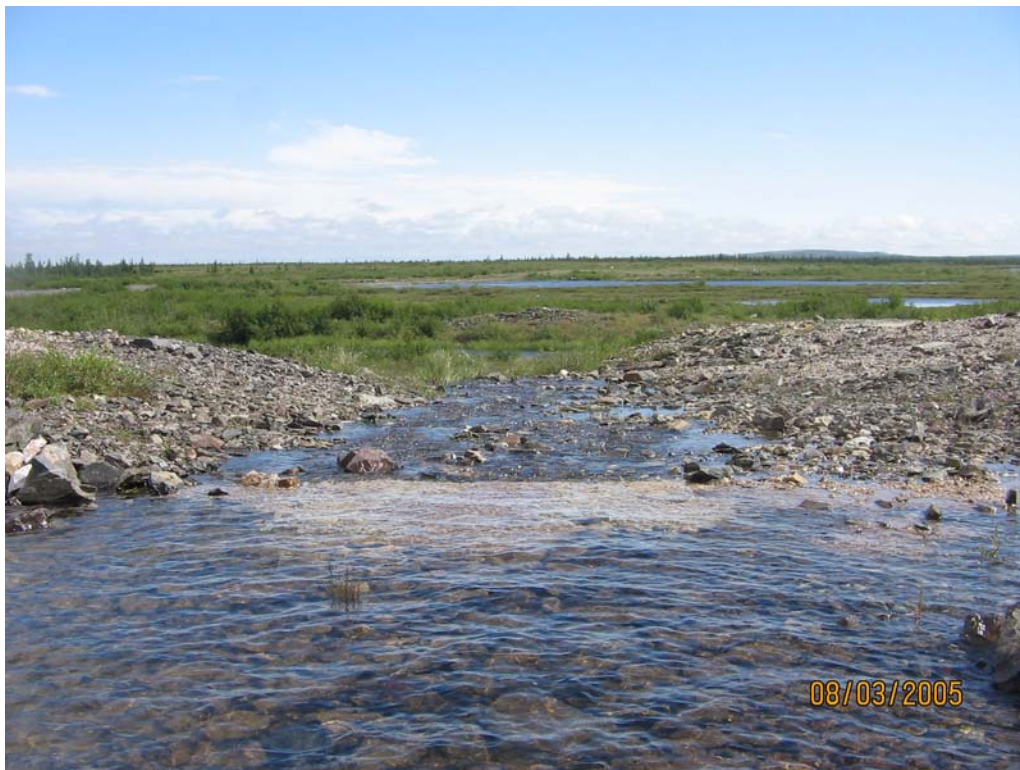
Photo 6 shows a view of the Dam No. 1 spillway channel. Flow was occurring over the spillway, to a depth of up to about 100 mm, as can be seen in Photo 6. This is slightly more than had been observed in previous years, due to the heavy rain experienced during this inspection period.

Portions of the rubber liner in the spillway channel were exposed, as observed in previous years. No repairs had been made subsequent to the recommendation of 1996, as indicated in the 2004 report. We have not observed any noticeable change in the spillway channel configuration since this was identified.

*Photo 6: Dam No. 1 Spillway looking downstream*

It is recommended that the condition of the Dam No. 1 spillway channel be monitored for erosion and if any is apparent, that the rubber liner in the Dam No. 1 spillway be repaired and restored to its original design configuration, to ensure that it is recovered with the appropriate rip-rap, such that erosion of the subbase does not occur.

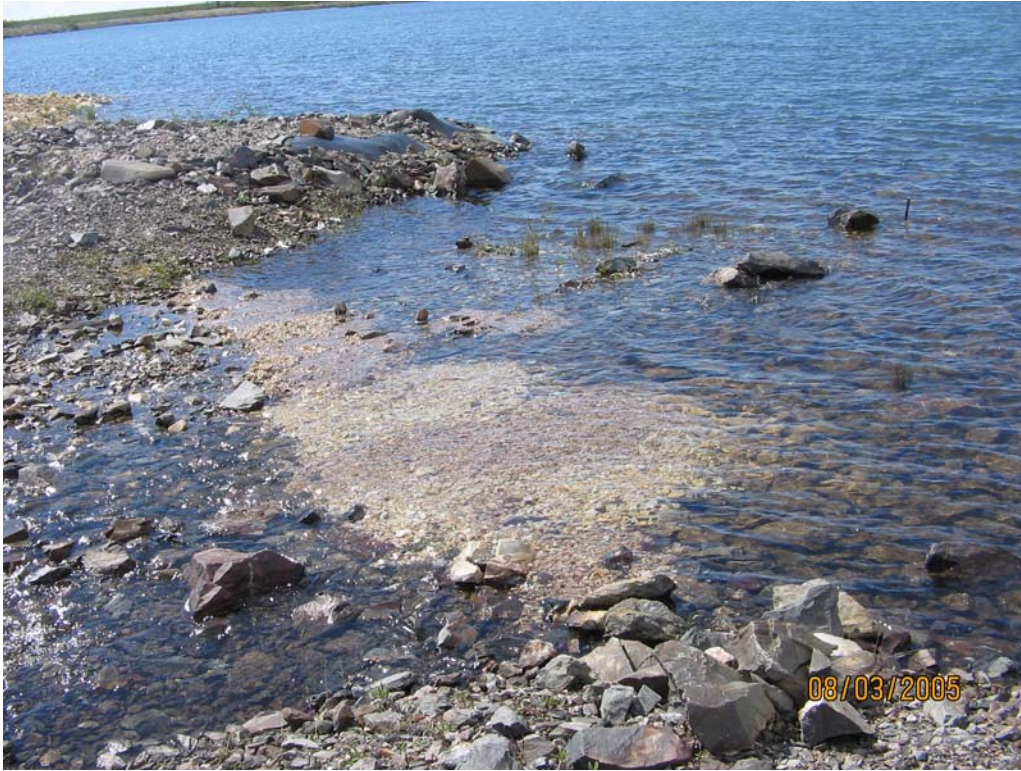
It was the intent of Barrick to facilitate repairs to the liner and spillway channel during this season's site visit, based on the recommendation made by Trow in the 2004 report. However, it is understood that last-minute logistical issues (equipment and fuel availability problems) prevented the mobilization and use of the planned power excavating equipment. Notwithstanding, some limited repairs were performed. Fine rockfill, from about 25 mm up to about 75 mm in particle size, was manually scavenged from local waste stockpiles and elsewhere across the site. This material was hauled in a small trailer pulled behind one of the ATVs that was brought to the site. The fine rockfill was manually placed in the spillway channel to cover the rubber liner, where exposed. In some areas, up to about 100 mm of material was placed and was spread as evenly as possible across the spillway channel. Photo 7 shows an area where this rockfill was placed. Since there was a lack of excavating equipment and only limited labour, no attempt was

made to excavate and restore the channel subgrade. Attempting to do so manually without the necessary power equipment, manpower and granular material stockpiled at the spillway site may have compromised the spillway channel and created irreparable problems.

The placement of this small amount (height) of rockfill will change the hydraulics of the spillway an insignificant amount, given the width of the channel and the available freeboard (which remains about 1 m).

*Photo 7: Dam No. 1 Spillway showing new fill at channel entrance*

Notwithstanding, we expect that this repair should suffice for the short term, at least, and it will be monitored over future inspections. Should erosion be observed, the repairs previously recommended should be undertaken.

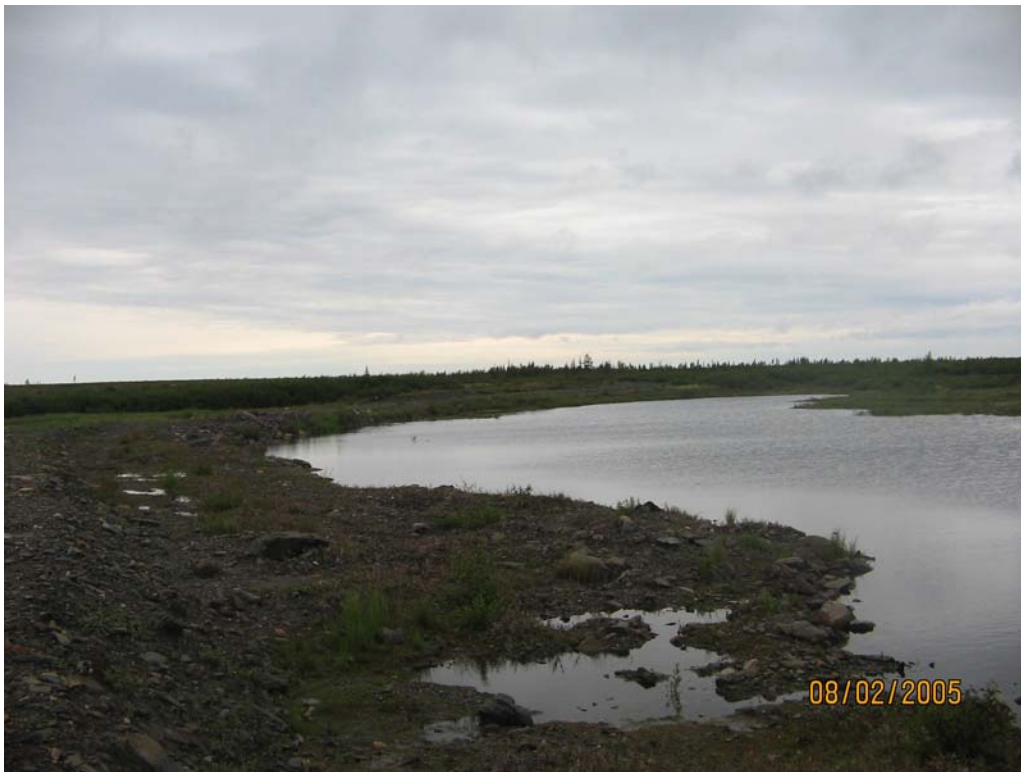
Photo 8 shows a view of Dam No. 2. As with the No. 1 dam, the principal construction material is local cohesionless till. The dam section and surface grade is irregular, although less so than Dam No. 1. The crest width varies but is in the order of 15 m. No seepages were observed on the day of examination, although the rainy weather prevented such observations. Photos 9 and 10 show upstream and downstream views of the Dam No. 2 spillway channel. Based on our 2005 as well as previous inspections and involvement with the project, the dam is not in any distress and is considered to be stable.

*Photo 8: View of Dam 2 looking south-southeast*

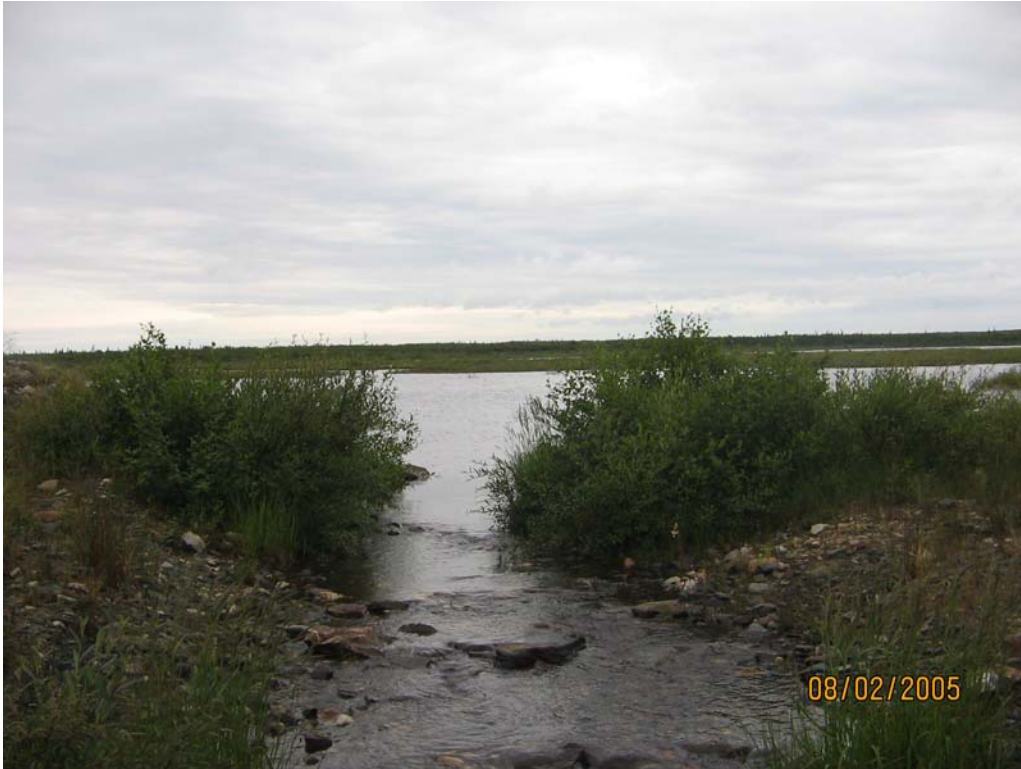
*Photo 9: Dam No. 2 Spillway looking upstream to Pond No. 2*

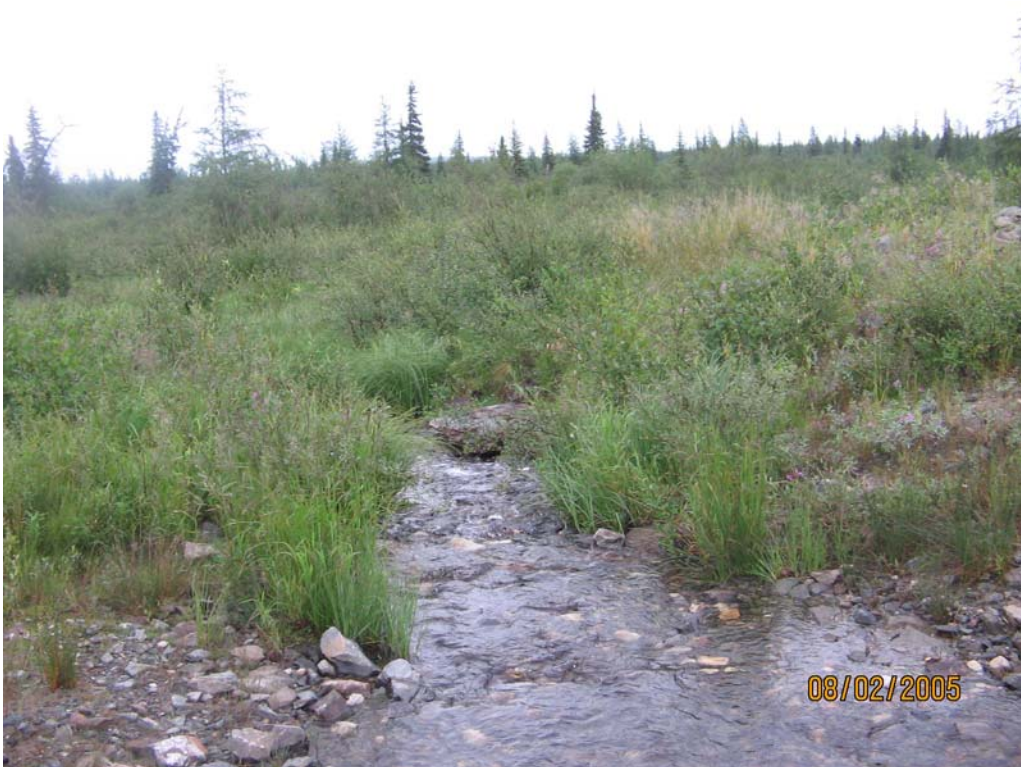
*Photo 10: Dam No. 2 Spillway looking downstream*
