October 11, 2006

Reference: F-90132

***2006 Tailings Dam Examination  
Cullaton Lake Gold Mine, Nunavut  
Licence NWB1CUL0207***

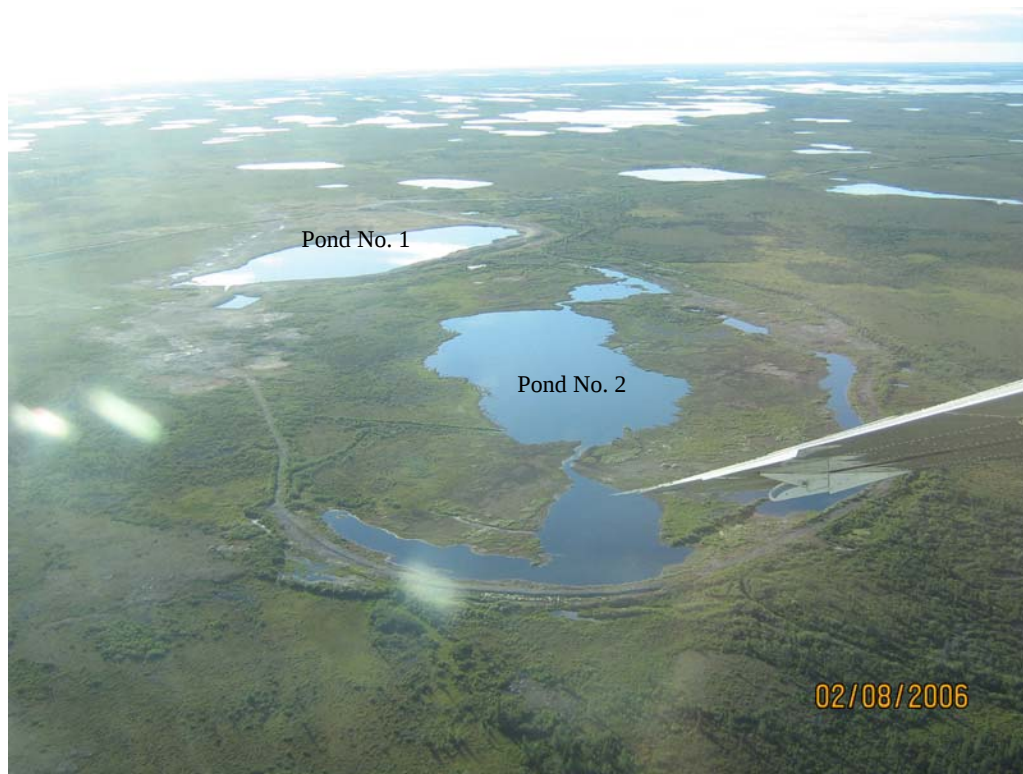
Photos 1 and 2, attached, show oblique views of the site taken from the air. The tailings area had been previously covered with local till as reported in Trow's previous inspection reports. Vegetation on the till covered tailings is small and sparse. However, it is noted that the density of the vegetation is increasing gradually, based on the comparative visual observations of previous years.

*Photo 1: Tailings facility – looking roughly west*

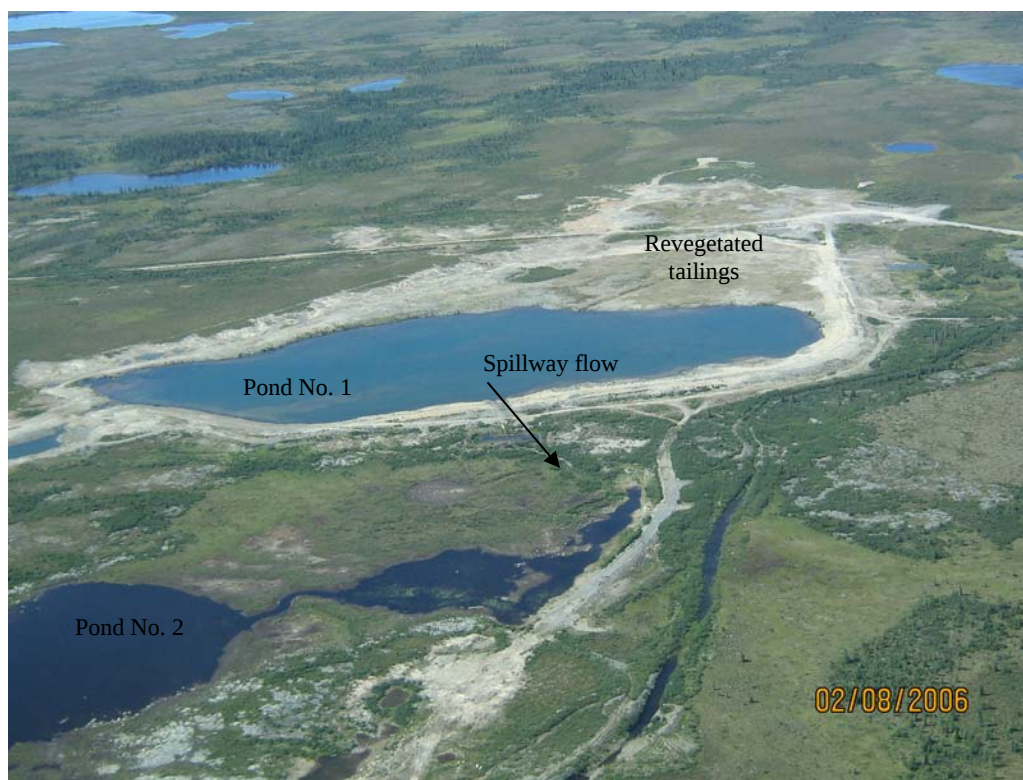
*Photo 2: Tailings facility looking roughly south*

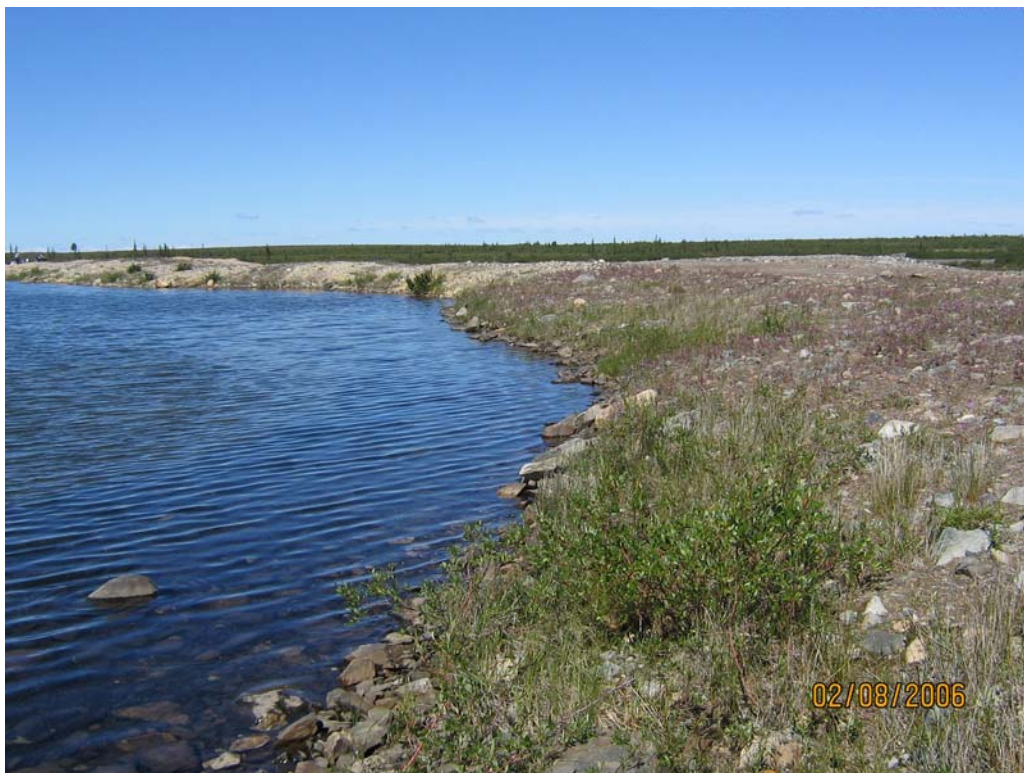
Photos 3 and 4 show views of Dam No. 1. Typically, the embankment, which is constructed principally with local cohesionless till, is irregular in section and surface grade. Average side slopes of the upstream and downstream sides were typically about 3H:1V and 6H:1V, respectively. The downstream side was estimated to be as steep as about 3H:1V in a few areas. The dam height ranges up to about 4 m. Some small erosion scars were observed on both the upstream and downstream sides; however, as described below, they appear to be stabilizing with vegetation and self-armouring with larger rock particles from the till and previously placed mine waste rock. These scars do not appear to be increasing in size, based on visual comparisons of previous years. The crest width varies but is in the order of 15 m. No seepages were observed on the day of inspection.

*Photo 3: Dam No. 1 - looking northwest*

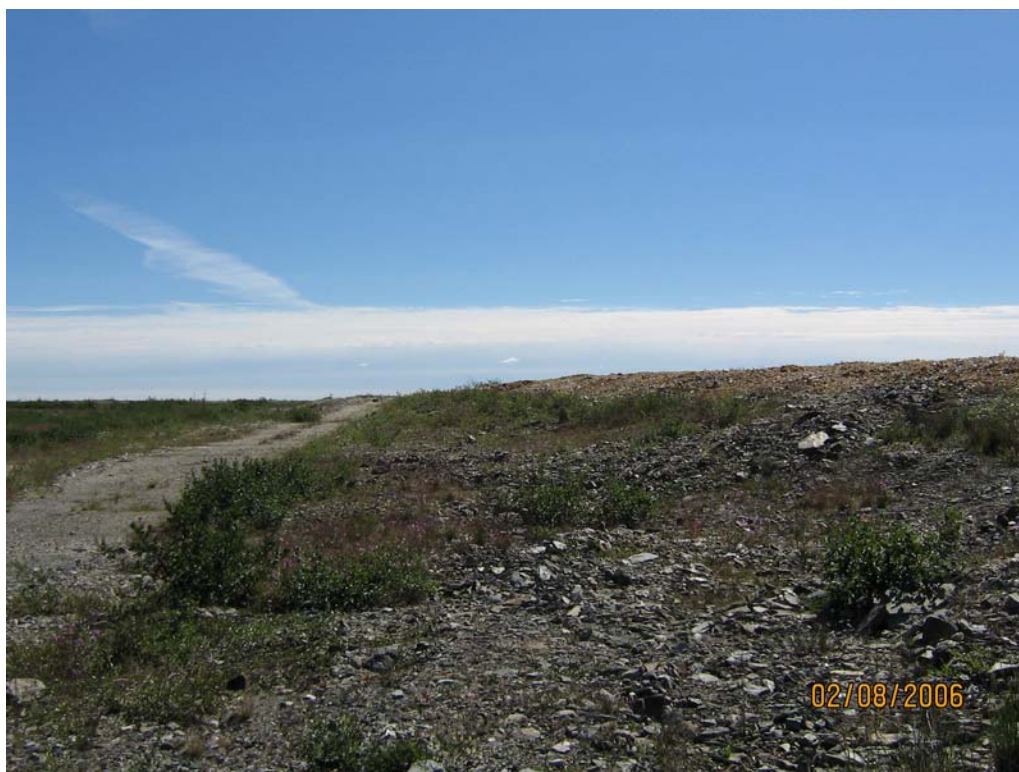
*Photo 4: Downstream section of Dam No. 1*

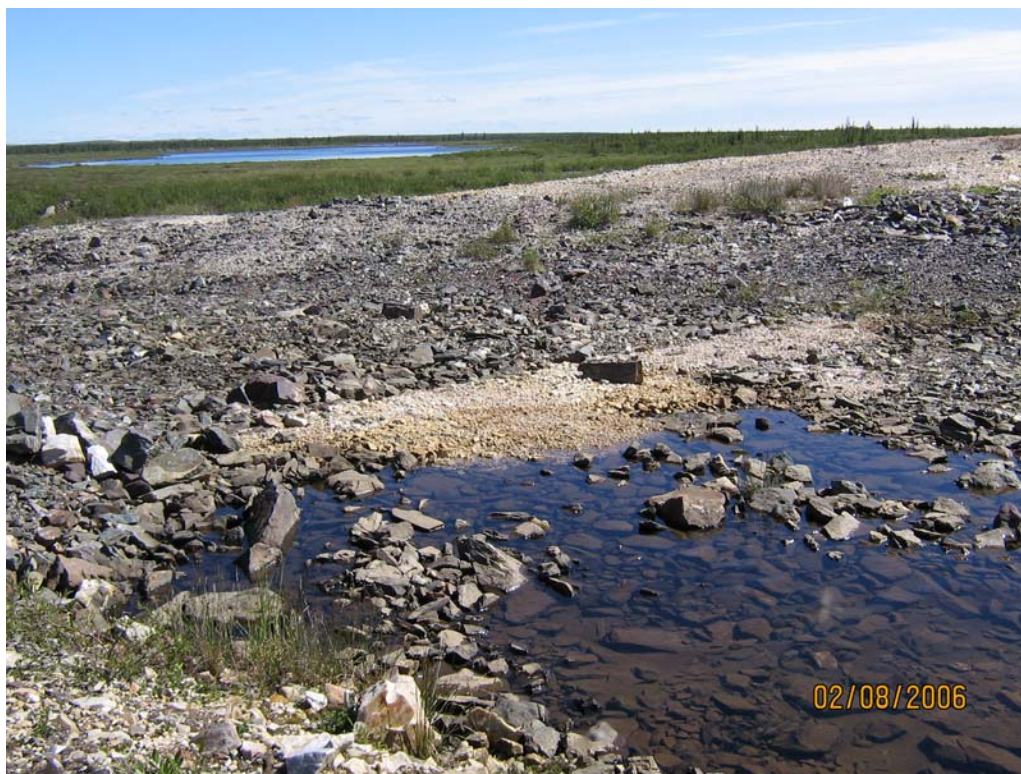
Photo 5 shows a view of the Dam No. 1 spillway channel. Flow was not occurring over the spillway as had been observed in most previous years. A minor trickle was observed to flow through the rockfill comprising the channel bottom. Based on our observations and hand level measurements, compared to previous years, the water level in the pond was estimated to be between about 100 mm and 150 mm lower than in 2005. This is attributed to a relatively dry period, compared to the 2005 inspection, during which, heavy rain was experienced. For comparison, Photo 6 shows the spillway flow during the August 2005 inspection.

Our visual inspection of the spillway channel, where additional fine rockfill was placed in 2005 to cover small areas of previously exposed rubber liner indicated that no erosion had occurred. We expect that monitoring of this during future inspections will indicate that this has been sufficient treatment.

*Photo 5: Dam No. 1 spillway looking downstream (no flow)*

It is recommended that the condition of the Dam No. 1 spillway channel be monitored for erosion and if any is apparent, remedial measures, such as the addition of additional rockfill, be implemented.

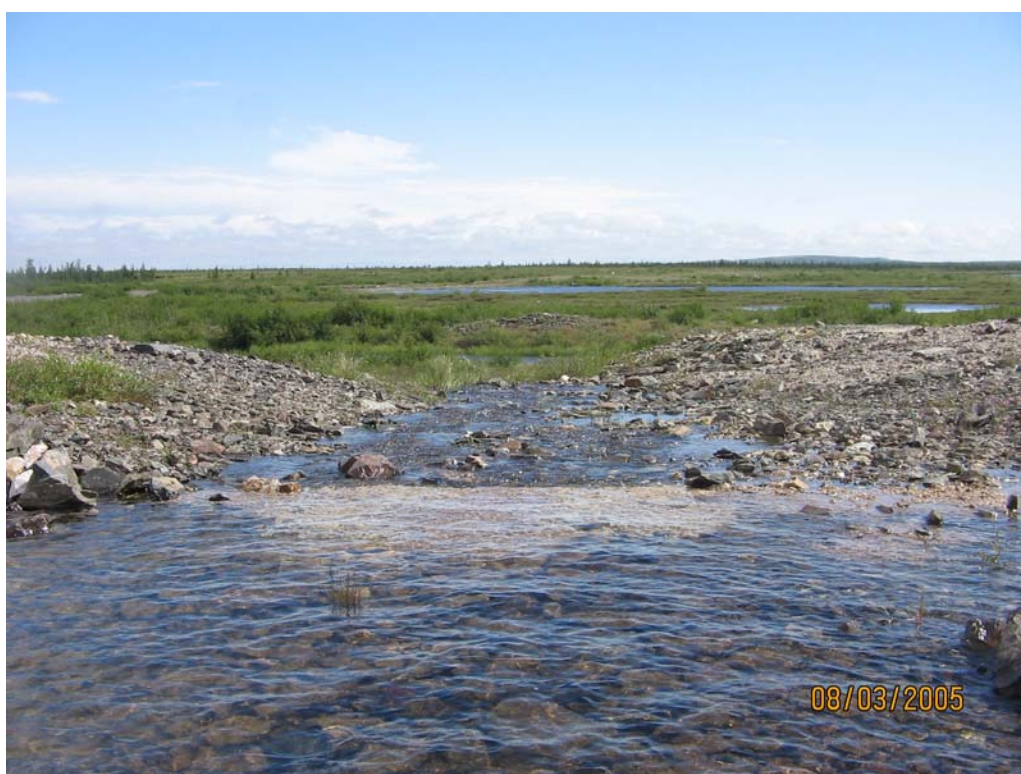
*Photo 6: Dam No. 1 Spillway looking downstream (2005)*

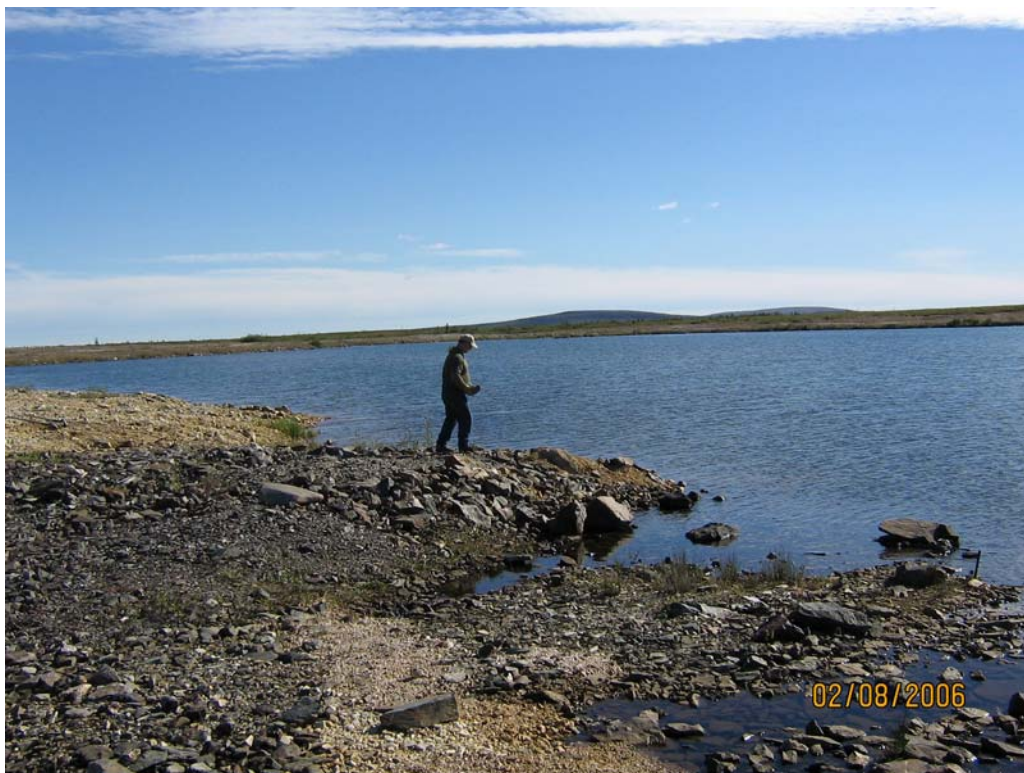
During the 2006 inspection trip, some of the rubber liner that had been exposed for many years on the south flank of the spillway inlet was removed and replaced with locally sourced fine and medium sized rockfill. These areas, shown repaired below the person in Photo 7, are well above the likely high water level. This effort was for cosmetic reasons. Photo 8, taken in 2005, shows the exposed rubber liner in two locations.

*Photo 7: Dam No. 1 spillway south flank showing repairs below person*

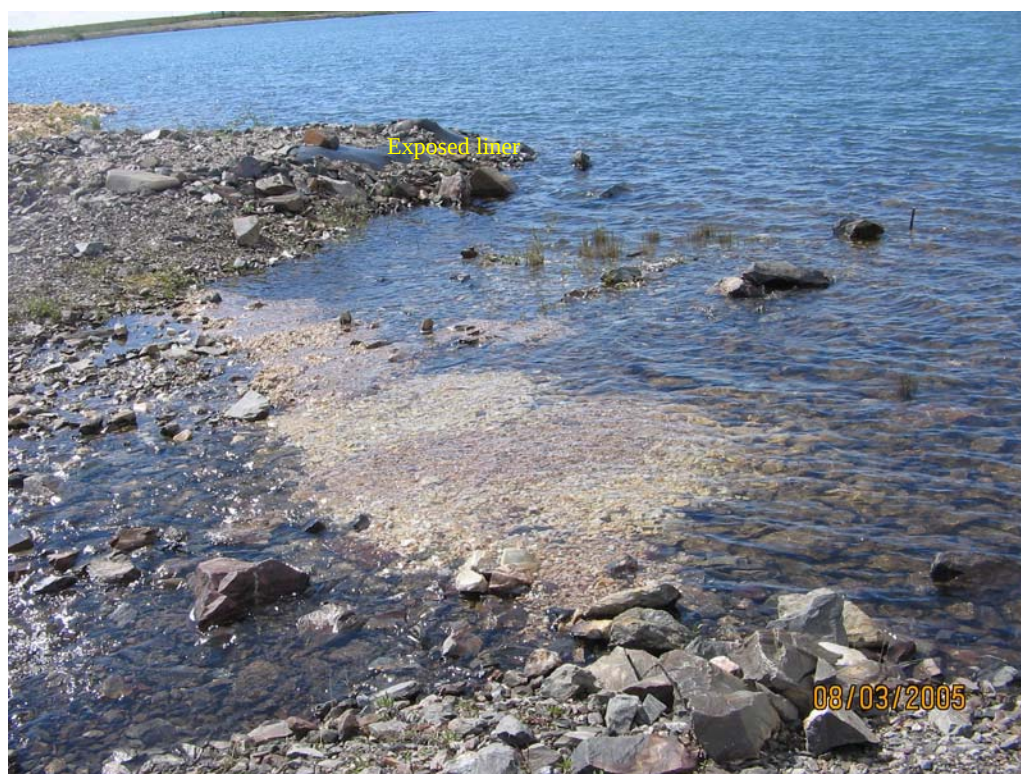
*Photo 8: Dam No. 1 spillway entrance showing exposed rubber liner (2005)*

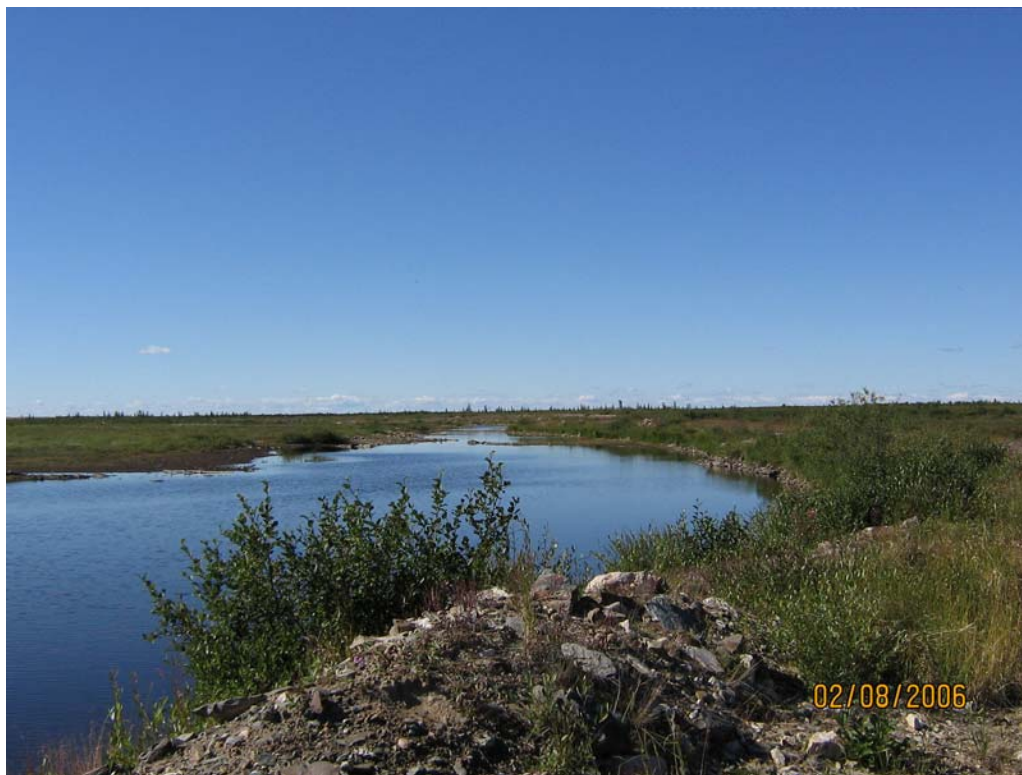
Photo 9 shows a view of Dam No. 2. As with Dam No. 1, the principal construction material is local cohesionless till. The dam section and surface grade is irregular, although less so than Dam No. 1. The crest width varies but is in the order of 15 m. No seepages were observed on the day of examination.

*Photo 9: View of Dam No. 2 and Pond No. 2*

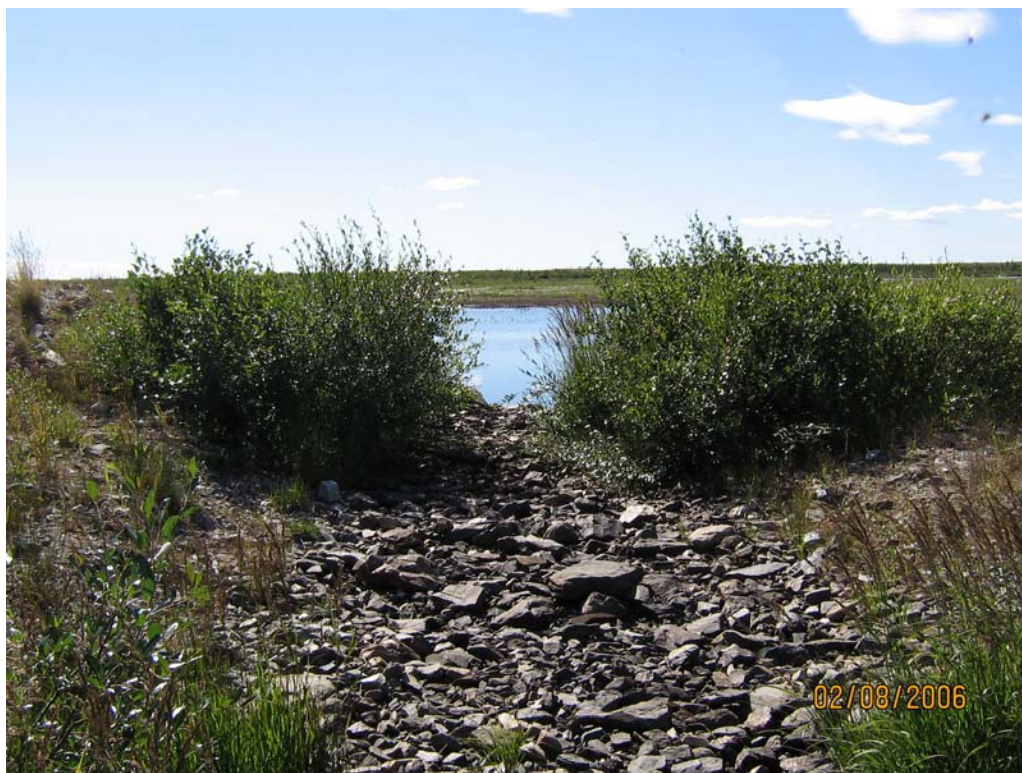
Photo 10 is an upstream view of the Dam No. 2 spillway channel. Note there is no flow over the spillway, compared to our August 2005 inspection, as shown in Photo 11. Based on our 2006 as well as previous inspections and involvement with the project, the dam is not in any distress and is considered to be stable.

*Photo 10: Dam No. 2 spillway looking upstream – note no flow*

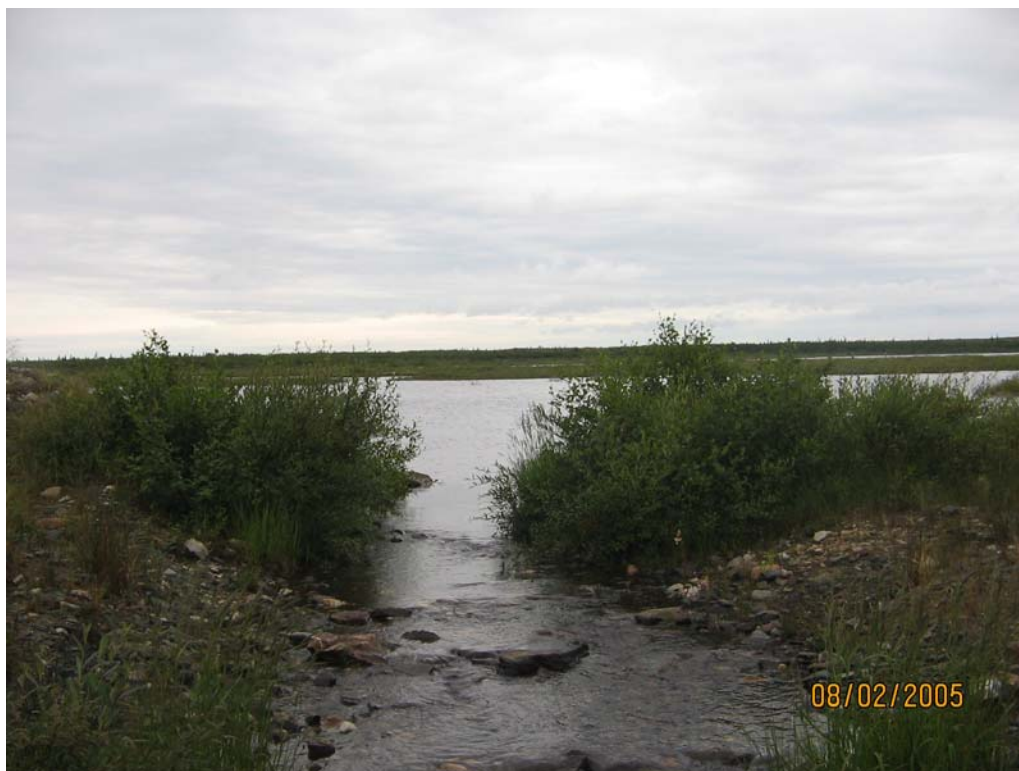
**Photo 11: Dam No. 2 spillway looking upstream to Pond No. 2 (2005)**

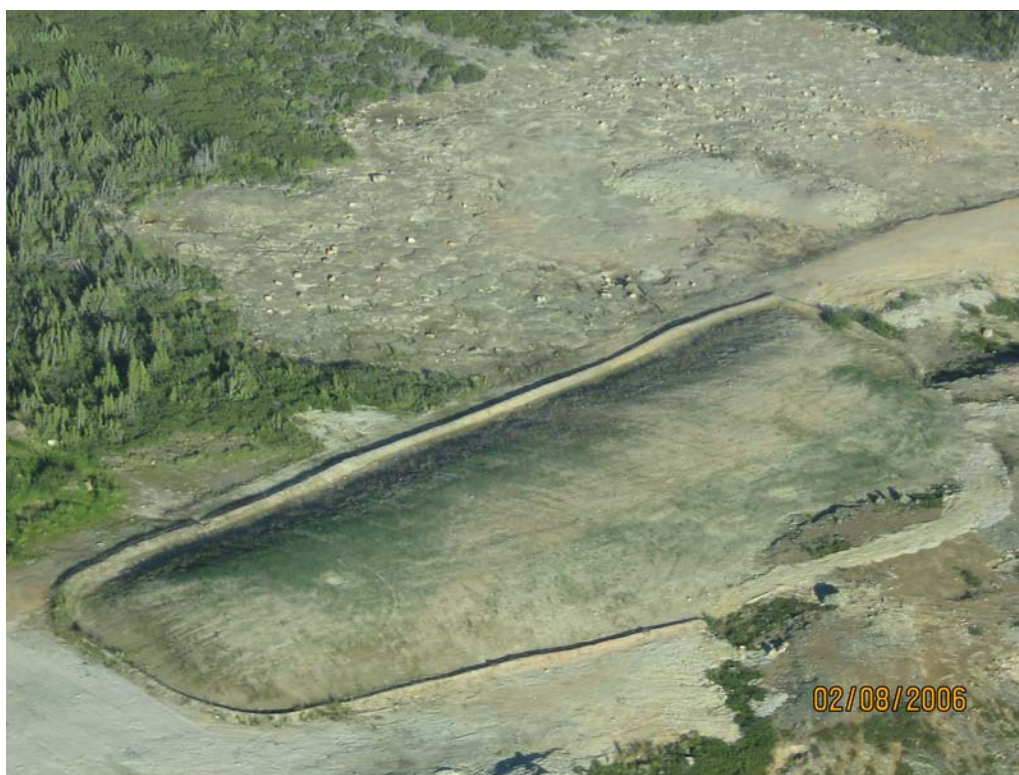
Our observations in August 2006 suggest that, while there are some sparse areas, the vegetation is helping to reduce erosion, in that very few small erosion gulleys/channels (20 to 30 mm deep/wide) were noticed on the side slopes. These generally were short and did not extend the full length of the slope. Most of these had been filled to some extent with small granular material in 2005, to minimize further erosion.

**Photo 12: Aerial view of Shear Lake Waste Rock Pile looking southeast**

Photos 12 to 15 show views of the Shear Lake Waste Rock Pile. Subsequent inspections should be made to verify the efficacy of the vegetation/till cover system.

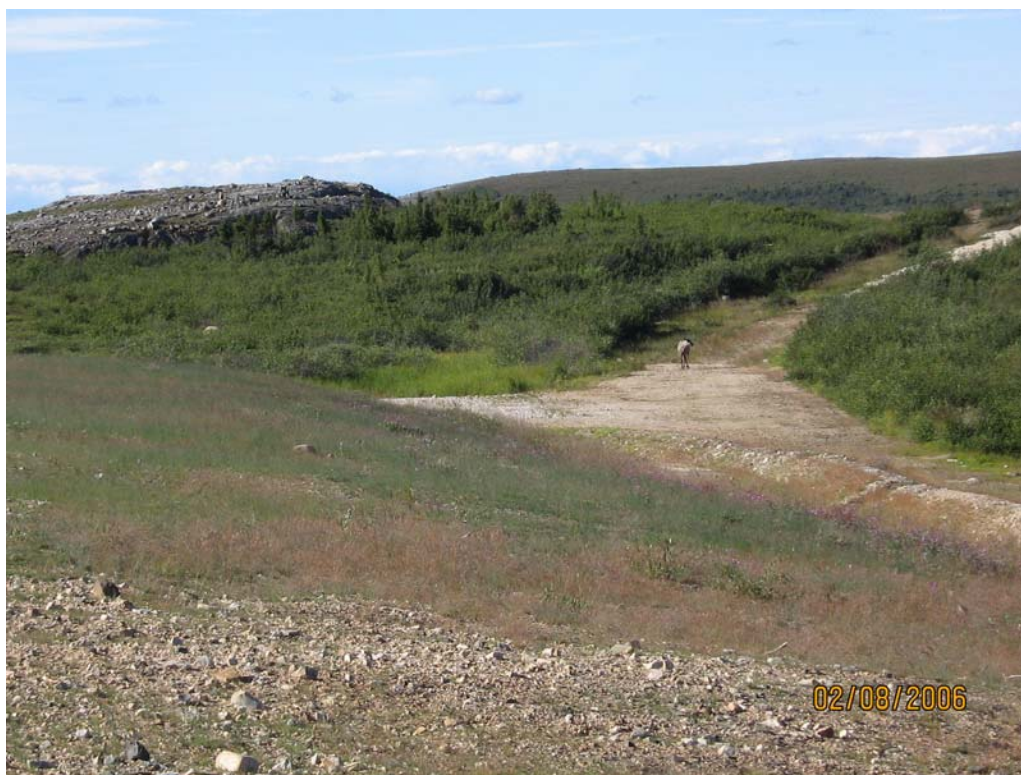
***Photo 13: Northeast corner of Shear Lake Waste Rock Pile showing grasses***

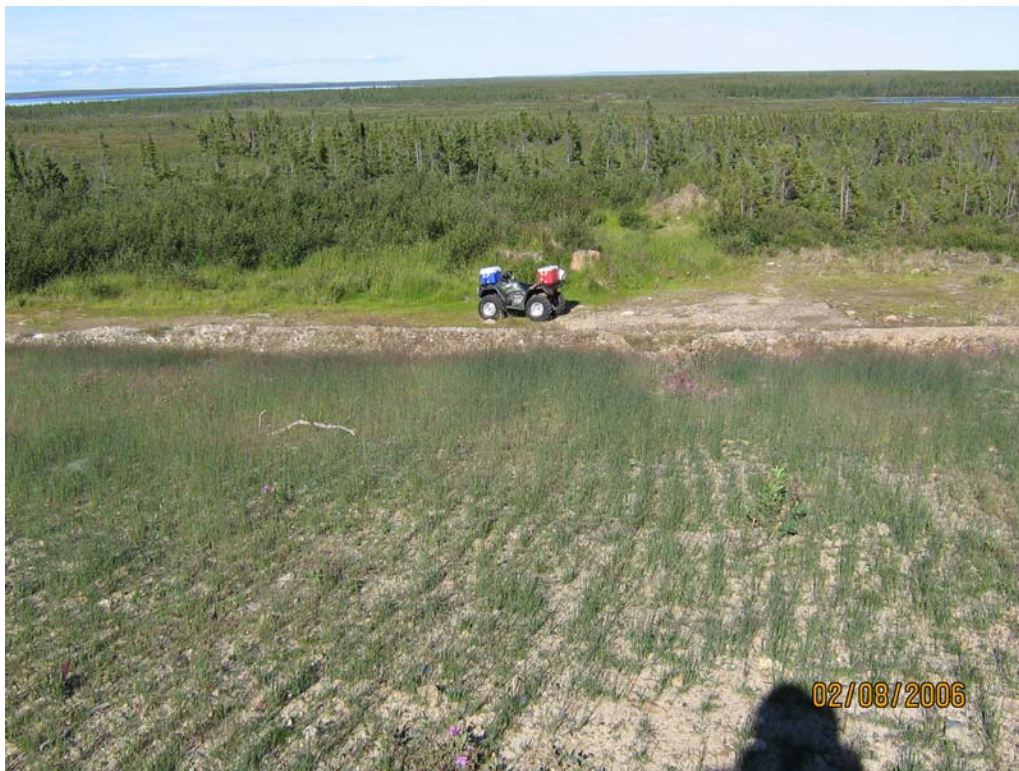
***Photo 14: Looking down east slope of Shear Lake Waste Rock Pile***

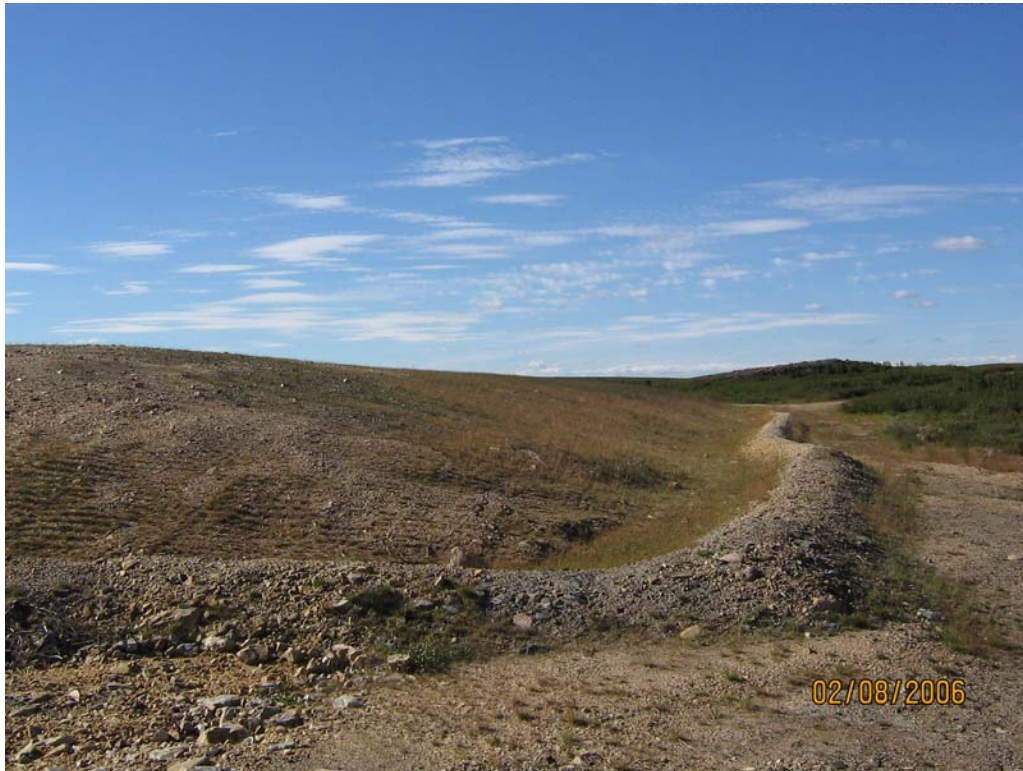
*Photo 15: Looking north from southeast corner of Shear Lake Waste Rock Pile*
