February 11, 2008

Reference: F-90132

***2007 Tailings Dam Examination
Cullaton Lake Gold Mine, Nunavut
Licence NWB1CUL0207***

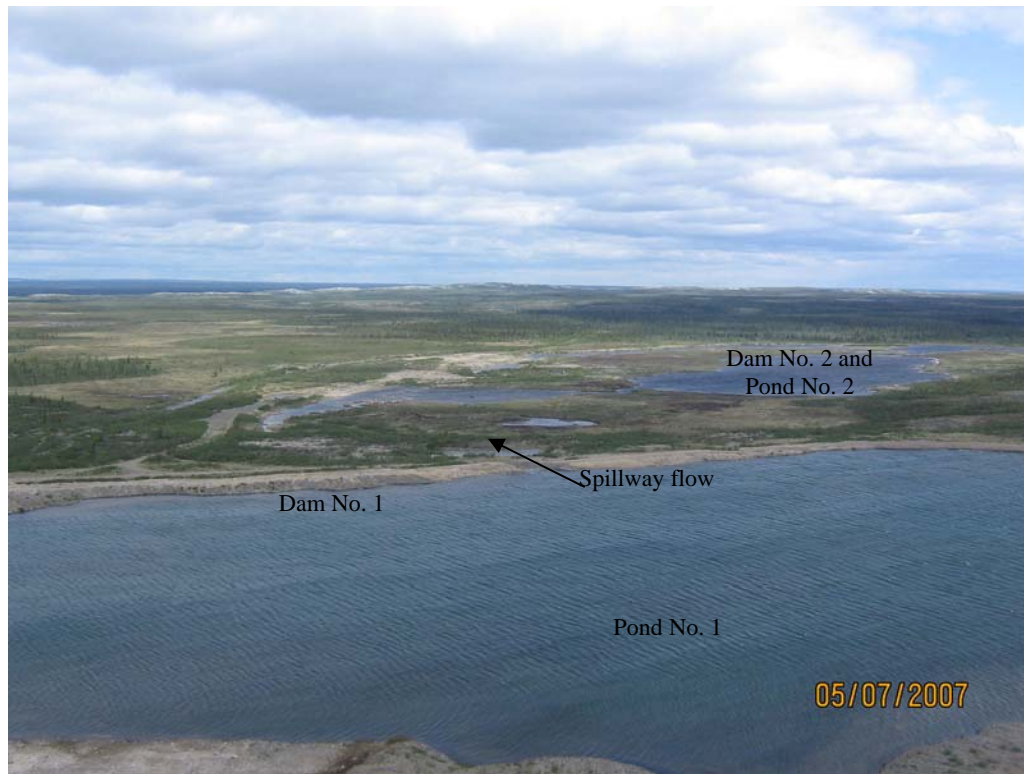
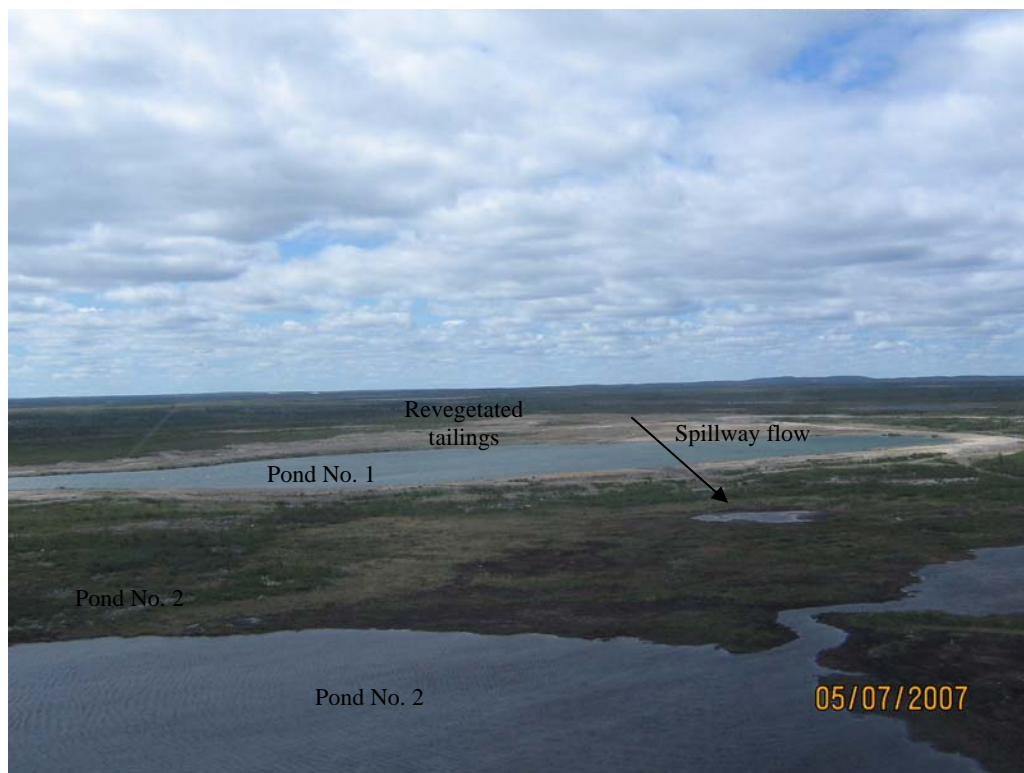
Photos 1 and 2, attached, show oblique views of the site taken from the air. The tailings area had been previously covered with local till as reported in Trow's previous inspection reports. Vegetation on the till covered tailings is small and sparse. However, it is noted that the density of the vegetation is increasing gradually, based on the comparative visual observations of previous years.

Photo 1: Tailings facility – looking roughly southeast

Photo 2: Tailings facility looking roughly west

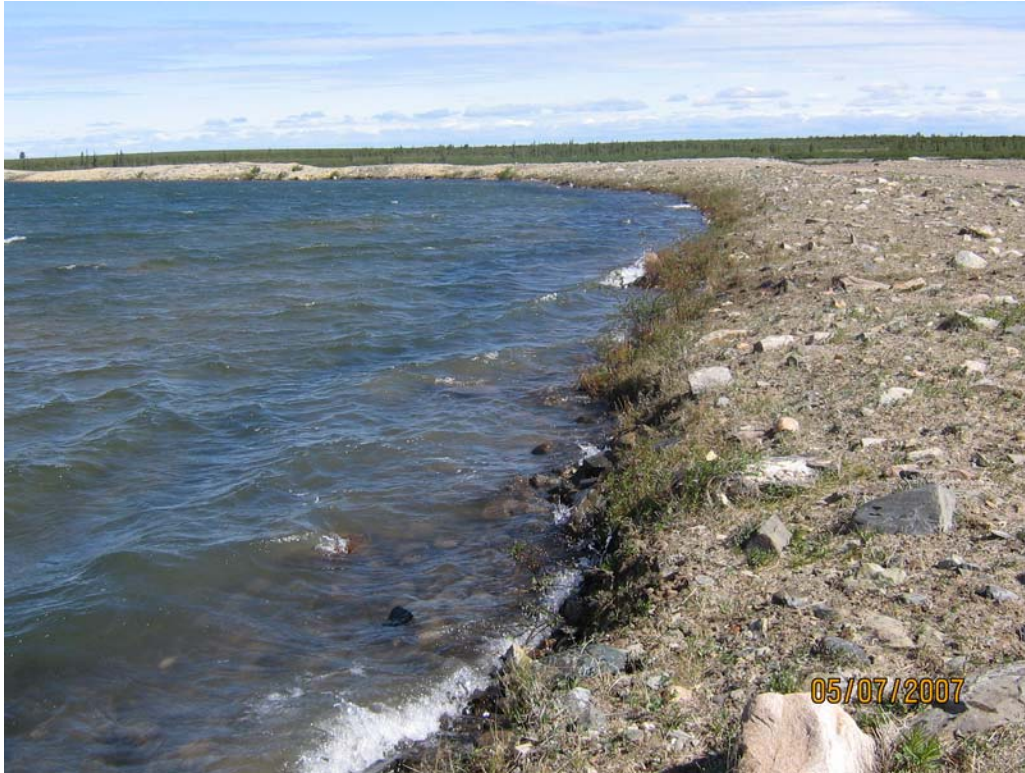
Photos 3 and 4 show views of Dam No. 1. Typically, the embankment, which is constructed principally with local cohesionless till, is irregular in section and surface grade. Average side slopes of the upstream and downstream sides were typically about 3H:1V and 6H:1V, respectively. The downstream side was estimated to be as steep as about 3H:1V in a few areas. The dam height ranges up to about 4 m. Some small erosion scars were observed on both the upstream and downstream sides; however, as described below, they appear to be stabilizing with vegetation and self-armouring with larger rock particles from the till and previously placed mine waste rock. These scars do not appear to be increasing in size, based on

visual comparisons of previous years. No new erosion scars were apparent based on visual comparison from previous years. The crest width varies but is in the order of 15 m. No seepages were observed on the day of inspection.

Based on the current as well as previous inspections and involvement with the project, the dam is not in any distress and is considered to be stable.

Photo 3: Dam No. 1 - looking northwest

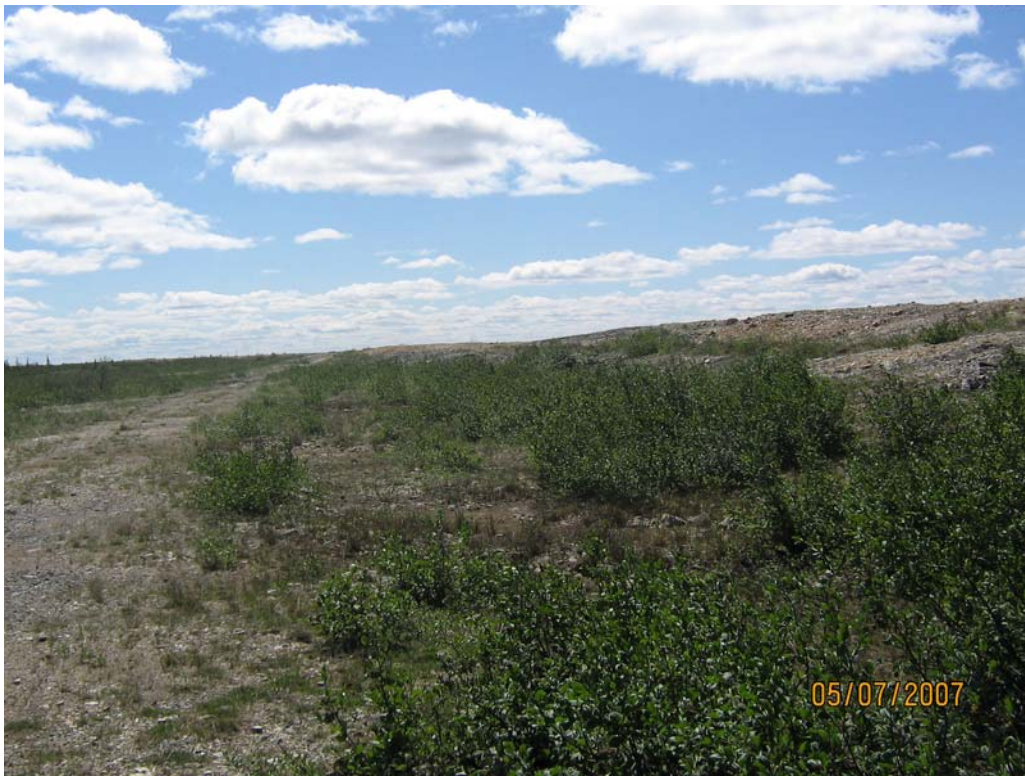
Photo 4: Downstream section of Dam No. 1

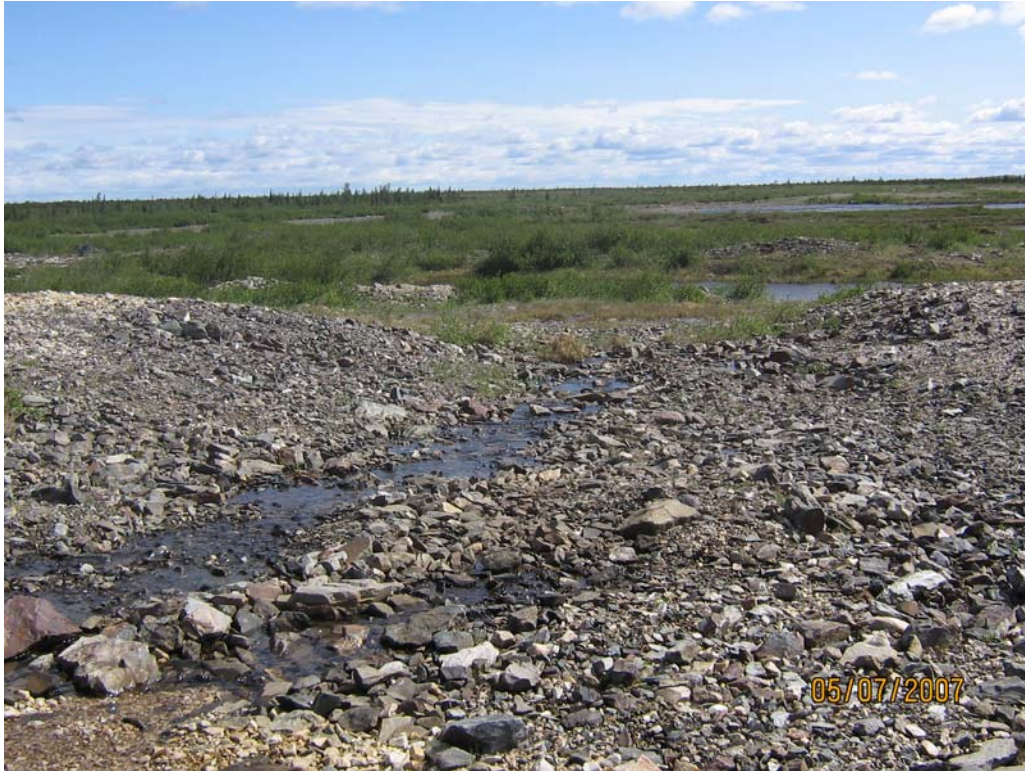
Photos 5 and 6 show views of the Dam No. 1 spillway channel. Minor flow was occurring over the spillway as had been observed in most previous years. A minor trickle was observed to flow through the rockfill comprising the channel bottom.

Our visual inspection of the spillway channel, where additional fine rockfill was placed in 2005 to cover small areas of previously exposed rubber liner indicated that no erosion had occurred. We expect that monitoring of this during future inspections will indicate that this has been sufficient treatment.

Photo 5: Dam No. 1 spillway looking downstream)

It is recommended that the condition of the Dam No. 1 spillway channel continue to be monitored for erosion and if any is apparent, remedial measures, such as the addition of additional rockfill, be implemented.

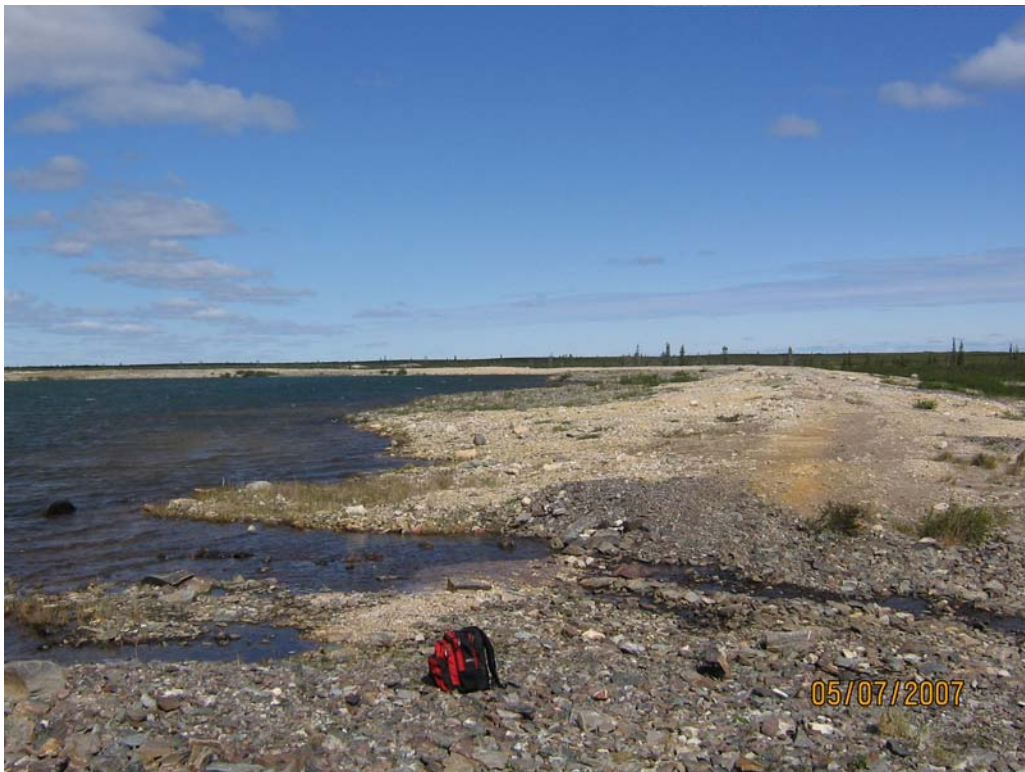
Photo 6: Dam No. 1 Spillway Inlet

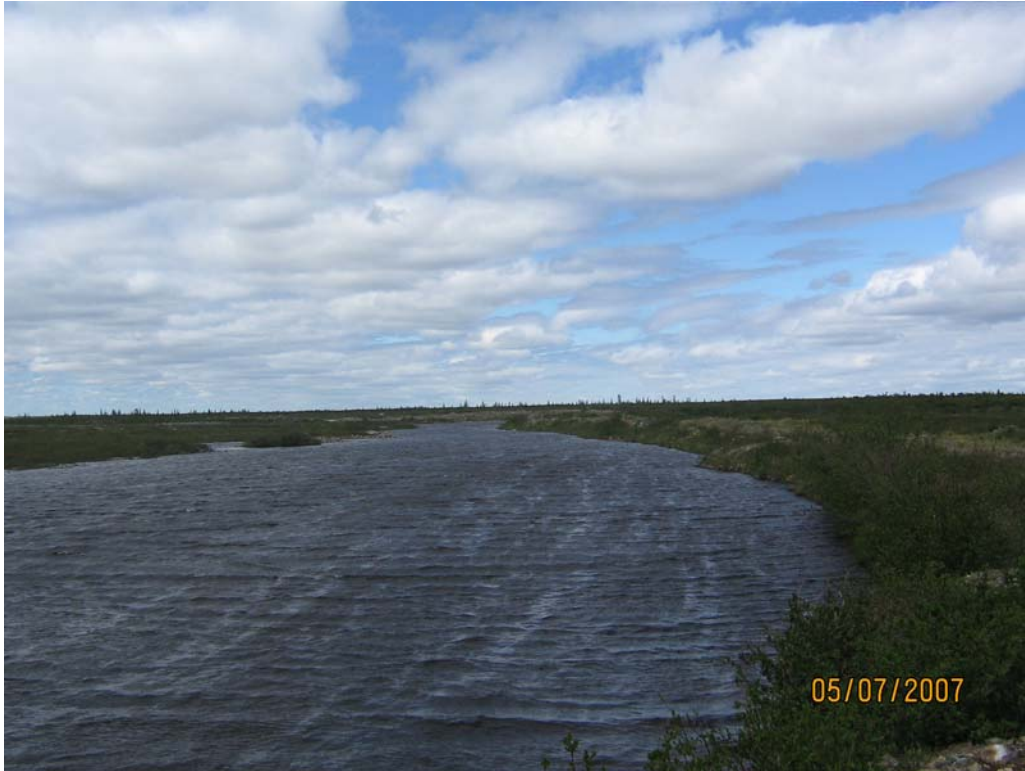
Photo 7 shows a view of Dam No. 2. As with Dam No. 1, the principal construction material is local cohesionless till. The dam section and surface grade is irregular, although less so than Dam No. 1. The crest width varies but is in the order of 15 m. No seepages were observed on the day of examination.

Photo 7: View of Dam No. 2 and Pond No. 2

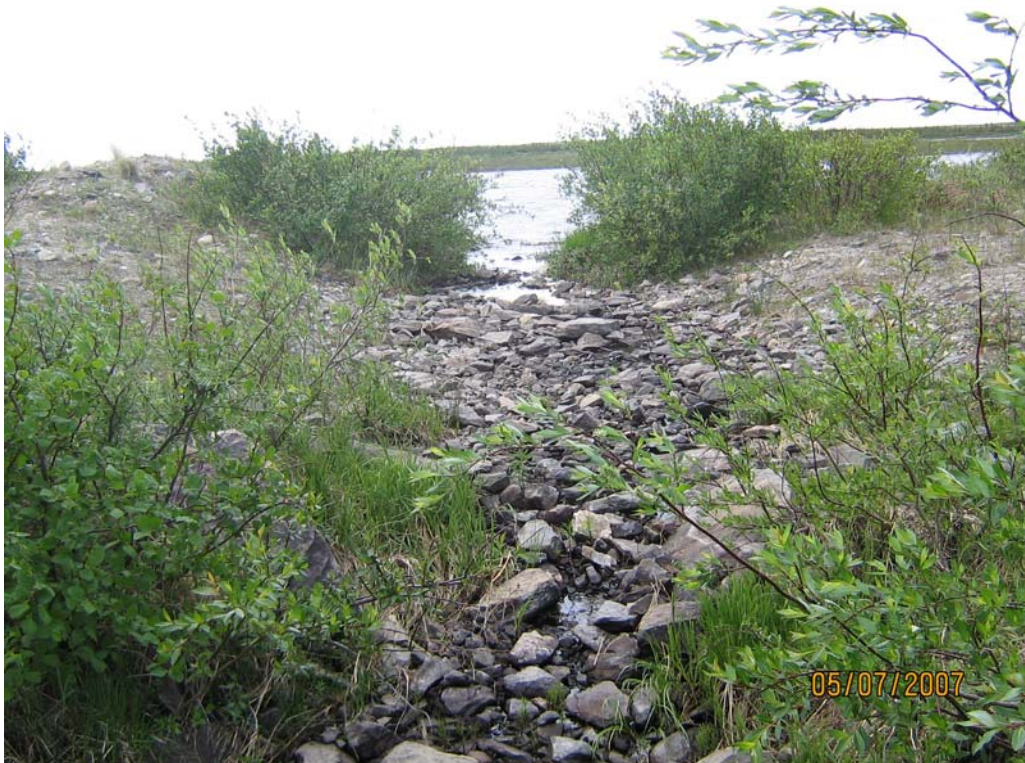
Photo 8 is an upstream view of the Dam No. 2 spillway channel. Note there is no flow over the spillway, similar to several of the previous years' observations. Based on the current as well as previous inspections and involvement with the project, the dam is not in any distress and is considered to be stable.

Photo 8: Dam No. 2 Spillway Channel looking upstream to Pond 2

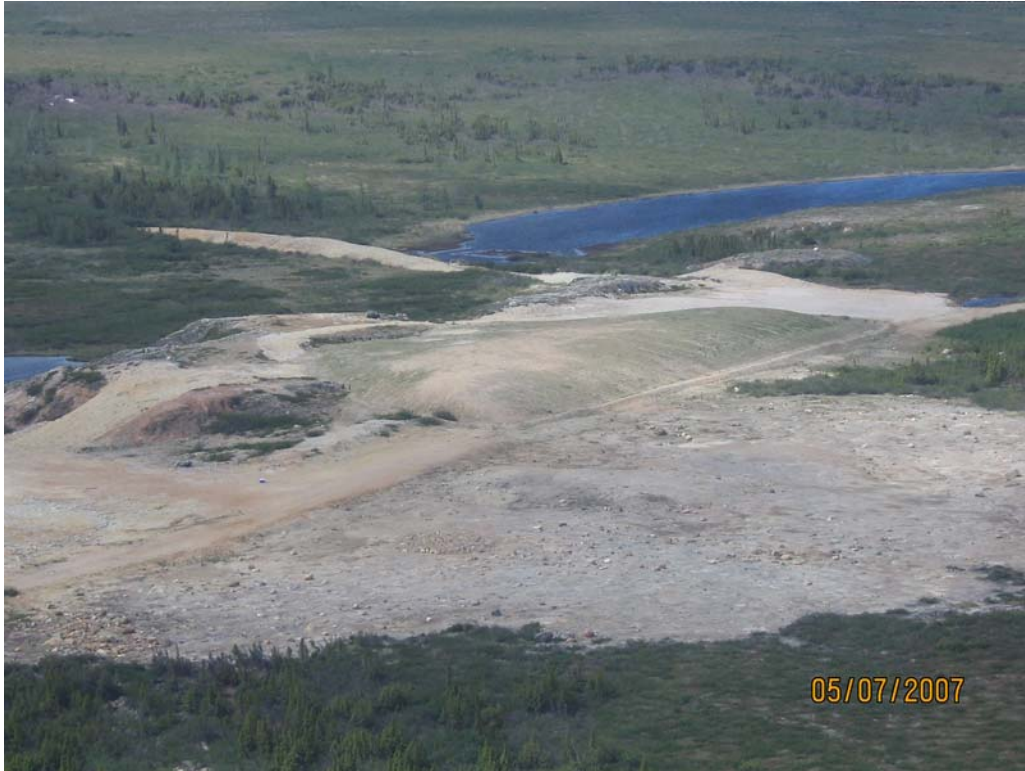
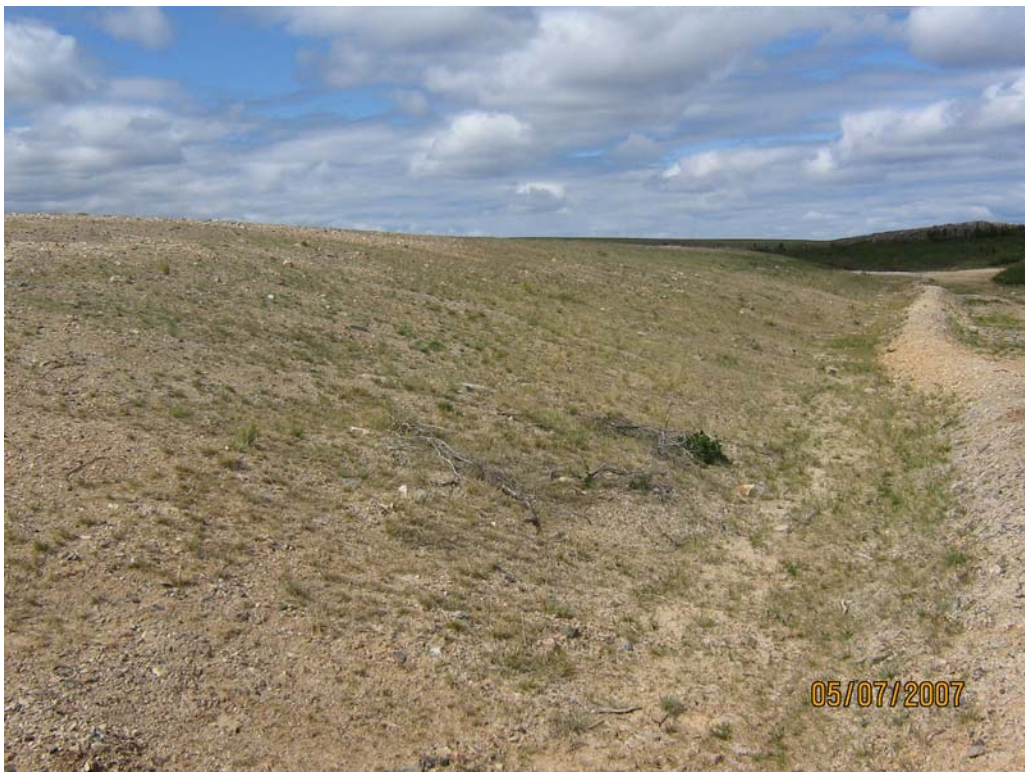
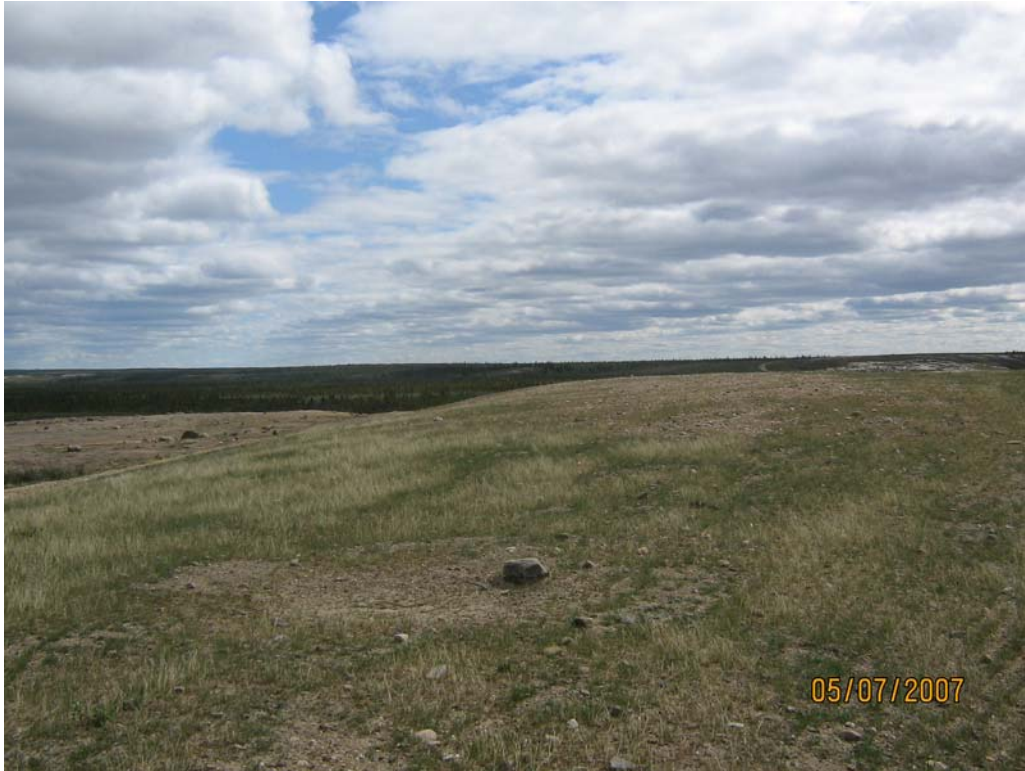
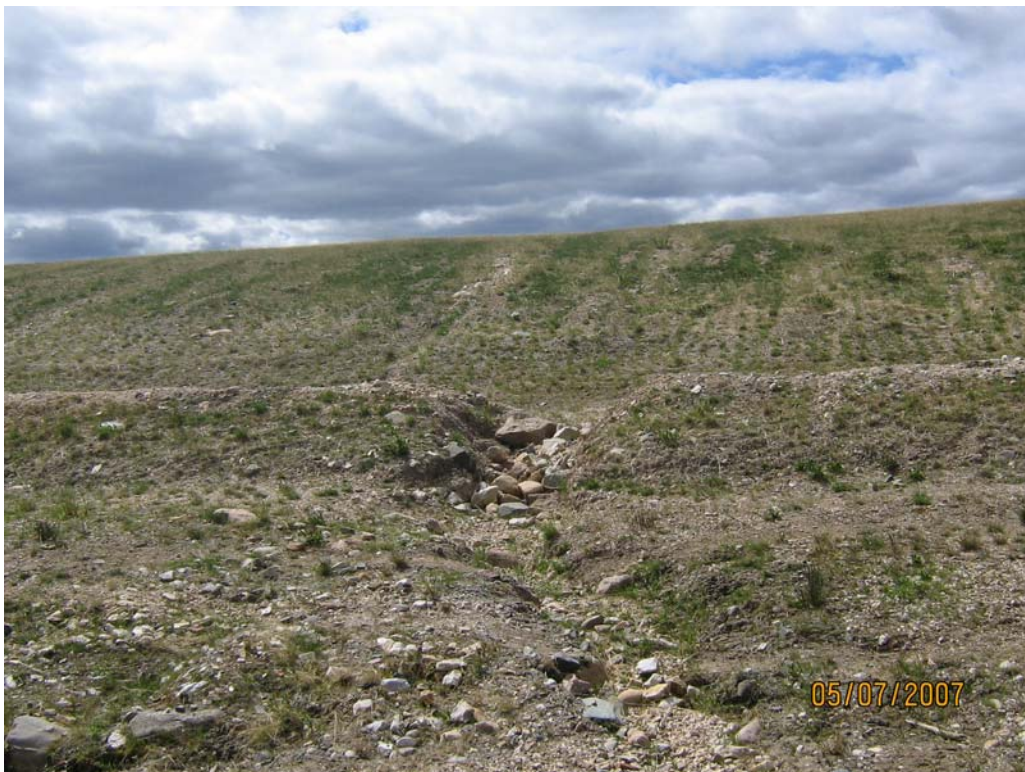
Our observations in August 2006 suggested that, while there are some sparse areas, the vegetation is helping to reduce erosion, in that very few small erosion gulleys/channels (20 to 30 mm deep/wide) were noticed on the side slopes. These generally were short and did not extend the full length of the slope. Most of these had been filled to some extent with small granular material in 2005, to minimize further erosion. Our observations in July 2007 were similar.

Photo 9: Aerial view of Shear Lake Waste Rock Pile looking northwest

Photo 10: East side of Shear Lake Waste Rock Pile showing grasses

Photo 11: Top of Shear Lake Waste Rock Pile looking south-southeast

Photo 12: Toe ditch outlet on east side of Shear Lake Waste Rock Pile

Photos 9 to 12, inclusive, show views of the Shear Lake Waste Rock Pile. Subsequent inspections should be made to verify the efficacy of the vegetation/till cover system. Any erosion gullies that form should be repaired with fine rock/gravel. It is expected that it will take several years for the vegetation to establish itself.
