December 16, 2008

Reference: TBGE00090132

***2008 Tailings Dam Examination  
Cullaton Lake Gold Mine, Nunavut  
Licence NWB1CUL0207***

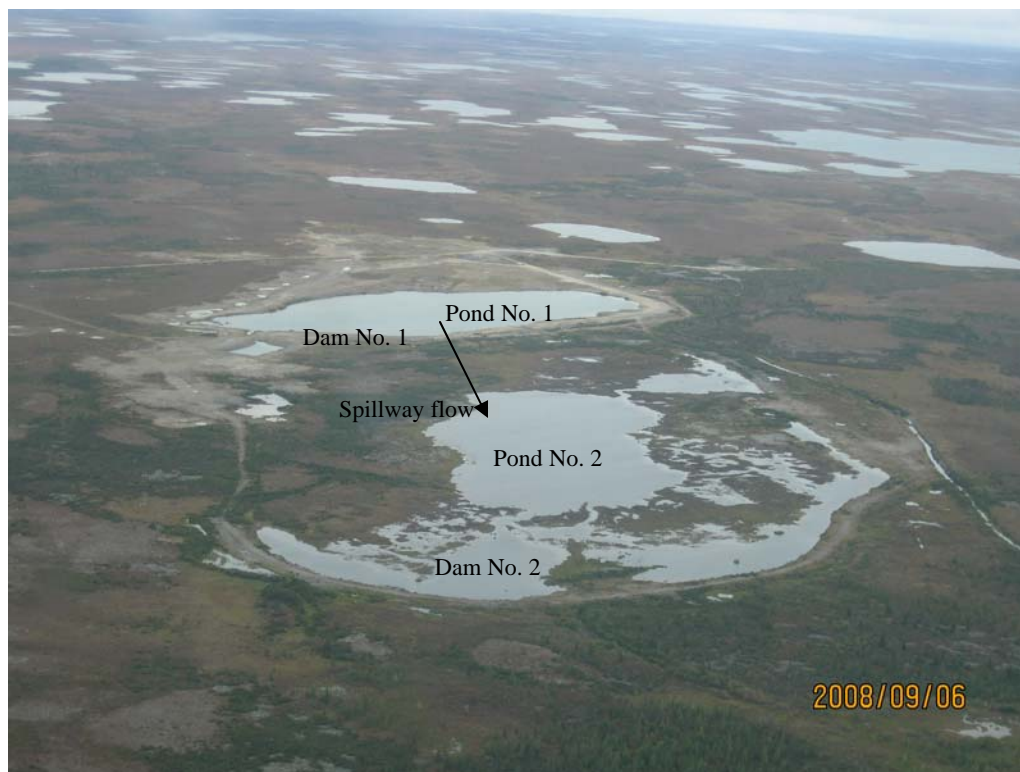
Photos 1 and 2, attached, show oblique views of the site taken from the air. The tailings area had been previously covered with local till as reported in Trow's previous inspection reports. Vegetation on the till covered tailings is small and sparse. However, it is noted that the density of the vegetation is increasing gradually, based on the comparative visual observations of previous years.

*Photo 1: Tailings facility – looking roughly west*

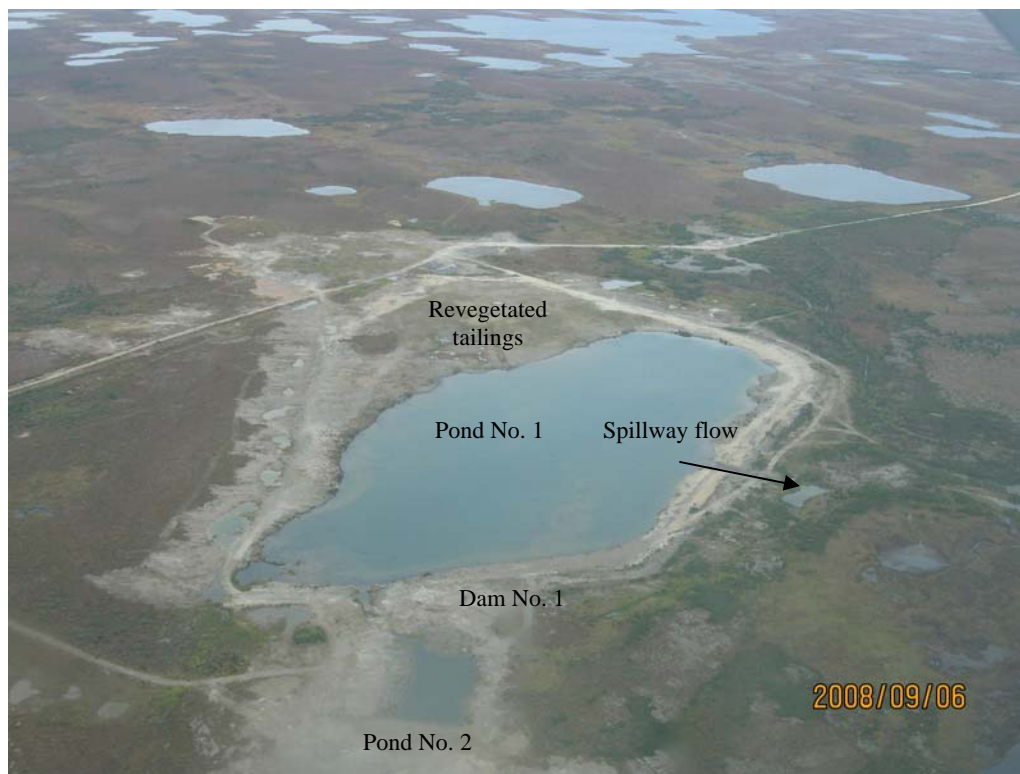
*Photo 2: Tailings facility looking roughly northwest*

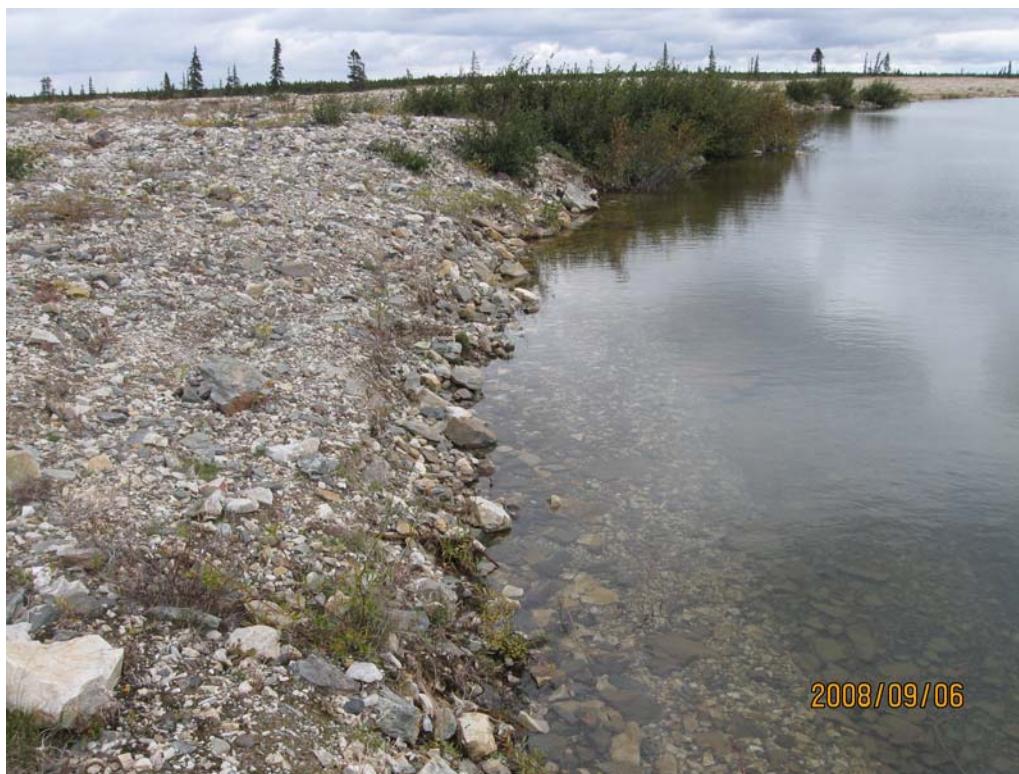
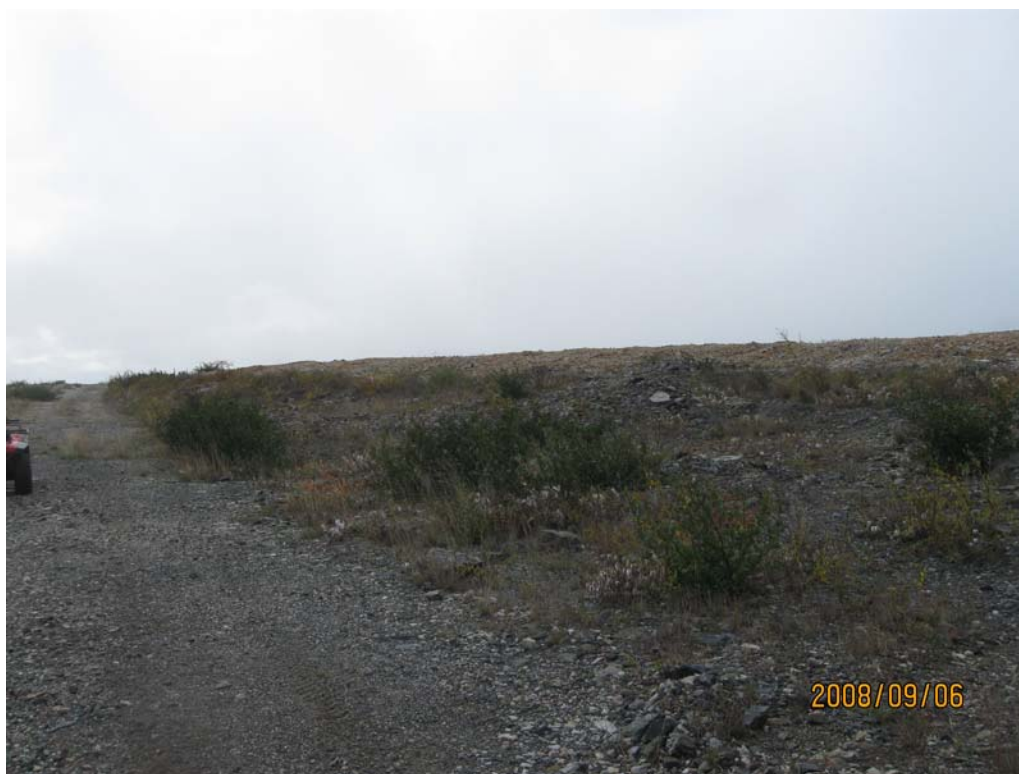
Photos 3 and 4 show views of Dam No. 1. Typically, the embankment, which is constructed principally with local cohesionless till, is irregular in section and surface grade. Average side slopes of the upstream and downstream sides were typically about 3H:1V and 6H:1V, respectively. The downstream side was estimated to be as steep as about 3H:1V in a few areas. The dam height ranges up to about 4 m. Some small erosion scars were observed on both the upstream and downstream sides; however, as described below, they appear to be stabilizing with vegetation and self-armouring with larger rock particles from the till and previously placed mine waste rock. These scars do not appear to be increasing in size, based on visual comparisons of previous years. No new erosion scars were apparent based on visual comparison from previous years. The crest width varies but is in the order of 15 m. No seepages were observed on the day of inspection. Within the tailings pond itself, no unsubmerged or exposed tailings were observed.

Based on the current as well as previous inspections and involvement with the project, the dam is not in any distress and is considered to be stable.

*Photo 3: Dam No. 1 - looking south - southeast*

*Photo 4: Downstream section of Dam No. 1*

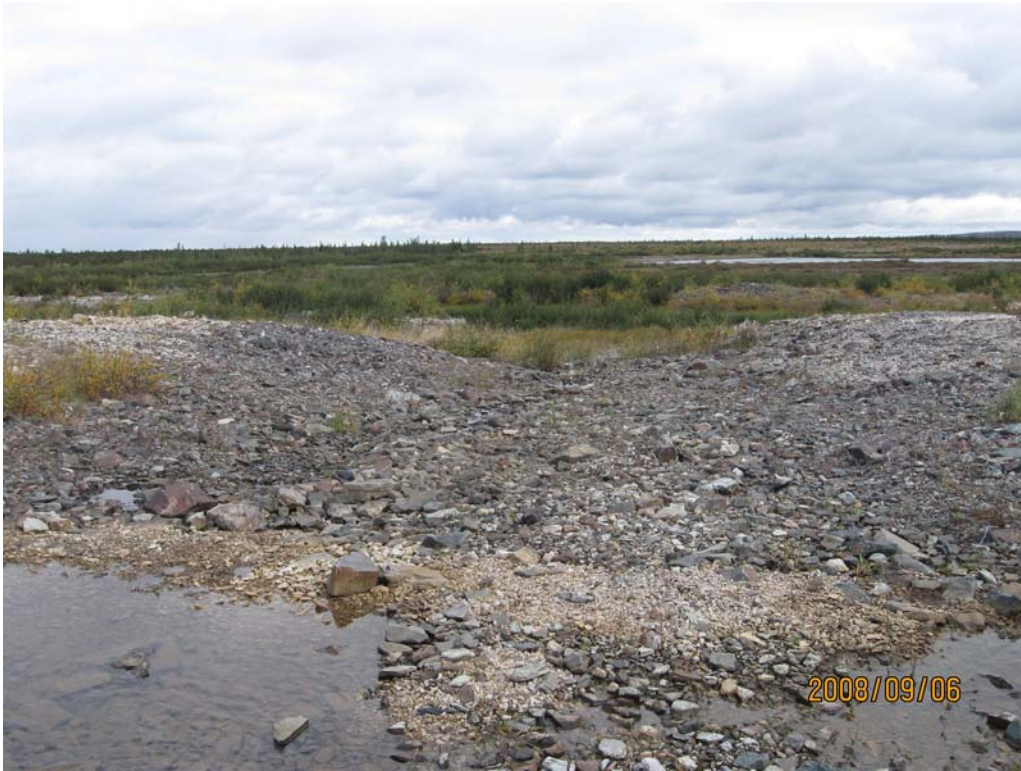
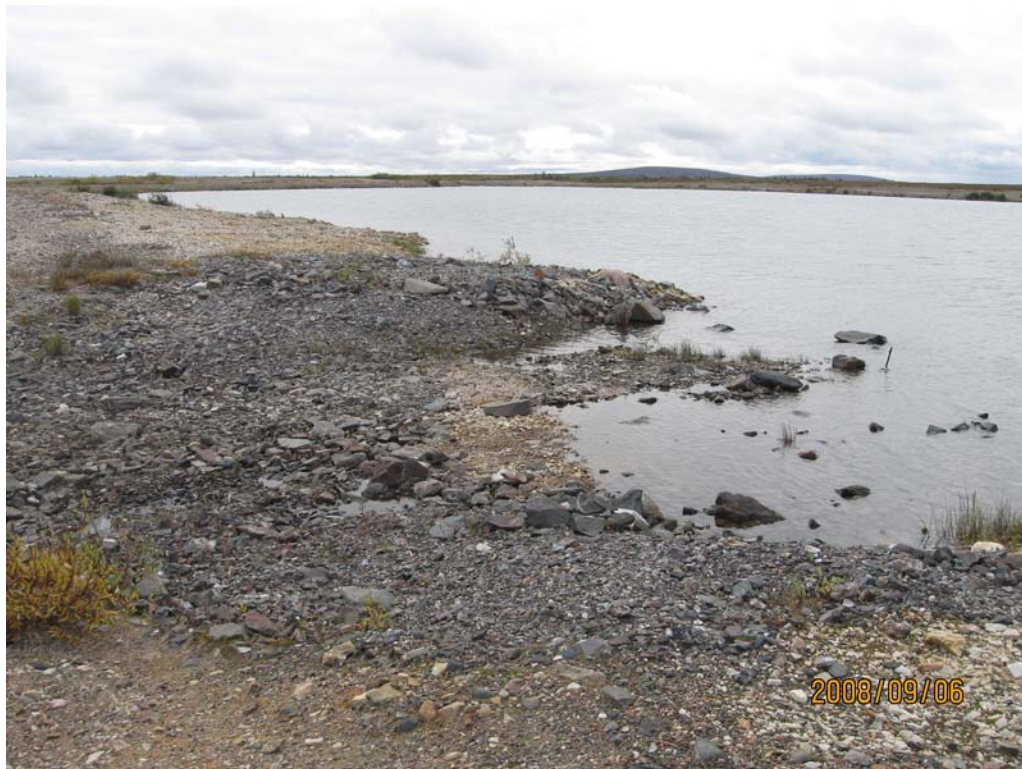
Photos 5 and 6 show views of the Dam No. 1 spillway channel. Only a very minor flow (trickle) was occurring at the spillway as had been observed in most previous years. A minor trickle was observed to flow through the rockfill comprising the channel bottom, somewhat less than that in 2007.

Our visual inspection of the spillway channel, where additional fine rockfill was placed in 2005 to cover small areas of previously exposed rubber liner indicated that no erosion had occurred. We expect that monitoring of this during future inspections will indicate that this has been sufficient treatment.

*Photo 5: Dam No. 1 spillway looking downstream)*

*Photo 6: Dam No. 1 Spillway Inlet*

It is recommended that the condition of the Dam No. 1 spillway channel continue to be monitored for erosion and if any is apparent, remedial measures, such as the addition of additional rockfill, be implemented.

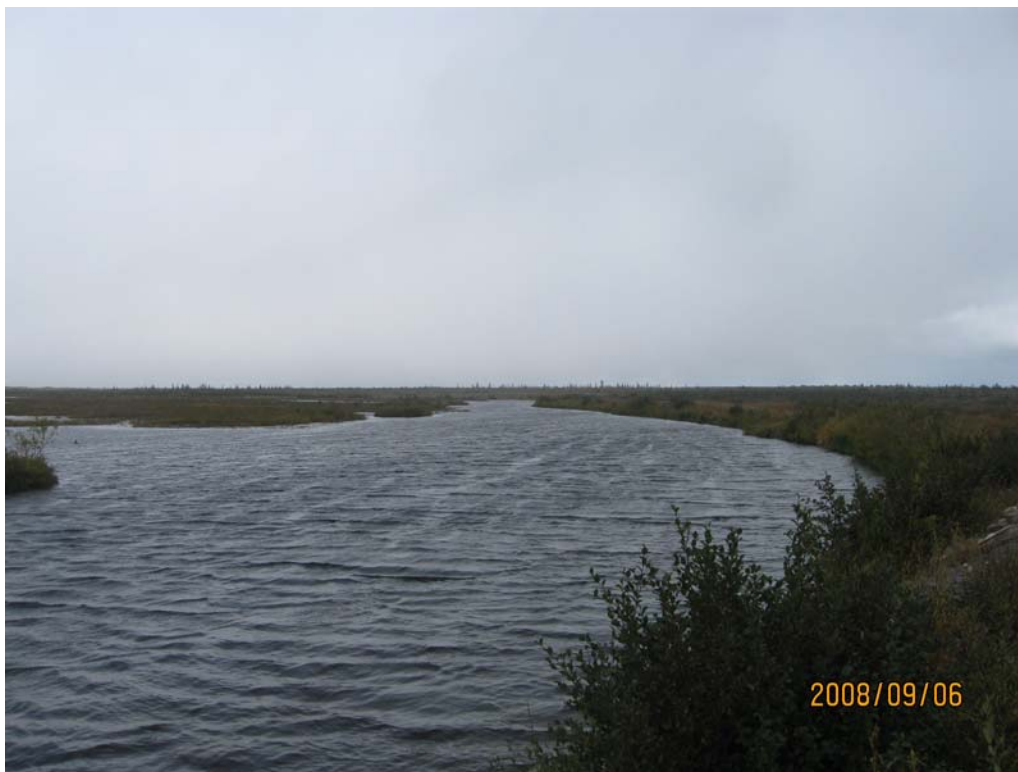
Photo 7 shows a view of Dam No. 2. As with Dam No. 1, the principal construction material is local cohesionless till. The dam section and surface grade is irregular, although less so than Dam No. 1. The crest width varies but is in the order of 15 m. No seepages were observed on the day of examination.

Based on the current as well as previous inspections and involvement with the project, the dam is not in any distress and is considered to be stable.

*Photo 7: View of Dam No. 2 (on the right) and Pond No. 2*

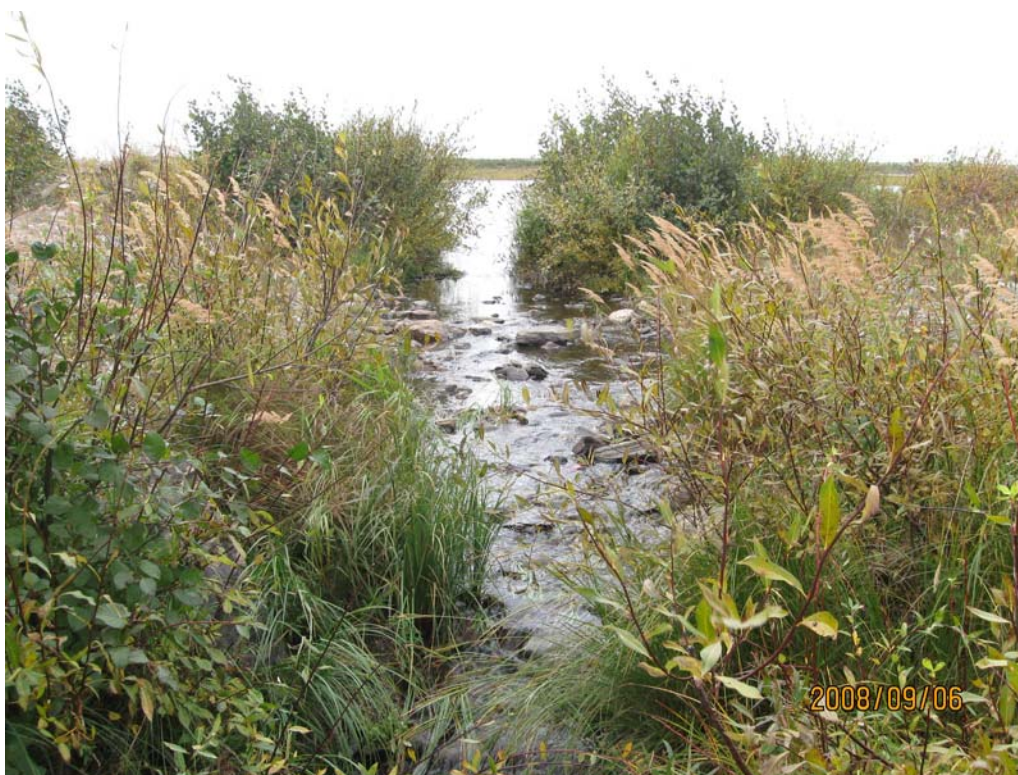
Photo 8 is an upstream view of the Dam No. 2 spillway channel. Flow was occurring over the spillway, noticeably more than most previous years.

*Photo 8: Dam No. 2 Spillway Channel looking upstream to Pond 2*

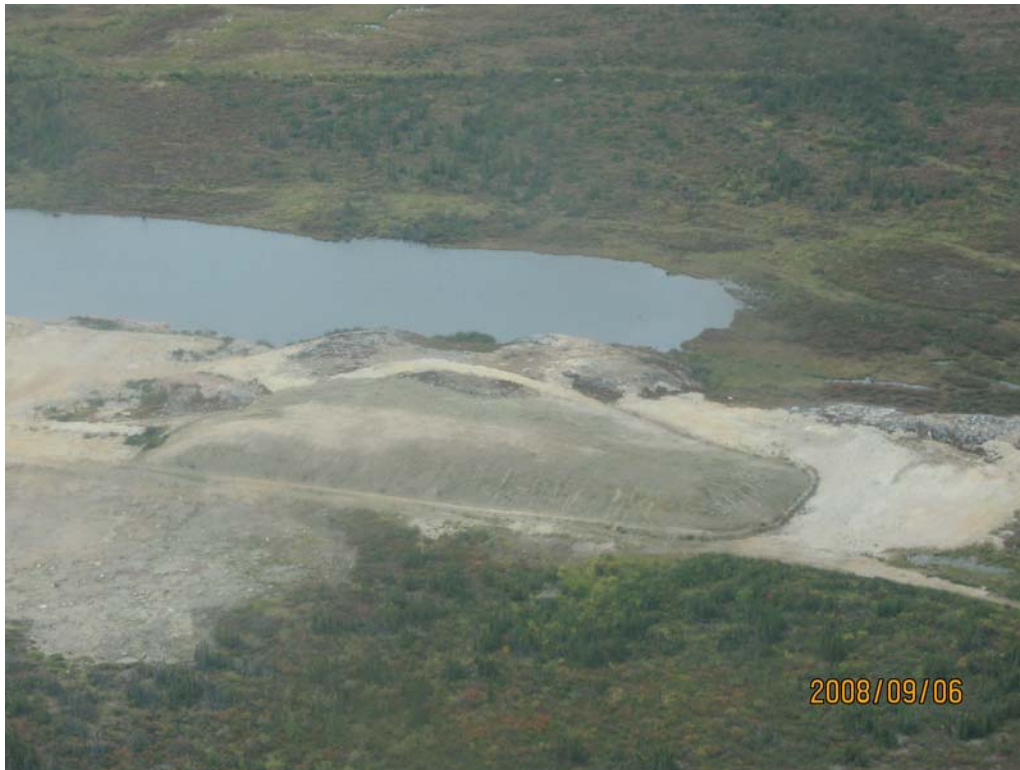
Photos 9 to 12, inclusive, show views of the Shear Lake Waste Rock Pile. The Shear Lake Waste Rock Pile, located on the east side of Shear Lake, some 4.5 km north of the former mill site, was reportedly capped with local, compacted glacial till to promote runoff and reduce infiltration. In 2005, Barrick personnel oversaw the re-seeding of the cap. The re-seeding (with grasses) was implemented to promote some vegetation growth which would reduce the erosion of the cover due to runoff, particularly along the side slopes.

*Photo 9: Aerial view of Shear Lake Waste Rock Pile looking west*

Subsequent inspections should be made to verify the efficacy of the vegetation/till cover system. Any erosion gullies that form should be repaired with fine rock/gravel. It is expected that it will take several years for the vegetation to establish itself.

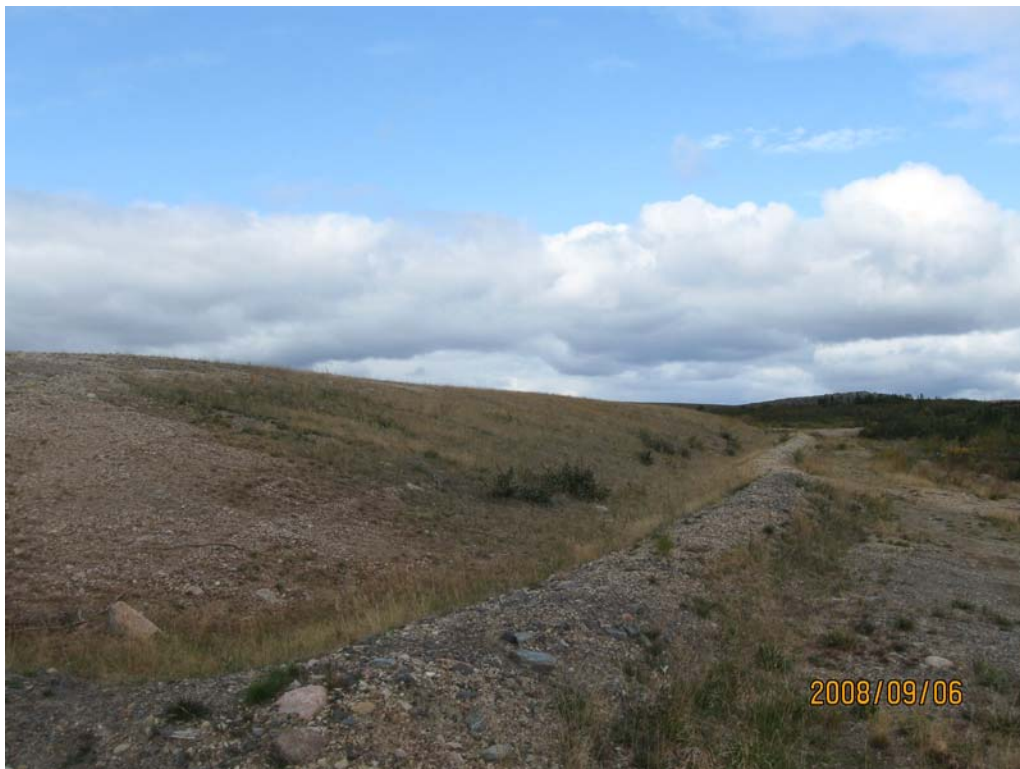
*Photo 10: East side of Shear Lake Waste Rock Pile showing grasses*

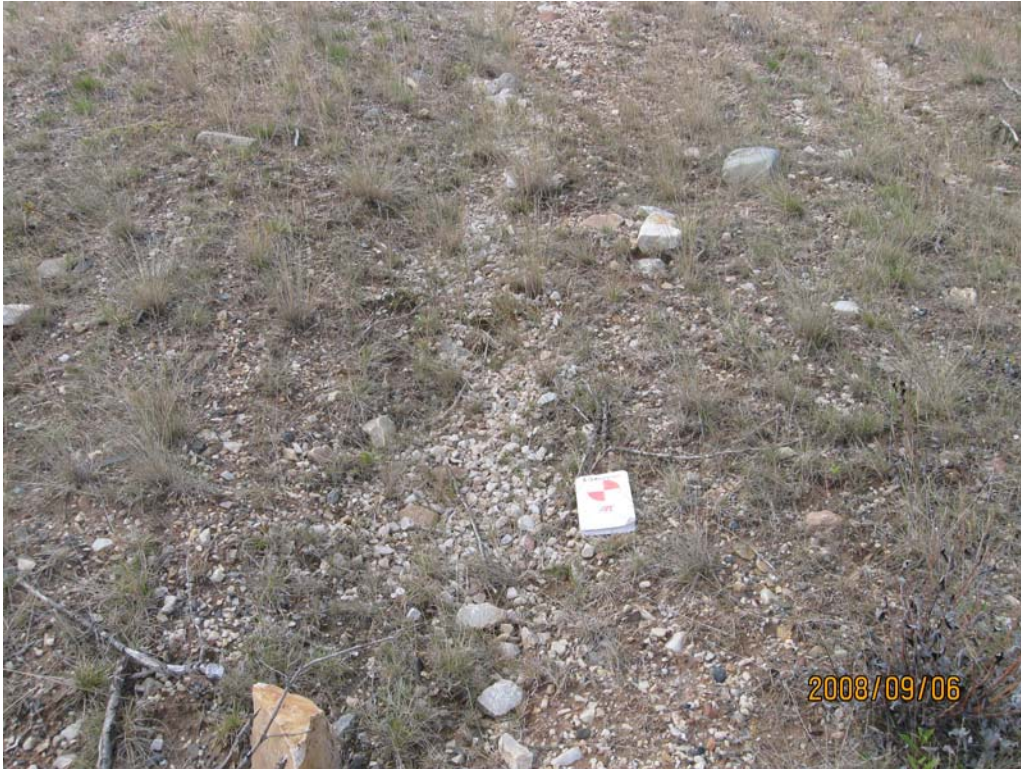
noticed on the side slopes. These generally were short and did not extend the full length of the slope. Most of these had been filled to some extent with small granular material in 2005, to minimize further erosion. Our observations in July 2007 and September 2008 were similar. Photo 11 shows that the gravel filled erosion gullies have been stabilized.

*Photo 11: Previously gravel filled erosion channels on Shear Lake Waste Rock Pile*

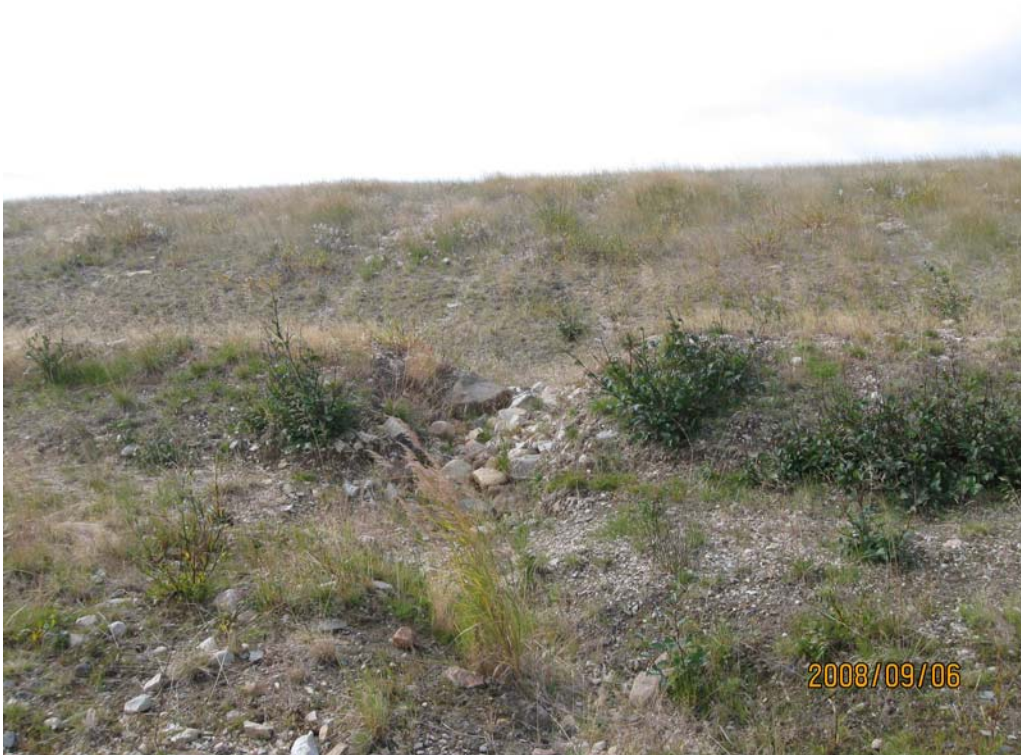
*Photo 12: Toe ditch outlet on east side of Shear Lake Waste Rock Pile*
