October 27, 2009

Reference: TBGE00090132

***2009 Tailings Dam Examination  
Cullaton Lake Gold Mine, Nunavut  
Licence NWB1CUL0207***

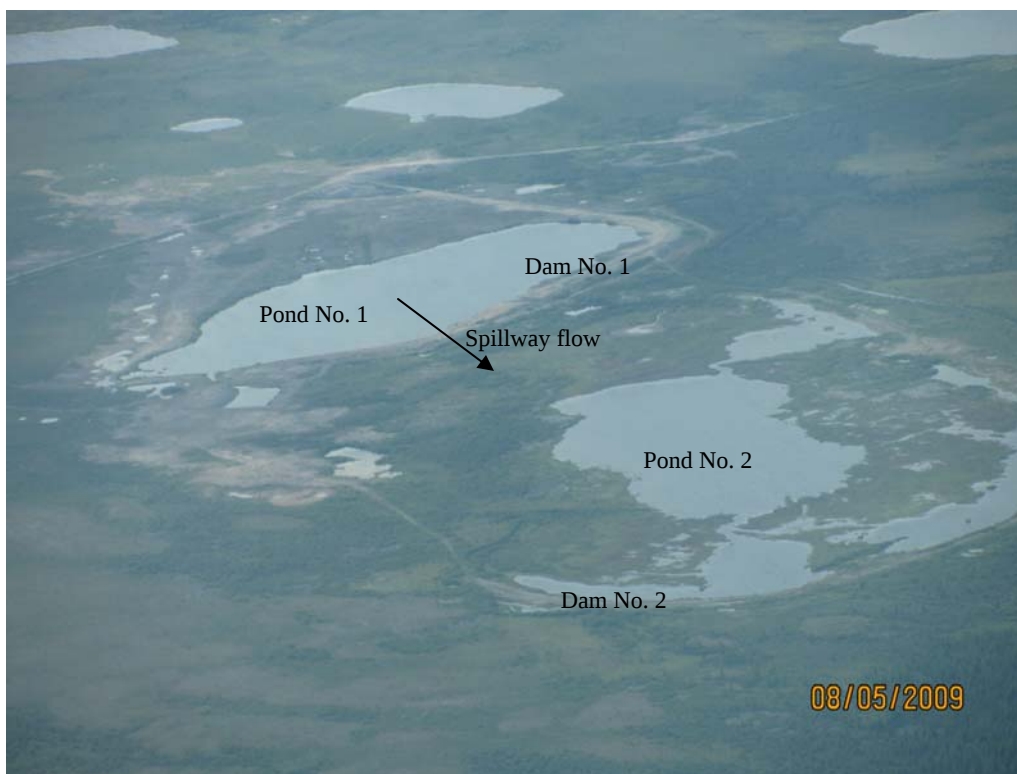
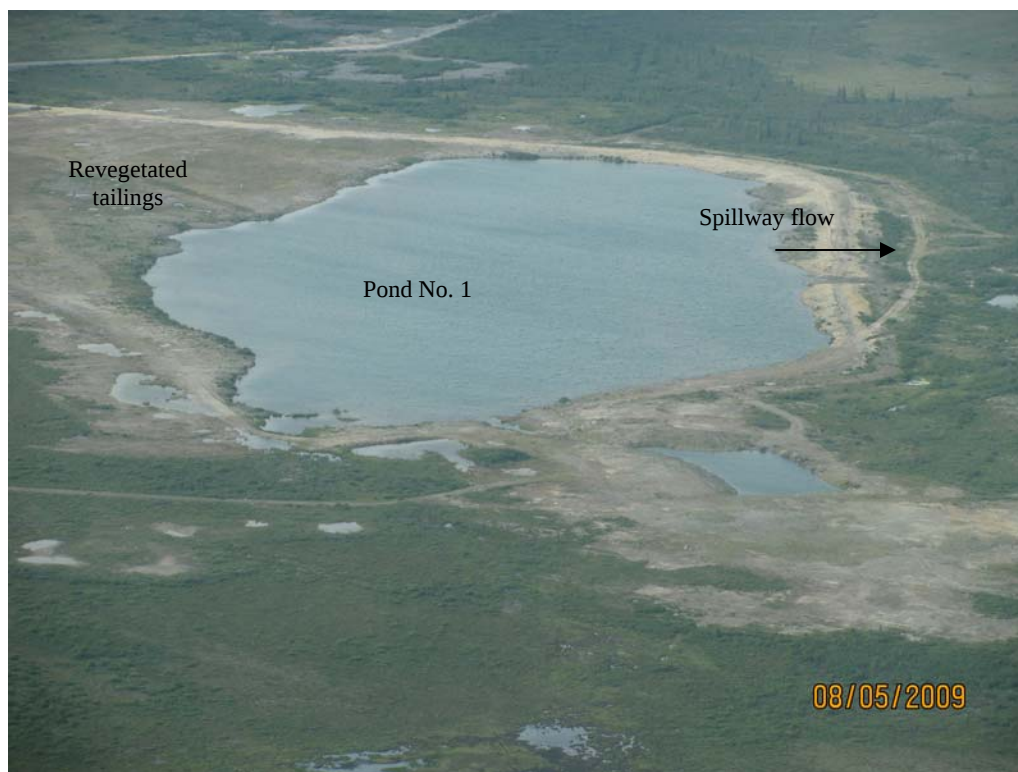
Photos 1 and 2, attached, show oblique views of the site taken from the air. The tailings area had been previously covered with local till as reported in Trow's previous inspection reports. Vegetation on the till covered tailings is small and sparse. However, it is noted that the density of the vegetation is increasing gradually, based on the comparative visual observations of previous years.

**Photo 1: Tailings facility looking roughly west**

**Photo 2: Tailings facility looking roughly northwest**

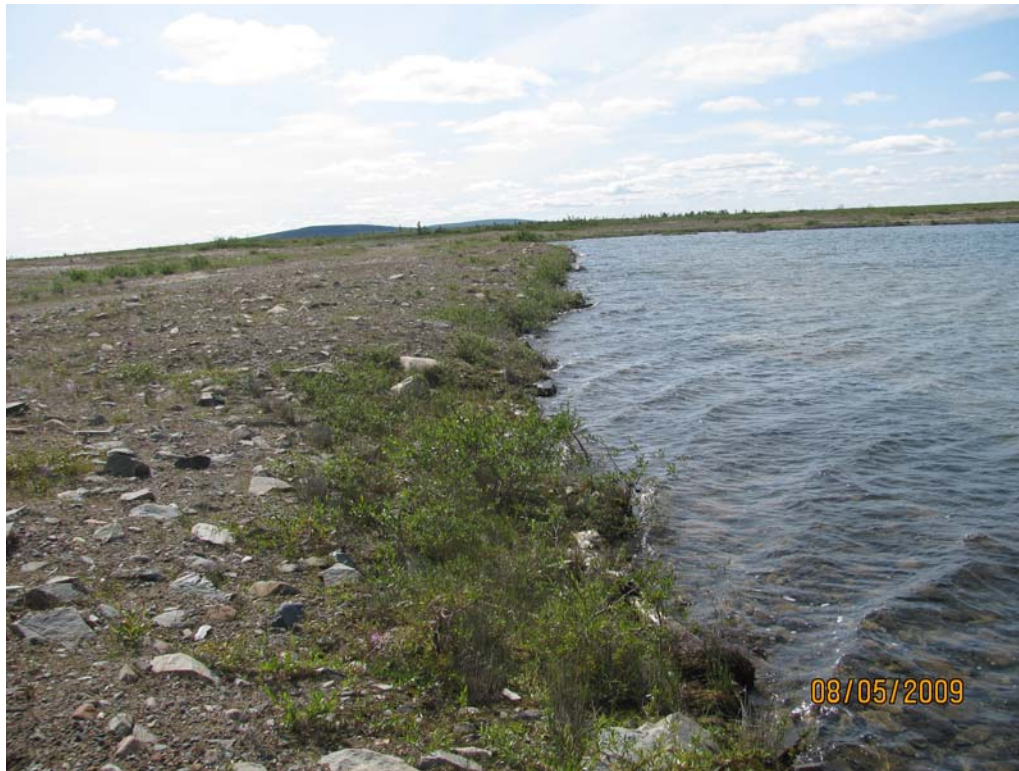
Photos 3 and 4 show views of Dam No. 1. Typically, the embankment, which is constructed principally with local cohesionless till, is irregular in section and surface grade. Average side slopes of the upstream and downstream sides were typically about 3H:1V and 6H:1V, respectively. The downstream side was estimated to be as steep as about 3H:1V in a few areas. The dam height ranges up to about 4 m. Some small erosion scars were observed on both the upstream and downstream sides; however, as described below, they appear to be stabilizing with vegetation and self-armouring with larger rock particles from the till and previously placed mine waste rock. These scars do not appear to be increasing in size, based on visual comparisons of previous years. No new erosion scars were apparent based on visual comparison from previous years. The crest width varies but is in the order of 15 m. No seepages were observed on the day of inspection. Within the tailings pond itself, no unsubmerged or exposed tailings were observed.

Based on the current as well as previous inspections and involvement with the project, the dam is not in any distress and is considered to be stable.

*Photo 3: Dam No. 1 - looking south - southeast*

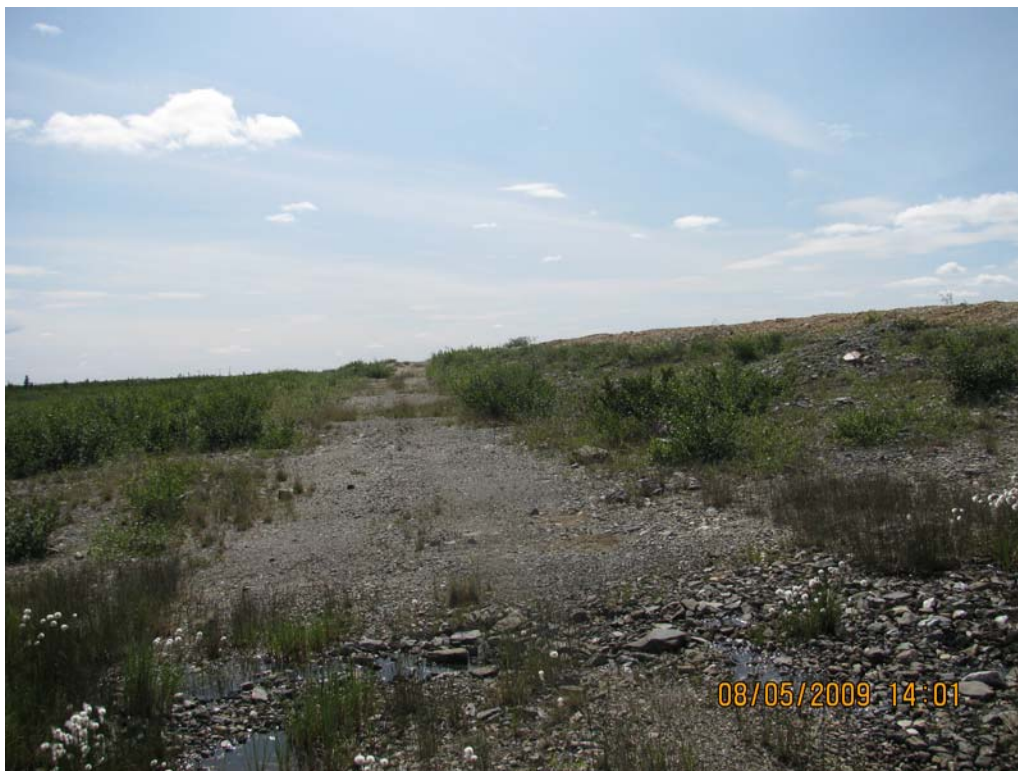
*Photo 4: Downstream section of Dam No. 1 near spillway channel*

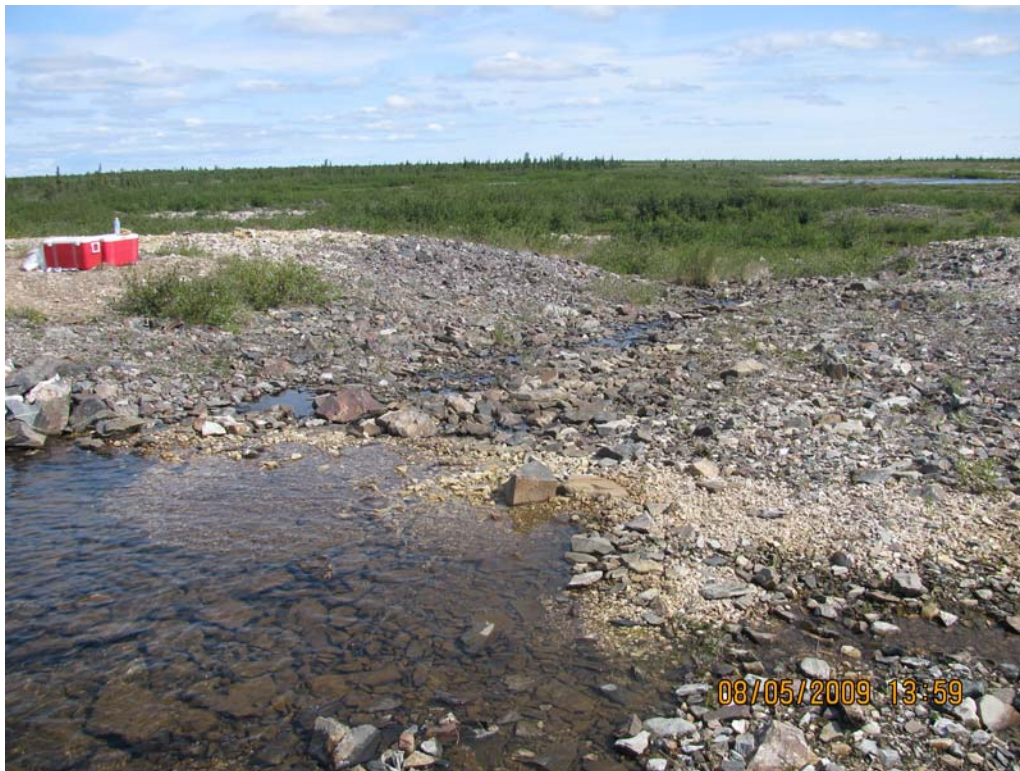
Photos 5 and 6 show views of the Dam No. 1 spillway channel. Only a very minor flow (trickle) was occurring at the spillway as had been observed in most previous years. A minor trickle was observed to flow over the rockfill comprising the channel bottom, slightly greater than in 2008, due to a pond level a few centimetres higher than in 2008.

Our visual inspection of the spillway channel, where additional fine rockfill was placed in 2005 to cover small areas of previously exposed rubber liner indicated that no erosion had occurred. We expect that monitoring of this during future inspections will indicate that this has been sufficient treatment.

*Photo 5: Dam No. 1 Spillway inlet looking downstream*

It is recommended that the condition of the Dam No. 1 spillway channel continue to be monitored for erosion and if any is apparent, remedial measures, such as the addition of additional rockfill, be implemented.

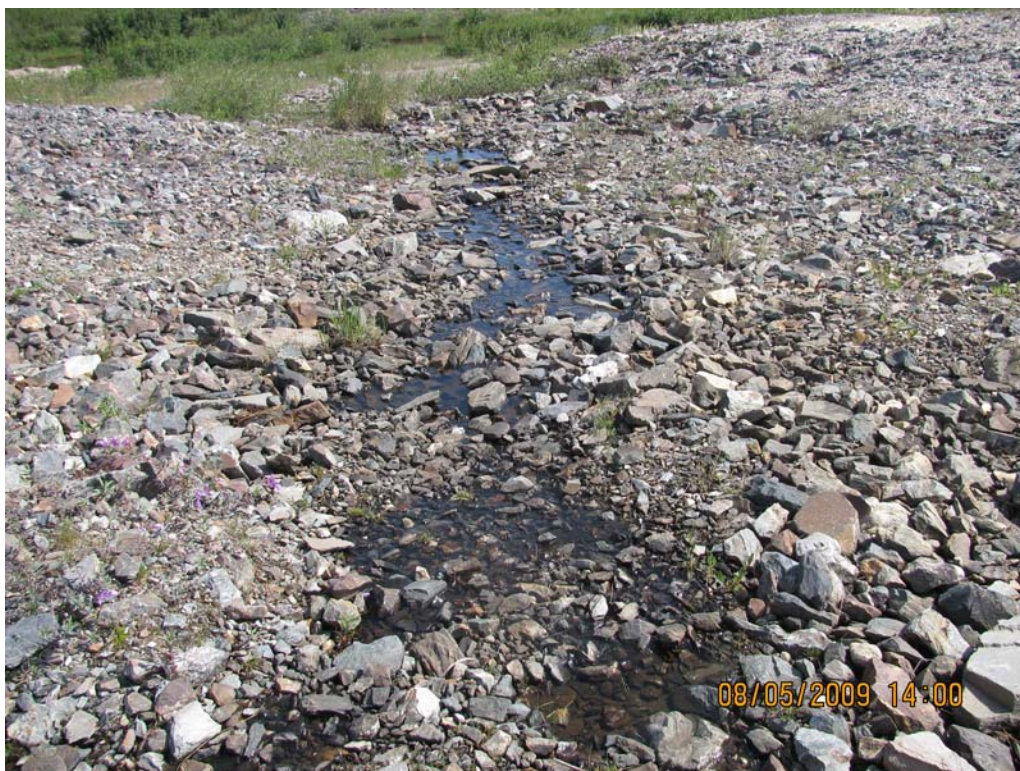
*Photo 6: Dam No. 1 Spillway downslope channel*

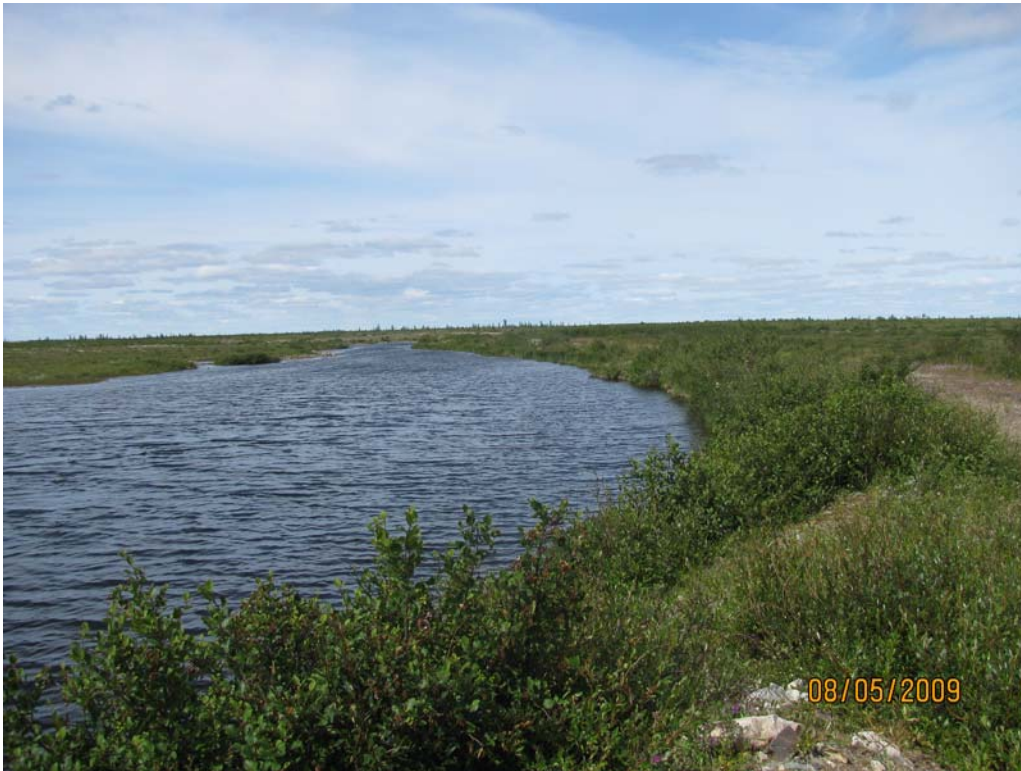
Photo 7 shows a view of Dam No. 2. As with Dam No. 1, the principal construction material is local cohesionless till. The dam section and surface grade is irregular, although less so than Dam No. 1. The crest width varies but is in the order of 15 m. No seepages were observed on the day of examination.

Based on the current as well as previous inspections and involvement with the project, the dam is not in any distress and is considered to be stable.

*Photo 7: View of Dam No. 2 (on the right) and Pond No. 2*

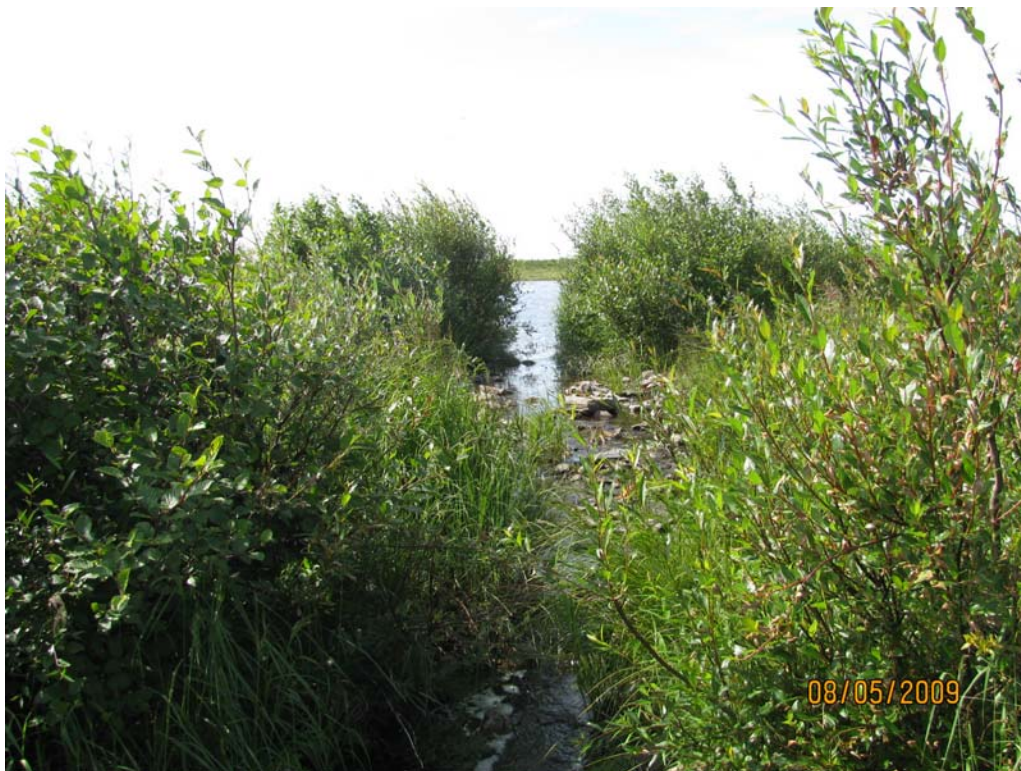
Photo 8 is an upstream view of the Dam No. 2 spillway channel. Flow was occurring over the spillway, slightly less than in 2008.

*Photo 8: Dam No. 2 Spillway Channel looking upstream to Pond 2*

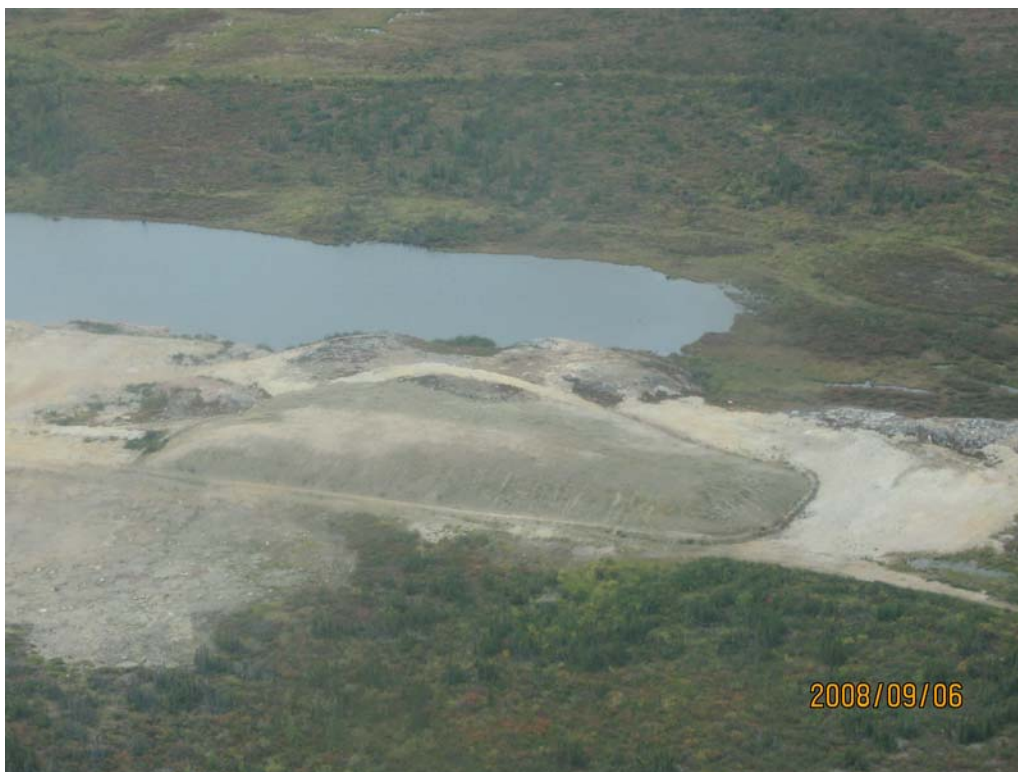
Photos 9 to 12, inclusive, show views of the Shear Lake Waste Rock Pile (Photo 9 is from 2008). The Shear Lake Waste Rock Pile, located on the east side of Shear Lake, some 4.5 km north of the former mill site, was reportedly capped with local, compacted glacial till to promote runoff and reduce infiltration. In 2005, Barrick personnel oversaw the re-seeding of the cap. The re-seeding (with grasses) was implemented to promote some vegetation growth which would reduce the erosion of the cover due to runoff, particularly along the side slopes.

*Photo 9: Aerial view of Shear Lake Waste Rock Pile looking west (2008)*

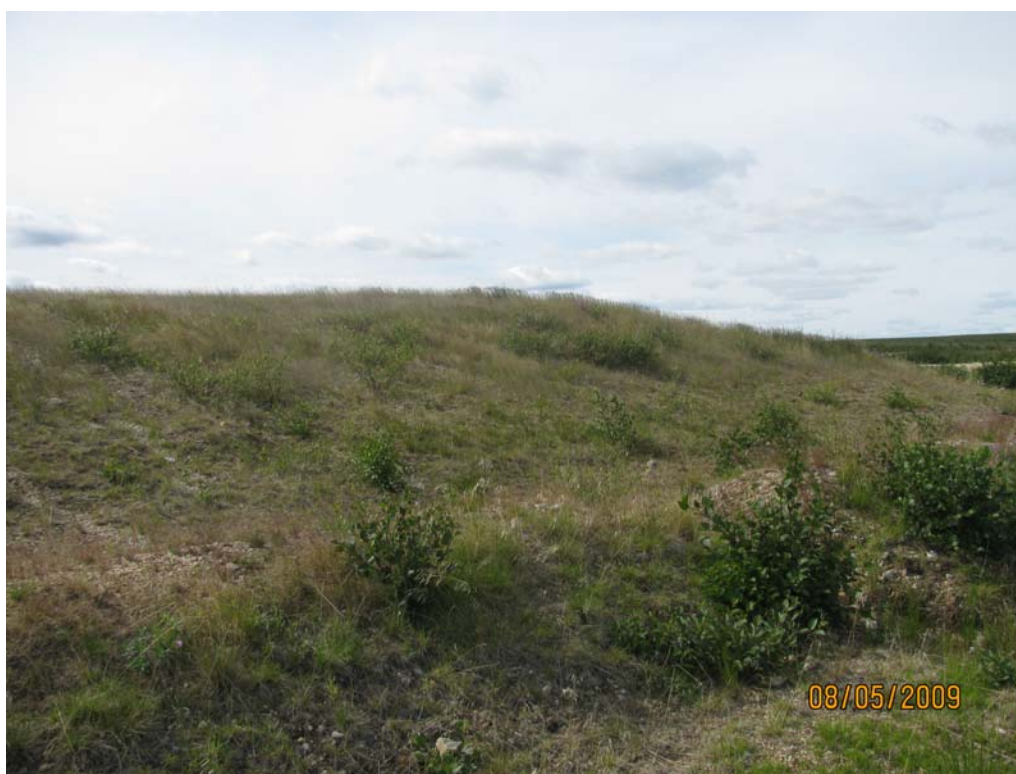
Our observations in August 2006 suggested that, while there are some sparse areas, the vegetation is helping to reduce erosion, in that very few small erosion gulleys/channels (20 to 30 mm deep/wide) were noticed on the side slopes. These generally were short and did not extend the full length of the slope. Most of these had been filled to some extent with small granular material in 2005, to minimize further erosion. Our observations in July 2007, September 2008 and this year, in August 2009, were similar. Photo 11 shows that the gravel filled erosion gulleys have been stabilized. A comparison of the photos from previous years shows that the vegetation is improving.

*Photo 10: East side of Shear Lake Waste Rock Pile showing grasses*

Subsequent inspections should be made to verify the efficacy of the vegetation/till cover system. Any erosion gulleys that form should be repaired with fine rock/gravel. It is expected that it will take several years for the vegetation to establish itself fully.

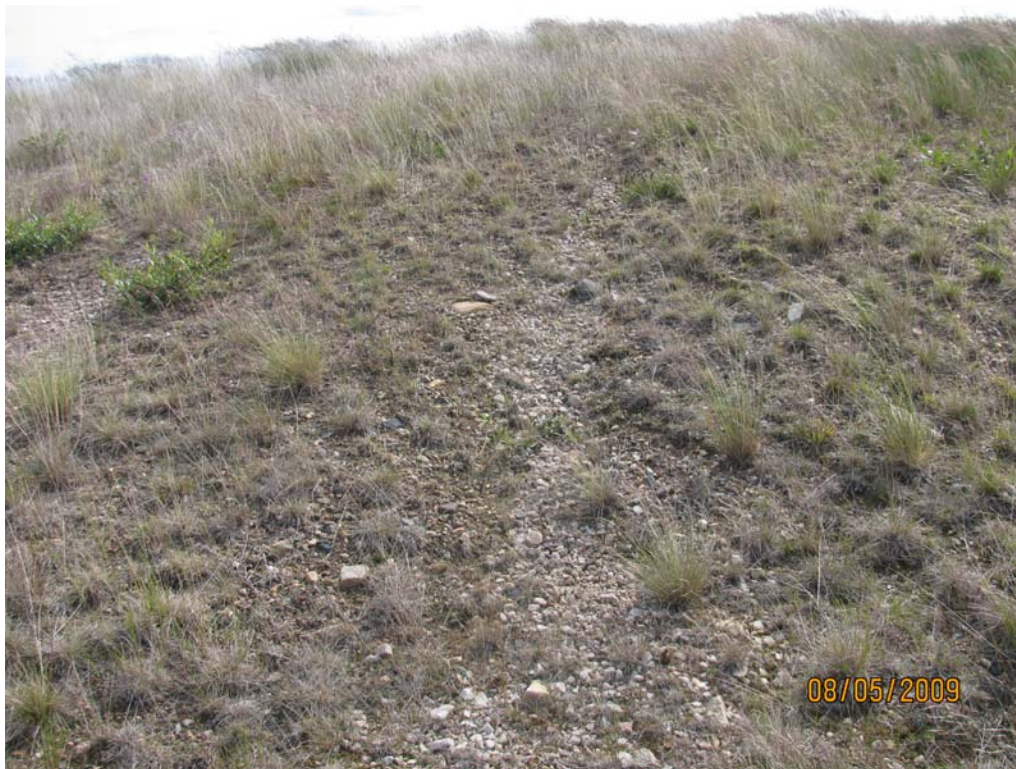
***Photo 11: Previously gravel filled erosion channels on Shear Lake Waste Rock Pile***

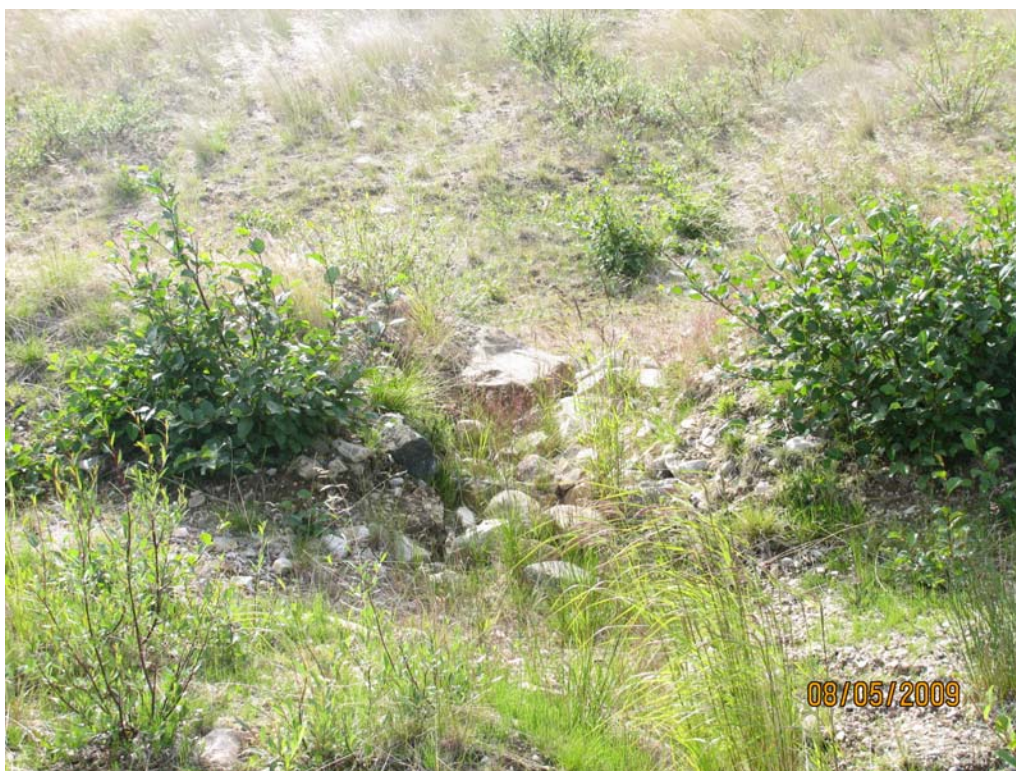
***Photo 12: Toe ditch outlet on east side of Shear Lake Waste Rock Pile***
