February 28, 2011

Reference: THB-000090132-A0

***2010 Tailings Dam Examination  
Cullaton Lake Gold Mine, Nunavut  
Licence NWB1CUL0207***

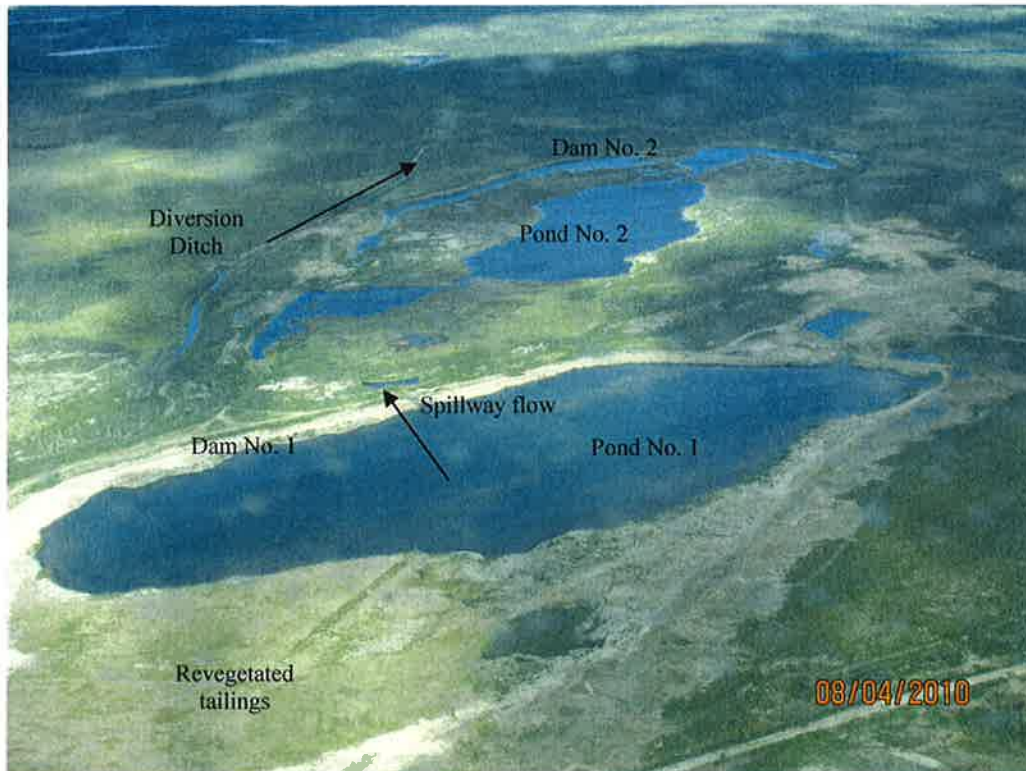
Photos 1 and 2, attached, show oblique views of the site taken from the air. The tailings area had been previously covered with local till as reported in Trow's previous inspection reports. Vegetation on the till covered tailings is small and sparse. However, it is noted that the density of the vegetation is increasing gradually, based on the comparative visual observations of previous years.

*Photo 1: Tailings facility looking roughly east*

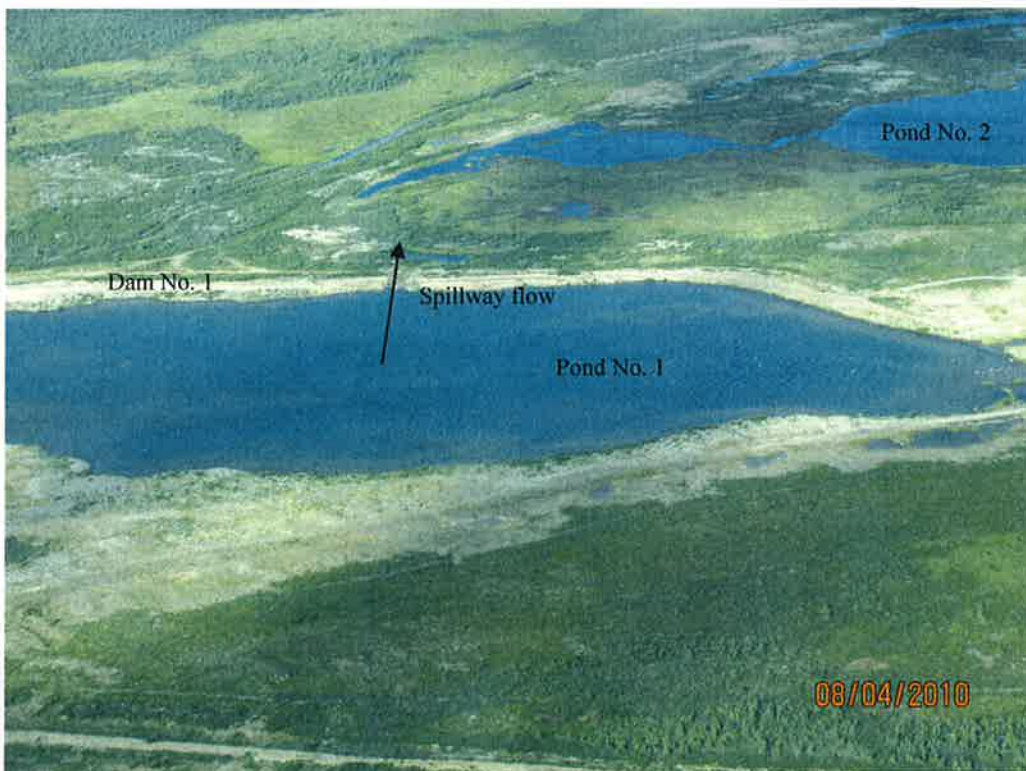
*Photo 2: Tailings facility looking roughly northwest*

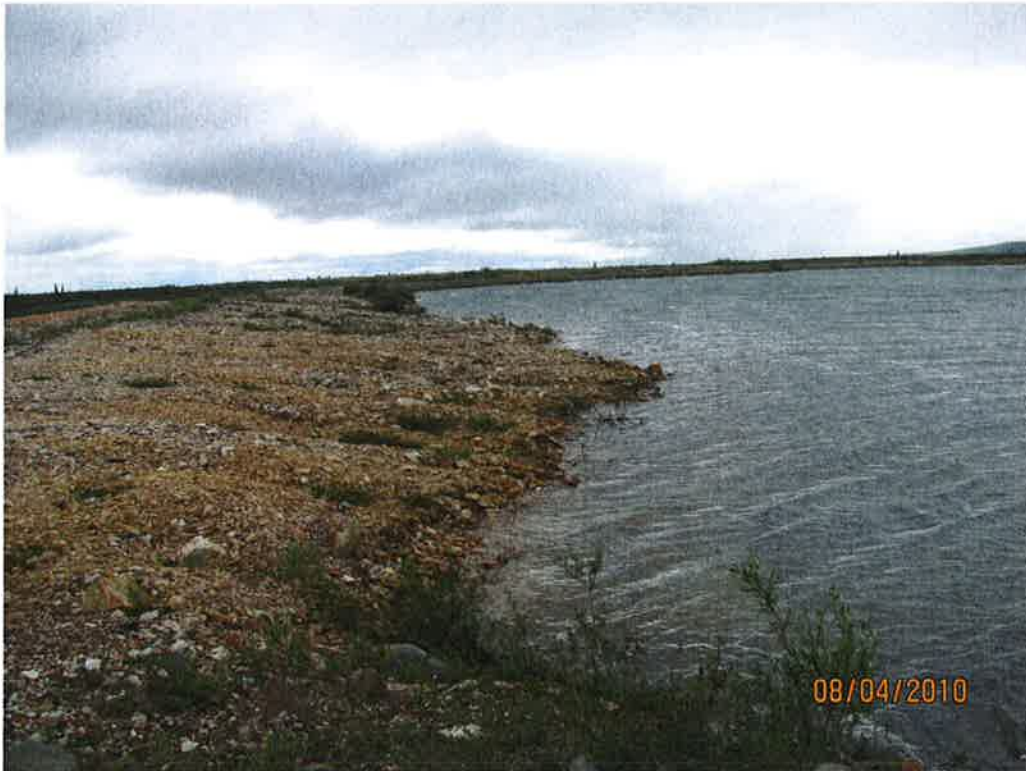
Photos 3 and 4 show views of Dam No. 1. Typically, the embankment, which is constructed principally with local cohesionless till, is irregular in section and surface grade. Average side slopes of the upstream and downstream sides were typically about 3H:1V and 6H:1V, respectively. The downstream side was estimated to be as steep as about 3H:1V in a few areas. The dam height ranges up to about 4 m. Some small erosion scars were observed on both the upstream and downstream sides; however, as described below, they appear to be stabilizing with vegetation and self-armouring with larger rock particles from the till and previously placed mine waste rock. These scars do not appear to be increasing in size, based on visual comparisons of previous years. The crest width varies but is in the order of 15 m. Within the tailings pond itself, no unsubmerged or exposed tailings were observed.

*Photo 3: Dam No. 1 - looking south - southeast*

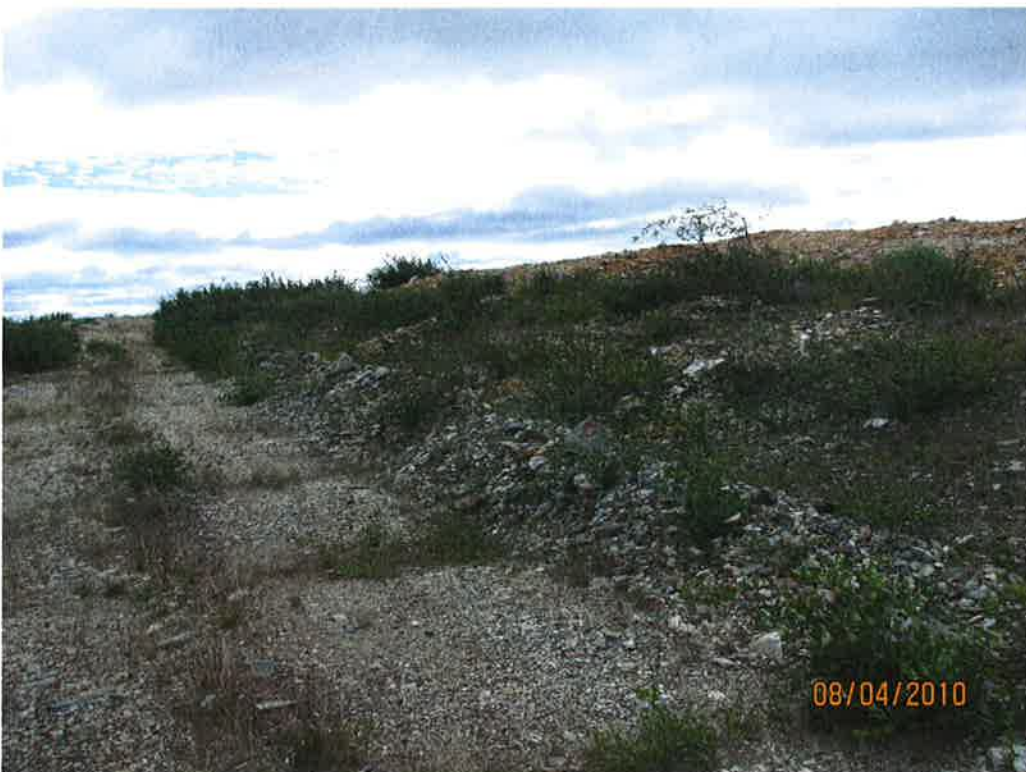
*Photo 4: Downstream section of Dam No. 1 near spillway channel*

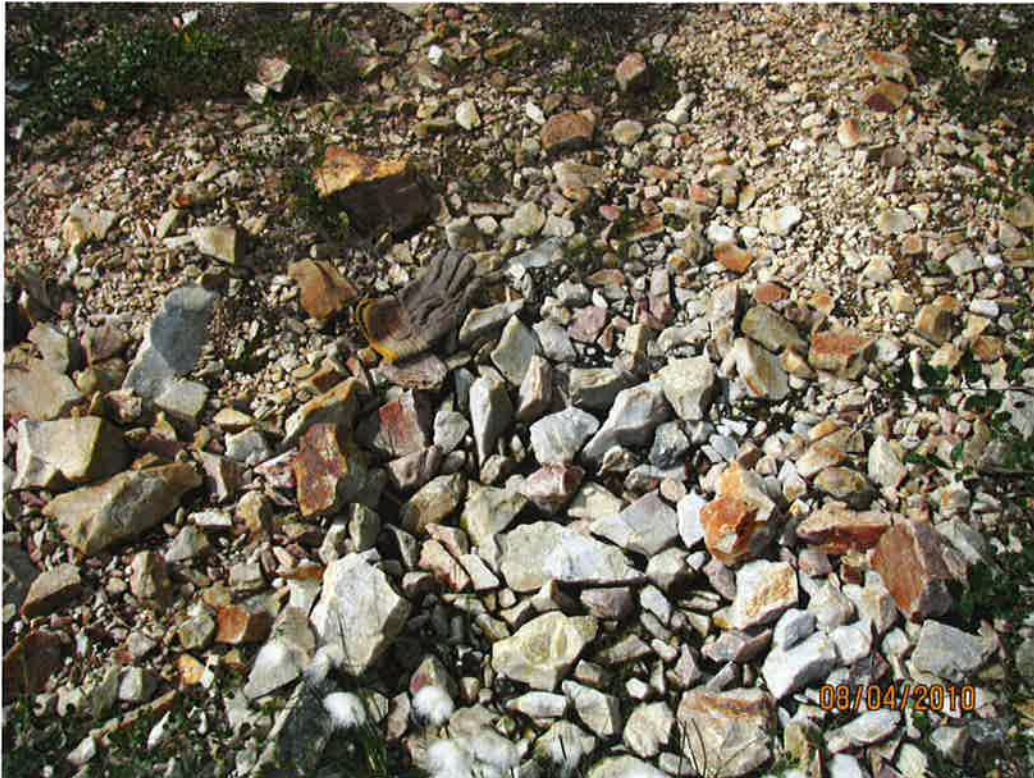
No seepages were observed on the day of inspection. However, a wet spot was observed about halfway down the downstream slope of the dam (see Photo 5), south of the spillway, at the approximate location shown on Figure 1 in Appendix A. As no flow was visible, it was not possible to determine if this was, in fact, a seep, or the result of recent precipitation that had pooled and not evaporated. Based on a hand level measurement, the base of the wet spot was about 150 mm to 300 mm below the Pond No. 1 water level on the date of site visit. For monitoring purposes, this location should be staked/marked in the field during the next site visit for ease of locating it in the future.

*Photo 5: Wet spot on downstream side of Dam No. 1*

It is recommended that the condition of the Dam No. 1 spillway channel continue to be monitored for erosion and if any is apparent, remedial measures, such as the addition of additional rockfill, be implemented. In addition, the wet spot noted on the downstream side of Dam No. 1, south of the spillway, should be marked in the field and monitored during each subsequent visit.

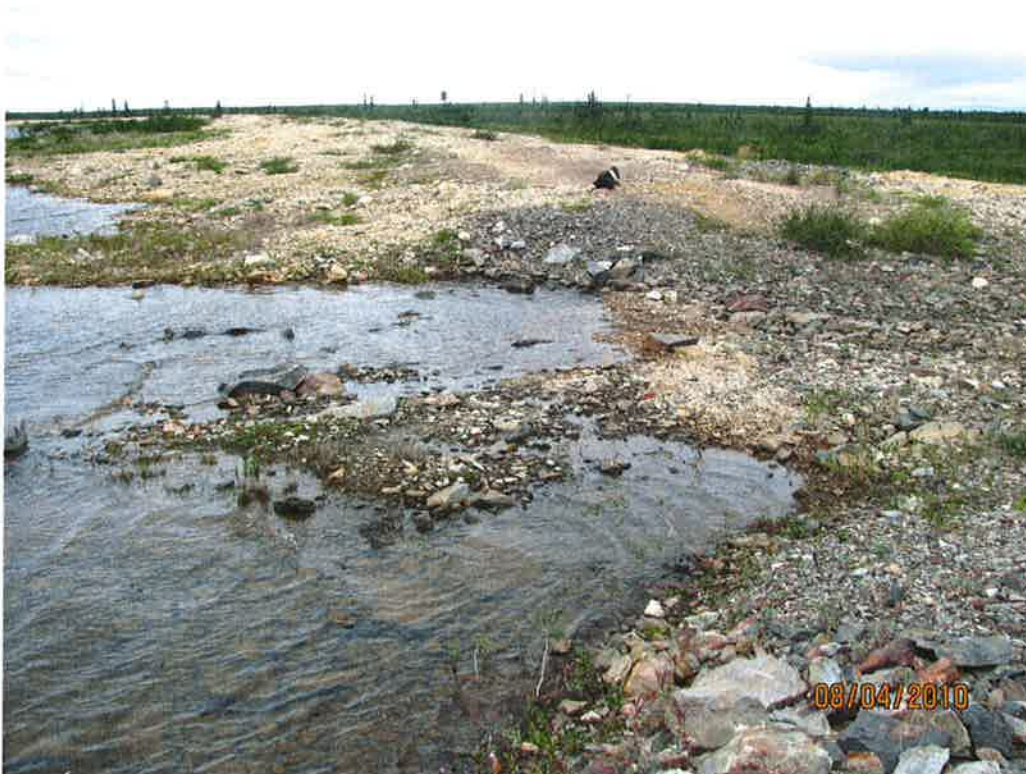
Photos 6 and 7 show views of the Dam No. 1 spillway channel. Only a minor flow (trickle) was occurring at the spillway as had been observed in most previous years. A minor trickle was observed to flow over the rockfill comprising the channel bottom, slightly less than in 2009, due to the pond level being a few centimetres lower than in 2009.

Our visual inspection of the spillway channel, where additional fine rockfill was placed in 2005 to cover small areas of previously exposed rubber liner indicates that no erosion has occurred. It is expected that monitoring of this area during future inspections will indicate that the treatment performed in 2005 has been sufficient.

*Photo 6: Dam No. 1 Spillway inlet and crest*

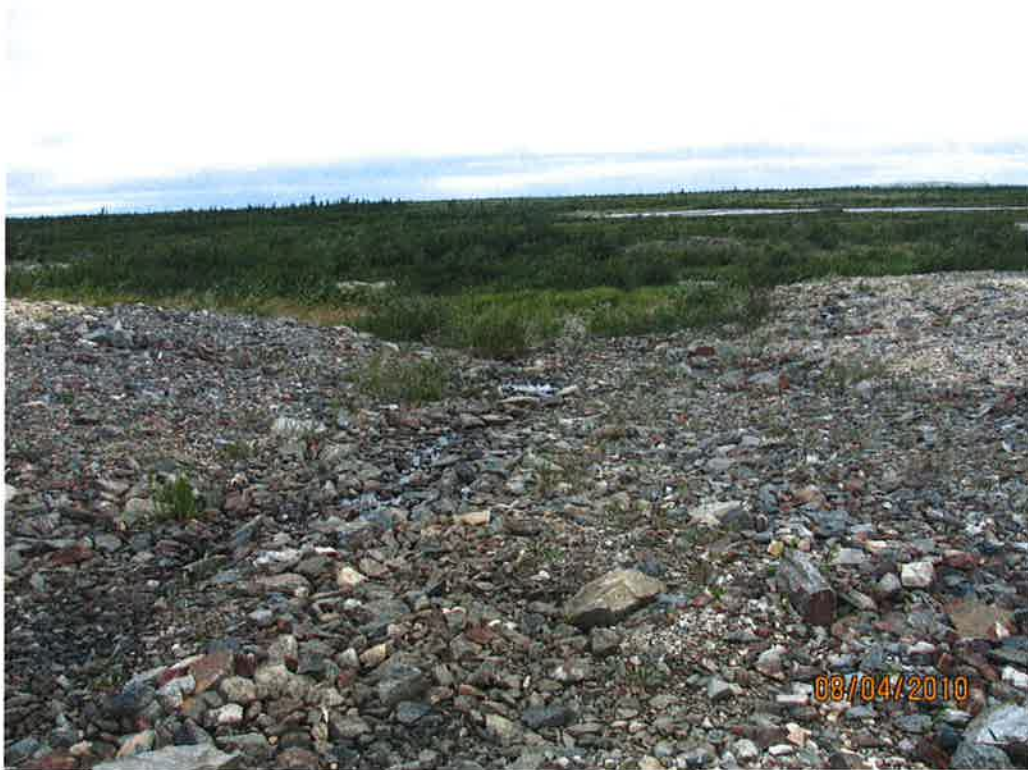
*Photo 7: Dam No. 1 Spillway downslope channel*

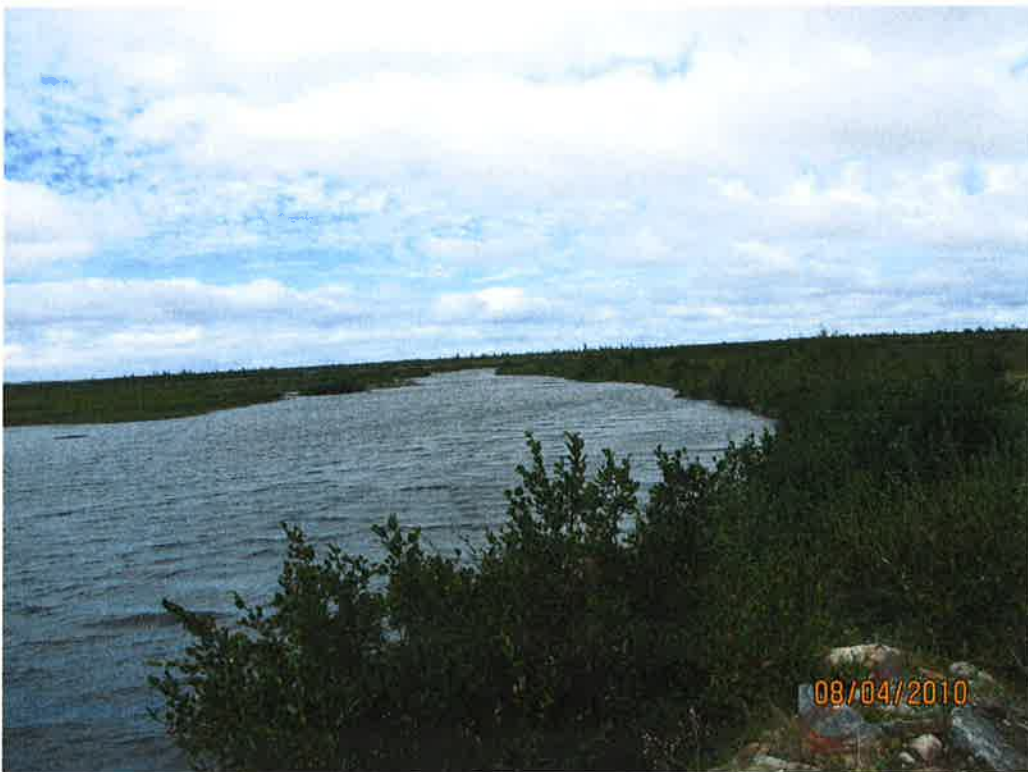
Photo 8 shows a view of Dam No. 2. As with Dam No. 1, the principal construction material is local cohesionless till. The dam section and surface grade is irregular, although less so than Dam No. 1. The crest width varies but is in the order of 15 m. No seepages were observed on the day of examination.

*Photo 8: View of Dam No. 2 (on the right) and Pond No. 2*

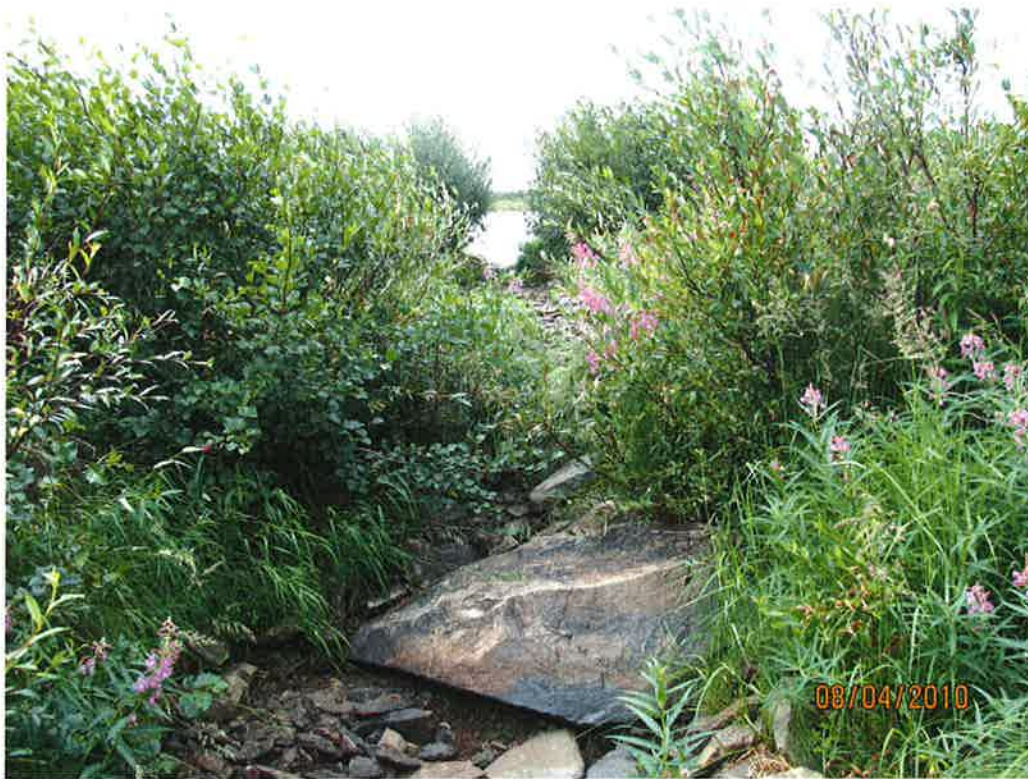
Photo 9 is an upstream view of the Dam No. 2 spillway channel. Flow was occurring over the spillway and in the channel, but considerably less than in 2009.

*Photo 9: Dam No. 2 Spillway Channel looking upstream to Pond 2*

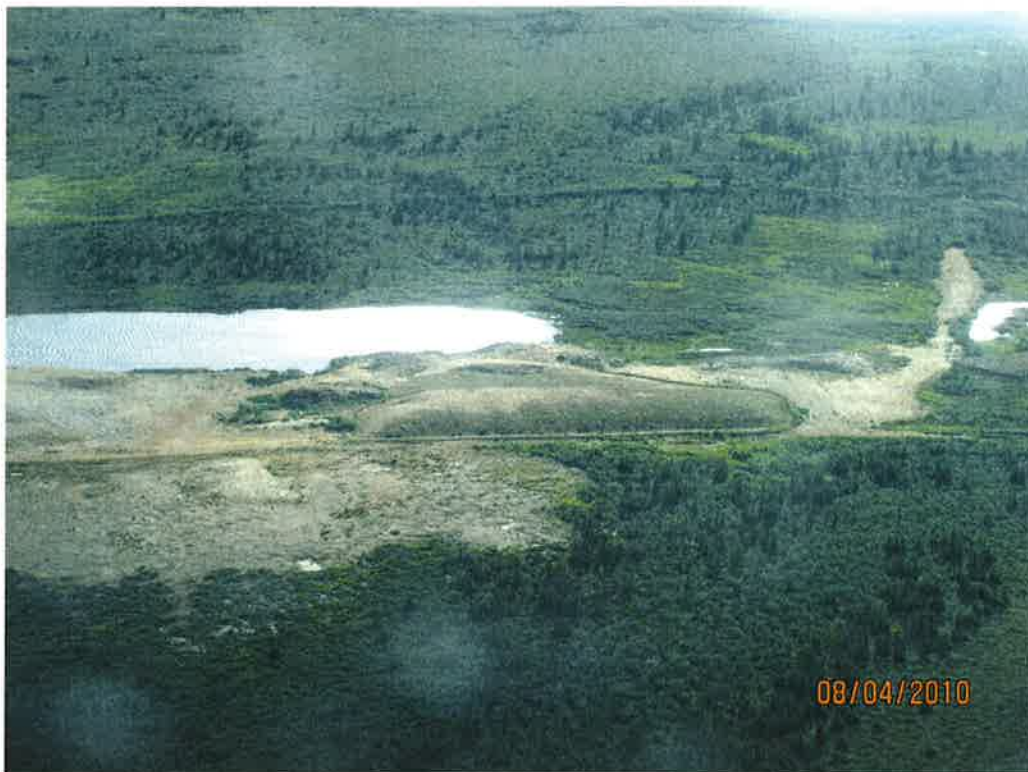
Photos 10 to 13, inclusive, show views of the Shear Lake Waste Rock Pile. The Shear Lake Waste Rock Pile, located on the east side of Shear Lake, some 4.5 km north of the former mill site, was reportedly capped with local, compacted glacial till to promote runoff and reduce infiltration. In 2005, Barrick personnel oversaw the re-seeding of the cap. The re-seeding (with grasses) was implemented to promote some vegetation growth which would reduce the erosion of the cover due to runoff, particularly along the side slopes.

*Photo 10: Aerial view of Shear Lake Waste Rock Pile looking west*

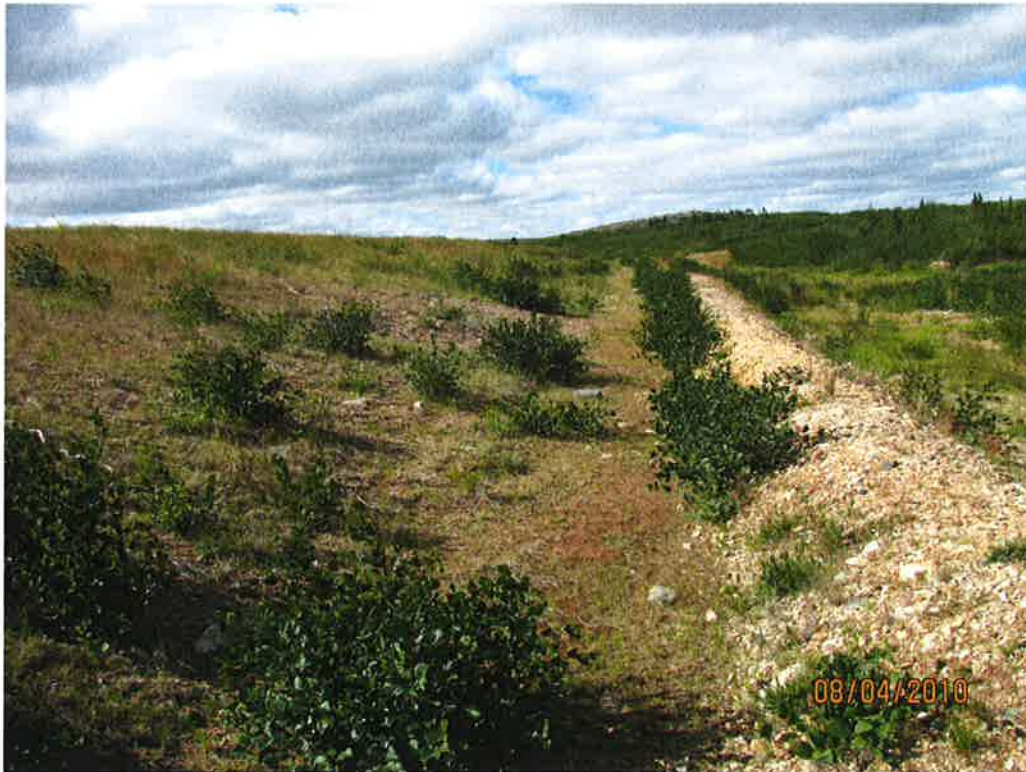
Our observations suggest that, while there are some sparse areas, the vegetation is helping to reduce erosion, in that very few small erosion gulleys/channels (20 to 30 mm deep/wide) were noticed on the side slopes. These generally were short and did not extend the full length of the slope. Most of these had been filled to some extent with small granular material in 2005, to minimize further erosion. Our

*Photo 11: East side of Shear Lake Waste Rock Pile showing grasses on left*

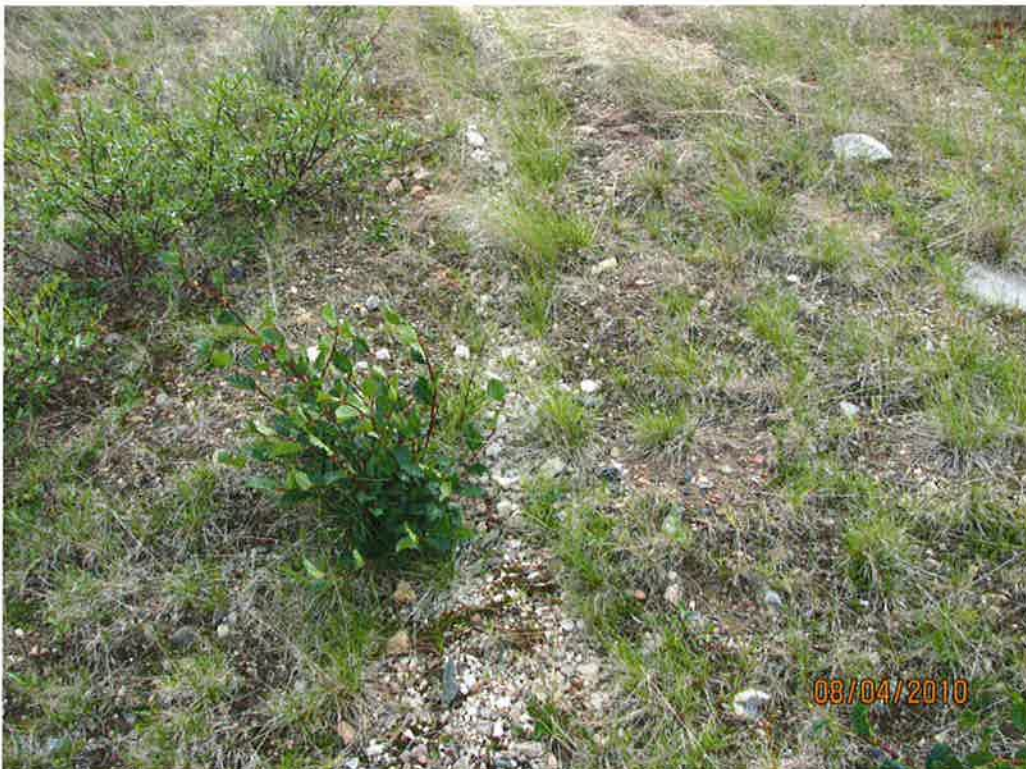
Photo 12 shows that the gravel filled erosion gullies have been stabilized. A comparison of the photos from previous years shows that the vegetation is improving.

*Photo 12: Previously gravel filled erosion channels on Shear Lake Waste Rock Pile*

Subsequent inspections should be made to verify the efficacy of the vegetation/till cover system. Any erosion gullies that form should be repaired with fine rock/gravel. It is expected that it will take several years for the vegetation to establish itself fully.

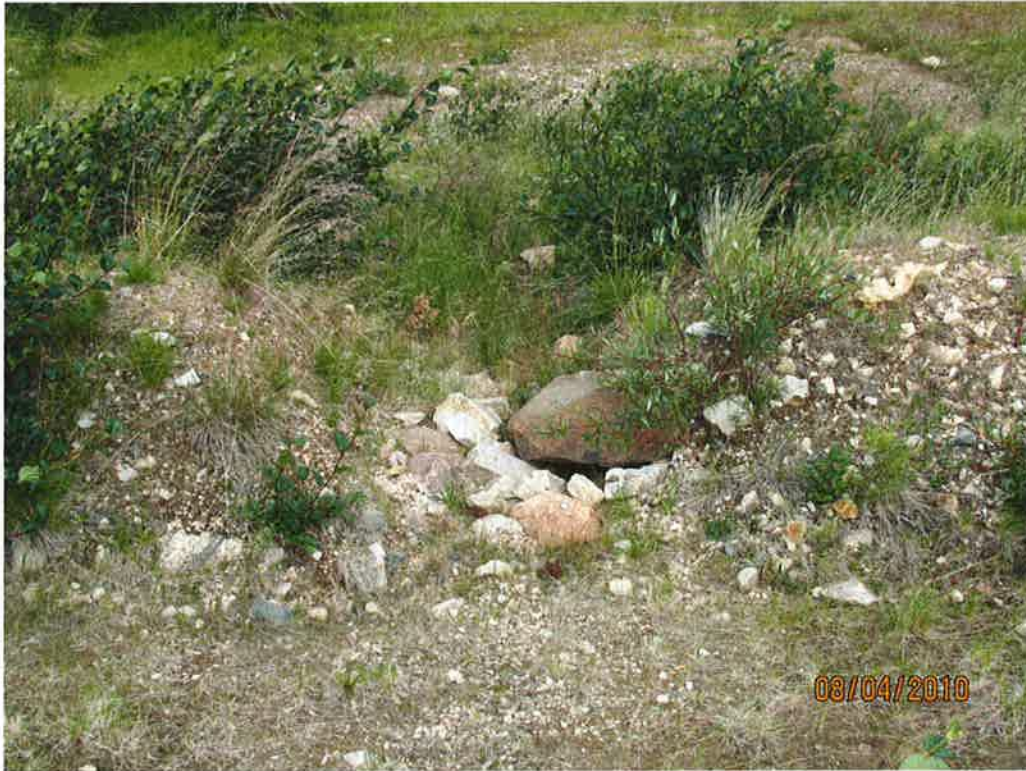
*Photo 13: Toe ditch outlet on east side of Shear Lake Waste Rock Pile*
