December 15, 2011

Re: **Project No. THB-00090132-A0**
2011 Tailings Dam Examination
Cullaton Lake Gold Mine, Nunavut
Licence NWB1CUL0207

Current Inspection – August 4, 2011

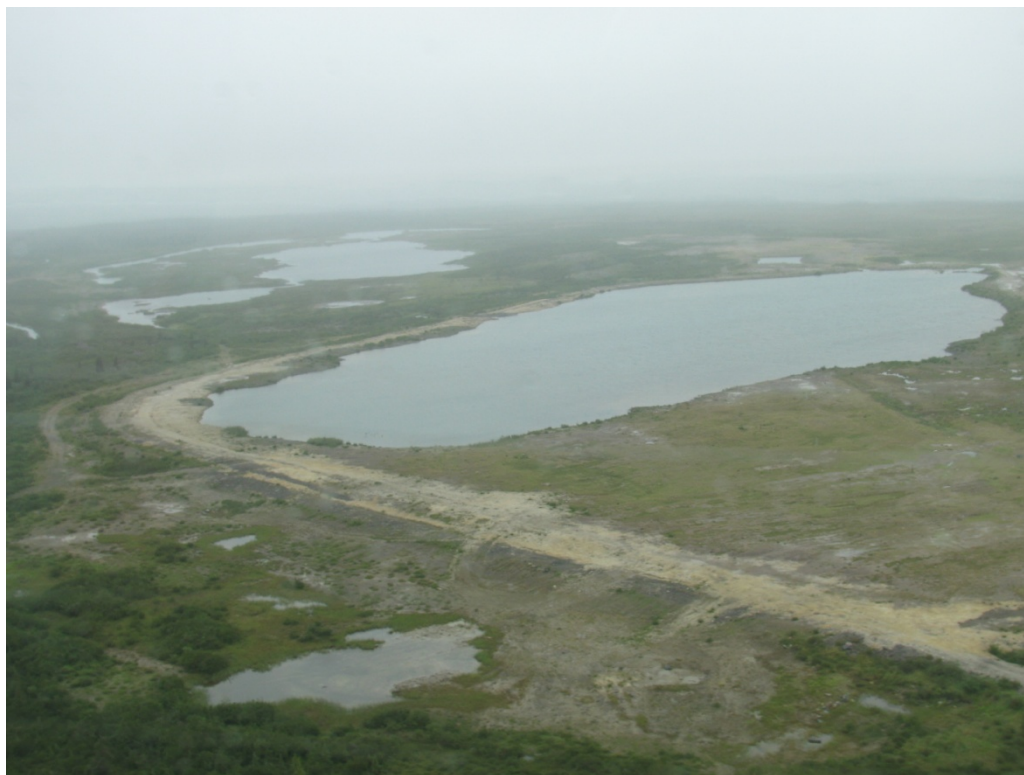
Photos 1 and 2, attached, show oblique views of the site taken from the air. The tailings area had been previously covered with local till as reported in Trow's previous inspection reports. Vegetation on the till covered tailings is small and sparse. However, it is noted that the density of the vegetation is increasing gradually, based on the comparative visual observations of previous years.

Photo 1: Tailings facility looking roughly east

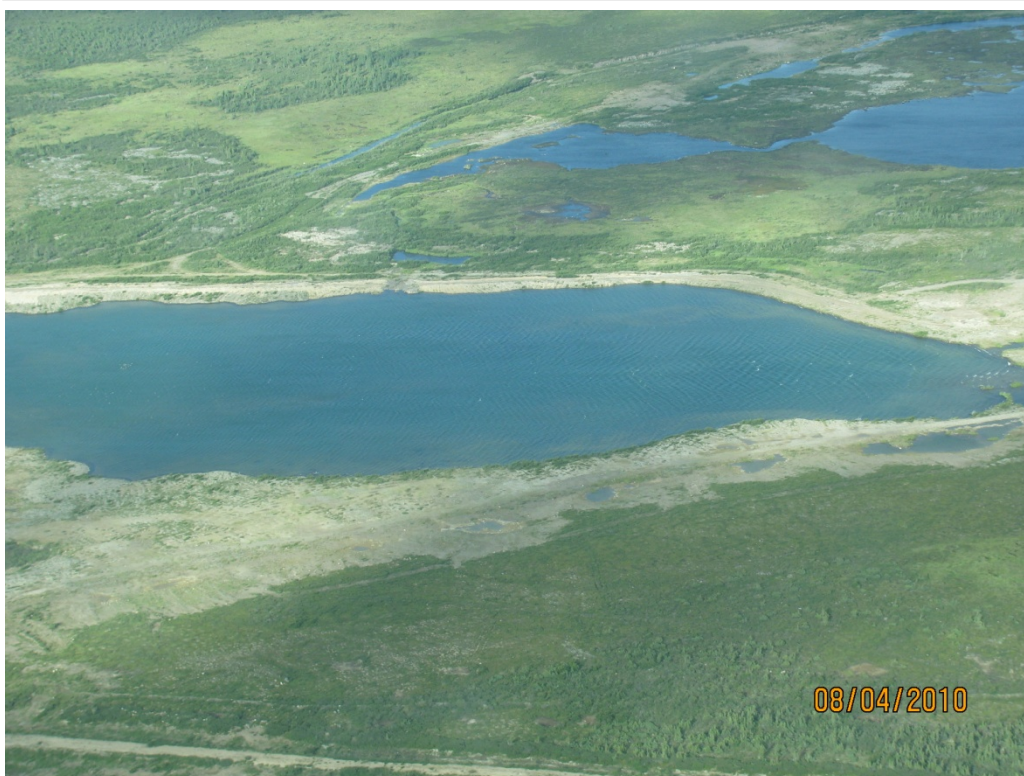
Photo 2: Tailings facility looking roughly northwest (2010 photo)

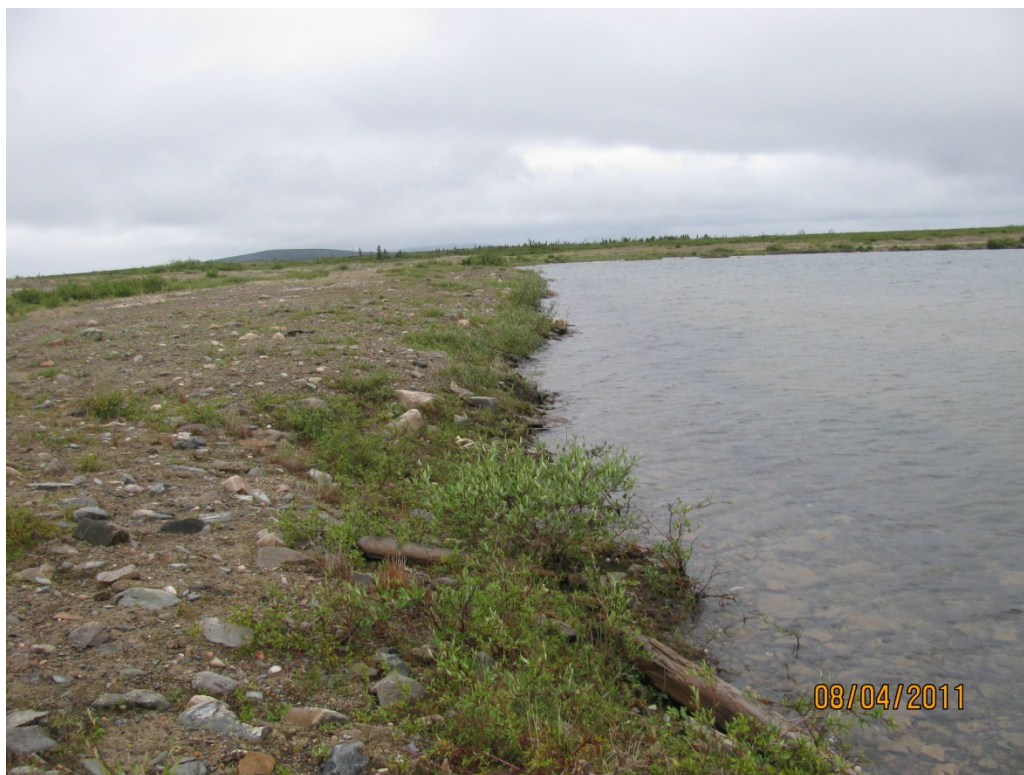
Photos 3 and 4 show views of Dam No. 1. Typically, the embankment, which is constructed principally with local cohesionless till, is irregular in section and surface grade. Average side slopes of the upstream and downstream sides were typically about 3H:1V and 6H:1V, respectively. The downstream side was estimated to be as steep as about 3H:1V in a few areas. The dam height ranges up to about 4 m. Some small erosion scars were observed on both the upstream and downstream sides; however, as described below, they appear to be stabilizing with vegetation and self-armouring with larger rock particles from the till and previously placed mine waste rock. These scars do not appear to be increasing in size, based on visual comparisons of previous years. The crest width varies but is generally in the order of 15 m. Within the tailings pond itself, no unsubmerged or exposed tailings were observed.

Photo 3: Dam No. 1 - looking south - southeast

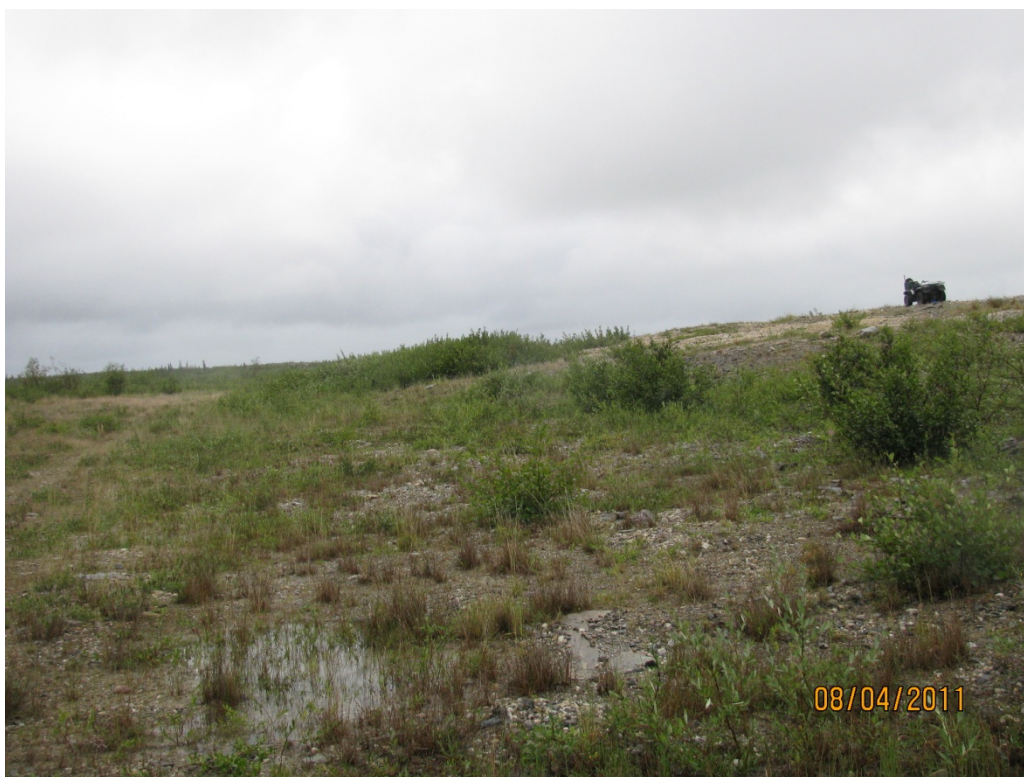
Photo 4: Downstream section of Dam No. 1 near spillway channel

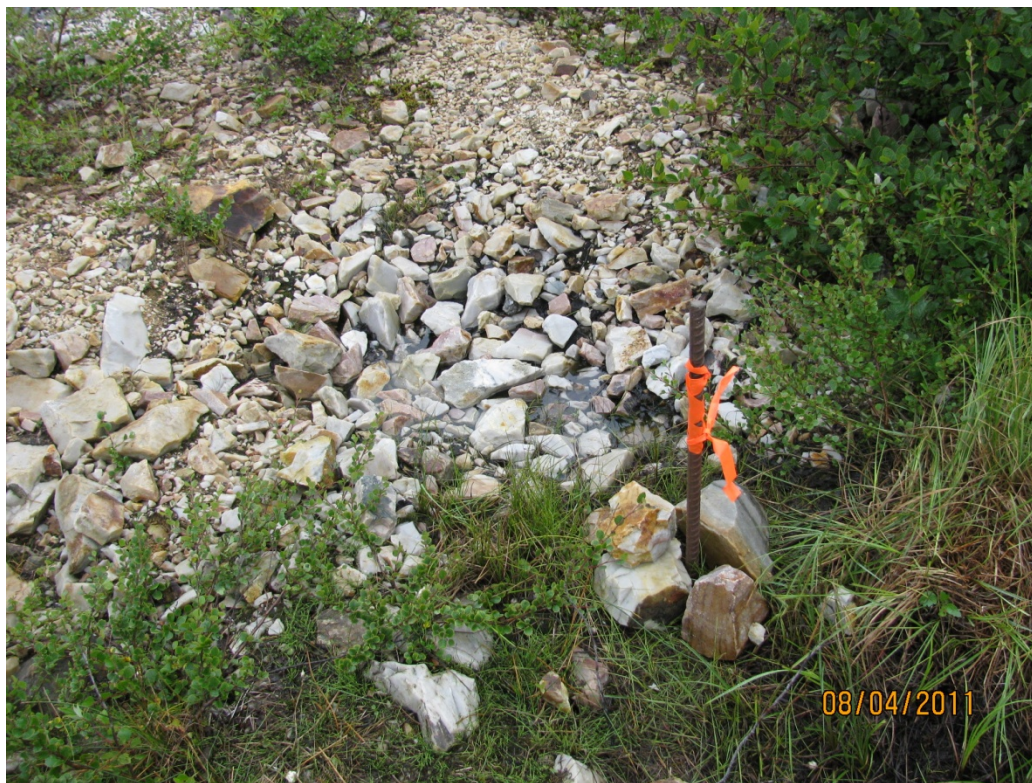
No seepages were observed on the day of inspection. However, a wet spot, first noted in the 2010 report, was observed about halfway down the downstream slope of the dam (see Photo 5), south of the spillway, at the approximate location shown on Figure 1 in Appendix A. As recommended in the previous report, the location was marked with a length of rebar. While there was accumulated water, no flow was visible. It was not possible to determine if this was, in fact, a seep, or the result of recent precipitation that had pooled and not evaporated. There was no evidence of any dam internal soil erosion. This should continue to be monitored during the scheduled inspections.

Photo 5: Wet spot on downstream side of Dam No. 1

It is recommended that the condition of the Dam No. 1 spillway channel continue to be monitored for erosion and if any is apparent, remedial measures, such as the addition of additional rockfill, be implemented. In addition, the wet spot noted on the downstream side of Dam No. 1, south of the spillway, should be monitored during each subsequent visit.

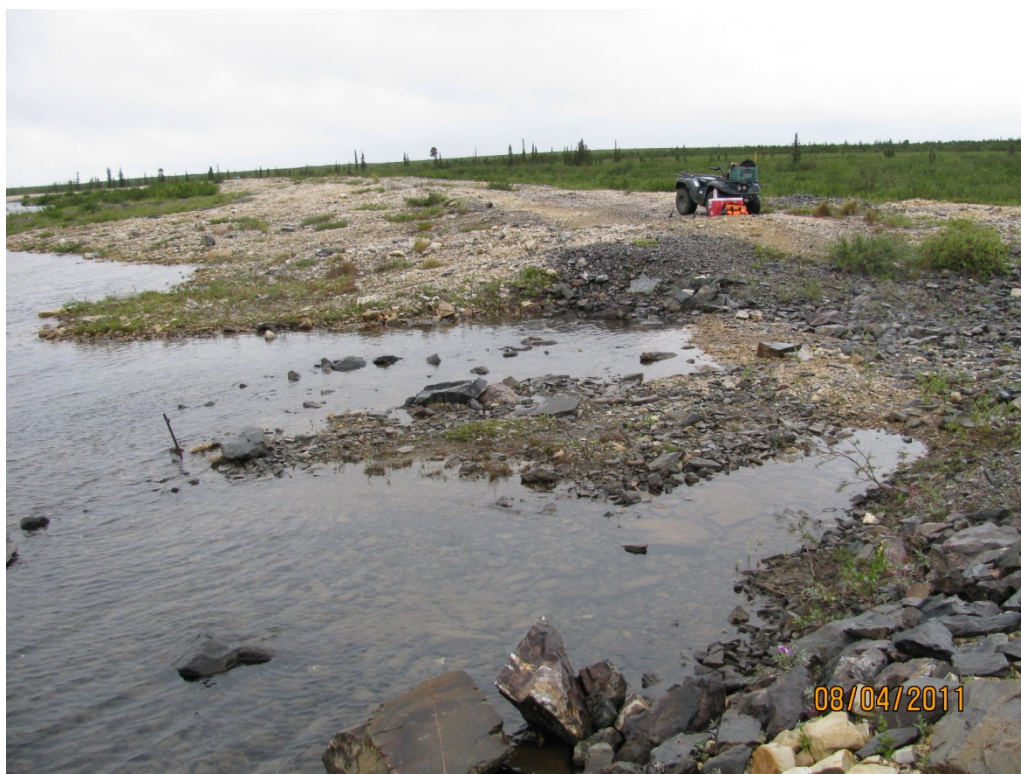
Photos 6 and 7 show views of the Dam No. 1 spillway channel. Only a minor flow (trickle) was occurring at the spillway as had been observed in most previous years. A minor trickle was observed to flow over the rockfill comprising the channel bottom, slightly less than in 2010, due to the pond level being a few centimetres lower than in 2010.

Our visual inspection of the spillway channel, where additional fine rockfill was placed in 2005 to cover small areas of previously exposed rubber liner indicates that no erosion has occurred. It is expected that monitoring of this area during future inspections will indicate that the treatment performed in 2005 has been sufficient.

Photo 6: Dam No. 1 Spillway inlet and crest

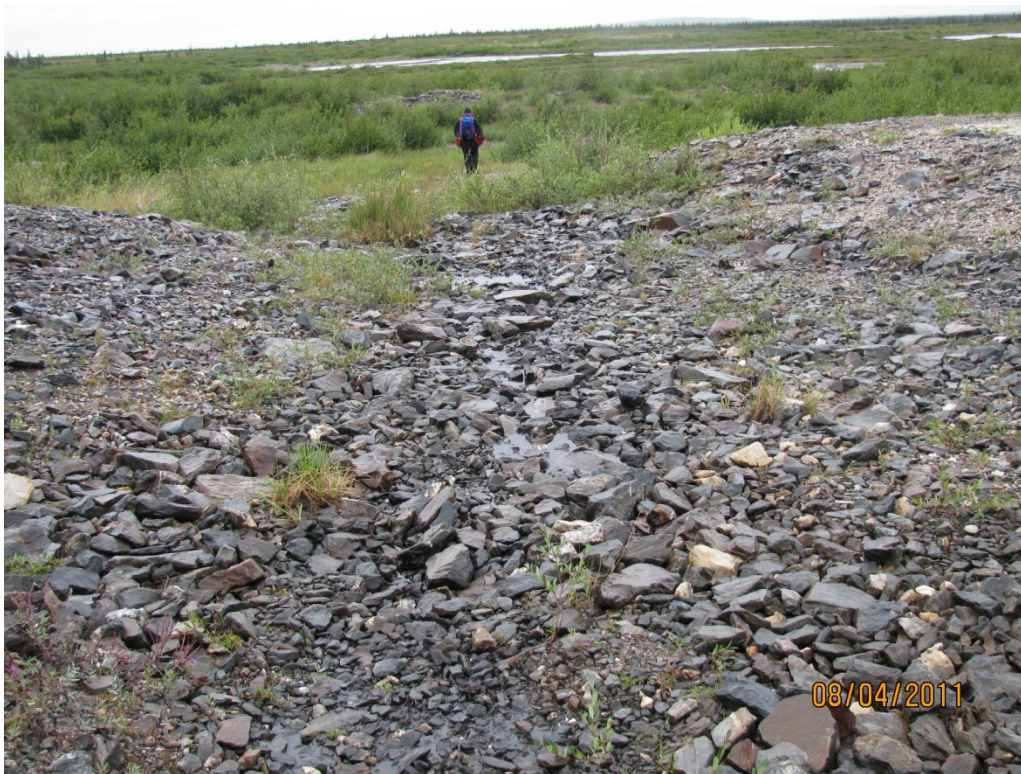
Photo 7: Dam No. 1 Spillway downslope channel

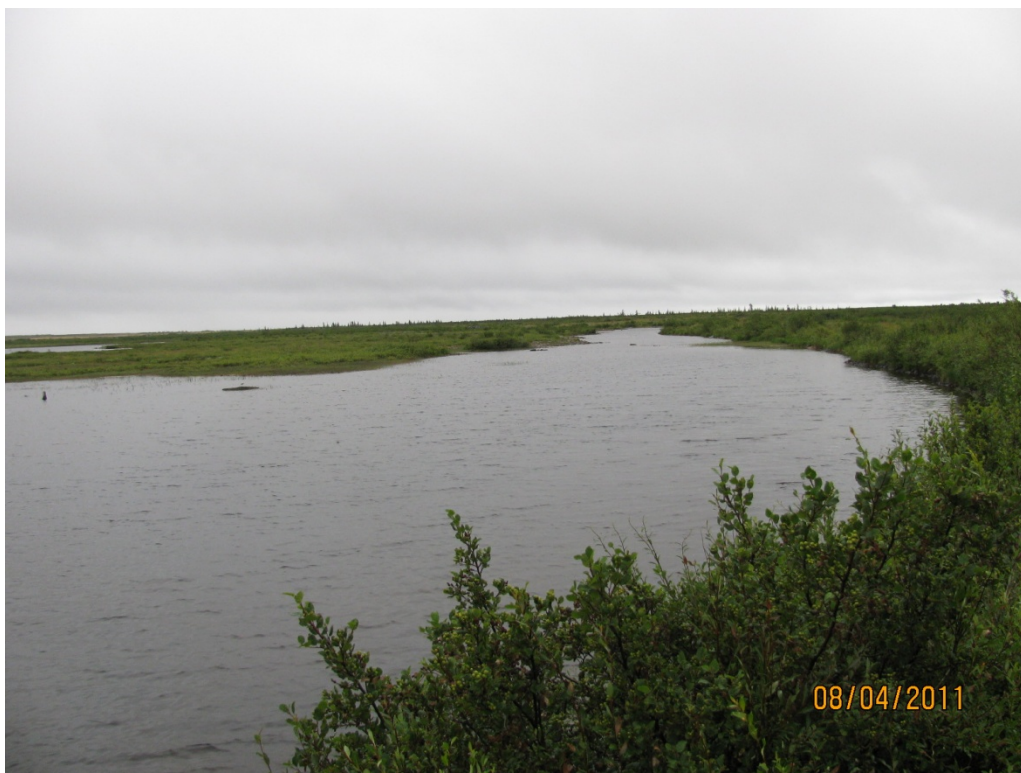
Photo 8 shows a view of Dam No. 2. As with Dam No. 1, the principal construction material is local cohesionless till. The dam section and surface grade is irregular, although less so than Dam No. 1. The crest width varies but is in the order of 15 m. No seepages were observed on the day of examination.

Photo 8: View of Dam No. 2 (on the right) and Pond No. 2

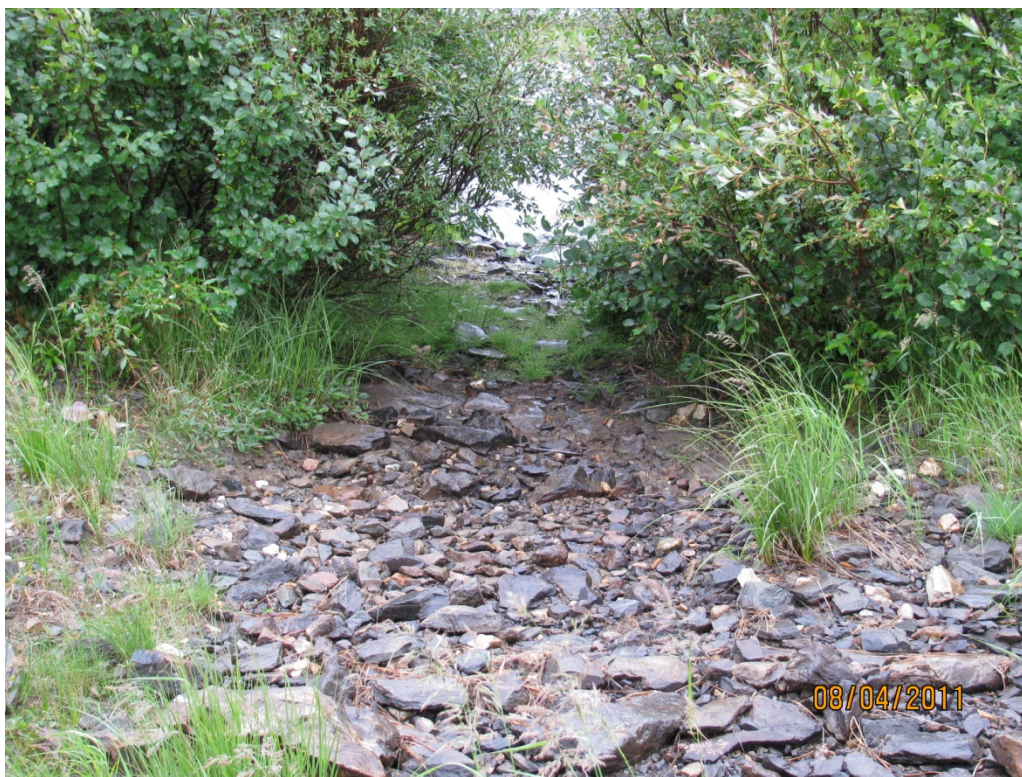
Photo 9 is an upstream view of the Dam No. 2 spillway channel. No flow was occurring over the spillway.

Photo 9: Dam No. 2 Spillway Channel looking upstream to Pond 2

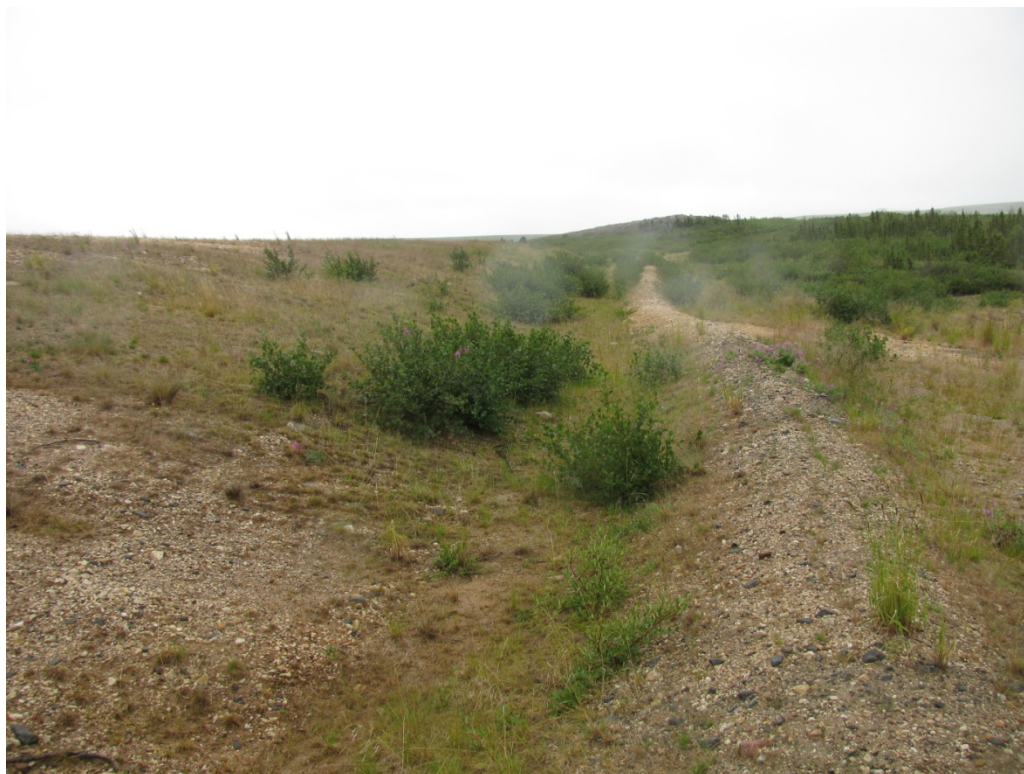
Photos 10 to 13, inclusive, show views of the Shear Lake Waste Rock Pile. The Shear Lake Waste Rock Pile, located on the east side of Shear Lake, some 4.5 km north of the former mill site, was reportedly capped with local, compacted glacial till to promote runoff and reduce infiltration. In 2005, Barrick personnel oversaw the re-seeding of the cap. The re-seeding (with grasses) was implemented to promote some vegetation growth which would reduce the erosion of the cover due to runoff, particularly along the side slopes.

Our observations suggest that, while there are some sparse areas, the vegetation is helping to reduce erosion, in that very few small erosion gulleys/channels (20 to 30 mm deep/wide) were noticed on the side slopes. These generally were short and did not extend the full length of the slope. Most of these had been filled to some extent with small granular material in 2005, to minimize further erosion. Our observations in July 2007, September 2008, August 2009 and 2010 and this year, in August 2011, were similar. Photo 12 shows that the gravel filled erosion gullies have been stabilized. A comparison of the photos from previous years shows that the vegetation is improving.

Photo 11: East side of Shear Lake Waste Rock Pile showing grasses on left

Subsequent inspections should be made to verify the efficacy of the vegetation/till cover system. Any erosion gullies that form should be repaired with fine rock/gravel. It is expected that it will take several years for the vegetation to establish itself fully.

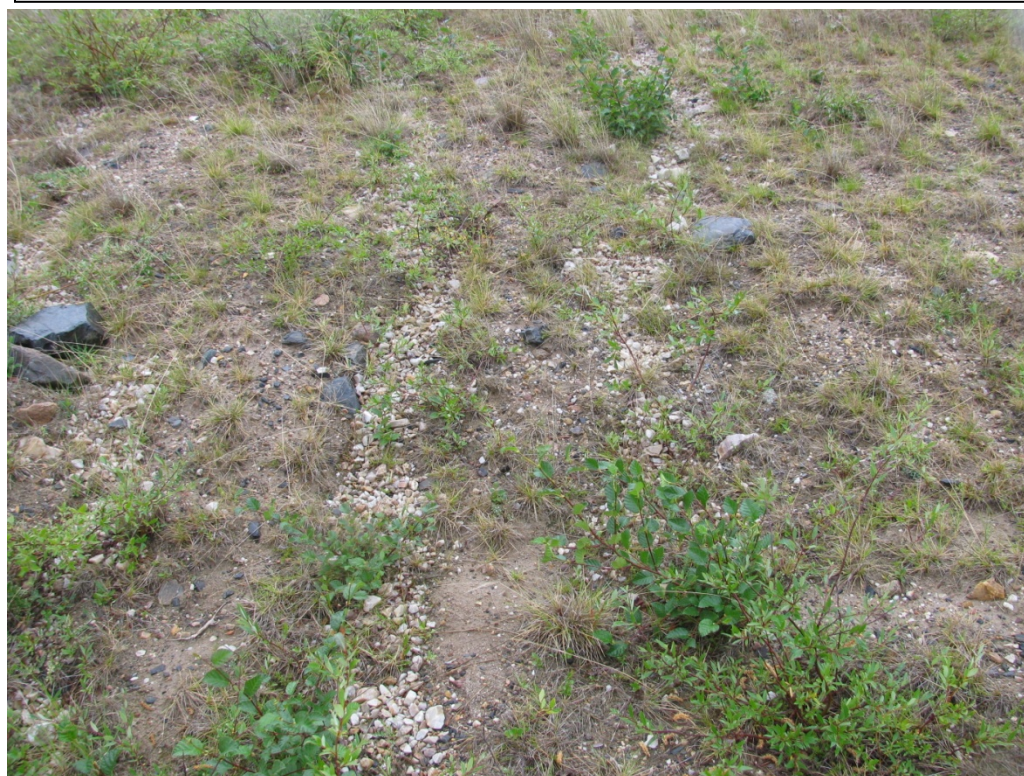
Photo 12: Previously gravel filled erosion channels on Shear Lake Waste Rock Pile

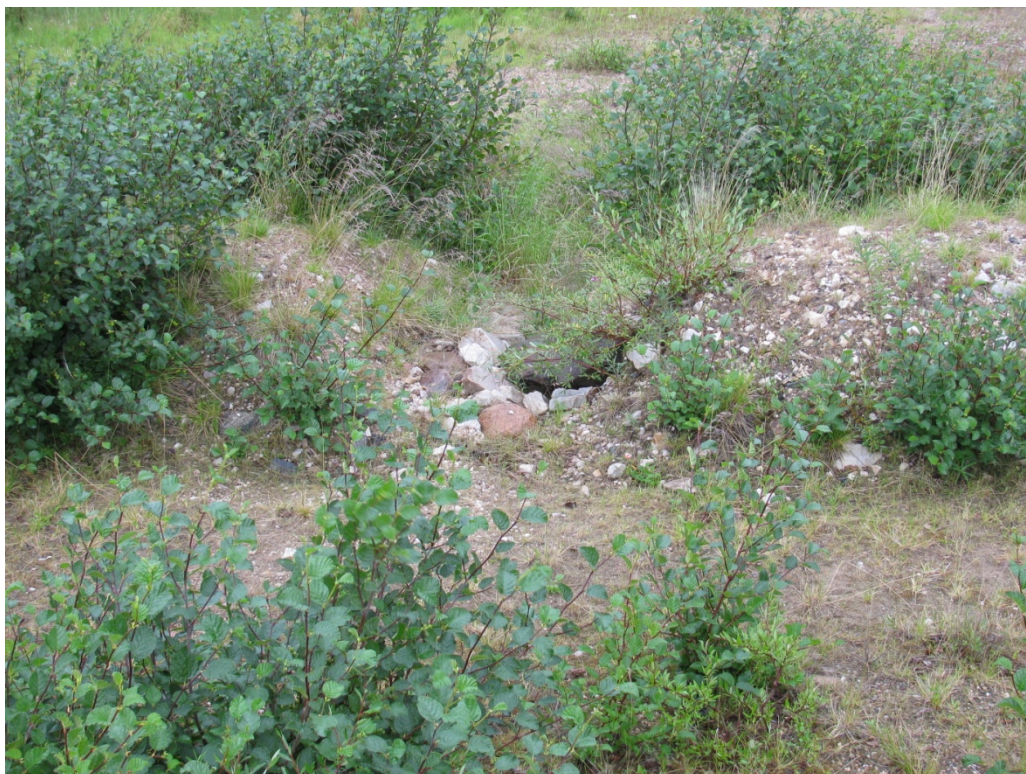
Photo 13: Toe ditch outlet on east side of Shear Lake Waste Rock Pile
