Re: **Project No. THB-00090132-BG**
2012 Tailings Dam Examination
Cullaton Lake Gold Mine, Nunavut
Licence NWB1CUL0207

Current Inspection – August 2, 2012

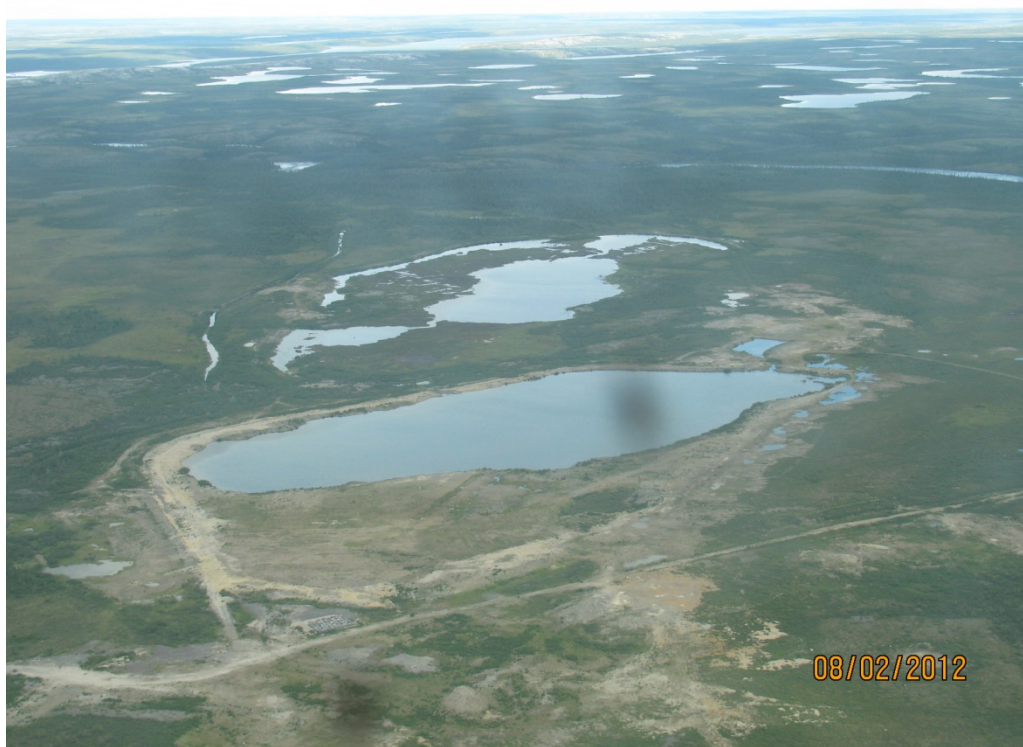
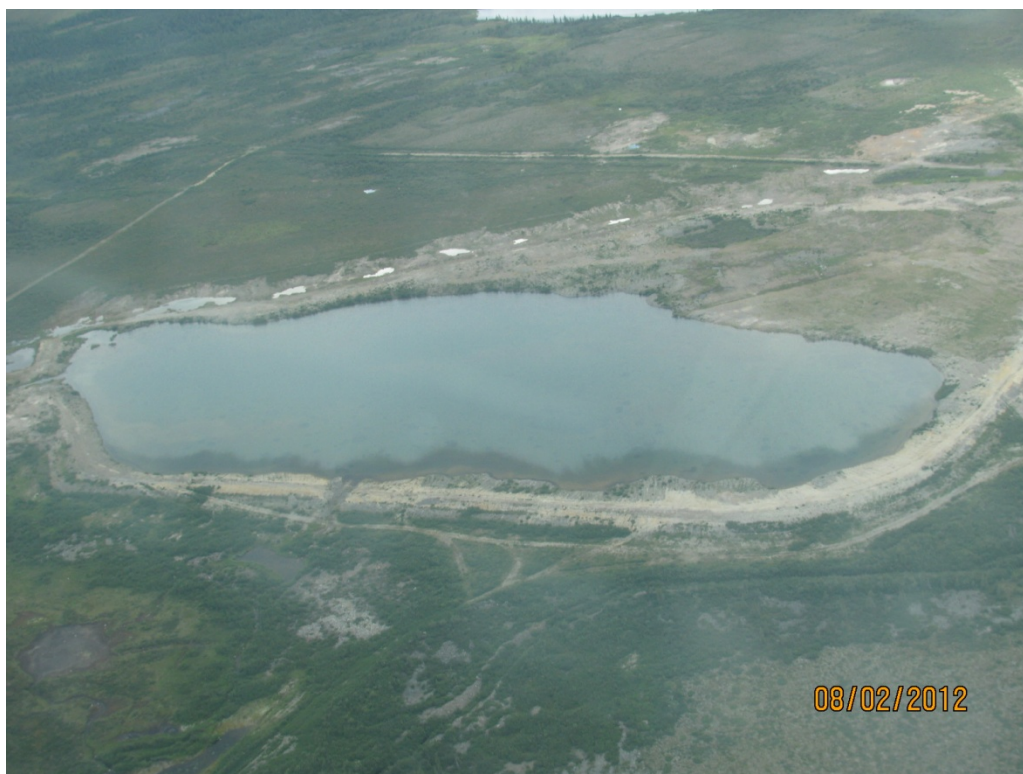
Photos 1 and 2, attached, show oblique views of the site taken from the air. The tailings area had been previously covered with local till as reported in Trow's previous inspection reports. Vegetation on the till covered tailings is small and sparse. However, it is noted that the density of the vegetation is increasing gradually, based on the comparative visual observations of previous years.

Photo 1: Tailings facility looking roughly east (Pond 1 foreground; Pond 2 background)

Photo 2: Tailings pond looking roughly west

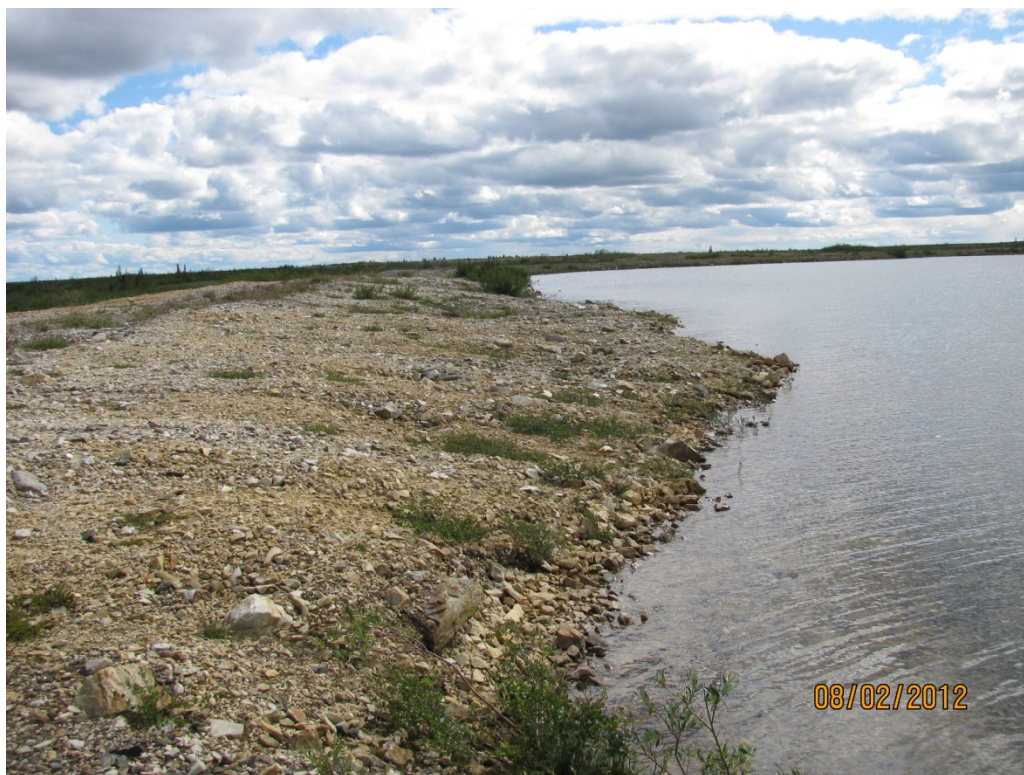
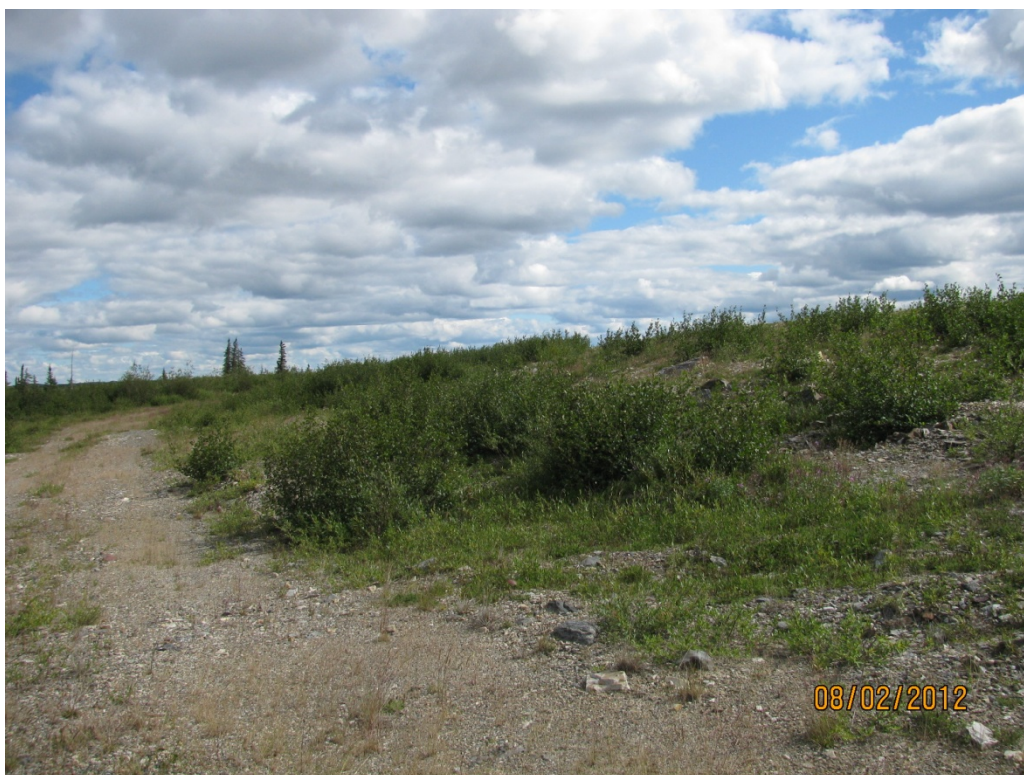
Photos 3 and 4 show views of Dam No. 1. Typically, the embankment, which is constructed principally with local cohesionless till, is irregular in section and surface grade. Average side slopes of the upstream and downstream sides were typically about 3H:1V and 6H:1V, respectively. The downstream side was estimated to be as steep as about 3H:1V in a few areas. The dam height ranges up to about 4 m. Some small erosion scars were observed on both the upstream and downstream sides; however, as described below, they appear to be stabilizing with vegetation and self-armouring with larger rock particles from the till and previously placed mine waste rock. These scars do not appear to be increasing in size, based on visual comparisons of previous years. The crest width varies but is generally in the order of 15 m. Within the tailings pond itself, no unsubmerged or exposed tailings were observed.

Based on the current, as well as previous, inspections and involvement with the project, Dam No. 1 is not in any distress and is considered to be stable.

Photo 3: Dam No. 1 - looking south - southeast

Photo 4: Downstream section of Dam No. 1 near spillway channel

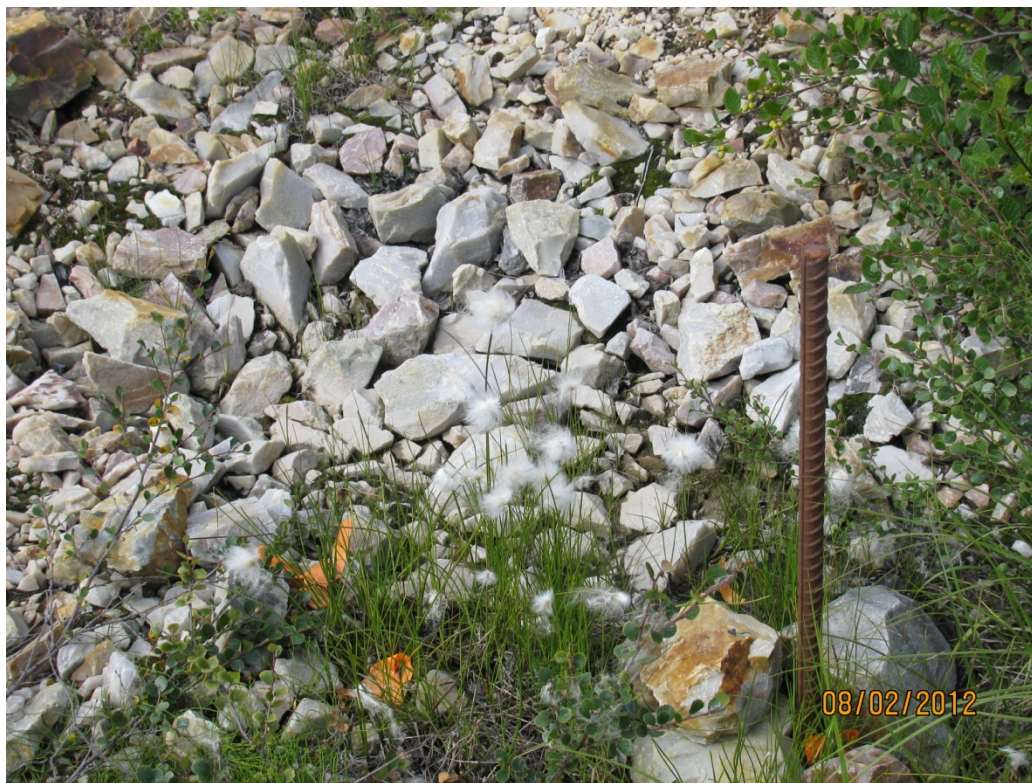
No seepages were observed on the day of inspection. However, a wet spot, first noted in the 2010 report, was observed about halfway down the downstream slope of the dam (see Photo 5), south of the spillway, at the approximate location shown on Figure 1 in Appendix A. As recommended in the previous report, the location had been marked with a length of rebar. While there was some accumulated water, no flow was visible. It was not possible to determine if this was, in fact, a seep, or the result of recent precipitation that had pooled and not evaporated. There was no evidence of any dam internal soil erosion. This should continue to be monitored during the scheduled inspections.

Photo 5: Wet spot on downstream side of Dam No. 1

It is recommended that the condition of the Dam No. 1 spillway channel continue to be monitored for erosion and if any is apparent, remedial measures, such as the addition of additional rockfill, be implemented. In addition, the wet spot noted on the downstream side of Dam No. 1, south of the spillway, should be monitored during each subsequent visit.

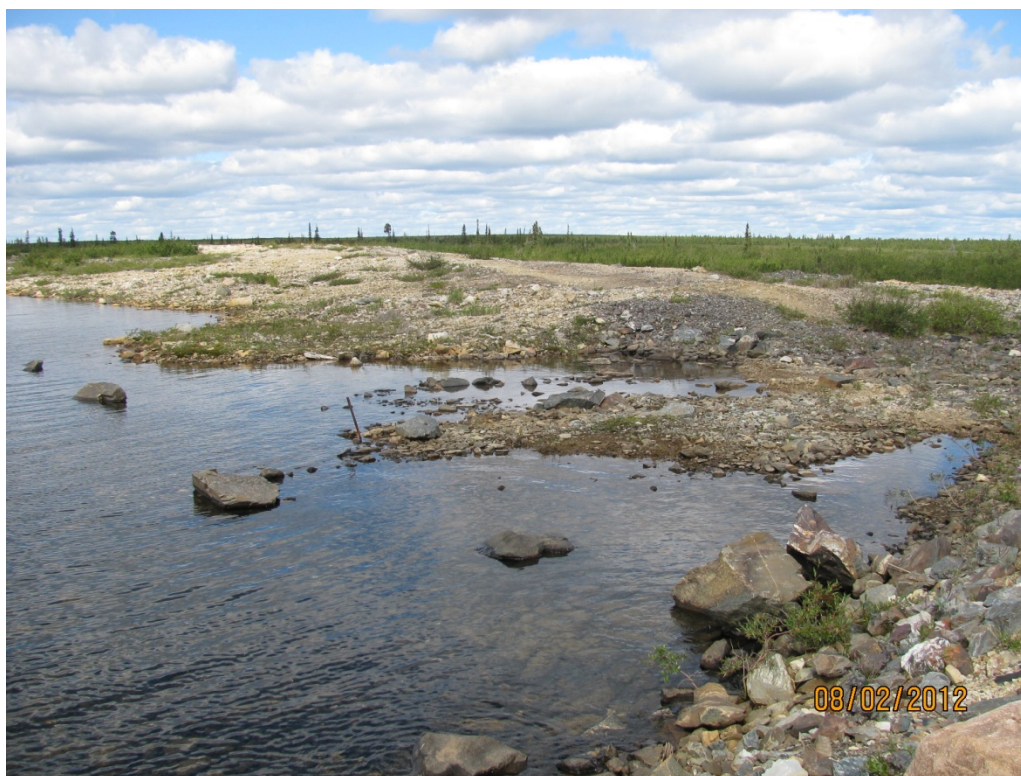
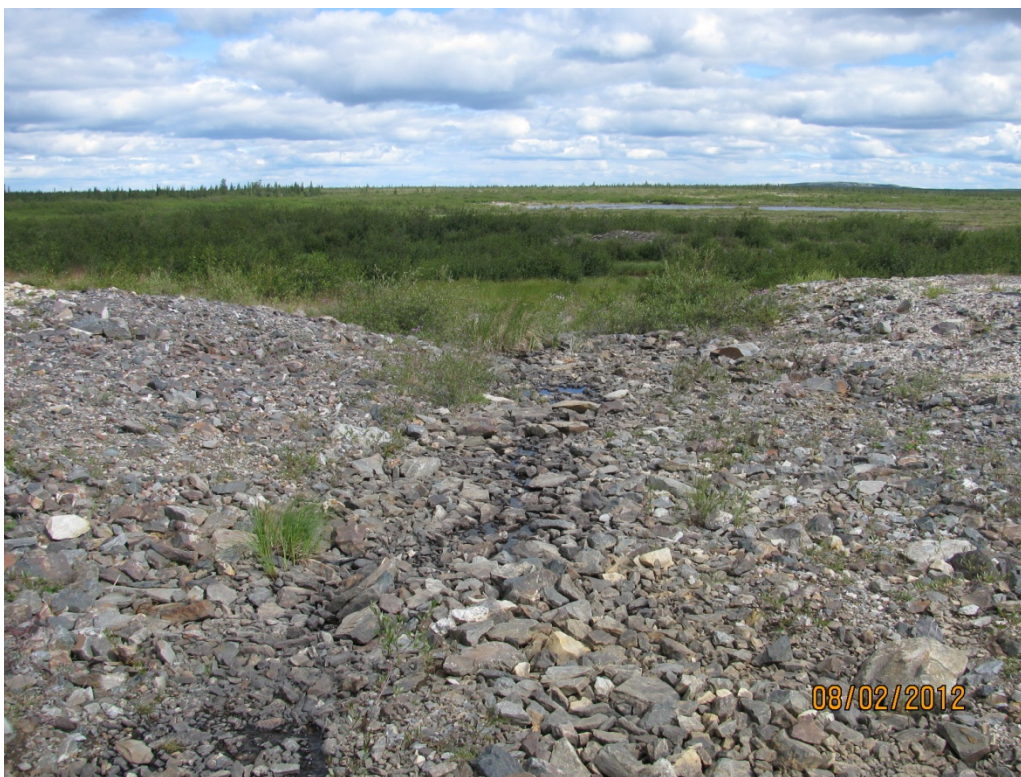
Photos 6 and 7 show views of the Dam No. 1 spillway channel. Only a minor flow (trickle) was occurring at the spillway as had been observed in most previous years. A minor trickle was observed to flow through the rockfill comprising the channel bottom, slightly less than in 2011, due to the pond level being a few centimetres lower than in 2011.

Our visual inspection of the spillway channel, where additional fine rockfill was placed in 2005 to cover small areas of previously exposed rubber liner, indicates that no erosion has occurred. It is expected that monitoring of this area during future inspections will indicate that the treatment performed in 2005 has been sufficient.

Photo 6: Dam No. 1 Spillway inlet and crest

Photo 7: Dam No. 1 Spillway downslope channel

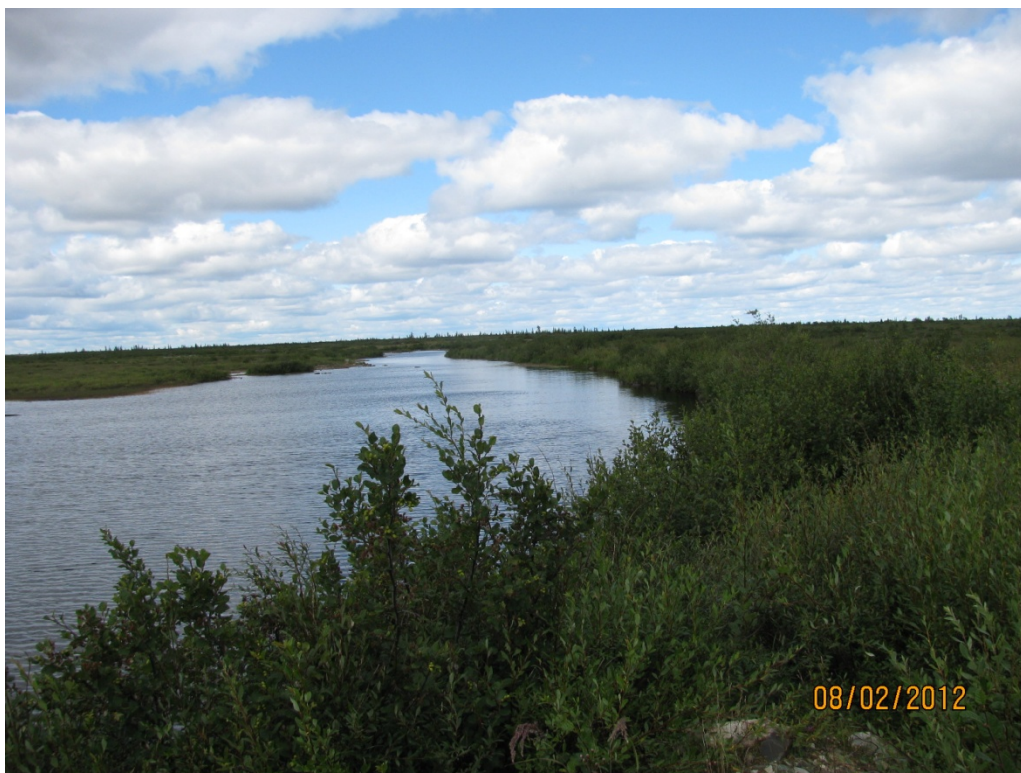
Photo 8 shows a view of Dam No. 2. As with Dam No. 1, the principal construction material is local cohesionless till. The dam section and surface grade is irregular, although less so than Dam No. 1. The crest width varies but is in the order of 15 m. No seepages were observed on the day of examination.

Based on the current as well as previous inspections and involvement with the project, the dam is not in any distress and is considered to be stable.

Photo 8: View of Dam No. 2 (on the right) and Pond No. 2

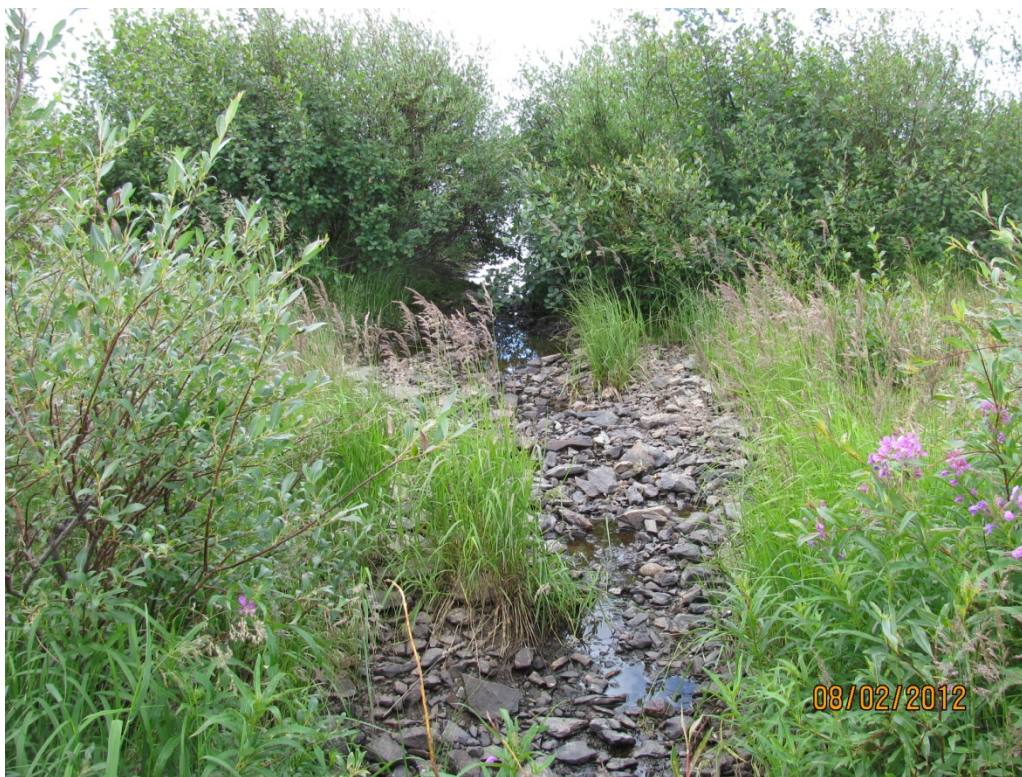
Photo 9 is an upstream view of the Dam No. 2 spillway channel. Minor flow was trickling through the rockfill channel.

Photo 9: Dam No. 2 Spillway Channel looking upstream to Pond 2

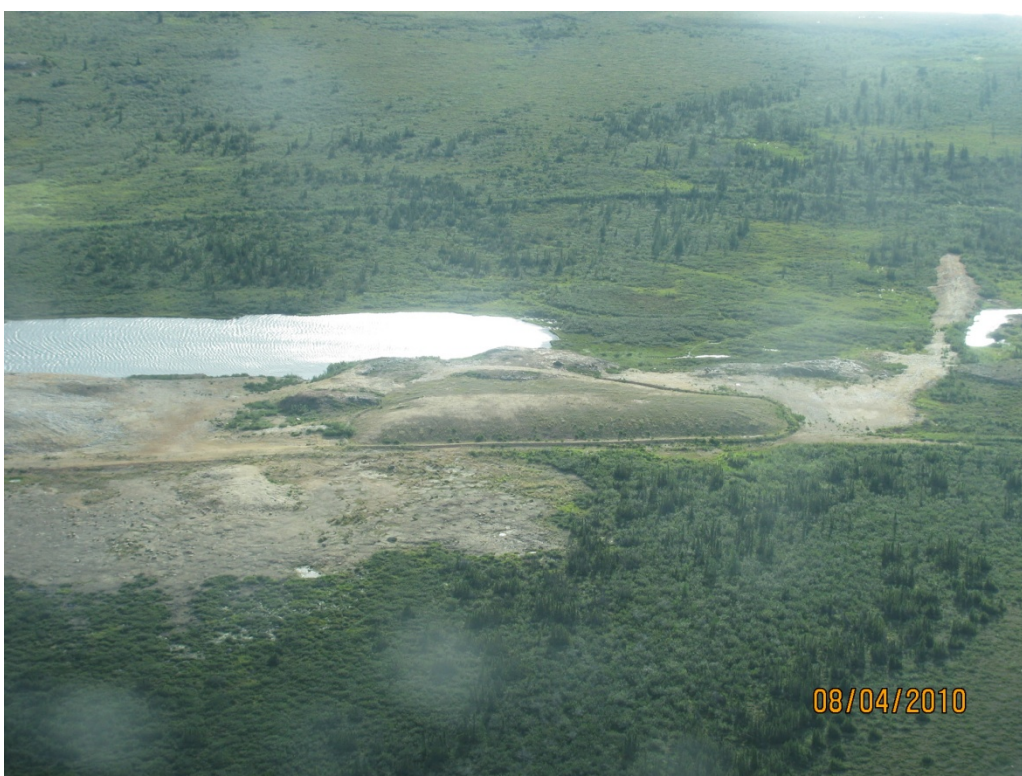
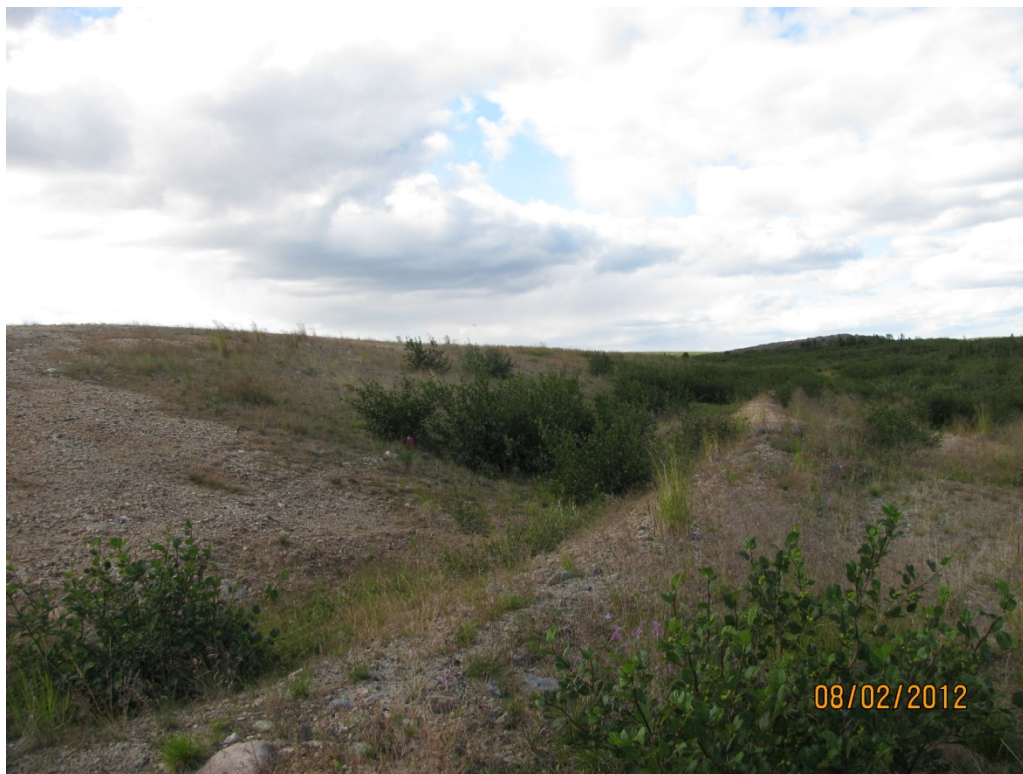
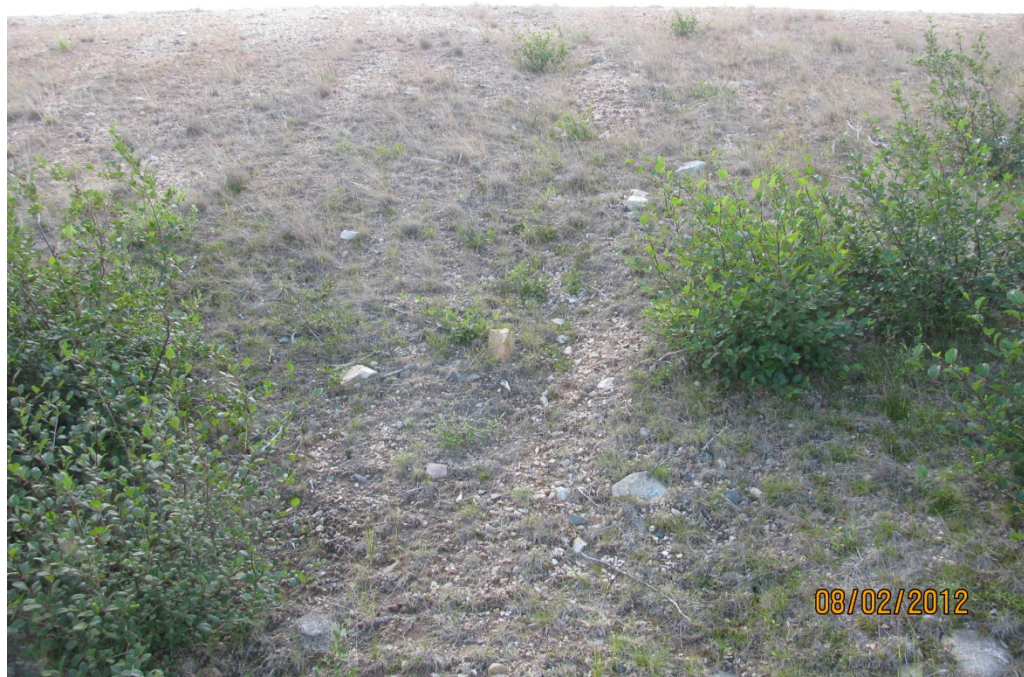
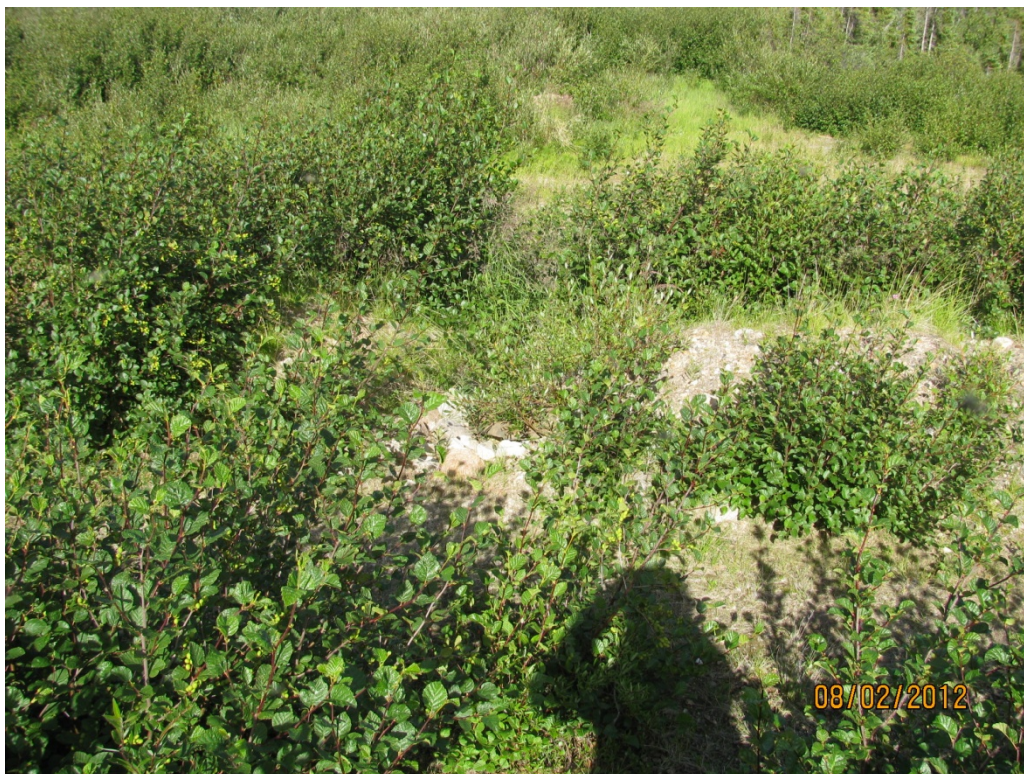
Photos 10 to 13, inclusive, show views of the Shear Lake Waste Rock Pile. The Shear Lake Waste Rock Pile, located on the east side of Shear Lake, some 4.5 km north of the former mill site, was reportedly capped with local, compacted glacial till to promote runoff and reduce infiltration. In 2005, Barrick personnel oversaw the re-seeding of the cap. The re-seeding (with grasses) was implemented to promote some vegetation growth which would reduce the erosion of the cover due to runoff, particularly along the side slopes.

Our observations suggest that, while there are some sparse areas, the vegetation is helping to reduce erosion, in that very few small erosion gulleys/channels (20 to 30 mm deep/wide) were noticed on the side slopes. These generally were short and did not extend the full length of the slope. Most of these had been filled to some extent with small granular material in 2005, to minimize further erosion. Our current observations were similar to the previous years. Photo 12 shows that the gravel filled erosion gullies have been stabilized. A comparison of the photos from previous years shows that the vegetation is improving.

Photo 10: Aerial view of Shear Lake Waste Rock Pile looking west (2010 photo)

Photo 11: East side of Shear Lake Waste Rock Pile showing grasses on left

Photo 12: Previously gravel filled erosion channels on Shear Lake Waste Rock Pile

Photo 13: Toe ditch outlet on east side of Shear Lake Waste Rock Pile

Subsequent inspections should be made to verify the efficacy of the vegetation/till cover system. Any erosion gullies that form should be repaired with fine rock/gravel. It is expected that it will take several more years for the vegetation to establish itself fully.
