February 28, 2014

Re: **Project No. THB-00090132-CG**  
**2013 Tailings Dam Examination**  
**Cullaton Lake Gold Mine, Nunavut**  
**Licence 1BR-CUL1118**

### **Current Inspection – August 15, 2013**

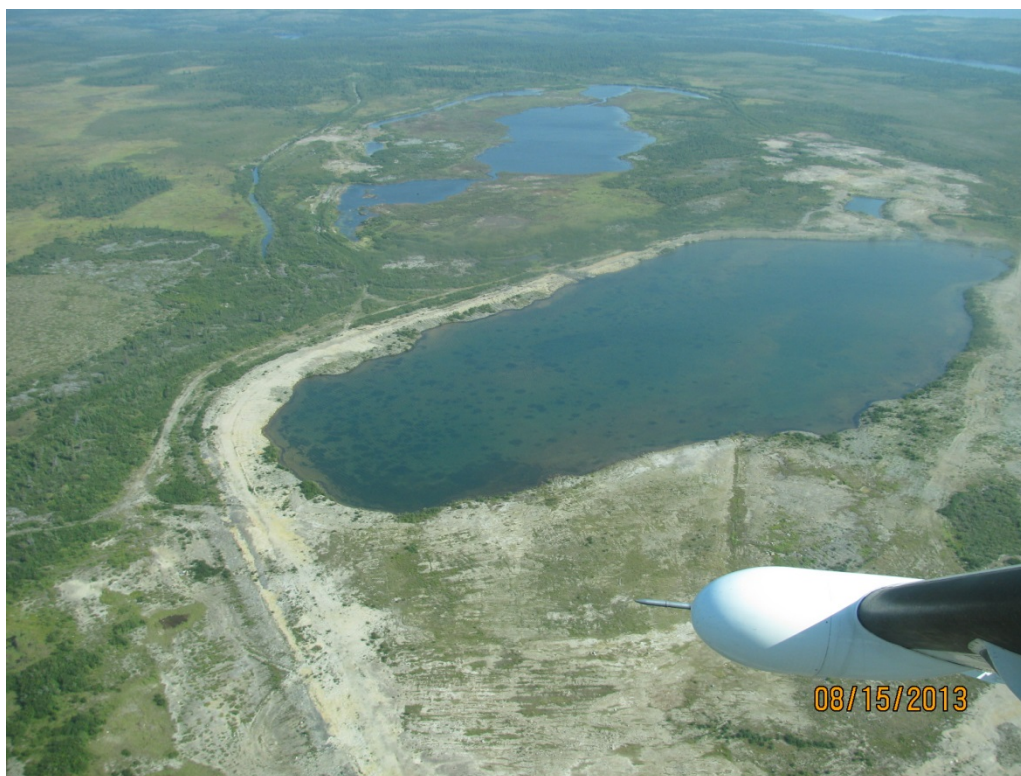
Photos 1 and 2, attached, show oblique views of the site taken from the air. The tailings area had been previously covered with local till as reported in Trow's previous inspection reports. Vegetation on the till covered tailings is small and sparse. However, it is noted that the density of the vegetation is increasing gradually, based on the comparative visual observations of previous years.

***Photo 1: Tailings facility looking roughly east (Pond 1 foreground; Pond 2 background)***

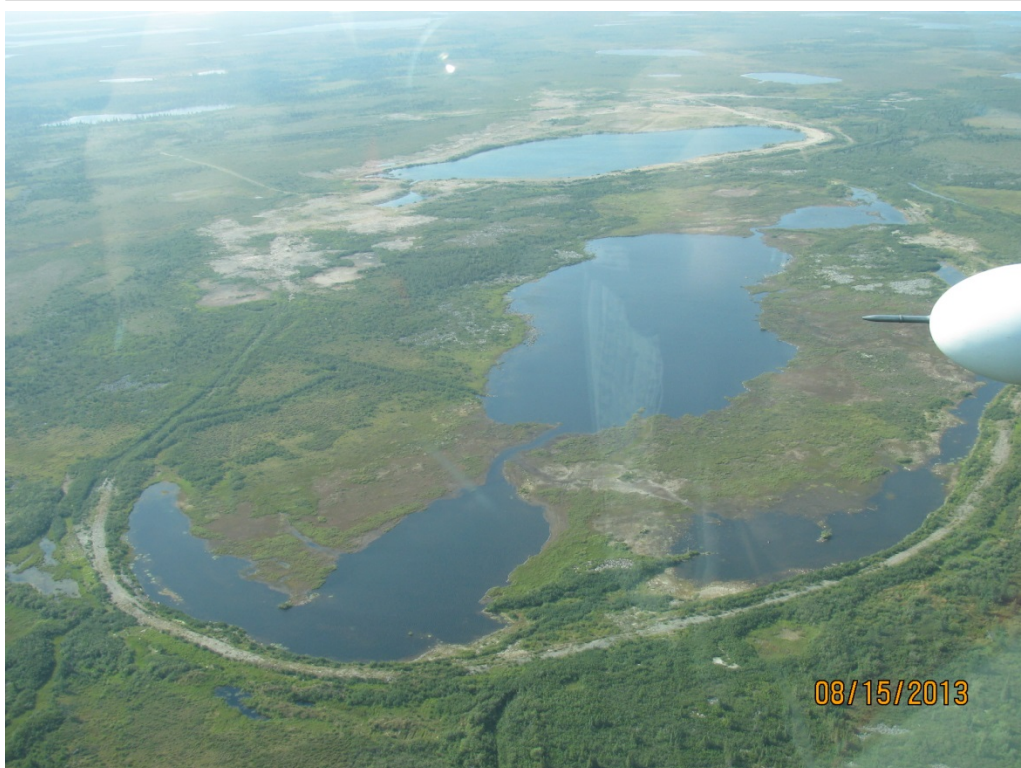
***Photo 2: Tailings facility looking roughly west (Pond 2 foreground; Pond 1 background)***

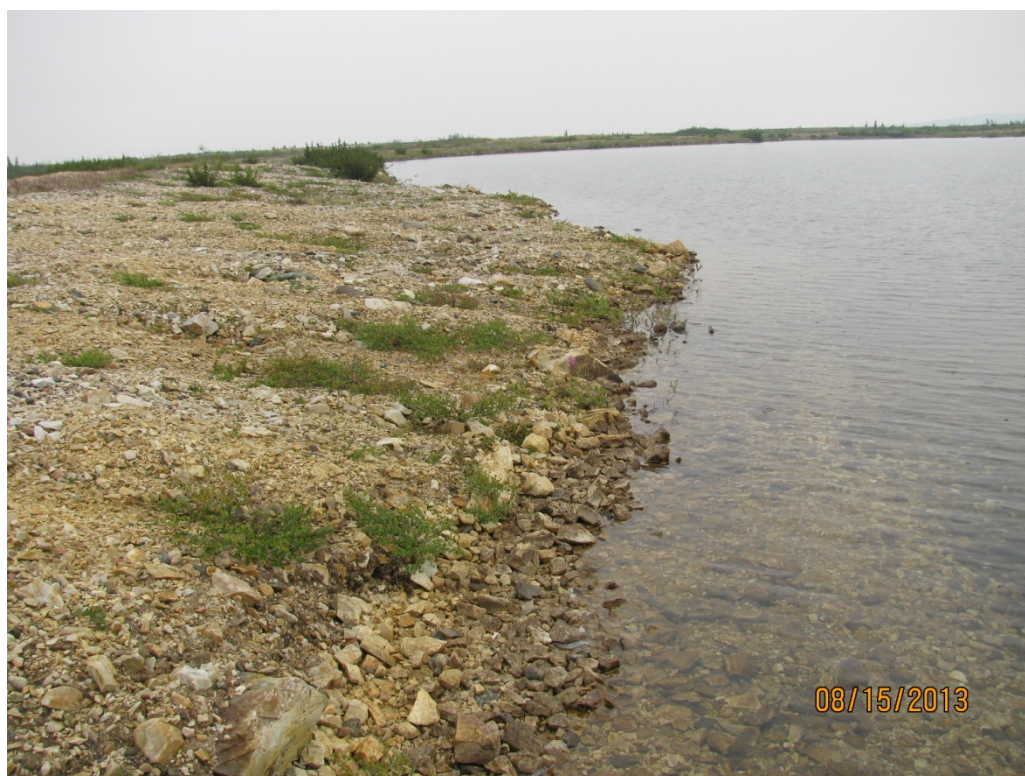
Photos 3 and 4 show views of Dam No. 1. Typically, the embankment, which is constructed principally with local cohesionless till, is irregular in section and surface grade. Average side slopes of the upstream and downstream sides were typically about 3H:1V and 6H:1V, respectively. The downstream side was estimated to be as steep as about 3H:1V in a few areas. The dam height ranges up to about 4 m. Some small erosion scars were observed on both the upstream and downstream sides; however, as described below, they appear to be stabilizing with vegetation and self-armouring with larger rock particles from the till and previously placed mine waste rock. These scars do not appear to be increasing in size, based on visual comparisons of previous years. The crest width varies but is generally in the order of 15 m. Within the tailings pond itself, no unsubmerged or exposed tailings were observed.

*Photo 3: Dam No. 1 - looking south - southeast*

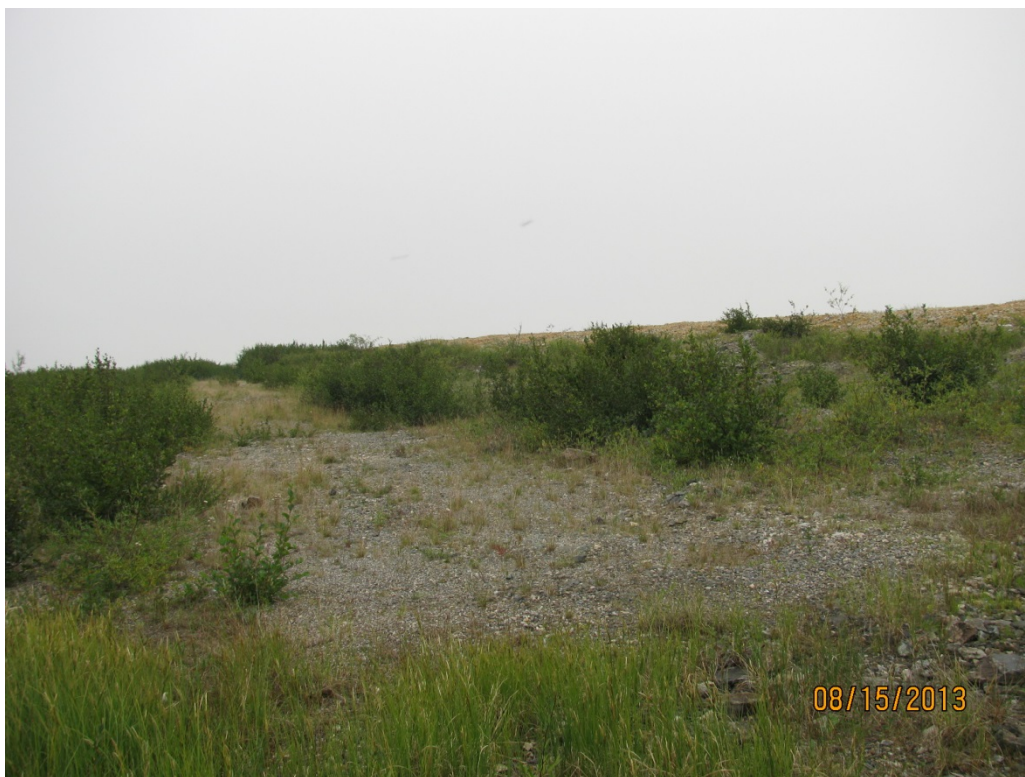
*Photo 4: Downstream section of Dam No. 1 near spillway channel*

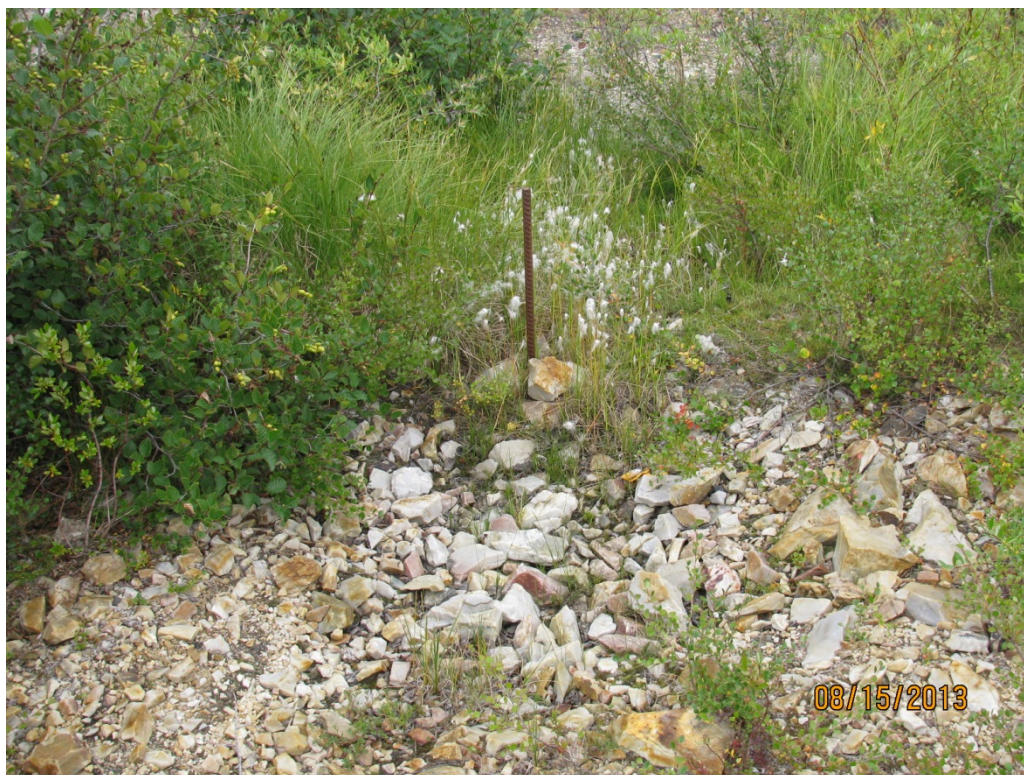
No seepages were observed on the day of inspection. However, a wet spot, first noted in the 2010 report, was observed about halfway down the downstream slope of the dam (see Photo 5), south of the spillway, at the approximate location shown on Figure 1 in Appendix A. As recommended in the previous report, the location had been marked with a length of rebar. While there was some minor accumulated water, no flow was visible. It was not possible to determine if this was, in fact, a seep, or the result of recent precipitation that had pooled and not evaporated. There was no evidence of any dam internal soil erosion. This should continue to be monitored during the scheduled inspections.

*Photo 5: Wet spot on downstream side of Dam No. 1*

It is recommended that the condition of the Dam No. 1 spillway channel continue to be monitored for erosion and if any is apparent, remedial measures, such as the addition of additional rockfill, be implemented. In addition, the wet spot noted on the downstream side of Dam No. 1, south of the spillway, should be monitored during each subsequent visit.

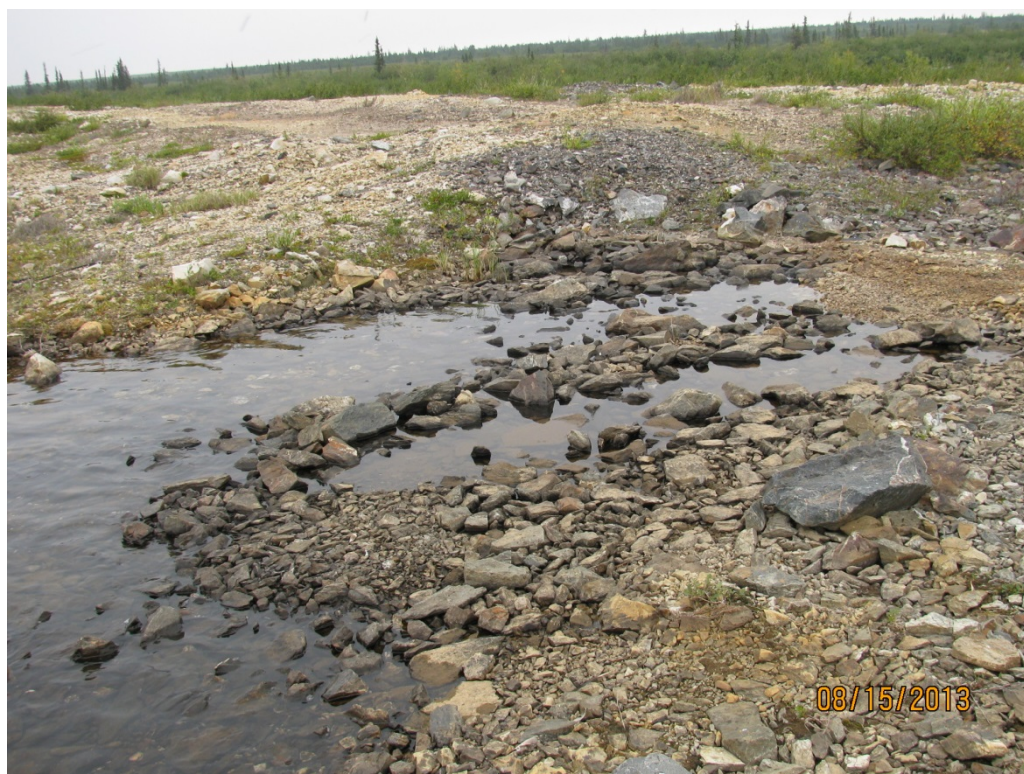
Photos 6 and 7 show views of the Dam No. 1 spillway channel. Only a minor flow (trickle) was occurring at the spillway as had been observed in most previous years. A minor trickle was observed

to flow through the rockfill comprising the channel bottom, slightly less than in 2012, due to the pond level being two to three centimetres lower than in 2012.

Our visual inspection of the spillway channel, where additional fine rockfill was placed in 2005 to cover small areas of previously exposed rubber liner, indicates that no erosion has occurred. It is expected that monitoring of this area during future inspections will indicate that the treatment performed in 2005 has been sufficient.

*Photo 6: Dam No. 1 Spillway inlet and crest*

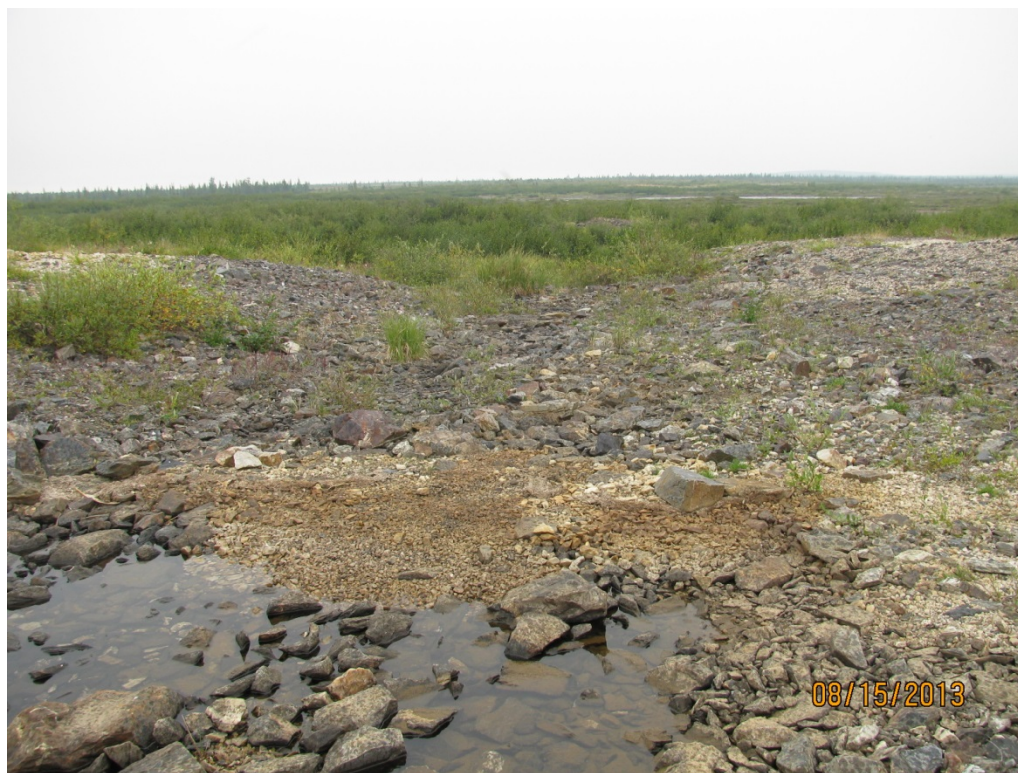
***Photo 7: Dam No. 1 Spillway downslope channel***

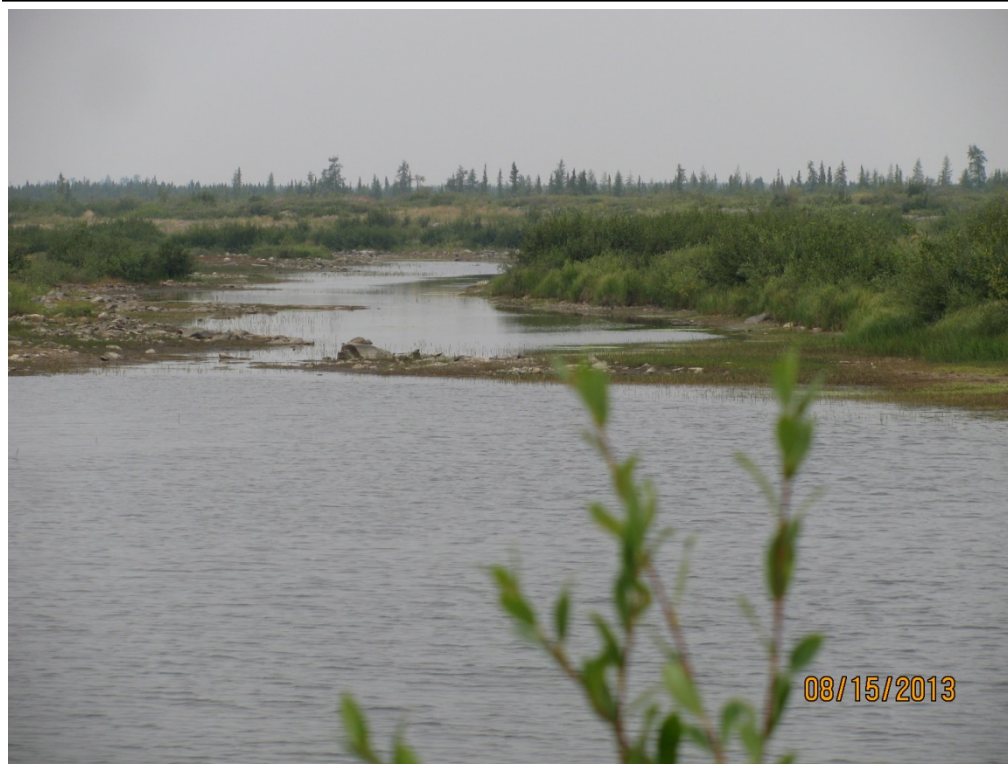
Photo 8 shows a view of Dam No. 2. As with Dam No. 1, the principal construction material is local cohesionless till. The dam section and surface grade is irregular, although less so than Dam No. 1. The crest width varies but is in the order of 15 m. No seepages were observed on the day of examination.

***Photo 8: View of Dam No. 2 (on the right) and Pond No. 2. Note low water level.***

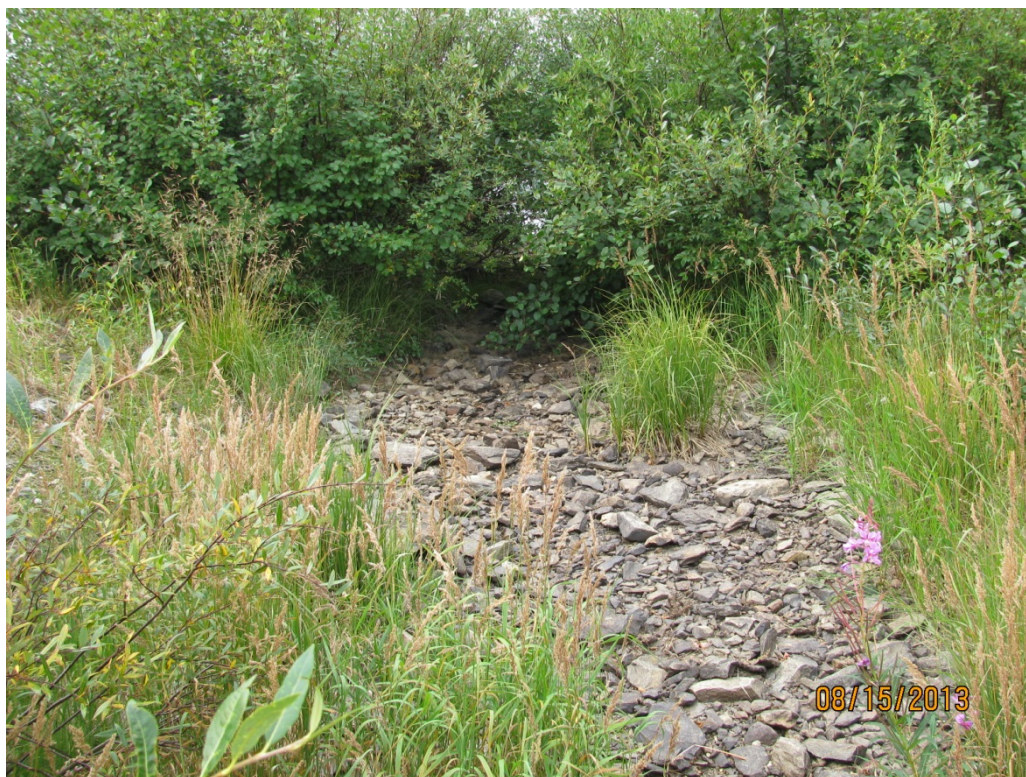
Photo 9 is an upstream view of the Dam No. 2 spillway channel. There was no flow observed over or through the rockfill channel, due to the lower water level of Pond 2.

***Photo 9: Dam No. 2 Spillway Channel looking upstream to Pond 2***

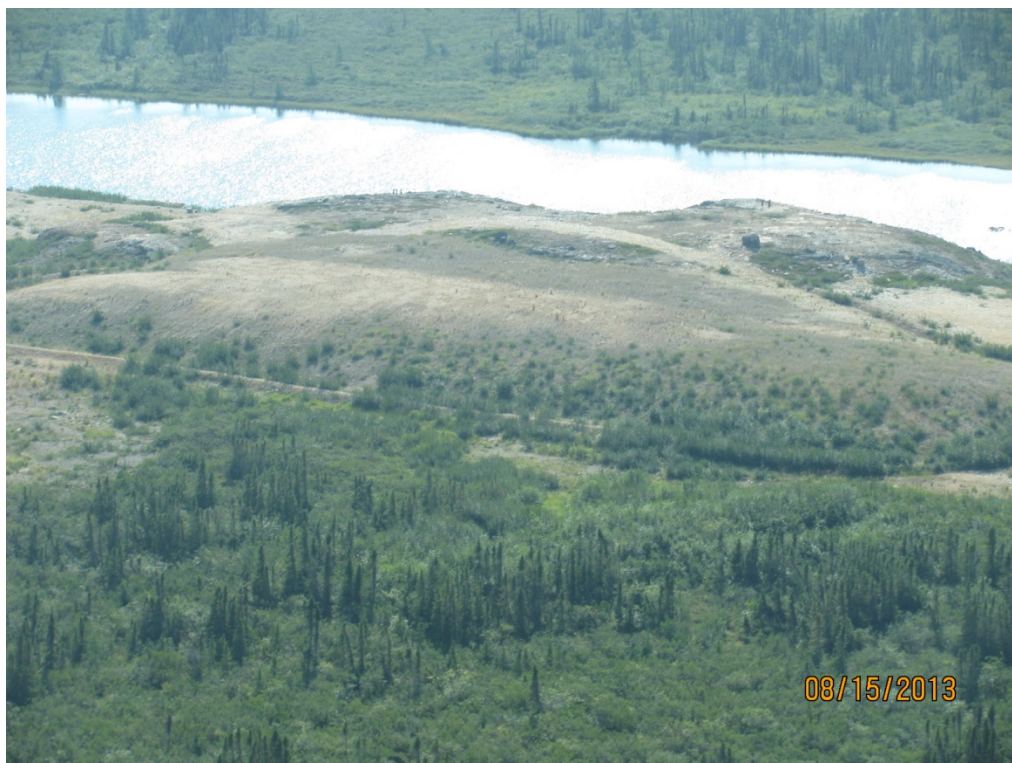
Photos 10 to 12, inclusive, show views of the Shear Lake Waste Rock Pile. The Shear Lake Waste Rock Pile, located on the east side of Shear Lake, some 4.5 km north of the former mill site, was reportedly capped with local, compacted glacial till to promote runoff and reduce infiltration. In 2005, Barrick personnel oversaw the re-seeding of the cap. The re-seeding (with grasses) was implemented to promote some vegetation growth which would reduce the erosion of the cover due to runoff, particularly along the side slopes.

Our observations suggest that, while there are some sparse areas, the vegetation is helping to reduce erosion, in that very few small erosion gulleys/channels (20 to 30 mm deep/wide) were noticed on the side slopes. These generally were short and did not extend the full length of the slope. Most of these had been filled to some extent with small granular material in 2005, to minimize further erosion. Our current observations were similar to the previous years. Photo 12 shows that the gravel filled erosion gullies have been stabilized. A comparison of the photos from previous years shows that the vegetation is improving.

***Photo 10: Aerial view of Shear Lake Waste Rock Pile looking west***

Subsequent inspections should be made to verify the efficacy of the vegetation/till cover system. Any erosion gullies that form should be repaired with fine rock/gravel. It is expected that it will take several more years for the vegetation to establish itself fully.

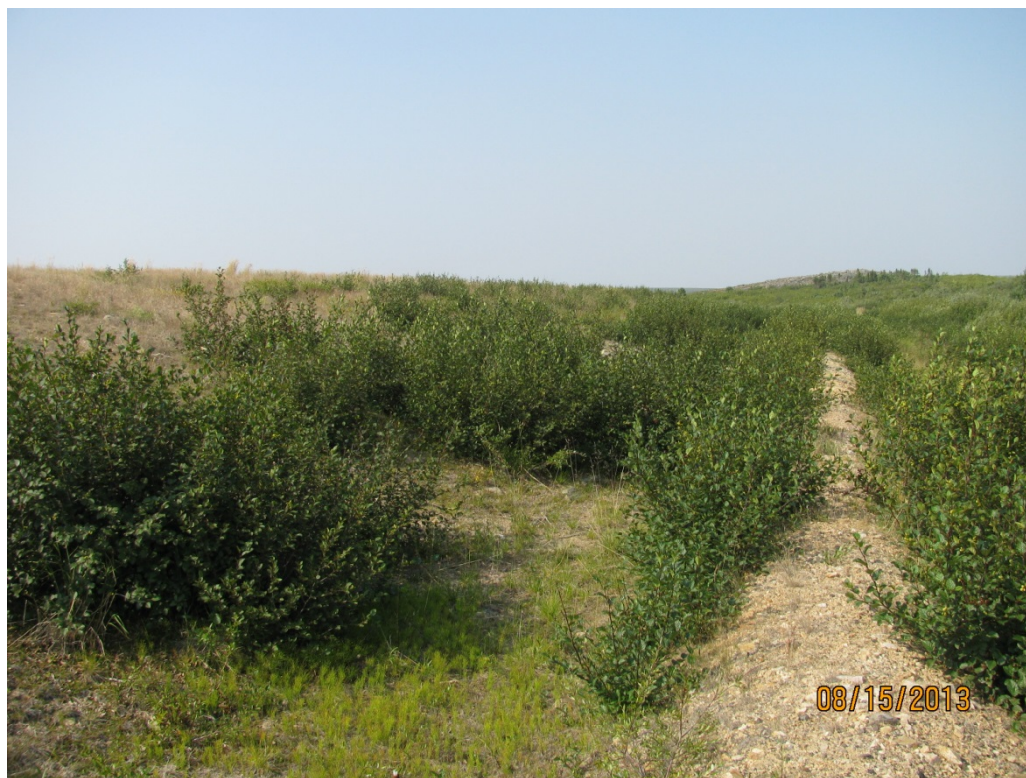
*Photo 11: East side of Shear Lake Waste Rock Pile showing grasses on left*

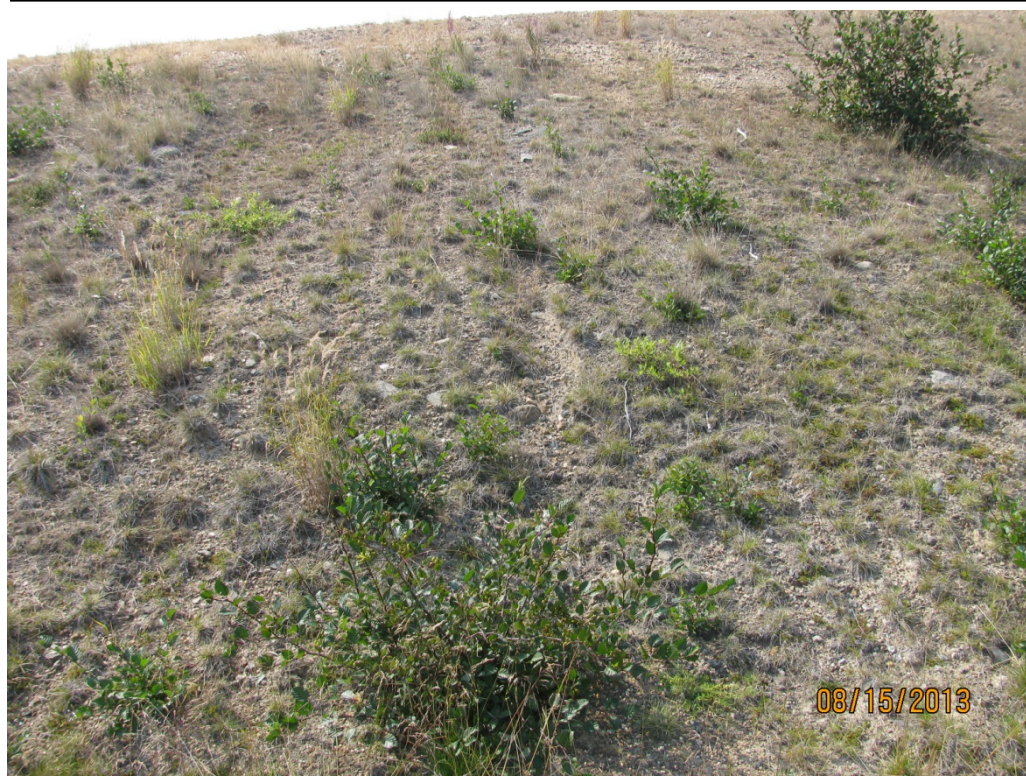
*Photo 12: Previously gravel filled erosion channels on Shear Lake Waste Rock*
