September 18, 2014

Re: **Project No. THB-00090132-DG**  
**2014 Tailings Dam Examination**  
**Cullaton Lake Gold Mine, Nunavut**  
**Licence 1BR-CUL1118**

#### **Current Inspection – August 12, 2014**

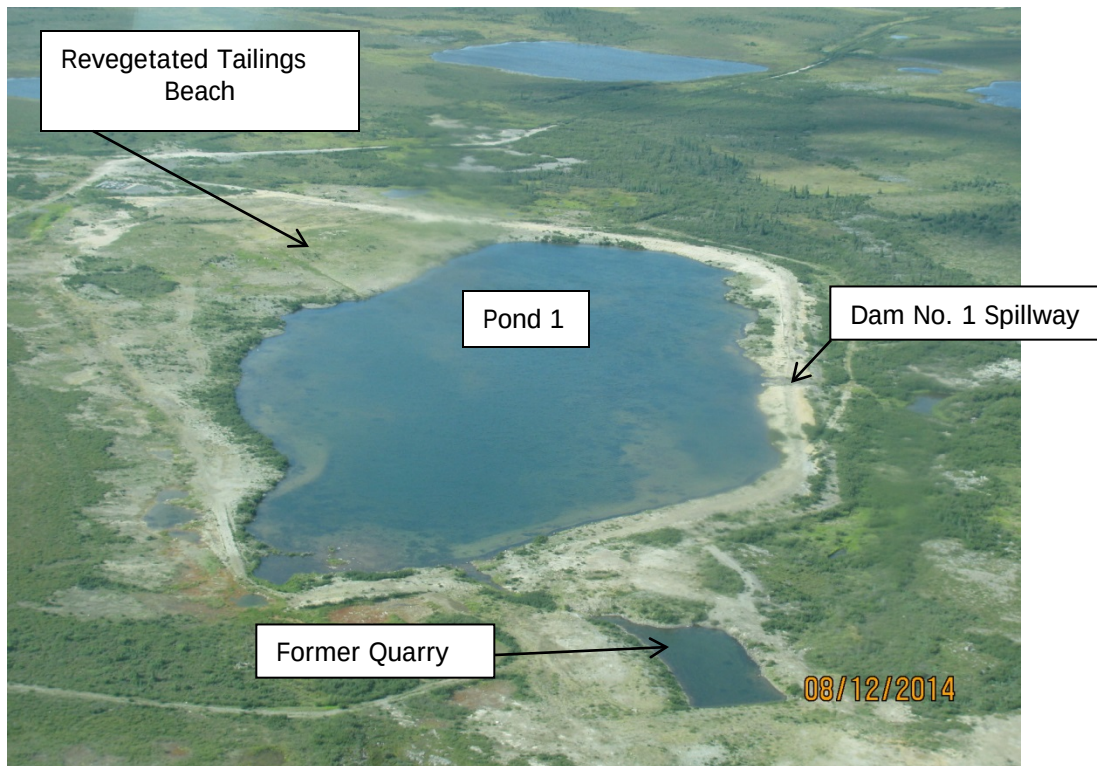
Photos 1 and 2, attached, show oblique views of the site taken from the air. The tailings area had been previously covered with local till as reported in Trow's previous inspection reports. Vegetation on the till covered tailings is small and sparse. However, it is noted that the density of the vegetation is increasing gradually, based on the comparative visual observations of previous years.

***Photo 1: Tailings Pond and Dam No. 1 (on right) looking north***

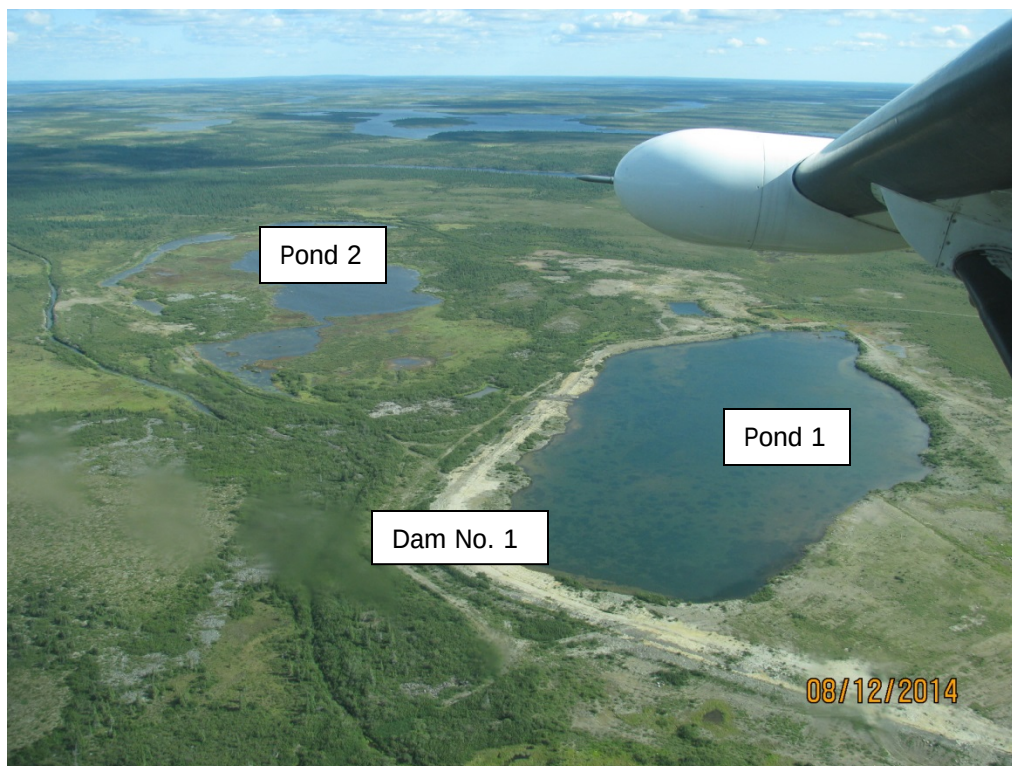
***Photo 2: Tailings facility looking roughly southeast***

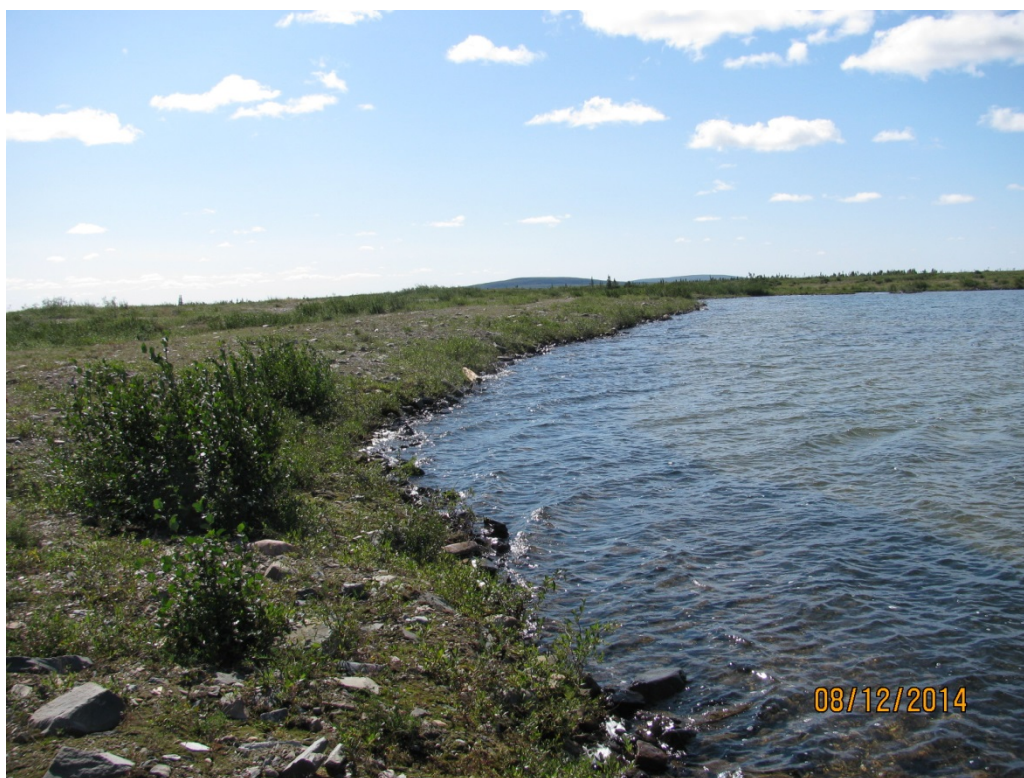
Photos 3 and 4 show views of Dam No. 1. Typically, the embankment, which is constructed principally with local cohesionless till, is irregular in section and surface grade. Average side slopes of the upstream and downstream sides were typically about 3H:1V and 6H:1V, respectively. The downstream side was estimated to be as steep as about 3H:1V in a few areas. The dam height ranges up to about 4 m. Some small erosion scars were observed on both the upstream and downstream sides; however, as described below, they appear to be stabilizing with vegetation and self-armouring with larger rock particles from the till and previously placed mine waste rock. These scars do not appear to be increasing in size, based on visual comparisons of previous years. The crest width varies but is generally in the order of 15 m. Within the tailings pond itself, no unsubmerged or exposed tailings were observed.

***Photo 3: Dam No. 1 – upstream bank looking south***

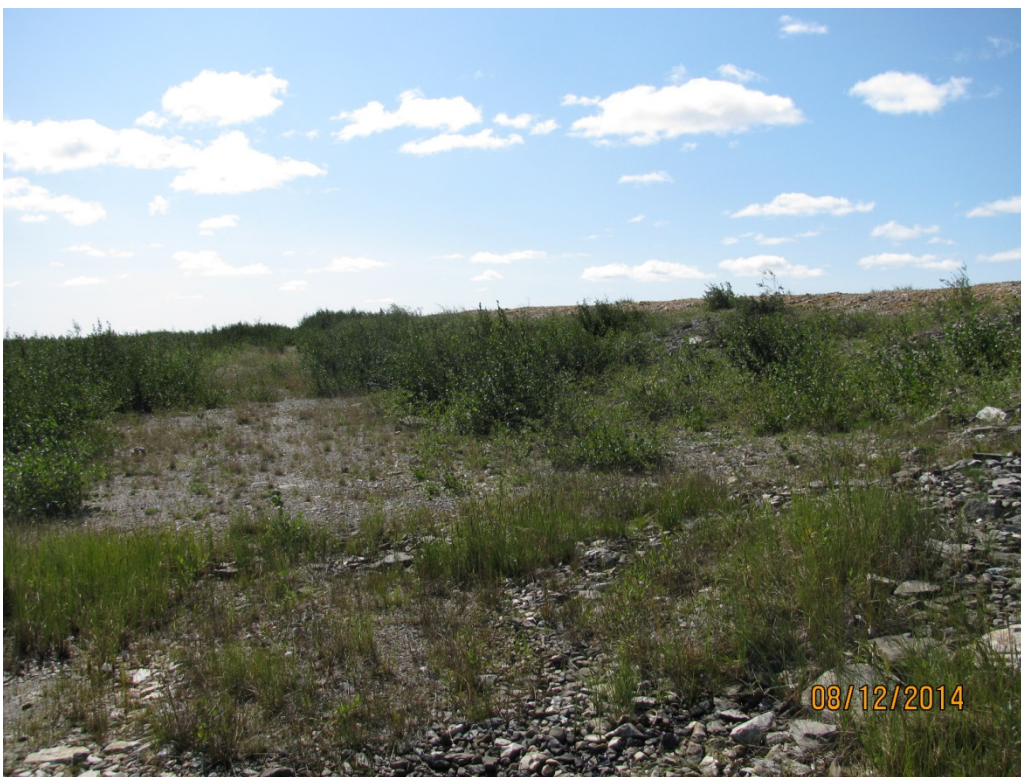
***Photo 4: Downstream section of Dam No. 1 near spillway channel***

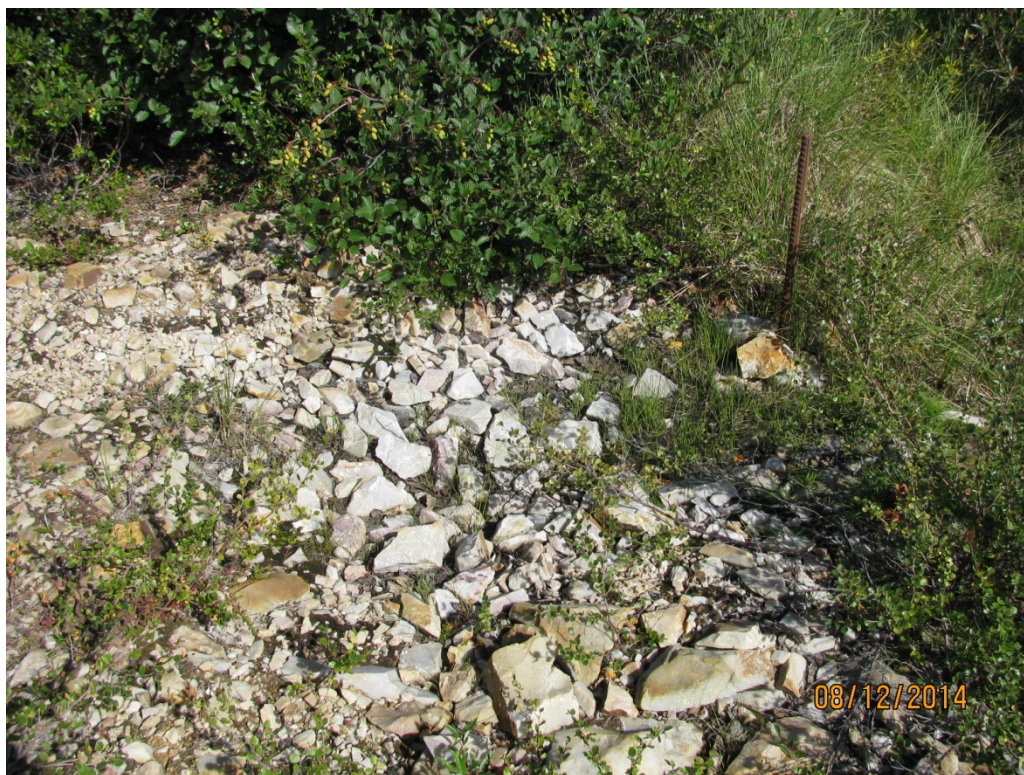
No seepages were observed on the day of inspection. However, a wet spot, first noted in the 2010 report, was observed about halfway down the downstream slope of the dam (see Photo 5), south of the spillway, at the approximate location shown on Figure 1 in Appendix A. As recommended in the previous report, the location had been marked with a length of rebar. While there was some minor wetness, no accumulated water or flow was visible. There was no evidence of any dam internal soil erosion. This should continue to be monitored during the scheduled inspections.

*Photo 5: Wet spot on downstream side of Dam No. 1- no seepage*

It is recommended that the condition of the Dam No. 1 spillway channel continue to be monitored for erosion and if any is apparent, remedial measures, such as the addition of additional rockfill, be implemented. In addition, the wet spot noted on the downstream side of Dam No. 1, south of the spillway, should be monitored during each subsequent visit.

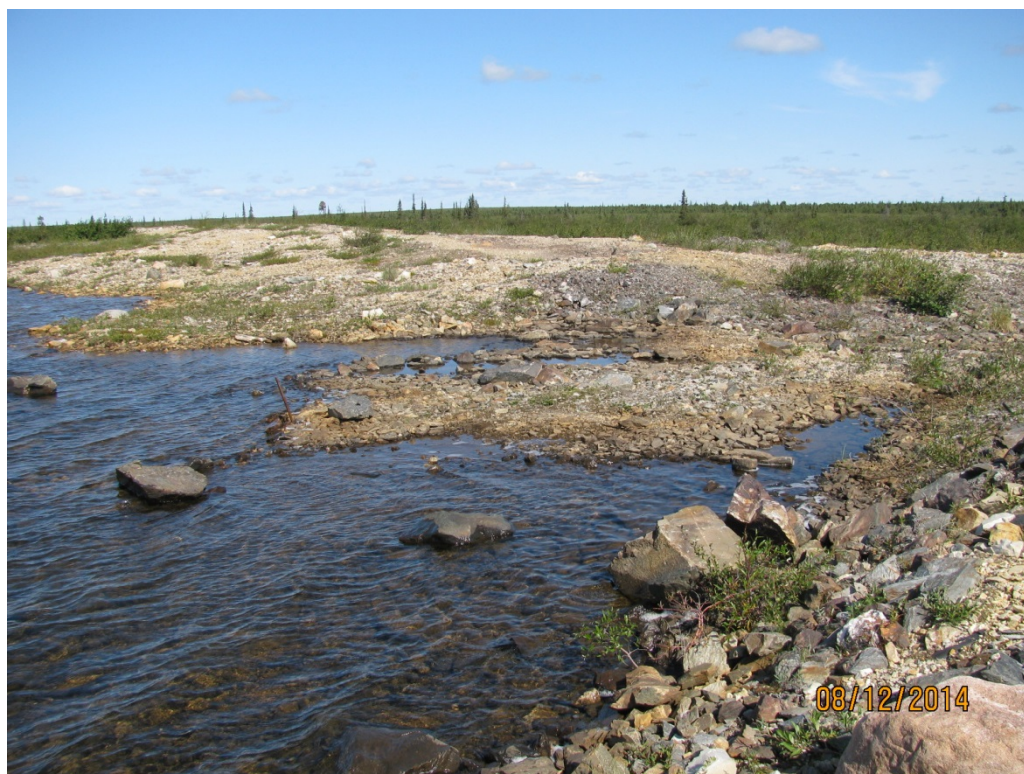
Photos 6 and 7 show views of the Dam No. 1 spillway channel. Only a minor flow (trickle) was occurring at the spillway as had been observed in most previous years. A minor trickle was observed to flow through the rockfill comprising the channel bottom, about the same as in 2013. The pond level appeared to be similar to that in 2013.

Our visual inspection of the spillway channel, where additional fine rockfill was placed in 2005 to cover small areas of previously exposed rubber liner, indicates that no erosion has occurred. It is expected that monitoring of this area during future inspections will indicate that the treatment performed in 2005 has been sufficient.

*Photo 6: Dam No. 1 Spillway inlet and crest*

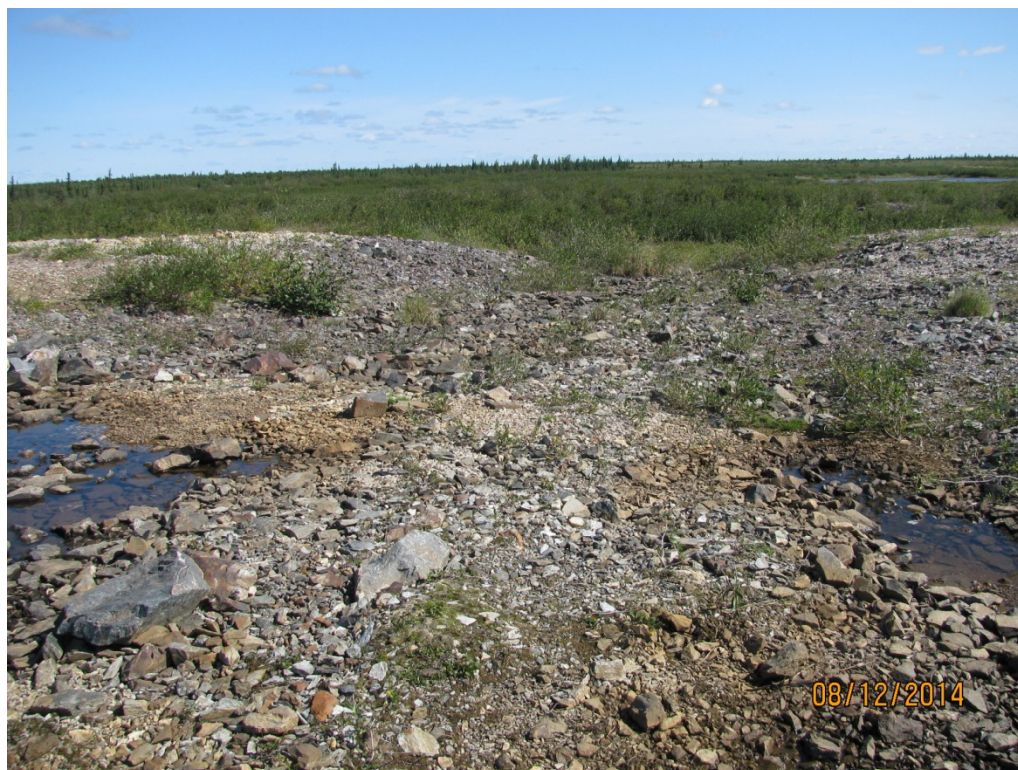
***Photo 7: Dam No. 1 Spillway downslope channel***

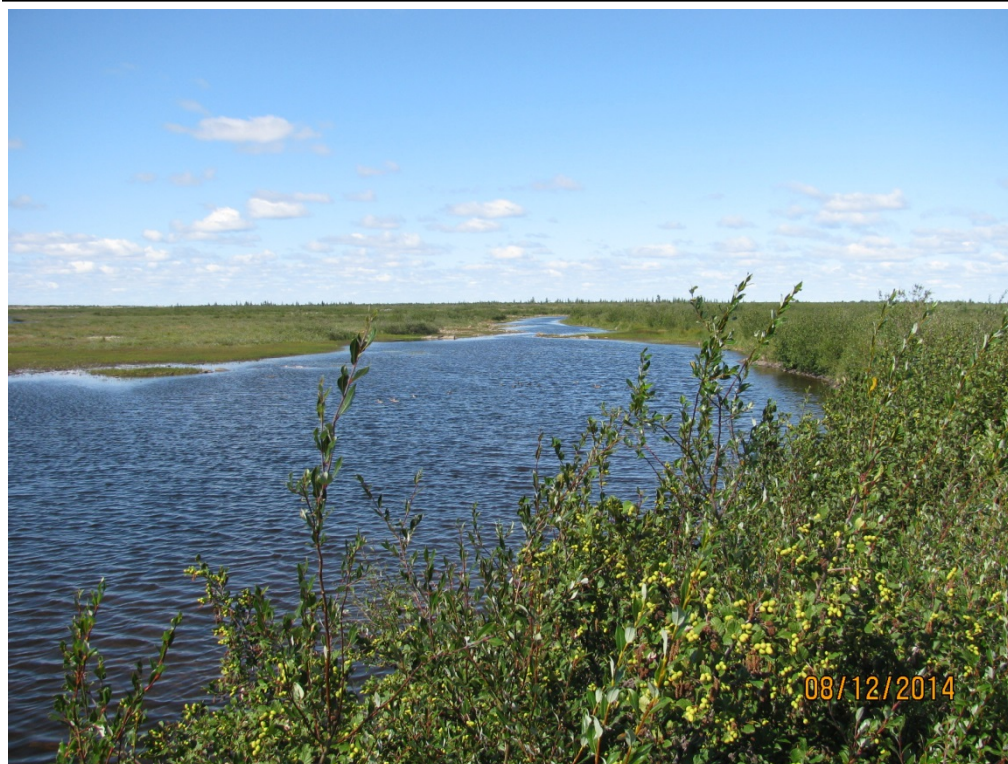
Photo 8 shows a view of Dam No. 2. As with Dam No. 1, the principal construction material is local cohesionless till. The dam section and surface grade is irregular, although less so than Dam No. 1. The crest width varies but is in the order of 15 m. No seepages were observed on the day of examination.

***Photo 8: View of Dam No. 2 (on the right) and Pond No. 2.***

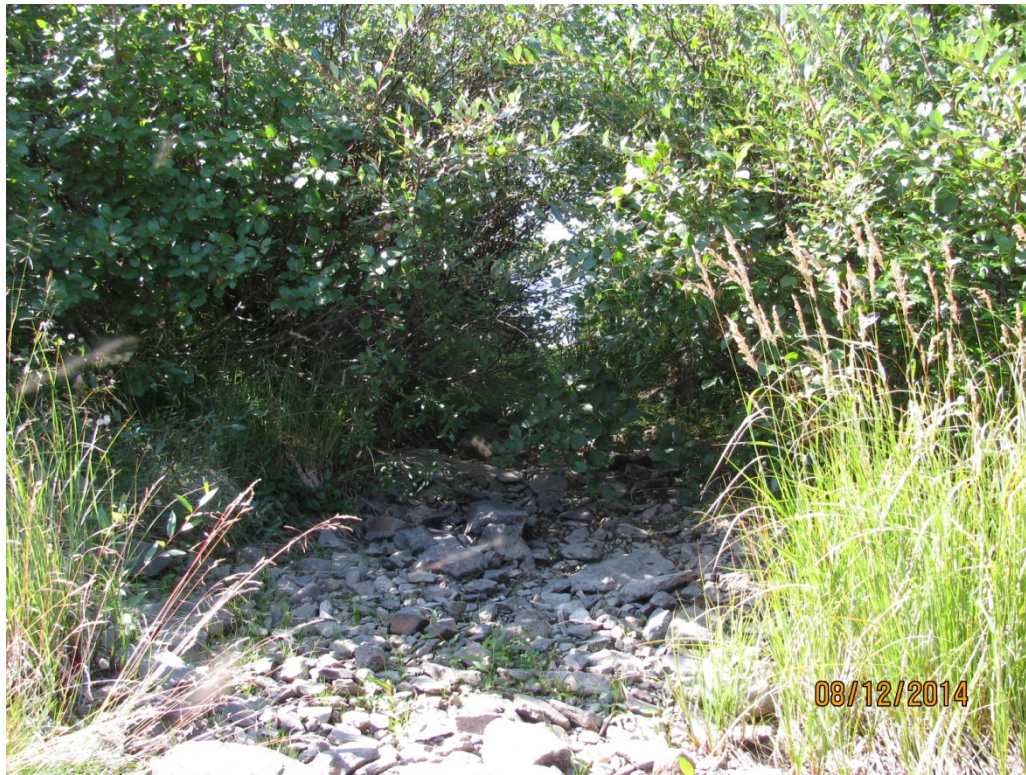
Photo 9 is an upstream view of the Dam No. 2 spillway channel. There was no flow observed over or through the rockfill channel, due to the lower water level of Pond 2.

***Photo 9: Dam No. 2 Spillway Channel with no flow looking upstream to Pond 2***

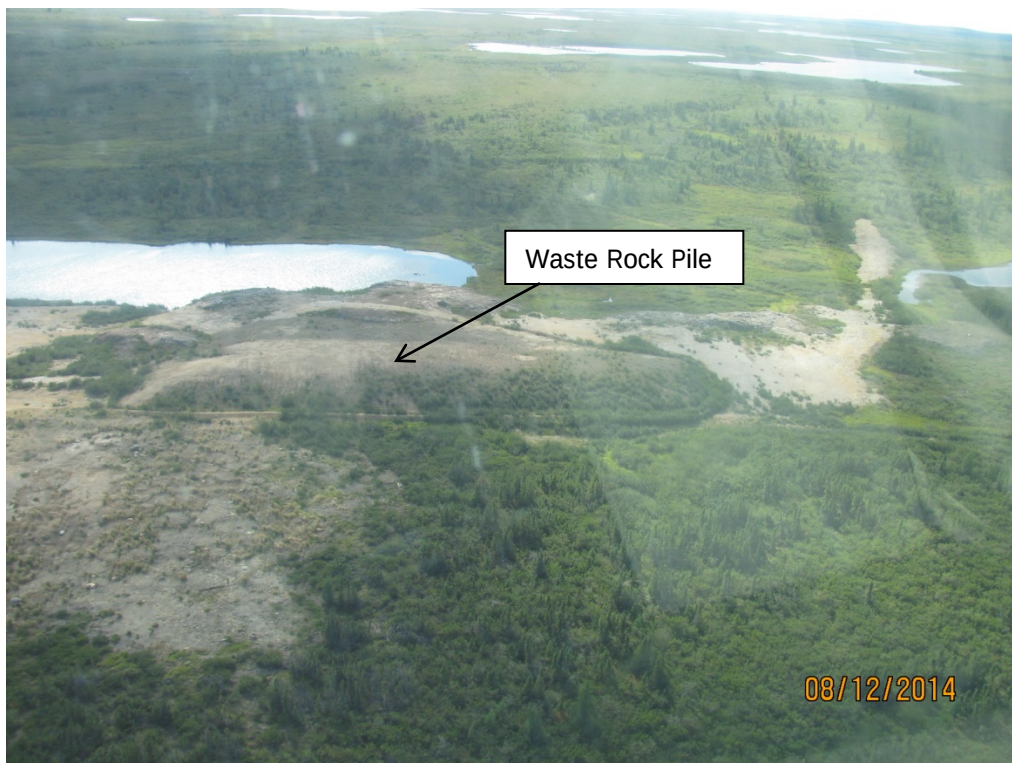
Photos 10 to 12, inclusive, show views of the Shear Lake Waste Rock Pile. The Shear Lake Waste Rock Pile, located on the east side of Shear Lake, some 4.5 km north of the former mill site, was reportedly capped with local, compacted glacial till to promote runoff and reduce infiltration. In 2005, Barrick personnel oversaw the re-seeding of the cap. The re-seeding (with grasses) was implemented to promote some vegetation growth which would reduce the erosion of the cover due to runoff, particularly along the side slopes.

Our observations suggest that, while there are some sparse areas, particularly on the top, the vegetation is helping to reduce erosion, in that very few small erosion gulleys/channels (20 to 30 mm deep/wide) were noticed on the side slopes. These generally were short and did not extend the full length of the slope. Most of these had been filled to some extent with small granular material in 2005, to minimize further erosion. Our current observations were similar to the previous years. Photo 12 shows that the gravel filled erosion gullies have been stabilized. A comparison of the photos from previous years shows that the vegetation is improving, especially on the majority of the side slopes.

***Photo 10: Aerial view of Shear Lake Waste Rock Pile looking west***

Subsequent inspections should be made to verify the efficacy of the vegetation/till cover system. Any erosion gullies that form should be repaired with fine rock/gravel. It is expected that it will take several more years for the vegetation to establish itself fully.

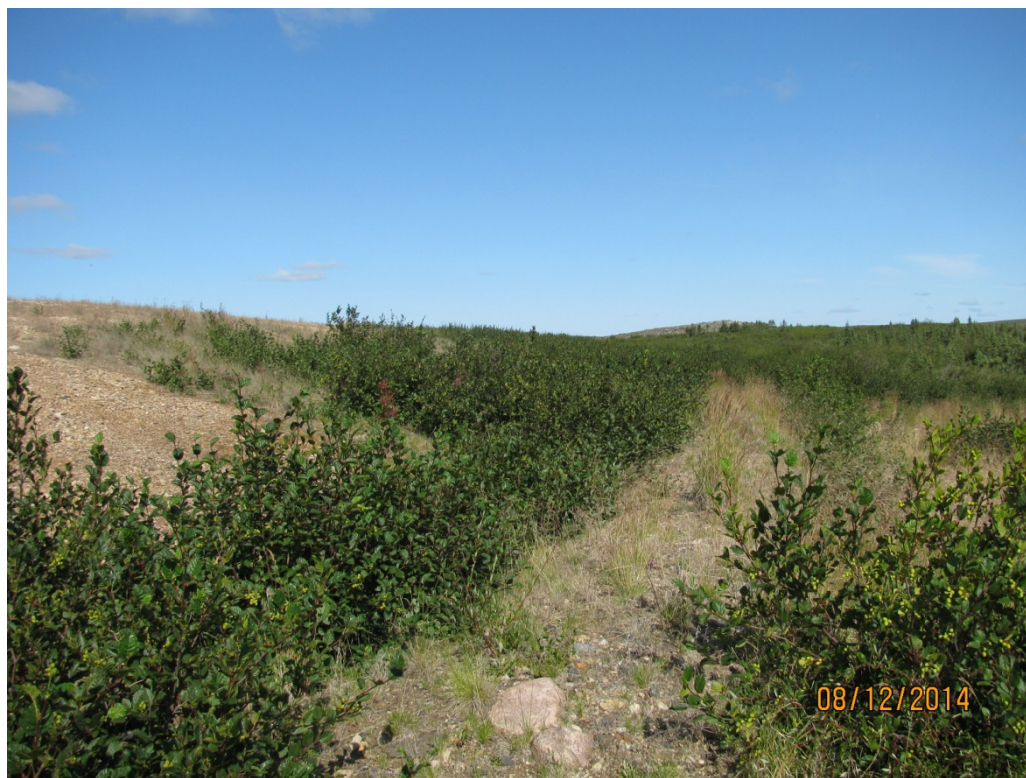
*Photo 11: East side of Shear Lake Waste Rock Pile showing grasses on left*

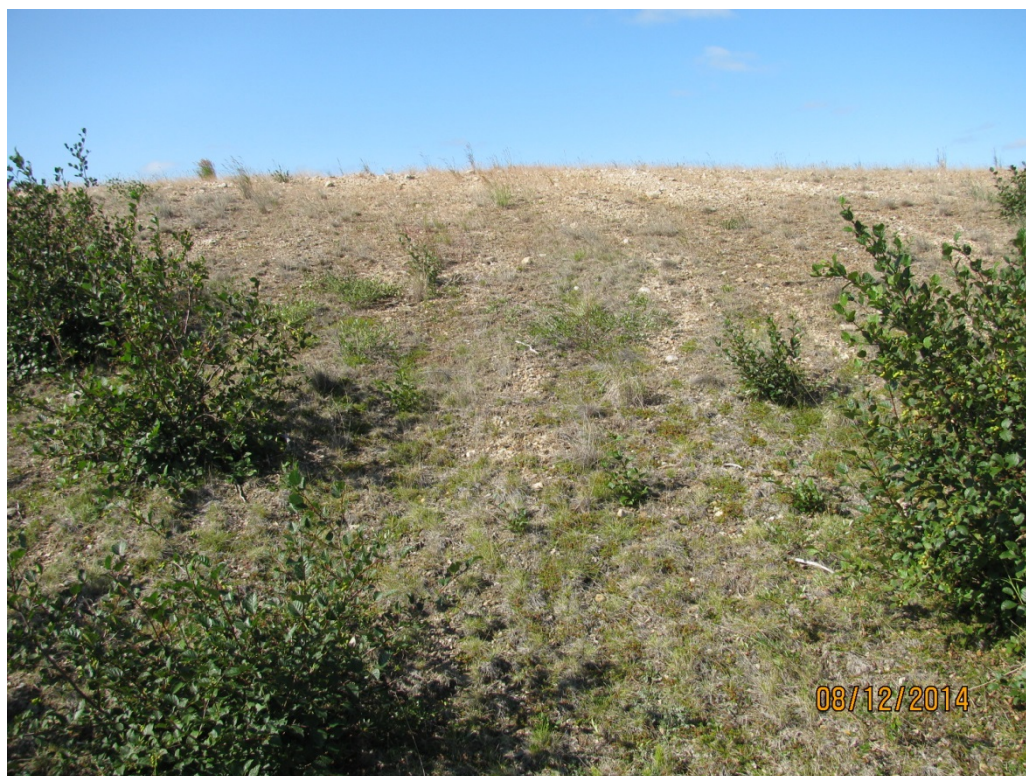
*Photo 12: Previously gravel filled erosion channels on Shear Lake Waste Rock*
