December 4, 2015

Re: **Project No. THB-00090132-EG**
2015 Tailings Dam Examination
Cullaton Lake Gold Mine, Nunavut
Licence 1BR-CUL1118

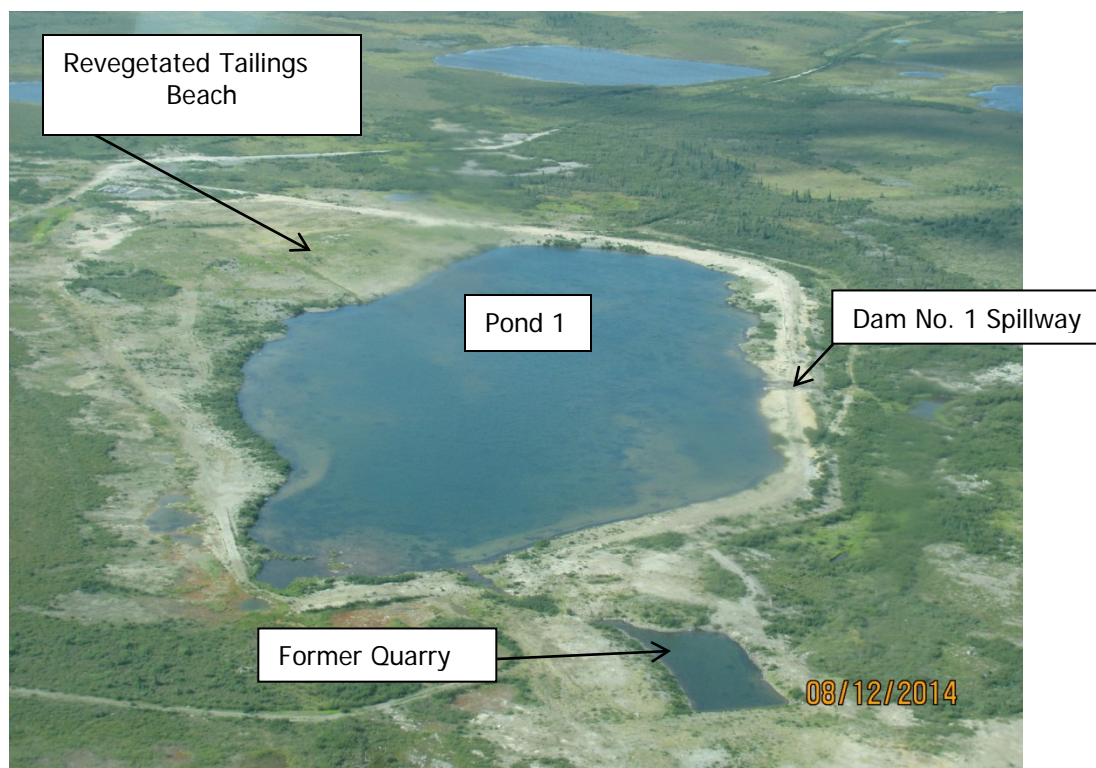
Aerial photos of the site were not possible due to poor weather (low ceiling) constraints. Photos 1 and 2, attached, show oblique views of the site taken in 2014. The tailings area had been previously covered with local till as reported in Trow's previous inspection reports. Vegetation on the till covered tailings is small and sparse. However, it is noted that the density of the vegetation is increasing gradually, based on the comparative visual observations of previous years.

Photo 1: Tailings Pond and Dam No. 1 (on right) looking north (from 2014)

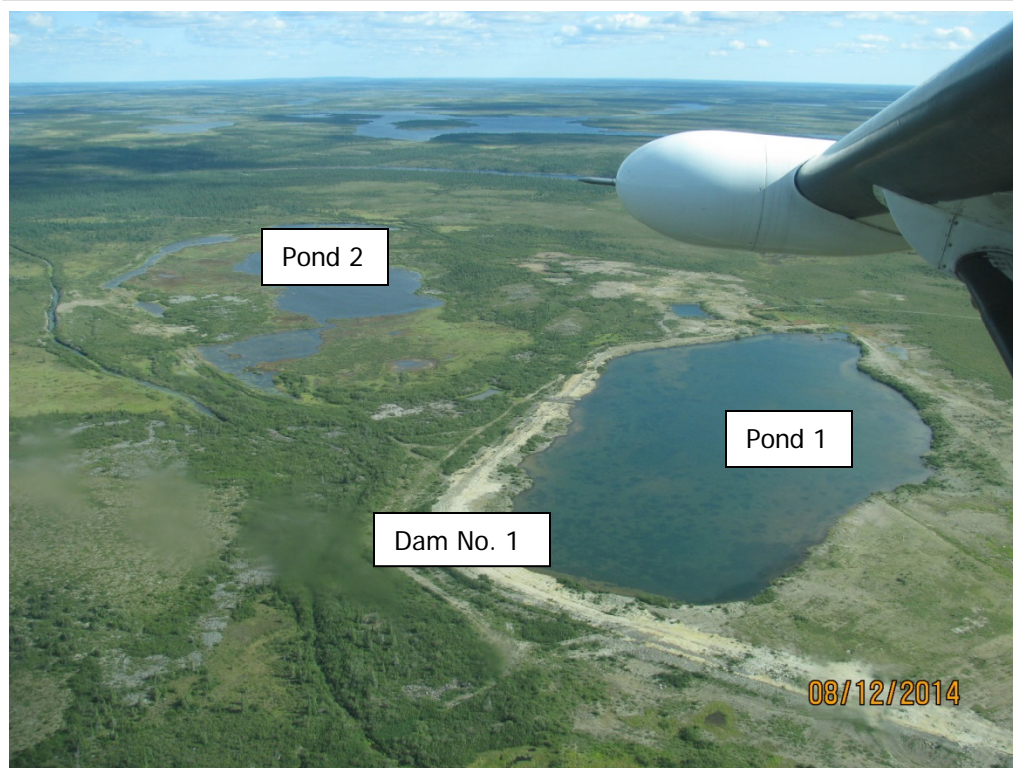
Photo 2: Tailings facility looking roughly southeast (from 2014)

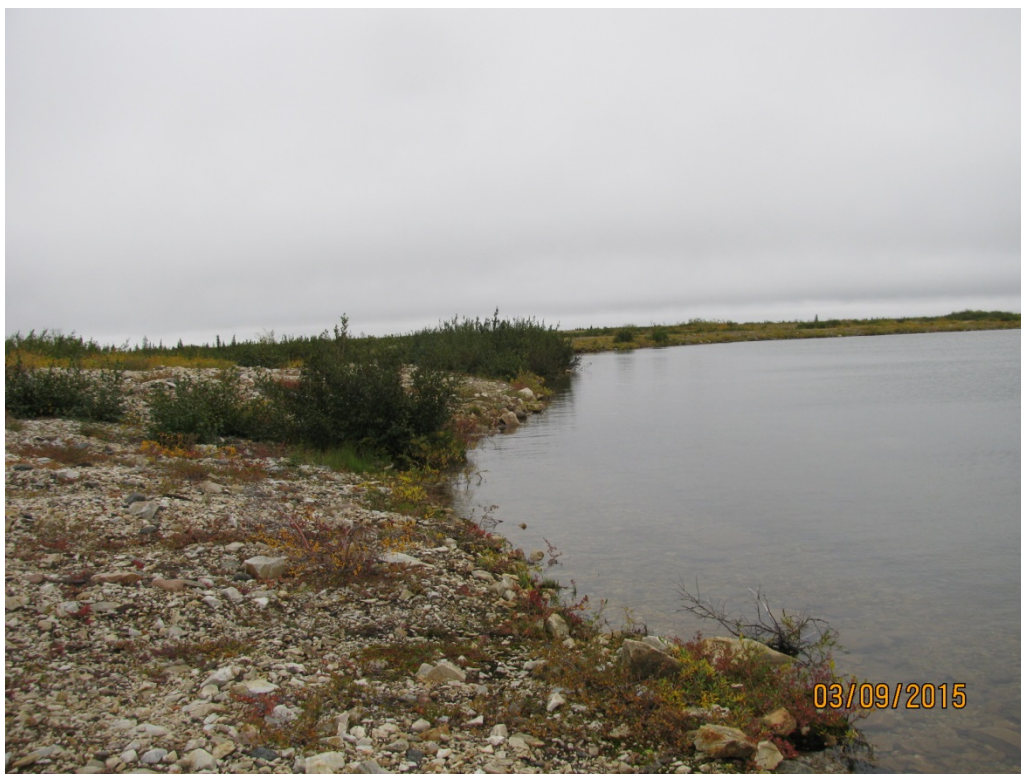
Photos 3 and 4 show views of Dam No. 1. Typically, the embankment, which is constructed principally with local cohesionless till, is irregular in section and surface grade. Average side slopes of the upstream and downstream sides are typically about 3H:1V and 6H:1V, respectively. The downstream side is estimated to be as steep as about 3H:1V in a few areas. The dam height ranges up to about 4 m. Some small erosion scars were observed on both the upstream and downstream sides; however, as described below, they appear to continue to stabilize with vegetation and self-armouring with larger rock particles from the till and previously placed mine waste rock. These scars do not appear to be increasing in size, based on visual comparisons of previous years. The crest width varies but is generally in the order of 15 m. Within the tailings pond itself, no unsubmerged or exposed tailings were observed.

Photo 3: Dam No. 1 – upstream bank looking south

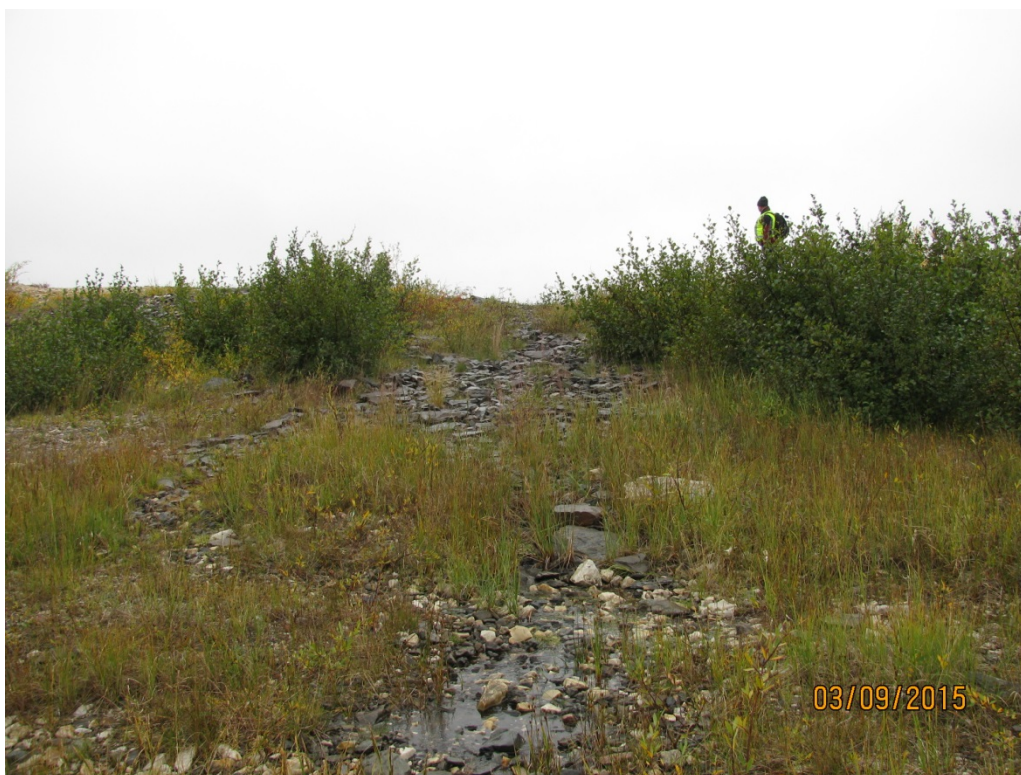
Photo 4: Downstream section of Dam No. 1 at spillway channel

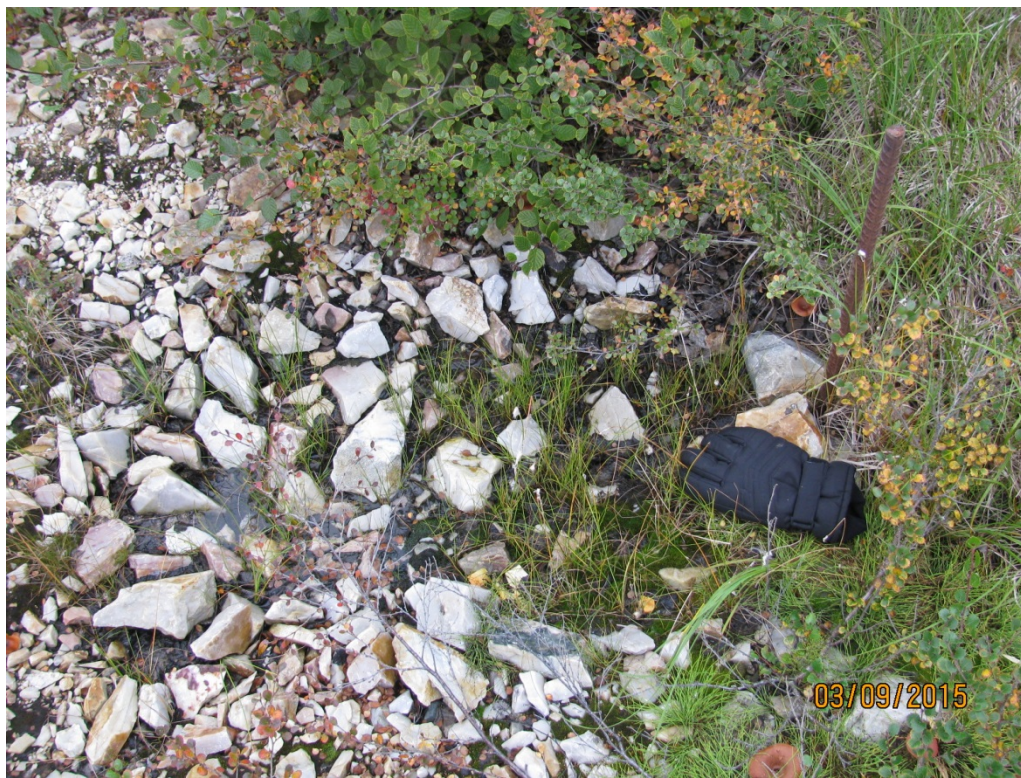
No seepages were observed on the day of inspection. However, a wet spot, first noted in the 2010 report, was observed about halfway down the downstream slope of the dam (see Photo 5), south of the spillway, at the approximate location shown on Figure 1 in Appendix A. As recommended in a previous report, the location had been marked with a length of rebar. While there was some minor wetness, no accumulated water or flow was visible. There was no evidence of any dam internal soil erosion. This should continue to be monitored during the scheduled inspections.

Photo 5: Wet spot on downstream side of Dam No. 1- minor seepage/ponding

It is recommended that the condition of the Dam No. 1 spillway channel continue to be monitored for erosion and if any is apparent, remedial measures, such as the addition of additional rockfill, be implemented. In addition, the wet spot noted on the downstream side of Dam No. 1, south of the spillway, should be monitored during each subsequent visit.

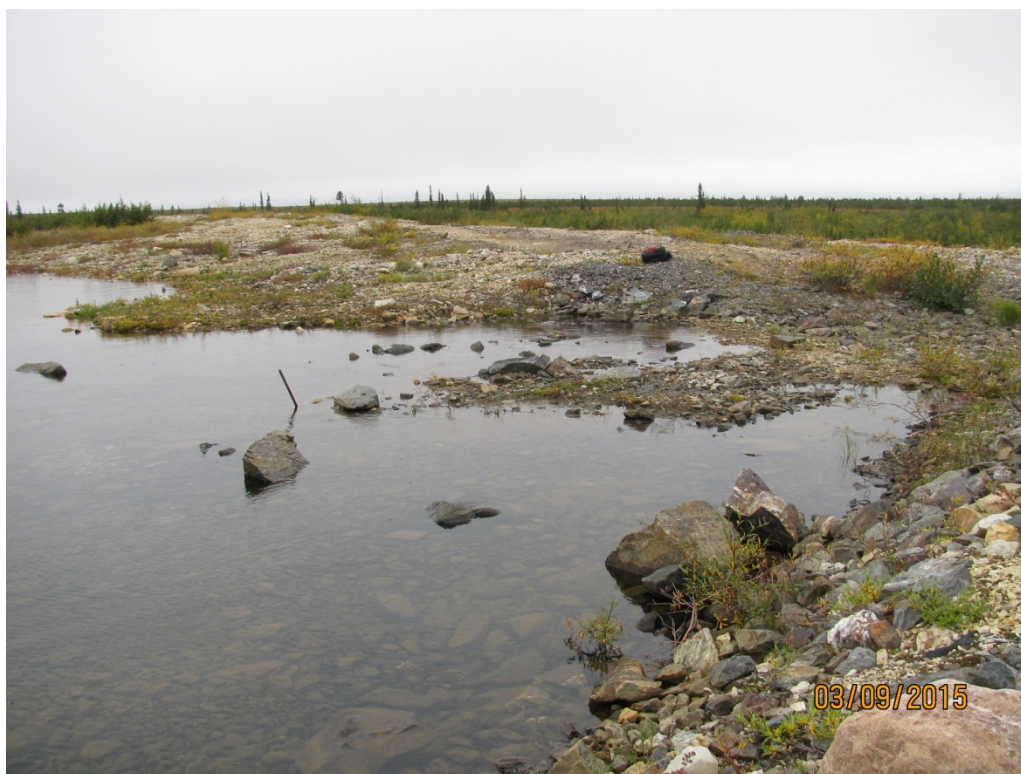
Photos 6 and 7 show views of the Dam No. 1 spillway channel. Only a minor flow (trickle) was occurring at the spillway as had been observed in most previous years. A minor trickle was observed to flow through the rockfill comprising the channel bottom, about the same as in previous years. The pond level was noted to be about two to three centimetres higher than in 2014. Based on all of the previous inspections, the pond level varies only a few centimetres, from year to year.

Our visual inspection of the spillway channel, where additional fine rockfill was placed in 2005 to cover small areas of previously exposed rubber liner, indicates that no erosion has occurred. It is expected that monitoring of this area during future inspections will indicate that the treatment performed in 2005 is sufficient.

Photo 6: Dam No. 1 Spillway inlet and crest

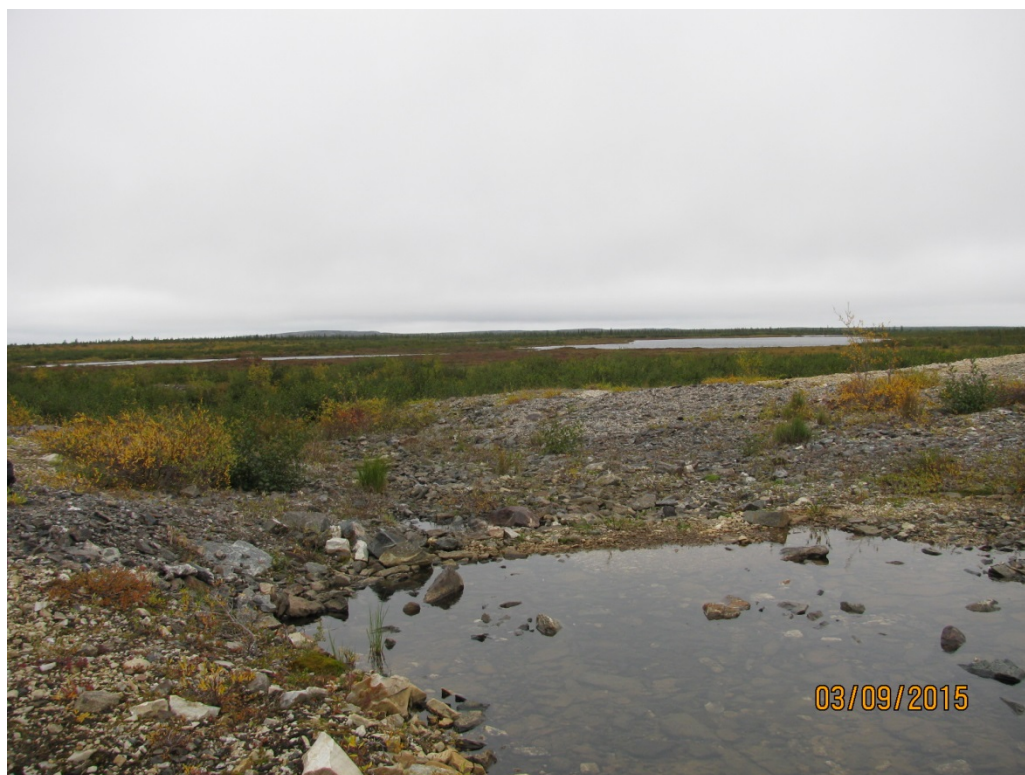
Photo 7: Dam No. 1 Spillway downslope channel

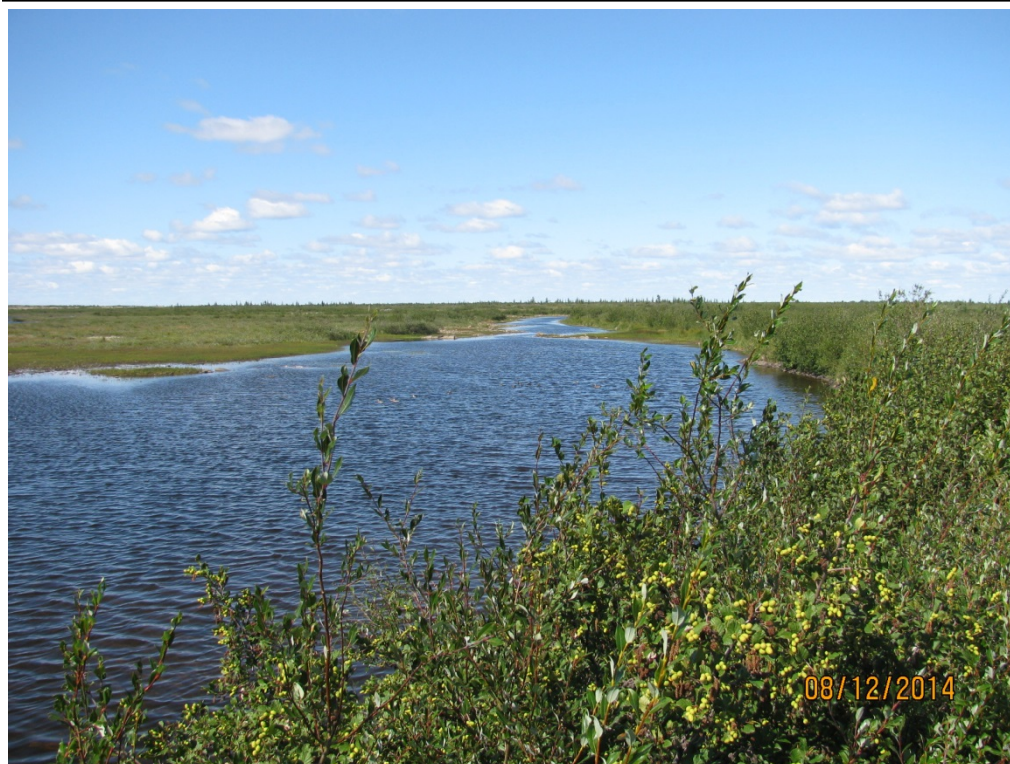
Photo 8 shows a view of Dam No. 2, taken in 2014. As with Dam No. 1, the principal construction material is local cohesionless till. The dam section and surface grade is irregular, although less so than Dam No. 1. The crest width varies but is in the order of 15 m.

Based on the current as well as previous inspections, the dam is not in any distress and is considered to be stable.

Photo 8: View of Dam No. 2 (on the right) and Pond No. 2 – from 2014.

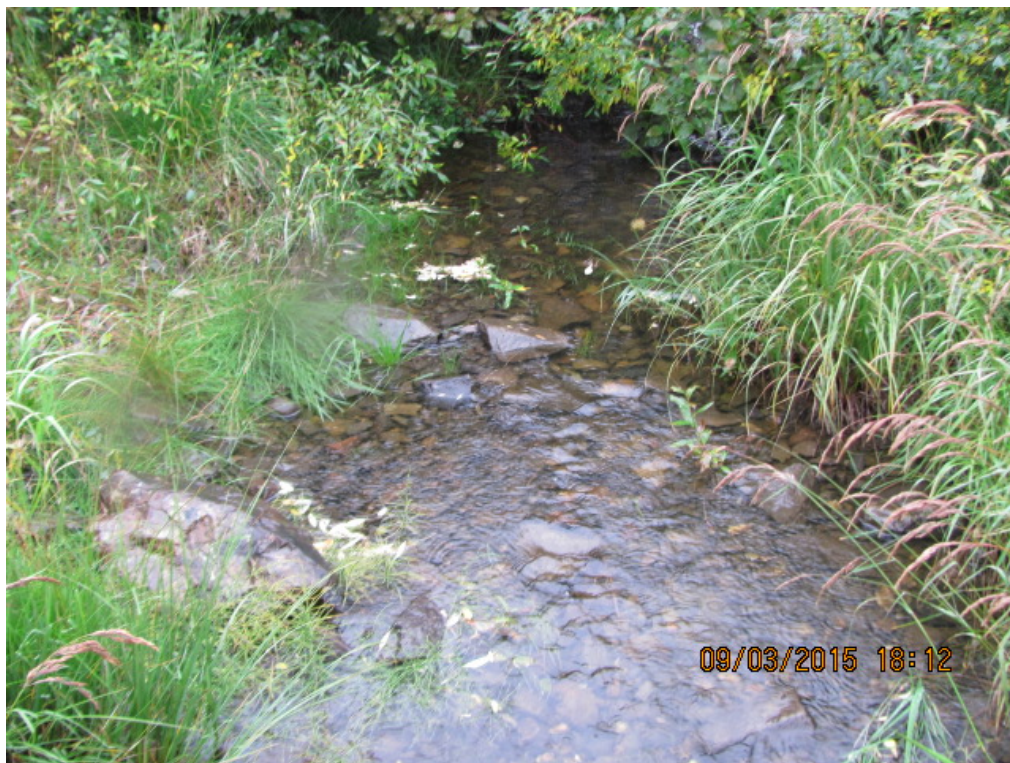
Photo 9 is an upstream view of the Dam No. 2 spillway channel. There was a small amount of flow observed over the rockfill channel, due to the slightly higher water level of Pond 2, compared to 2014.

Photo 9: Dam No. 2 Spillway Channel with flow looking upstream to Pond 2

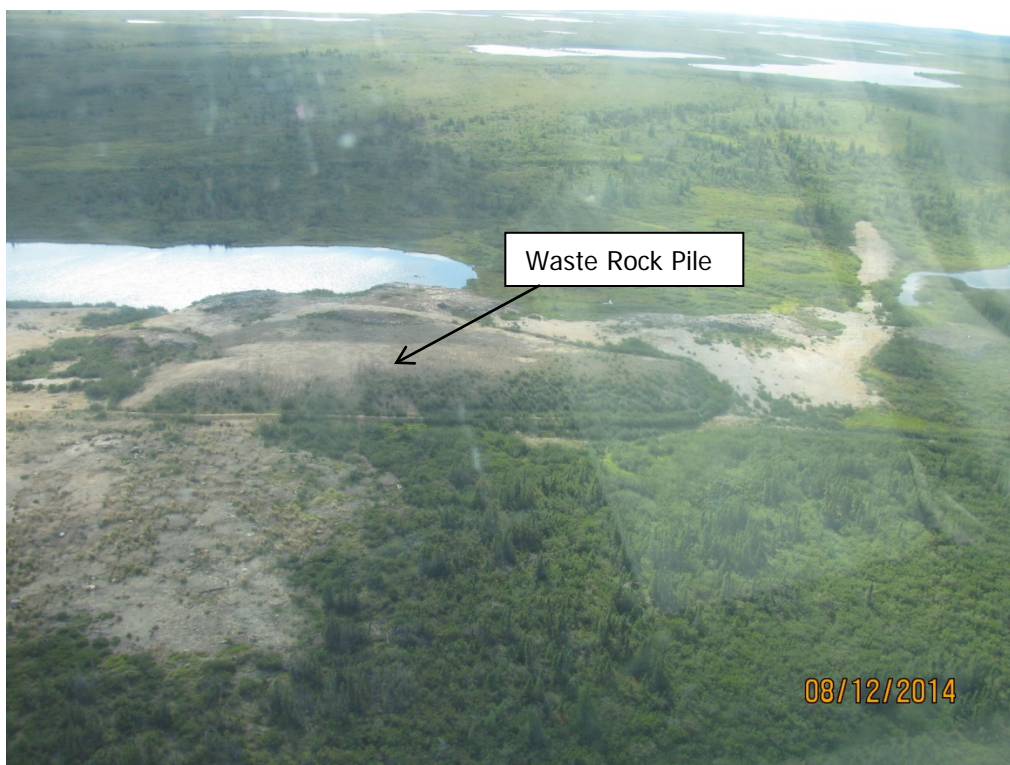
Photos 10 (2014) to 12, inclusive, show views of the Shear Lake Waste Rock Pile. As previously described, an aerial photo of the pile was not possible in 2015, due to poor weather conditions. The Shear Lake Waste Rock Pile, located on the east side of Shear Lake, some 4.5 km north of the former mill site, was reportedly capped with local, compacted glacial till to promote runoff and reduce infiltration. In 2005, Barrick personnel oversaw the re-seeding of the cap. The re-seeding (with grasses) was implemented to promote some vegetation growth which would reduce the erosion of the cover due to runoff, particularly along the side slopes.

Our observations suggest that, while there are some sparse areas, particularly on the top, the vegetation is helping to reduce erosion, in that very few small erosion gulleys/channels (20 to 30 mm deep/wide) were noted on the side slopes. These generally are short and do not extend the full length of the slope. Most of these had been filled to some extent with small granular material in 2005, to minimize further erosion. Our current observations are similar to the previous years. A comparison of the photos from previous years shows that the vegetation is improving, especially on the majority of the side slopes.

Photo 10: Aerial view of Shear Lake Waste Rock Pile looking west (2014)

Subsequent inspections should be made to verify the efficacy of the vegetation/till cover system. Any erosion gullies that form should be repaired with fine rock/gravel. It is expected that it will take several more years for the vegetation to establish itself fully.

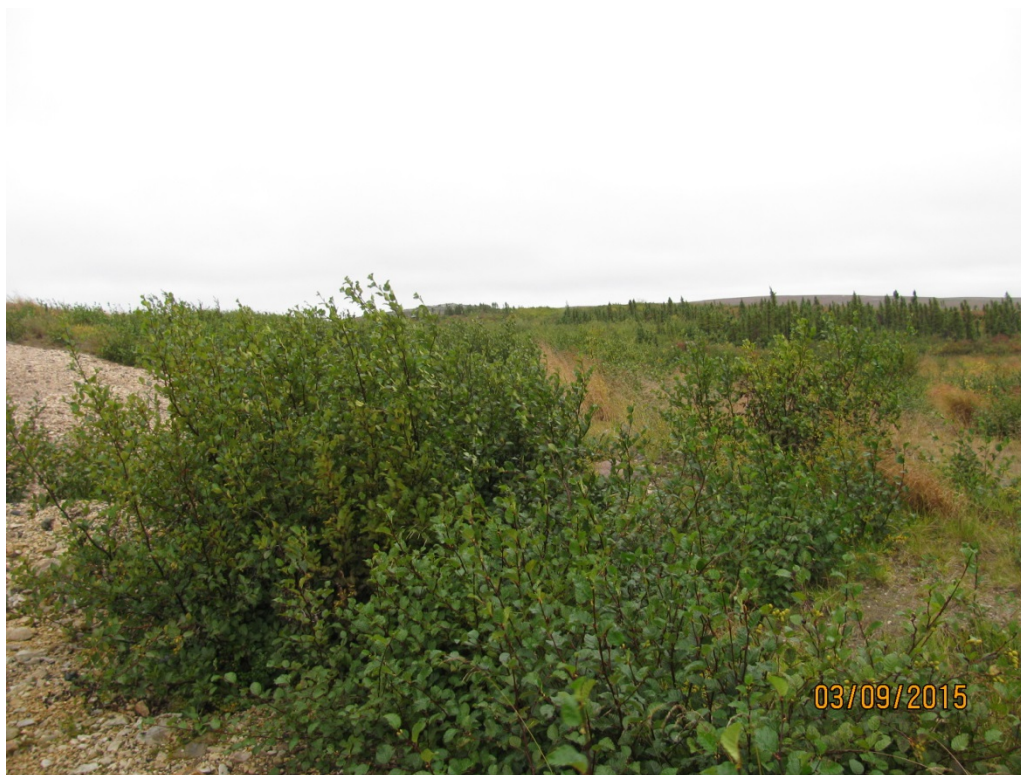
Photo 11: East side of Shear Lake Waste Rock Pile showing grasses on left

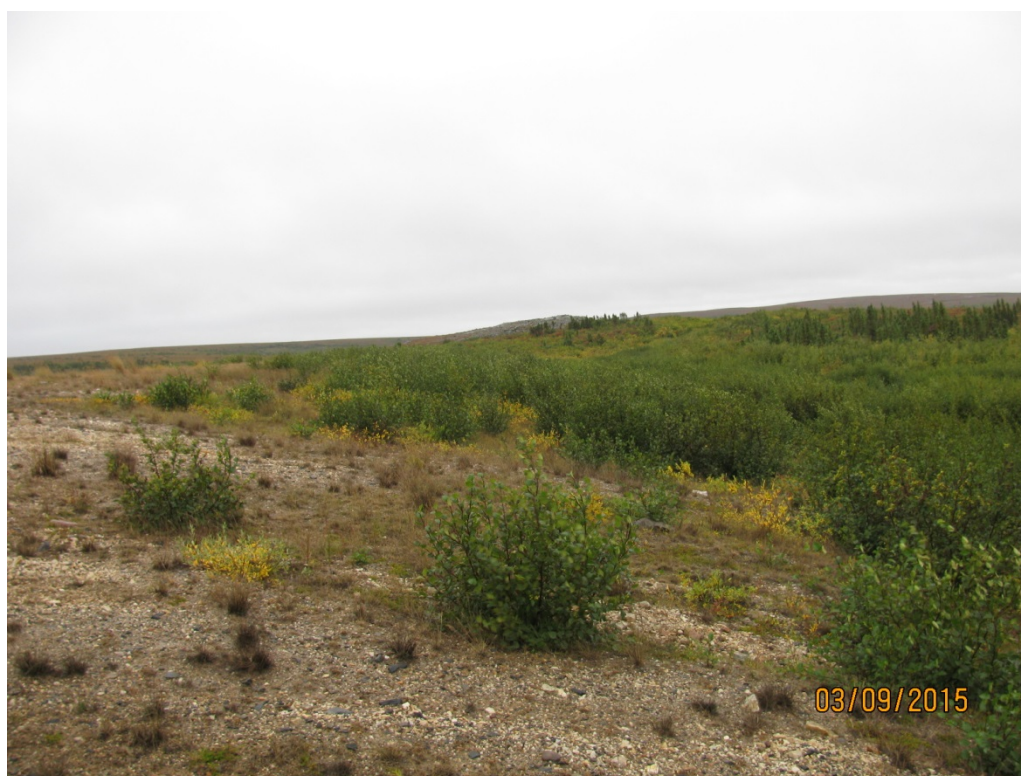
Photo 12: Stable gravel/till covered slope on Shear Lake Waste Rock Pile
