**CULLATON LAKE MINE
DAM SAFETY REVIEW**

**Report
to
Barrick Gold Corporation**

Date: July 20, 2016
File: 19-7004-0

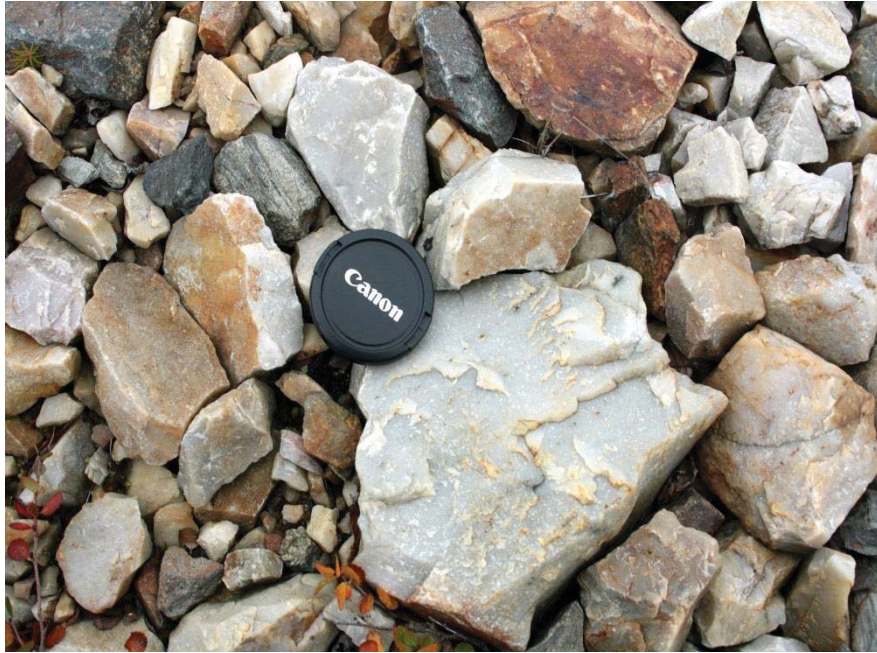
Waste rock has been used extensively to protect and armour the crest and side slopes of TP1 as shown in Photo 1. On both the upstream and downstream sides of the dam, evidence of small erosion scars were found. However, the scars are not increasing in size according to the previous inspections by Barrick and EXP personnel, and are stabilizing due to accelerating vegetation

Photo 1. Typical waste rock over crest of Tailings Dam

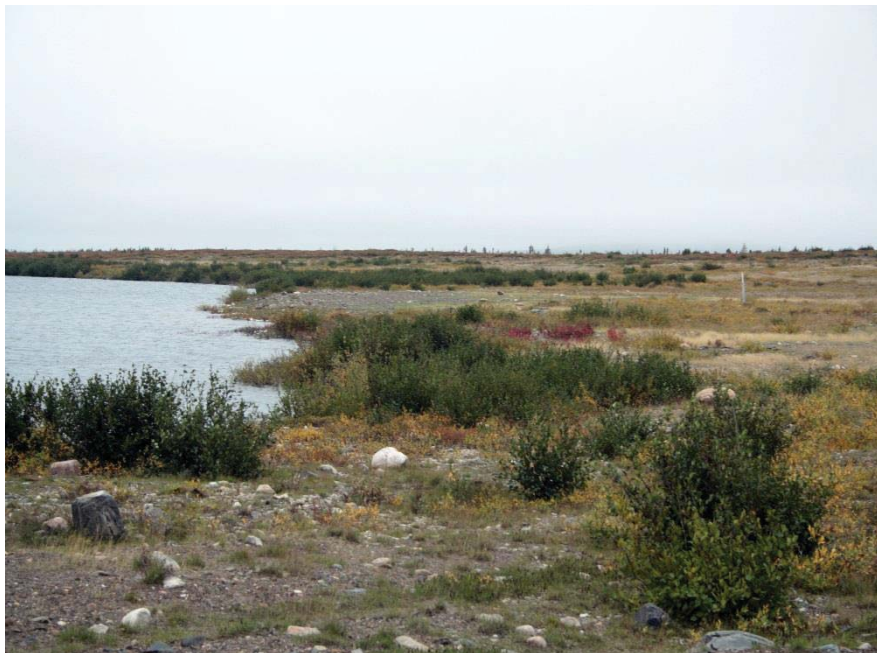
It was noted by Mr. Paul Brugger and Mr. Demetri Georgiou that the density of the vegetation has increased gradually, based on their visual observations of previous years and this year. Photo 2 gives the view of the progression of vegetation over the covered tailings. Over all exposed areas, pioneer species of bush that has rapidly accelerated in growth this summer was observed (Photo 5). The areas of previously exposed gold tailings was covered by a layer of till and seeded, and which is now largely restored with a natural growth of vegetation, as can be seen in Photos 15 and 17.

Photo 2. Progression of vegetation cover over tailings and cover

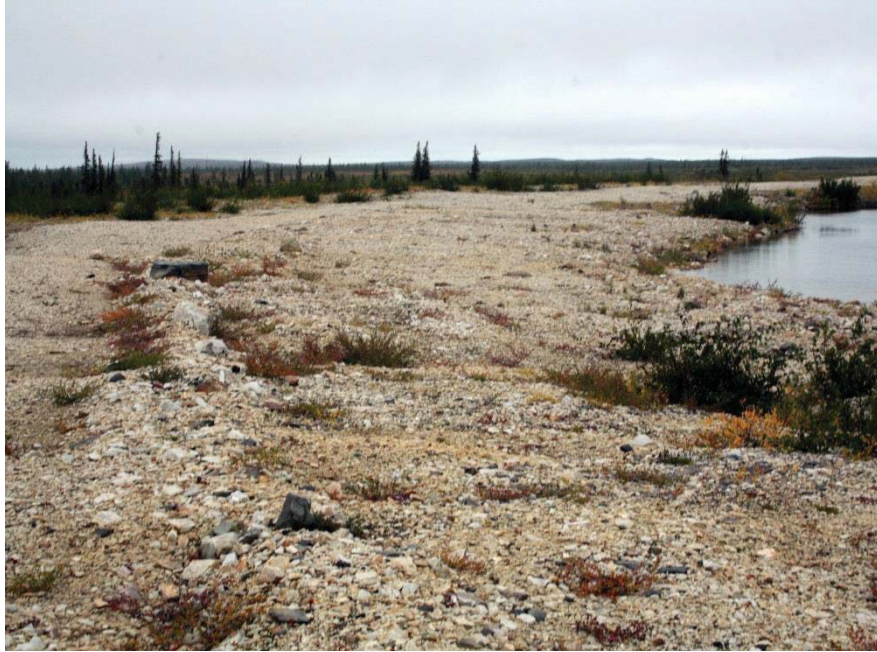
Photo 3. Faint evidence of oxidation of waste rock (yellowing).

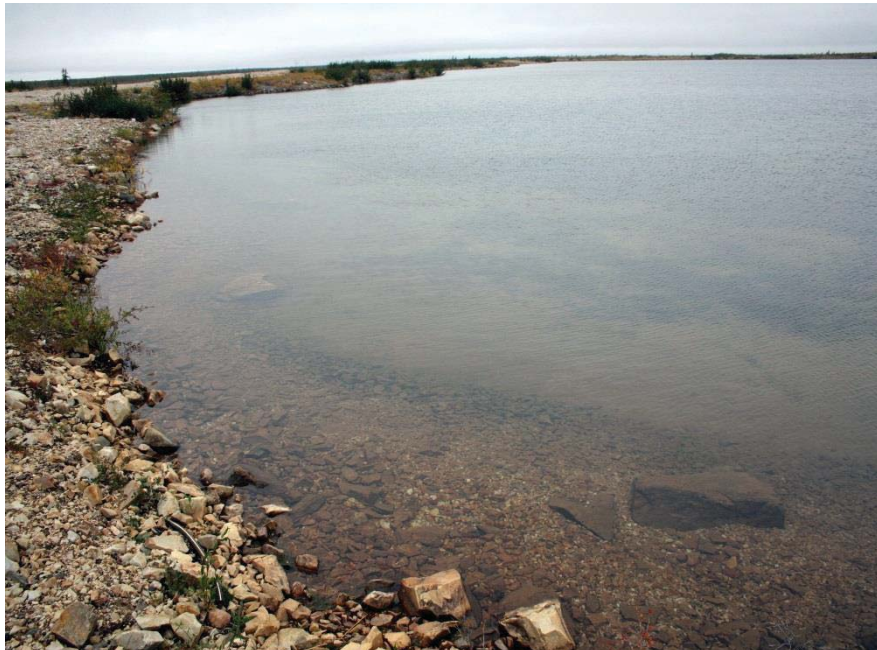
Photo 4. Tailings and sheetwash faintly visible below surface.

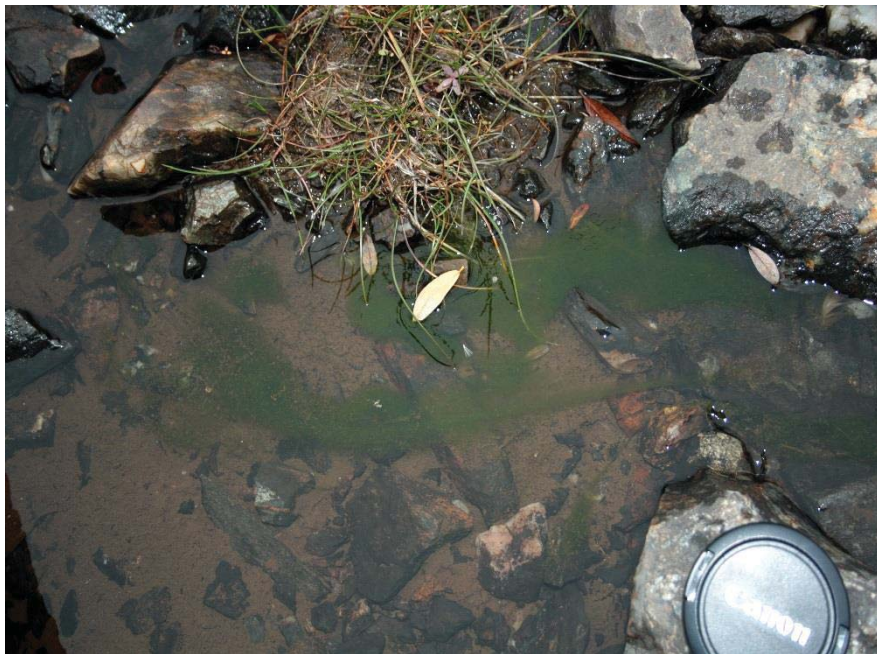
Photo 6. Biotic activity in spillway of No. 1 dam.

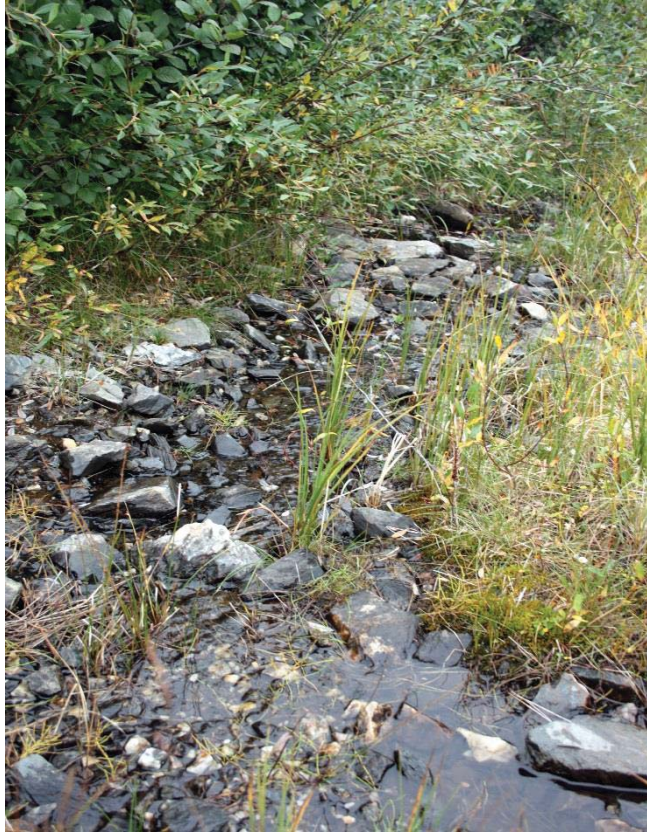
Photo 7. Vegetation cover in lightly flowing spillway of TP1.

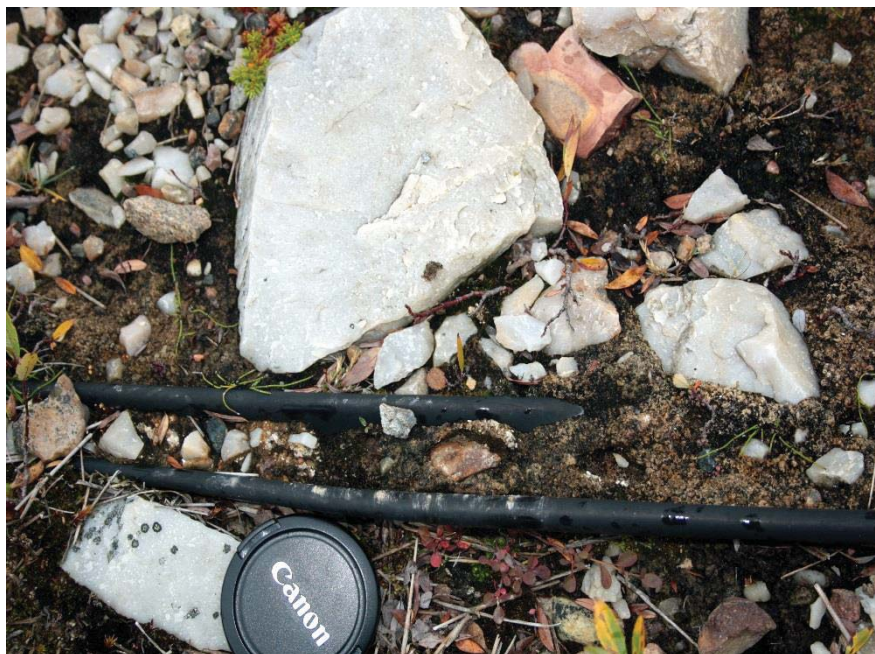
Photo 8. Exposure of edge of liner in spillway.

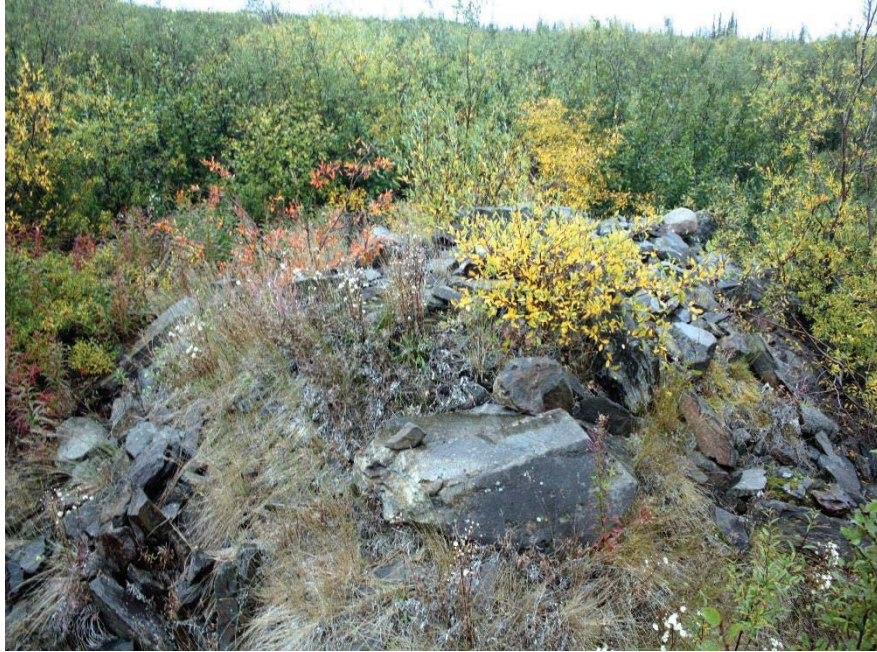
No seepage was observed in the pond located at the downstream side of the spillway channel. A view of the waste rock pile on the downstream slope of TP1 and immediately downstream of the spillway can be found in Photos 9 and 10, respectively. A wet spot was located during the 2010 field inspection and was reported in EXP's annual geotechnical inspection (EXP, 2014b). Photo 11 shows the wet patch on the downstream toe of Dam 1 and photo 12 shows the semi-permanent wet area at the downstream toe. The approximate location of the wet spot is shown in Figure 1 of Appendix B.

Photo 9. Waste rock pile on downstream slope of TP1.

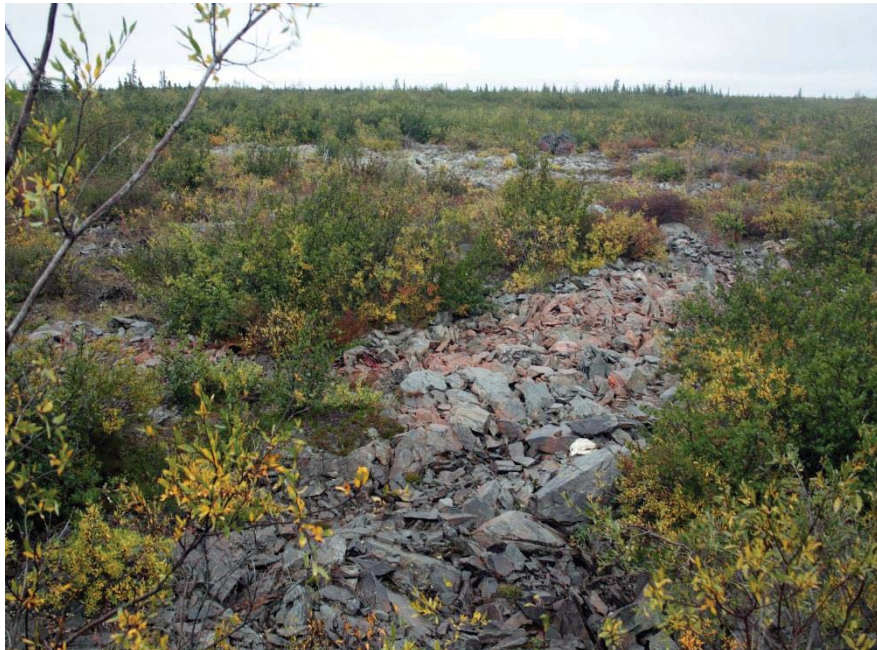
Photo 10. View immediately downstream of spillway of TP1.

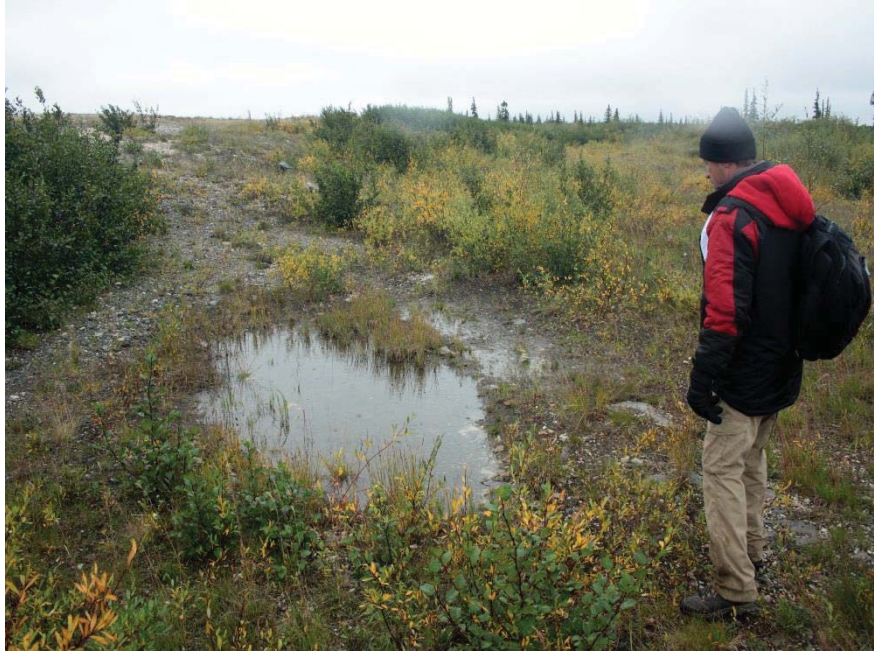
Photo 11. Wet patch on downstream toe of TP1 with D. Georgiou, P.Eng.

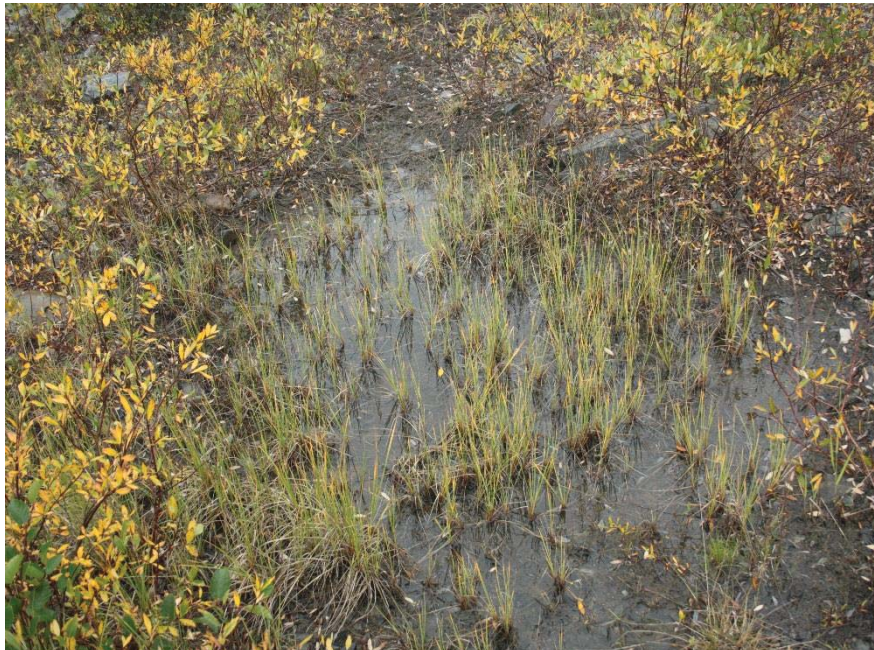
Photo 12. Semi-permanent wet area at downstream toe. (Ref D. Georgiou)

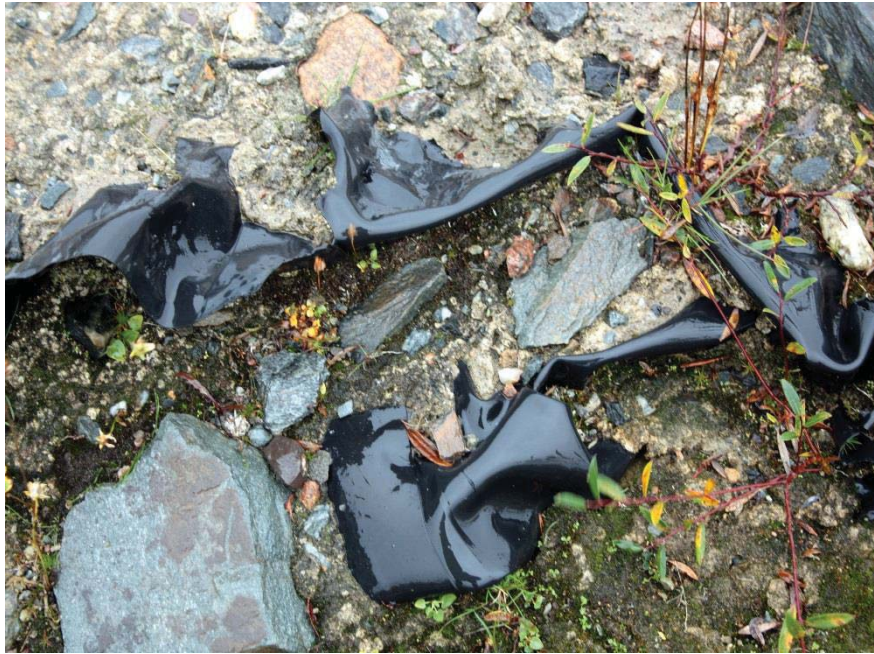
- Photo 13 shows the remains of an HDPE liner which was transported from TP2 to TP1 when till was used to cover the exposed gold tailings at the time. The waste HDPE pieces thus observed in a few isolated places serve no function today.

Photo 13. Shreds of liner dumped with spoil obtained from wall of TP2, to cover tailings in TP1.

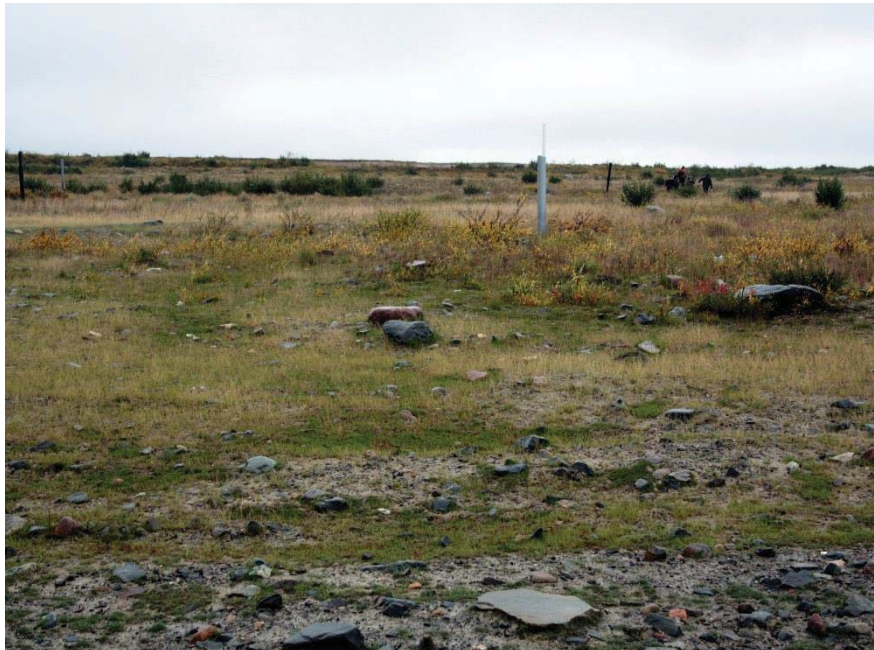
- Photo 14 shows the general location of the original thermistors (installed some 15 years ago) and the location of the permafrost depth test pit.

Photo 15. Area of tailings showing old thermistor locations and location of permafrost test pit.

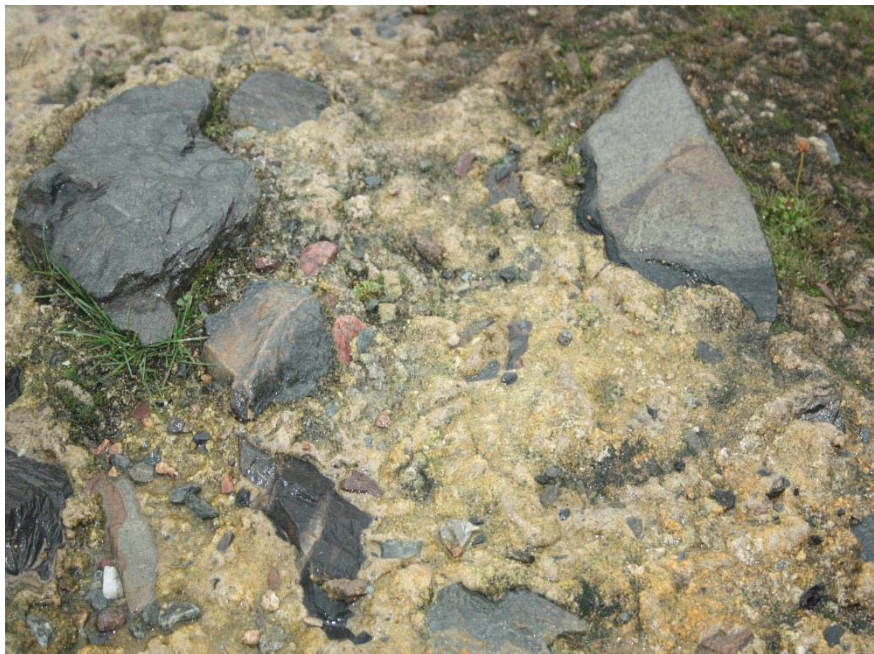
As mentioned earlier in this report, some small erosion scars were observed on both upstream and downstream sides of TP1. However, the scars do not appear to be increasing in size compared to the previous inspections performed and recorded by EXP in annual inspection reports. The exposed till mixed with waste rock, with a developing natural vegetative cover, is visible in Photo 16. No evidence of dam internal erosion (piping) was found.

Photo 16. Till cover mixed with waste rock with natural vegetative cover appearing.

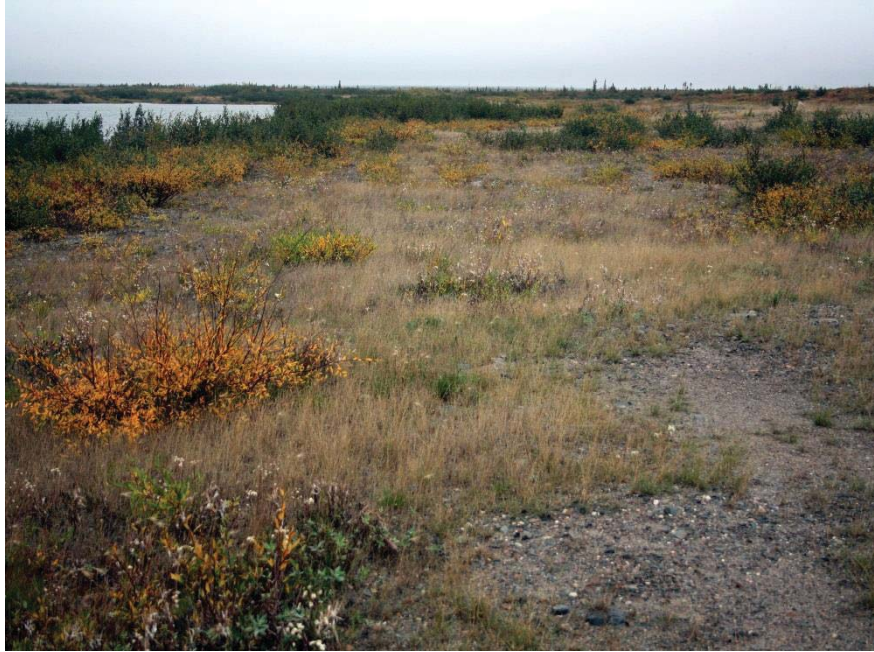
Photo 17. Area of previously exposed gold tailings, now covered with till and progressively being revegetated naturally.

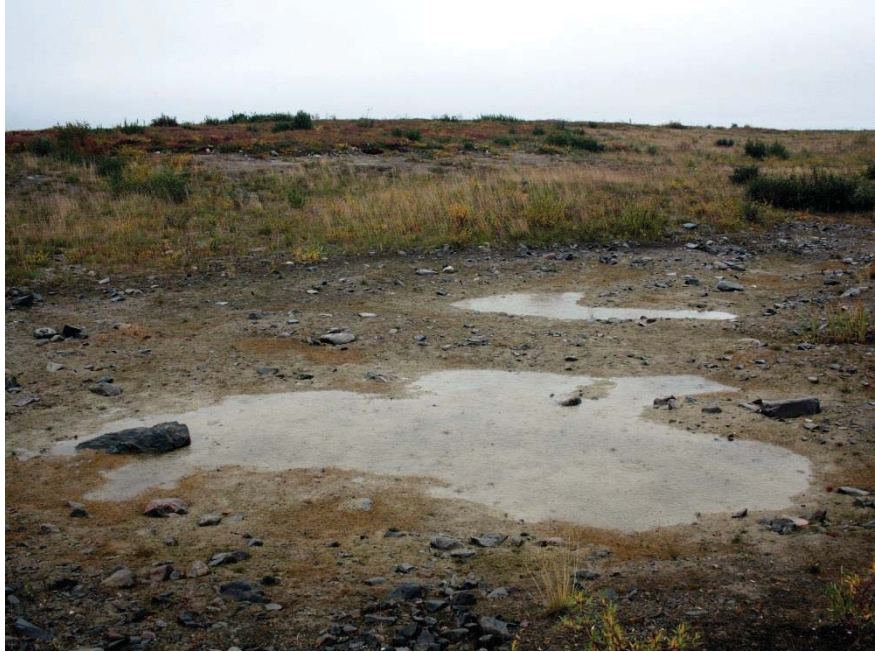
- Photo 21 shows exposed till on site – a small bare patch of some 8 m by 5 m.
- Photo 22 shows hand excavation in progress of a test pit to determine the depth to the permafrost, which was found to be 1.42 m (56 in). The unoxidized gold tailings (grey in colour) is visible in the spoil pile to the right were found under 900 mm of cover material. It was from this source that a sample of gold tailings was recovered for testing.

A limited number of small isolated bare patches were found across the site. An example is shown in Photo 21.

Photo 21. Bare patches with some exposed till.

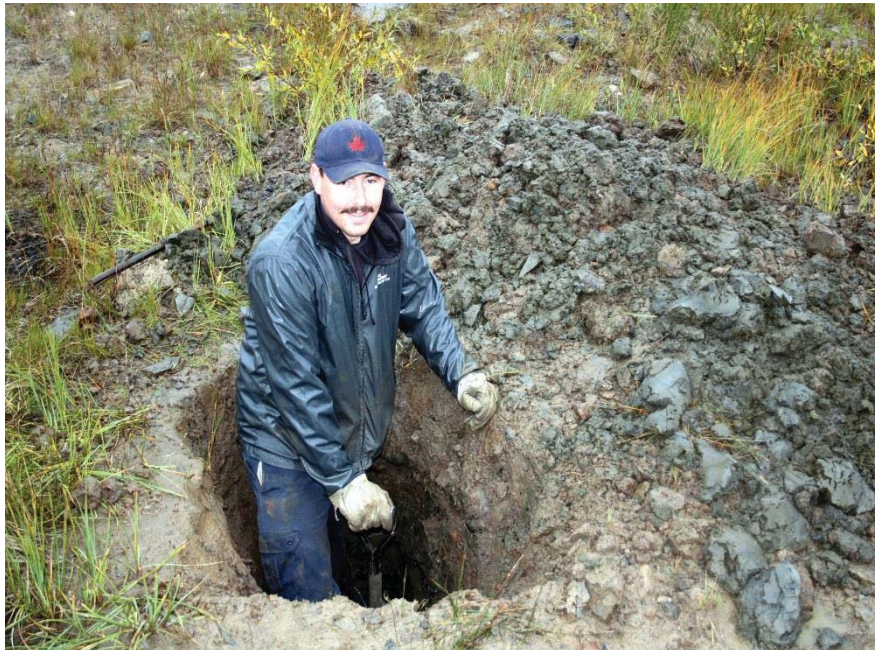
Since the thermistors installed in 1991 are no longer operational, depth to permafrost has been determined annually since 2007 by hand excavation of a test pit in the tailings, as shown in Photo 22 in Appendix A. The depth to permafrost was determined to be about 1.4 m (56 in) on September 3, 2015.

Photo 22. Excavation to permafrost depth showing unoxidized gold tailings (grey colour).

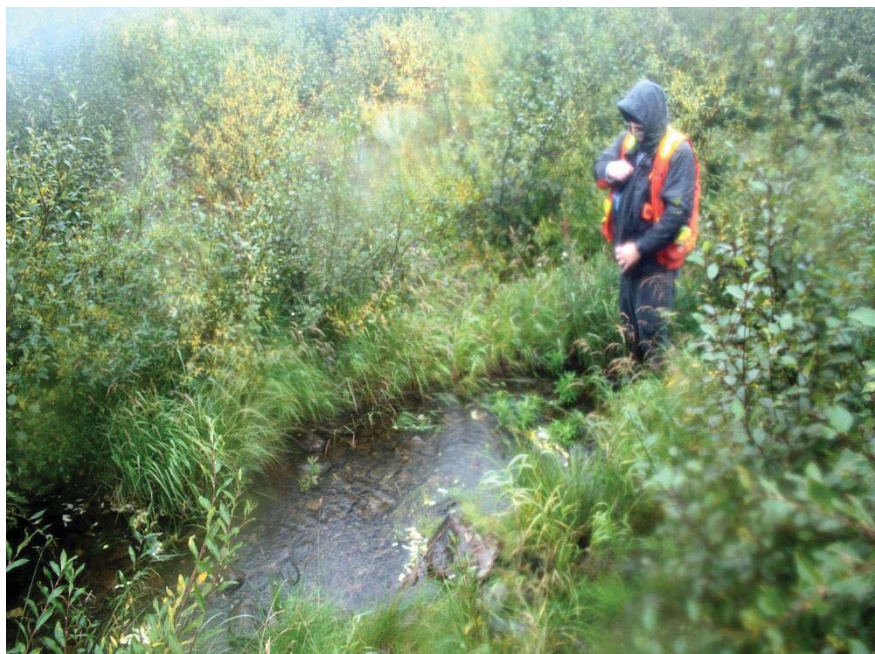
Photo 24. Flow from spillway of Dam no. 2.
