Re: **Project No. THB-00090132-FG**
2016 Tailings Dam Examination
Cullaton Lake Gold Mine, Nunavut
Licence 1BR-CUL1118

Current Inspection – September 7, 2016

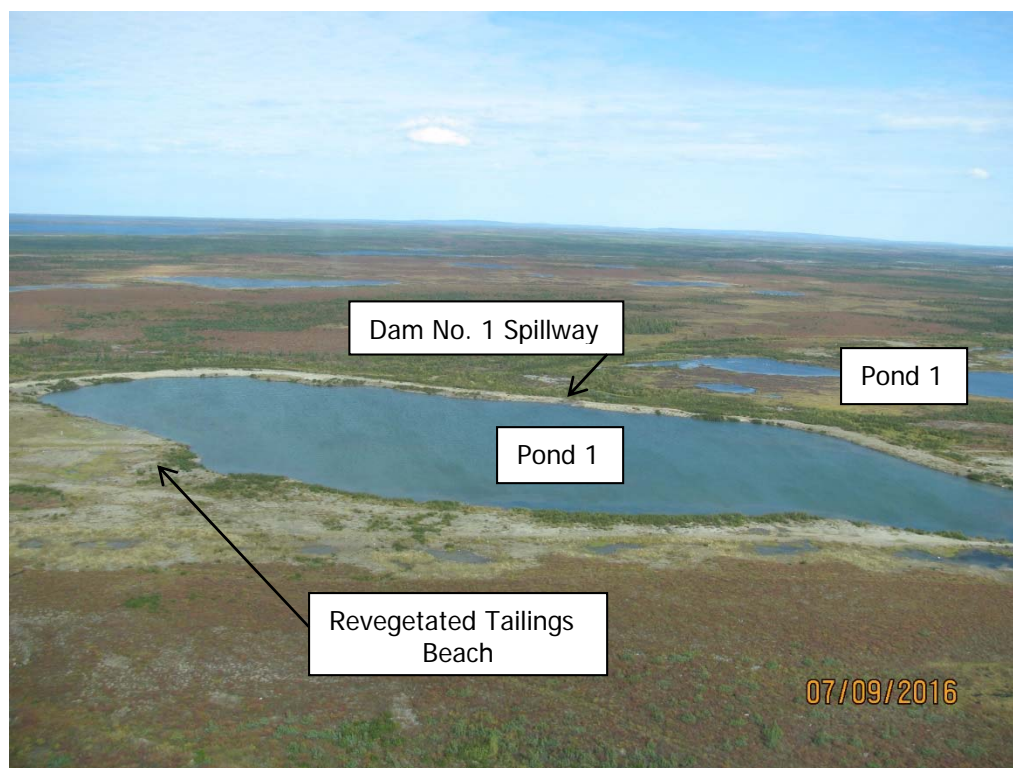
Photos 1 and 2 are aerial views of the tailings area. The tailings beach adjacent to the northwest edge of Pond 1 had been previously covered with local till as reported in Trow's previous inspection reports. Vegetation on the till covered tailings is small and sparse. However, it is noted that the density of the vegetation is increasing gradually, based on the comparative visual observations of previous years.

Photo 1: Tailings Pond and Dam No. 1 looking east

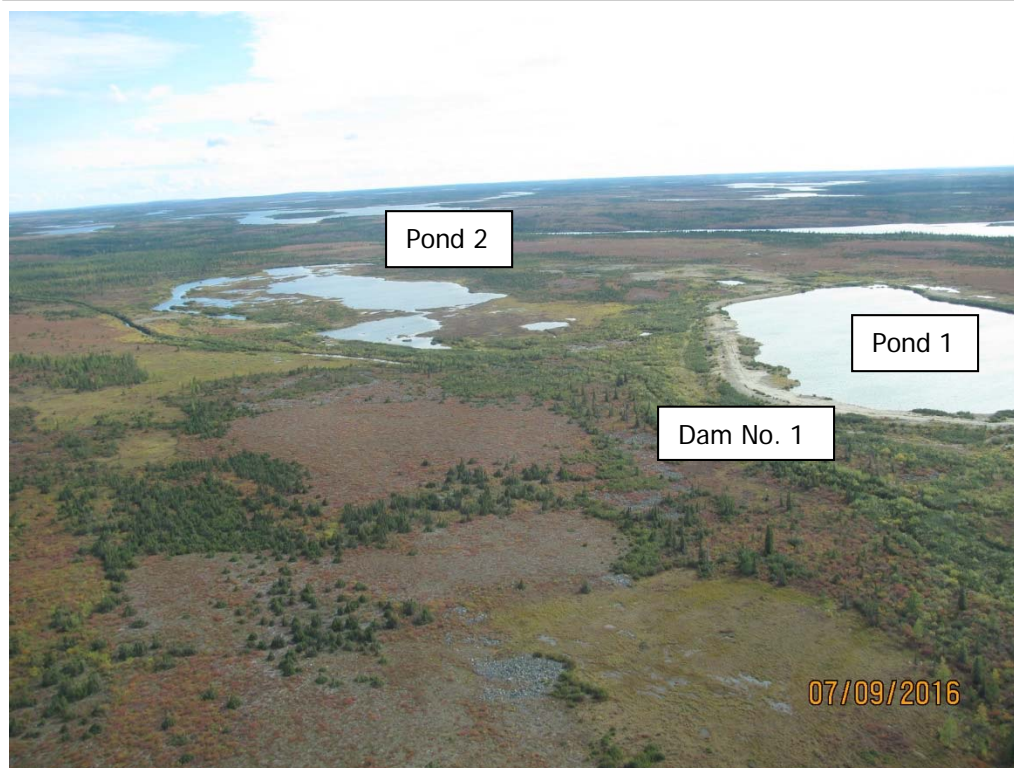
Photo 2: Tailings facility looking roughly southeast

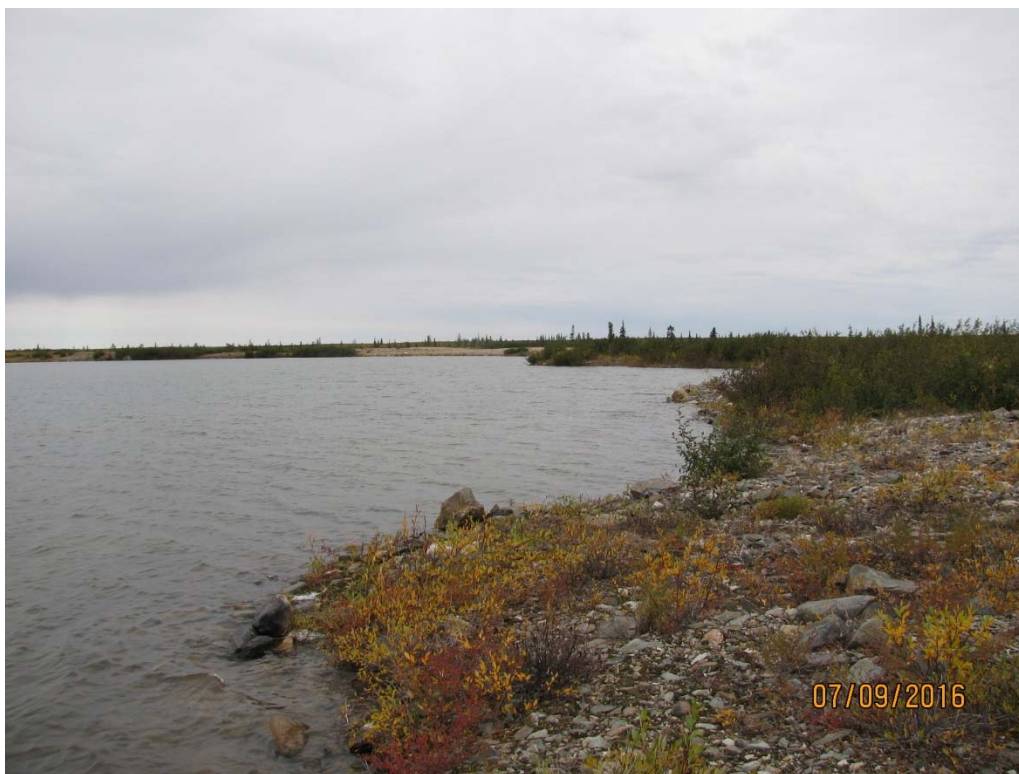
Photos 3 and 4 show views of Dam No. 1. Typically, the embankment, which is constructed principally with local cohesionless till, is irregular in section and surface grade. Average side slopes of the upstream and downstream sides are typically about 3H:1V and 6H:1V, respectively. The downstream side is estimated to be as steep as about 3H:1V in a few areas. The dam height ranges up to about 4 m. Some small erosion scars were observed on both the upstream and downstream sides; however, as described below, they appear to continue to stabilize with vegetation and self-armouring with larger rock particles from the till and previously placed mine waste rock. These scars do not appear to be increasing in size, based on visual comparisons of previous years. The crest width varies but is generally in the order of 15 m. Within the tailings pond itself, no unsubmerged or exposed tailings were observed.

Photo 3: Dam No. 1 – upstream bank looking north-northwest

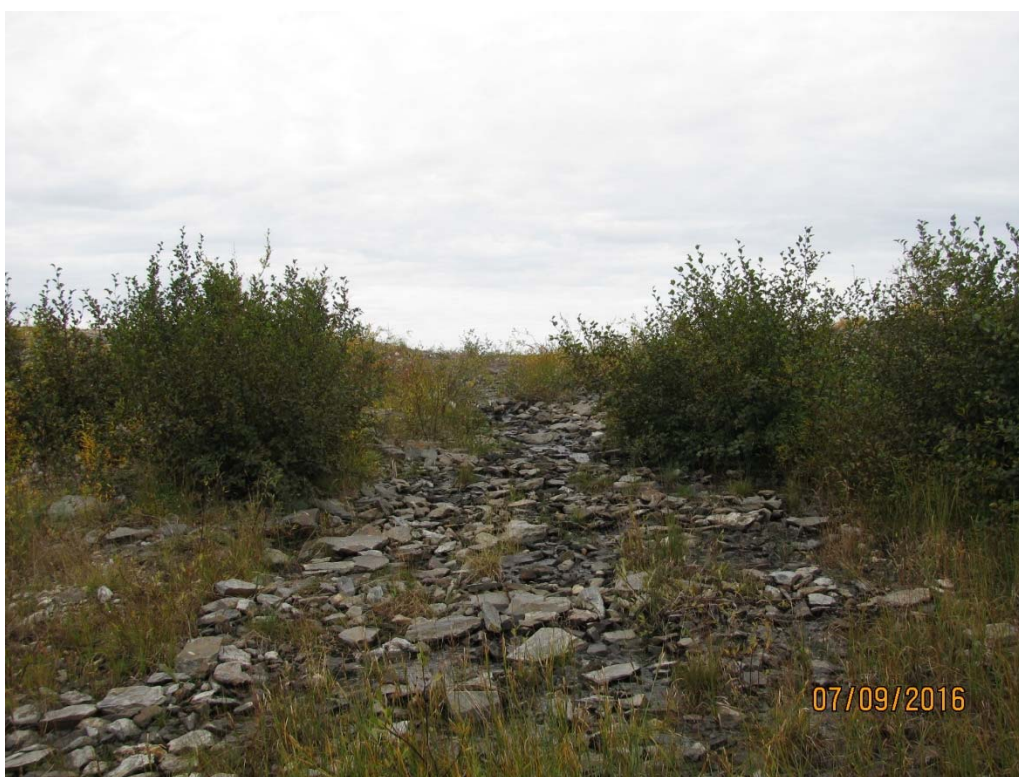
Photo 4: Downstream section of Dam No. 1 at spillway channel

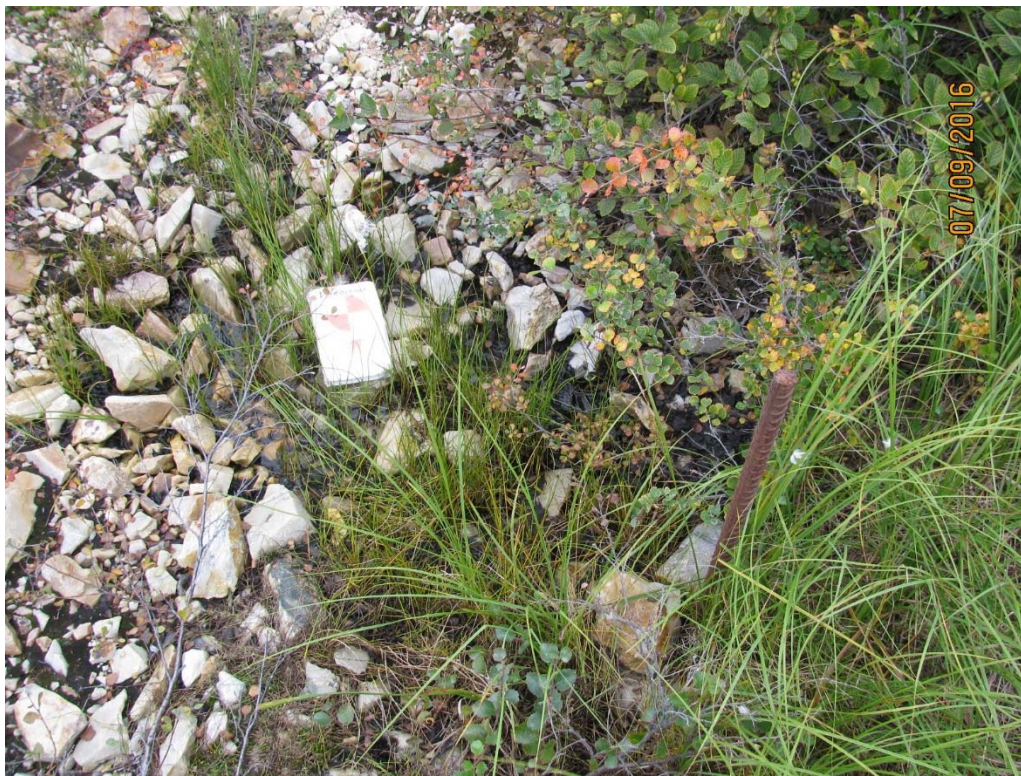
No seepages were observed on the day of inspection. However, a wet spot, first noted in the 2010 report, was observed about halfway down the downstream slope of the dam (see Photo 5), south of the spillway, at the approximate location shown on Figure 1 in Appendix A. As recommended in a previous report, the location had been marked with a length of rebar. While there was some minor wetness, no accumulated water or flow was visible. There was no evidence of any dam internal soil erosion. This should continue to be monitored during the scheduled inspections.

Photo 5: Wet spot on downstream side of Dam No. 1- minor seepage/ponding

It is recommended that the condition of the Dam No. 1 spillway channel continue to be monitored for erosion and if any is apparent, remedial measures, such as the addition of additional rockfill, be implemented. In addition, the wet spot noted on the downstream side of Dam No. 1, south of the spillway, should be monitored during each subsequent visit.

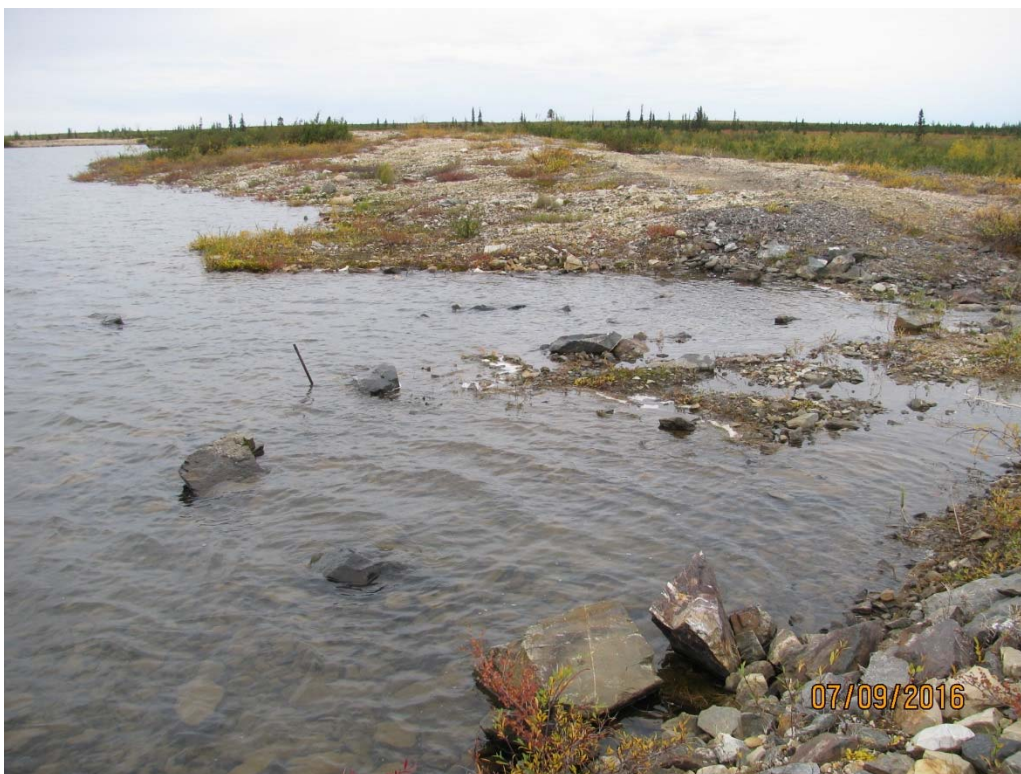
Photos 6 and 7 show views of the Dam No. 1 spillway channel. Only a minor flow was occurring at the spillway as had been observed in most previous years. A minor trickle was observed to flow through the rockfill comprising the channel bottom, about the same as in previous years. The pond level was noted to be about three to four centimetres higher than in 2015. Based on all of the previous inspections, the pond level varies only a few centimetres, from year to year.

Our visual inspection of the spillway channel, where additional fine rockfill was placed in 2005 to cover small areas of previously exposed rubber liner, indicates that no erosion has occurred. It is expected that monitoring of this area during future inspections will indicate that the treatment performed in 2005 is sufficient.

Photo 6: Dam No. 1 Spillway inlet and crest

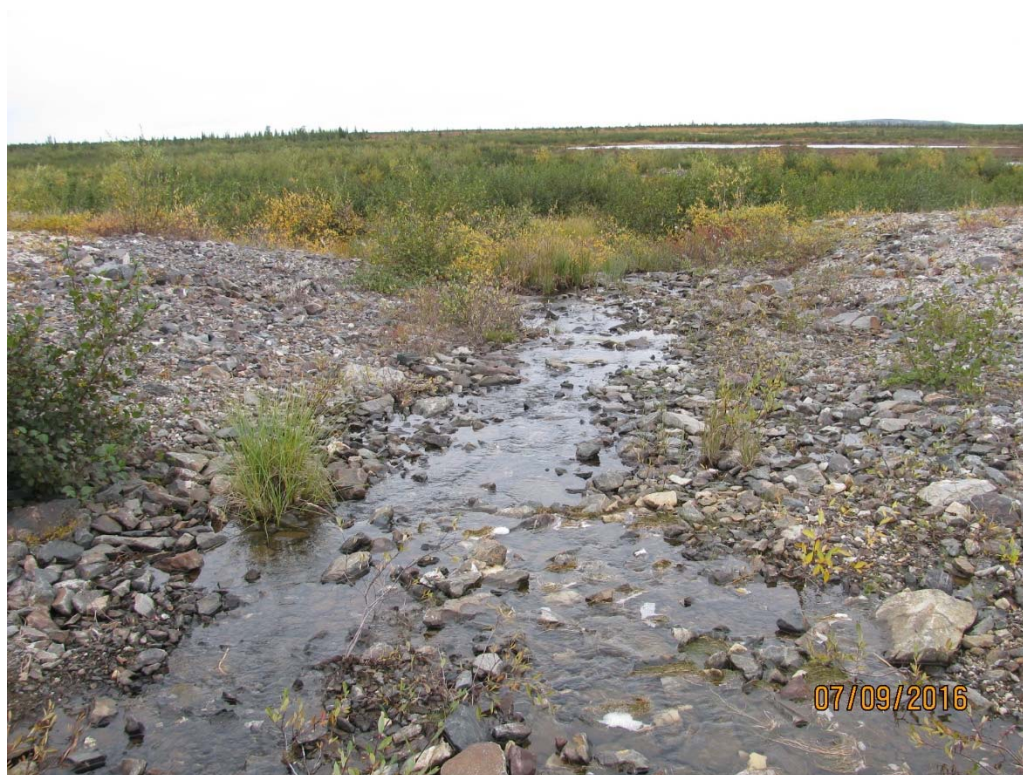
Photo 7: Dam No. 1 Spillway downslope channel

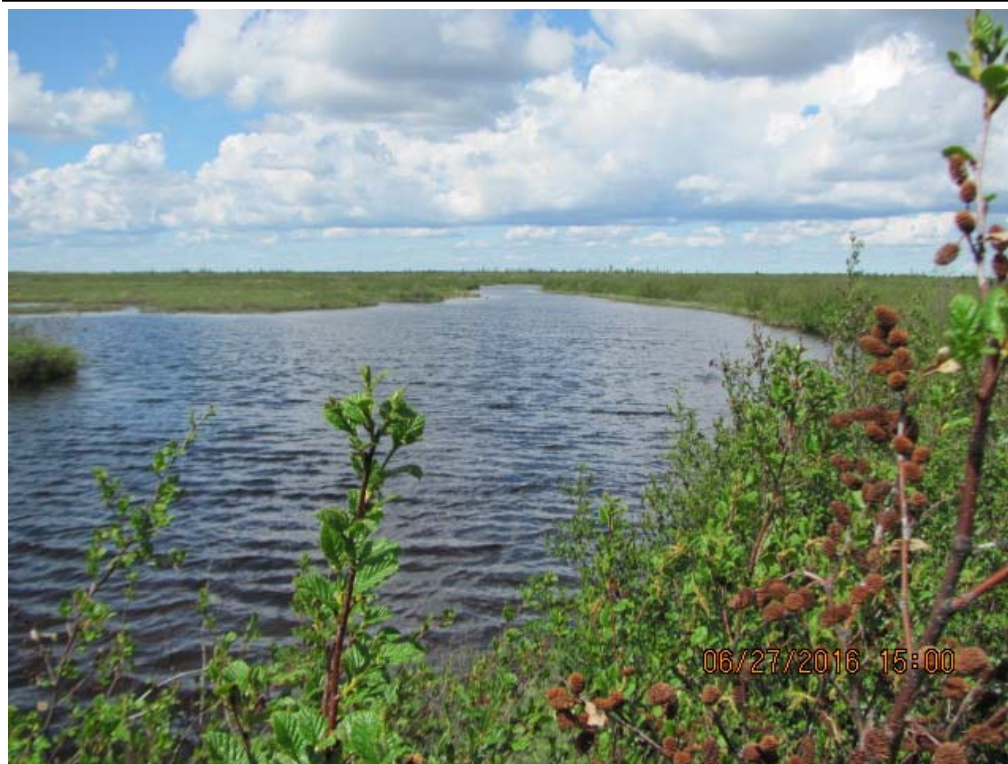
Photo 8 shows a view of a portion of Dam No. 2, taken in the early summer 2016. As with Dam No. 1, the principal construction material is local cohesionless till. The dam section and surface grade is irregular, although less so than Dam No. 1. The crest width varies but is in the order of 15 m.

Based on our observations as well as previous inspections, the dam is not in any distress and is considered to be stable.

Photo 8: View of Dam No. 2 (on the right) and Pond No. 2.

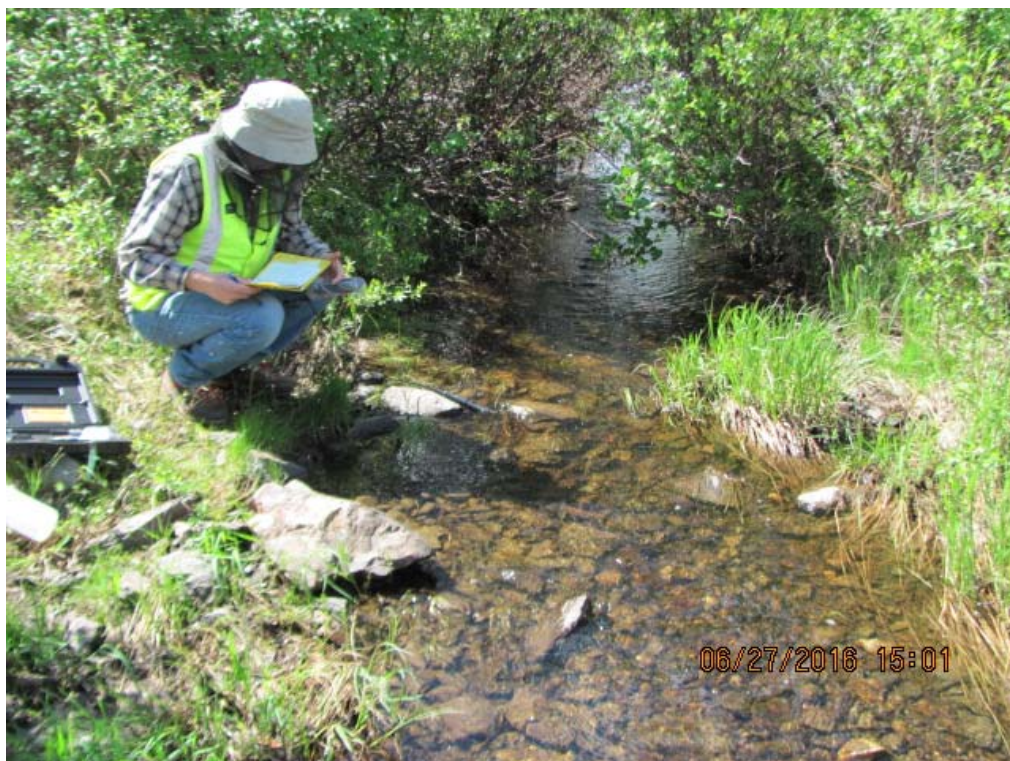
Photo 9 is an upstream view of the Dam No. 2 spillway channel, also taken in summer 2016. There was a small amount of flow observed over the rockfill channel, due to the slightly higher water level of Pond 2, compared to 2015.

Photo 9: Dam No. 2 Spillway Channel with flow looking upstream to Pond 2

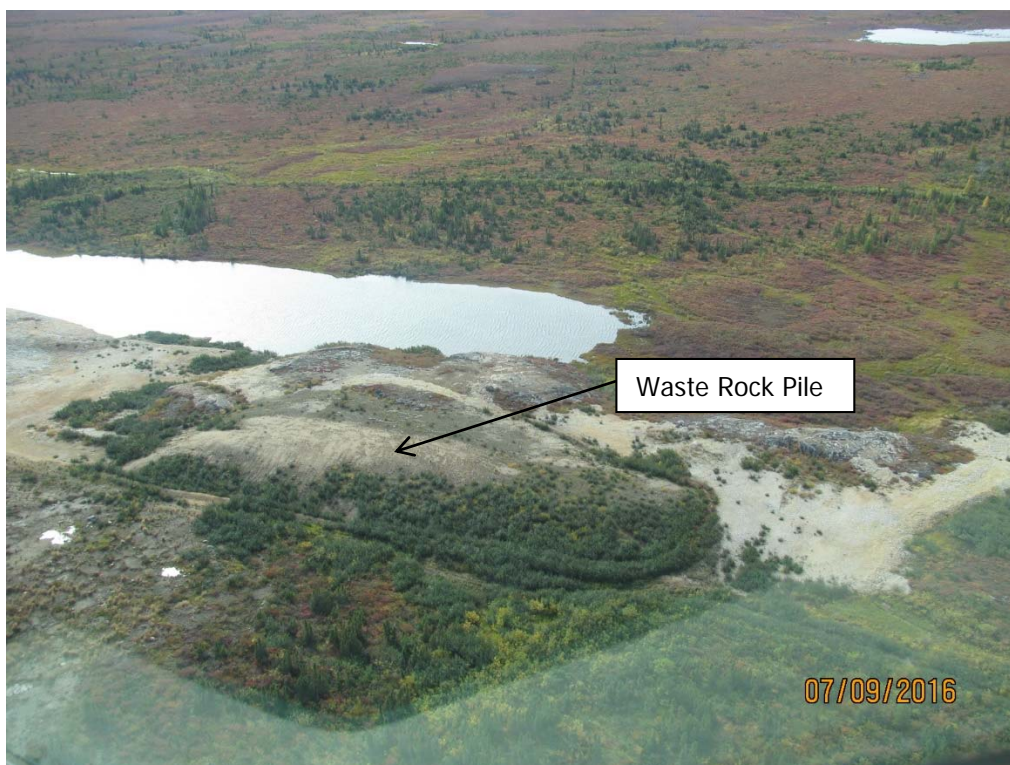
Photos 10 (2014) to 12, inclusive, show views of the Shear Lake Waste Rock Pile. The Shear Lake Waste Rock Pile, located on the east side of Shear Lake, some 4.5 km north of the former mill site, was reportedly capped with local, compacted glacial till to promote runoff and reduce infiltration. In 2005, Barrick personnel oversaw the re-seeding of the cap. The re-seeding (with grasses) was implemented to promote some vegetation growth which would reduce the erosion of the cover due to runoff, particularly along the side slopes.

Our observations suggest that, while there are some sparse areas, particularly on the top, the vegetation is helping to reduce erosion, in that very few small erosion gulleys/channels (20 to 30 mm deep/wide) were noted on the side slopes. These generally are short and do not extend the full length of the slope. Most of these had been filled to some extent with small granular material in 2005, to minimize further erosion. Our current observations are similar to the previous years. A comparison of the photos from previous years shows that the vegetation is improving, especially on the majority of the side slopes.

Photo 10: Aerial view of Shear Lake Waste Rock Pile looking west

Subsequent inspections should be made to verify the efficacy of the vegetation/till cover system. Any erosion gullies that form should be repaired with fine rock/gravel. It is expected that it will take several more years for the vegetation to establish itself fully.

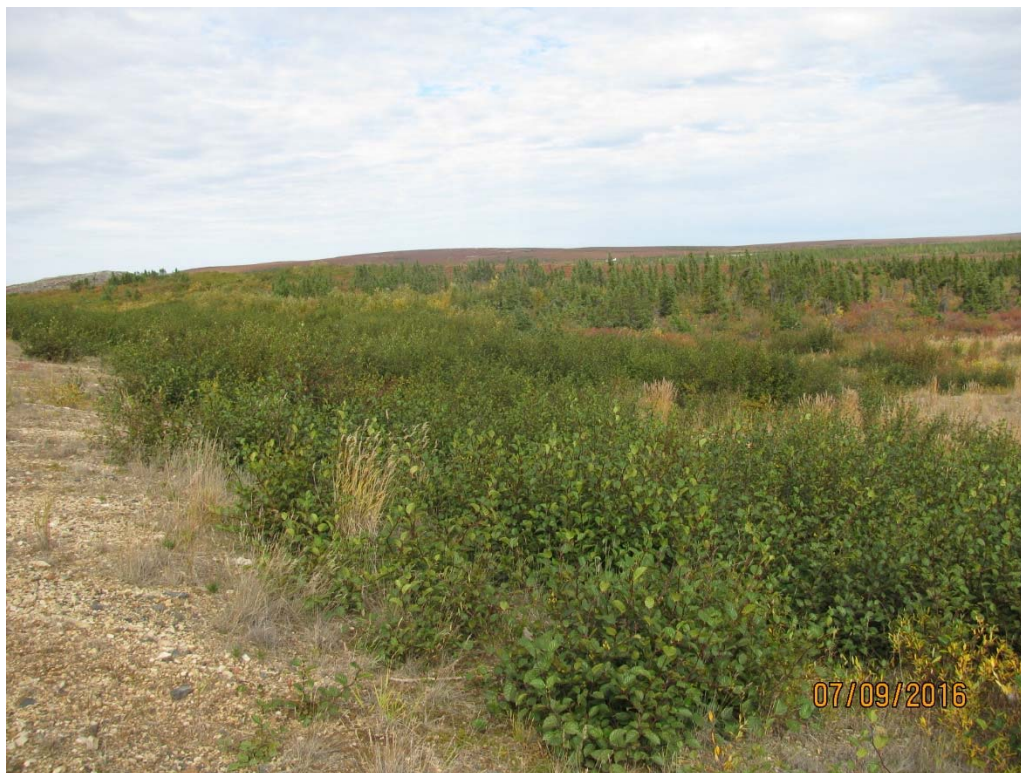
Photo 11: East side of Shear Lake Waste Rock Pile showing grasses near toe

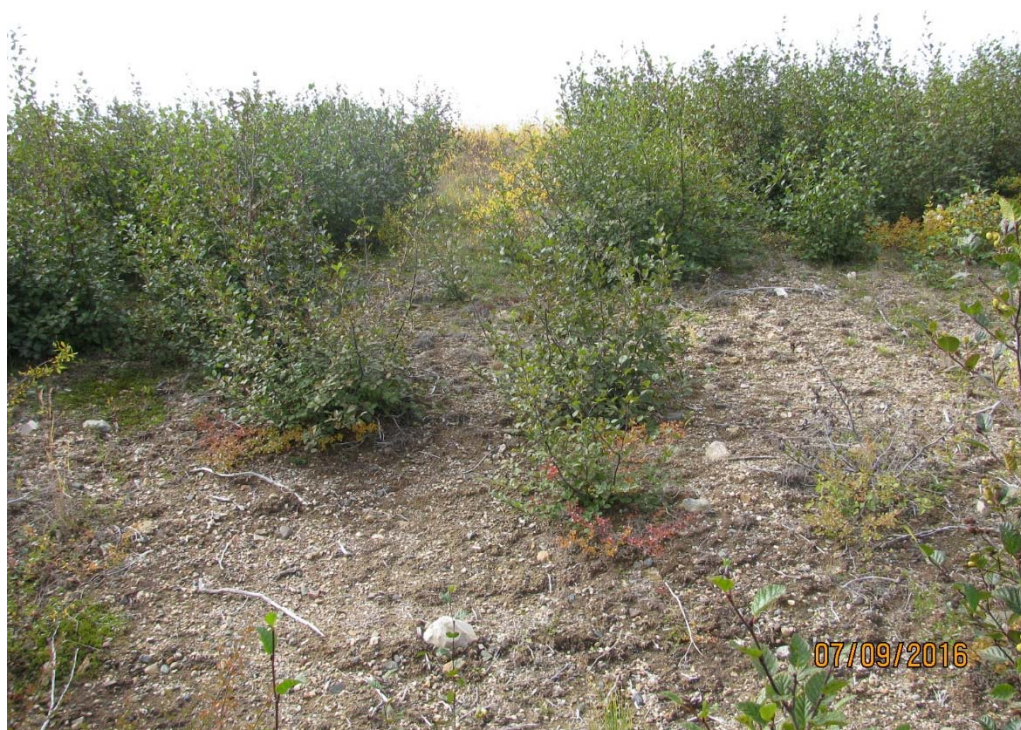
Photo 12: Stable gravel/till covered slope on Shear Lake Waste Rock Pile
