Pursuant to Part D, Article 8(d) and (e) of Water Licence 1BR-CUL1118, please find appended 2 paper copies of a report by **exp** Services Inc. entitled "2017 Tailings Facility Examination, Cullaton Lake Gold Mine". A third electronic copy has been e-mailed to you concurrent with this release.

Re: **Project No. THB-00090132-GG**
2017 Tailings Facility Examination
Cullaton Lake Gold Mine, Nunavut
Licence 1BR-CUL1118

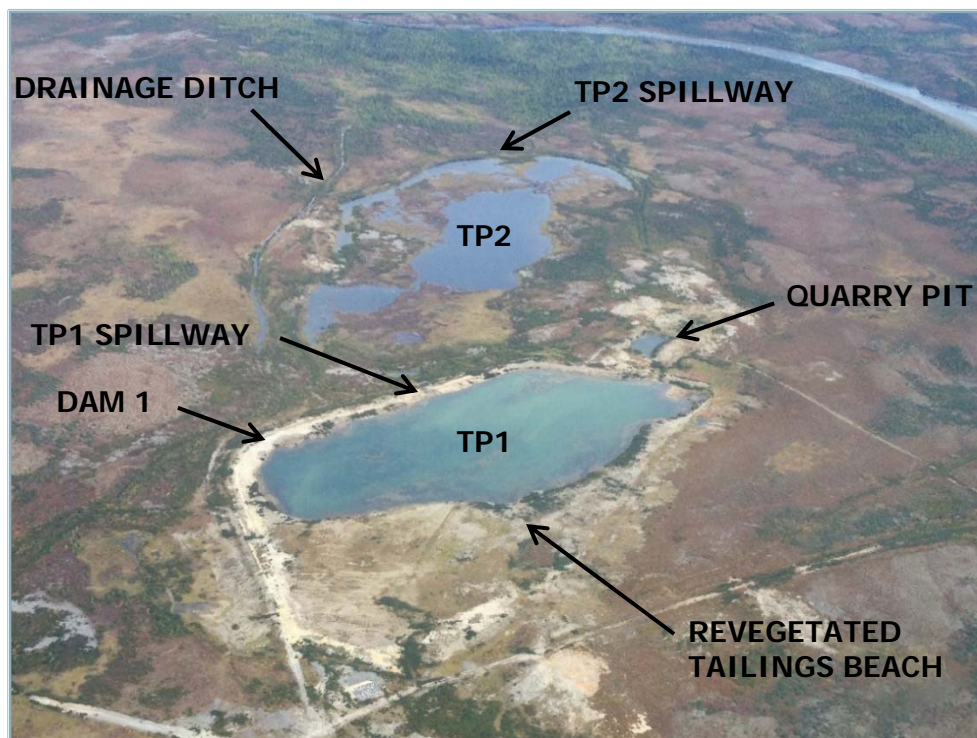
Photo 1: Aerial view of TP1 and TP2 (looking east).

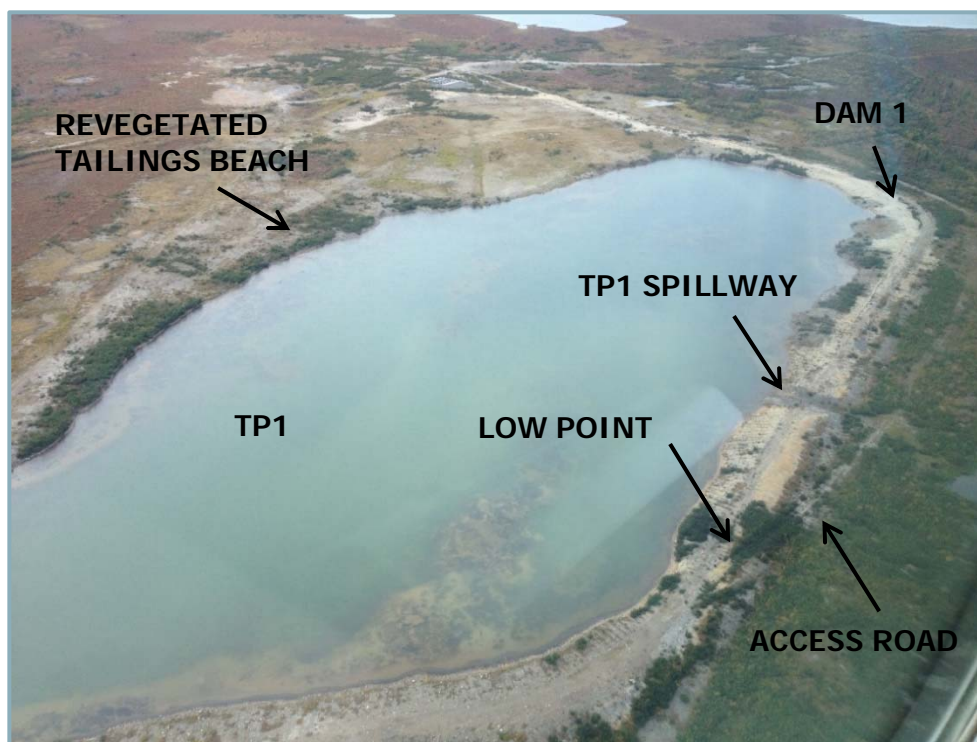
Vegetation on the till covered tailings is small and sparse. However, it is noted that the density of the vegetation is increasing gradually, based on the comparative visual observations of previous years (Photo 2).

Photo 2: Aerial view of TP1 (looking northwest).

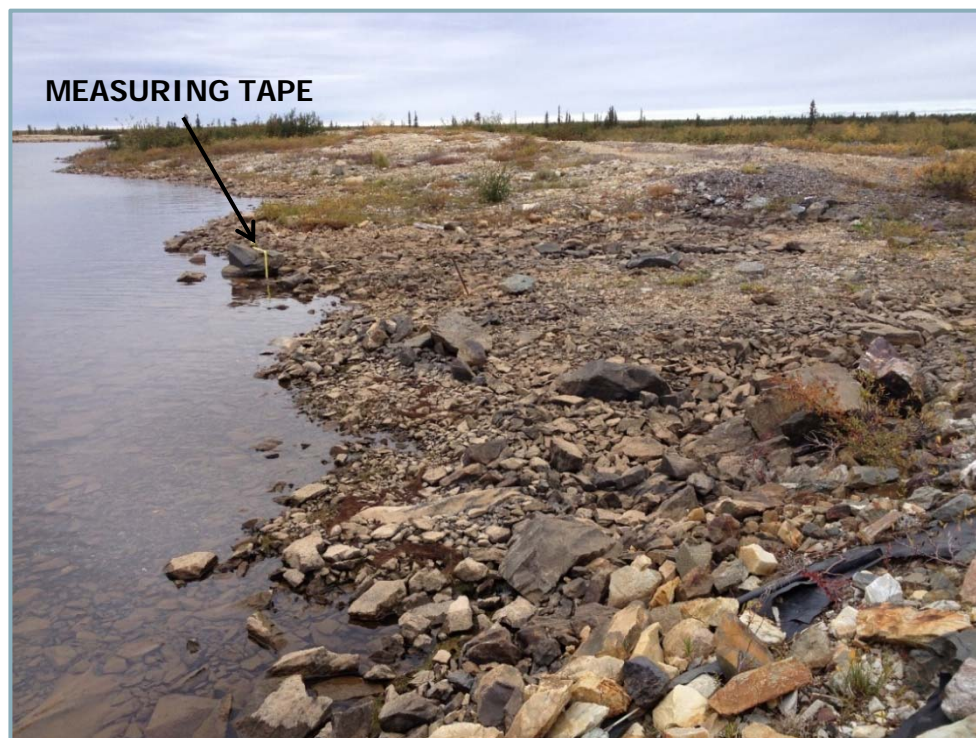
The water level in TP1 was significantly lower compared to previous years. Comparison of photographs from present and past inspections suggests that the water level this year was about 0.4 m lower than last year at the same time. The spillway appeared dry. No water was observed in the rockfill comprising the spillway channel bottom (Photos 3 and 4). A piece of rock visible in Photo 3 exposed at the water's edge and marked with a measuring tape (on the left in the photo) was almost submerged in 2016.

Photo 3: No water visible in the TP1 spillway (looking north across the spillway).

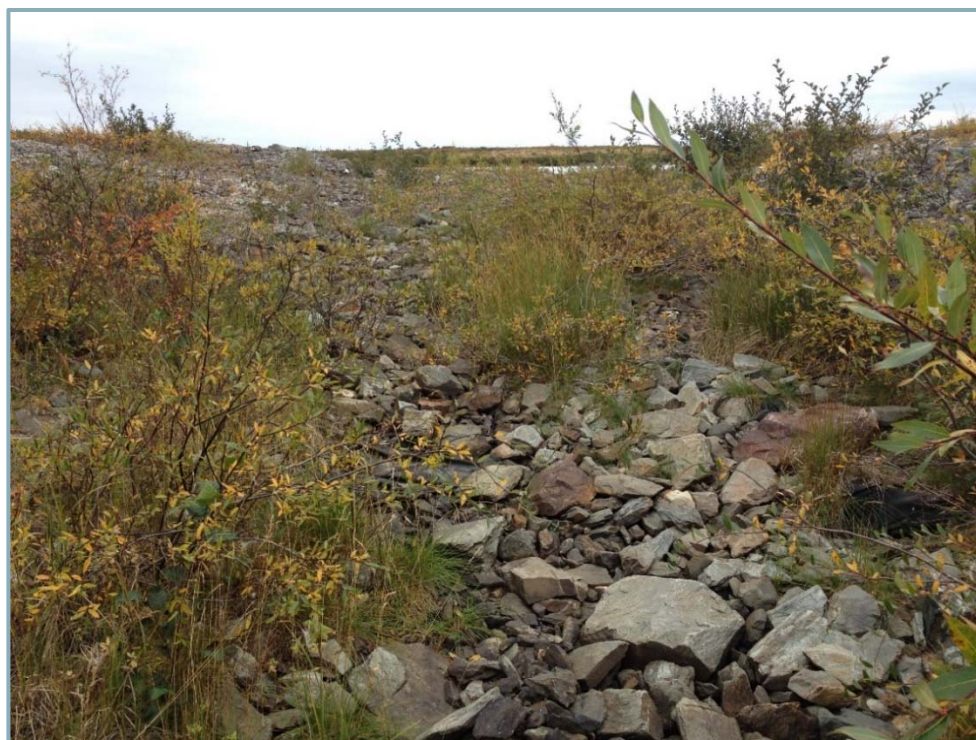
Photo 4: No water visible in TP1 spillway (looking up-spillway towards the pond).

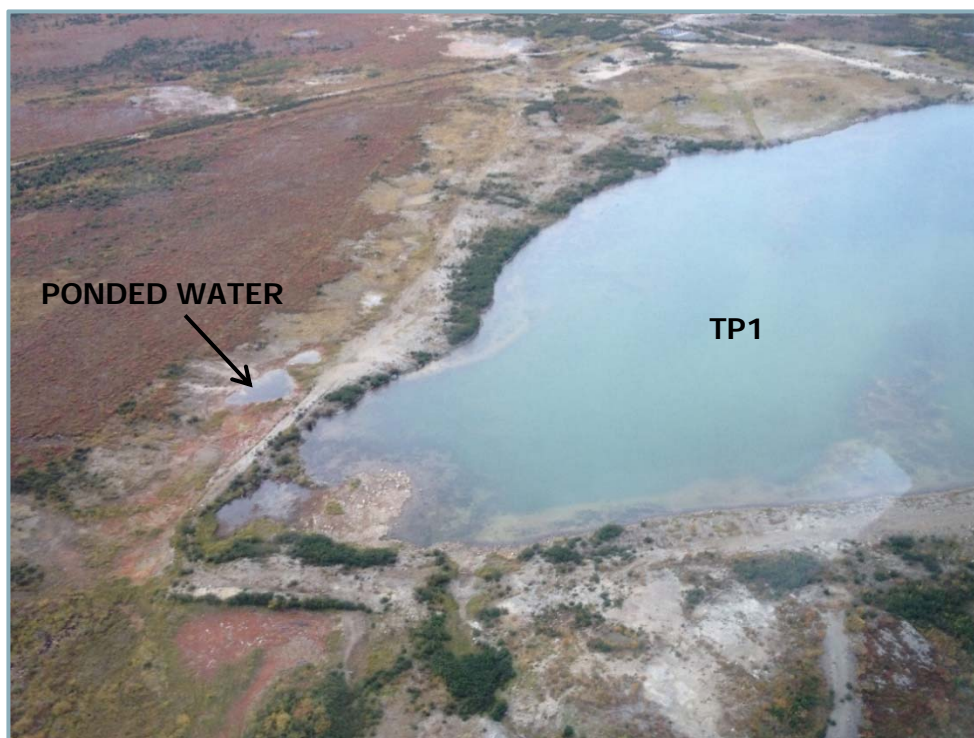
Minor ponding was observed west of the TP1 pond (Photo 5) consistent with observations from previous years.

Photo 5: Minor ponding and small areas of exposed tailings in TP1 (looking west).

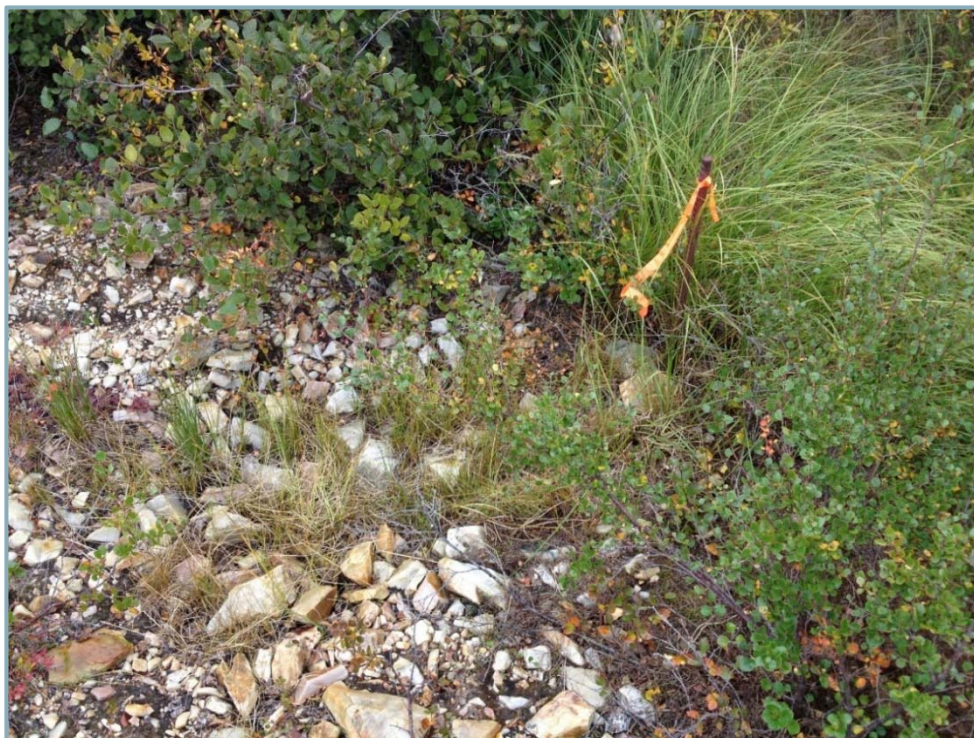
The “wet spot” exhibited no wetness in 2017 (Photo 6). The “wet spot” was first noted during 2010 inspection because it contained some visible moisture. The spot is located south of the spillway halfway down the downstream face of Dam 1 (Drawing No. 1 in Appendix A). This spot is visible from the dam crest and is currently marked with a piece of rebar and red flagging.

Photo 6: Dam 1 “wet spot” exhibiting no water in 2017.

- the condition of the TP1 spillway continues to be monitored for erosion and if any is apparent, remedial measures, such as the addition of additional rockfill, be implemented;
- the “wet spot” exhibiting no water in 2017 located south of the TP1 spillway is monitored during each subsequent visit;
- the cracking noted in 2017 is monitored during each subsequent visit; and,
- the frequency of the formal geotechnical inspections be reduced to once every three years. While the inspections have been largely qualitative, there has been no visible evidence of deterioration of the dam or spillway structures over the last several years. Routine inspections should be provided by Barrick personnel during their annual site visits to collect water samples.

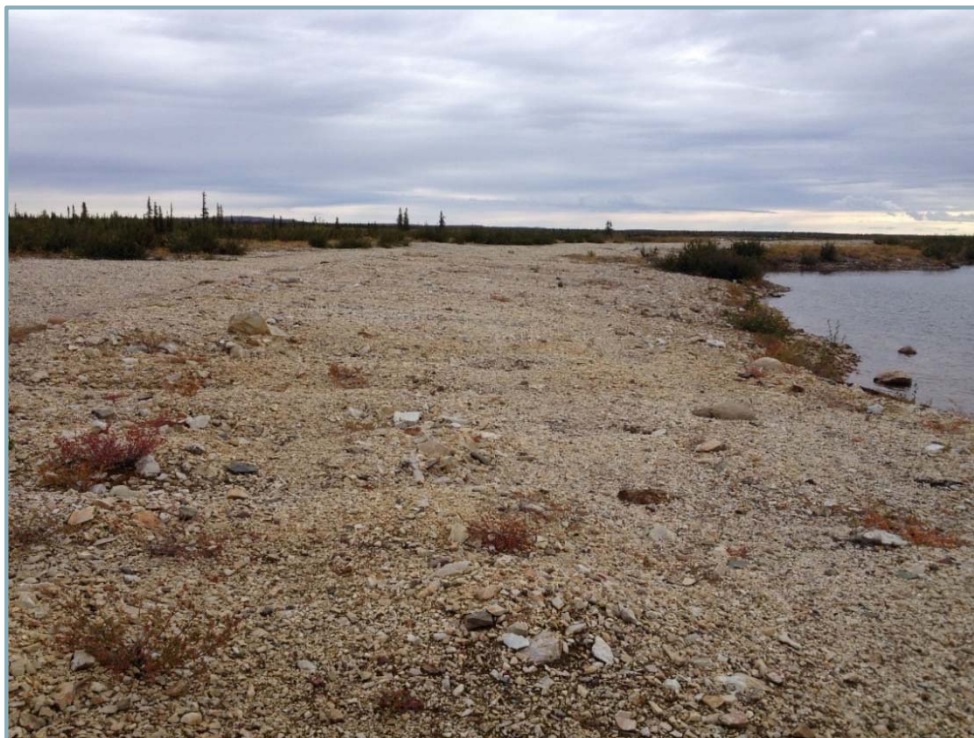
Some small erosion scars were observed on both the upstream and downstream sides; however, as described below, they appear to continue to stabilize with vegetation and self-armouring with larger rock particles from the till and previously placed mine waste rock. These scars do not appear to be increasing in size, based on visual comparisons of previous years.

Photo 7: Dam 1 upstream face and crest north of TP1 spillway (looking southeast).

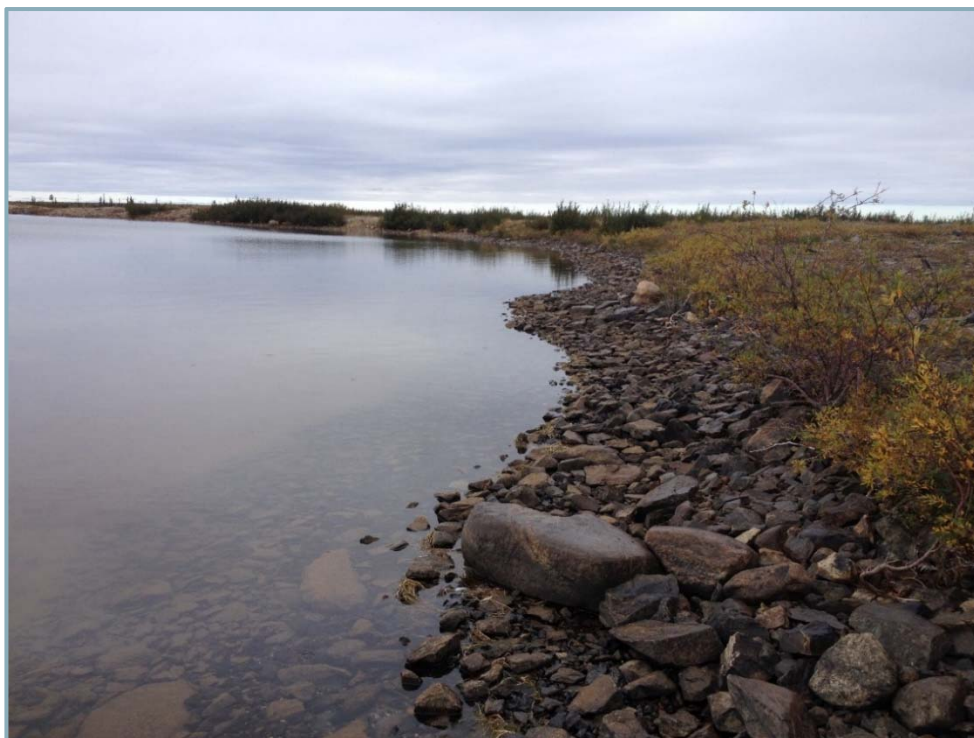
Photo 8: Dam 1 upstream face south of TP1 spillway (looking north).

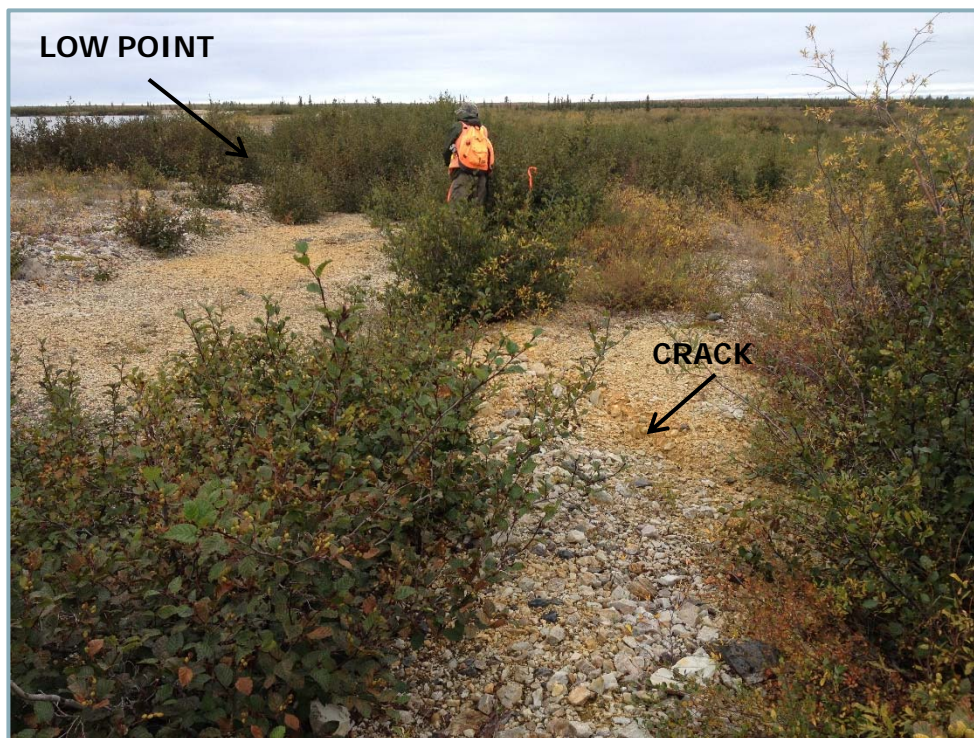
Localized longitudinal cracking was observed (Drawing No. 1 in Appendix A) where the access road adjoins the crest south of the spillway (Photos 9 and 10) and some localized surface cracking was noted on the crest north of the spillway (Photo 11). This cracking does not have an impact on Dam 1 performance. The cracking should be monitored during subsequent inspections. Photo 9 shows red flagging marking the location of the crack.

Photo 9: Cracking where access road adjoins Dam 1 crest (looking north).

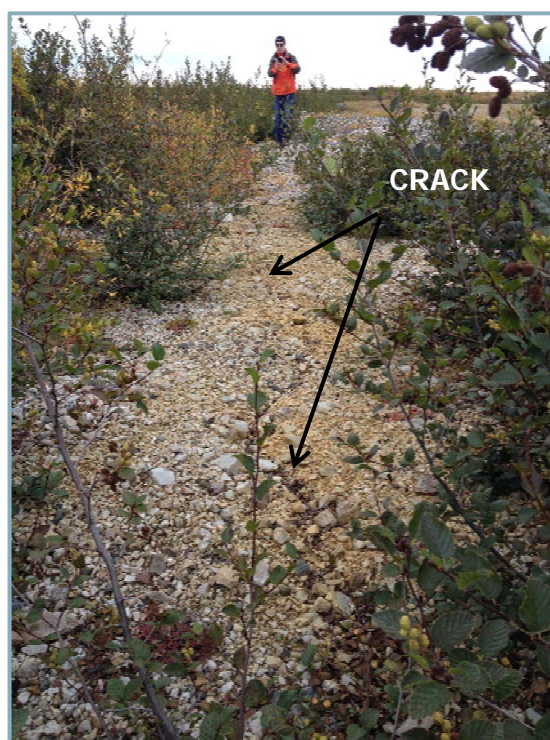
Photo 10: Cracking where access road adjoins Dam 1 crest (looking south).

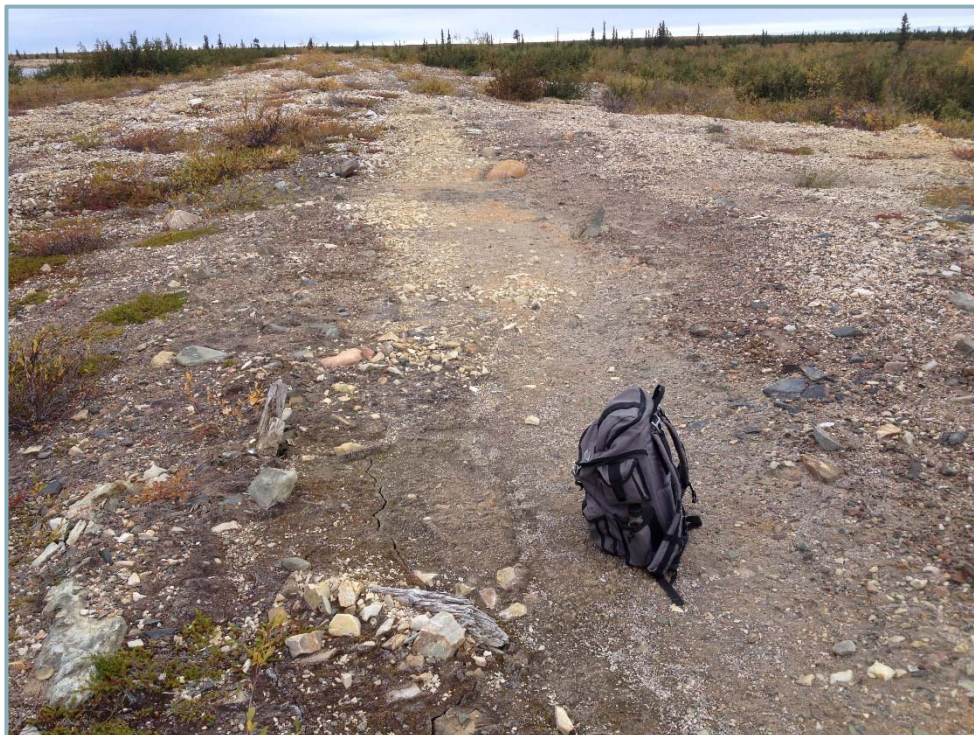
Photo 11: Localized surface cracking north of TP1 spillway (looking north).

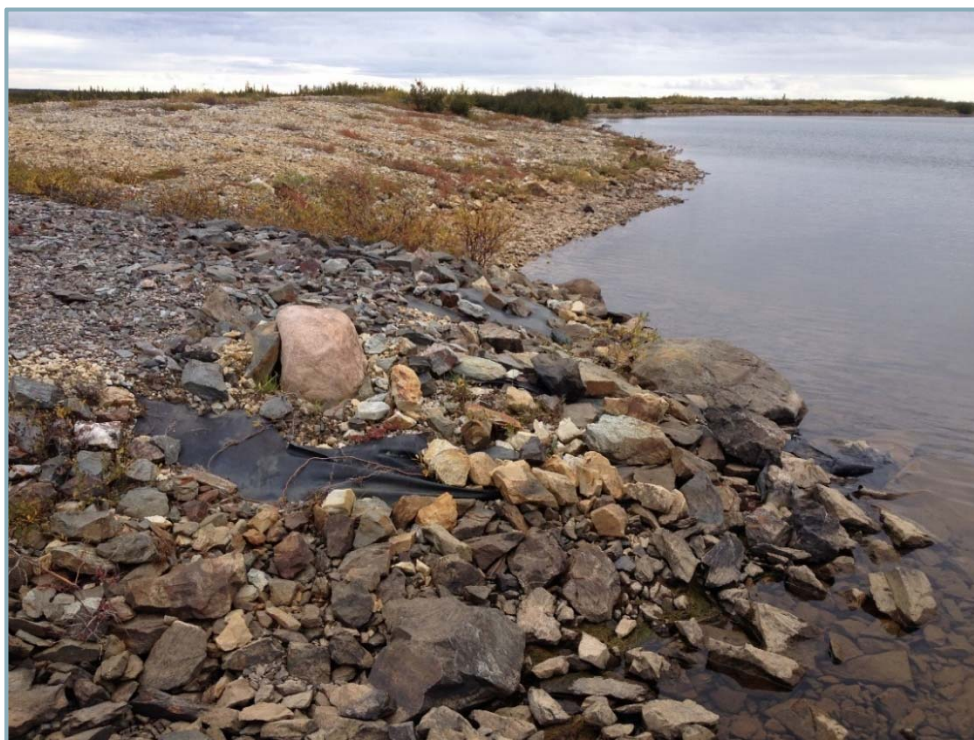
The TP1 spillway was visually inspected. The inspection indicated that the rockfill covering the liner in the spillway serves its purpose thus confirming that addition of fine rockfill in 2005 was a sufficient treatment. Small erosion of the rockfill was noted on the south bank of the spillway (Photos 3 and 12). Small areas of the liner became exposed in this area most likely due to a steeper grade. The rockfill in the spillway should be monitored for erosion and rockfill replaced if the exposed areas become larger.

Photo 12: Liner exposed at the south edge of TP1 spillway (looking south).

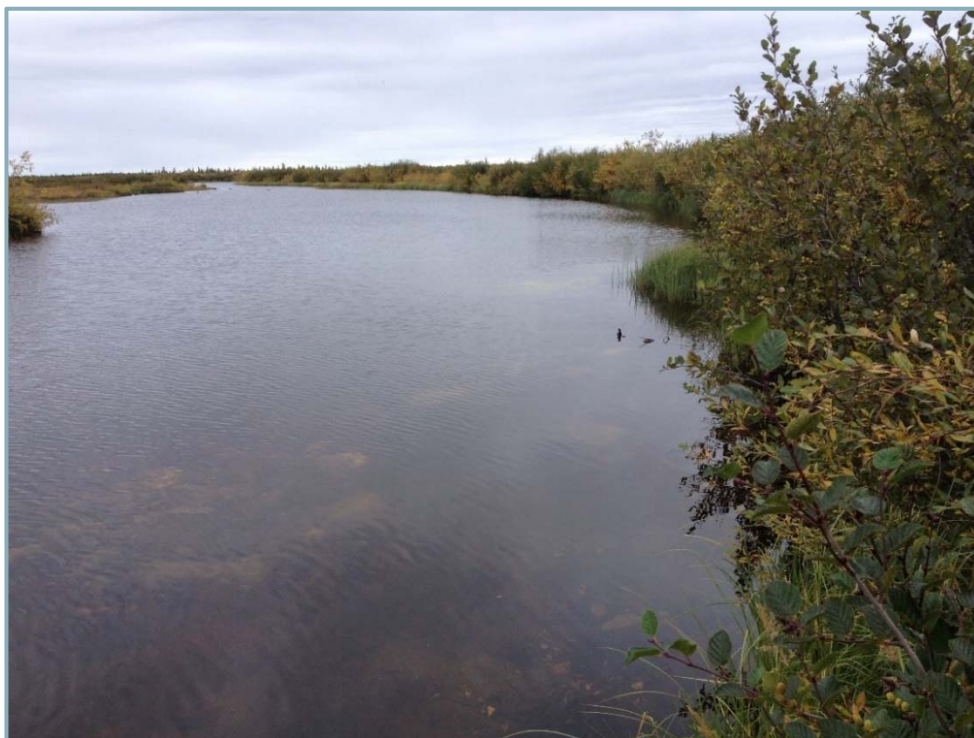
The TP2 spillway was observed. Dam 2 was observed from the TP2 spillway location (Photo 13). As with Dam 1, the principal construction material is local cohesionless till. Dam 2 section and surface grade is irregular, although less so than Dam 1. The crest width varies but is in the order of 15 m.

Photo 13: Dam 2 (on the right) seen from TP2 spillway (looking northwest).

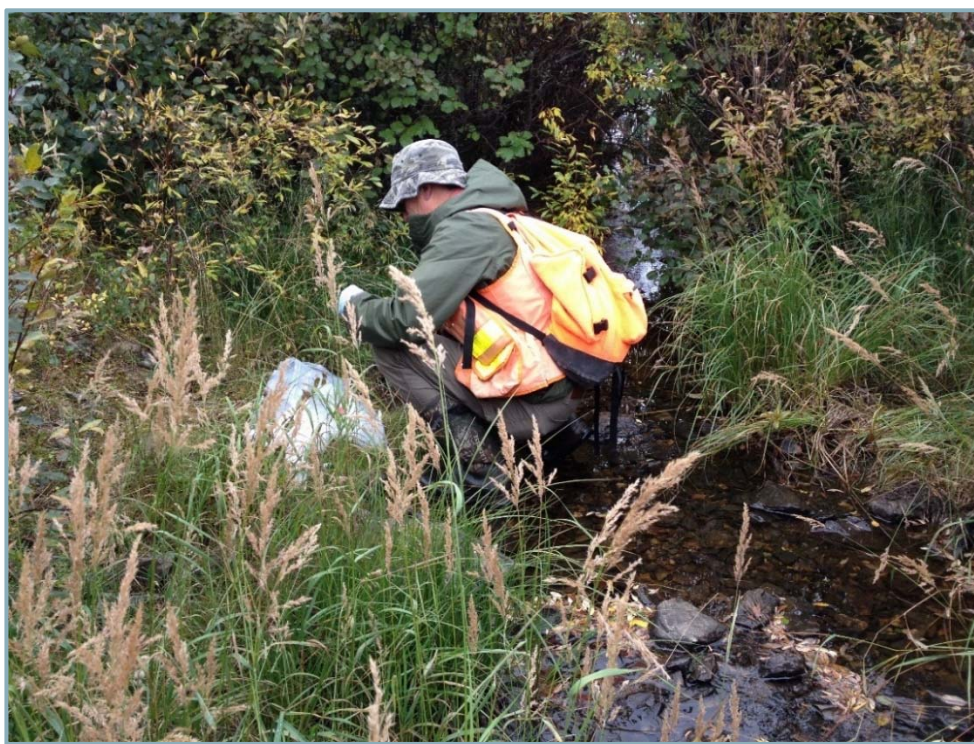
Photo 14: TP2 spillway with flow looking upstream to TP2 pond.

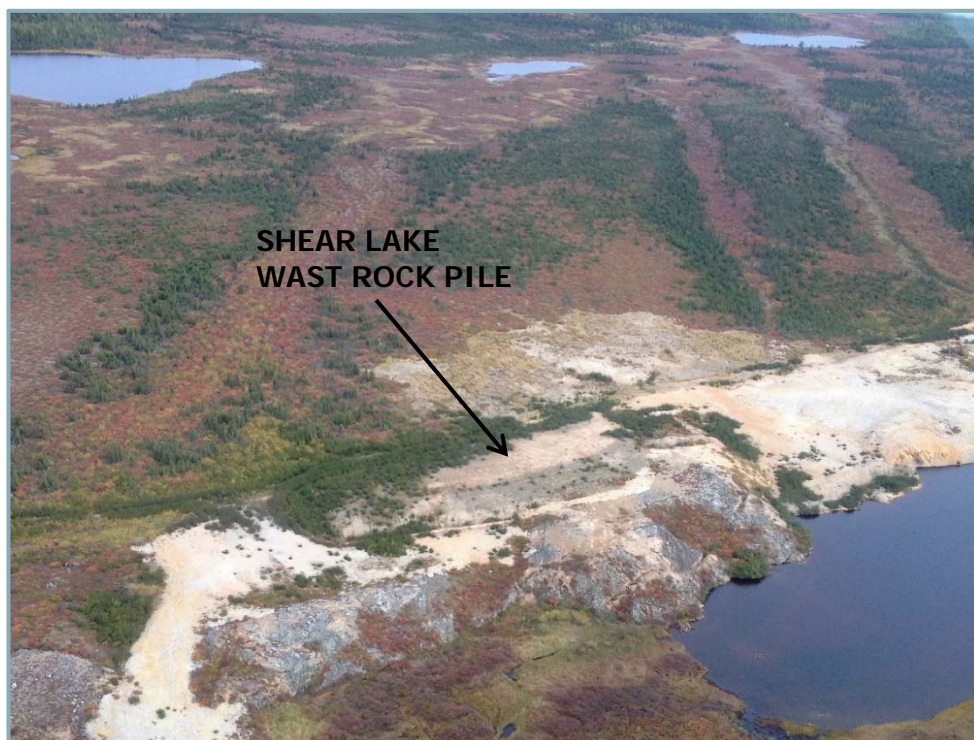
Photo 15 shows an aerial view of the Shear Lake Waste Rock Pile. The Shear Lake Waste Rock Pile, located on the east side of Shear Lake, some 4.5 km north of the former mill site (at the TP1), was reportedly capped with local, compacted glacial till to promote runoff and reduce infiltration. The re-seeding (with grasses) was implemented to promote some vegetation growth which would reduce the erosion of the cover due to runoff, particularly along the side slopes. In 2005, Barrick personnel oversaw the re-seeding of the cap. Some erosion control on the till cap was performed in 2005. A berm approximately 0.5 m high is surrounding the pile near the bottom (Photo 16) reaching to the pile top on the south and west sides.

Photo 15: Aerial view of Shear Lake Waste Rock Pile (looking southeast).

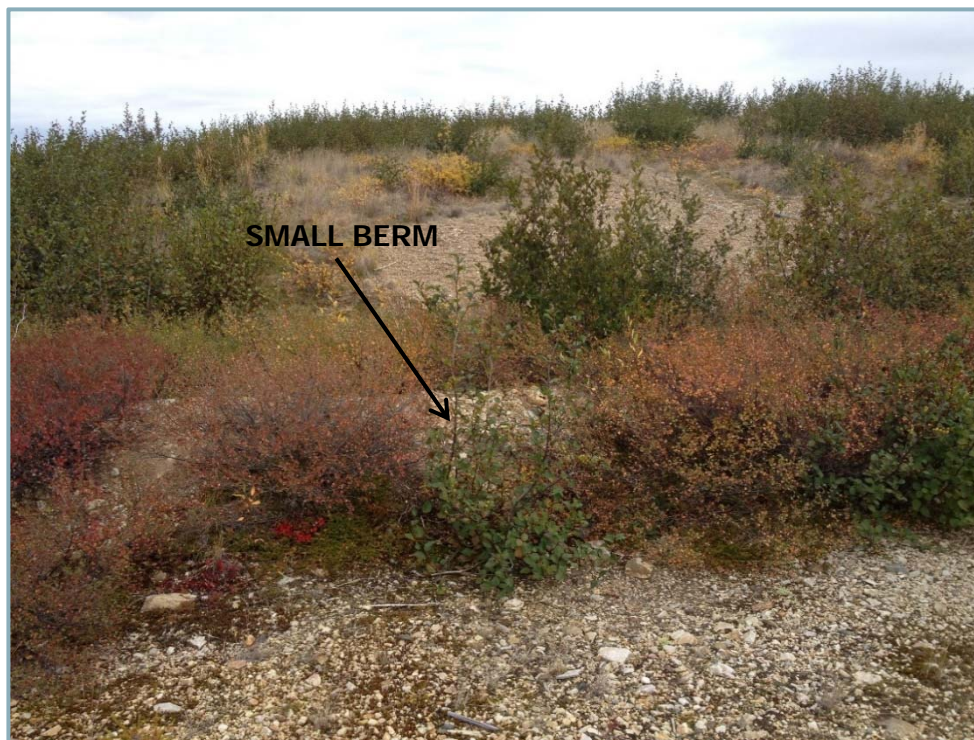
Photo 16: North side of Shear Lake Waste Rock Pile with berm and grasses (looking south).

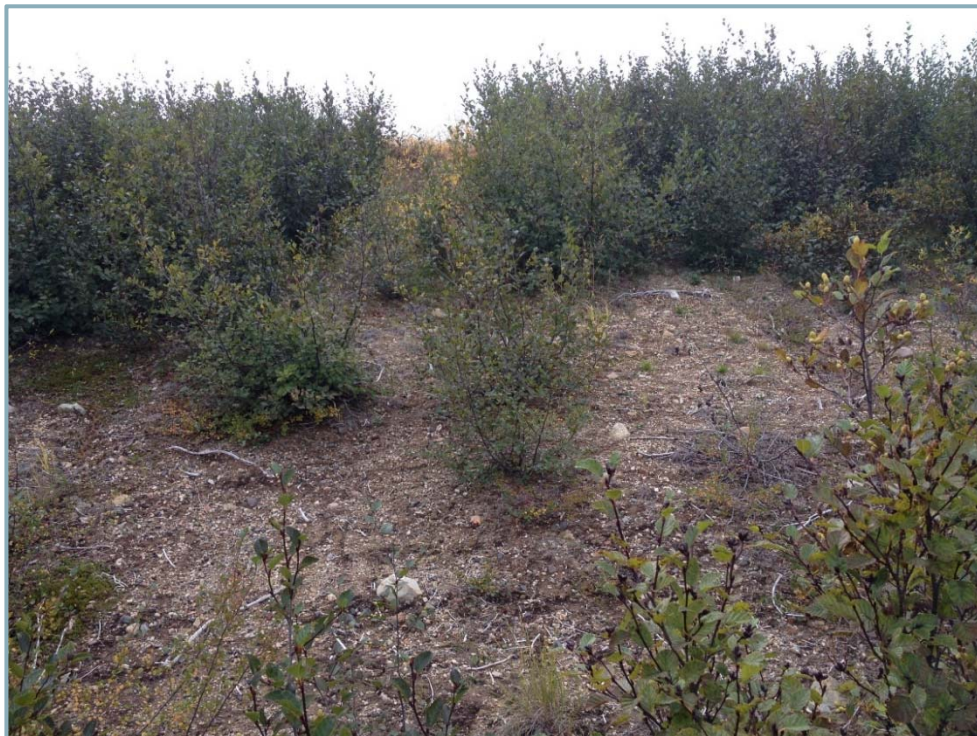
Our observations were similar to previous years and suggest that the vegetation is helping to reduce erosion. Consistent with previous inspection findings, very few small erosion gulleys/channels (20 to 30 mm deep/wide) were noted on the side slopes. These generally are short and do not extend the full length of the slope. Most of these had been filled to some extent with small granular material in 2005, to minimize further erosion.

Photo 17: Stable gravel/till covered east slope of Shear Lake Waste Rock Pile (looking west).

Subsequent inspections should be made to verify the efficacy of the vegetation/till cover system. Any erosion gullies that form should be repaired with fine rock/gravel. It is expected that it will take several more years for the vegetation to establish itself fully.

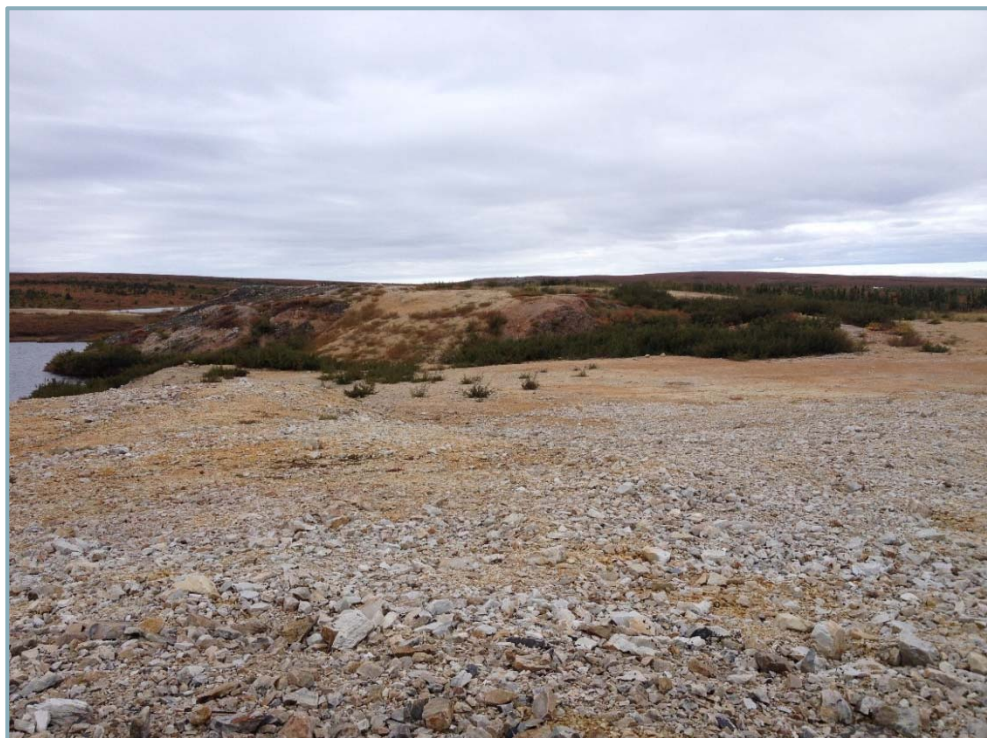
Photo 18: South side of Shear Lake Waste Rock Pile showing grasses (looking north).
