September 25, 2018

Re: **Project No. THB-00090132-HG**  
**2018 Tailings Facility Examination**  
**Cullaton Lake Gold Mine, Nunavut**  
**Licence 1BR-CUL1118**

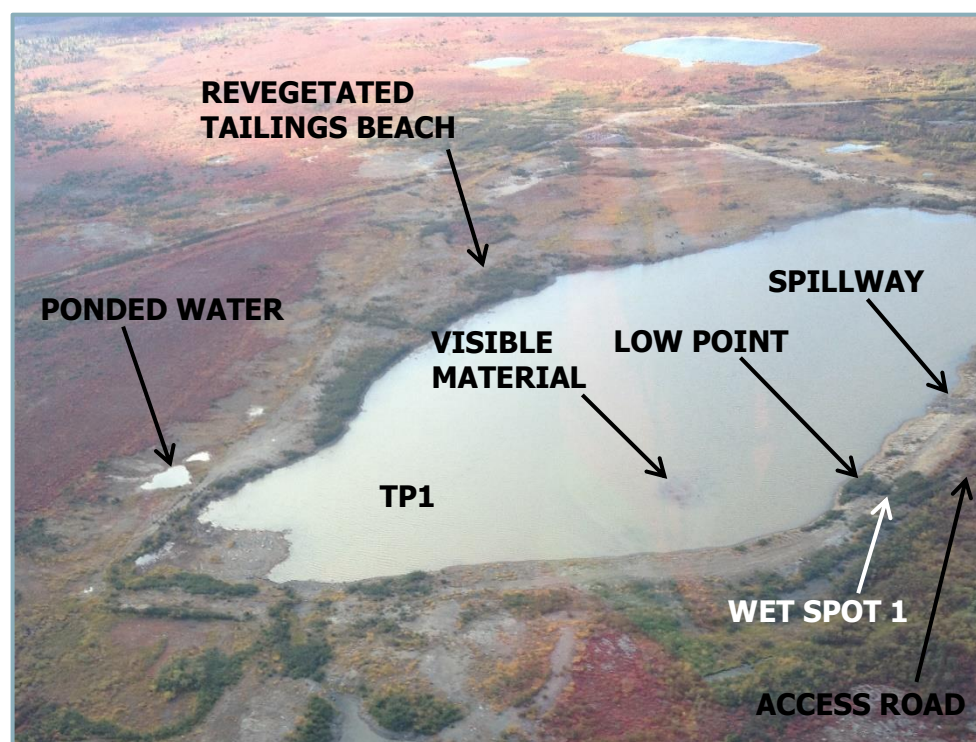
Minor ponding west of the TP1 pond shown in Photo 2 was observed consistent with observations from previous years.

Two wet spots that were wet were observed in 2018. Wet Spot 1 was observed in the area of the low point, about 20 m north of the low point and 15 m downstream of the dam toe. Wet Spot 2 was observed on the north side of the dam near the water sampling point 940-22, about 15 m downstream of the dam toe. Wet Spot 1 had a trace of standing water near a rock surface that appeared to be bedrock, as shown in Photo 7. Wet Spot 2 had a trace of standing water by a cluster of boulders, as shown in Photo 8. The elevation of both spots appeared to be below the water level of the pond. The location of both spots is shown on the survey plan in Appendix A and in Photo 1 (Wet Spot 2) and Photo 2 (Wet Spot 1). The area of Wet Spot 1 is marked with pink flagging.

*Photo 2: Aerial view of TP1 (looking northwest).*

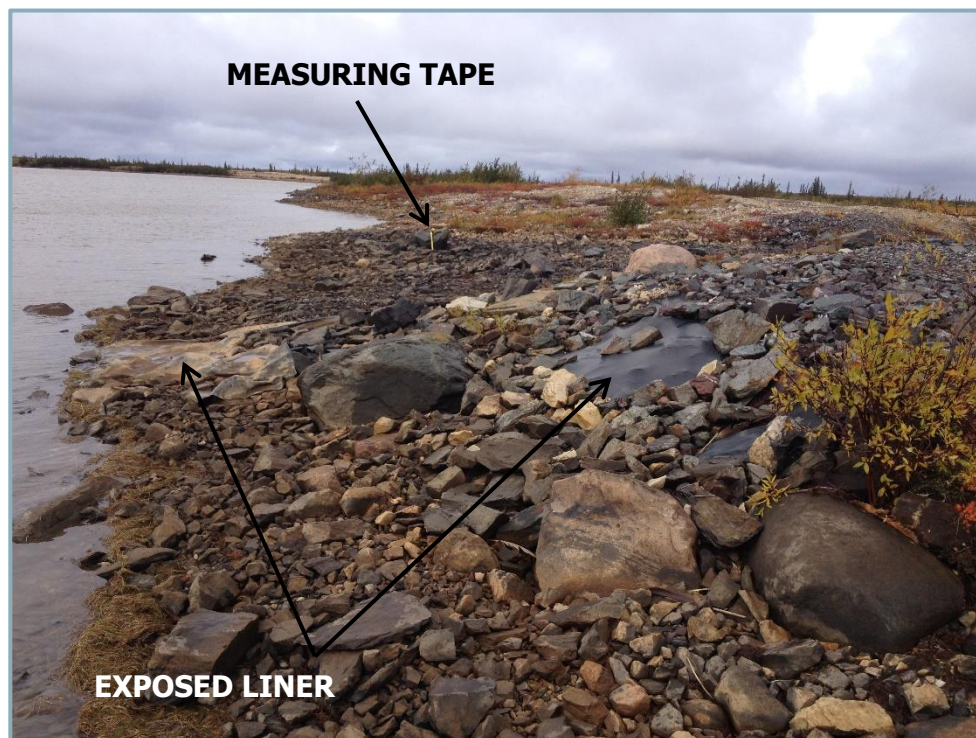
The water level in TP1 was lower than in 2017. This water level continues to be significantly lower compared to previous years. Comparison of photographs from present and past inspections suggests that the water level this year was about 0.3 m lower than last year at similar time. The spillway appeared dry. No water was observed in the rockfill comprising the spillway channel bottom, as shown in Photos 3 and 4. A piece of rock marked with a measuring tape visible in Photo 3 was at the water's edge in 2017.

*Photo 3: No water visible in the TP1 spillway (looking north across the spillway).*

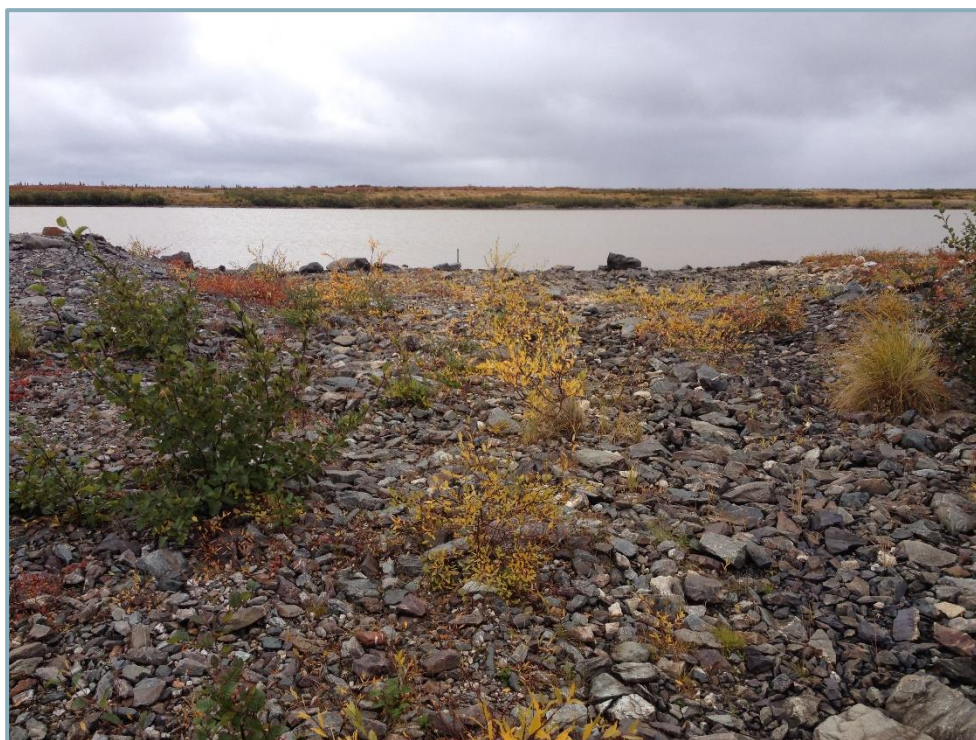
*Photo 4: No water visible in TP1 spillway (looking up-spillway towards the pond).*

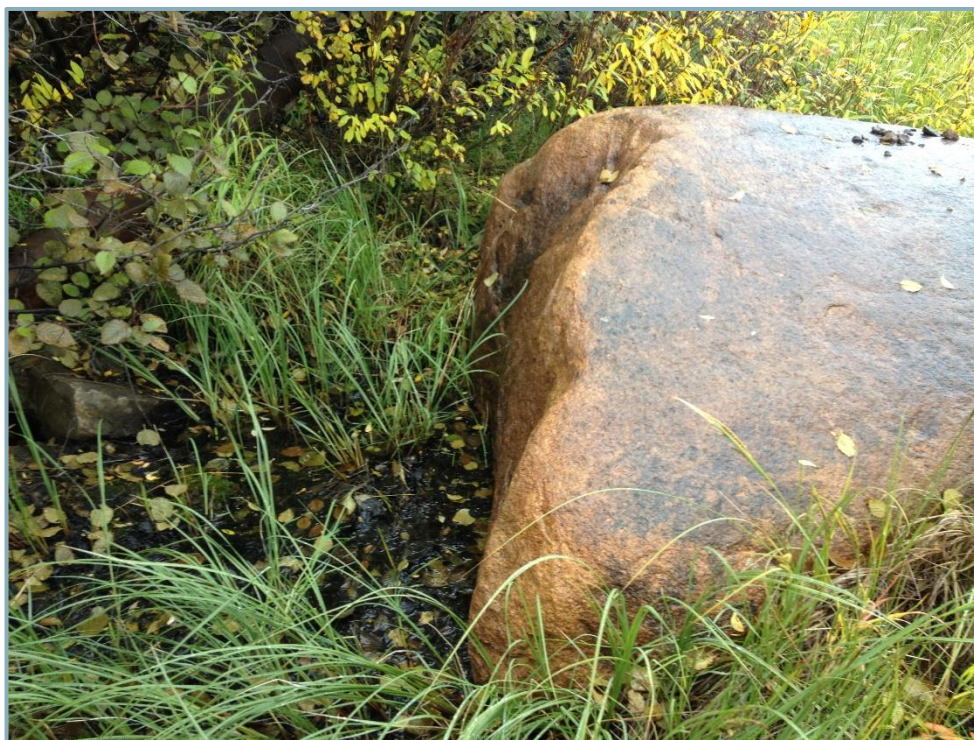
*Photo 6: Water level in the low area downstream of the TP1 spillway.*

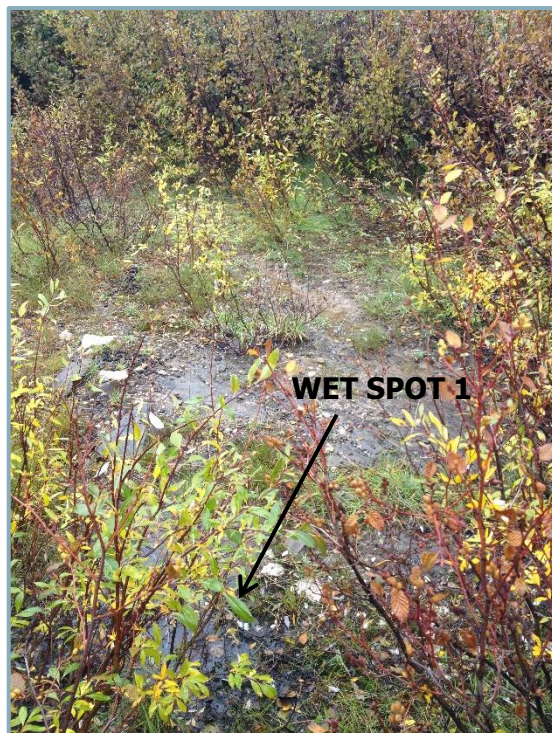
*Photo 7: Wet Spot 1 downstream of the low spot first identified in 2018.*

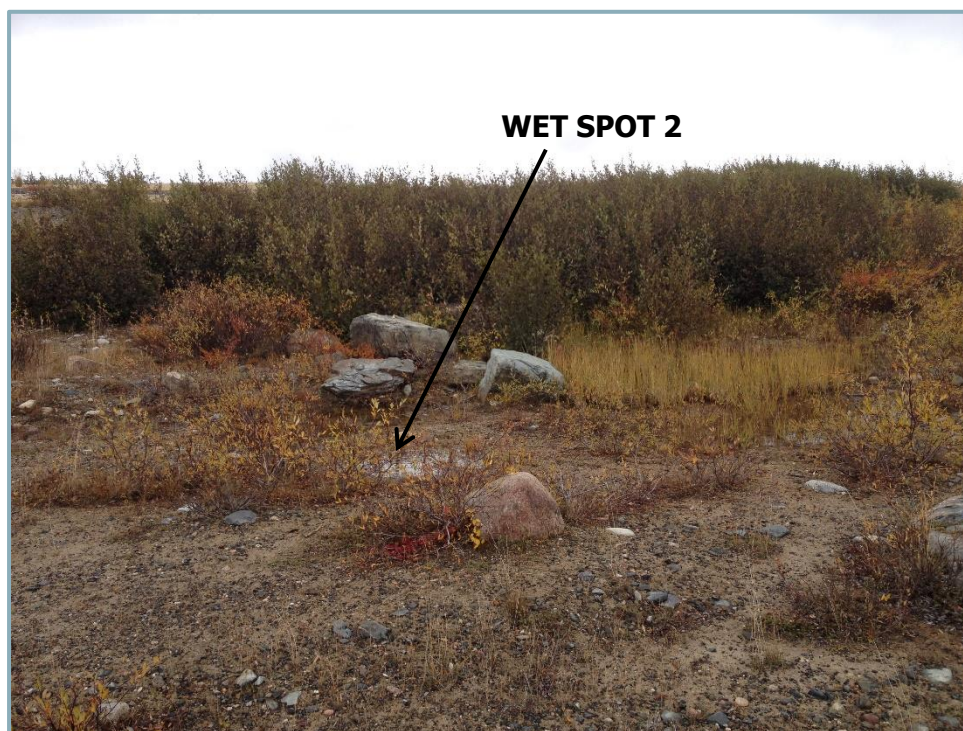
*Photo 8: Wet Spot 2 north of Dam 1 near the water sampling point 940-22 (looking southwest).*

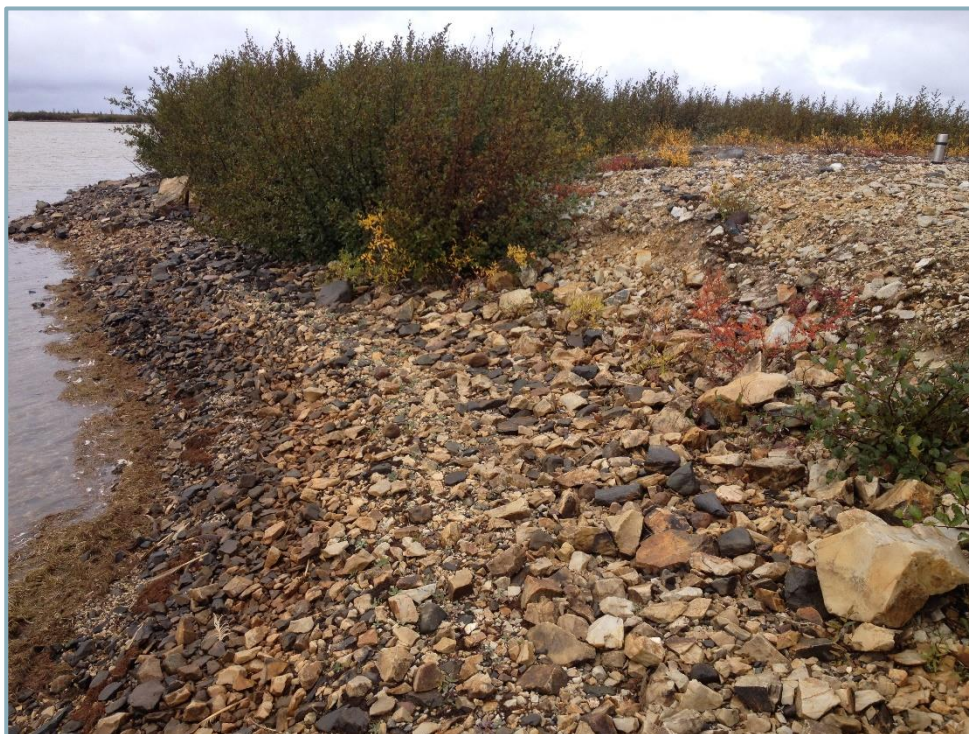
Some small erosion scars were observed on both the upstream and downstream sides; however, as described below, they appear to continue to stabilize with vegetation and self-armouring with larger rock particles from the till and previously placed mine waste rock. These scars do not appear to be increasing in size, based on visual comparisons of previous years. Minor sloughing was observed on the upstream slope south of the low point, as shown in Photo 11 and on the survey plan in Appendix A.

*Photo 11: Minor sloughing on upstream slope (looking north).*

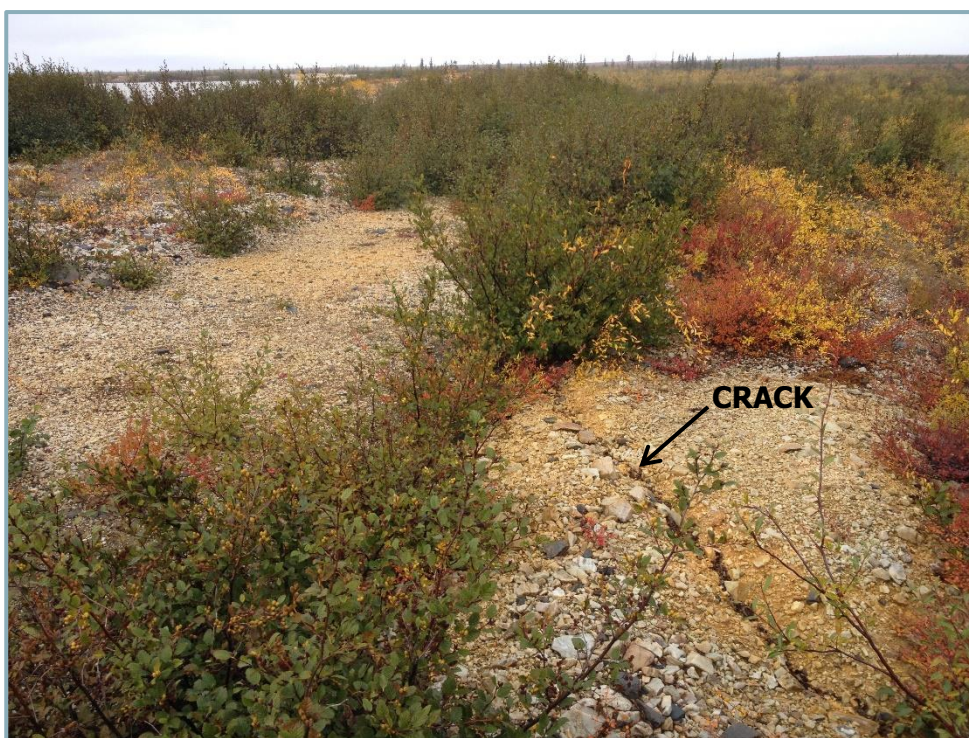
Localized longitudinal cracking first identified in 2017 was observed in 2018, as shown in Photo 12. The cracking was located where the access road adjoins the crest south of the spillway, as shown on the survey plan in Appendix A. The cracking appeared to be in a similar condition as in 2017. The localized surface cracking first identified in 2017 on the crest north of the spillway was observed in a similar condition in 2018. These cracks do not have an impact on Dam 1 performance. The cracking should be monitored during subsequent inspections.

*Photo 12: Cracking where access road adjoins Dam 1 crest (looking north).*

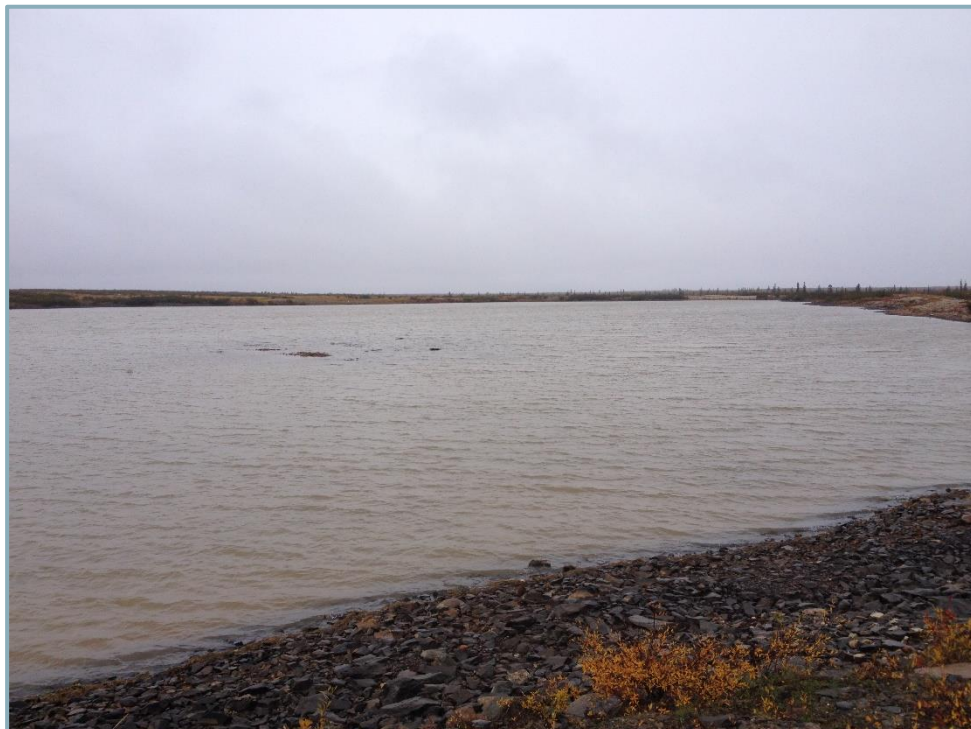
*Photo 13: Visible material above water level in TP1 (looking north).*

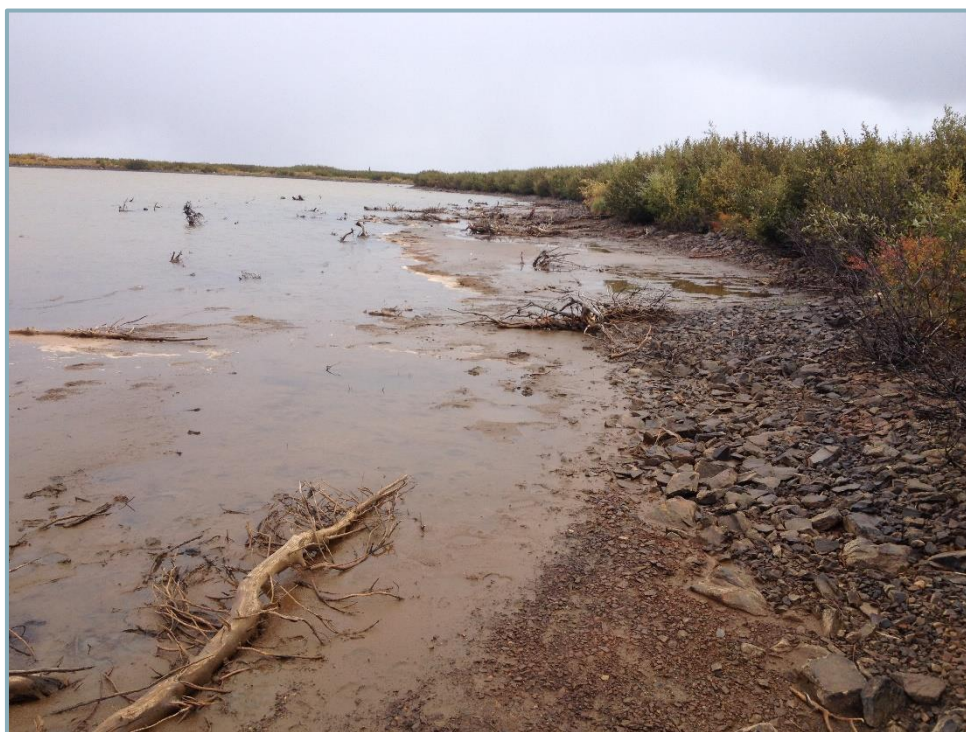
*Photo 14: The west side of the TP1 pond showing the impact of low water levels (looking south).*

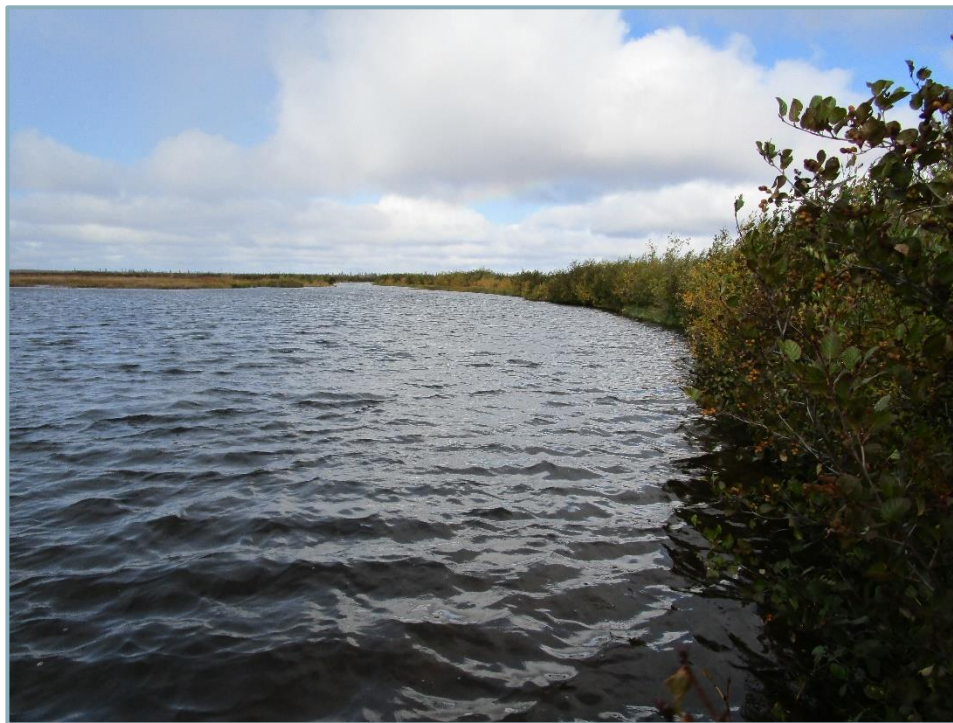
Tailings pond TP2 and Dam 2 were not visited by EXP in 2018. Inclement weather delayed the charter flight to the Site. Our review is only based on photographic comparison between ones provided by Barrick taken on September 12, 2018 (Photos 15 and 16) and EXP photos taken in the past years. Photo 15 shows Dam 2 observed from the TP2 spillway location. As with Dam 1, the principal construction material was local cohesionless till. Dam 2 section and surface grade is irregular, although less so than Dam 1. The crest width varies but is in the order of 15 m.

*Photo 15: Dam 2 (on the right) seen from TP2 spillway (looking northwest).  
Photo provided by Barrick.*

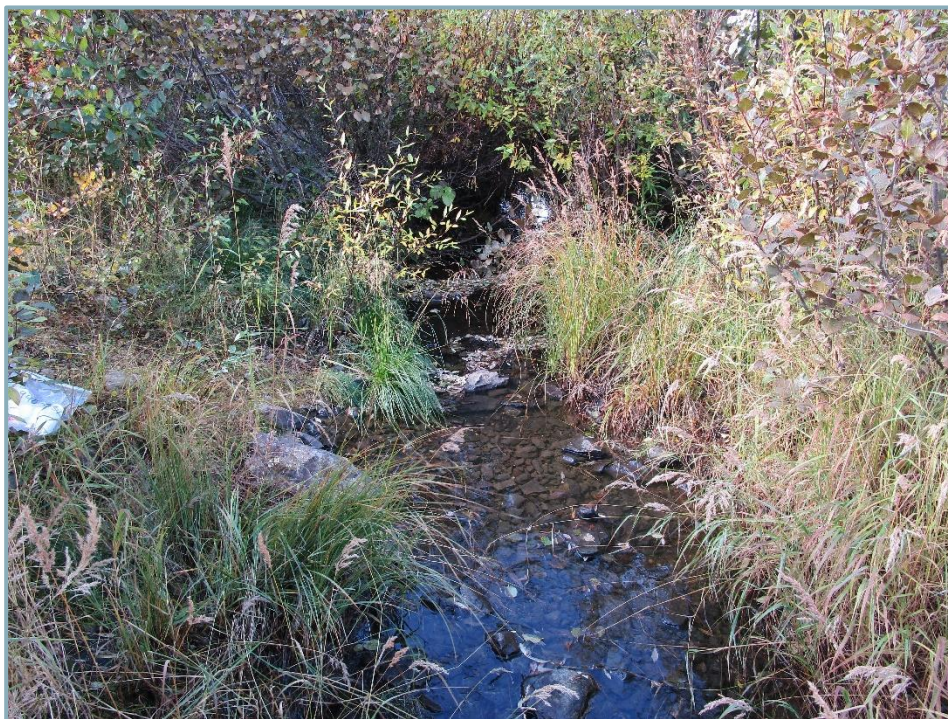
*Photo 16: TP2 spillway with flow looking upstream to TP2 pond. Photo provided by Barrick.*

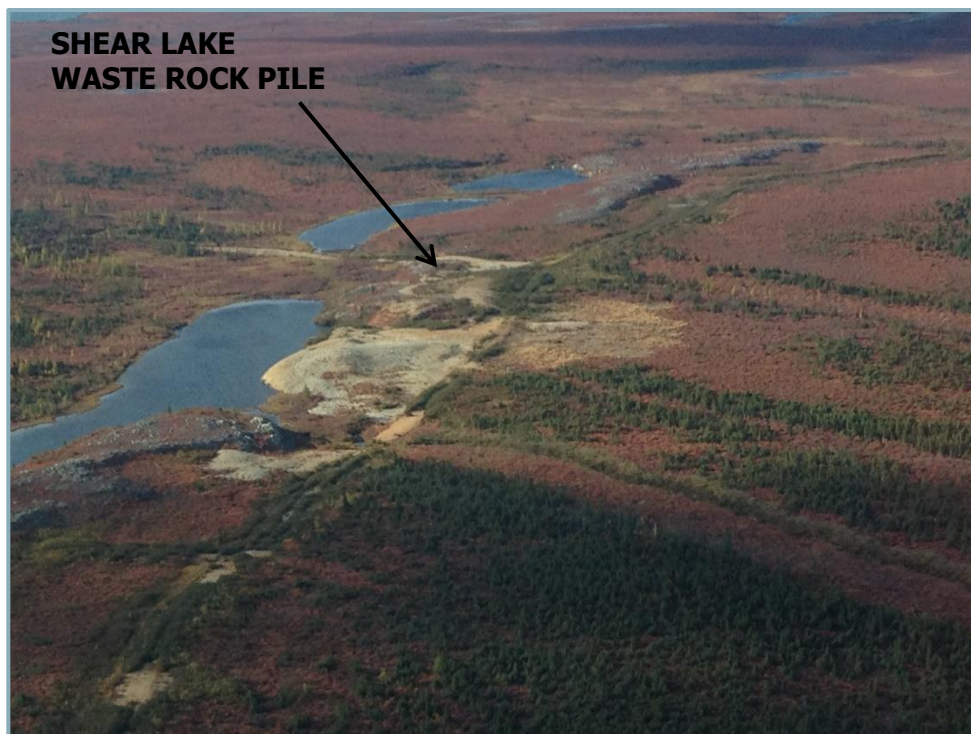
The Shear Lake waste rock cap was inspected this year. Photo 17 shows an aerial view of the Shear Lake waste rock pile. The Shear Lake waste rock pile, located on the east side of Shear Lake, some 4.5 km north of the former mill site (at the TP1), was reportedly capped with local, compacted glacial till to promote runoff and reduce infiltration. Some erosion control on the till cap was performed in 2005. A berm approximately 0.5 m high shown in Photo 18 is surrounding the pile near the bottom reaching to the pile top on the south and west sides.

*Photo 17: Aerial view of Shear Lake Waste Rock Pile (looking north).*

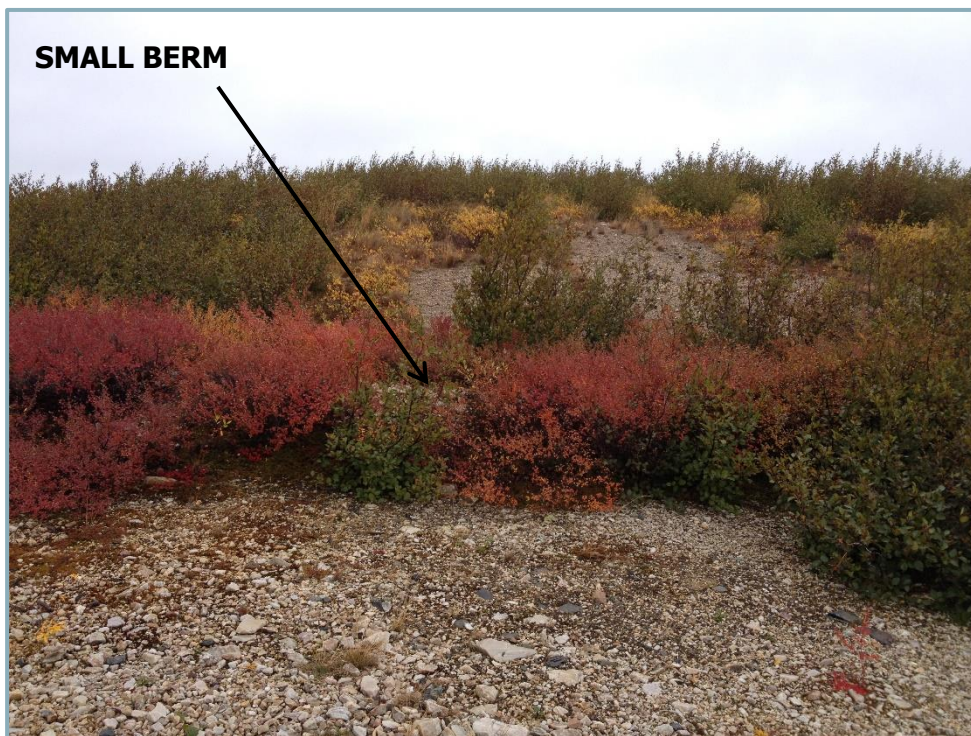
*Photo 18: Small berm covered with grasses on the north slope of Shear Lake Waste Rock Pile (looking south).*

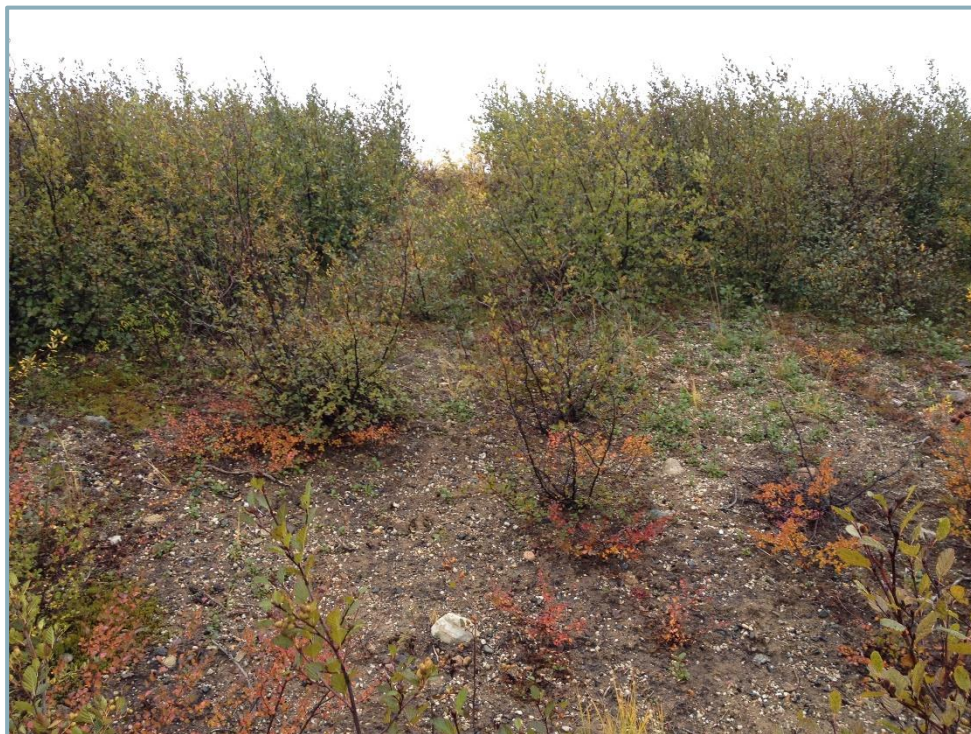
*Photo 19: Stable gravel/till covered east slope of Shear Lake Waste Rock Pile (looking west).*

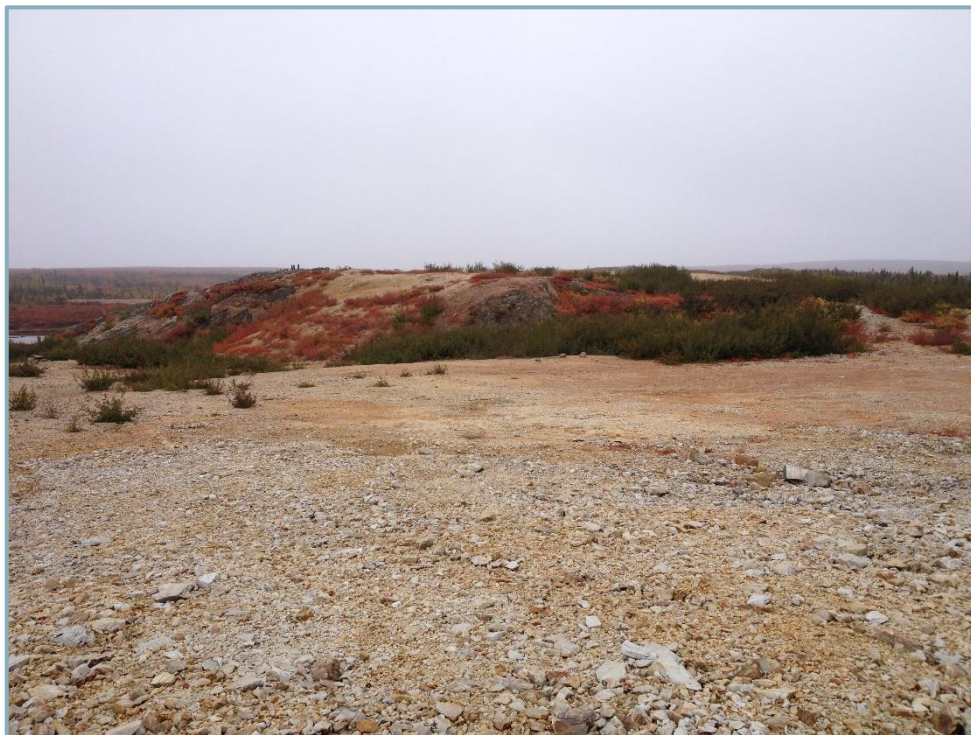
*Photo 20: South slope of Shear Lake Waste Rock Pile showing grasses (looking north).*
