Re: Cullaton Lake Water Licence NWB1CUL9902

WORK PLAN

**FOR THE FINAL RESTORATION OF
CULLATON LAKE GOLD MINES**

WORK PLAN FOR THE FINAL RESTORATION OF CULLATON LAKE GOLD MINES

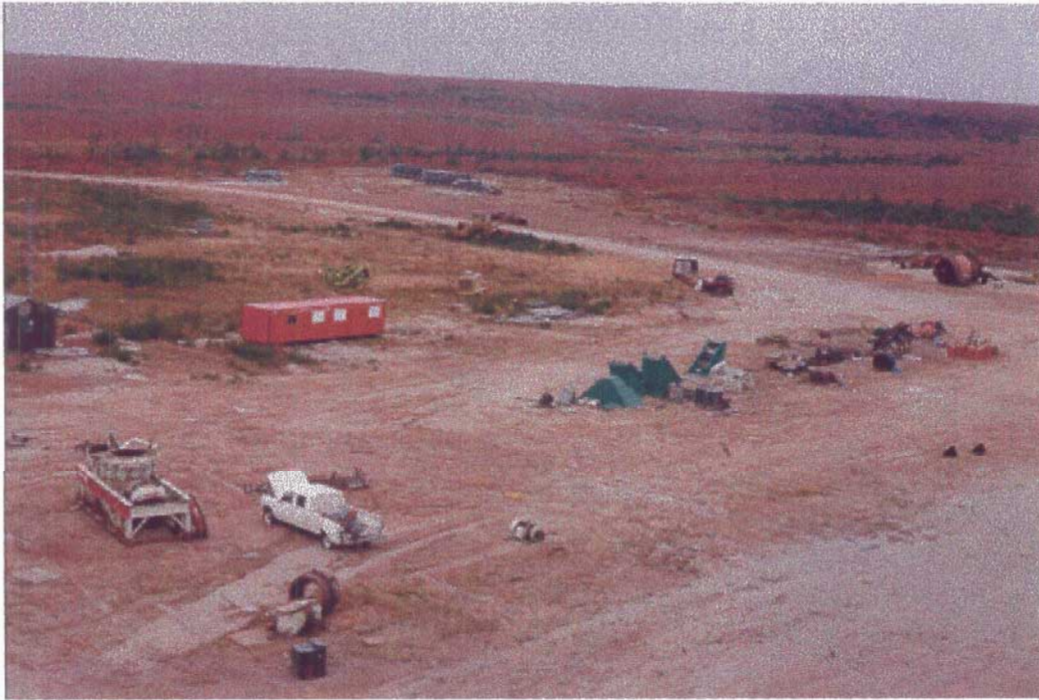
Non-salvageable materials located along east end of airstrip will be removed to the disposal area.

Non-salvageable equipment and a small wooden building are located along the edge of the airstrip. 2001 work will consist of removing the non-salvageable equipment and the building to the quarry pit disposal site. The airstrip will be left in good condition.

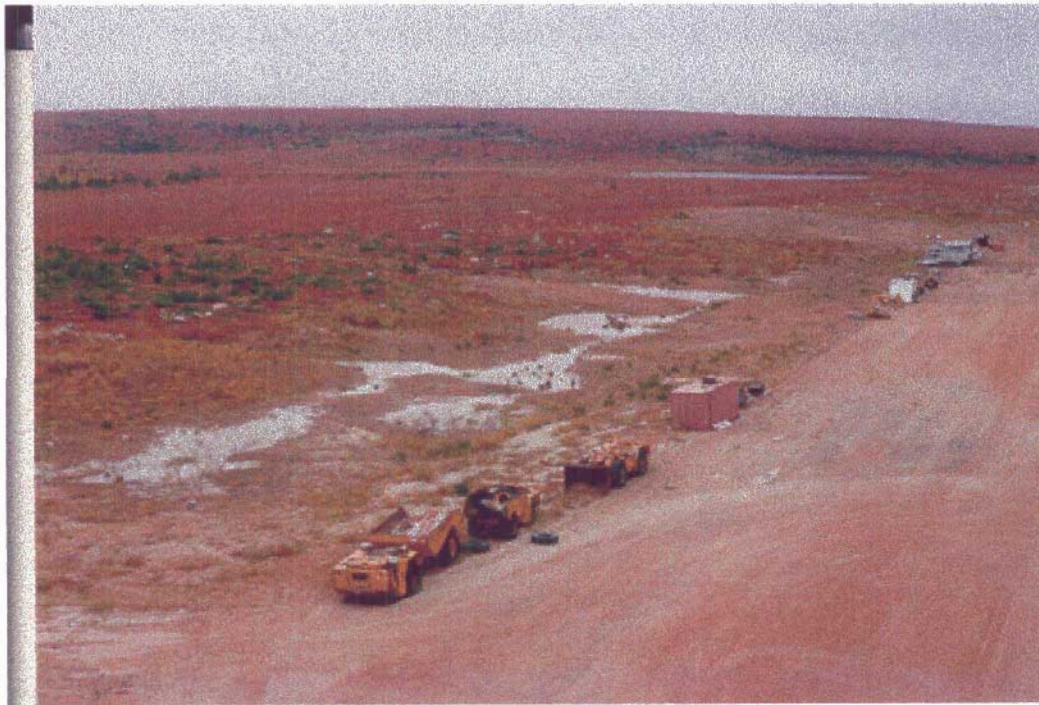
Non-salvageable equipment located along west end of the airstrip will be removed to the disposal area.

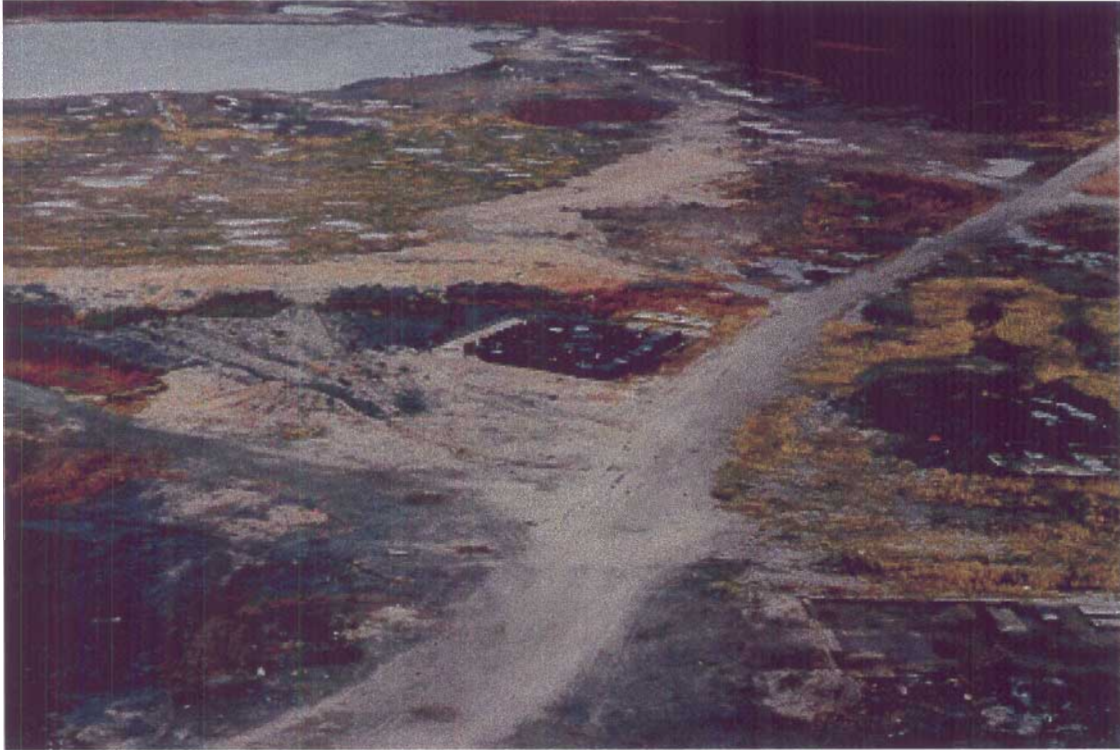
Former mill site has been cleaned up. Re-vegetated grasses are growing on the covered tailings impoundment (background) and at the mill site.

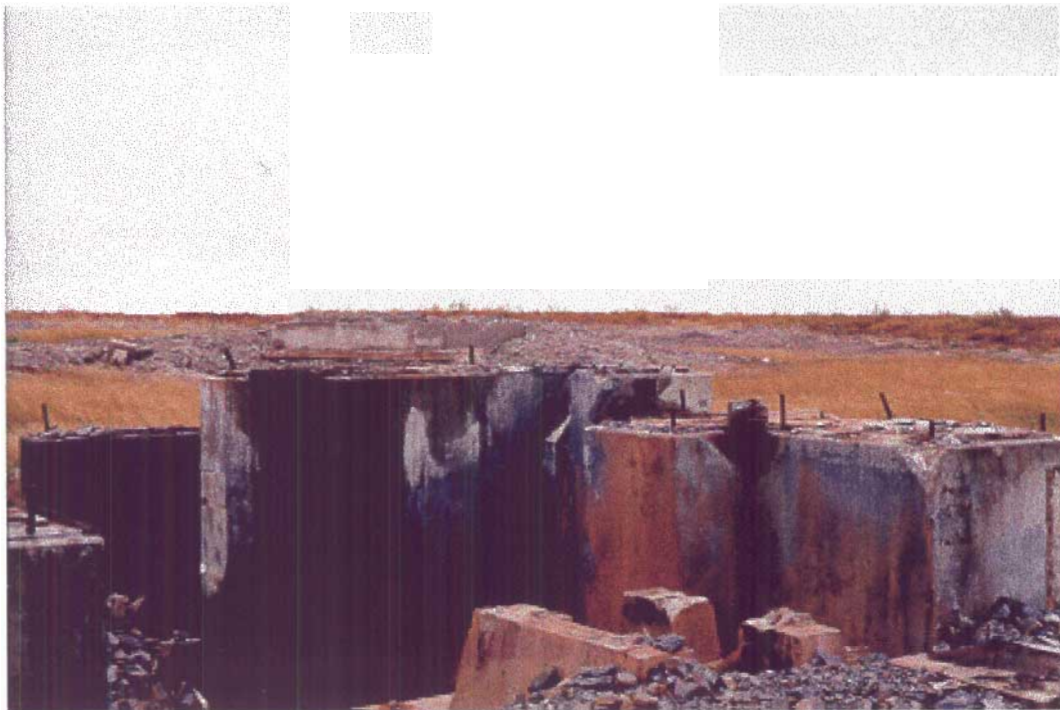
Foundations at mill site. The exposed rebar will be removed.

All material and equipment has been removed from this site. Foundations remain. Some foundations contain protruding rebar which will be cut off and disposed of. Where possible, the foundations will be covered with till and contoured or, if necessary to conform to the 2 metre height requirement, partially covered and contoured.

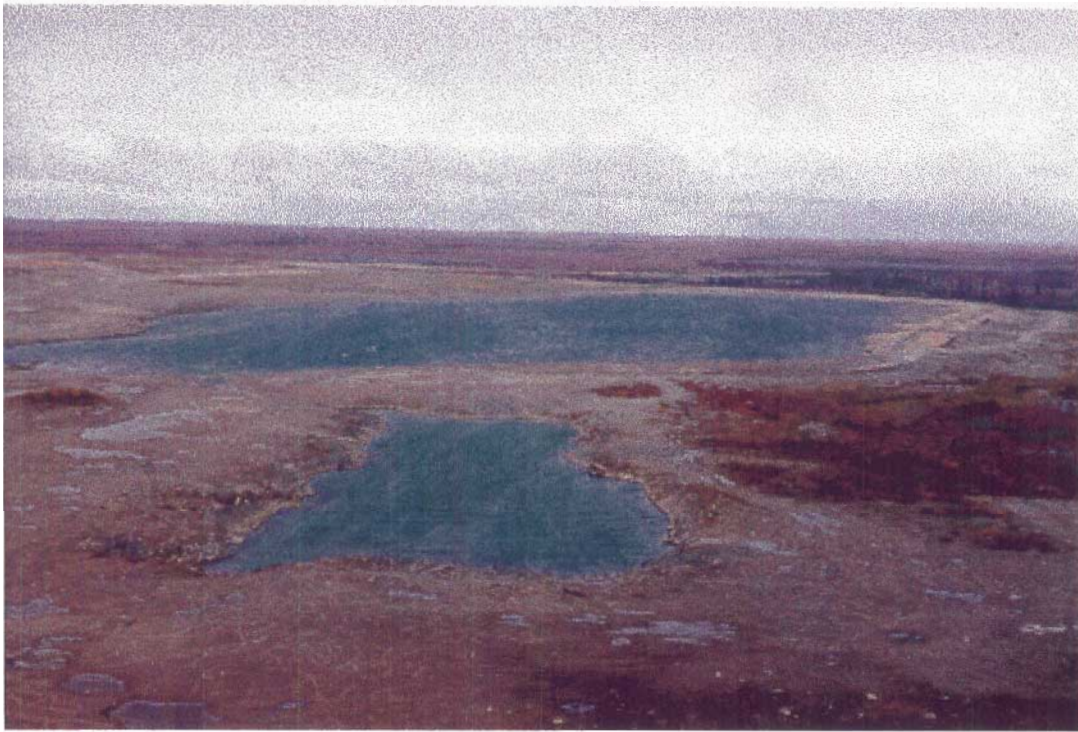
The quarry was partially filled and covered as per the modification to the A & R plan, but in 1999 and again this year (2000), the pit and the drainage ditch have both filled to the top with water. As this is considered unacceptable, Homestake intends to de-water the quarry in 2001, fill the quarry to the top with the remaining non-salvageable materials (cut to size and crushed, with any voids filled with overburden). The non-salvageables will then be covered with a minimum of 1 metre of overburden from material located alongside the tailings impoundment on Homestake's surface lease. The material will be mounded over the waste in a convex manner to allow for settlement. The drainage ditch will also be filled in.

Quarry pit in foreground with tailings pond behind. The quarry and ditch connecting it to the tailings pond have filled with water.

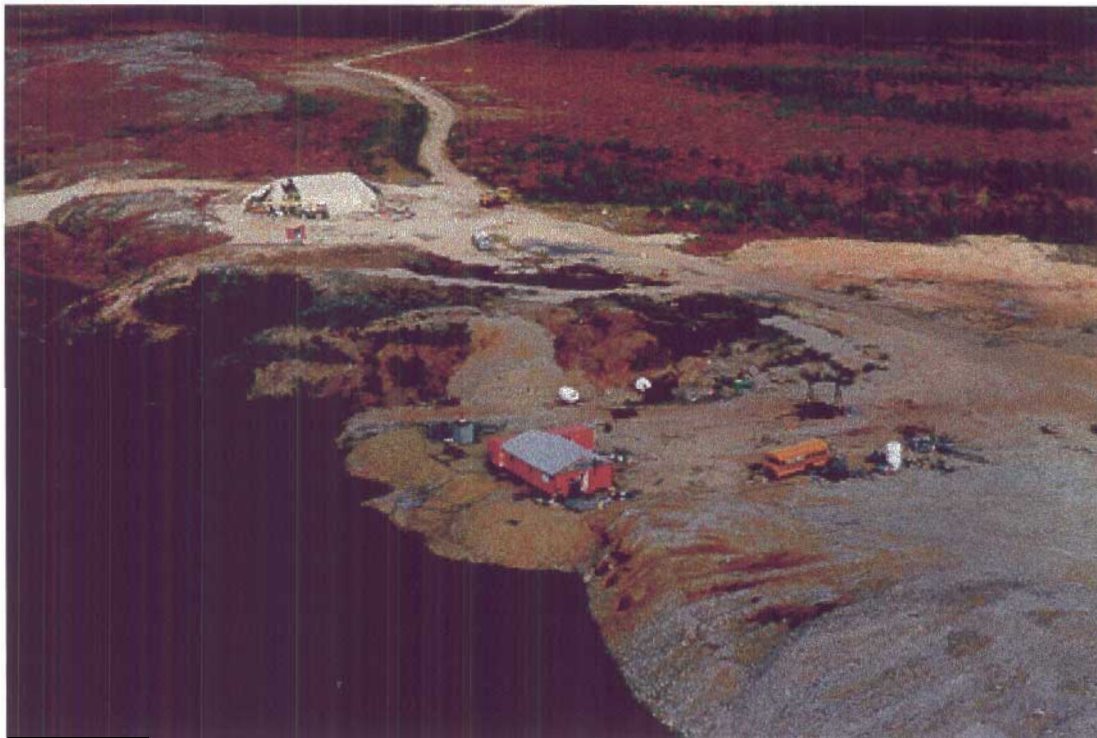
The Shear Lake site. All structures, material and equipment will be removed from this site for disposal, and the area will be cleaned up.

Two Acto trailers, a sprung tent structure, and some mine equipment and debris now remain at this location. In 2001 this non-salvageable material will be cut up/crushed and removed to the quarry pit disposal site. All fuel contaminated areas will be cleaned up and the contaminated soils will be burned in the burn pit or spread in a thin layer on the airstrip for passive remediation, as approved by DIAND in June 1996.

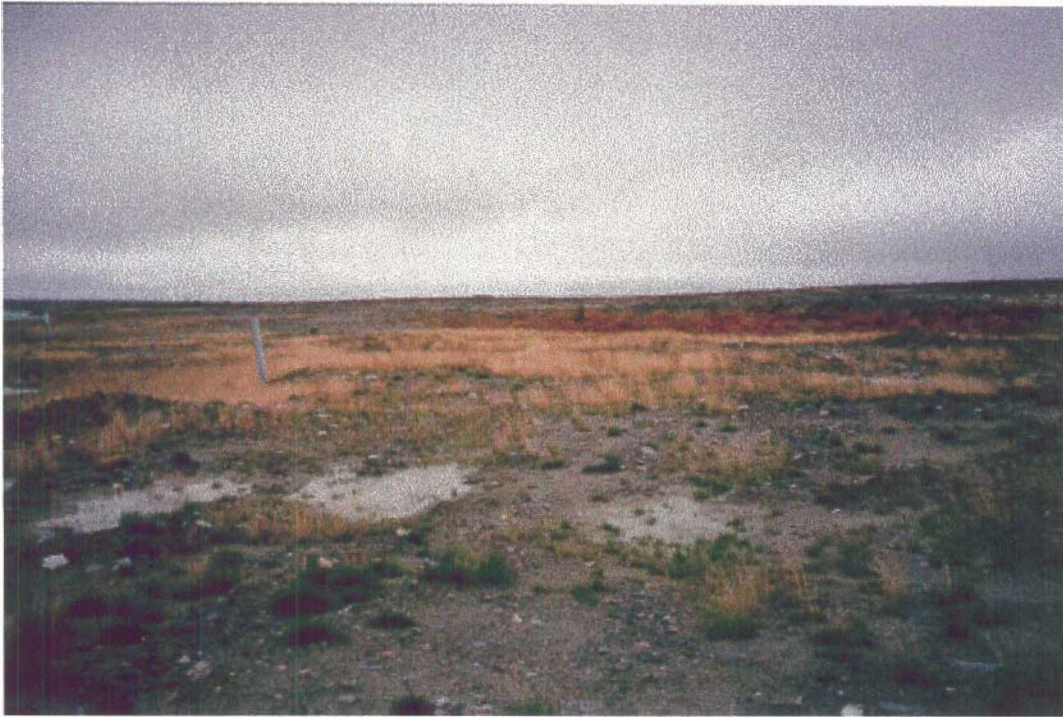
Reclaimed tailings area showing fall vegetation. This area requires no additional remediation.

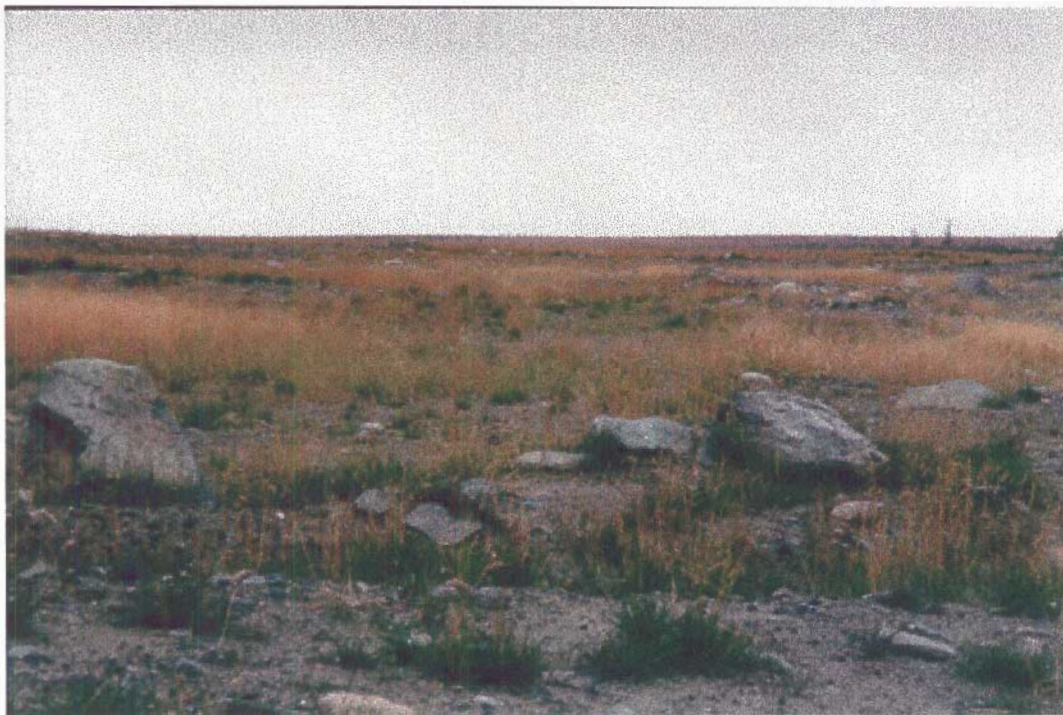
The tailings was seeded and fertilized in 1997 with an arctic seed mix.
