Re: Cullaton Lake Reclamation Program – 2001 Status Report

**Cullaton Lake Reclamation Project
2001 Status Report**

APPENDIX A
PROJECT PICTURES

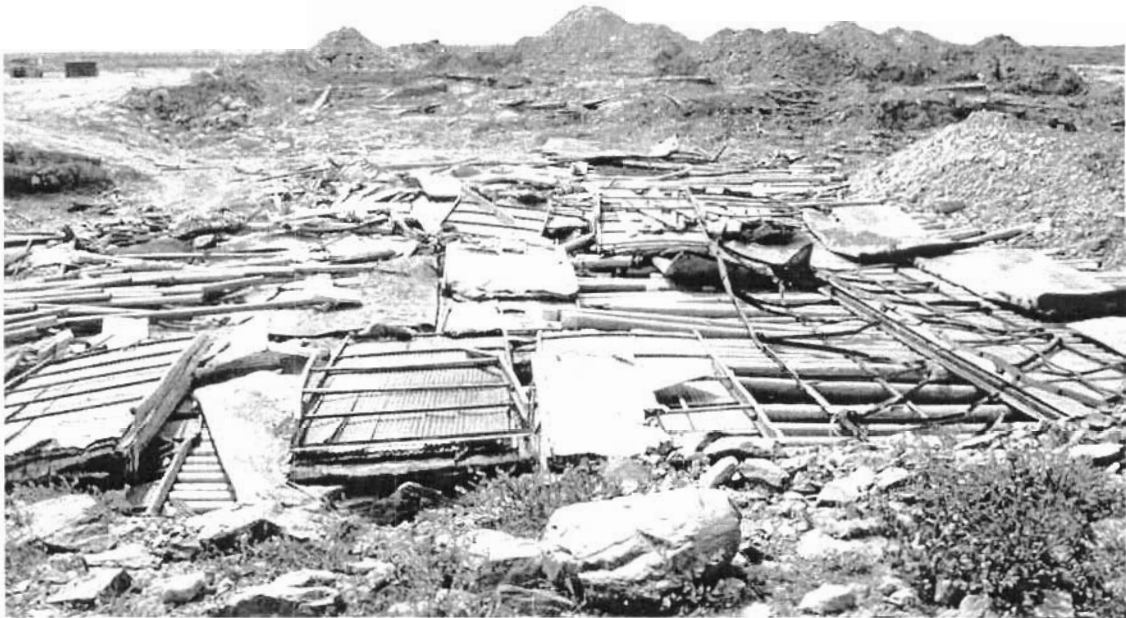
Material placed in Quarry Pit

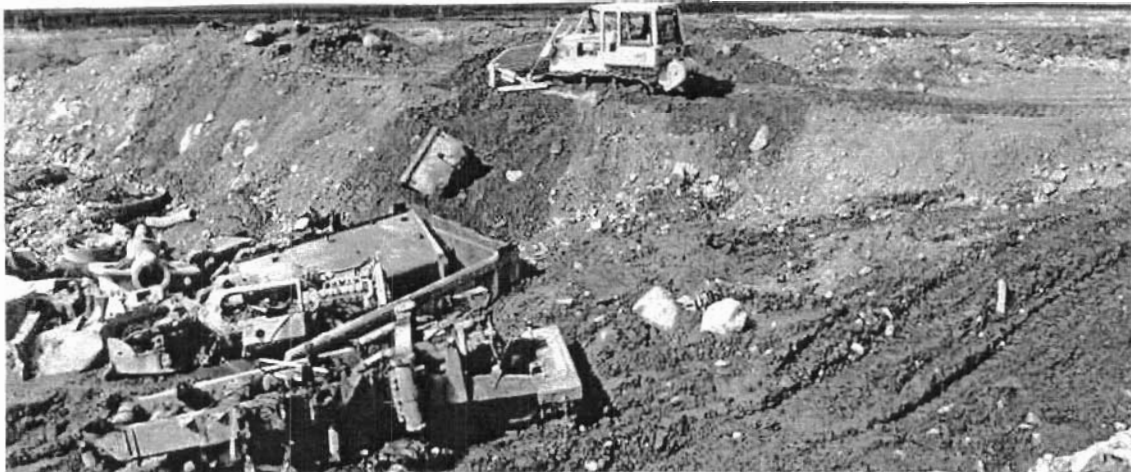
Cover being placed on Quarry Pit

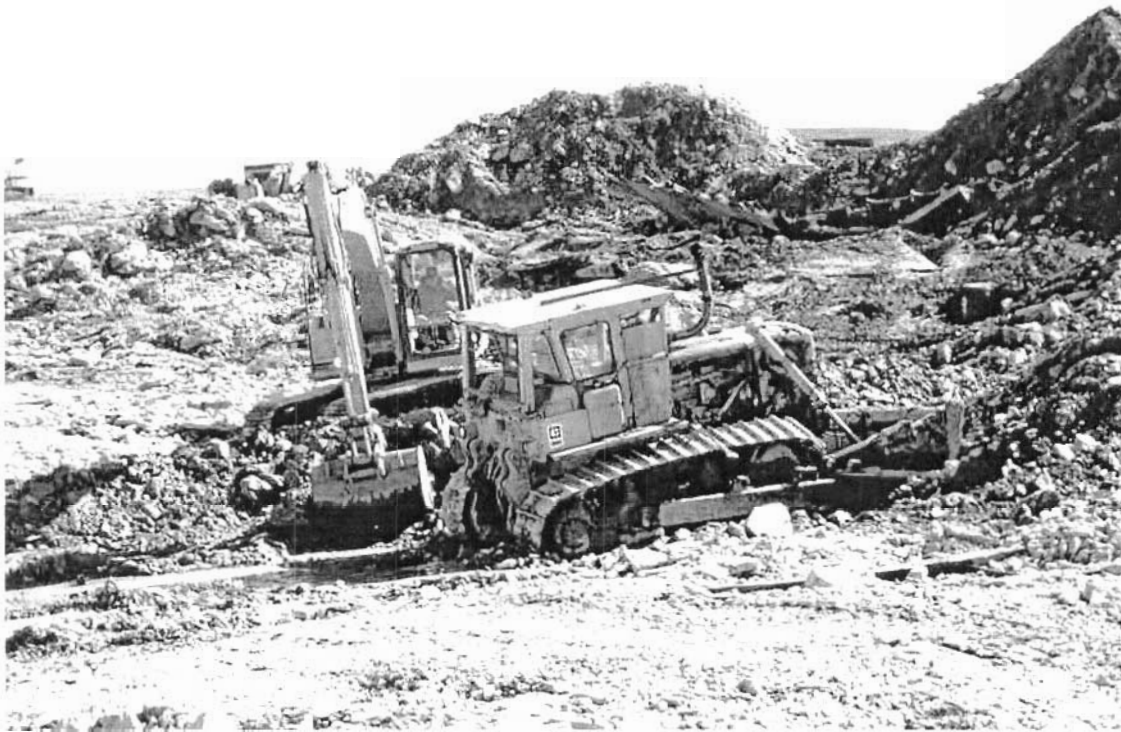
Dozer and Hoe flattening scrap material

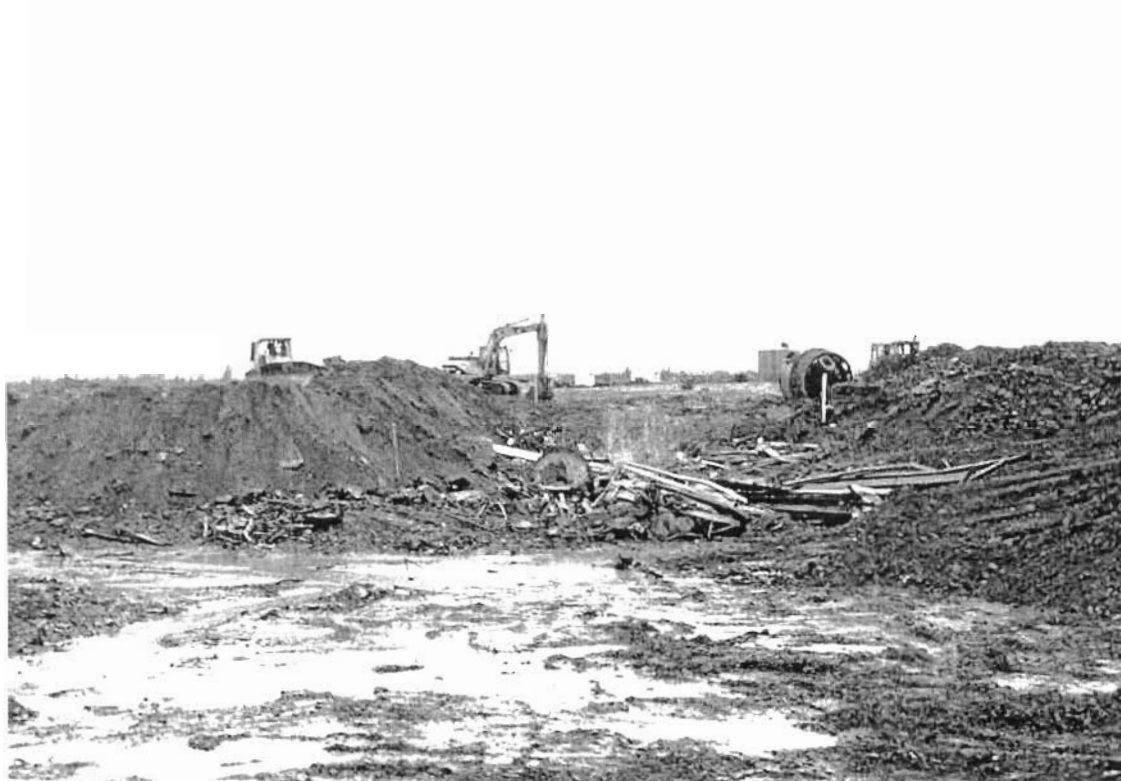
Cover being placed on Quarry Pit

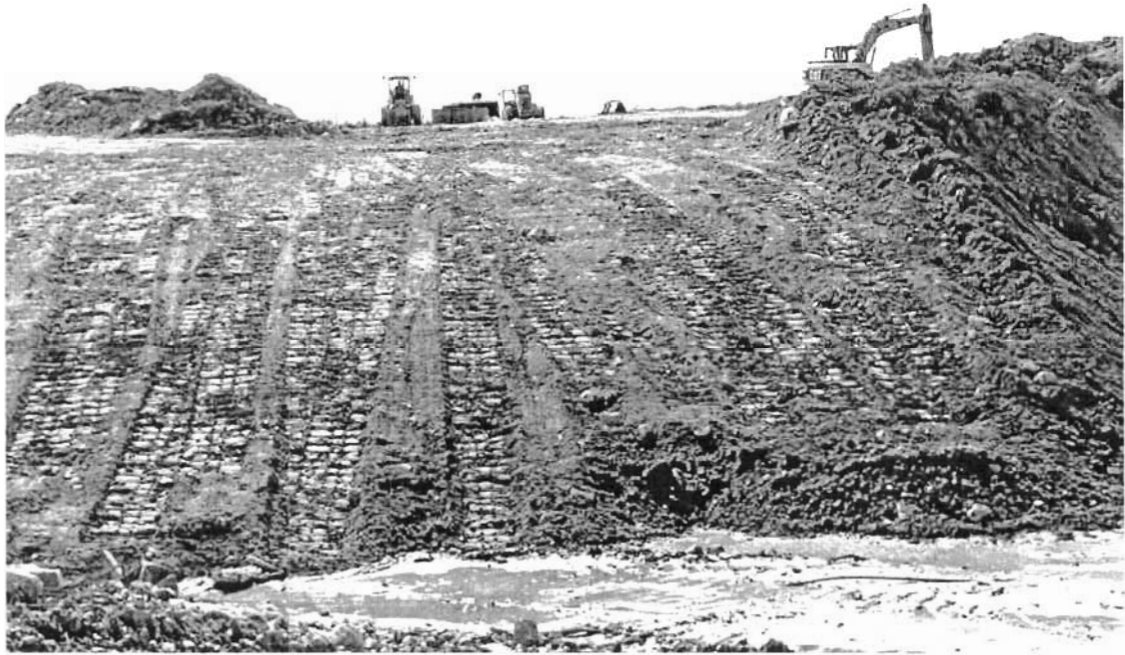
Final slope on Quarry Pit Cover

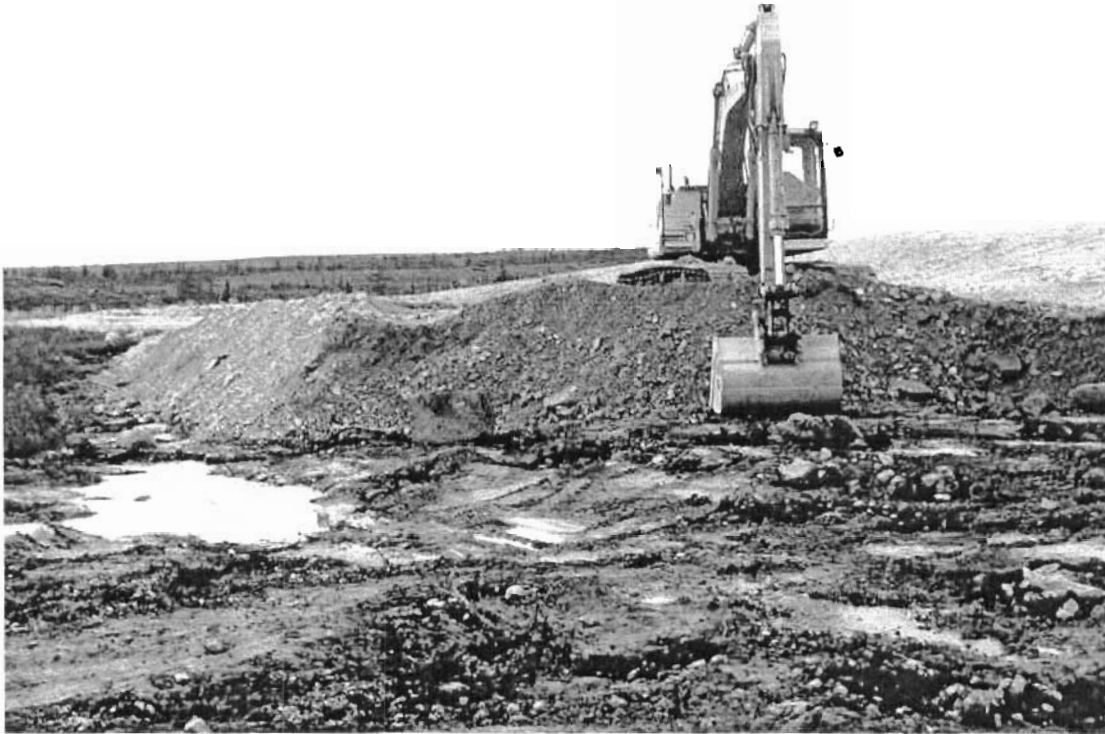
During the 2000 site visit and planning process HCI staff noticed dead vegetation around the toe of the Shear Lake Waste Rock area. Samples of the rock were collected and analysed in the fall of 2000. It was determined that the rock was generating acid from sulphides contained in the rock.

Waste Rock being picked up

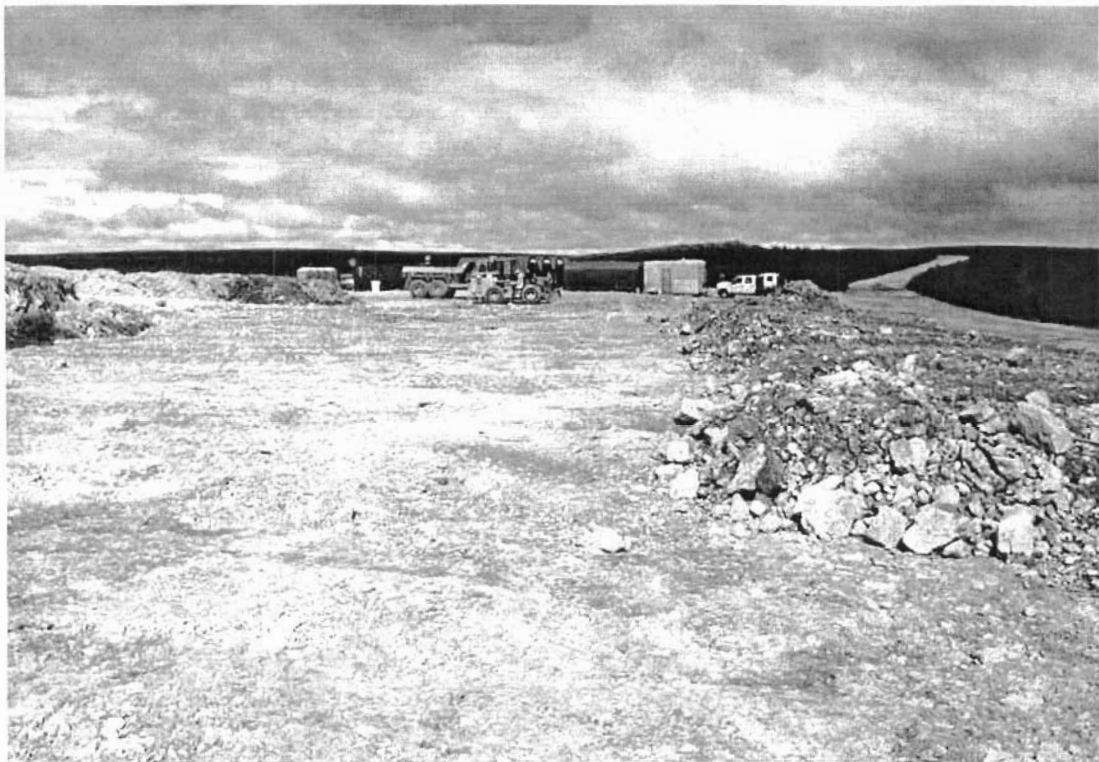
Base prepared for waste rock encapsulation

Based on the fact that the end of the construction season was approaching and a concern that placement of the material in Shear Lake would not be approved, HCI developed an alternate disposal method as a contingency plan. The waste rock would be scraped up into a pile. Some of the underlying fine base material would then be used to construct a pad adjacent to the Shear Lake portal area where drainage would be away from the lake. The waste rock would then be placed on the pad and encapsulated with compacted fine material. The entire area would then be covered with till obtained from the access road.

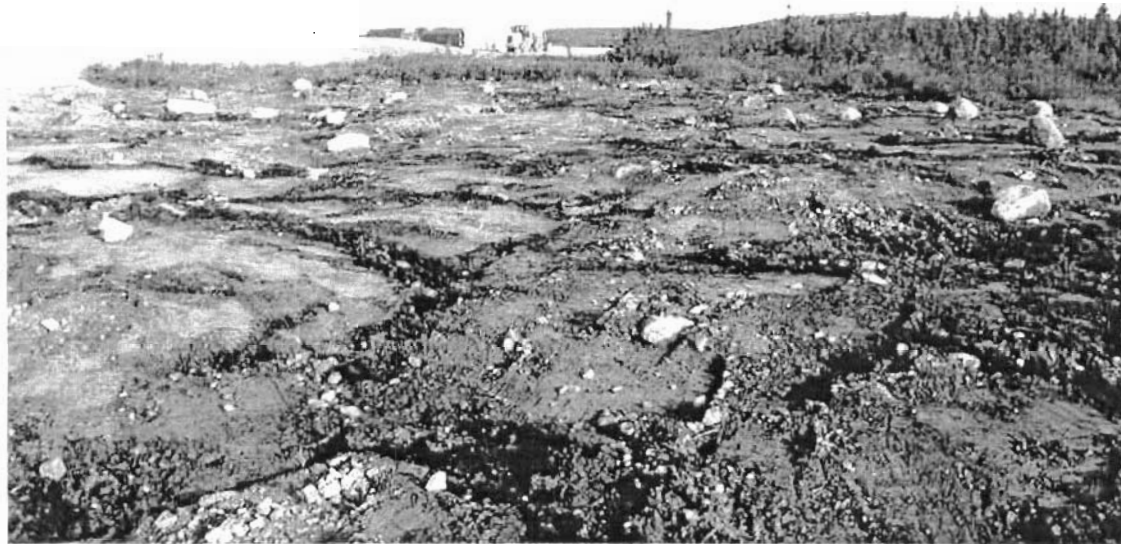
Old waste rock pile after clean up

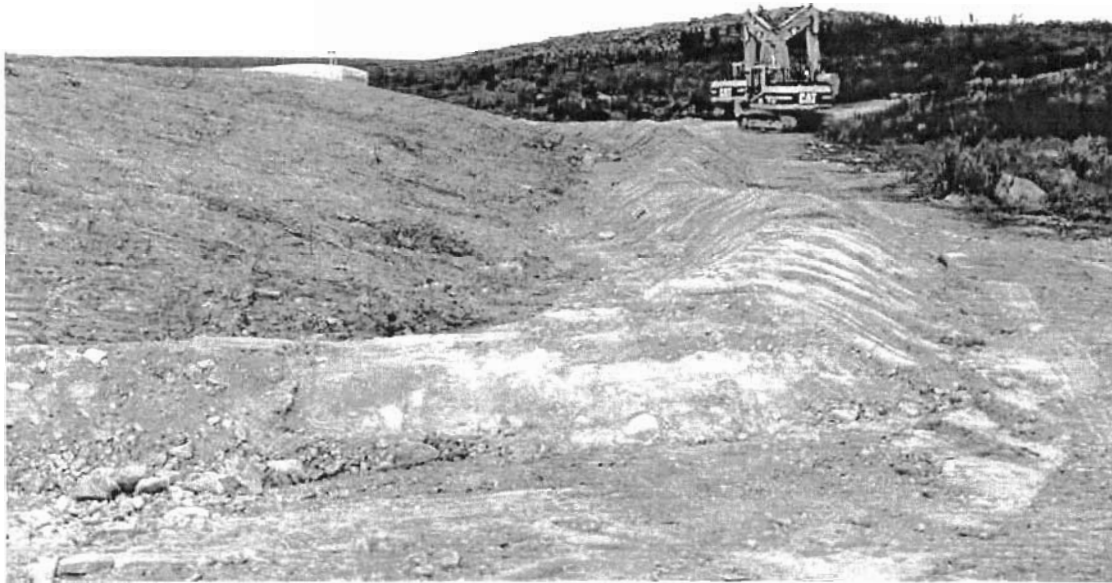
Encapsulated waste rock – 2 meter cover

HCI believes that the encapsulation of the waste rock, including the proper shaping of the area to prevent water infiltration, will prevent future acid generation from the rock. In addition, the cover of 2 meters of fine material and till will leave the waste rock in a frozen state for much of the year. Therefore, HCI requests approval from the Nunavut Water Board to amend the approved Abandonment and Reclamation plan to approve the encapsulation as final reclamation for the waste rock.

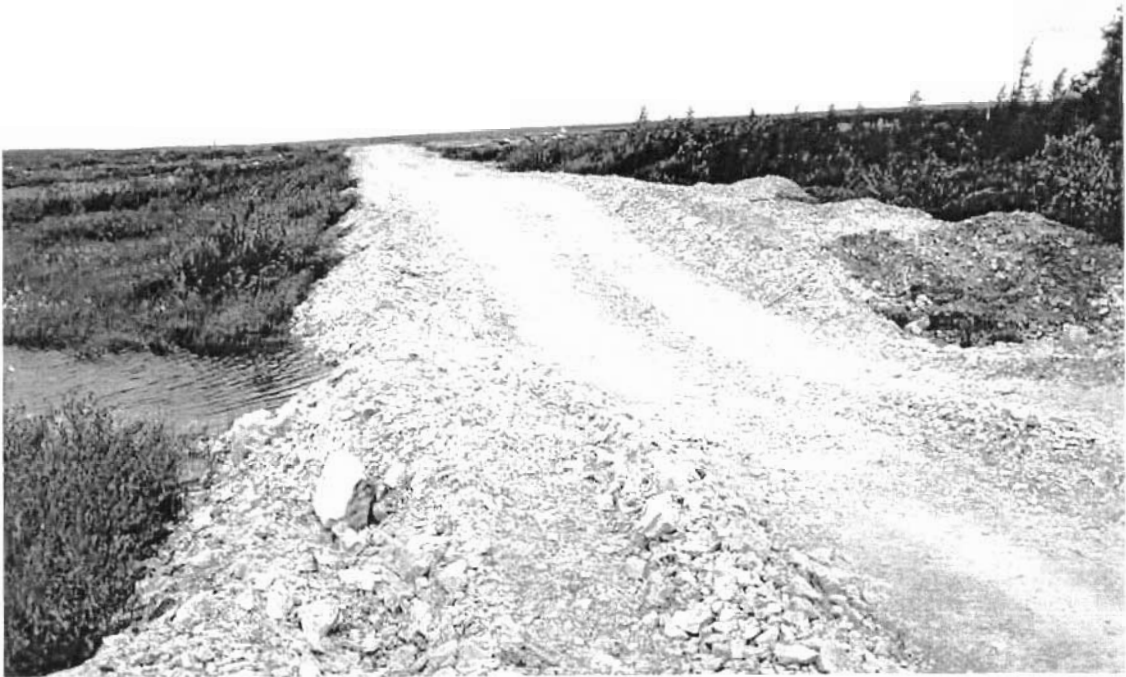
Stream crossing before reclamation

The first phase of this clean up was to reclaim the road from Shear Lake to the mill and tailings area. This included restoring all stream crossings to a natural state (See pictures in Appendix A). Culverts had already been removed and buried at the Quarry Pit and replaced with plastic pipe for the current season's work. These pipes were removed from site. Clumps of shrubs were excavated from the immediate road side and planted on the road surface to enhance revegetation of the road.

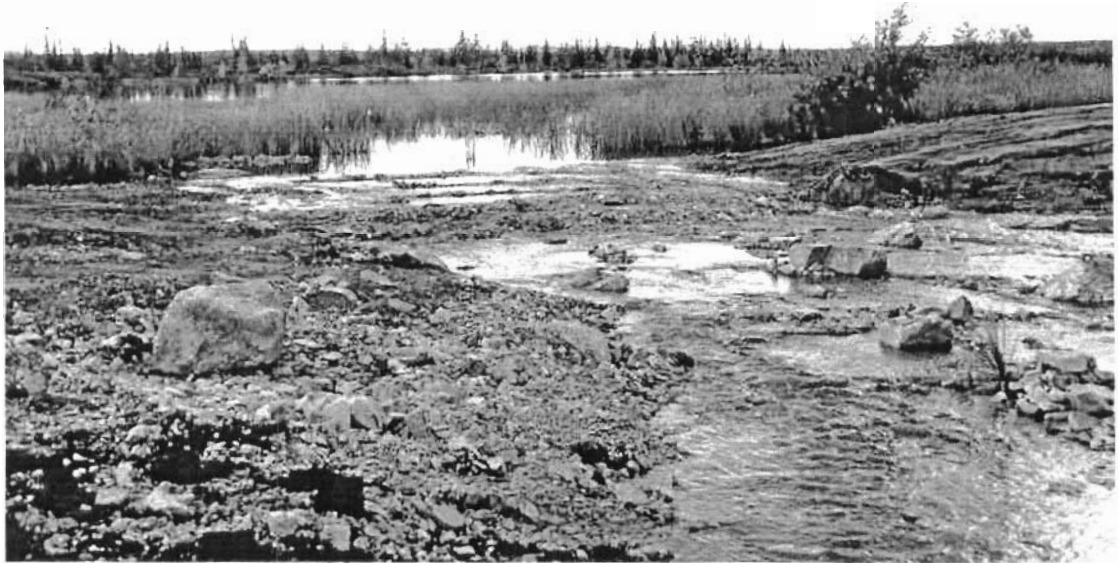
Stream crossing after reclamation
