# **Cullaton Lake Mine**

## **Closure and Reclamation Plan**

*Prepared For*  
Barrick Gold Inc.

June 30, 2017

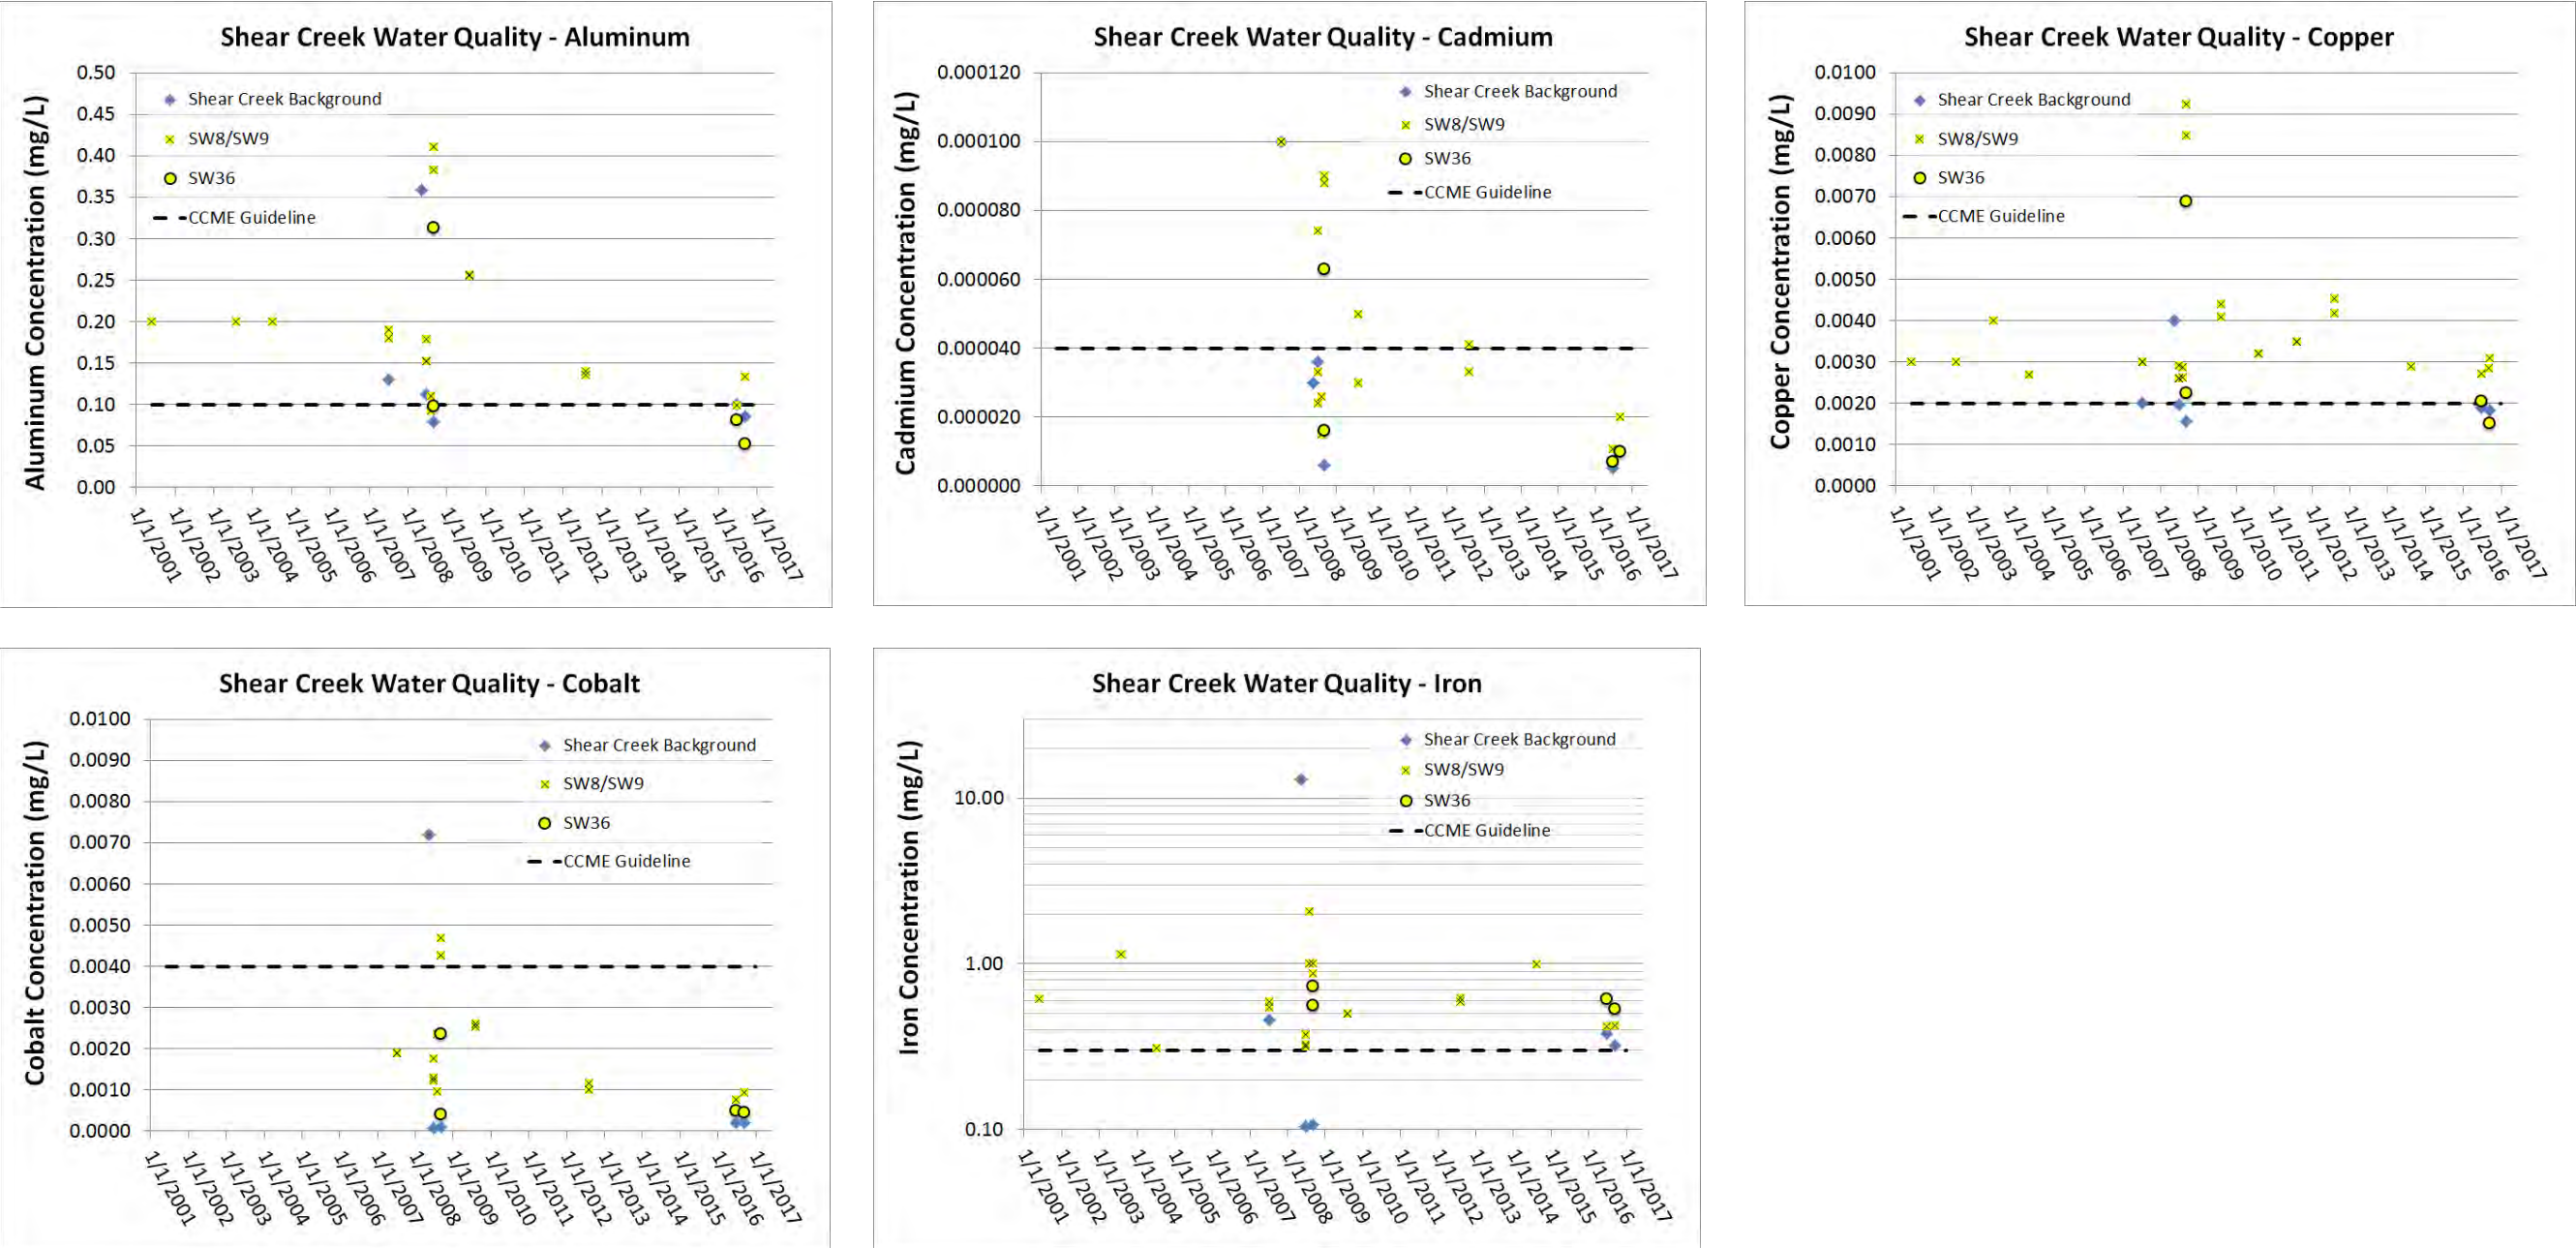
Figure 3-4. Water Quality in Shear Creek for Parameters of Interest

CCME exceedances have been observed in Shear Creek for Al, Cd, Co, Cu, and Fe. Time series plots for those parameters (Figure 3-4) indicated that water quality in Shear Creek does not appear to be deteriorating over time. At monitoring station SW36, 2016 concentrations were generally below CCME guidelines and close to background concentrations. Concentrations at SW36 for Al, Cu, and Fe were observed to be slightly higher than CCME guidelines in some 2016 samples. However, for those parameters, the background concentrations were typically near CCME guideline levels as well. Site-specific water quality guidelines may be appropriate for those parameters.

The time series plots are consistent with Lorax's work in the ERA (AECOM, 2009) where they concluded that because of the absence of remaining sulphides in the residual waste rock, the water quality of the waste rock drainage is unlikely to get any worse over time.

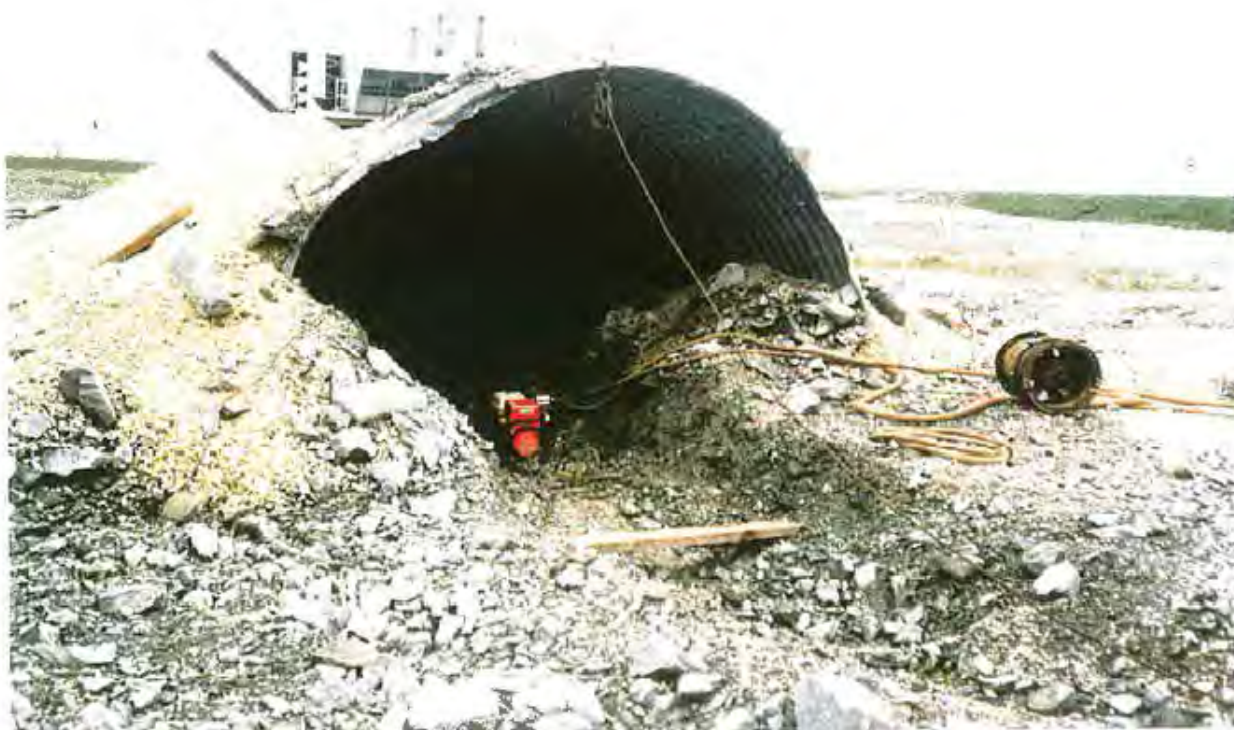
Photograph 5-1 shows the B-Zone mine portal and is believed to be representative of the portal conditions at the time of closure. Although no information is available to determine whether the stopes were backfilled during mining, the mine drawings show that the stopes were all at depth and that their extent was rather limited.

***Photograph 5-1. B-Zone mine portal at the time of closure.***

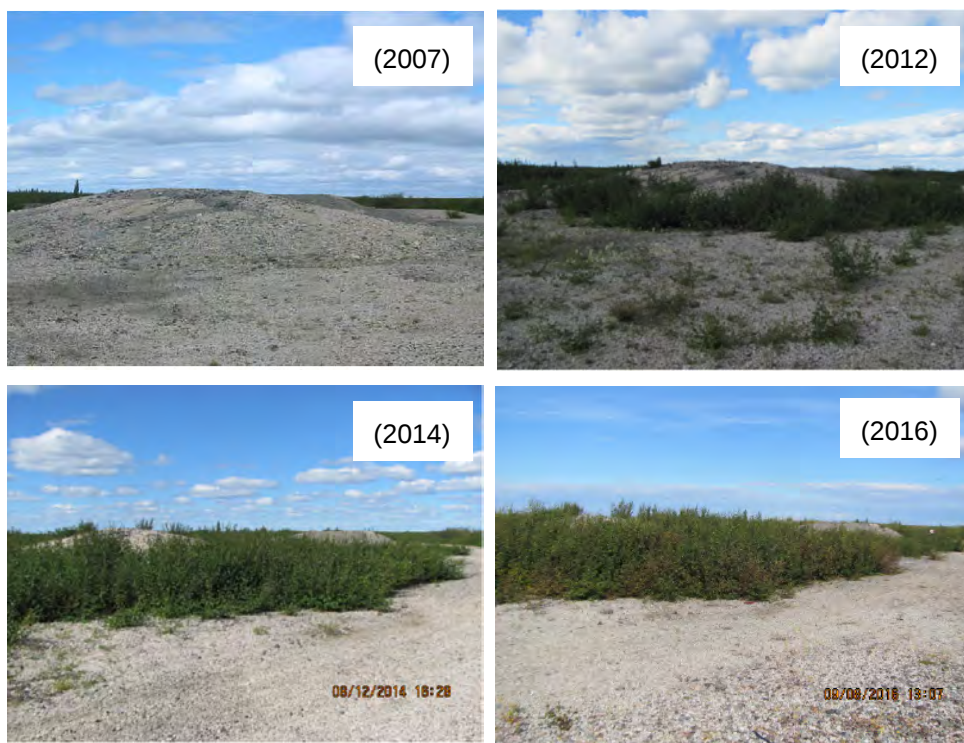
The photos of the B-Zone mine portal and ventilation raise taken during the annual inspections after the 2001 reclamation works show that the area reclaimed around the portal and ventilation raise has gradually become covered in shrubs (Photograph 5-2).

***Photograph 5-2. Former B-Zone portal and ventilation raise in post-reclamation conditions***

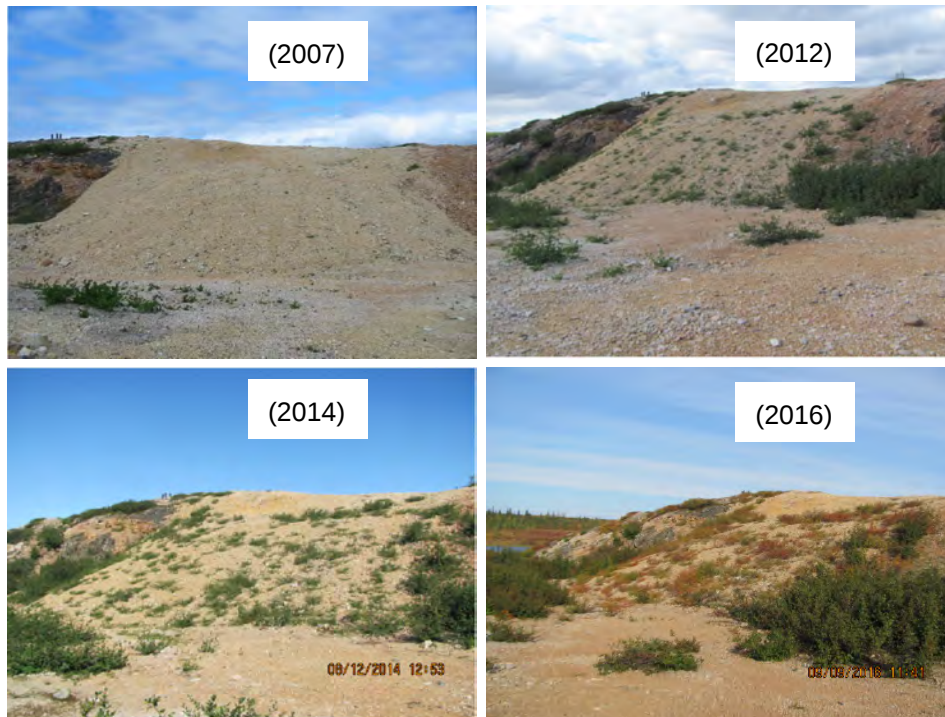
With regard to the integrity of the backfill at the mine portals, settlement of the fill occurred in the Shear Lake portal, as observed during the DIAND site inspection in August 2006. Minor subsidence was observed in the 2009 annual inspection and was refilled in August 2009 (Brugger, 2010). No further settlement has been noted in subsequent annual inspections (Brugger, 2010; 2011; 2012; 2013; 2014; 2015; 2016; 2017).

*Photograph 5-3. Former Shear Lake Zone portal in post-reclamation conditions*

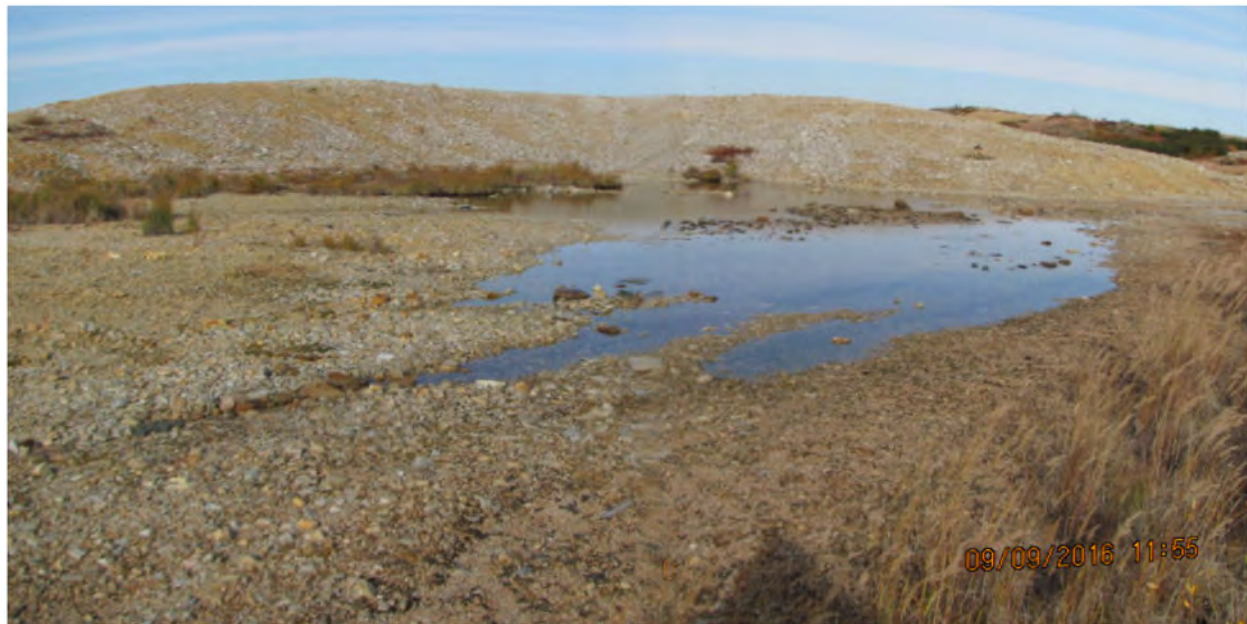
**Photograph 5-5. Shear Lake Low pH Pool Area (SW6 sample location)**

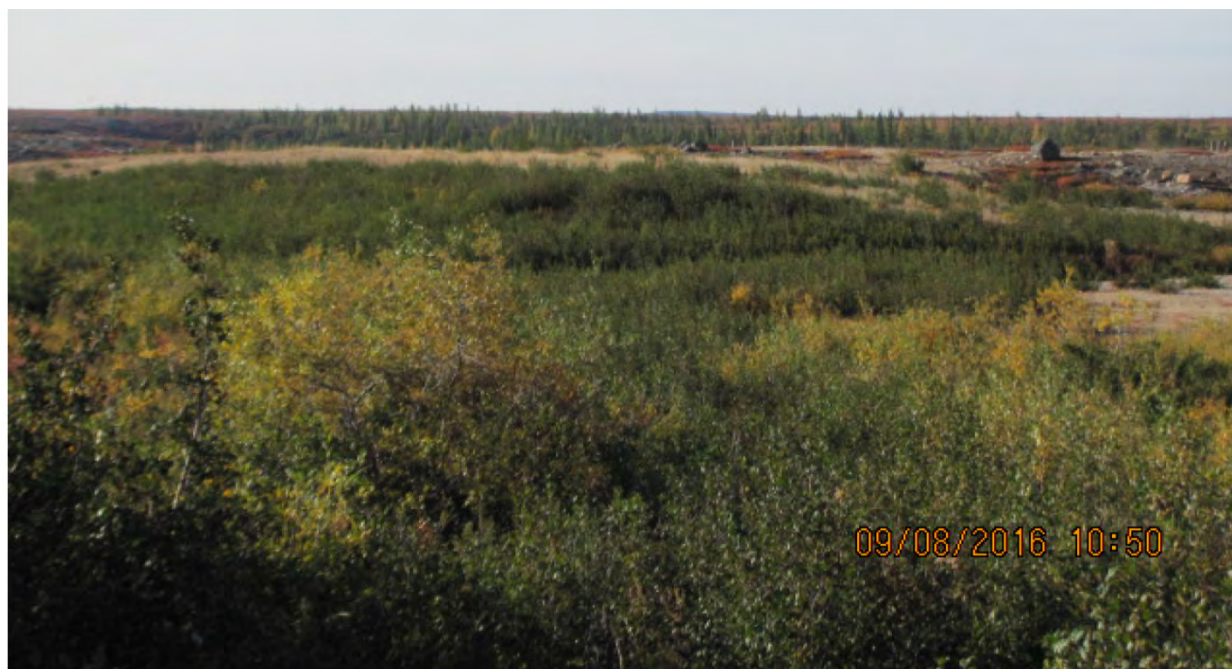
In 2005, Barrick personnel oversaw the re-seeding of the EWR cap (with grasses) to promote some vegetation growth and reduce the erosion of the cover due to runoff, particularly along the side slopes. While some sparse areas remain (particularly on the top), the vegetation is helping to reduce erosion, in that a few small erosion gulleys / channels (20 to 30 cm deep/wide) (exp. 2014) were observed on the side slopes. These generally were short and did not extend the full length of the slope. It is expected that it will take several more years for the vegetation to establish itself fully (Brugger, 2017). Photograph 5-6 shows a region of established vegetation on the waste rock cap.

***Photograph 5-6. Encapsulated waste rock at Shear Lake 11 years after the application of additional seed and fertilizer***

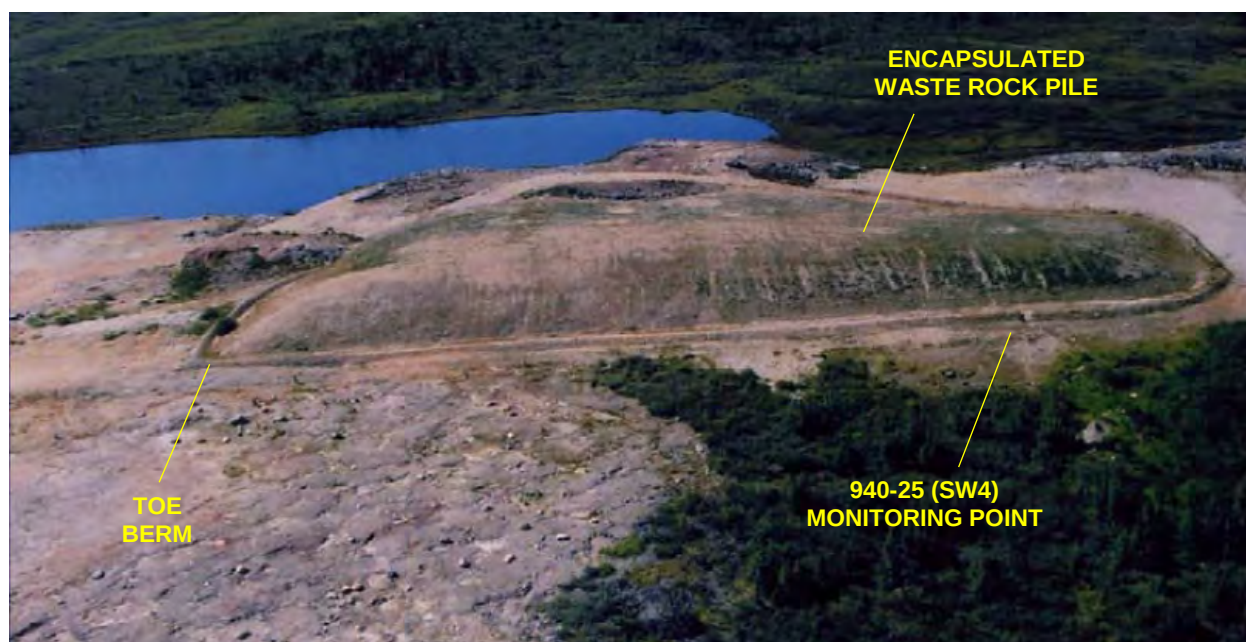
**Photograph 5-7. Encapsulated Waste Rock Prior to Establishment of Vegetation**

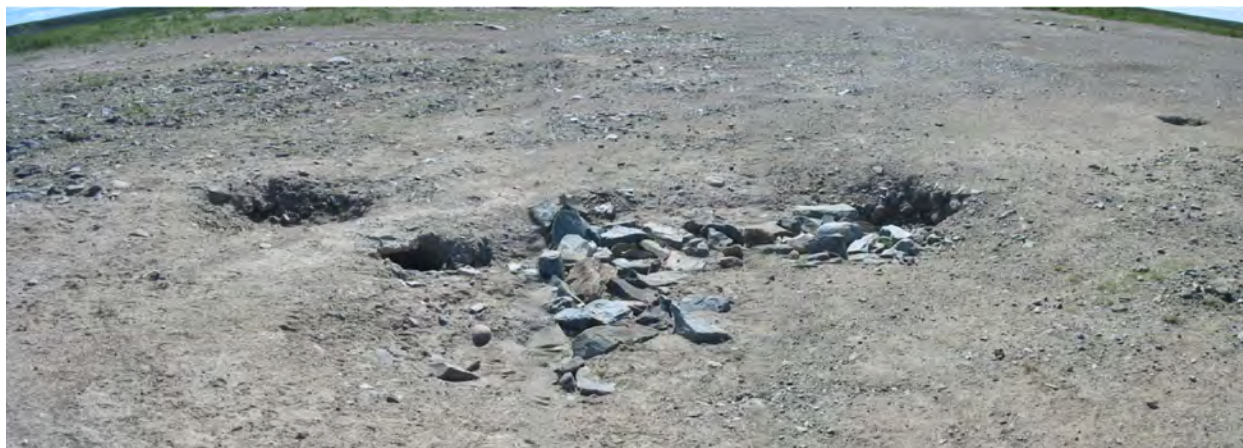
Minor settlement in the southeast corner of the quarry pit cover was observed during the annual inspection of 2007 (Photograph 5-12). The settlement areas remained largely unchanged and became populated by arctic ground squirrels until 2016, when two additional sinkholes were identified during the annual inspection (Photograph 5-13).

*Photograph 5-12. Settlement areas in southeast corner of quarry pit cover (July 2007)*

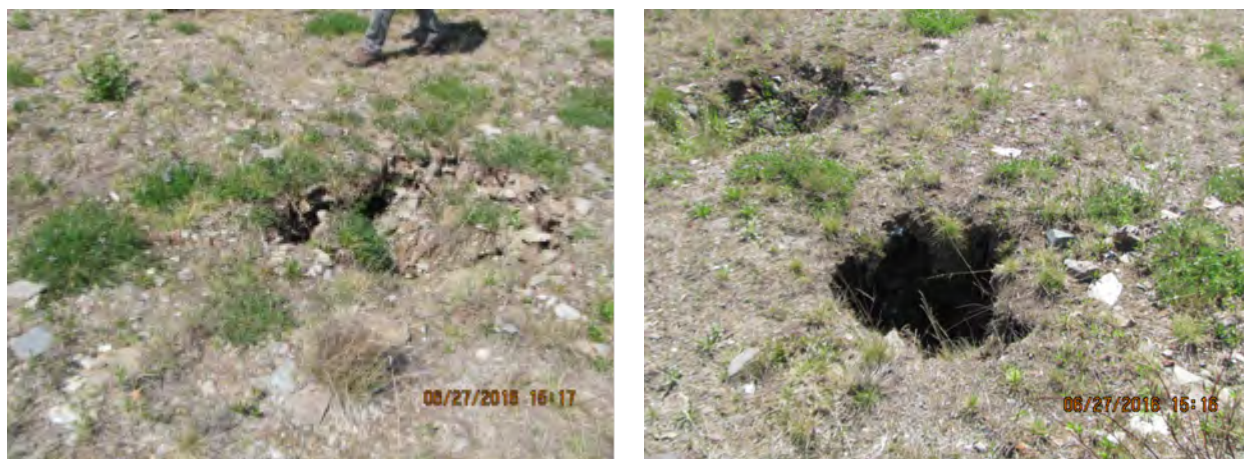
***Photograph 5-13. Settlement areas in southeast corner of quarry pit cover (left) and new sinkholes identified in 2016 (right).***

The 2016 inspection conducted in relation to the current water license identified that some of the sinkholes in the quarry pit cover expose metal waste.
