WATER LICENCE INSPECTION FORM

Licensee		Licensee Representative	
David Rochette Regional Director General Department of Indigenous and Northern Affairs Canada P.O. Box 2200 Iqaluit, NU X0A 0H0 E-mail:		Ben Lefebvre – Englobe (Biogene)	
Licence No. / Expiry		Representative's Title	
1BR-DPI1217		Site Supervisor	
Land / Other Authorizations		Land / Other Authorizations	
N2012X0011		2014QP0027	
Date of Inspection		Inspector	
August 1, 2016		A.Keim	
Activities Inspected			
<input checked="" type="checkbox"/> Camp <input type="checkbox"/> Drilling <input type="checkbox"/> Mining <input type="checkbox"/> Construction <input checked="" type="checkbox"/> Reclamation <input checked="" type="checkbox"/> Fuel Storage			
<input type="checkbox"/> Roads/Hauling <input type="checkbox"/> Other: Water Discharge <input type="checkbox"/> Other: Municipal

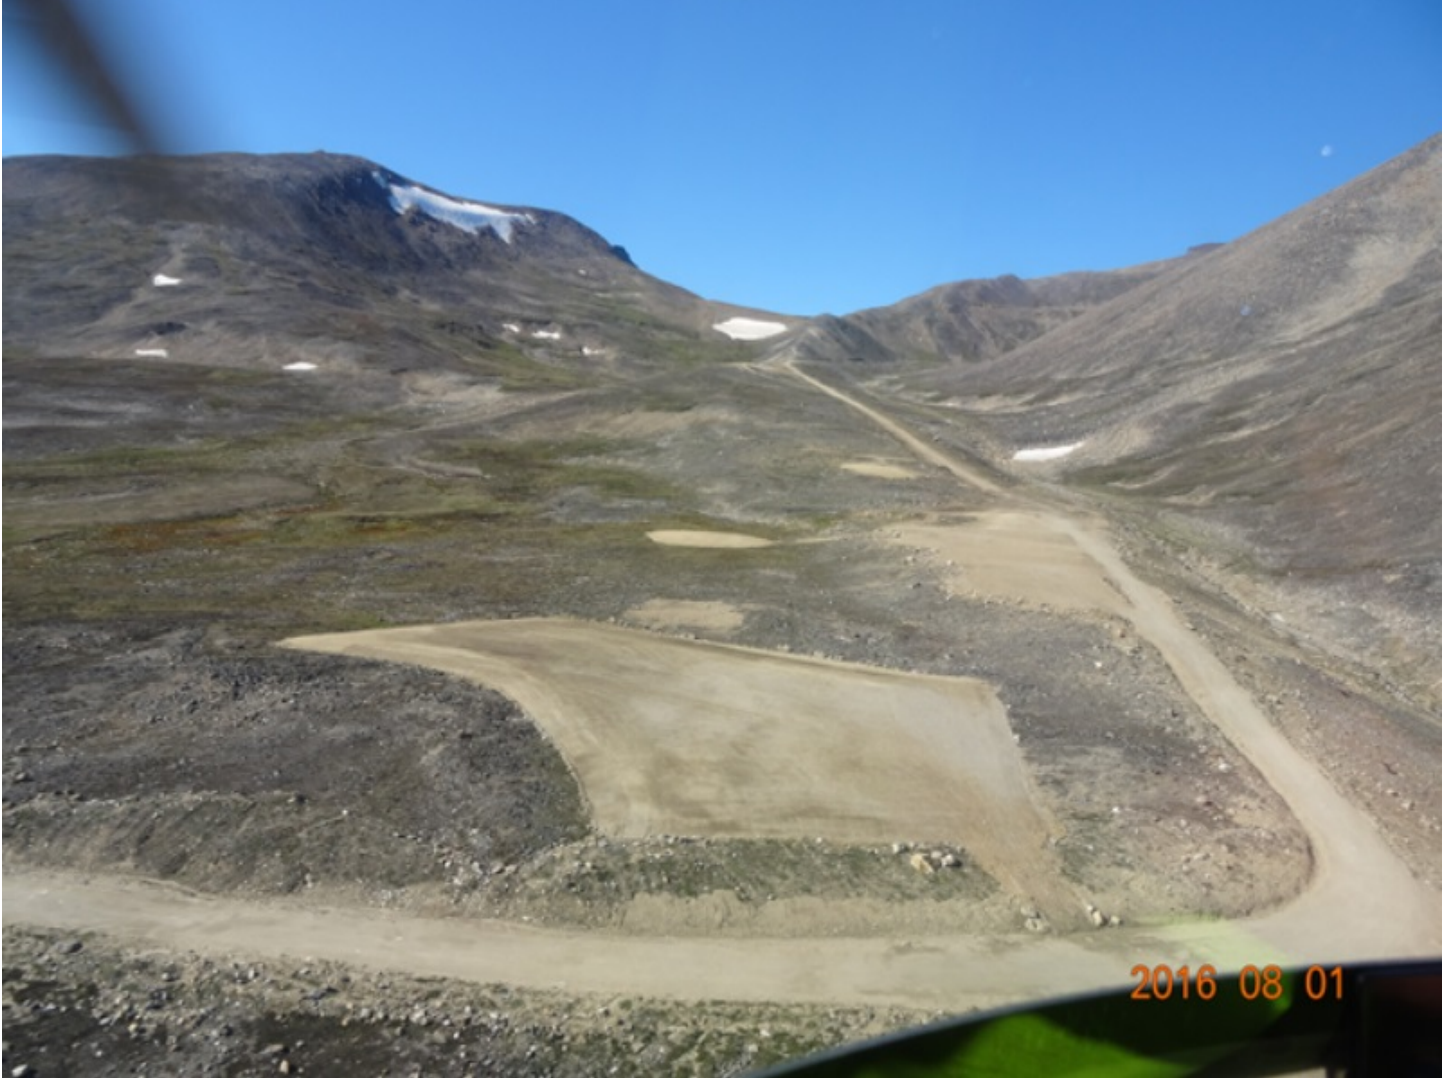
Figure 1 Durban Island - Lower site - Fuel tank pads reclaimed

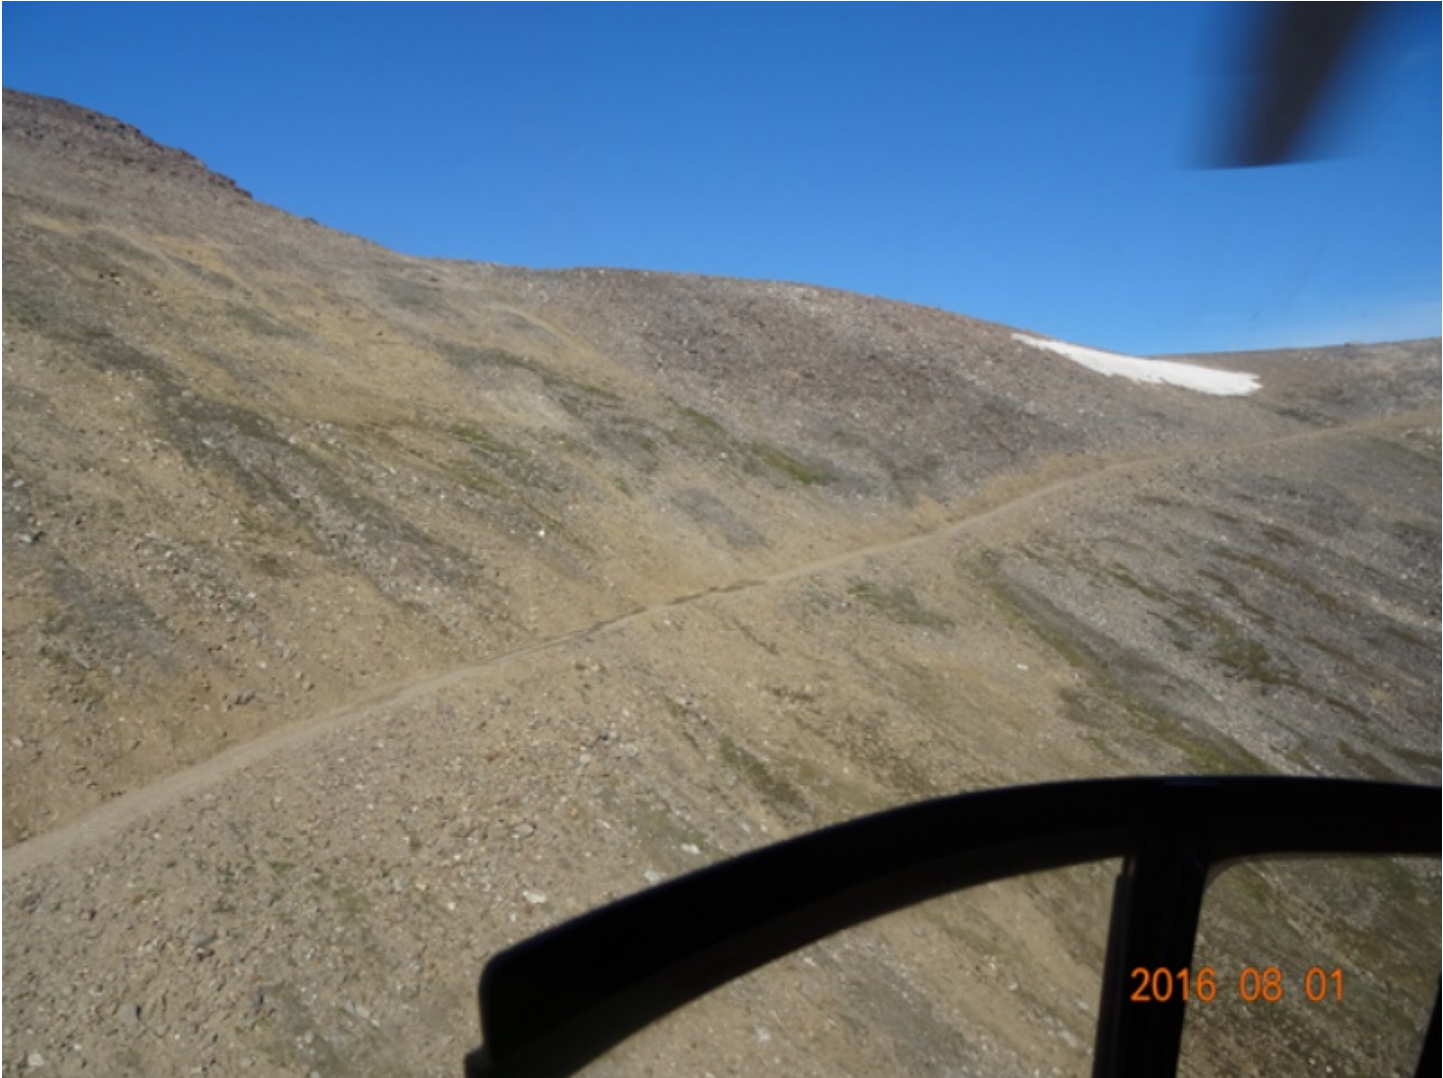
Figure 2 Durban Island. Road to upper site / summit

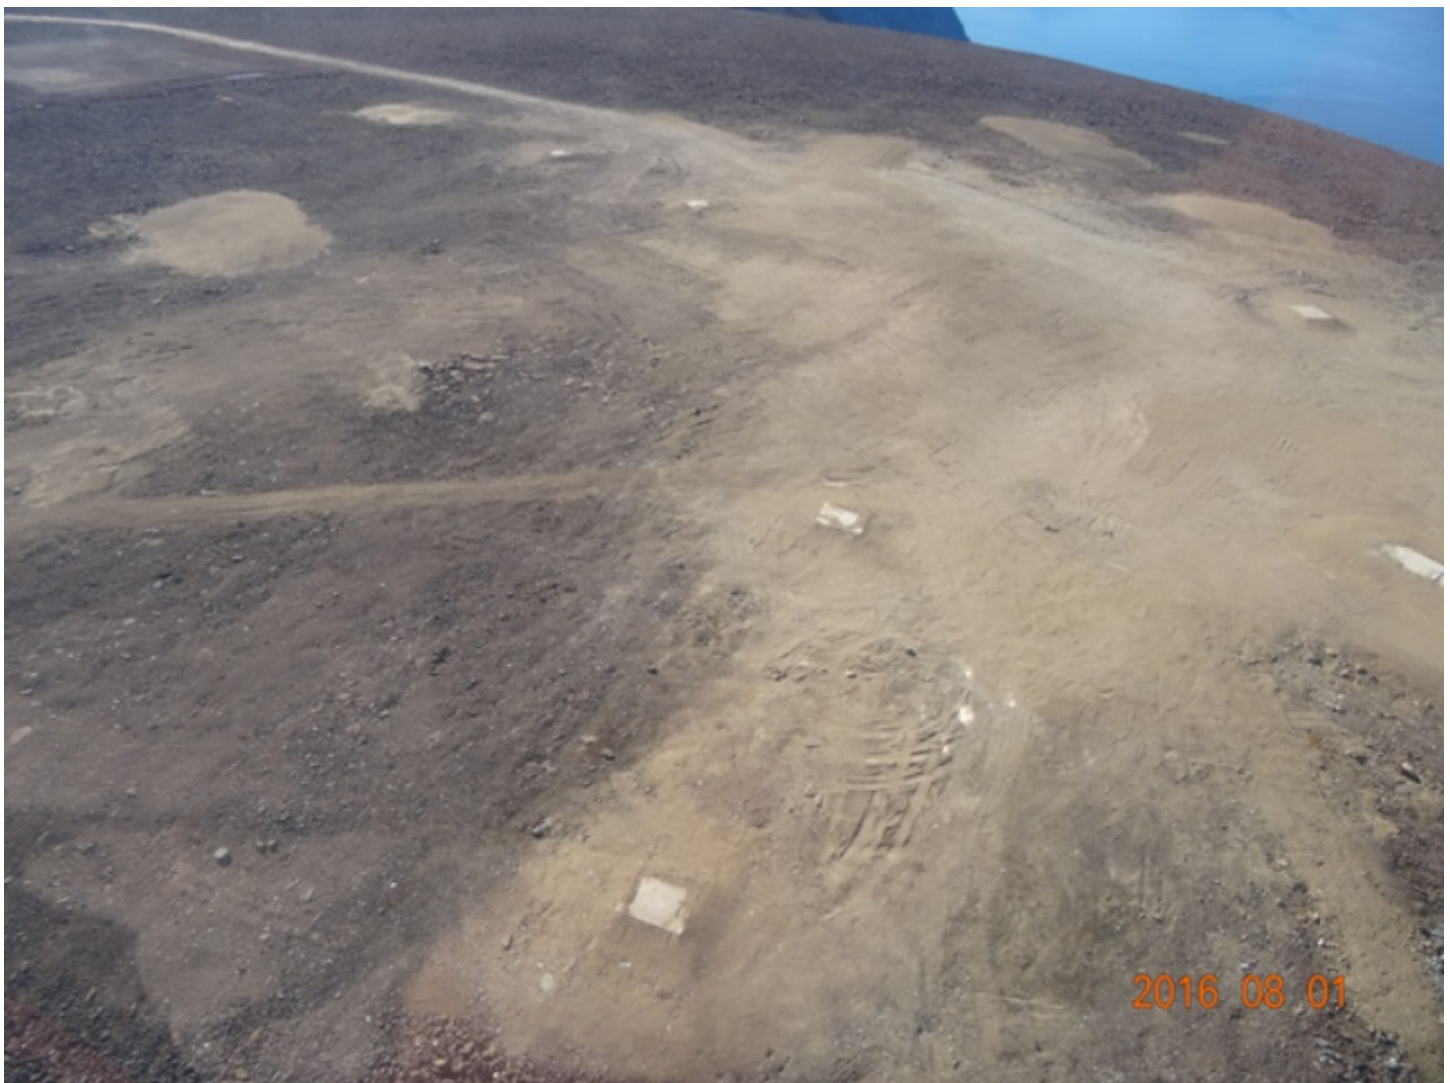
Figure 6 Durban Island Summit(4) - Note concrete pads that could not be removed

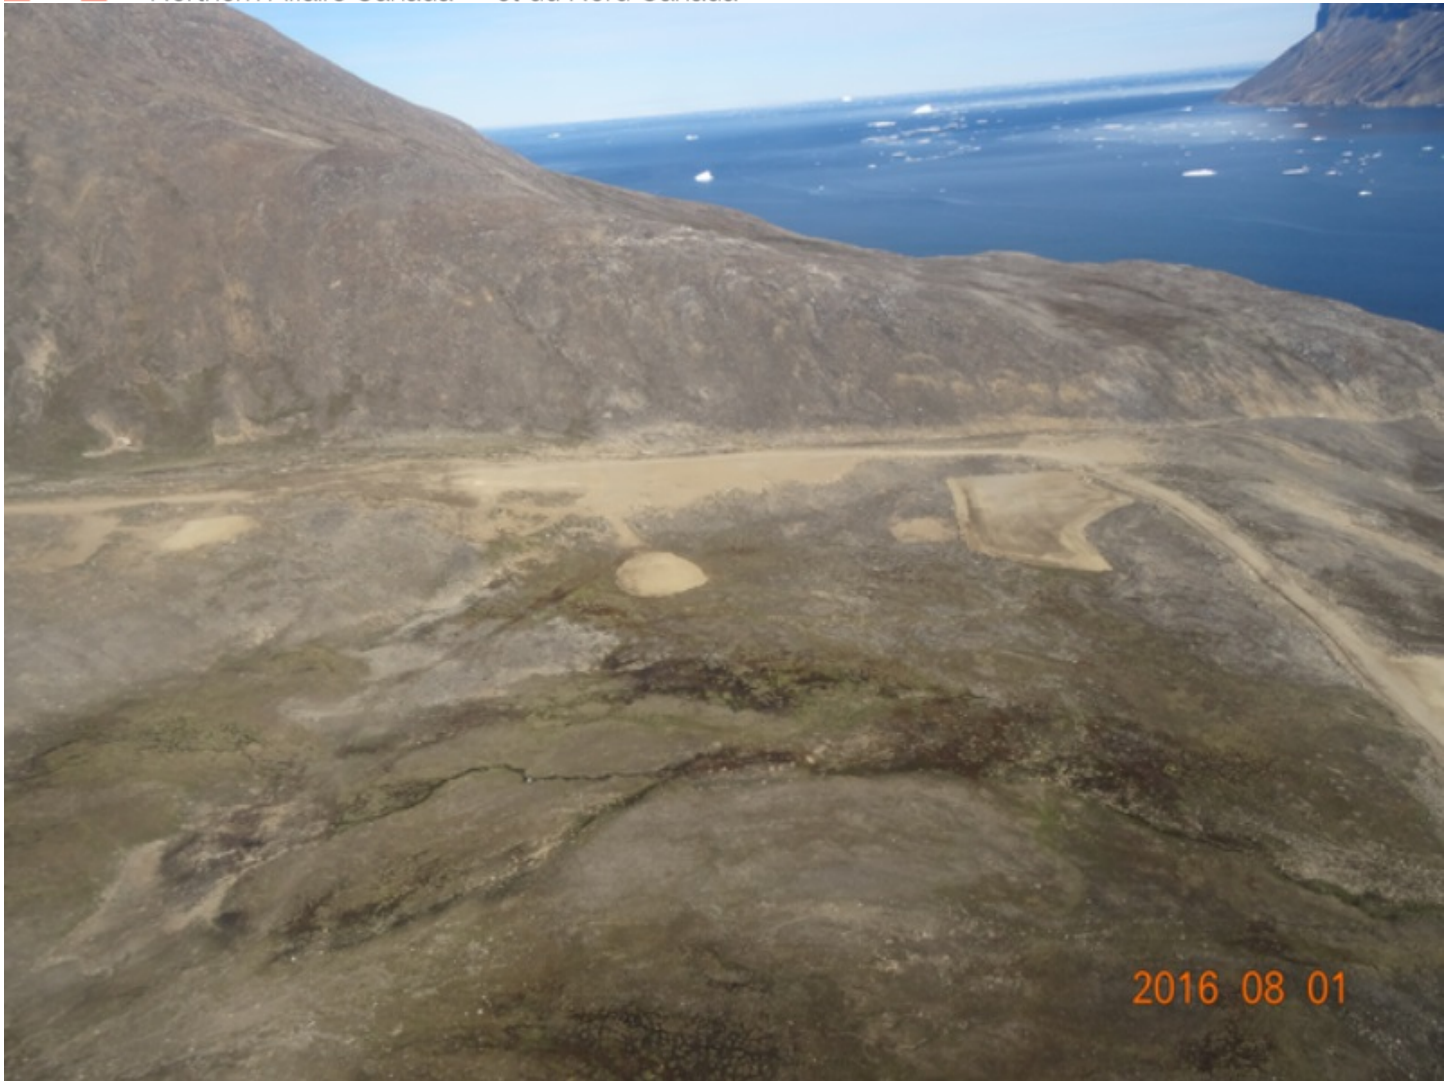
Figure 7 Duban Island - Road between upper and lower sites. note reclaimed borrows.

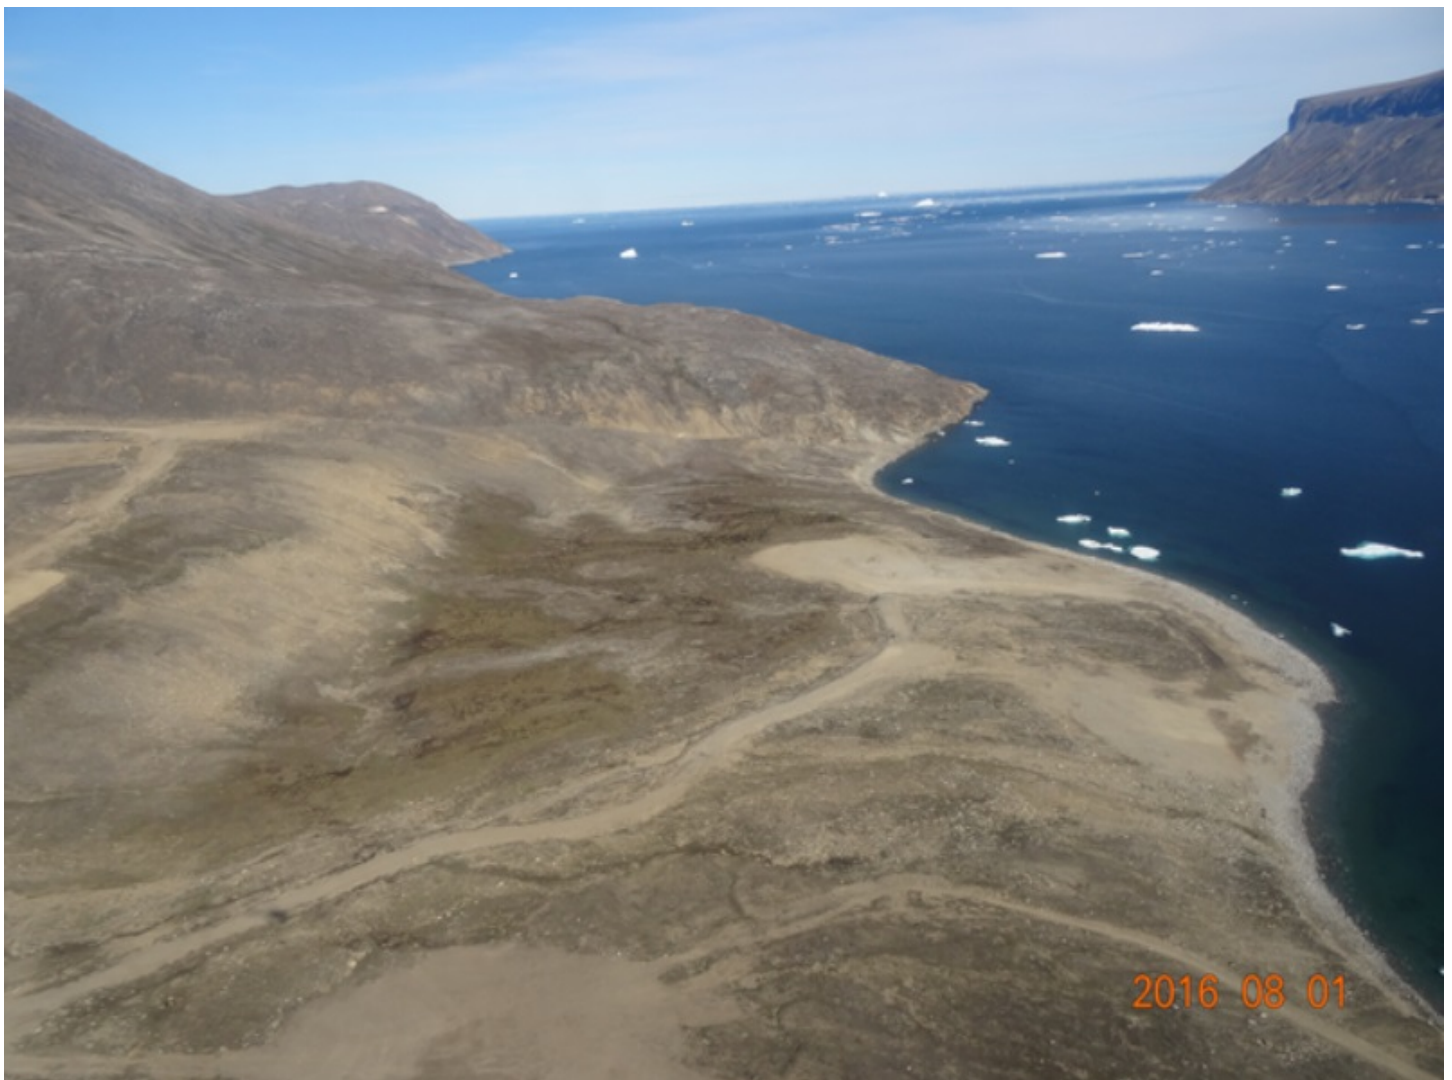
Figure 8 Durban Island - Lower site/ beachhead lay down

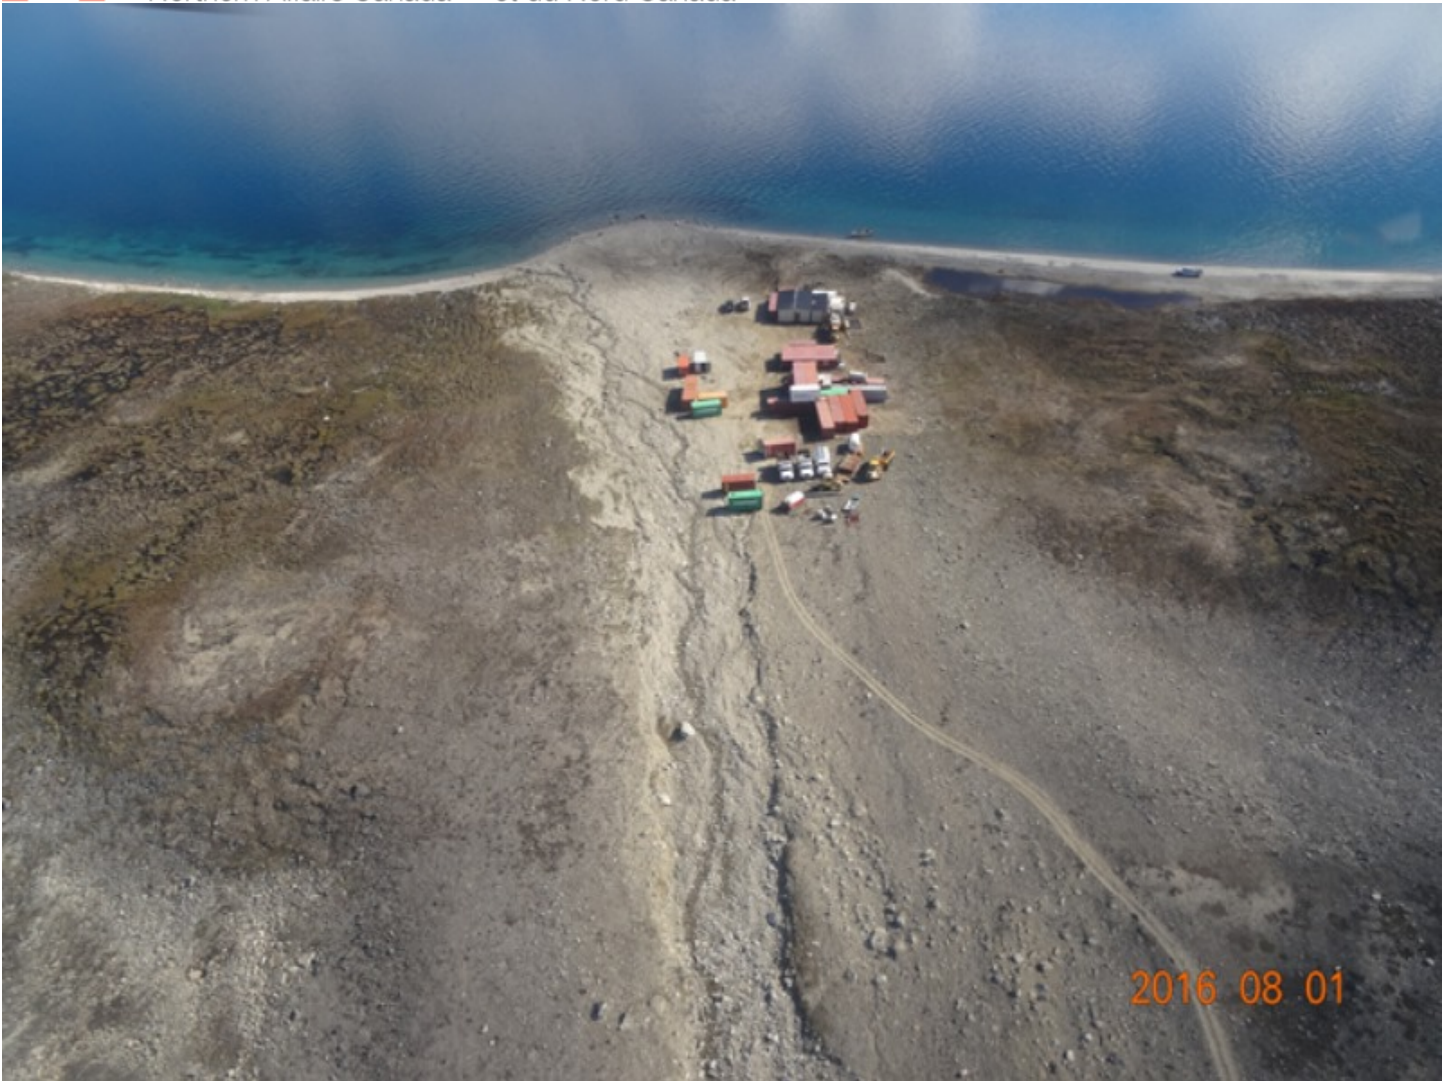
Figure 9 Padloping Island - Beach head and consolidated camp and facilities

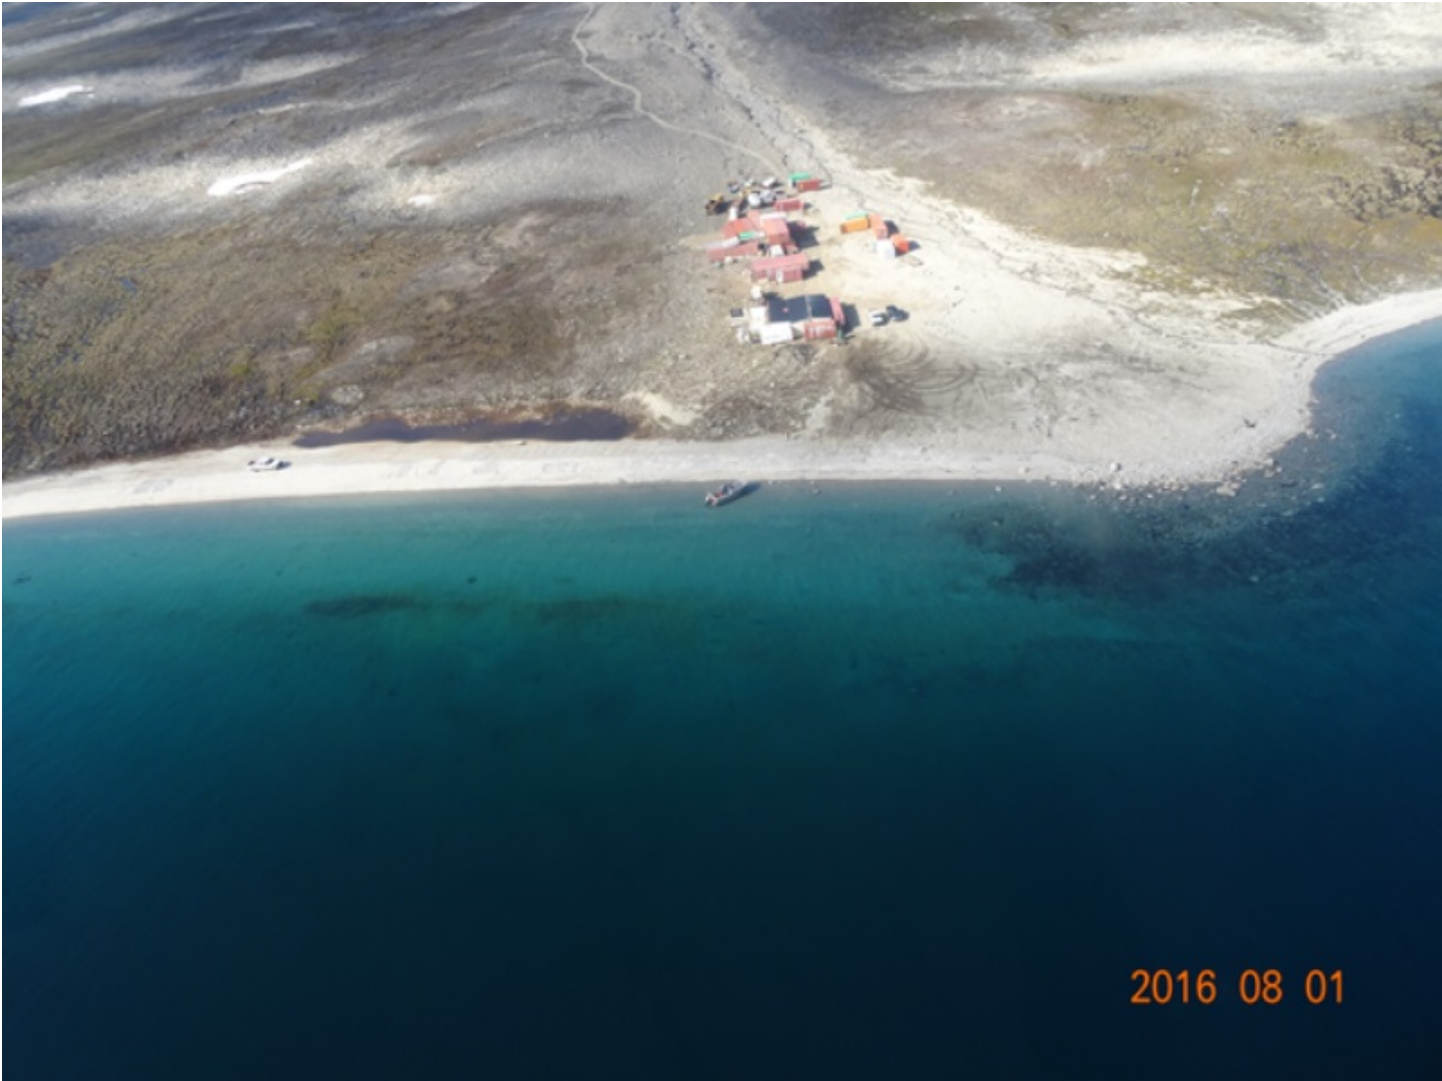
Figure 10 Padloping Island - Camp and Local Boat

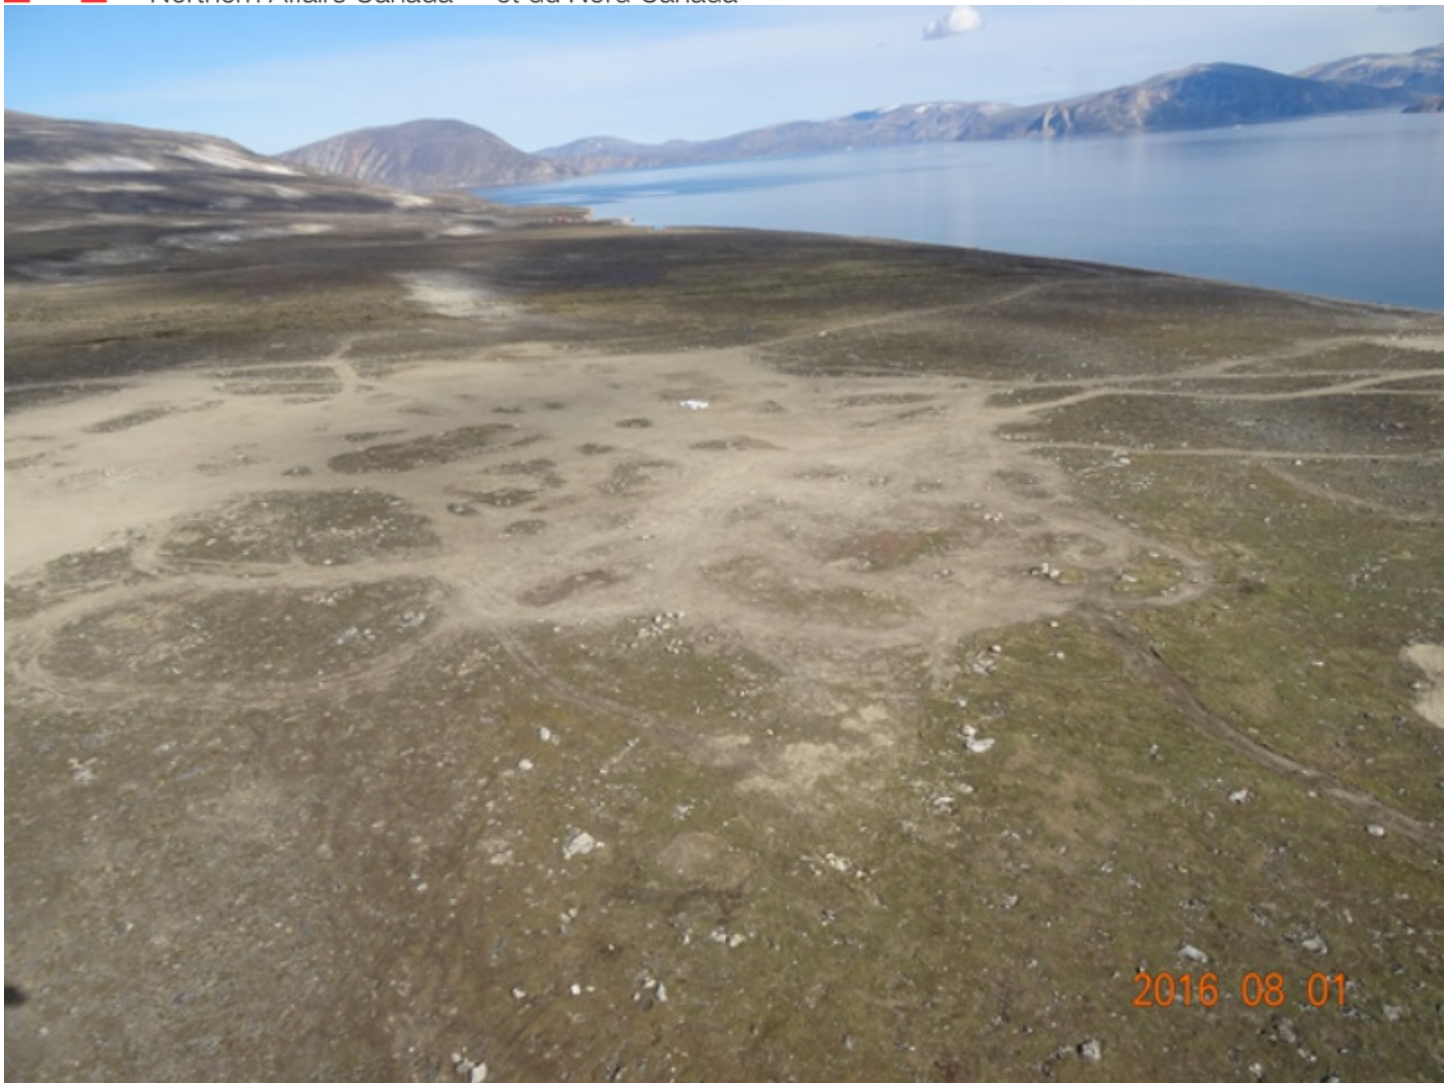
Figure 13 Padloping Island – Main camp – white bags of contaminated soils to be hauled off site.

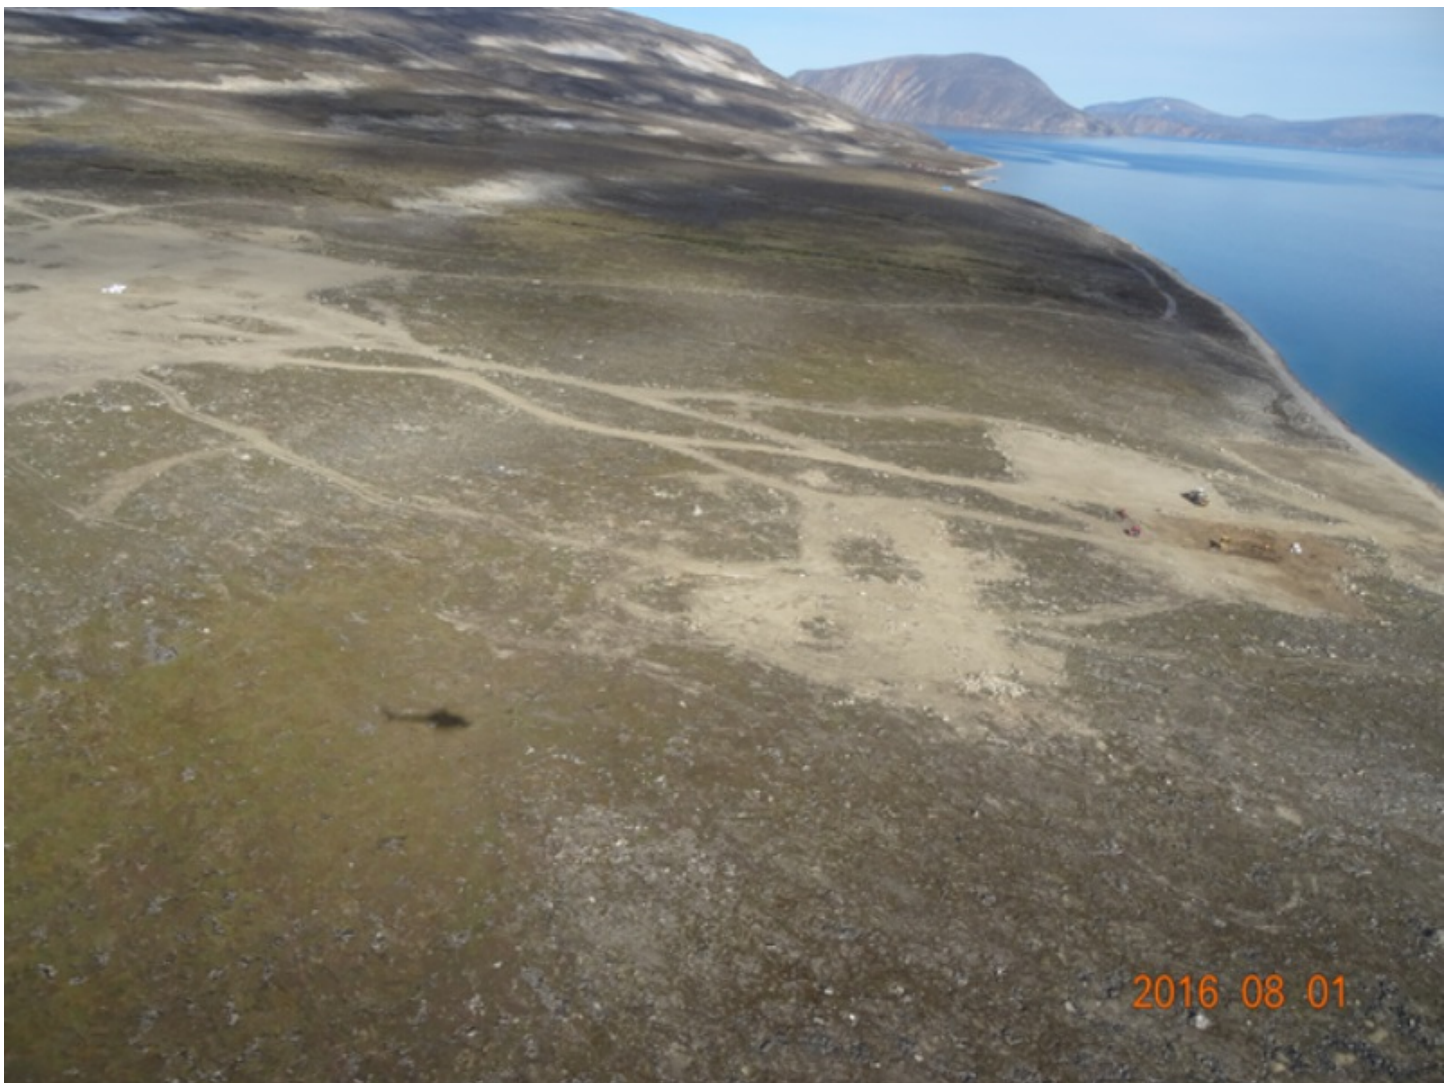
Figure 14 Padloping Island - Main camp on Left and old town site on right

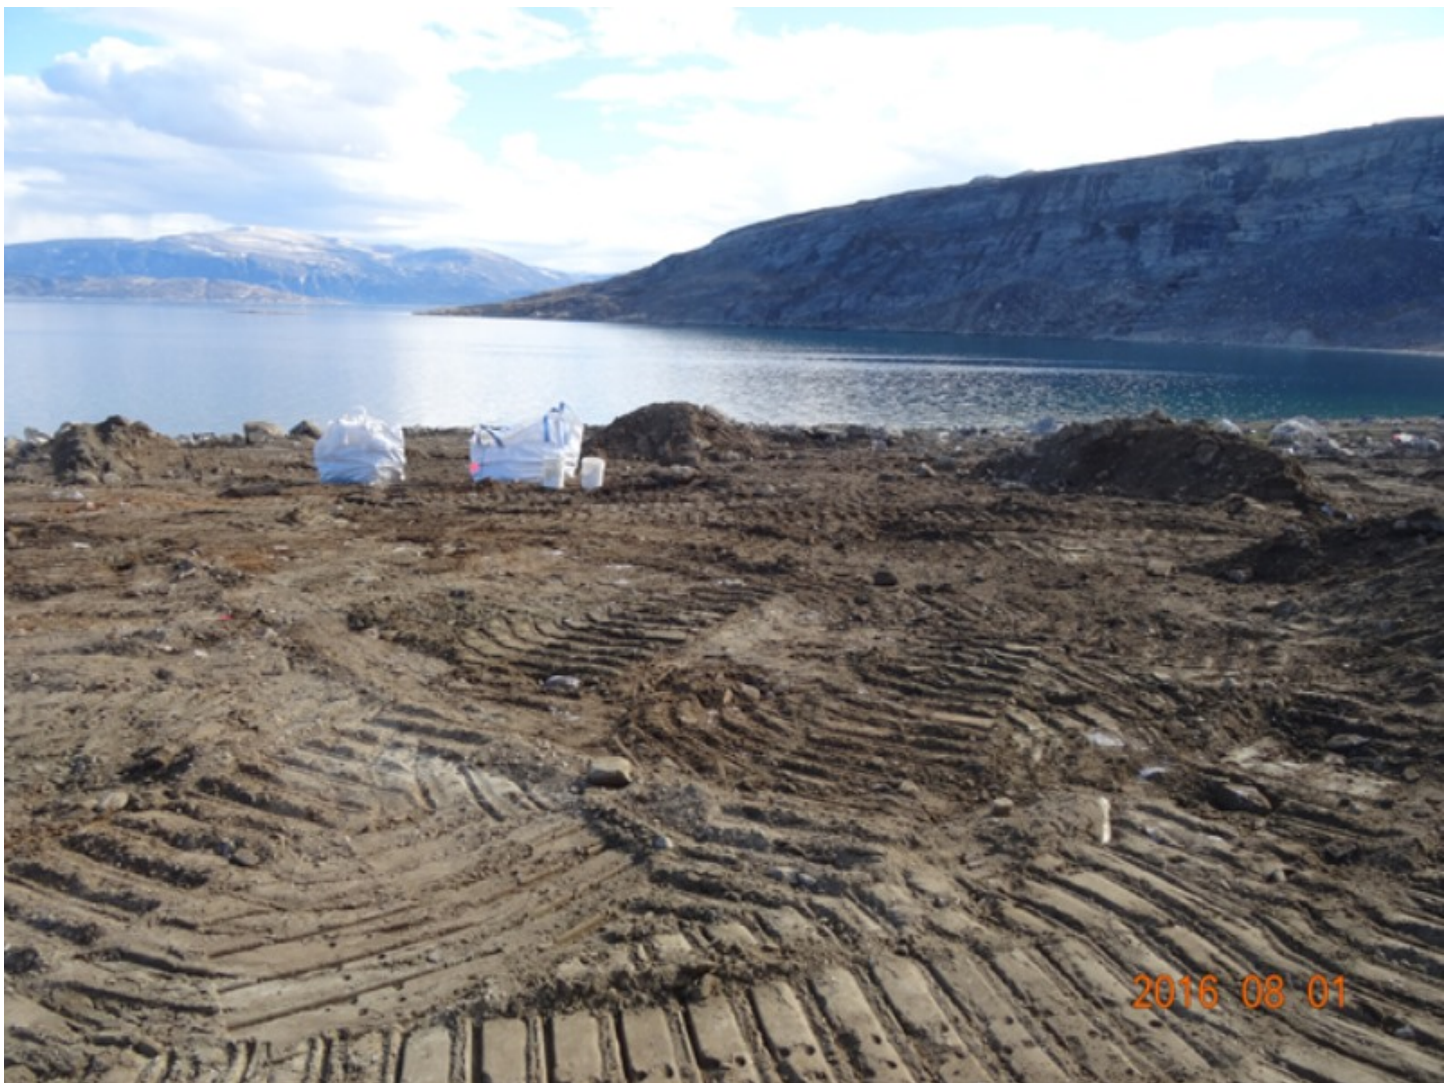
Figure 16 Clean up . last stages - metal debris is collected into bags for transport off site

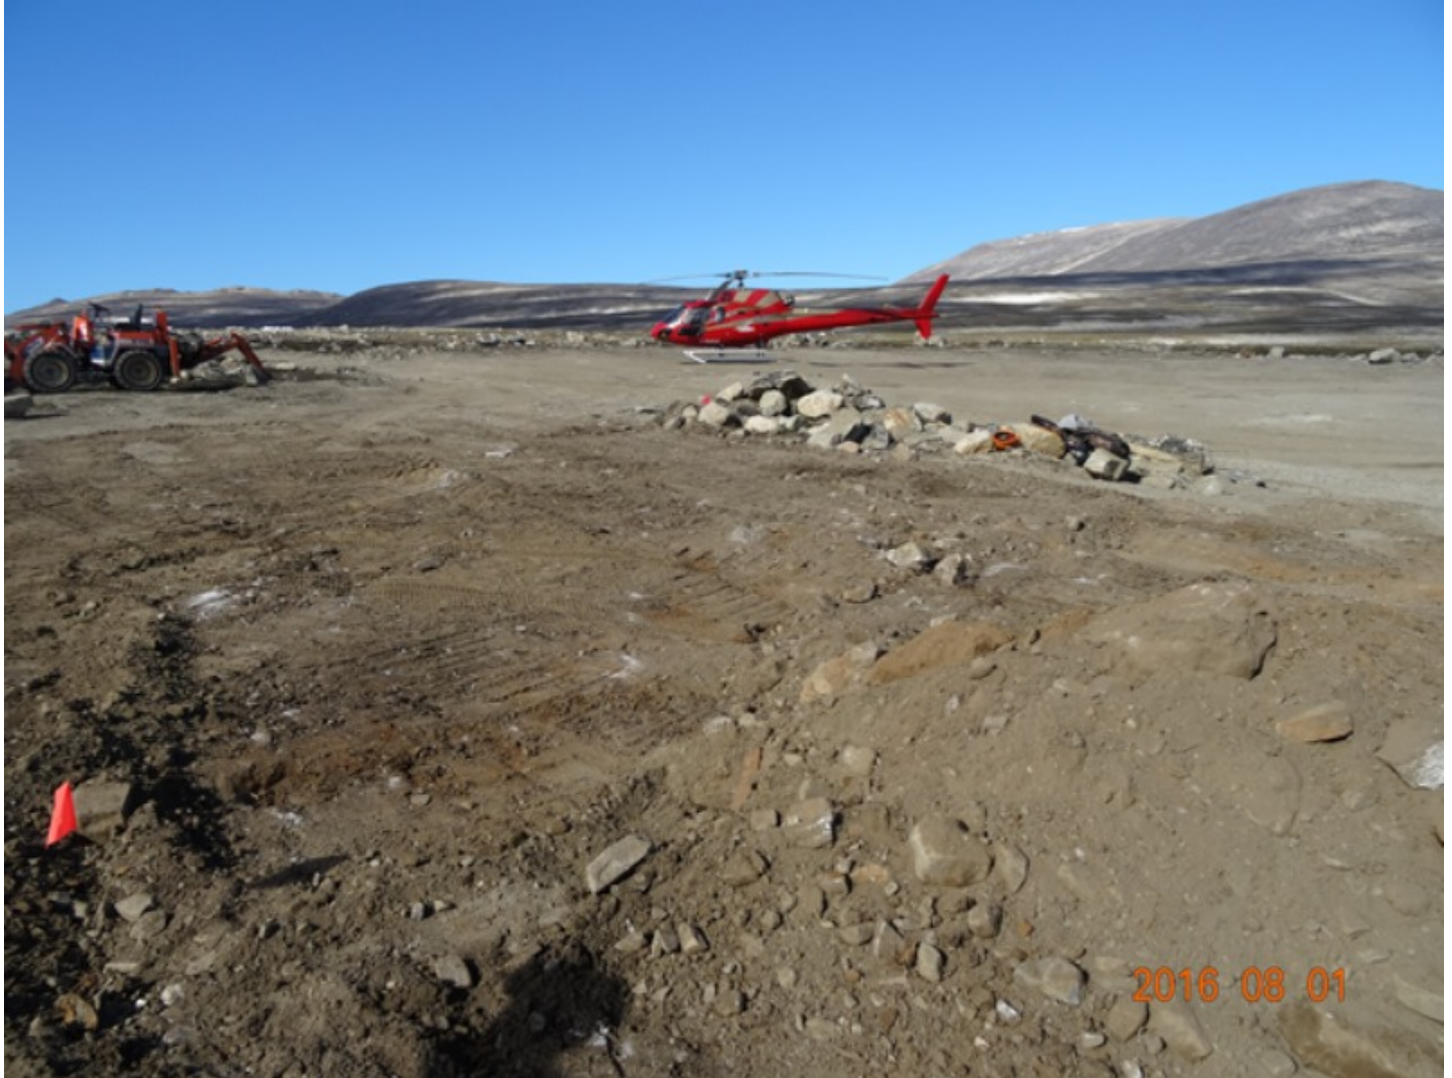
Figure 17 Padloping island final clean up

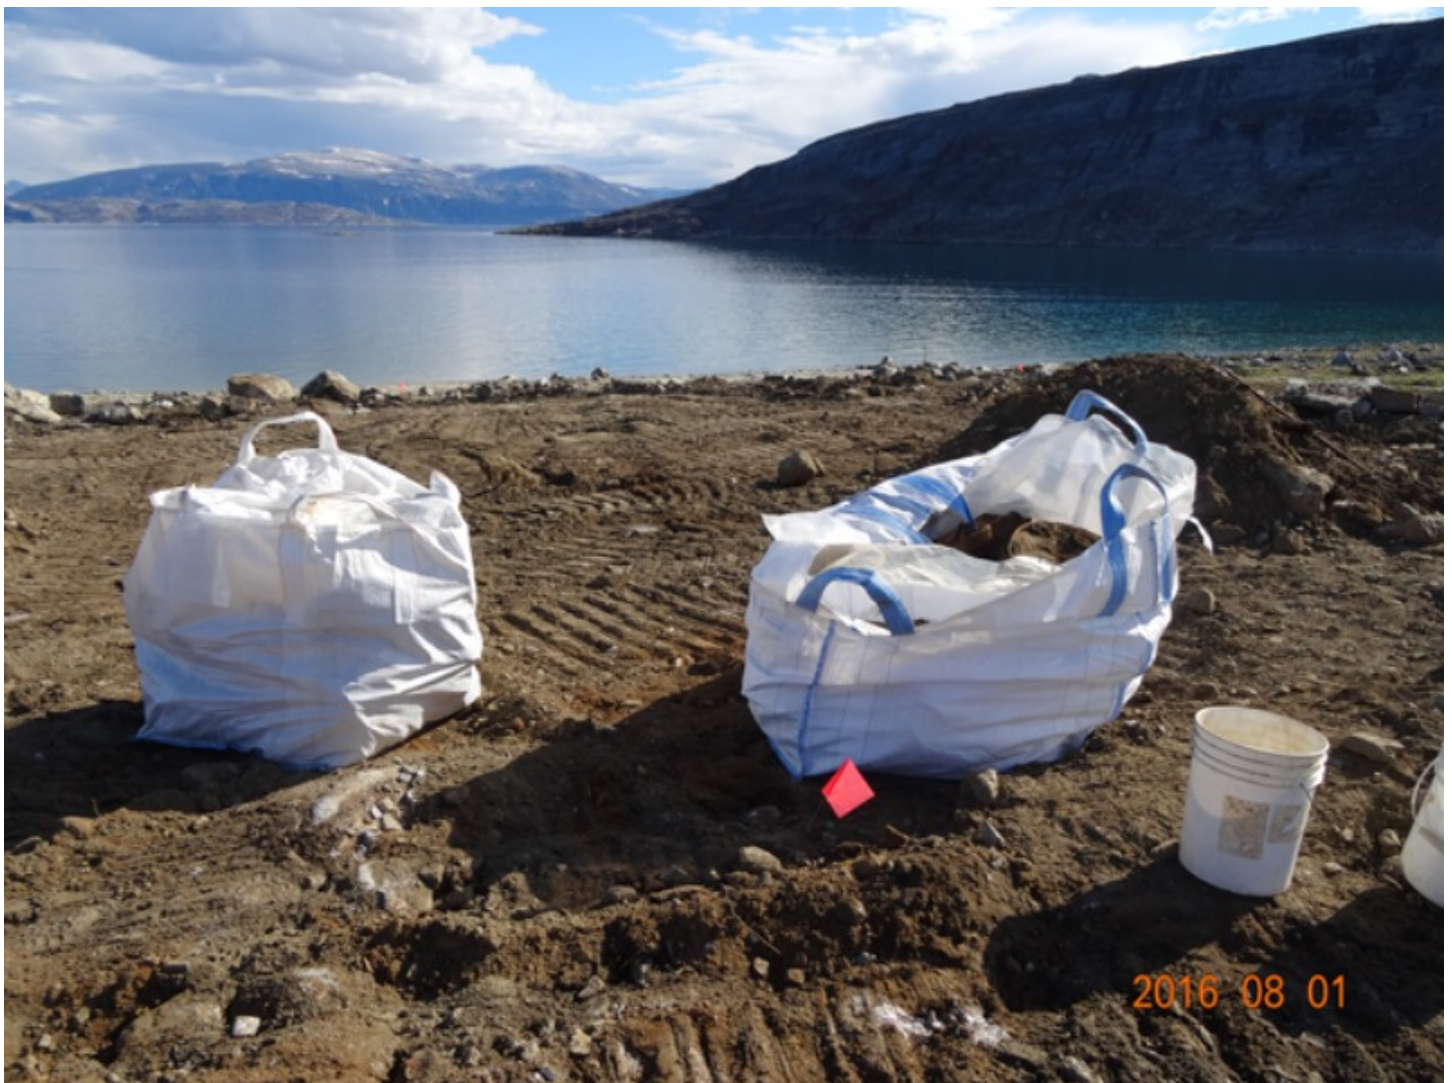
Figure 18 Padloping island - bags of metal debris
