Project Number: DYE-M (3.6)

Re: 2007 Annual Report: Water Use License #1BR-DYE0409

UMA Engineering Ltd. is pleased to submit this annual report as per the requirements of Part B.1 of water use license 1-BR-DYE0409. The report was prepared on behalf of Defence Construction Canada and the Department of National Defence.

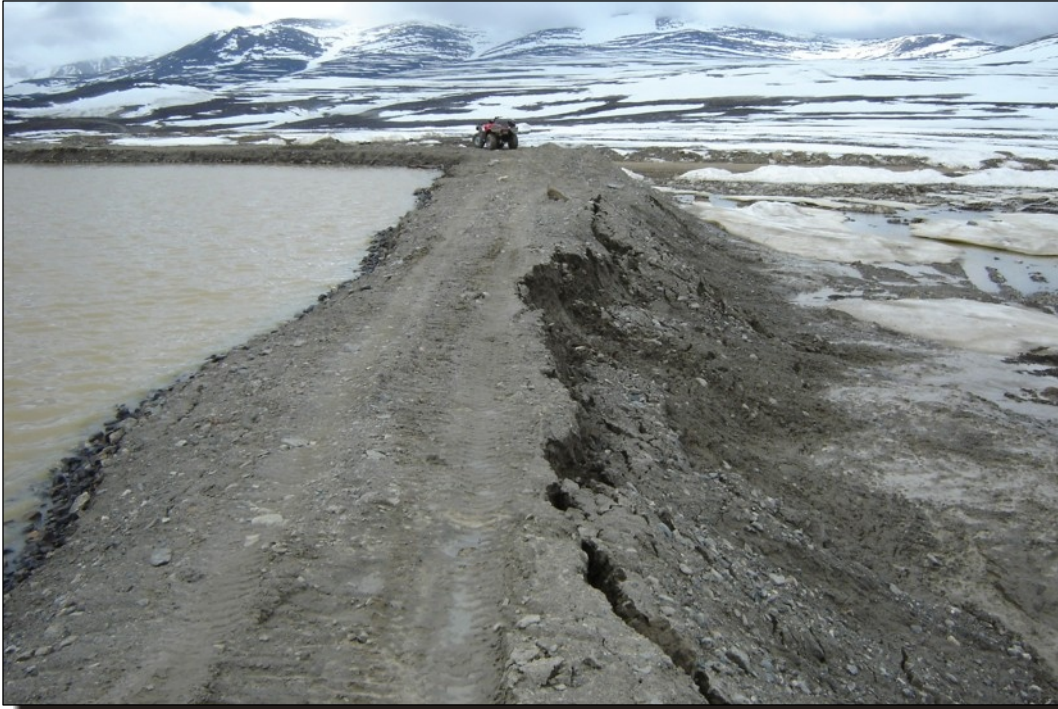
Photo 13

At the beginning of the 2007 season, the temporary containment berm began cracking due to the excess pressure from the water contained by the landfarm. The berm was reinforced and the buttress was extended to provide extra support. Additional details are provided in the attached report.

Sloughing of east landfarm berm near northeast corner. Note water level approximately 0.3 m below berm crest.
Photo taken June 27, 2007.

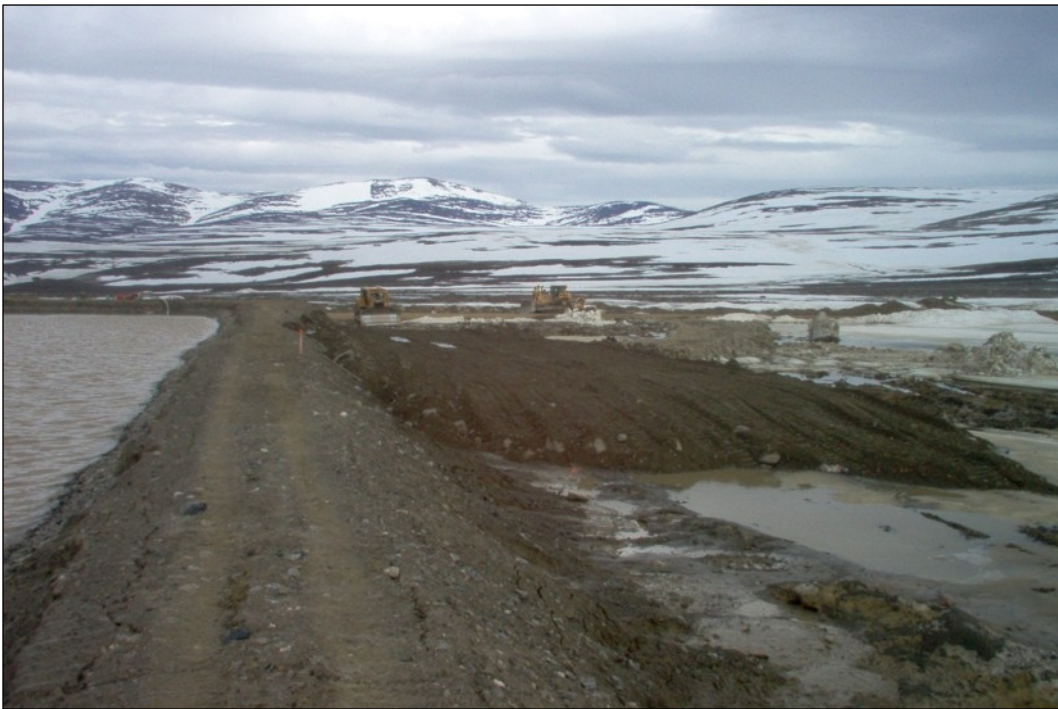
Photo 14

Completion of buttress to stabilize east landfarm berm. Photo taken June 29, 2007.

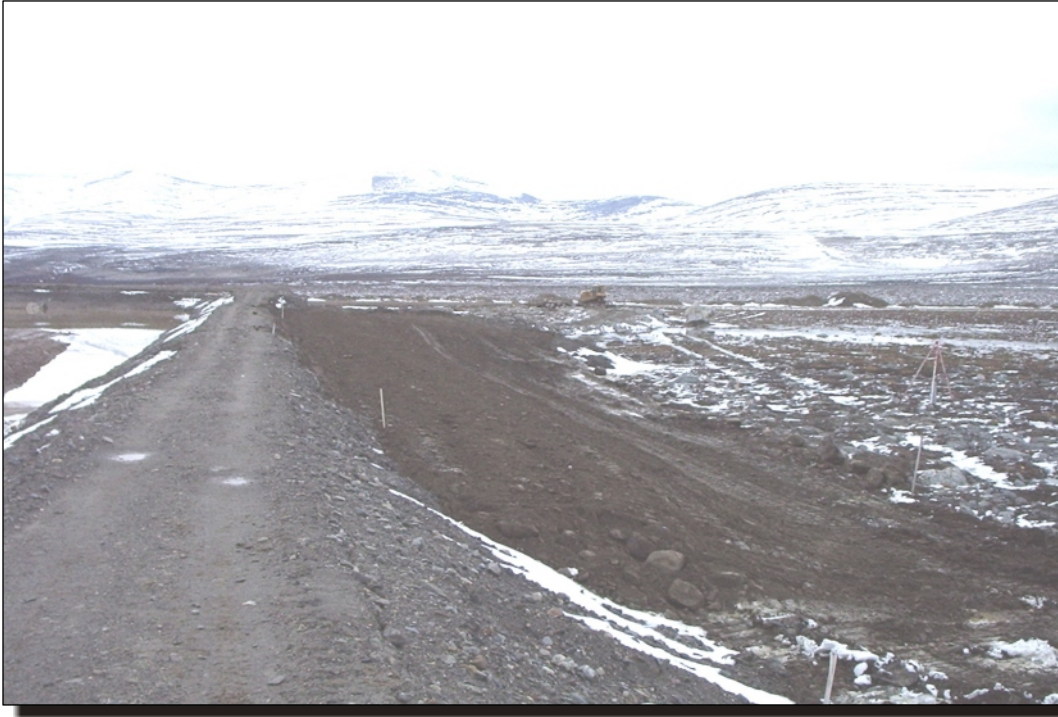
Photo 15

Completed Landfarm buttress extension. Photo taken September 8, 2007.

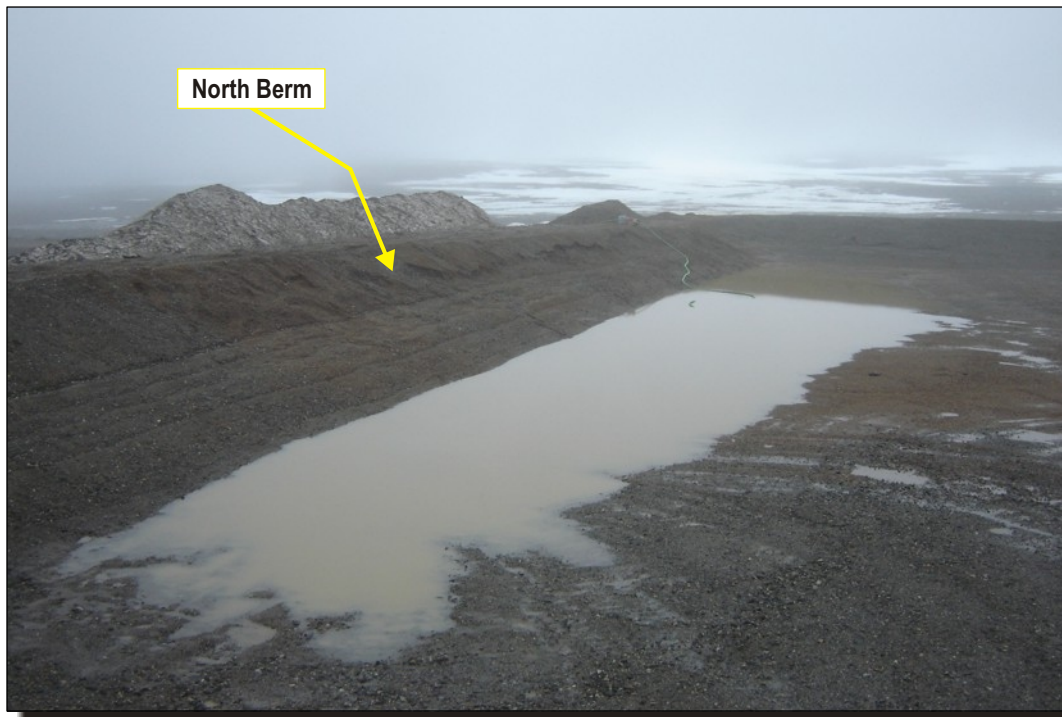
Photo 16

Sloughing of Type 5 material at the Lower Site Tier II Disposal Facility, north berm. Photo taken June 25, 2007.

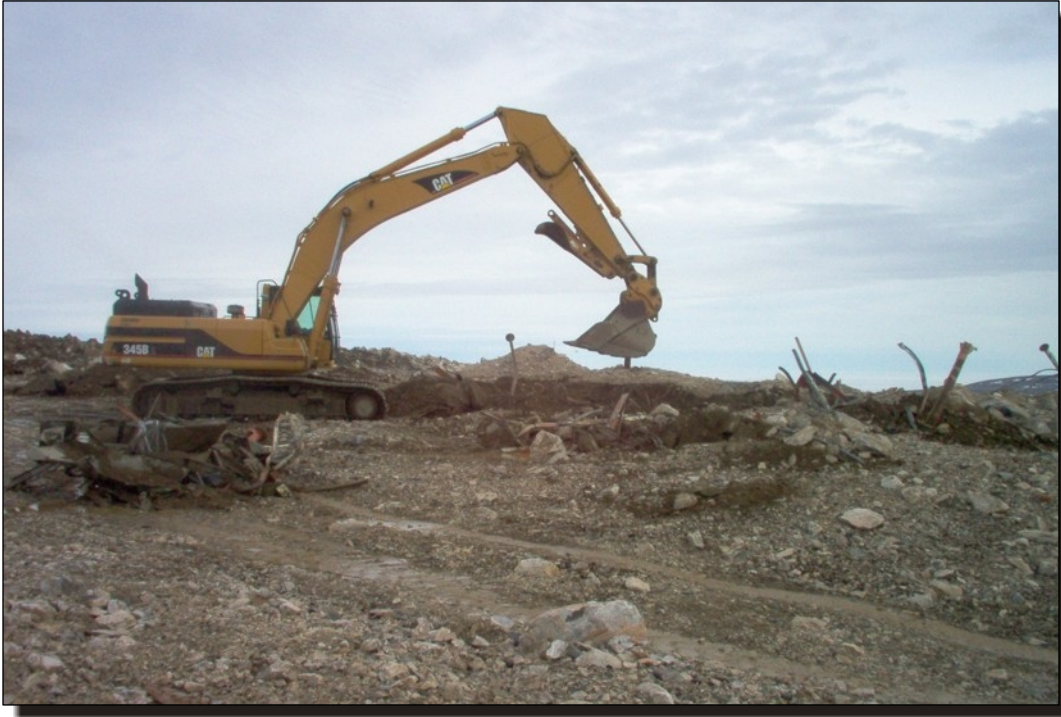
Photo 17

Removing partially buried debris from within the Upper Site tier II Disposal Facility footprint. Photo taken July 3, 2007.

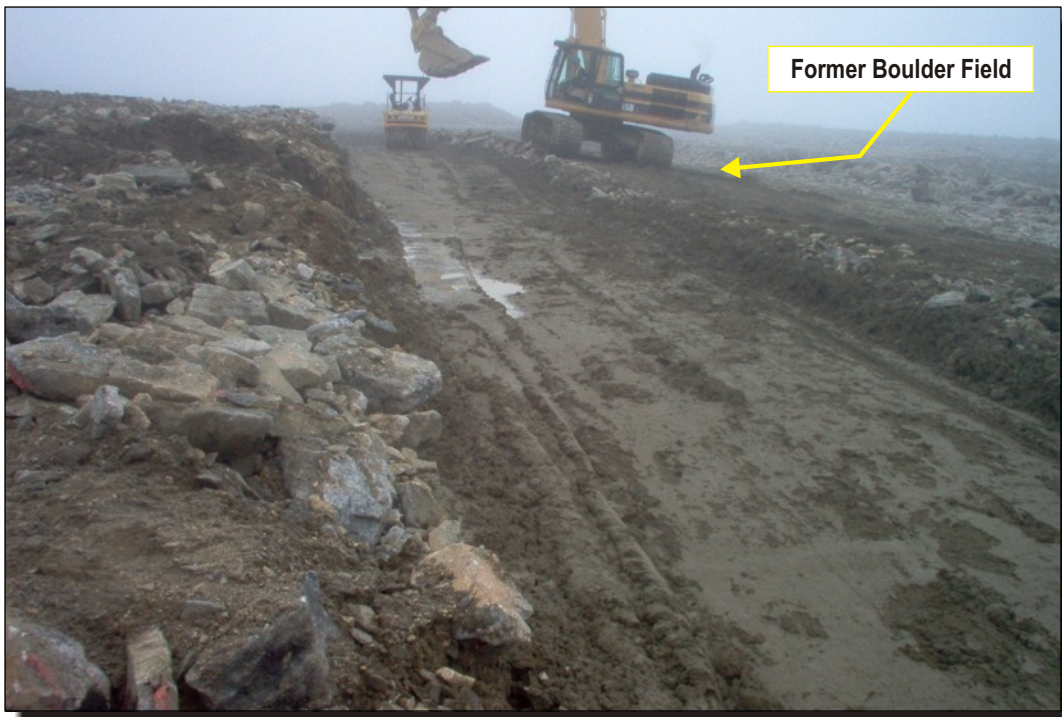
Photo 18

Placing Type 4 material in west key trench at Upper Site Tier II Disposal Facility. Note boulder field adjacent to the trench location has been removed. Photo taken July 28, 2007.

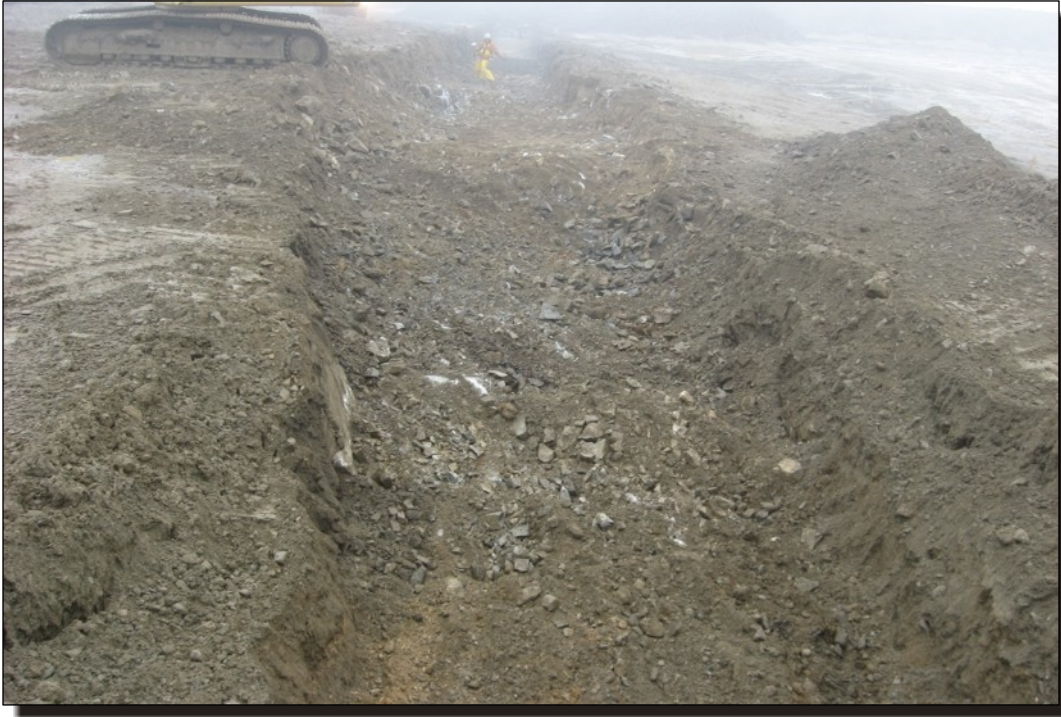
Photo 19

Upper Site Tier II Disposal Facility. Bedrock exposed during excavation of the east key trench. Photo taken August 17, 2007.

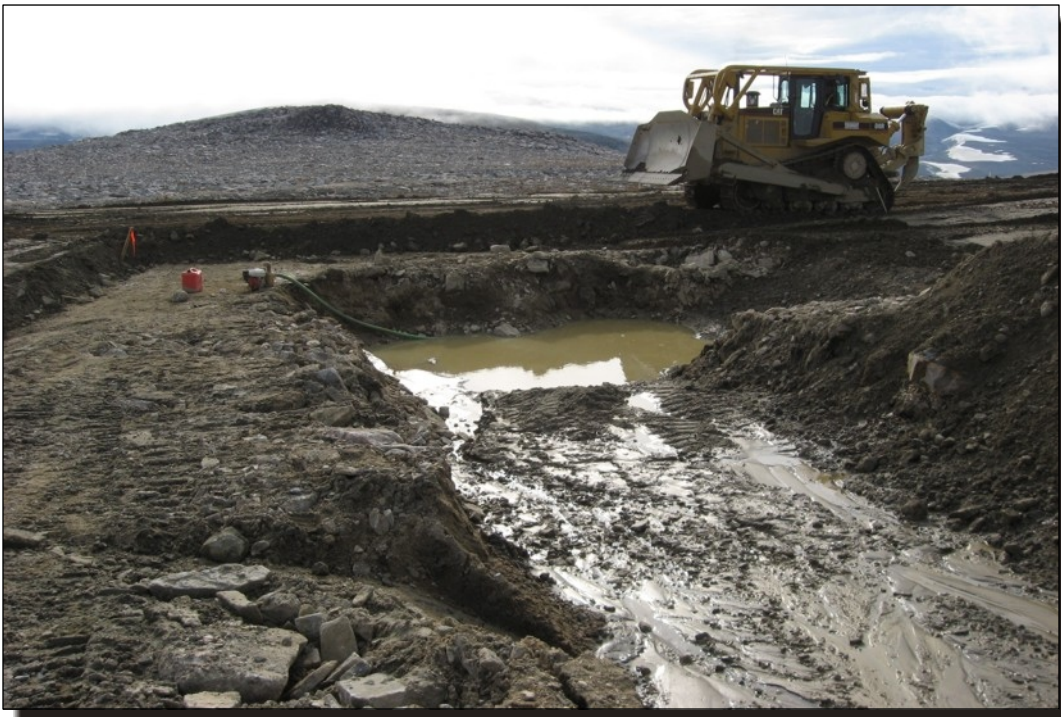
Photo 20

Upper Site Tier II Disposal Facility. Water impounding in southwest corner of the key trench excavation. Area dewatered prior to placing Type 4 granular fill. Photo taken August 7, 2007.

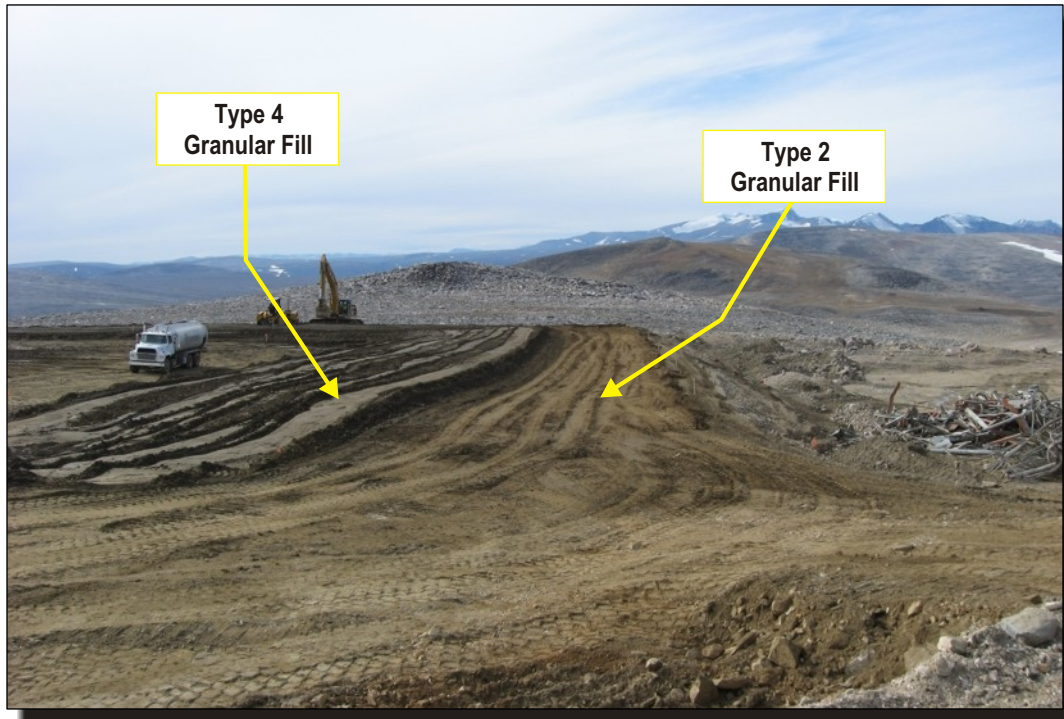
Photo 21

Upper Site Tier II Disposal Facility. Type 2 granular fill placed concurrently with Type 4 granular fill placement. Photo taken August 19, 2007.

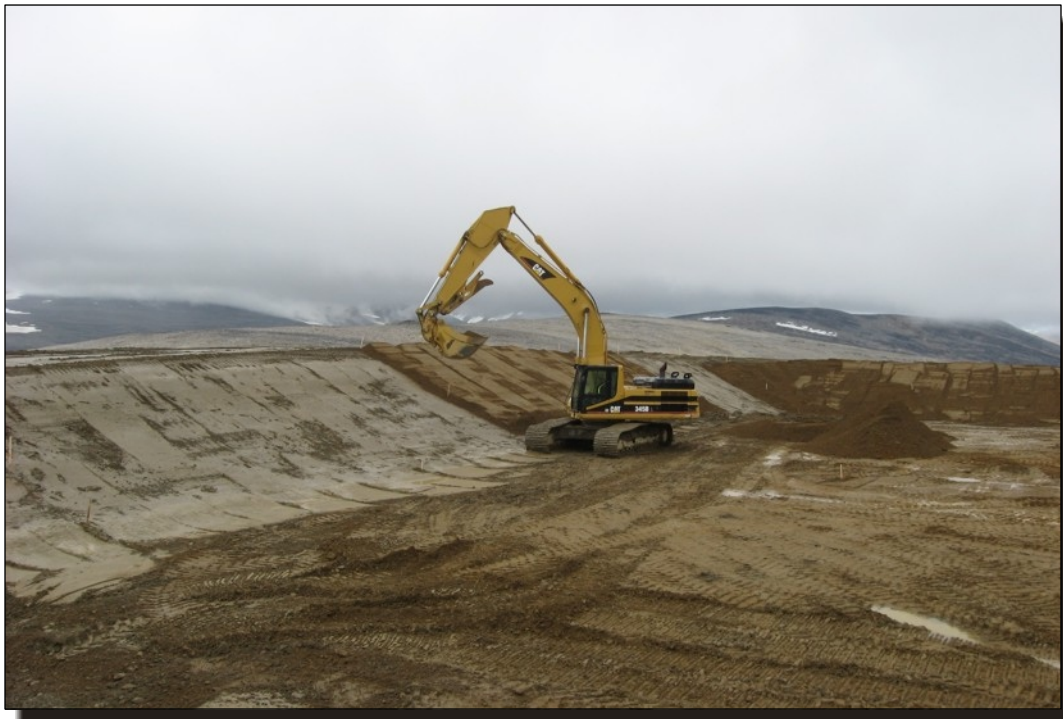
Photo 22

Upper Site Tier II Disposal Facility. Placing Type 5 material on the interior slopes. Photo taken August 17, 2007.

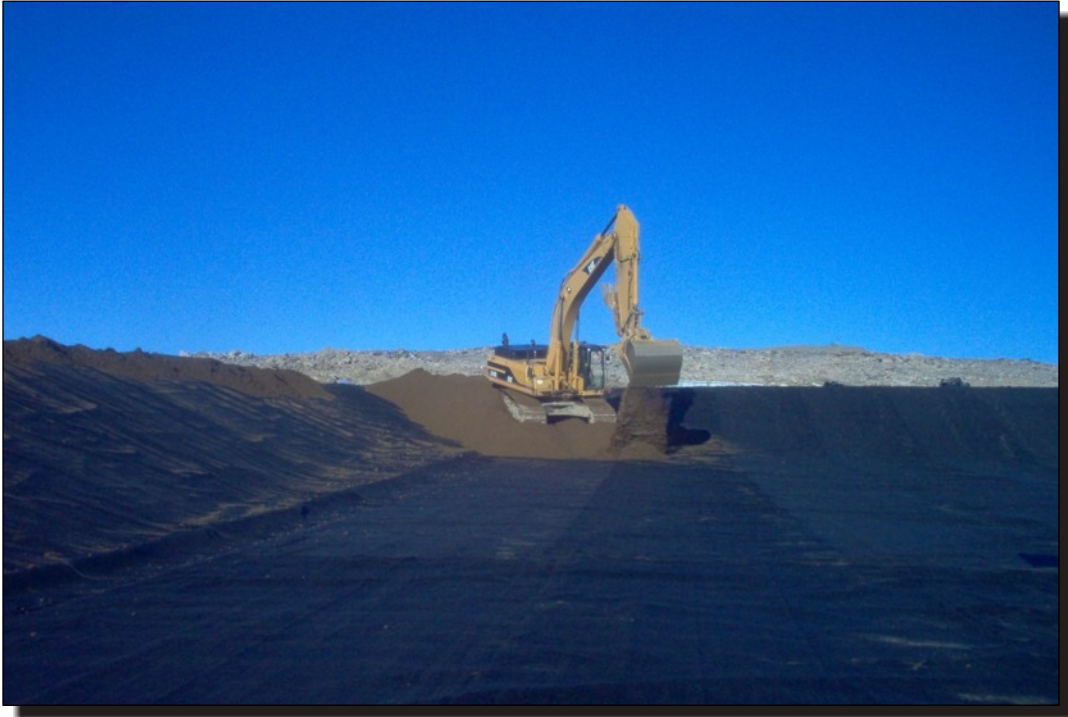
Photo 23

Placing Type 5 cover material at the Upper Site Tier II Disposal Facility. Excavator working off a thicker pad to support weight of the excavator. Photo taken August 30, 2007.

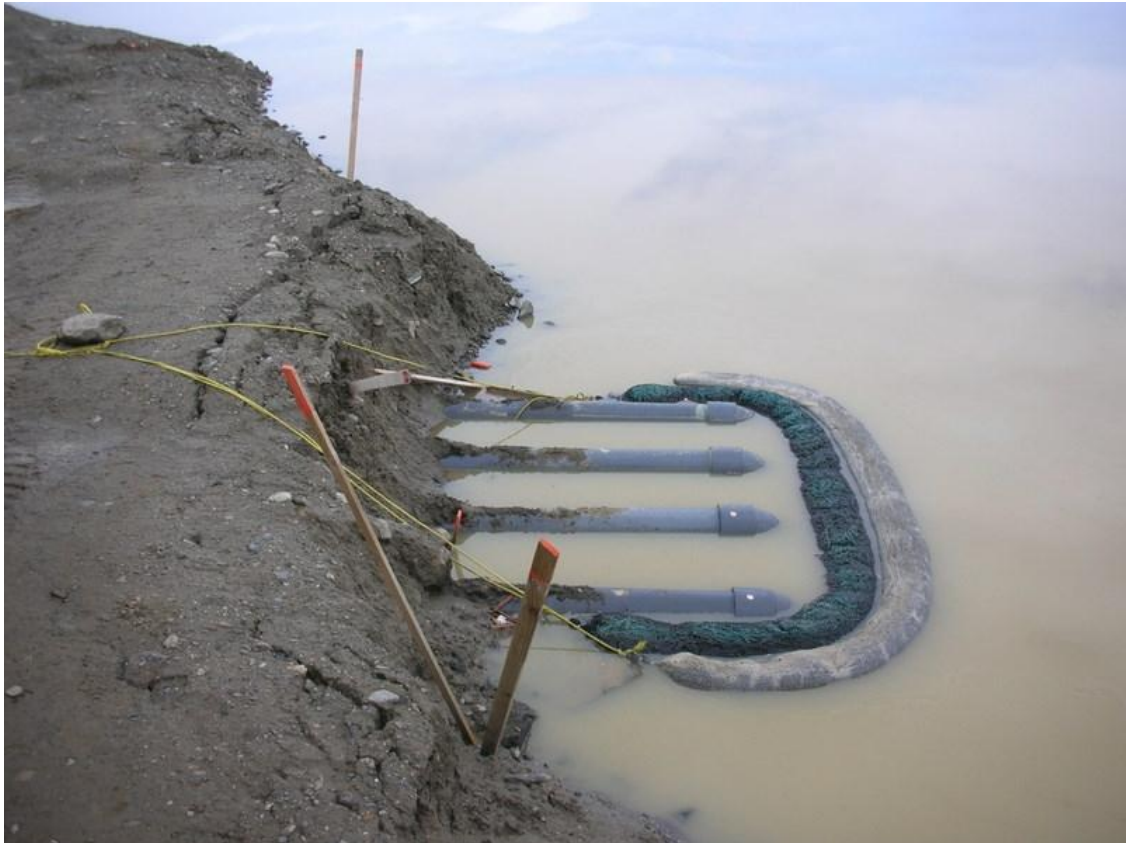
Figure 2. Photograph of oil-absorbent booms placed around intake of overflow pipes within landfarm.

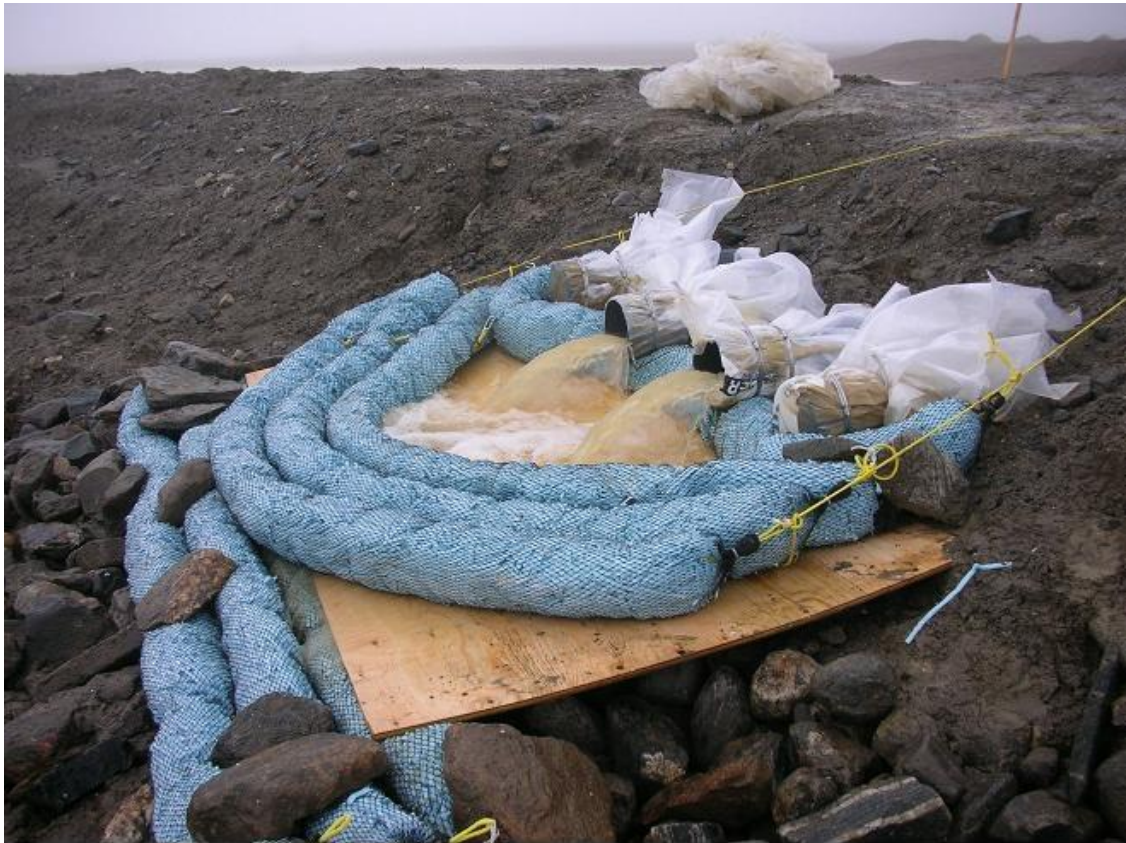
Figure 3. Photograph of oil-absorbent booms placed around discharge of the overflow pipes external to the landfarm.

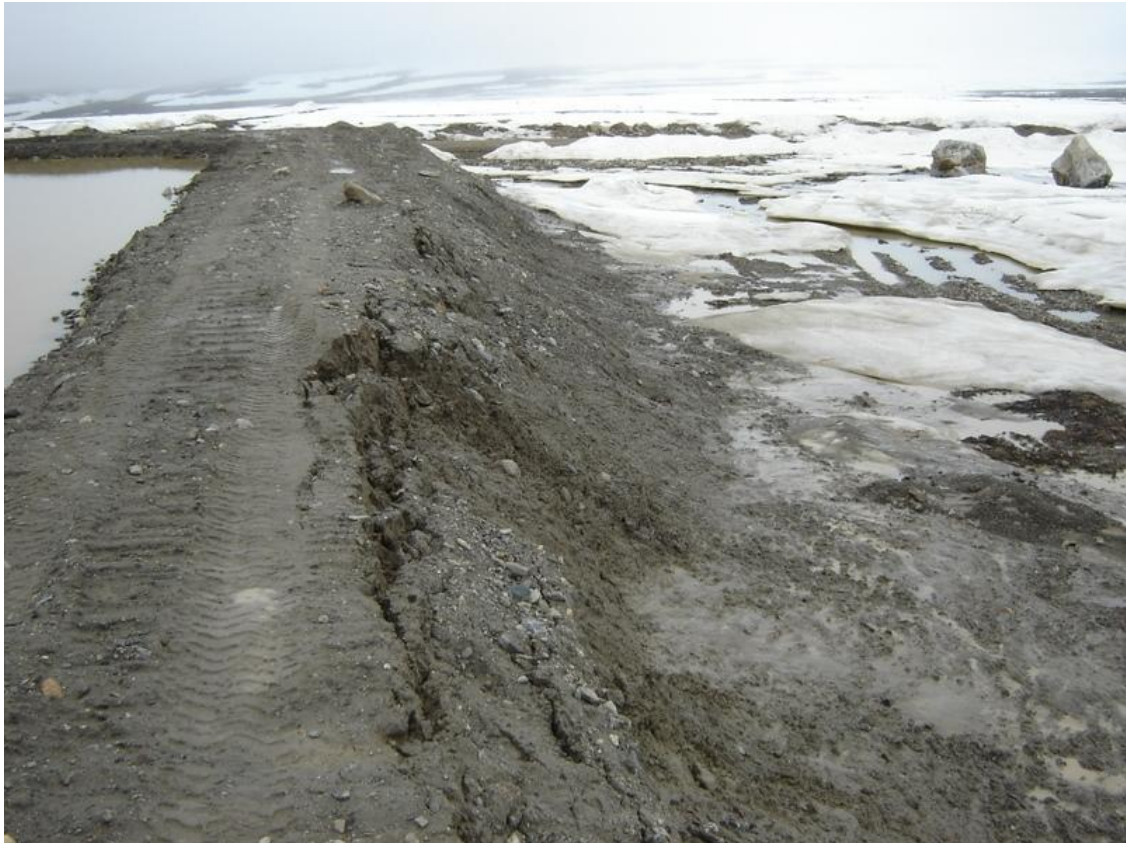
- Intermittent rainstorms kept the water level within the landfarm facility at a level that compromised the structural integrity of the berms.
- On Wednesday, EBA observed that a section of the facility's east berm had started to slough (**Figure 4**). DCC recommended to SLEC that they discharge water throughout the night.

- The high water levels put intense hydraulic pressure on the east berm of the landfarm, nearly resulting in failure of the berm (as evidenced by the sloughing and crack formation along the structure).

Figure 4. East berm of landfarm facility exhibiting sloughing on the outer side.

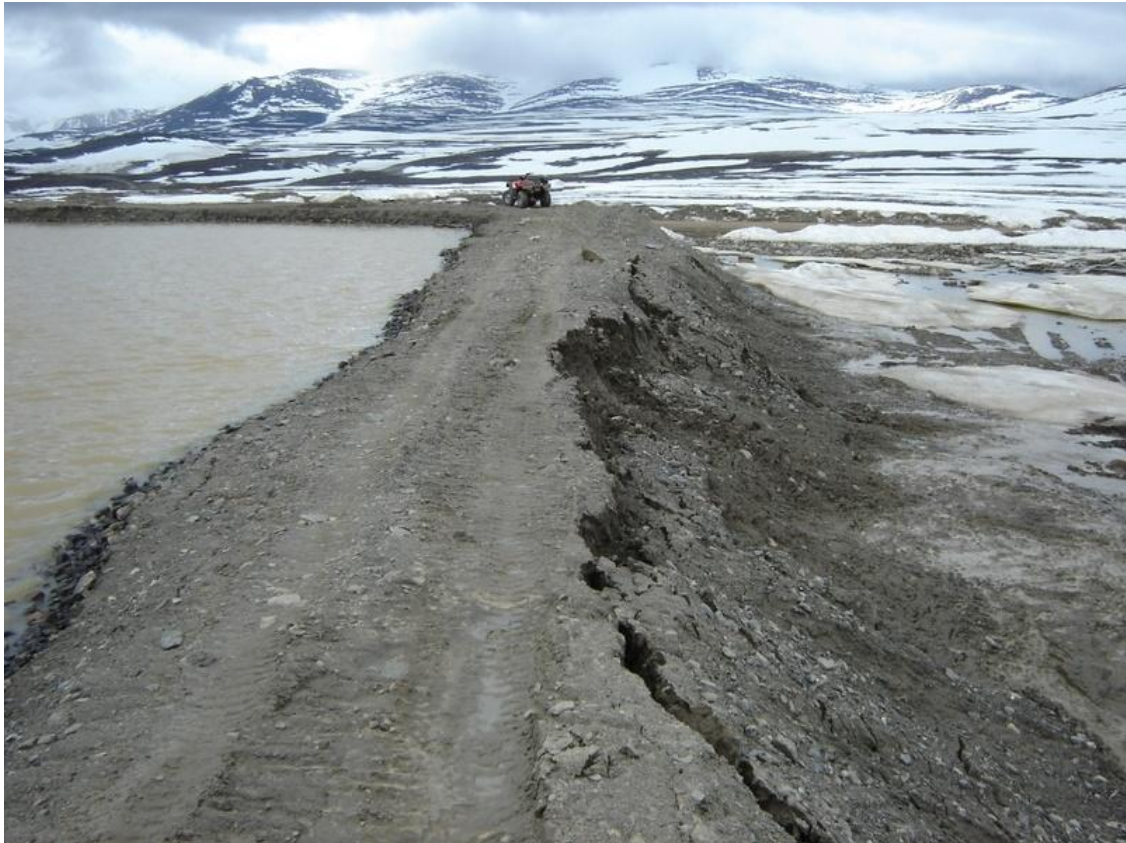
- Thursday afternoon, the EBA Geotechnical engineer observed the formation of a crack on top of the east berm (**Figure 5**), and indicated that the risk of berm failure was imminent unless immediate action was taken to reduce the hydraulic pressure on the berm. DCC/EBA recommended that SLEC take action to discharge the water at the maximum capacity, and to stabilize the berm. SLEC placed material behind the berm to stabilize it. Three pumps (two 2" and one 4" lines) were utilized to reduce the water volume. Absorbent booms were placed at the pump discharges.

Figure 5. East berm of landfarm facility exhibiting cracking.
