Re: 2008 Annual Report for Water Use License 1BR-DYE0409: DYE-M, Cape Dyer DEW Line Site

# **1BR-DYE0409: Executive Summary**

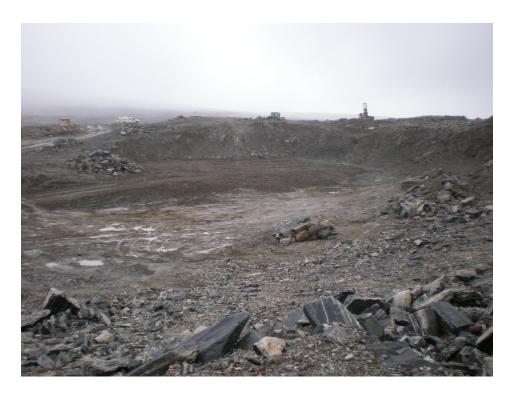
**Photograph 1.** Lower Camp Landfill East – Landfill Excavation.

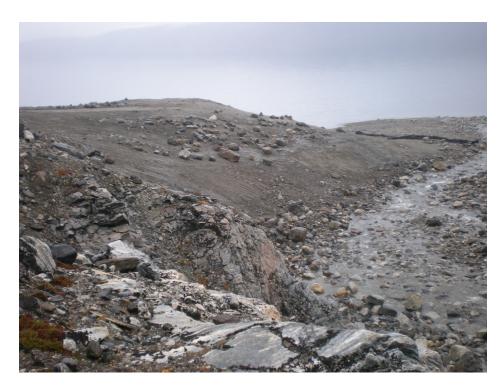
**Photograph 2.** Beach Landfill North – Completed Landfill Excavation.

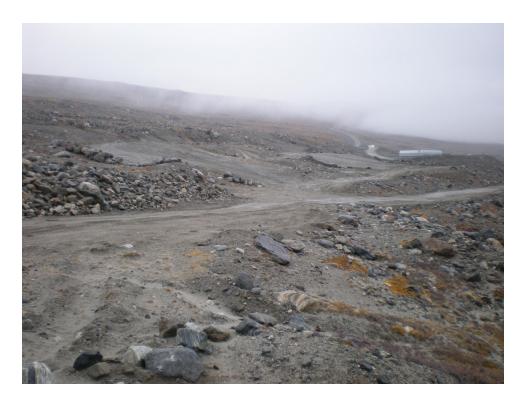
**Photograph 3.** Regrade Areas within Debris Area #12.

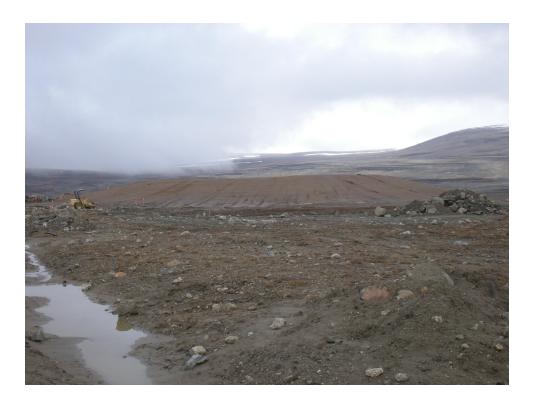
Photograph 4. Powerhouse Landfill.

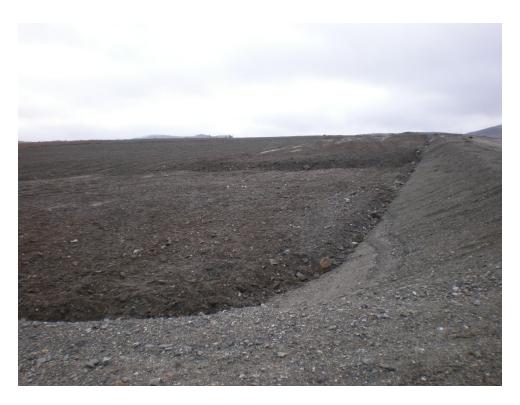
Photograph 5. Lower Site Tier II Disposal Facility.

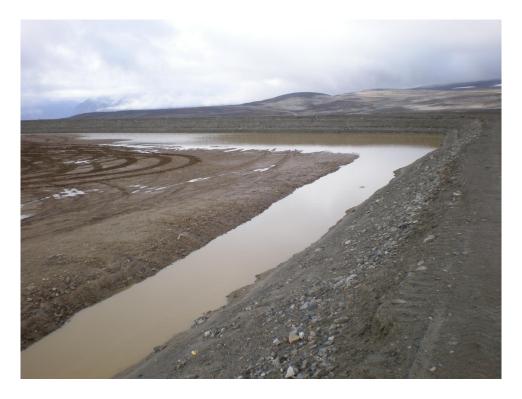
**Photograph 6.** Landfarm – Containment Berms and Runoff Collection.

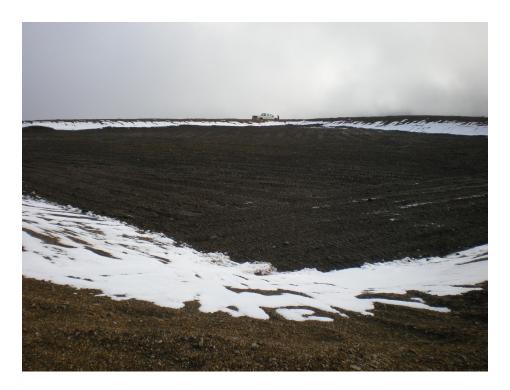
Photograph 7. Upper Site Tier II Disposal Facility.

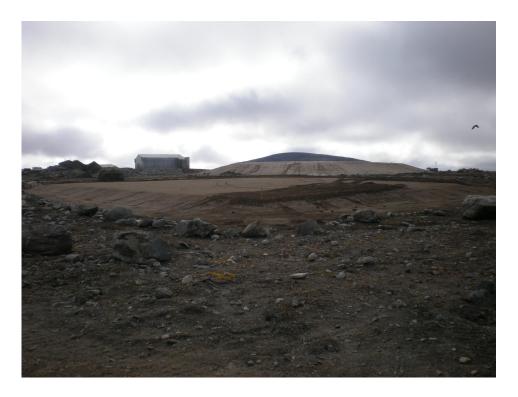
Photograph 8. Foundation Landfill.

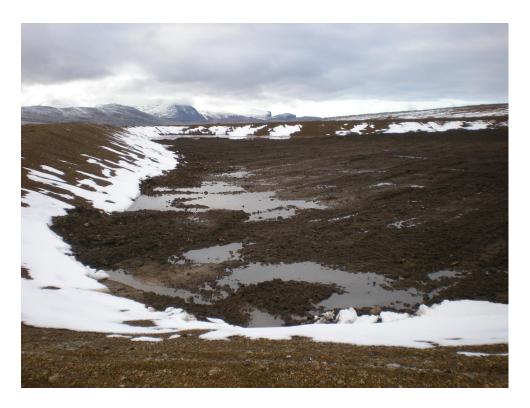
Photograph 9. Upper Site Non-Hazardous Waste Landfill.

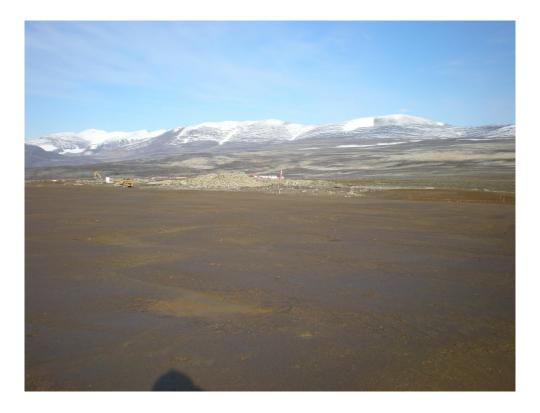
Photograph 10. Crossroads Landfill.

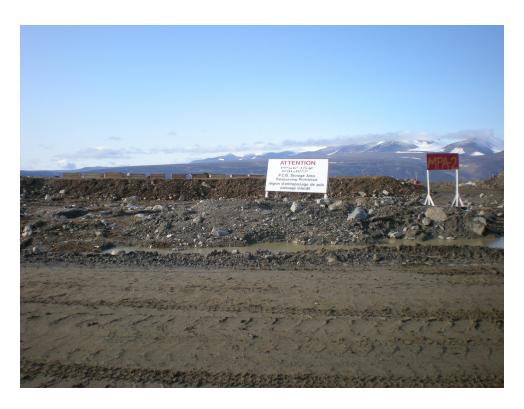
Photograph 11. PCB Storage Area.

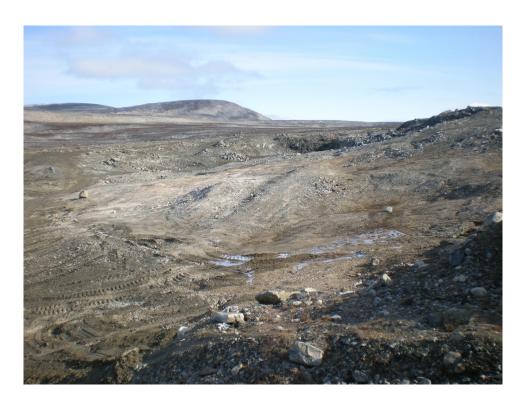
Photograph 12. Lower Camp Landfill – East.
