Defence Construction Canada

DYE-M Cape Dyer Year 1 Landfill Monitoring

AECOM

November 19, 2015

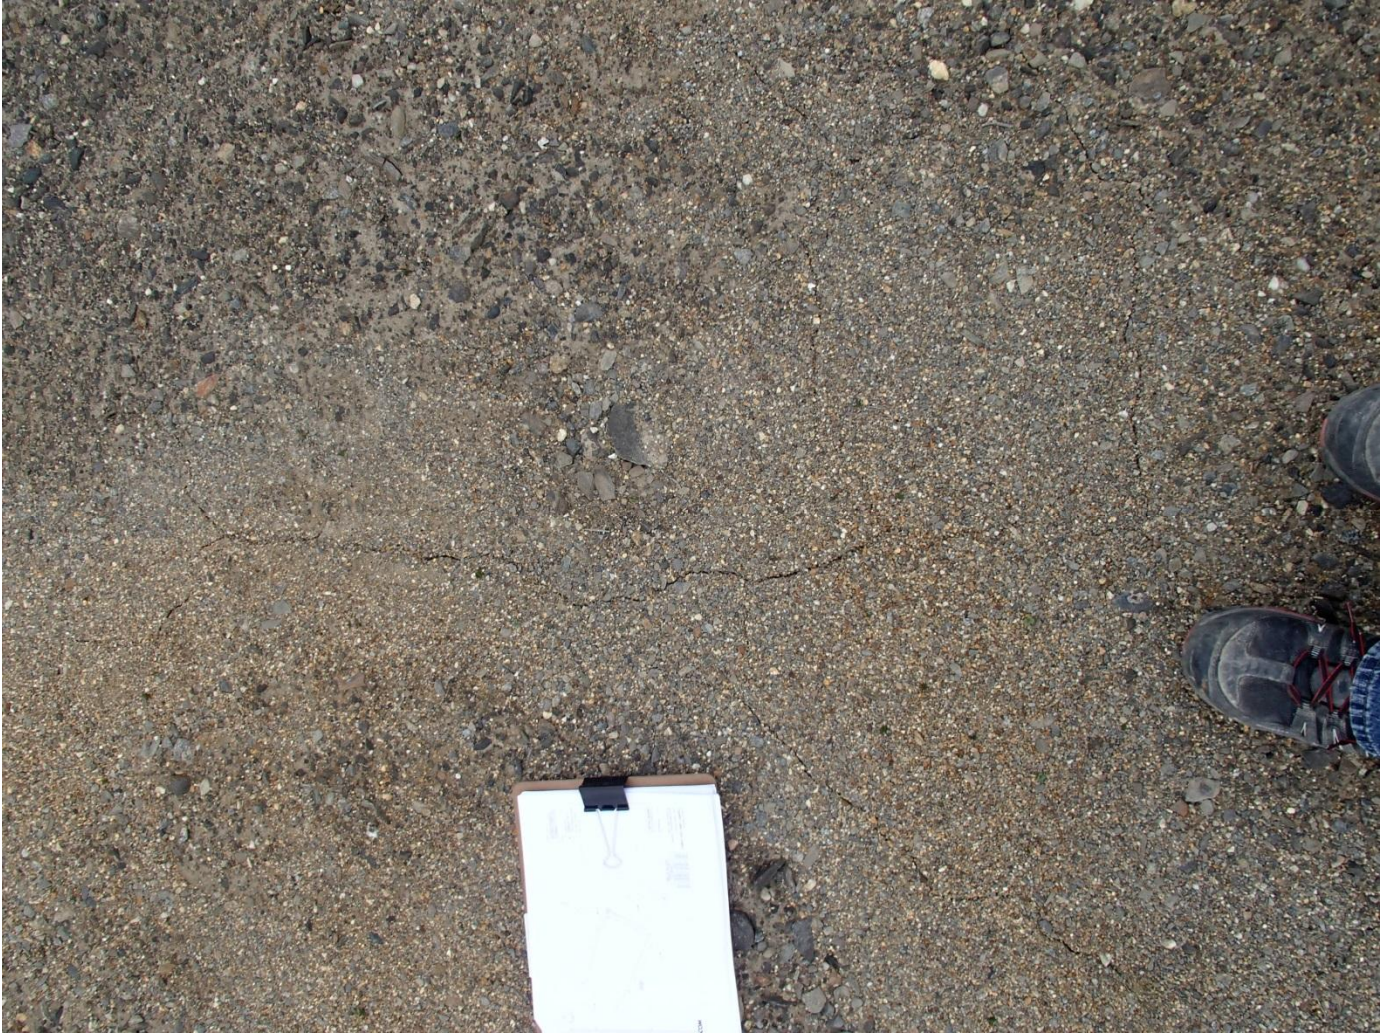
Isolated minor tension cracks were noted on the top surface of the landfill during the inspection along with sparse areas of vegetation. Other indications of consolidation or settlement were not observed.

Photograph 85. Minor tension cracks in the landfill surface ↑

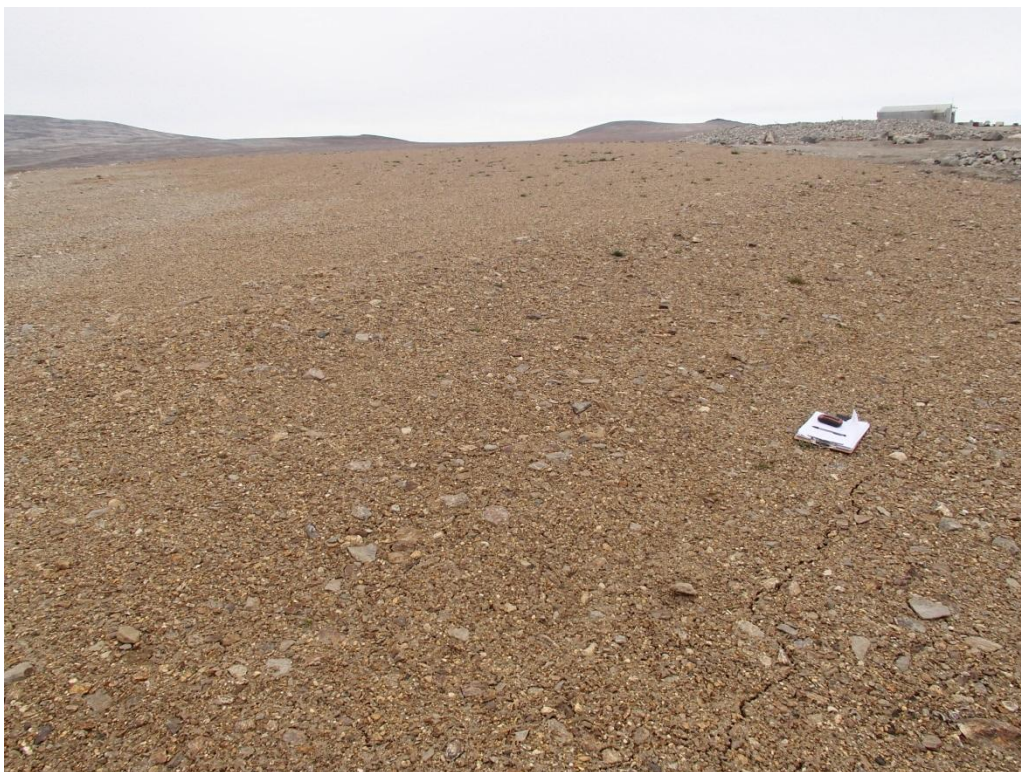
Photograph 91. Minor tension cracks in the landfill surface ↑

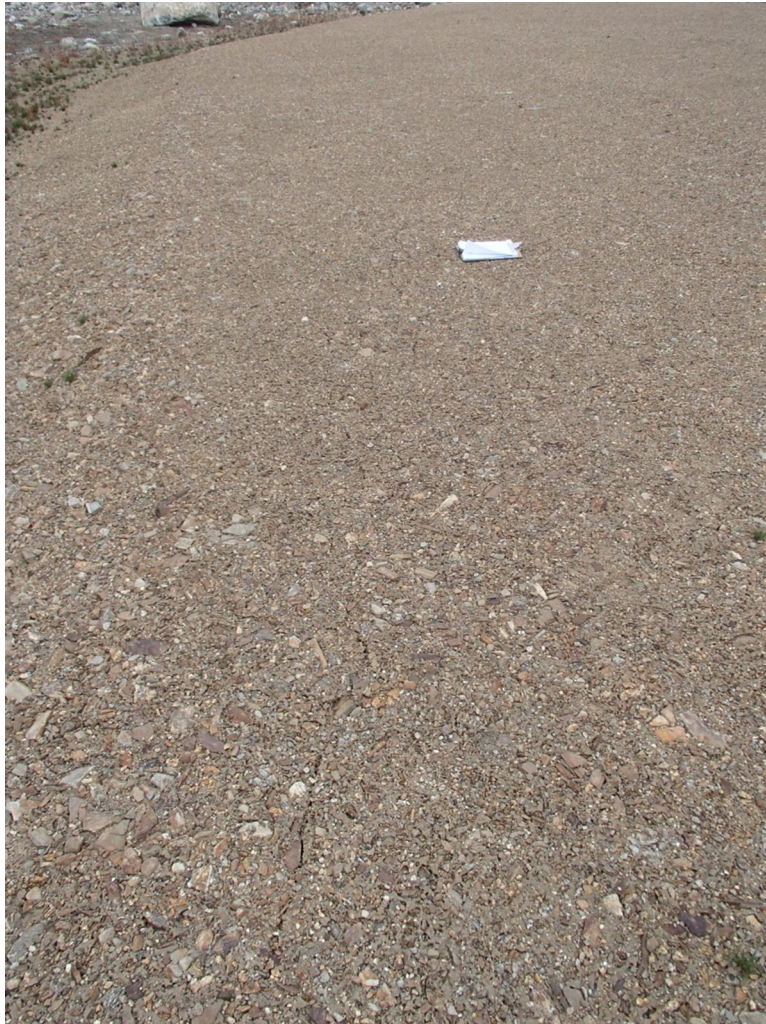
Photograph 94. Minor cracking on the surface of the landfill ↑

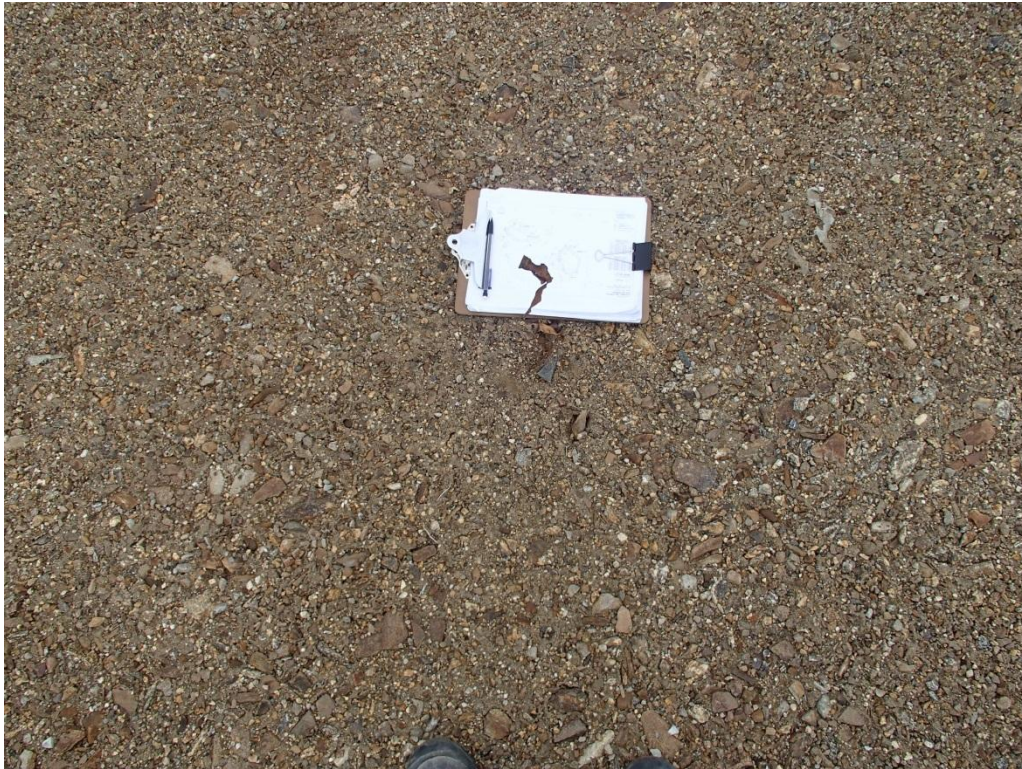
Photograph 95. Debris in capping material ↑

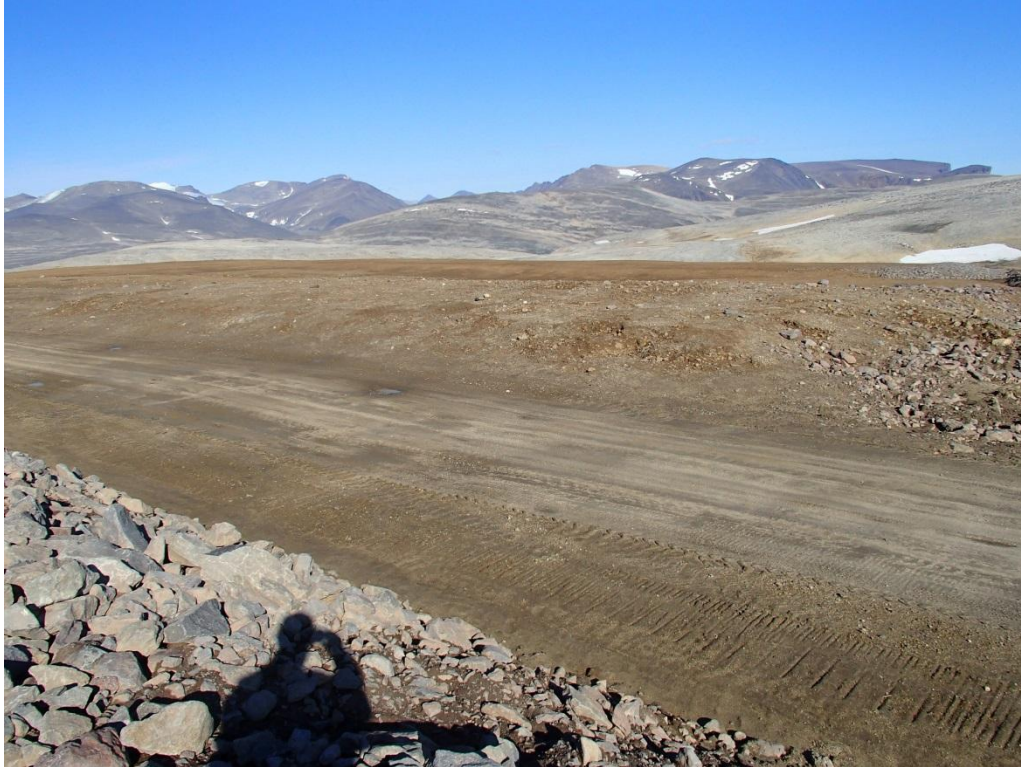
There was some damage noted on the south edge of the Centre Lobe A. The damage to Centre Lobe A is likely as a result of road clearing activities. There was minor evidence of settlement and therefore, the landfill performance is rated as acceptable.

Photograph 1. Damage on the southeast corner of the Centre Lobe A ↑

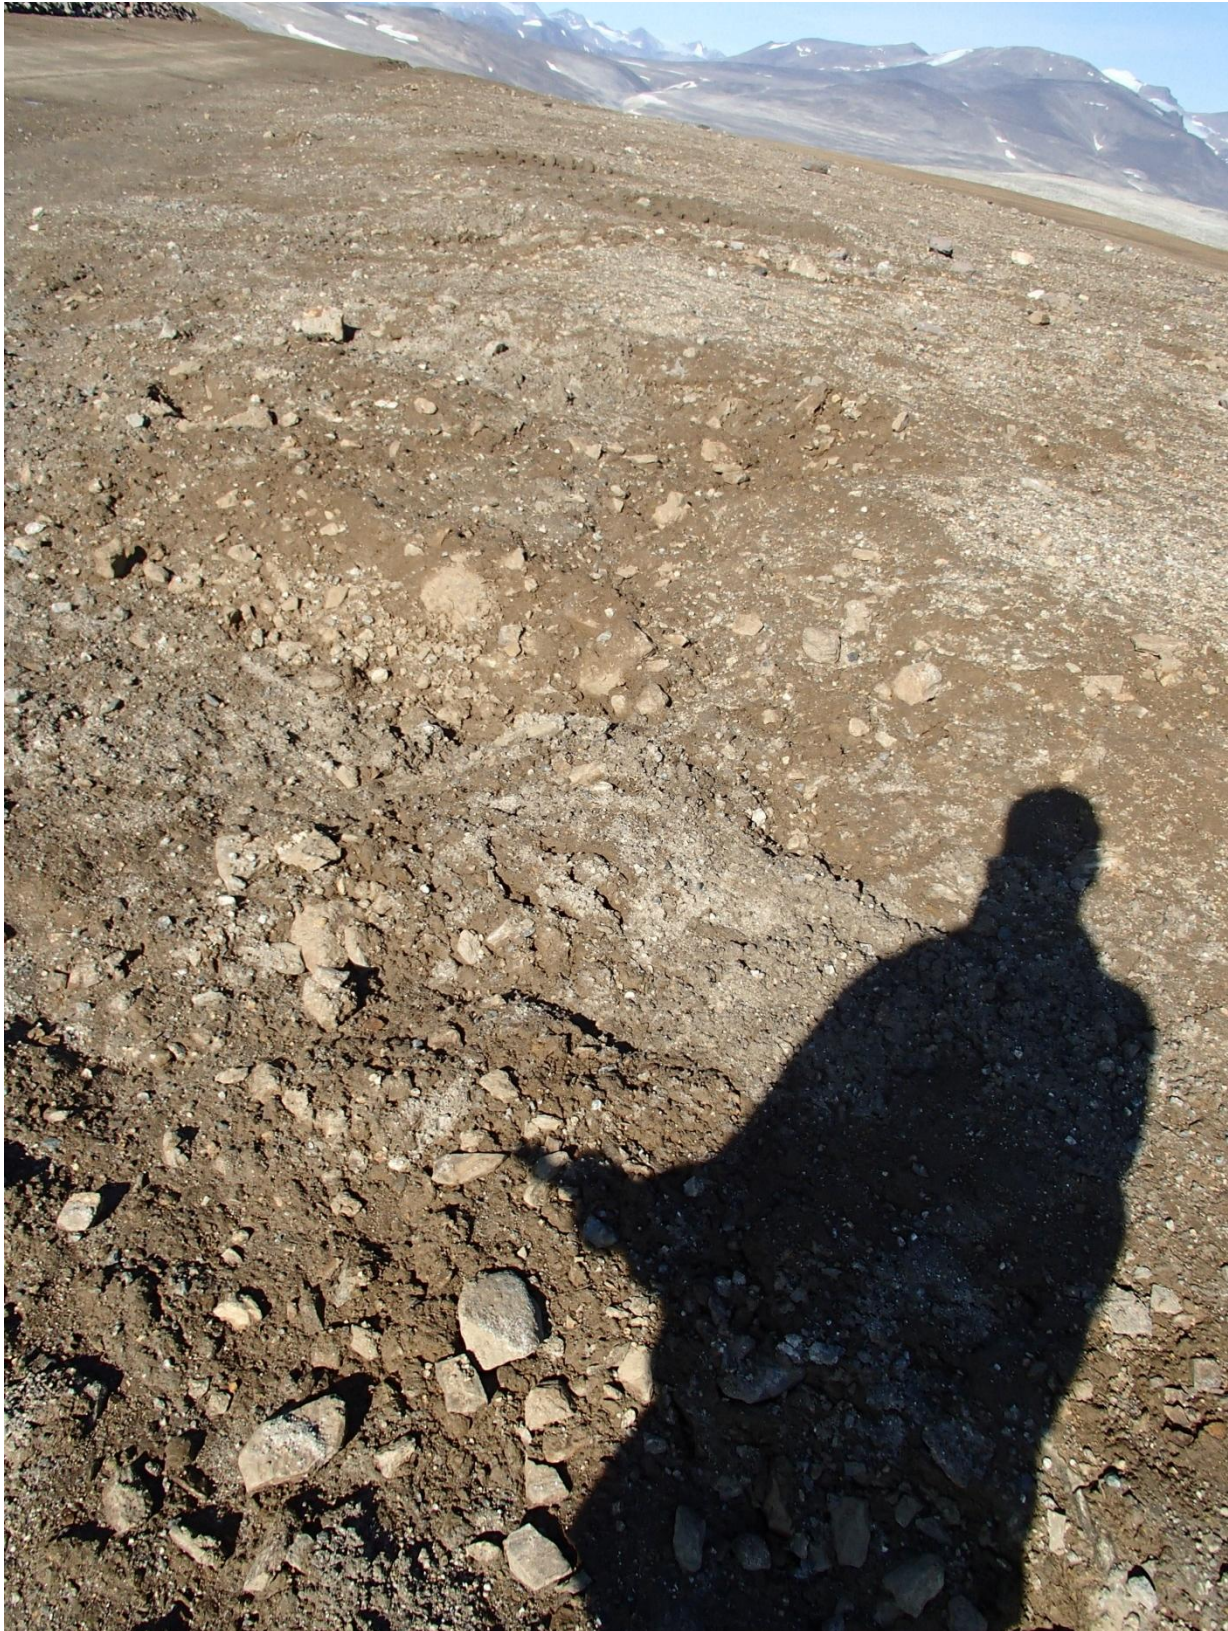
Photograph 2. **Damage to the southeast corner of the Centre Lobe A ↑**

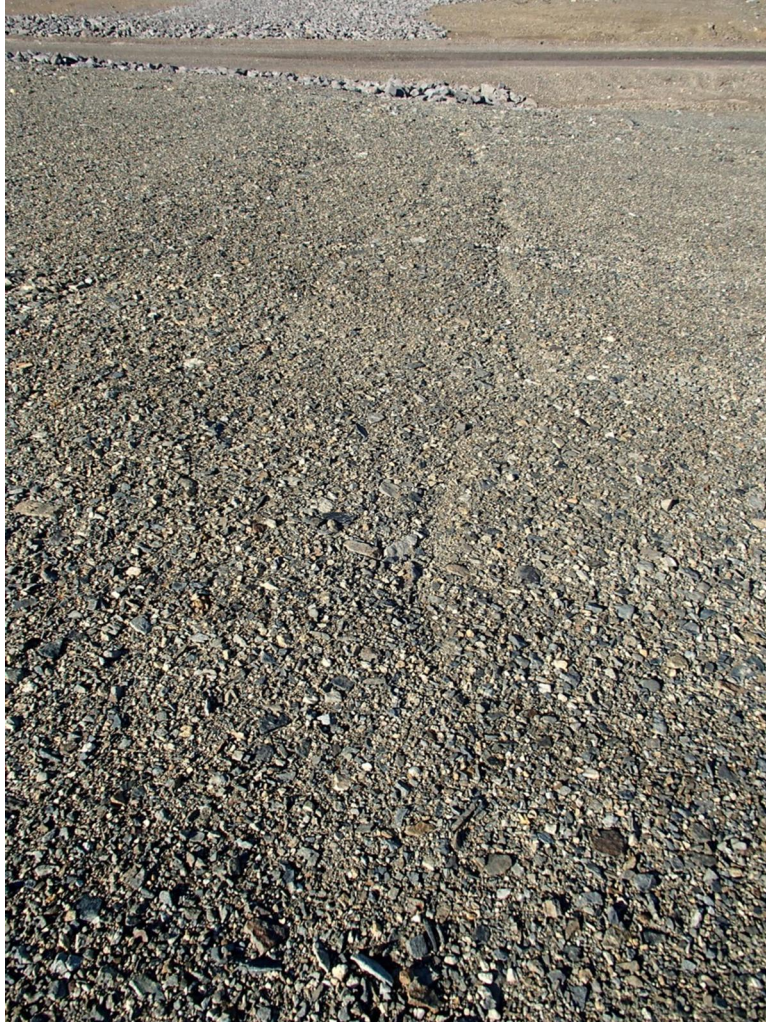
Photograph 8. Minor cracking on the surface of the East Lobe ↑

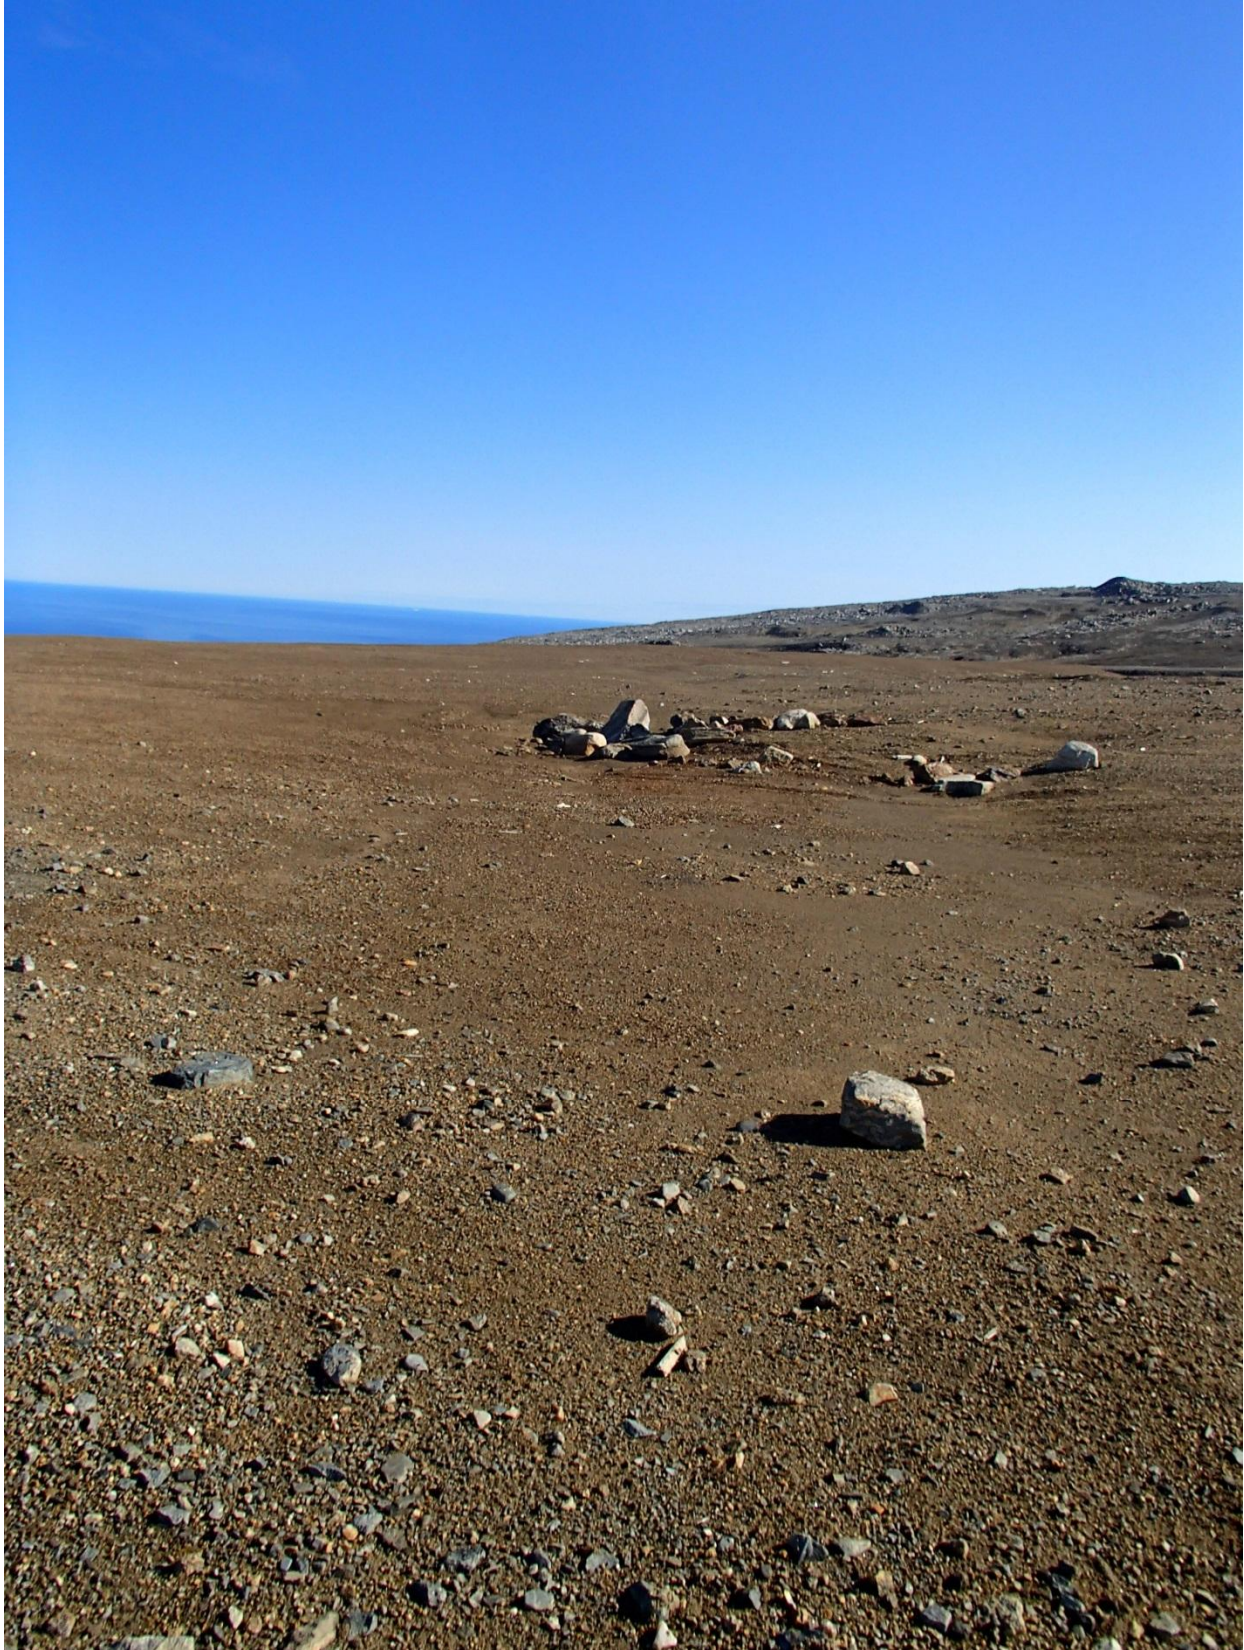
Photograph 16. **Low area at the south toe of the Centre Lobe ↑**

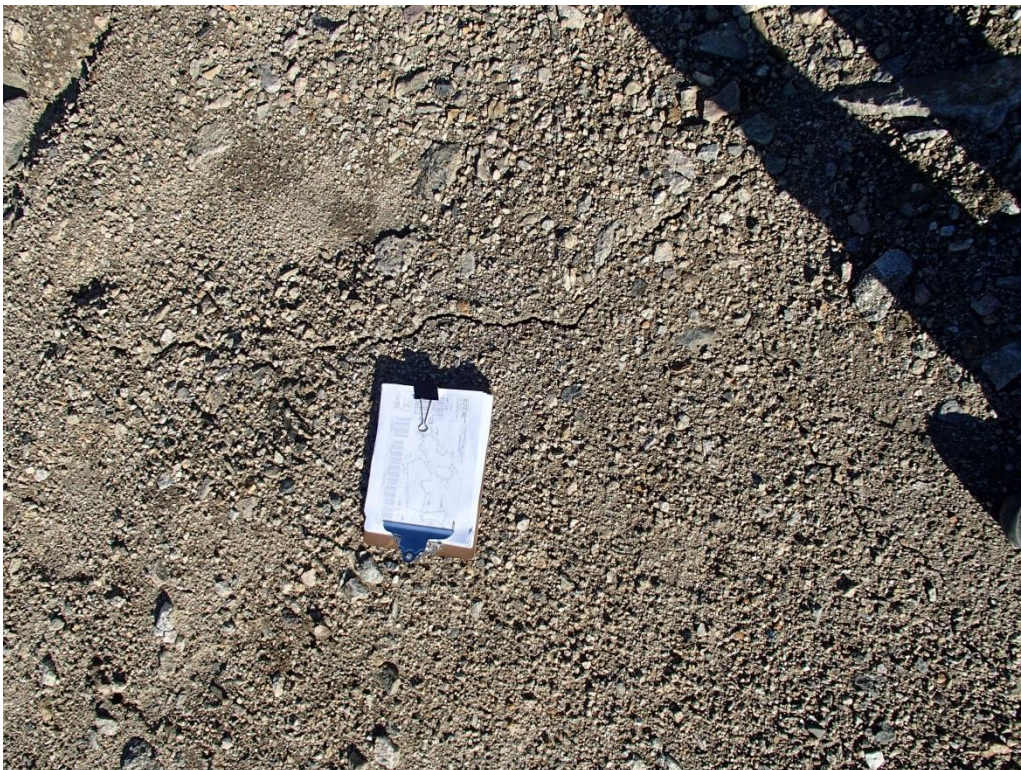
Photograph 70. Minor tension cracks at Lobes 2, 3 and 4 ↑

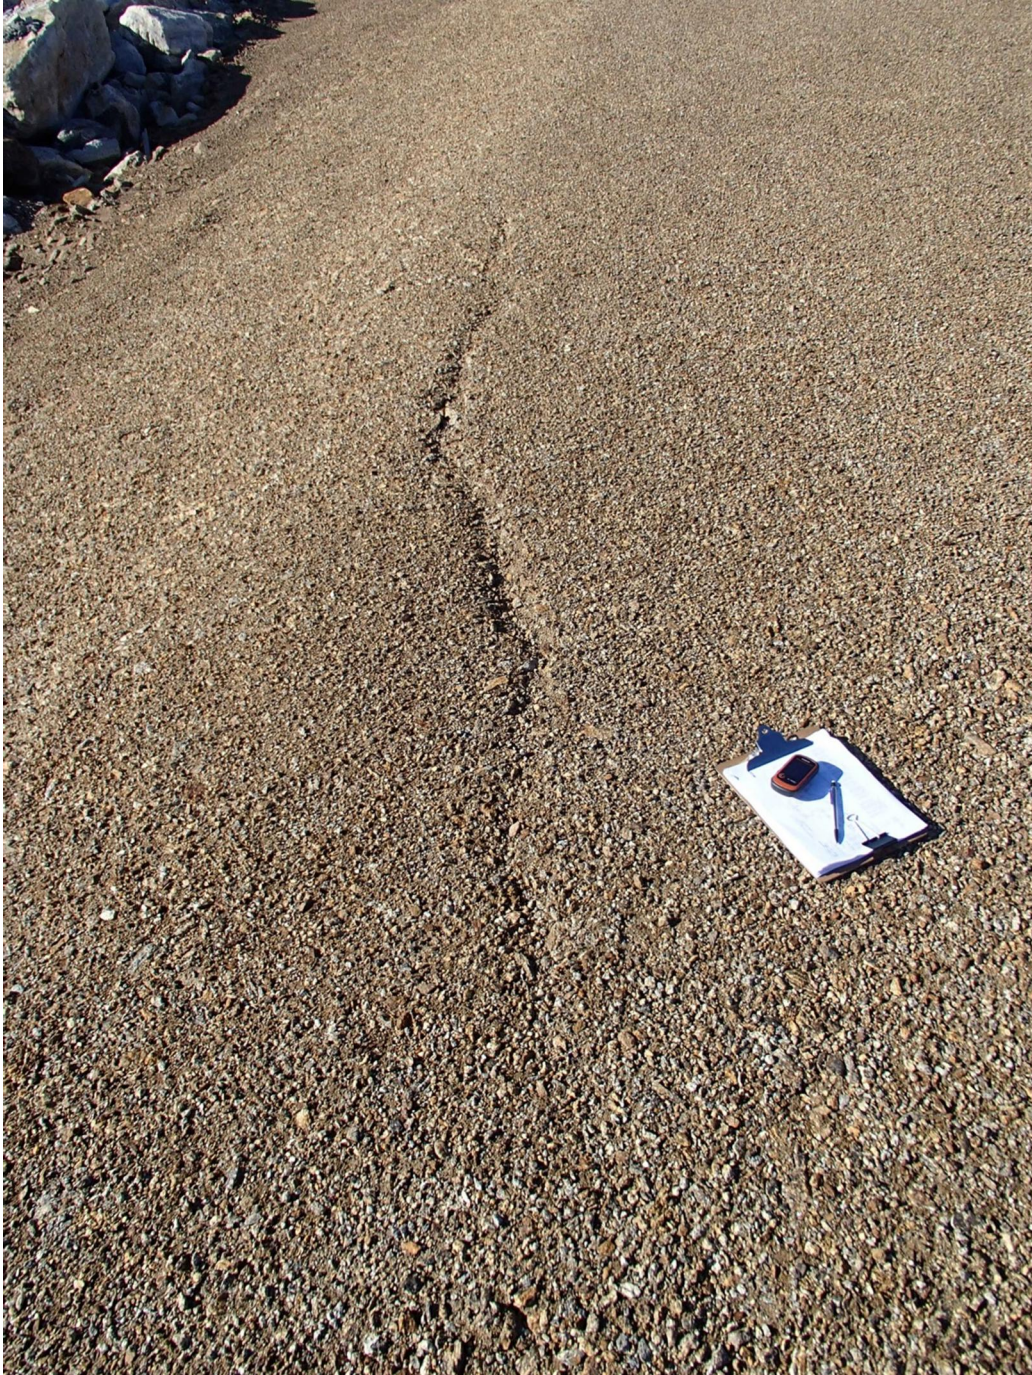
Photograph 80. Minor tension cracks on Lobe 1 ↑

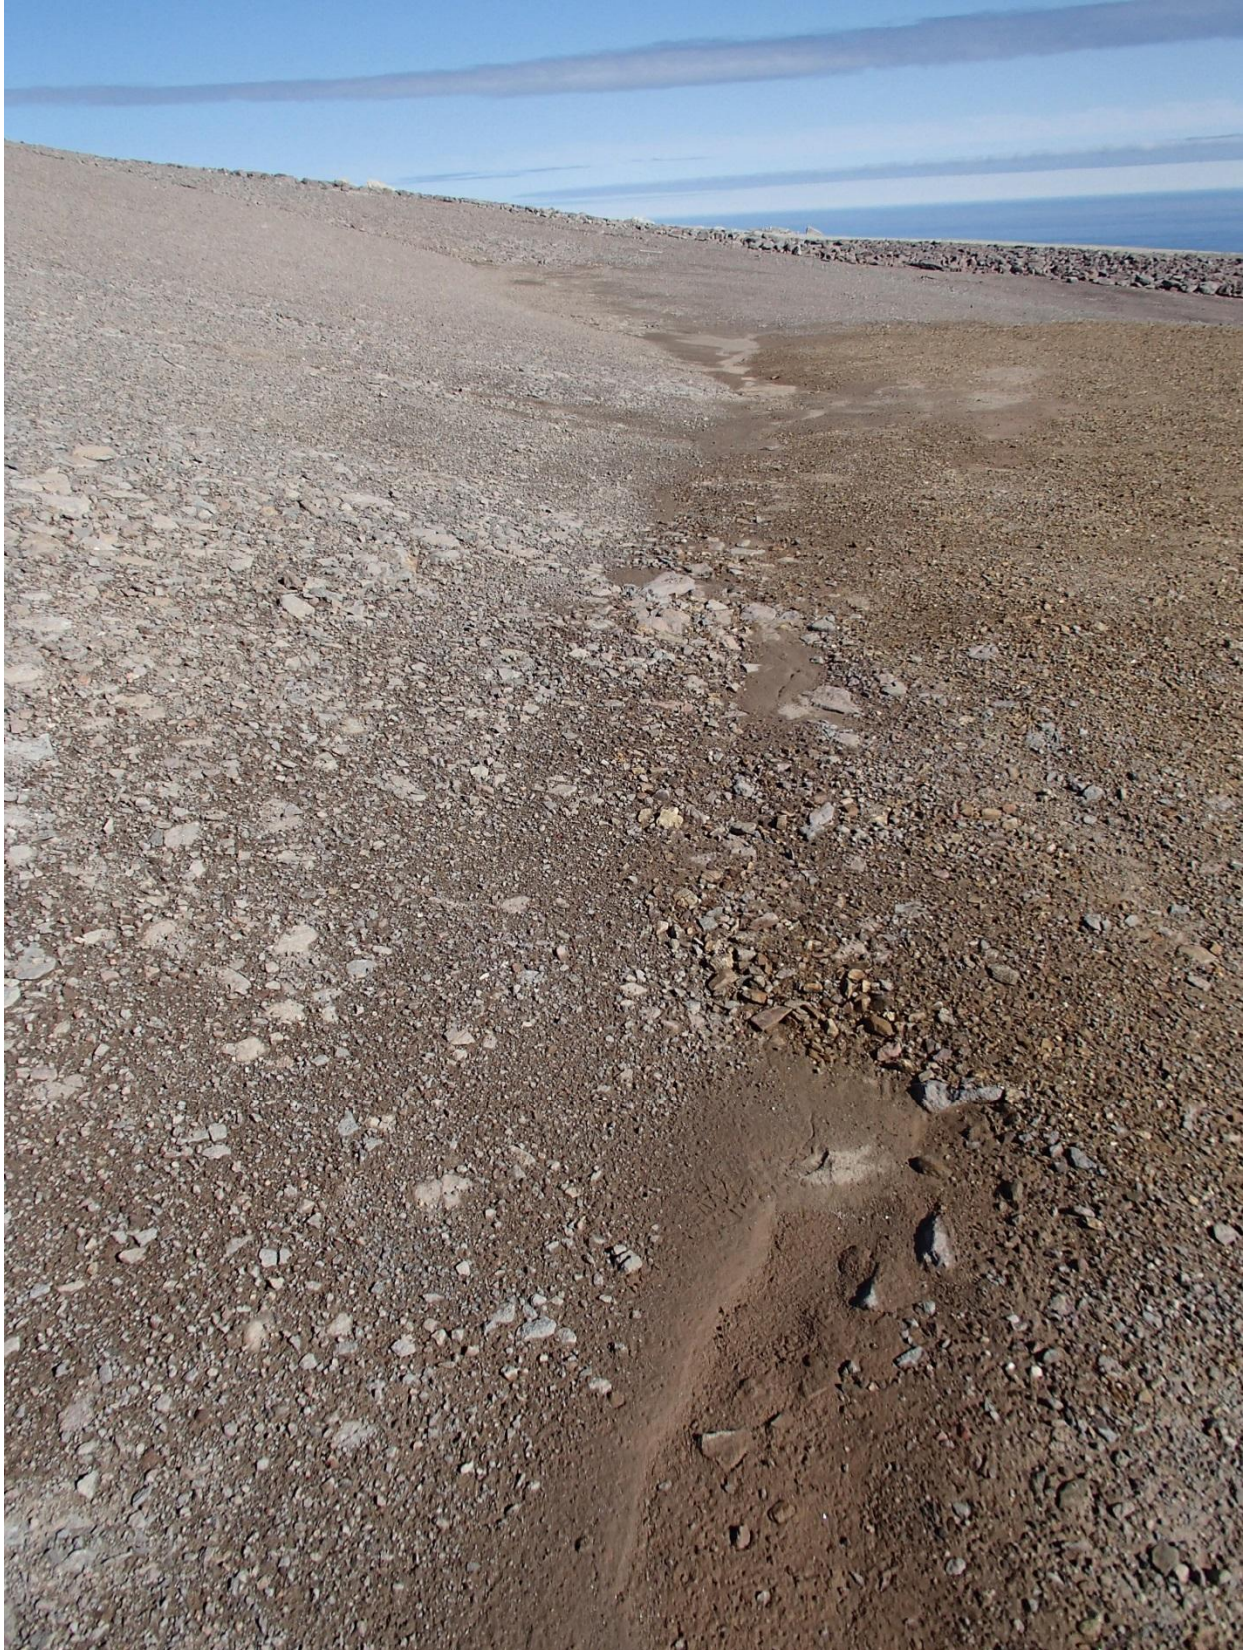
Photograph 50. Sedimentation along the ridge at the centre of the landfill ↑
