**DEW LINE CLEAN UP PROJECT  
FOX-C (EKALUGAD FJORD)  
DEW LINE SITE  
2004 GEOTECHNICAL INVESTIGATION**

**Project No. 1100065.001**

**MARCH 2005**

# **EBA Engineering Consultants Ltd.**

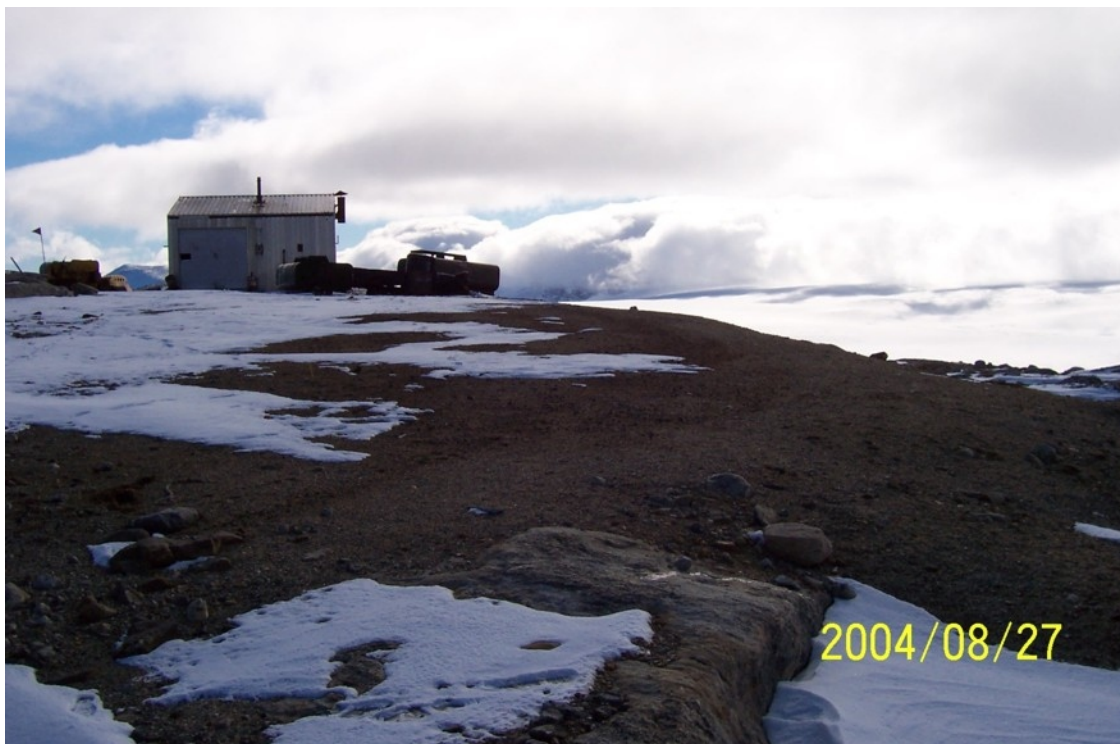
**Photo 13**

The West Laydown Debris Area is located at the Upper Station site and includes two lobes (West Laydown Debris Area Lobe A and B) located west of the Garage as shown in Figure 2A and Photo 13. Geophysical survey results are presented in Figures 2B, 2C and 2D. Lobe A is an area of buried debris. The ground surface is relatively flat, and level within the remainder of the laydown area. There is little surface debris in the area. It is recommended that Lobe A be regraded with additional fill 0.7 m thick, provided that environmental assessments by others indicate there are no environmental concerns in the area. The recommended area of regraded fill is shown on Figure 2.

Lobe B is located on the north side of a pad area. The ground surface of the area is relatively flat and level with the pad. There are no visible signs of surface debris. It is recommended that Lobe B be regraded with fill 0.7 m thick, provided that environmental assessments by others indicate there are no environmental concerns in the area. A recommended area to be regraded is shown on Figure 2A.

West Laydown Debris Area looking east, Lobe A in foreground, Lobe B in background.

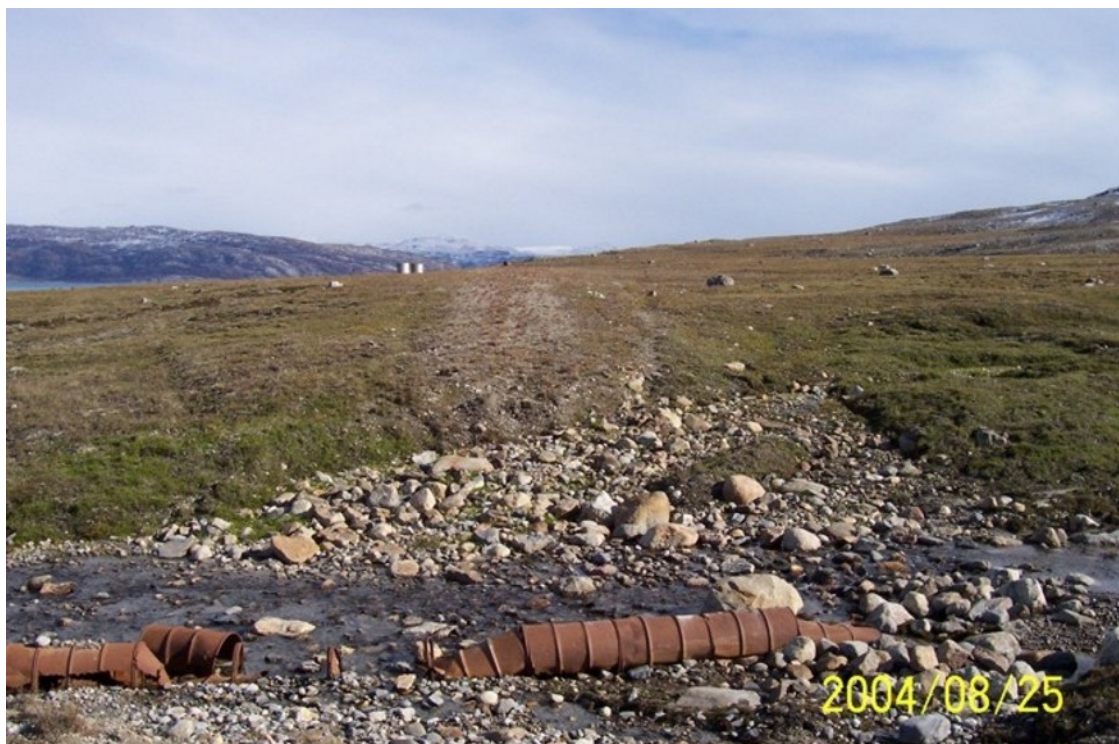
**Photo 35**  
Beach Road looking northeast at BR Crossing 1.

All existing culverts on the Beach road were constructed out of 45 gallon barrels welded together. Breaks in the road where the road would be impassable by haul trucks exist at drainage crossings where the either culverts have failed (BR Crossings 1, 2 and 3) or where the road appears to have been washed out because no culverts were installed (BR Crossing 4).

Between BR Crossing 1 and the Junction there are at least two additional culvert crossings that may require replacement as the existing culverts are no longer structurally sound. All existing culvert crossings should be assessed at the time of construction with the aid of heavy equipment.

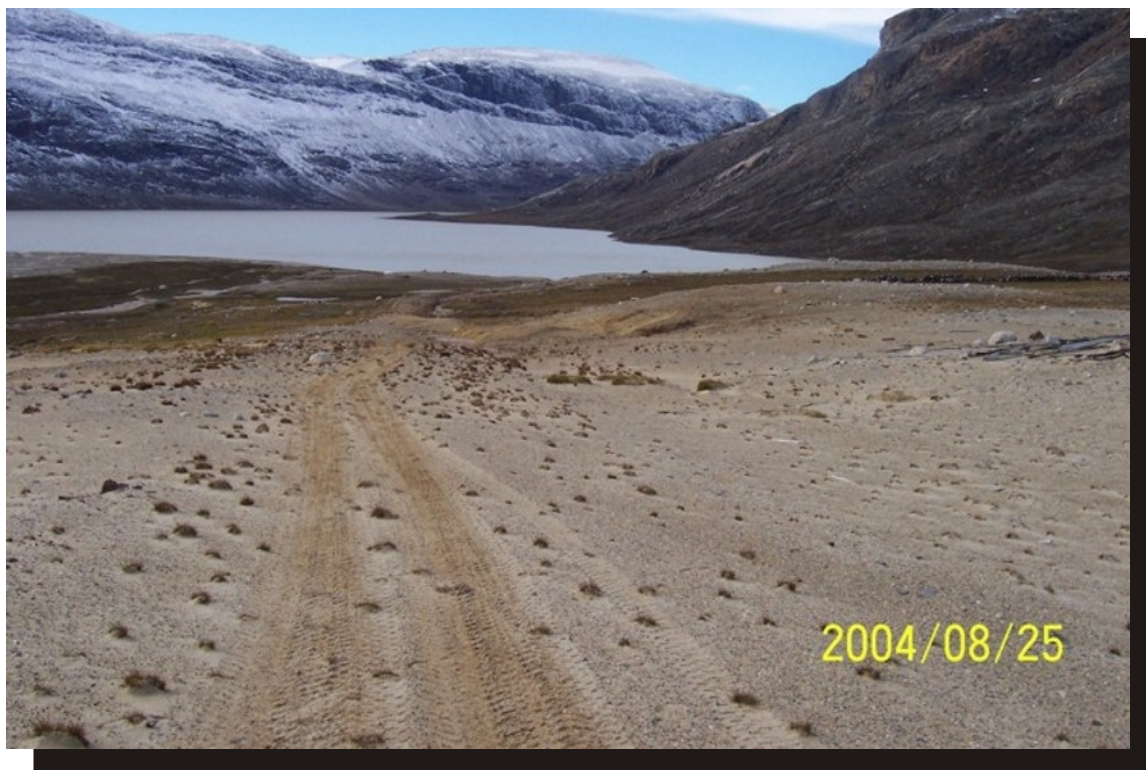
**Photo 41**  
Lake Road looking southwest towards the freshwater lake.

Lake Road is approximately 1.1 km long (Figure 1, Photos 41 and 42). The road surface width ranges from approximately 2.3 to 5.5 m and is typically 3 m. The road has been constructed from the granular material obtained from near the roadway. The soils range from sand to sand and gravel. No culvert crossings are present on the Lake Road. Generally the road is trafficable and in satisfactory condition for light traffic. Some grading is required over the extent of the roadway prior to any haul traffic. Approximate 240 m length of the road located on cross-sloped terrain requires reconstruction due erosion.

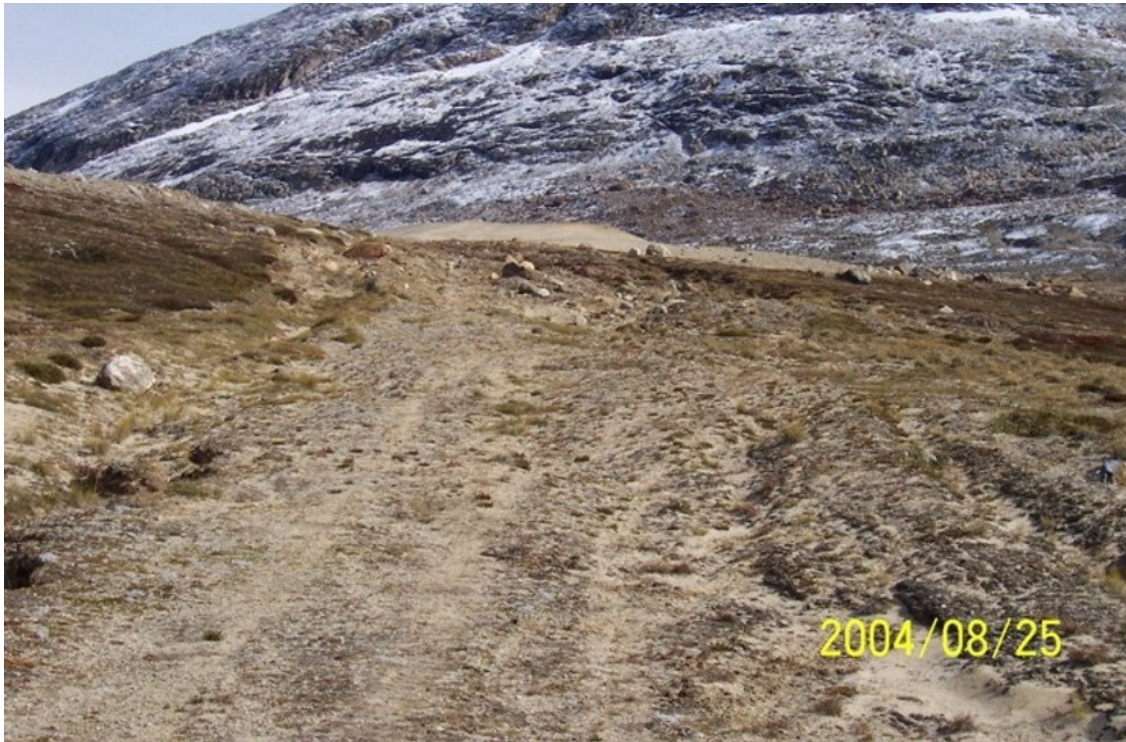
**Photo 42**

Lake Road looking northeast, regrade area in background.

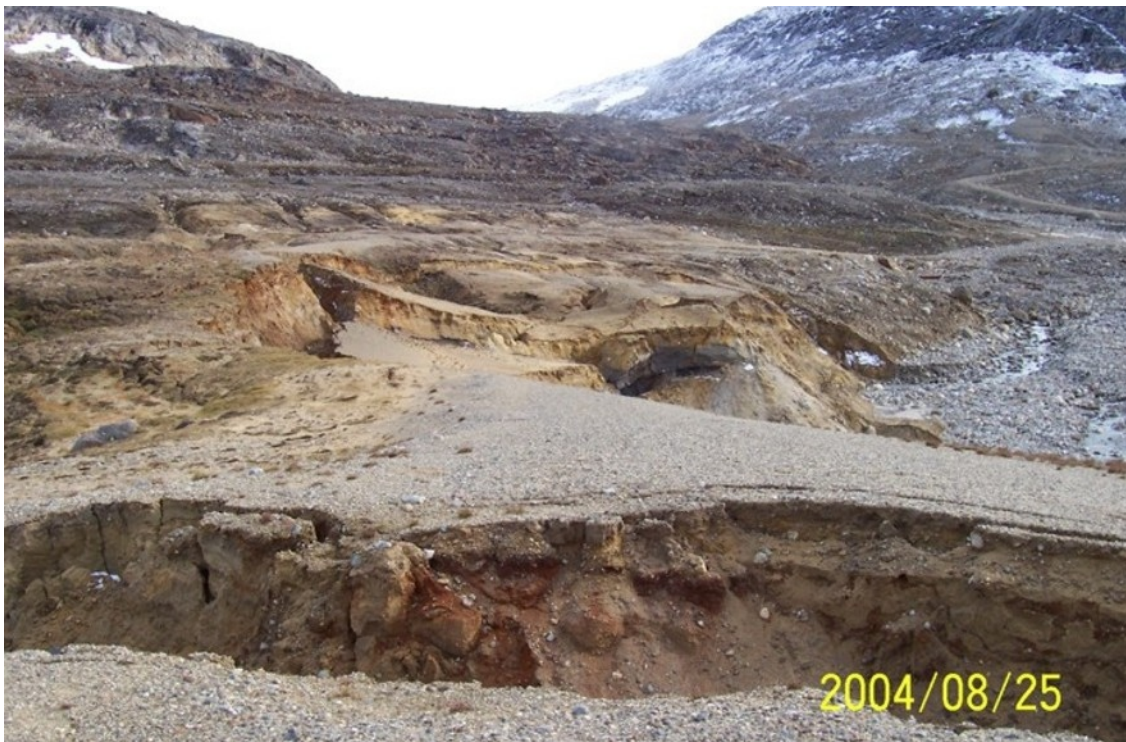
**Photo 43**

Station Road looking southeast. Road Failure Area, existing road undercut and requires reconstruction.

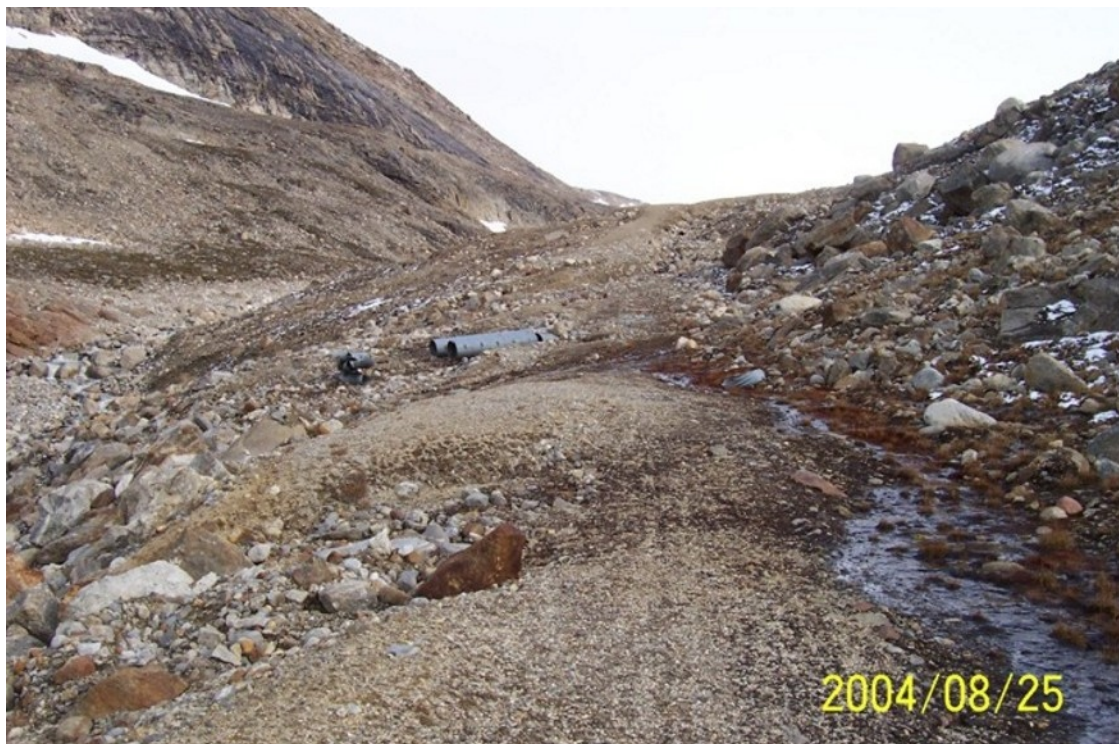
**Photo 44**  
Station Road looking east, Washout 1.

Station Road from the Junction to the end of the road at the Upper Station is approximately 5.9 km long. The existing road surface width (shoulder to shoulder) between Kilometre 0 (Junction) and Kilometre 3.0 of Station Road ranges from approximately 2.5 to 5.5 m, but is typically 3 to 4 m. The general condition of the roadway to Kilometre 3.0 (approximately Crossing 2) is shown in Photos 49 to 54. A substantial amount of road structure remains that is in satisfactory condition for heavy equipment traffic, however, many sections will require varying amounts of surface preparation requiring fills resourced locally from the road right-of-way and/or from imported borrow. Road impasses in the first 3.0 kilometres include one failed road section, two river crossings (Crossing 1 and Crossing 2) and five washouts (Washouts 1 to 5).
