Memo

To: Bob Martin
From: Brad Thompson
CC:
Date: January 13, 2006
Re: FOX-C Site Observations and Agreements

On September 1, 2005 a site inspection was completed at the former FOX-C DEW Line site and surrounding area, to review elements of the remediation plan. Attendees included community representatives, regulatory authorities, and the remediation contractor. Areas specifically looked at included the beach (following the unloading of the remediation equipment), the rivers and barrels located within it, and areas where remediation efforts occur on Inuit-owned land. Additional details regarding the site inspection are provided below.

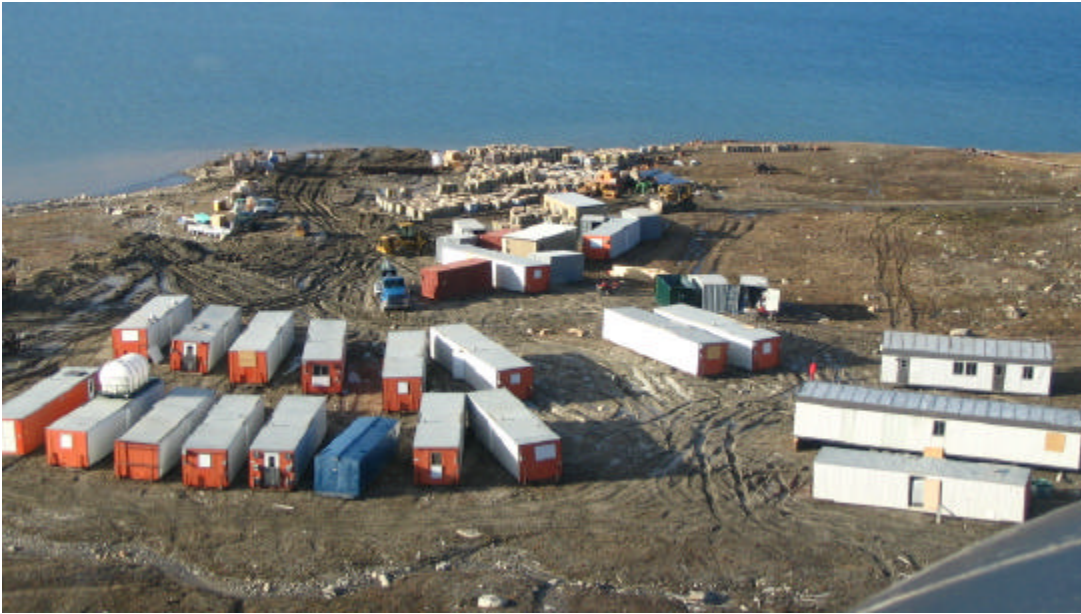
The sea-lift containing the first shipment of remediation equipment and supplies was unloaded on August 26 and 27, 2005. At that time, extremely wet conditions were encountered at the site which hindered the unloading process and resulted in some soil rutting within the active layer.

Photo 1: Aerial view of unloaded equipment. Note vehicle rutting resulting from extremely soft soil conditions leading from the beach.

INAC and PWGSC recognize the importance of remediating the site. Prior to QC leaving the site, the disturbed area of the beach was back-bladed and smoothed out. For work completed adjacent to, or extending into the water, DFO stipulated that activities cannot occur between August 7 to September 7. Outside of this time period,

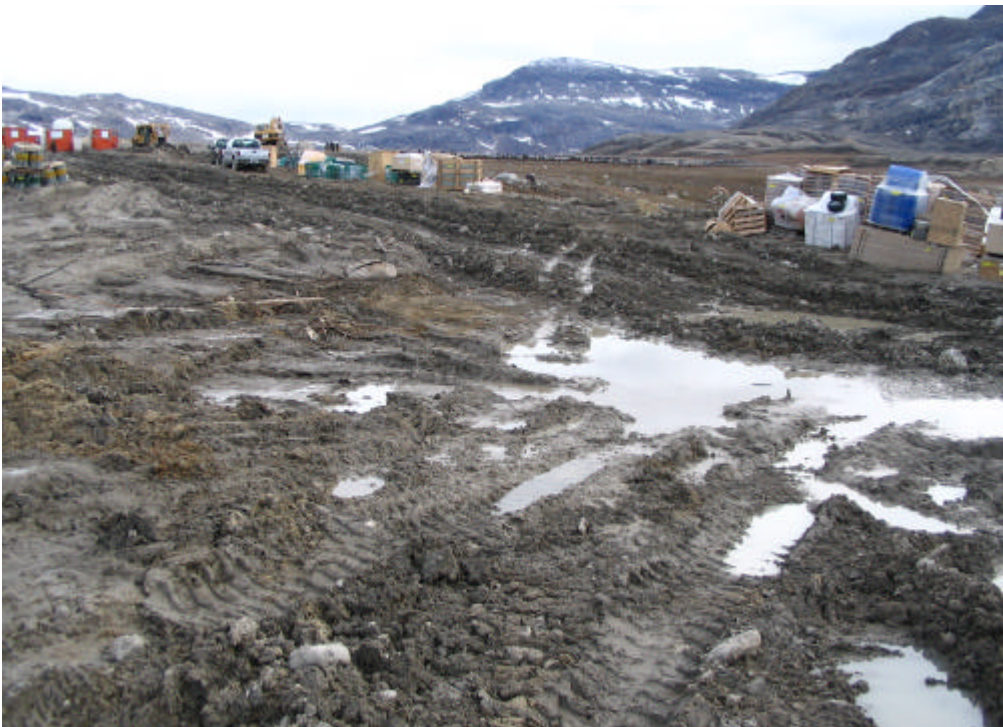
Photo 2: Soil conditions near beach unloading area.

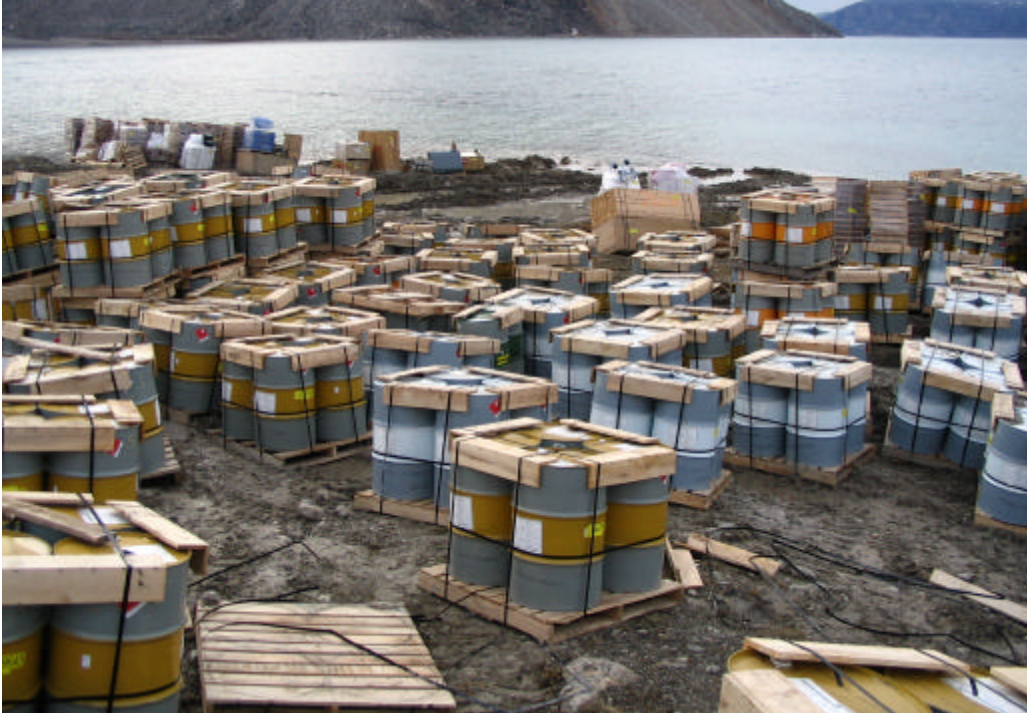
Barreled fuel was unloaded within 30 m of the high water mark; however, these barrels were moved back to a safe distance from the shoreline prior to the contractor demobilizing from the site for this year.

Photo 3: Fuel barrels unloaded from sealift. These have since been moved back from the high-water mark

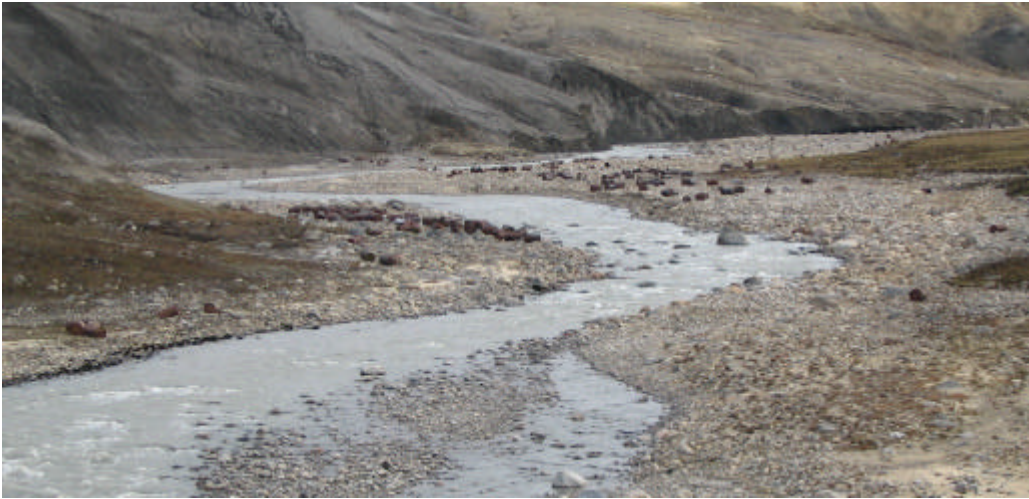
Clean up of barrels located adjacent to and within the river connecting the freshwater lake to the fiord was discussed.

Photo 4: Barrels located along river between water lake and the fiord.

- Inspect all barrels located near or adjacent to the waterway for the presence of petroleum products. If petroleum products are identified within the barrels, special procedures for pumping out the barrel will be implemented prior to removing the barrel
- Once it is confirmed that the barrel does not contain any petroleum products, they will be approached using all-terrain vehicles (ATVs) and loaded into trailers connected to the ATVs.
- If barrels are partially buried, the barrels will be removed using a winch attached to the ATV.

For barrels on the west side of the river, DFO acknowledged that the river at shallow locations could be traversed by ATVs. However, to minimize any risk to fish or fish habitat in the river, barrel removal activities will not be permitted between August 7 and September 7. During this period the char may be migrating up the river.

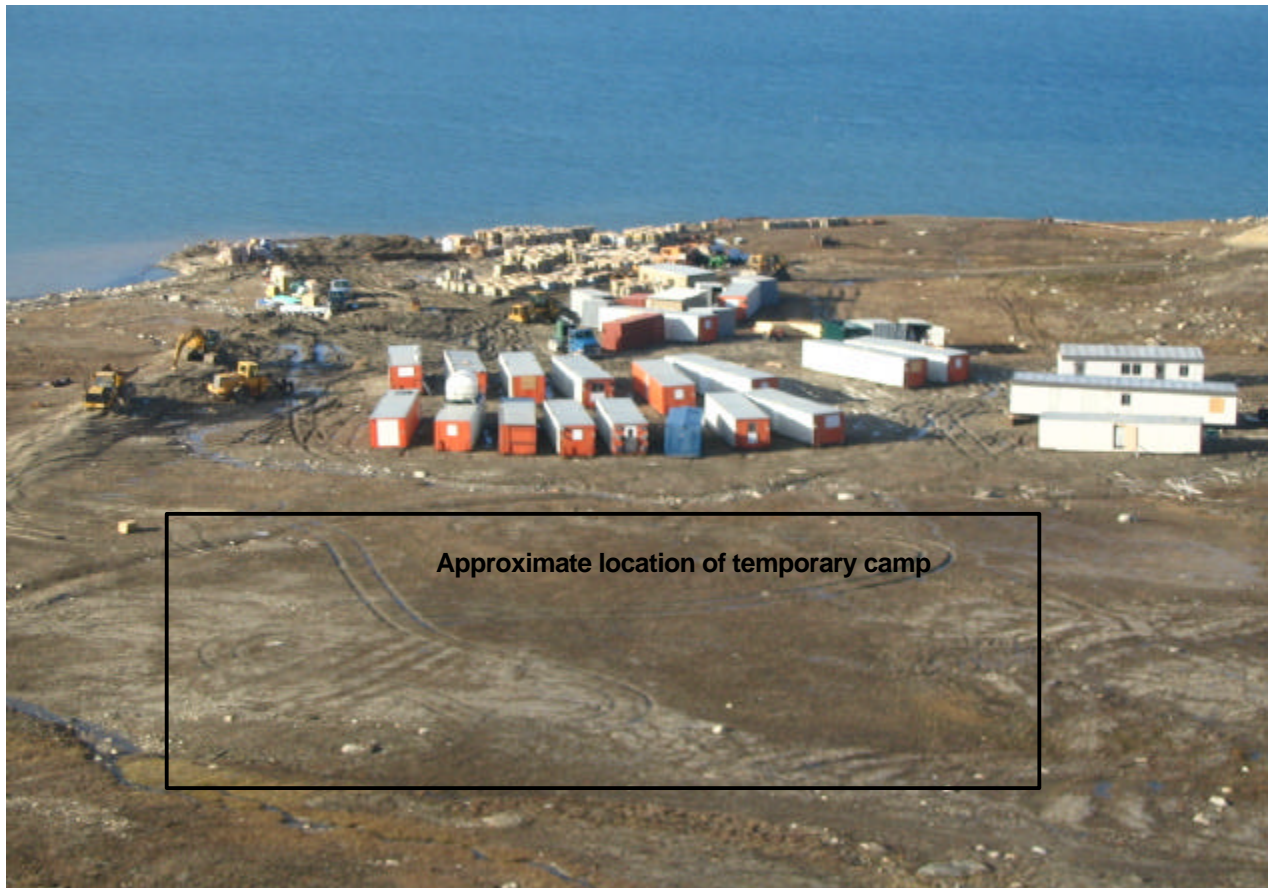
which best met these criteria was the within the beach area, south of where the equipment was unloaded as shown below.

Photo 5: Location of temporary camp.

It was determined that a granular pad would have to be constructed before moving the camp trailers into this area in order to meet the regulatory requirements described in QIA Certificate of Exemption (Q05XX17) and the Land Use Permit (N2005X0009).

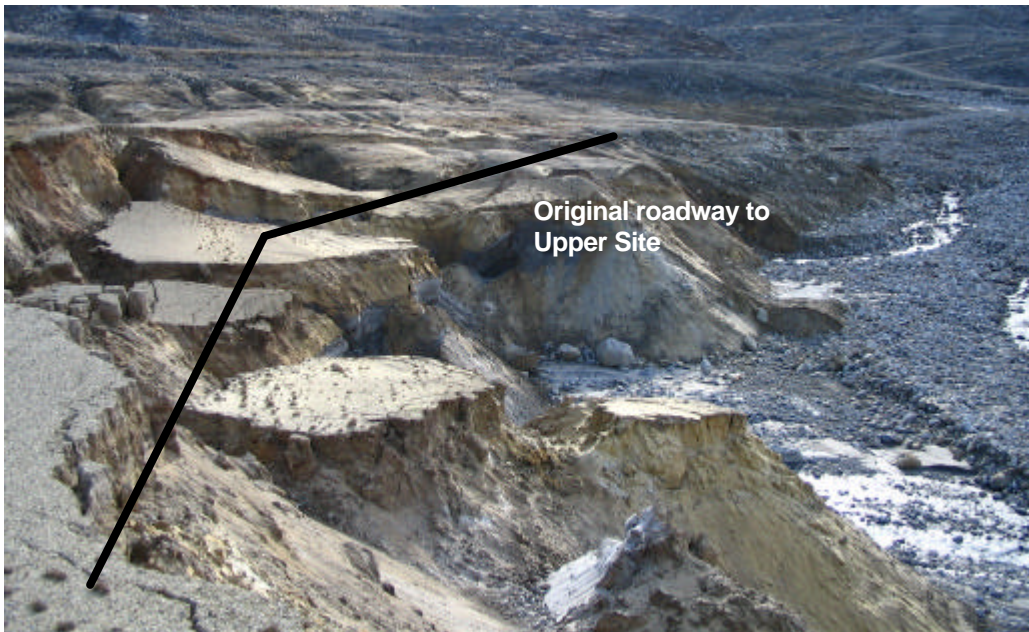
Since the site has been abandoned for over 40 years, significant degradation of the roadways has occurred. In order to facilitate the remediation activities, these roads will have to be restored. Every attempt will be made to repair the existing roads; however, there are some locations where new roads have to be constructed, since the previous roads are beyond repair. An example of this is the road to the Upper Site immediately after the 3-way intersection (see Photo 7). Where situations like this occur,

Photo 7: Road to Upper Site which is beyond repair resulting from glacial outwash and erosion of the sand.

a new roadway will be constructed at a location to minimize new disturbance to the surrounding land.

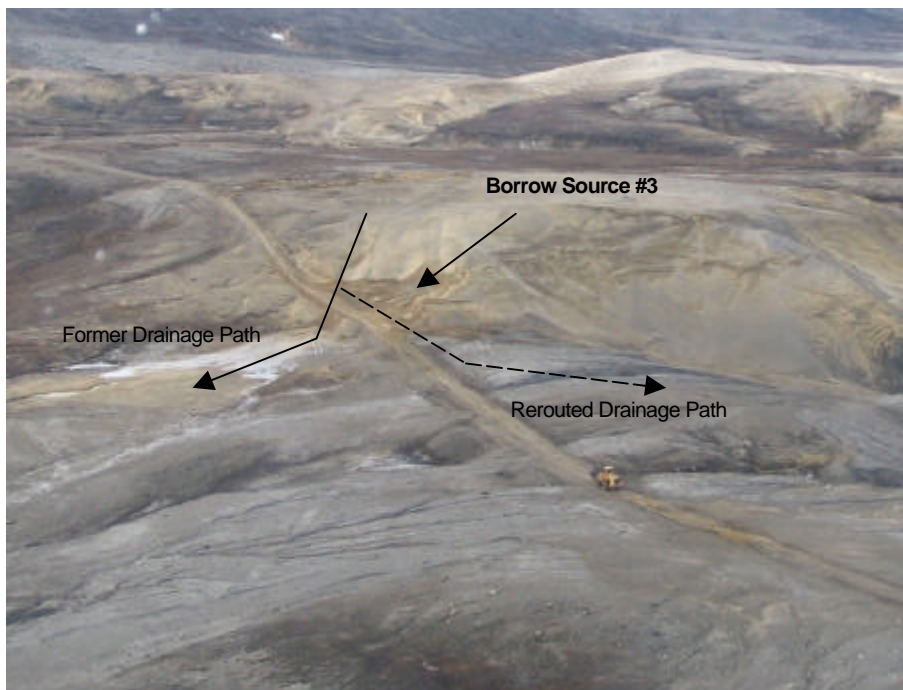
During the site visit, it was observed that the road, near borrow source #3, had been washed out from a seasonal drainage channel. Options were discussed between DFO, QIA representatives, and QC and it was decided the best way to manage the temporary drainage channel was to reroute it from draining to the northeast to draining to the west, as shown below.
