NWB Annual Report

License No: 1BR-EKA0607 Issued Date: June 19, 2006
Expiry Date: December 31, 2007

Project Name: FOX-C Ekalugad Fjord Remediation Project

Licensee: Indian and Northern Affairs Canada

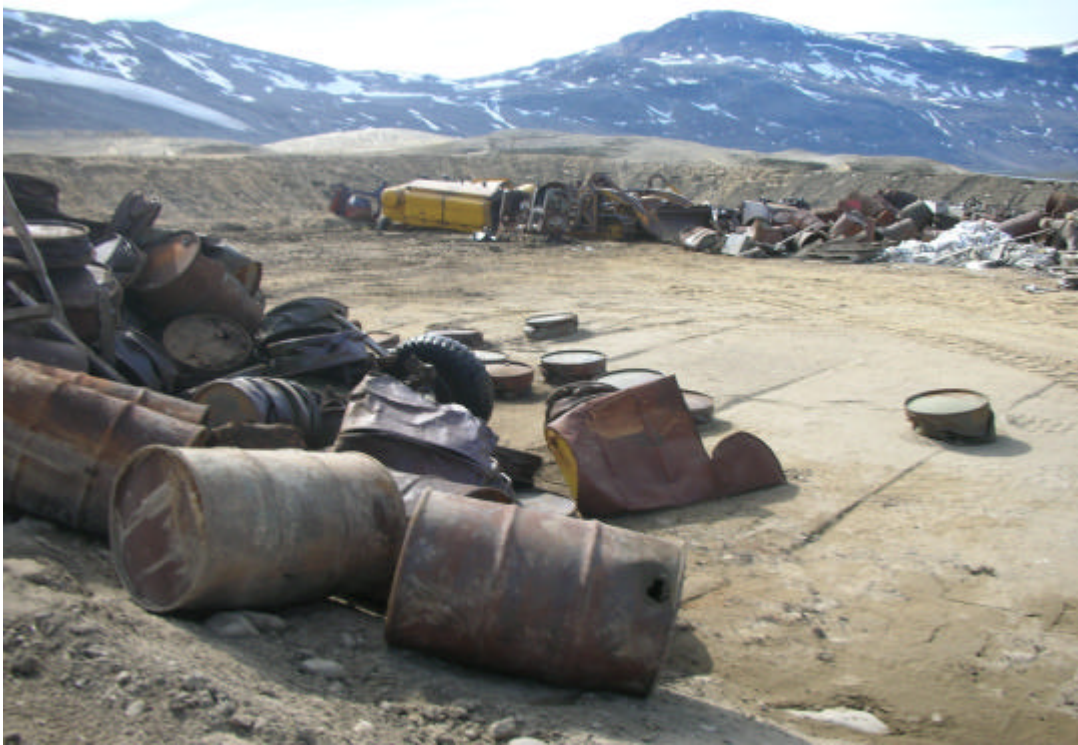
Lower Site Non-Hazardous Waste Landfill

- Installation of monitoring wells at lower site
 - Completed
- Lower Site Non Hazardous Waste Landfill
 - Berm Construction 3 of 4 completed
- Sewage Lagoon

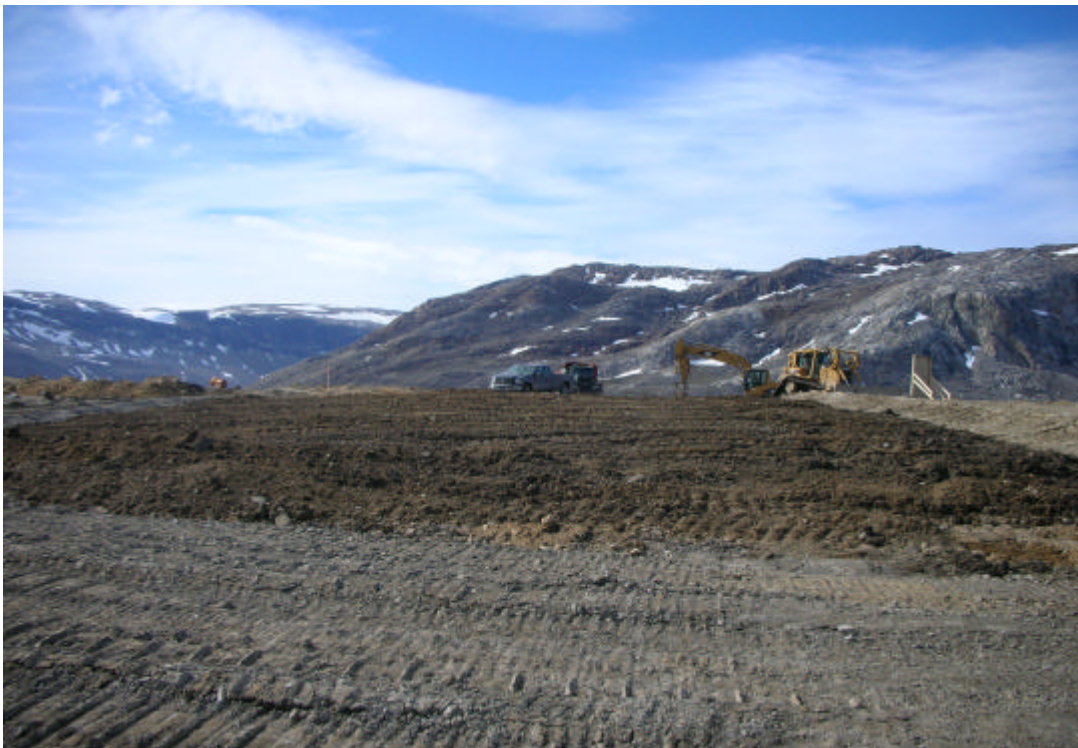
Landfarm (in Operation)

- Mid Station Debris removal and drum processing
 - Initiated, work remaining for 2007
- Beach Landfarm operation
 - Contaminated soil placed, fertilizer added, soil tilled 2 times

- Additional contaminated soil:
 - 146 cubic metres of F1/F2 soil from the lake area was stockpiled at the landfarm while we await approval for the landfarm extension
- Debris from the old site:
 - 2 cubic metres of wood was collected into a pile to be burned
 - 122 of drums were cleaned, crushed & land filled
- River dump debris:
 - a dump consisting of 53 cubic metres of waste cans, bottles, wooden crates, and paper was found at the start of the river from the lake to the fjord. The majority of this debris was collected and placed in the Non Hazardous Landfill.
 - some debris (approximately 11 cubic metres) remains and will be hand collected and land filled in 2007.
