NWB Annual Report

Year being reported: 2008

Project Name: FOX-C Ekalugad Fjord Remediation Project

Licensee: Indian and Northern Affairs Canada

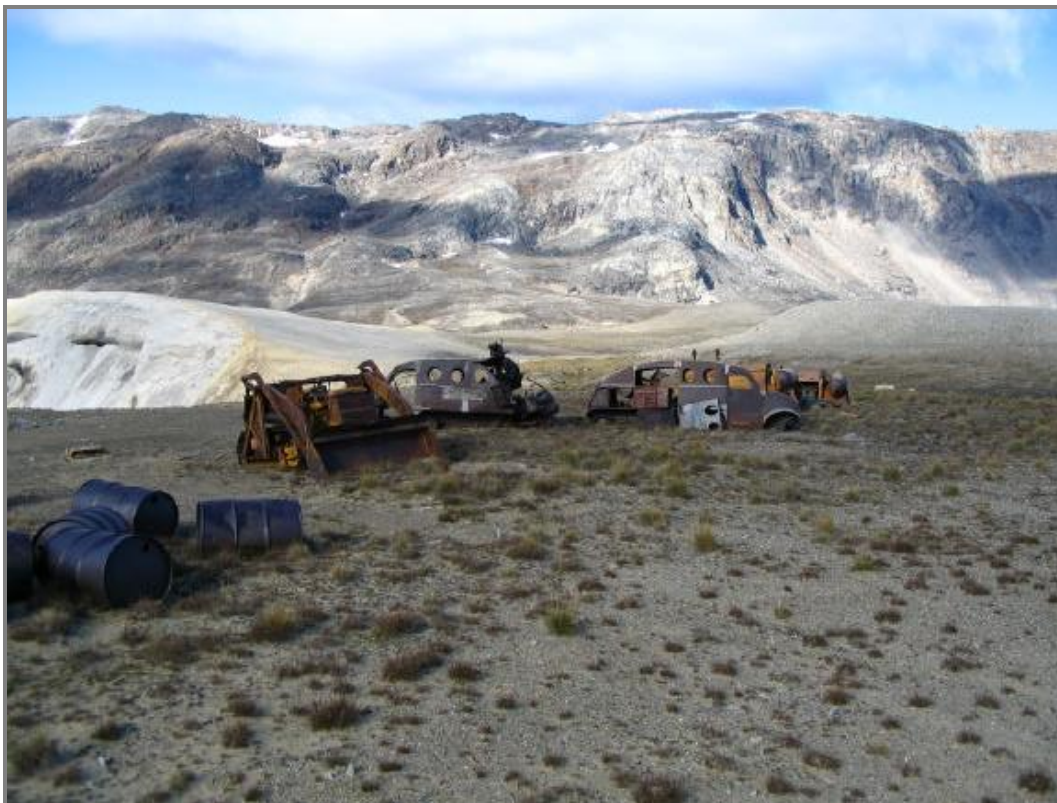
Picture 1: Lower Site Vehicle Debris - Before.

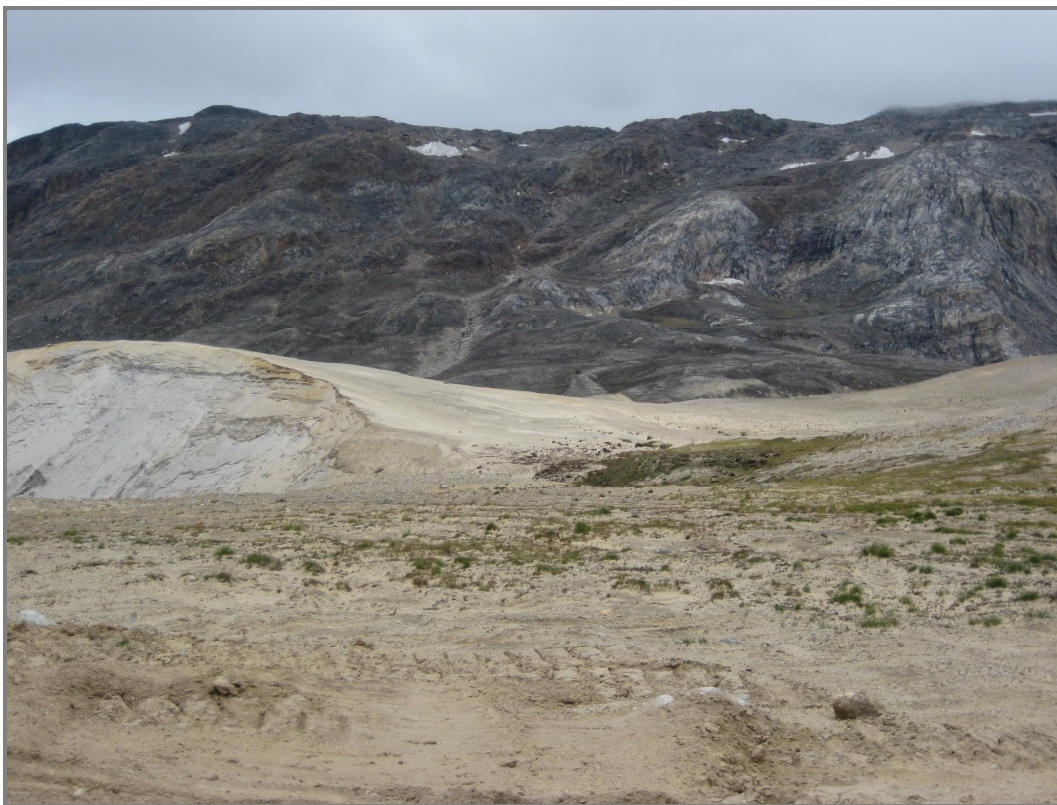
Picture 2: Lower Site Vehicle Debris - After.

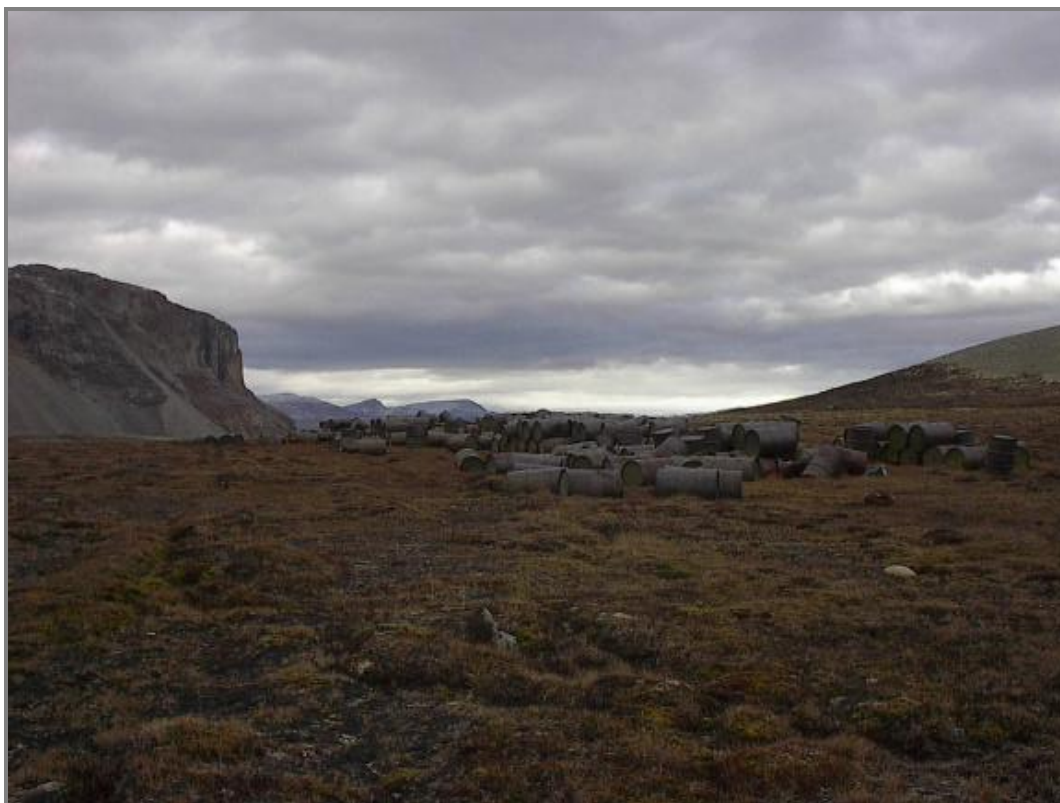
Picture 3: Lower Site Barrel Cache - Before.

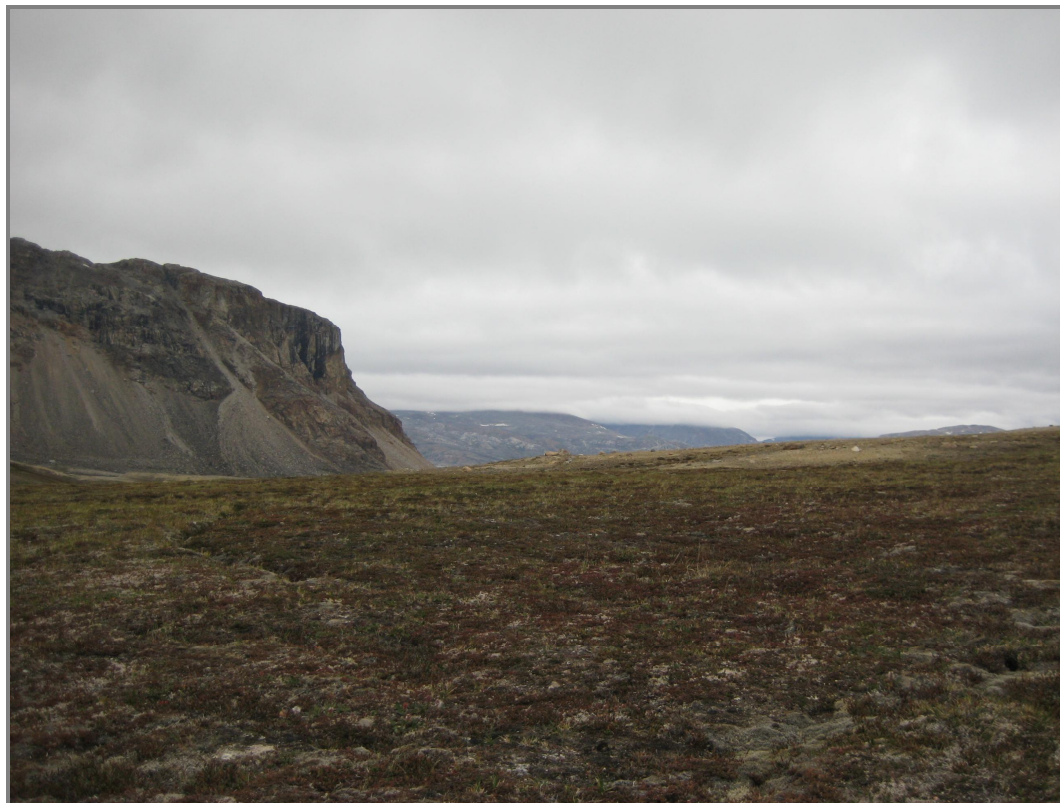
Picture 4: Lower Site Barrel Cache - After.

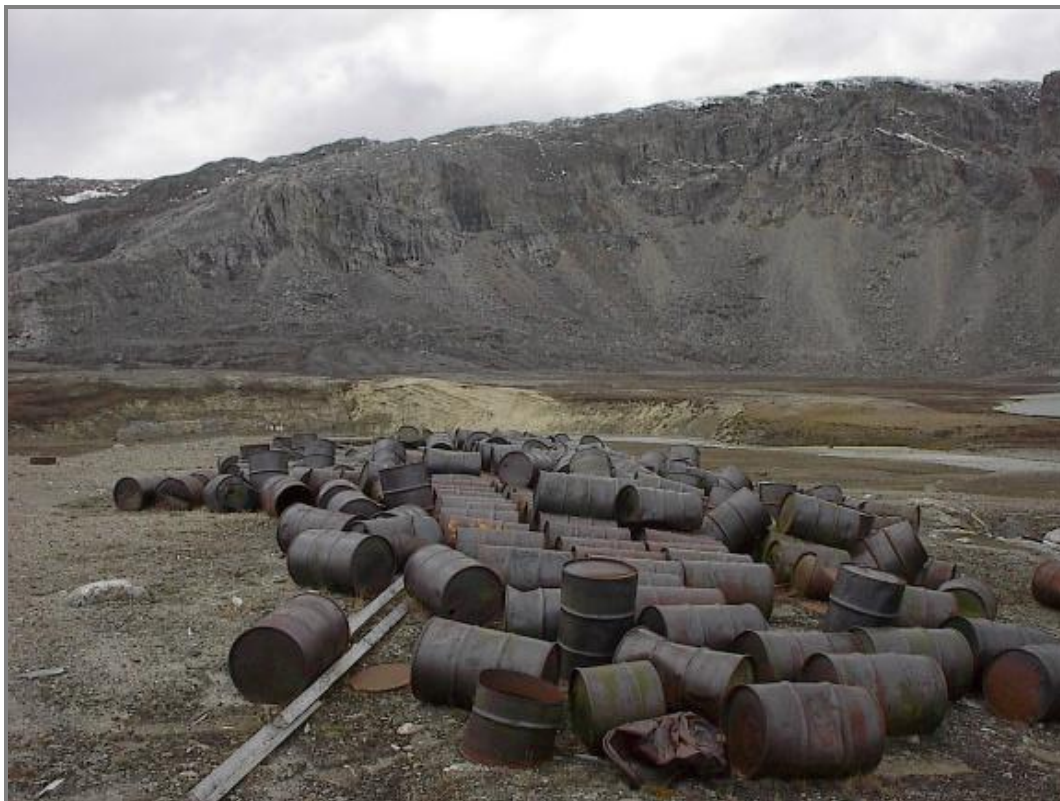
Picture 5: Lower Site Barrel Cache – Before.

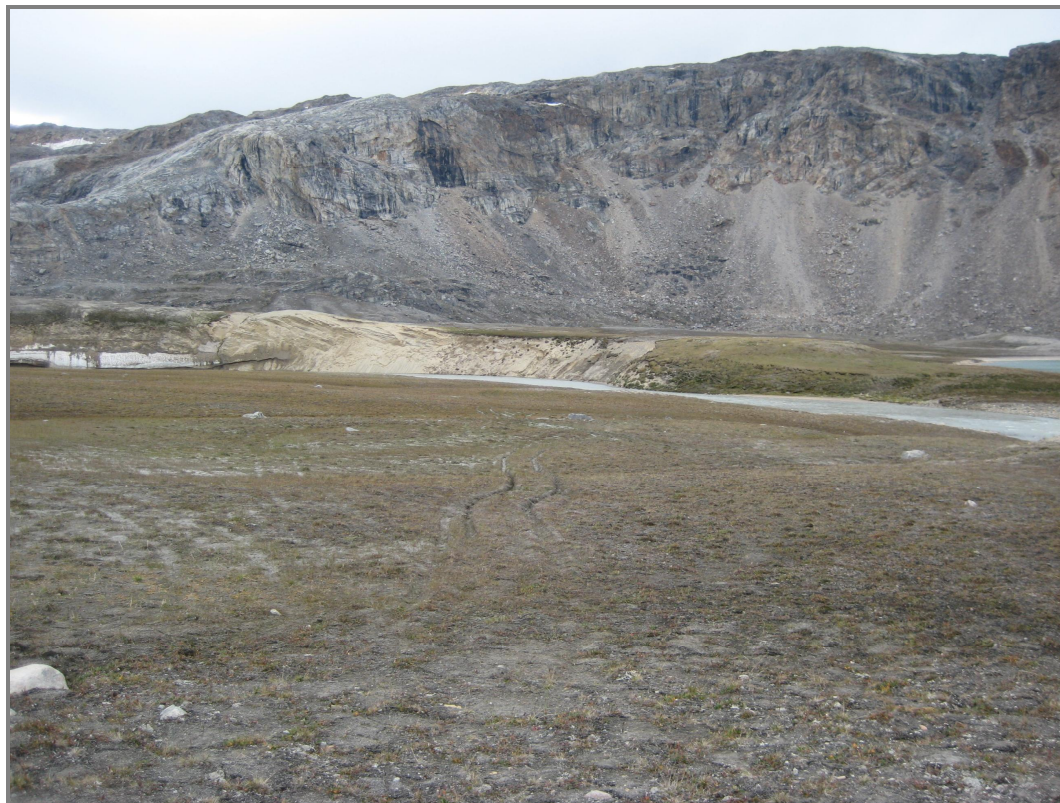
Picture 6: Lower Site Barrel Cache - After.

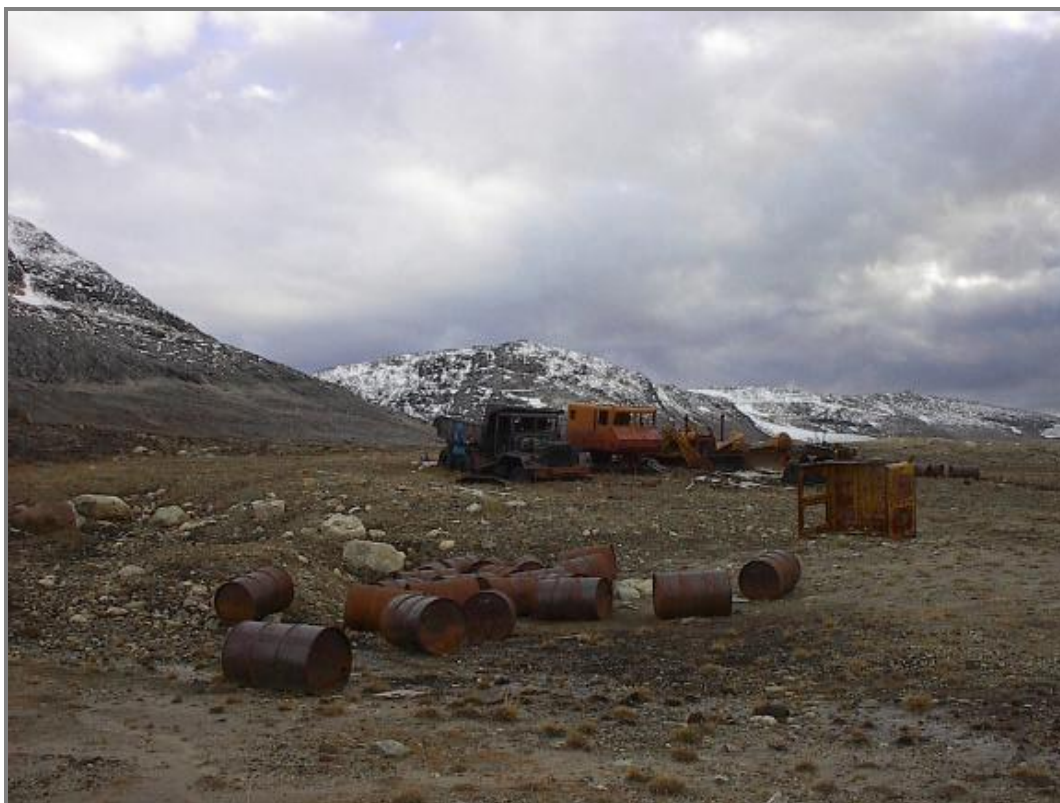
Picture 7: Lower Site Debris - Before.

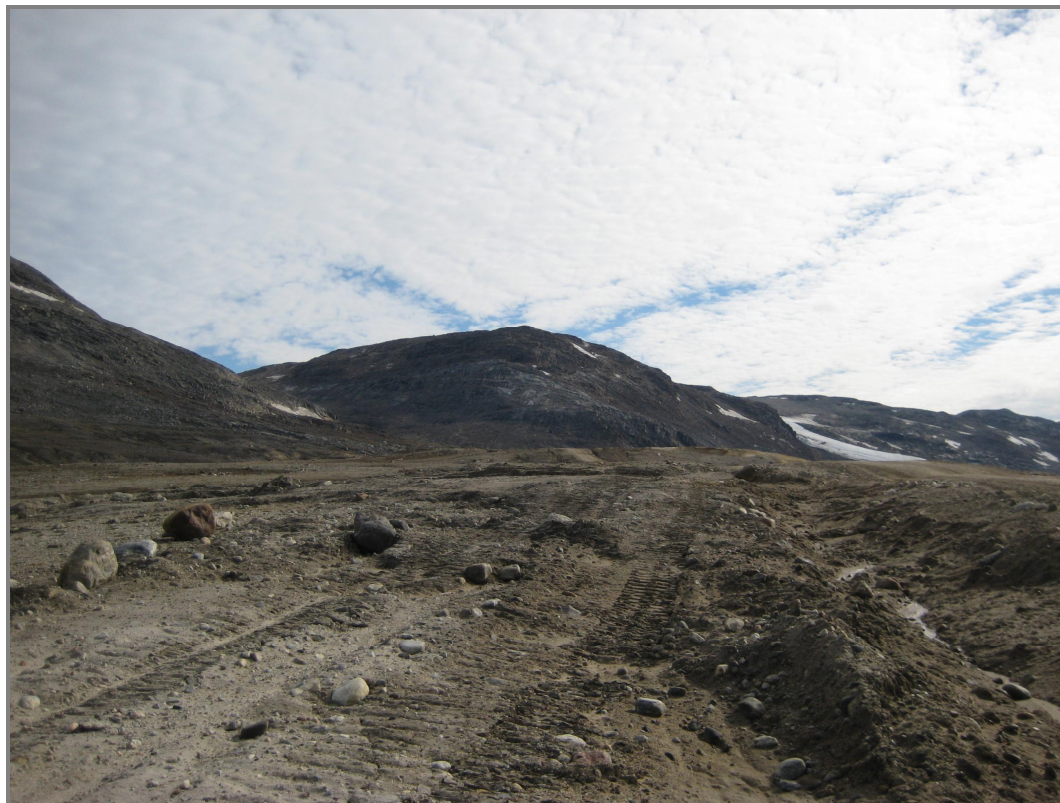
Picture 8: Lower Site Debris - After.

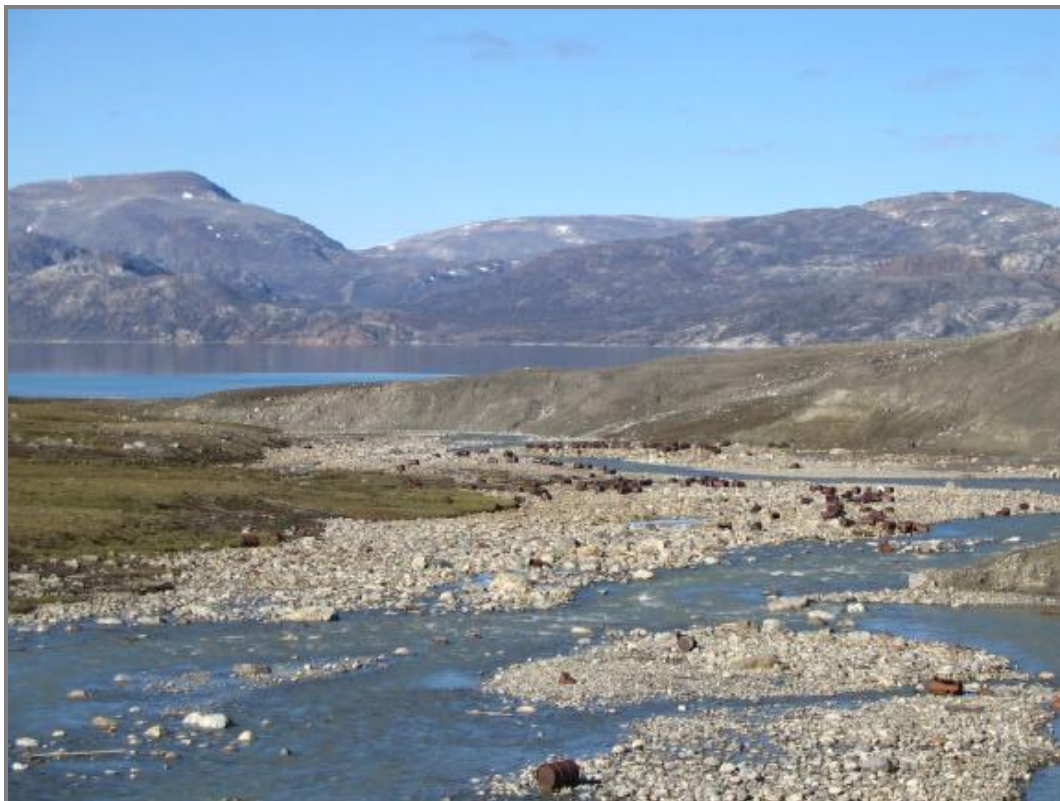
Picture 9: Lower Site Barrels in River - Before.

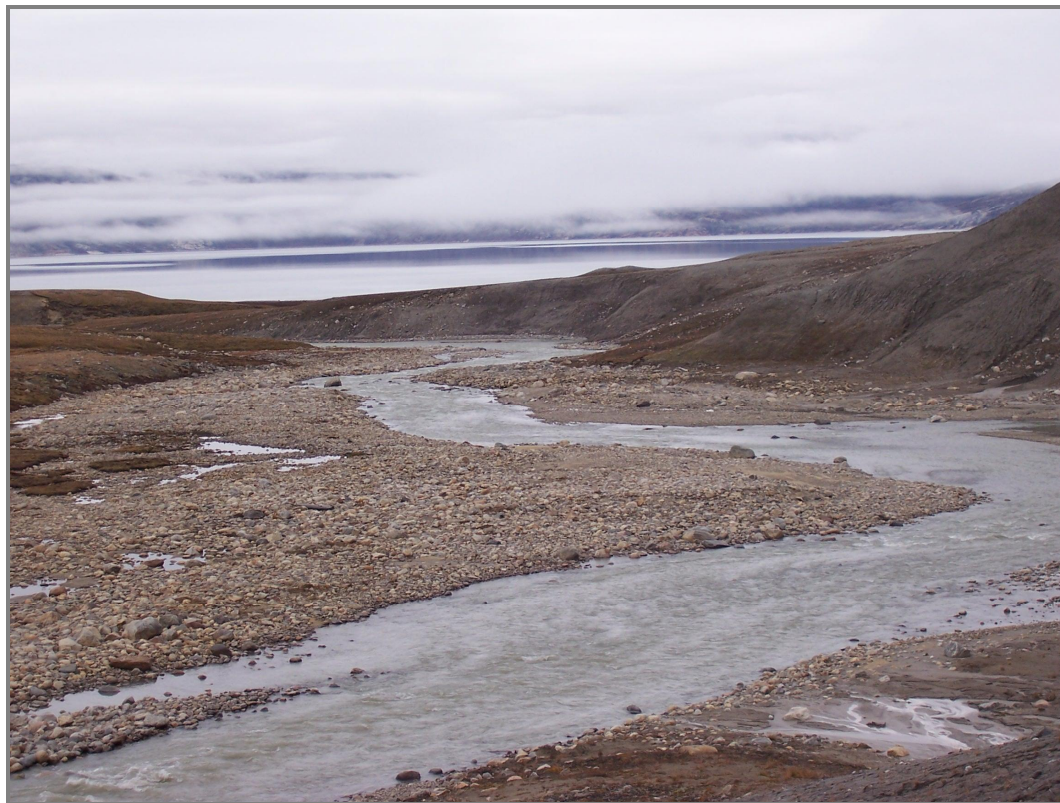
Picture 10: Lower Site Barrels in River - After.

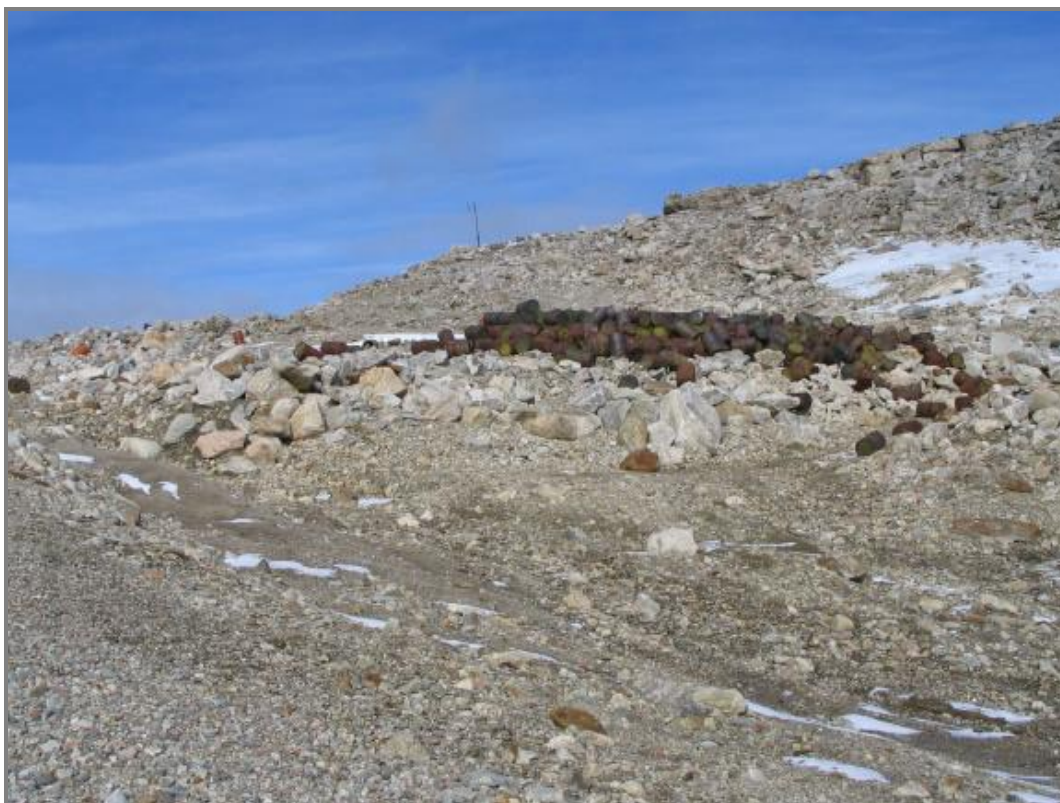
Picture 11: Mid-Station Barrel Cache - Before.

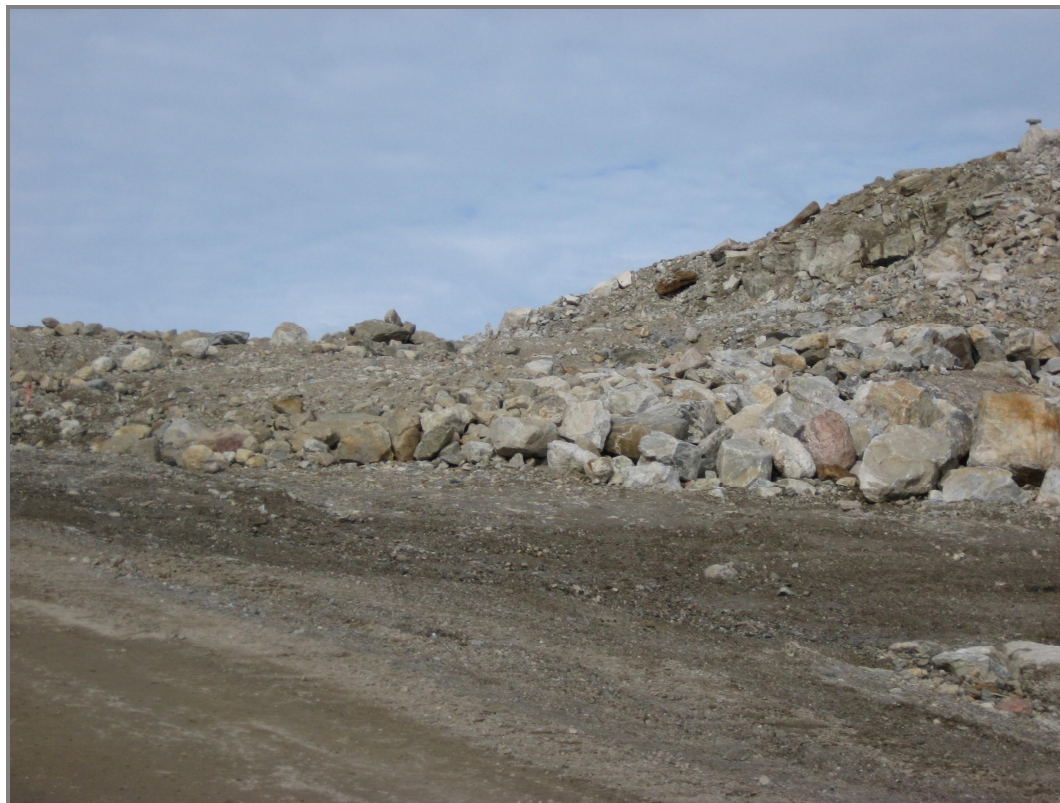
Picture 12: Mid-Station Barrel Cache - After.

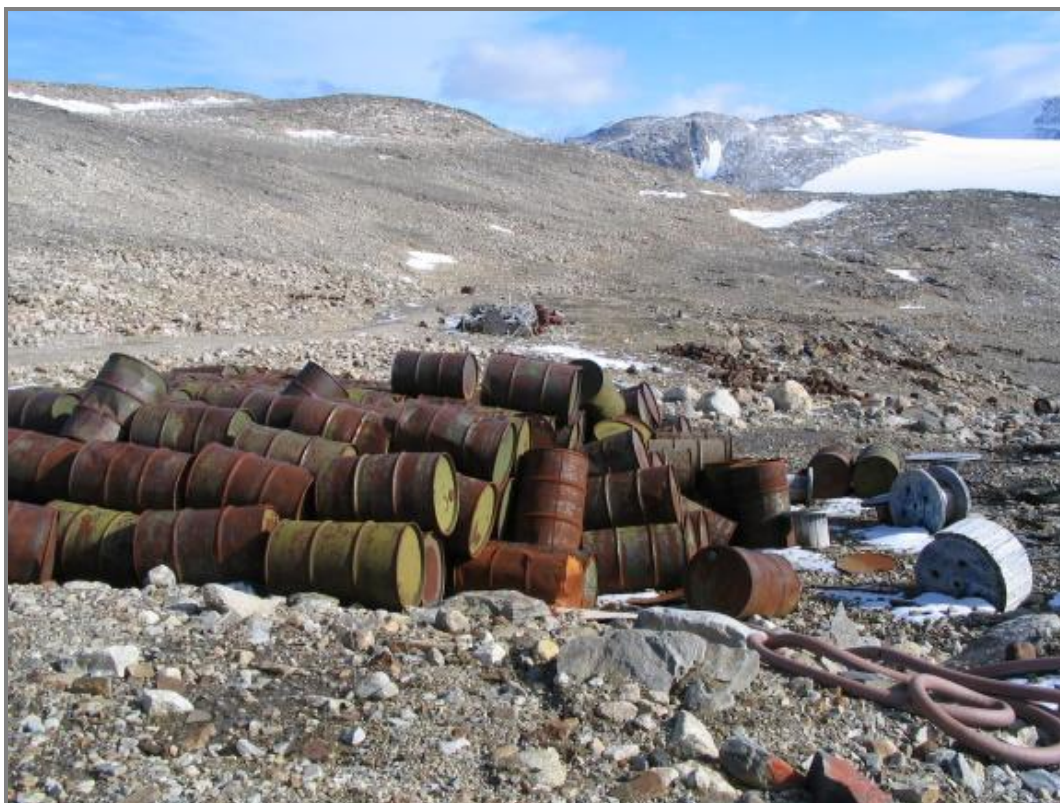
Picture 13: Mid-Station Barrel Cache and Quonset Hut Debris - Before.

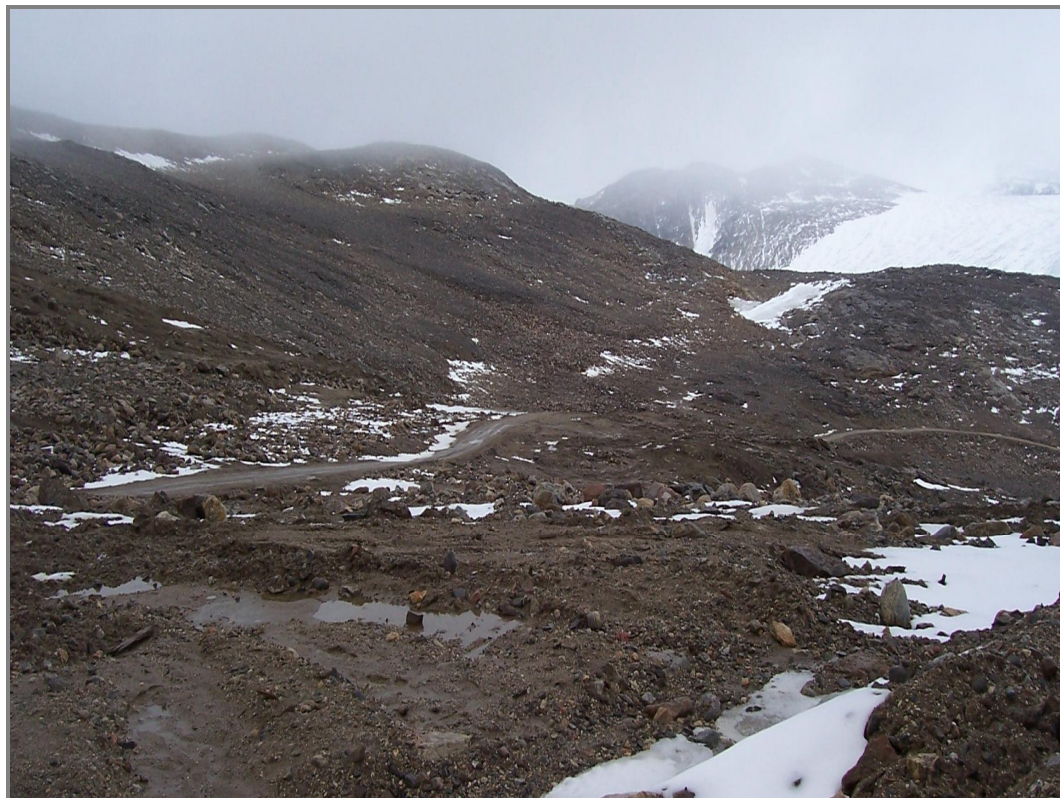
Picture 14: Mid-Station Barrel Cache and Quonset Hut Debris - After.

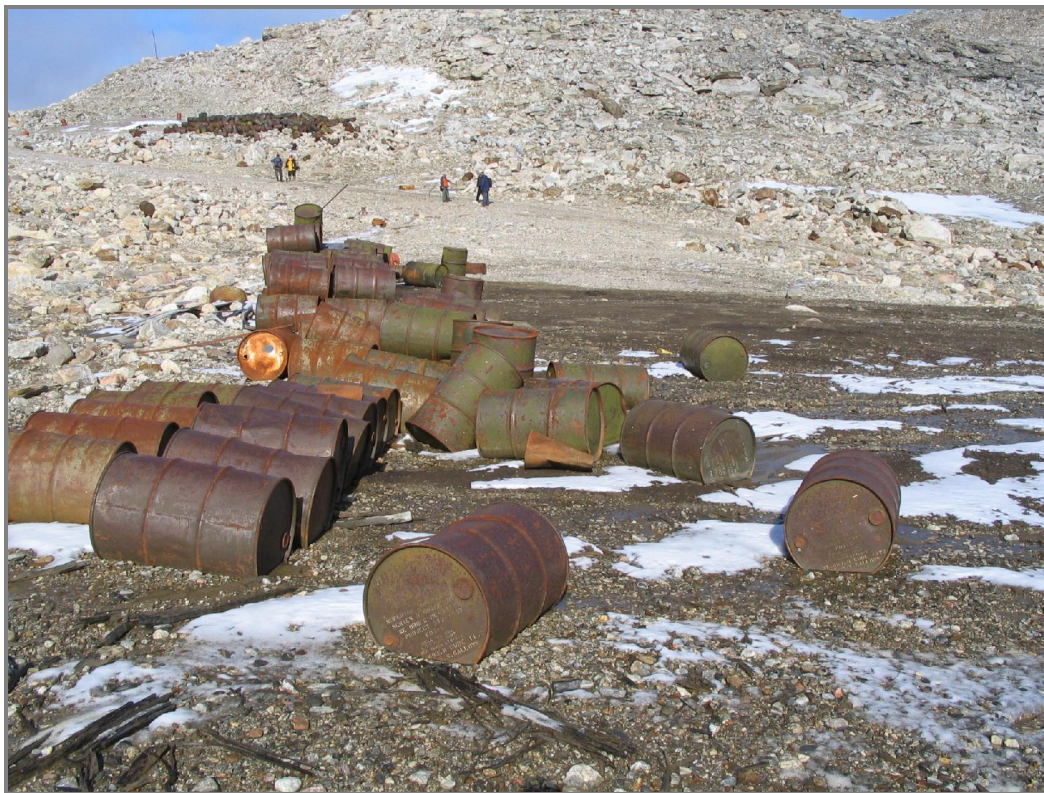
Picture 15: Mid-Station Barrel Cache & Staining - Before.

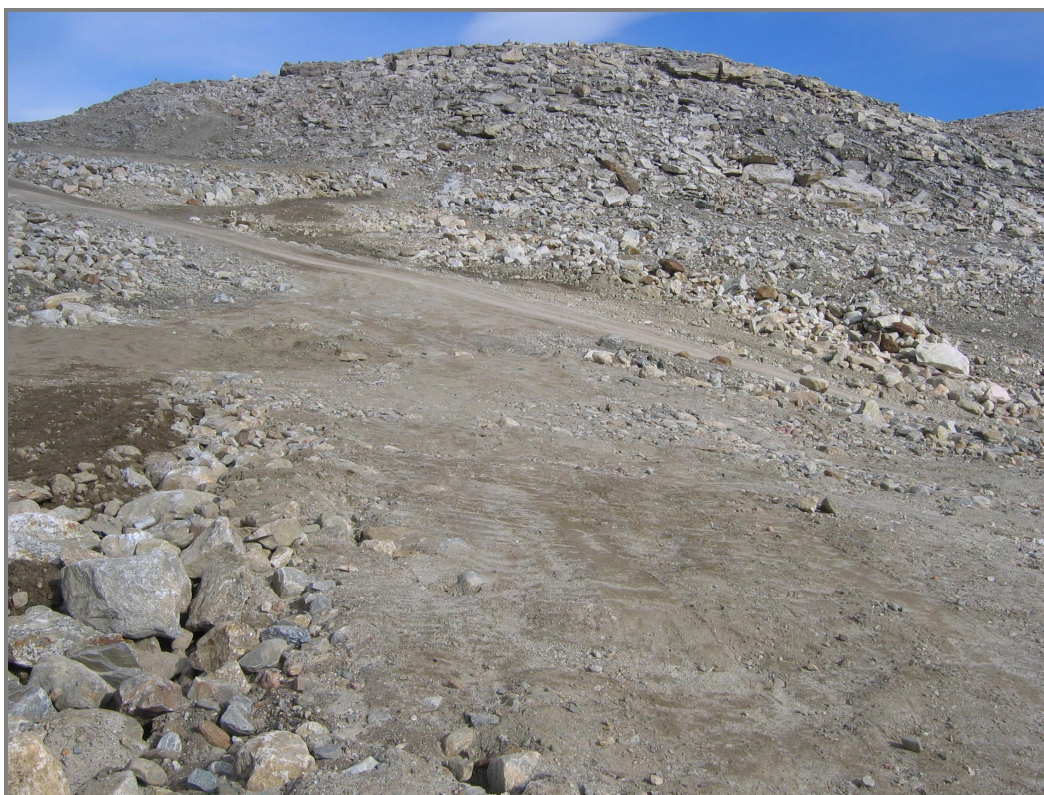
Picture 16: Mid Station Barrel Cache & Staining - After.

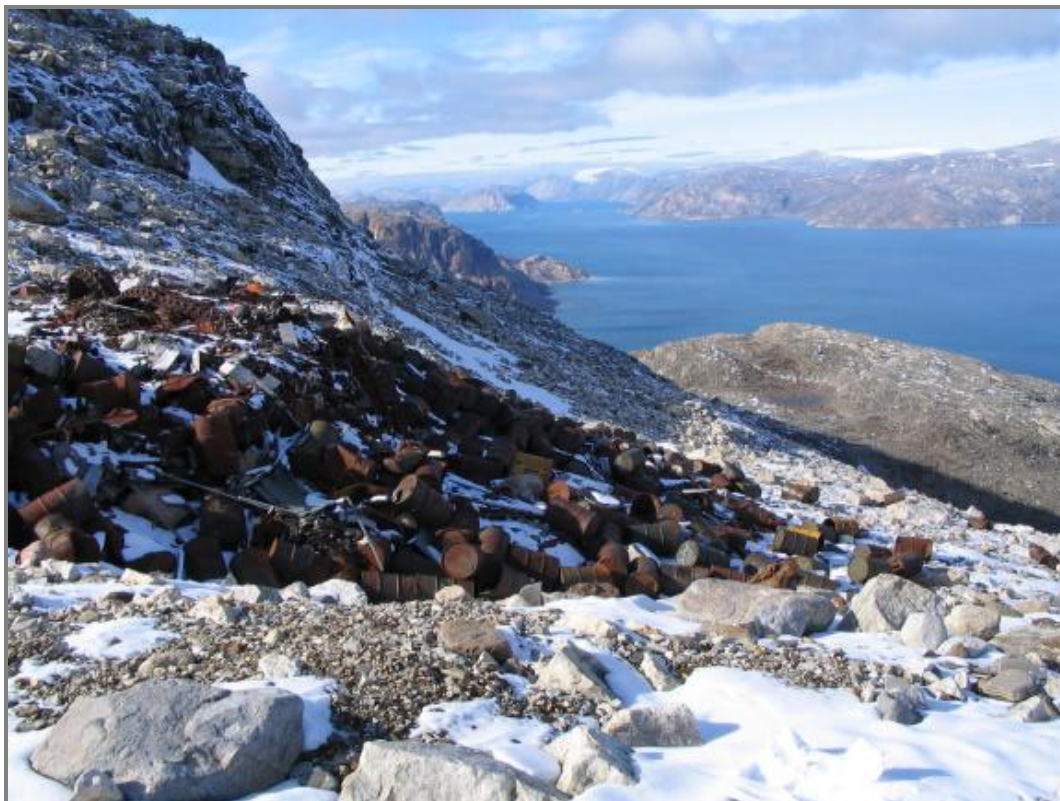
Picture 17: Mid-Station Dump Lobe B - Before.

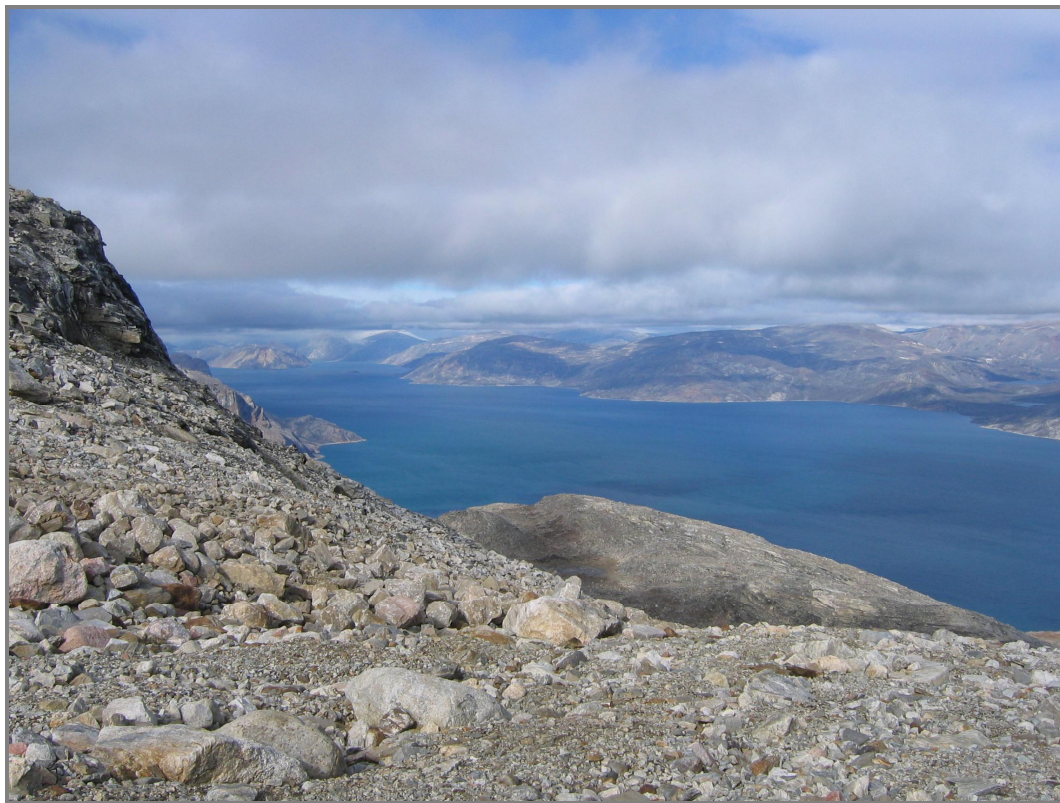
Picture 18: Mid-Station Dump Lobe B - After.

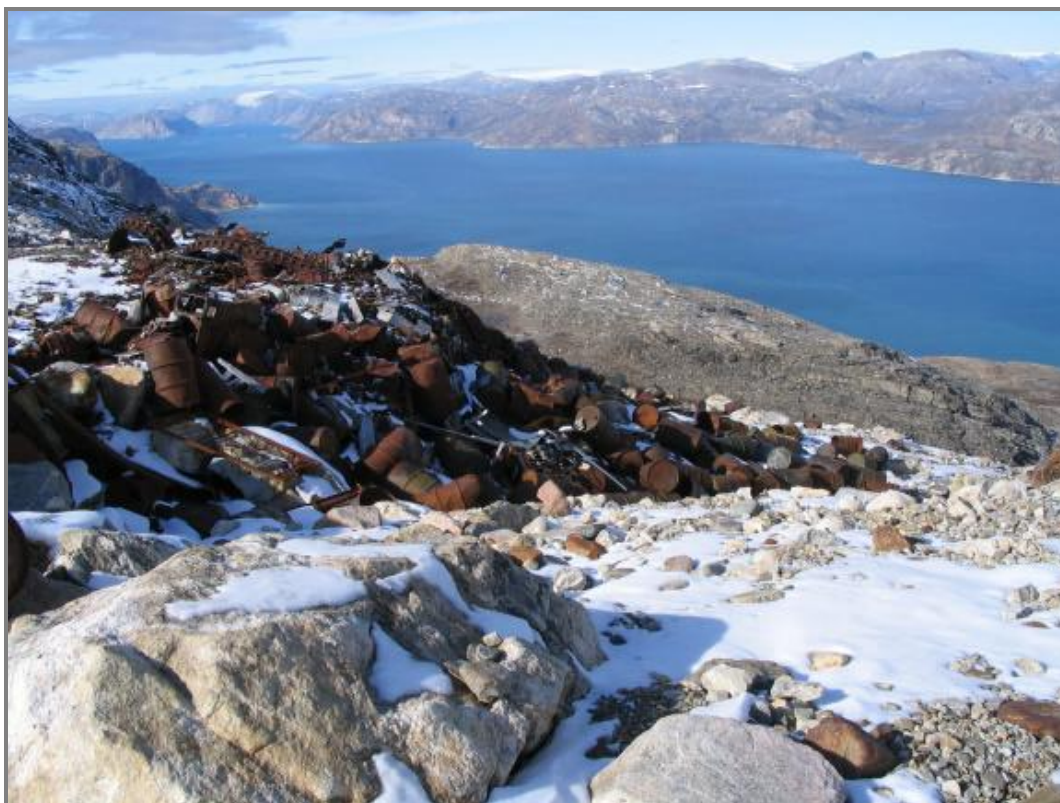
Picture 19: Mid-Station Dump Lobe B - Before.

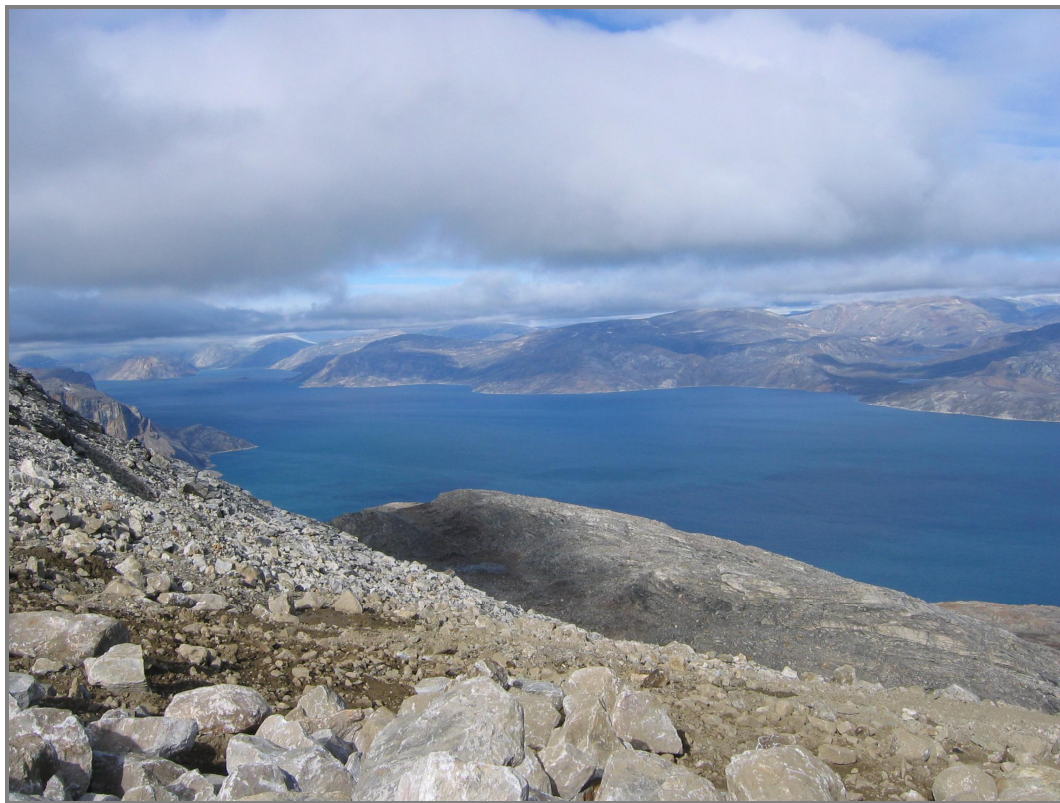
Picture 20: Mid-Station Dump Lobe B - After.

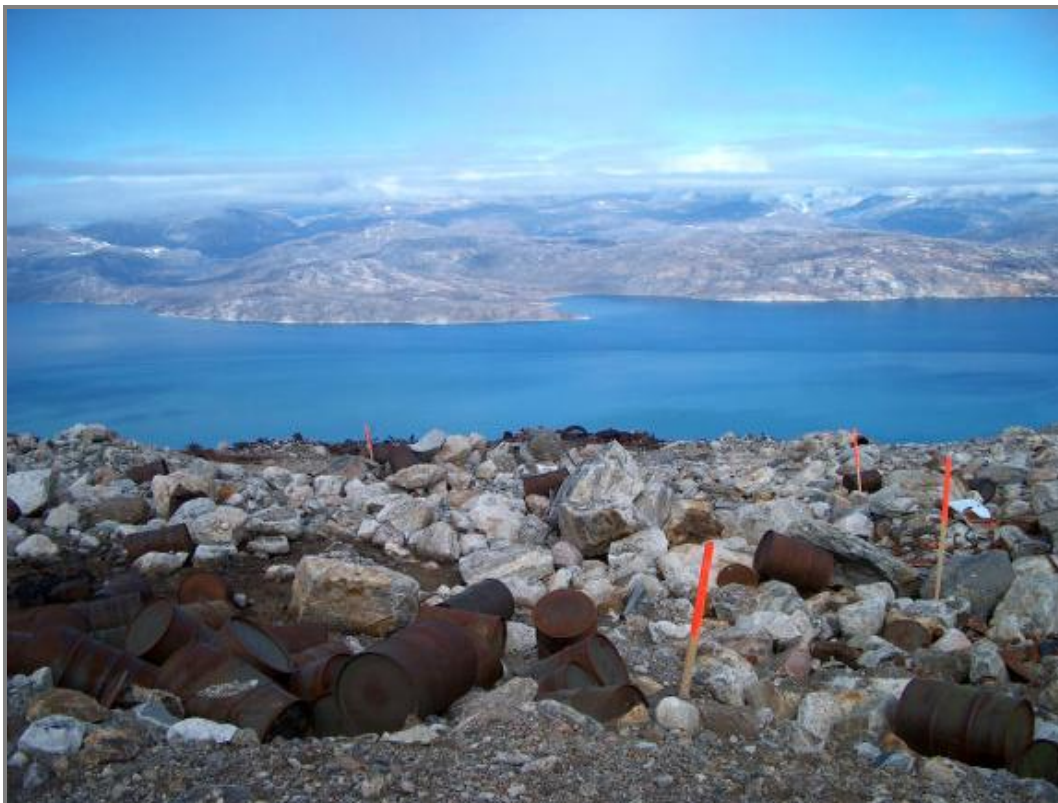
Picture 21: Mid-Station Dump Lobe B - Before.

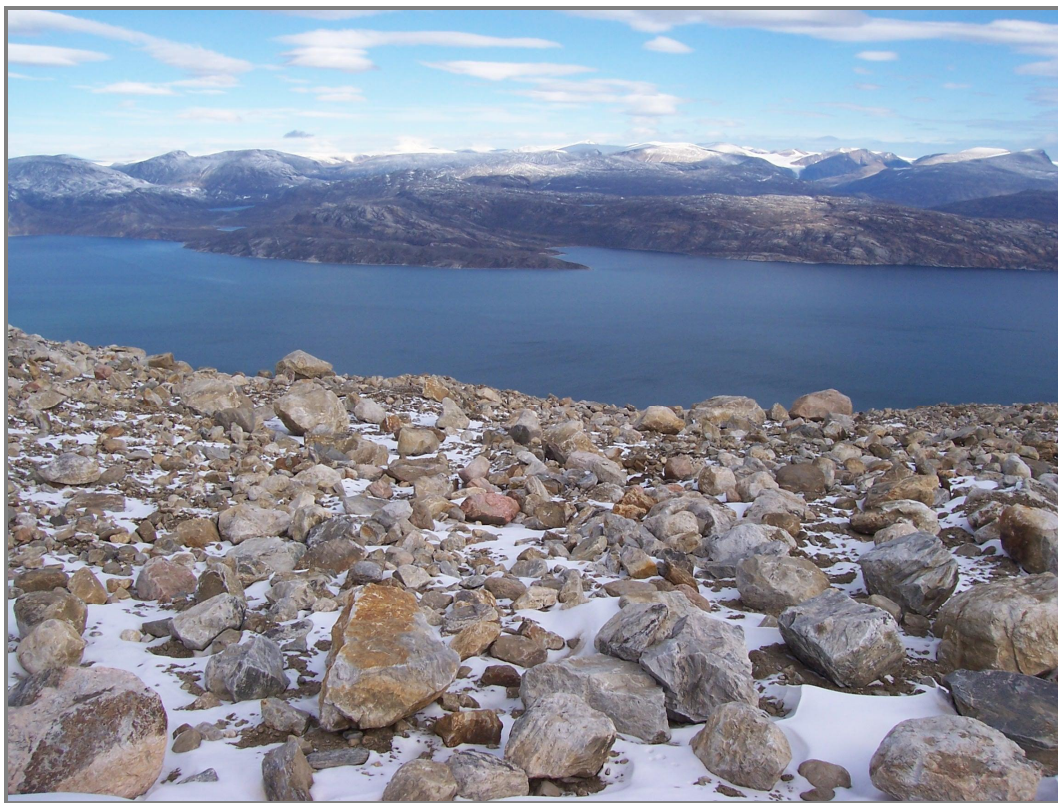
Picture 22: Mid-Station Dump Lobe B - After.

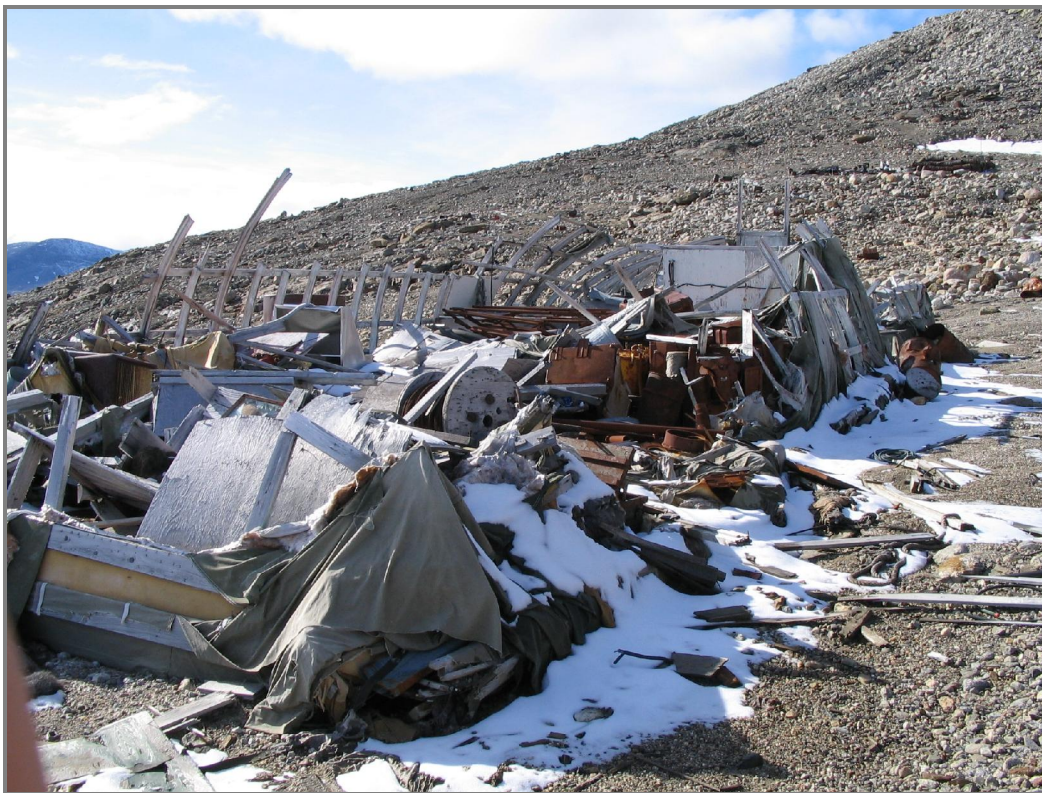
Picture 23: Mid Station Quonset Hut Debris - Before.

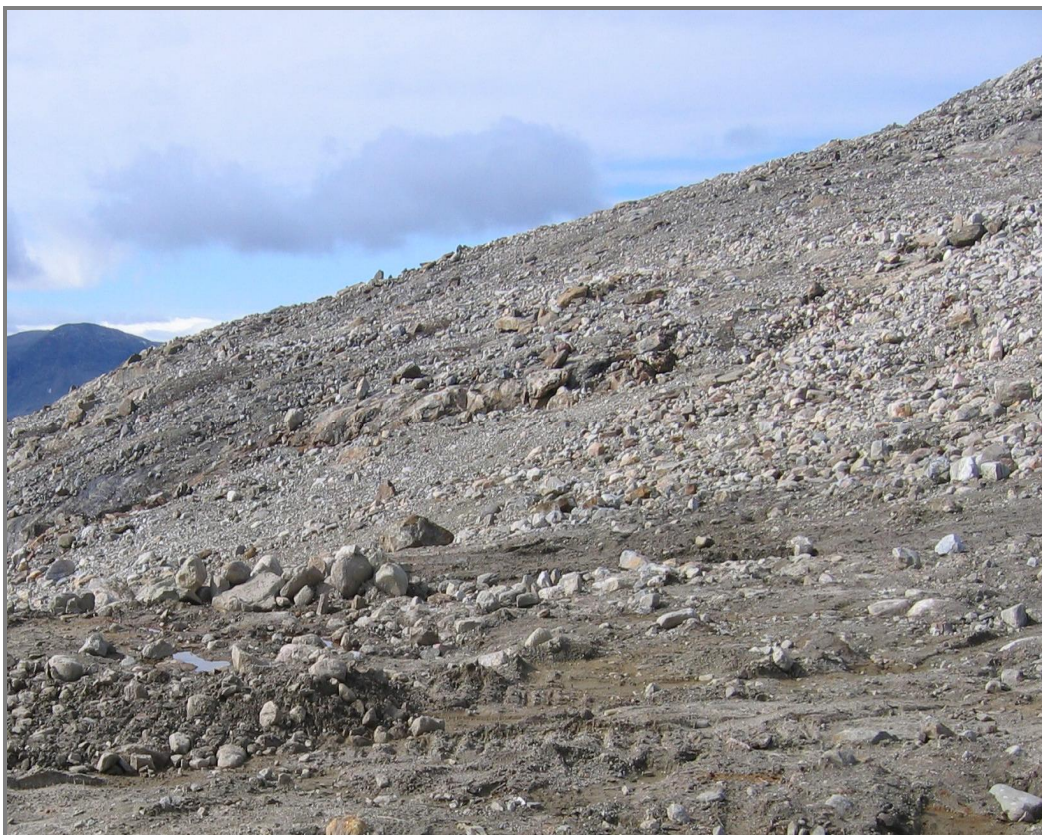
Picture 24: Mid Station Quonset Hut Debris - After.

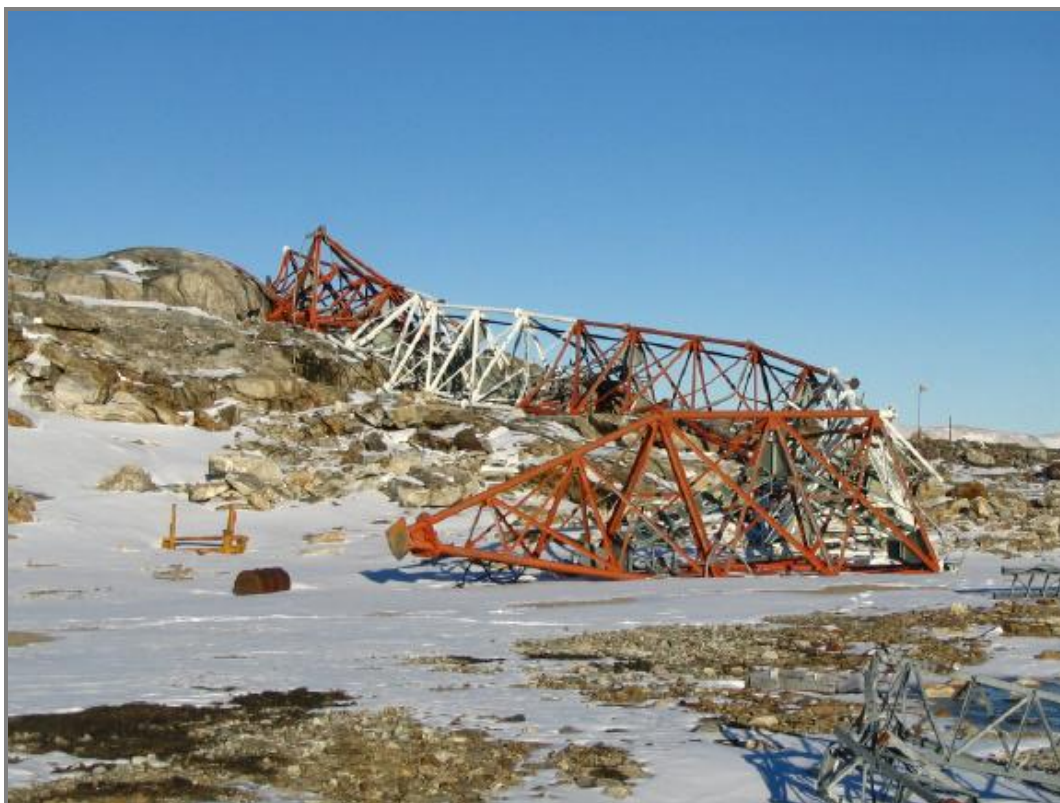
Picture 25: Upper Satellite Antenna Debris - Before.

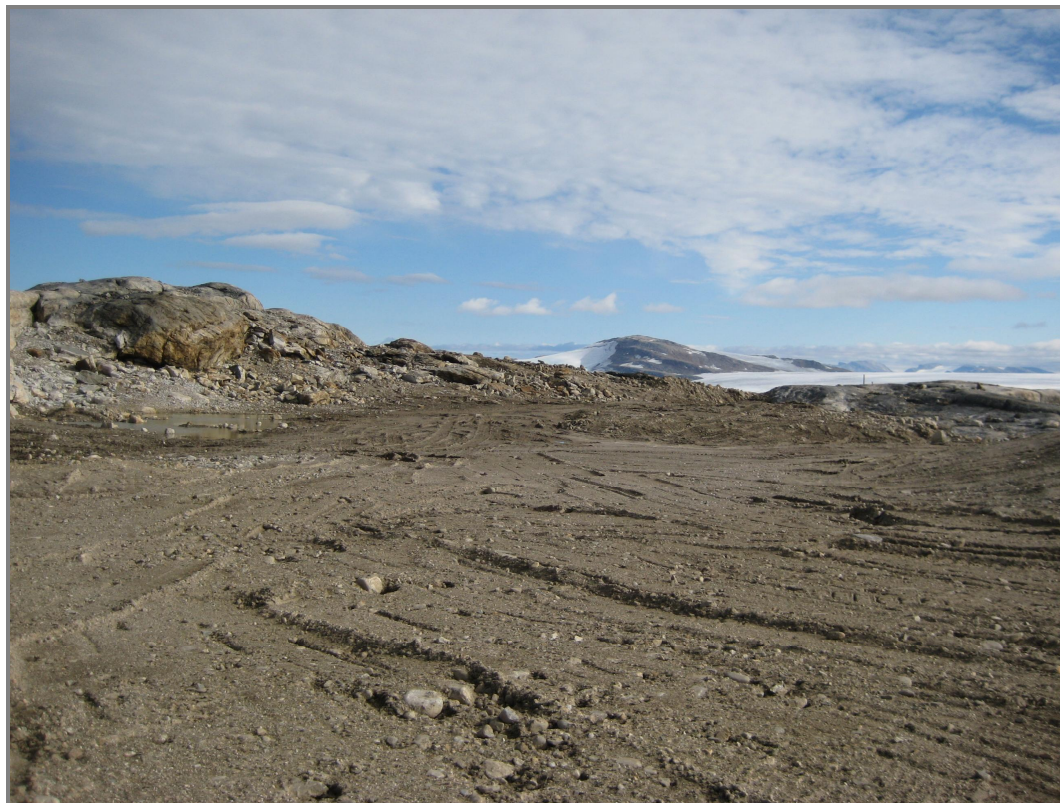
Picture 26: Upper Satellite Antenna Debris - After.

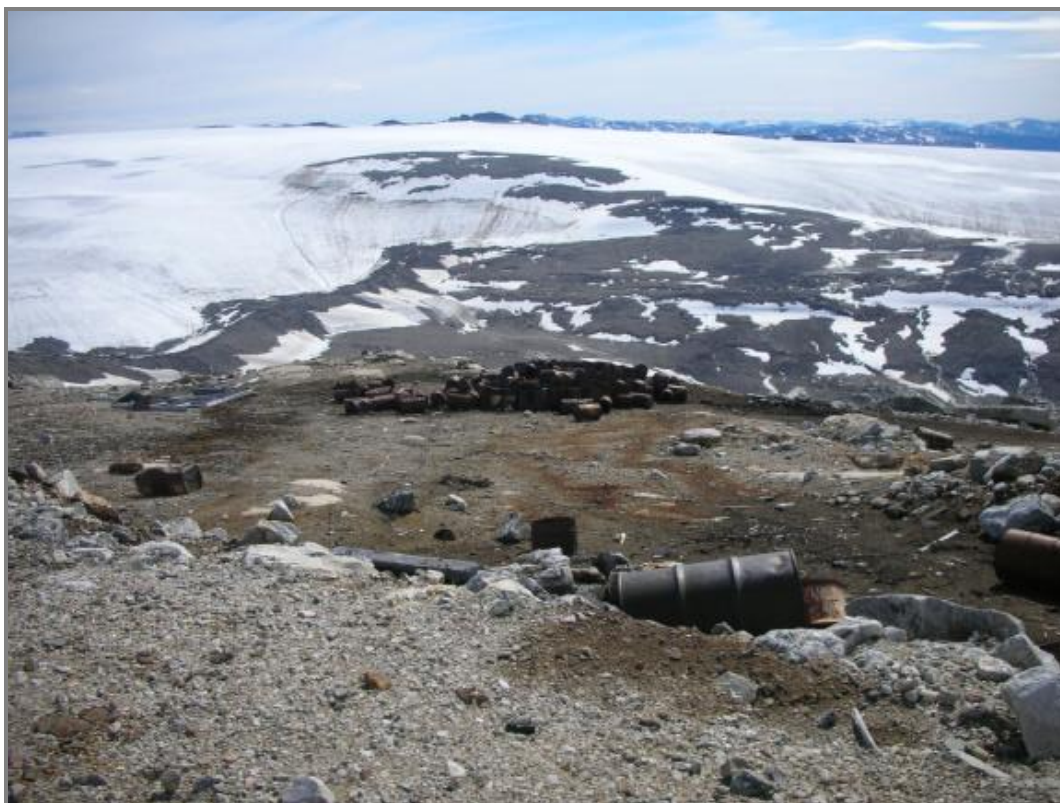
Picture 27: Upper Station Barrel Debris - Before.
