NWB Annual Report

Year being reported: 2008

Project Name: FOX-C Ekalugad Fjord Remediation Project

Licensee: Indian and Northern Affairs Canada

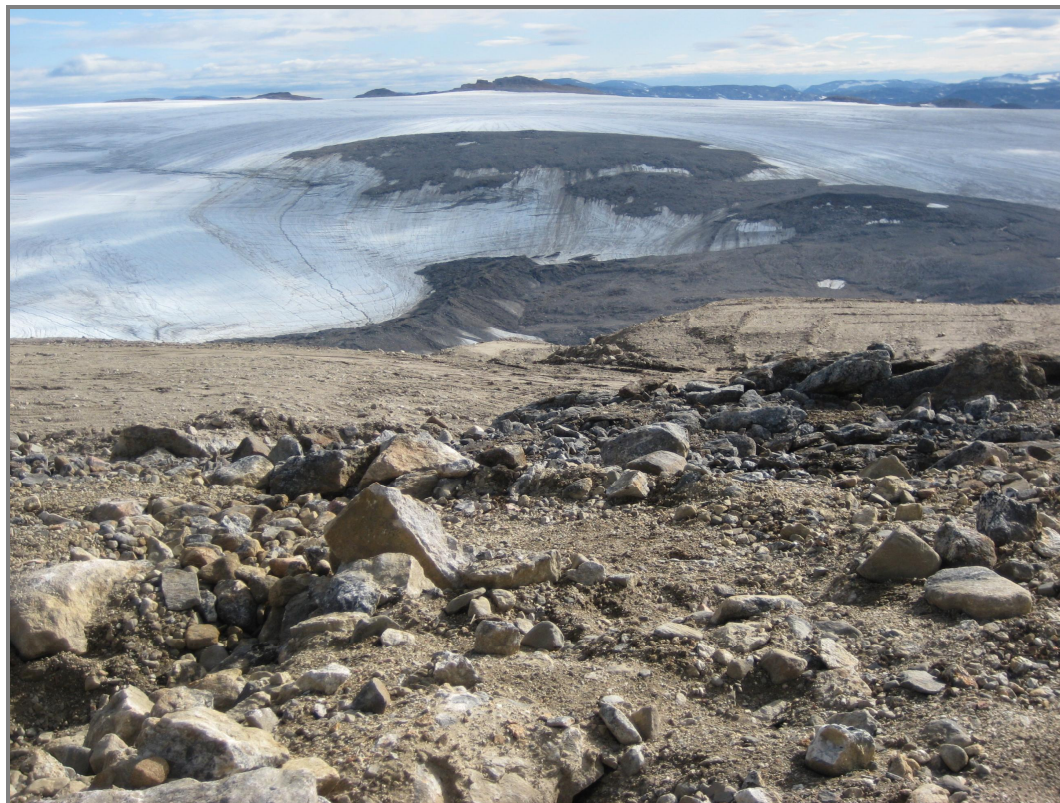
Picture 28: Upper Station Barrel Debris - After.

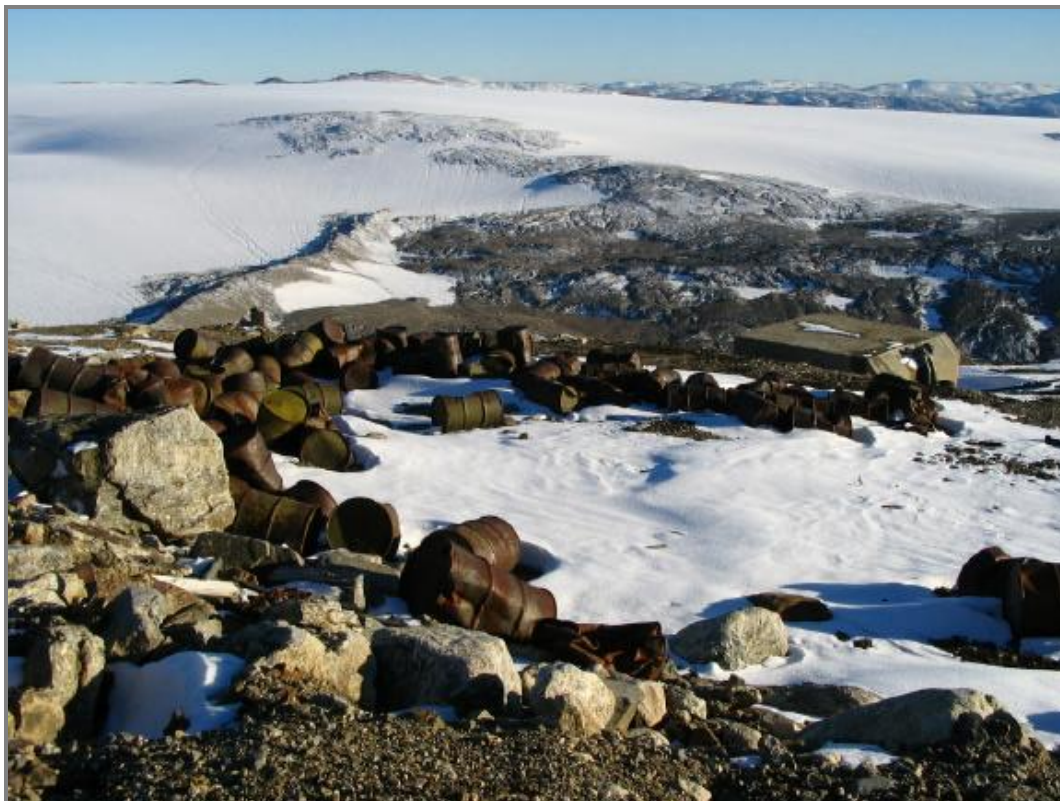
Picture 30: Upper Station Barrel Debris & Antenna Anchor Block - Before.

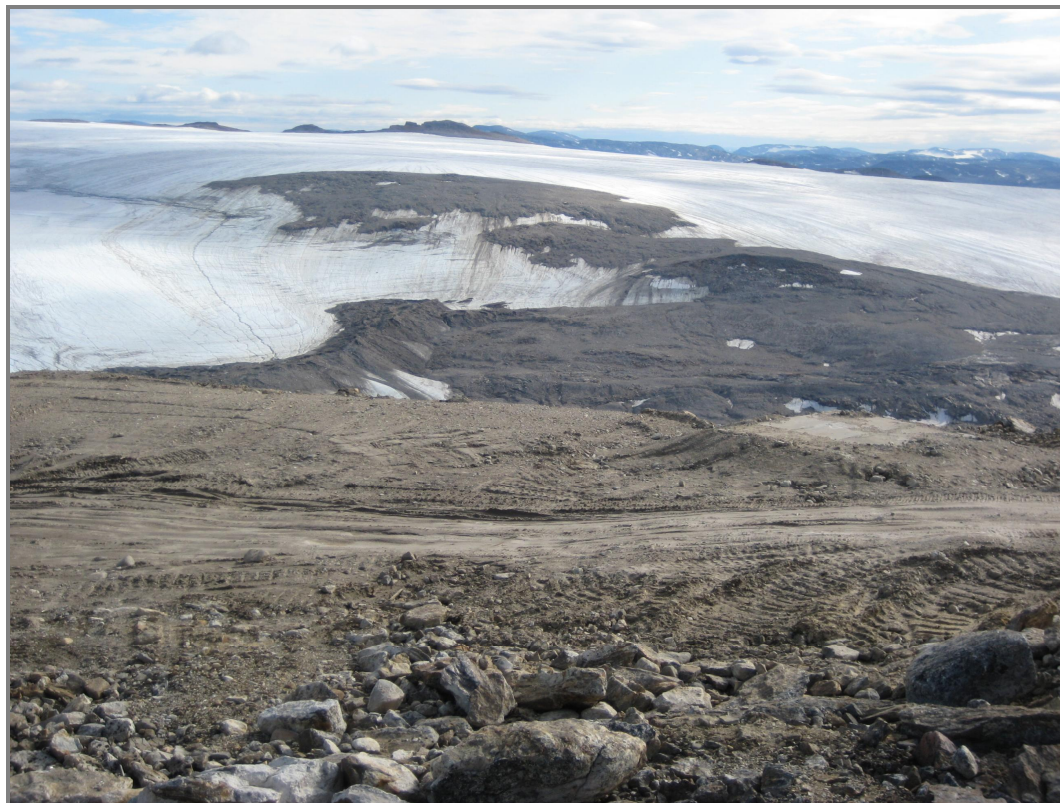
Picture 31: Upper Station Barrel Debris & Antenna Anchor Block - After.

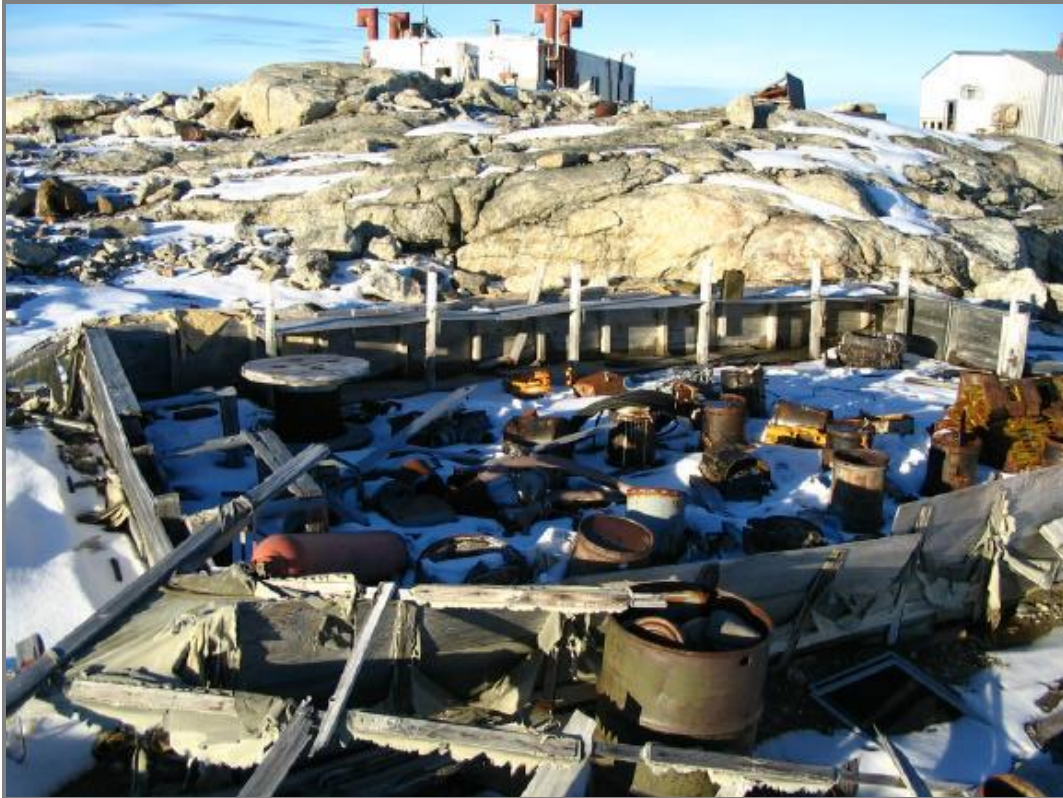
Picture 32: Upper-Station Building Debris (Module Train & Warehouse in Background) - Before.

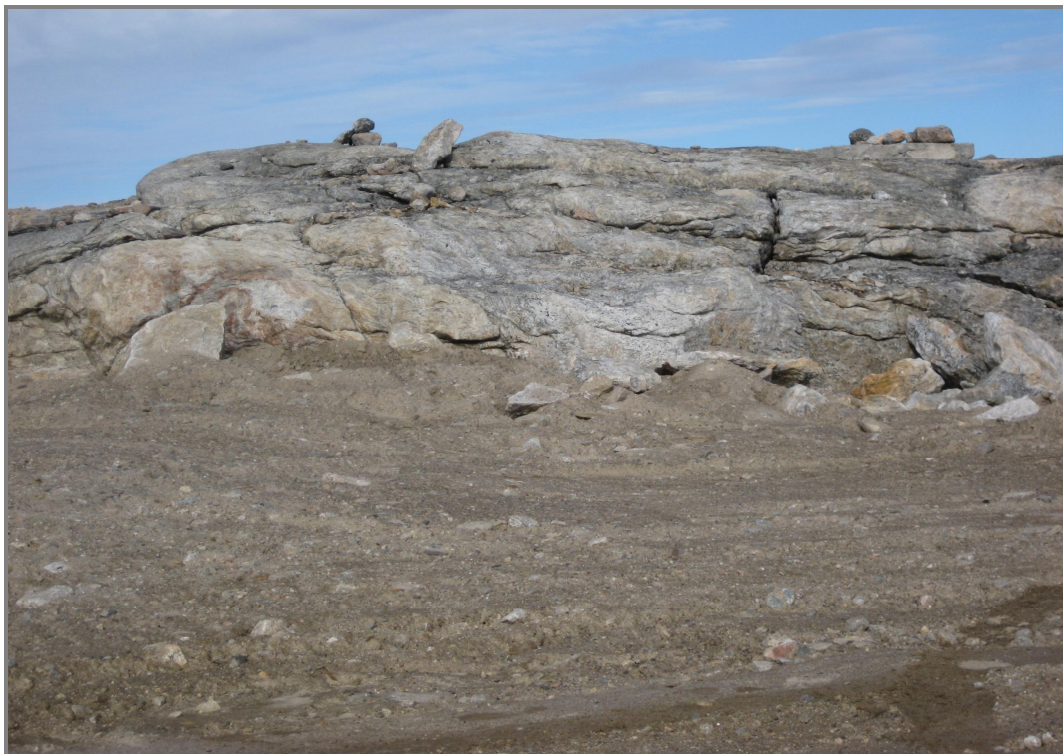
Picture 33: Upper-Station Building Debris (Module Train & Warehouse in Background) - After.

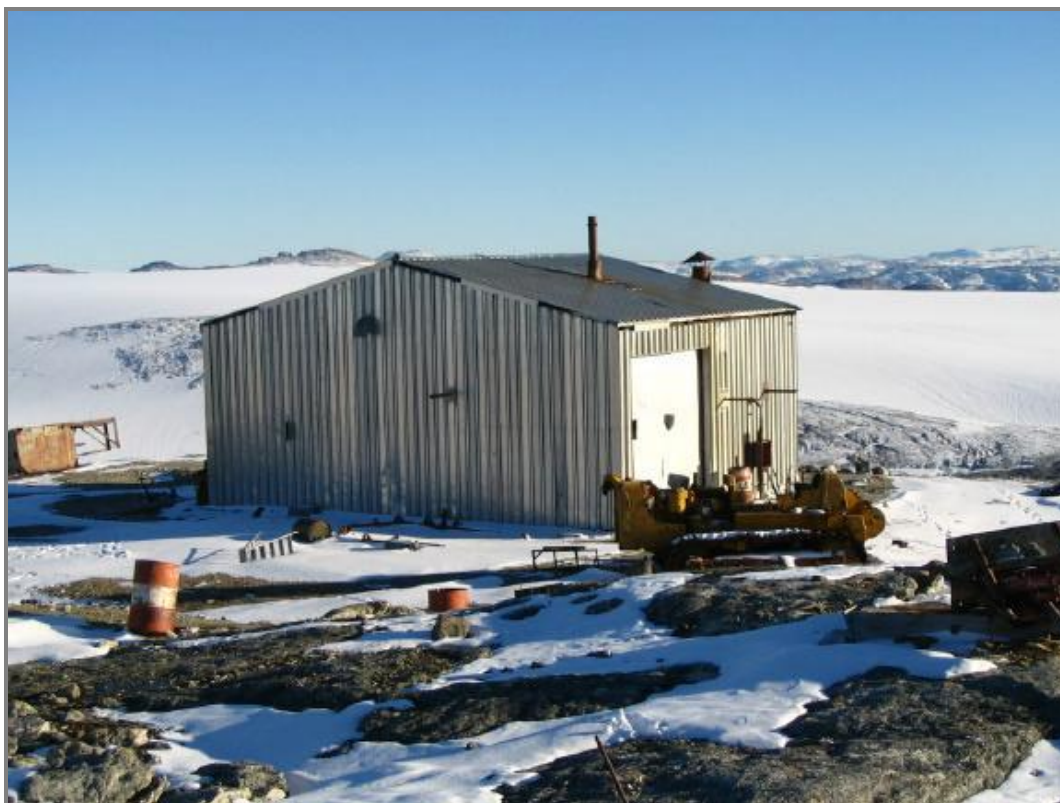
Picture 34: Upper Station Garage - Before.

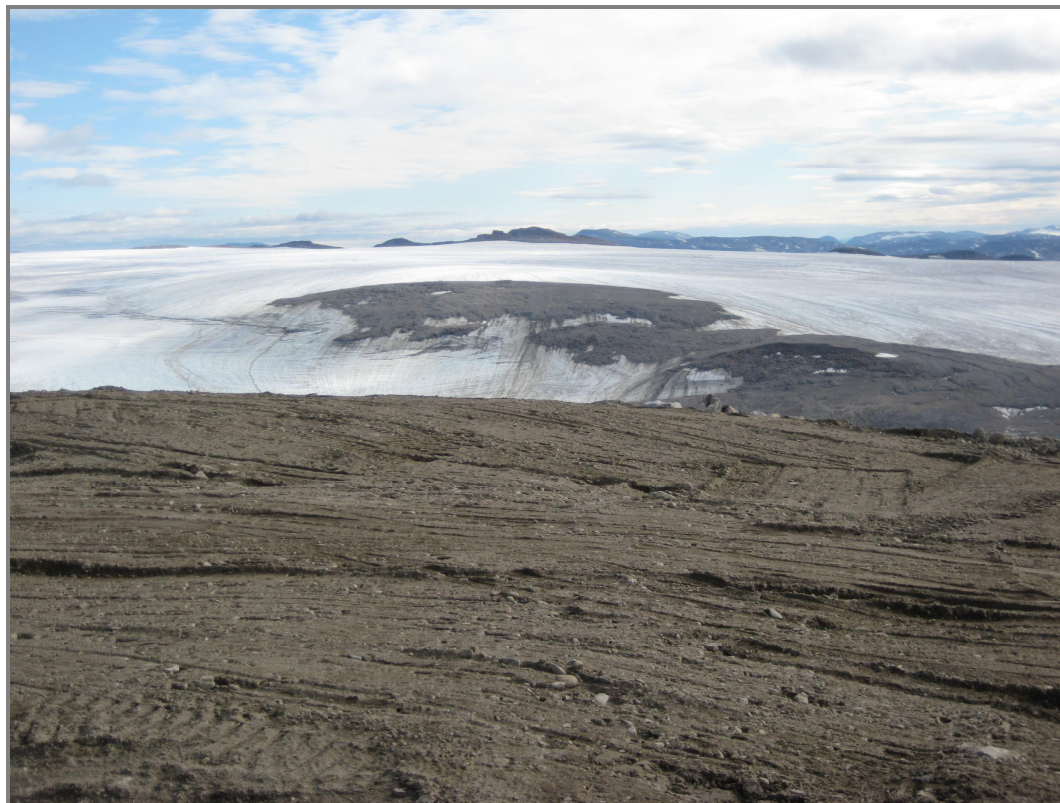
Picture 35: Upper Station Garage - After.

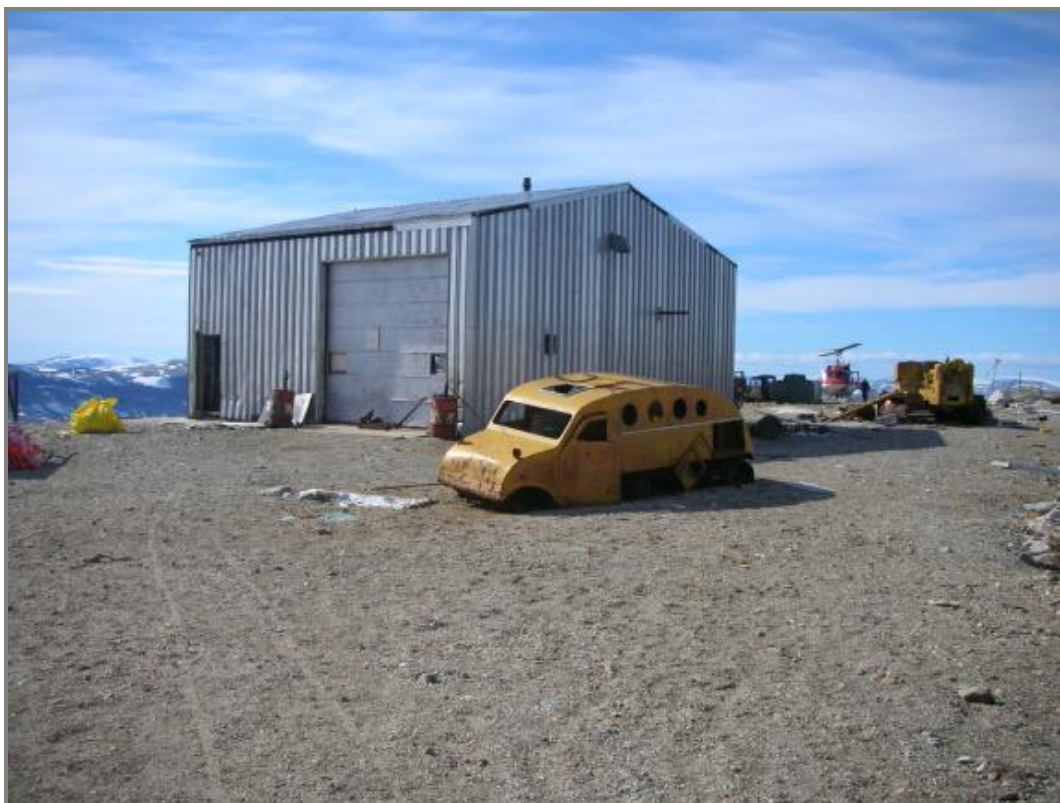
Picture 36: Upper Station Garage - Before.

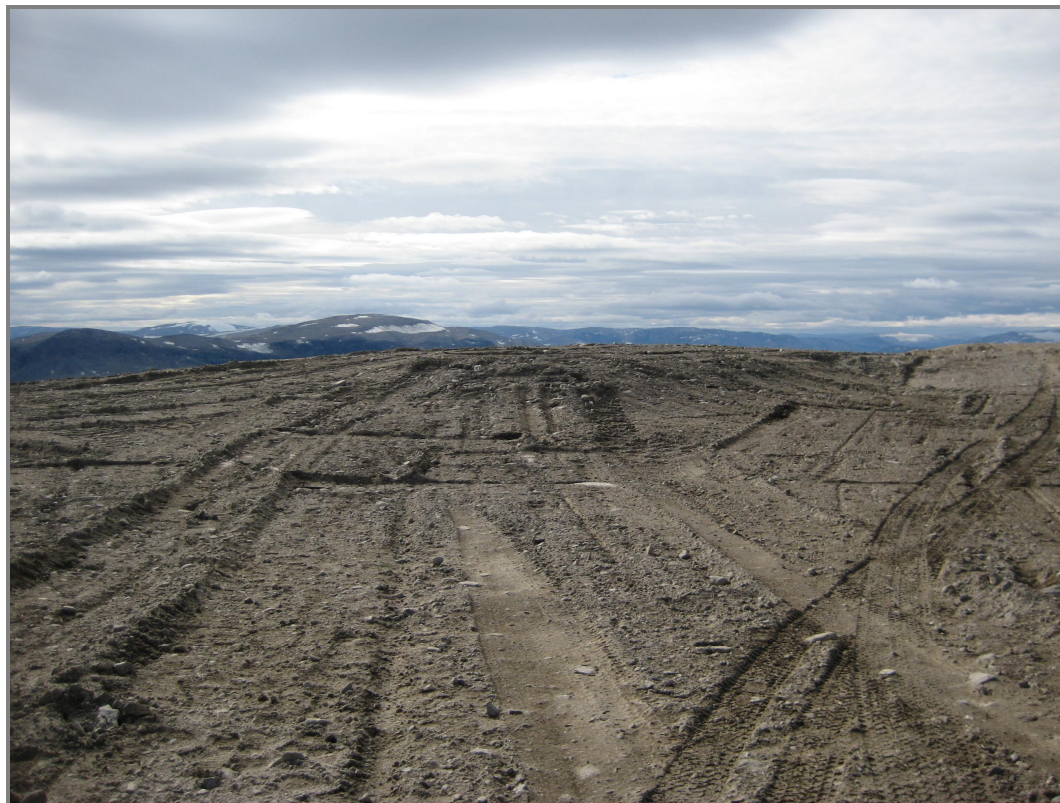
Picture 37: Upper Station Garage - After.

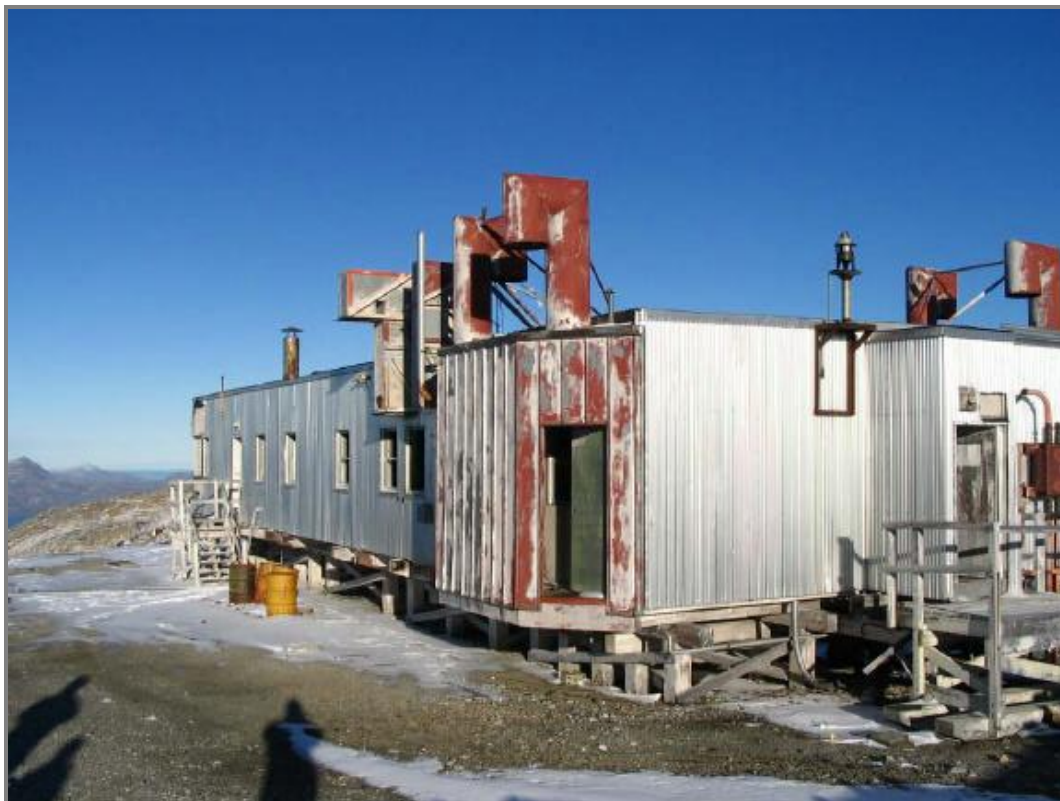
Picture 38: Upper Station Module Train - Before.

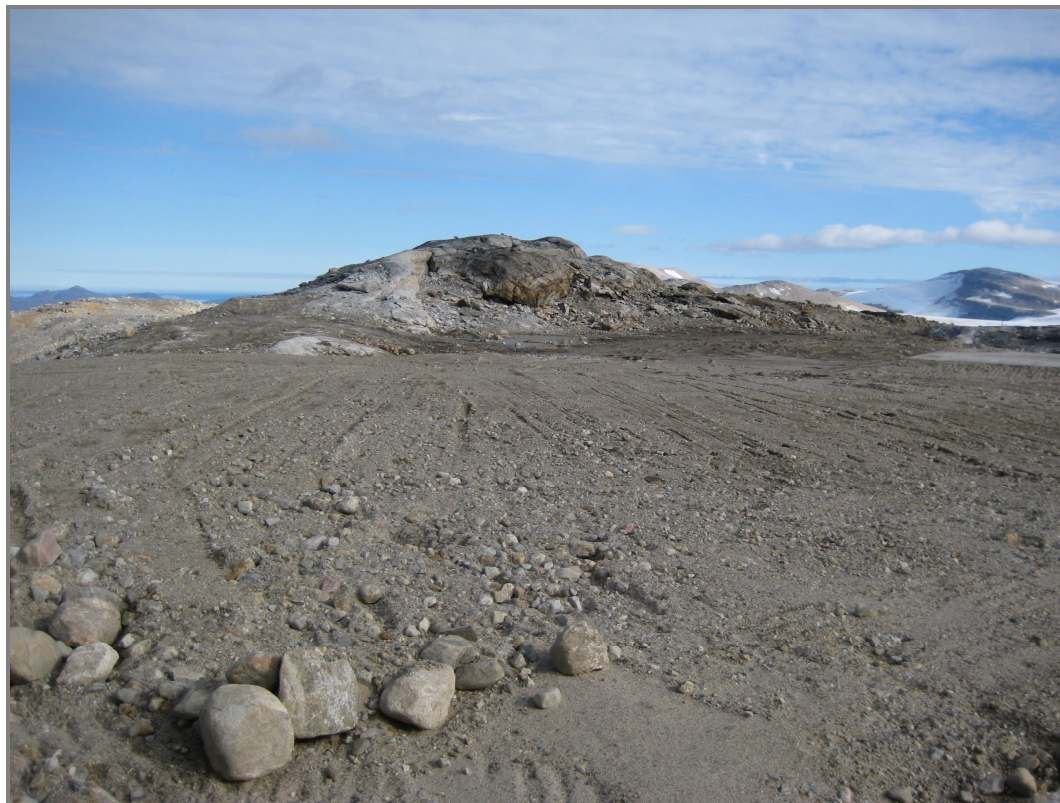
Picture 39: Upper Station Module Train - After.

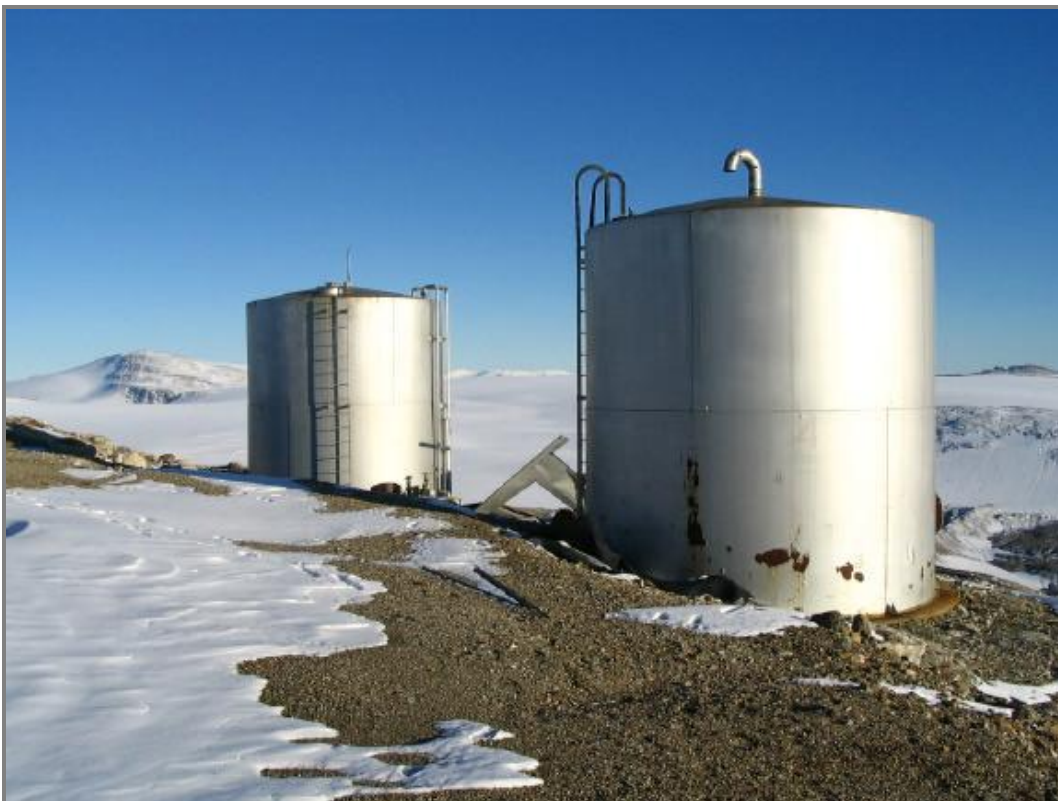
Picture 40: Upper Station POL Tanks - Before.

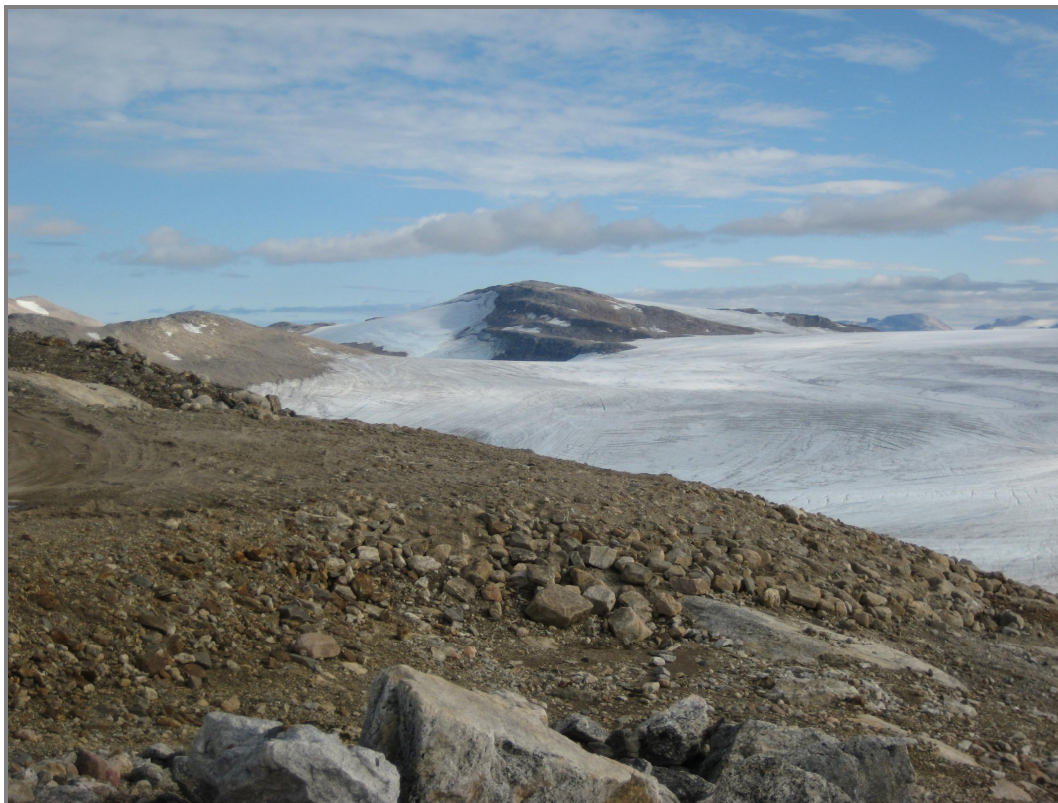
Picture 41: Upper Station POL Tanks - After.

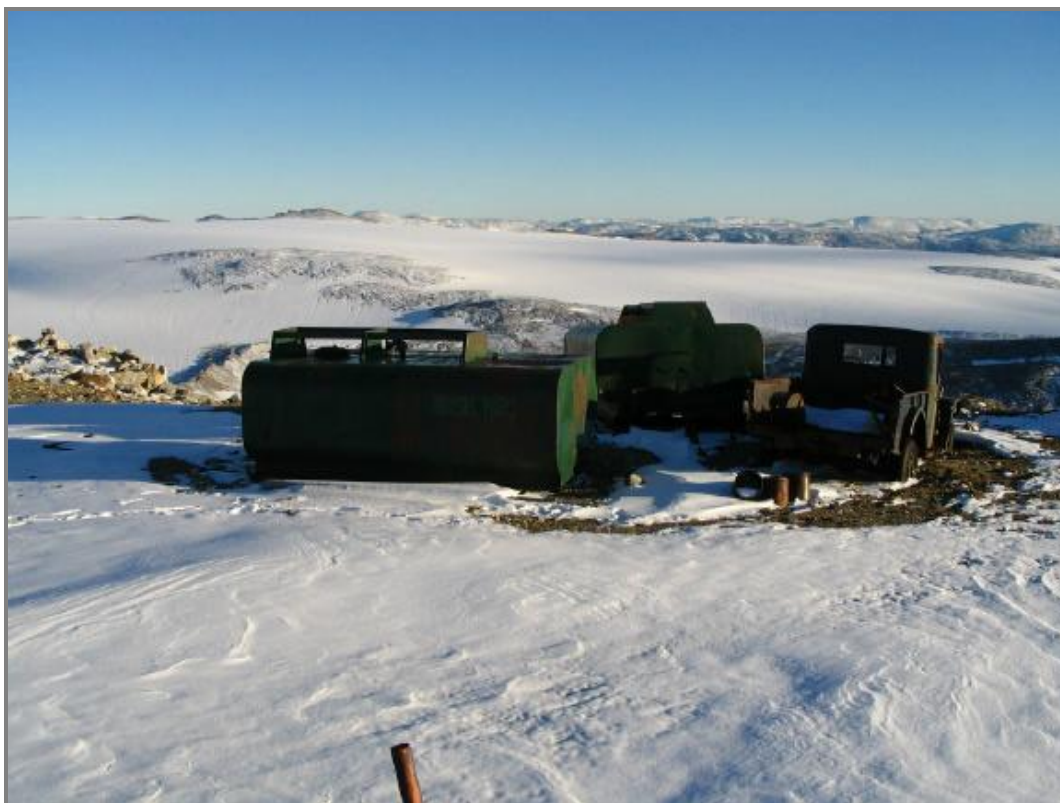
Picture 42: Upper Station Truck & Tanks - Before.

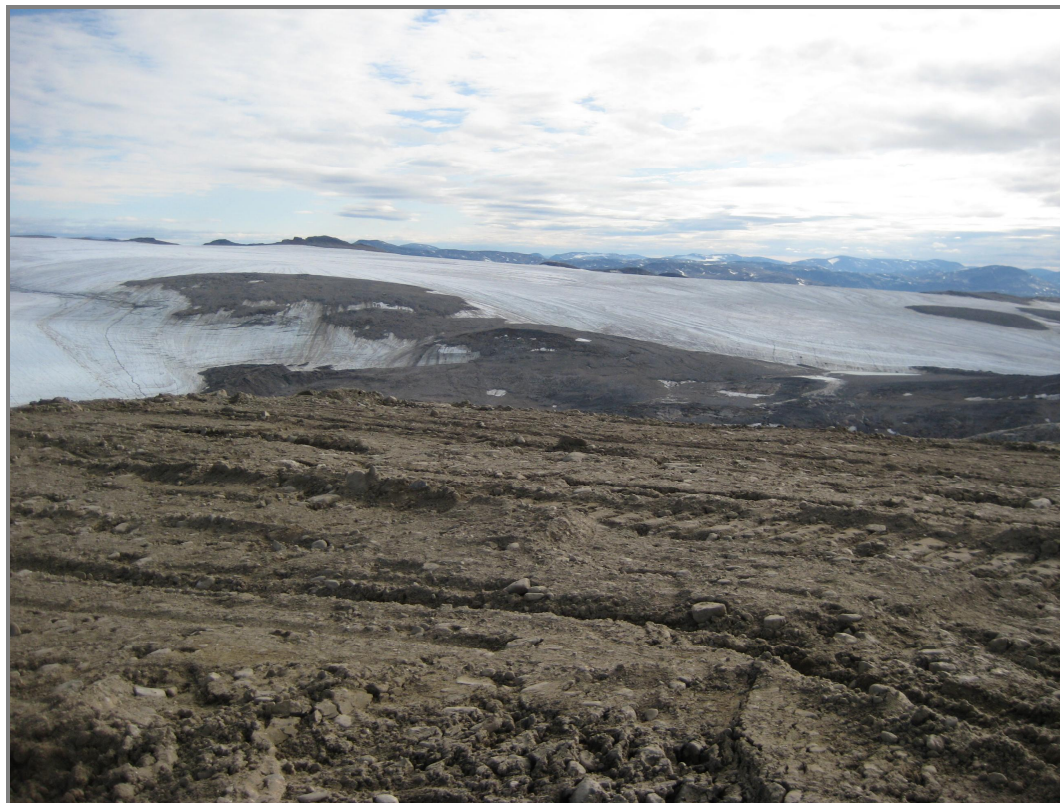
Picture 43: Upper Station Truck & Tanks - After.

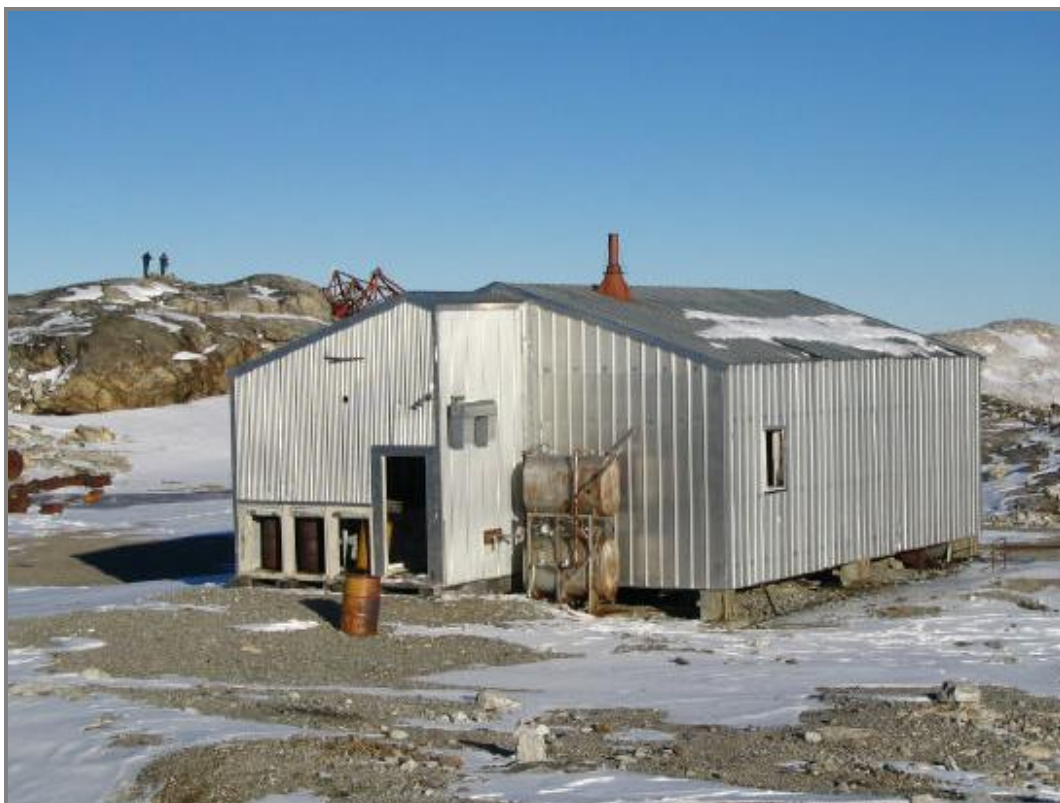
Picture 44: Upper Station Warehouse - Before.

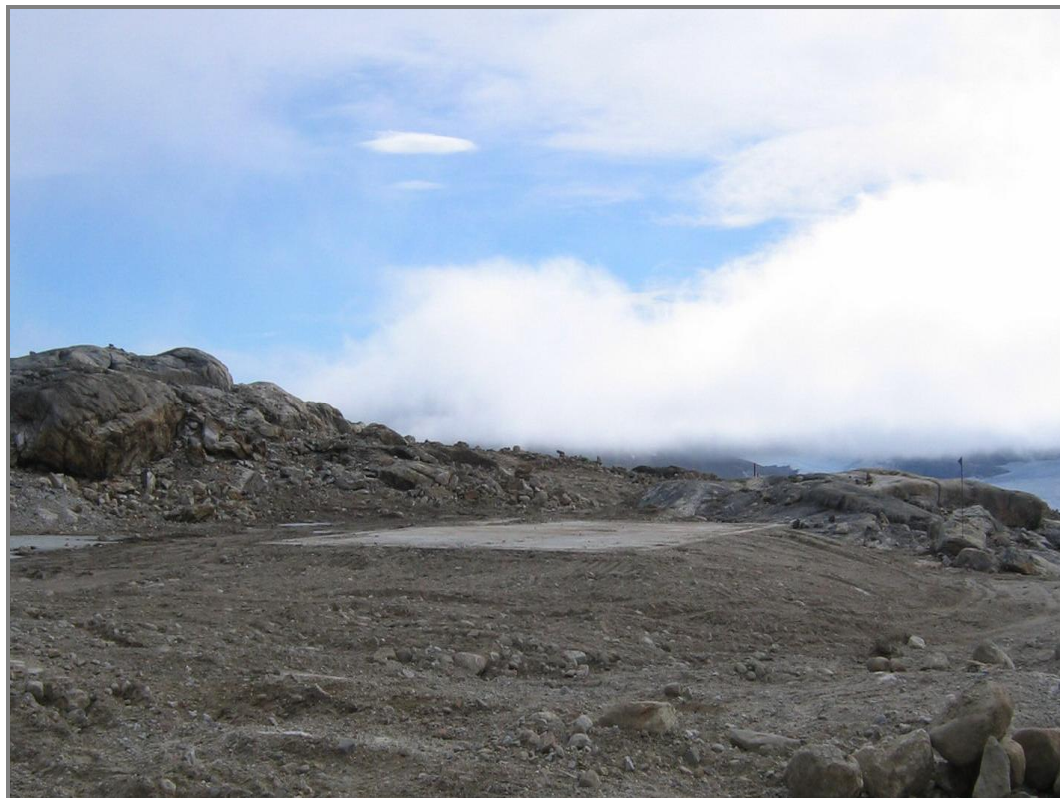
Picture 45: Upper Station Warehouse - After.
