Long Term Monitoring, 2009 FOX-C, Ekalugad Fjord, Nunavut

FINAL REPORT

Project No. 1697-0902
November 27, 2009

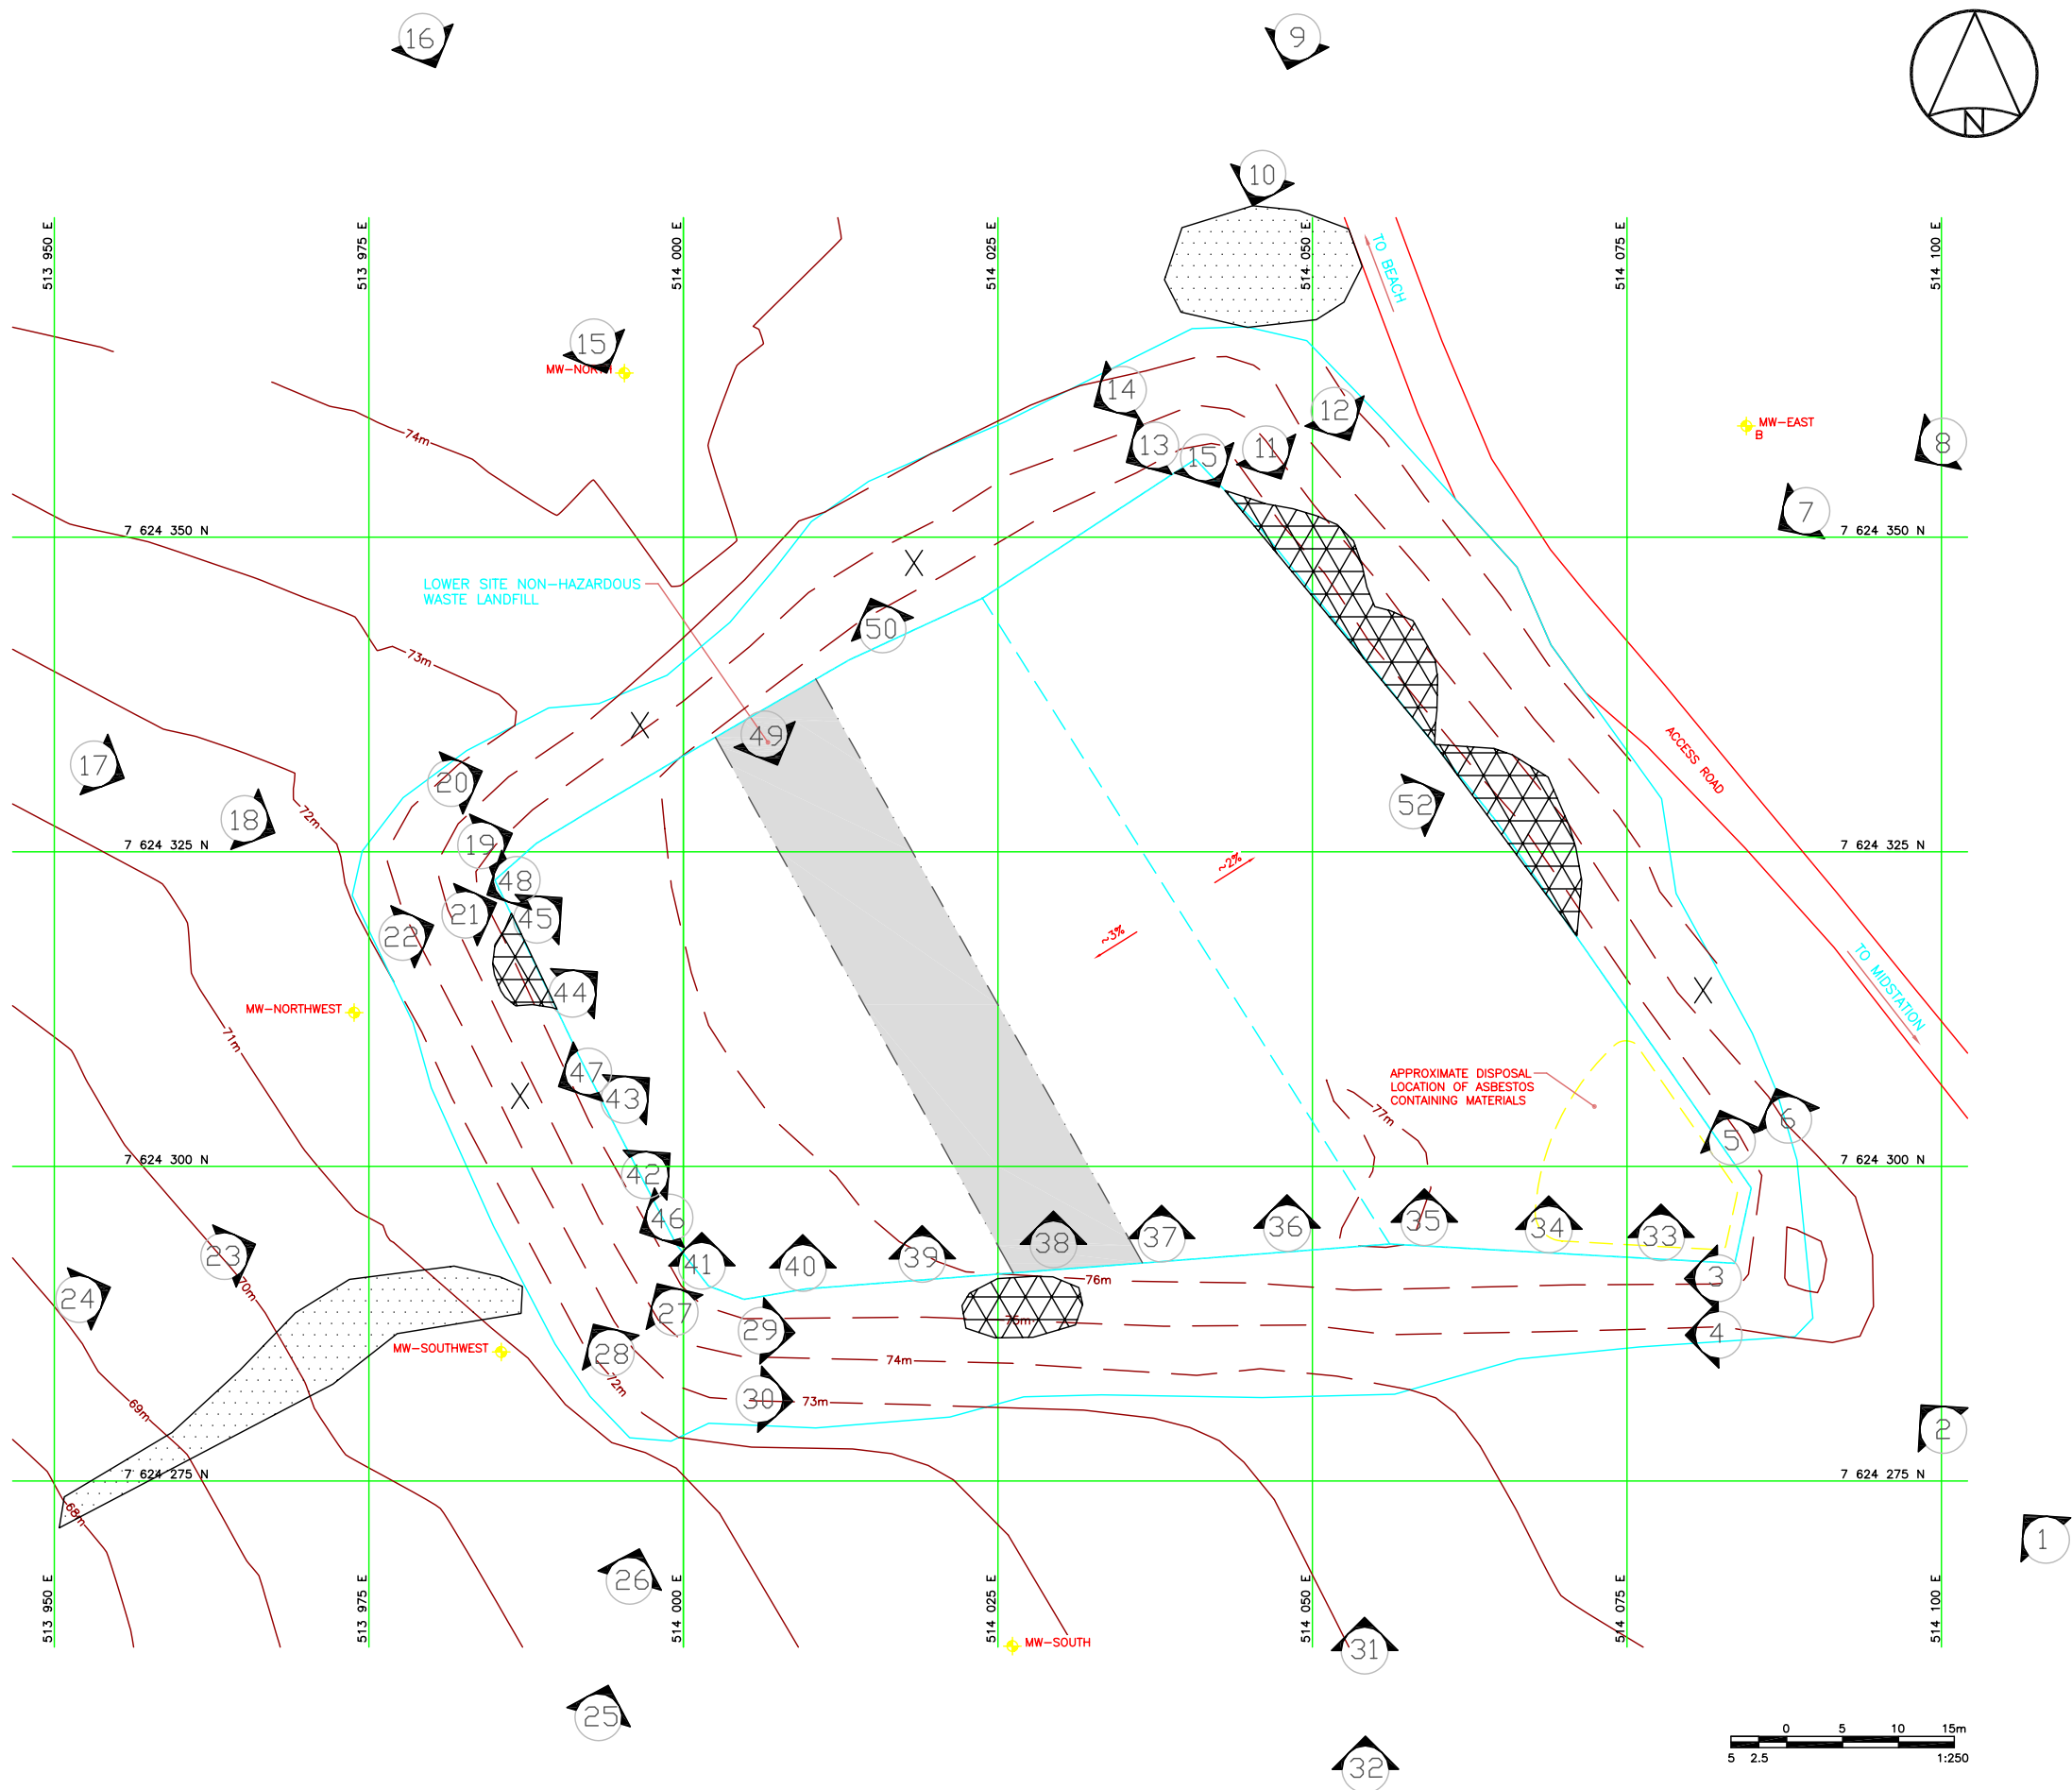
NON-HAZARDOUS WASTE LANDFILL

There is very little erosion on or near the NHWL. As indicated in Figure A-1, Appendix A, cobbles have been uncovered in select areas, and except for a few small potholes (Photo 3, Appendix B), erosion is surficial, not more than 5 cm deep (Photo 4, Photo 5 and Photo 6, Appendix B).

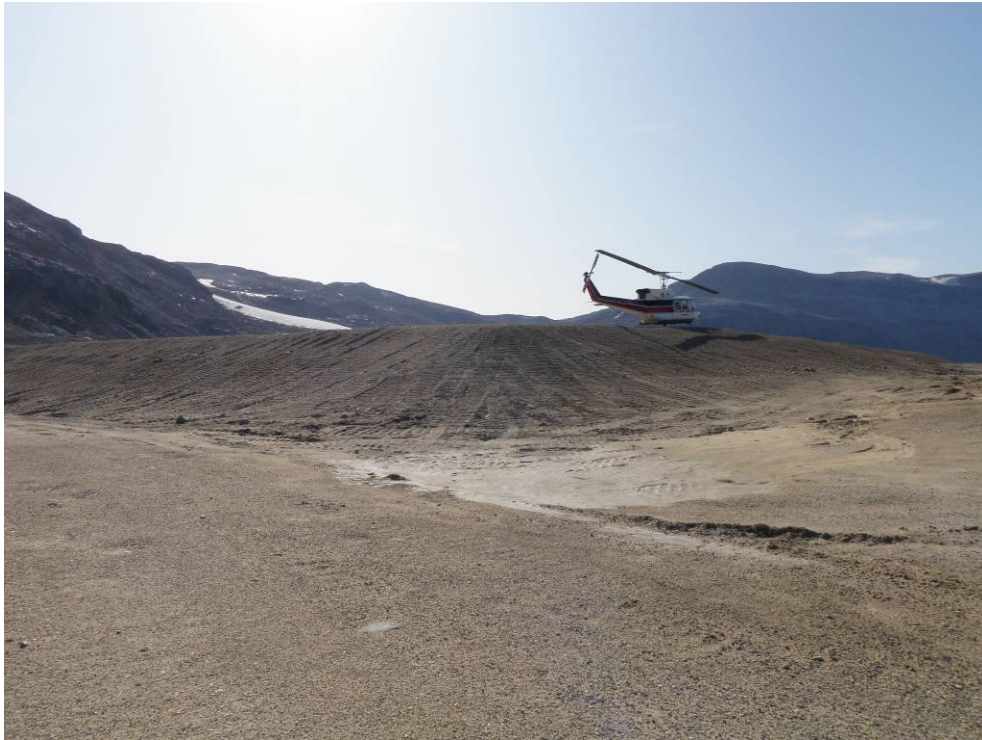
Additionally, two areas of noticeable depression have occurred at the foot of the NHWL: one to the northeast of the landfill (Photo 1, Appendix B); and another off its southwestern corner (Photo 8 and Photo 9, Appendix B). The depression to the northeast was damp and appears to contain ponded water at times of high rainfall. The second depression may be a manifestation of the natural topography, which clearly shows an erosion channel as one follows the depression away from the landfill. Neither appear to impact the structure at present.

ITEM	PRESENCE/ ABSENCE	EXTENT	DESCRIPTION/ PHOTOGRAPHIC REFERENCE
Surrounding depressions	Yes	1) radius ~ 3 m; depth ~ 0.2 m 2) 4 m x 8 m; max depth ~ 0.4 m	1) Photo 1, Appendix B. 2) Photo 8 and Photo 9, Appendix B.

Photo 1. Moist settlement off the northern corner of the NHWL; picture viewpoint number 9 (Figure A-1, Appendix A).
Direction photo taken: S (P8270420).

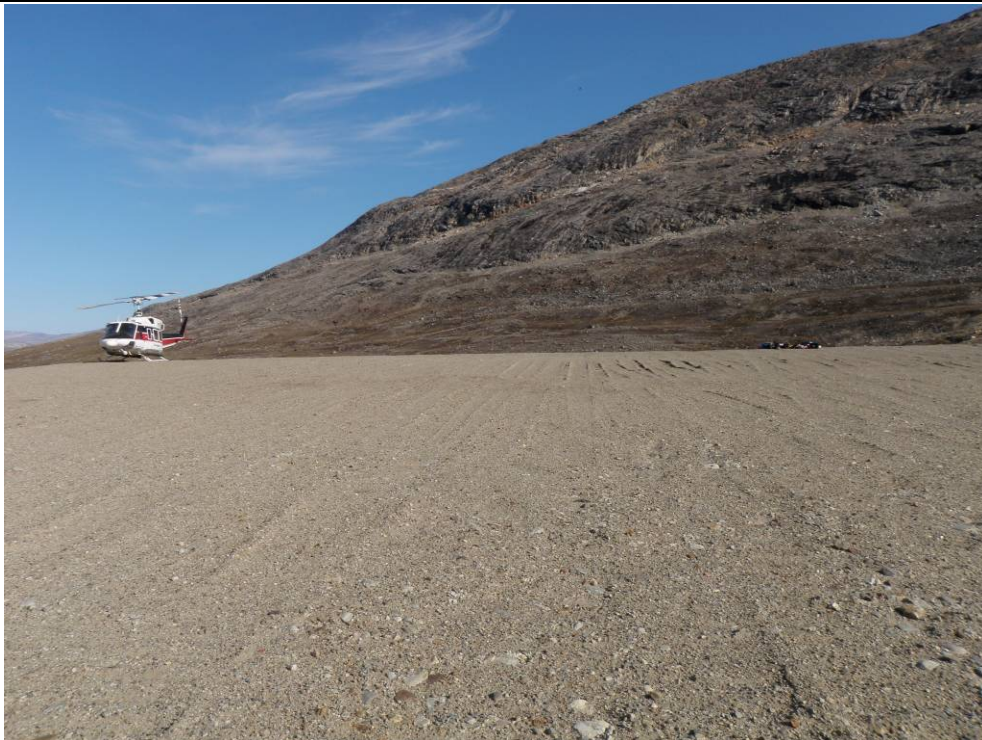
One area of settlement was noted running from north to south on the top of the landfill (Photo 2, Appendix B), in the central area along the top of the NHWL. The landfill slopes upwards slightly from the east to a high point in the centre, after which it slopes downwards gently to the west. Immediately to the west of the high point, a slight depression across the width of the NHWL is obvious. This settlement is likely an artifact of the techniques used to build the NHWL.

Photo 2. NHWL showing very slight settlement running N-E (L to R in picture) along the NHWL; picture viewpoint number 43 (Figure A-1, Appendix A). Direction photo taken: NE (P8270455).

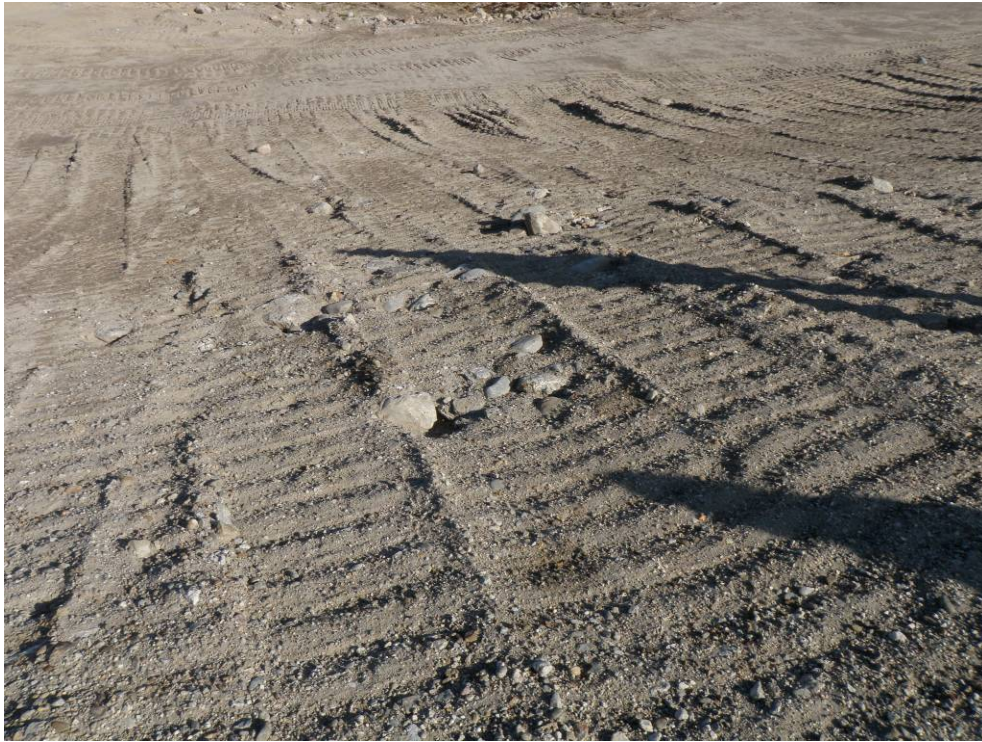
Photo 3. Close-up of eastern side of NHWL showing a few small potholes and exposed cobbles; picture viewpoint number 52 (Figure A-1, Appendix A). Direction photo taken: NE (P8270464).

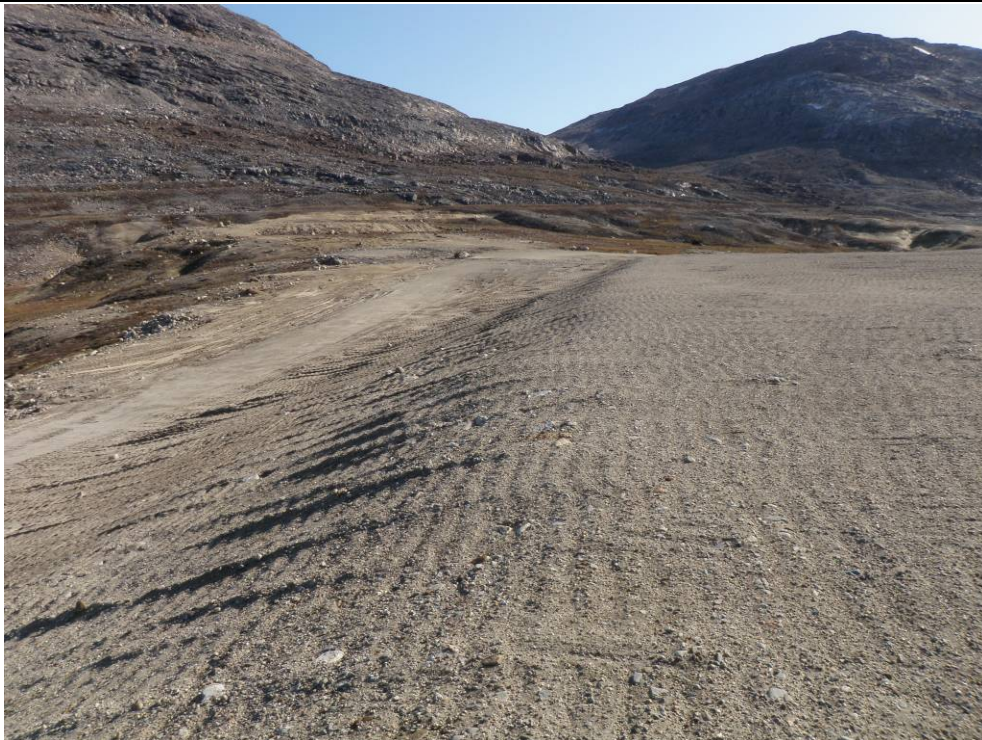
Photo 4. Eastern side of NHWL showing small amounts of exposed cobbles; picture viewpoint number 51 (Figure A-1, Appendix A). Direction photo taken: SE (P8270463).

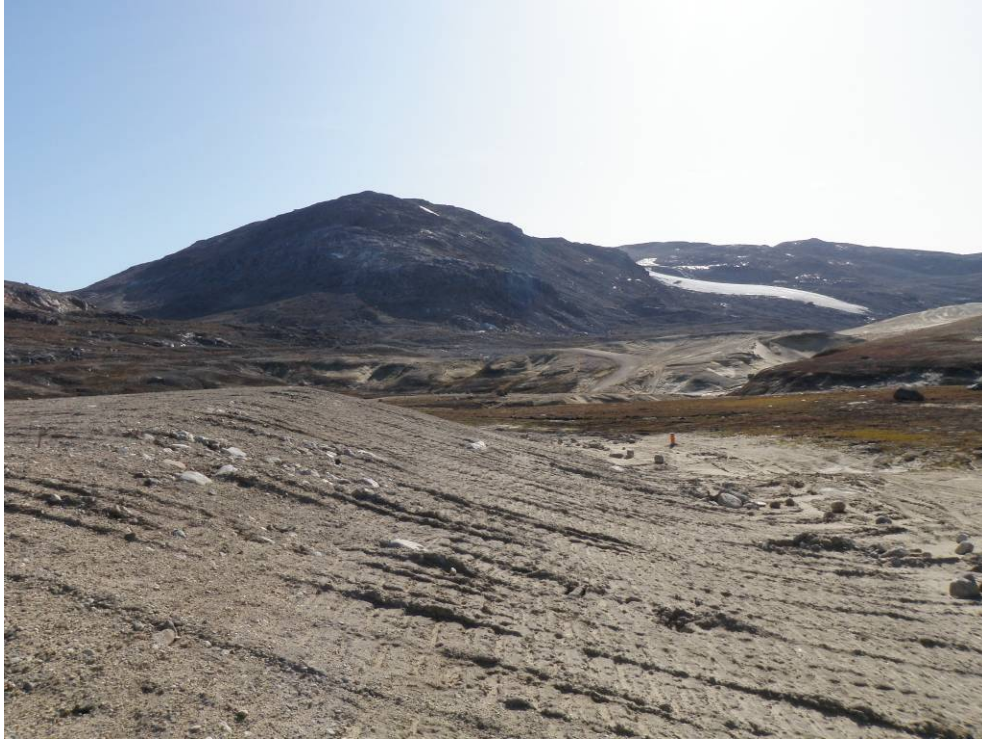
Photo 5. Exposed stone near NW corner of NHWL; picture viewpoint number 21 (Figure A-1, Appendix A). Direction photo taken: SE (P8270433).

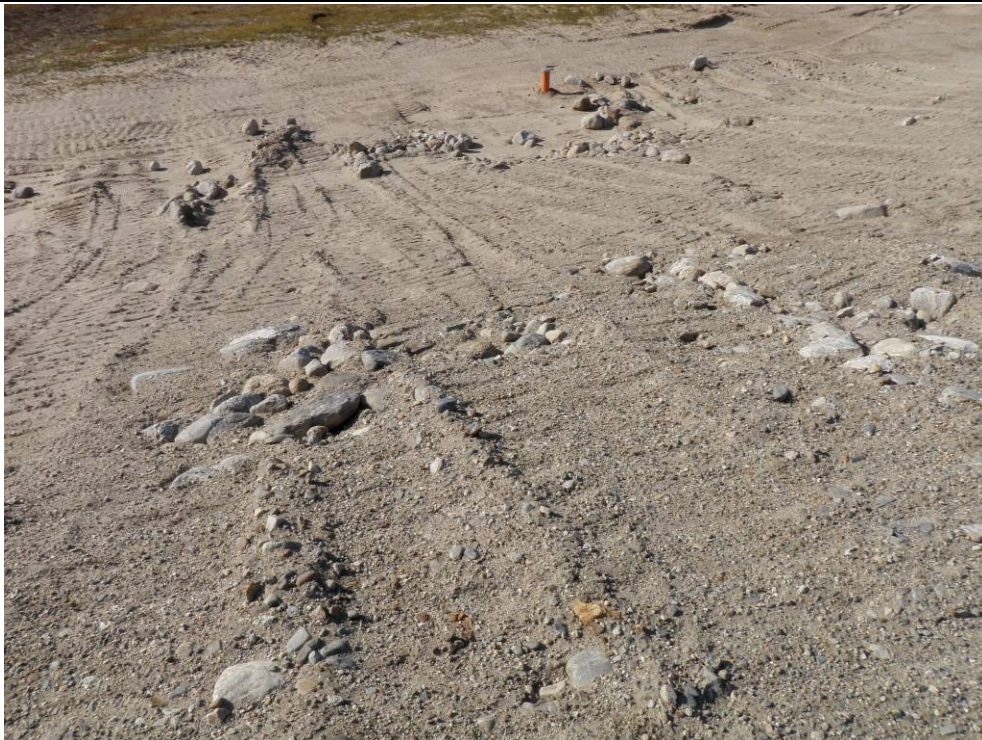
Photo 6. Exposed stone near NW corner of NHWL; picture viewpoint number 48 (Figure A-1, Appendix A). Direction photo taken: SW (P8270460).

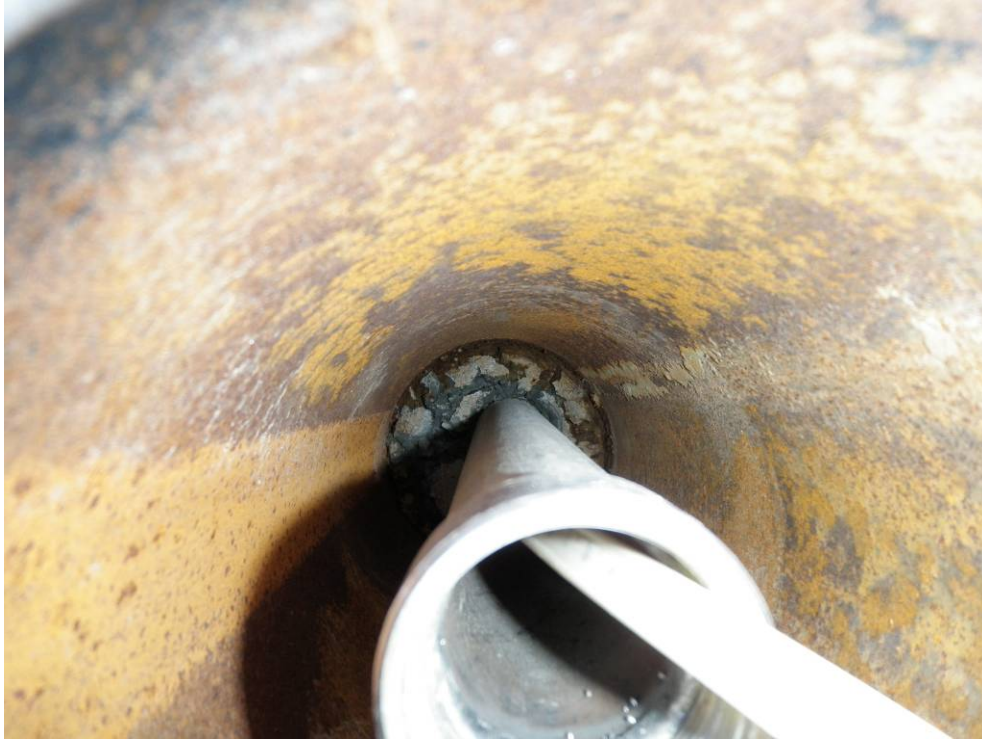
Some upwelling of bentonite inside well stickups was observed (Photo 7, Appendix B). This may be evidence of frost action at the site; however, limited movement of the well casing inside the stickups was observed. No test pits were advanced at the site; the subsurface conditions were not examined in detail.

Photo 7. Monitoring well, MW-East, showing a good surface seal with minor cracking. Photograph number P8270371.

MW-EAST - SURFACE SEAL LOOKS
GOOD WITH MODERATE CRACKING.
HINGE OF STICKUP CAP IN ROUGH SHAPE.
(now broken)
CL 27/8/09

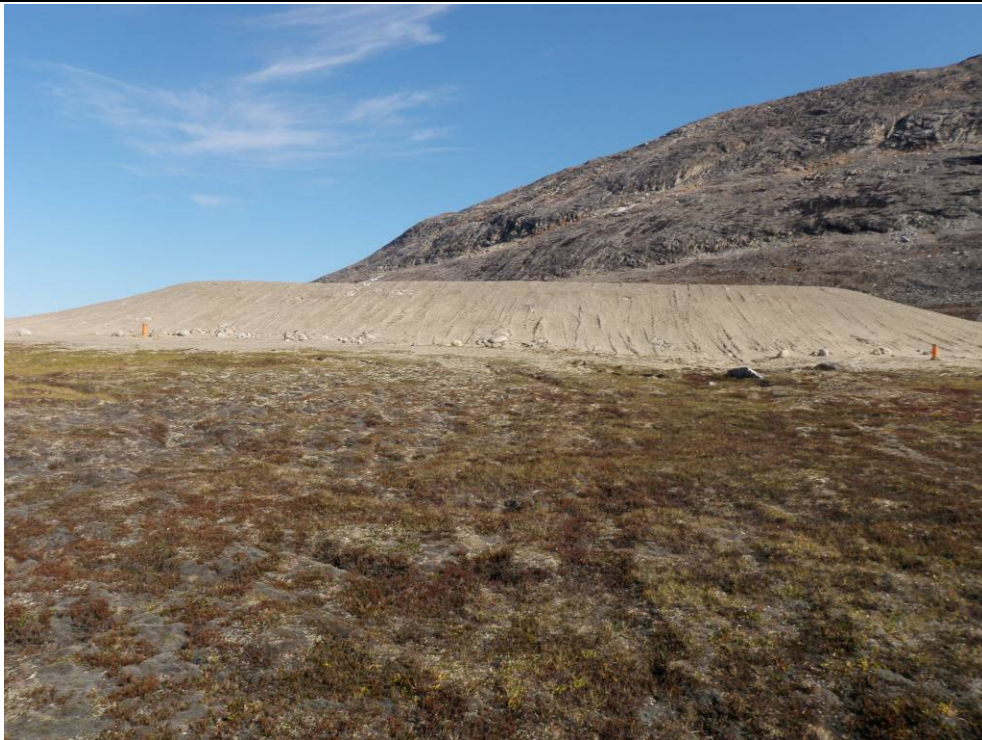
Photo 8. NHWL. Picture viewpoint number 24 (Figure A-1, Appendix A). Direction photo taken: SW (P8270436).

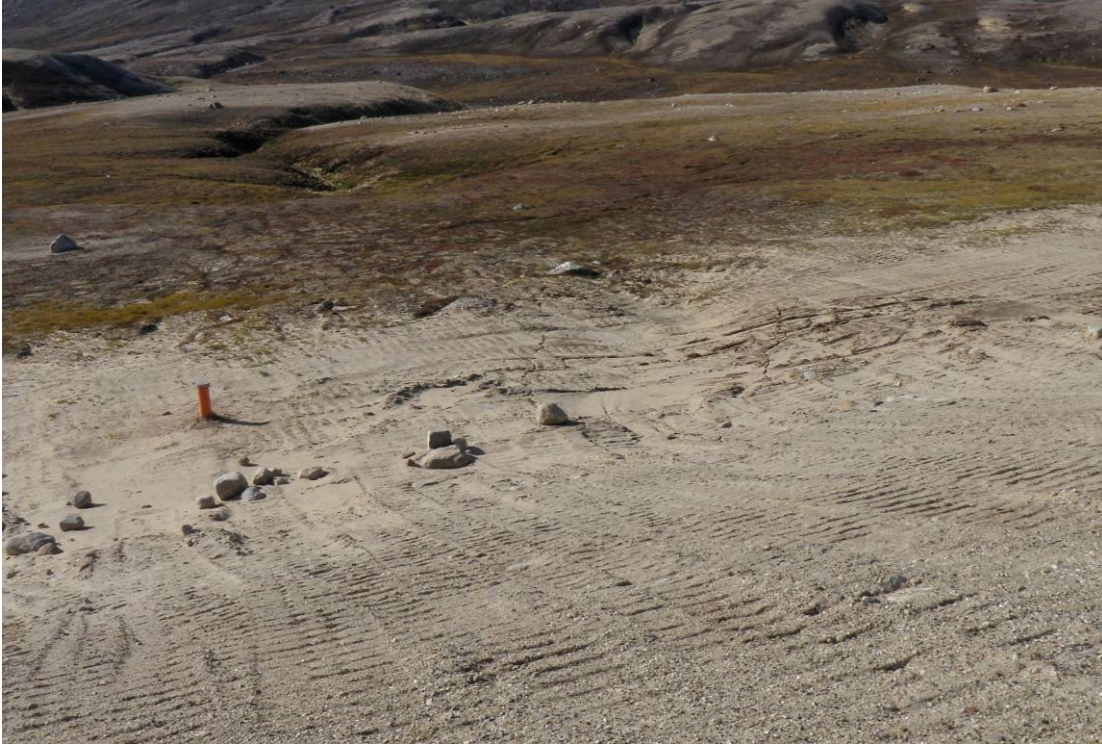
Photo 9. Depression near western side of NHWL; picture viewpoint number 46 (Figure A-1, Appendix A). Direction photo taken: W (P8270458).

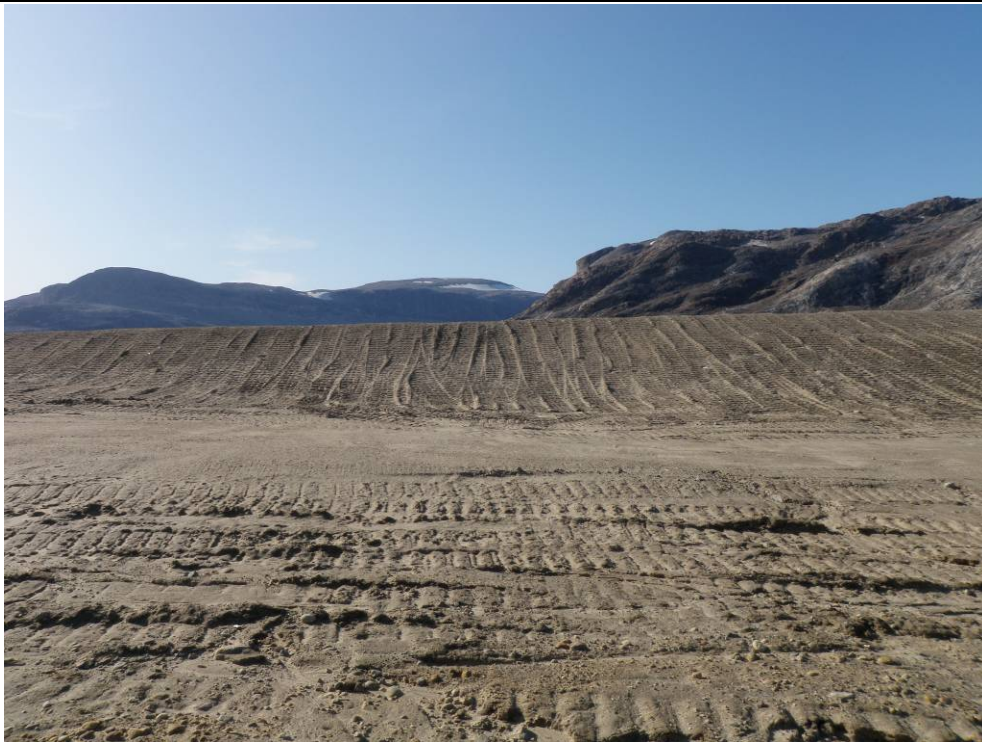
All physical observations suggest that the NHWL is performing as designed and is containing the enclosed waste. Groundwater samples were not taken due to the frozen state of all the monitoring wells. Soil samples were not collected given the lack of evidence (e.g. staining) of any anomalies. The facility appears in satisfactory condition (Photo 10, Appendix B).

Photo 10. Eastern sideslope of NHWL; picture viewpoint number 7 (Figure A-1, Appendix A). Direction photo taken: SW (P8270418).

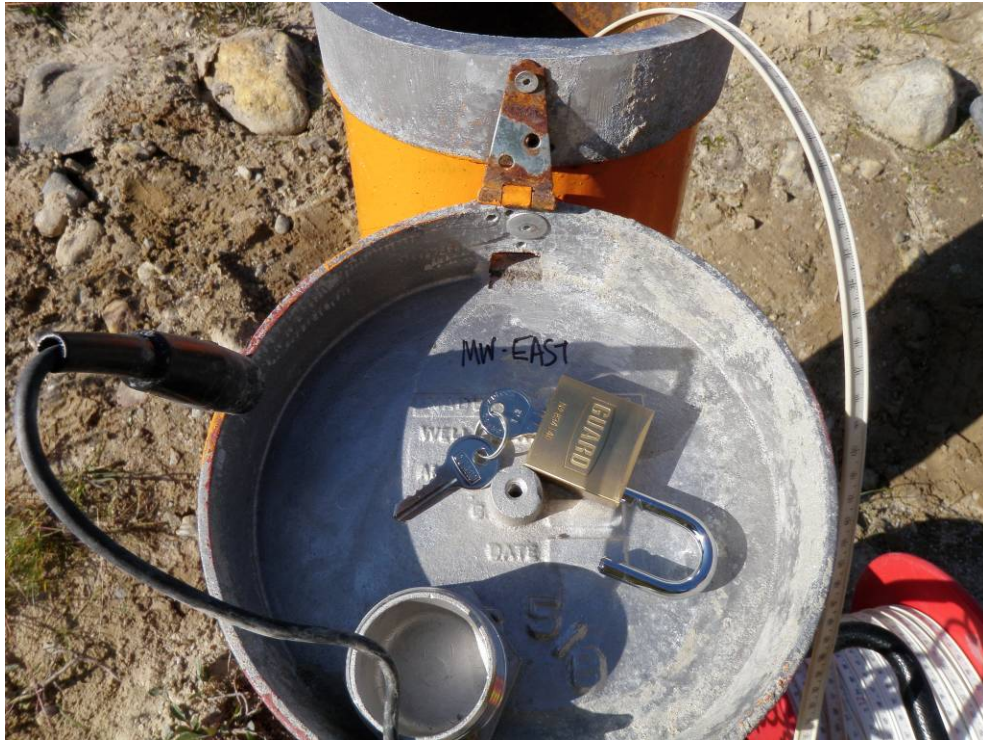
ITEM	PRESENCE/ ABSENCE	EXTENT	DESCRIPTION/ PHOTOGRAPHIC REFERENCE
<i>Instructions</i>	<i>Yes or No</i>	<i>Provide dimensions as applicable: Length, Width, Depth</i>	<i>Features of note, photographic reference with scale, point of view & direction</i>
Settlement	Yes	Roughly 40 m x 8 m x 0.1 m	Photo 2, Appendix B; Figure A-1, Appendix A
Erosion	Yes	Negligible.	Photo 4, Photo 5 and Photo 6, Appendix A.---
Frost Action	No	---	---
Animal Burrows	No	---	---
Vegetation	No	---	---
Staining	No	---	---
Vegetation Stress	No	---	---
Seepage Points	No	---	---
Exposed Debris	No	---	---
Condition of Monitoring Instruments	Good, but frozen.	---	<ul style="list-style-type: none"> - Minor bentonite upwelling in some wells (Photo 7, Appendix B). - New Guard, 40 mm locks (No 834, key no 102) installed on three wells. - Lid on MW-East requires riveting (Photo 11, Appendix B).

Photo 11. Monitoring well MW-East with failing rivets on lid; rivets have since failed. Photograph number P8270376.

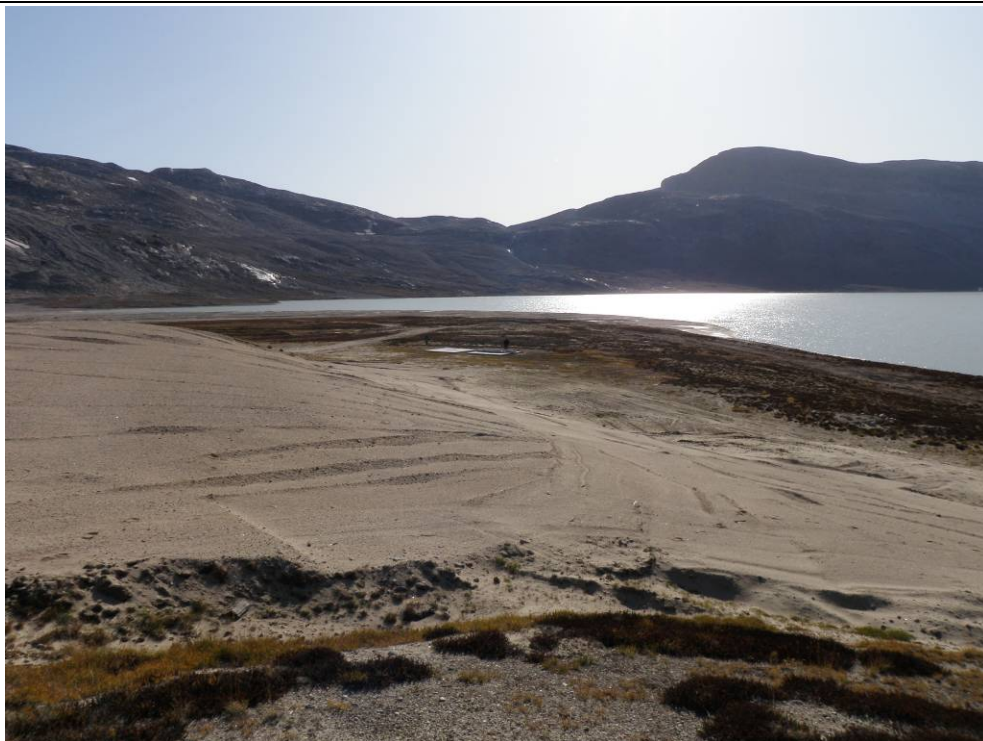
To the southwest of the NHWL (Lower Site Landfill Area) lies the Lake Area, in which are found Borrow Areas 5 and 6 as well as the in-situ treatment area. This regraded area appears to be in good condition, with only two minor anomalies. The first is a small stain (area < 1 m²) in Borrow Area 6 with a distinctly PHC-like smell, which was likely left by the regrading machinery (Photo 13, Appendix B); it does not appear connected to the failure or malfunctioning of any on-site facility. The second is a couple of small platforms, close to the in-situ treatment area, suspected to have been left by a local hunter (Photo 12, Appendix B).

During the site visit, the Franz field assessors observed two platforms adjacent to the lake (photo 12, Appendix B). These may have been left by a local hunter, suspected of setting up a shelter.

Photo 12. Reggraded borrow area 6 in Lake Area. Materials recently brought, presumably by local hunter, shown in centre. Direction photo taken: S (P8270491).

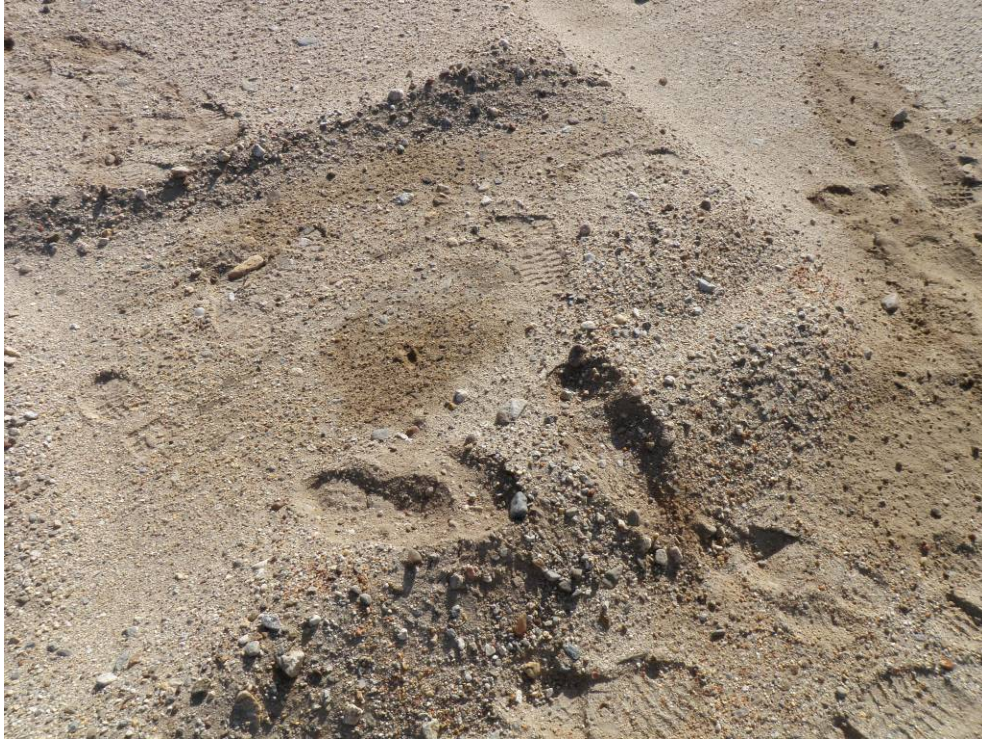
Photo 13. Staining in borrow area 6. Picture number P8270495.

NOTE: PICS 100-0494, 95 OF STAINED
AREA IN BORROW 5/6 AREA (POSSIBLY
IN SITU TREATMENT AREA). DISTINCT
PHC - LIKE SMELL

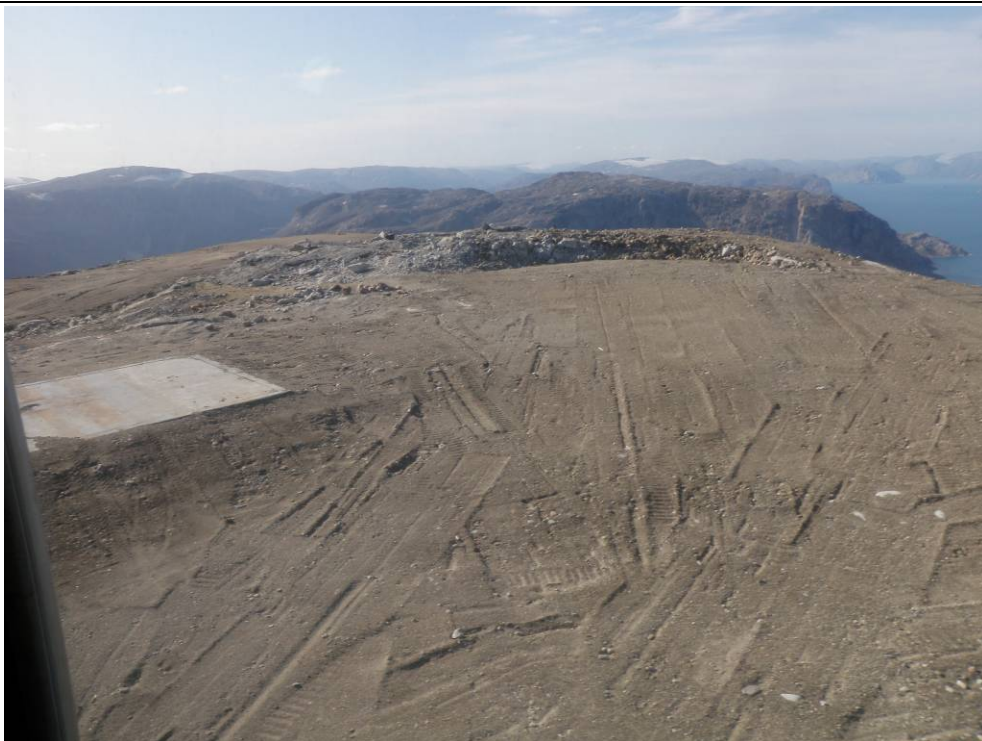
Photo 14. Regrading at the Upper Station Area. Direction photo taken: W (P8270497).

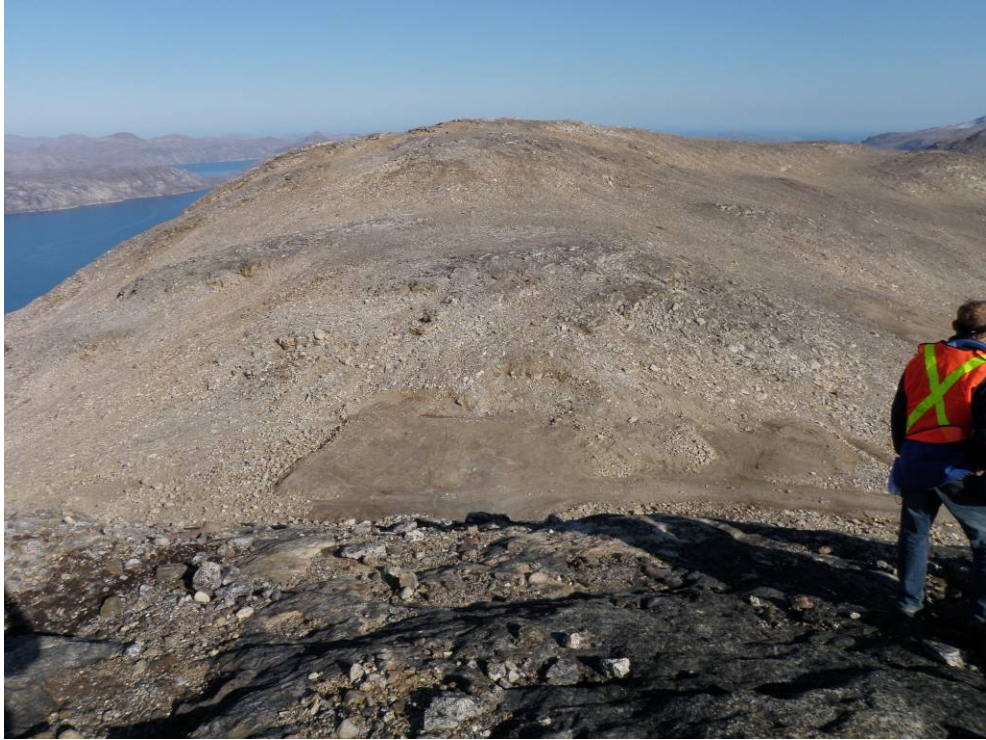
The Upper Station Area is located on the nearest peak to the east of the NHWL, at over 700 masl. The Midstation Area is slightly to east of this, roughly 100 m lower than the Upper Station. These areas presented no visual signs of degradation (Photo 14, Appendix B). The Midstation area, which formerly contained much of the waste found in the NHWL, was aesthetically graded and, other than a couple of small bits of metal, clean (Photo 15, Appendix B).

Photo 15. Overlooking the former Midstation Area dump from the eastern edge of the Upper Station Area. Direction photo taken: E (P8270508).
