## **Long Term Monitoring, 2011 FOX-C, Ekalugad Fjord, Nunavut**

### **FINAL REPORT**

Franz Environmental Inc.  
329 Churchill Avenue, Suite 200  
Ottawa, Ontario  
K1Z 5B8  
Tel. (613) 721-0555  
Fax: (613) 721-0029

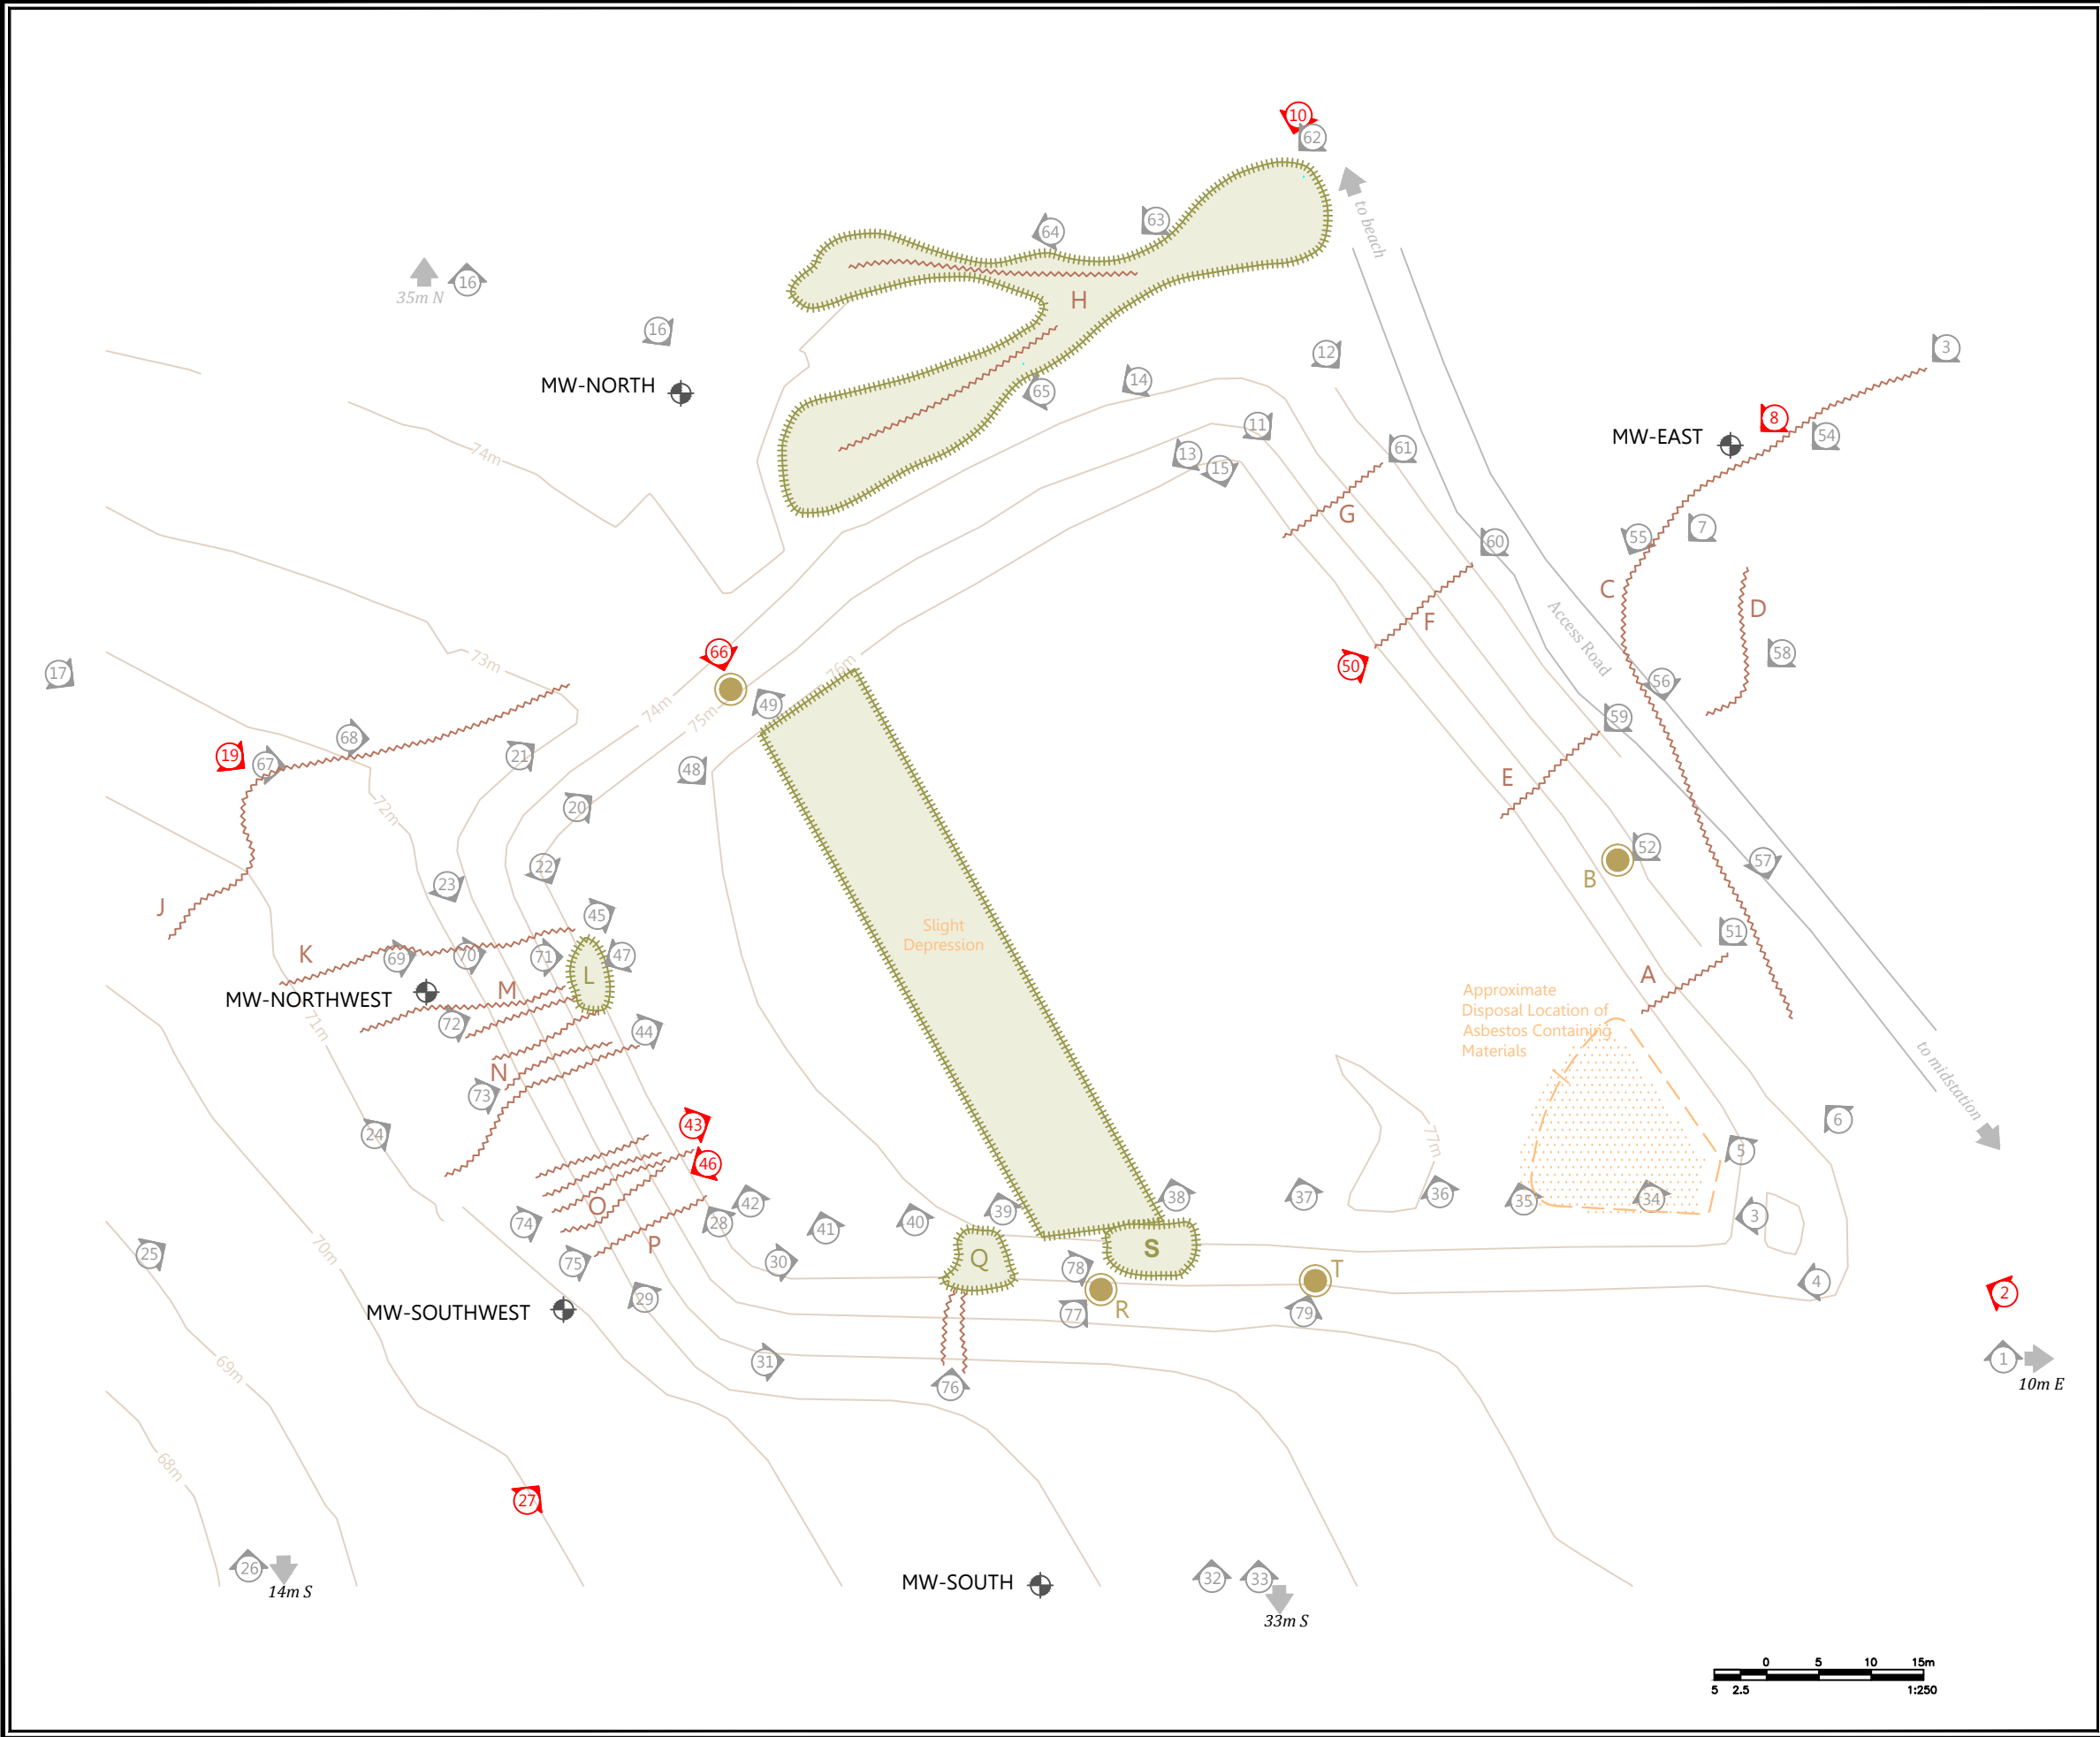
Title: Non-Hazardous Waste Landfill	
FRANZ ENVIRONMENTAL INC. CONSULTING ENGINEERING TECHNOLOGIES	Project: FOX-C Ekalugad Fiord 1697-1101
Date: January 2012	Client: Aboriginal Affairs and Northern Development Canada
Scale as shown	
Figure A-1

A linear area of settlement was noted running from north to south on the entire top of the landfill (Figure A-1; Appendix A), in the central area along the apex of the NHWL. The landfill slopes upwards slightly from the east to a high point in the centre, after which it slopes downwards gently to the west. Immediately to the west of the high point, a slight depression across the width of the NHWL is present. This settlement is likely an artifact of the techniques used to build the NHWL and may not be a settlement issue as was noted in the 2009 report. Based on the photographic evidence from 2009, the extent of the depression has not changed significantly since previously noted and if anything has decreased in importance.

Additionally, an area of noticeable depression was observed directly north of the NHWL (Feature H, Figure A-1; Appendix A and Photographs 10, 62 to 65, CD-ROM). This 389 m<sup>2</sup> depression was damp during the site visit and appears likely to contain ponded water at times of high rainfall and spring melt. The depression does not currently appear to impact the structure of the landfill.

Several potholes were noted ranging in volume from 0.006 m<sup>3</sup> to 0.016 m<sup>3</sup> (Feature B, I, R, and T, Figure A-1; Appendix A and Photographs 52, 66, 77, and 79, Attached CD-ROM). These features are likely a result of erosion and not settlement as most of the potholes contained one or more large cobbles at the downgradient extent. The presence of large cobbles embedded in the landfill berm's cause eddy currents to form in the run-off water and therefore mechanically erode away some of the fine soil particles. This action is contributing to the pothole development.

Minor erosion channels were observed running down the berms of the landfill on the northeast, and southwest sides (Feature A, E, F, G, K, M, N, O, and P, Figure A-1; Appendix A and see Tale 4-3 for photograph references); and to a lesser extent the northwest, south sides. Additional erosion channels were observed at the toe of the landfill on the northeast side (Feature C and D, Figure A-1; Appendix A and Photographs 53 to 58; CD-ROM) running down towards MW-East B, as well as on the northwest toe (Feature J, Figure A-1; Appendix A and Photographs 18, 19, 67 and 68; CD-ROM) and southwest side (Features Q and S, Figure A-1; Appendix A and Photographs 76 to 78; CD-ROM). The maximum depth of the erosion channels noted was less than 0.2 m and on average less than 0.1 m.

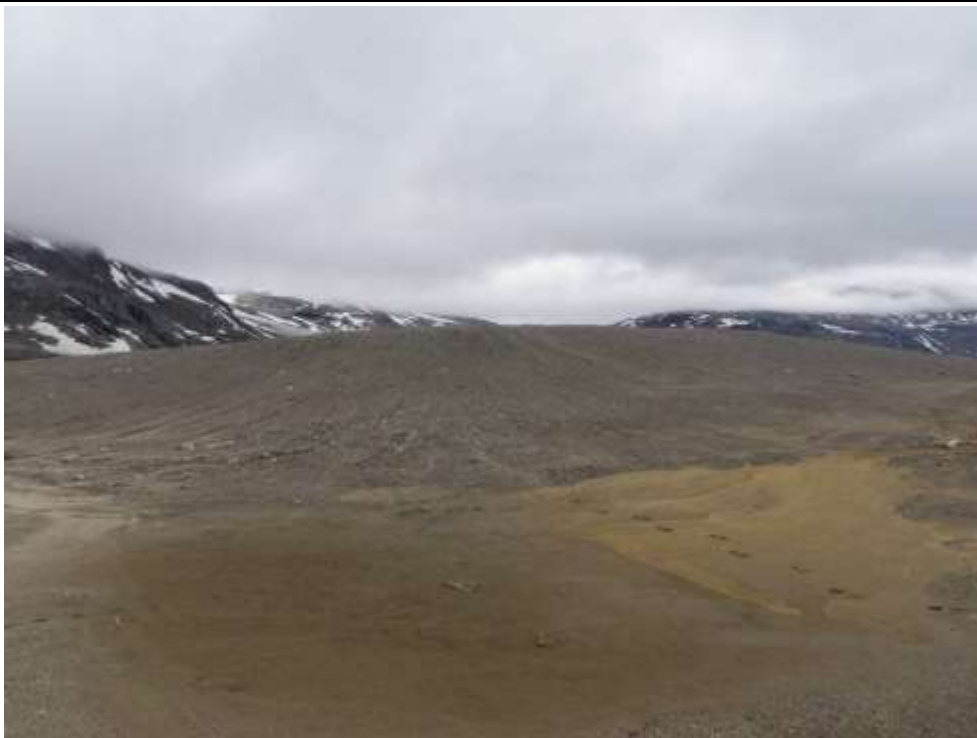
North corner of the NHL. Note the damp depression area. Viewpoint 10 (Figure A-1; Appendix A). Photograph reference 10 (CD-ROM). Direction photo taken: SW

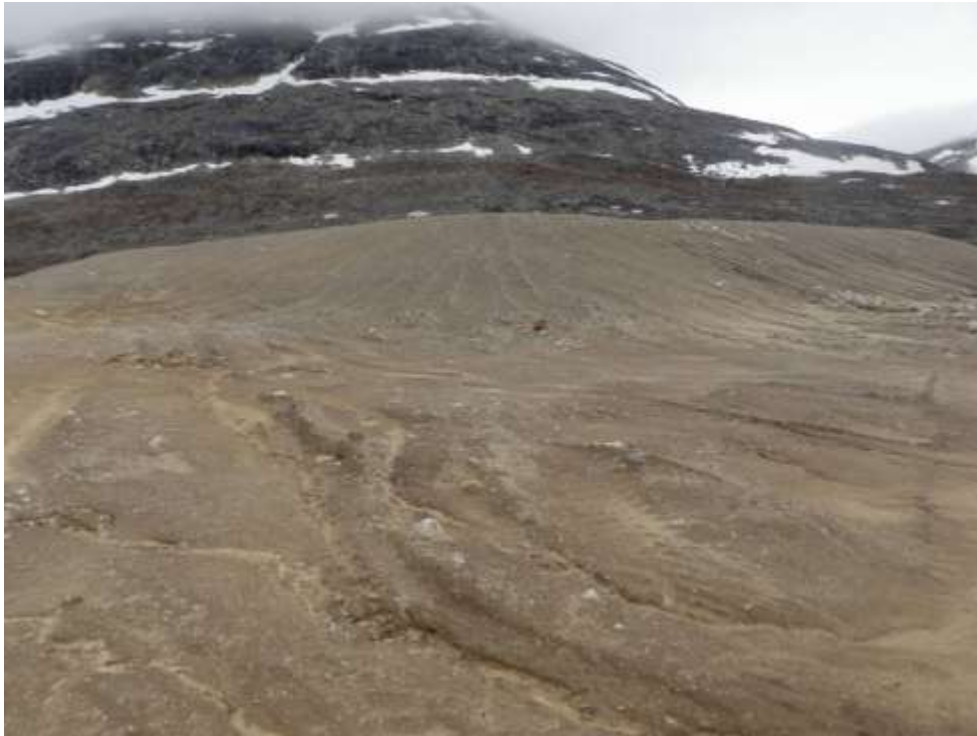
West corner of the NHWL. Note the erosion channel at the toe of the NHWL. Viewpoint 19 (Figure A-1; Appendix A). Photograph reference 19 (CD-ROM). Direction photo taken: SE

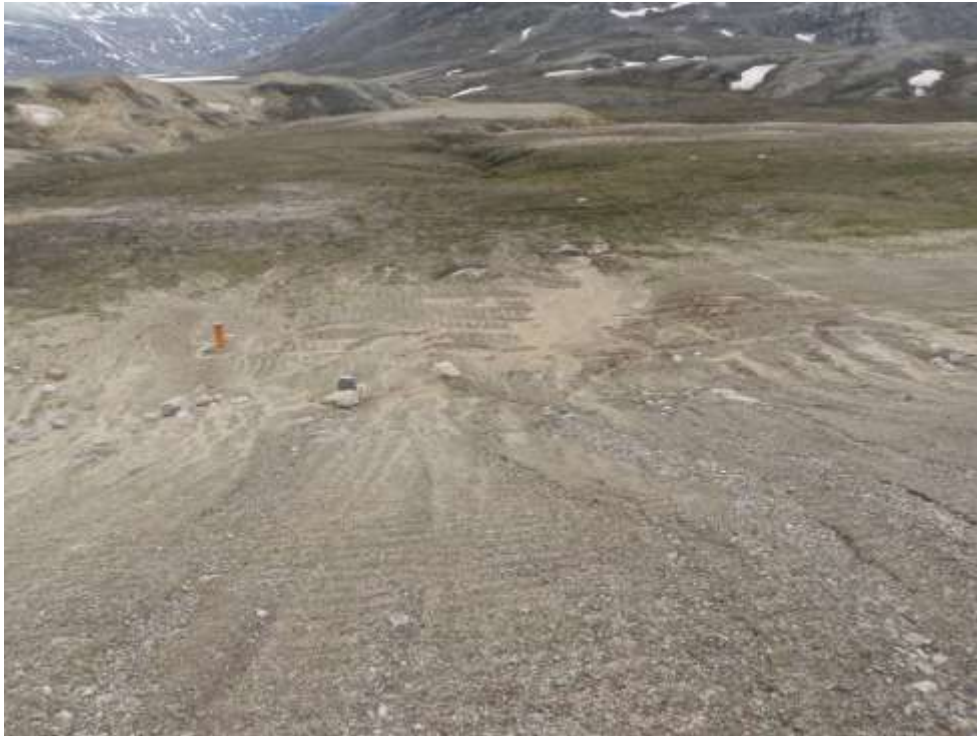
Southwest edge of the landfill. Monitoring well MW-Southeast is at the toe of NHWL. Note the erosion channels.  
Viewpoint 46 (Figure A-1; Appendix A). Photograph reference 10 (CD-ROM). Direction photo taken: SW

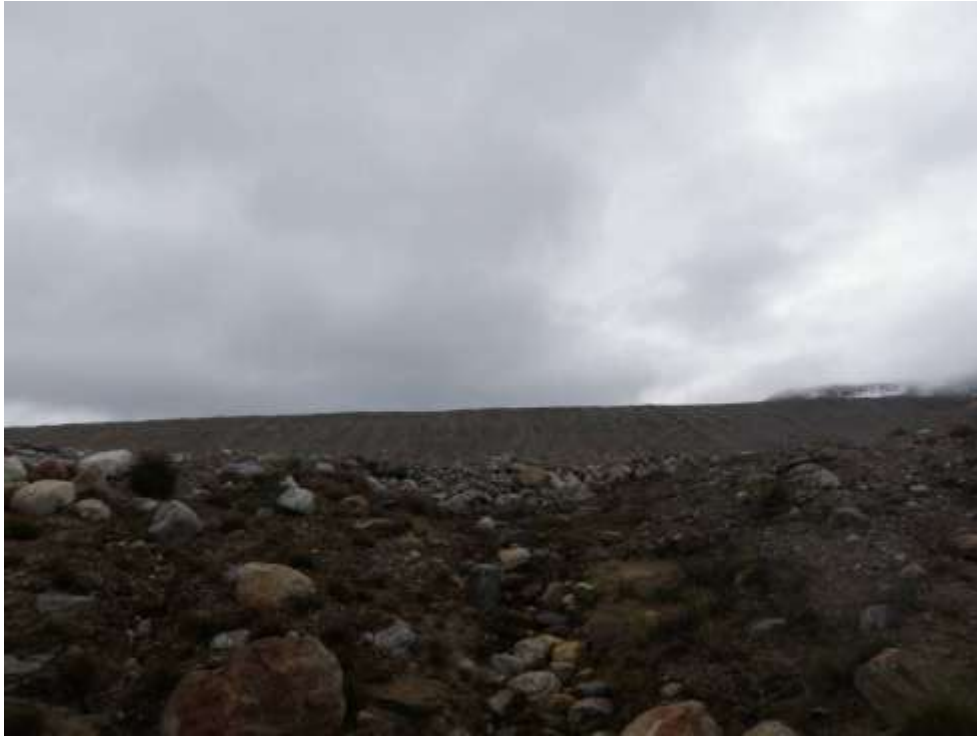
Erosion Channel of the northeast toe of NHWL. Viewpoint 8 (Figure A-1; Appendix A). Photograph reference 8.  
Direction photo taken: NW

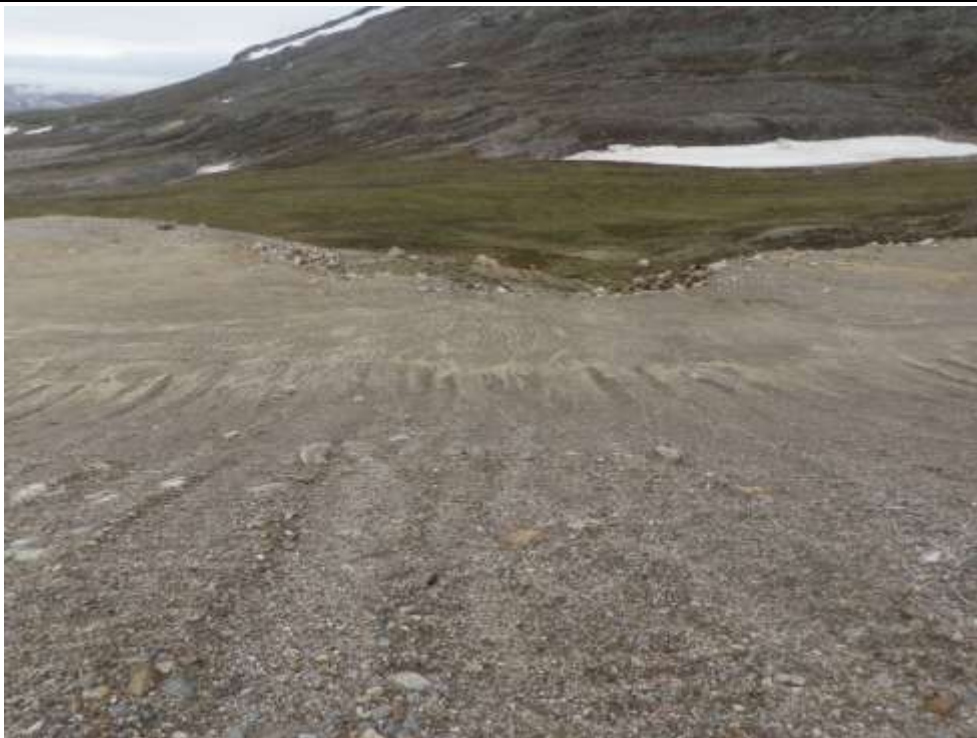
Northeast side of NHWL. Note the erosion channels. Viewpoint 50 (Figure A-1; Appendix A). Photograph reference 50 (CD-ROM). Direction photo taken: NE

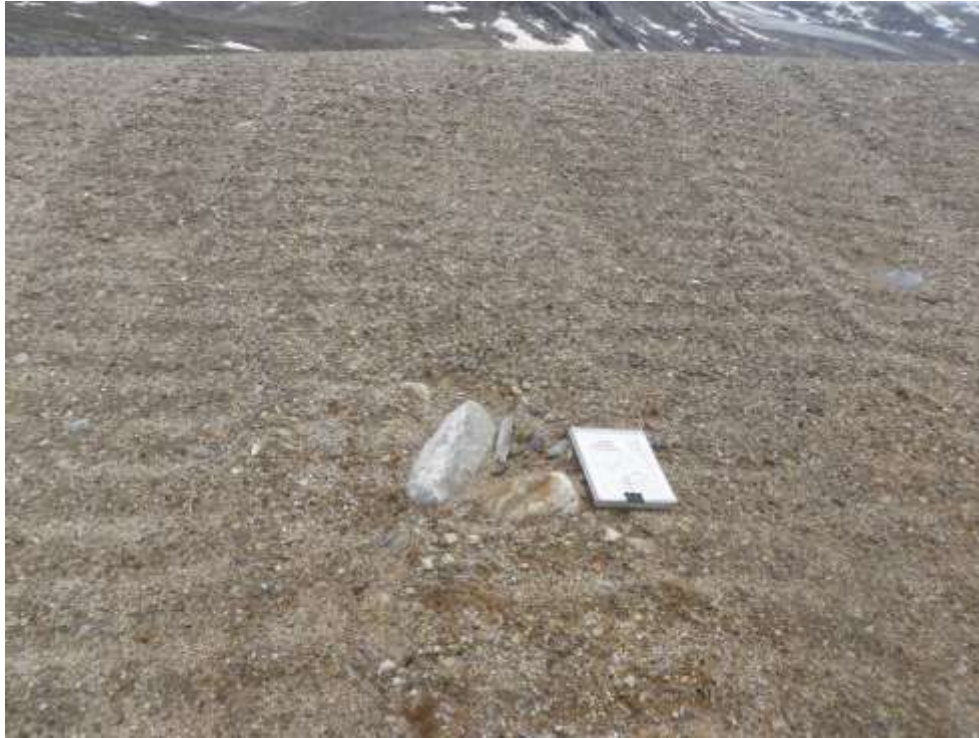
Pothole along northwest side of the NHWL. Viewpoint 66. Photograph reference 66 (CD-ROM). Direction photo taken: S

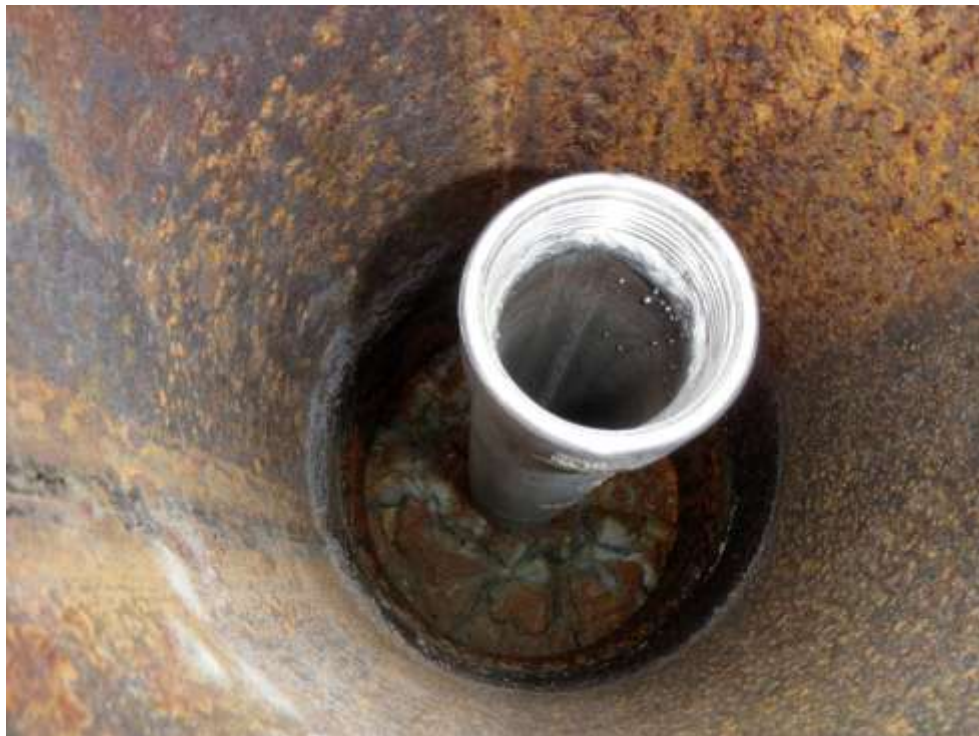
Some upwelling of bentonite inside well stickups was observed (Photo 80, Attached CD-ROM). This may be evidence of frost action at the site; however, limited movement of the well casing inside the stickups was observed.

Inside casing of MW-South. Note the bentonite uprising. Viewpoint N/A. Photograph reference 80 (CD-ROM). Direction photo taken: N/A
