Long Term Monitoring, 2013 FOX-C, Ekalugad Fjord, Nunavut

FINAL REPORT

Franz Environmental Inc.
329 Churchill Avenue, Suite 200
Ottawa, Ontario
K1Z 5B8
Tel. (613) 721-0555
Fax: (613) 721-0029

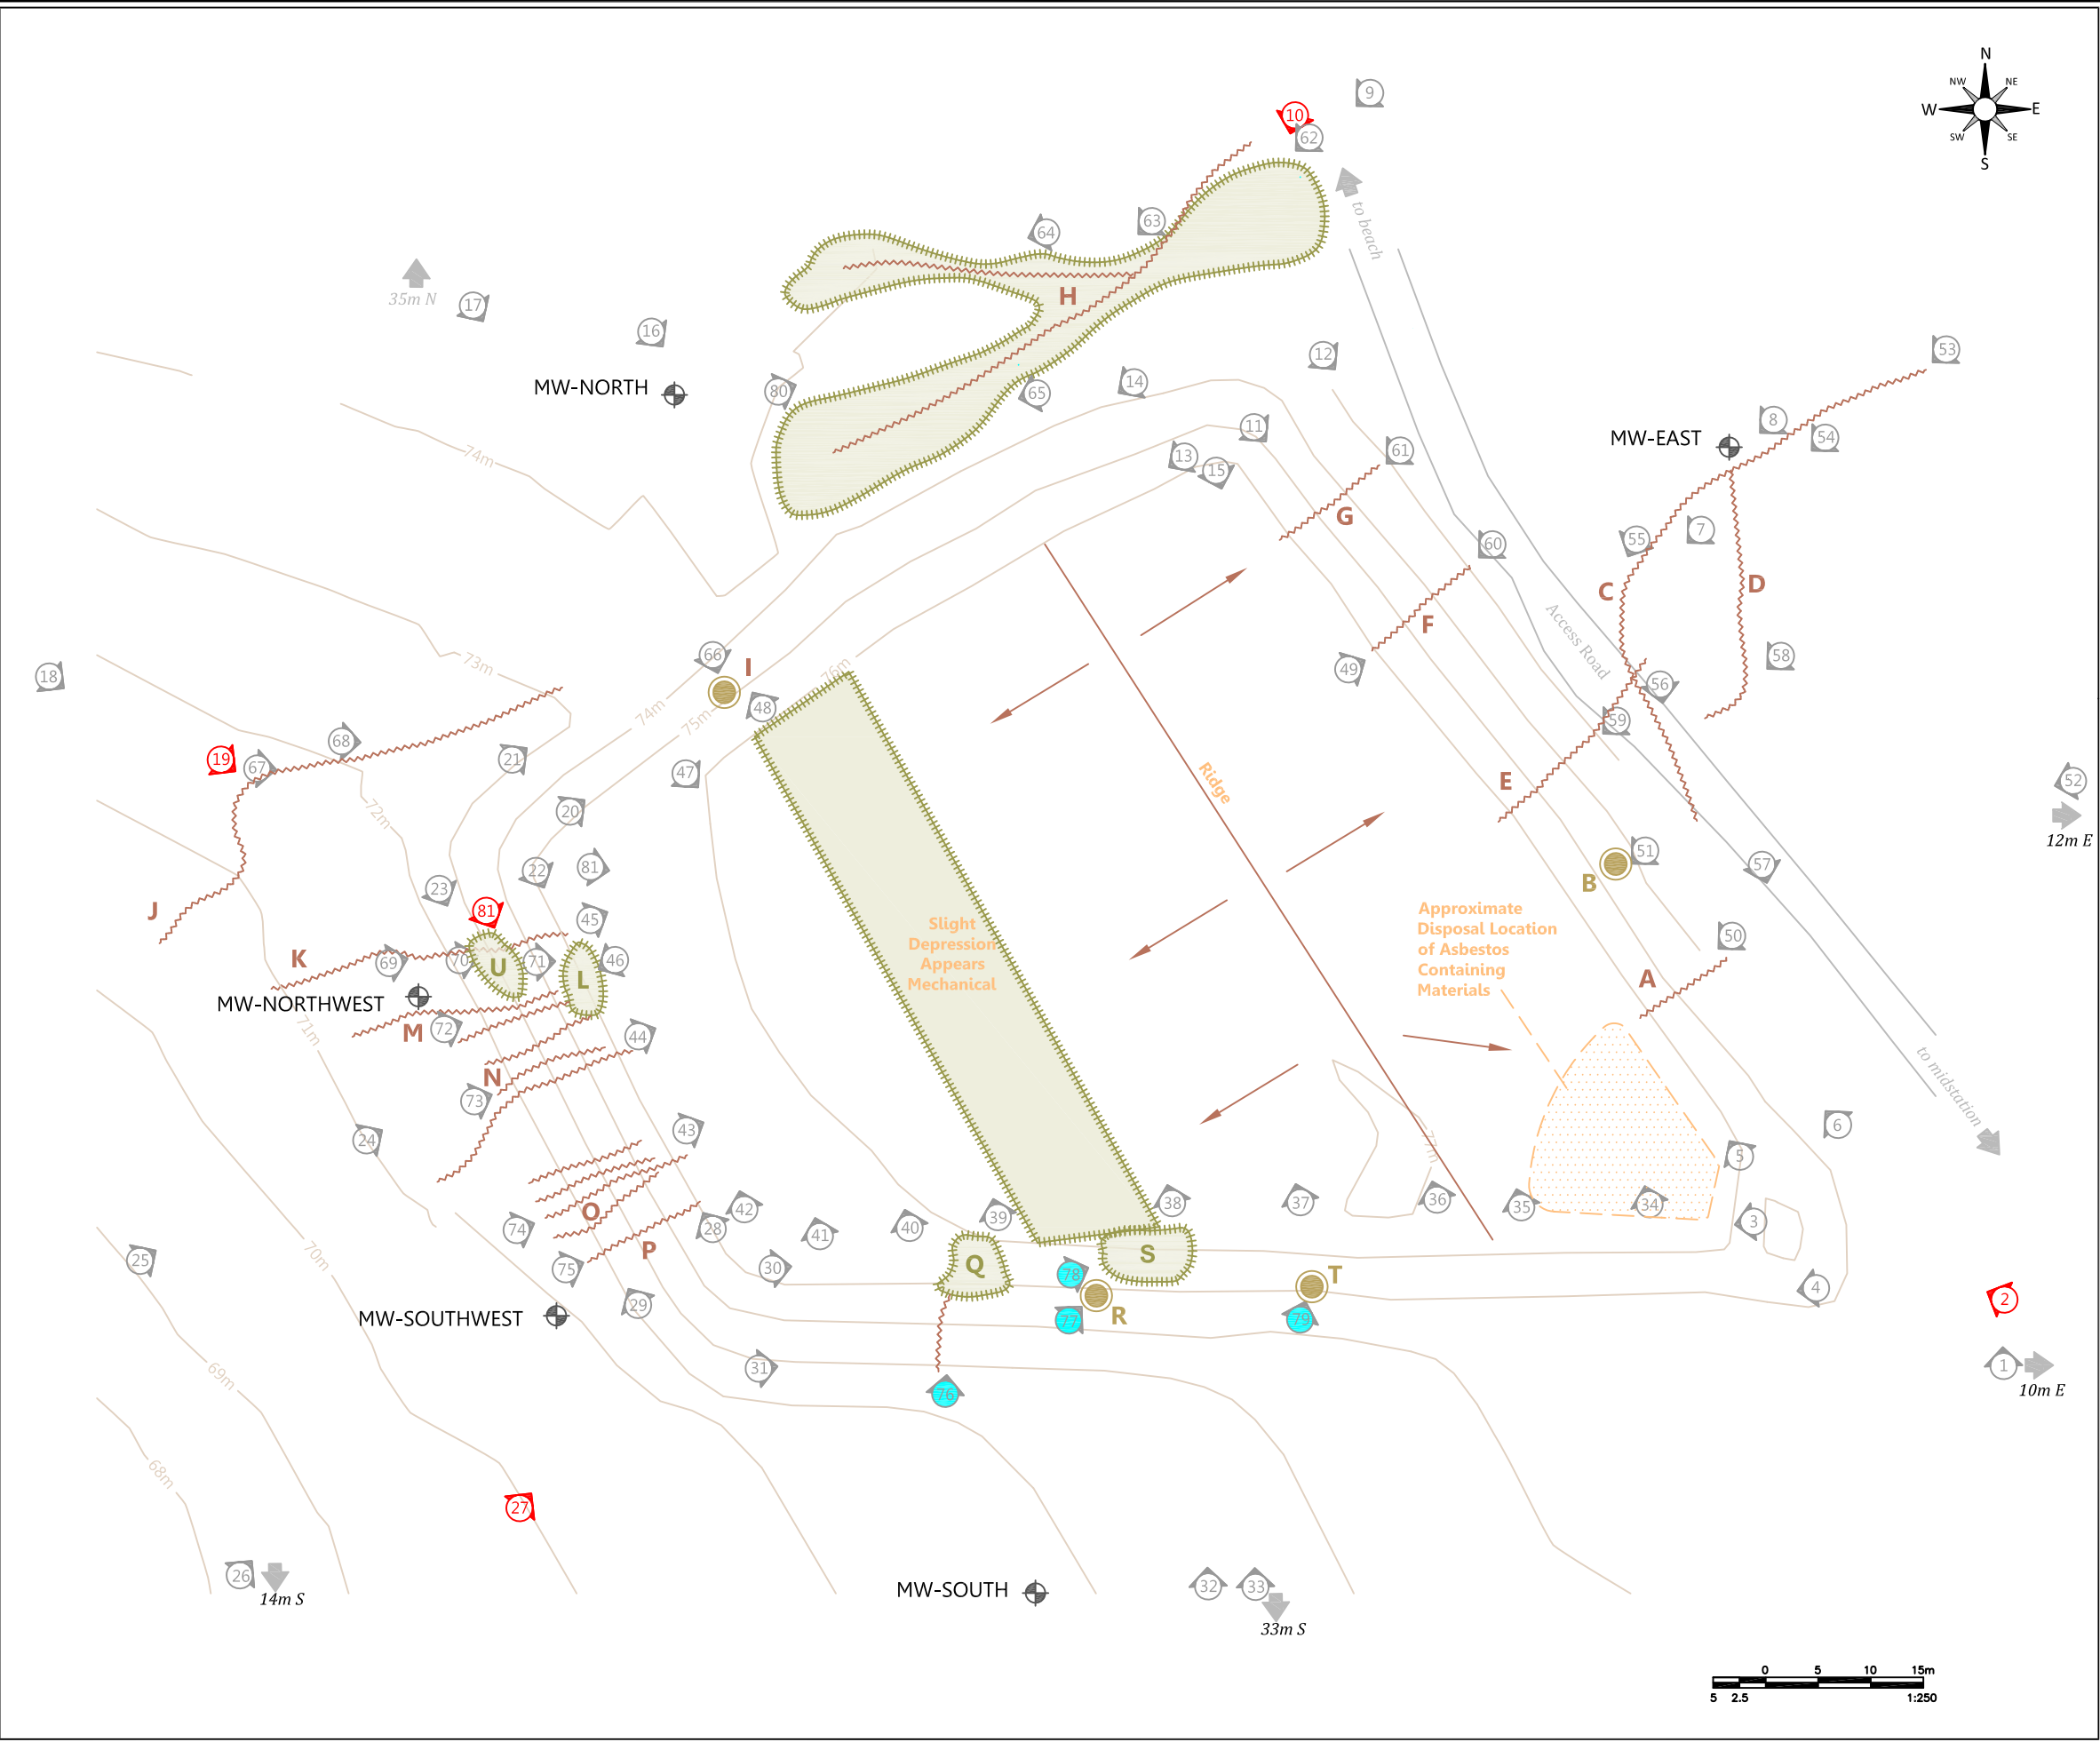
Title: Non-Hazardous Waste Landfill	
  FRANZ ENVIRONMENTAL INC. CONSULTING • ENGINEERING • TECHNOLOGIES	Project: FOX-C Ekalugad Fiord 1697-1301
Date: December 2013	Client: Aboriginal Affairs and Northern Development Canada
Scale as shown	Figure A-1

A linear area of settlement was noted running from north to south on the entire top of the landfill (Figure A-1; Appendix A), in the central area along the apex of the NHWL. This settlement appears to be the result of the techniques used to build the NHWL and may not be a settlement issue as was noted in the 2009 report. Based on the photographic evidence from 2009 and 2011, the extent of the depression has not changed significantly since previously noted and, if anything, has decreased in importance. As noted in Figure A-1, Appendix A, the landfill surface appears to be traversed by a ridge in a north-south direction. The landfill gently slopes westward and eastward to the west and east sides of the ridge, respectively.

An area of noticeable depression was observed directly north of the NHWL in 2011 (Feature H, Figure A-1; Appendix A and Photographs 10, 62 to 65, and, 80 on CD-ROM). This 390 m² depression was dry during the 2013 site visit; however, it likely contains ponded water at times of high rainfall and spring melt as evident by the dry cracking soil conditions and moss growth. On the south side of the NHWL, at the top of the berm at both features Q and S, minor

Several potholes were noted in 2011 ranging in volume from 0.006 m³ to 0.016 m³ (Feature B, I, R, and T, Figure A-1; Appendix A and Photographs 51, 66, 77, and 79, Attached CD-ROM). These features remain unchanged in 2013. These features are likely a result of erosion and not settlement as most of the potholes contained one or more large cobbles at the downgradient extent. The presence of large cobbles embedded in the landfill berms cause eddy currents to form in the run-off water and therefore mechanically erode away some of the fine soil particles. This action is contributing to the pothole development.

Minor erosion channels were observed running down the berms of the landfill on the east, northwest, and southwest sides (Feature A, E, F, G, K, M, N, O, and P, Figure A-1; Appendix A and see Tale 4-3 for photograph references); and to a lesser extent the south side. Additional erosion channels were observed at the toe of the landfill on the east side (Feature C and D, Figure A-1; Appendix A and Photographs 53 to 55; CD-ROM) running down towards MW-East, as well as on the northwest toe (Feature J, Figure A-1; Appendix A and Photographs 19, 67 and 68; CD-ROM) and southwest side (Features Q and S, Figure A-1; Appendix A and Photographs 76 to 78; CD-ROM). The maximum depth of the erosion channels noted was less than 0.2 m and on average less than 0.1 m.

Some larger particles (cobbles) are exposed at the top of the berms on the southwest and south sides of the NHWL. These features appear to be a result of water washing the finer grained soils away down the slope of the berm. An area of exposed cobbles was observed at the toe of the berm on the northwest side (Feature U, Figure A-1; Appendix A and Photograph 81; CD-ROM). This feature was not previously identified.

One potential seepage point was observed to the northeast of the NHWL. This feature was identified as feature D and did not contain any evidence of staining or product seepage from the landfill. This feature appeared to be caused only by melt water. Feature D may also be a result of erosion and not seepage; however, it is noted here to track progress in future monitoring programs. Feature D has increased in width and depth since 2011.

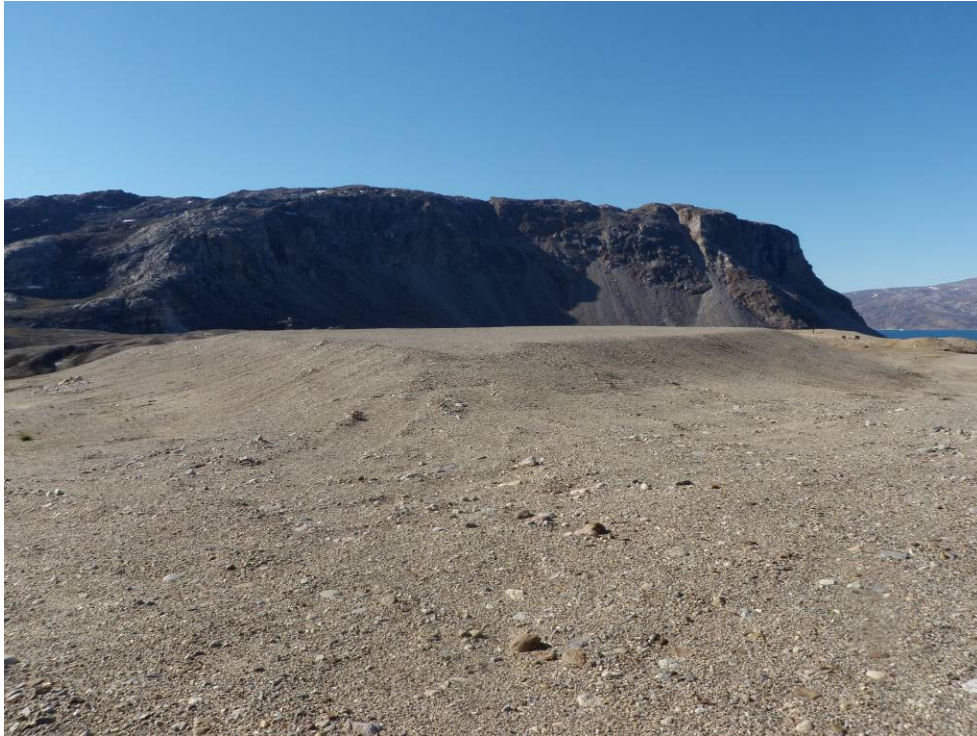
East corner of the NHWL. Viewpoint 2 (Figure A-1; Appendix A). Photograph reference 2 (CD-ROM). Direction photo taken: NW

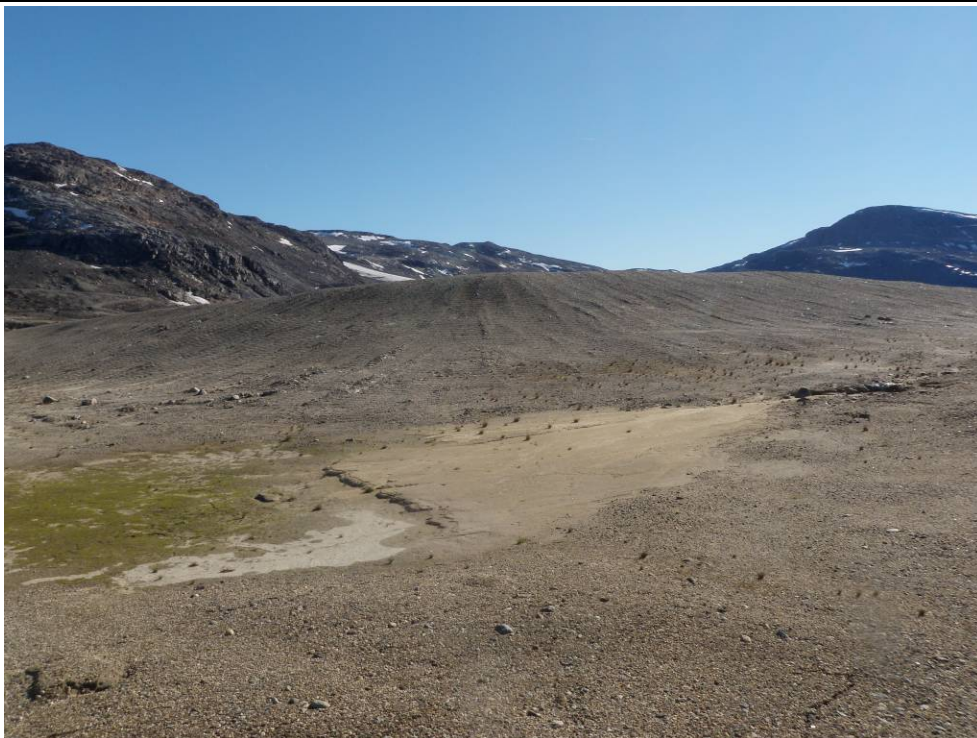
North corner of the NHWL. Note the damp depression area. Viewpoint 10 (Figure A-1; Appendix A). Photograph reference 10 (CD-ROM). Direction photo taken: SW. Feature H in foreground – depression is dry with moss growth.

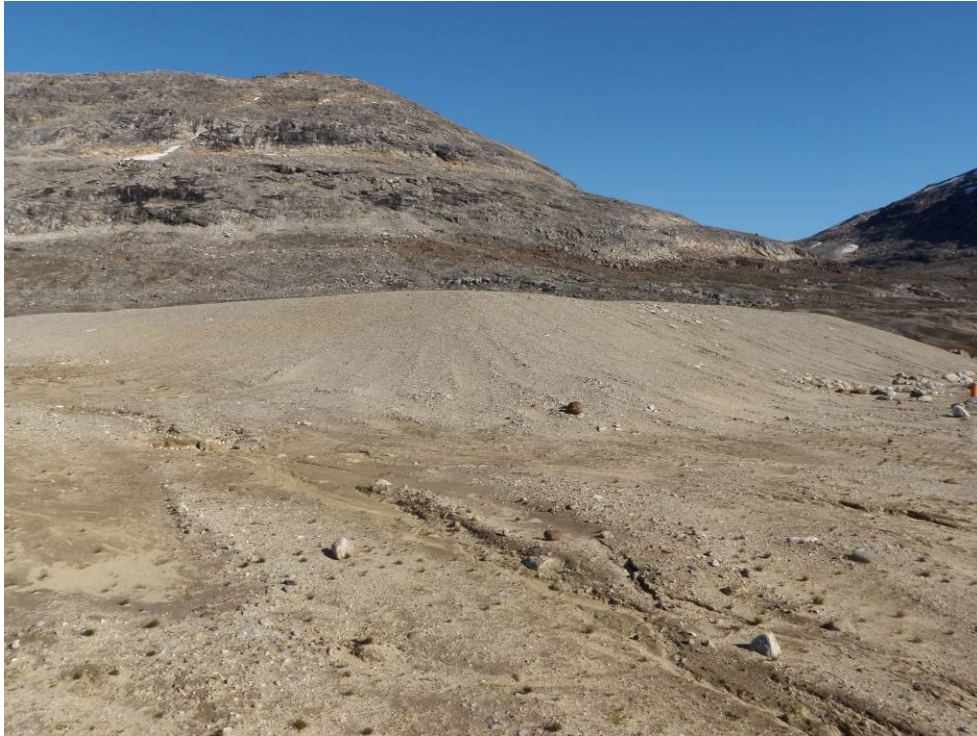
West corner of the NHWL. Note the erosion channel at the toe of the NHWL. Viewpoint 19 (Figure A-1; Appendix A). Photograph reference 19 (CD-ROM). Direction photo taken: SE

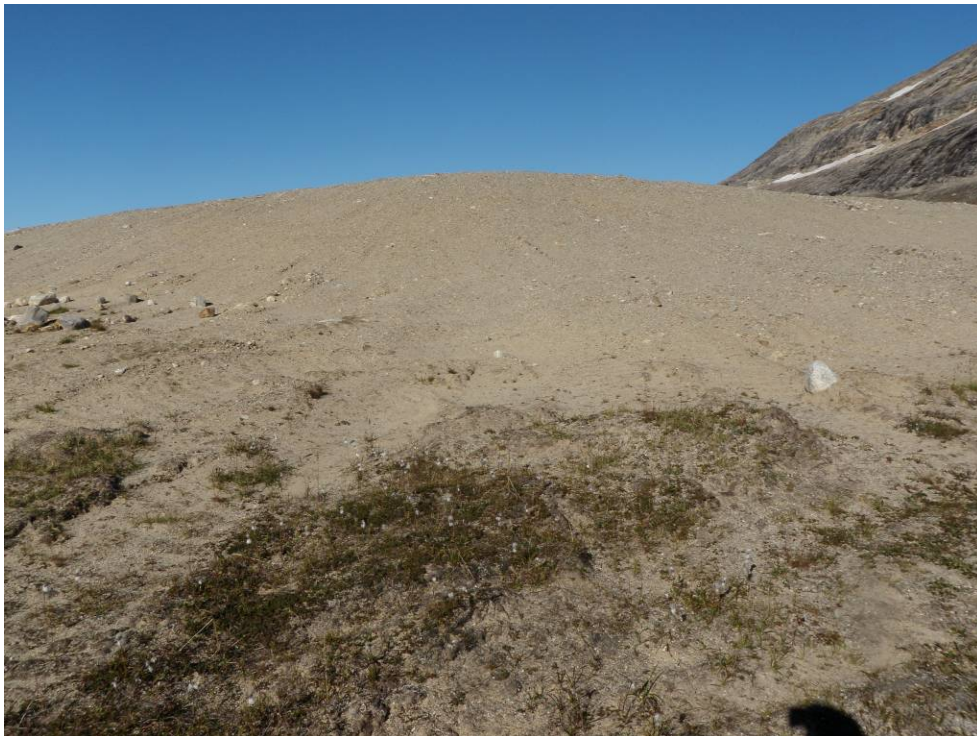
South corner of the NHWL. Viewpoint 27 (Figure A-1; Appendix A). Photograph reference 27 (CD-ROM). Direction photo taken: NE

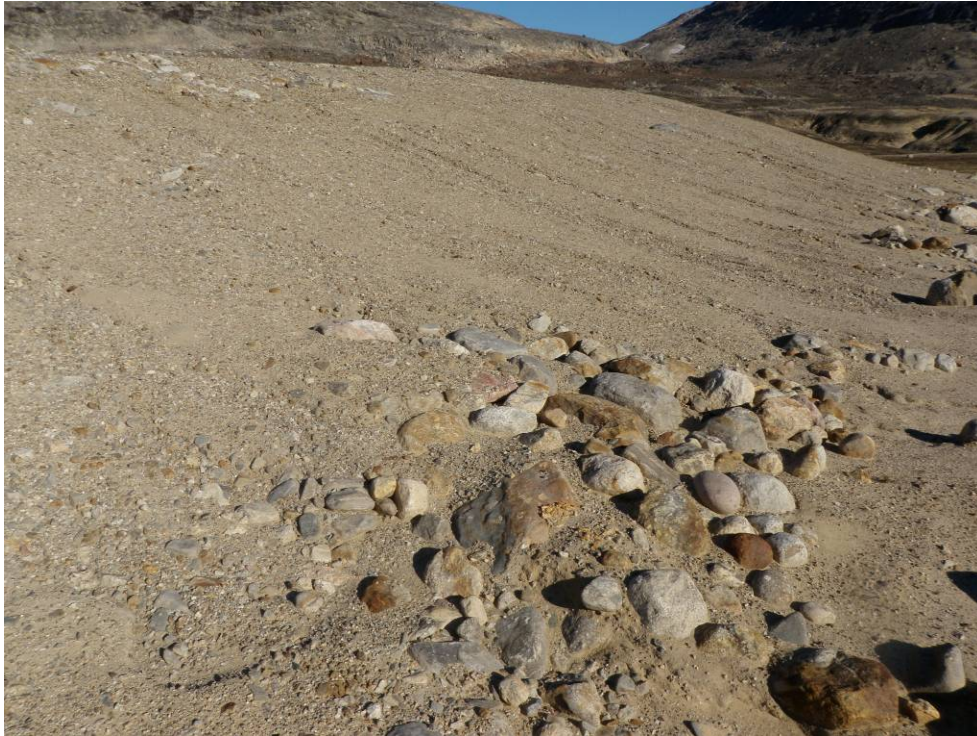
Exposed cobbles at NW corner of landfill at toe of berm. Note the erosion channels in background (Features M & N). Viewpoint 81 (Figure A-1; Appendix A). Photograph reference 81 (CD-ROM). Direction photo taken: S

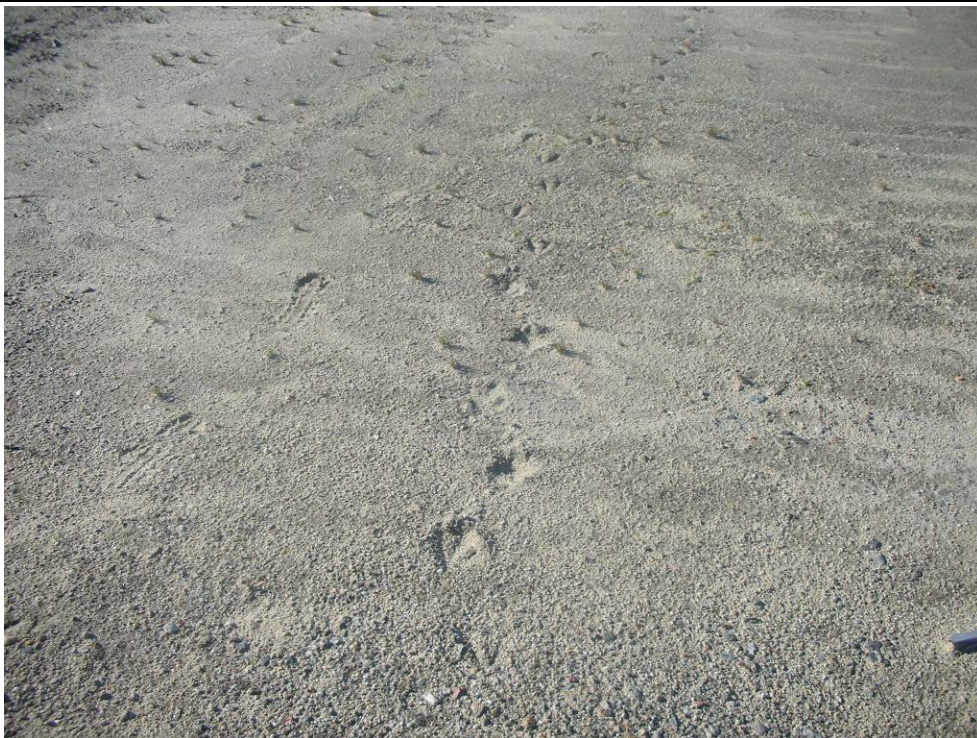
View of Geese tracks near NHL. Photograph reference 82 (CD-ROM). Direction photo taken: NA

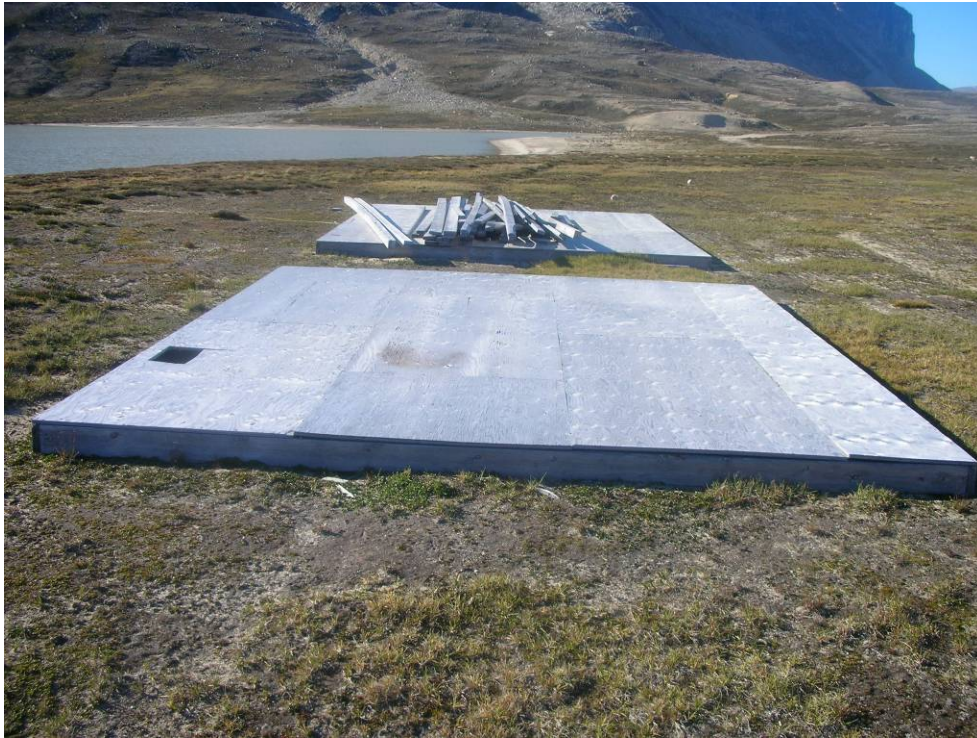
To the southwest of the NHWL (Lower Site Landfill Area) lies the Lake Area, including Borrow Areas 5 and 6 and the *in-situ* treatment area. This area was observed during the 2013 field program by the AANDC representative. Two wood platforms, one with a pile of 2 x 4 wood planks, were observed near the shore of the lake. These wood platforms were in good condition and were assumed to have been left after site remedial works, and not from time of site operations.

Wood platforms at Lake Area. Photograph reference 83 (CD-ROM). Direction photo taken: NW

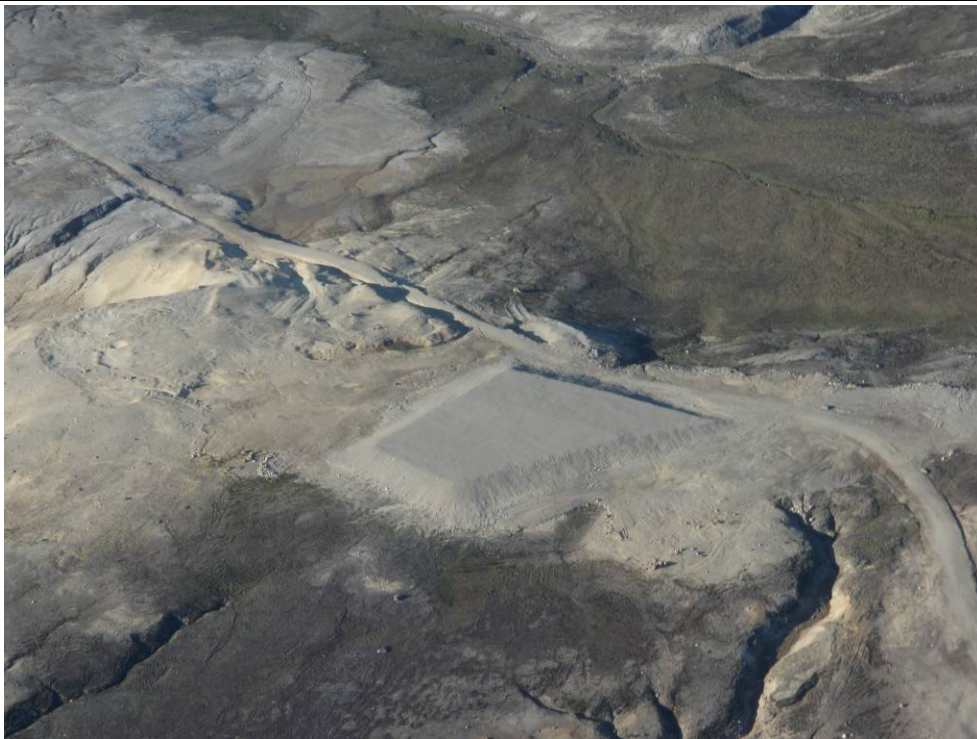
Aerial shot of NHWL. Roadway towards Beach Area in top corner and towards Upper Station in bottom corner.
Photograph reference 84 (CD-ROM). Direction photo taken: NE

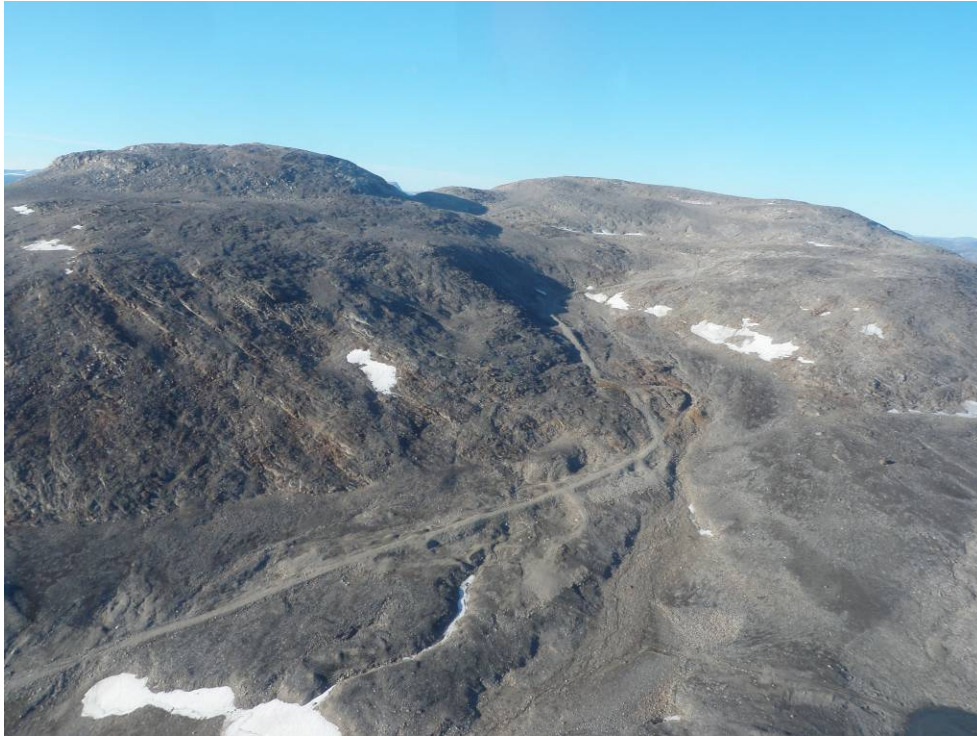
Aerial view of roadway to Upper Station. Photograph reference 85 (CD-ROM). Direction photo taken: E

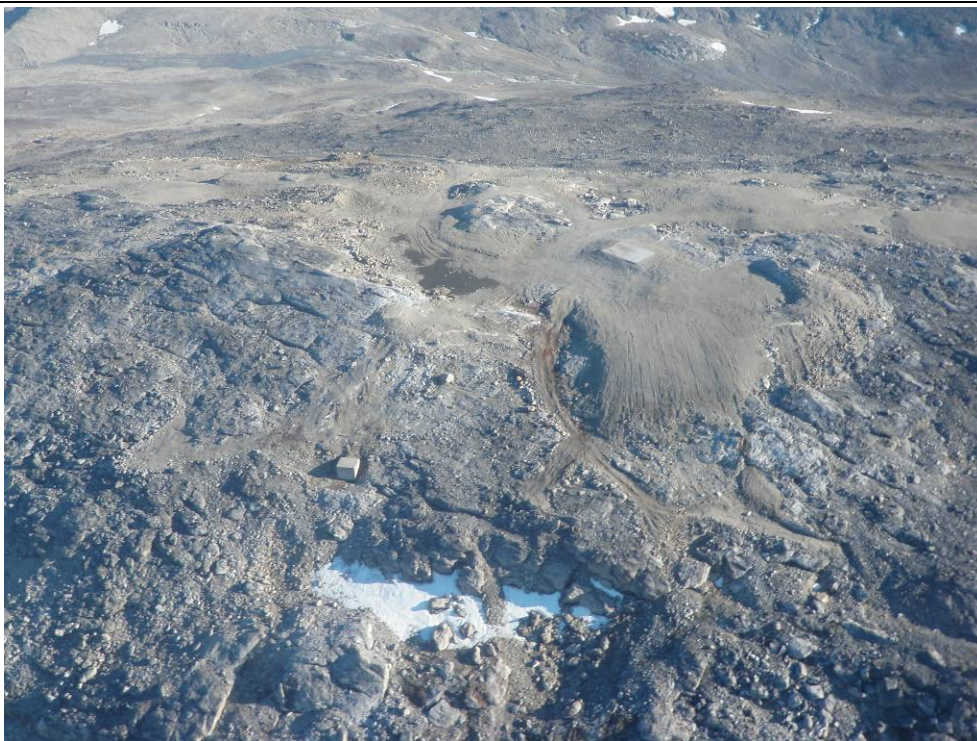
Aerial view of Upper Station. A cement pad and tower anchor block. Photograph reference 86 (CD-ROM). Direction photo taken: SW
