## LONG TERM MONITORING, 2016

FOX-C Ekalugad Fjord, Nunavut

February 3, 2017

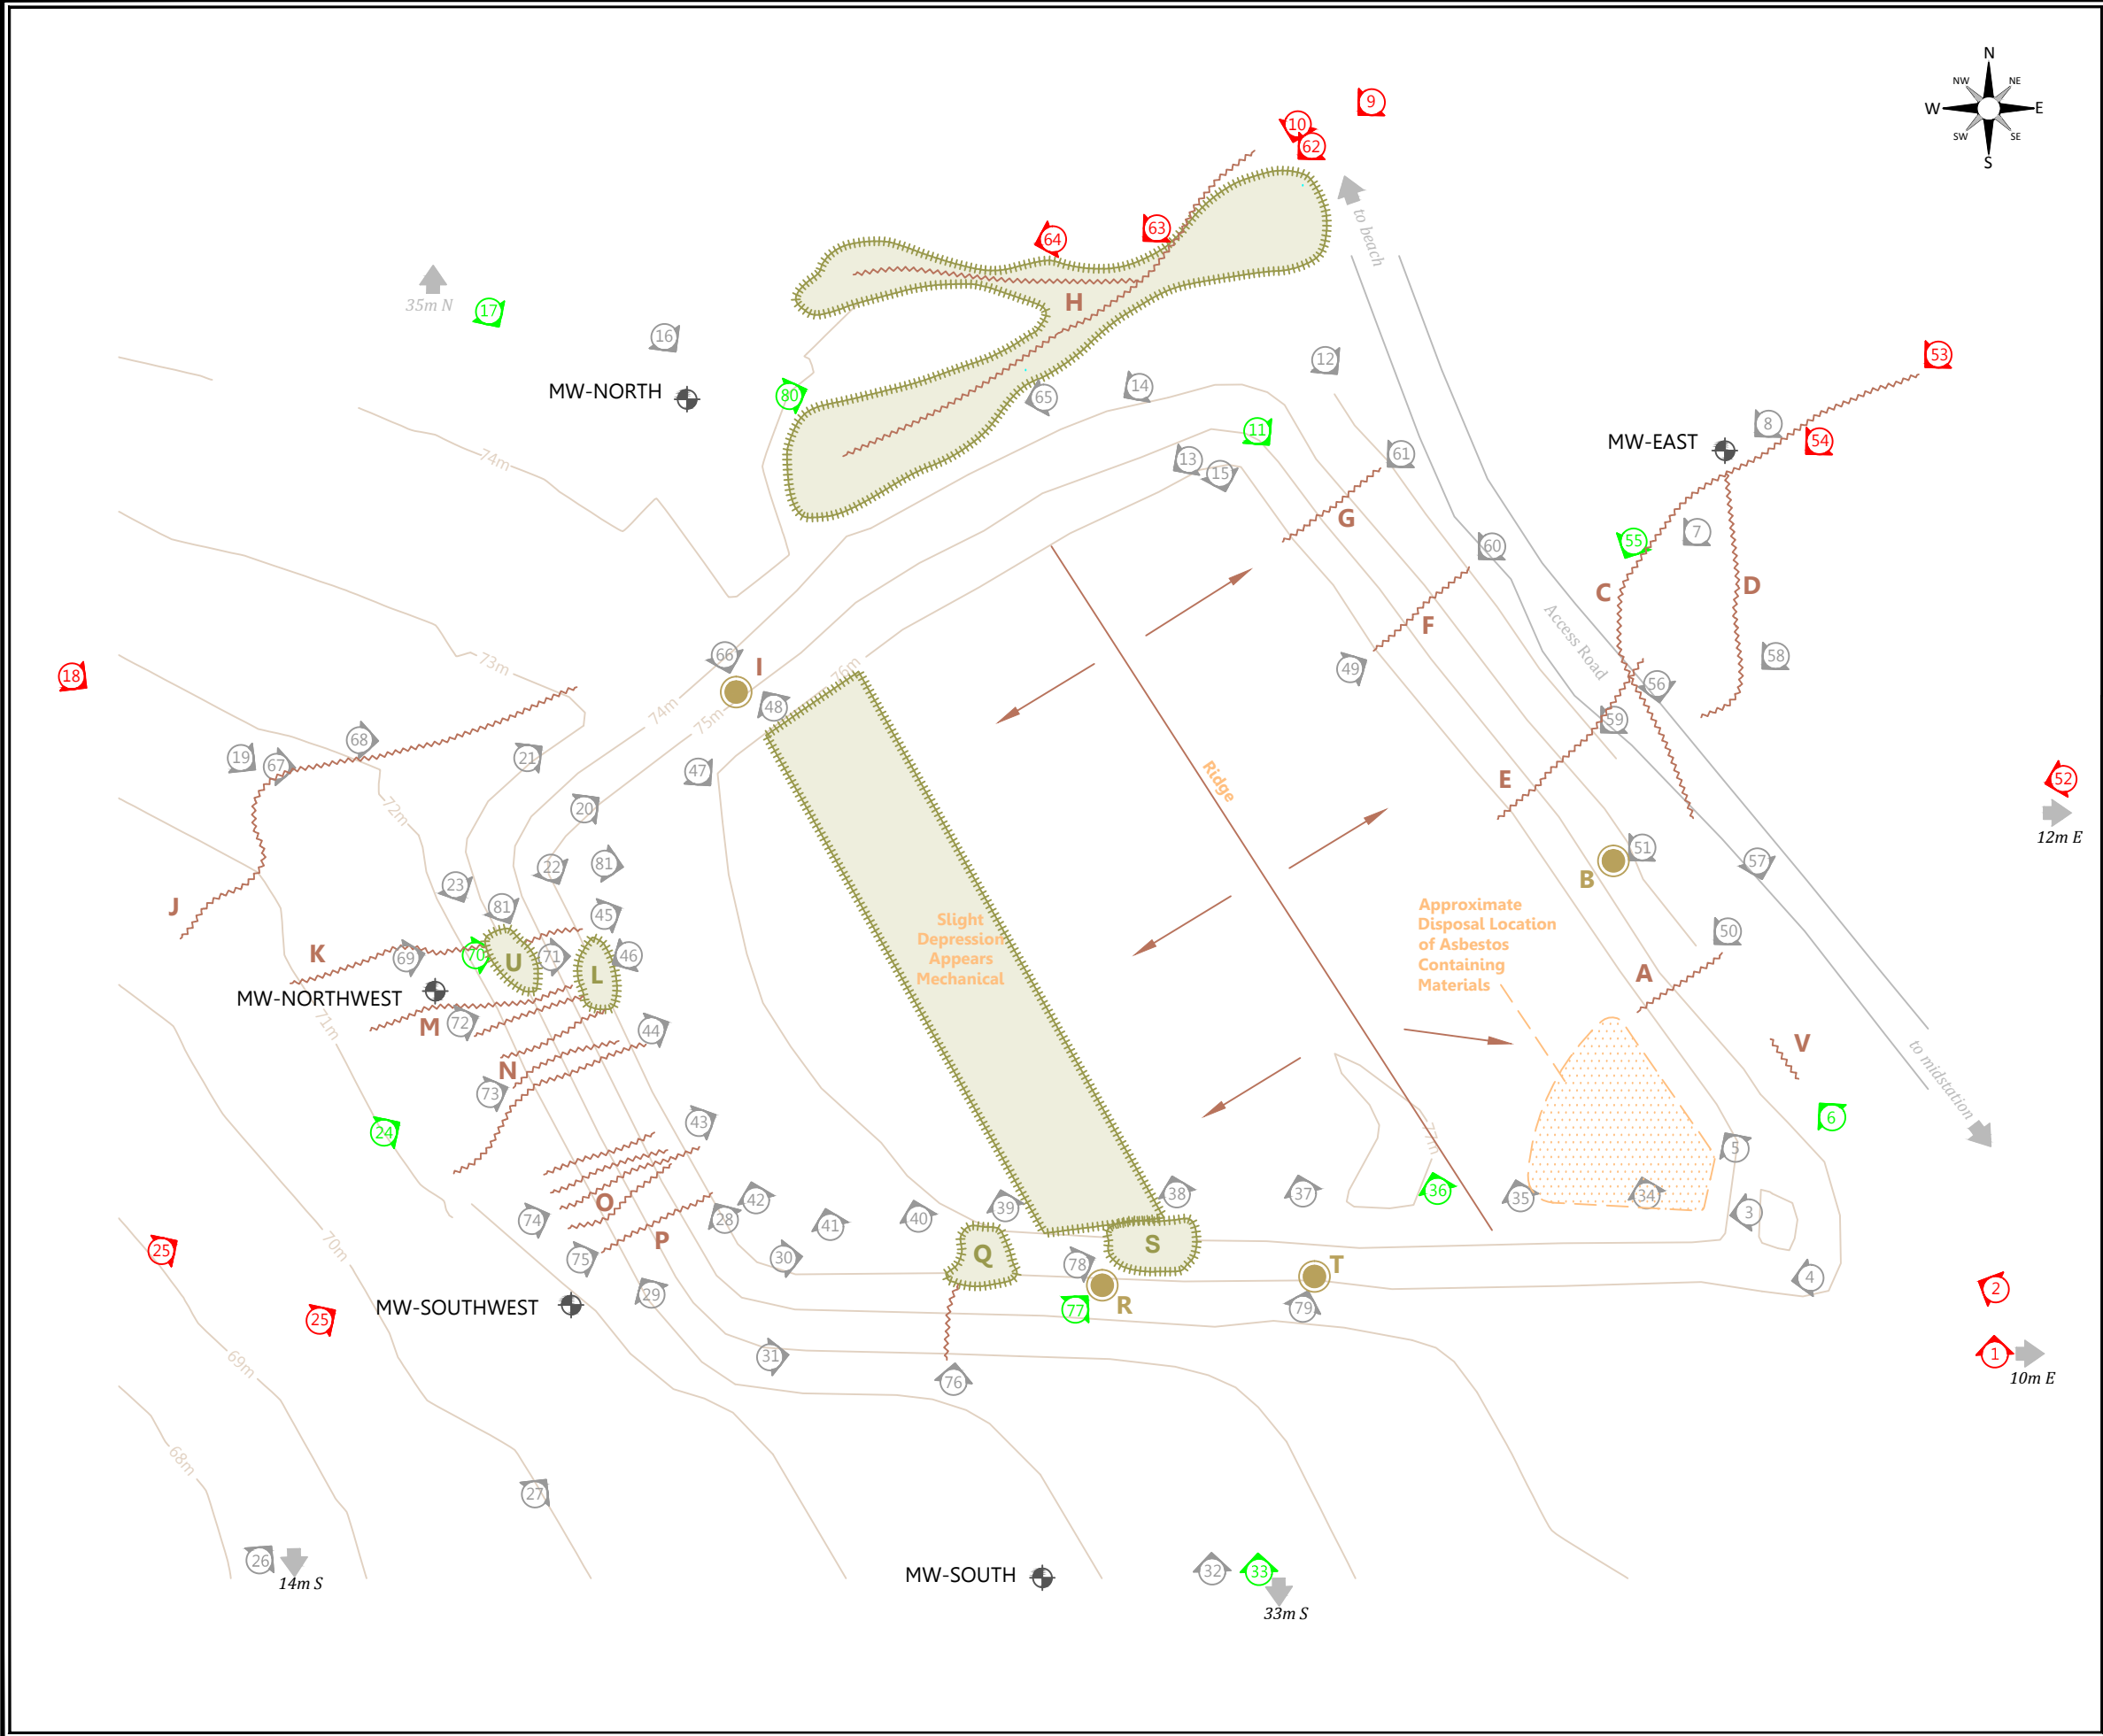
Title: Non-Hazardous Waste Landfill	
	Project: FOX-C Ekalugad Fiord 100347-001
Date: October 2016	Client: Indigenous and Northern Affairs Canada

A linear area of settlement was observed running from north to south on the entire top of the landfill (Figure 2; located after Section 9), in the central area along the apex of the NHWL. It was suggested in the 2009 LTM report (FRANZ, 2010) that this is result of the techniques used to build the NHWL and may not be a settlement issue. Based on the photographic evidence from 2009, 2011 and 2013, the extent of the depression has not changed significantly since previously noted and, if anything, has decreased in importance. As noted in Figure 2, the landfill surface appears to be traversed by a ridge in a north-south direction. The landfill gently slopes westward and eastward from this ridge. Photo 12 (Appendix C) is taken looking along this ridge.

An area of noticeable depression was observed directly north of the NHWL in 2011 (Feature H, Figure 2; and Photo 11). This approximately 390 m<sup>2</sup> depression was dry during the 2013 and 2016 site visits; however, it likely contains ponded water at times of high rainfall and spring melt as evident by the dry

On the south side of the NHL, minor settlement was observed at the top of the berm (Features Q and S, Photo 8). The depression and minor settlement area do not currently appear to impact the structure of the landfill.

Several potholes were noted in 2011 ranging in volume from approximately 0.006 m<sup>3</sup> to approximately 0.016 m<sup>3</sup> (Features B, I, R, and T, Figure 2 and Viewpoints 51, 66 and 77 on the attached DVD). These features remain unchanged in 2016. These features may be a result of erosion and not settlement as most of the potholes contained one or more large cobbles at the downgradient extent. The presence of large cobbles embedded in the landfill berms might cause eddy currents to form in the run-off water and therefore mechanically erode away some of the fine soil particles. This action is likely contributing to the pothole development.

Minor erosion channels were observed running down the berms of the landfill on the east and west sides (Features A, E, F, G, K, M, N, O, and P, Figure 2 and see Table 5-2 for photograph references); and to a lesser extent the south side (Feature Q). Additional erosion channels were observed at the toe of the landfill on the east side (Feature C and D, Figure 2 and Viewpoints 54, 56, 58 and 59 on the DVD) running down towards MW-East, as well as on the north and northeast side (Features H and J, Figure 2 and Viewpoints 19, 65, 67, 68 and 80). Features C, D, H and J have all increased in size since 2013. These erosion channels lead away from the NHL and are likely the result of meltwater and rainwater flowing away from the NHL. They do not appear to currently affect the integrity of the NHL. Measurements were not obtained in 2016, due to limited time on-site, so this should be made a priority in future field visits.

A new erosion channel was observed in 2016. It is located approximately 15 m from the southeast corner of the NHL, along the toe of the eastern berm (Figure 2). Designated Feature V, it was observed to be approximately 4 m long, 3 cm wide and 1 cm deep (see Photo 9).

Some larger particles (cobbles) are exposed at the top of the berms on the southwest and south sides of the NHL. These features appear to be a result of water washing the finer grained soils away down the slope of the berm. An area of exposed cobbles was observed at the toe of the berm on the northwest side (Feature U, Figure 2 and Viewpoint 81; DVD).
