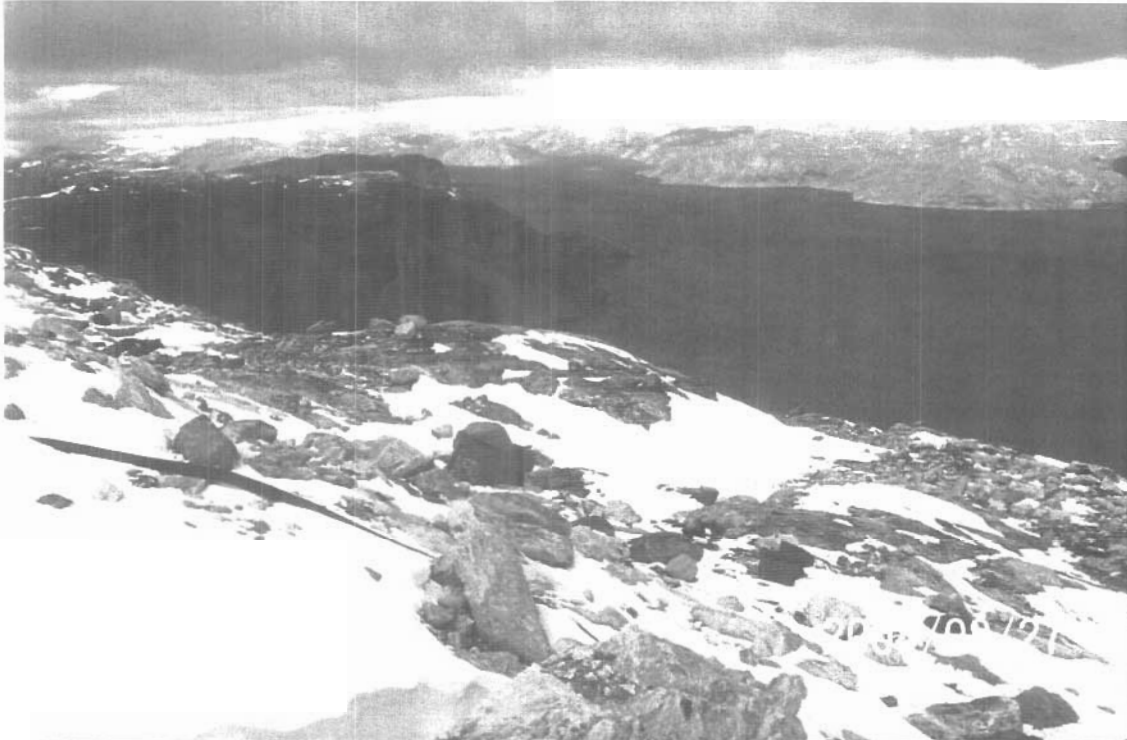
Photo 1
Main Dump looking west

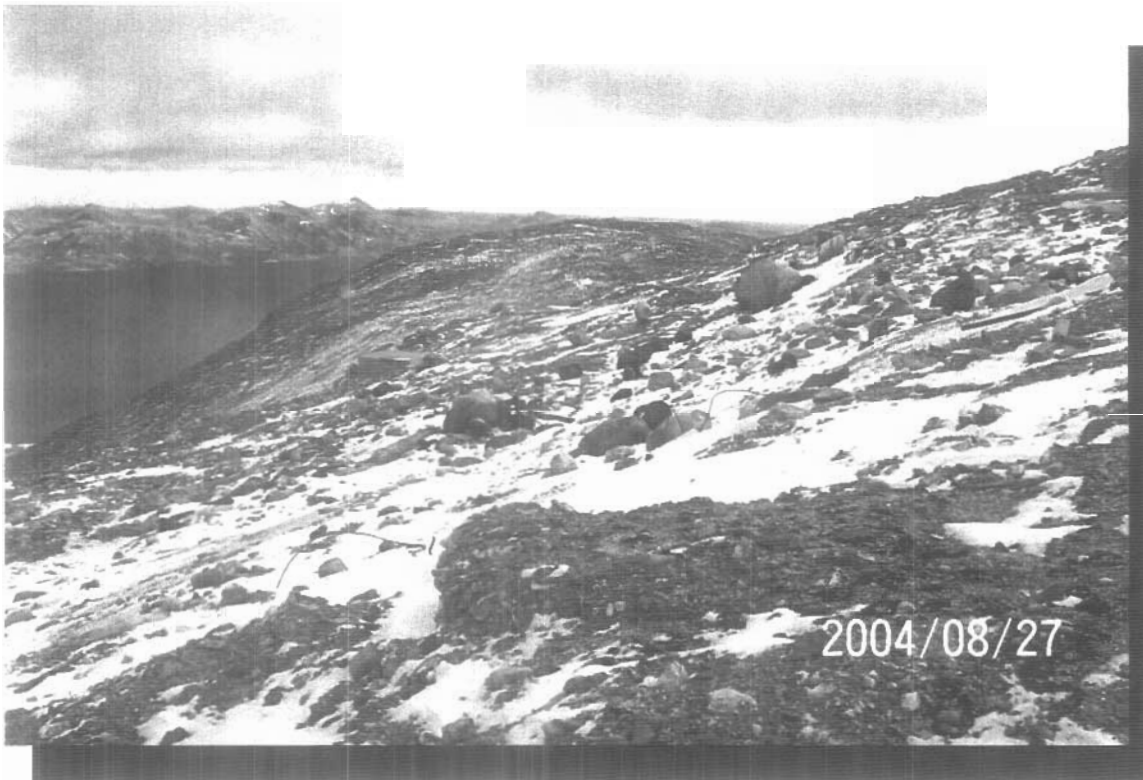
Photo 2
Main Dump looking east.

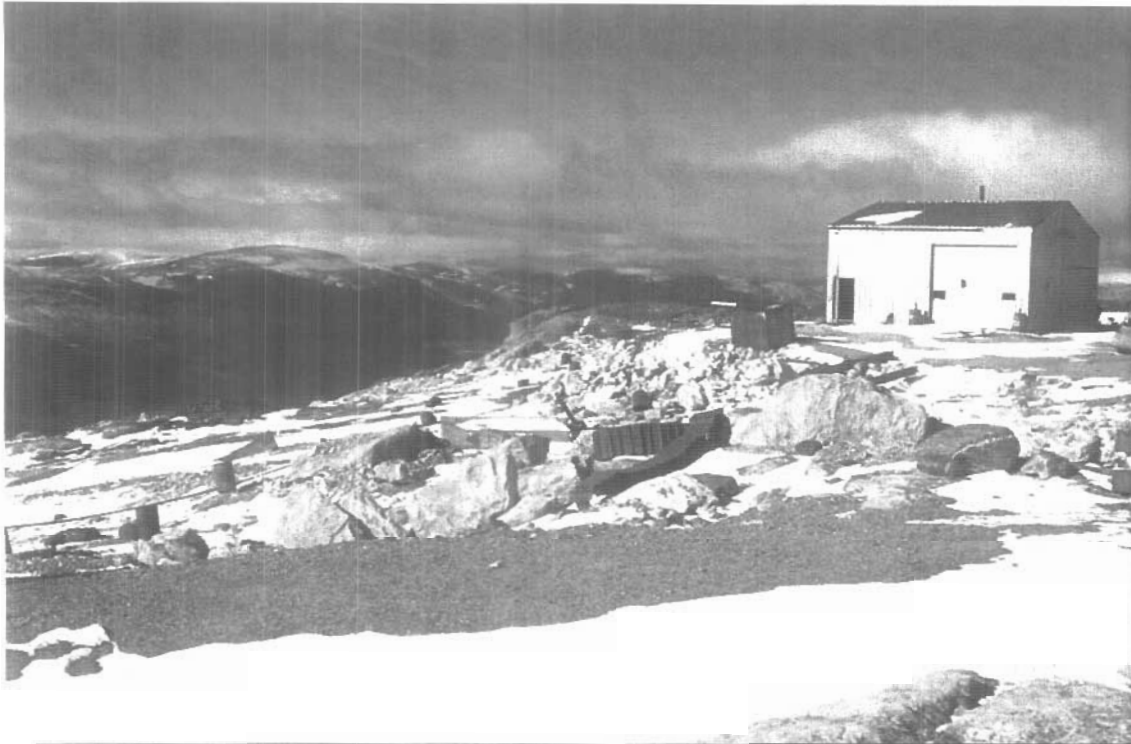
**Photo 3**

Garage Dump looking southwest, Lobe A in foreground.

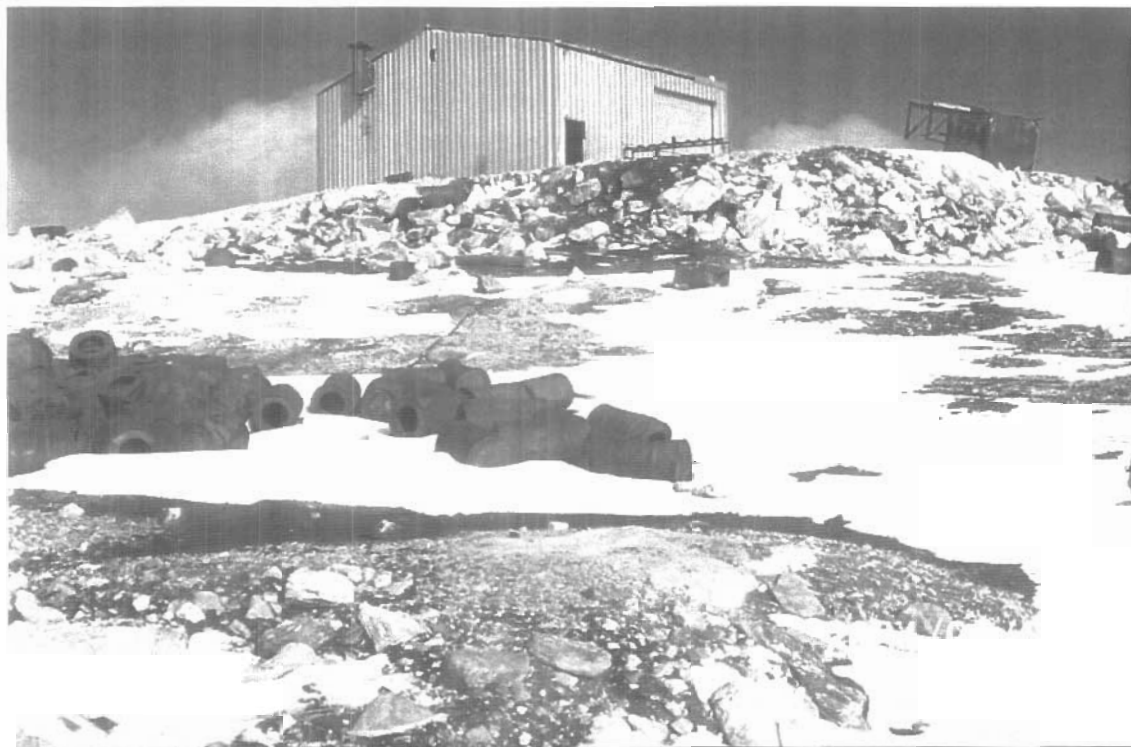
**Photo 4**

Garage Dump looking north, Lobe B in foreground.

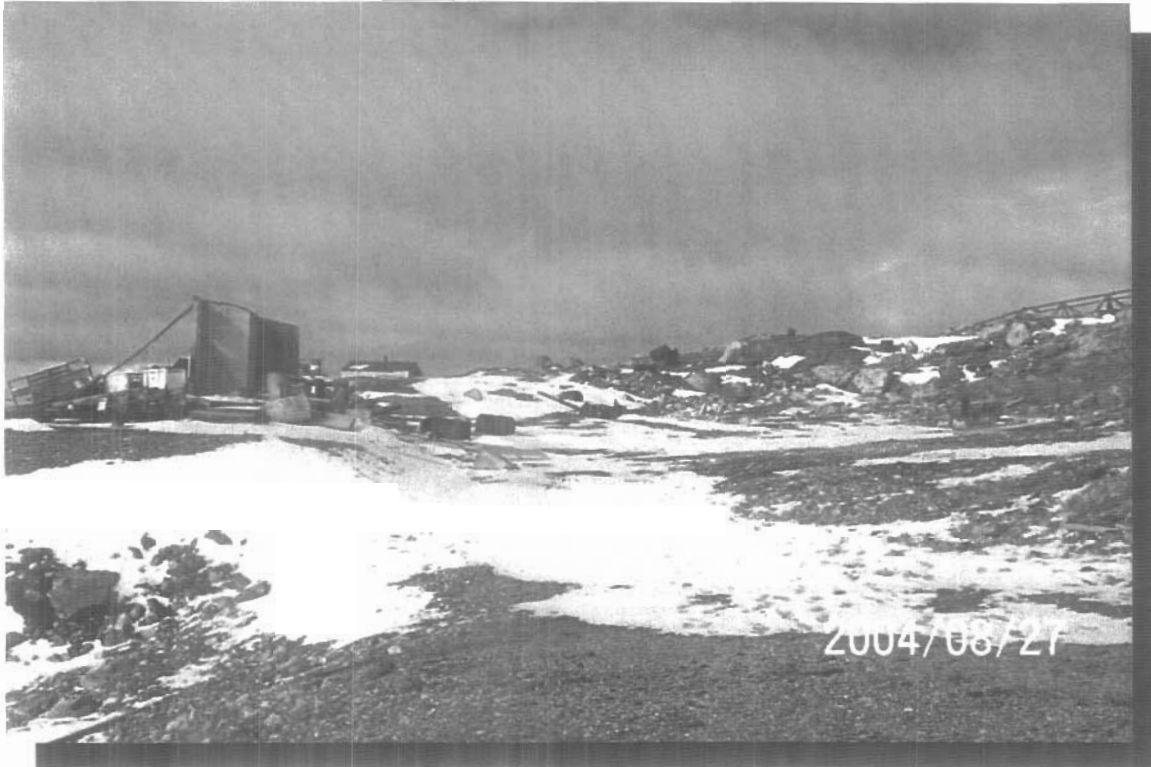
**Photo 5**

House Dump looking west, remnants of Inuit house on left, House Dump on right.

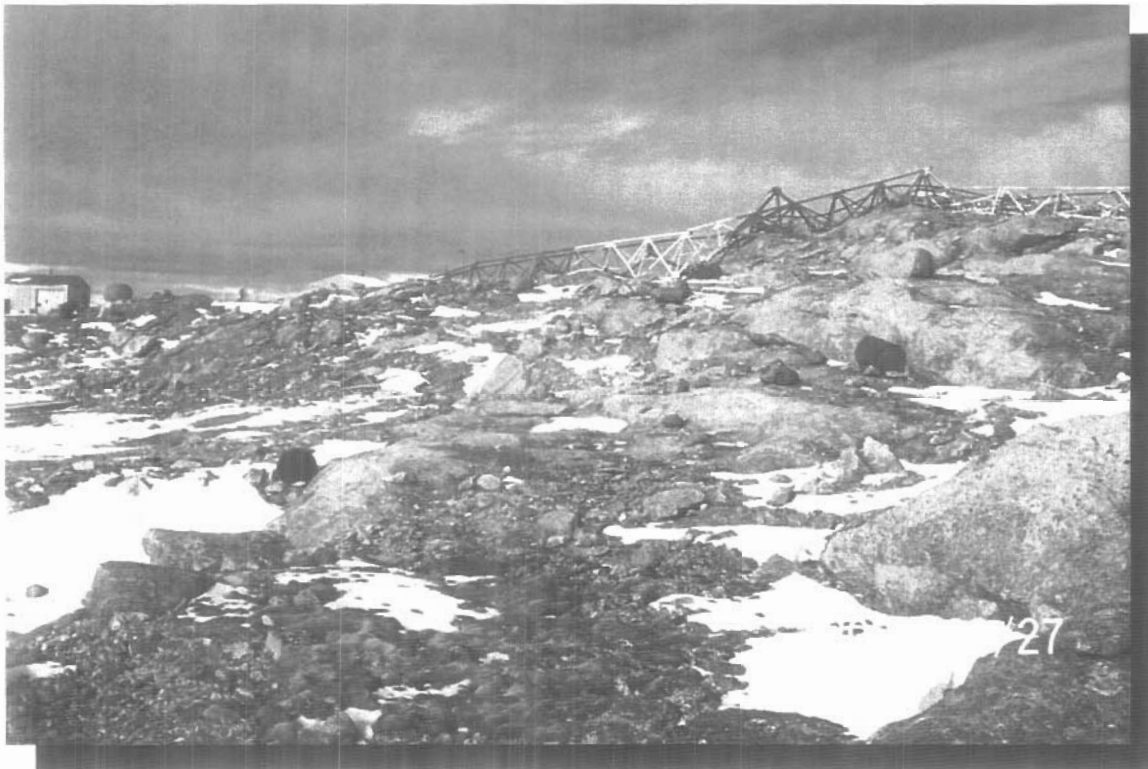
**Photo 6**

House Dump looking north.

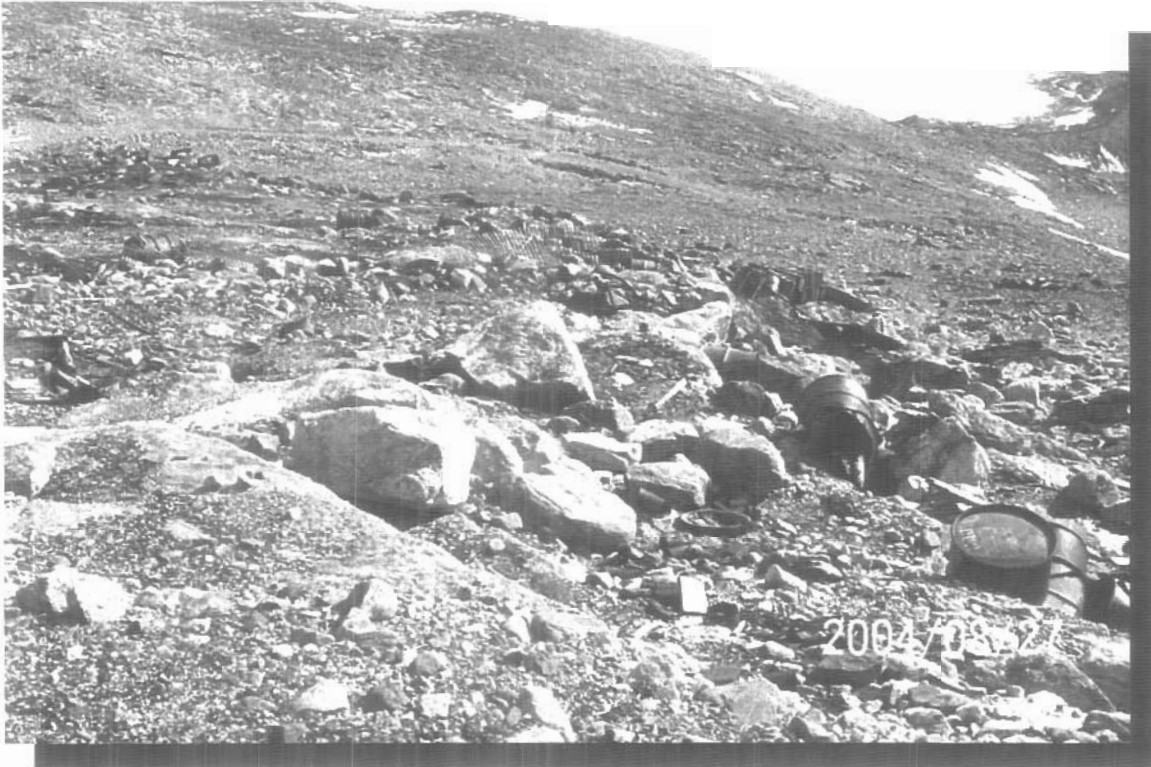
**Photo 7**

Original Dump looking southwest, west side of Station Road.

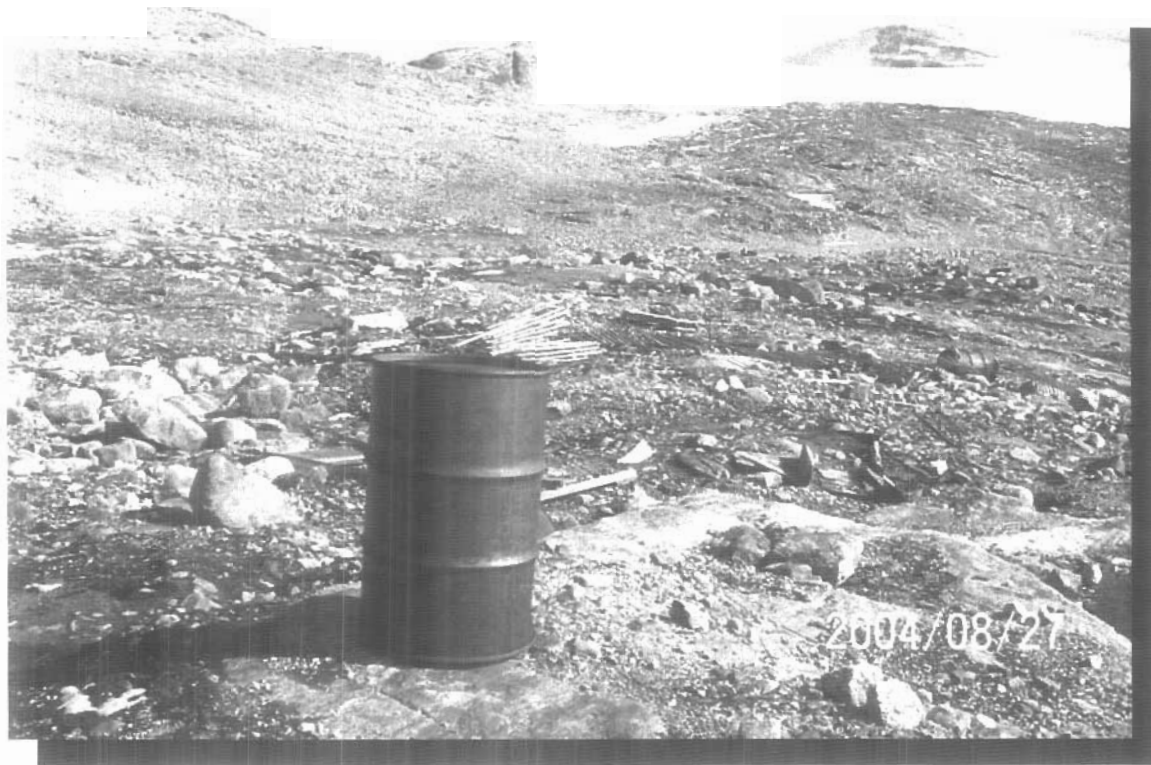
**Photo 8**

Original Dump looking southwest, east side of Station Road.

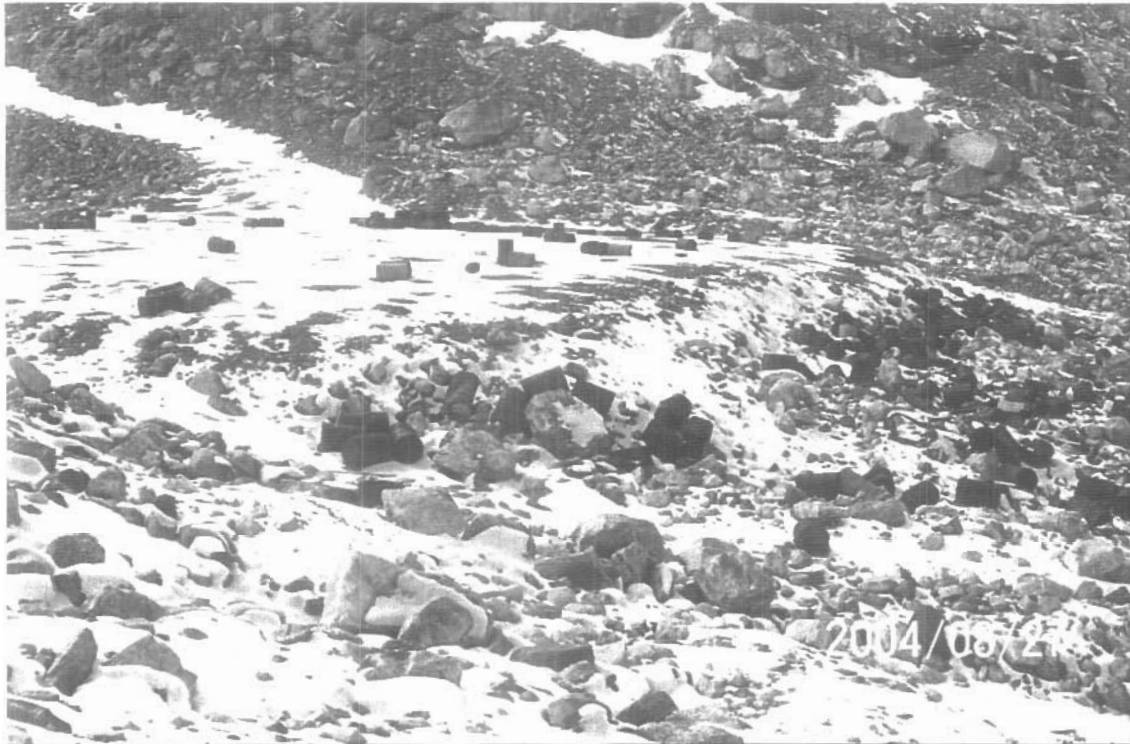
Photo 9
Midstation Dump Lobe A looking northwest, pad area.

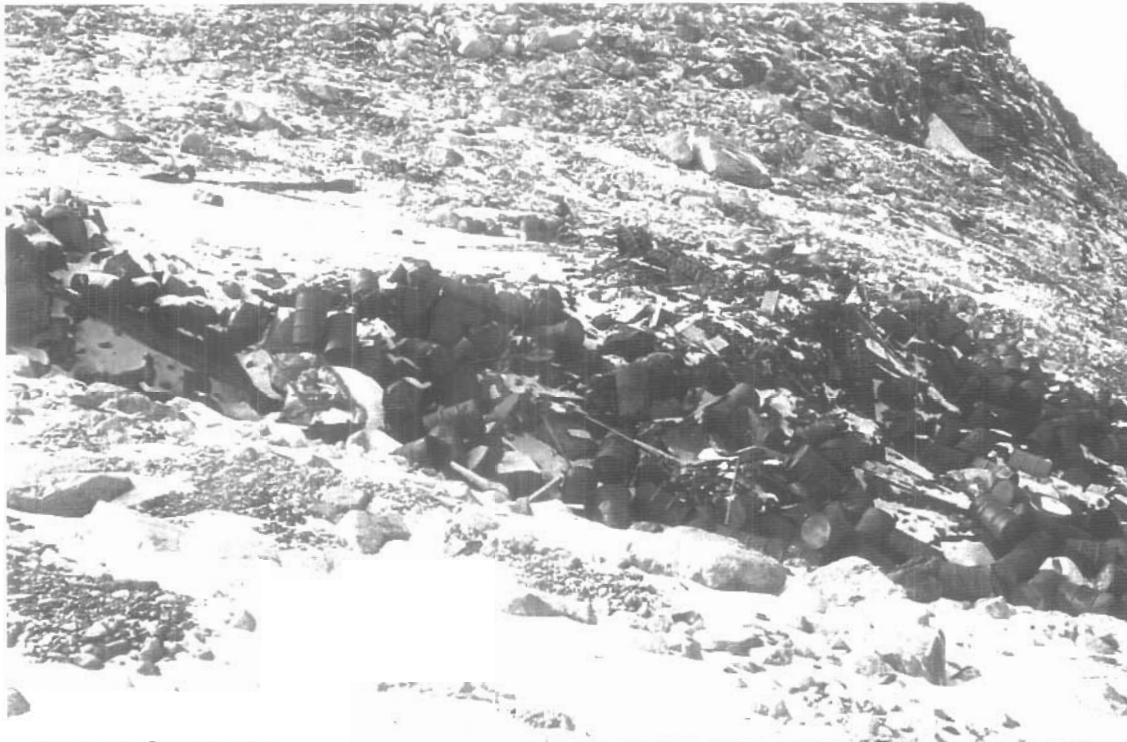
Photo 10
Midstation Dump looking north, Lobe B.

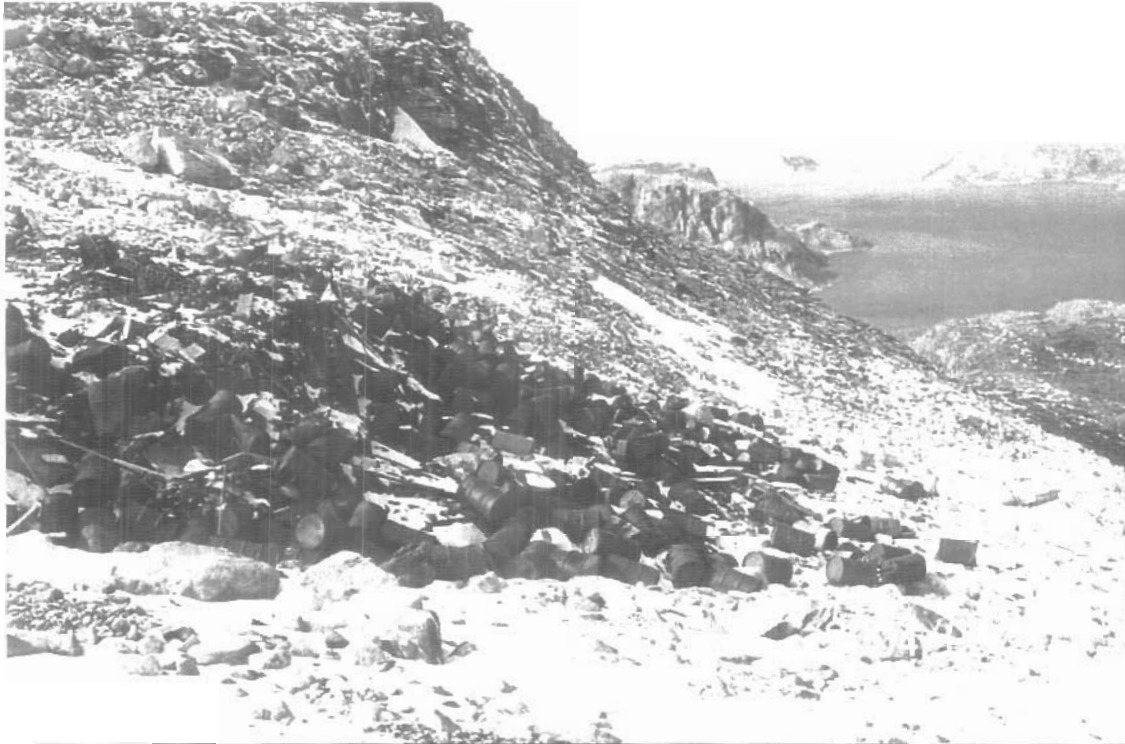
**Photo 11**

Midstation Dump looking north, Lobe B in foreground.

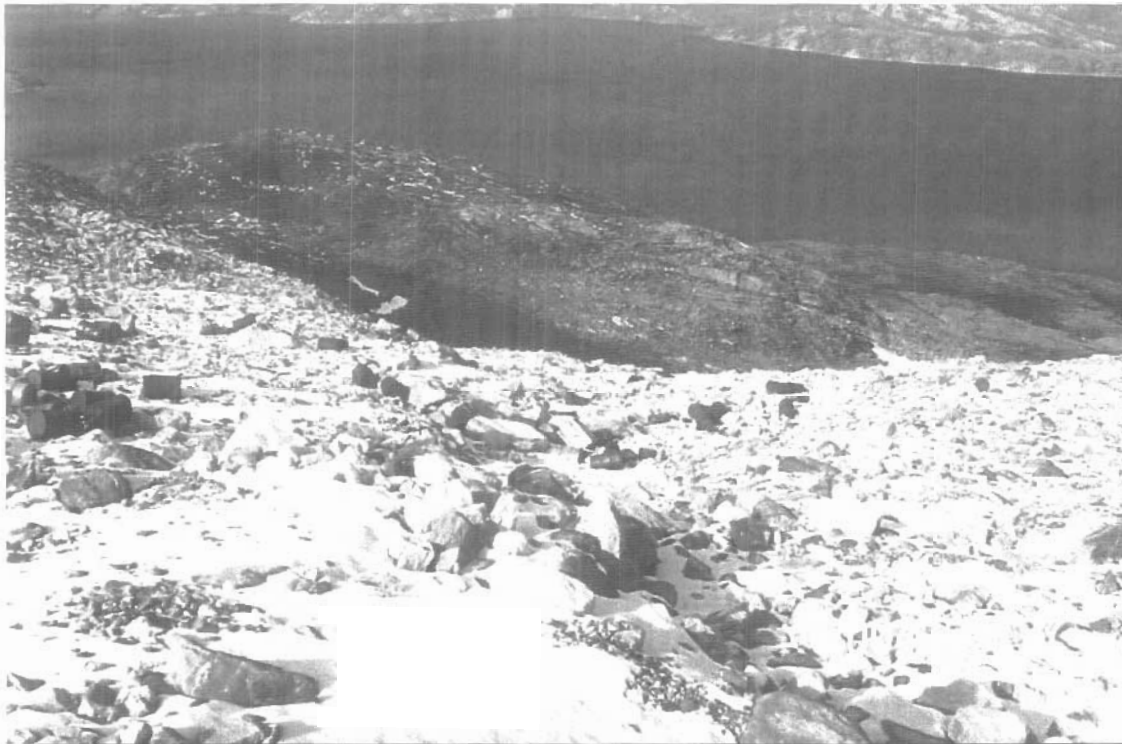
**Photo 12**

Midstation Dump looking east, toe of Lobe B.

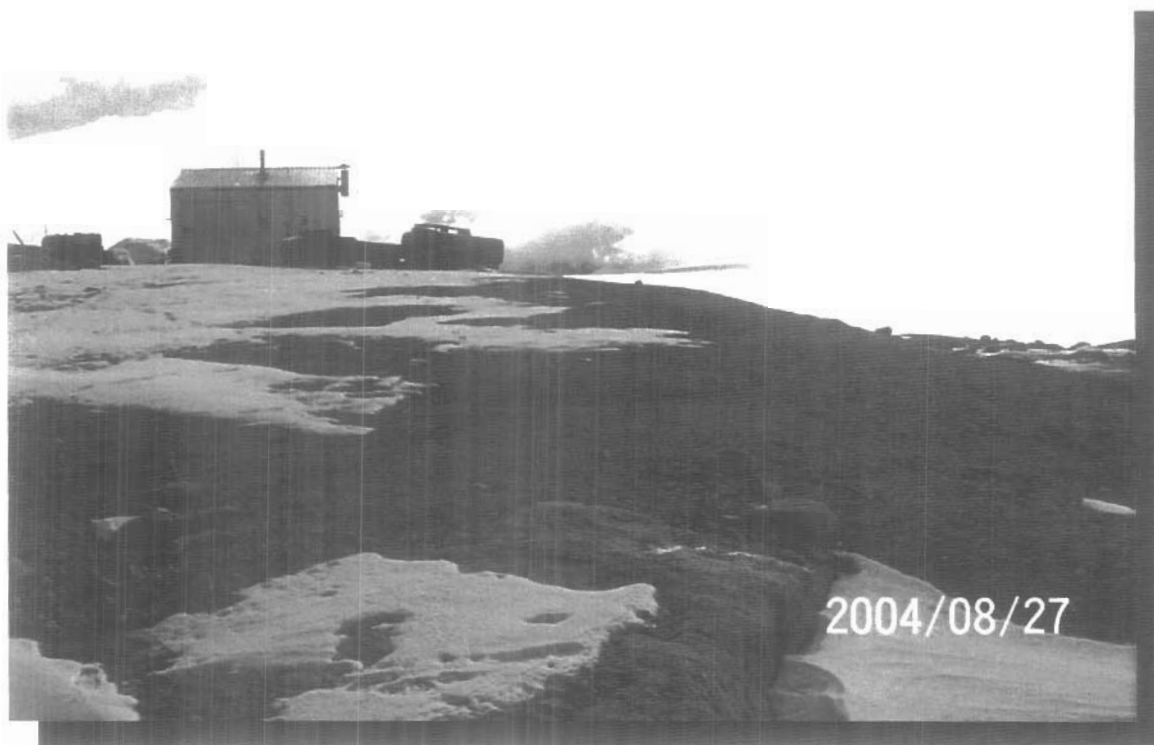
**Photo 13**

West Laydown Debris Area looking east, Lobe A in foreground, Lobe B in background.

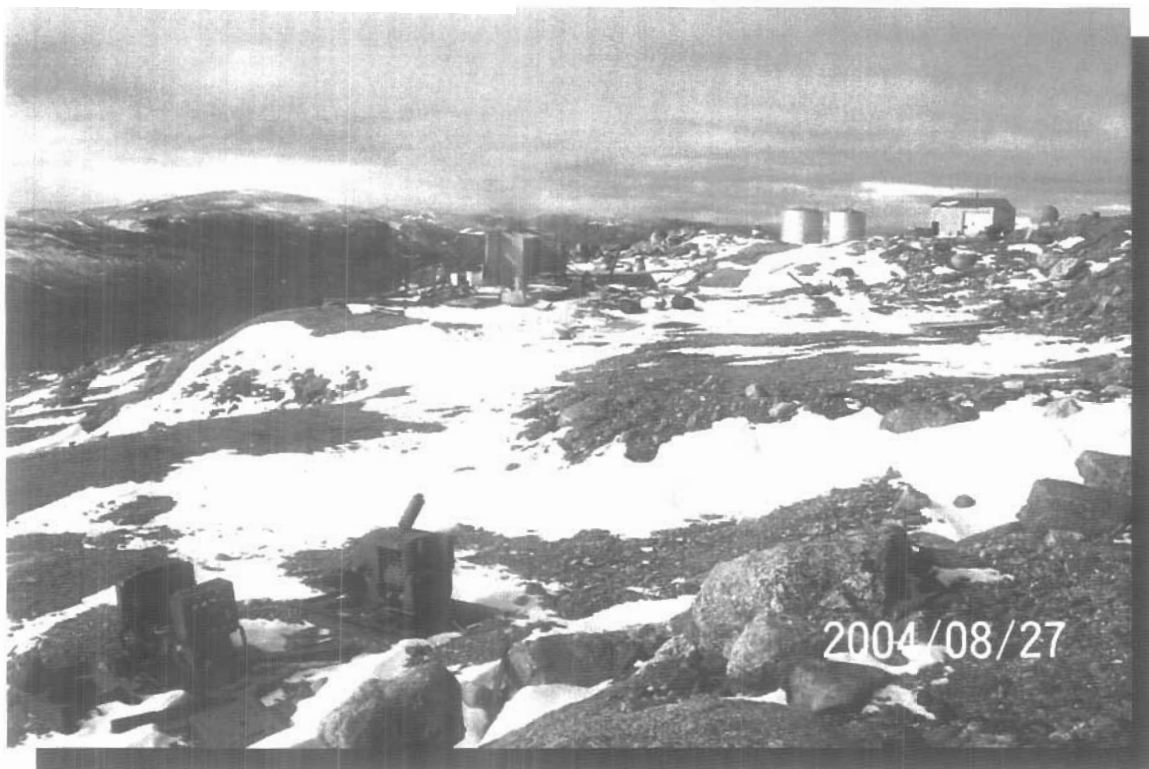
**Photo 14**

East Laydown Debris Area looking west, Lobe B in foreground.

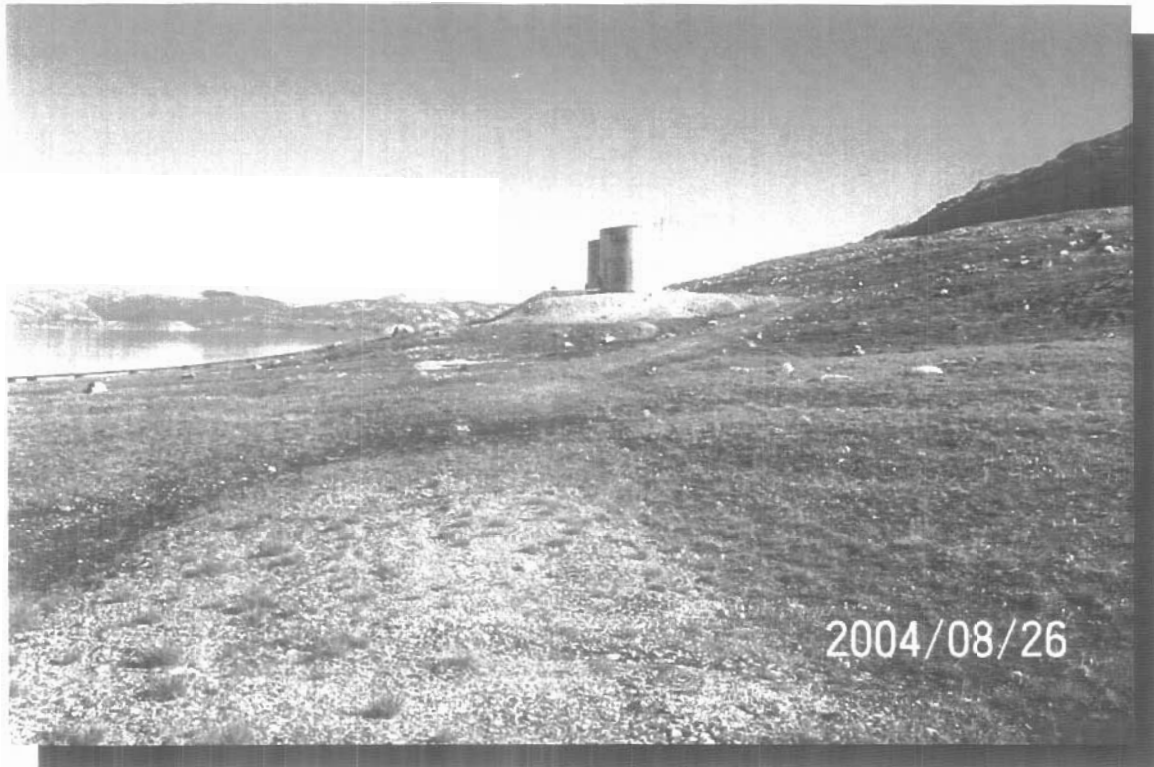
**Photo 15**

Beach POL Debris Area looking northeast, Lobe A in background.

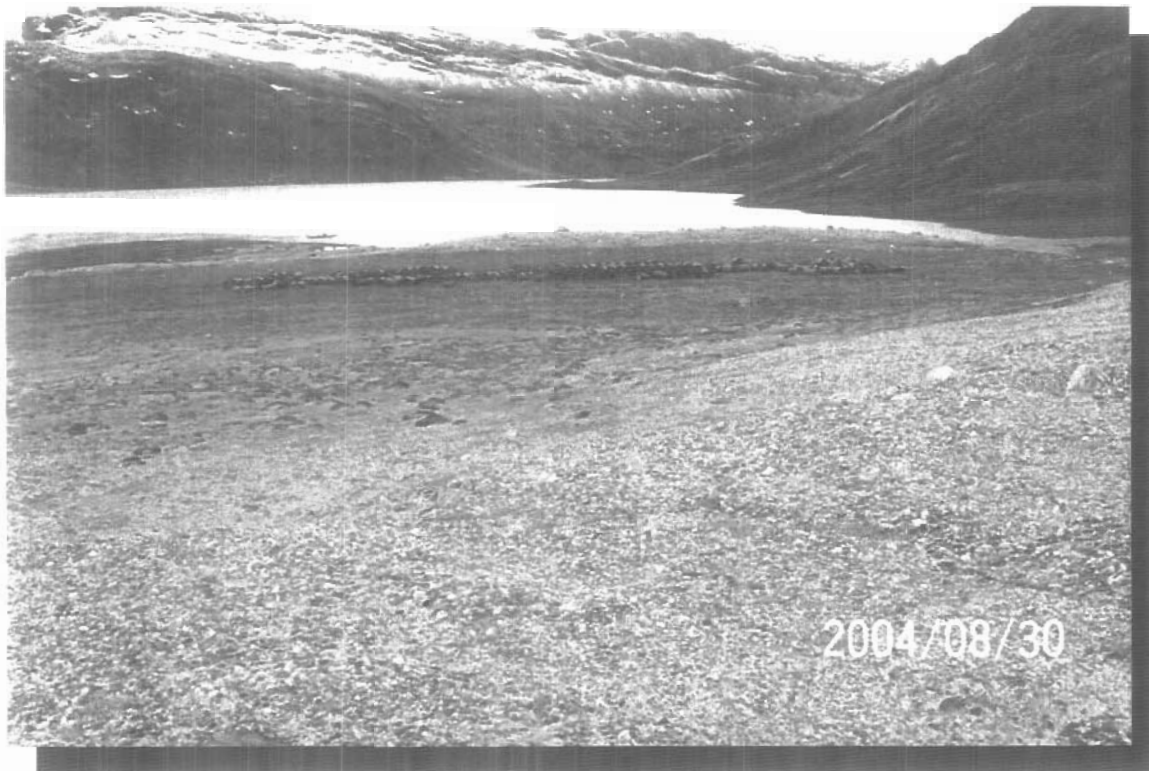
**Photo 16**

Potential Debris Landfill Location 2 looking northwest, barrel cache in background.

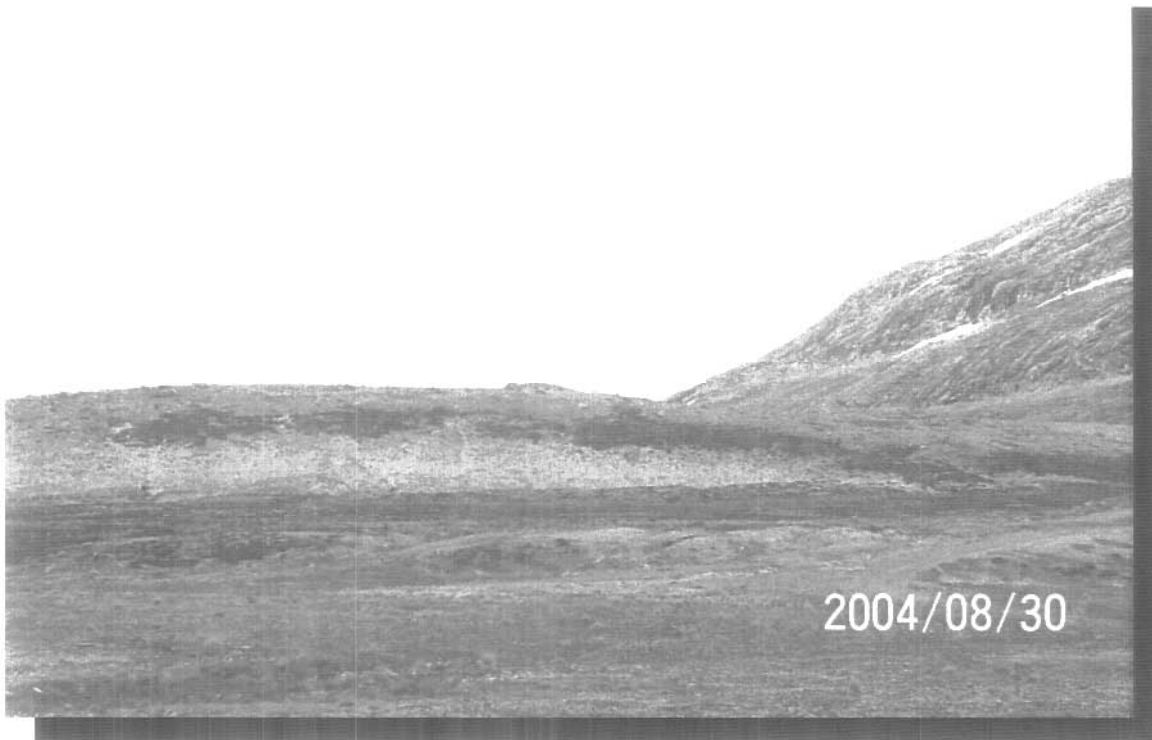
Photo 17
Potential Debris Landfill Location 3 looking west.

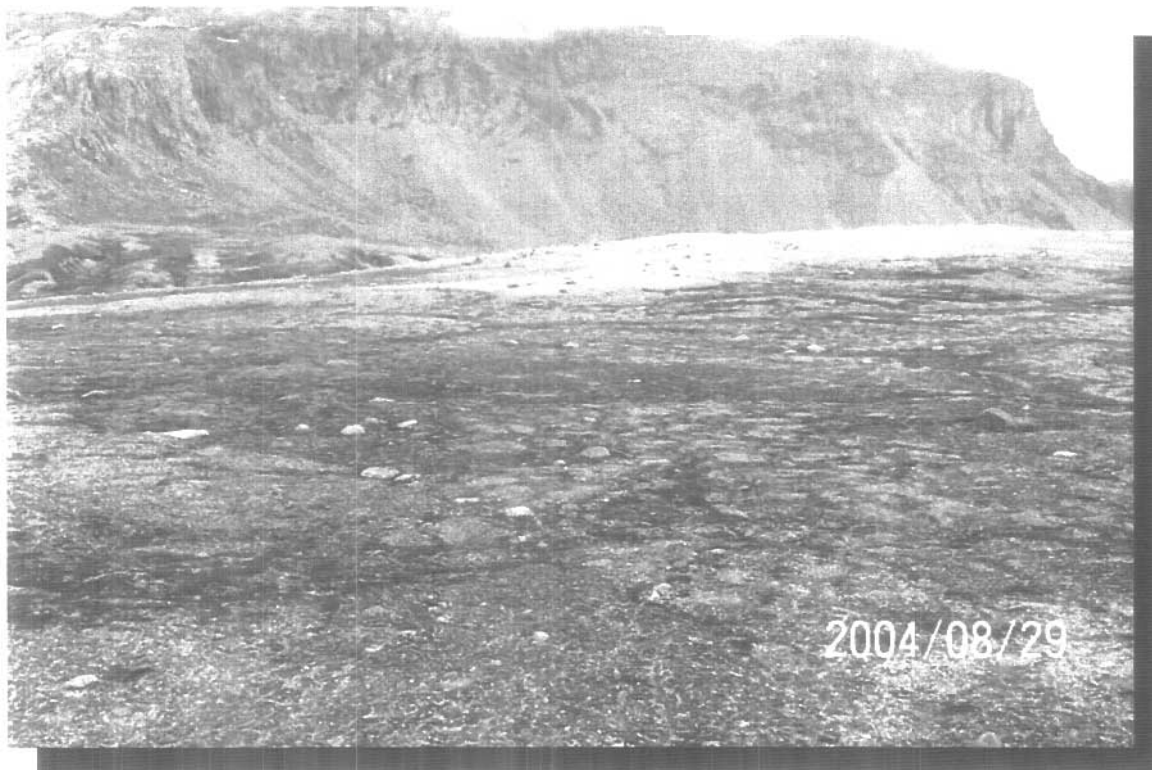
Photo 18
Potential Debris Landfill Location 4 looking west.

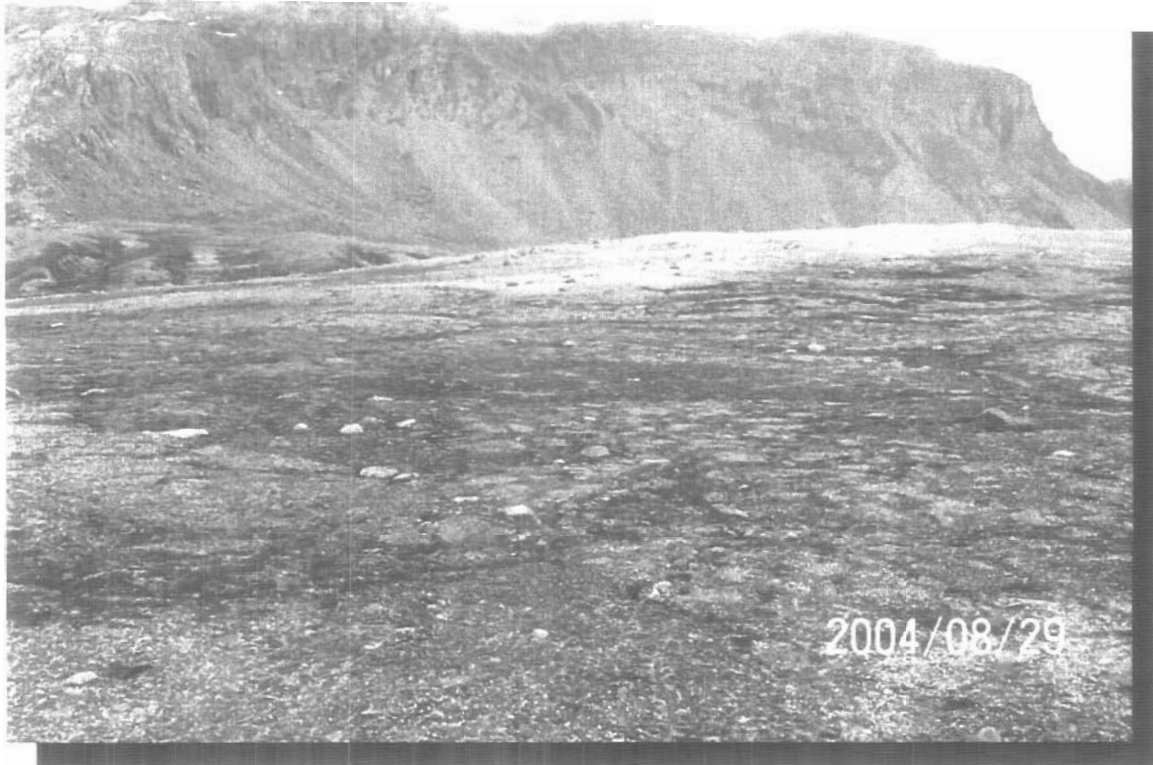
Photo 19
Potential Debris Landfill Location 4 looking southwest.

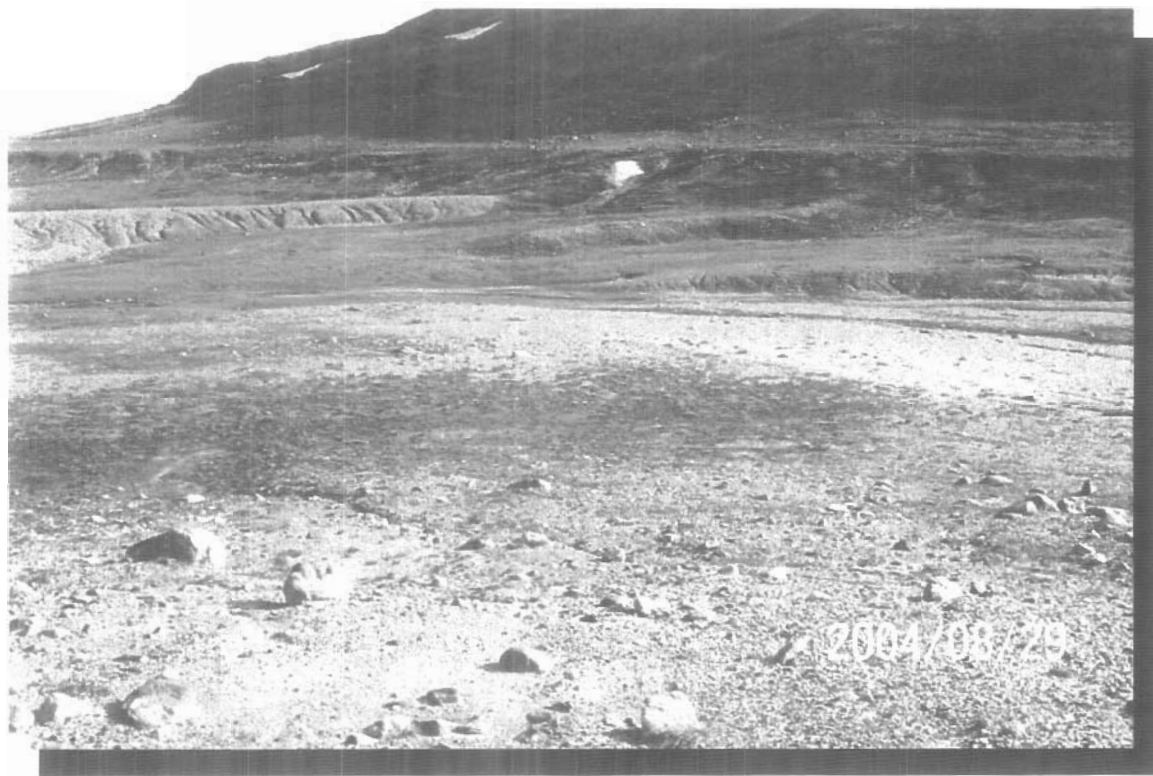
Photo 20
Potential Soil Disposal Facility Location 1 looking northeast.

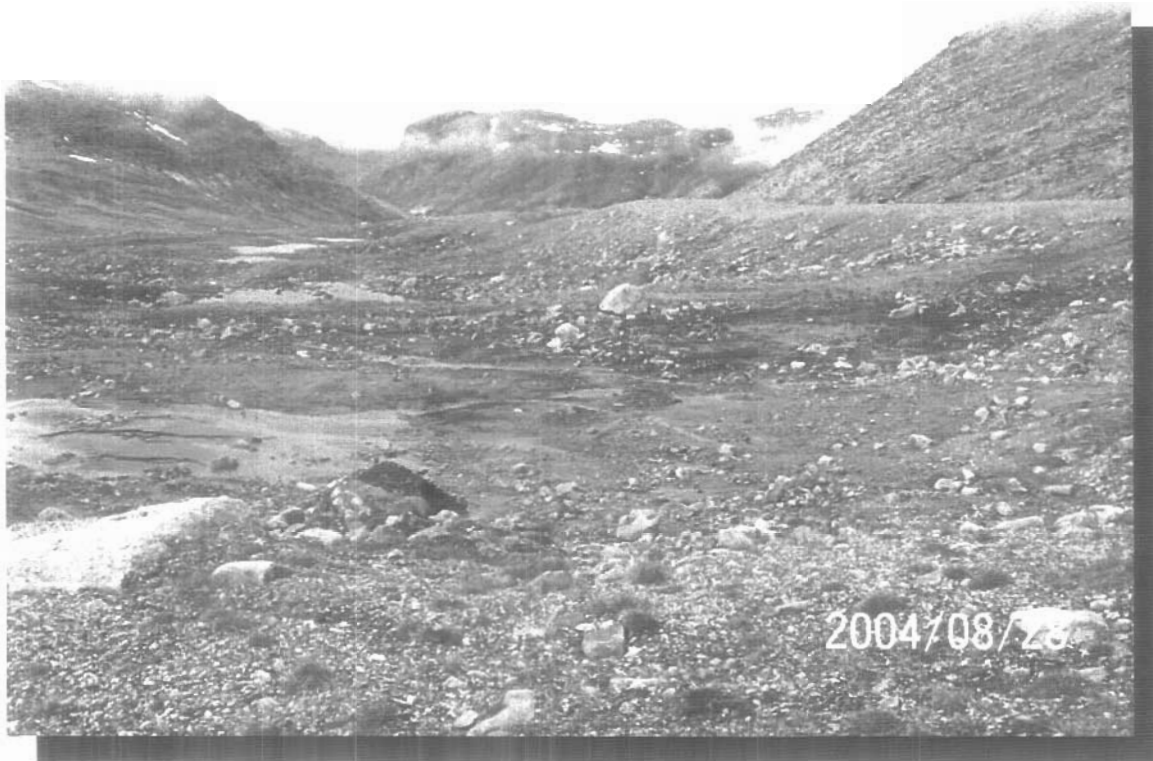
Photo 21
Proposed Borrow Area 1 looking west.

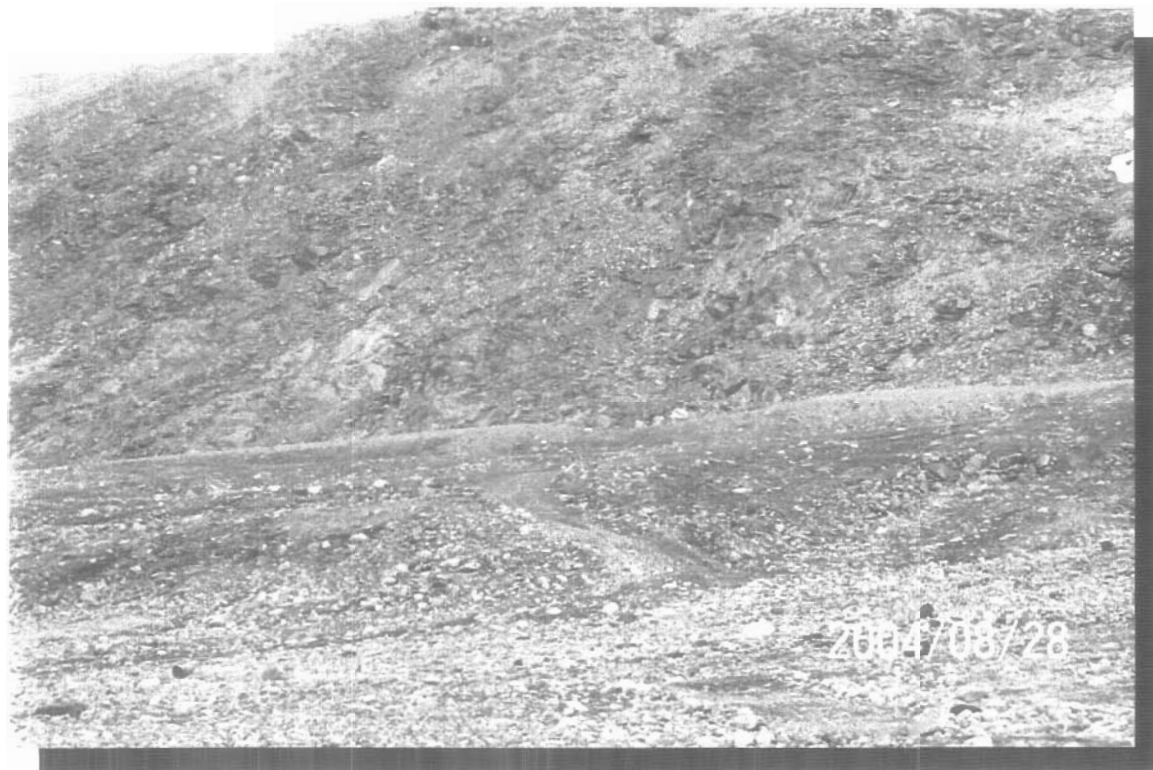
Photo 22
Proposed Borrow Area 1 looking north.
