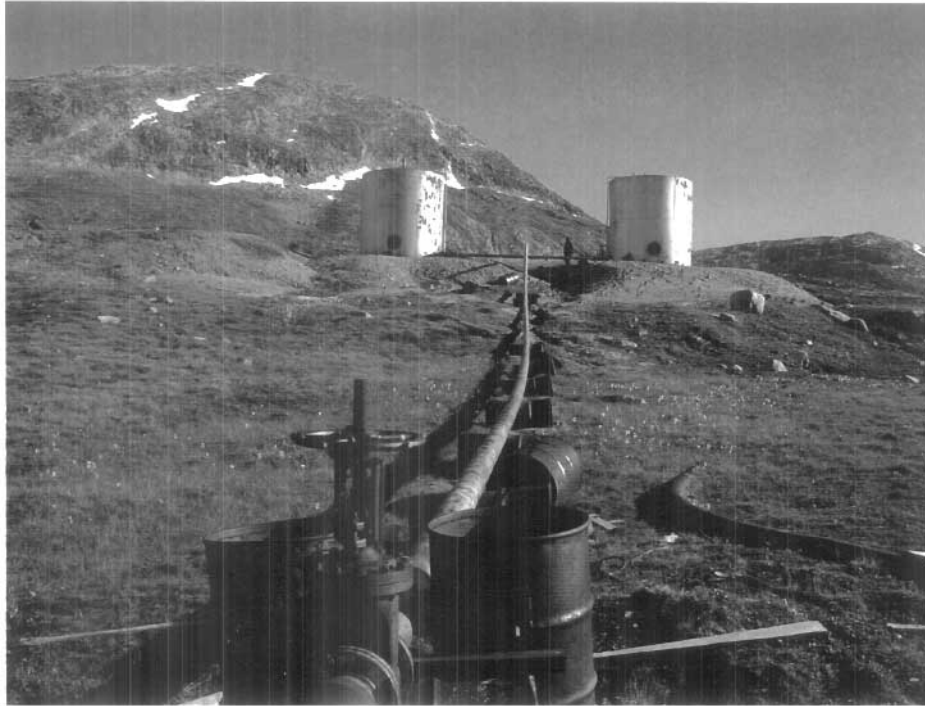
Photo 1 Beach Area POL tanks and pipeline, looking south

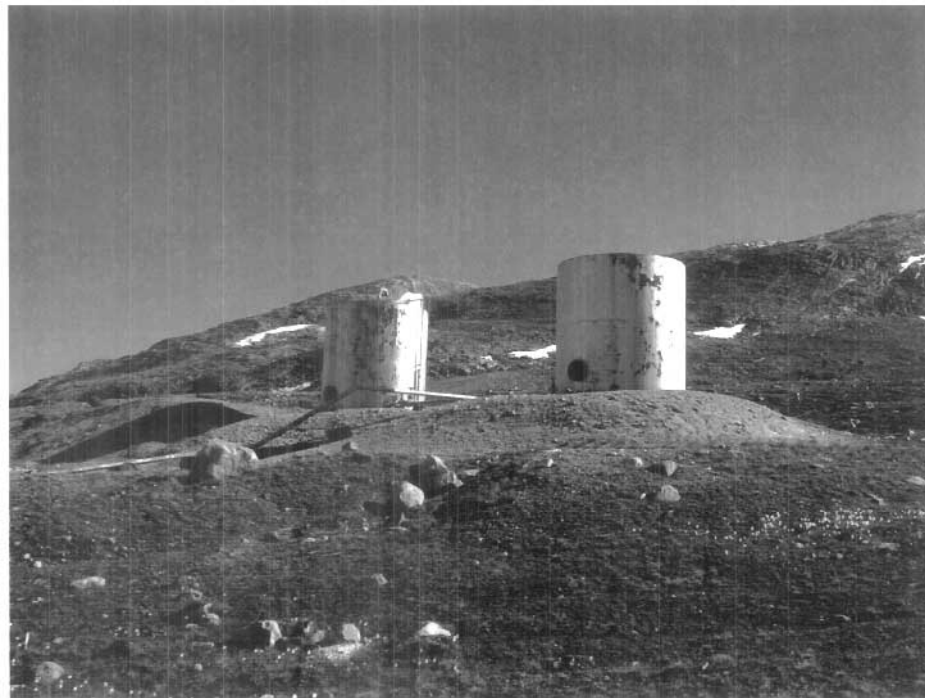
Photo 2 Beach Area POL tanks, looking southeast

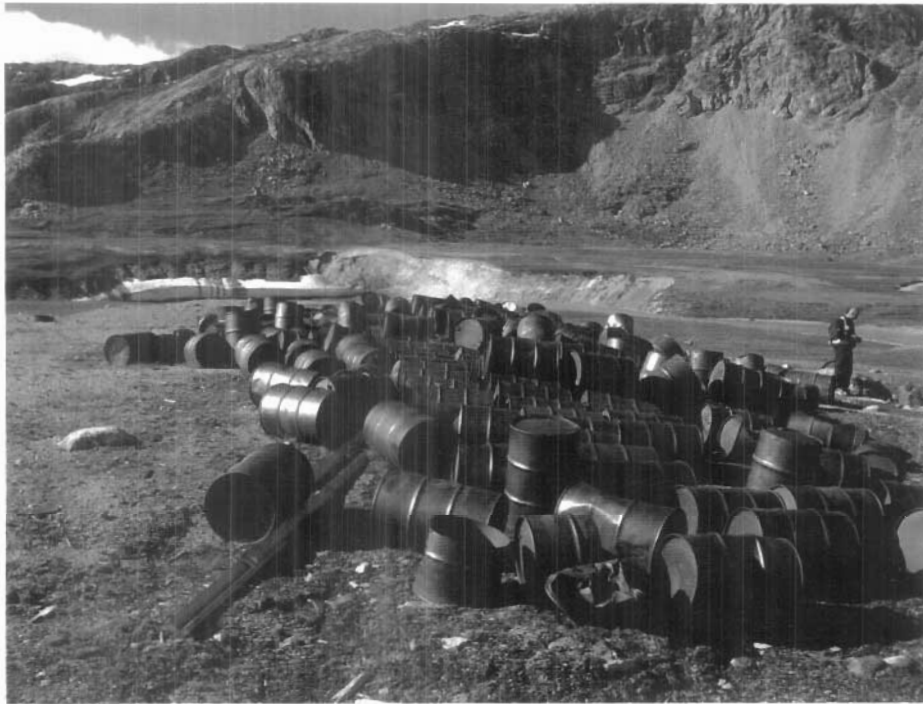
Photo 3 Barrel Dump #1, looking west

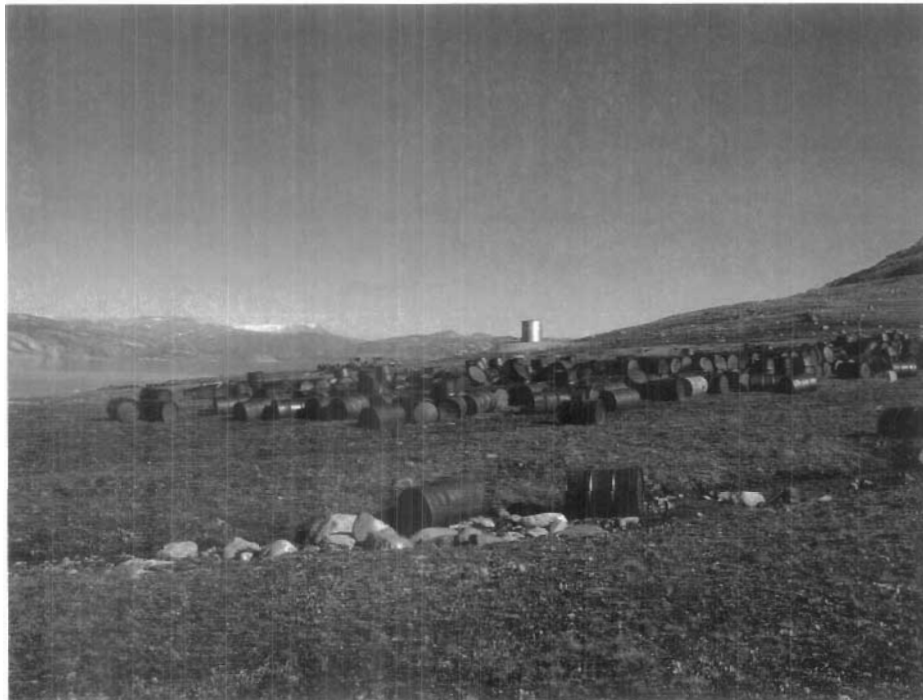
Photo 4 Barrel Dump #2, looking east

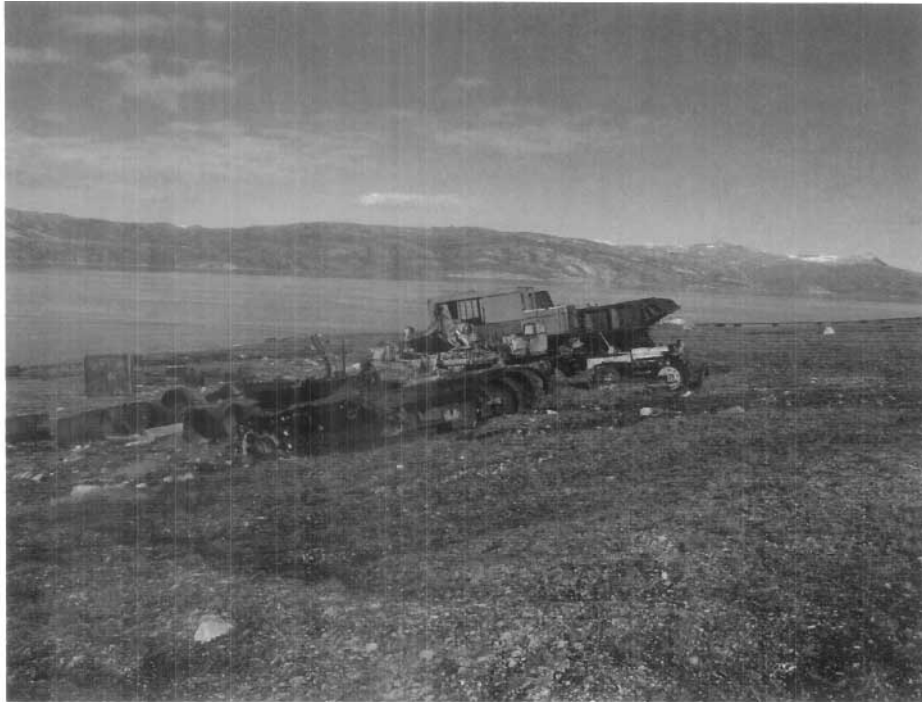
Photo 5 Beach area vehicle dump, looking northeast

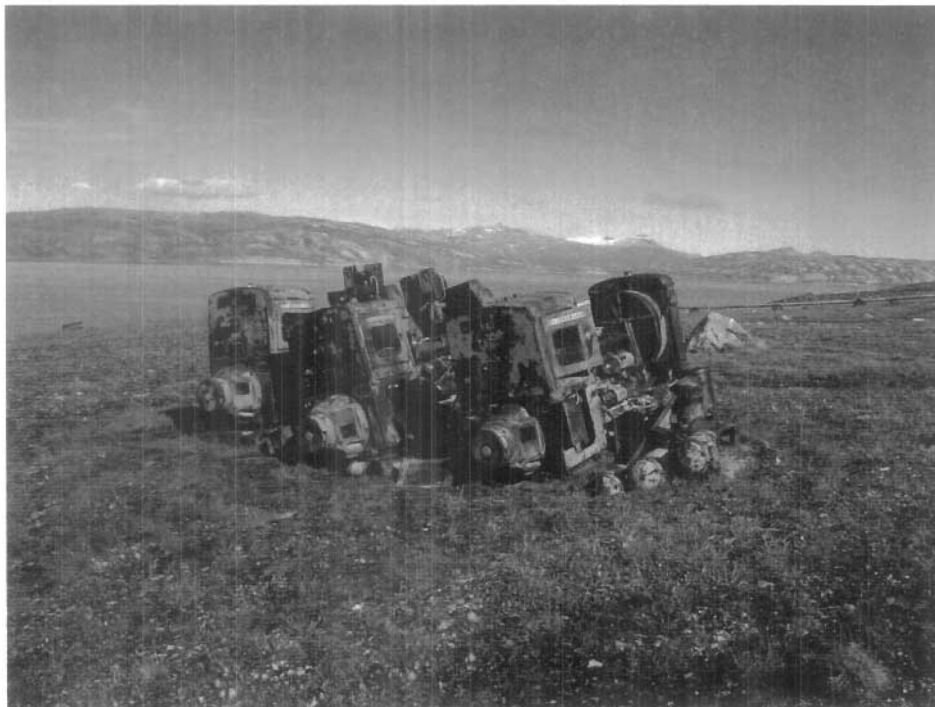
Photo 6 Beach area vehicle dump

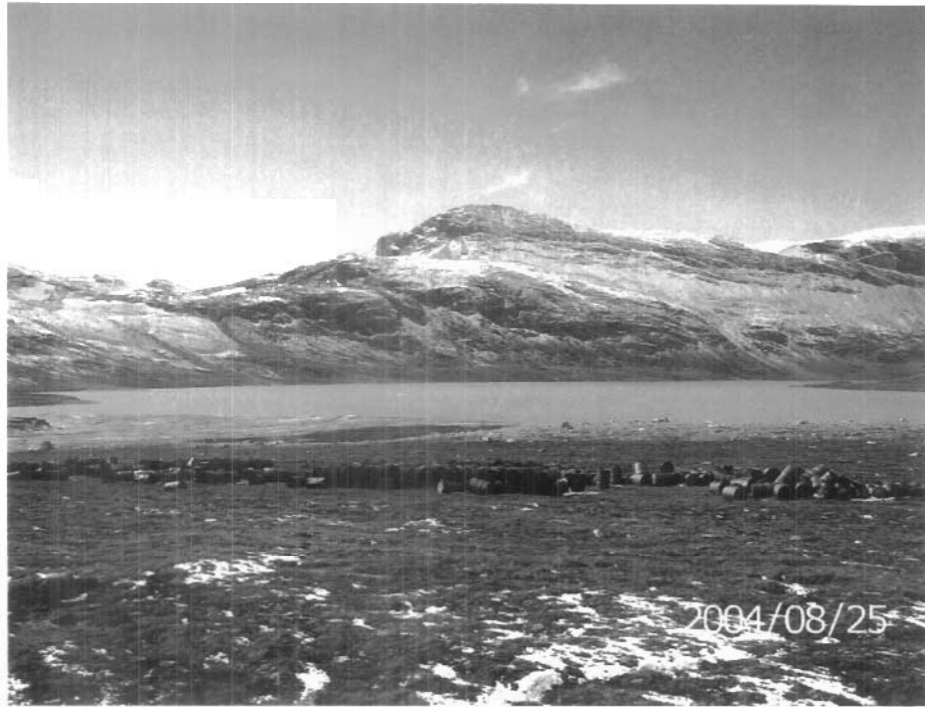
Barrel Dump # 1 consisted of approximately 250 empty barrels, a large amount of wood debris was also observed up gradient of the site. In 1994, RRMCC had collected one soil sample from this area. The recovered samples were all analyzed for metals and the data indicated that there were no exceedances above DCC or CCME residential/parkland criteria however, based on field observations it was estimated that there may be approximately 1,500 m³ of hydrocarbon impacted soils at this site.

The 2004 investigation at this site consisted of the installation of three testholes (WL-1001, WL-1002 and WL-1003). Two of the testholes were installed on the down gradient side of the site and one borehole was installed at the same location of the RRMCC sample location (#62) in order to confirm the depth of hydrocarbon levels at this location. Figure 4.0 shows the location of the boreholes at this site. An inspection of this site indicated no signs of distressed vegetation or surface staining around this barrel dump.

Table 3.1 presents a summary of the analytical data from the samples collected at this site. The analytical data indicated that all the hydrocarbons (BTEX and CWS F1-F4 fractions) were below detection limits or well below CCME criteria.

Photo 7 Water Lake barrel dump, looking southwest

Based on results from this investigation and from the metal analysis completed in the previous investigation, no additional investigation is recommended at this location. At the time the barrels are removed, it is recommended that the area be re-inspected to confirm if there is any residual hydrocarbon impacted soils located below the barrels that would require remedial action.

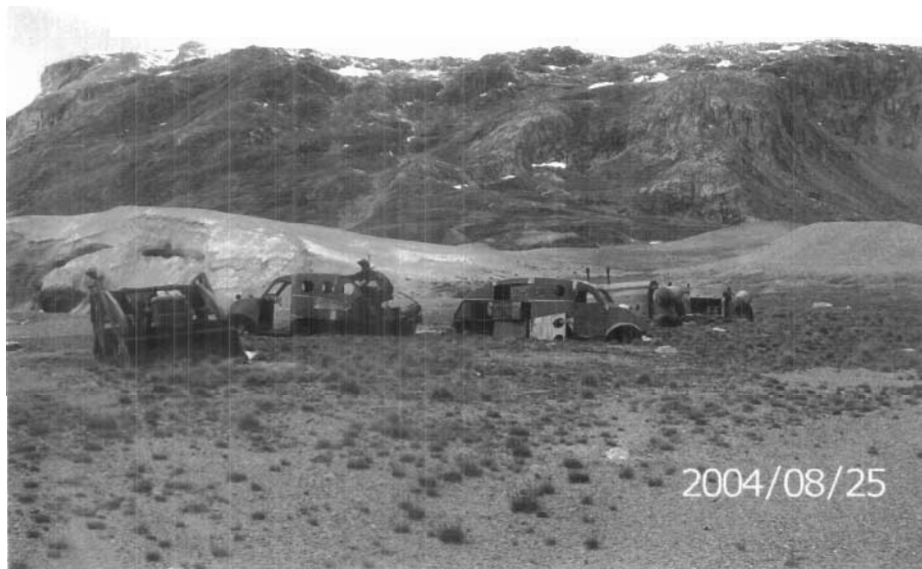
Photo 8 Water Lake vehicle dump, looking west

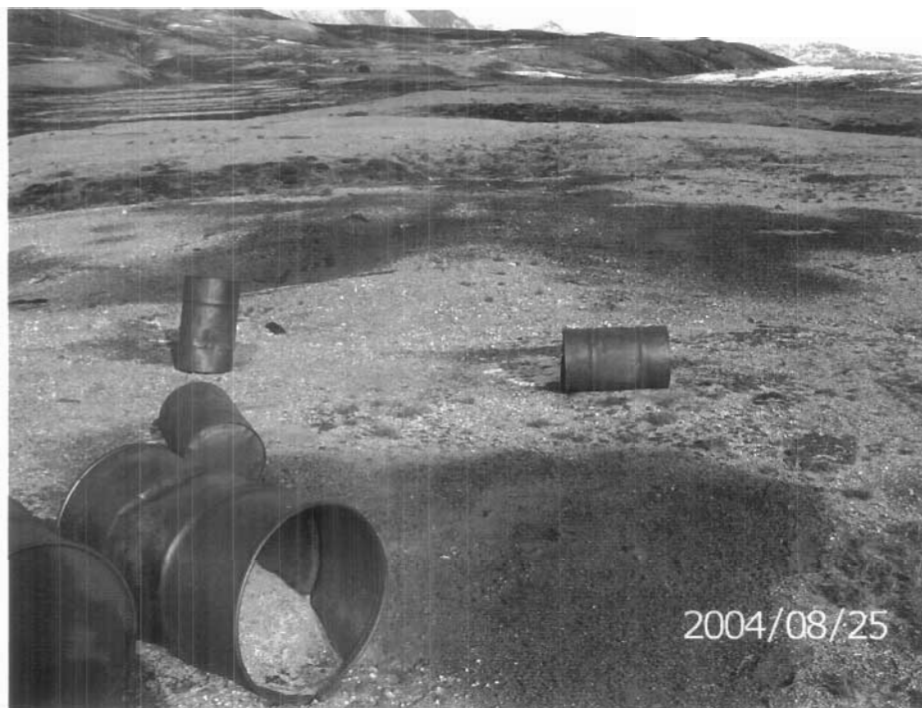
Photo 9 Surface stains near helicopter landing pad, looking north

In the area that was used as a helicopter landing pad in 2004, a number of surface stains, which covered an area of approximately 90 m², was observed. Photo 9 presents a photo of this area. Other waste debris in the area included, ten barrels, a wooden spool with large diameter cable as well as scattered wood debris. The site is located at the western edge of an outwash deposit that overlooks the lake. Stained areas were also observed in two adjacent drainage courses at the north and south end of the stain.

A summary of all the hydrocarbon analysis is presented in Table 3.1 in Appendix D. The analytical data indicated that elevated F3 concentrations (exceeding CCME criteria) were recorded down to a depth of 0.75 m in the center of the stain (Borehole WL-1005). Due to site conditions, Earth Tech was unable to collect soil samples at depths greater than 0.75 m with a hand auger. Delineation to the east and north was achieved from the data collected in WL-1004 and WL-1007. The F3 concentration in the soil sample collected from WL-1006 (depth 40-60 cm) was only slightly above criteria (838 ppm vs. 800 ppm). The maximum depth of excavation with a hand auger at this location was 0.6 m.

Based on the lateral extent of the stained area and a maximum depth of contamination of 75 cm. The volume of impacted soils in this area is estimated at 75 m³. However, this value should be considered as a rough estimate since the maximum depth of impacted soils was not confirmed in the hand excavated testholes.

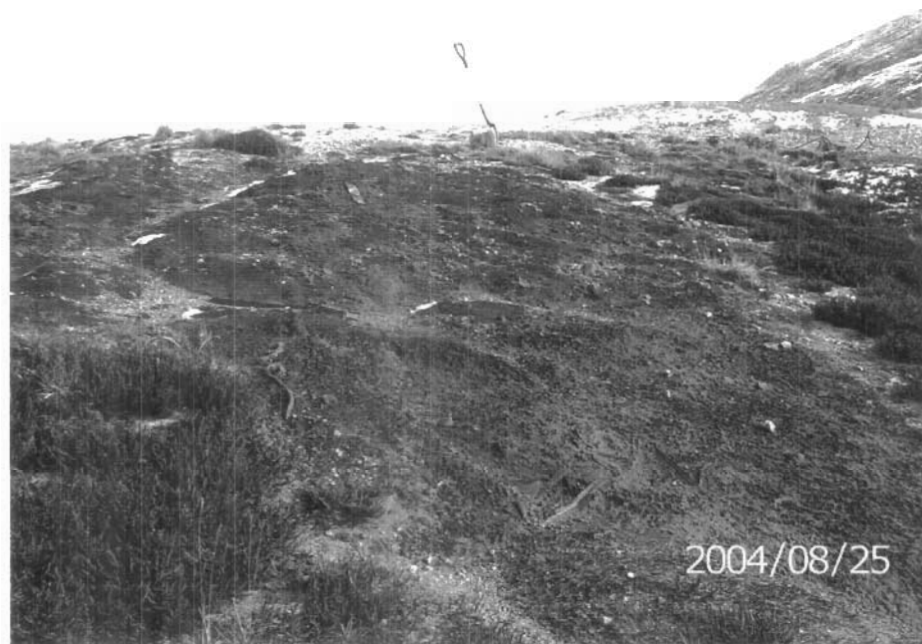
Photo 10 Surface stain in drainage course, north of helicopter landing pad, looking north

This stain covered an area of approximately 18 m² and was located on the side slope of an overland drainage channel leading off the outwash deposit. Oily rags and dead vegetation were also observed in the area. Photo 10 presents a photo of the stain. One borehole was excavated (WL-1008) at this site. One surface soil sample was collected and analyzed for BTEX, F1-F4 fractions as well as PCBs. Tables 3.1 and 3.3 present a summary of the analytical data from this borehole. The analytical data indicated both the F3 and F4 fractions exceeded the CCME criteria at this location. A second soil sample was collected at a depth of 0.3 m and screened in the field with a Petro Flag kit. The analysis for total petroleum hydrocarbon with this kit indicated a TPH concentration less than 50 ppm. Due to the low concentration for TPH, no additional hydrocarbon investigation was completed at this site.

Based on the results of this investigation, a volume of 6 m³ of hydrocarbon impacted soils has been estimated at this site.

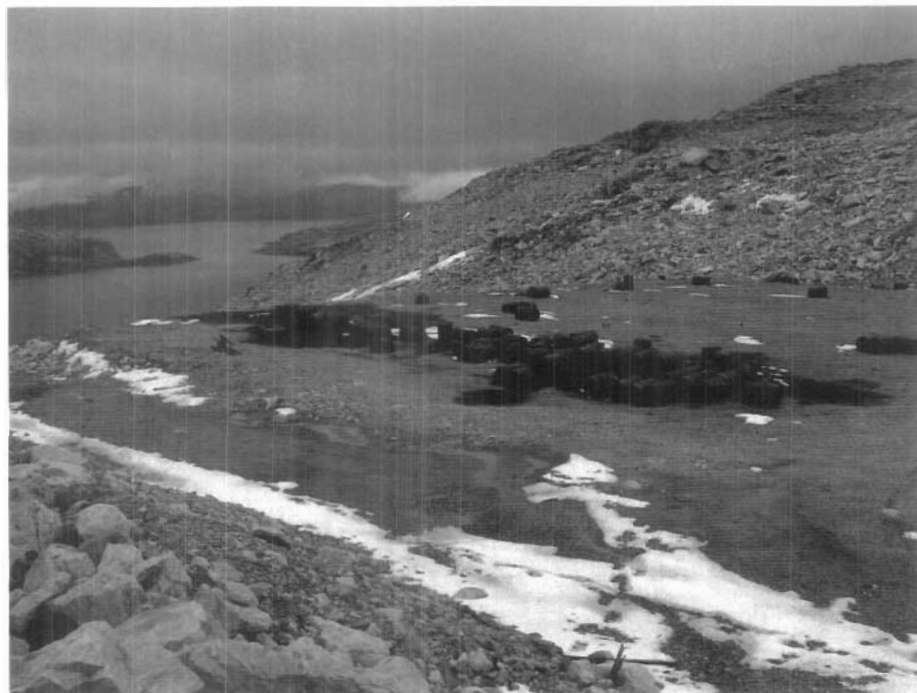
This pad area, which has approximate dimensions of 50 m x 50 m, was constructed by leveling the area and bridging over the voids in the boulders with smaller sized rock and gravel. There was approximately 0.15 m of sand material used as the surface material. Due to the sizes of the voids between the boulders, the bridging has subsided in some locations, leaving deep cavities in the pad surface. Black staining was also observed to be present in some of the voids located below the pad.

The analytical results indicated that there was an exceedance above CCME criteria for the F3 and F4 hydrocarbon fractions in the area where the barrels had been burned (MS-1086) and an exceedance for F3 at the north edge of the pad (MS-1080). The PAH analysis indicated that there was an exceedance above CCME residential criteria for phenanthrene (6.54 ppm vs. 5 ppm).

Assuming that there is a layer of accessible fine grained material with a thickness of 15 cm and the impacted material is confined to the stained area, the volume of hydrocarbon impacted soils in this area is approximately 75 m³. However, due to the presence of large boulder sized rocks and the small amount of fine grained material within the stained area, remediation of all the impacted material is difficult to impracticable due to the difficulty in removing contaminants from around the rock material.

Photo 12 Staining at barrel storage area, looking northeast

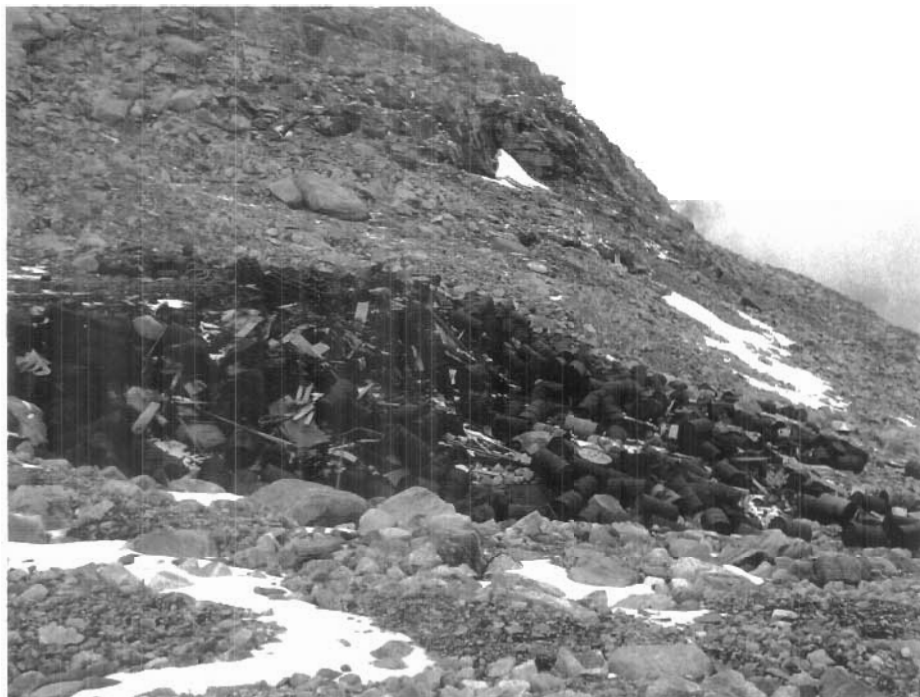
dishes, pots, cloth), used vehicle and heavy equipment parts, various types of filters, and batteries. The dumpsite was situated on a 20° slope (determined from vertical survey data). It should be noted that the material at the toe end of the dumpsite mainly consisted of scattered metal (barrels) and wood debris on the ground surface and the footprint of dumped materials was estimated at approximately 600 m². Approximately 75 m beyond the toe end of the dump, the slope dramatically increased and became a cliff. A number of barrels were noticed at the bottom of this cliff.

Photo 13 Waste materials at dumpsite, looking north

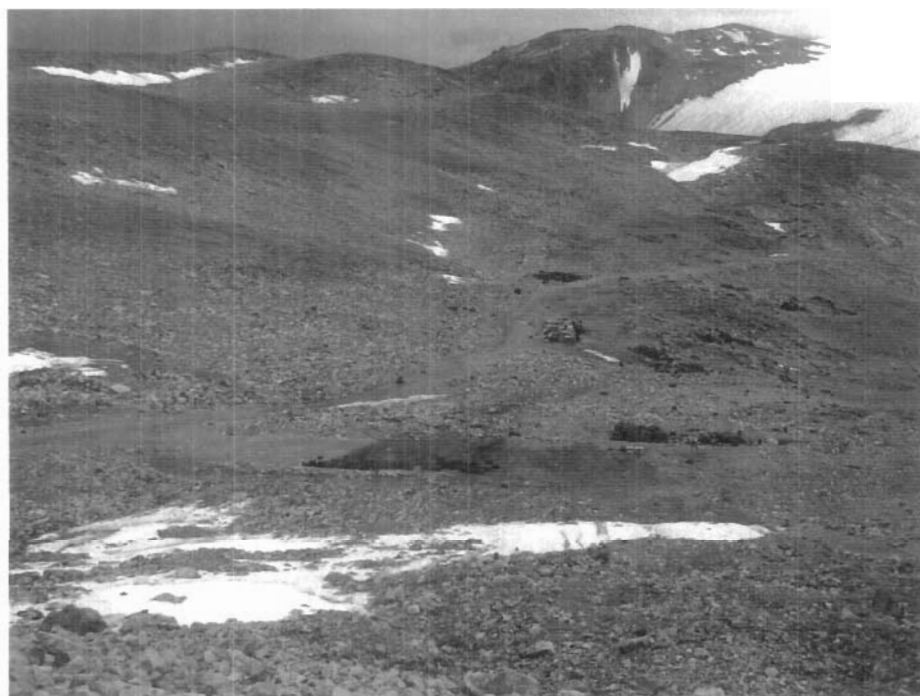
Photo 14 Staining below Barrel Dump #2, looking south

Barrel Dump #2 consists of approximately 120 barrels, which were labeled as containing lubricating oil. These barrels are located in a storage area that is located off the main road. This storage area had been leveled and surfaced with a gravel/sand material. Large boulders and cobble sized material surrounded the site. Some of the barrels were partially full and evidence indicated that the barrels were split open while they were stockpiled at this location. Viewed from above, a large stain was visible on the down gradient side of the barrels and extended down the mountain for a considerable distance. Aerial photos showing the staining at this site are presented in Photo 14 and Photo 15 shows one of the split opened barrels.

Soil samples were typically recovered at depths ranging from the ground surface to a maximum depth of 10 cm and in areas where fine and coarse weathered material had accumulated (typically in seasonal drainage courses). The majority of the stained material was located around and below large sized rocks. Due to the size of the rock material that is located below the ruptured barrels, it is possible that a large percentage of the released oil has migrated vertically downwards until it reached bedrock material. The

Table 8.1 in Appendix D presents a summary of the analytical data from this site. As indicated in analytical summary table, exceedances for the hydrocarbon fraction F3 and F4 were recorded adjacent to the barrels extending in an area approximately 90 m down gradient of the site. Determination of the down gradient extent of hydrocarbon contamination was not achieved.

Based on the area observed to be stained in the aerial photos the stained area may cover an area of approximately 1,600 m². Calculation of the volume of impacted material is difficult due to the lack of soil media within the contaminant plume, remediation of the impacted material is also difficult to impracticable due to the difficulty in removing contaminants from around the rock material. Based on observations, there is approximately 50 m³ of accessible granular material located around the base of the barrels. It is recommended that this material be removed since it continues to be a source for future down gradient contamination.

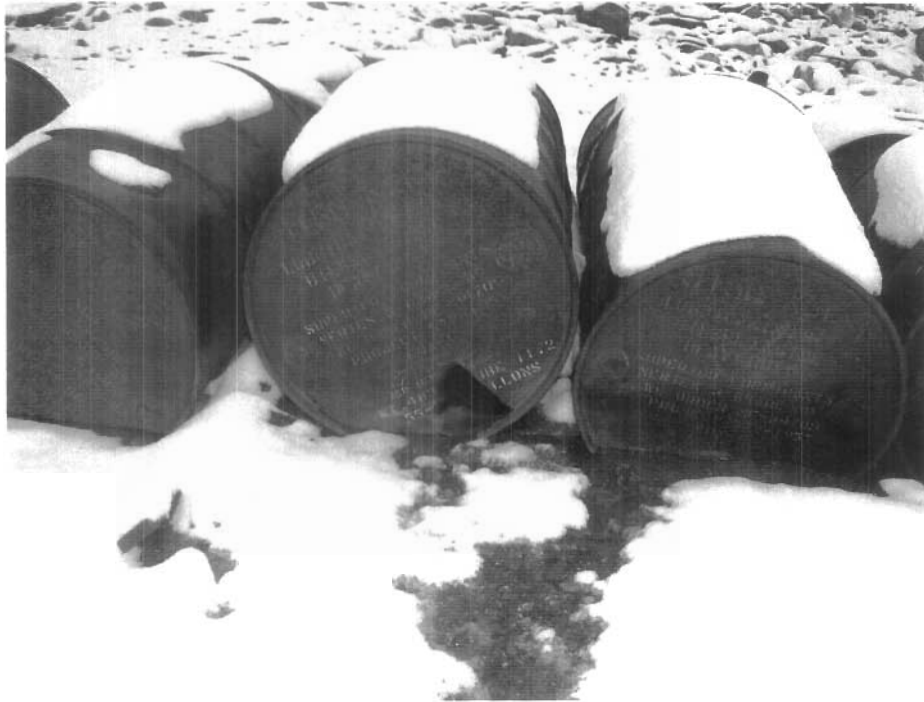
Photo 15 Split open lubricating oil barrel, Barrel Dump #2

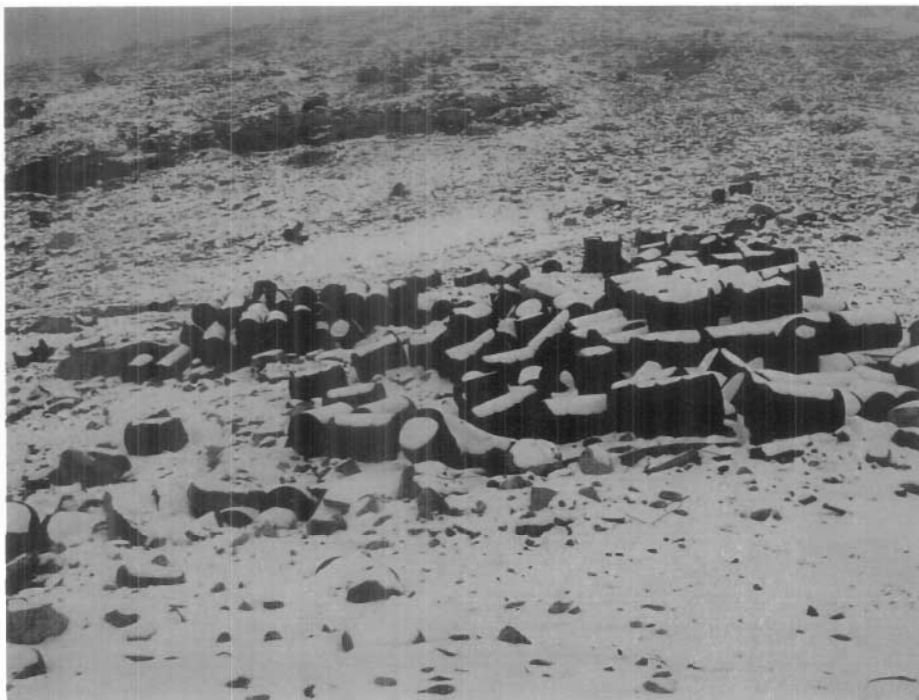
Photo 16 Barrel Dump #4, looking west

Barrel Dump #4 consists of approximately 200 empty barrels located on the south side of the remains of Quonset Hut #1. Waste debris is scattered around the hut as well as amongst the barrel piles (see Photos 16 and 17). In order to confirm that there was no residual hydrocarbon contamination within the confines of the barrel dump and immediately down gradient of the barrels, three grab samples were collected and analyzed for hydrocarbons. One sample from MS-1091 was also analyzed for PCBs. Tables 8.1 and 8.3 presents a summary of the analytical data from the three samples collected from barrel dump #4. The three samples (MS-1091, MS-1092, and MS-1093) were collected between the ground surface and a depth of 10 cm in an area where fine materials had accumulated. The analysis indicated that the BTEX concentrations were below detectable levels. The F1-F4 fractions were detectable however they were also below the applicable CCME residential/parkland remediation criteria. It should be noted that the F3 fraction in the sample collected from MS-1091 was close to the CCME generic guideline (726 ppm vs. 800 ppm). The PCB concentration in the sample collected from MS-1091 was below laboratory detection limits.

Based on results from this investigation and from the metal analysis completed in the previous investigation, no additional investigation is recommended at this location. At the time the barrels are removed, it is recommended that the area be re-inspected to confirm if there is any residual hydrocarbon impacted soils located below the barrels.

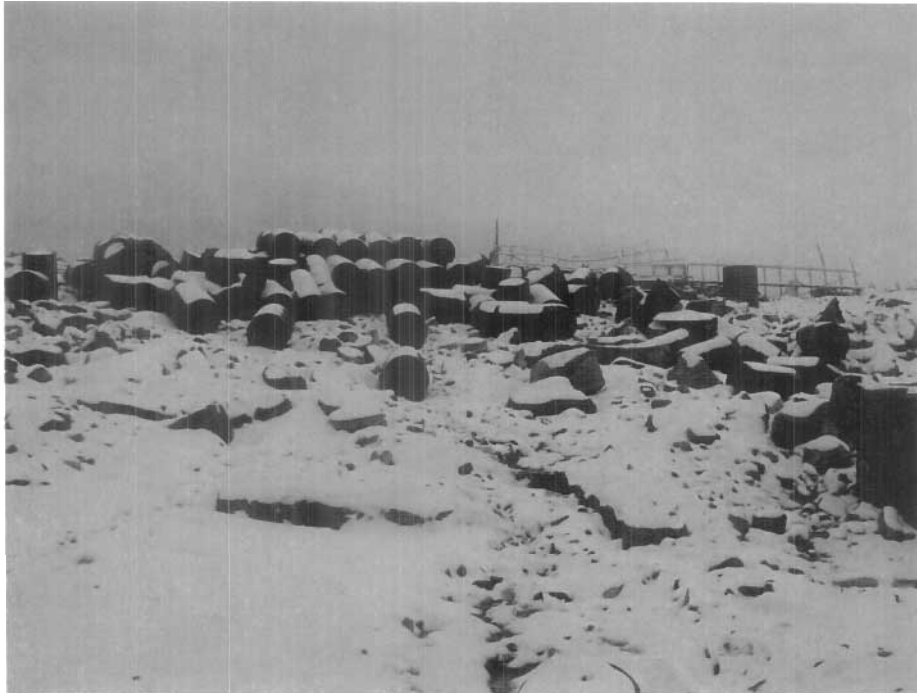
Photo 17 Barrels and debris around Quonset Hut #1

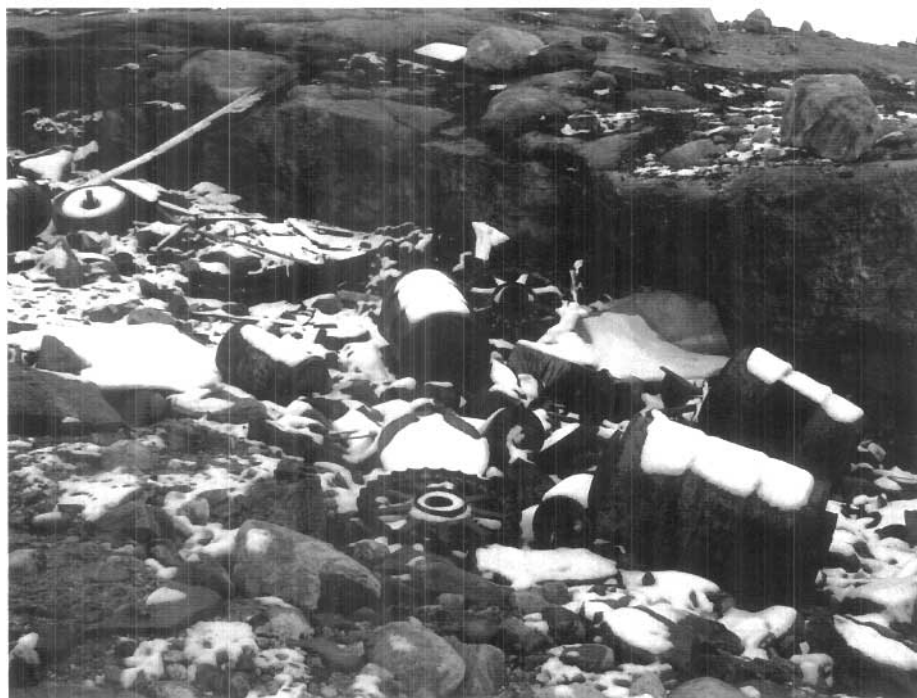
Photo 18 Staining and debris at Barrel Dump #6

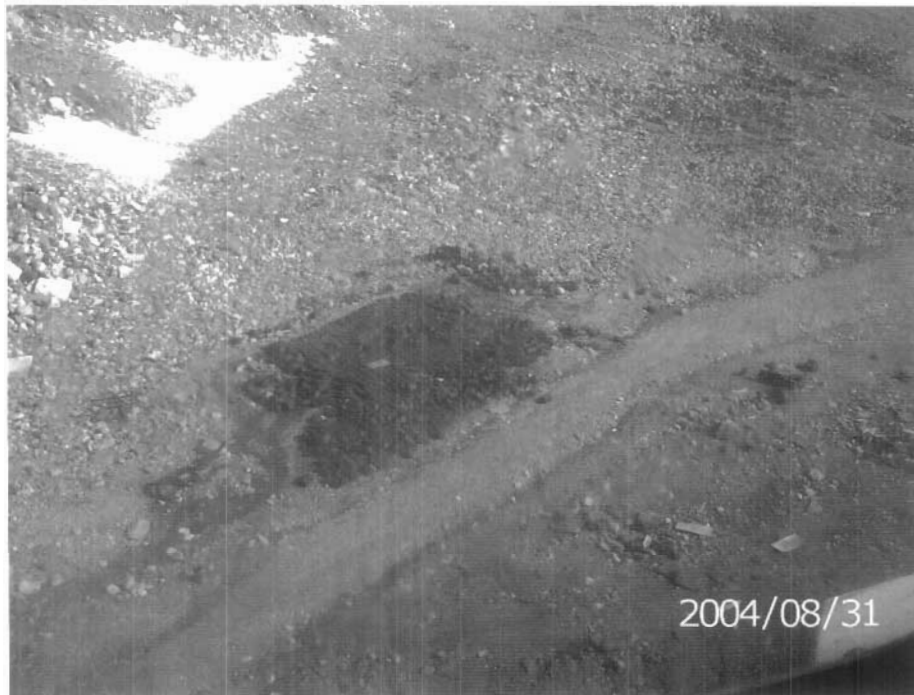
Photo 19 Barrel Dump #5 across from Quonset huts

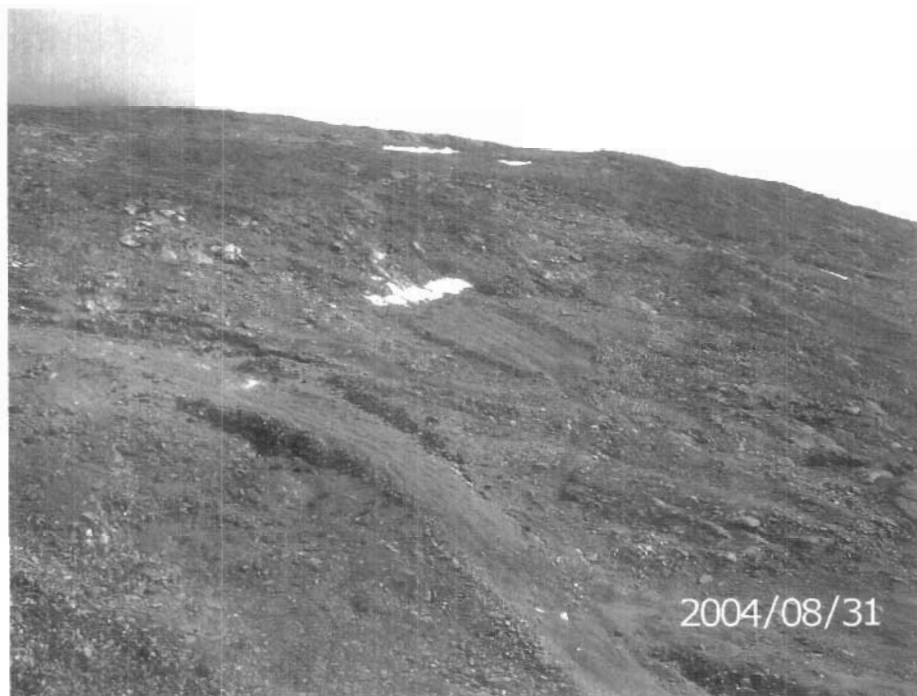
Photo 20 Barrel Dump #7
