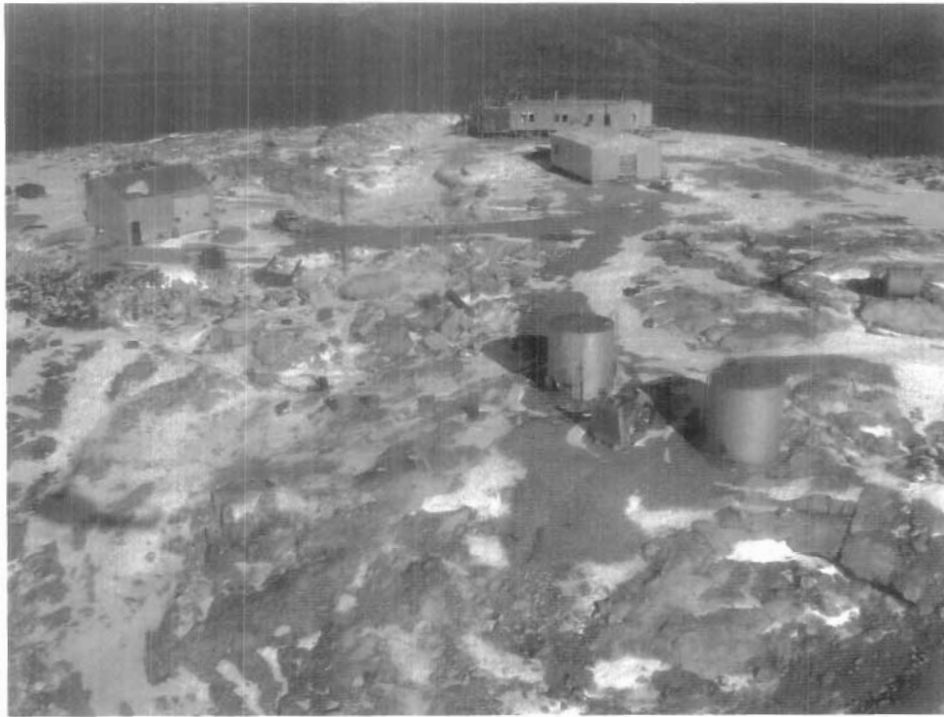
Photo 21 FOX- C Upper Station

Access to the summit was achieved with the construction of a road located on the southern and eastern sides of the mountain. Facilities of the Upper Station area included the modular train, warehouse, garage, POL storage facility, barrel storage areas, antenna remains as well as the remains of several buildings (Quonset style house, paint shed and Inuit house). Large amounts of waste debris, including vehicles, barrels, and misc. metal and wood pieces are scattered around the summit. Figure 6.0 and Photo 21 presents the layout and features of the Upper site.

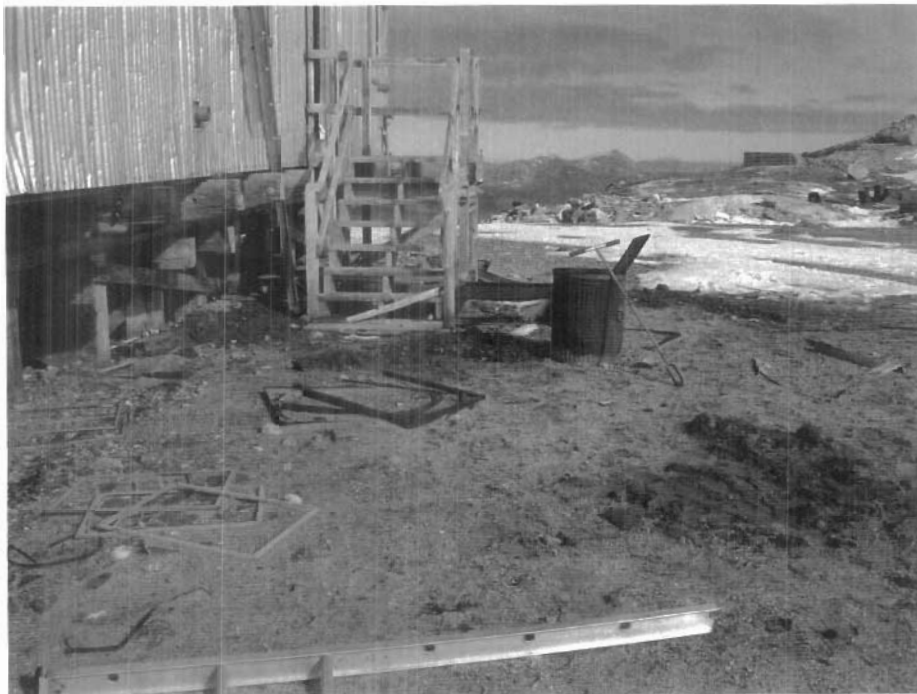
Photo 22 PCB impacted area on south side of Module Train

The previous investigation identified PCB contamination in the vicinity of the staircase on the south side of the train. This location was labeled as RRMC #3 and had a recorded PCB concentration of 5.6 ppm (highest level recorded in 1994 investigation and only exceedance above DCC Tier 2 criteria for PCBs). This site was partially delineated with sample locations RRMC # 2 (PCB <1 ppm) and RRMC #4 (PCB <1 ppm). Figure 6.1 and Photo 22 show the location of this site.

The scope of work for the 2004 investigation included the excavation of three testpits around the site and one testpit (US-1037) adjacent to sample location RRMC #3 in order to confirm the maximum depth of PCB contamination. The four testpits advanced in this investigation were labeled US-1034 through US-1037. The analytical results from this investigation program are summarized in Table 9.1. This data indicates that all PCB levels in the delineating boreholes were less than detection limits.

Based on the information obtained in this investigation it is assumed that the maximum depth of PCBs in the vicinity of RRMC #3 sample point is less than 0.45 m (sample depth of US-1037) and the volume of PCB contaminated soils is approximately 7 m<sup>3</sup>.

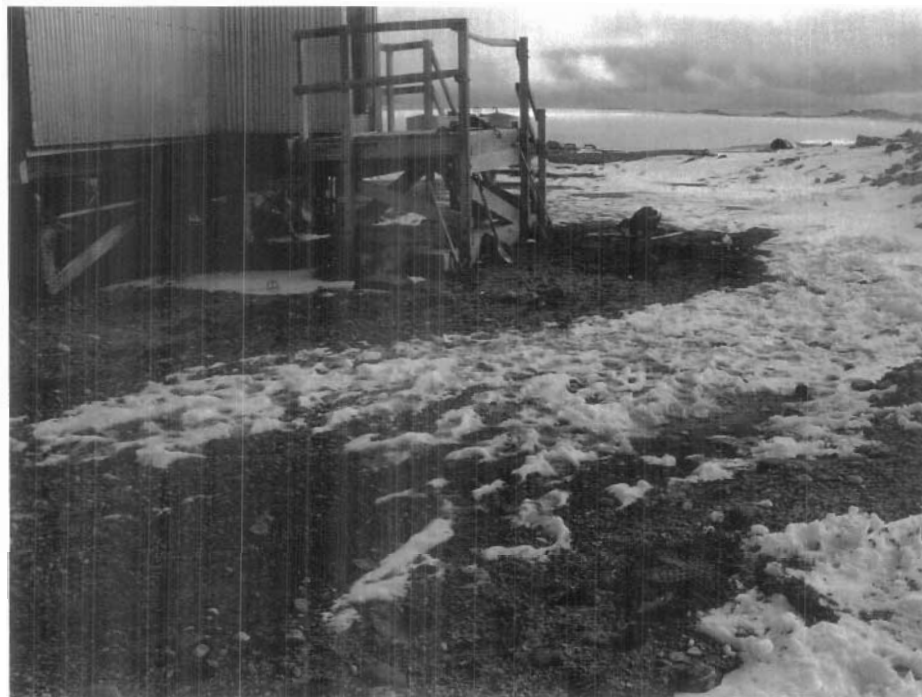
The 1994 investigation identified elevated zinc levels (316 ppm) in soils in an area off the west end of the modular train. The recorded zinc levels were below DCC Tier 2 criteria. This location was labeled as RRMC #5. Figure 6.1 and Photo 23 show the location of this site.

investigation program are summarized in Tables 9.1 – 9.3. The recovered soils samples were analyzed for metals and due to the presence of a hydrocarbon odor the soil samples were also analyzed for PCBs and hydrocarbons. This data indicates that all metal concentrations (including zinc) were below DCC and CCME residential criteria. All PCB levels in the delineating boreholes were less than detection limits. Hydrocarbon analysis indicated that there were exceedances for hydrocarbons in US-1038 (F2 and F3), US-1040 (F2 and F3) and US-1041 (F2).

Based on the results of this investigation program it appears that the elevated zinc levels in soil determined in the previous investigation are contained to material located on the ground surface. Based on the placement of the testpits, the hydrocarbon contamination plume covers an area of at least 25 m<sup>2</sup>. Vertical delineation of the hydrocarbon contamination could not be achieved due to the presence of frozen materials. However, assuming that the fill in this area is approximately 0.45 m thick and the hydrocarbon impacted material covers an area of 30 m<sup>2</sup>, there may be approximately 14 m<sup>3</sup> of hydrocarbon impacted soils in this area.

Photo 23 Metal impacted at west end of Modular Train

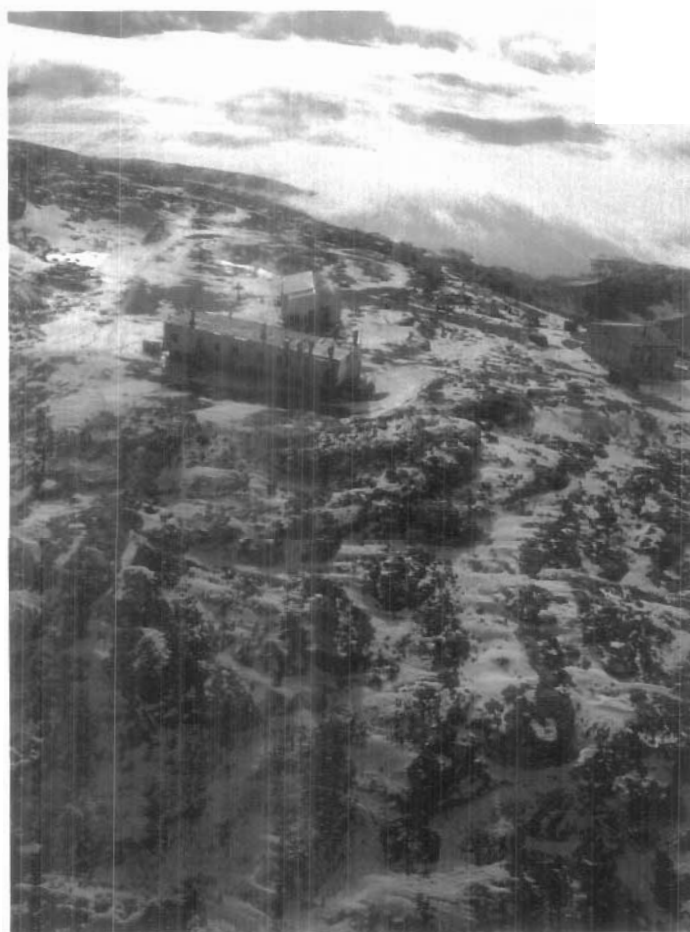
Located on the north side of the modular train is the sewage outfall as well as an area that was previously referenced as a dump. This portion of the summit consists of a number of steps, which drop in elevation prior to becoming a steep cliff (approximately) 60 – 80 m north of the modular train. The sewage outfall area extended from the end of the sewer discharge line down the north mountain face. Pieces of the drain line are visible, however the original alignment and the discharge end of the sewer line are unknown. Due to the site conditions and the amount of snow at the time of the 2004 investigation, the identification of surface stained areas as well as the location of the previous sample points was difficult. Photos 24, 25 and 26 show the sewage outfall and dump area.

Photo 24 Discharge area of sewage outfall

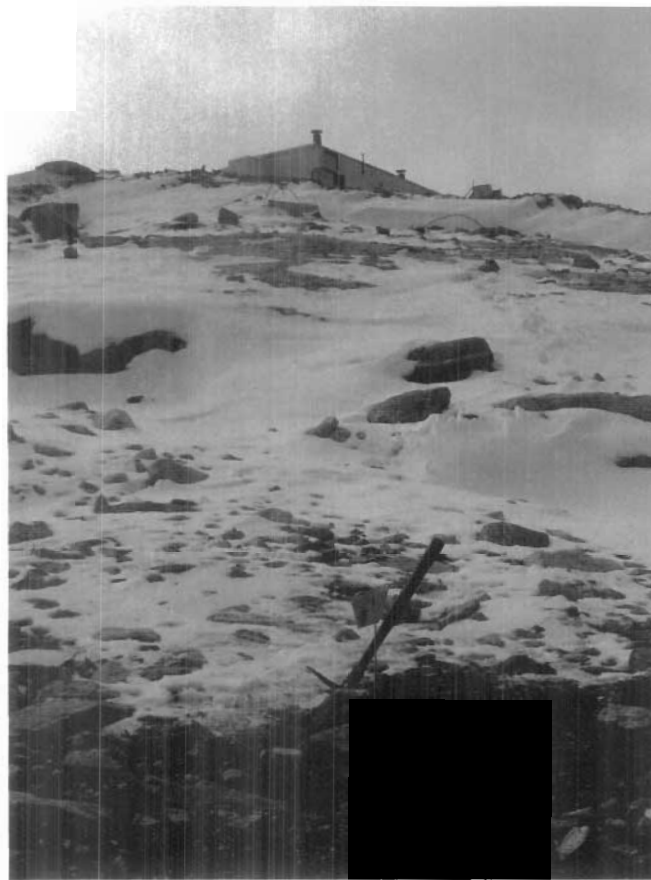
Photo 25 Sample location US-1028 below sewage outfall

A summary of the analytical data is presented in Table 10.1, 10.2 and 10.3 in Appendix D. The analytical data indicates that delineation of the metal and PCB contamination was achieved in all areas of the study area except PCBs in Testpit US-1028. The analytical data, indicated this sample had a PCB concentration of 2.2 ppm and a F3 concentration of 1050 ppm, both of which exceeded the respective DCC Tier 1 and CCME remediation criteria. Testpit US-1028 is located approximately 80 m northeast of the outfall area (Photo 25). Delineation down gradient of US-1028 is achieved with US-1026. Metals, hydrocarbons and PCBs were all below DCC and CCME criteria in this testpit.

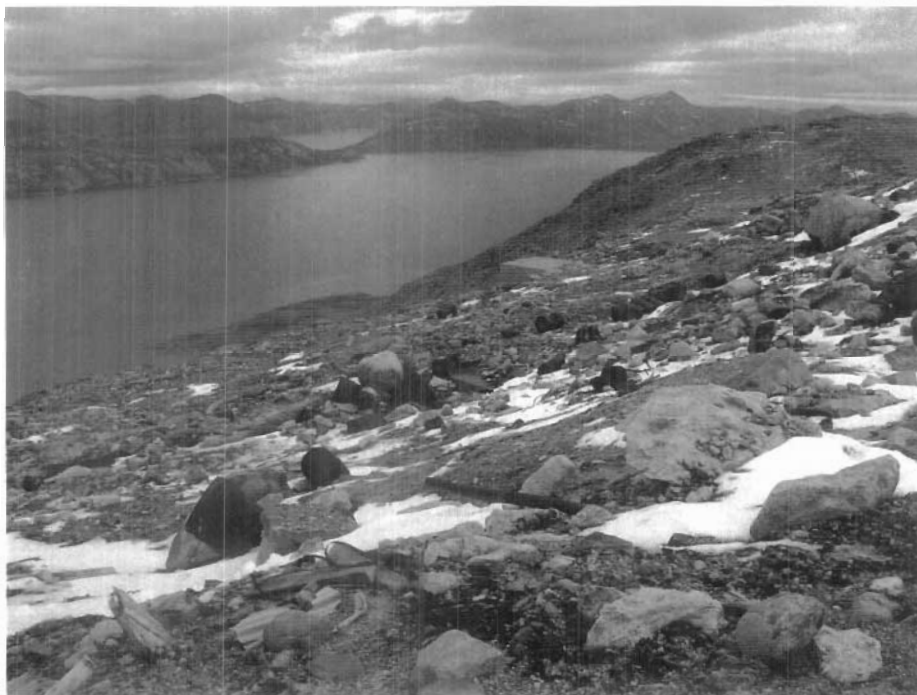
An inspection of the north side of the mountain indicated that the dump consisted of occasional piles of scattered debris over the northern slope. The debris consisted of piles of filters, barrels, strapping, cable, wire, wooden crates and assorted steel pieces. One partially filled and leaking barrel was also located at the location of RRMC flag #10. Located in the vicinity of the barrel was a narrow (0.6 m wide ribbon of staining which followed a natural drainage pathway down the mountain face. Field observations indicated that this drainage pathway originated higher up on the mountain and it potentially may have received runoff from the sewer outfall. Due to the terrain on this site of the mountain there were a number of natural pathways, which lead to areas down gradient. Various amounts of sand and gravel material (depths between 0.1 to 0.5 m) were located in the drainage pathways as well as along portions of the rock faces. Surface water was not observed on the north face of the mountain in 2004.

Photo 26 Scattered debris in outfall dump area

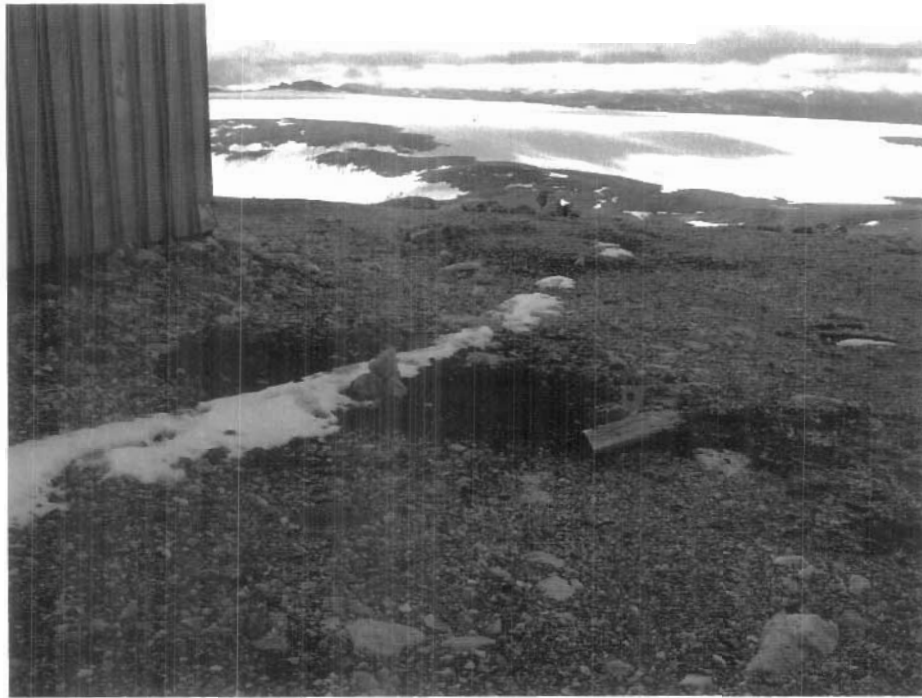
Located 2 m west of the Garage is a surface stain that covers an area of approximately 2 m x 2.5 m (5 m<sup>2</sup>). This site is presented in Figure 6.2 and in Photo 27. The analysis of a surface sample (RRMC tag #22) from this stain in 1994, determined that there was PCB and metal exceedances above CCME residential criteria. The PCB concentration was 3.8 ppm and there were elevated metal concentrations for chromium, lead and zinc. One testpit was hand excavated at this site in 2004 (US-1075) in an area close to the previous sample point. The maximum depth of excavation in this testpit was limited to 0.20 m due to the presence of solid rock below that depth. One soil sample was recovered between the depths of 0.15 m to 0.20 m and was analyzed for hydrocarbons, PCBs and metals.

Due to the concentrations of PCBs in the sample analyzed, it appears that the contamination in this area is confined to the near surface levels and is less than DCC Tier 2 criteria. Based on the size of the surface stain and the maximum depth of fill in this location, there is approximately 1 m<sup>3</sup> of PCB contaminated material at this location.

Photo 27 PCB impacted area west of Garage

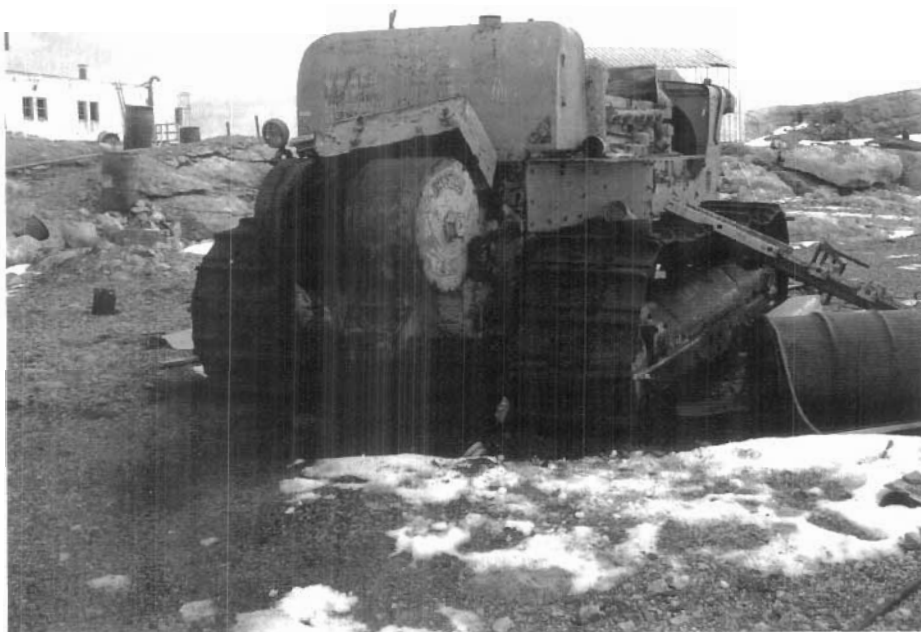
Located northwest of the Garage is a D8 Cat, below the cat is a surface stain that covers an area of approximately 4 m x 4 m (16 m<sup>2</sup>). This stain appeared to be originating from liquids dripping out of the back end of the cat. The previous environmental investigation did not include any investigation in this stain area. This site is presented in Figure 6.2 and in Photo 28.

The 2004 investigation included the excavation of one testpit (US-1076) in this stain to determine hydrocarbon concentrations in the granular material located on top of the underlying rock. Two soil samples were analyzed from this testpit. One sample was collected from a depth of 0-15 cm and the second was collected at a depth of 20 cm. The analytical data presented in Table 11.2 indicates that there were exceedances above the CCME criteria for the F2 (6540 ppm) and F3 (15600) ppm in the sample collected at a depth of 0-15 cm and there were no hydrocarbon exceedances from the sample collected at 20 cm. Based on the scope of work completed at this stain and the depth of fill materials in this area, there is approximately 4 m<sup>3</sup> of hydrocarbon contaminated material in this area.

Photo 28 Stain below D8 Cat, west of Garage

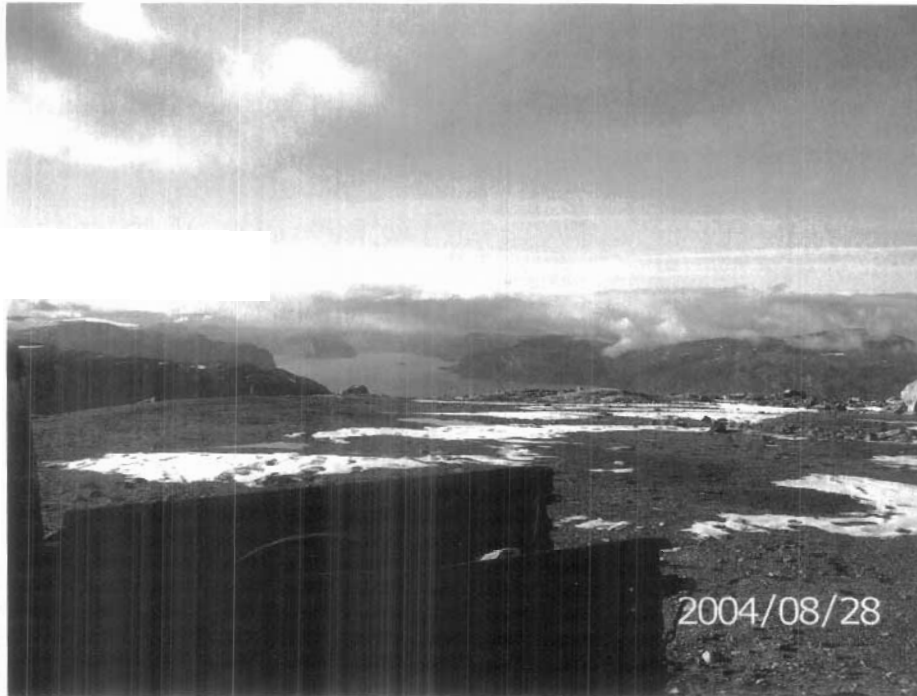
Located west of two portable fuel tanks and a truck, on the west side of the garage is a level pad with a sandy gravel surface. A light stain was visible on the surface of this pad. This pad has approximate dimensions of 14 m x 40 m. and the stained area covered approximately 60% of this area. This site is presented in Figure 6.2 and in Photo 29.

Photo 29 Staining on gravel pad west of Garage

These two samples were submitted for hydrocarbon analysis. Table 11.2 presents a summary of the data from sample US-1071. The data indicates that there were no exceedances in the sample collected at a depth of 0.2 m however, there was a F3 exceedance (1210 ppm vs. criteria of 800) in the sample collected at a depth of 0.5 m. Due to the small amount of evidence in the field which indicated hydrocarbon contamination at this site, no additional boreholes were installed around the perimeter of the pad area. Assuming that there is a layer of hydrocarbon impacted material between the depths of 0.5 m and 0.75 m over the entire area of the pad, there may be approximately 140 m<sup>3</sup> of material, which exceeds CCME residential criteria for the F3 hydrocarbon fraction, in this area.

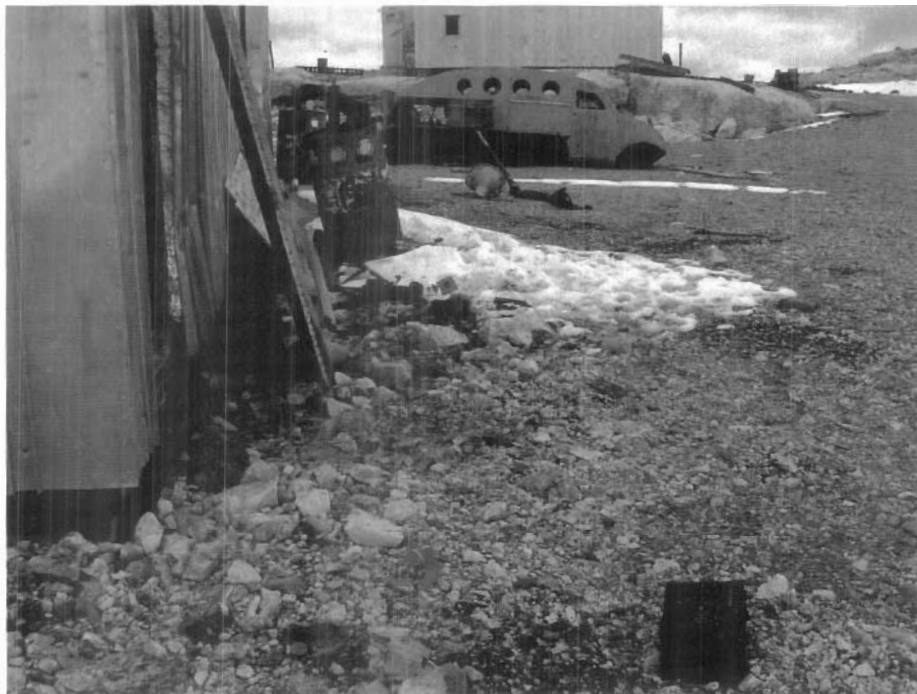
Photo 30 PCB and metal impacted area, east of Garage

The previous investigation identified a surface stain approximately 16 m<sup>2</sup> in size on the east side of the Garage. The stain was located between the man door and the overhead door on the east side of the garage. One soil sample, RRMC flag #21, was collected from this area and was analyzed for PCBs and metals. The PCB concentration was determined to be 3.6 ppm and the metals that exceeded DCC Tier 2 criteria included copper, lead and zinc. This site is presented in Figure 6.2 and in Photo 30.

At the time of the 2004 investigation, the previously identified 16 m<sup>2</sup> size stain was not apparent in this area however, a black stain approximately 8 m<sup>2</sup> was visible along the garage wall and a second stain <2 m<sup>2</sup> in size was visible off the northeast corner of the garage. The scope of work in the 2004 investigation included the excavation of four testpits at this site in order to delineate subsurface contamination. One of the testpits was excavated adjacent to RRMC flag #21 (US-1079) in order to determine the vertical extent of contamination and three testpits (US-1050, US-1078 and US-1079) were excavated to delineate the horizontal extent.

Tables 11.1 and 11.2 present a summary of the PCB and hydrocarbon analysis from this location. The analysis of the sample from US-1079 indicated that the maximum depth of PCB contamination was less than 0.3 m and was delineated horizontally in testpits, US-1050 and US-1078. An exceedance of the DCC Tier 1 criteria of 1.3 ppm was detected in US-1079 (1.7 ppm) therefore PCB delineation to the north was not achieved. Hydrocarbon contamination (F3) exceeding CCME criteria was detected in all boreholes, except for US-1050. Figure 6.2 shows the approximate extent of the PCB and hydrocarbon contaminant plume in this area. Based on the position of the boreholes, the PCB and hydrocarbon plume covers an area of approximately 40 m<sup>2</sup>, assuming a maximum depth of contamination at 0.2 m, there is at least 8 m<sup>3</sup> of PCB (DCC Tier 1) and metals (DCC Tier 2) and hydrocarbon impacted material at this site.

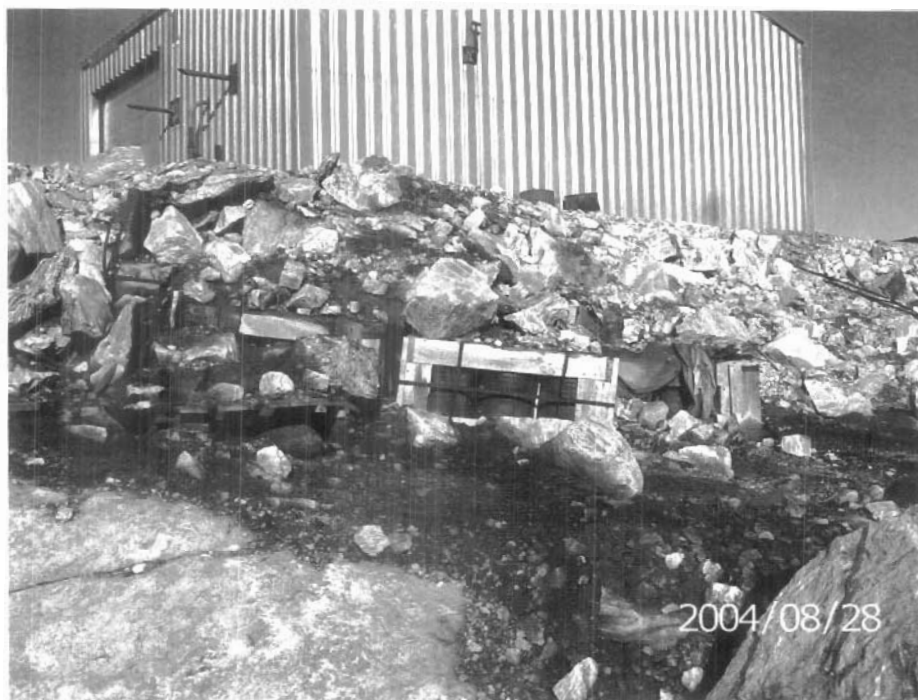
The surface stain was visible on the rocky slope immediately below the Garage, and appeared to get more extensive at the base of the slope and in the areas adjacent to the pipeline from the POL storage facility (See Photos 31 - 35). A second large surface stain was visible below a pile of leaking 45 L barrels. This stain had migrated down an access road and then flowed down the mountain slope (Photo 36-38) to the south (approximately 60 m from the Garage). Due to the presence of a number of small cliffs and valleys, the contaminants were directed to migrate down gradient through a number of natural drainage courses.

An extensive amount of surface staining was observed on the side and at the bottom of the embankment below the Garage. The source of the staining appeared to be from the disposal of waste oil. There was also an extensive amount of staining observed in the vicinity of the POL storage pipeline that was located at the base of the embankment. Potentially this pipeline may have been leaking while it was in use. Very high F3 and F4 fractions were identified in samples collected in US-1051, US-1052 and US-1073. Delineation to the down gradient side of the stain was achieved with testpits US-1042,

Photo 31 Staining below southwest corner of Garage

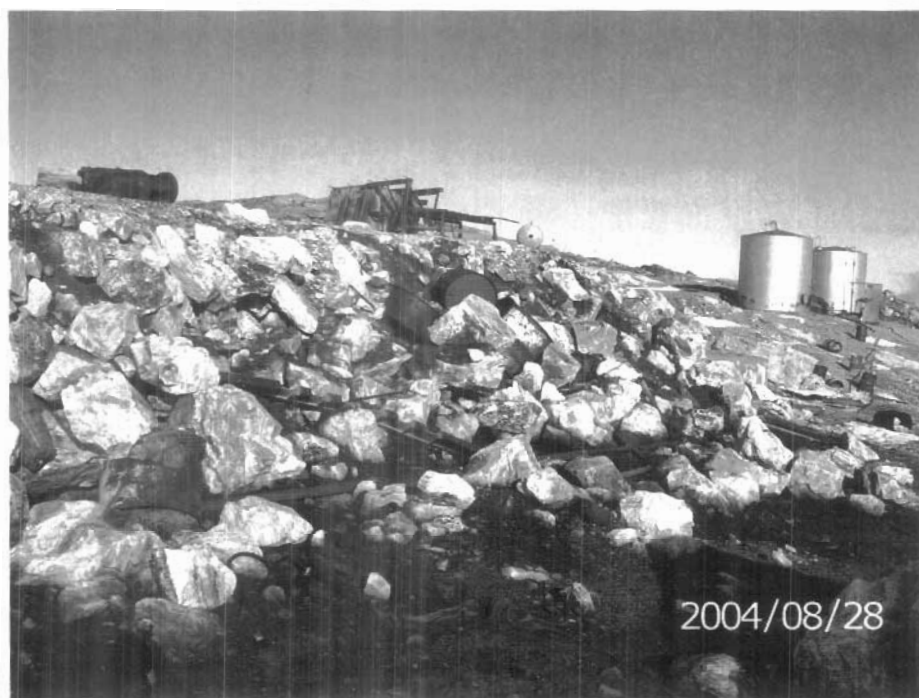
Photo 32 Staining below southeast corner of Garage, note semi buried fuel pipeline

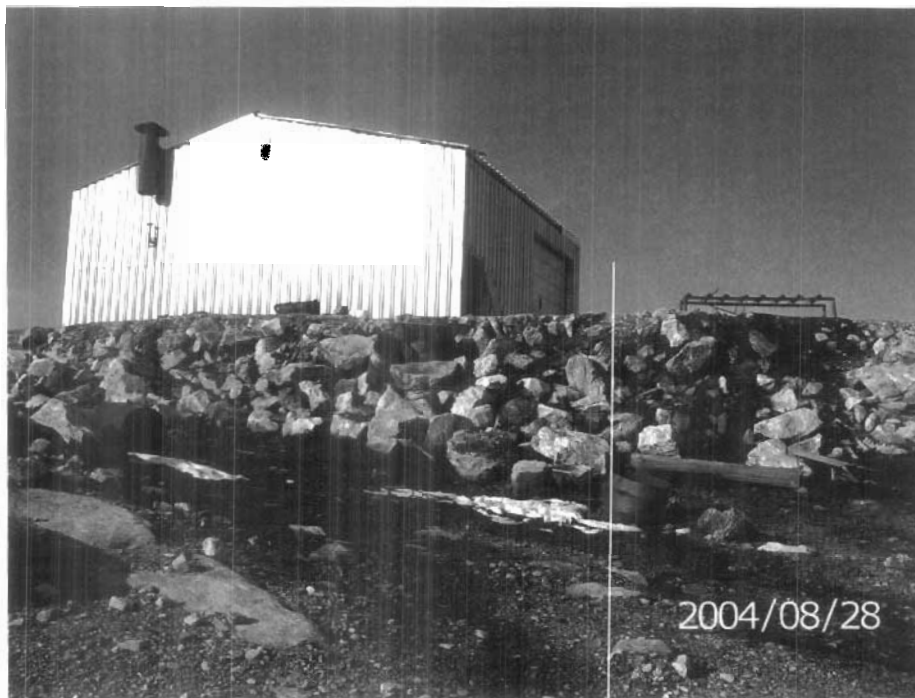
Photo 33 Staining below Garage, looking north

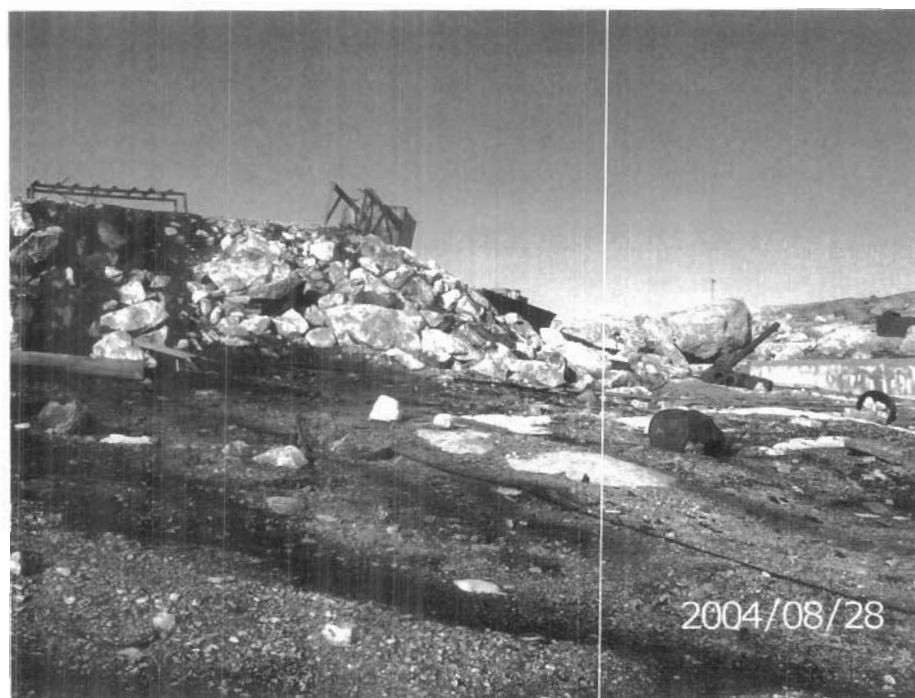
Photo 34 Staining below Garage, looking north east

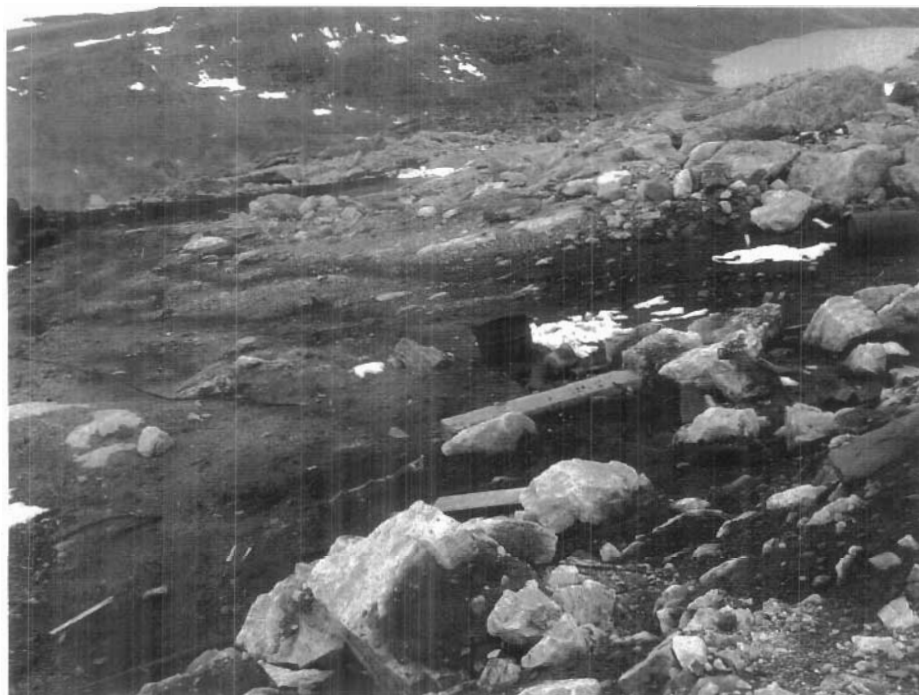
Photo 35 Staining below Garage, looking south

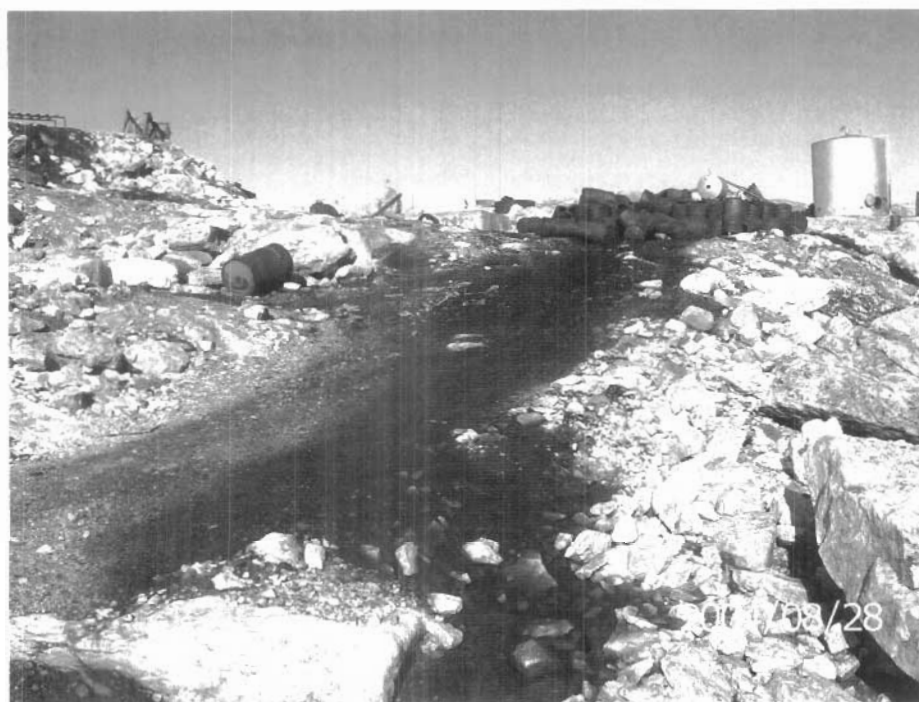
Photo 36 Staining below leaking barrels in Garage dump area

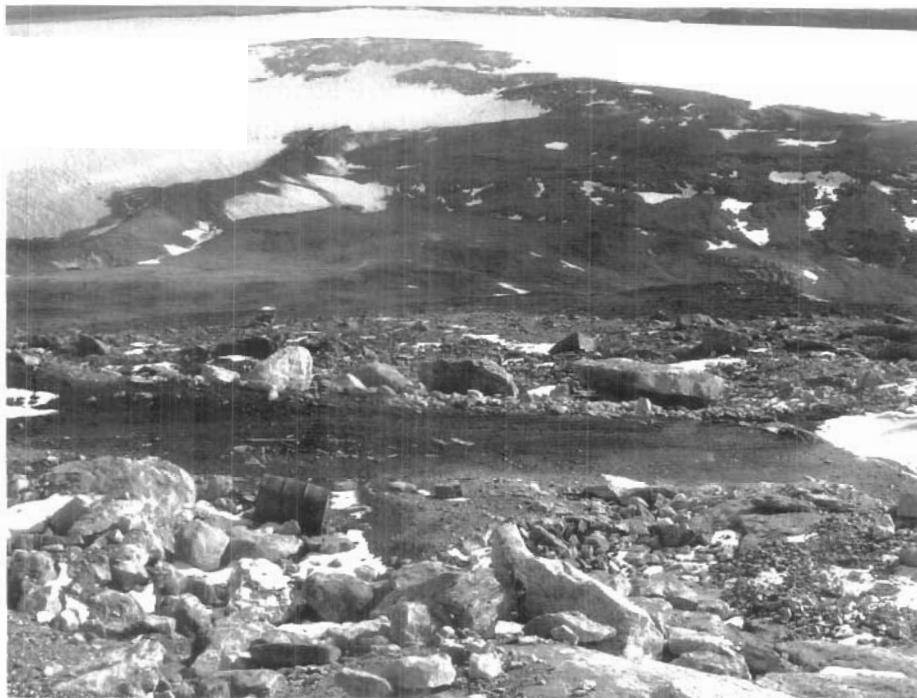
Photo 37 Staining below leaking barrels, looking south

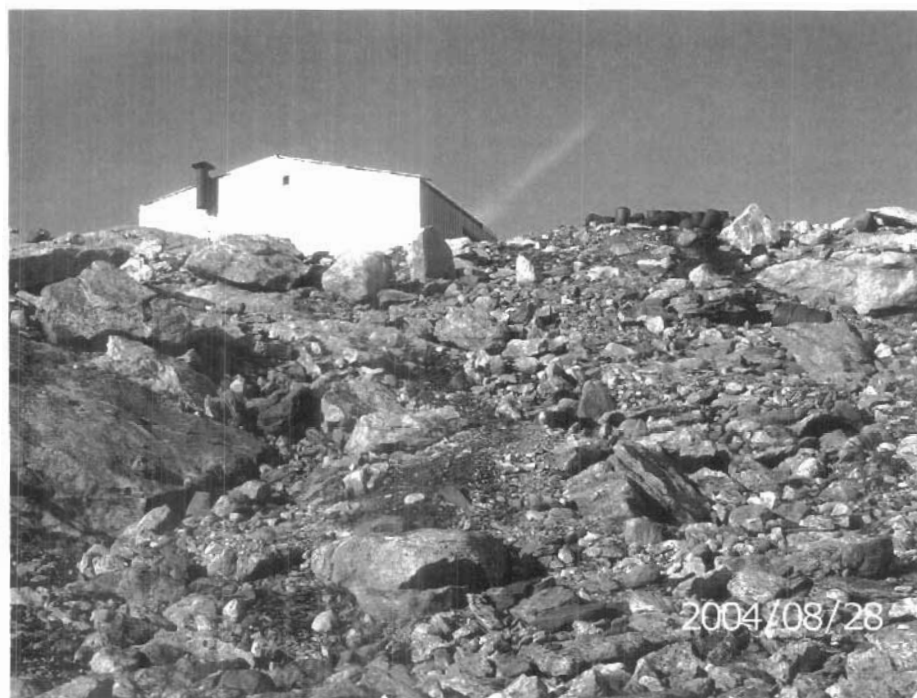
Photo 38 Sample location US-1045, down-gradient of dump
