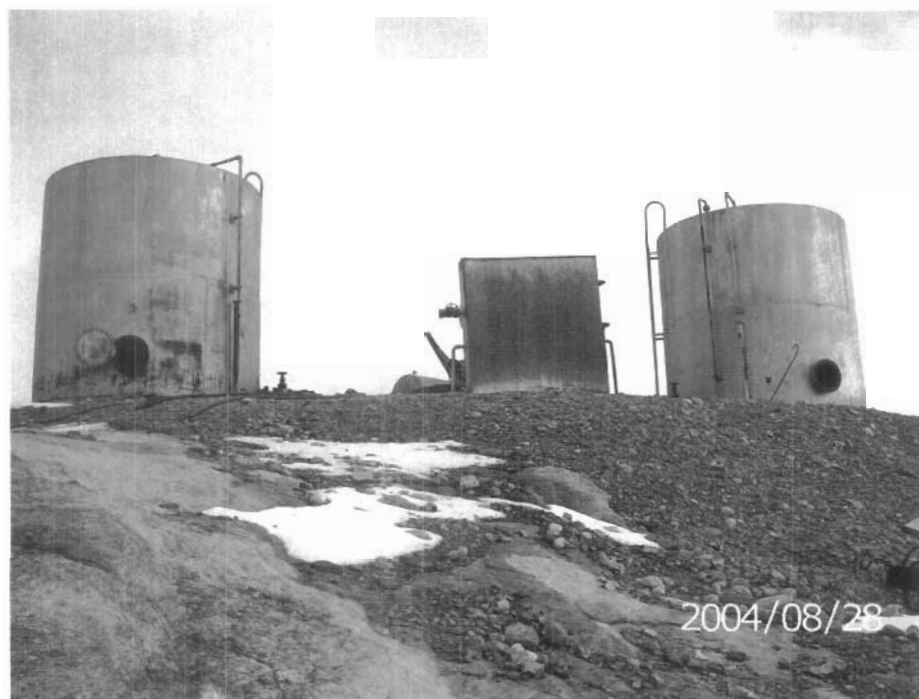
Located between the Inuit house and the Garage is the POL storage facility. This facility consisted of two 75,700 L ASTs as well as the remains of a pumphouse building. The pumphouse was used to transfer fuel via an aboveground 75 mm diameter pipeline to the Garage, Warehouse and Modular Train. Portions of the pipeline are buried around these buildings. There were no signs of surface staining at this site. Both fuel tanks were open and water had collected in the tanks up to the bottom of the man way. The POL storage facility is shown in Photos 39 and on Figure 6.2.

Observations indicated that this site was constructed by leveling an area with imported gravel material. The largest amounts of fill were recorded below the fuel tanks and around the pumphouse (at least 40 cm). A bare rock face with minor amounts of gravel on the surface was located immediately down gradient of the site.

Table 14.1 and 14.2 present a summary of the analytical data from this site. The analytical data indicates that there were no exceedances for the PAHs (all compounds were below detection limits). There were exceedances for F2 and F3 in US-1056, US-1057 and US-1061 (all up gradient and down gradient of the site) and exceedances for F2 were detected in US-1058, US-1059 and US-1060 (around the fuel tanks and pumphouse). Based on the information obtained in this investigation, the contaminant plume covers an area of approximately 650 m<sup>2</sup> and assuming that the average depth of contamination in this area is 0.3 m, there is at least 200 m<sup>3</sup> of hydrocarbon impacted gravel at this site. It is assumed that a portion of this material would be accessible if the site was remediated however, it is expected that rock material located below the surface gravels are also impacted with hydrocarbons. Remediation of this rock (by excavation) material may be impractical.

Photo 39 POL Storage Facility, looking north

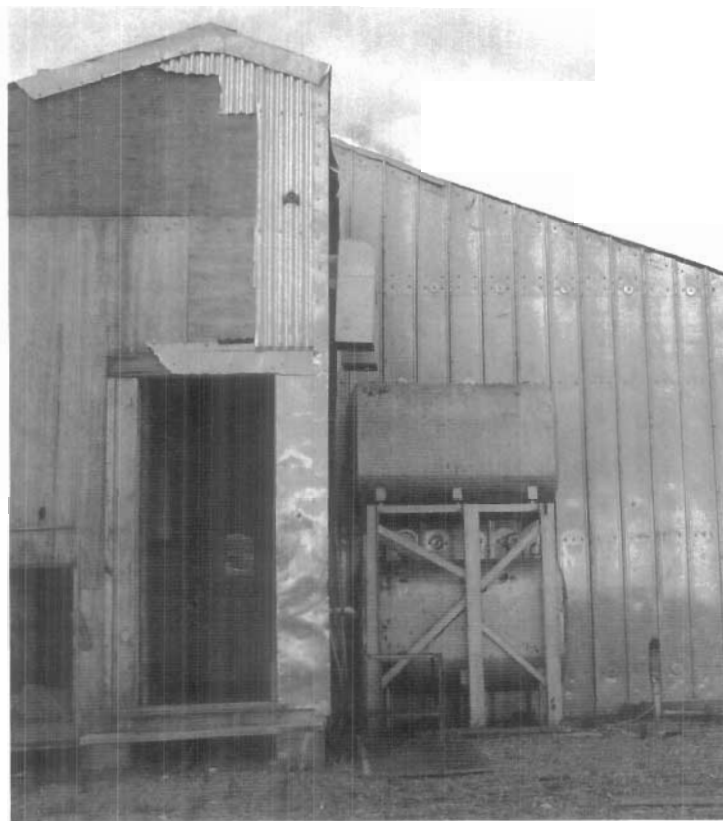
Located on the west side of the Warehouse are two 1040 L aboveground storage tanks, which were used to supply fuel to the generators located inside the Warehouse (Photo 40). The investigation at this site included the collection of soil samples from three hand excavated testpits. As was seen in other areas of the summit, the surficial materials consisted of approximately 0.10 to 0.50 m of sand/gravel fill on top of rock. In some areas the fill materials were frozen. The subsurface investigation that was completed at this site consisted of the collection of soil samples from US-1062, US-1069 and US-1070. All three of these samples were collected between the depths of 0.30 m to 0.50 m and analyzed for hydrocarbons and PAHs. Tables 15.2 and 15.3 present a summary of the analytical data. Figure 6.1 shows the locations of the three testpits at the Warehouse.

Photo 40 Configuration of Warehouse ASTs

The analytical data indicates that there were no exceedances for the PAHs (all compounds were below detection limits) and there were exceedances for F2 in US-1062 and US-1069. These two testpits were located adjacent to the south end and north ends of the tanks. There were no exceedances in US-1070, which was located 5 m west of the storage tanks and at a depth of 0.50 m. Due to the frozen materials located below the warehouse, Earth Tech was unable to determine if there was any subsurface hydrocarbon contamination located below this building. Assuming a maximum depth of impacted soils at 0.5 m and there is no contamination below the warehouse, there is approximately 15 m<sup>3</sup> of hydrocarbon impacted soils in this area.

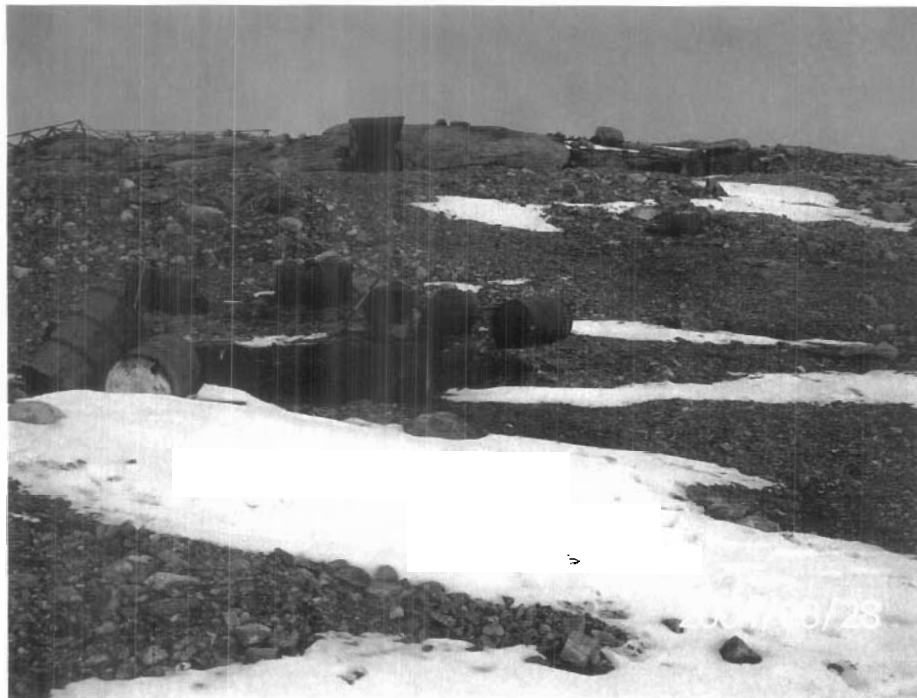
Sample US-1053, US-1054 and US-1055 were located in an area previously determined to have elevated concentrations of zinc and chromium. The metal concentrations were below DCC criteria. In addition, located in this area were 19 barrels and a surface stain that covered an area of approximately 31 m<sup>2</sup>. This stain was concentrated around the base of a number of barrels (Photo 41) however, a narrow ribbon of staining (0.3 m wide, 11 m long) was visible extending from the southern end of the stain.

Based on the information obtained in this investigation it is assumed that the hydrocarbon and metal contamination at this site is limited to the extent of the stained area. Assuming a maximum achievable depth of 35 cm, there is approximately 14 m<sup>3</sup> of hydrocarbon and metal impacted sands/gravels in this area.

Photo 41 Surface stain near Inuit House

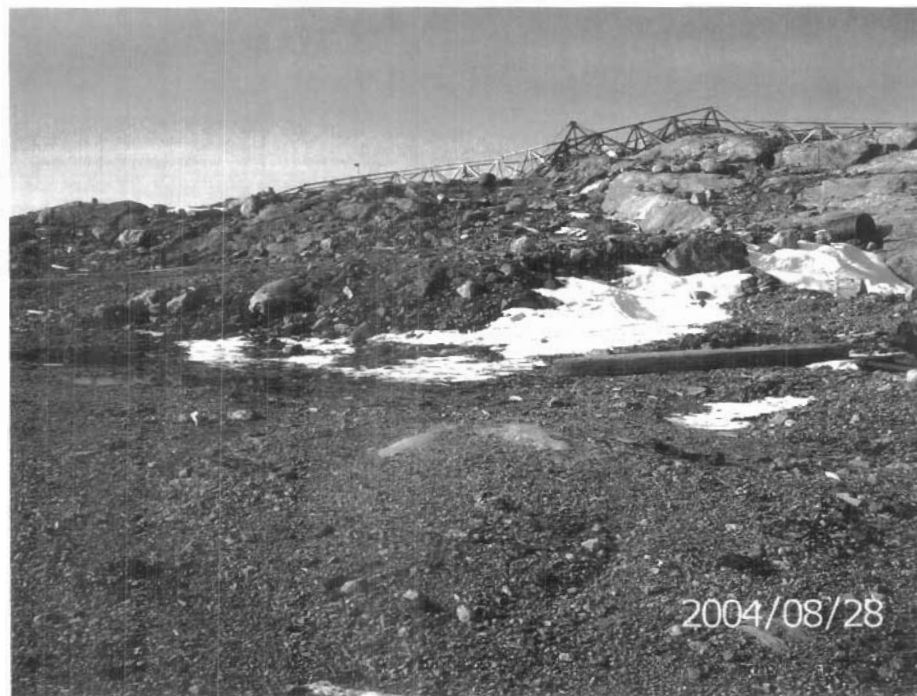
During the completion of the geophysical survey of the upper station, an area north east of the Inuit House was identified as a being a potential buried dump site (Photo 42). In order to confirm if any contaminants were migrating off this site, four testpits were hand excavated and soil samples were collected. These testpits are labeled US-1065, US-1066, US-1067 and US-1068 on Figure 6.3. A sample from each of these testpits was analyzed

for metals and samples from the two down gradient testpits (US-1066 and US-1067) were also analyzed for hydrocarbons and PCBs. The analysis of these additional samples indicated that metals, PCB and hydrocarbon concentrations were less than DCC and CCME criteria. Tables 17.1, 17.2 and 17.3 present a summary of the analytical results for these samples.

During the excavation of the testpits at this dumpsite, perched groundwater flowed into the open excavations. A sample of the groundwater recovered from US-1067 was collected and analyzed for PCBs, hydrocarbons and metals (total and dissolved). Tables 18.1, 18.2 and 18.3 present a summary of the groundwater analytical data. The data indicated that the hydrocarbon concentrations were substantially less than the CCME Freshwater Aquatic Life criteria. The PCB analysis was 1.7 µg/L, which is elevated compared to the former CCME criteria of 0.1 µg/L. Currently the CCME does not have any publish criteria for PCBs in water. Total metal analysis also determined exceedances for several metals (aluminum, arsenic, copper, lead, molybdenum, nickel, silver, thallium and zinc) all above CCME Freshwater Aquatic Life criteria.

Photo 42 Inuit House dump location, antenna structure in background

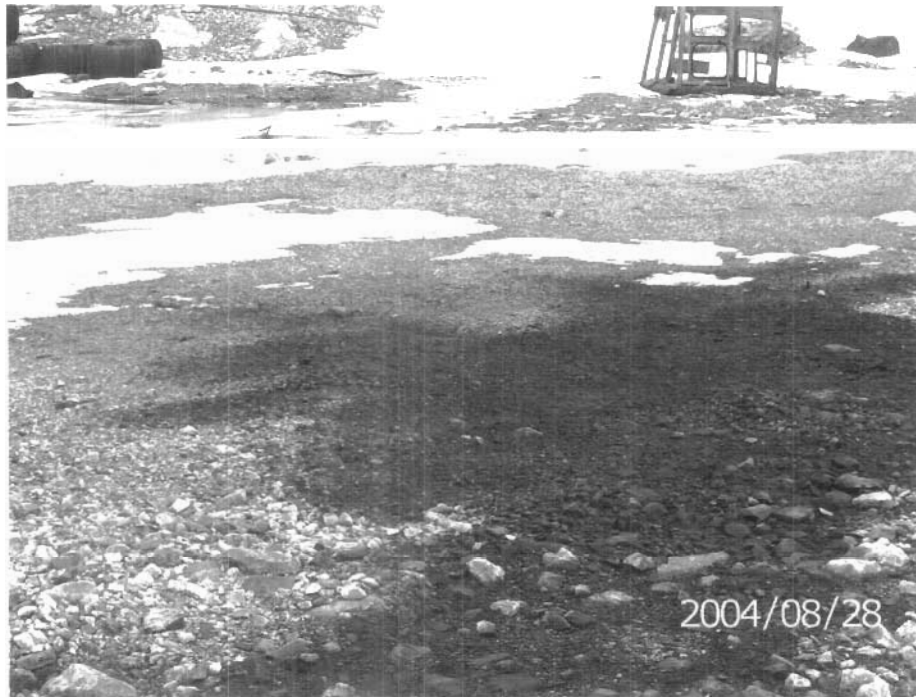
Three very dark surface stains were observed on the ground surface in an area north of the antenna base (Photo 43). Figure 6.1 shows the location of these three stains. These stains were close together and covered an area of approximately 35 m<sup>2</sup>. The previous investigation did not include any investigative activity at these stains. These stains did not appear to be related to any adjacent activity and were likely caused by intentional or inadvertent spills.

One composite surface sample was collected from the three stains and one testpit was excavated in the center stain in order to determine the vertical depth of soil contamination. Due to size of the subsurface rocks, this testpit could not be excavated beyond a depth of 0.50 m and vertical delineation was not achieved. The samples from this location were analyzed for hydrocarbons, PCBs and PAHs. The analytical data indicated that PCBs and PAHs were not detected however; there were very high exceedances above CCME F3 criteria in both samples. The F3 fraction in the composite sample was 29,200 ppm and the F3 fraction in the sample collected at a depth of 0.5 m was 16,300 ppm. Tables 15.1, 15.2 and 15.3 in Appendix D presents a summary of the analytical data.

Based on the information obtained from this limited investigation there is approximately 25 m<sup>3</sup> of impacted accessible material (<0.5 m in depth, non rock material) in this area.

**Photo 43 Surface stain near antenna base**

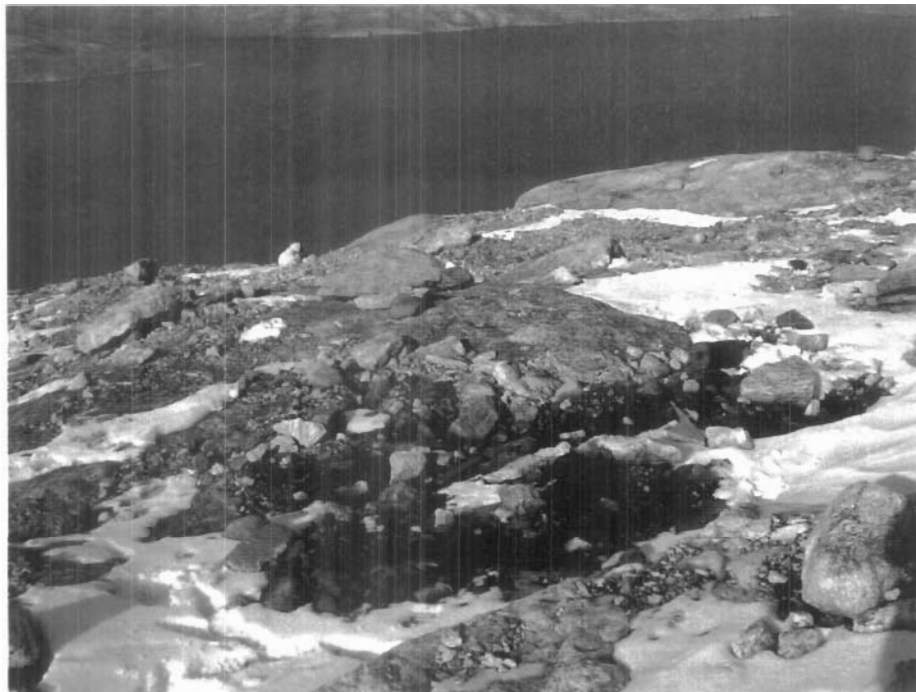
**Photo 44 Surface stain off northwest corner of Modular Train**

During an inspection of this area in 2004, a total of eight stains were observed north and north west of the module train. The stains were located on rock ledges north of the train or on a lower plateau located below the train. Scattered debris in this area consisted of oil filters, metal strapping, cables, sheet metal roofing and barrels. The total surface area of the stains were difficult to determine due to the snow cover and since the stains were also located in, on, and below boulders and rock crevasses. However, it is estimated that they cover an area of at least 85 m<sup>2</sup>. Material at the location of the stains was typically fine sand and gravel or boulder size rocks. The maximum depth of sampling in the stain areas was limited to depths less than 10 cm due to site conditions. The stain in the area of RRMC flag #78 was approximately 31 m<sup>2</sup> in size. Photos 44 and 45 show the staining on the west side of the train and Figure 6.1 shows the locations of the stains.

One composite soil sample was collected in order to get an understanding of the contaminant levels for the entire stained area. Table 15.1 presents a summary of the analytical data for this sample (NW Stains). This sample was analyzed for hydrocarbons, PCBs and PAHs. The analytical data indicated that the only exceedance that was recorded in the composite sample was in the F3 and F4 hydrocarbon fractions. The PCB concentration of this sample was determined to be 0.5 ppm. To help determine if there were any impacts down gradient of the stained areas, one soil sample (US-1043) was collected in an obvious drainage pathway down gradient of the stains. This sample was collected between the depths of 0-0.10 m. The data from this sample was previously presented in Tables 10.2 and 10.3. The analysis for this sample indicated that the hydrocarbon and PCB concentrations were well below CCME residential criteria.

Due to the lack of granular material in the area of stains, the maximum depth of contamination is assumed to be 0.10 m. Based on this depth and the size of the staining, there is approximately 10 m<sup>3</sup> of PCB (<DCC Tier 2 criteria) and hydrocarbon impacted material at these sites.

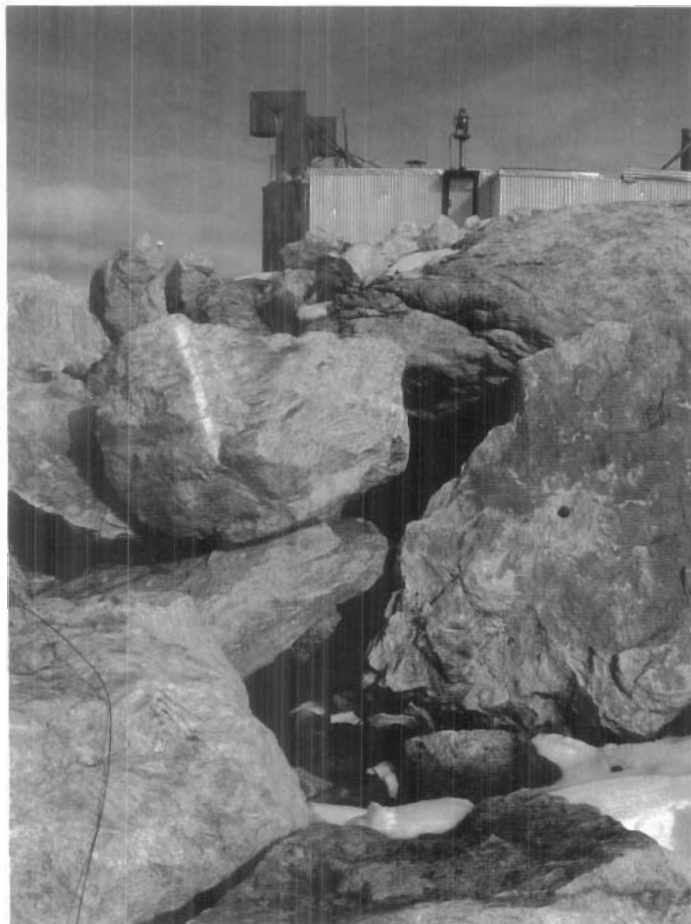
Photo 45 Staining below boulder sized rock, west side of Modular Train

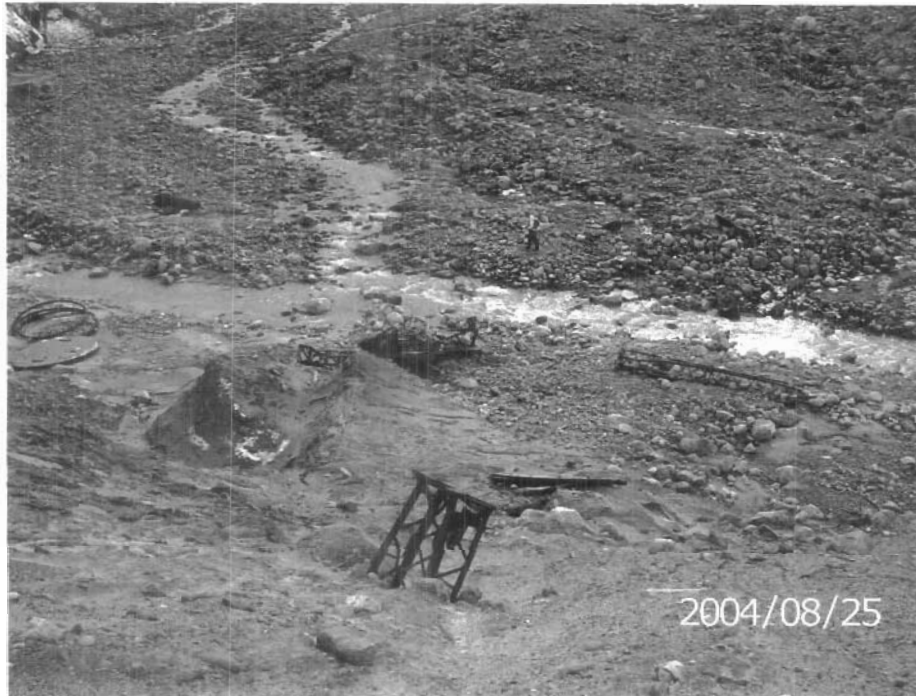
It should be noted that remains of a crane were visible partially buried in a landslide slope, west of the vehicle dump. Portions of the materials were located adjacent and in the adjacent stream. Photo 46 shows a picture of this debris. To successfully remove this debris, the contractor will need to make special precautions to prevent any releases into the stream and to ensure the safety of onsite workers.

Photo 46 Buried debris adjacent to creek below Water Lake Vehicle Dump

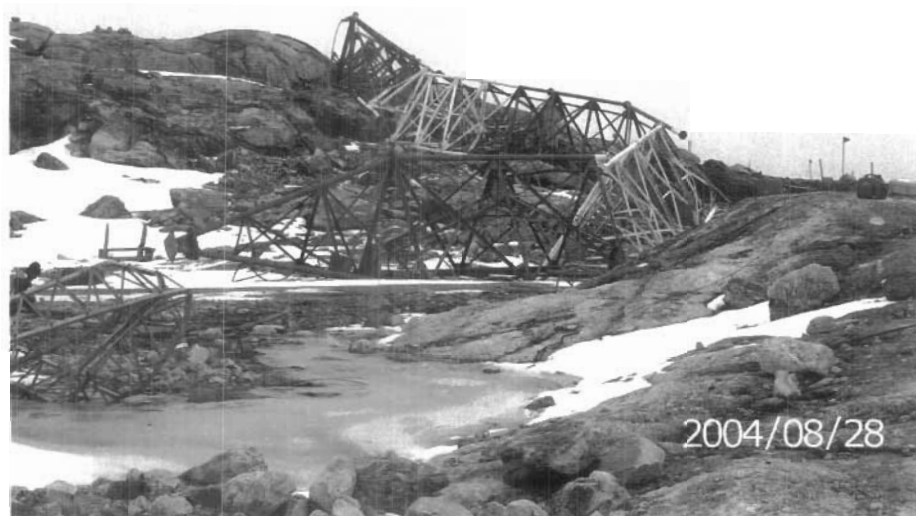
Photo 47 Downed antenna structure

The outfall area is located at the north end of the Upper Station site. The outfall area contains stained soils, out fall piping, oil filters, barrels and a concrete foundation for the former antenna (Photo 47).

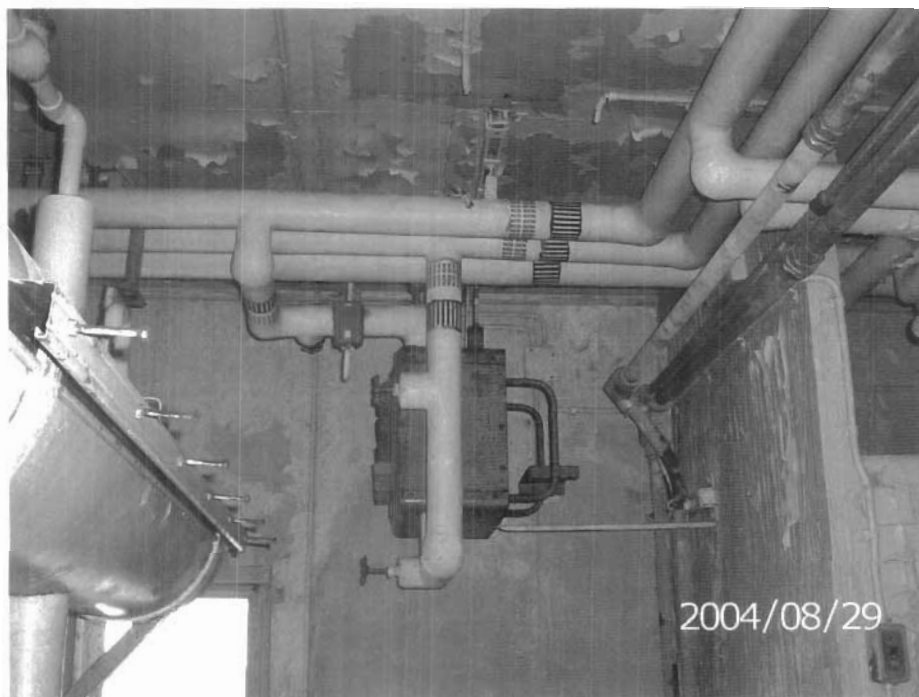
Nearly all painted substances (including water tanks and interior plywood) contained PCB's in the paint. Previously sampled areas had laboratory values for PCB's in interior paints from 4000 to 30,000 ppm and the 2004 site visit yielded values of PCB's in interior paints of 3.3 to 42,000 ppm.

**Photo 49 Typical piping insulation and paint condition – Module Train**

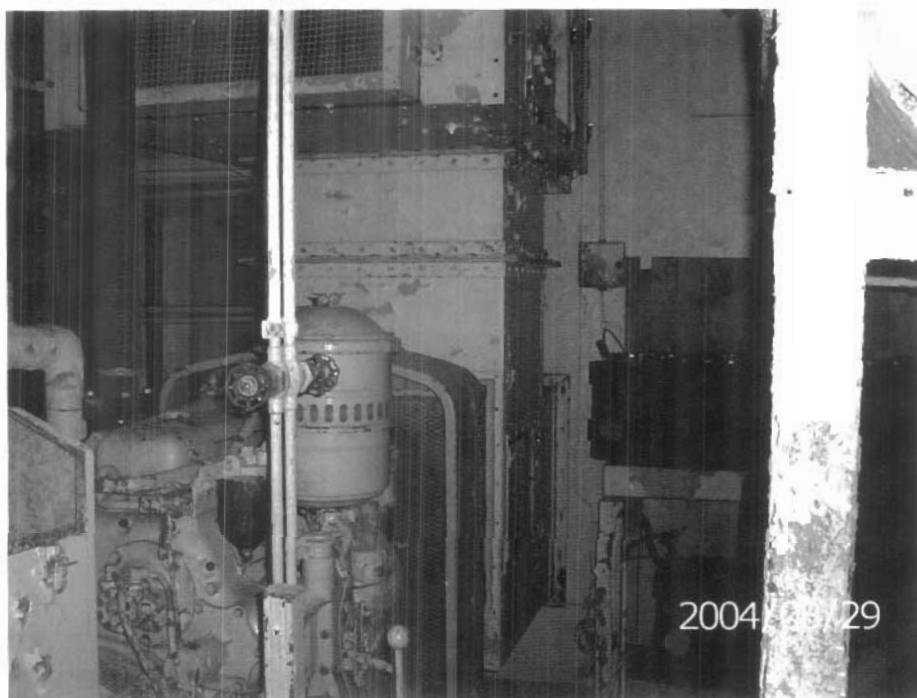
**Photo 50 Genset - Module Train**

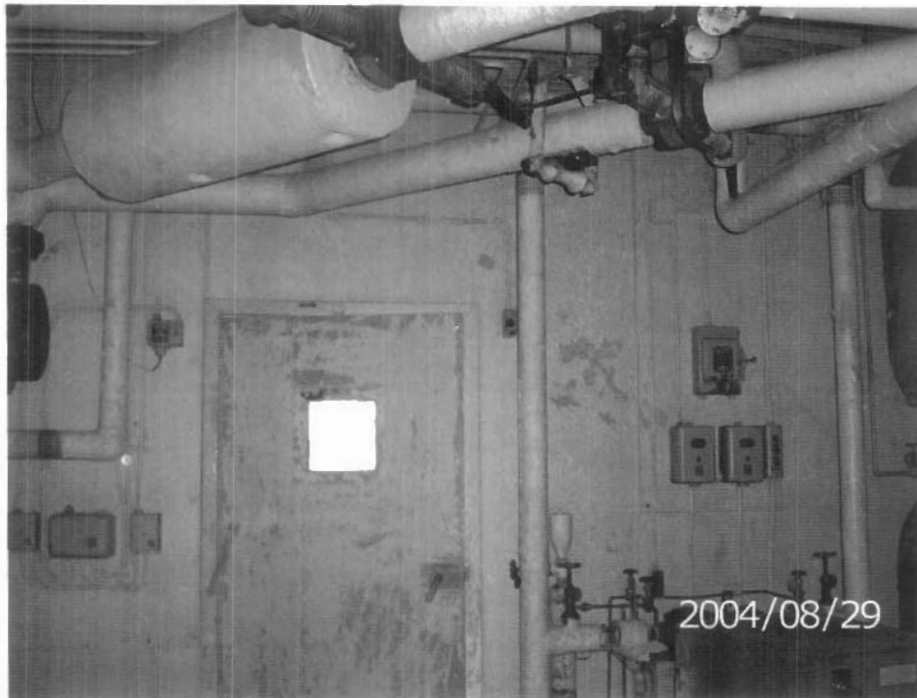
Not all the interior walls of the warehouse are painted. Unpainted panels of galvanized or aluminum metal were visible. Paint on plywood inside the warehouse was found to contain PCB paint.

Photo 51 Typical piping in Warehouse

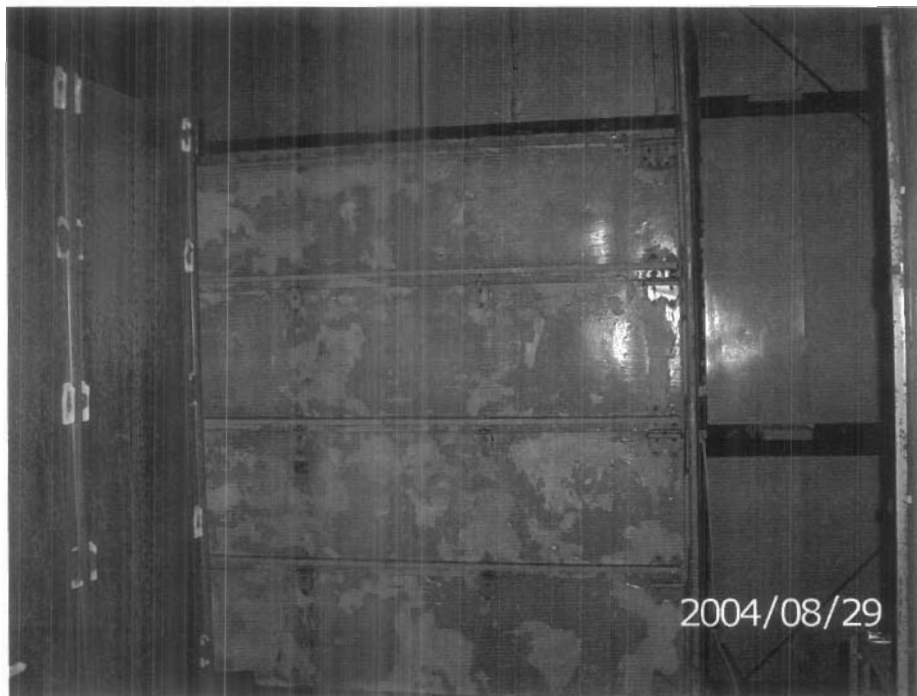
Photo 52 Overhead door and exterior wall cladding – Warehouse

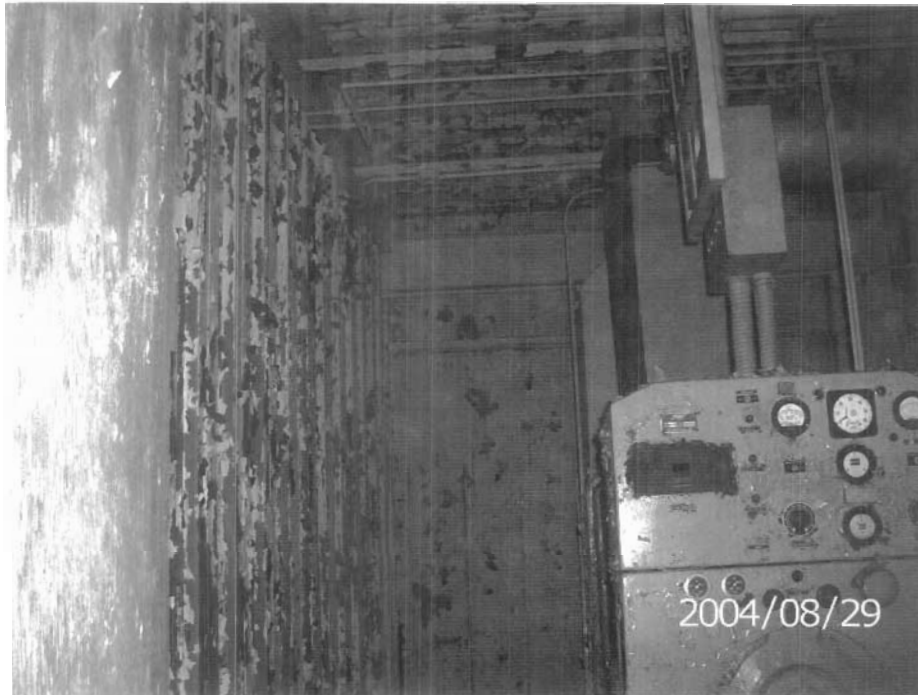
The Garage is still intact and contains two large generators. Paint sampling conducted in the Garage indicate that the majority of painted surfaced surfaces contain PCB Paint. The paint on the interior cladding is severely flaked and a large amount of paint flakes exist on the floor of the Garage. The heating unit room contains exposed asbestos insulation. The Garage concrete floor slab contains some staining and associated PCB levels of approximately 38 ppm. There is also a large tracked vehicle in the main bay. Both of the overhead doors are coated with PCB containing paint.

**Photo 53 Genset and peeling paint in Generator Room – Garage**

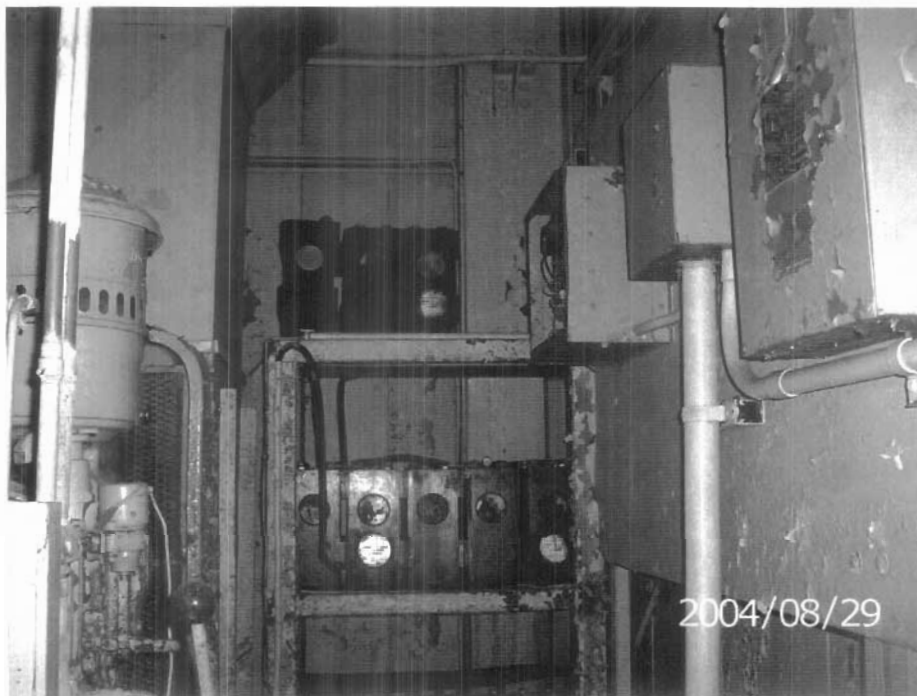
**Photo 54 Batteries in Generator Room - Garage**
