ENNADAI LAKE  
REMEDATION PROJECT

## REMEDIAL ACTION PLAN FORMER WEATHER STATION ENNADAI LAKE, NUNAVUT

NOVEMBER 2012  
ISSUED FOR REVIEW  
EBA FILE: Y22101286.0012

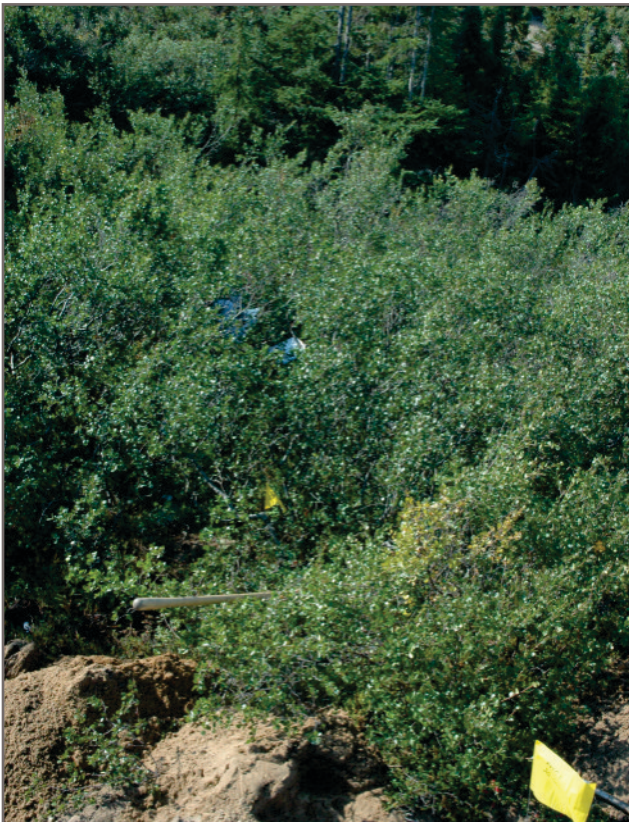
**Photo E-2:** APEC 1 - Stain 1 - Flag locations  
for delineation soil samples  
APEC 1-SS004 and SS005 in a  
low lying depressional area

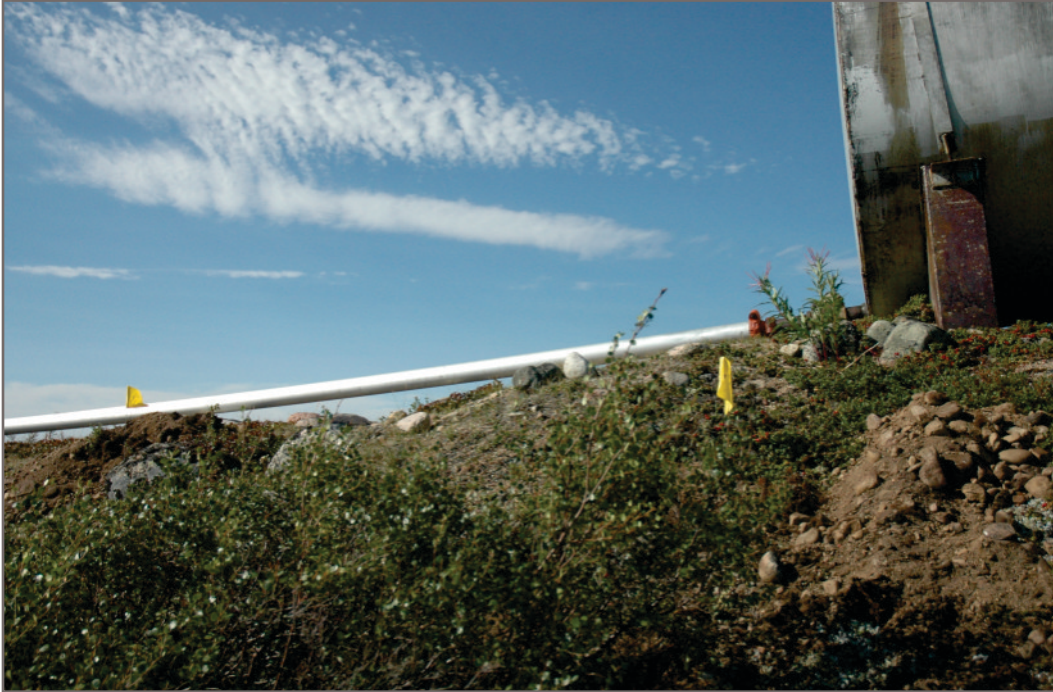
**Photo E-6:** APEC 4b - Tank 5 - Delineation of tanks; staining can be seen at the valve

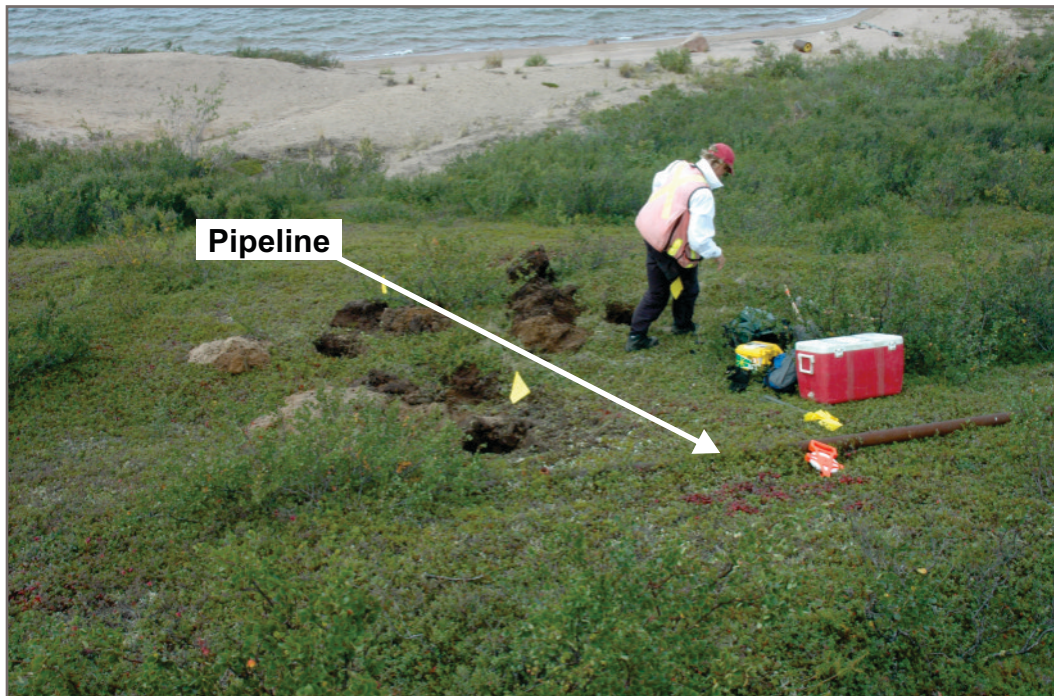
**Photo E-8:** APEC 4a - Tank 5 - Flag locations for soil samples APEC 4a- SS001, staining was noted at the valve of the AST

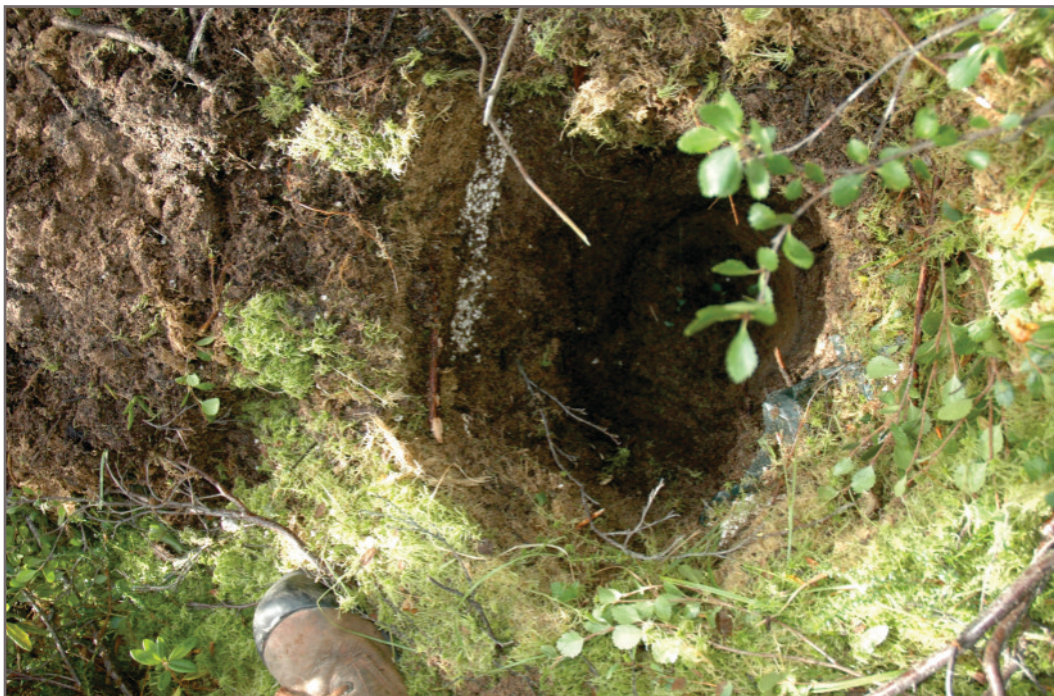
**Photo E-9:** APEC 8 - Pipeline - Flag locations for delineation soil samples APEC 8-SS004, SS005 and SS006; staining was noted along the pipeline at a junction

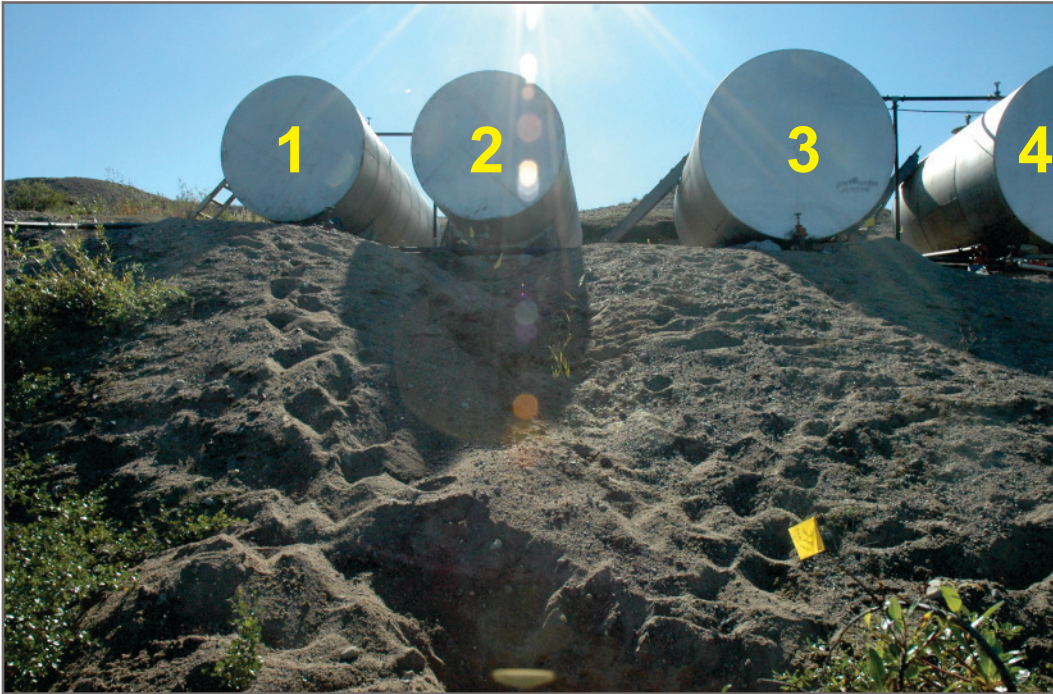
**Photo E-10:** APEC 8 - Pipeline - Sample location taken down-gradient of APEC1; delineation soil sample APEC 8-SS011 is shown; both samples taken in a low lying depressional area, hydrocarbon odour was noted

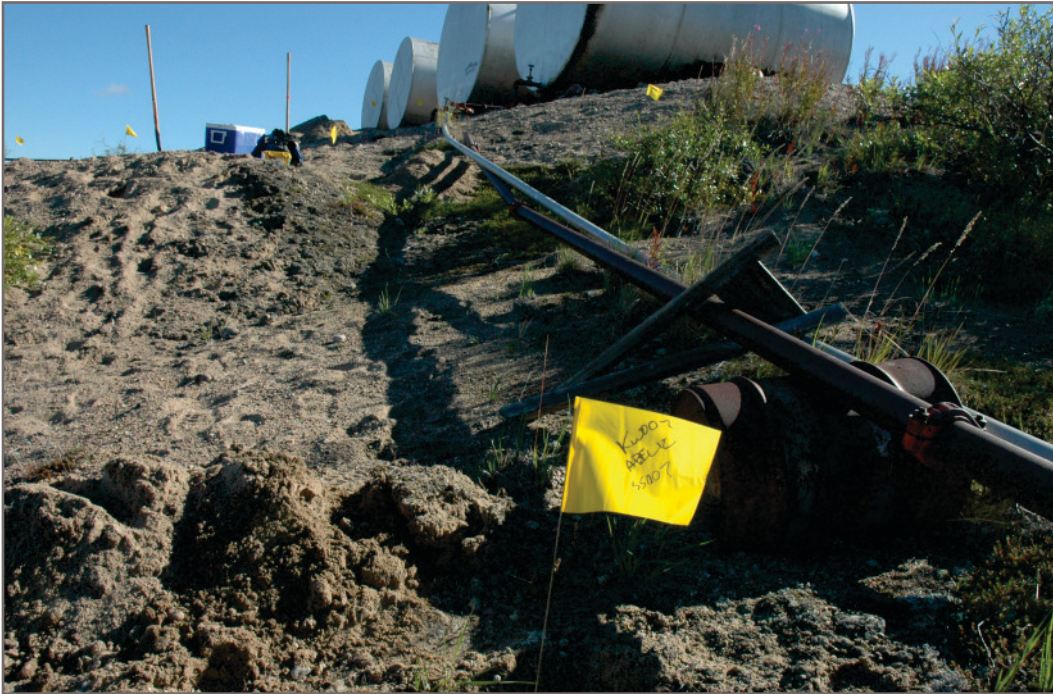
**Photo E-12:** APEC 9 - Tank 1- Soil sample location APEC 9- SS001; the soil sample was taken down-gradient of the fuel distribution lines; significant hydrocarbon odour and staining around the valves was noted

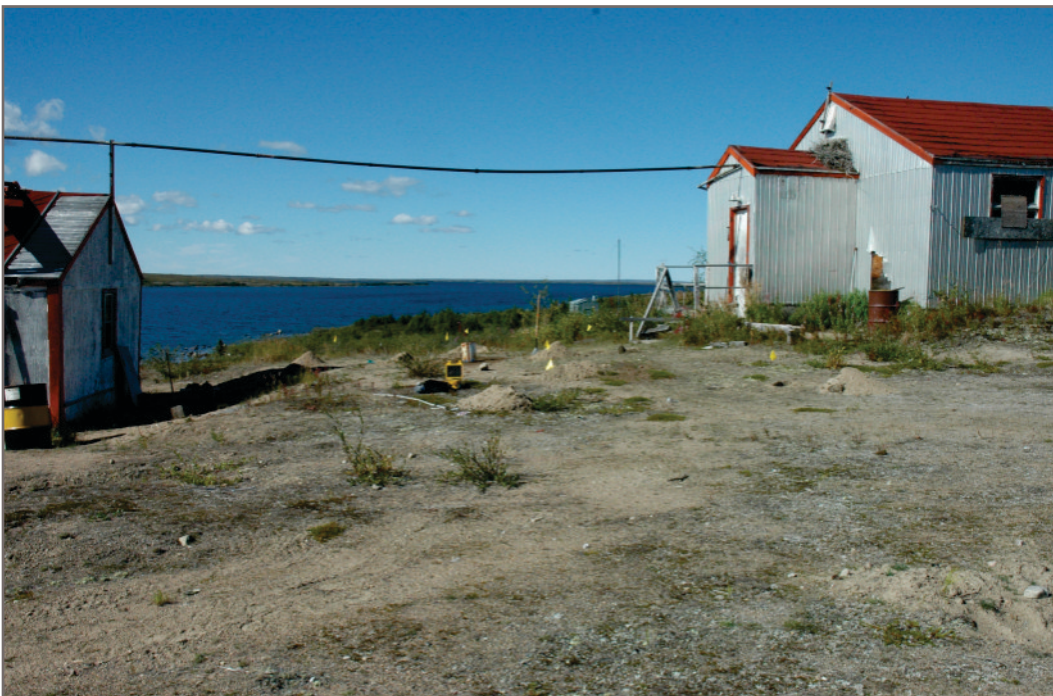
**Photo E-13:** APEX 12 - Tank 4 - Delineation soil sample APEX 12-SS007 is shown looking north toward the tank farm; in the background soil samples APEX 12-SS001 to SS005 can be seen delineating the hydrocarbon plume

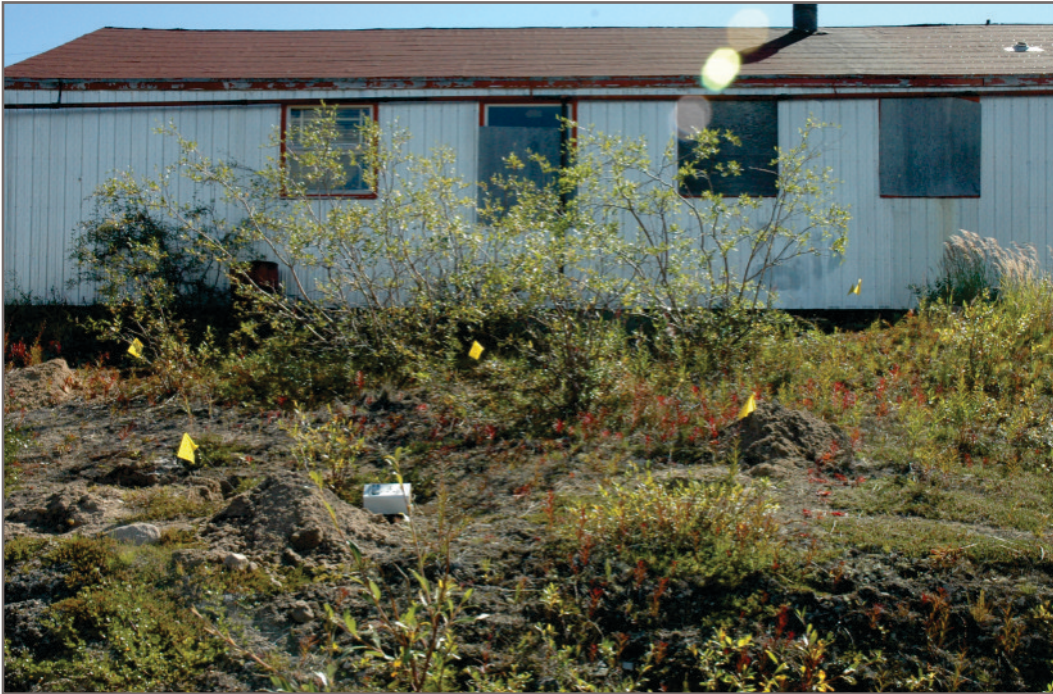
overhead piping, however, a fuel oil stain approximately 1.5 metres in diameter was observed below a threaded union in the overhead piping. A total of 10 litres of fuel was drained out of the piping system into a drum on-site to prevent further leaking.

**Photo E-14:** APEX 13-Overhead Pipeline- Delineation soil samples APEX 13 SS002 to SS009 are seen between Building 3 (APEX 16) and Building 5 (APEX 18). An active leak was present at the time of the Site investigation.

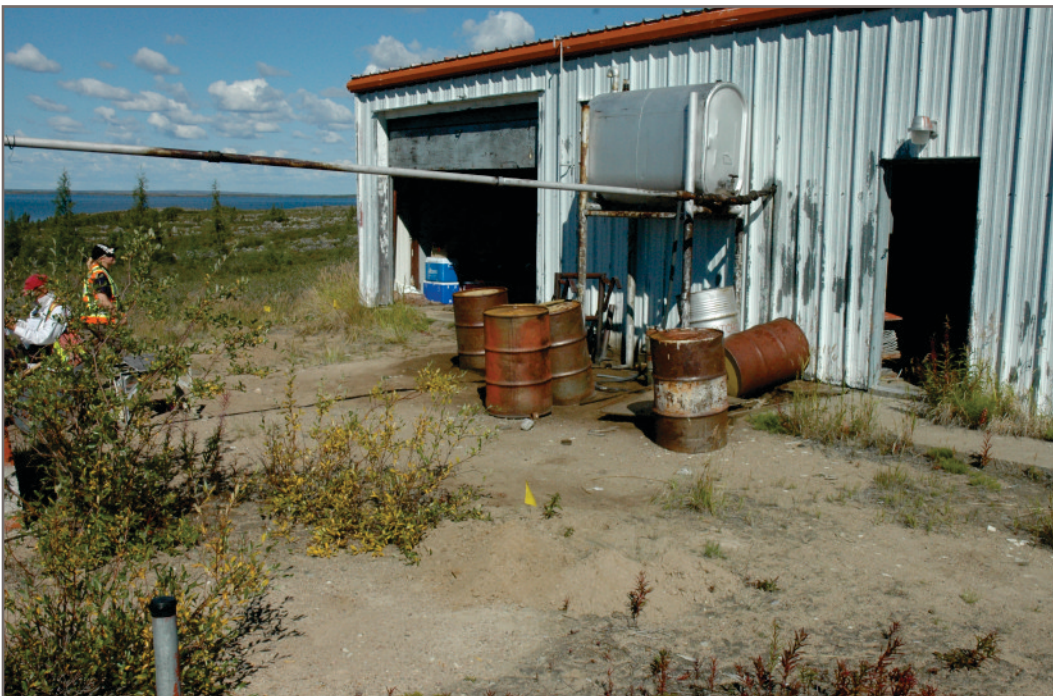
**Photo E-15:** APEC 13/APEC 14 - Overhead Pipeline/Building 1 - Delineation soil sample locations APEC 13-SS010 to SS017 are shown; hydrocarbon odour was noted at the base of the foundation

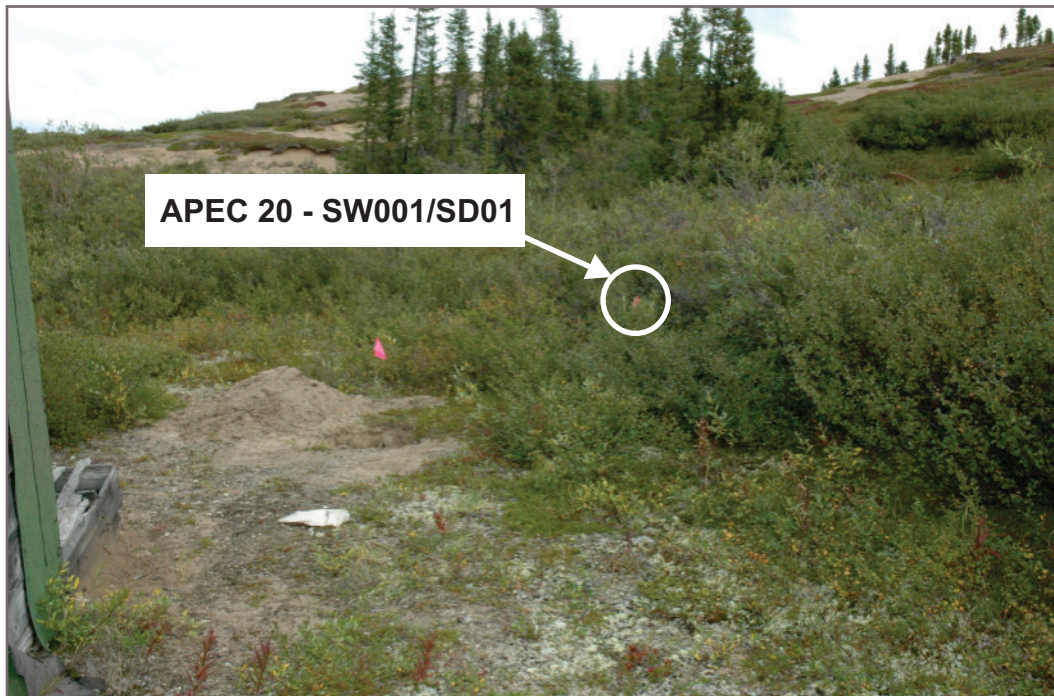
**Photo E-22:** APEC 19 and 20 - Buildings 7 and 8 - Two areas of hydrocarbon contamination were identified. The approximate locations of the areas are shown.

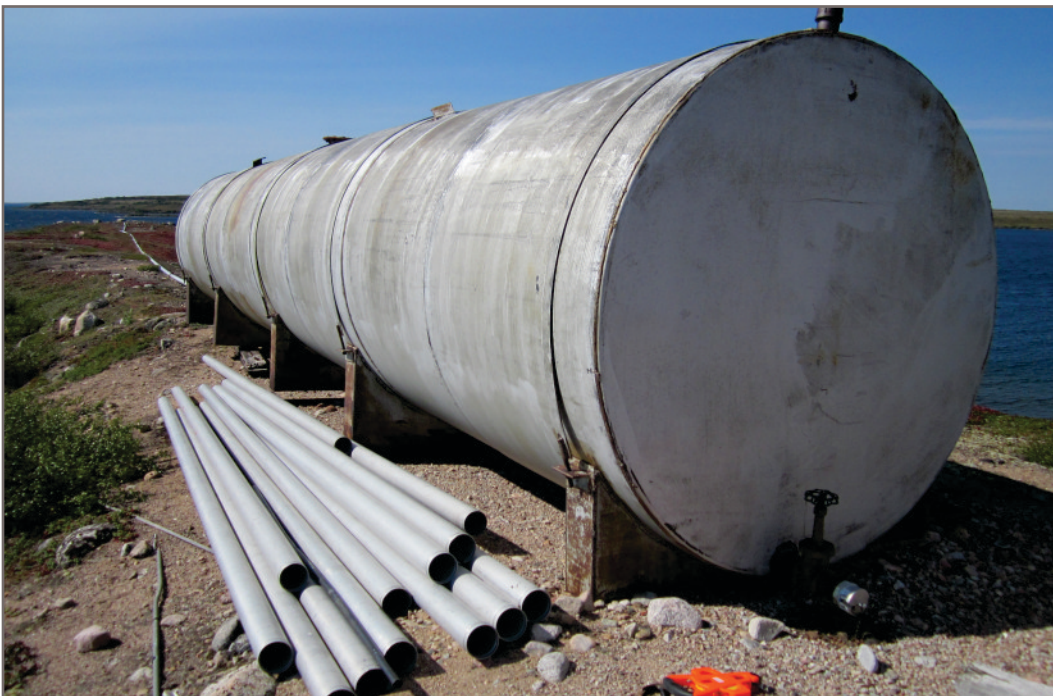
**Photo H-1:** APEC 3 – Stain 3 – Organic content remaining in the pipeline

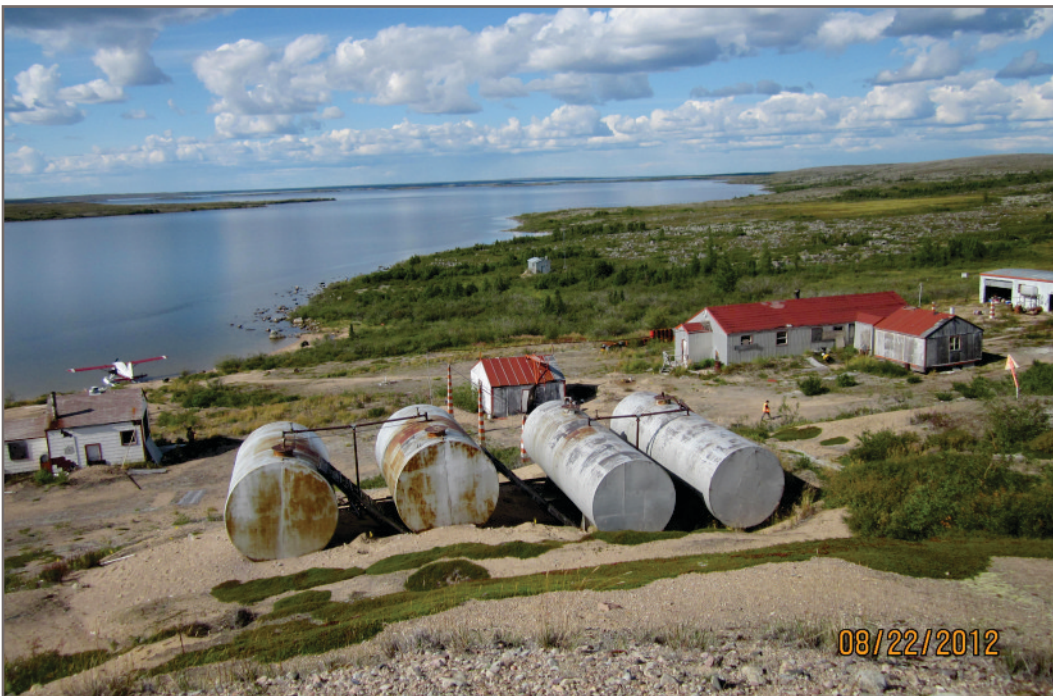
**Photo H-8:** APEC 9 - 12 - Tanks 1-4 - View looking west, Tank 1 on the far right and Tank 4 is on the far left; asbestos gaskets on all tanks and organic content in all tanks, except for Tank 3

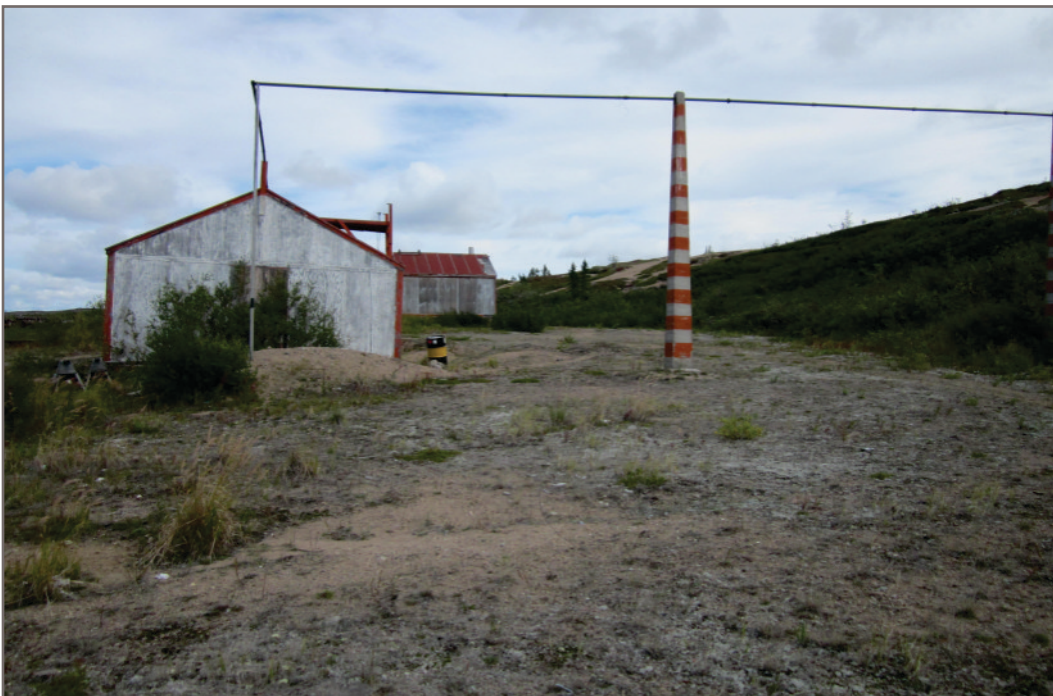
**Photo H-10:** APEC 13 - Overhead piping from tanks to Buildings - View of overhead piping towards Building 3; total and leachable lead painted concrete and organic content in pipeline

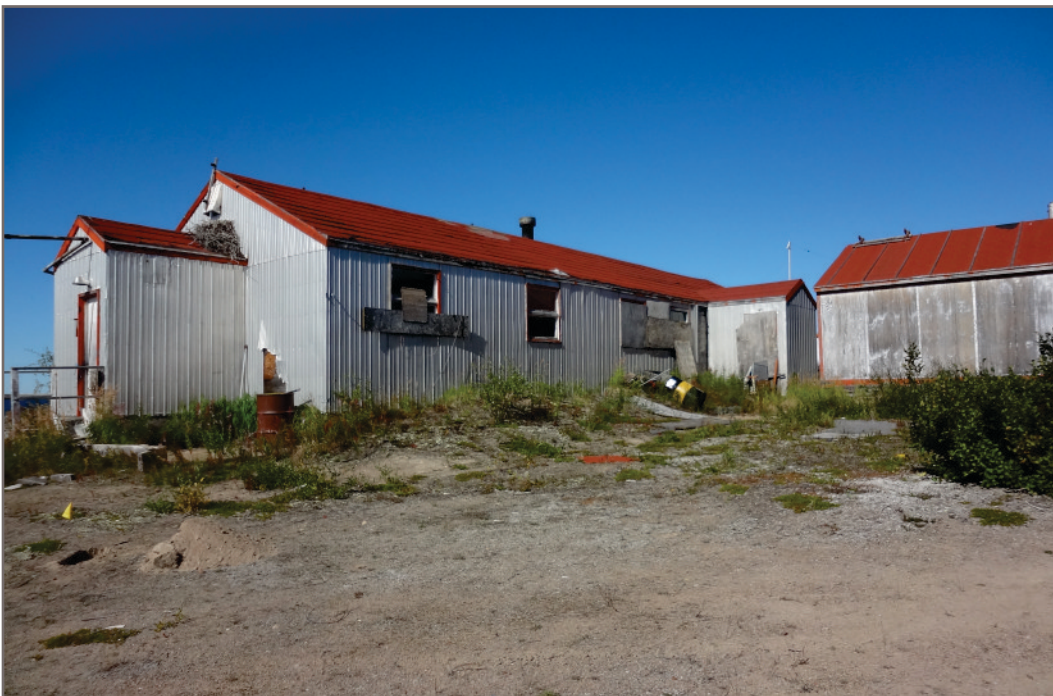
**Photo H-12:** APEC 14 - Building 1 - Asbestos black felt, asbestos window caulking, total and leachable lead painted wood

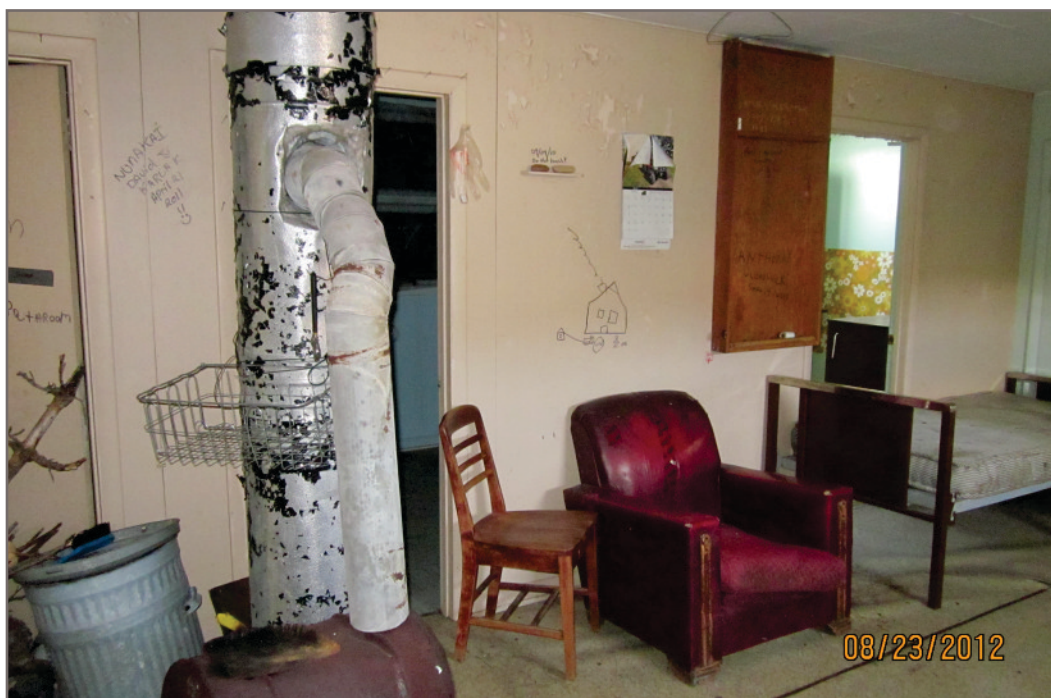
**Photo H-20:** APEC 14 - Building 1 - Main floor living room and bedrooms; asbestos flooring, wall panels and ceiling

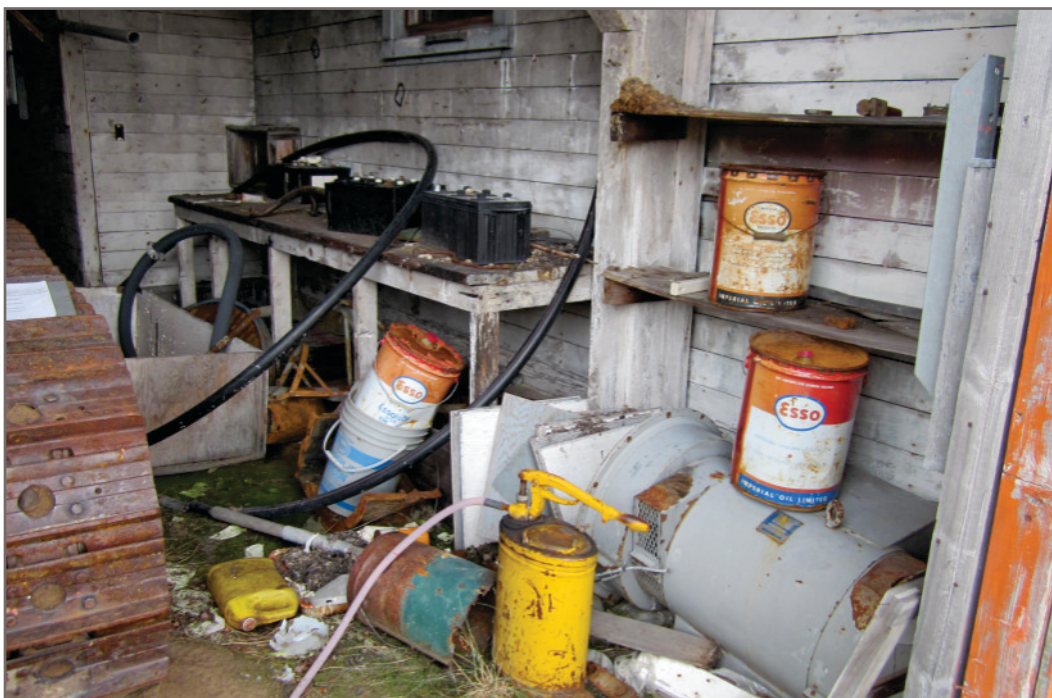
**Photo H-35:** APEC 18 - Building 5 - Total lead and leachable lead painted wood and equipment, lead acid batteries and miscellaneous containers of oil/lubricants
