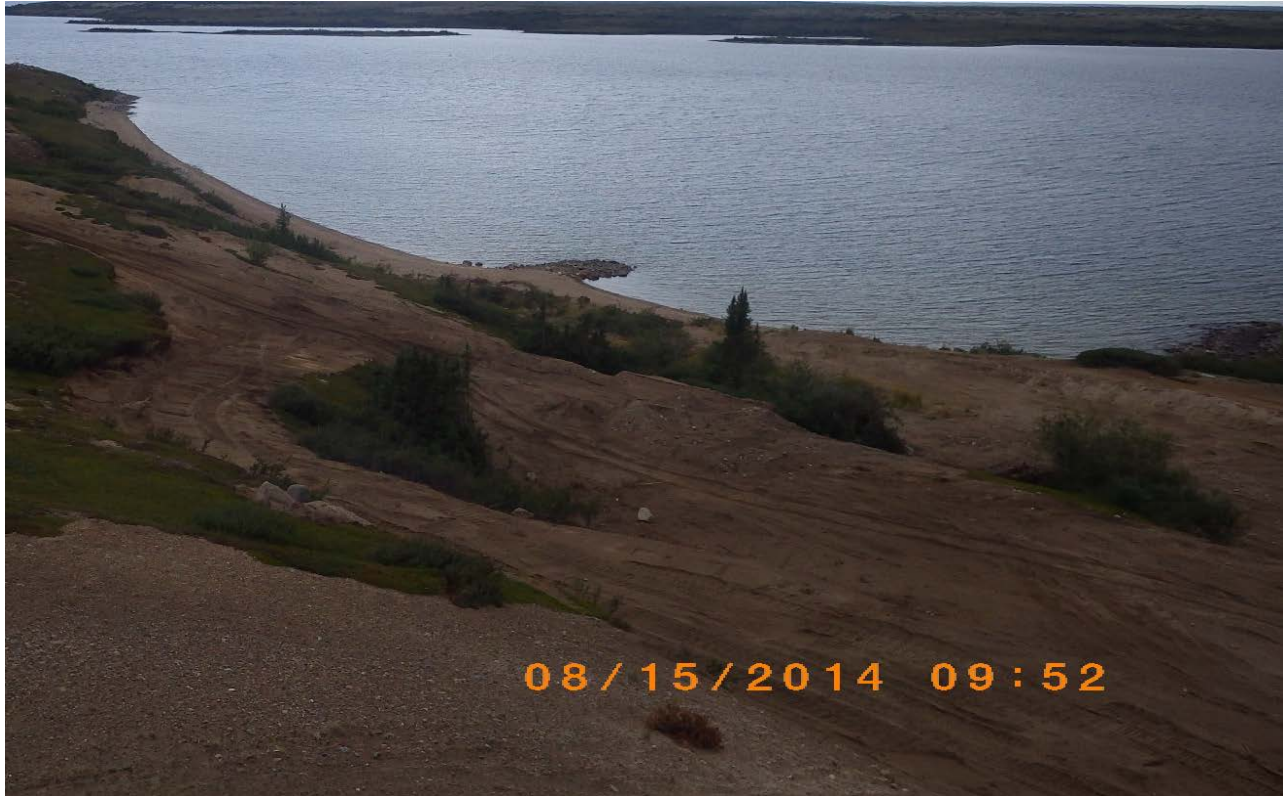
Photo 17: Looking west over backfilled and re-graded APEC 8.2 (centre) and APEC 1 (lower right corner) (August 15, 2014).

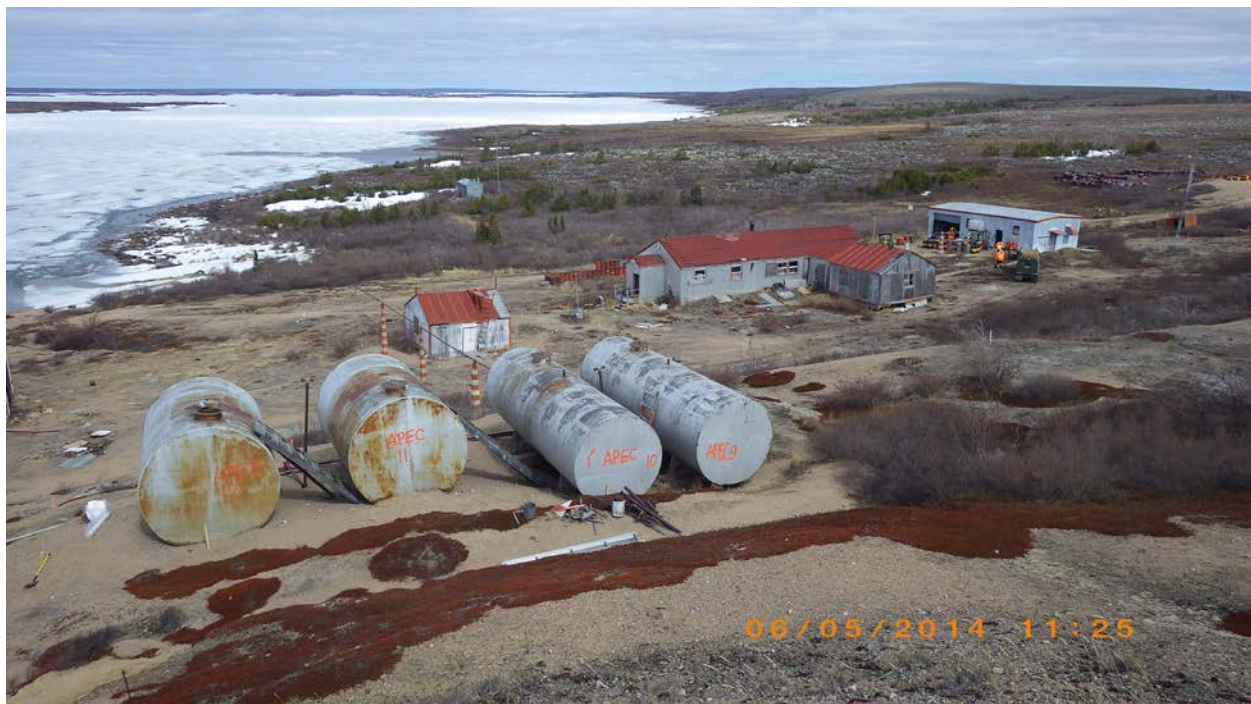
Photo 18: Overlooking the main site. Tanks right to left: APEC 9 (Tank 1), APEC 10 (Tank 2), APEC 11 (Tank 3), APEC 12 (Tank 4). Buildings left to right: APEC 16 (Building 3), APEC 14 (Building 1), APEC 17 (Building 4), and APEC 15 (Building 2) (June 5, 2014).

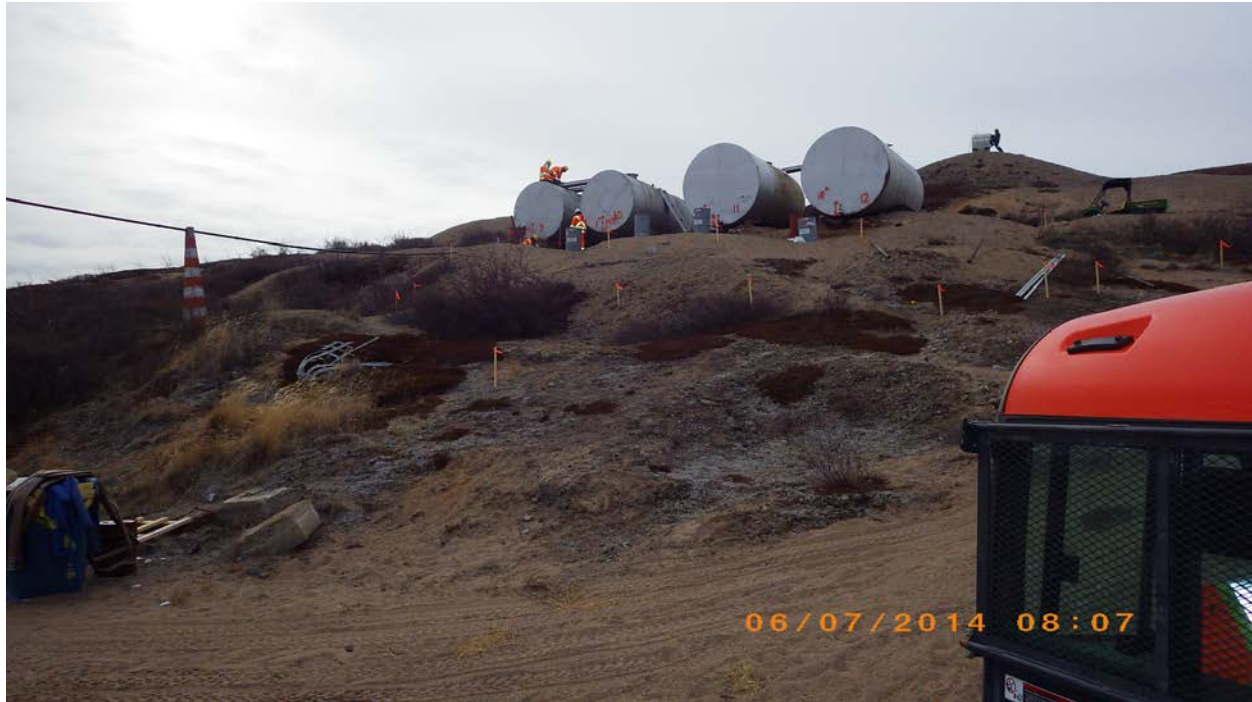
Photo 19: Looking south up at APECs (from left to right): APEC 9 (Tank 1), APEC 10 (Tank 2), APEC 11 (Tank 3), and APEC 12 (Tank 4). The stakes mark out APEC 12 excavation. APEC 13, overhead pipeline, is visible on the left (June 7, 2014).

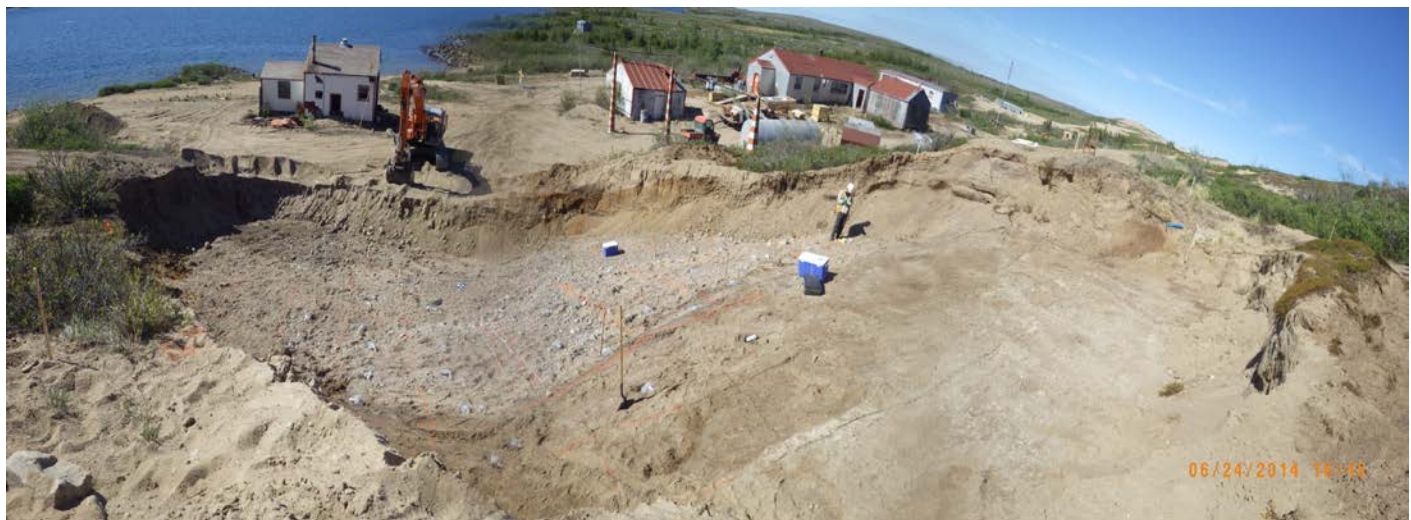
Photo 20: Looking northwest over APEC 12 excavation to survey limits (June 24, 2014).

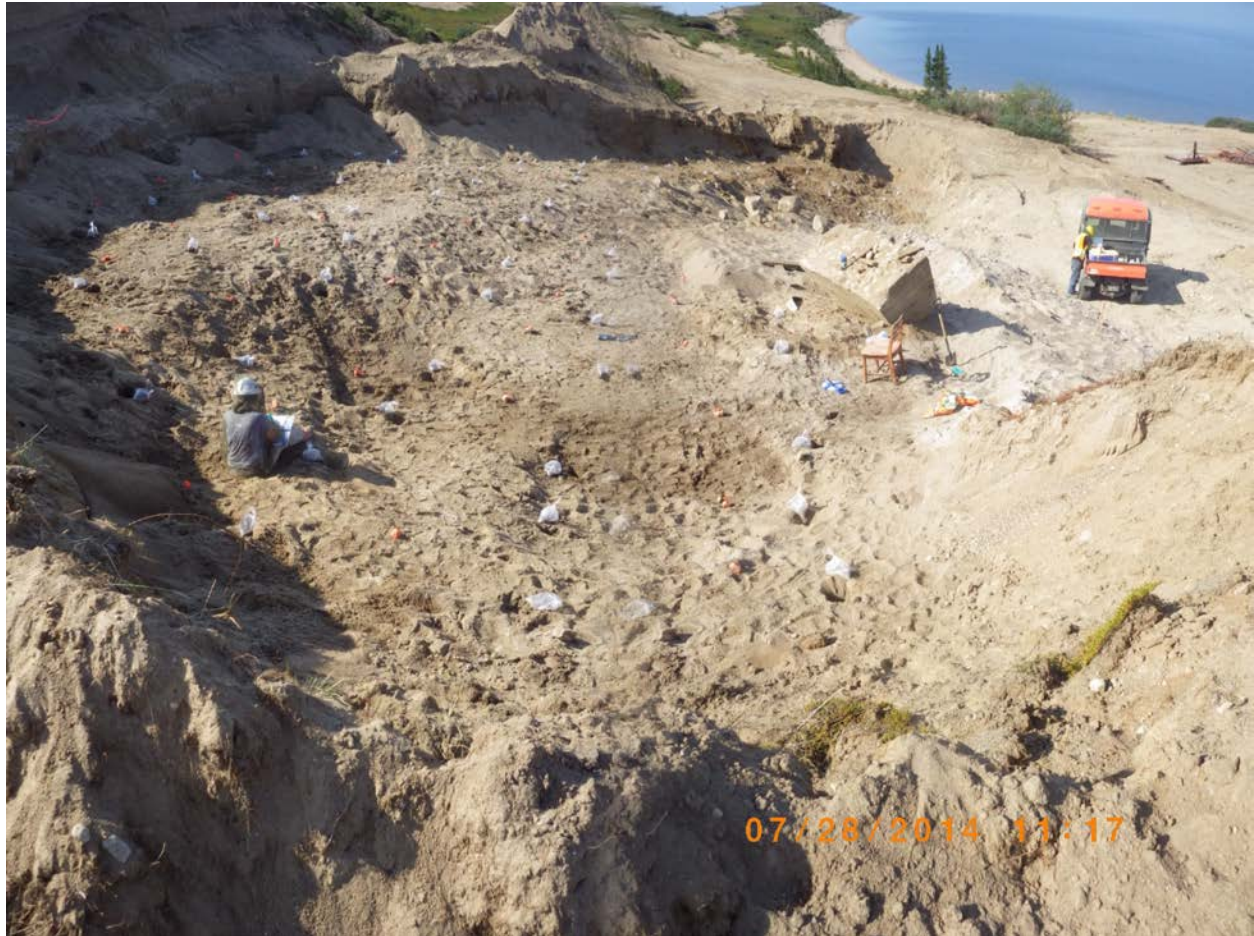
Photo 21: Looking southwest at additional excavation of the south and southwest walls of APEC 12 excavation. APEC 12 areas 2 and 3 are backfilled in the top right corner (July 28, 2014).

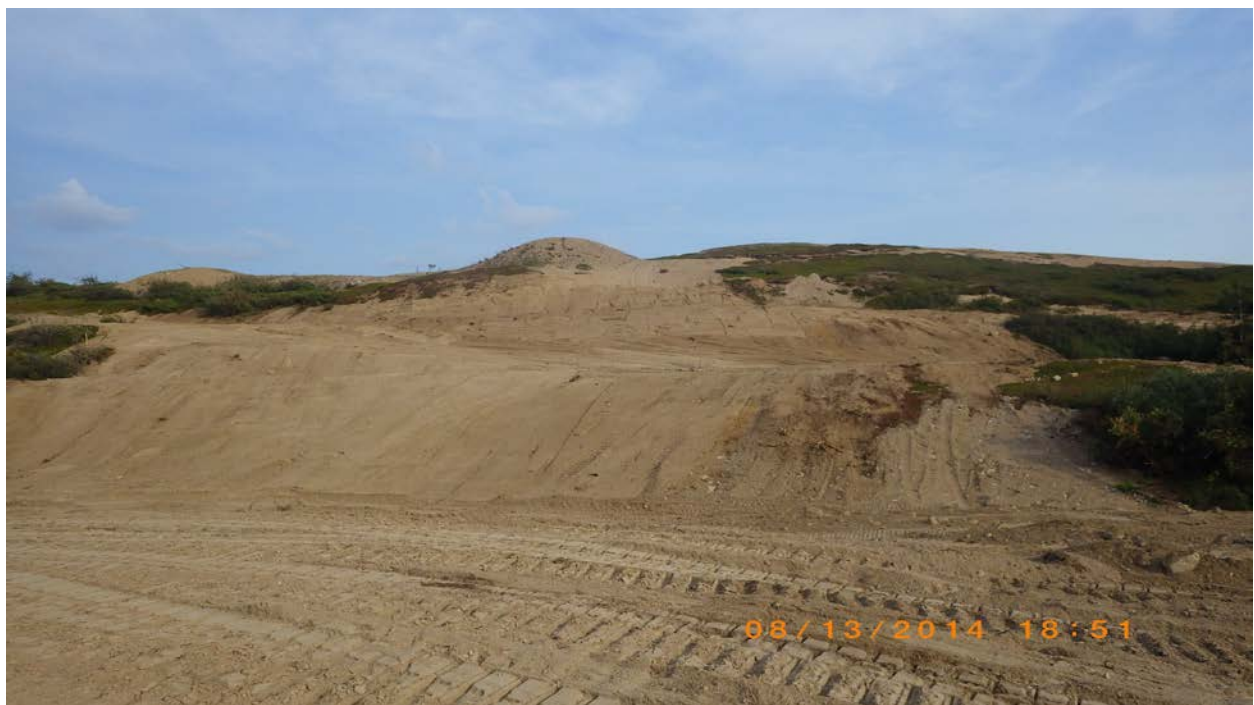
Photo 22: Looking south at backfilled and re-graded APEC 12 excavation (August 13, 2014).

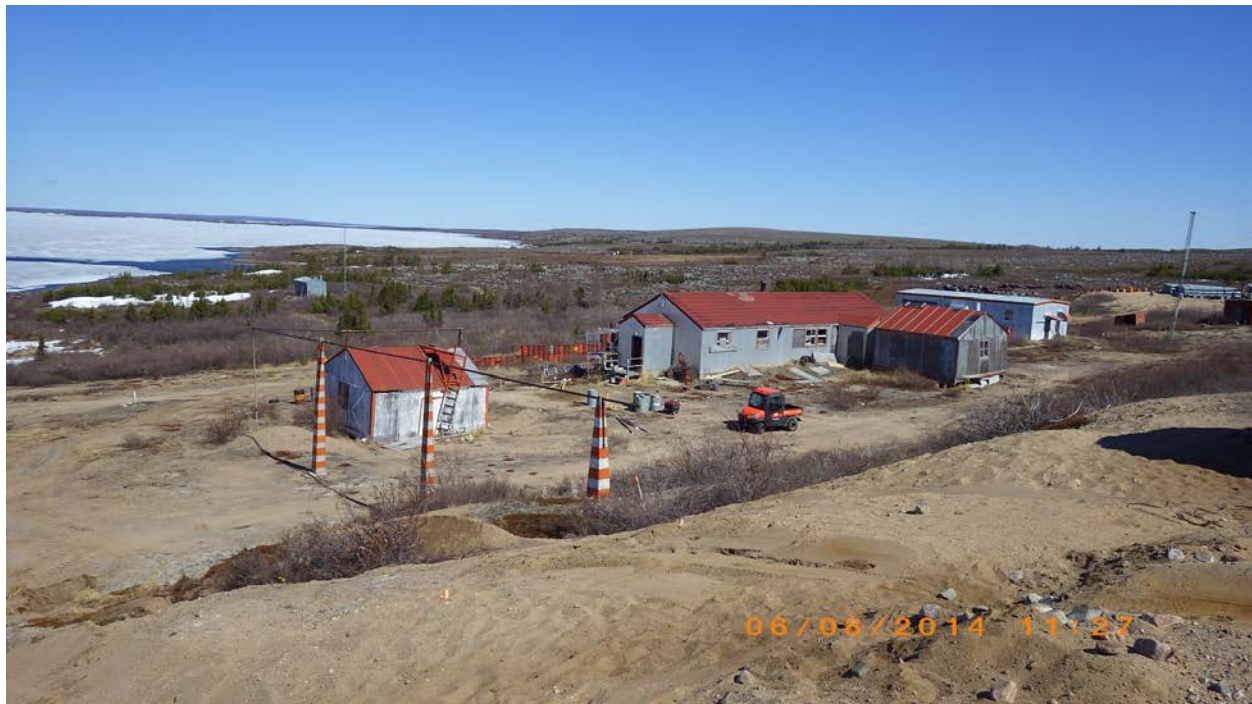
Photo 23: Looking north at APEC 13, overhead pipeline, and buildings (left to right): APEC 16 (Building 3), APEC 14 (Building 1), APEC 17 (Building 4) and APEC 15 (Building 2).

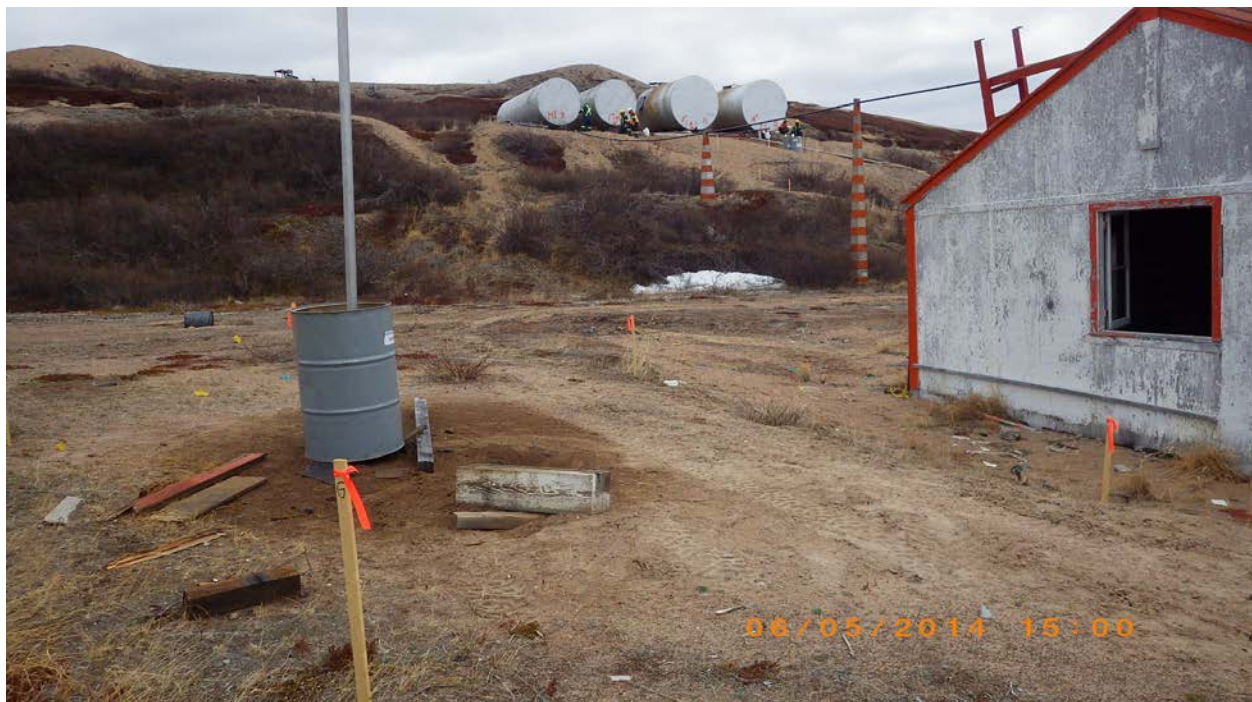
Photo 24: Looking south at APEC 13.1 the stained soil to be excavated between APEC 16 (Building 3) on the right, and APEC 14 (not shown) (June 5, 2014).

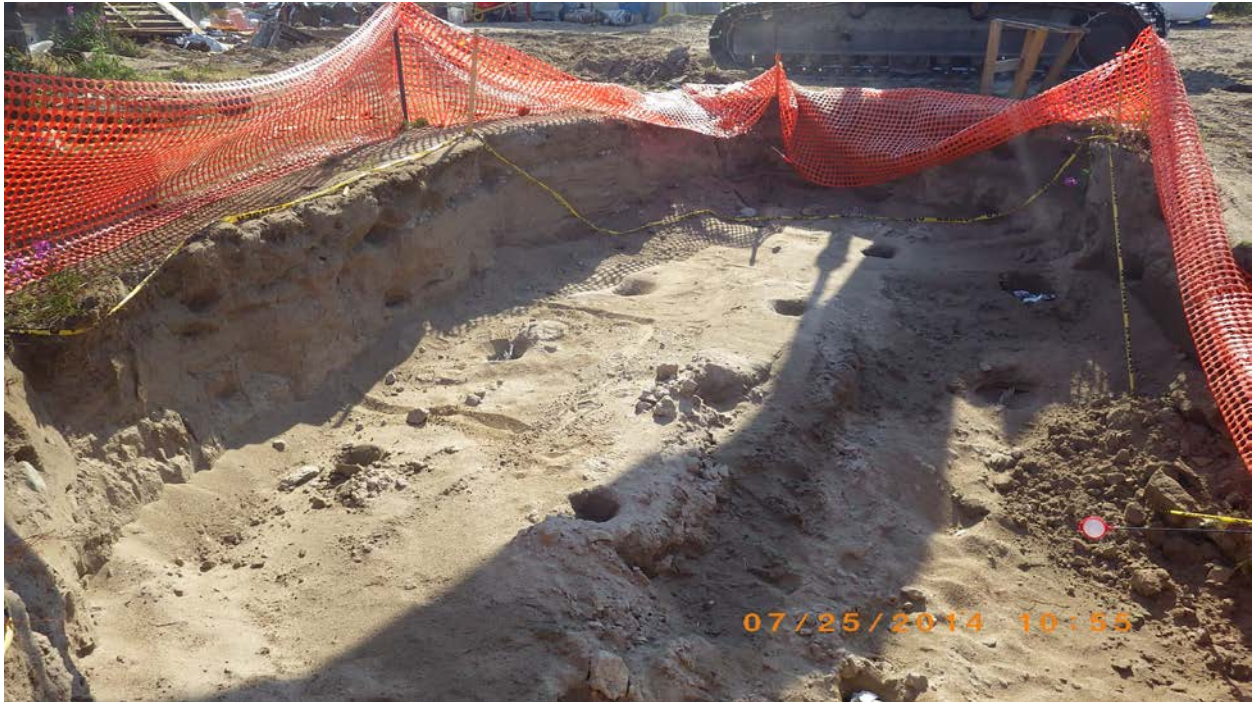
Photo 25: Looking south over APEC 13.1 excavated to survey limits. Note square on left hand side indicating sample exceedance that was further excavated (July 25, 20114).

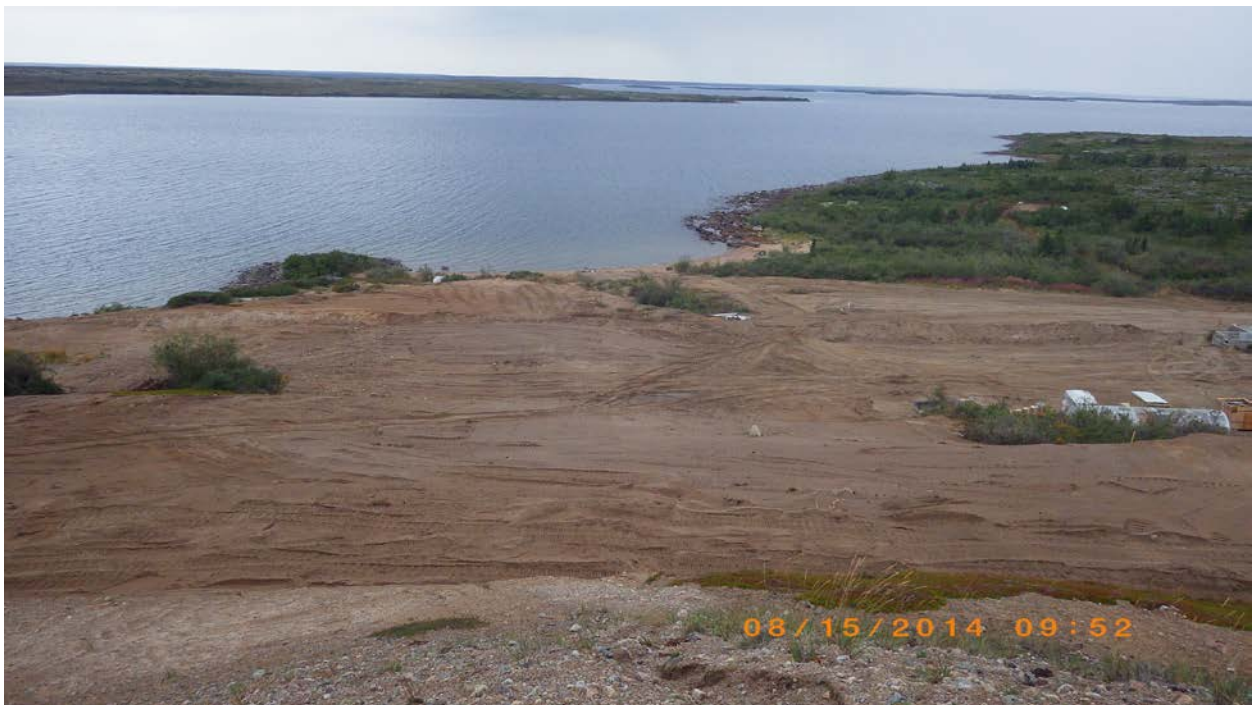
Photo 26: Looking north at former locations of APEC 18 (Building 5), APEC 16 (Building 3) and APEC 13.1 excavation.

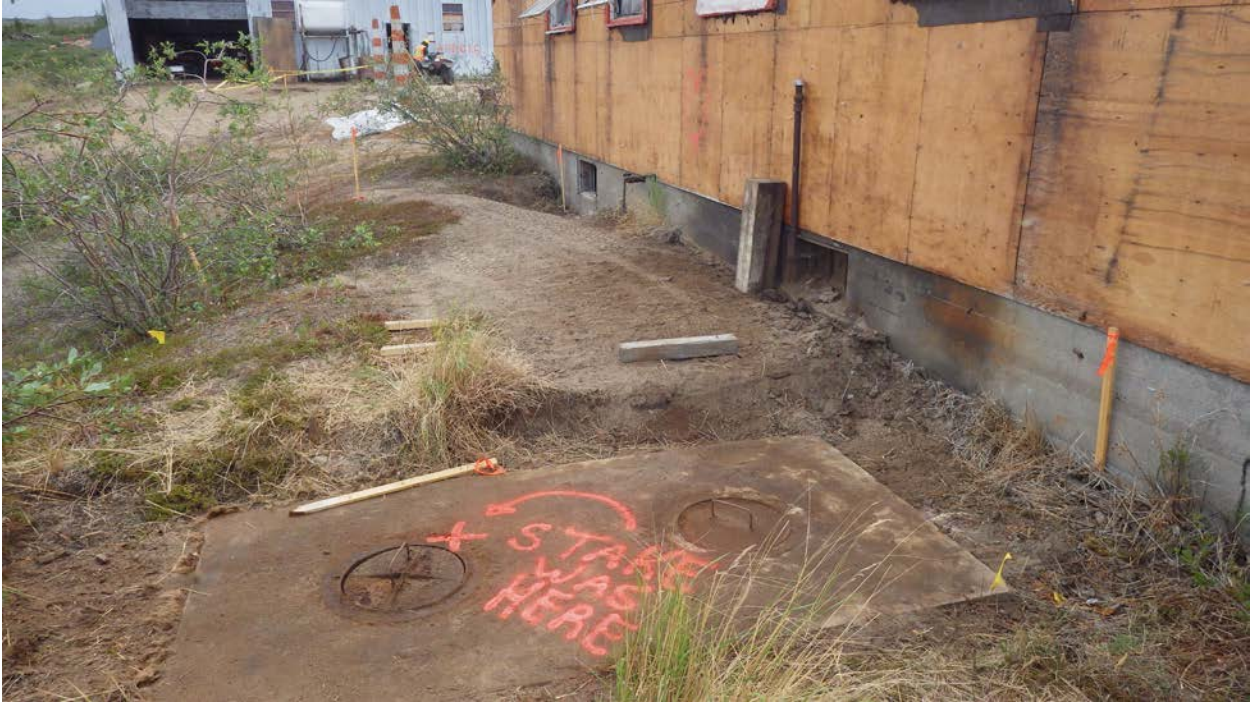
Photo 27: Looking northeast at APEC 13.2 excavation indicated by survey stakes (June 28, 2014).

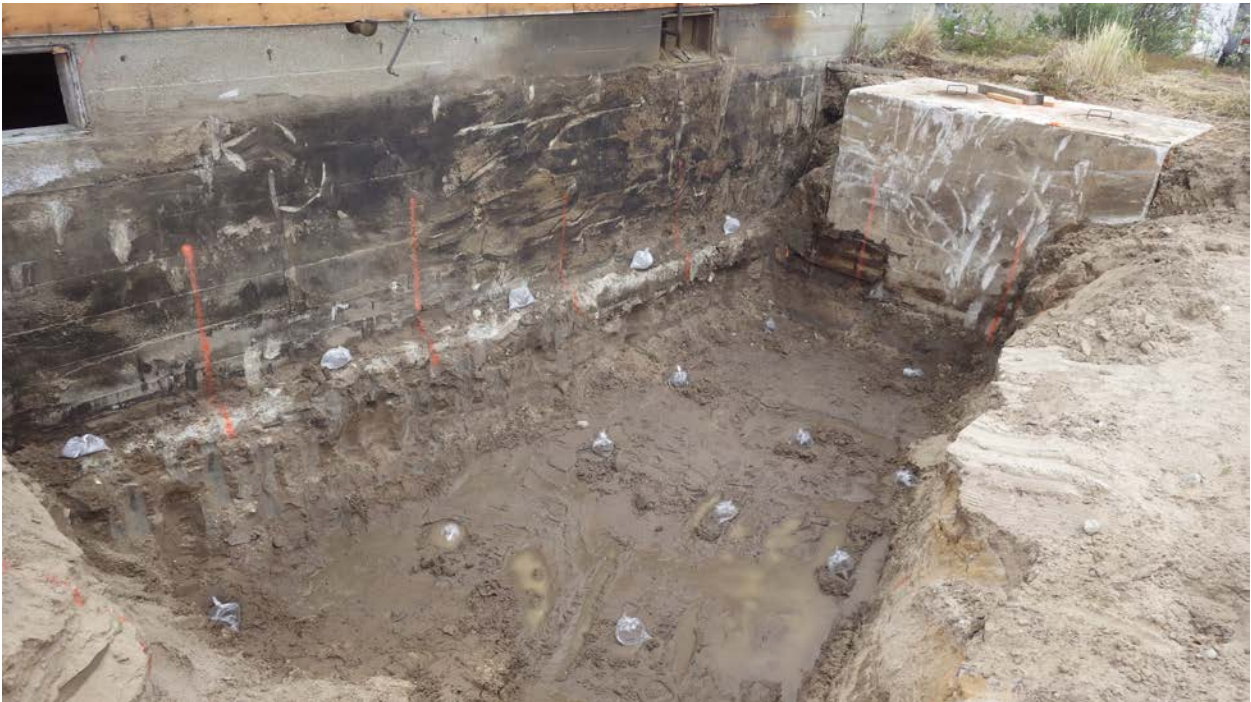
Photo 28: Looking south at APEC 13.2 excavation to survey limits (June 30, 2014).

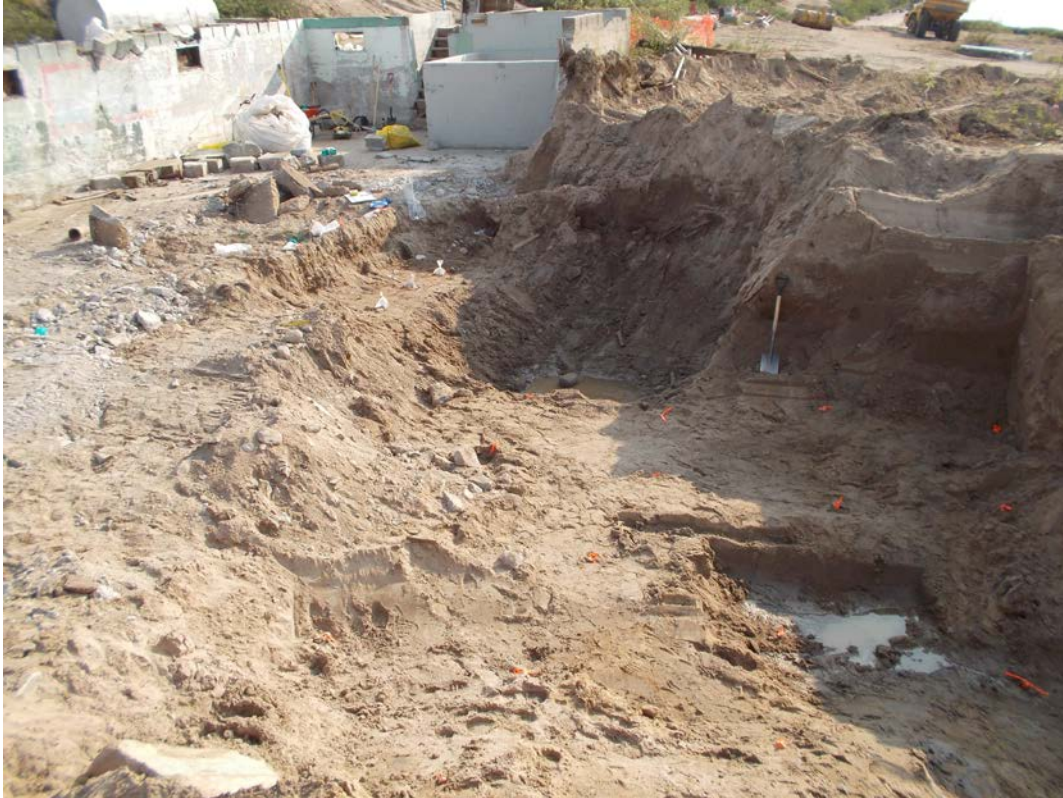
Photo 29: Looking south at additional excavation of APEC 13.2 to the north and south (under the basement floor of APEC 14(Building 1)) (July 28, 2014).

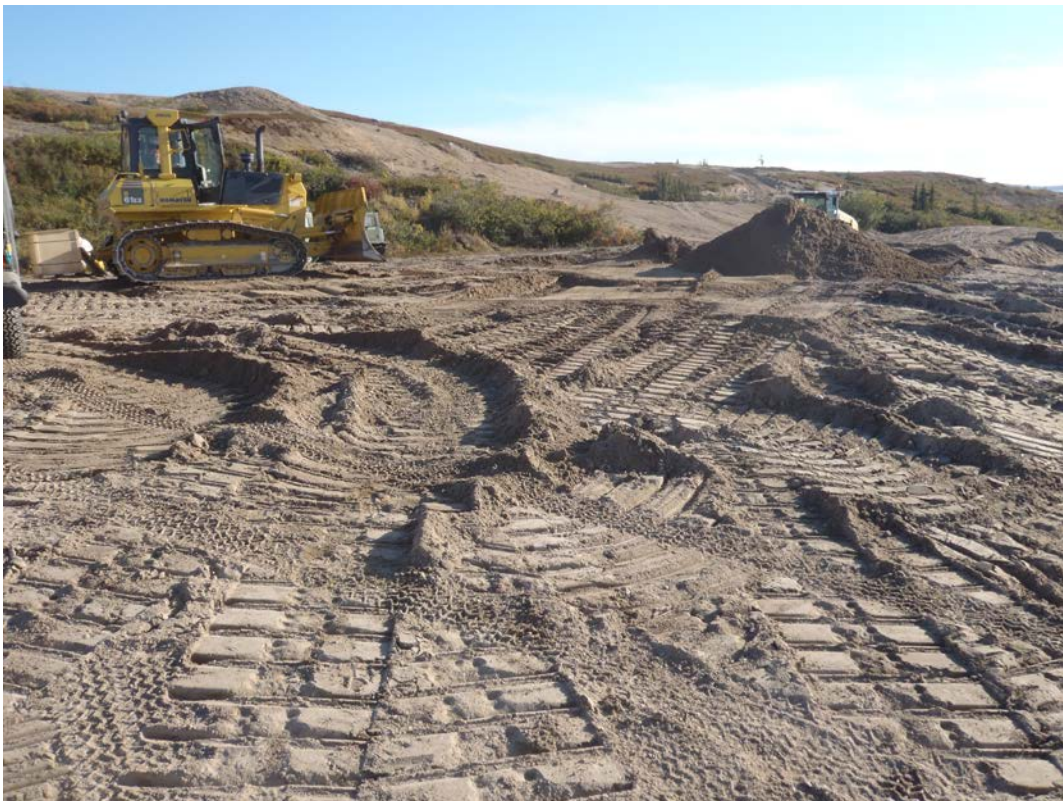
Photo 30: Looking south at backfilled APEC 13.2, APEC 14 (Building 1) and APEC 17 (Building 4) (August 30, 2014).

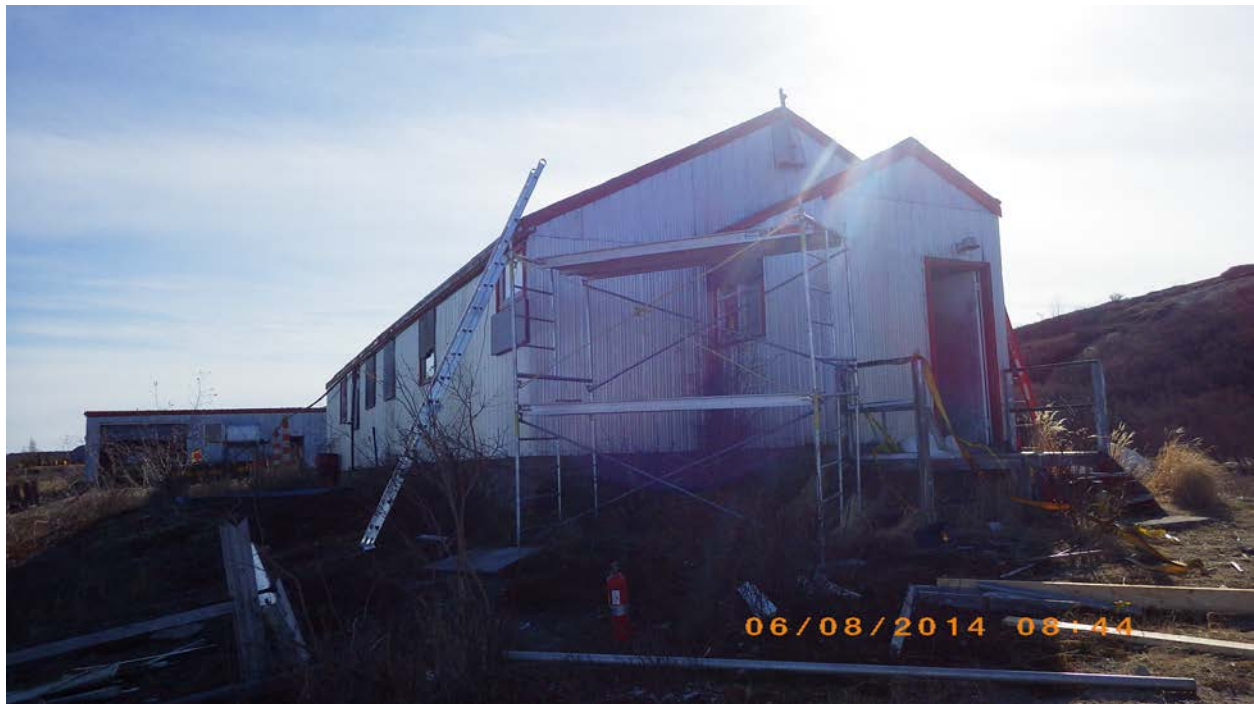
Photo 31: Looking east at the southwest side of APEC 14 (Building 1) (June 8, 2014).

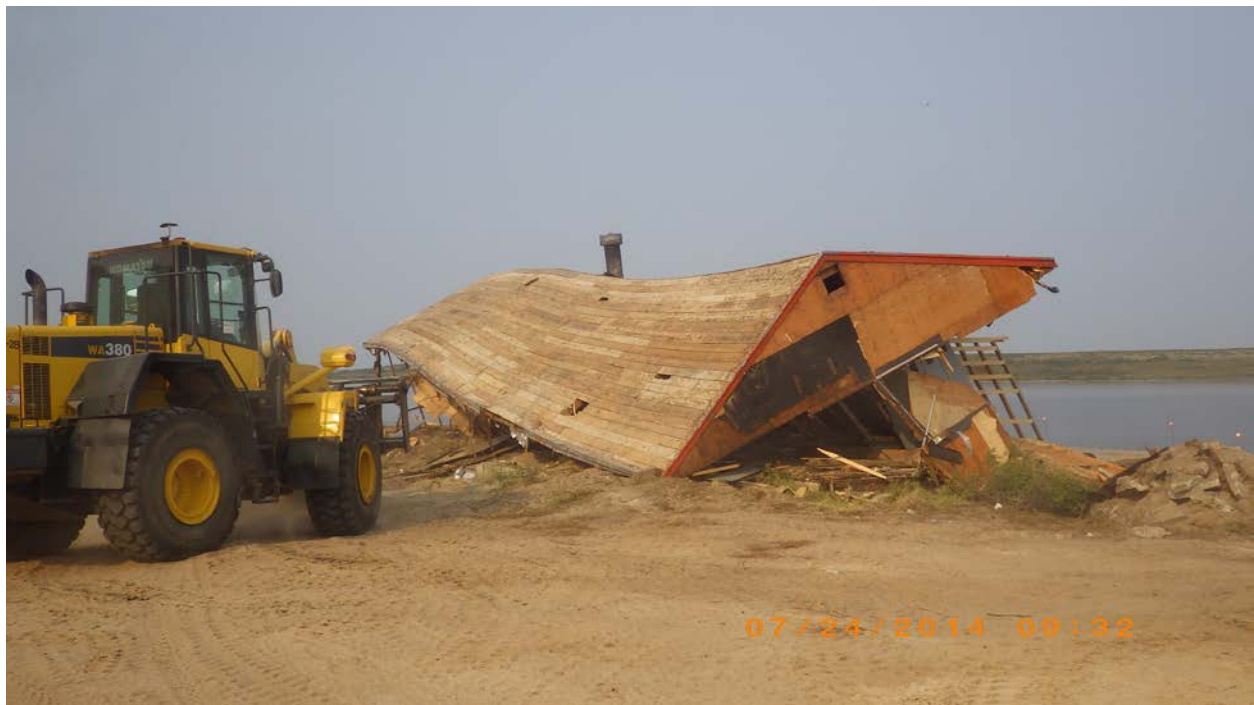
Photo 32: Demolition of APEC 14 (Building 1) (July 24, 2014). See Photo 30 for backfilled APEC 14 (Building 1).

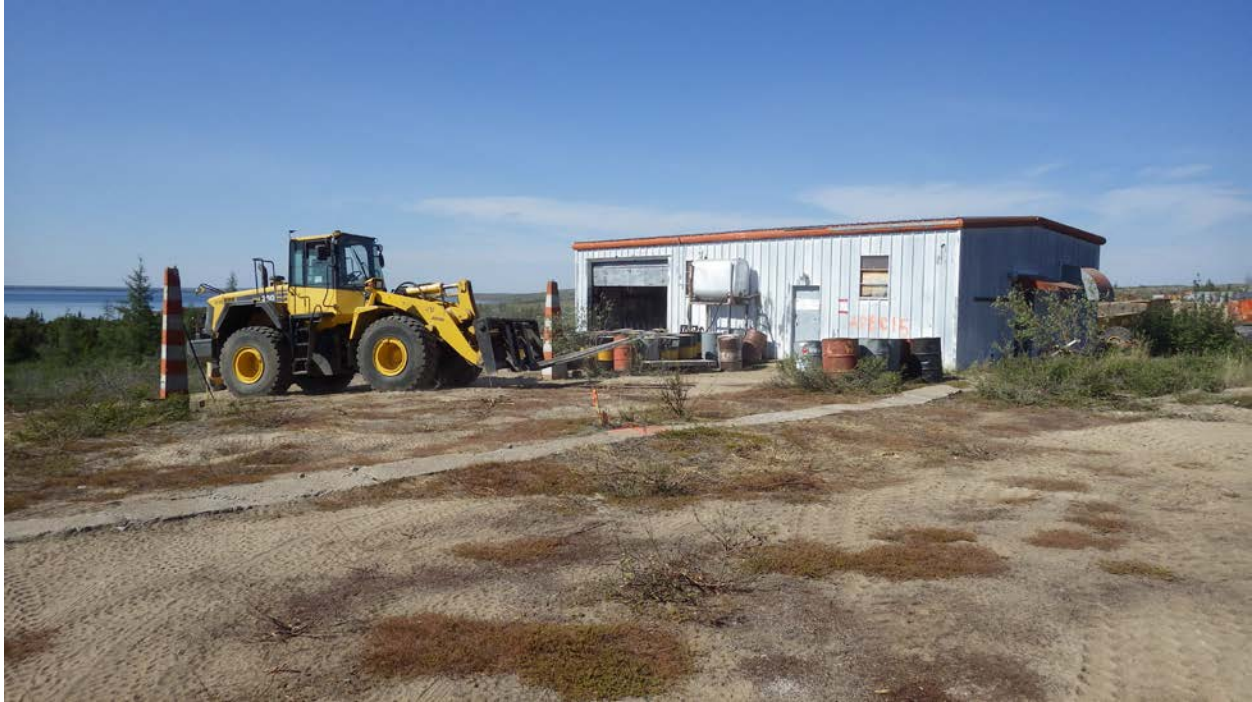
Photo 33: Looking northeast at the southwest face of APEC 15 (Building 2) (June 26, 2014).

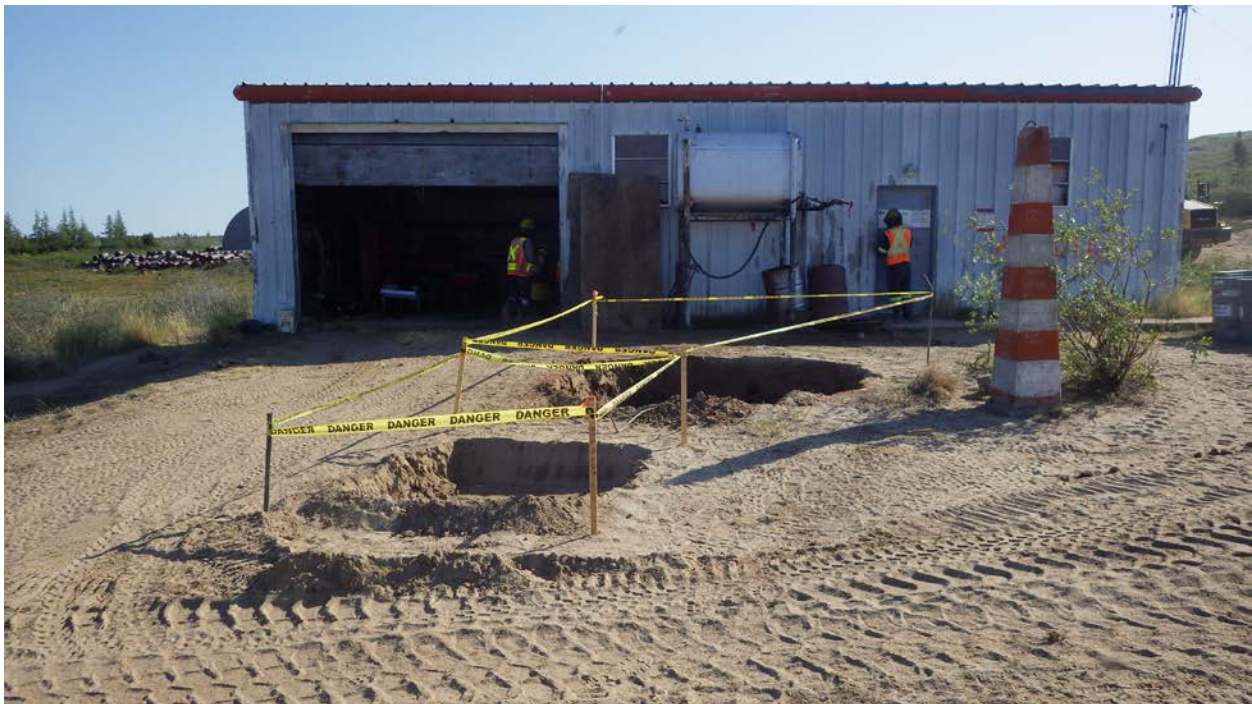
Photo 34: Excavations of metal impacted soil (APEC 15.Met) and APEC 15.1 to the southwest of APEC 15 (Building 2) (June 27, 2014).

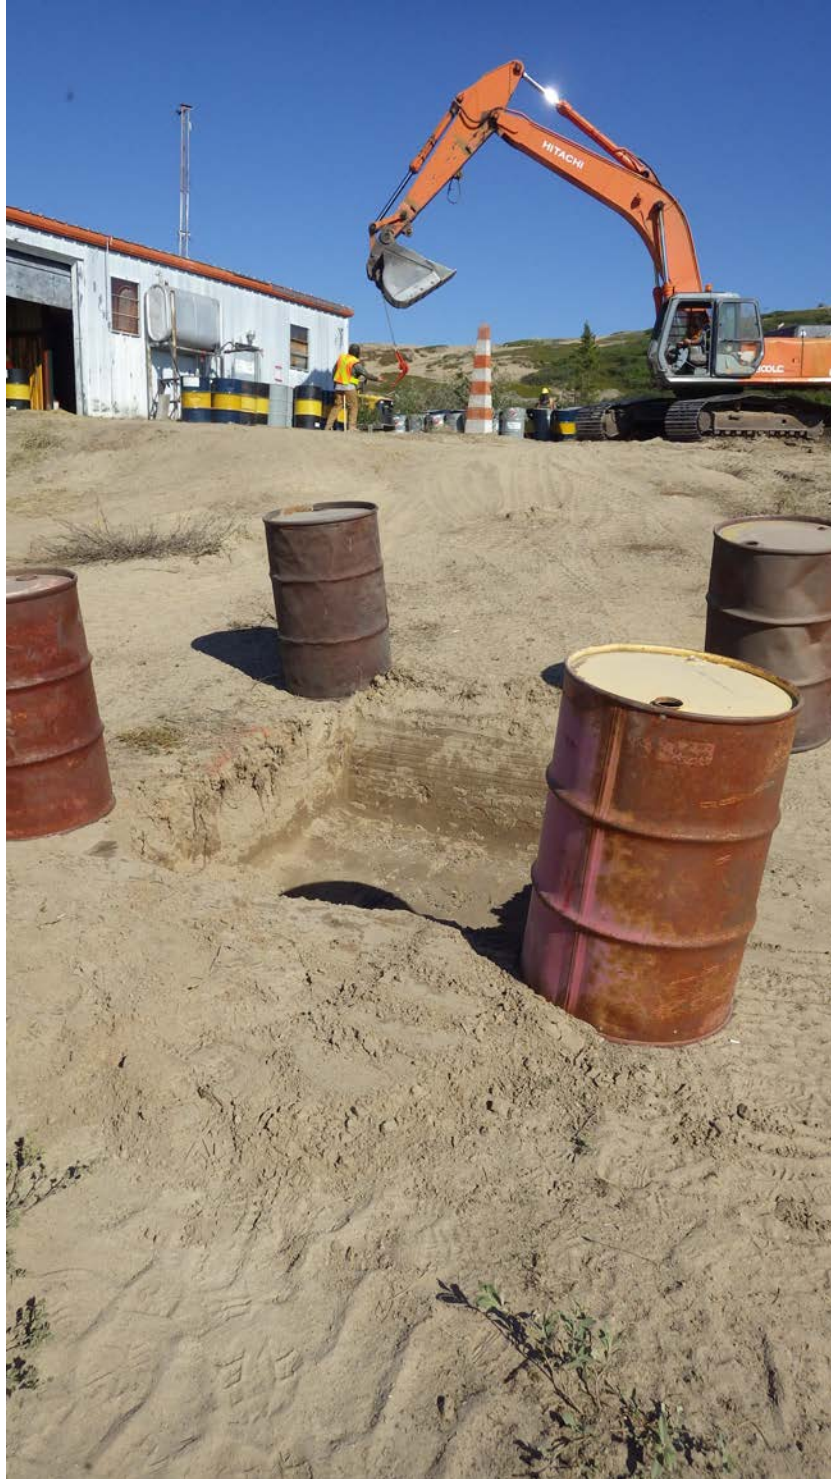
Photo 35: Looking southeast at APEC 15.2 excavation west of APEC 15 (Building 2) (June 26, 2014).

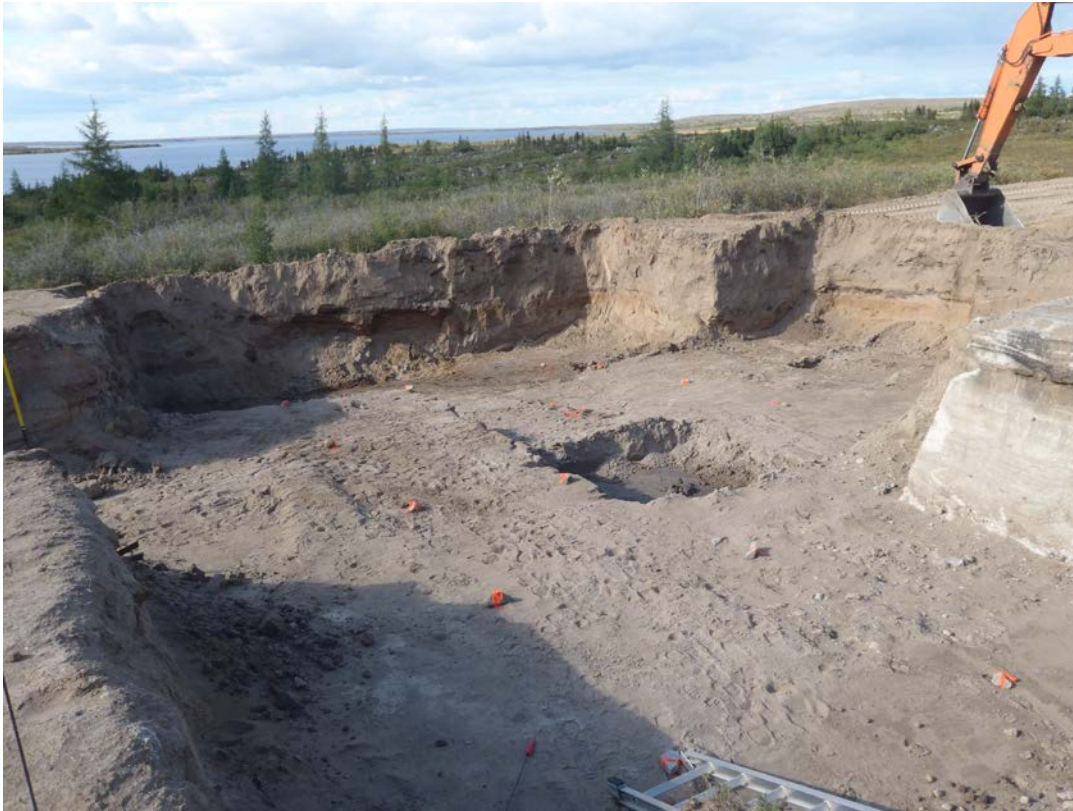
Photo 36: APEC 15.3 unidentified soil excavation along the southwest side of APEC 15 (Building 2) and expanding under the northwest corner of APEC 15 (Building 2) (August 24, 2014).

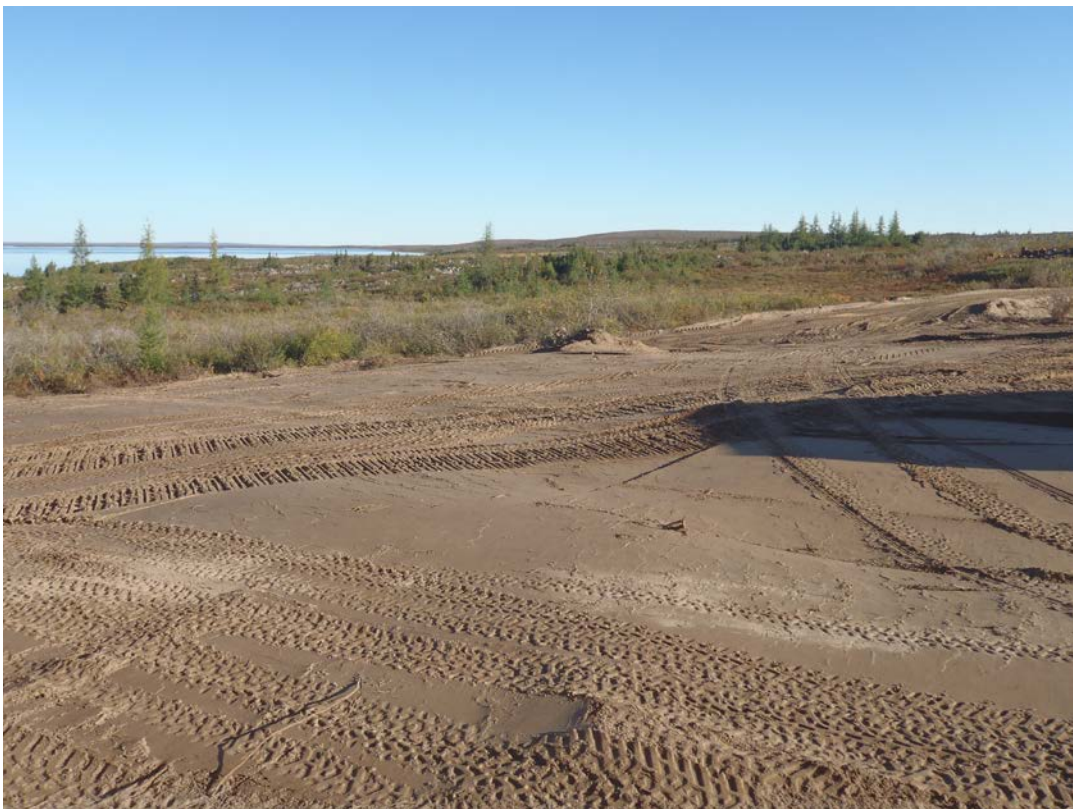
Photo 37: APEC 15 (Building 2) and APEC 15.3 excavation backfilled and re-graded (August 30, 2014).

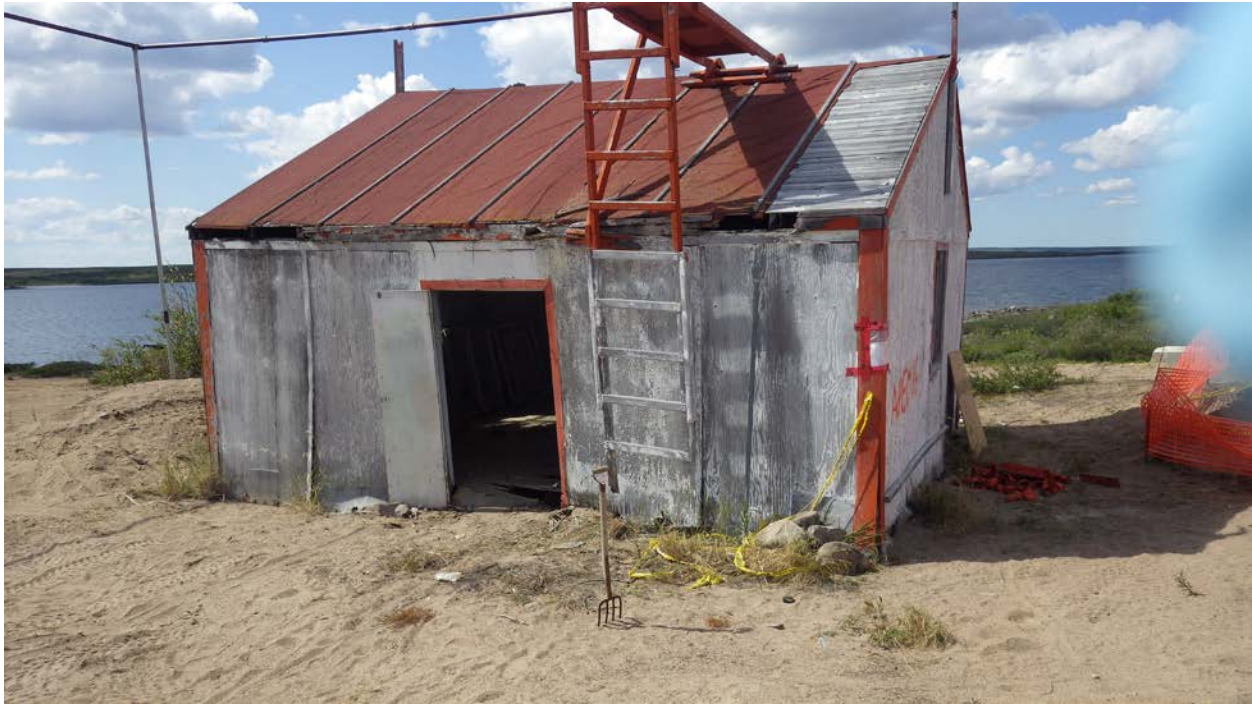
Photo 38: Looking northwest at the south side of APEC 16 (Building 3) (July 2, 2014).

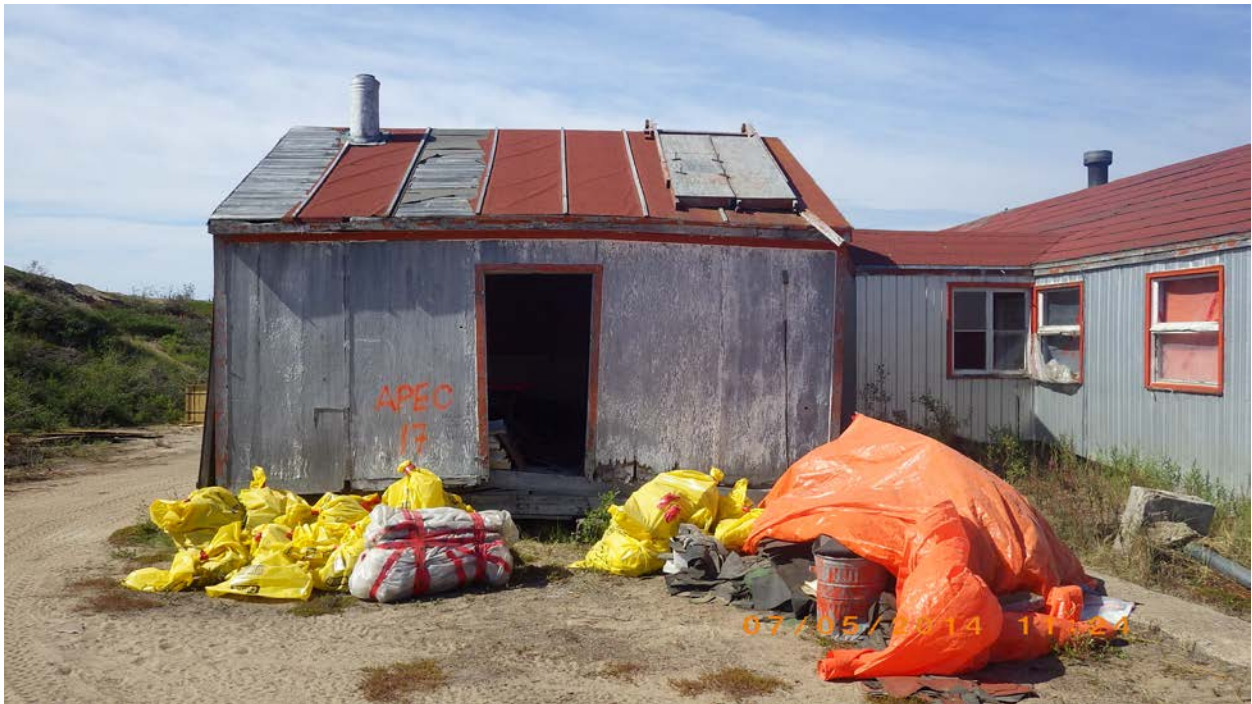
Photo 39: Looking southwest at the northeast side of APEC 17 (Building 4), with asbestos wrapped material in front, and APEC 14 (Building 1) to the right (July 5, 2014). See Photo 29 for post demolition photo.

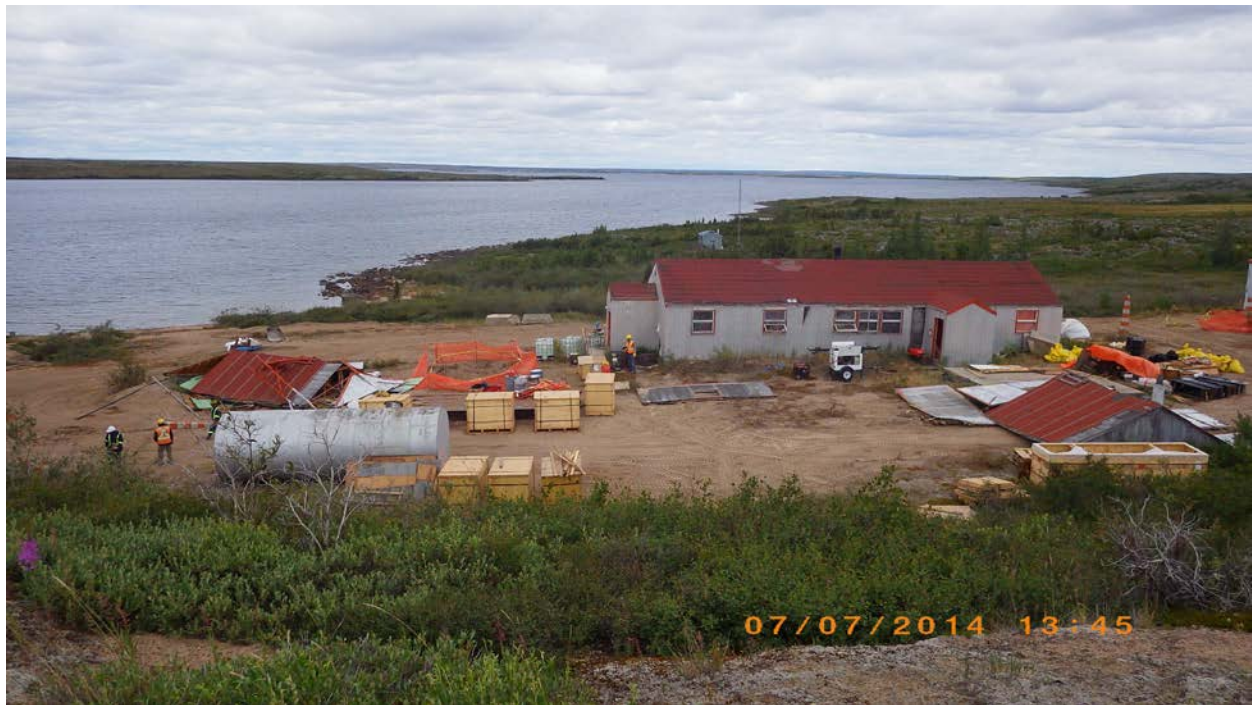
Photo 40: Looking northwest at the demolition of APEC 16 (Building 3) on the left and APEC 17 (Building 4) on the right and APEC 14 (Building 1) in the center (July 7, 2014).
