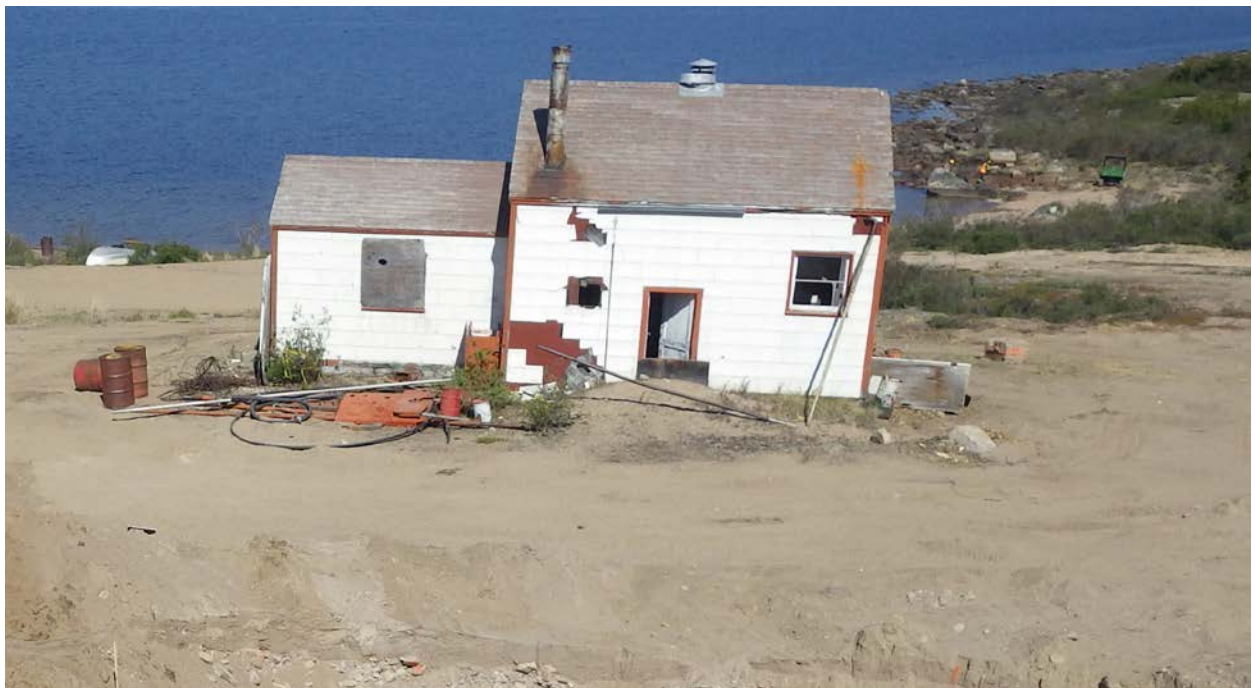
Photo 41: APEC 18 (Building 5) prior to demolition (June 26, 2014).

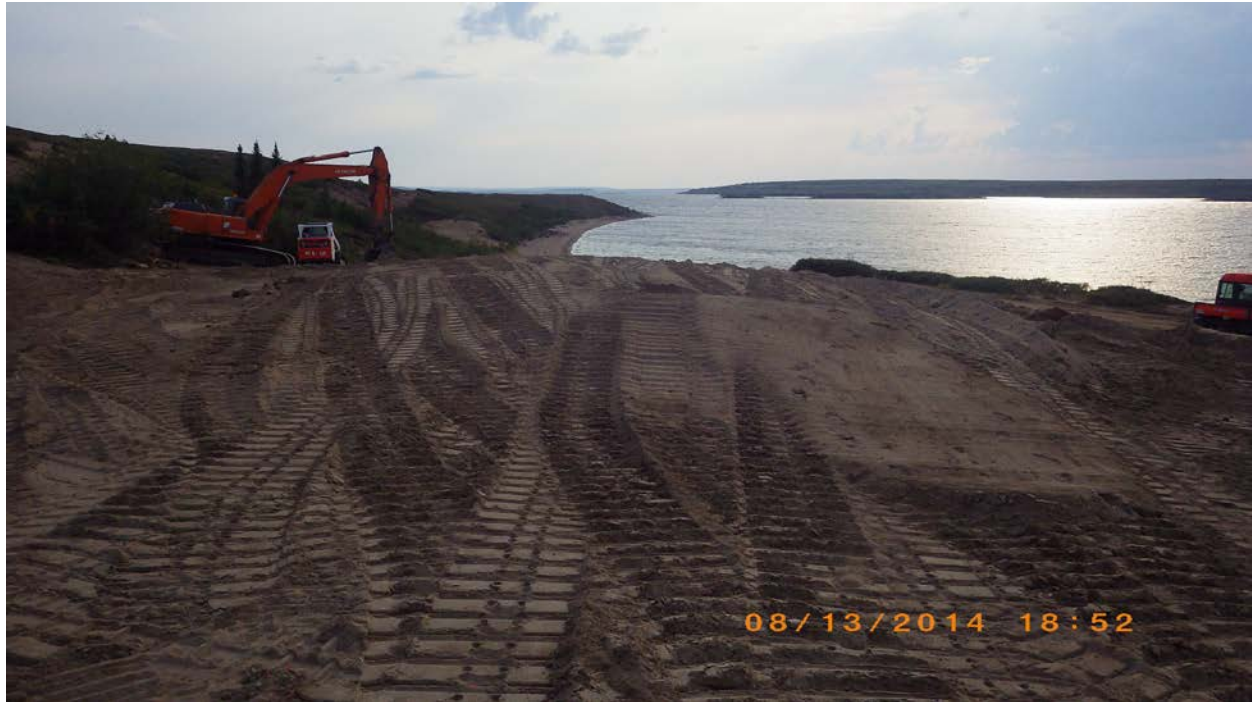
Photo 42: Looking southwest at former location of APEC 18 (Building 5) (August 13, 2014).

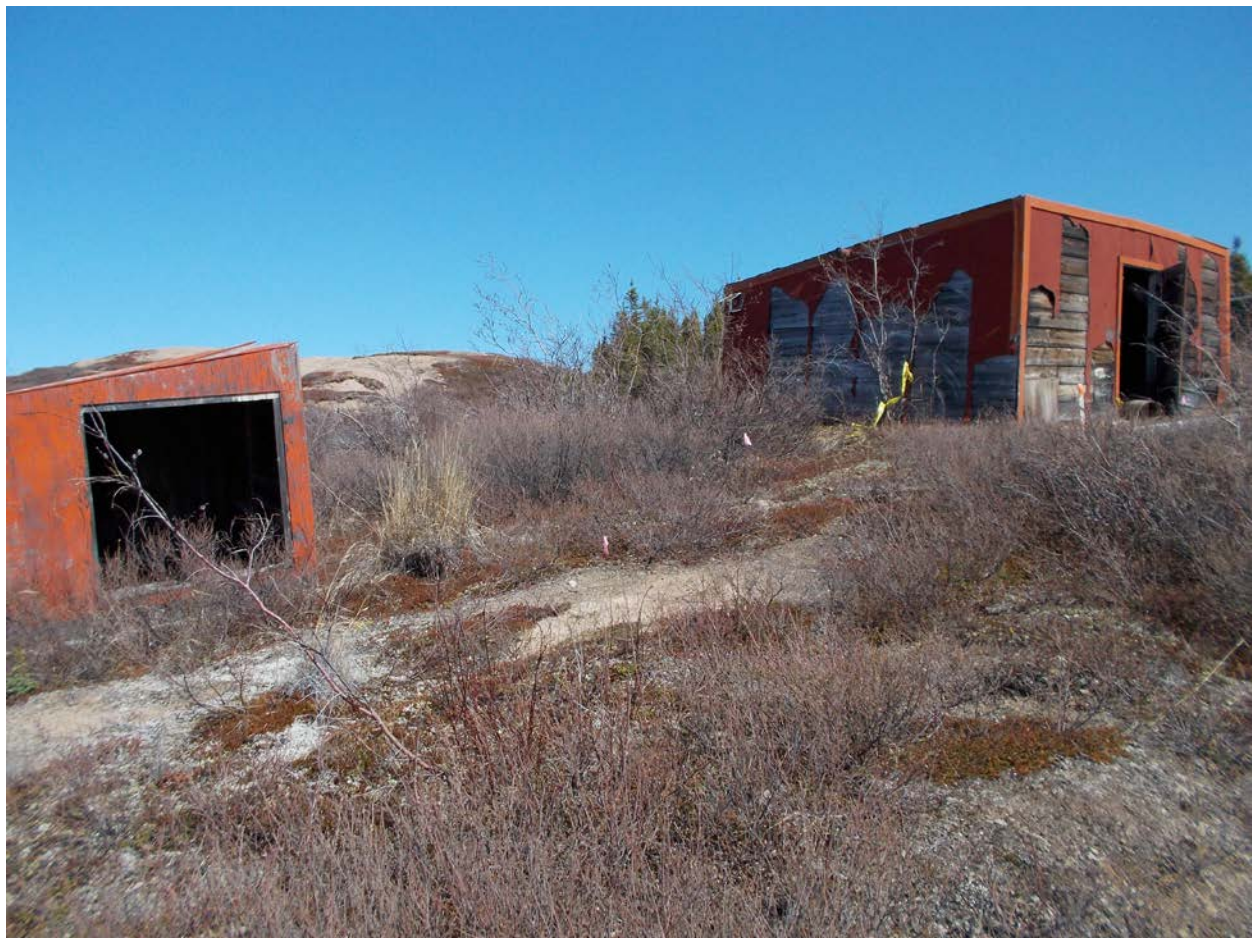
Photo 43: Looking northeast APEC 19 (Building 6) and APEC 20 (June 3, 2014).

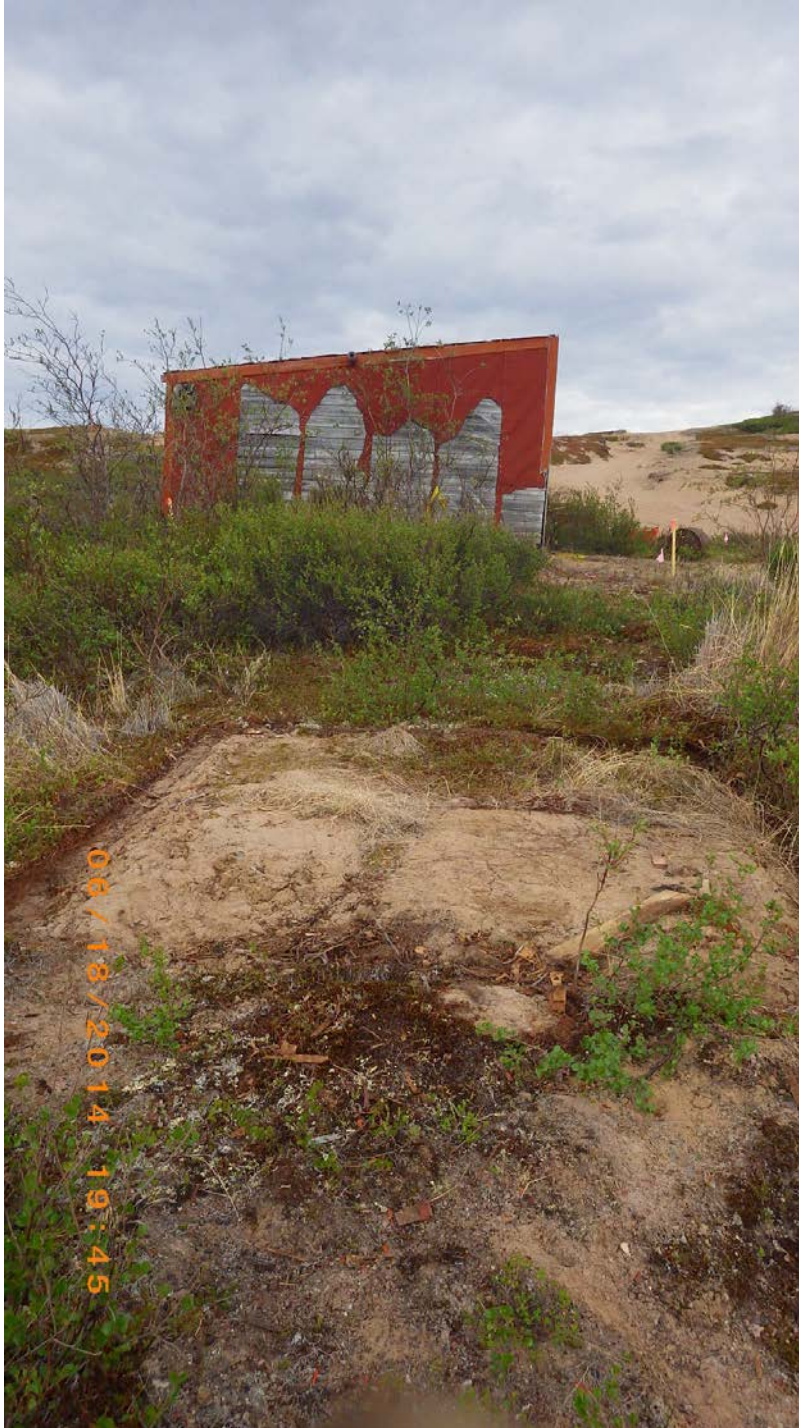
Photo 44: Footprint of former APEC 19 (Building 6) post demolition. APEC 20 (Building 7) is visible in the background (June 18, 2014).
