REMEDIATION OF THE ENNADAI LAKE FORMER WEATHER STATION, NU

Appendix E LU/WL Inspection
March 31, 2016

Project: Ennadai Lake Remediation

Water Licence No.: 1BR-ELR1419

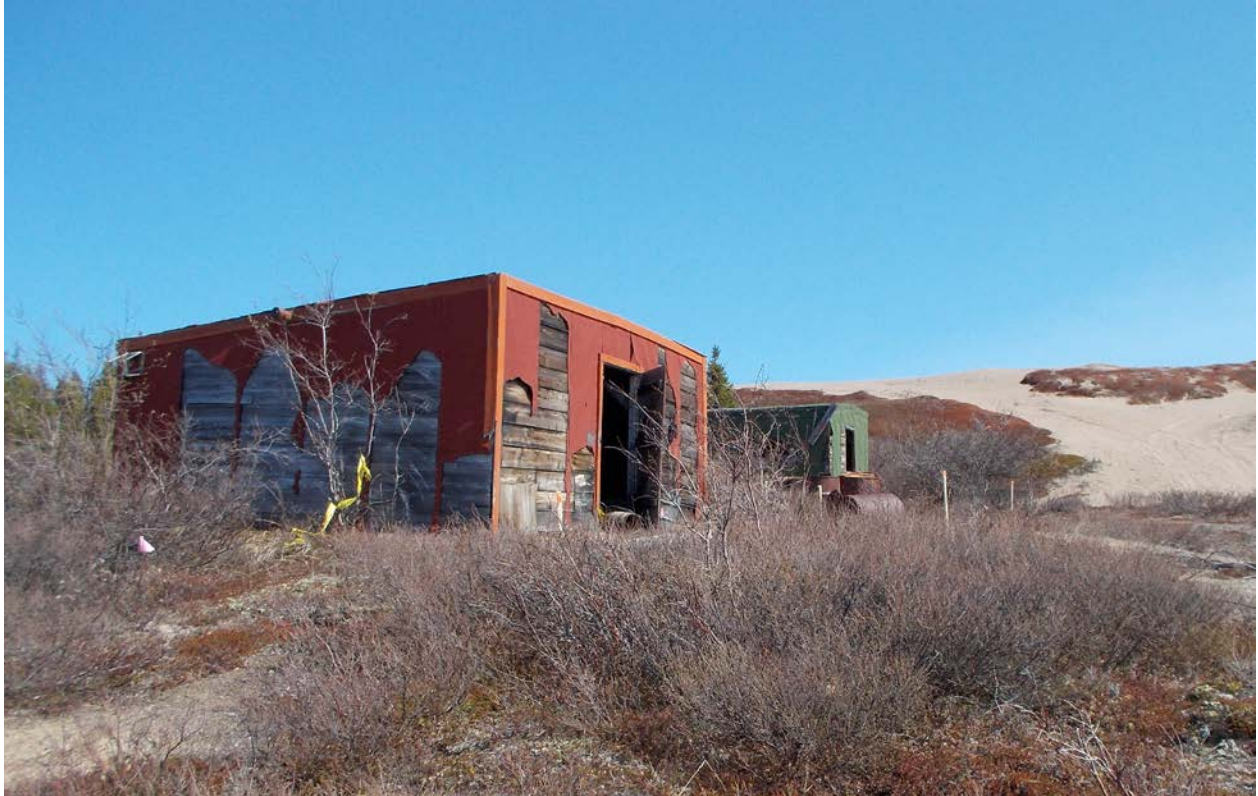
Photo 45: Looking southeast at APEC 20 (Building 7) and APEC 21 (Building 8) (June 3, 2014).

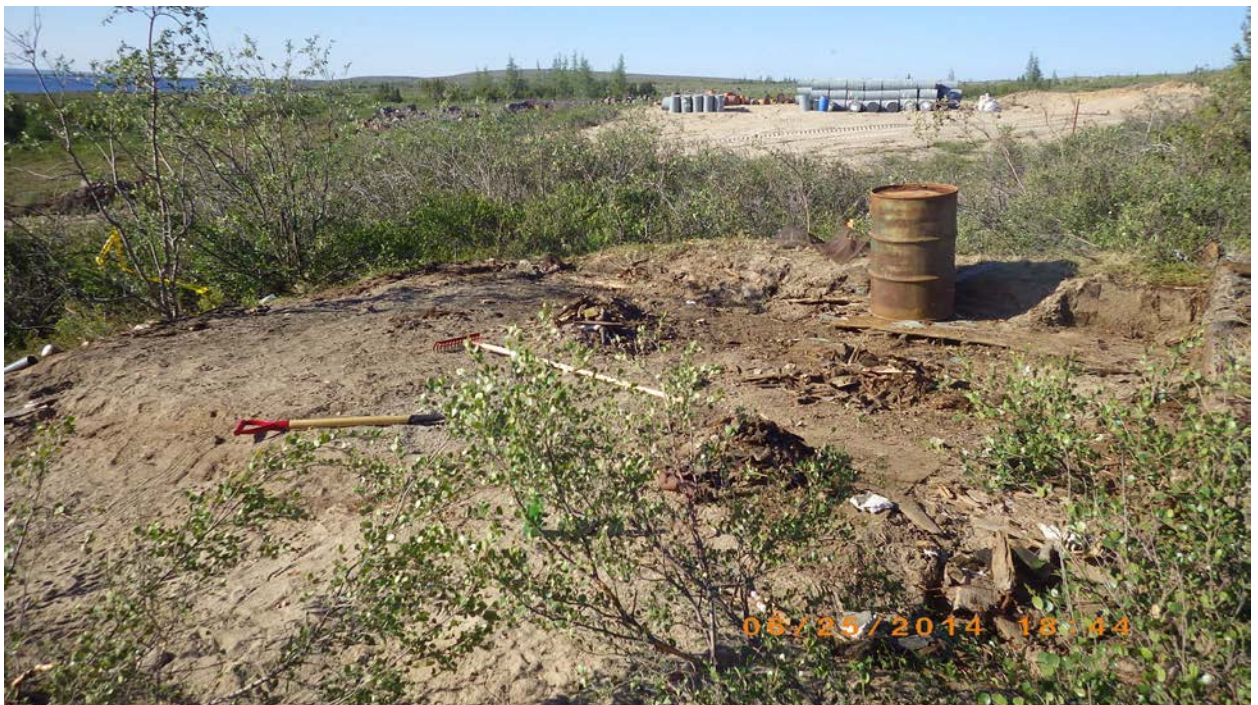
Photo 46: APEC 20 (Building 7) post demolition (June 25, 2014).

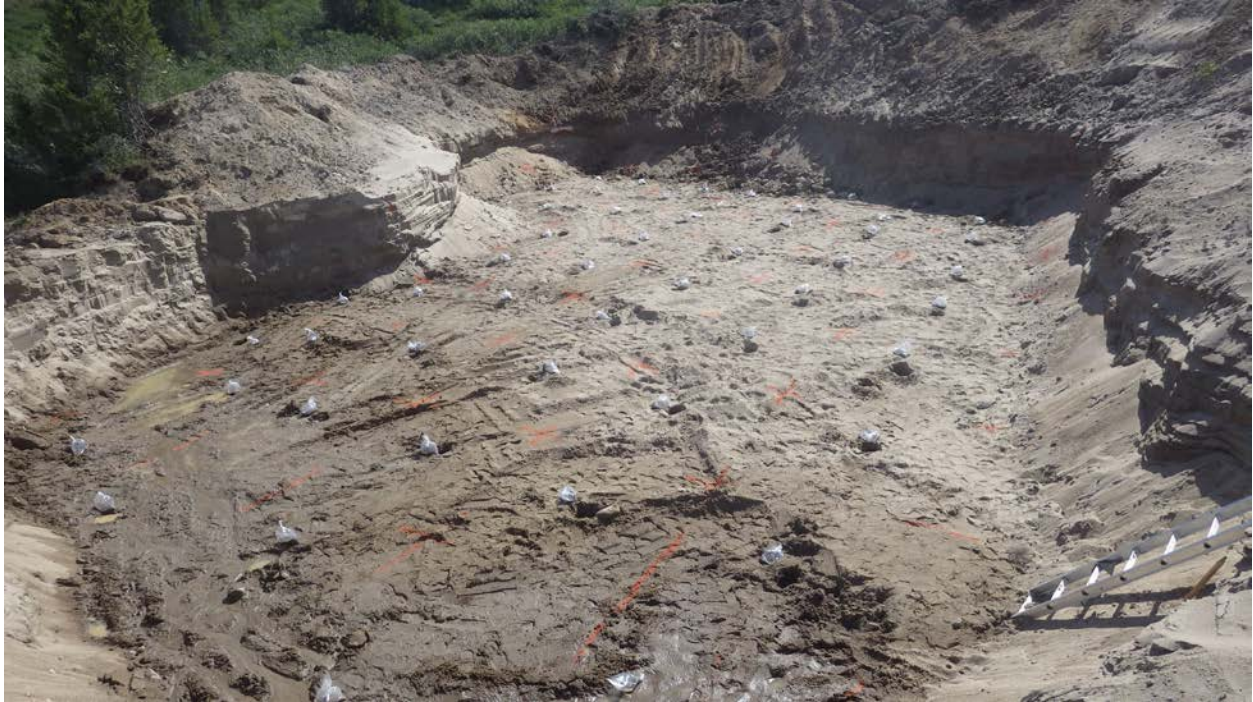
Photo 47 APEC 20.1 excavation completed to survey limits (July 2, 2014).

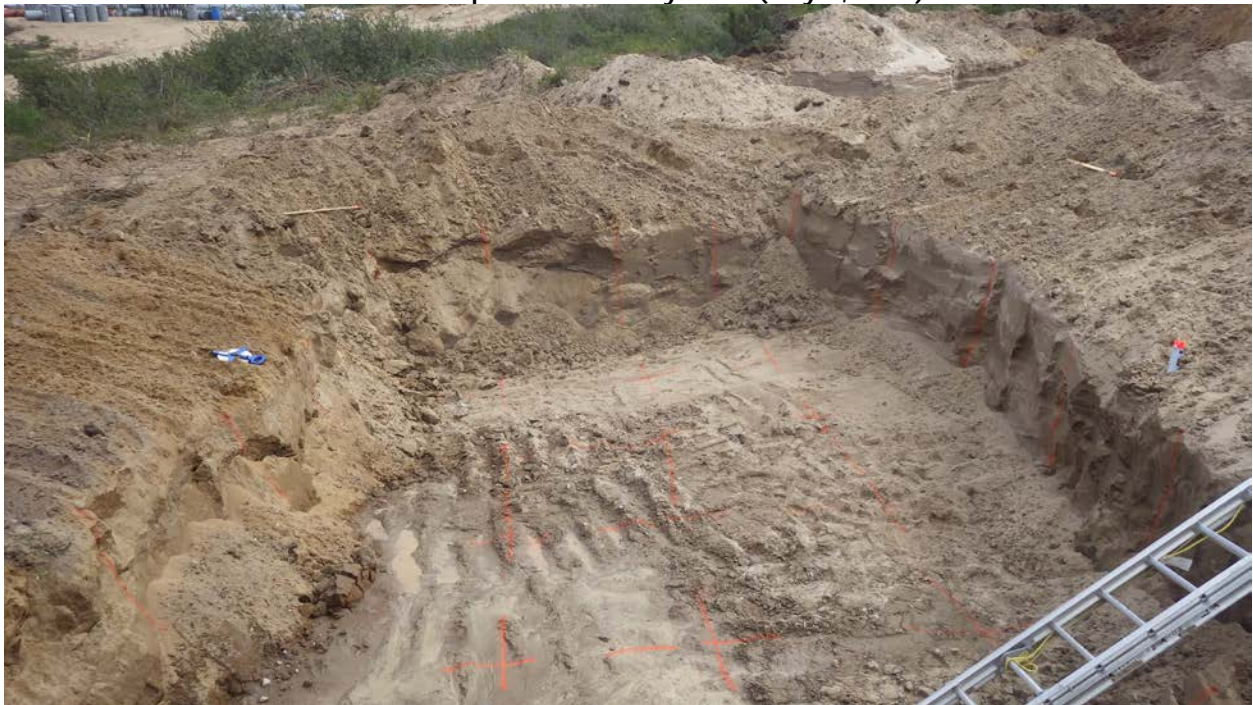
Photo 48: Looking northeast at APEC 20.2 excavation completed to survey limit (June 30, 2014).

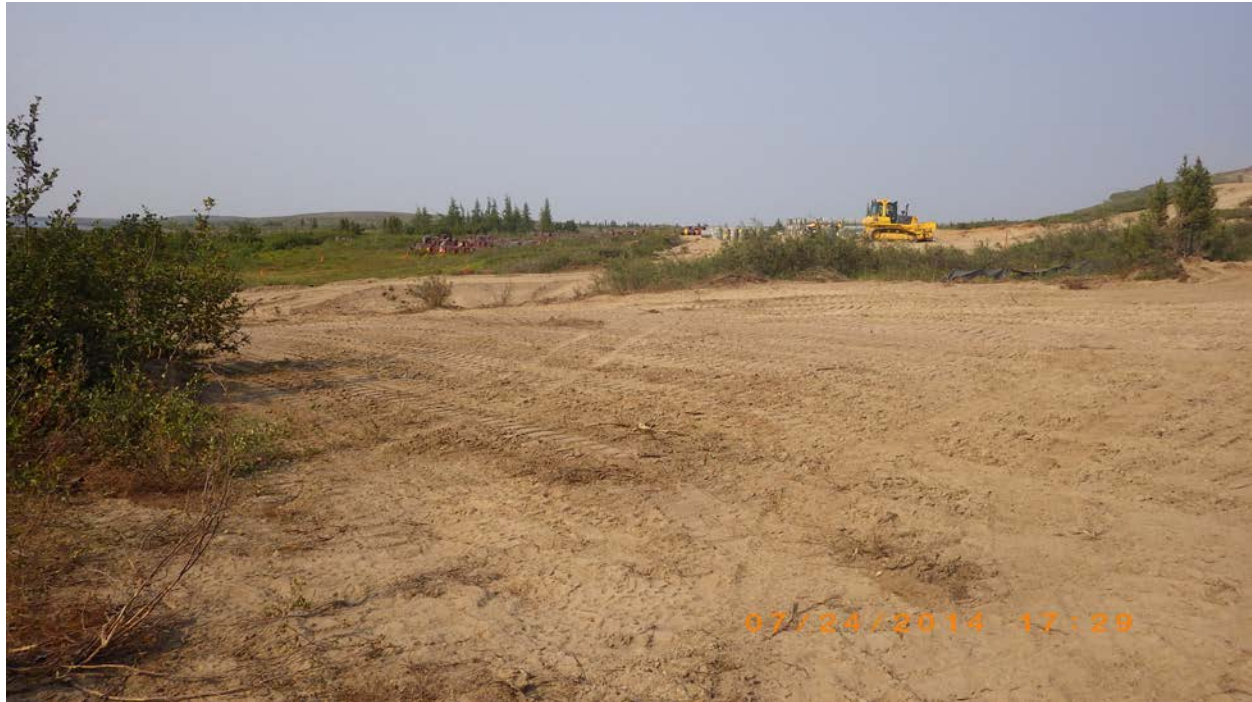
Photo 49: Looking northeast at backfilled APEC 20.1 and APEC 20.2 (July 24, 2014).

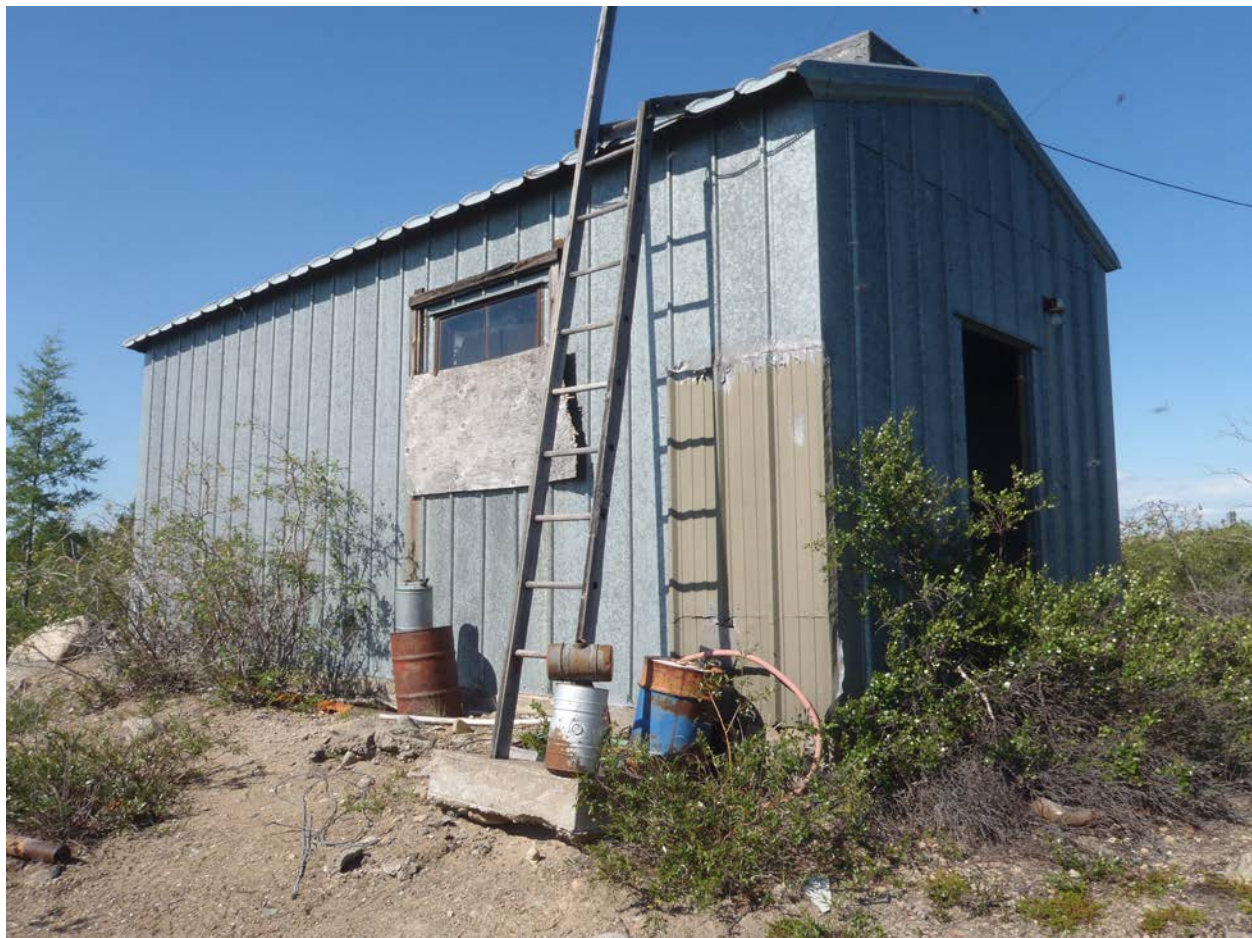
Photo 50: Building 9 at APEC 22 prior to demolition (July 3, 2014).

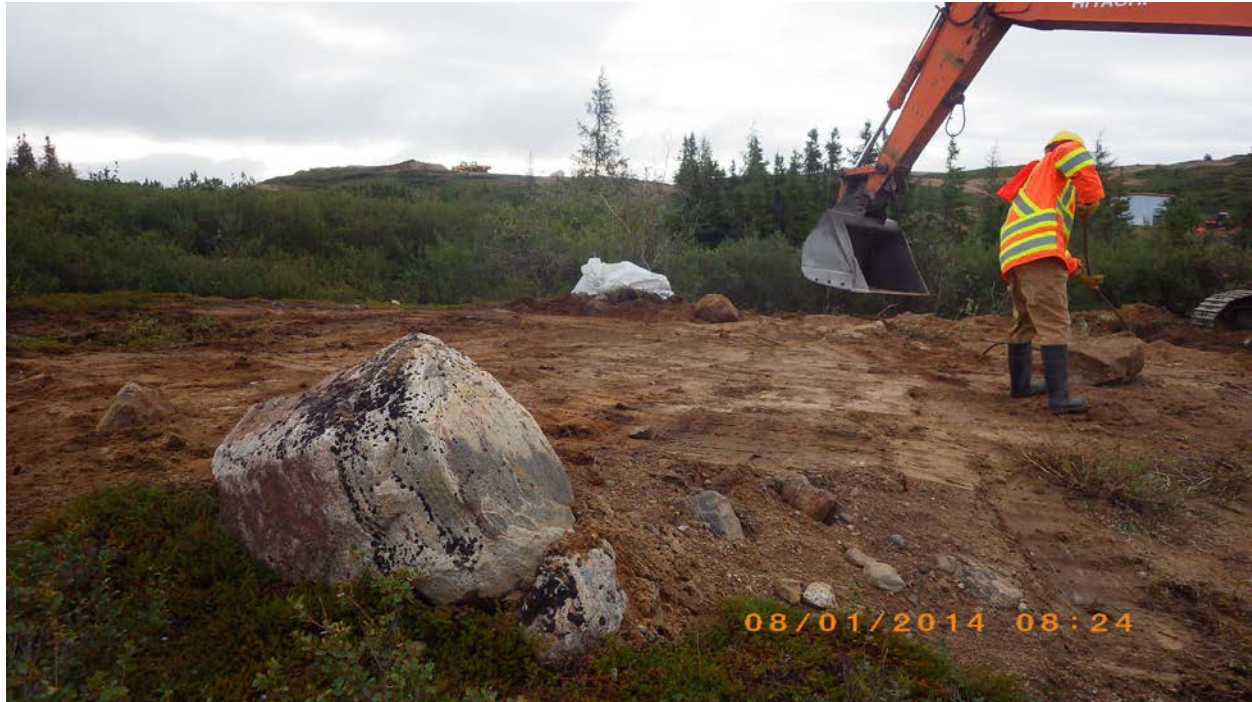
Photo 51: Backfilled excavations and re-graded area at APEC 22 (August 1, 2014).

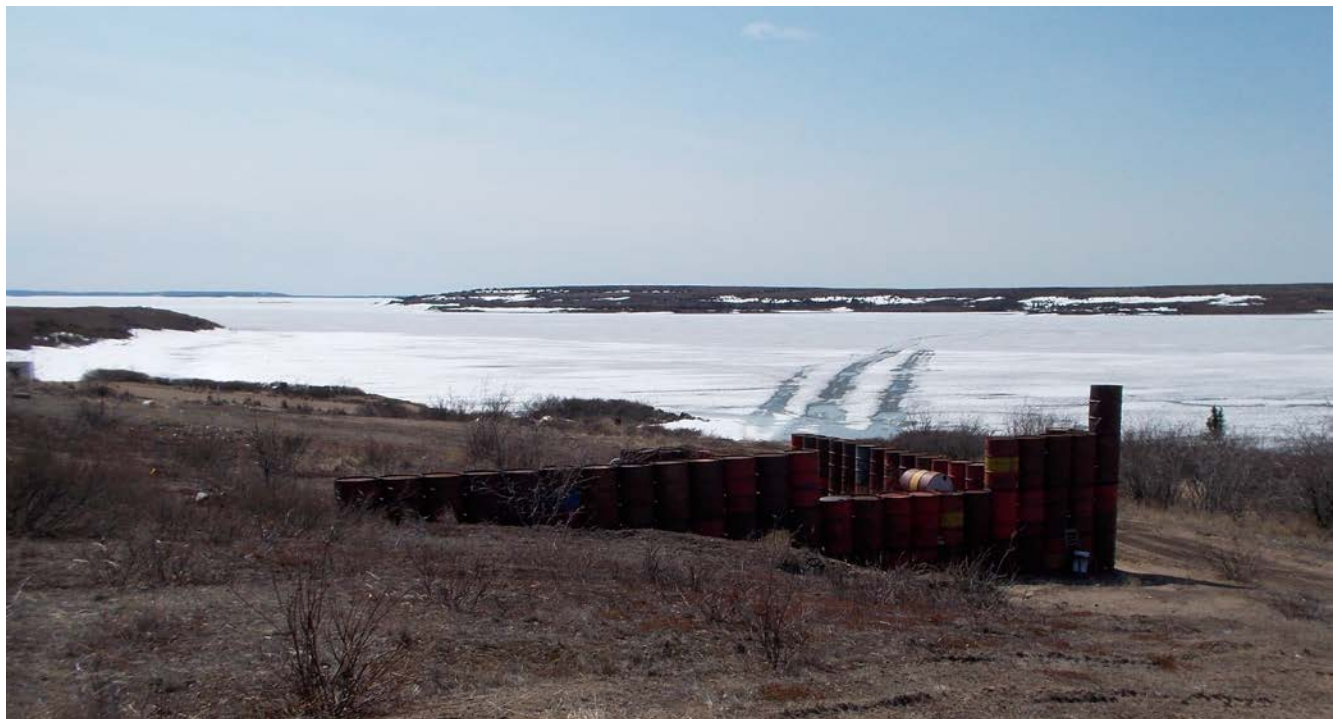
Photo 52: Looking southwest at APEC 23 (barrel walls) north of APEC 14 (Building 1). See Photo 25 for re-graded area of APEC 23.

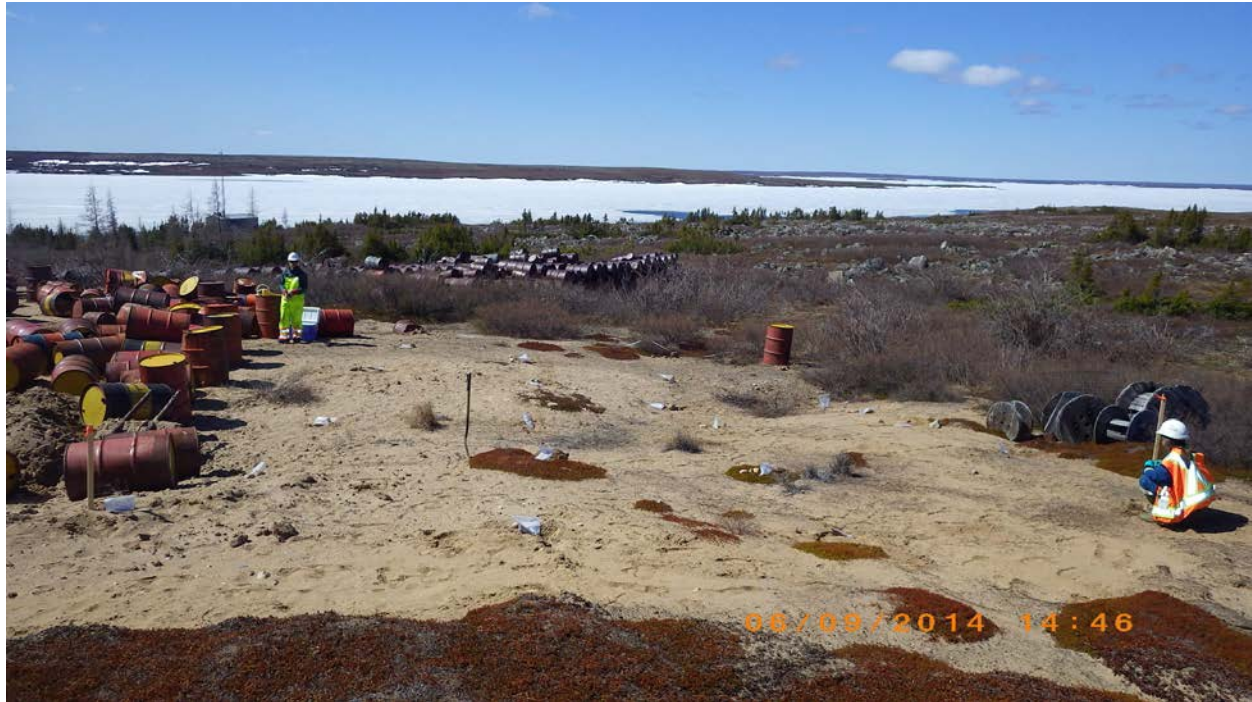
Photo 53: Baseline sampling of barrel processing area, APEC 24, with APECs 25 to 27 in the background to the left (June 9, 2014).

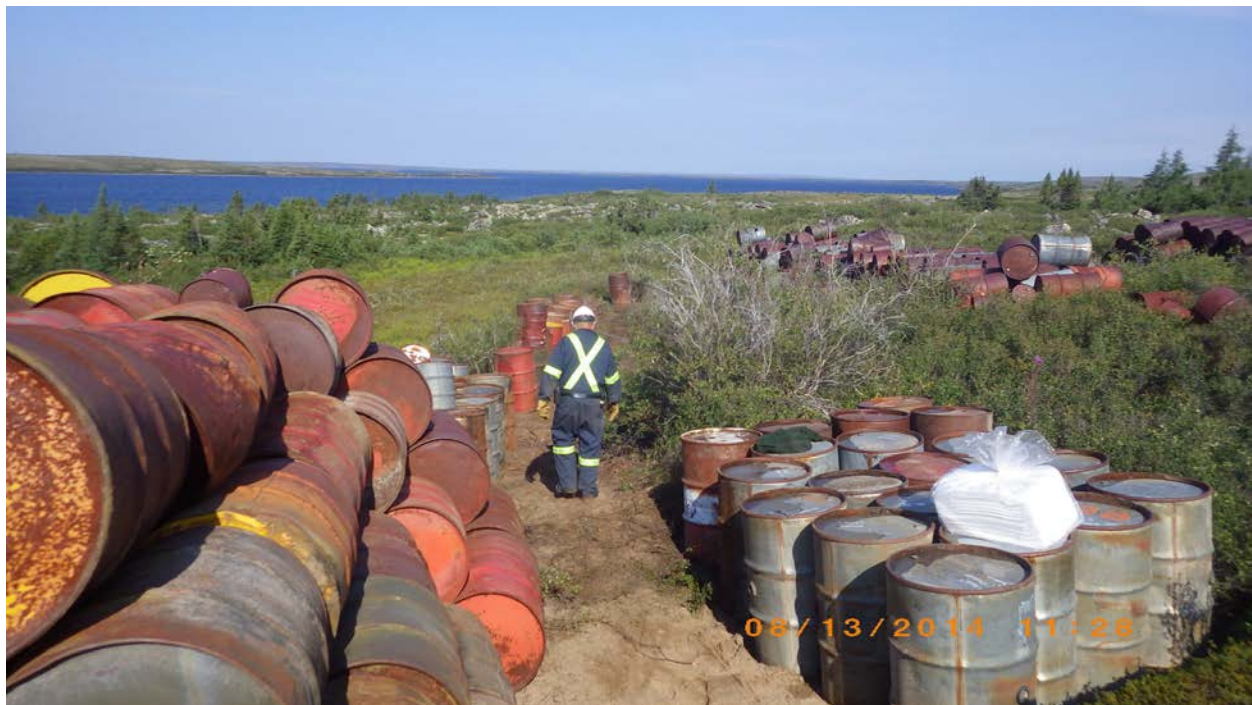
Photo 54: Looking northwest at APEC 27, with APEC 26 and APEC 25 to the right (August 13, 2014).

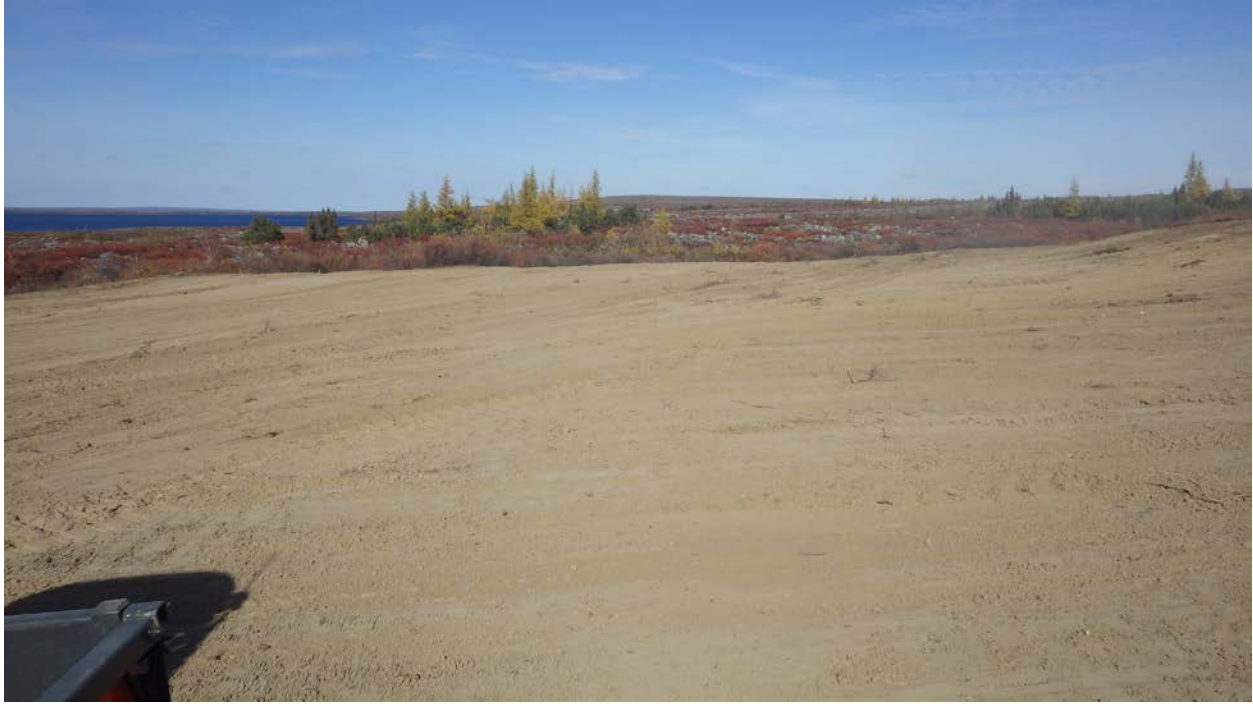
Photo 55: Looking north over re-graded APEC 24 (September 17, 2014).

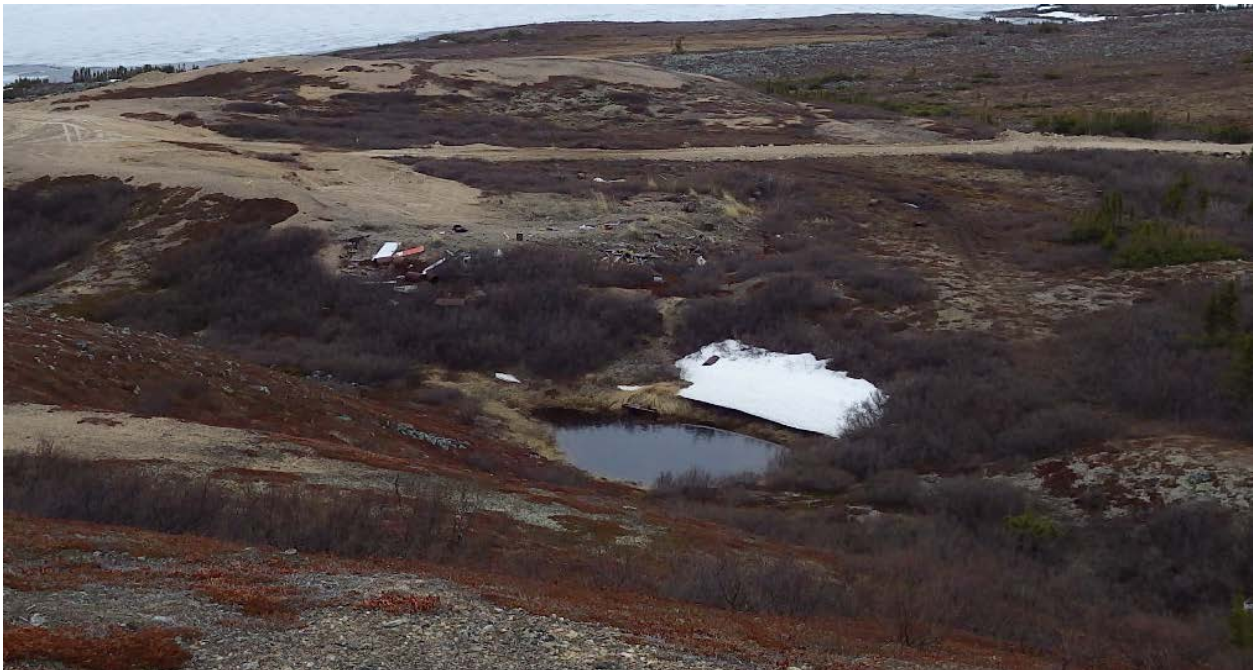
Photo 56: Looking north over APEC 28, buried debris area and former landfill (June 6, 2014).

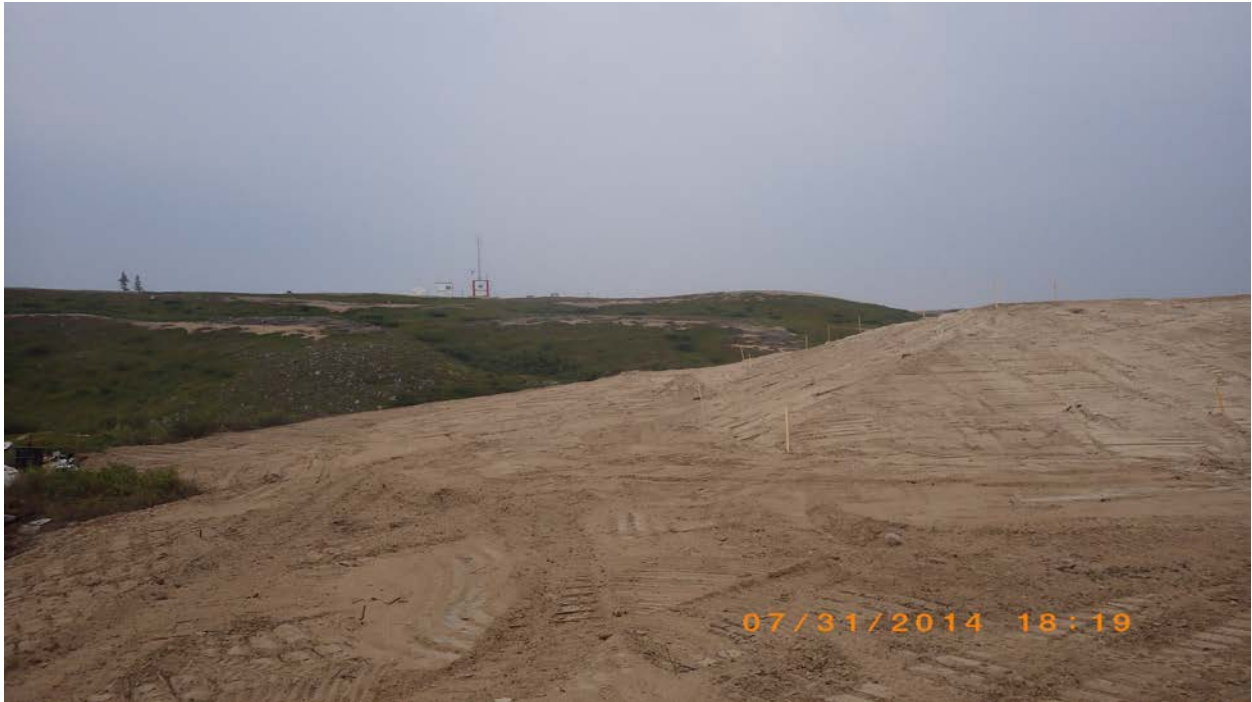
Photo 57: Looking south, at re-graded APEC 28, as the east side of the current landfill (July 31, 2014).

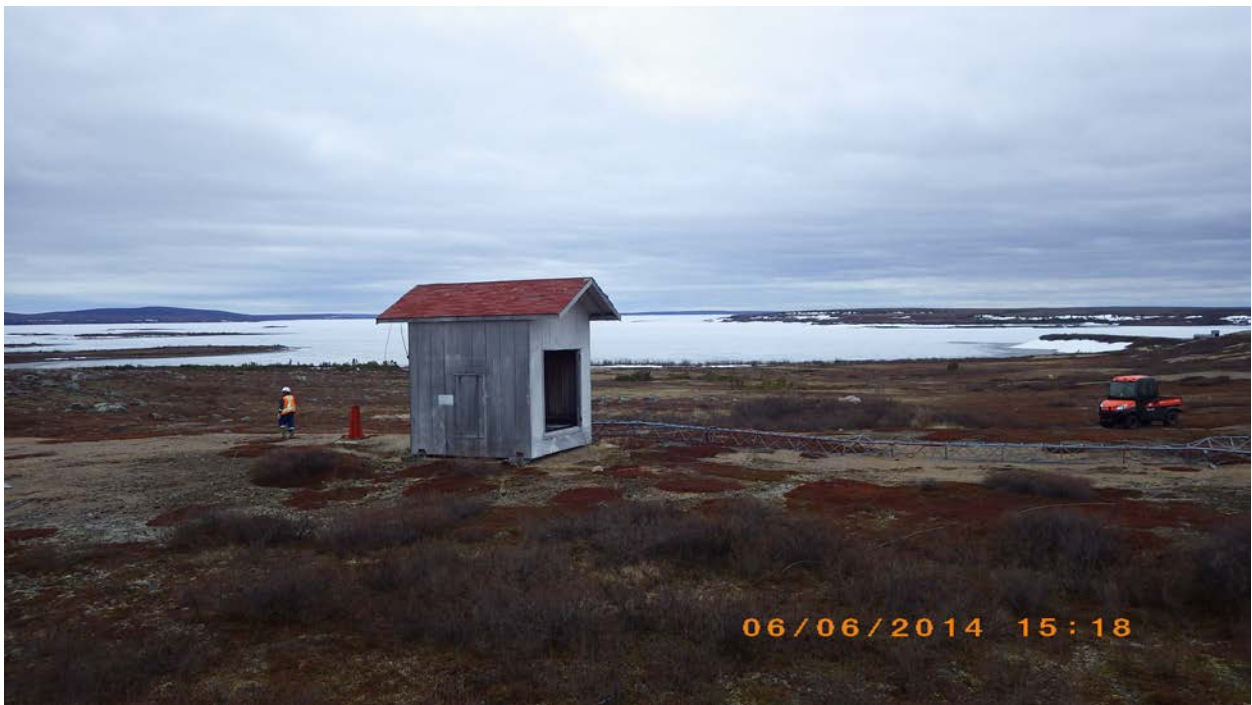
Photo 58: Looking southwest at Building 10 (June 6, 2014).

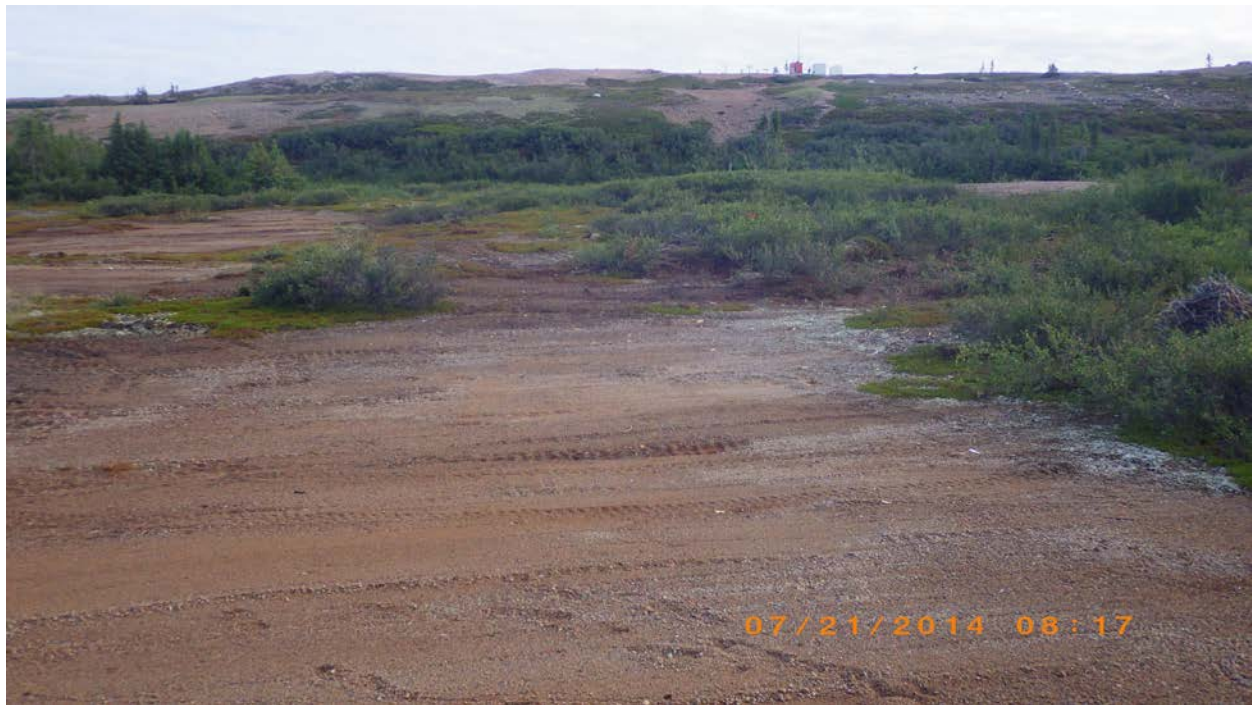
Photo 59: Looking north at re-graded area of former Building 10 (July 21, 2014).

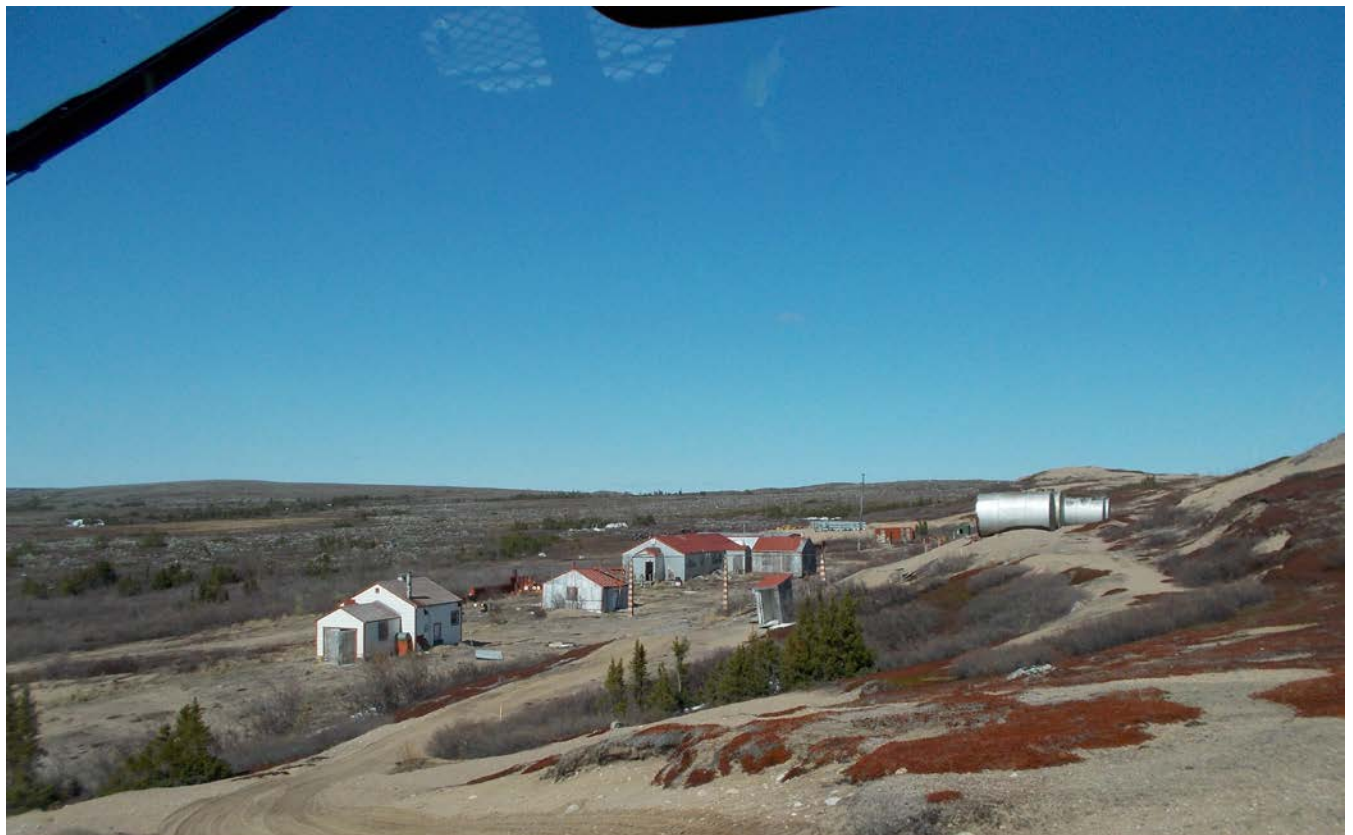
Photo 60: Overview of the Site before remediation (June 3, 2014).

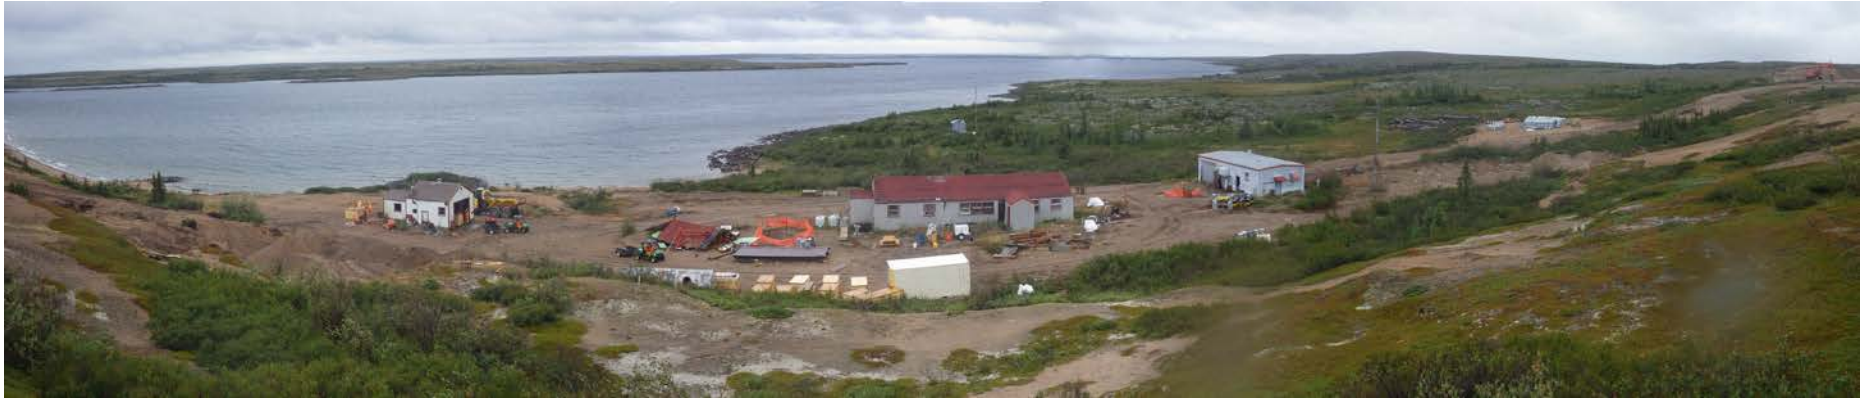
Photo 61: Overview of Site during remediation (July 12, 2014)

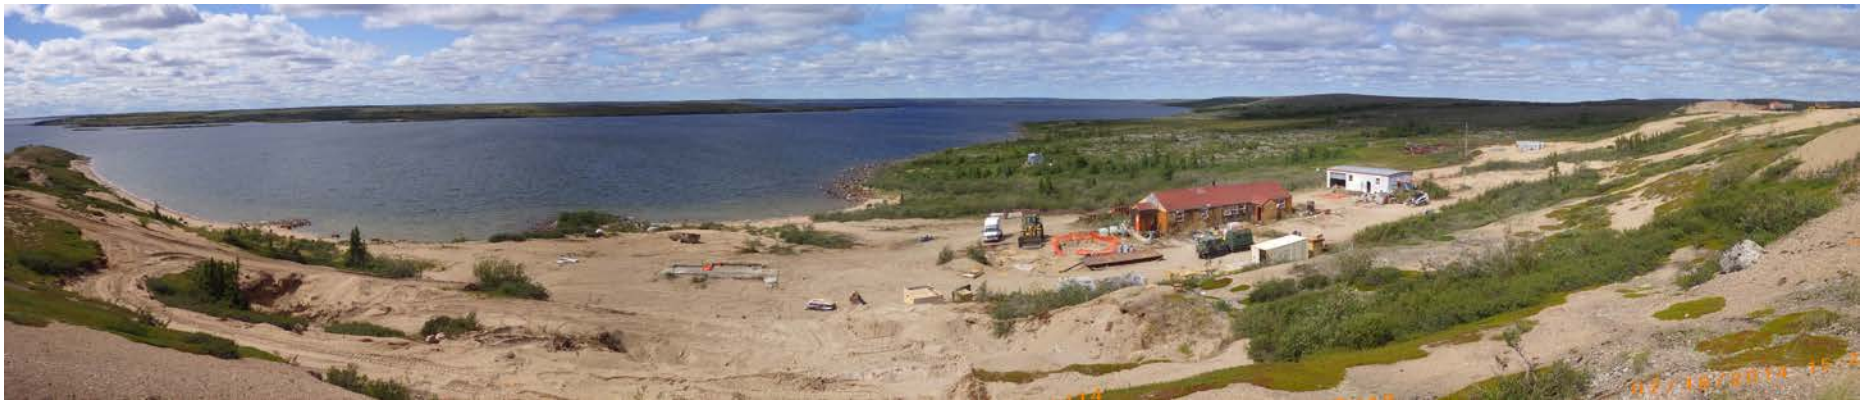
Photo 62: Overview of the Site during demolition (July 18, 2014).

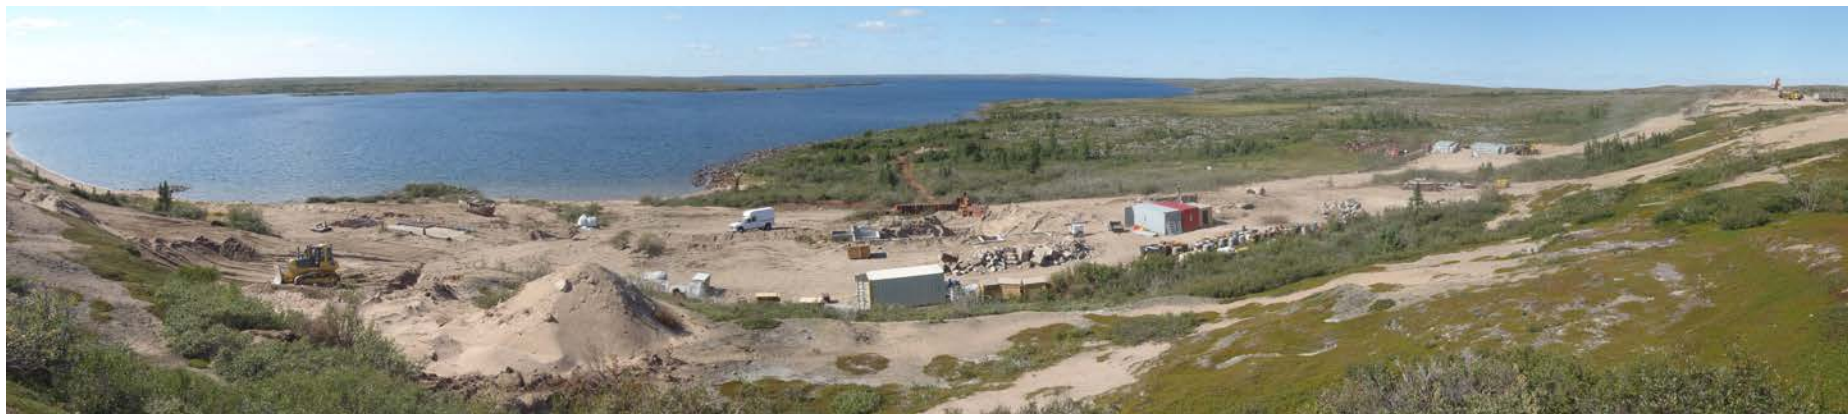
Photo 63: Overview of Site during demolition and additional excavations (August 12, 2014).

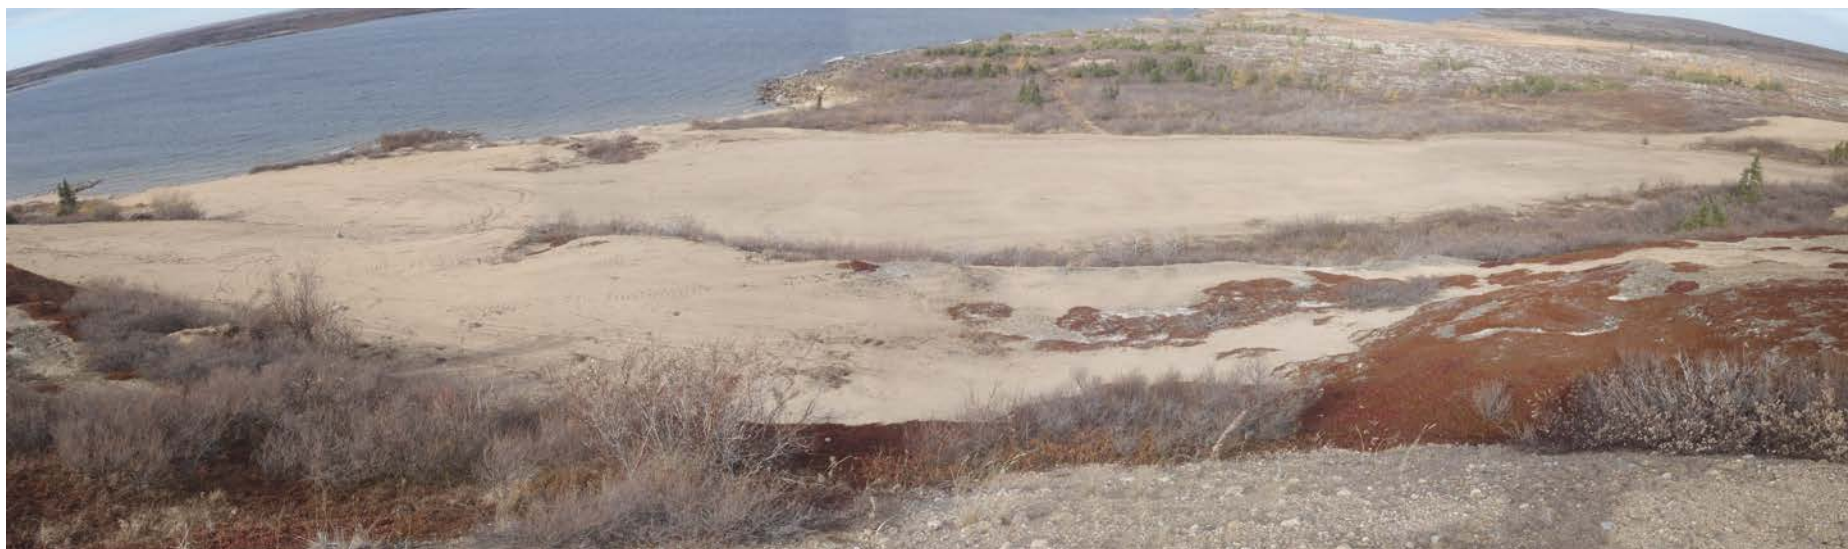
Photo 61: Overview of the Site after remediation (September 28, 2014)

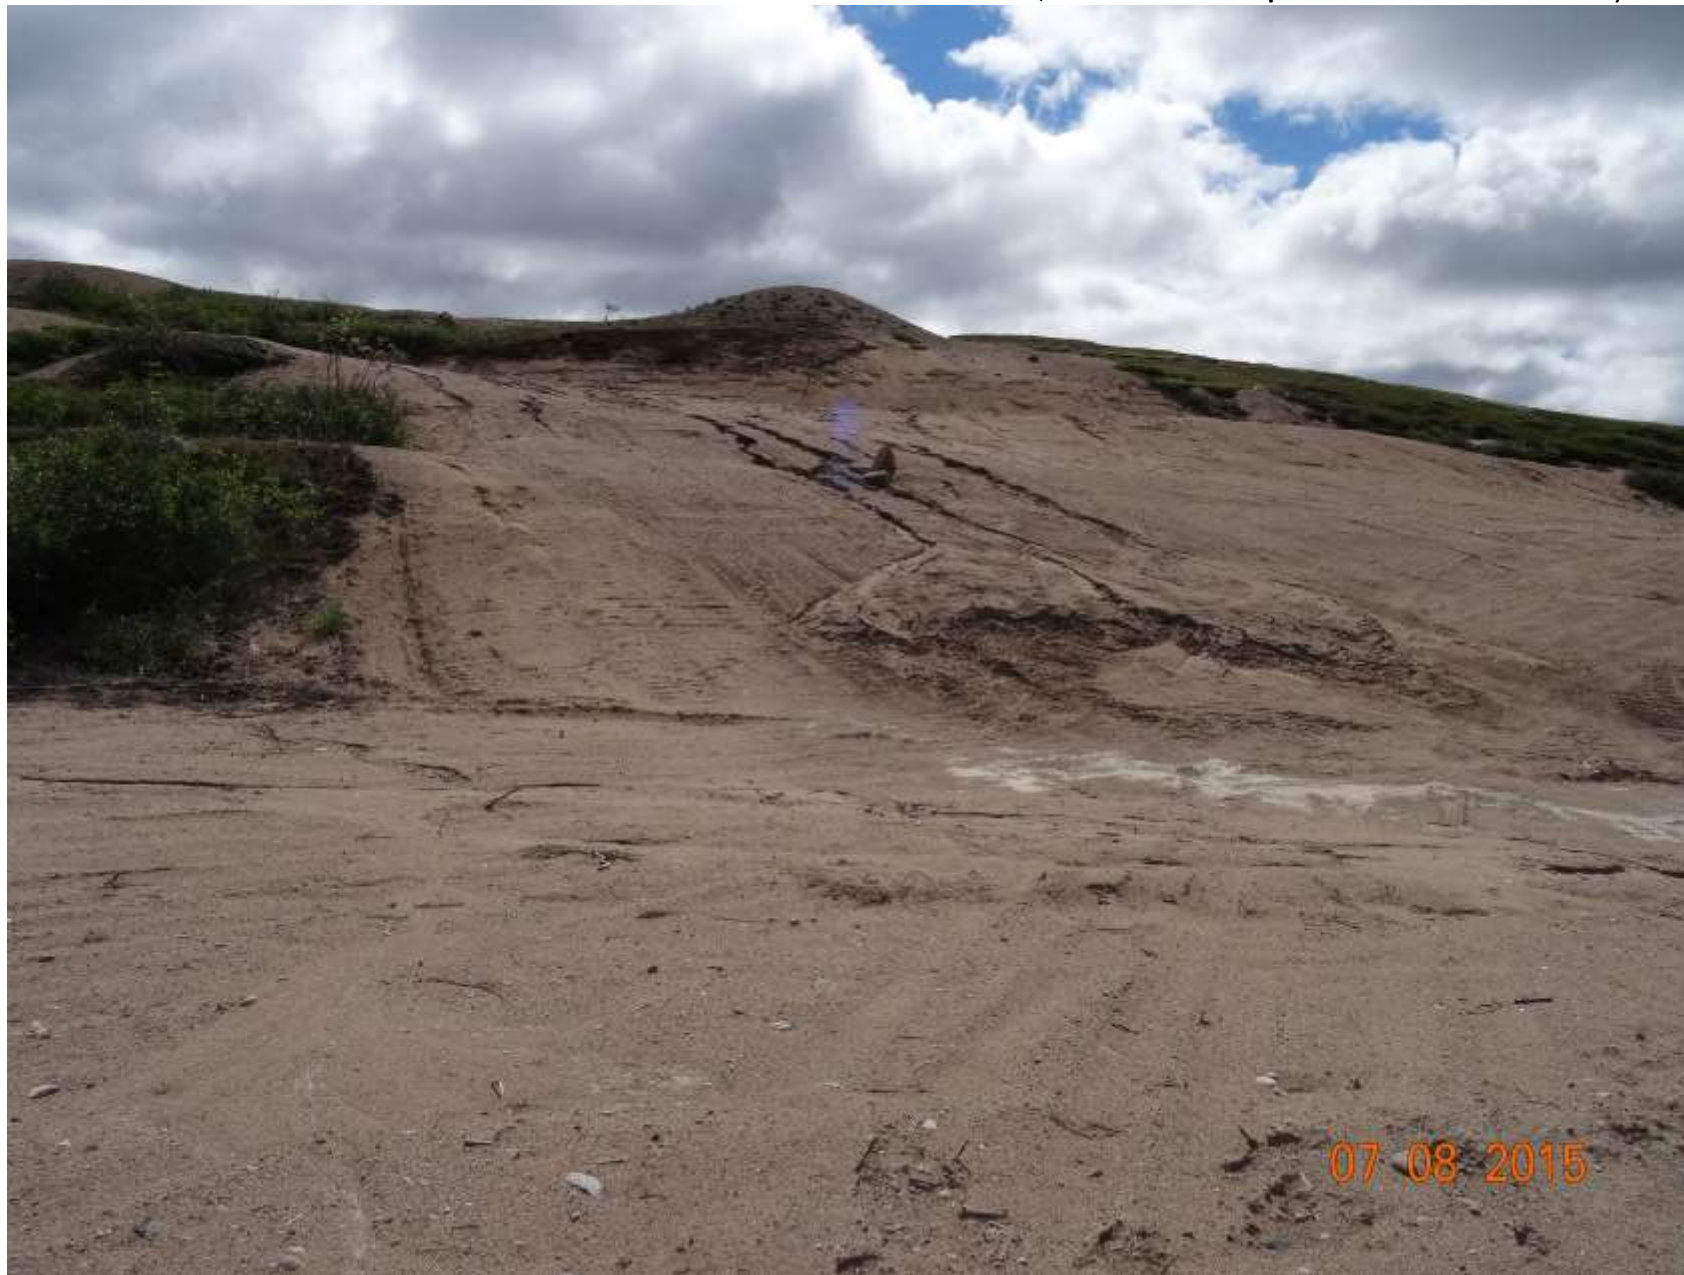
Observation: Erosion to hill side near old fuel tank locations (61° 7' 52.82"N, 100° 53' 20.8"W), Ennadia Lake Remediation Project,

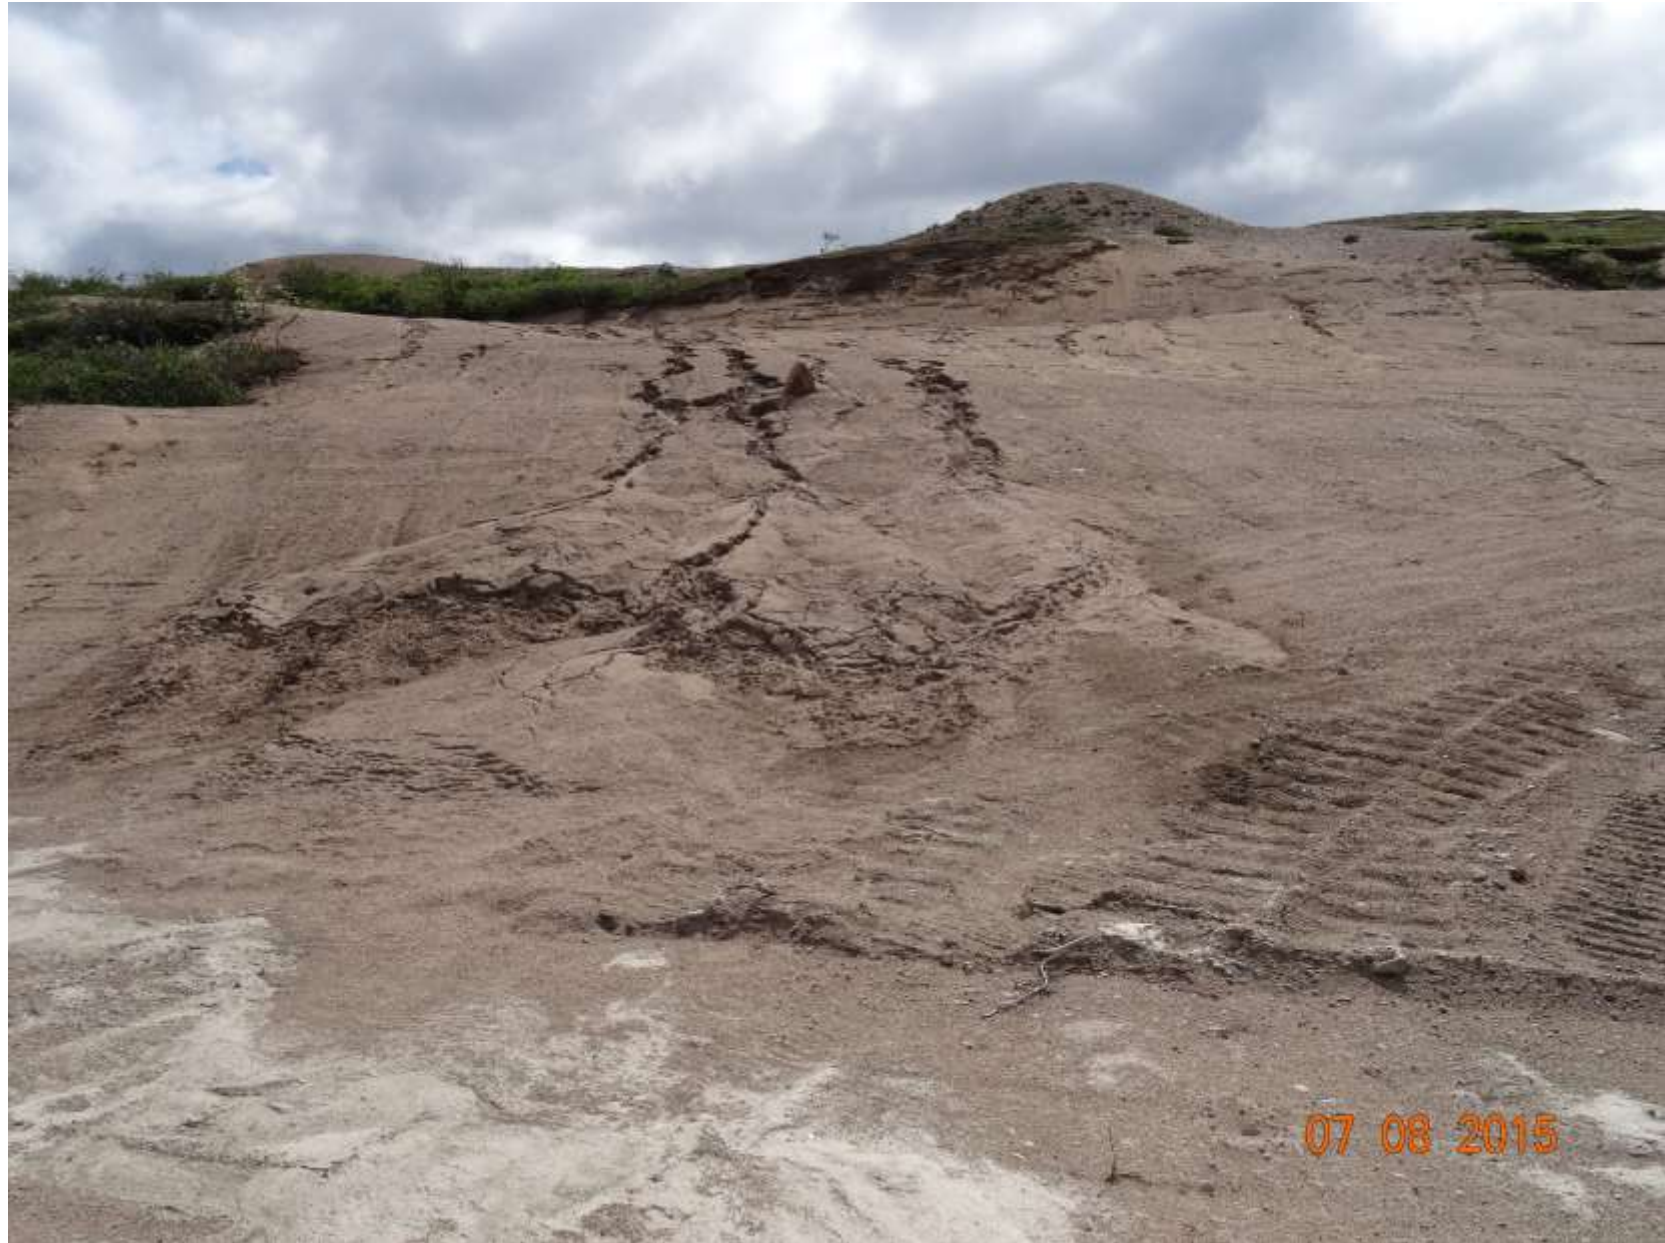
Observations: Erosion (61° 7' 52.82"N, 100° 53' 20.8"W) sedimentation observed in water around lakefront near activity (61° 7' 54"N, 100° 53' 25"W).
