REMEDIATION OF THE ENNADAI LAKE FORMER WEATHER STATION, NU

Appendix E LU/WL Inspection
March 31, 2016

Project: Ennadai Lake Remediation

Water Licence No.: 1BR-ELR1419

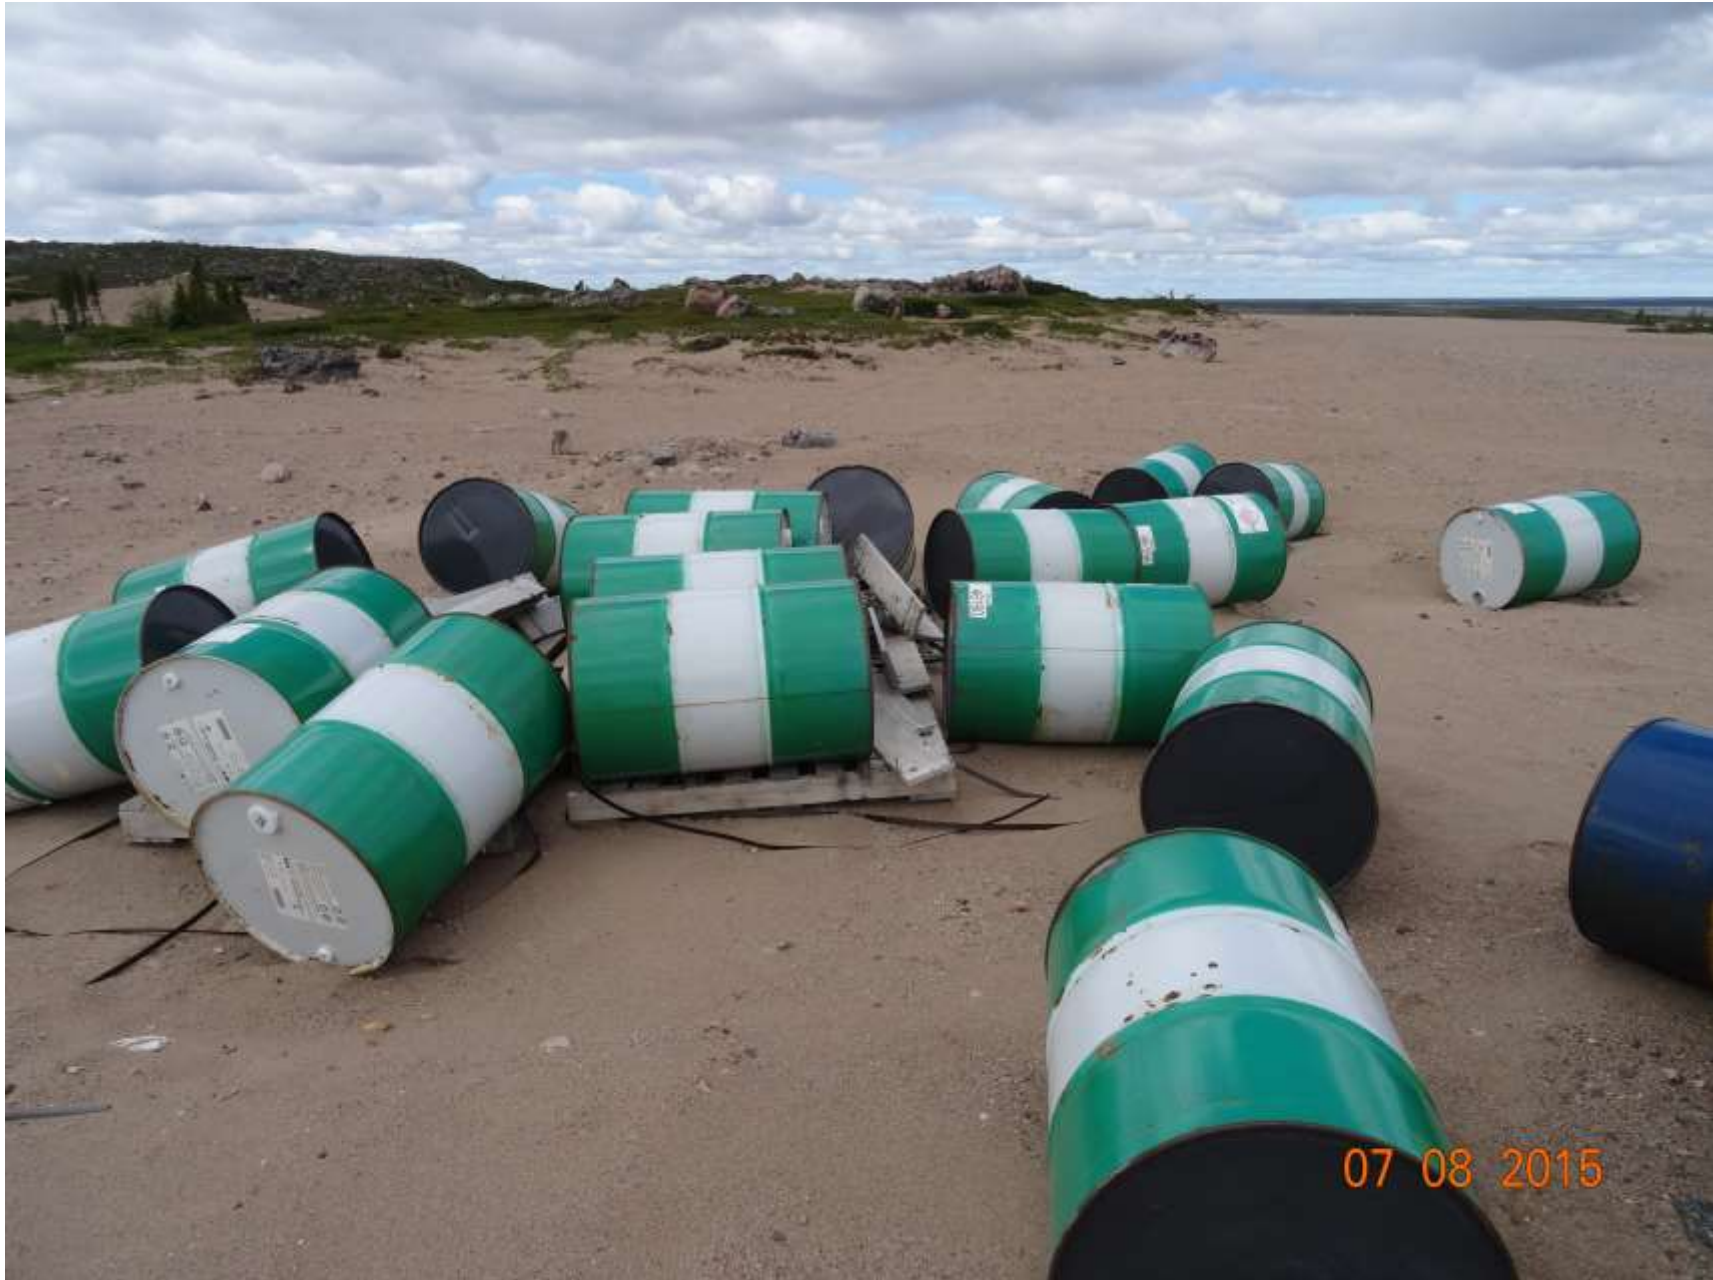
Observations: 20 fuel drums, unlabeled, suspected owner GN-DOE (61° 8' 1.78"N, 100° 52' 26"W)

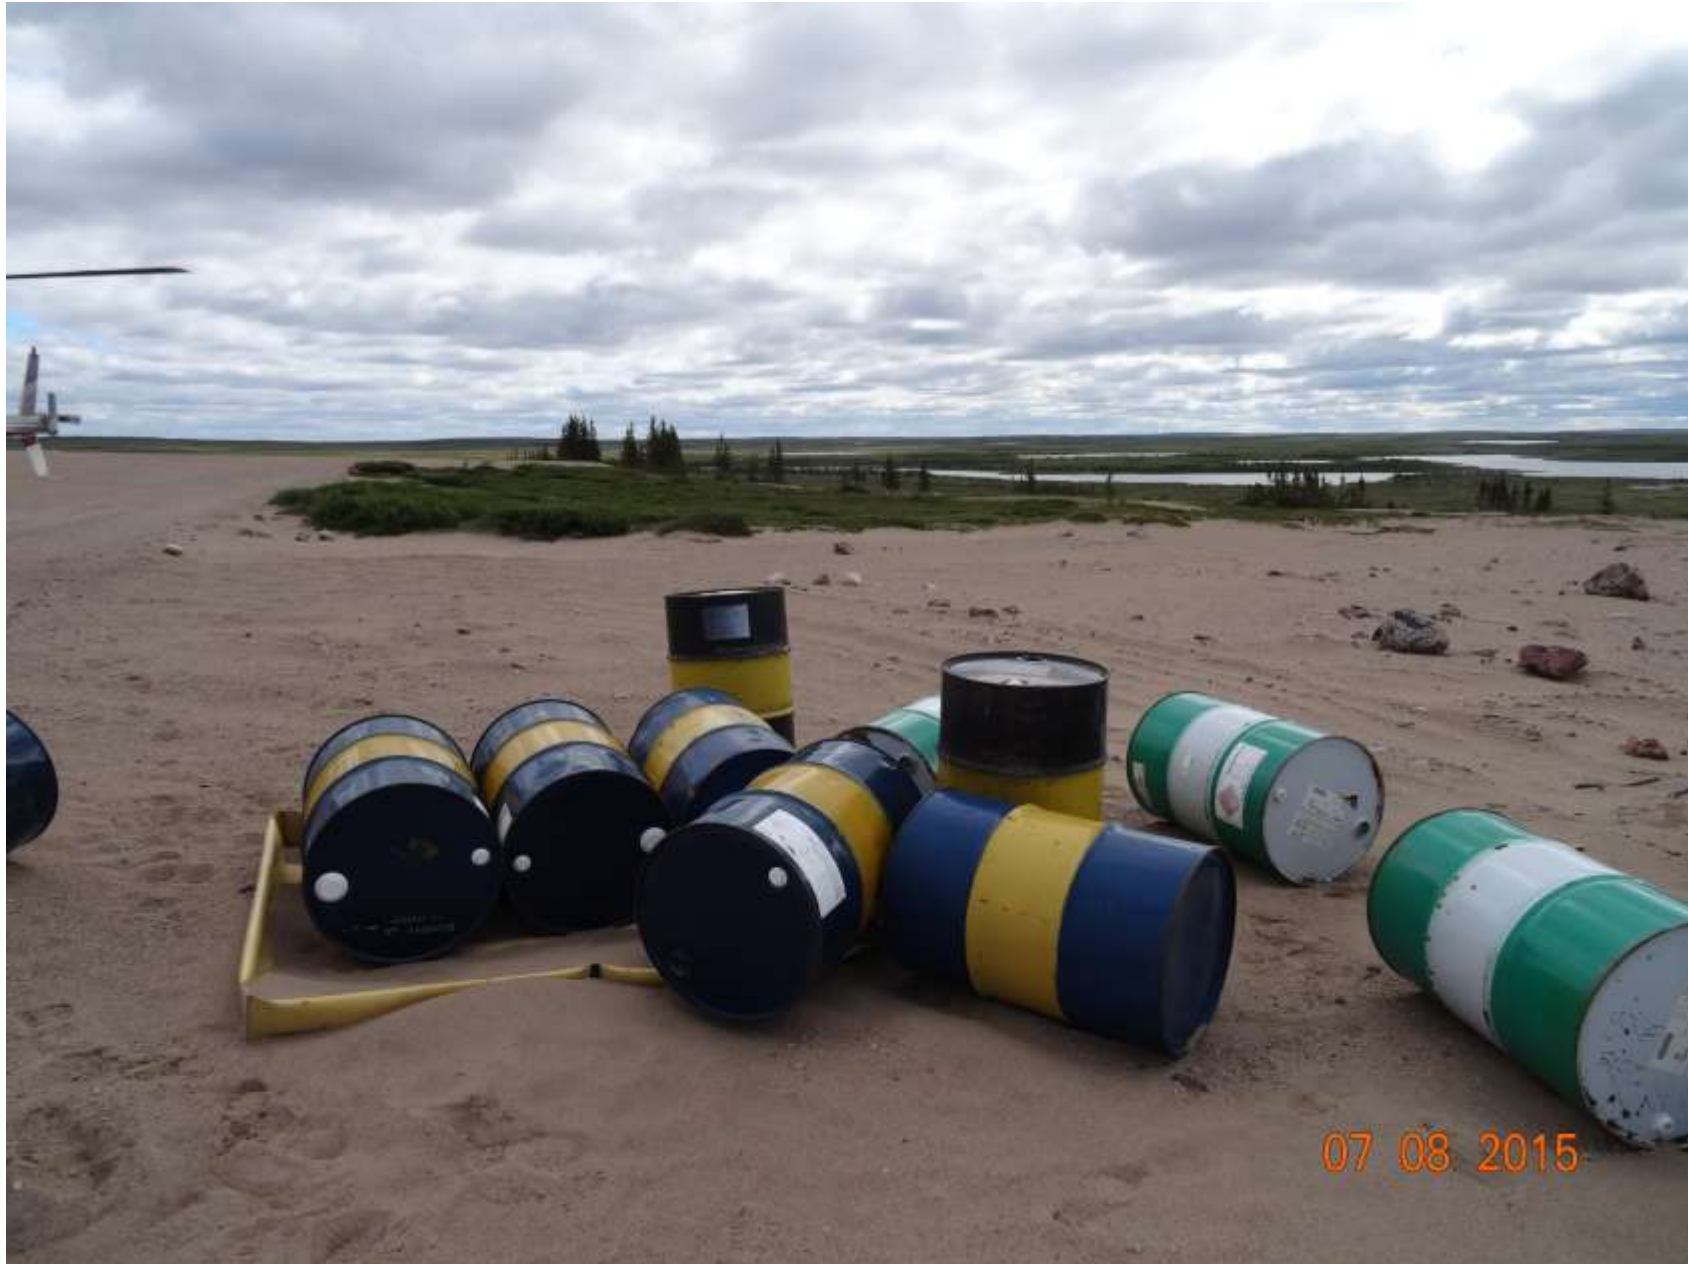
Observations: 7 drums of fuel with public works labels and 20 unknown drums at airstrip (61° 8' 1.78"N, 100° 52' 26"W)

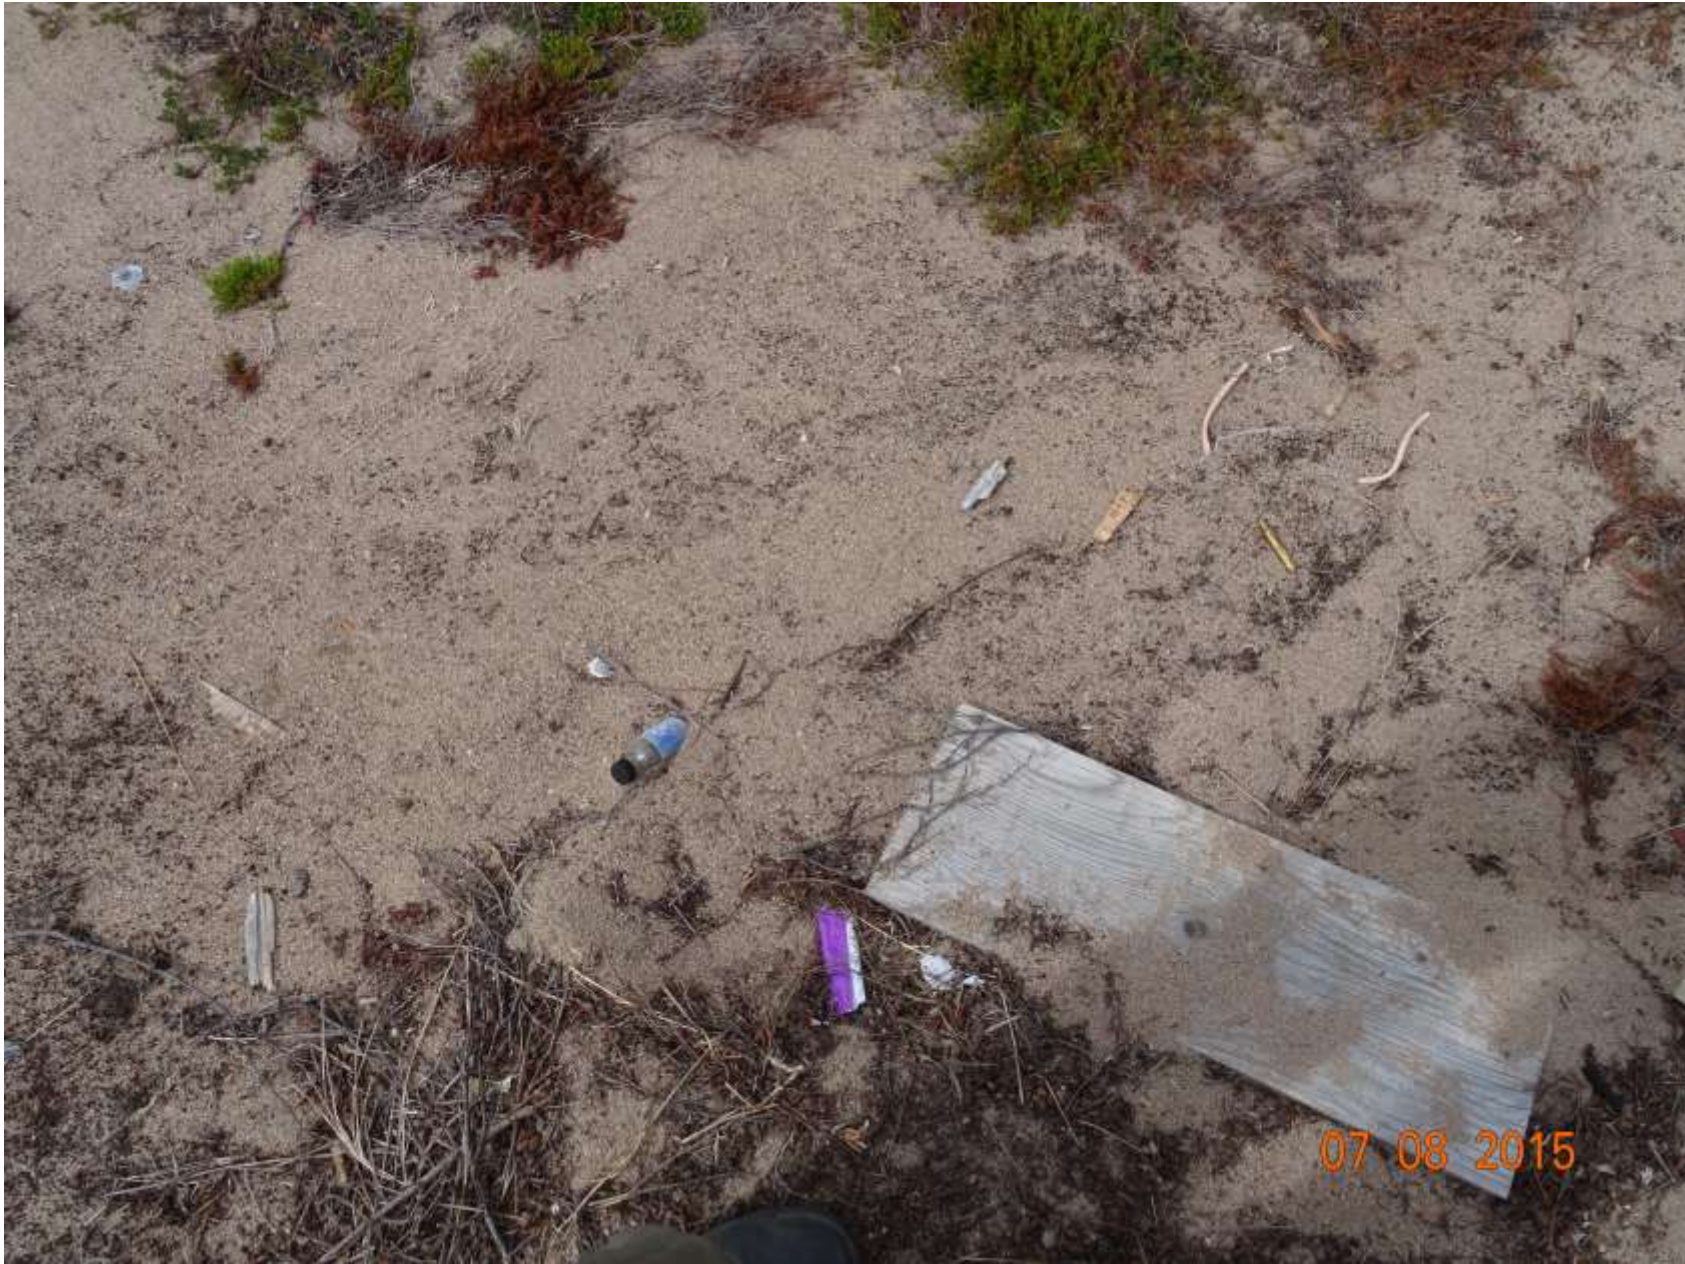
Observations: A number of locations had little pieces of garbage near old main building area (61° 7' 53.89"N, 100° 53' 25.68"W)
