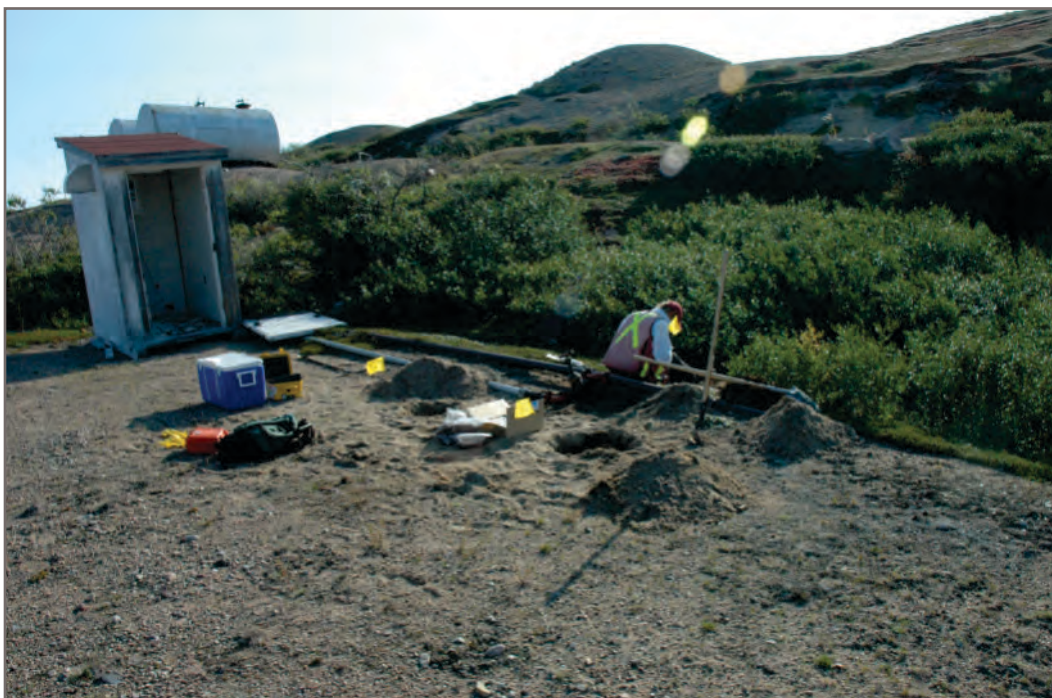
Photo E-1: APEC 1 - Stain 1 - Flag markers depicting soil delineation samples
APEC 1-SS001, SS002 and SS003

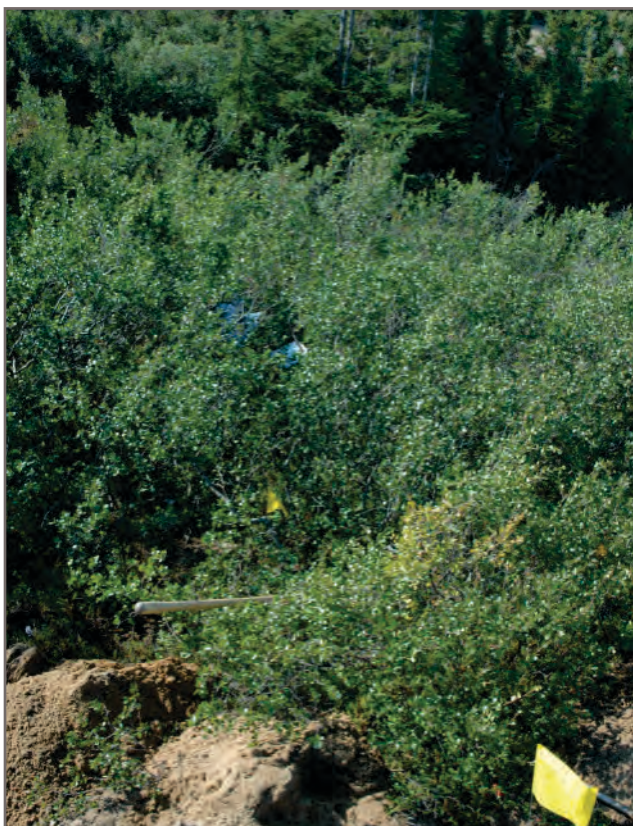
Photo E-2: APEC 1 - Stain 1 - Flag locations
for delineation soil samples
APEC 1-SS004 and SS005 in a
low lying depressional area

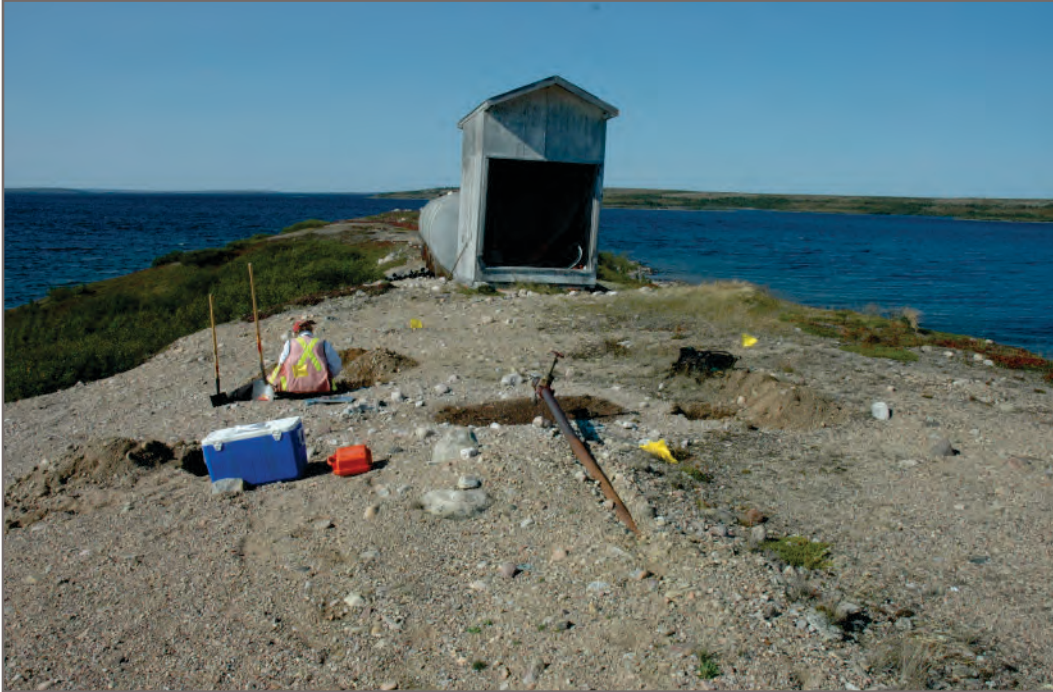
Photo E-3: APEC 2 - Stain 2 - Flag locations for delineation soil samples APEC 2-SS001, SS002 and SS003; coarse-grained sand and cobbles were prevalent throughout the esker

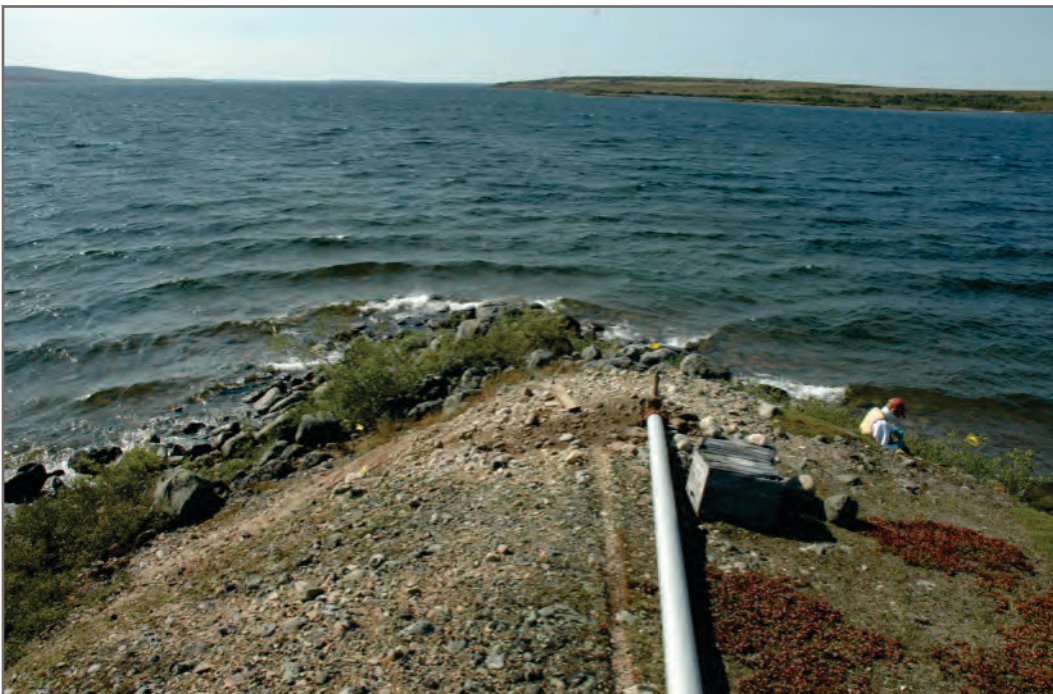
Photo E-4: APEC 3 Stain 3 - Delineating terminal extent of the pipeline

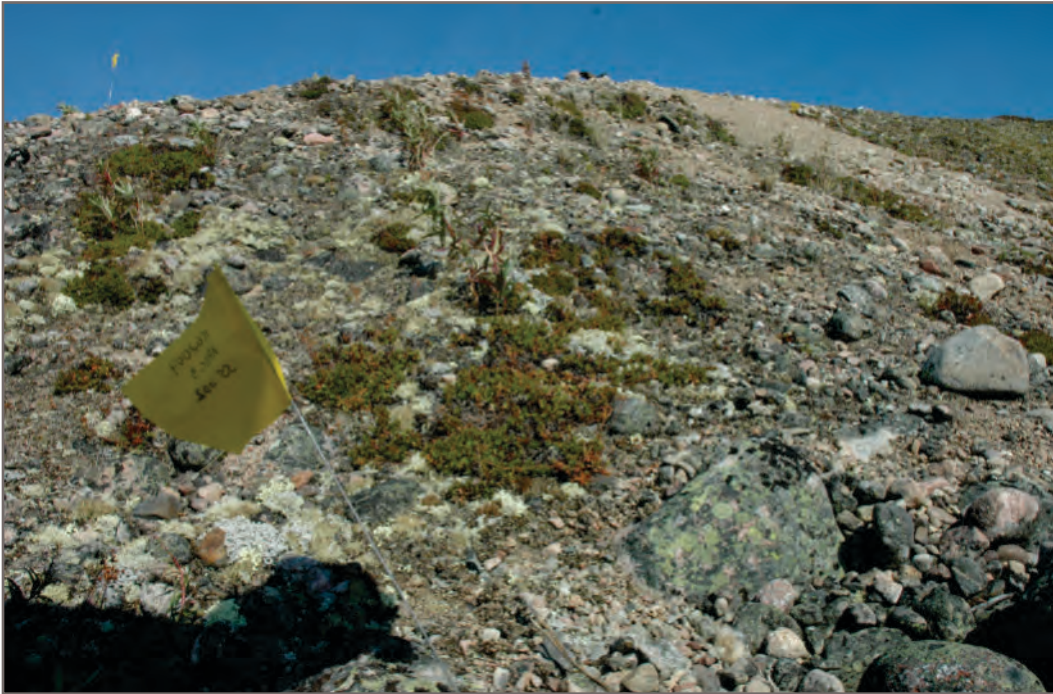
Photo E-5: APEC 3 - Stain 3 - Terminal extent of pipeline facing up-gradient from the shoreline

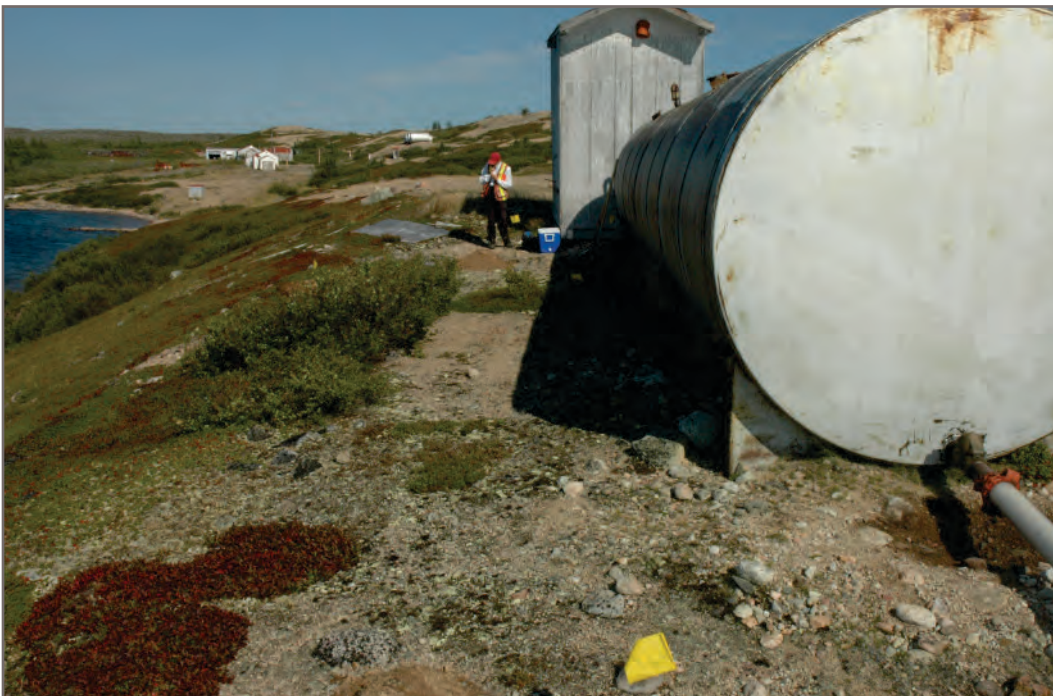
Photo E-6: APEC 4b - Tank 5 - Delineation of tanks; staining can be seen at the valve

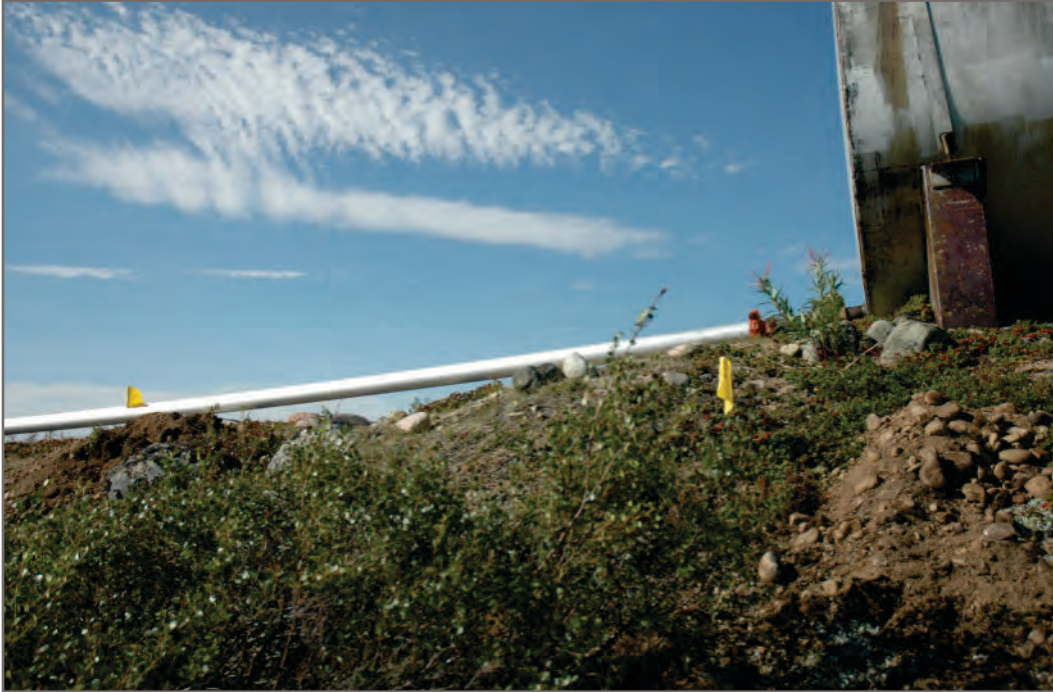
Photo E-7: APEC 4a - Tank 5 - Flag locations for delineation soil samples facing up-gradient toward the tank

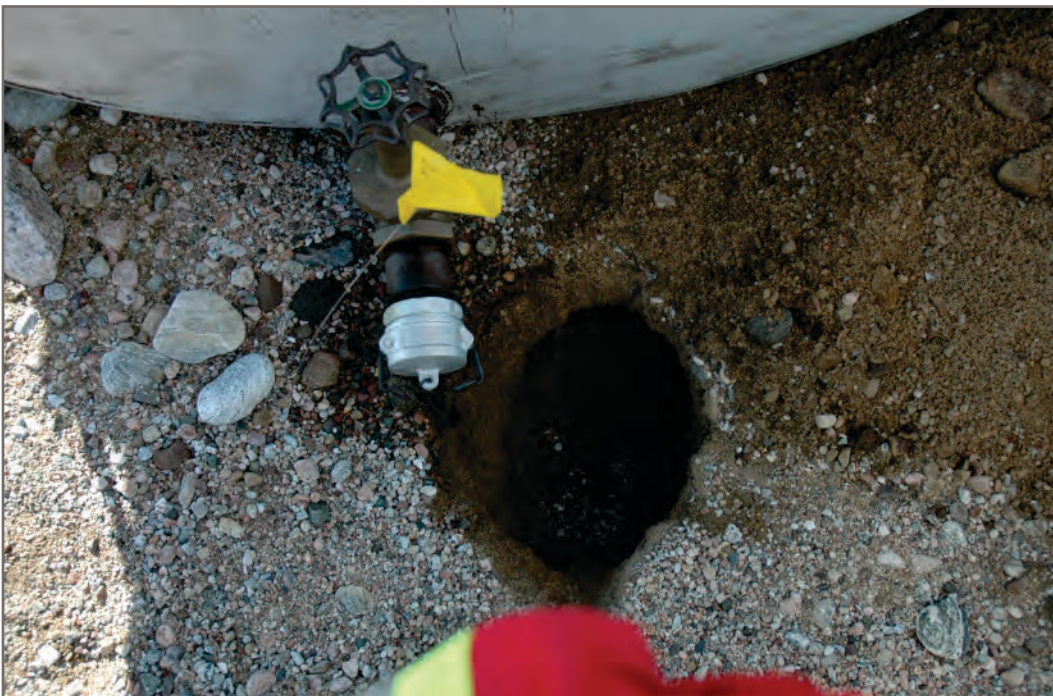
Photo E-8: APEC 4a - Tank 5 - Flag locations for soil samples APEC 4a- SS001, staining was noted at the valve of the AST

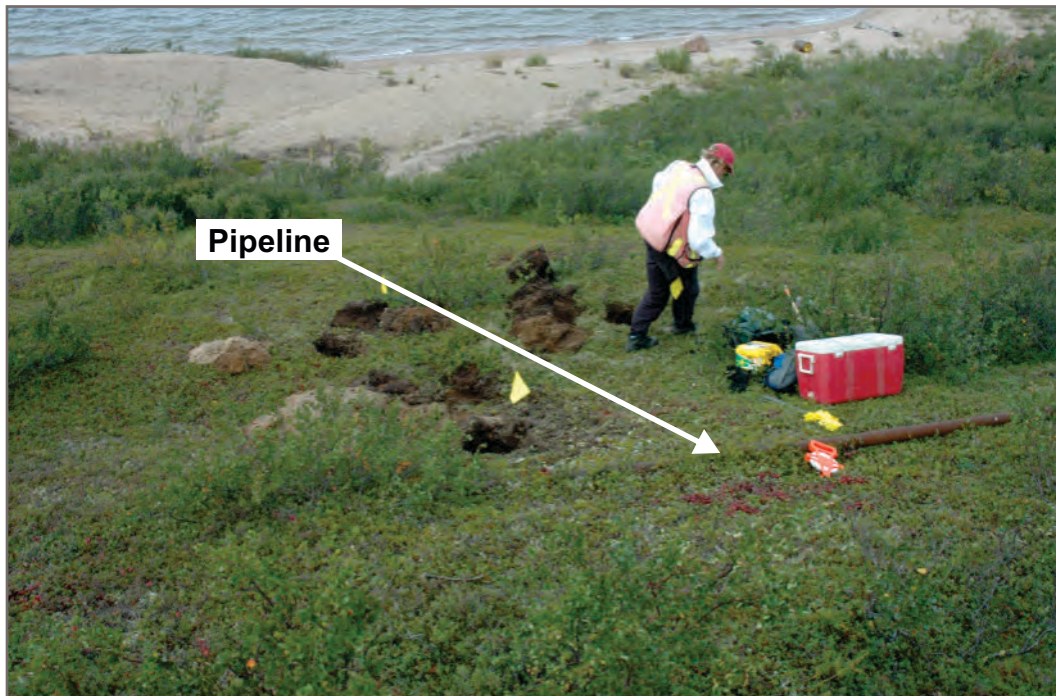
Photo E-9: APEC 8 - Pipeline - Flag locations for delineation soil samples APEC 8-SS004, SS005 and SS006; staining was noted along the pipeline at a junction

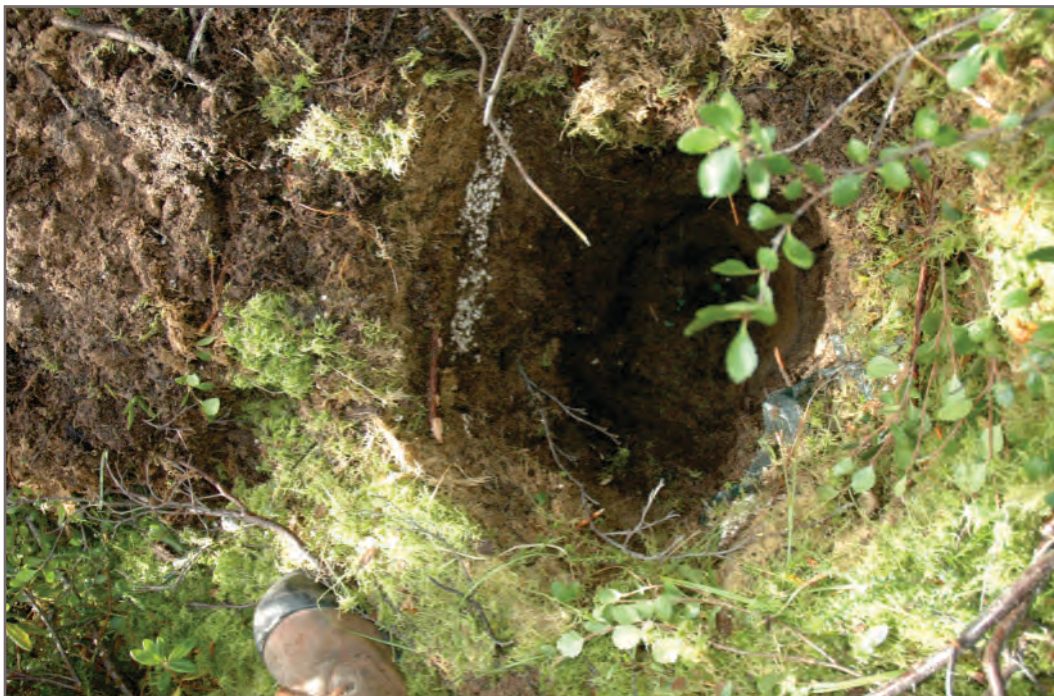
Photo E-10: APEC 8 - Pipeline - Sample location taken down-gradient of APEC1; delineation soil sample APEC 8-SS011 is shown; both samples taken in a low lying depressional area, hydrocarbon odour was noted

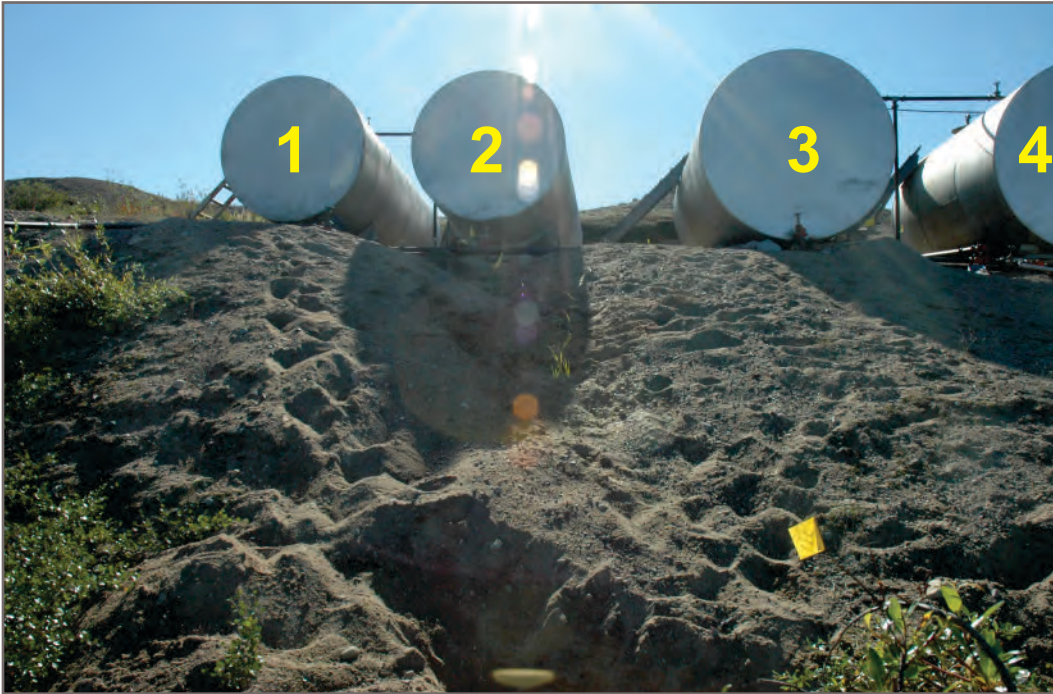
Photo E-11: APEC 9 - 12 - Delineation soil sample APEC 9-SS004 and Tanks 1 - 4 are shown; the picture was taken looking east up-gradient toward the tank farm; sand fill was present on the slope

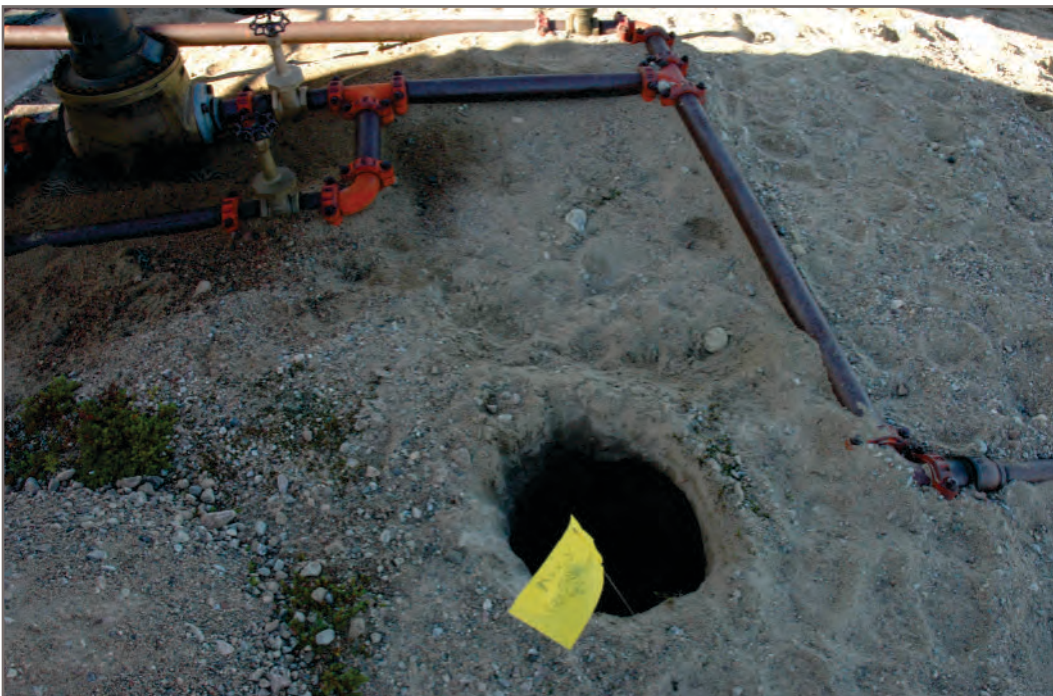
Photo E-12: APEC 9 - Tank 1- Soil sample location APEC 9- SS001; the soil sample was taken down-gradient of the fuel distribution lines; significant hydrocarbon odour and staining around the valves was noted

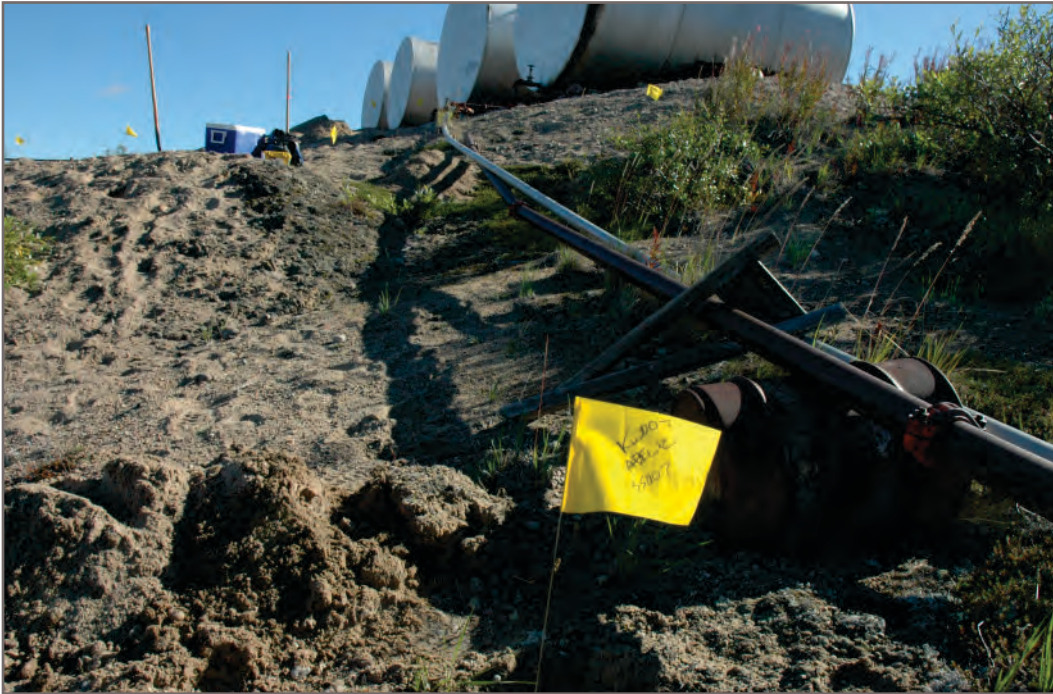
Photo E-13: APEC 12 - Tank 4 - Delineation soil sample APEC 12-SS007 is shown looking north toward the tank farm; in the background soil samples APEC 12-SS001 to SS005 can be seen delineating the hydrocarbon plume

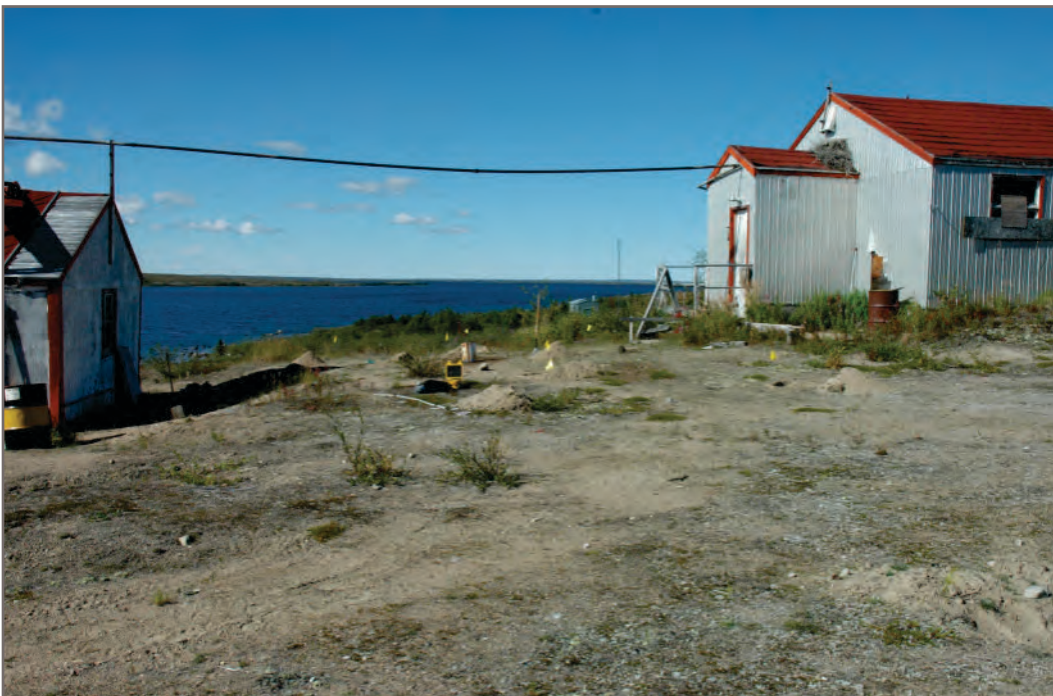
Photo E-14: APEC 13-Overhead Pipeline- Delineation soil samples APEC 13 SS002 to SS009 are seen between Building 3 (APEC 16) and Building 5 (APEC 18). An active leak was present at the time of the Site investigation.

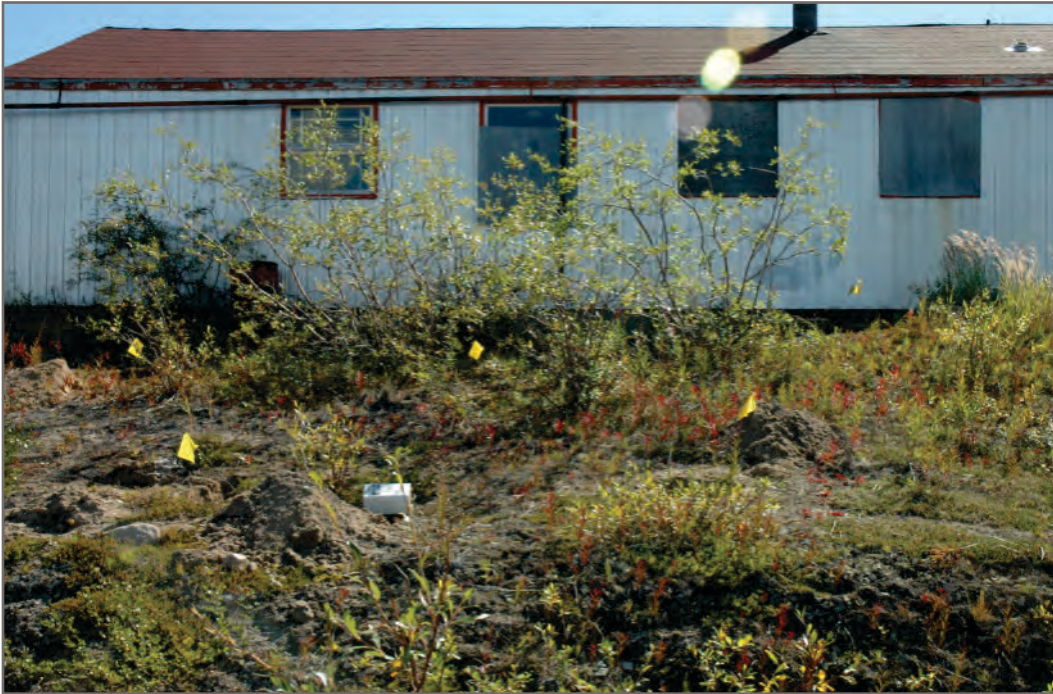
Photo E-15: APEC 13/APEC 14 - Overhead Pipeline/Building 1 - Delineation soil sample locations APEC 13-SS010 to SS017 are shown; hydrocarbon odour was noted at the base of the foundation

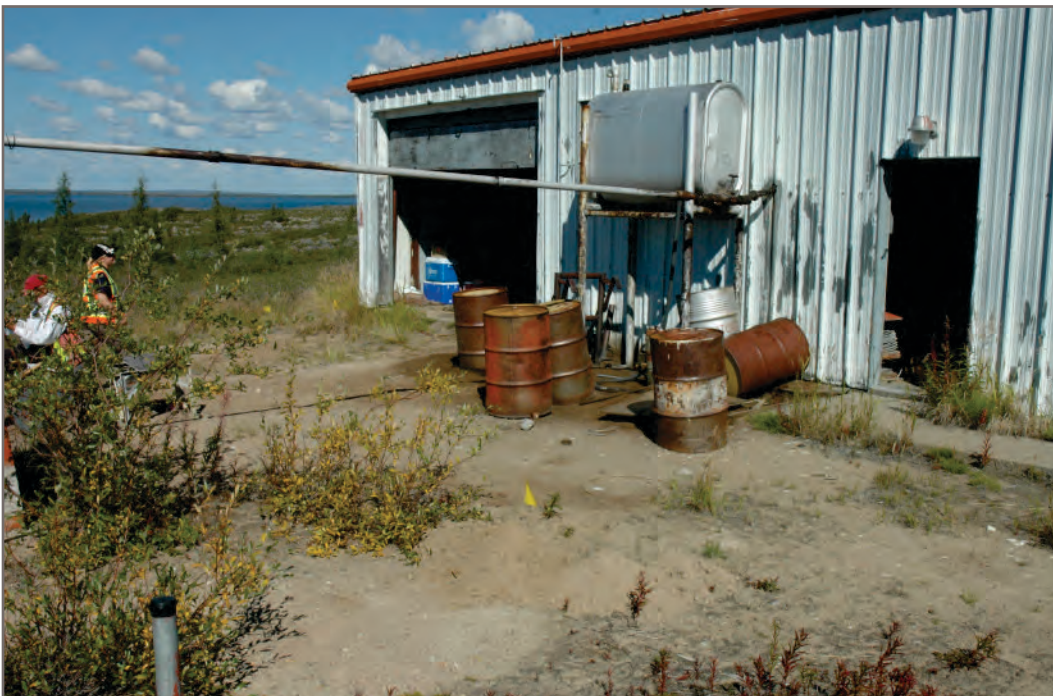
Photo E-16: APEC 15 - Building 2 - Delineation soil sample locations APEC 15 SS001 to SS003 are shown; the picture was taken facing northwest

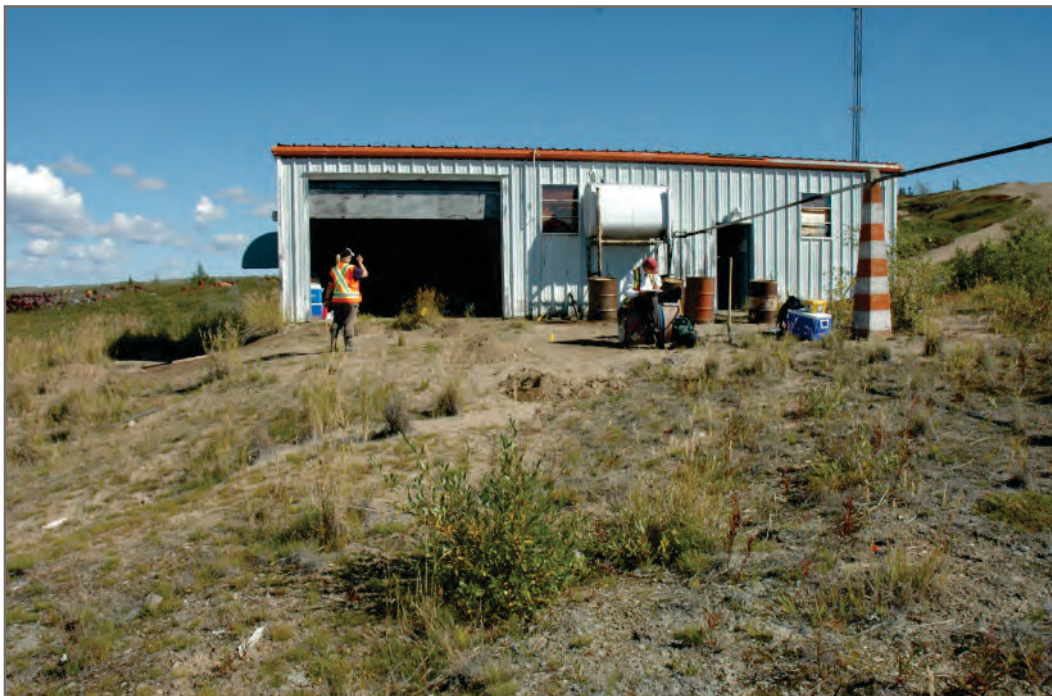
Photo E-17: APEC 15 - Building 2 - Delineation soil sample locations APEC 15-SS002 to SS005 shown; the picture was taken facing north

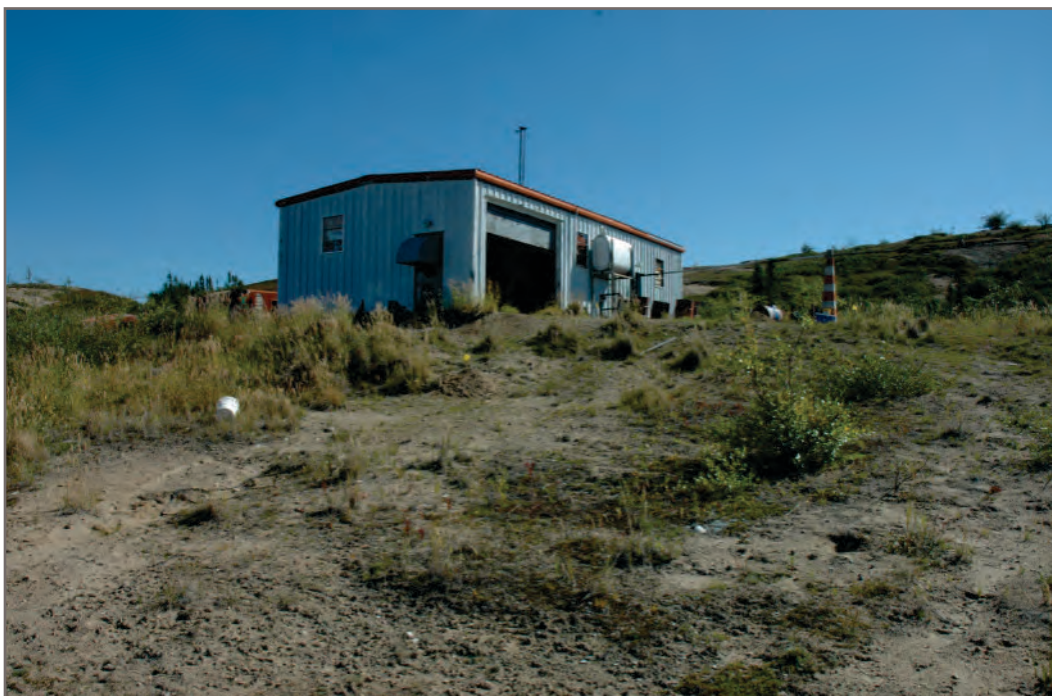
Photo E-18: APEC 15 - Building 2 - Delineation soil sample locations APEC 15-SS005, SS006 and SS008; the picture was taken facing northeast

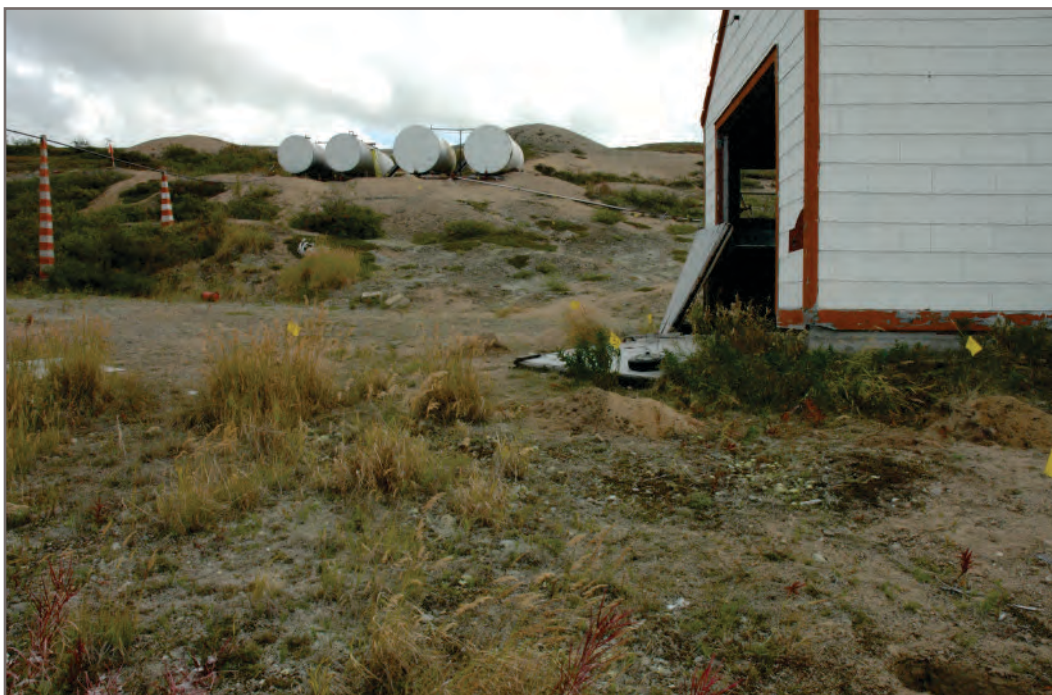
Photo E-19: APEC 18 - Building 5 - Delineation soil sampling locations APEC 18-SS001 to SS006; a concrete pad and excavator were present in the building

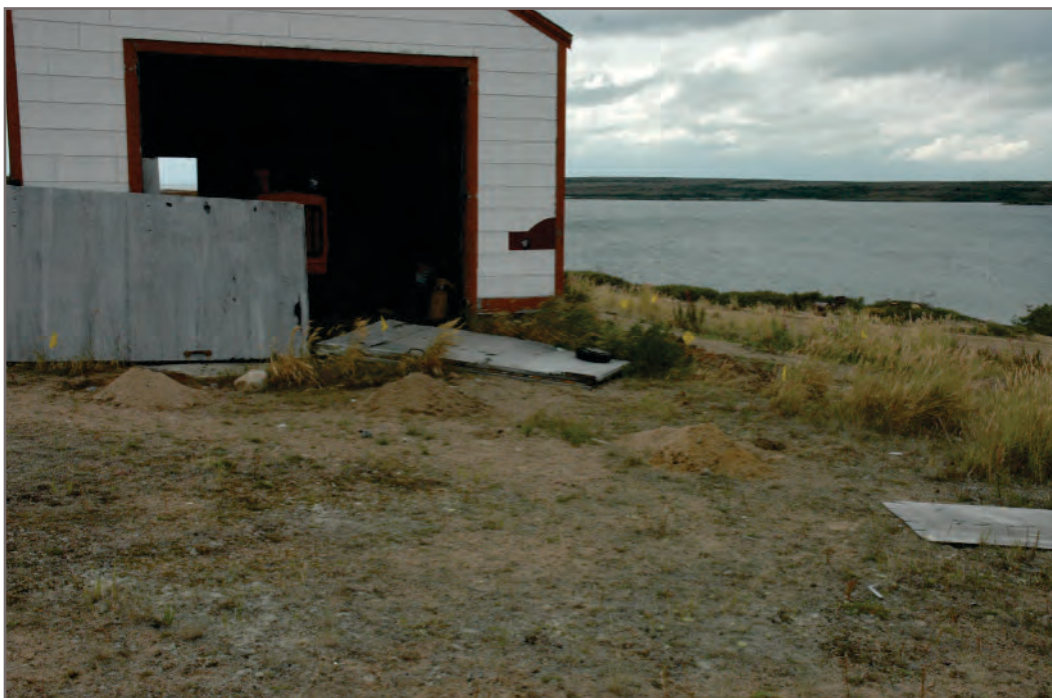
Photo E-20: APEC 18 - Building 5 - Delineation soil sampling locations APEC 18-SS001 to SS006; the photo was taken facing south toward the building

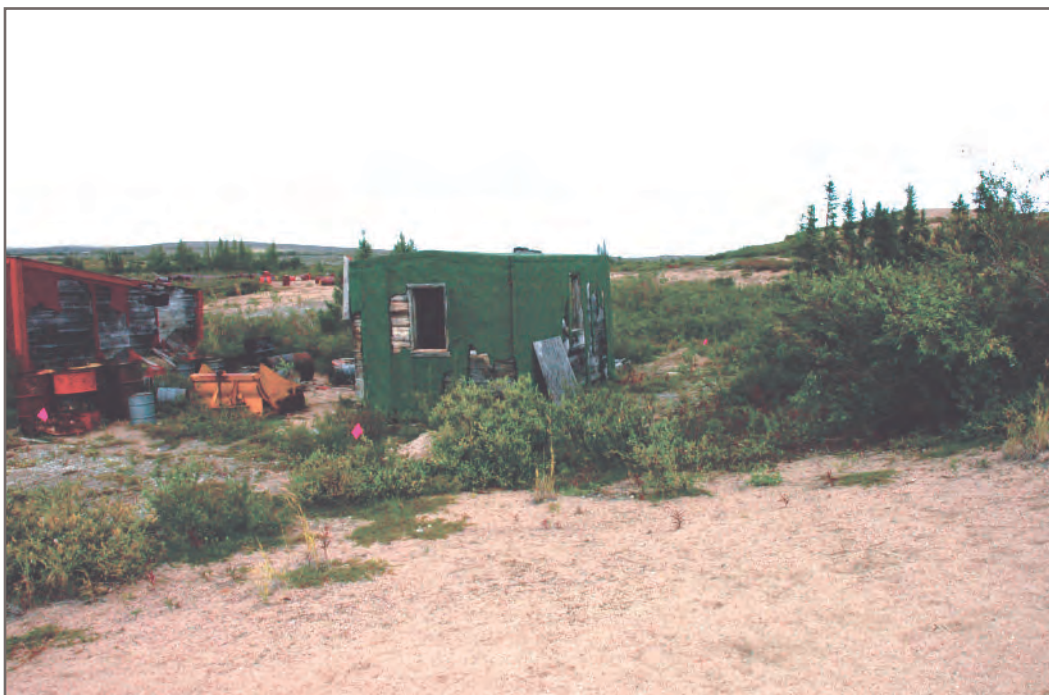
Photo E-21: APEC 19 and APEC 20 - Buildings 7 and 8 - Hydrocarbon contamination was identified between the buildings

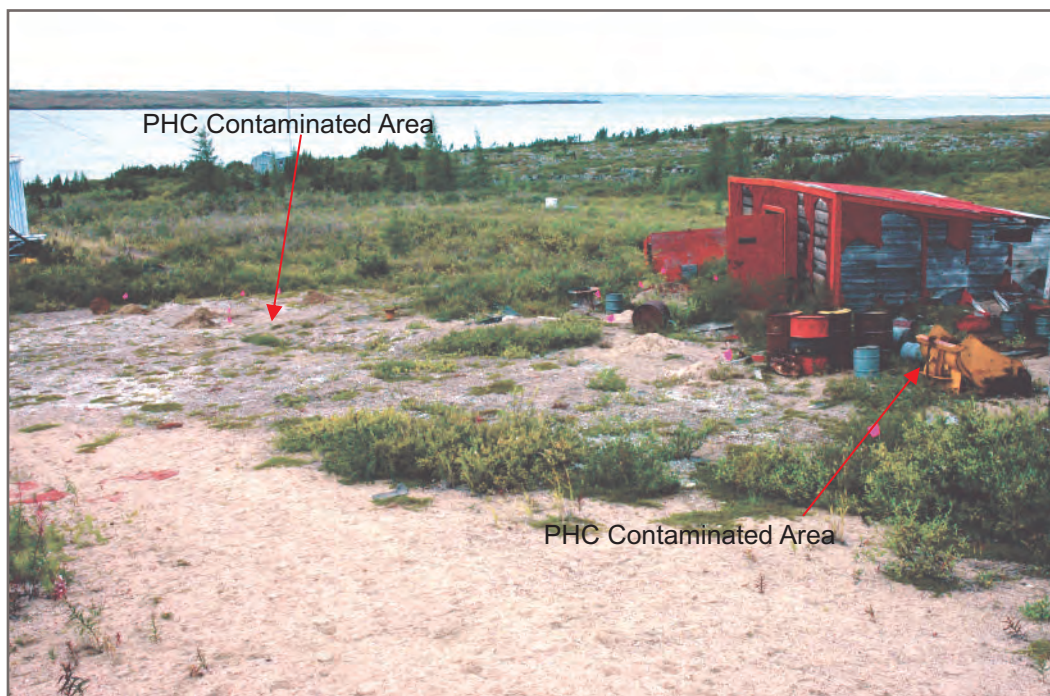
Photo E-22: APEC 19 and 20 - Buildings 7 and 8 - Two areas of hydrocarbon contamination were identified. The approximate locations of the areas are shown.

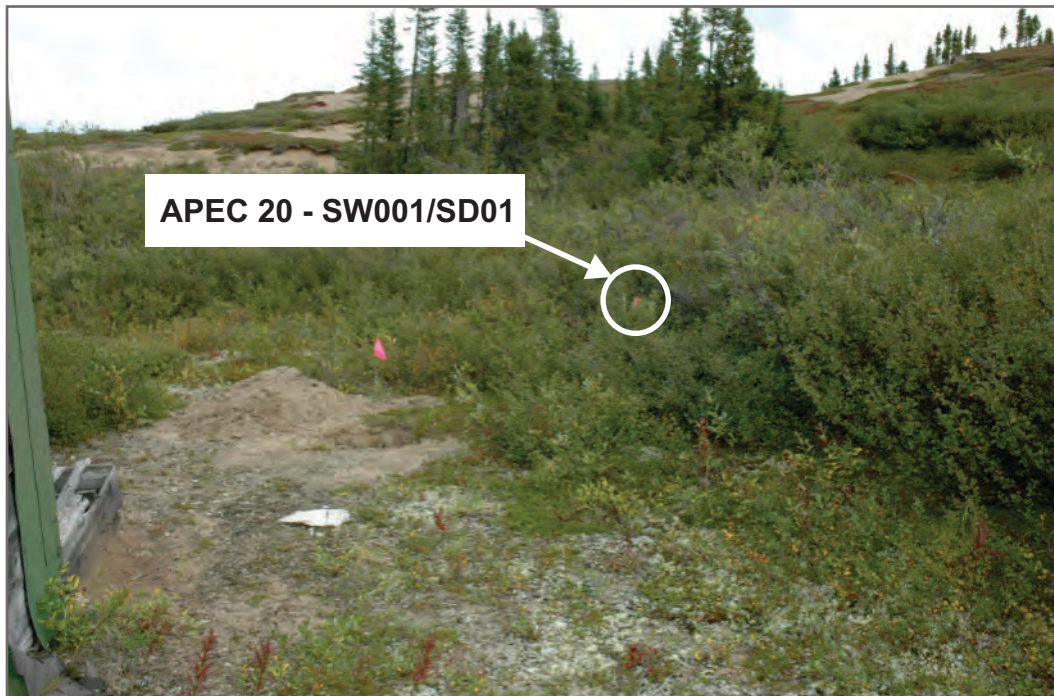
Photo E-23: APEC 19 - Building 7 - A drainage/seepage pathway was located behind the APECs running toward Ennadai Lake; sediment and surface water samples APEC 20-SW001 and APEC 20-SD-01 are shown

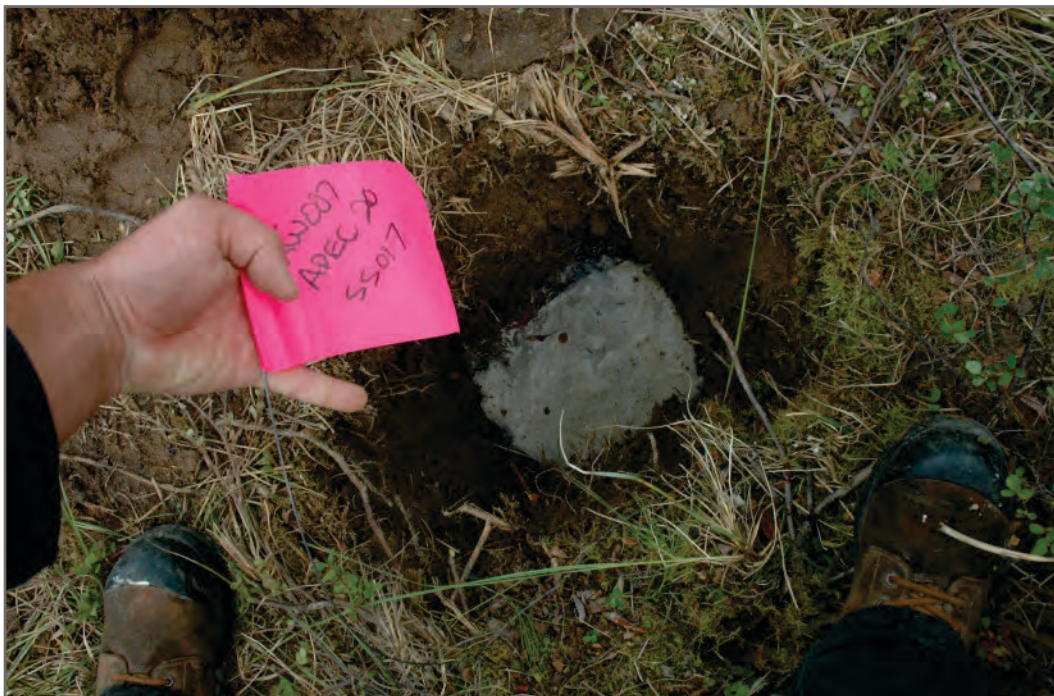
Photo E-24: APEC 20 - Building 8 - Soil sample APEC 20-SS017 is shown; water was encountered upon the completion of the test pit

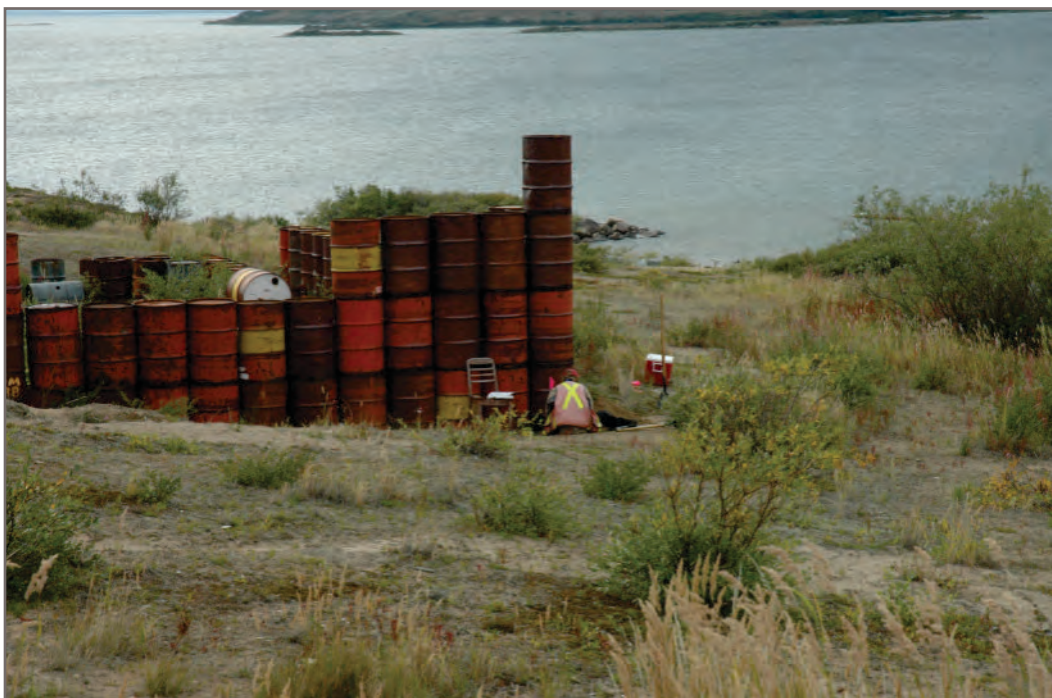
Photo E-25: APEC 23 - Drum Cache 1/Wind Break- Delineation soil samples APEC 23-SS001, SS003 and SS005 are shown; a historic fuel cache was formerly located south of APEC 23 toward Ennadai Lake

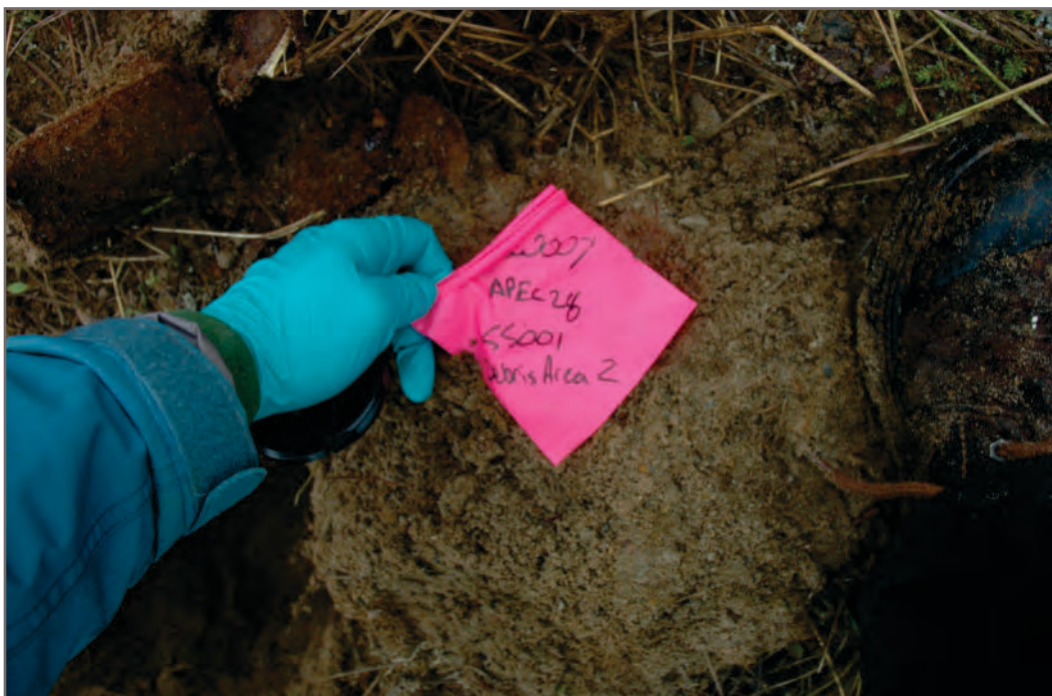
Photo E-26: APEC 28 - Debris Area, organic soil/matter was encountered overlaying sand, multiple layers of waste were discovered during test pitting
